NC DEPARTMENT OF TRANSPORTATION  
DIVISION OF HIGHWAYS  
STRUCTURE MANAGEMENT UNIT

## Structure Safety Report

### Routine Element Inspection - Contract

COUNTY: HALIFAX STRUCTURE NUMBER: 410138 FREQUENCY: 24 MONTHS  
FACILITY CARRIED: SR1309 MILE POST: \_\_\_\_\_  
LOCATION: 0.6 MI.W.SR1308  
FEATURE INTERSECTED: LITTLE FISHING CREEK  
LATITUDE: 36° 20' 9.4" LONGITUDE: 77° 55' 6.8"  
SUPERSTRUCTURE: TIMBER FLOOR ON I-BEAMS  
SUBSTRUCTURE: REINF.CONC.ABUTS.  
SPANS: 1@36'10'  
☐ FRACTURE CRITICAL ☐ TEMPORARY SHORING ☒ SCOUR CRITICAL ☒ SCOUR PLAN OF ACTION  
PRESENT CONDITION: Fair INSPECTION DATE: 09/01/2015  
POSTED SV: 10 POSTED TTST: 14  
OTHER SIGNS PRESENT: (3) DELINEATORS, (2) ONE LANE BRIDGE

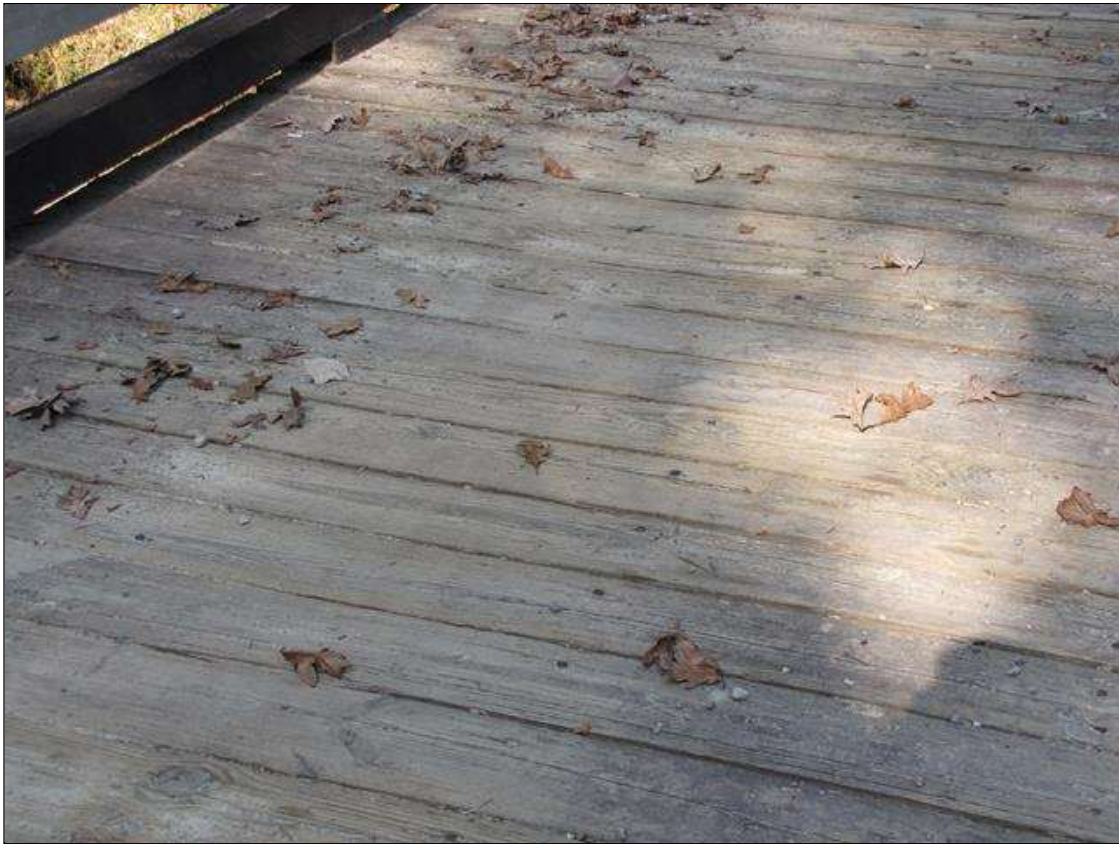
498 Square Feet of Abrasion/Wear (Timber): ABRASION TO TIMBER DECK BOARDS ALONG TOP SURFACE

Span 1 Deck: ABRASION TO TIMBER DECK BOARDS ALONG TOP SURFACE

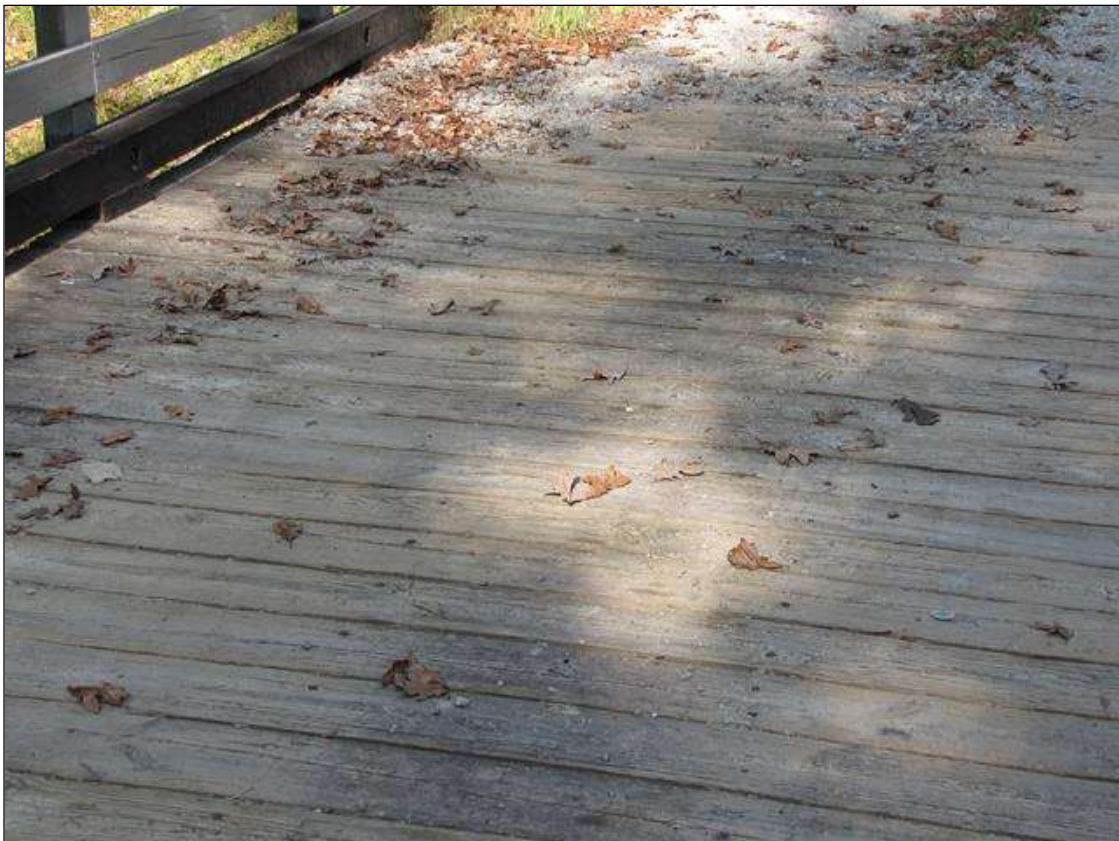
**Details** ROADWAY GRAVEL AT END BENT 2 SPILLING ONTO DECK OF BRIDGE.

Deck Debris: ROADWAY GRAVEL AT END BENT 2 SPILLING ONTO DECK OF BRIDGE

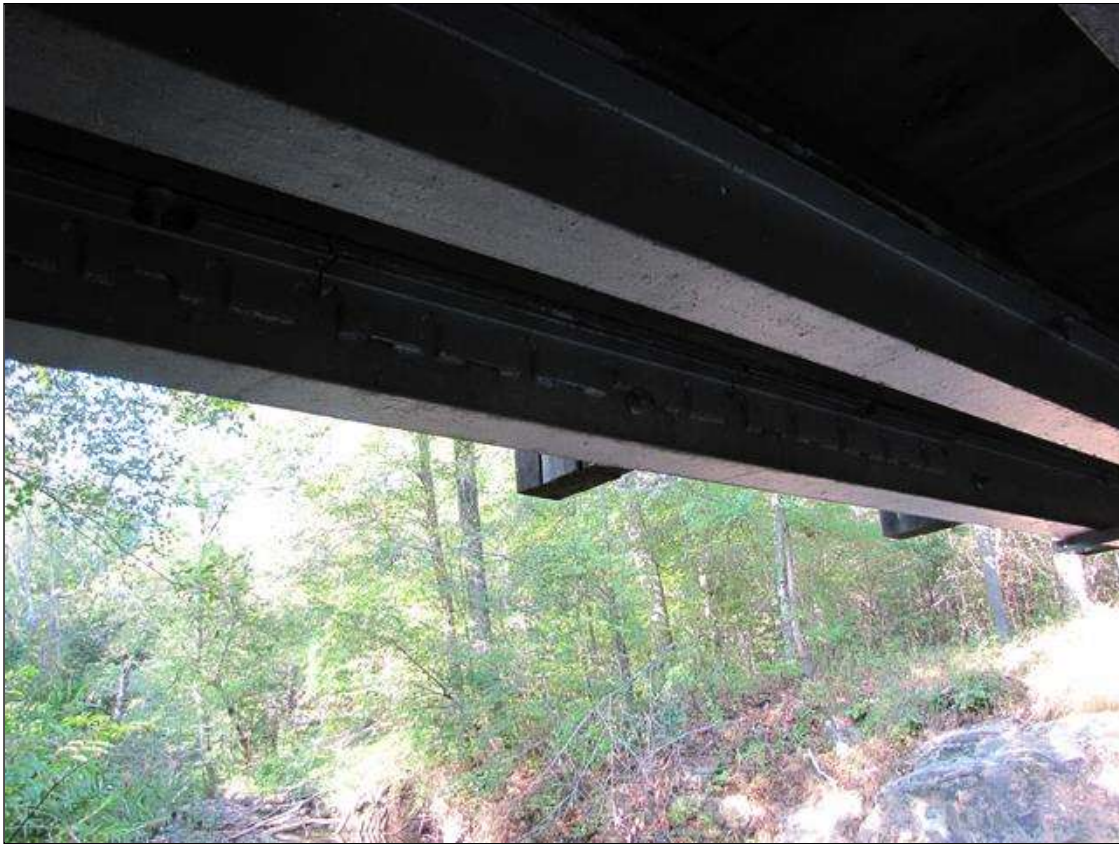
REPAIR TO TOP FLANGE FROM ABUTMENT 1 TO MID-SPAN SINCE LAST CYCLE.

Span 1 Beam 1: REPAIR TO TOP FLANGE FROM ABUTMENT 1 TO MID-SPAN.

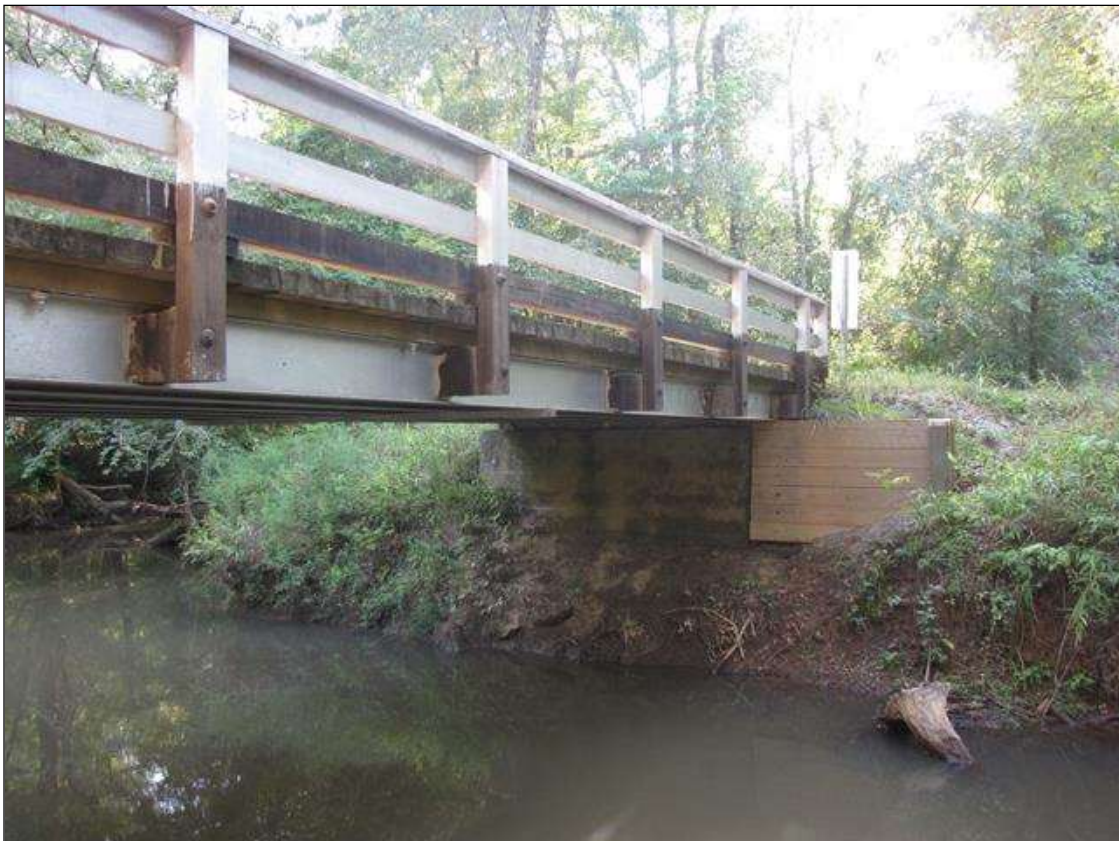
LEFT SIDE TIMBER BULKHEAD ADDED SINCE LAST CYCLE.

ABUTMENT 1 PROFILE (NOTE: LEFT SIDE TIMBER BULKHEAD ADDED SINCE LAST CYCLE)
