# BRIDGE INSPECTION REPORT

INSPECTION TYPE: Routine Inspection - Contract

COUNTY NASH BRIDGE NUMBER 630126 INSPECTION CYCLE 0 YRS  
ROUTE SR1310 ACROSS BIG PEACHTREE CREEK M.P. 0

INSPECTION DATE 04/03/2014

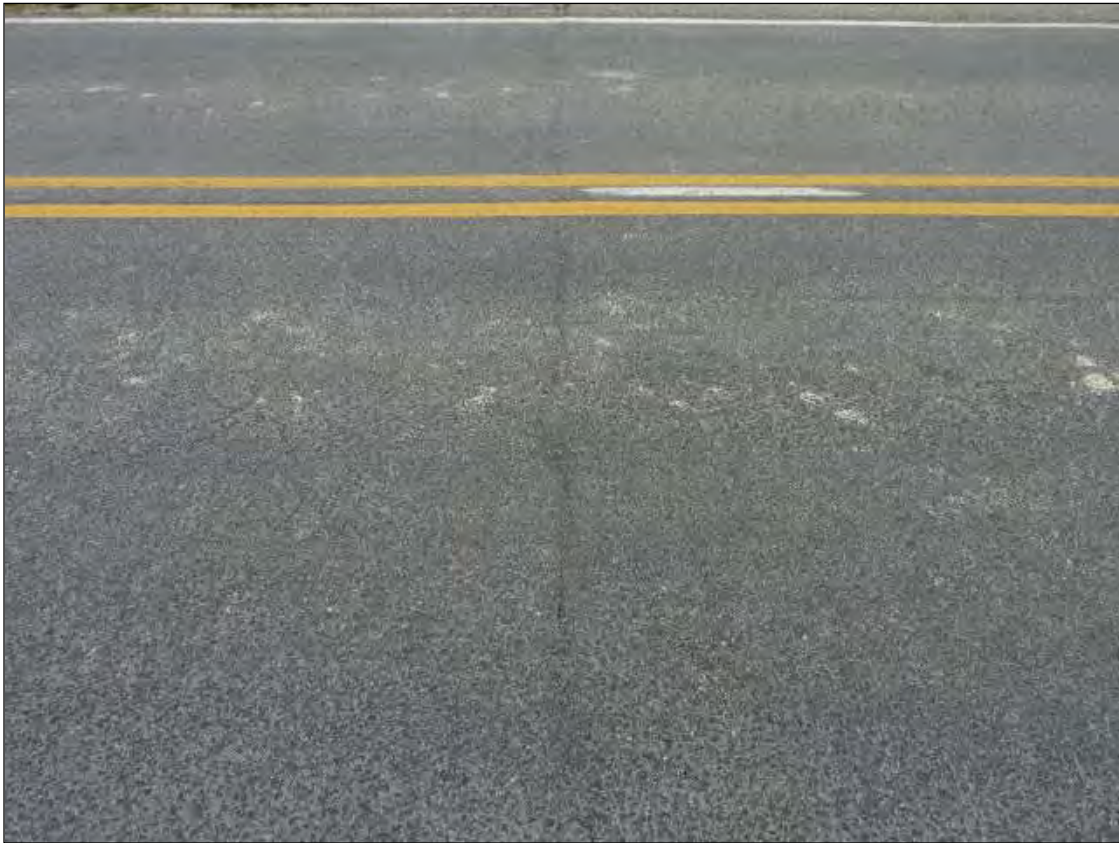
| 50 | G | TRANSVERSE CRACKS IN THE ASPHALT WEARING SURFACE ALONG BOTH END BENT FILL FACES. SEE PHOTO OF THE CRACK IN THE ASPHALT WEARING SURFACE ALONG END BENT 1 FILL FACE. | |

TRANSVERSE CRACK IN ASPHALT WEARING SURFACE ALONG END BENT 1 FILL FACE

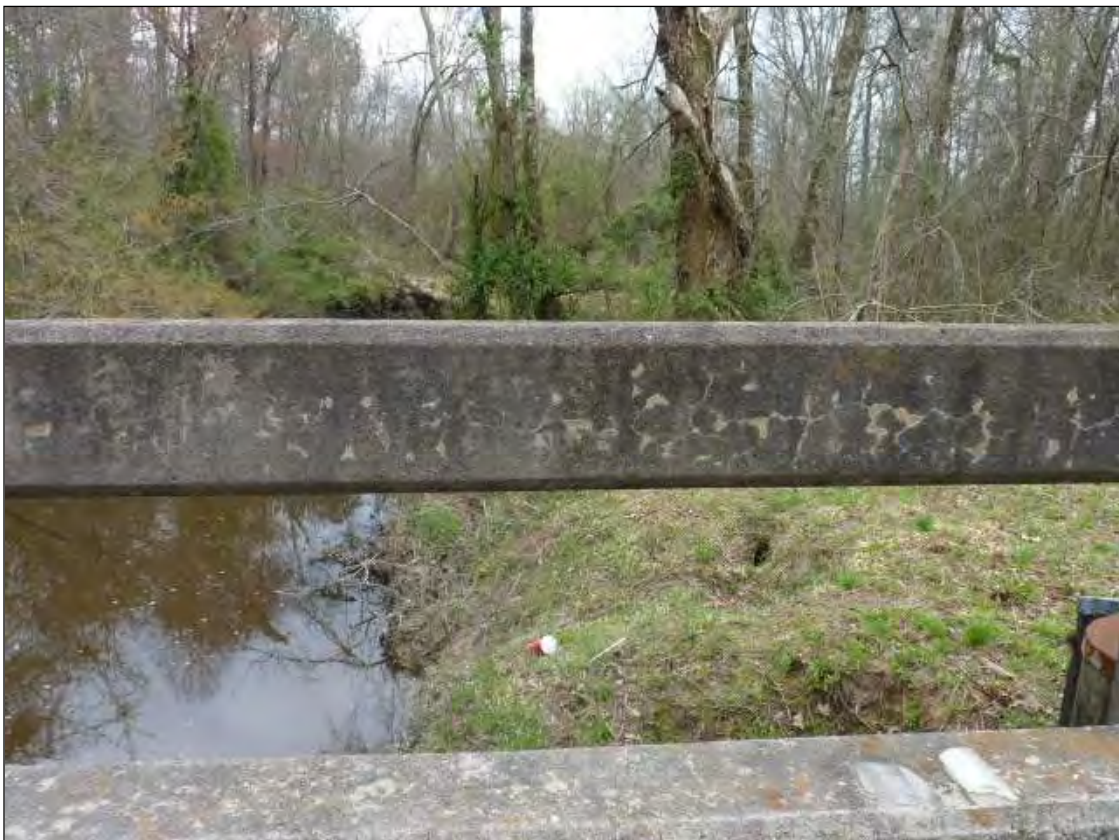
HAIRLINE MAP CRACKING WITH EFFLORESCENCE IN FACE OF DOWNSTREAM RAIL IN SPAN 1

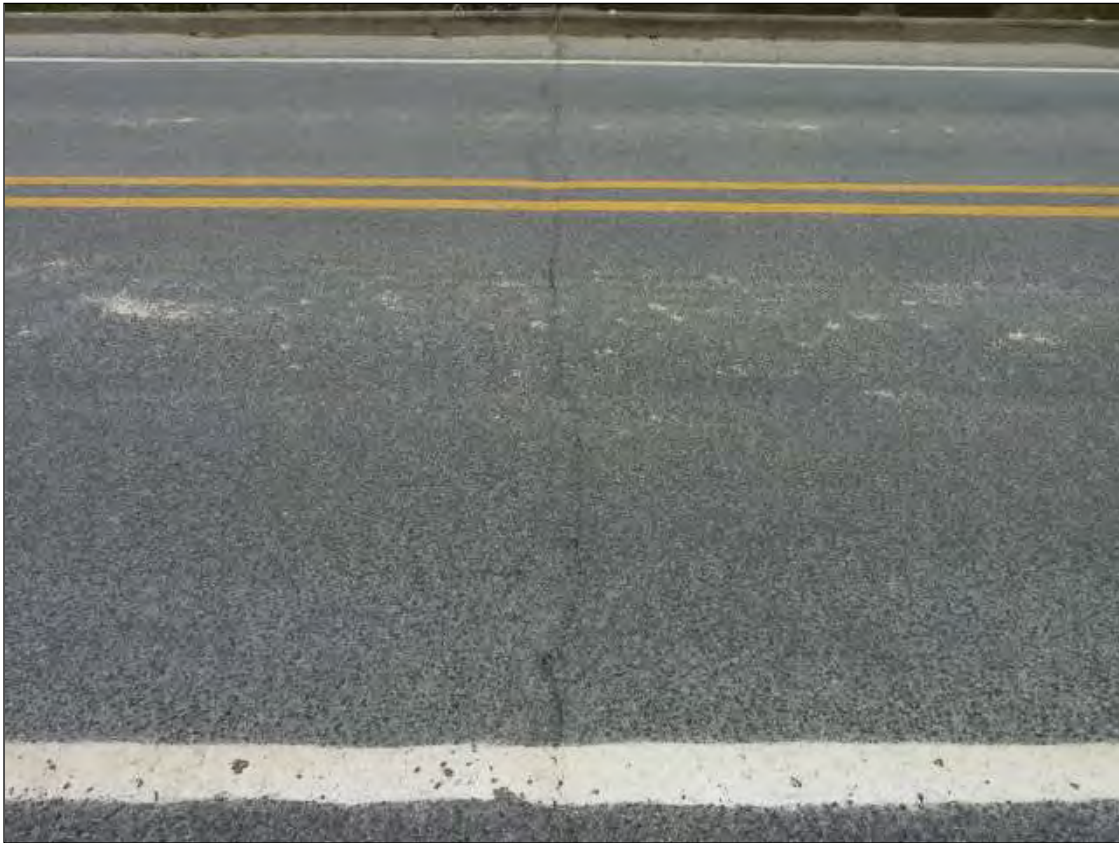
| 1 | G | TRANSVERSE CRACK IN THE ASPHALT WEARING SURFACE ALONG BENT 1 JOINT (SEE PHOTO). SIMILAR CRACKS IN THE ASPHALT WEARING SURFACE ALONG BENT 2 JOINT. | |

TRANSVERSE CRACK IN ASPHALT WEARING SURFACE ALONG BENT 1 JOINT

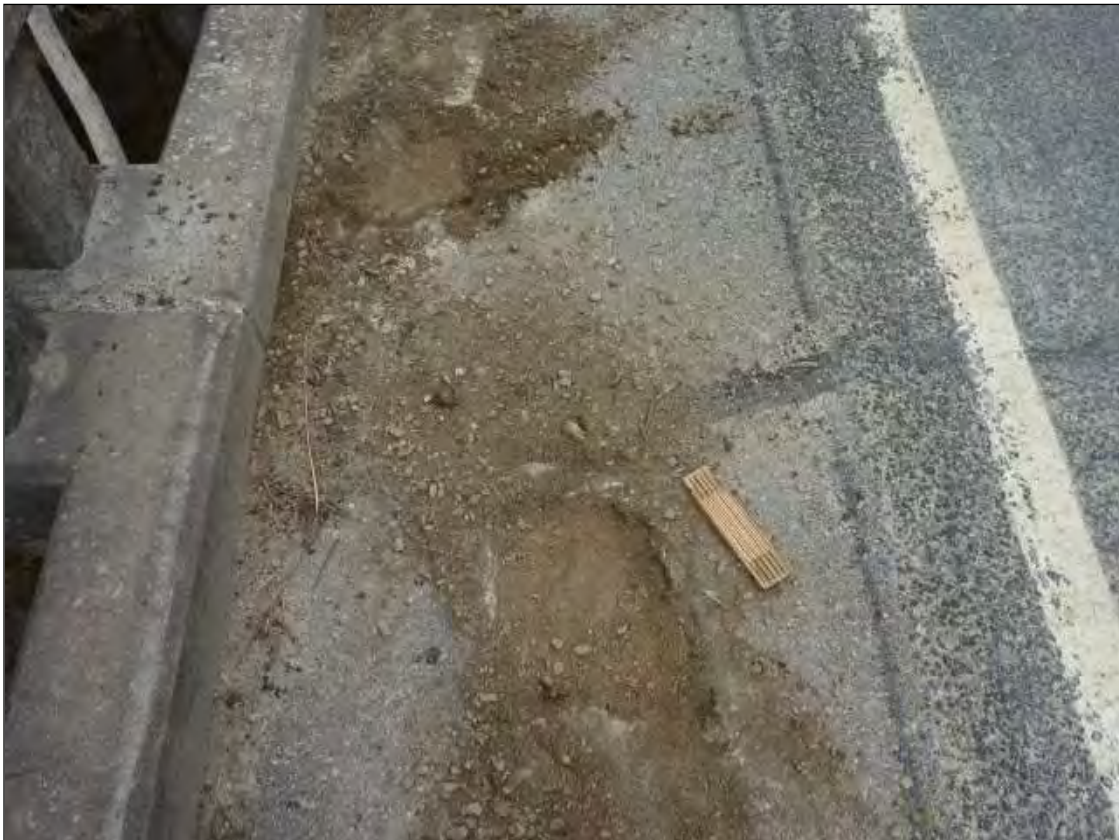
UP TO 14" X 12" X 2" DEEP POTHOLES IN ASPHALT WEARING SURFACE IN UPSTREAM SHOULDER OF SPANS 2 AND 3 AT BENT 2

| MMS Code | Description of Function | Unit | Quantity | Remarks | Est. Cost |
|---|---|---|---|---|---|
| 2816 | Asphalt Surface Repair or Replacement | SY | 1 | UP TO 14" X 12" X 2" DEEP POTHOLES IN THE ASPHALT WEARING SURFACE IN THE UPSTREAM SHOULDER OF SPANS 2 AND 3 AT BENT 2. | |

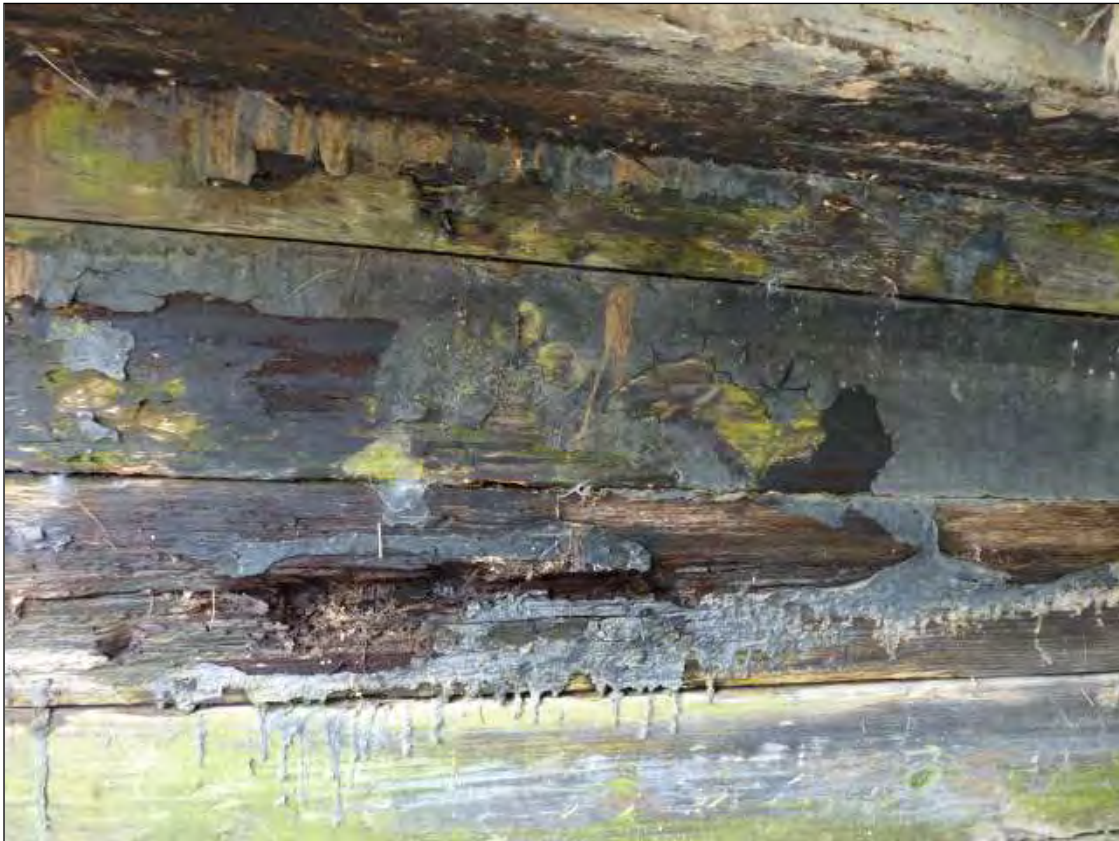
| 35c | F | <p>7' X 20" X UP TO 2" DEEP AREA OF DECAY IN END BENT 1 BULKHEAD BETWEEN PILES 3 AND 4 (SEE PHOTO).</p> <p>A 3" X 8" TIMBER BOARD HAS BEEN ADDED TO SUPPORT END BENT 1 BULKHEAD BETWEEN PILES 1 AND 2, LOCATED APPROXIMATELY 32" FROM PILE 1.</p> <p>7' X 16" X FULL DEPTH AREA OF DECAY IN THE SOUTHWEST WINGWALL (SEE PHOTO).</p> | |

7' X 20" X UP TO 2" DEEP AREA OF DECAY IN END BENT 1 BULKHEAD BETWEEN PILES 3 AND 4

| MMS Code | Description of Function | Unit | Quantity | Remarks | Est. Cost |
|---|---|---|---|---|---|
| 3346 | Repair / Maintain Timber Wings & Blkhds | SF | 21 | 7" X 6" X 3" DEEP AREA OF DECAY IN THE TOP OF PILE 3 AT END BENT 2.<br>7' X 20" X UP TO 2" DEEP AREA OF DECAY IN END BENT 1 BULKHEAD BETWEEN PILES 3 AND 4.<br><br>7' X 16" X FULL DEPTH AREA OF DECAY IN THE SOUTHWEST WINGWALL. | |

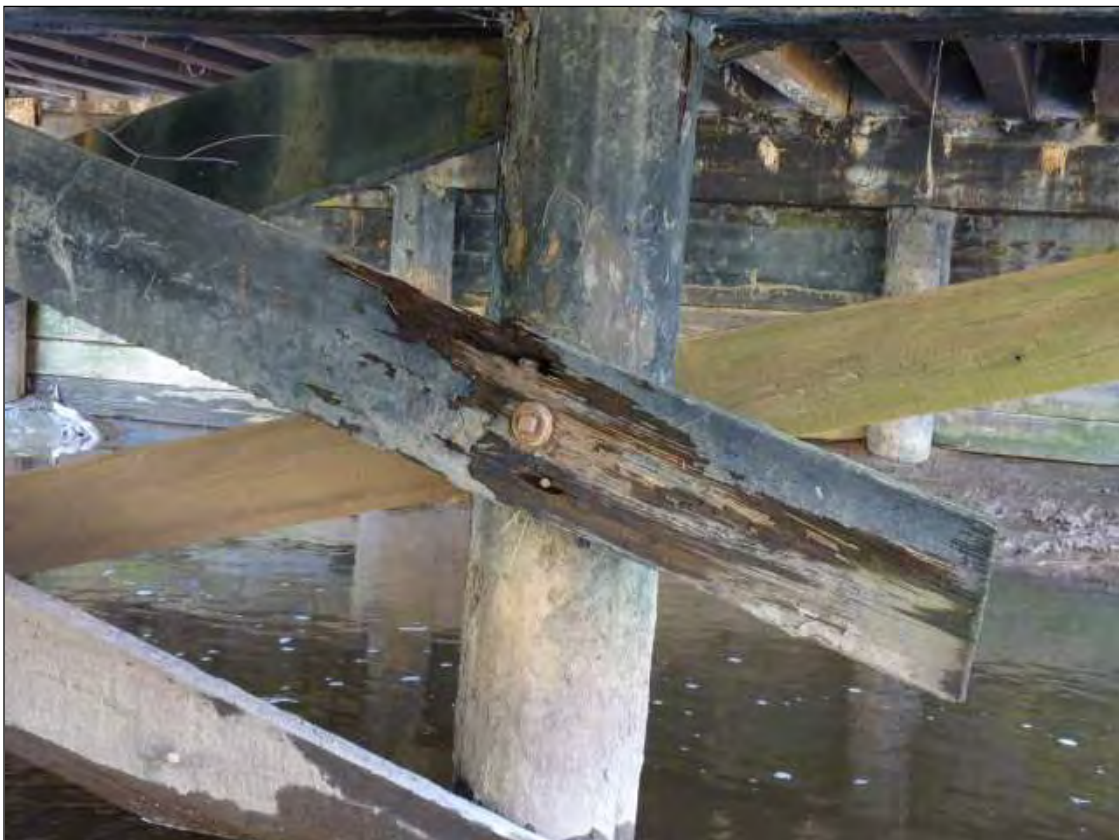
24" X 10" X FULL DEPTH AREA OF DECAY IN SPAN 2 FACE OF BENT 1 CROSS BRACING AT PILE 2

| MMS Code | Description of Function | Unit | Quantity | Remarks | Est. Cost |
|---|---|---|---|---|---|
| 3344 | Repair / Replace Timber Substructure Components | LF | 10 | 24" X 10" X FULL DEPTH AREA OF DECAY IN SPAN 2 FACE OF BENT 1 CROSS BRACING AT PILE 2 AND IN SPAN 1 FACE OF BENT 1 CROSS BRACING AT PILE 3.<br><br>40" X 6" X 3" DEEP AREA OF DECAY IN THE DOWNSTREAM FACE OF THE PILE AT THE UPSTREAM END OF END BENT 1 BULKHEAD.<br><br>UP TO 1" WIDE VERTICAL CRACK IN THE UPSTREAM FACE OF PILE 1 CONCRETE ENCASEMENT AT BENT 1. | |

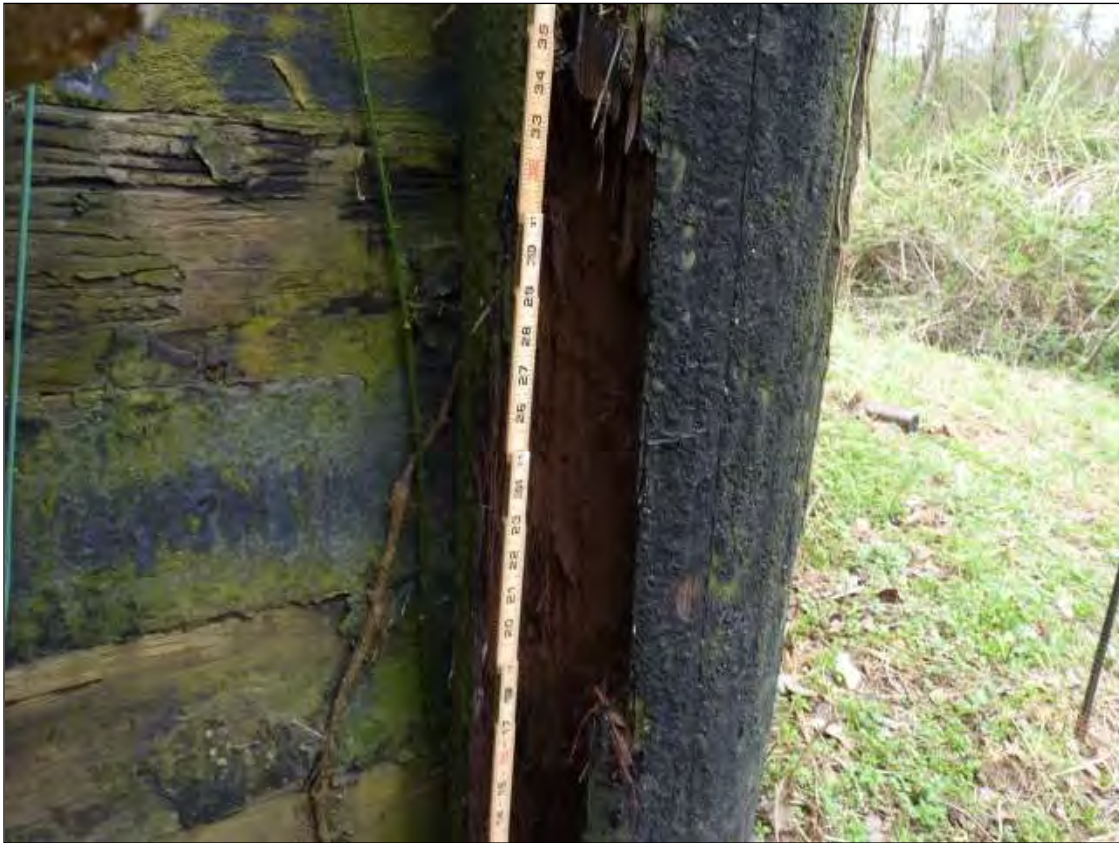
40" X 6" X 3" DEEP AREA OF DECAY IN DOWNSTREAM FACE OF PILE AT UPSTREAM END OF END BENT 1 BULKHEAD

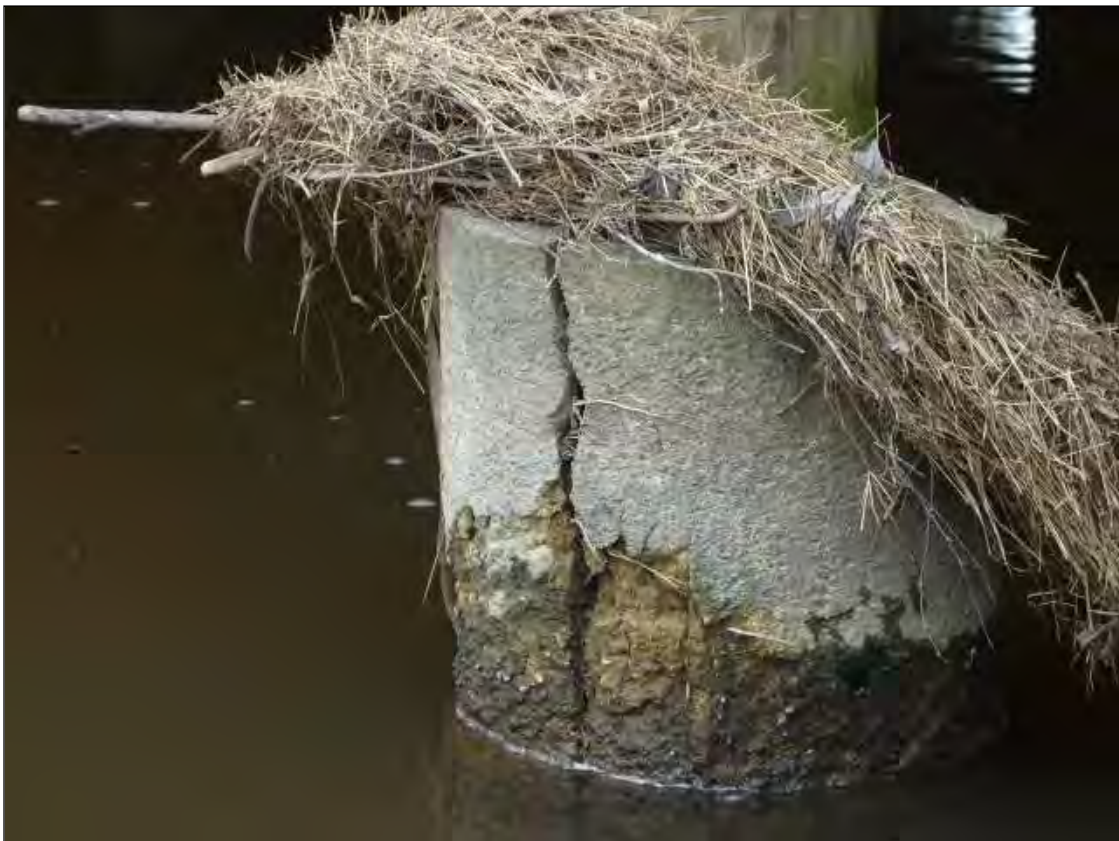
UP TO 1" WIDE VERTICAL CRACK IN UPSTREAM FACE OF PILE 1 CONCRETE ENCASEMENT AT BENT 1

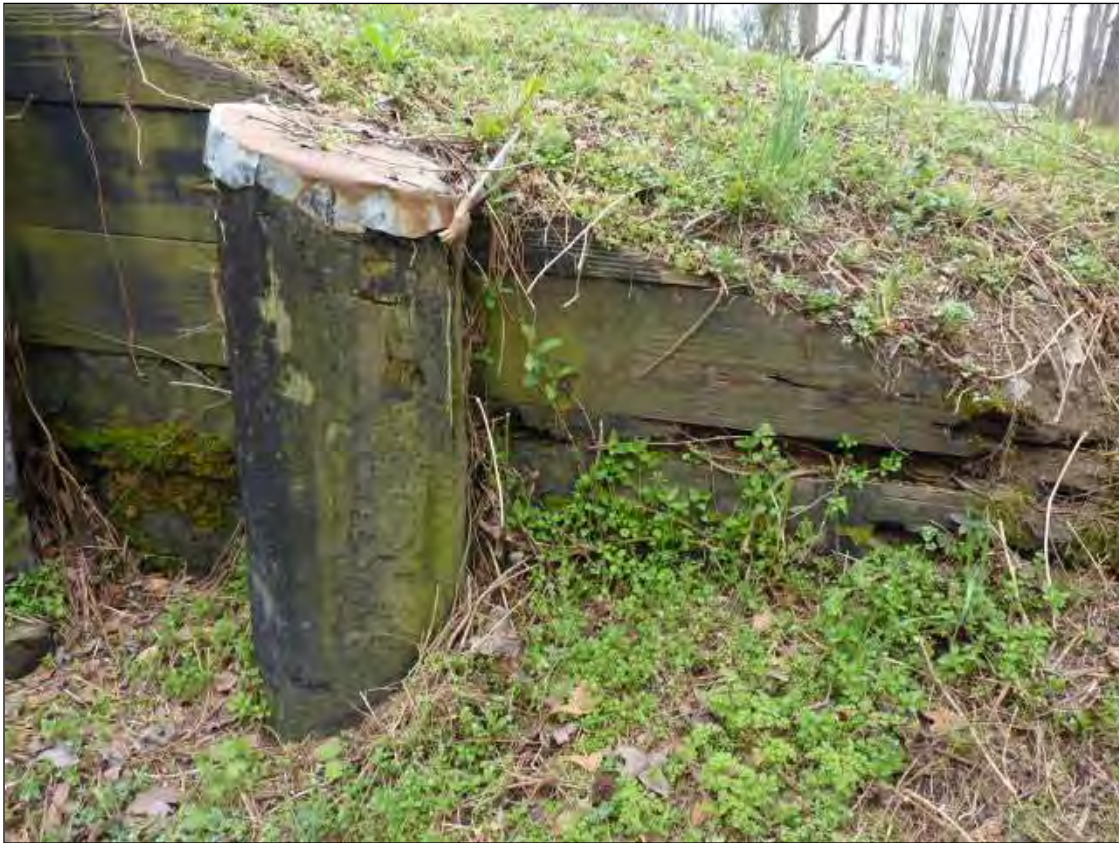
7' X 16" X FULL DEPTH AREA OF DECAY IN SOUTHWEST WINGWALL

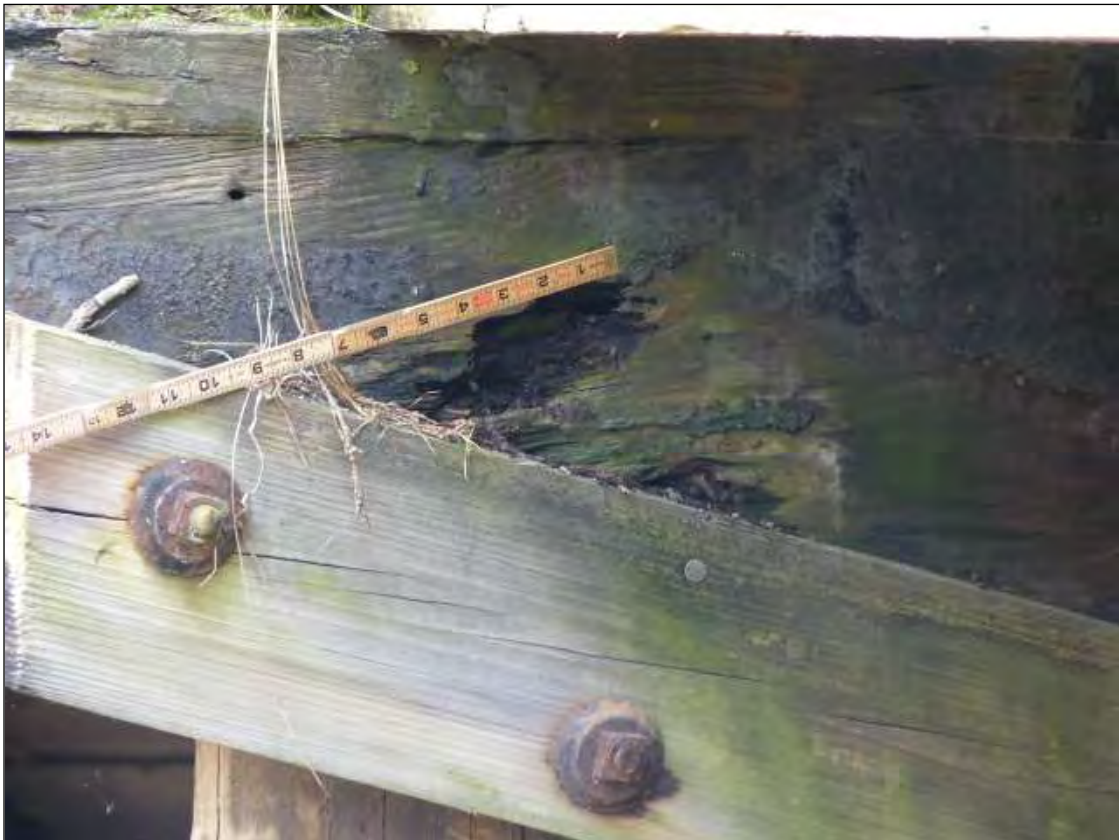
6" X 2" X 1 1/2" DEEP AREA OF DECAY IN SPAN 1 FACE OF BENT 1 CAP BENEATH JOIST 1

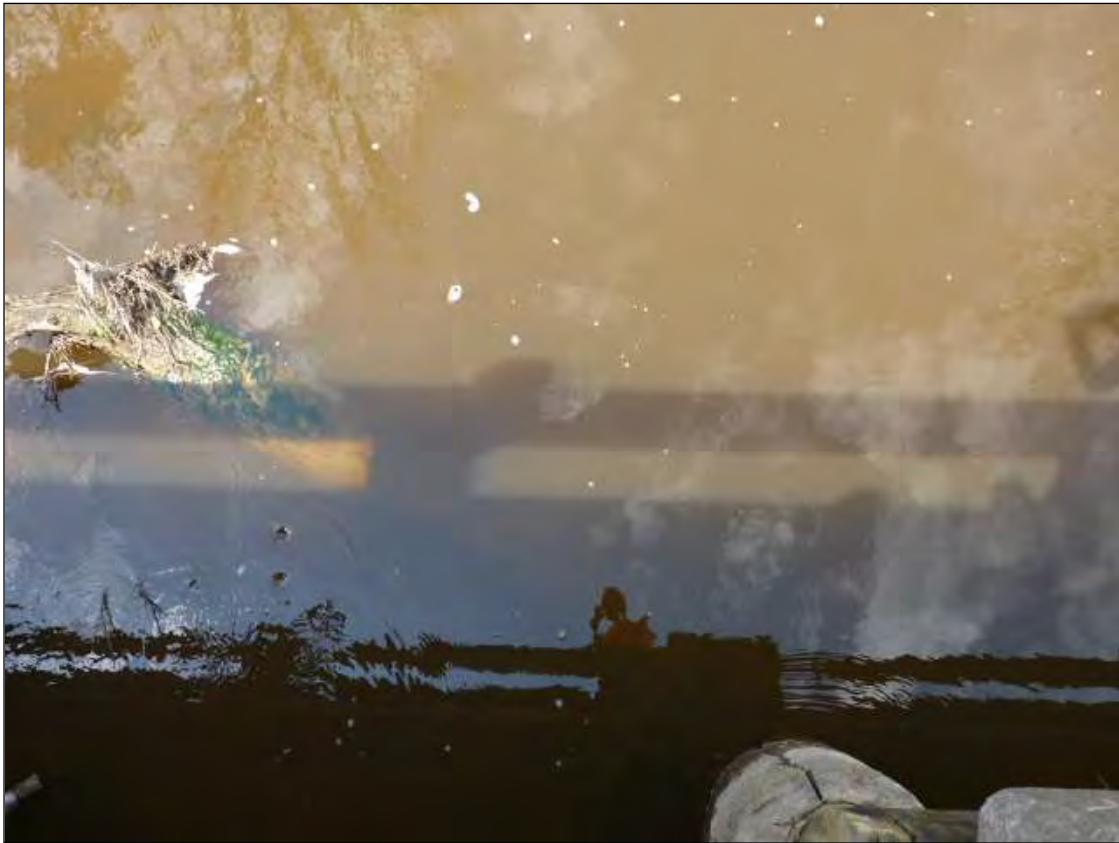
| 41 | F | 10" DIAMETER LOG AT THE UPSTREAM END OF BENT 1 IN SPAN 1 (SEE PHOTO). | |

10" DIAMETER LOG AT UPSTREAM END OF BENT 1 IN SPAN 1

| MMS Code | Description of Function | Unit | Quantity | Remarks | Est. Cost |
|---|---|---|---|---|---|
| 3366 | Drift and Debris Removal | HR | 16 | 10" DIAMETER LOG AT THE UPSTREAM END OF BENT 1 IN SPAN 1.<br><br>0.5 CY OF DRIFT AND 6" DIAMETER LOG AT THE UPSTREAM END OF BENT 2. | |

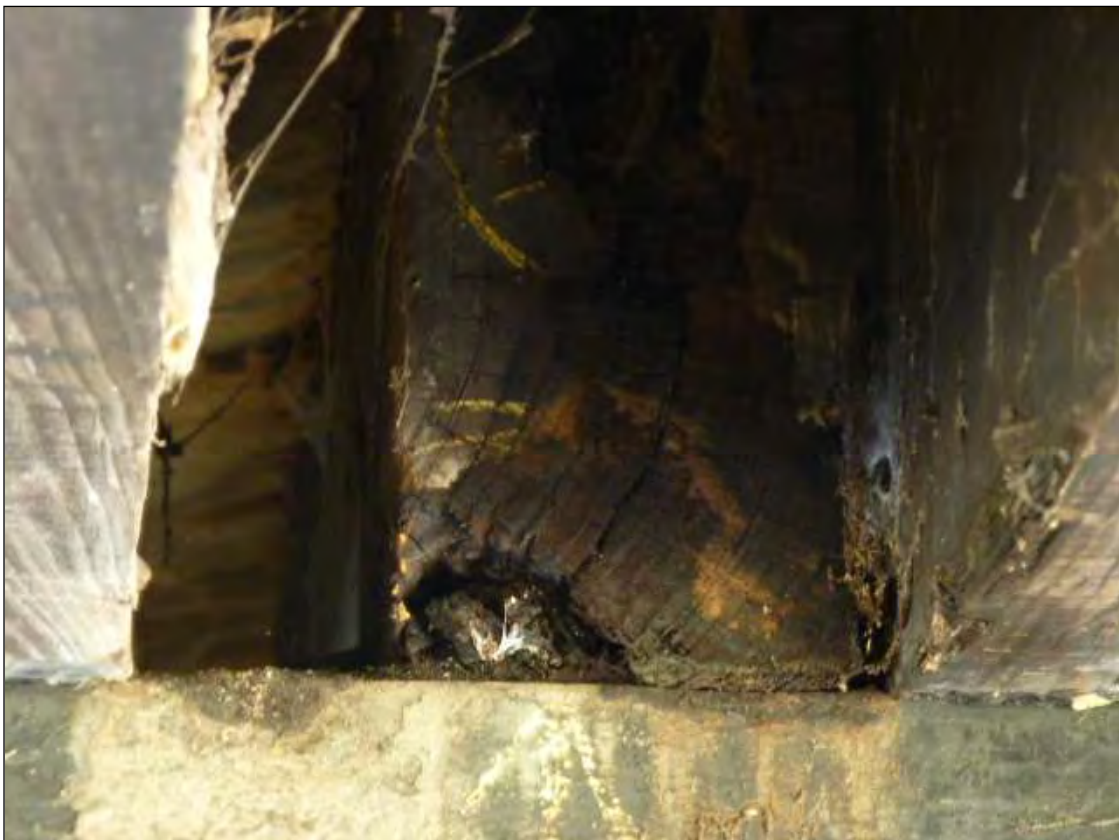
2" X 2" X 4" DEEP AREA OF DECAY IN END OF JOIST 4 IN SPAN 1 AT BENT 1

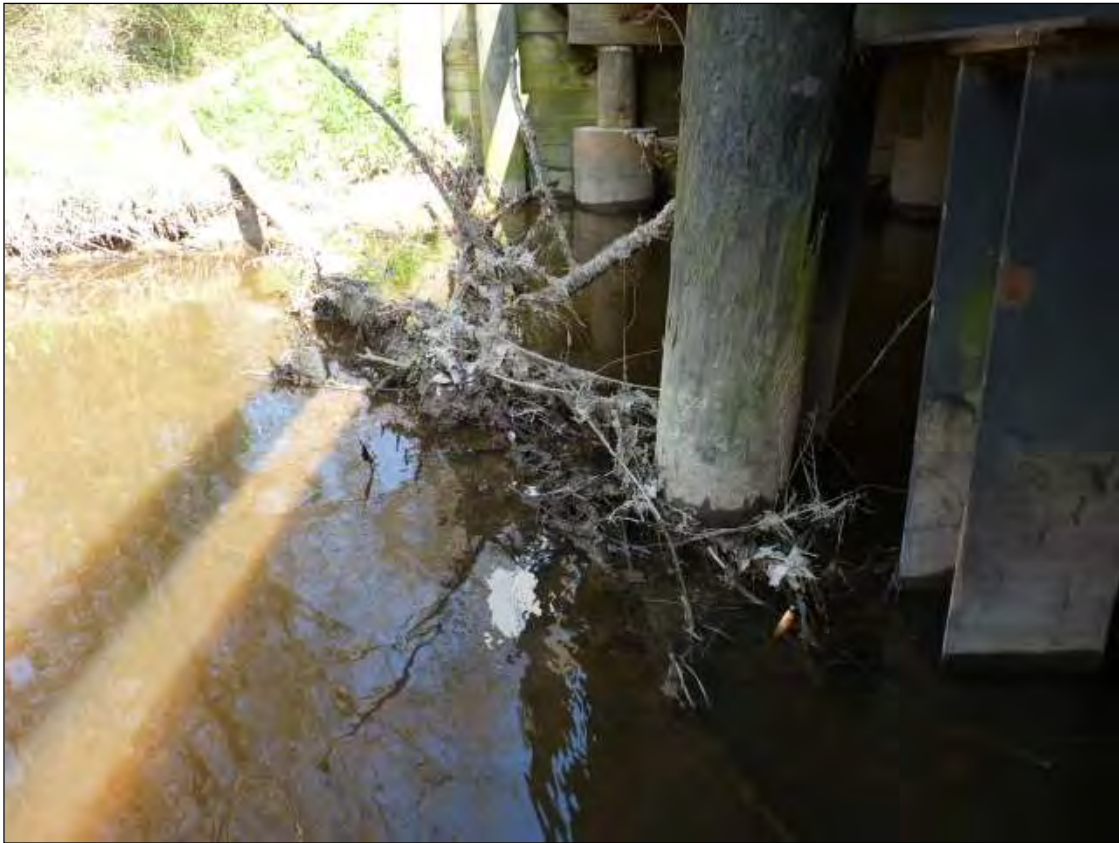
| | | 0.5 CY OF DRIFT AND 6" DIAMETER LOG AT THE UPSTREAM END OF BENT 2 (SEE PHOTO). | |

0.5 CY OF DRIFT AND 6" DIAMETER LOG AT UPSTREAM END OF BENT 2

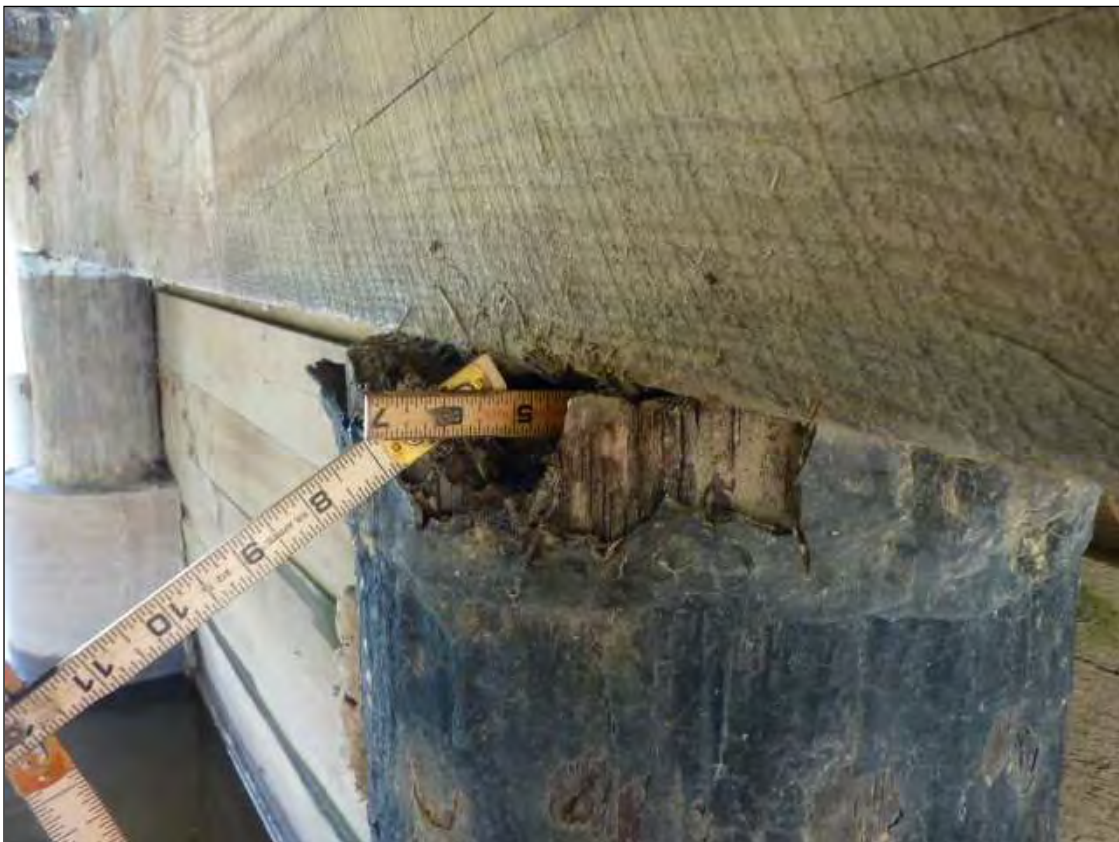
7" X 6" X 3" DEEP AREA OF DECAY IN TOP OF PILE 3 AT END BENT 2

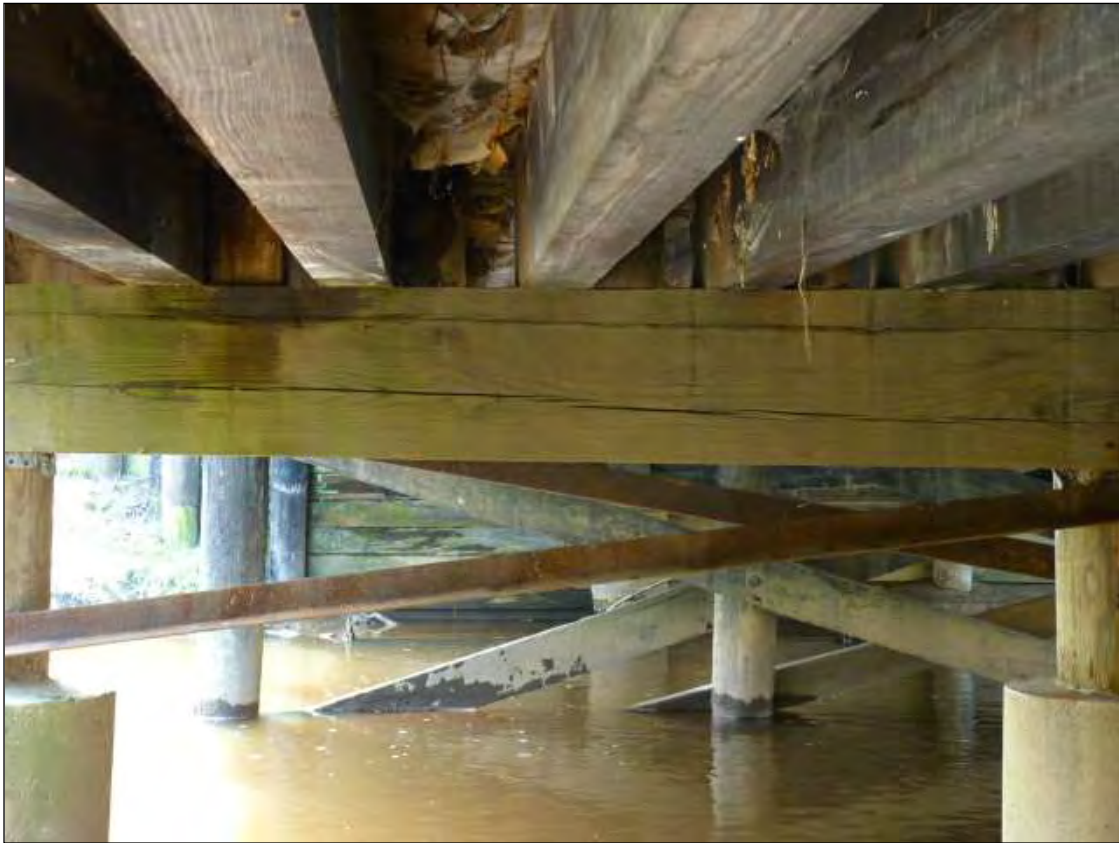
APPROXIMATELY 10' LONG X 3/16" SPLIT IN SPAN 3 FACE OF BENT 2 CAP BETWEEN PILES 3 AND 4

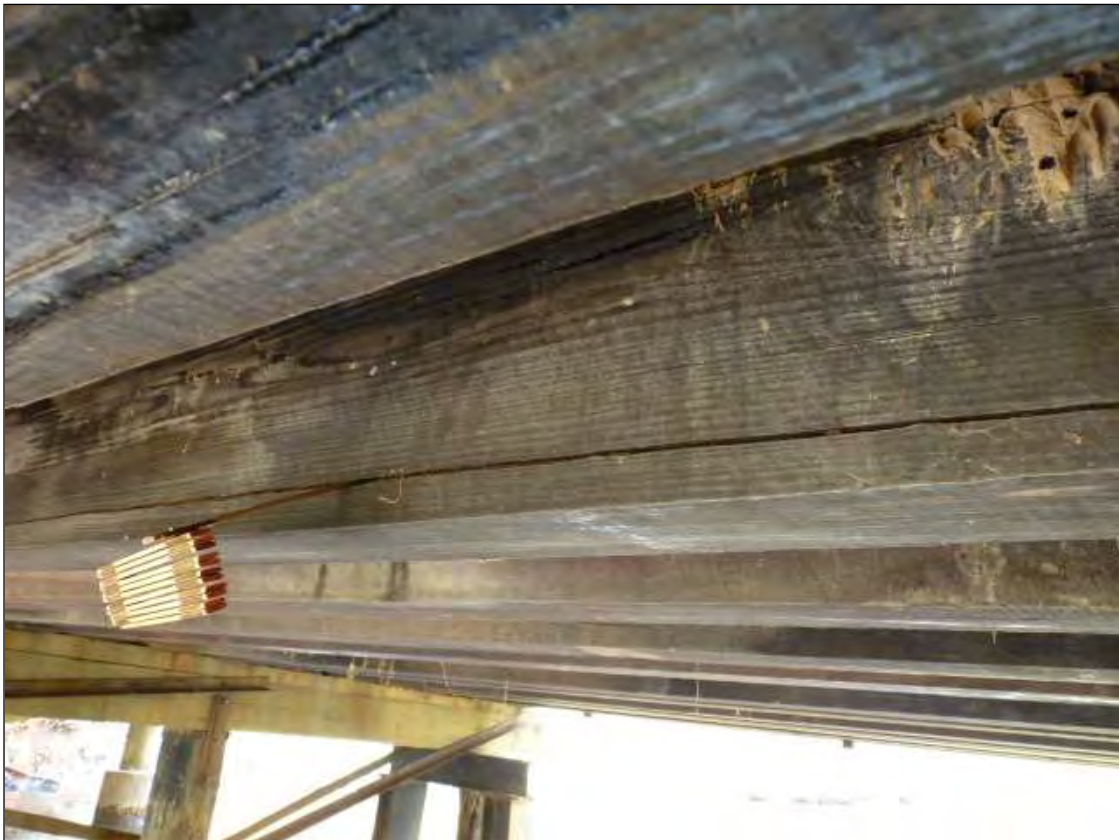
APPROXIMATELY 5' LONG X 3/16" SPLIT IN DOWNSTREAM FACE OF JOIST 13 IN SPAN 3 EXTENDING FROM  
END BENT 2

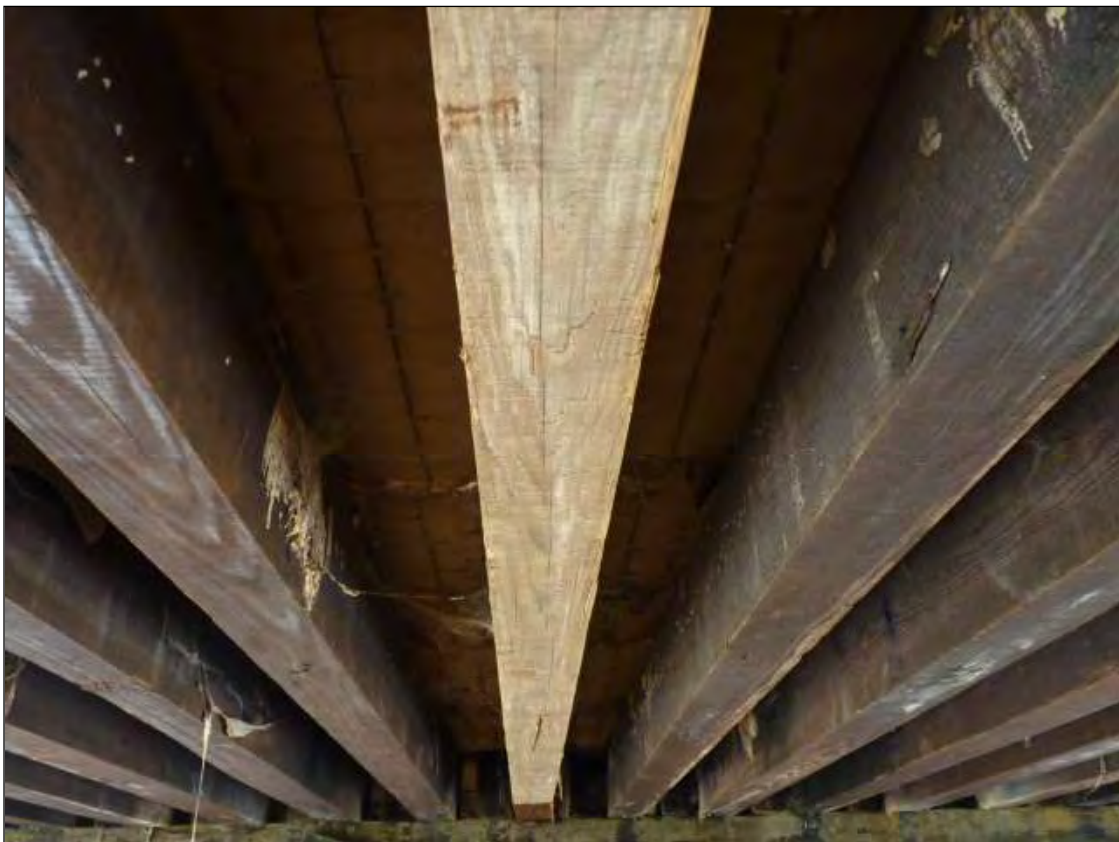
| 11 | F | <p>REPAIR: THE FOLLOWING JOISTS WERE REPLACED WITH NEW PRESSURE TREATED JOISTS PRIOR TO THE 2012 INSPECTION:</p> <p>SPAN 1:</p> <p>1) JOIST 1;<br/> 2) JOIST 8 (SEE STRUCTURE PHOTO);<br/> 3) JOIST 19;</p> <p>SPAN 2:</p> <p>4) JOIST 1;<br/> 5) JOIST 18;<br/> 6) JOIST 19;</p> <p>SPAN 3:</p> <p>7) JOIST 1;<br/> 8) JOIST 3;<br/> 9) JOIST 19.</p> <p>2" X 2" X 4" DEEP AREA OF DECAY IN THE END OF JOIST 4 IN SPAN 1 AT BENT 1 (SEE PHOTO). SIMILAR CONDITION IN THE ENDS OF THE JOISTS IN VARIOUS LOCATIONS THROUGHOUT THE STRUCTURE.</p> <p>SOFT TIMBER AND SURFACE DECAY IN THE BOTTOM OF JOIST 7 IN SPAN 2 AT BENT 1.</p> <p>APPROXIMATELY 5' LONG X 3/16" SPLIT IN THE DOWNSTREAM FACE OF JOIST 13 IN SPAN 3 EXTENDING FROM END BENT 2 (SEE PHOTO).</p> | |

JOIST 8 REPLACEMENT IN SPAN 1

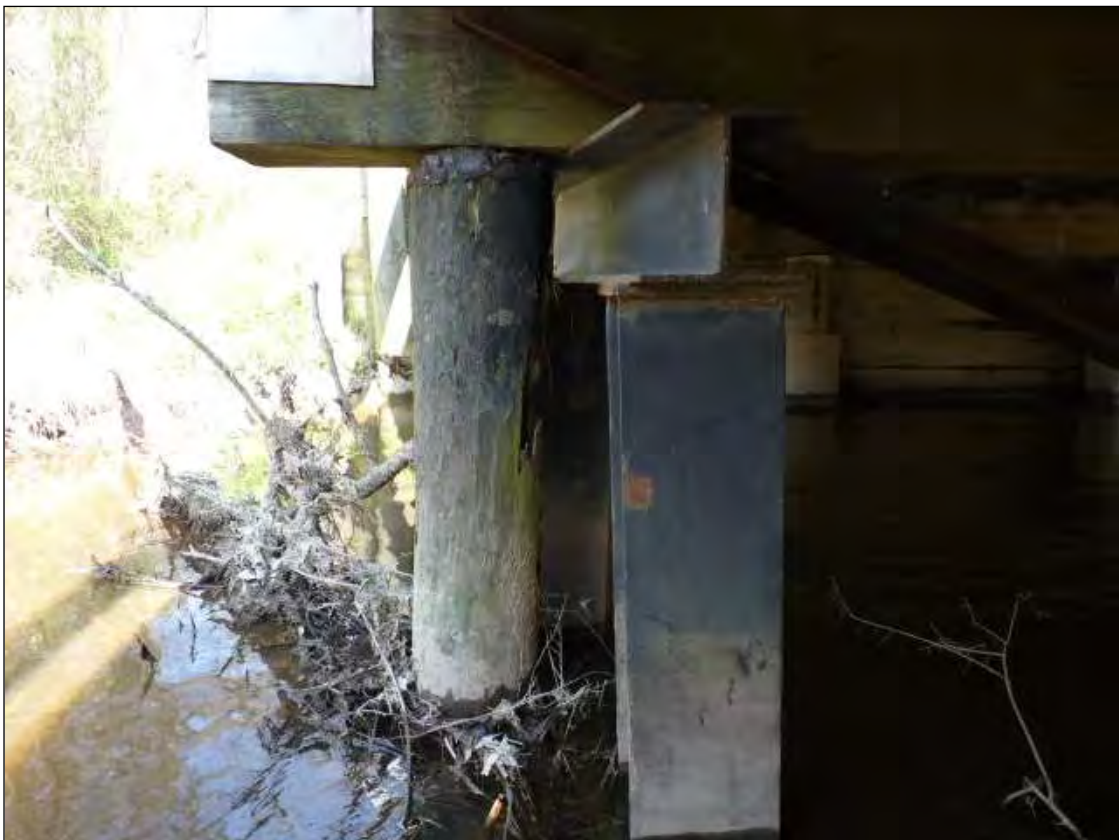
| 37a | G | STEEL CRUTCH PILE ADJACENT TO PILE 1 AT BENT 2 (SEE STRUCTURE PHOTO). | |

CRUTCH PILE AT PILE 1 AT BENT 2

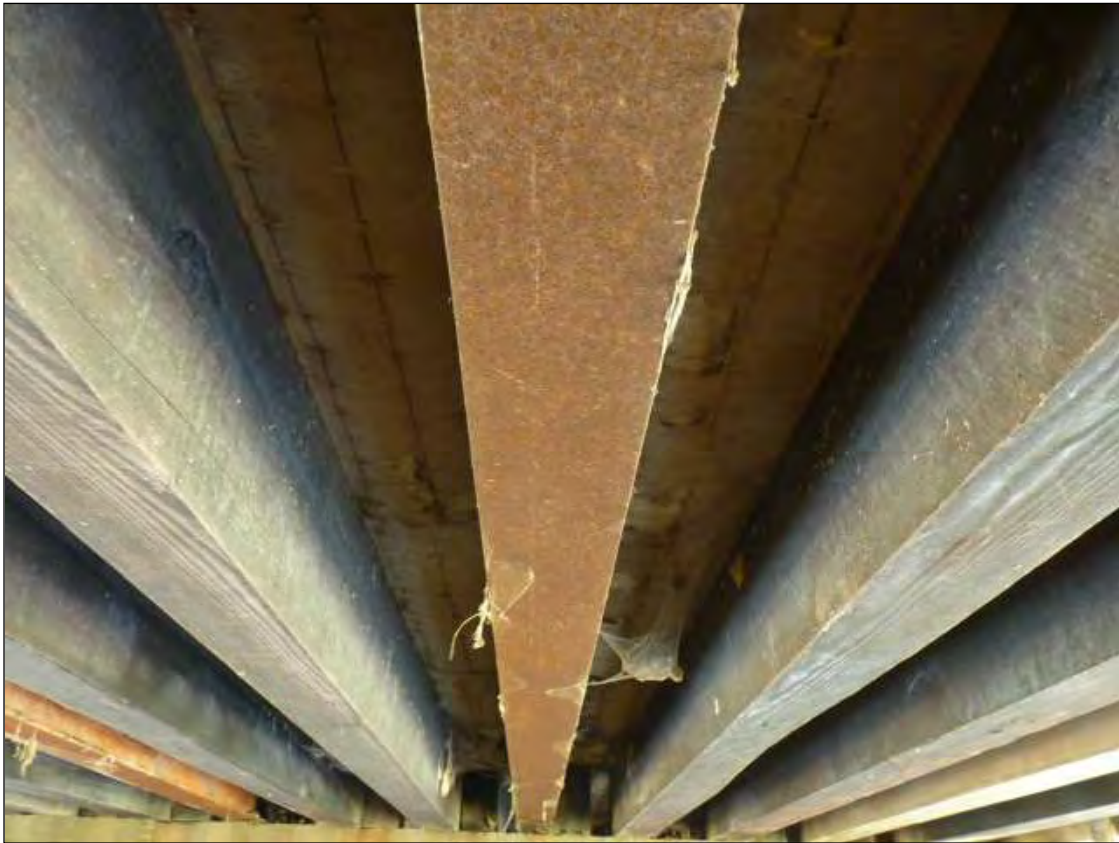
| 10 | F | REPAIR: JOIST 6 IN SPAN 3 WAS REPLACED WITH A 6" X 10" STEEL BEAM PRIOR TO THE 2012 INSPECTION (SEE STRUCTURE PHOTO). SIMILAR REPLACEMENT BEAM FOR JOIST 9 IN SPAN 3. SURFACE CORROSION AND PITTING ALONG BOTH BEAMS. | |

6" X 10" STEEL BEAM REPLACEMENT FOR JOIST 6 IN SPAN 3, REPLACEMENT BEAM FOR JOIST 9 IN SPAN 3  
SIMILAR
