NC DEPARTMENT OF TRANSPORTATION  
DIVISION OF HIGHWAYS  
STRUCTURE MANAGEMENT UNIT

## Structure Safety Report

### Routine Element Inspection

COUNTY: JOHNSTON STRUCTURE NUMBER: 500046 FREQUENCY: 24 MONTHS  
FACILITY CARRIED: SR1124 MILE POST: \_\_\_\_\_  
LOCATION: 0.1 MI. N. OF SR1122  
FEATURE INTERSECTED: MILL CREEK  
LATITUDE: 35° 17' 16.38" LONGITUDE: 78° 25' 48.78"  
SUPERSTRUCTURE: PRESTRESSED CONCRETE CHANNELS(STD.BMD-13)  
SUBSTRUCTURE: E.BTS&BTS:PPC CAPS TIM.PILES@BT.1PILE3 SPLICED ENC.W/CONC.  
SPANS: 3@30'  
☐ FRACTURE CRITICAL ☐ TEMPORARY SHORING ☐ SCOUR CRITICAL ☒ SCOUR PLAN OF ACTION  
PRESENT CONDITION: Fair INSPECTION DATE: 12/08/2015  
POSTED SV: 26 POSTED TTST: 30  
OTHER SIGNS PRESENT: 4 Delineators

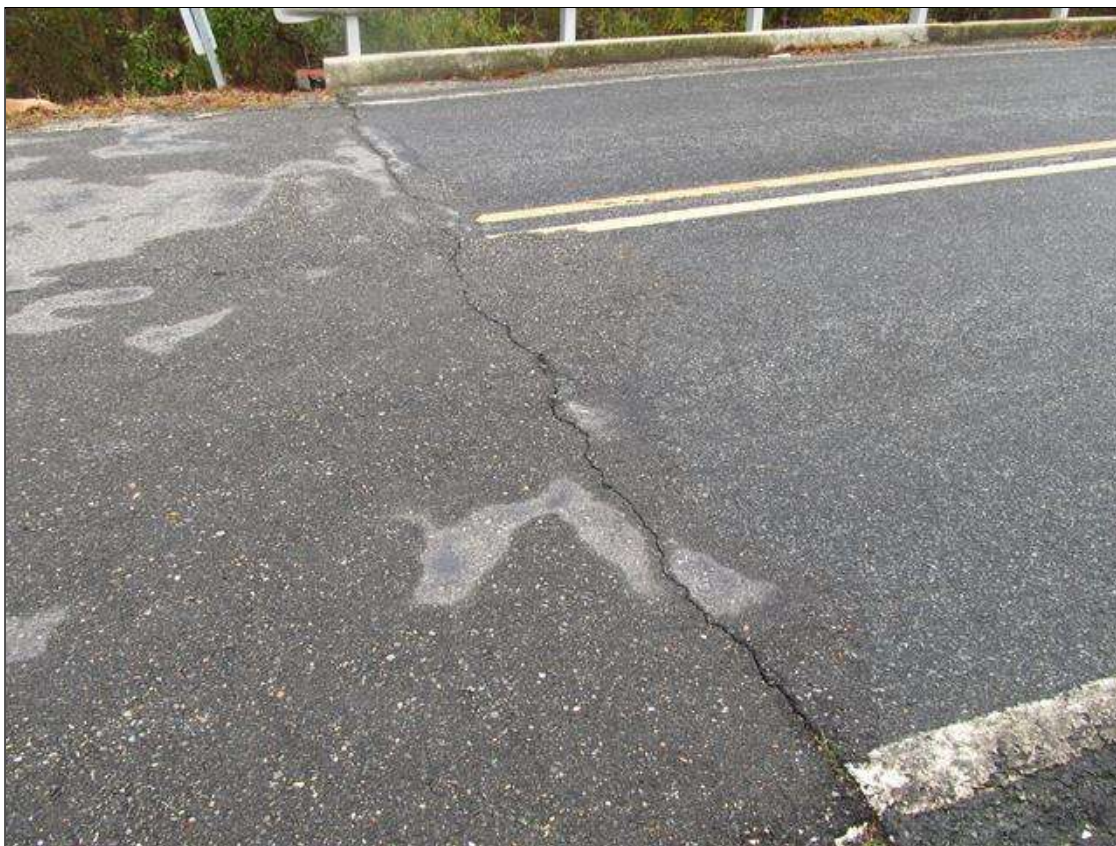
24 Square Feet of Cracking over End Bent 1 (Wearing Surface): Width of more than 0.05 in. or spacing of less than 1.0 ft.

Transverse crack in Wearing surface over End Bent 1

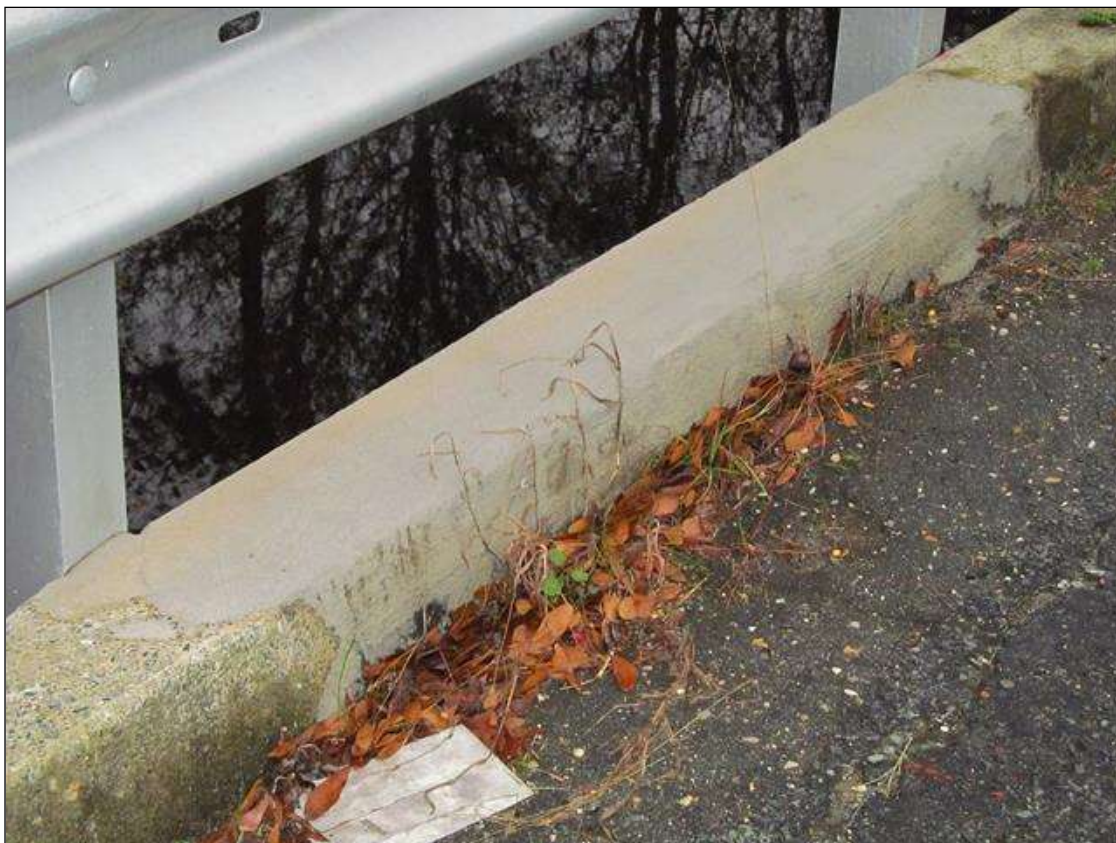
1 Square Foot of Spalling in the left curb: Spall 1 in. or less deep or 6 in. or less in diameter. Patched area that is sound.

Repair patch in the left curb of Span 1

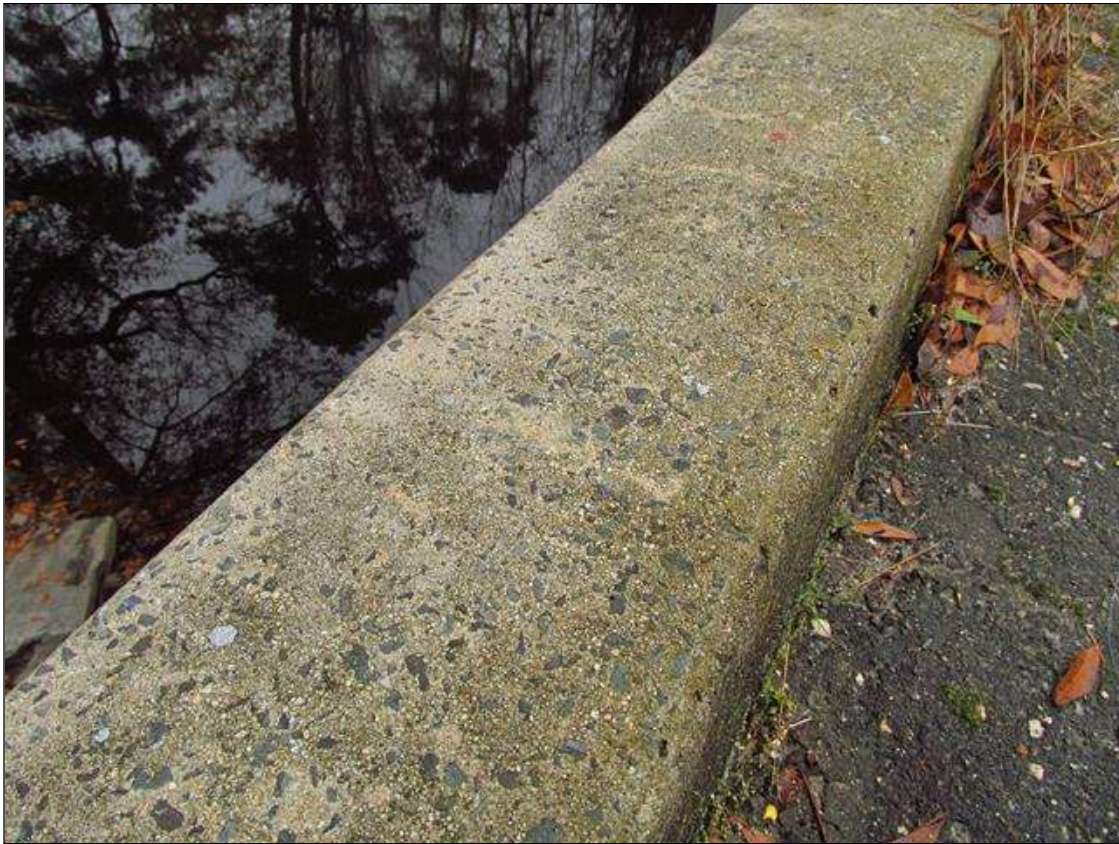
15 Square Feet of Abrasion/Wear along the left curb: Abrasion or wear has exposed coarse aggregate but aggregate remains secure in the concrete.

Abrasion with exposed aggregate along curblines

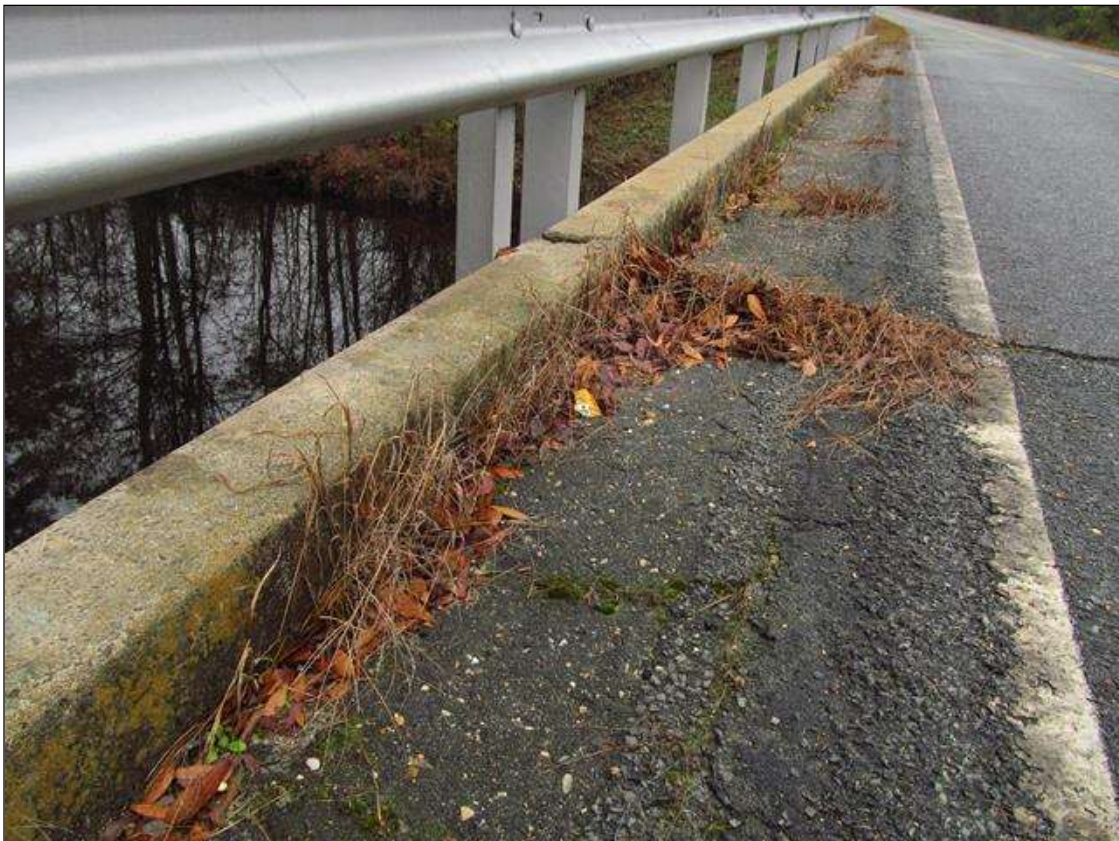
Debris and Vegetation along curblines

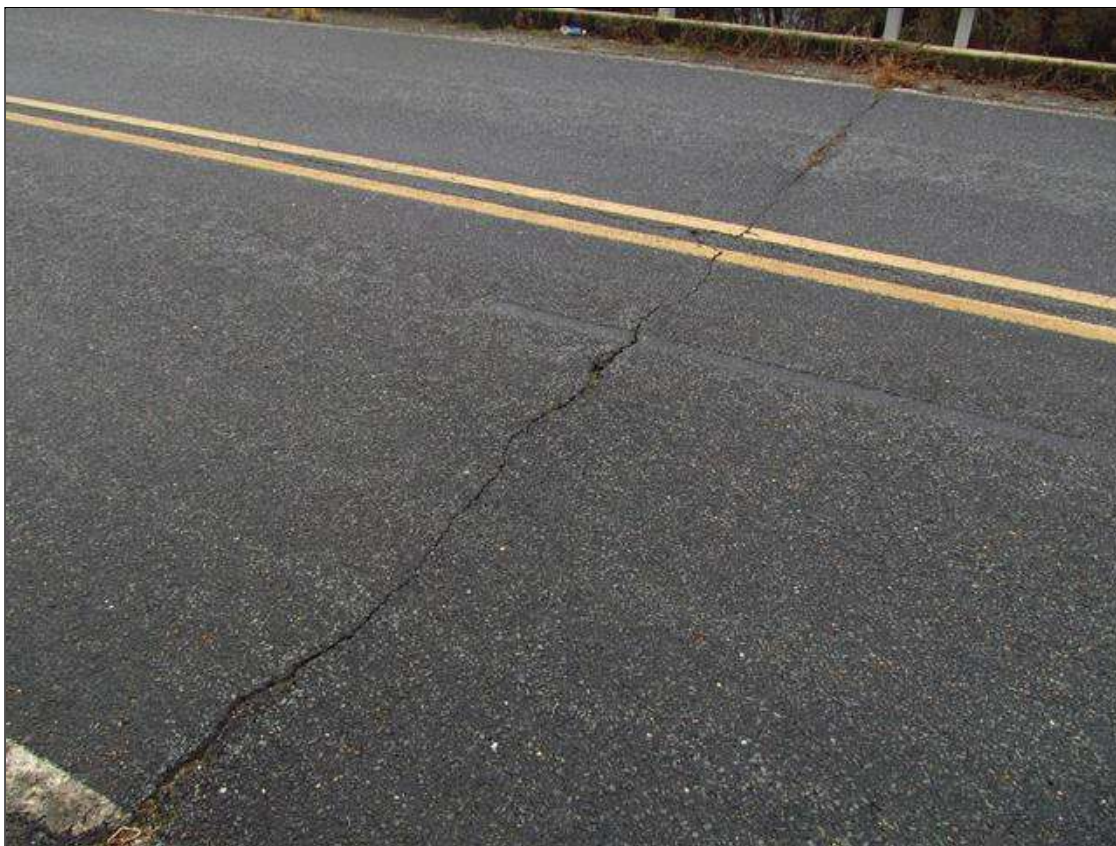
Transverse crack in Wearing surface over Bent 1

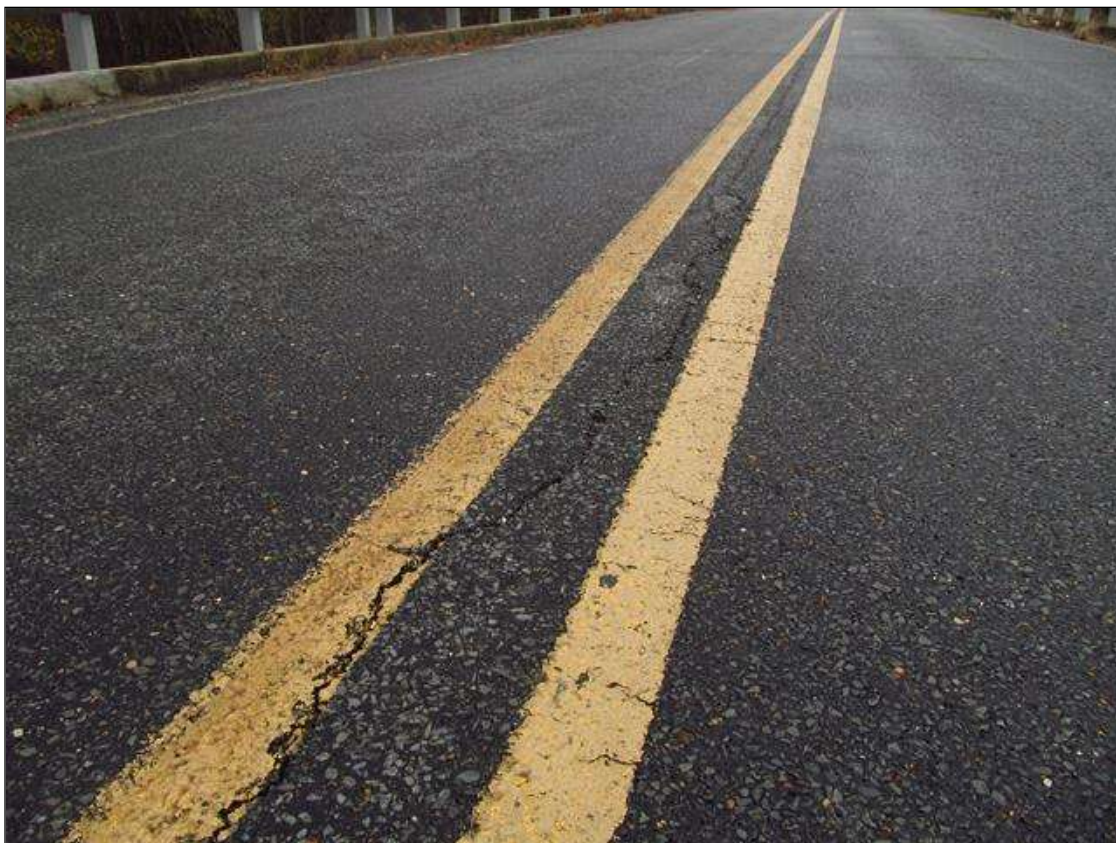
30 Square Feet of longitudinal Cracking along centerline of span (Wearing Surface): Width of more than 0.05 in. or spacing of less than 1.0 ft.

Longitudinal crack along the centerline of Wearing surface in all spans

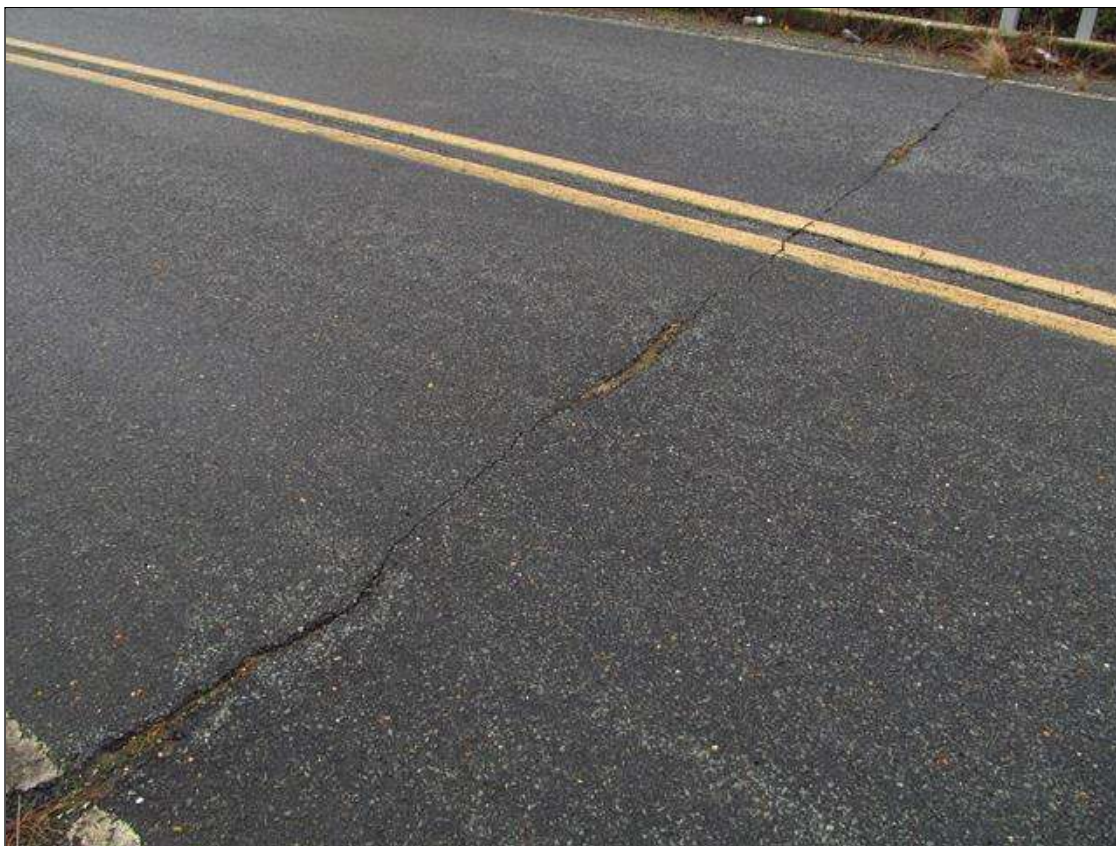
Transverse crack in Wearing surface over Bent 2

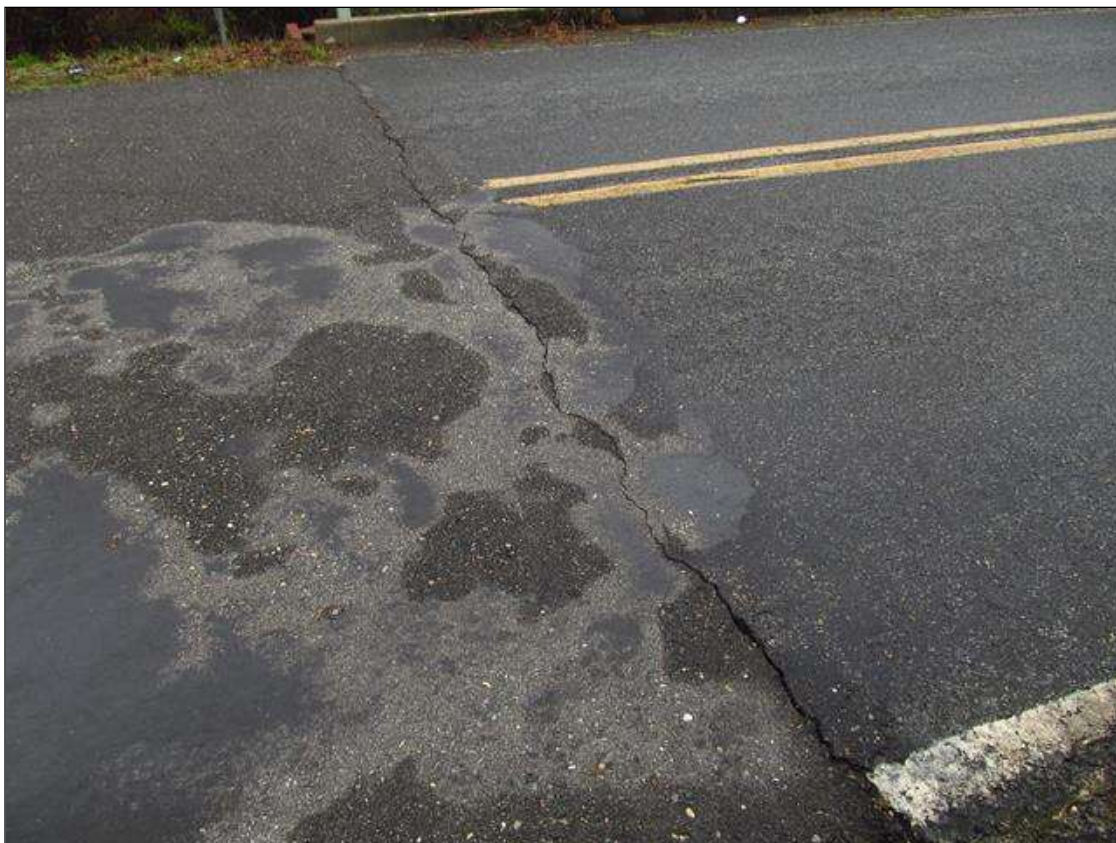
Wearing surface cracked and uneven over End Bent 2

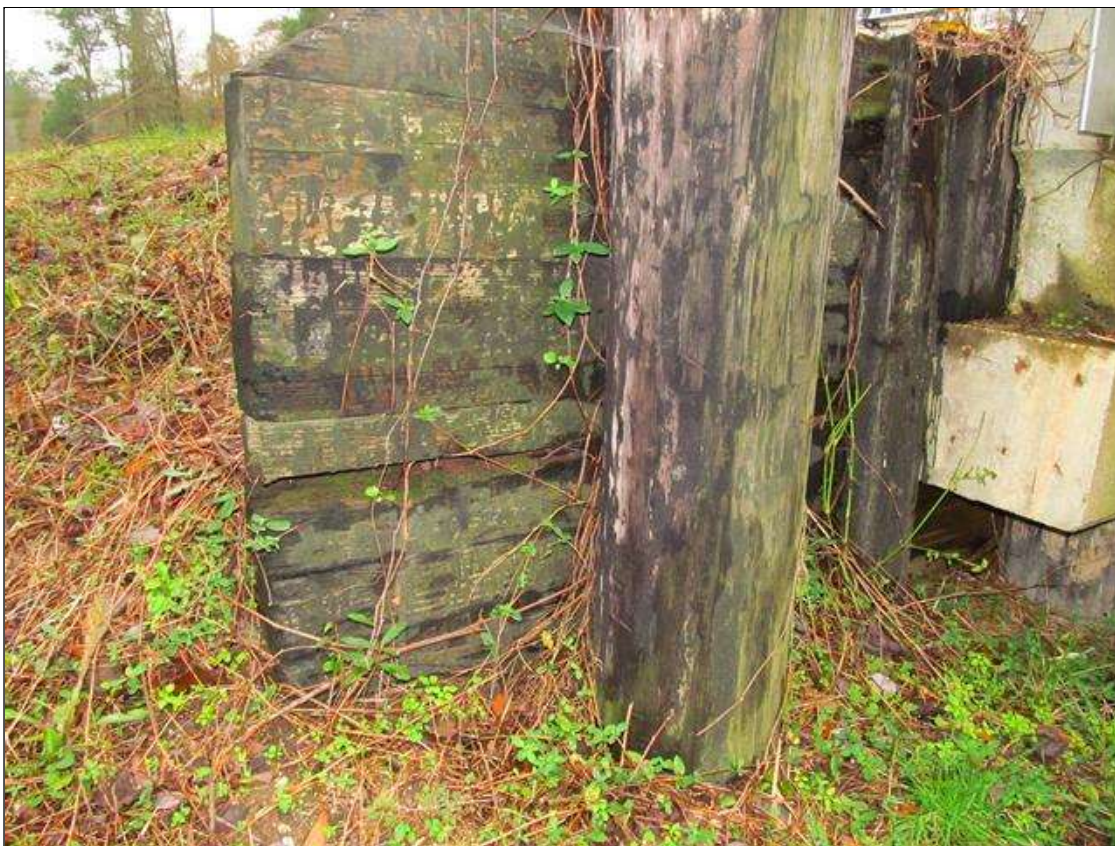
4 Feet of Decay/ Top board at left end decayed 3 in deep from left end to cap and vertical nailer at left end of cap decayed thru.  
 2 Feet of Check/Shake in bulkhead piles : Penetrates 5%-50% of the thickness of teh member and not in a tension zone.  
 10 Feet of Check/Shake: in bulkhead boards Penetrates 5%-50% of the thickness of teh member and not in a tension zone.  
 1 Feet of Decay/ 6 in diameter x 2 in deep in bulkhead board between pile 3 -4.  
 5 Feet of Decay/ in bulkhead board 3 in deep from pile 5 to right end.

Decay in right end of Bulkhead boards at End Bent 1

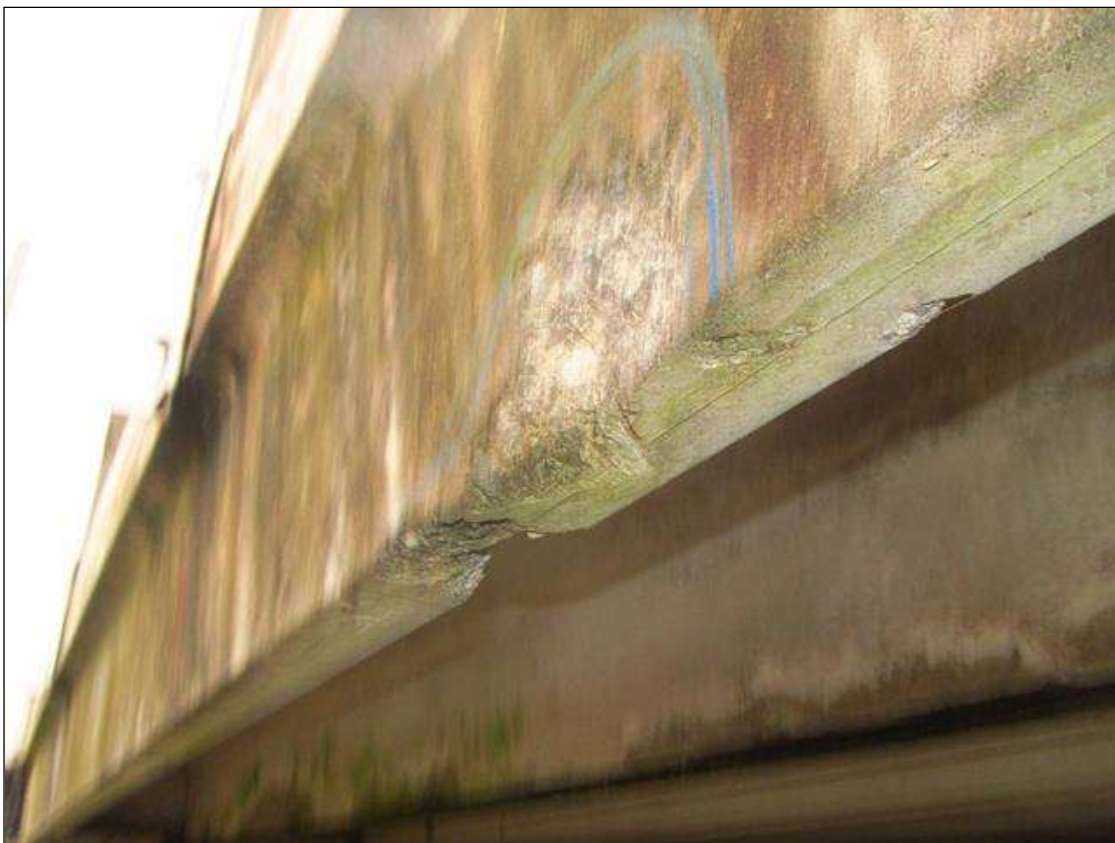
Spall in the right leg of Channel beam 10 in Span 1

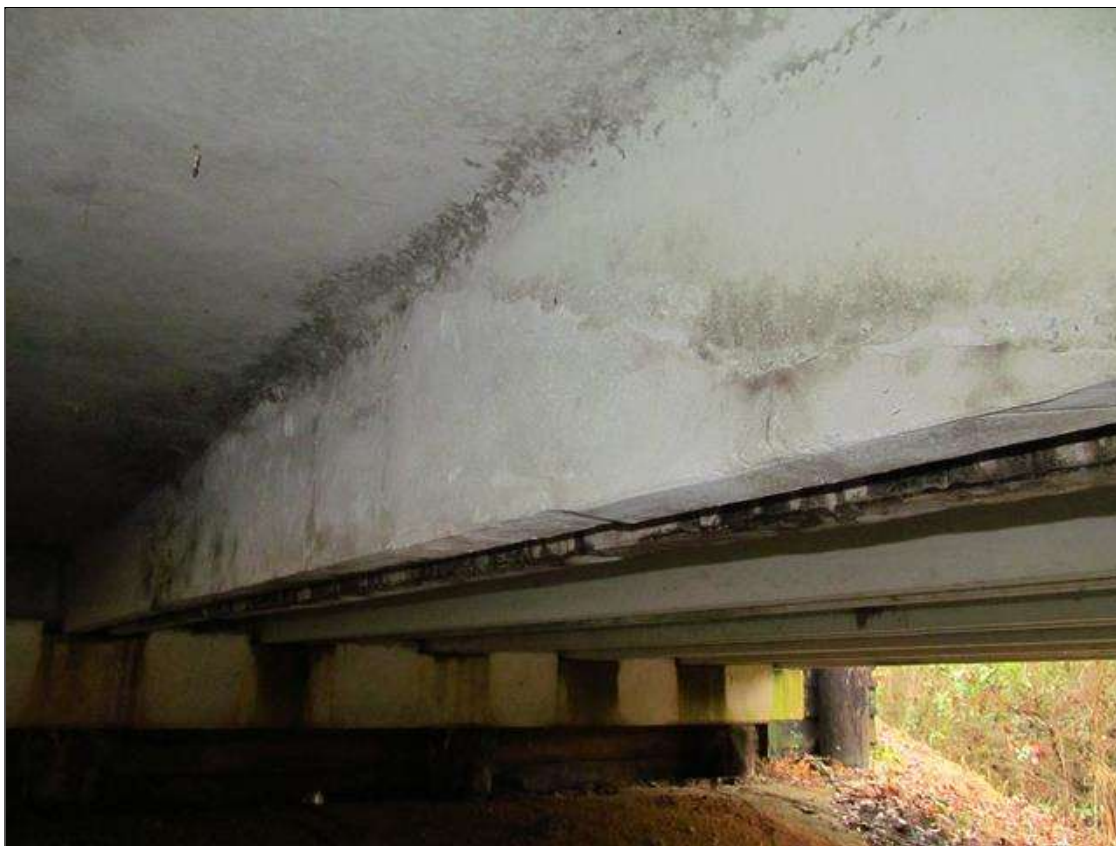
Repair patch in the left lge of Channel beam 6 in Span 1 - other repairs similar throughout structure

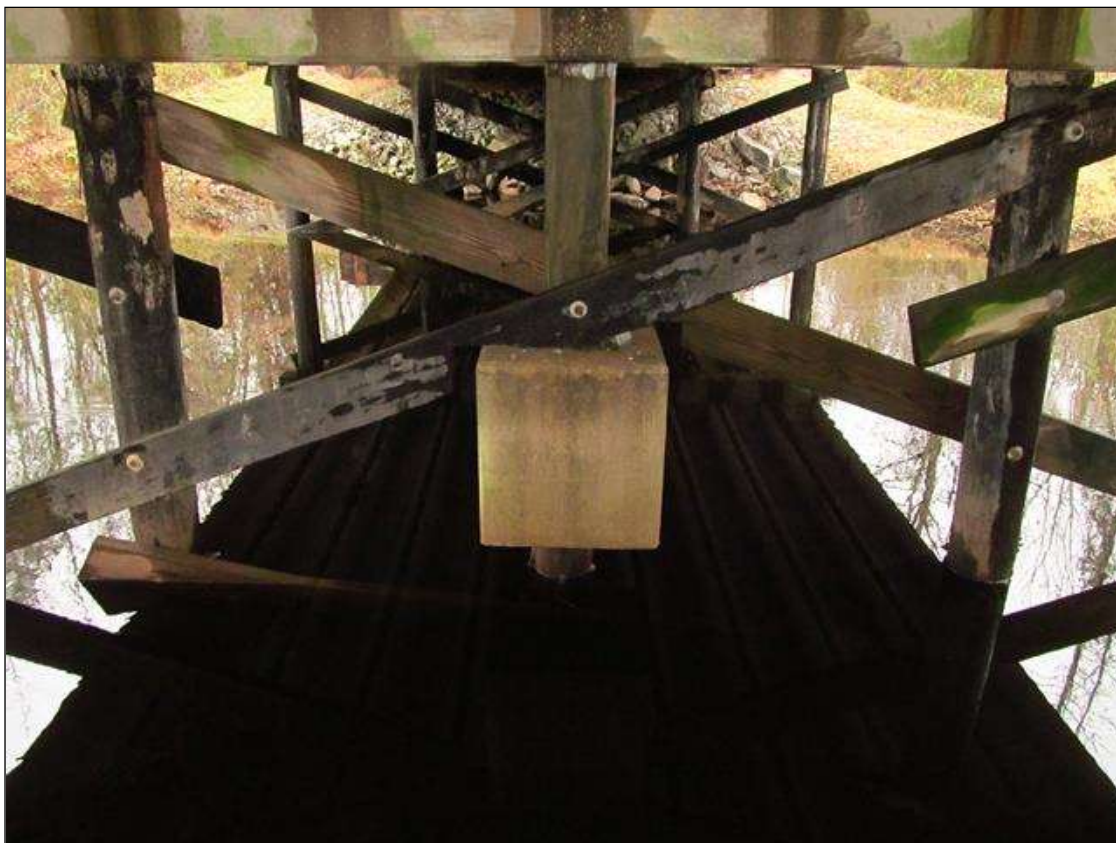
Temporary Repair at Bent 3 Span 3 - others similar

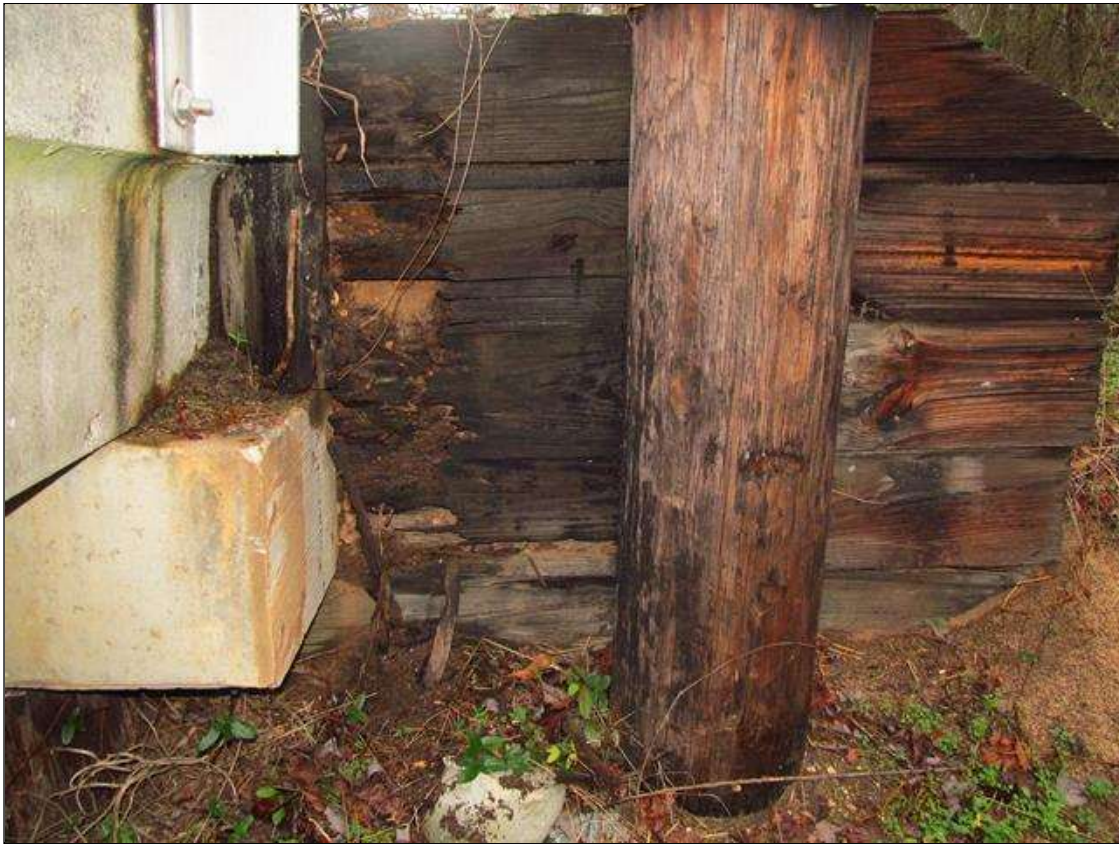
12 Feet of Check/Shake in bulkhead boards and bulkhead piles: Penetrates 5%-50% of the thickness of teh member and not in a tension zone.  
4 Feet of Decay/ in bulkhead boards 3 in deep and nailer from left end tp pile 1.  
5 Feet of Decay/vertical nailer decayed thru at right end of cap and bulkhead boards decayed 2 to 3 in deep from pile 5 to right end .

Right side bulkhead at End Bent 2 decayed with fill exposed - Left side similar

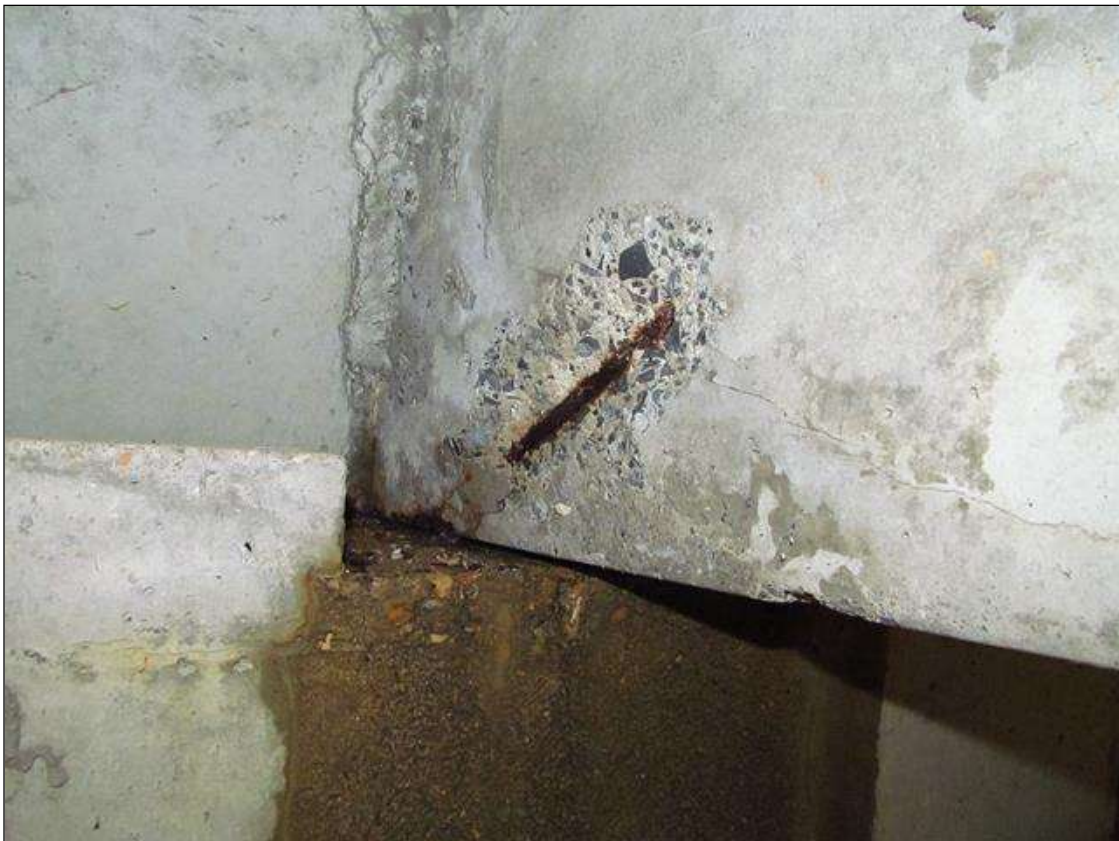
1 Feet of Exposed Rebar: in a spall 6 in x 3 in x 3/4 in deep in right leg at end bent 2.

Spall with Exposed rebar in the right leg of Channel beam 2 at End Bent 2

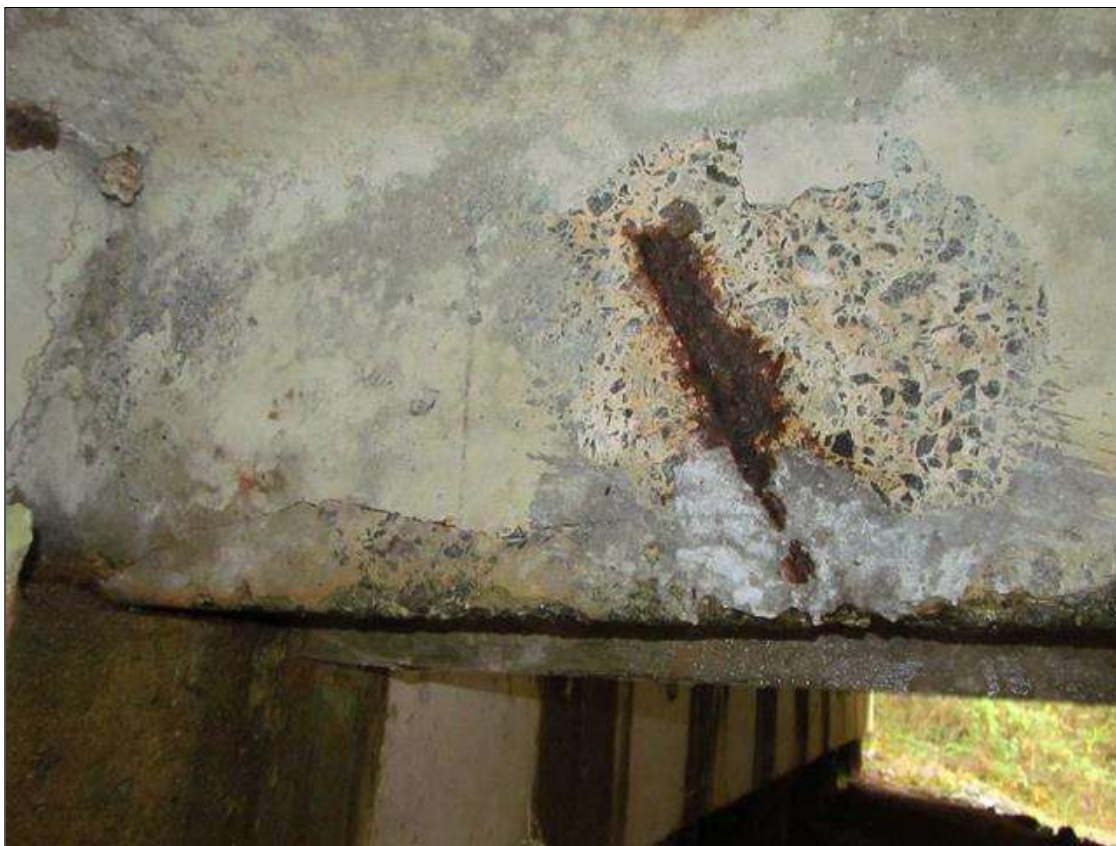
Spall with Section loss to Exposed rebar in the right leg of Channel beam 1 at End Bent 2

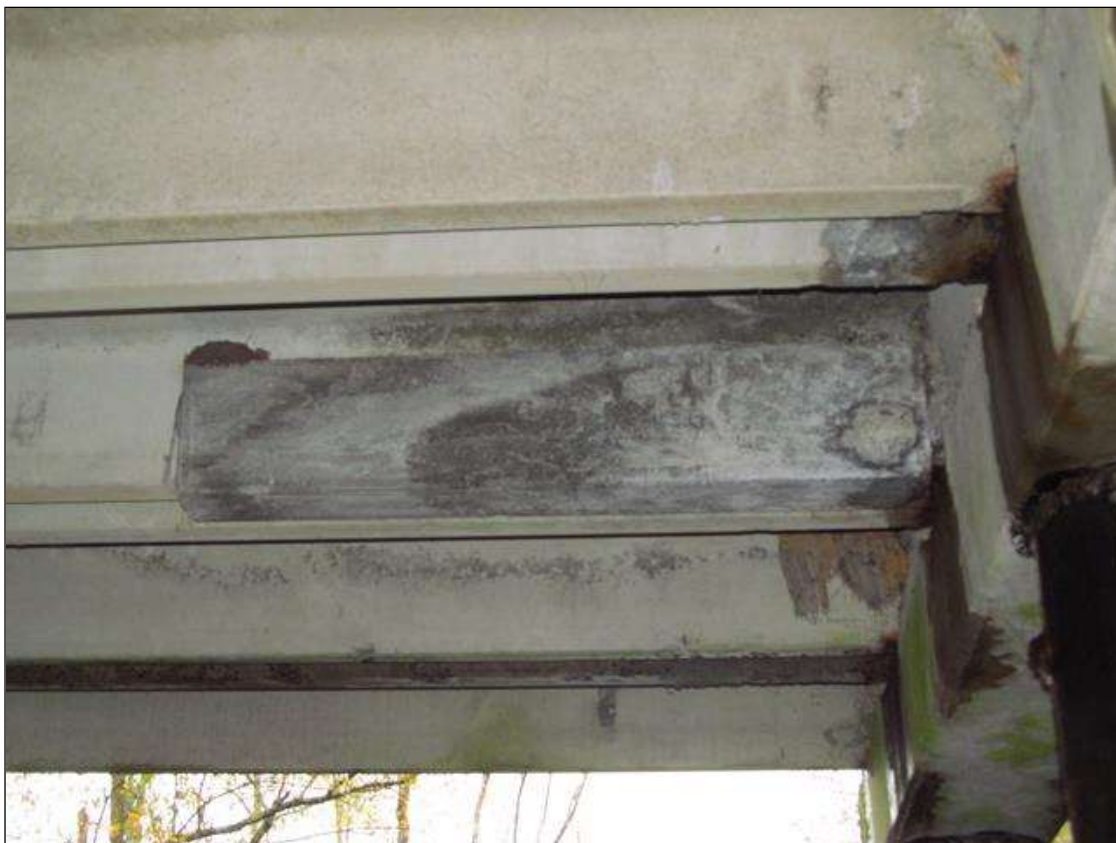
Repair patch on the left leg of Channel beam 3 in Span 2 near Bent 2 - other repairs similar throughout structure

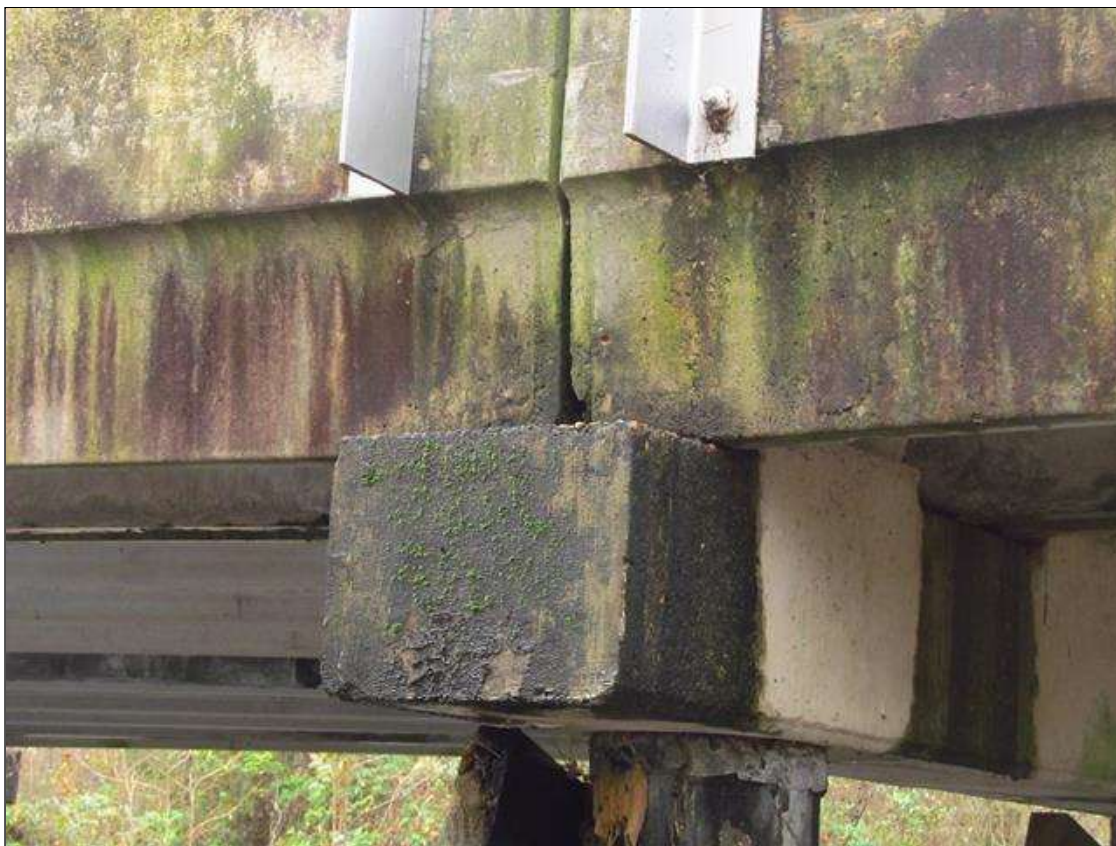
Superstructure over End of cap at Bent 1 - Bent 2 similar
