NC DEPARTMENT OF TRANSPORTATION  
DIVISION OF HIGHWAYS  
STRUCTURE MANAGEMENT UNIT

## Structure Safety Report

### Routine Element Inspection - Contract

COUNTY: JOHNSTON STRUCTURE NUMBER: 500145 FREQUENCY: 24 MONTHS

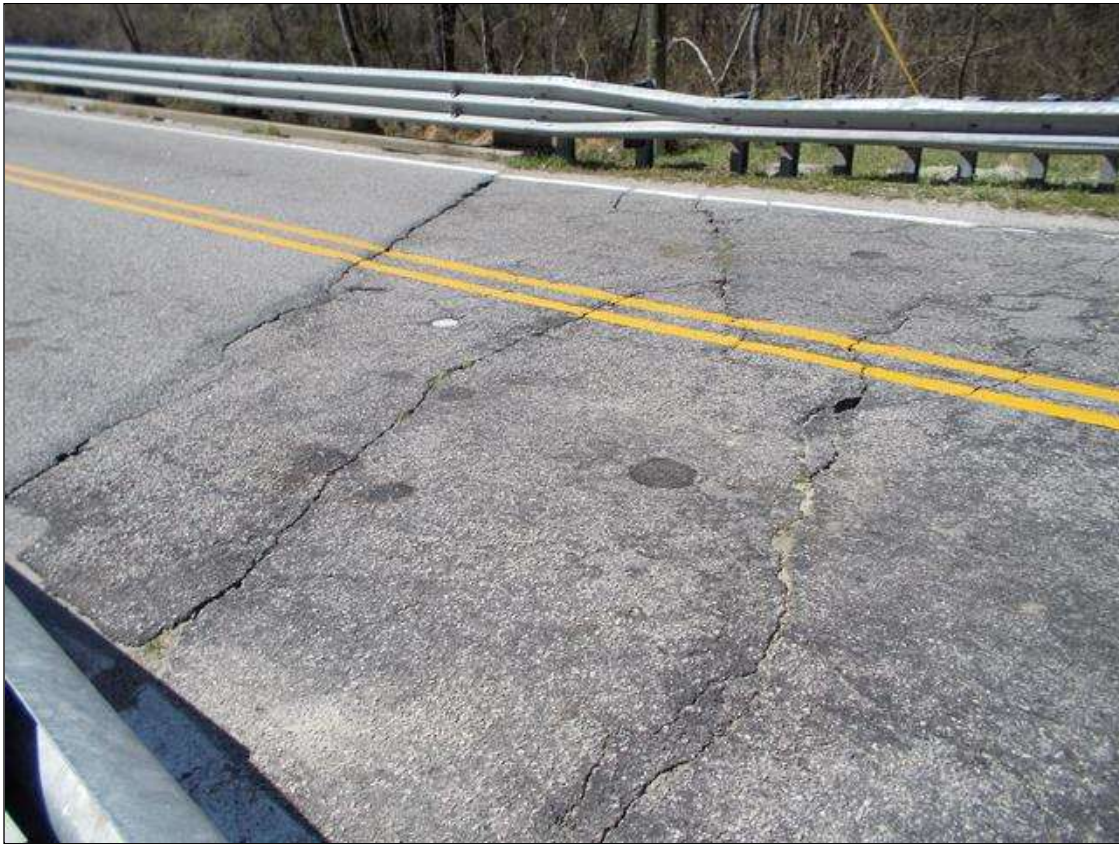
Approach Roadway: 15' X 22' AREA OF UP TO 1/2" CRACKS IN ASPHALT WEARING SURFACE, NORTH APPROACH.

SLOPE PROTECTION END BENT 1 : SETTLEMENT UP TO 1/8"

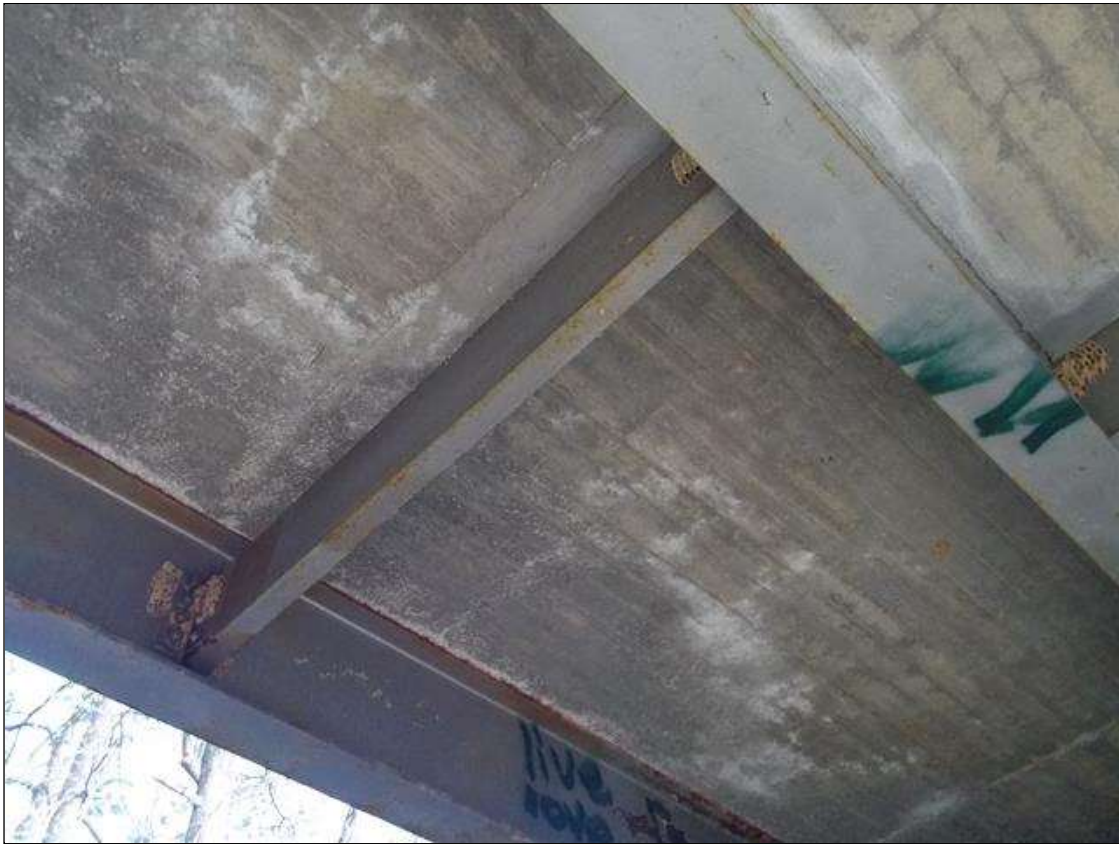
Span 1 Deck: EFFLORESCENCE, UNDERSIDE OF DECK, ALL BAYS, ISOLATED LOCATIONS.

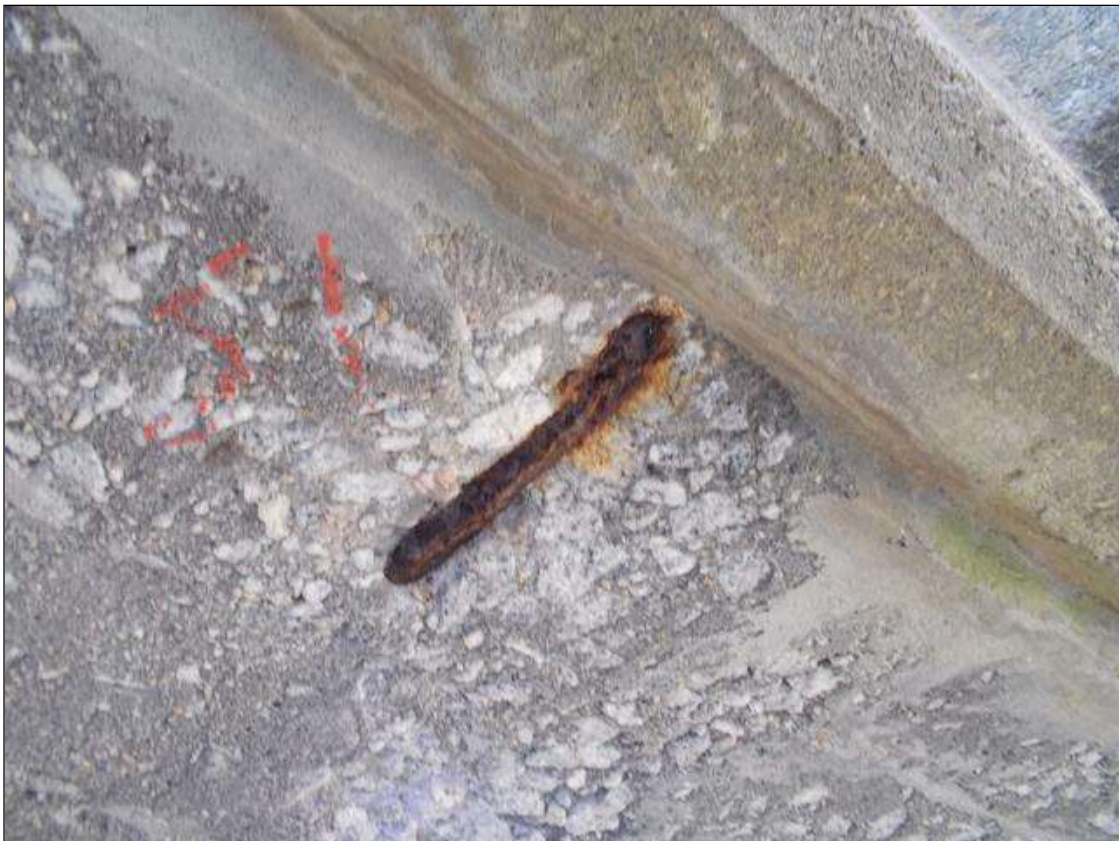
Span 1 Deck: (6) UP TO 6" DIAMETER X 1/2" SPALLS WITH EXPOSED REINFORCING, UNDERSIDE OF DECK, AT RANDOM THROUGHOUT.

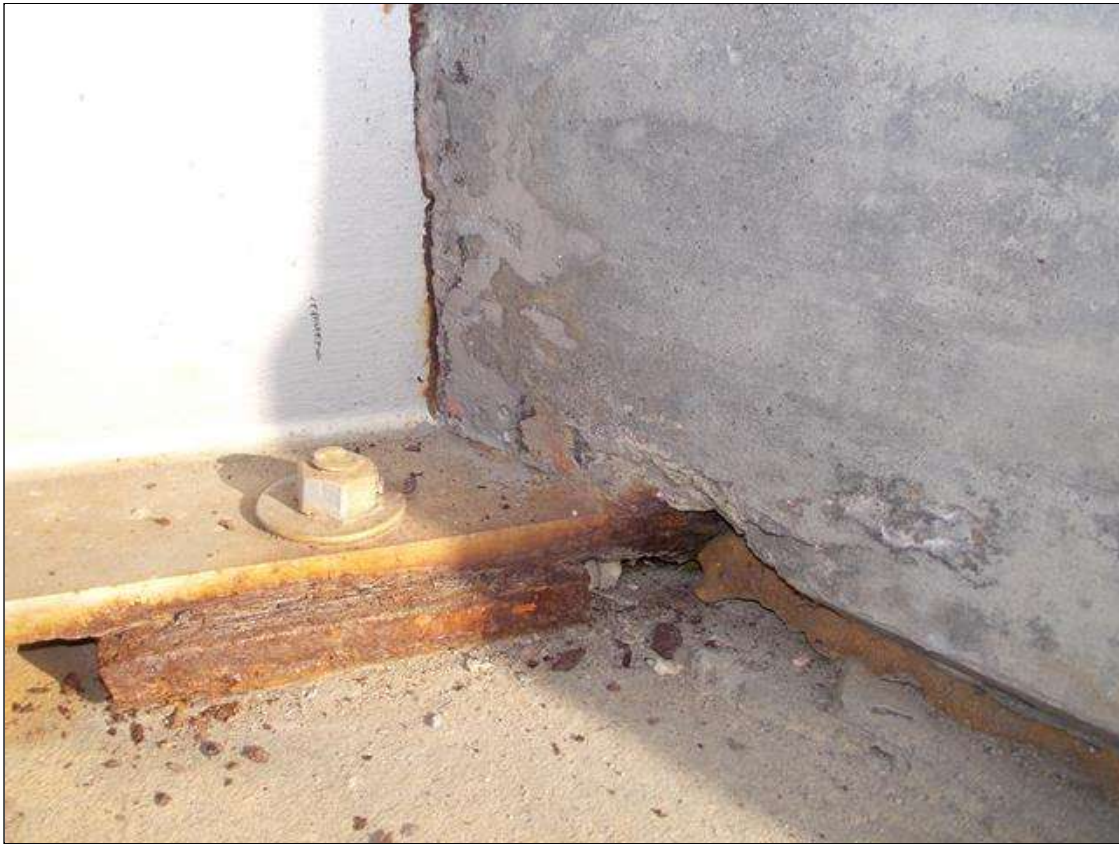
Span 1 Beam 1: 1' PACK RUST, BOTTOM FLANGE AND WEB, NO SECTION LOSS, AT NEAR BEARING.

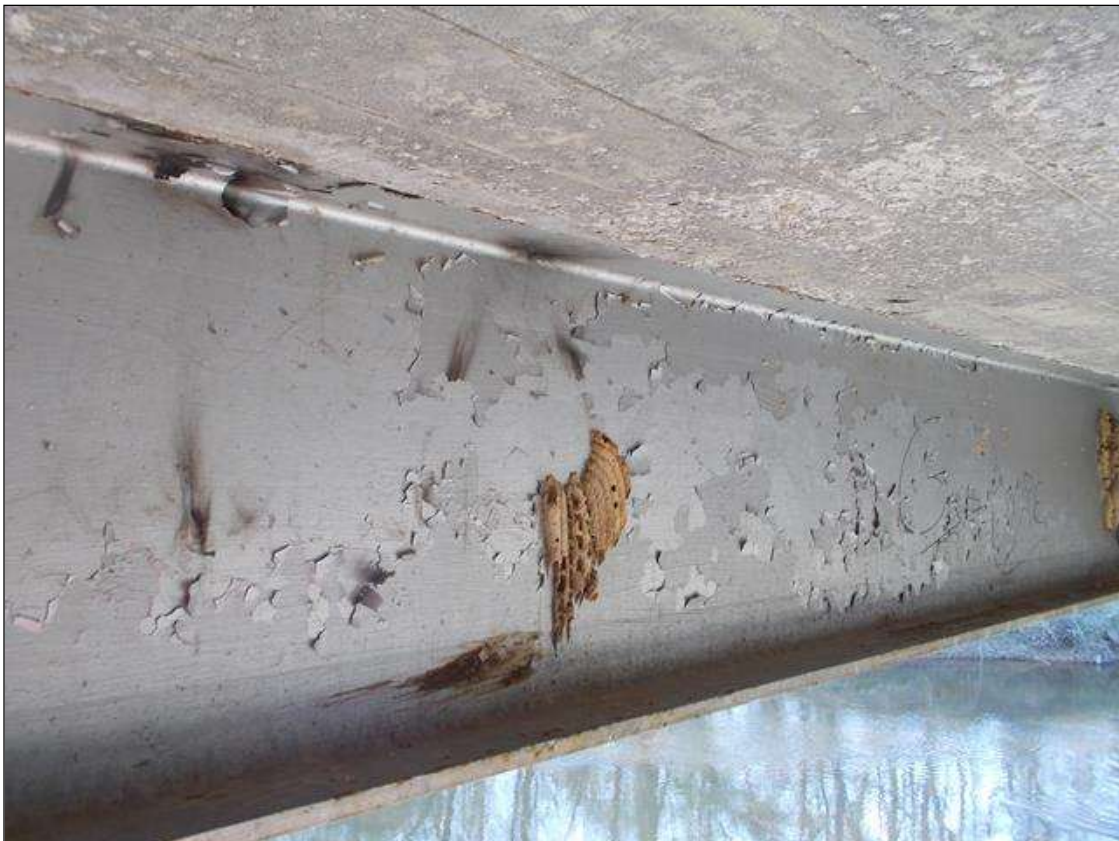
Span 1 Beam 1: 20% PEELING OF THE TOP COAT OF PAINT.

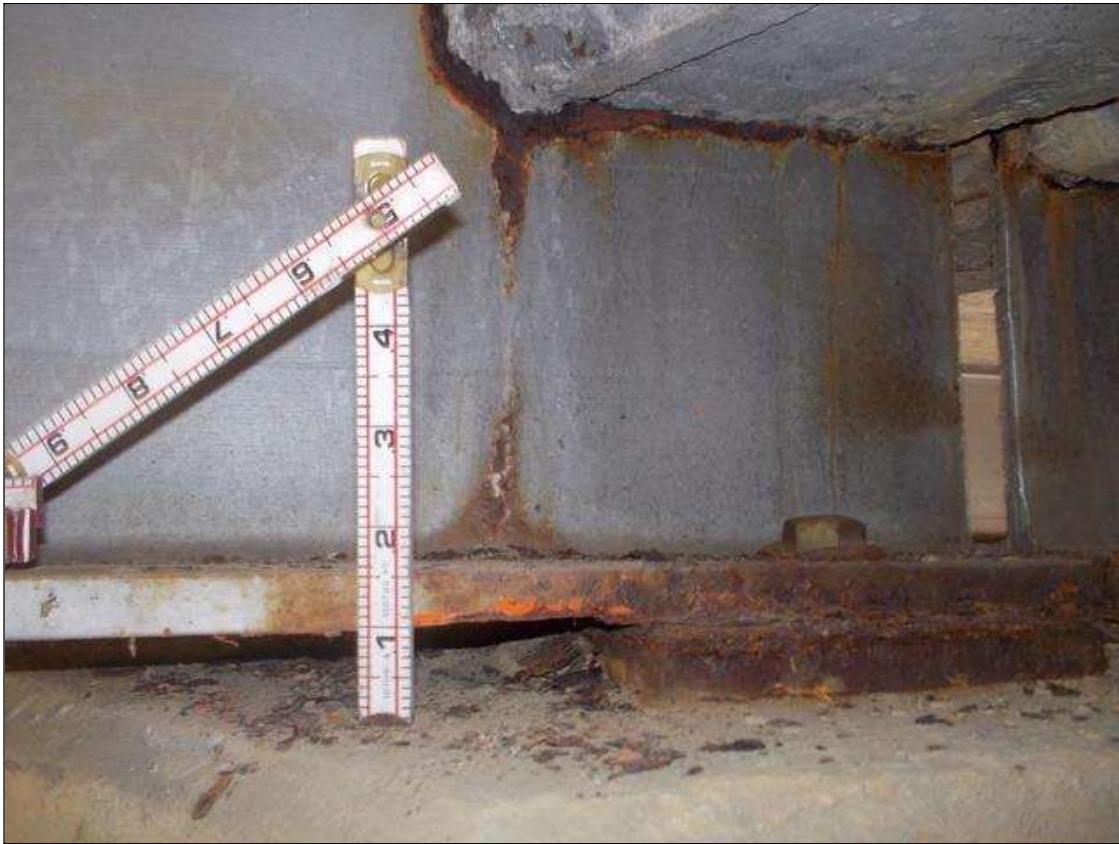
Span 1 Beam 3: 1' RUST SCALE WITH SECTION LOSS, 0.6" REMAINING, BOTTOM FLANGE AND WEB AT DIAPHRAGM, AT BENT 1 BEARING (PRIORITY MAINTENANCE).

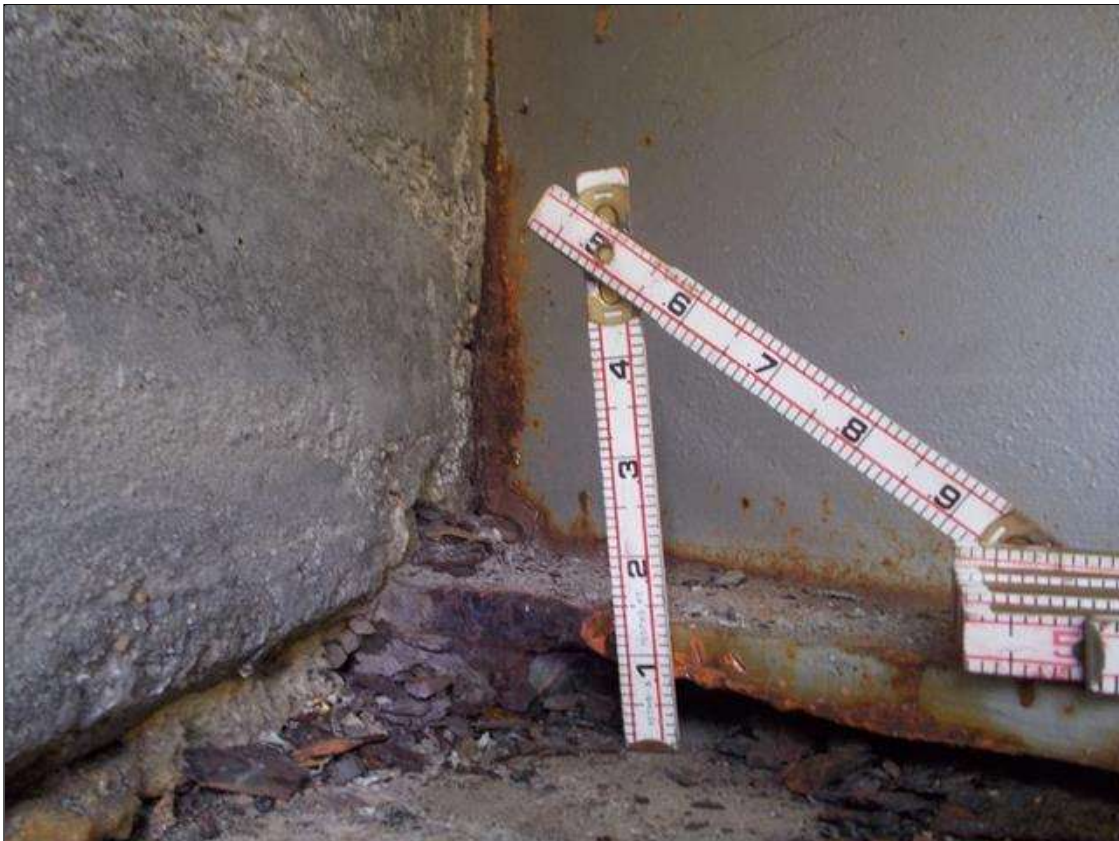
Span 1 Beam 4: 1' RUST SCALE WITH SECTION LOSS, 0.44" REMAINING, BOTTOM FLANGE EXTENDING 6" INTO THE WEB, AT END BENT 1 BEARING (PRIORITY MAINTENANCE).

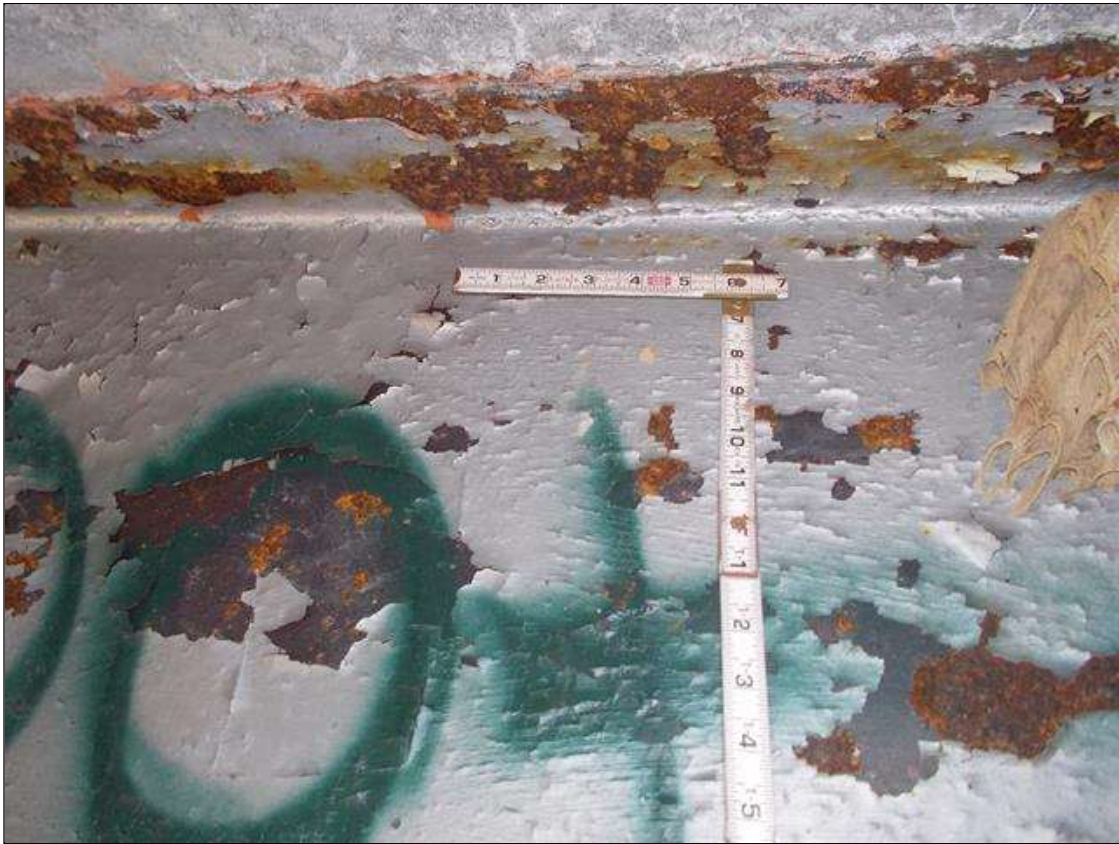
Span 1 Beam 4: 33' FRECKLED RUST AND LIGHT SURFACE RUST, TOP AND BOTTOM FLANGE, AND AT RANDOM THROUGHOUT THE WEB.

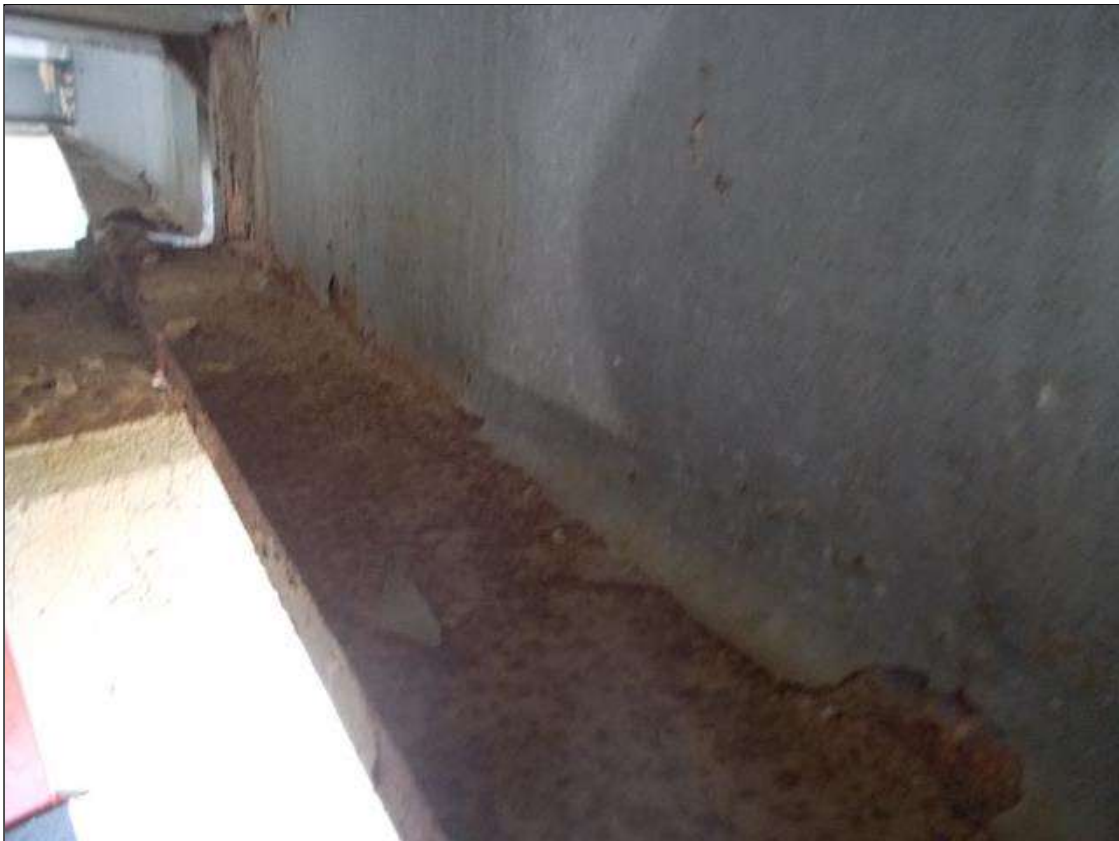
Span 1 Beam 4: 2' SHALLOW PITTING, BOTTOM FLANGE, AT BENT 1 BEARING.

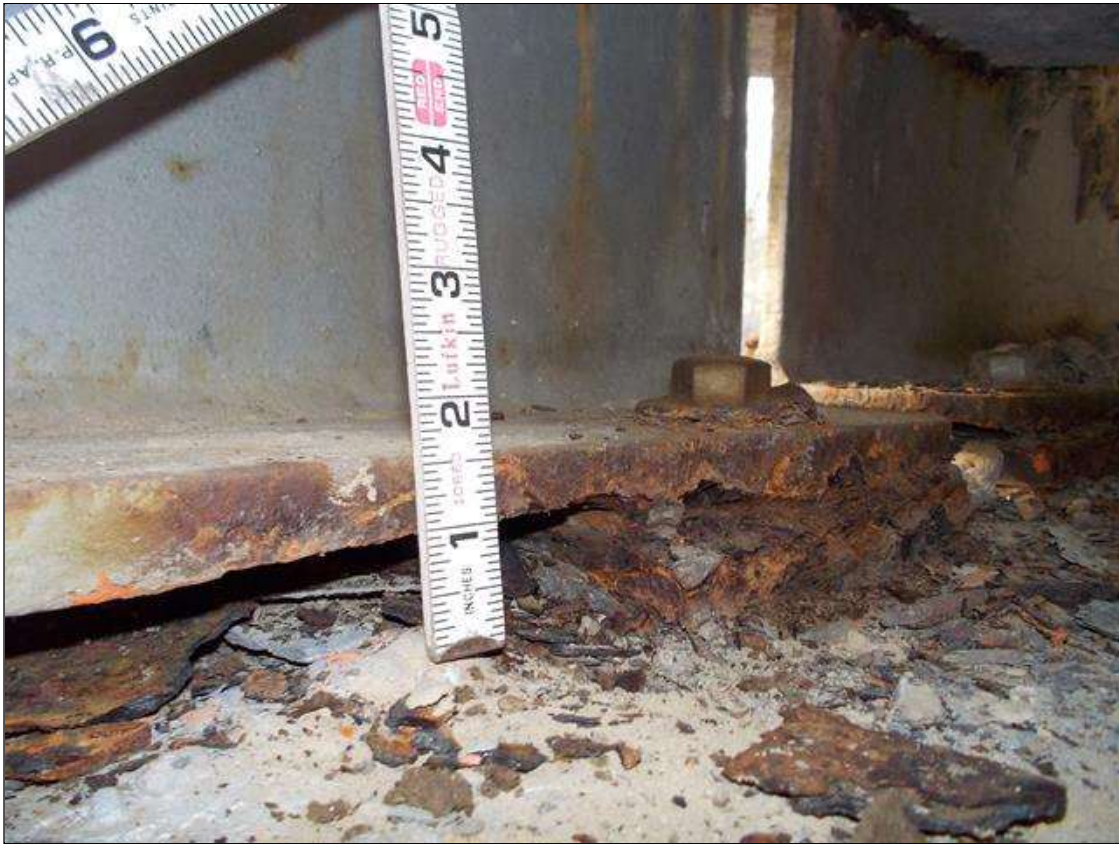
Span 1 Beam 1: 1' RUST SCALE WITH SECTION LOSS, 0.5" REMAINING, BOTTOM FLANGE, AT BENT 1 BEARING (PRIORITY MAINTENANCE).

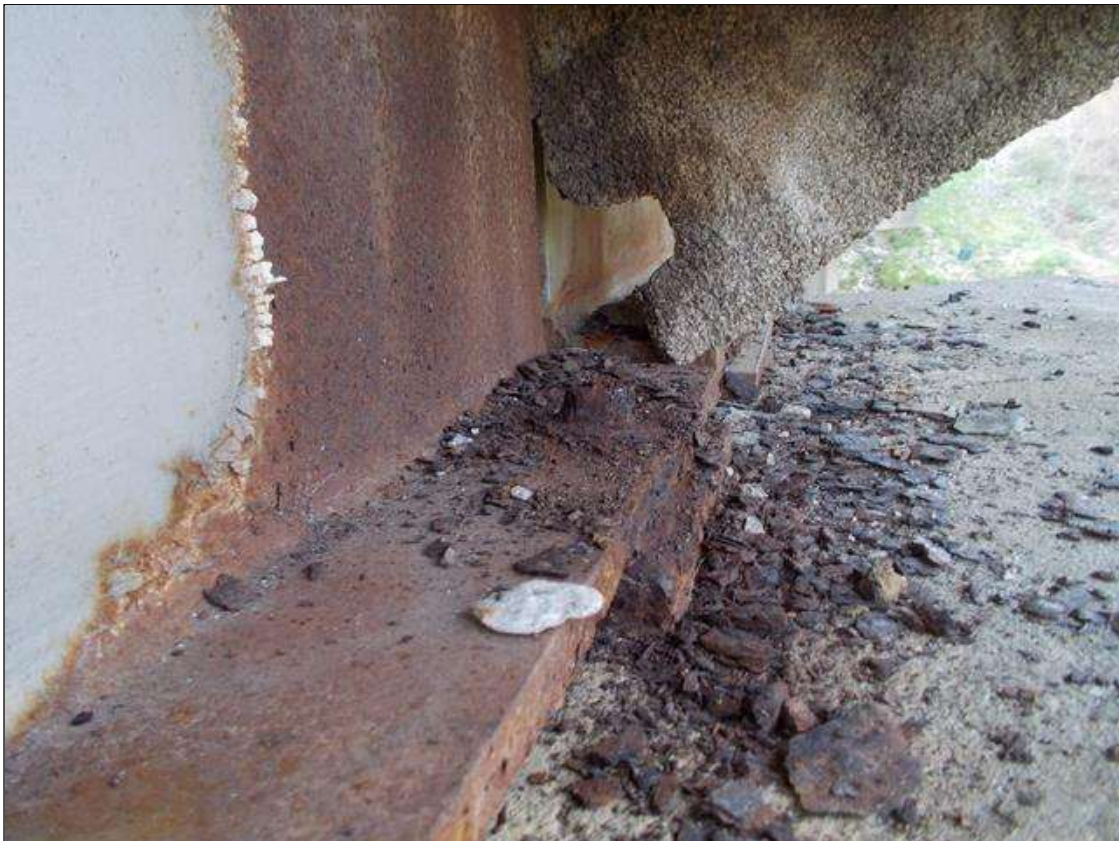
Span 1 Beam 4 Far Bearing : PACK RUST, MASONRY PLATE WITH 70% SECTION LOSS TO THE EXTERIOR ANCHOR BOLT NUT.

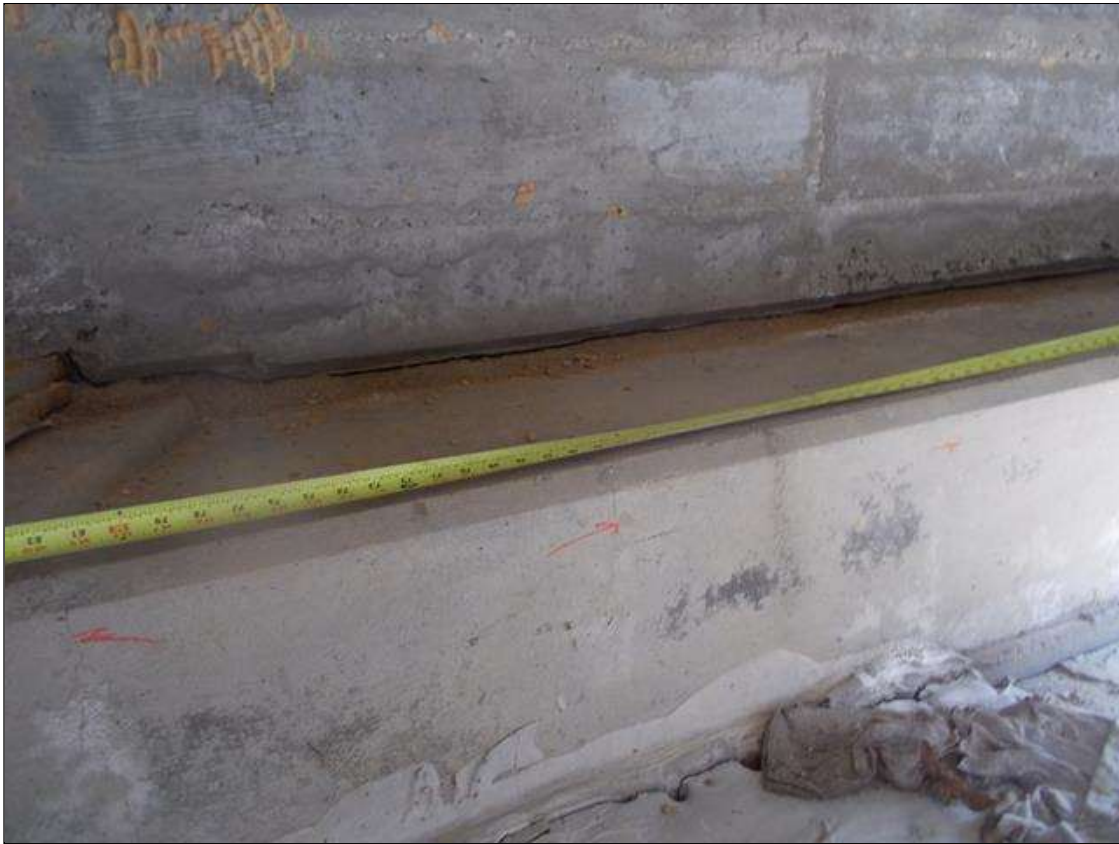
End Bent 1 Cap : 18' AREA OF HAIRLINE TRANSVERSE VERTICAL CRACKS, APPROXIMATELY 16" ON CENTER, BENEATH BAYS 1, 2, AND 3' INTO BAY 3.

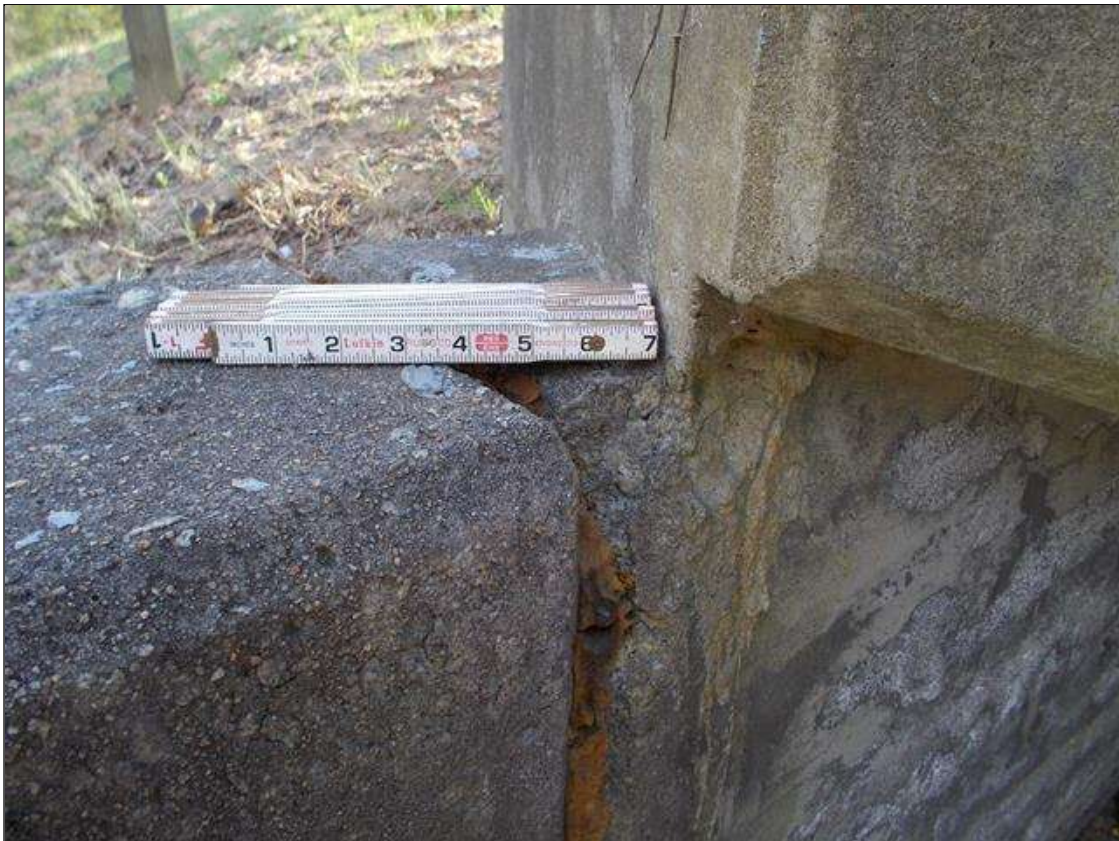
End Bent 1 Abutment/Backwall : 3" X 5" X 2" SPALL, TOP OF ABUTMENT BACKWALL, RIGHT END.

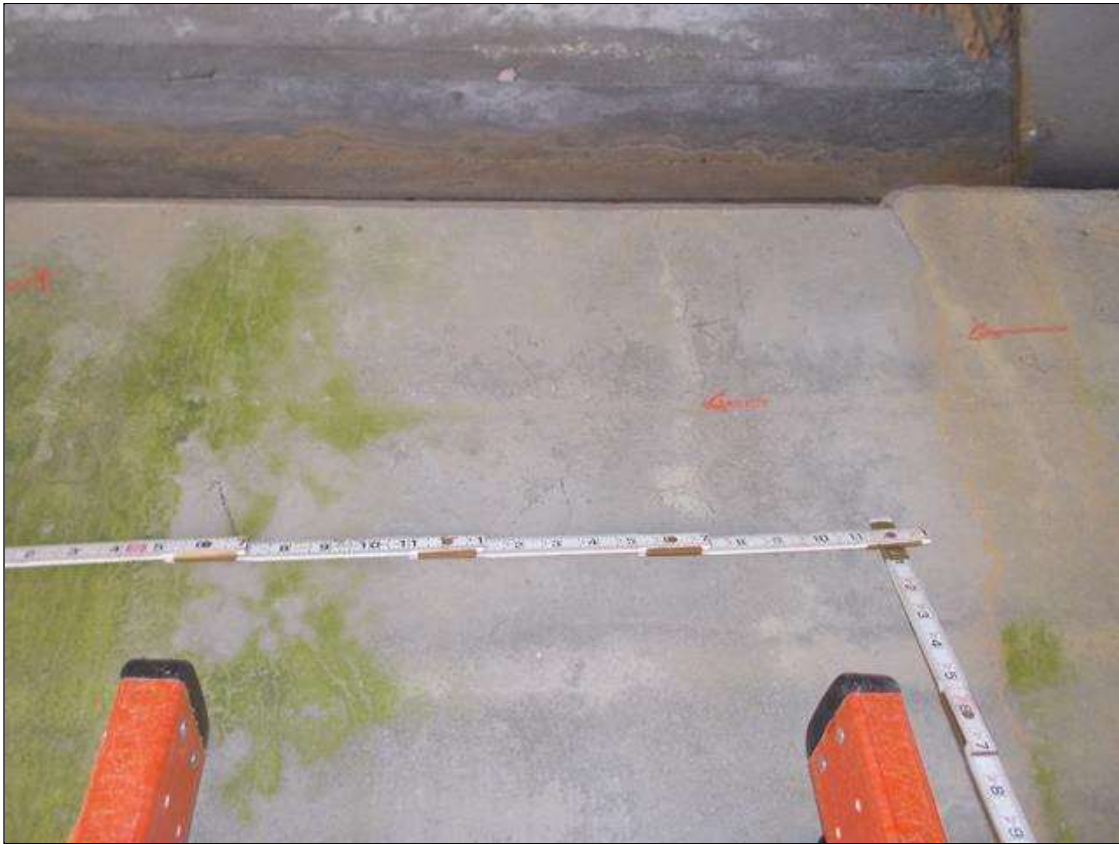
Bent 1 Cap : 12' AREA OF HAIRLINE VERTICAL CRACKS, APPROXIMATELY 1' ON CENTER, BENEATH BAYS 1 AND 2, SPAN 1 FACE.

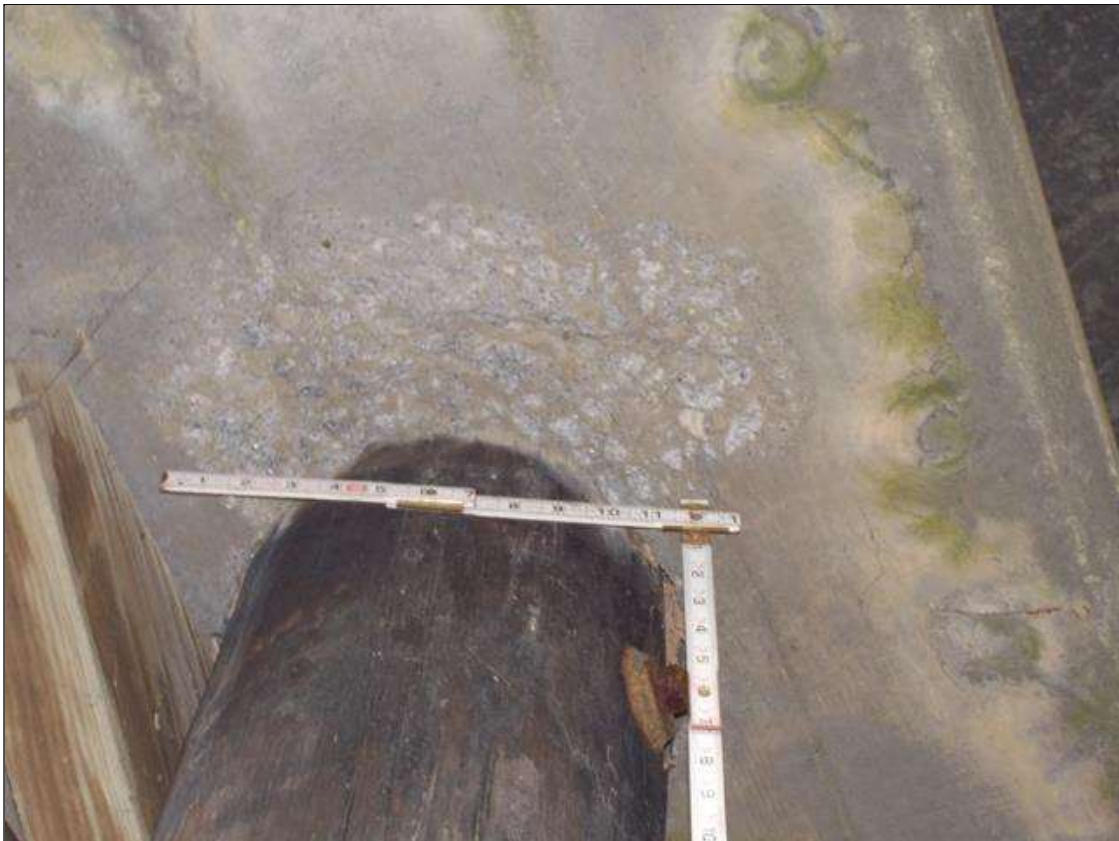
Bent 1 Cap : 14" X 7" X 2" SPALL, UNDERSIDE OF CAP, AT PILE 1.

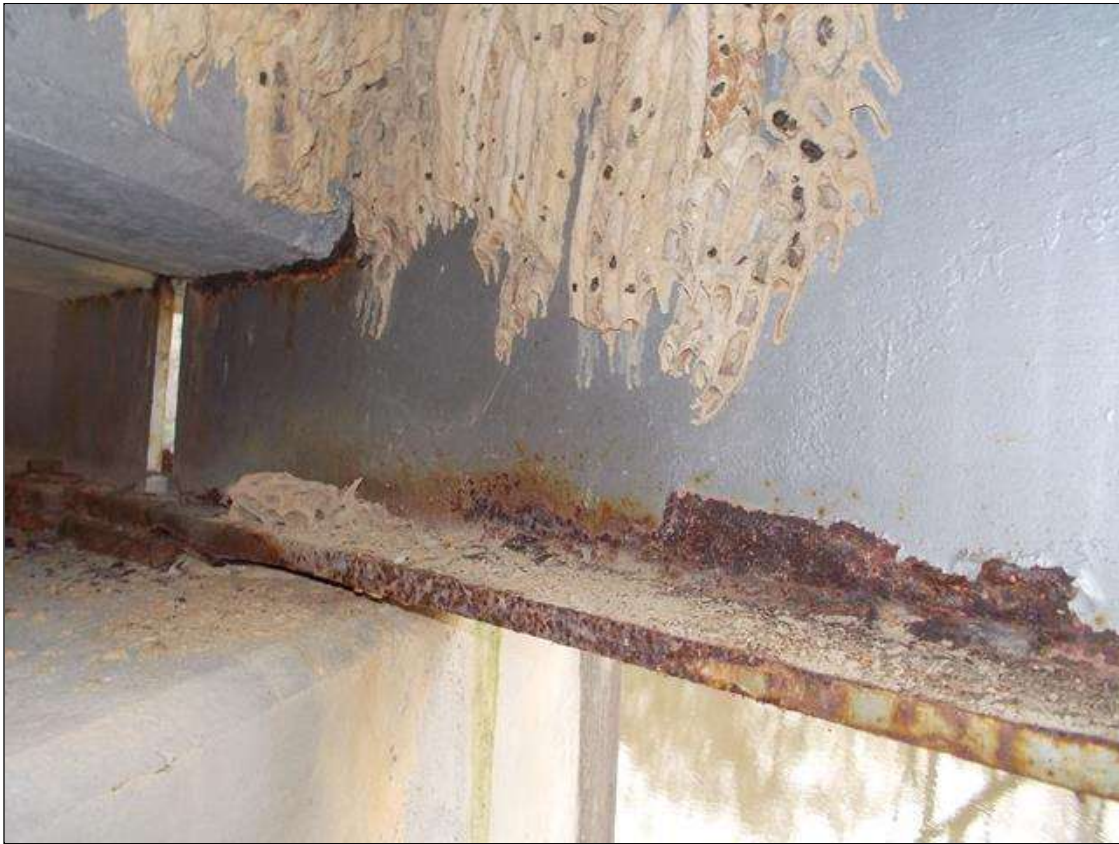
Span 2 Beam 1: 1' RUST SCALING WITH NO SECTION LOSS, BOTTOM FLANGE AND WEB, AT NEAR BEARING.

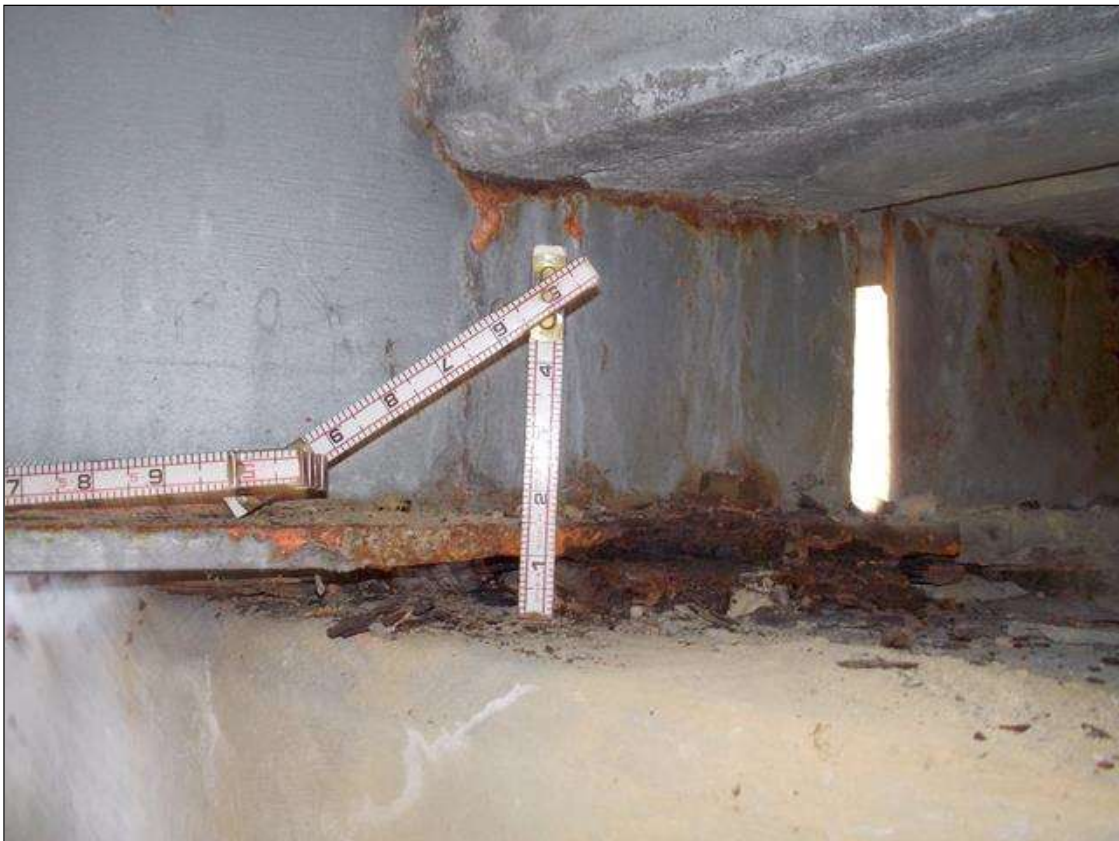
Span 2 Beam 1: 1' RUST SCALE WITH SECTION LOSS, 0.5" REMAINING, BOTTOM FLANGE, AT BENT 2 BEARING (PRIORITY MAINTENANCE).

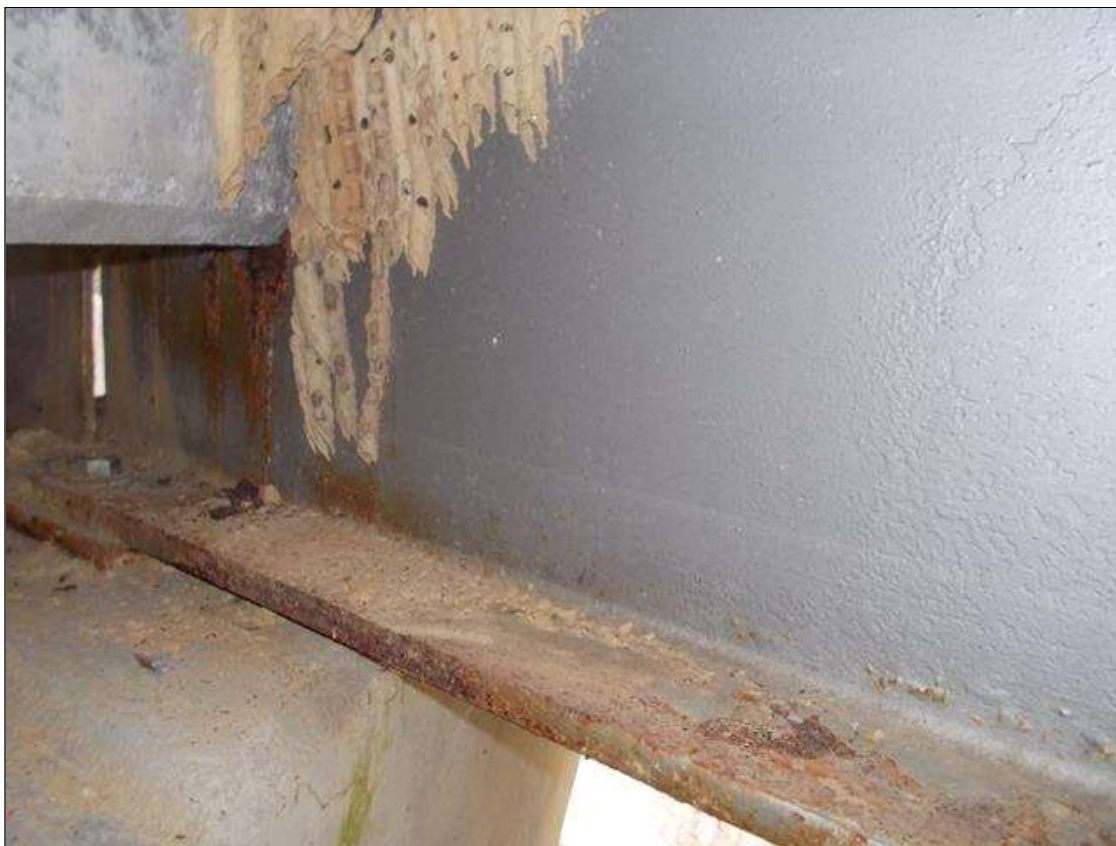
Span 2 Beam 2: 1' RUST SCALING WITH NO SECTION LOSS, WEB AT BENT 1 DIAPHRAGM.

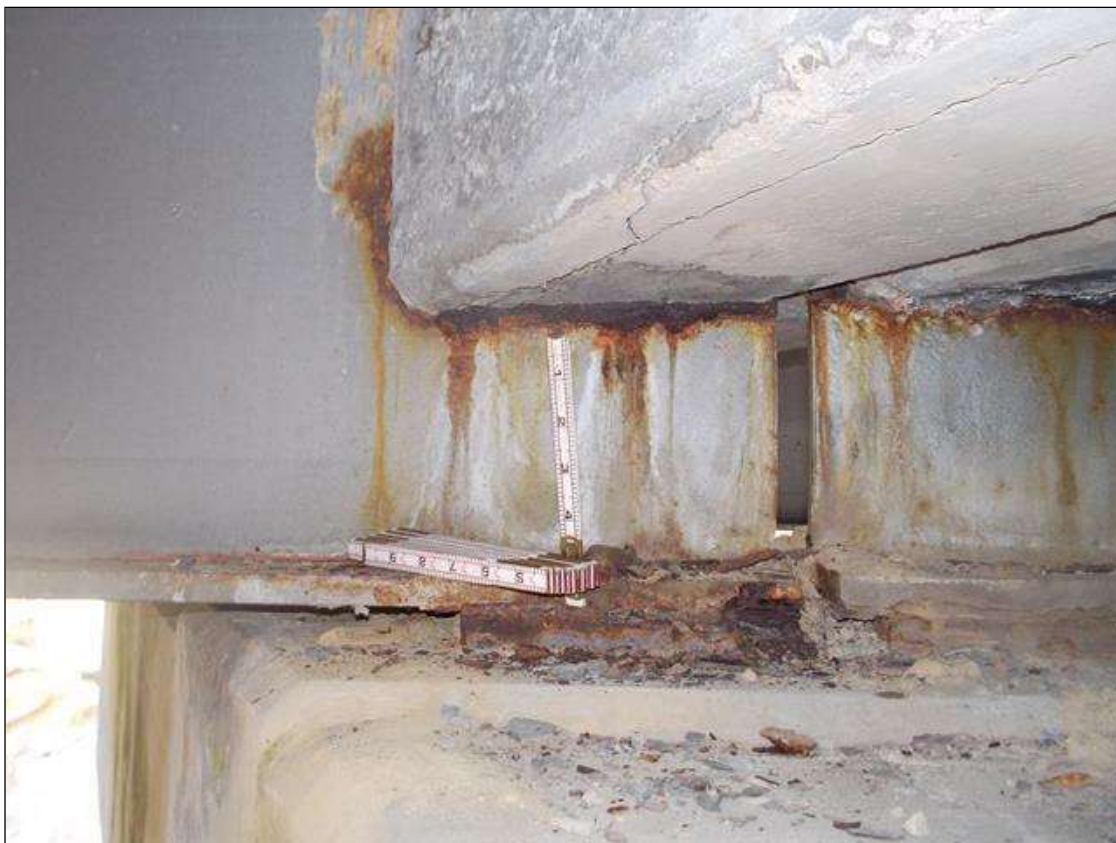
Span 2 Beam 2: 1' RUST SCALING, BOTTOM FLANGE AND WEB, NO SECTION LOSS, AT FAR BEARING.

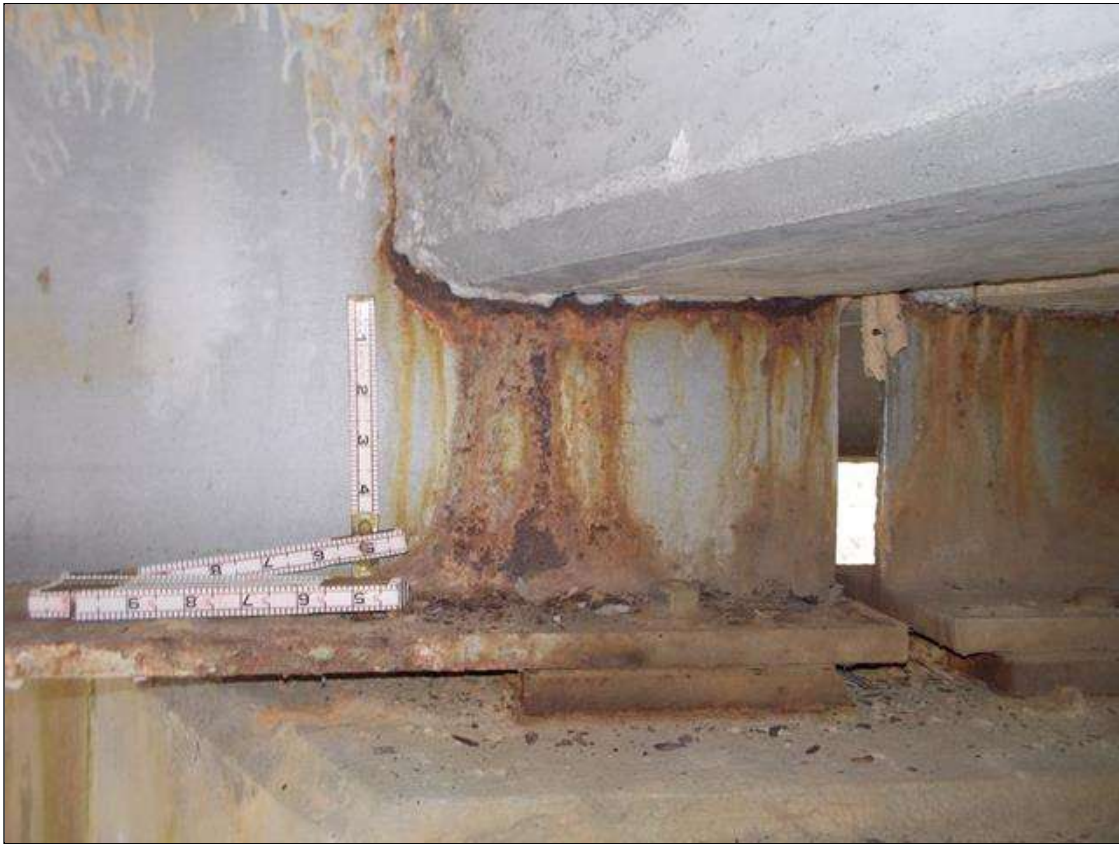
Span 2 Beam 3: 1' RUST SCALING WITH NO SECTION LOSS, WEB, AT BENT 2 DIAPHRAGM.

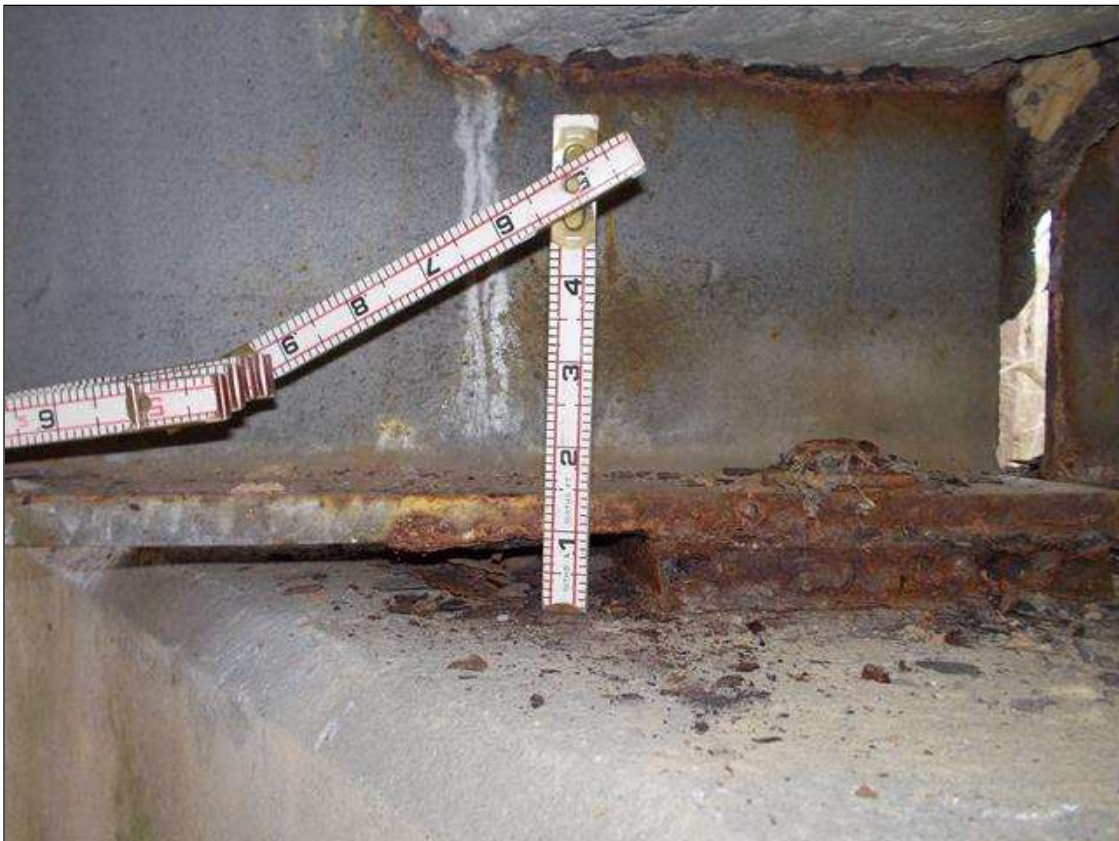
Span 2 Beam 4: 1' RUST SCALE WITH SECTION LOSS, 0.5" REMAINING, BOTTOM FLANGE, AT BENT 1 BEARING (PRIORITY MAINTENANCE).

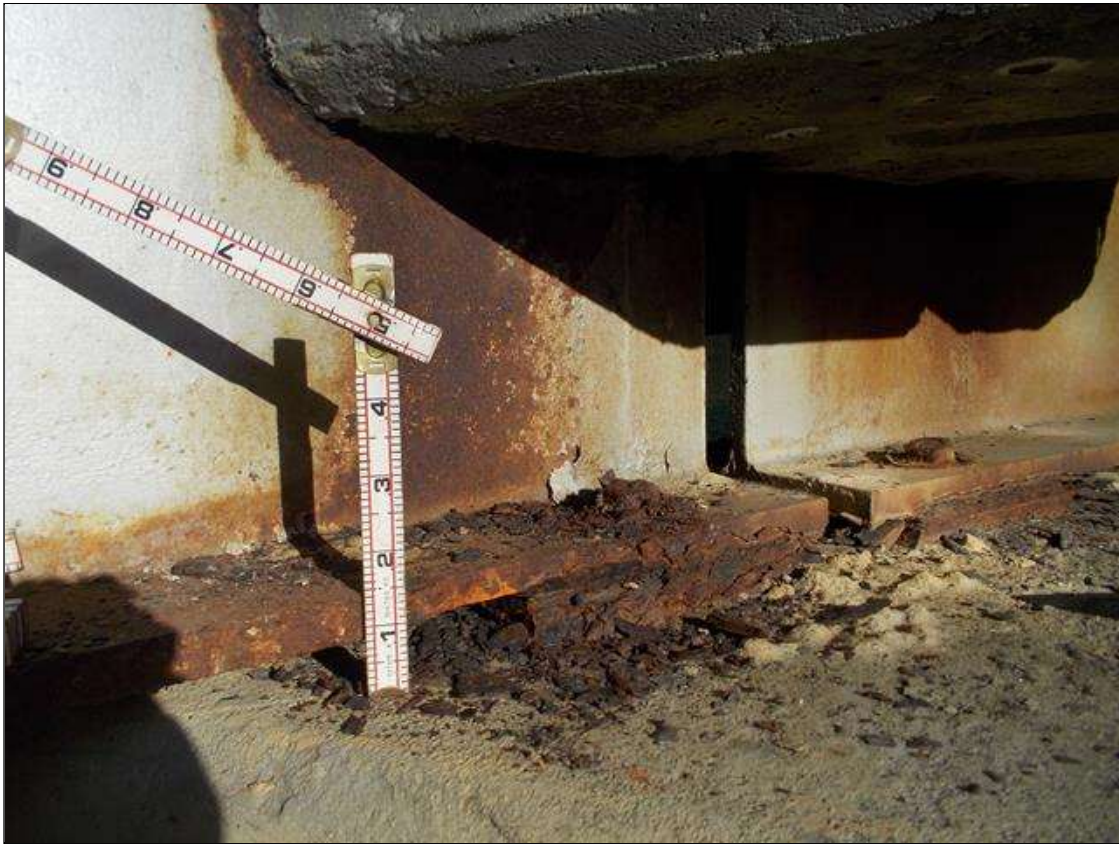
Span 2 Beam 4: 1' RUST SCALE WITH SECTION LOSS, 0.5" REMAINING, BOTTOM FLANGE AND WEB, AT BENT 2 BEARING (PRIORITY MAINTENANCE).

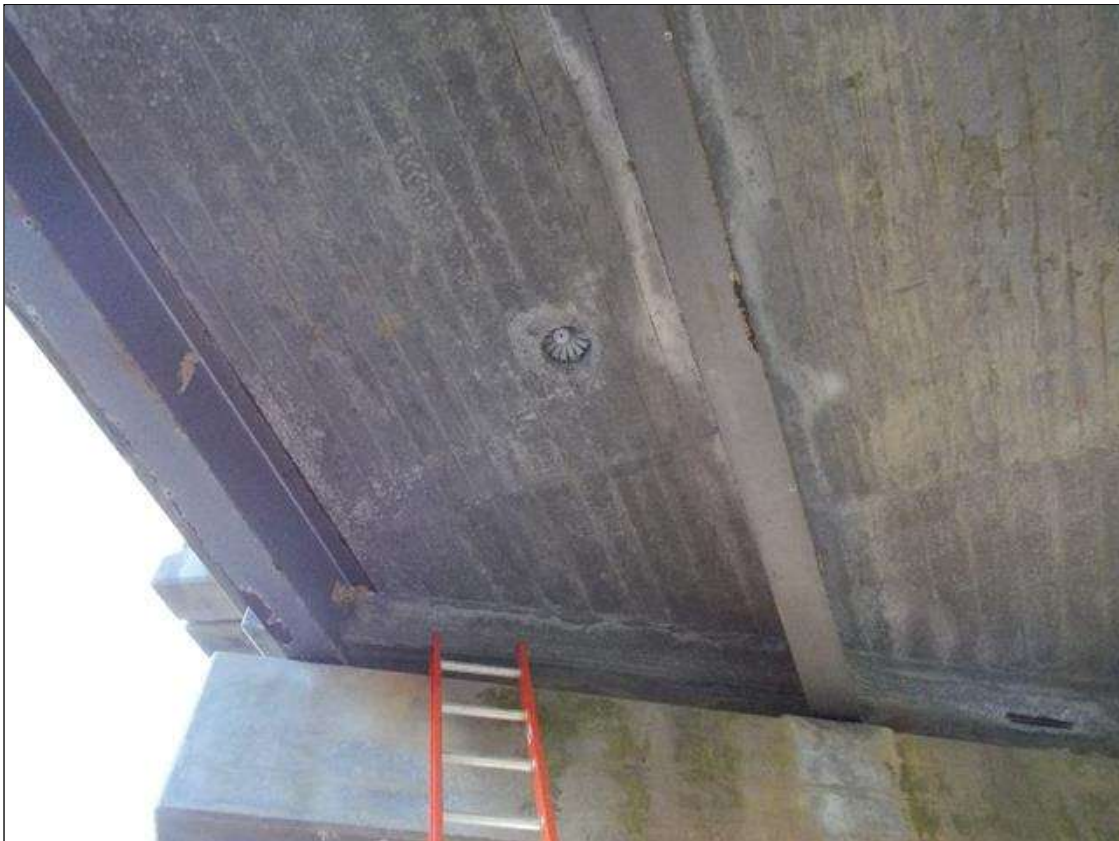
Span 2 Deck: 1 SF PATCHED AREA, AROUND 6" DIAMETER CORED HOLE, BAY 1, 9' FROM BENT 2.

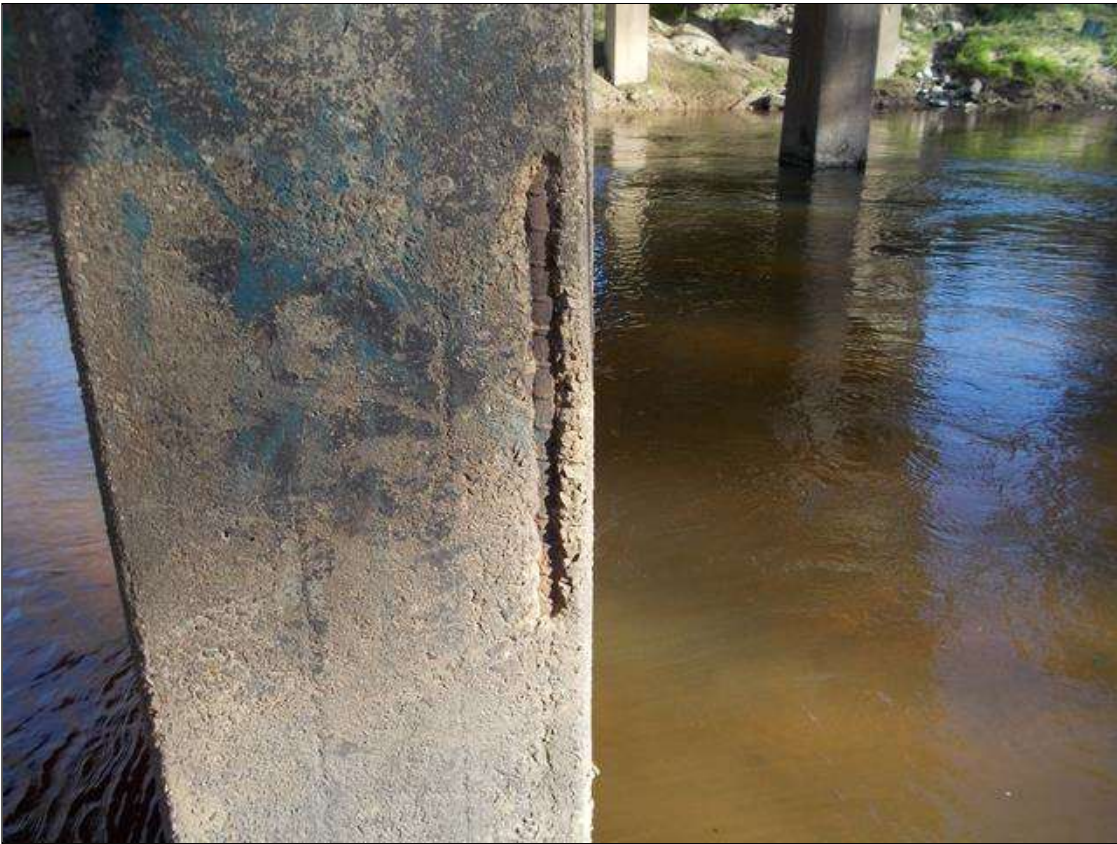
Bent 2 Pile 2: 30"X6" CORNER DELAMINATION ON UPSTREAM FACE, 12"X6" ON SPAN 3 FACE, MID-HEIGHT.
