NC DEPARTMENT OF TRANSPORTATION  
DIVISION OF HIGHWAYS  
STRUCTURE MANAGEMENT UNIT

## Structure Safety Report

### Routine Element Inspection - Contract

COUNTY: JOHNSTON STRUCTURE NUMBER: 500145 FREQUENCY: 24 MONTHS

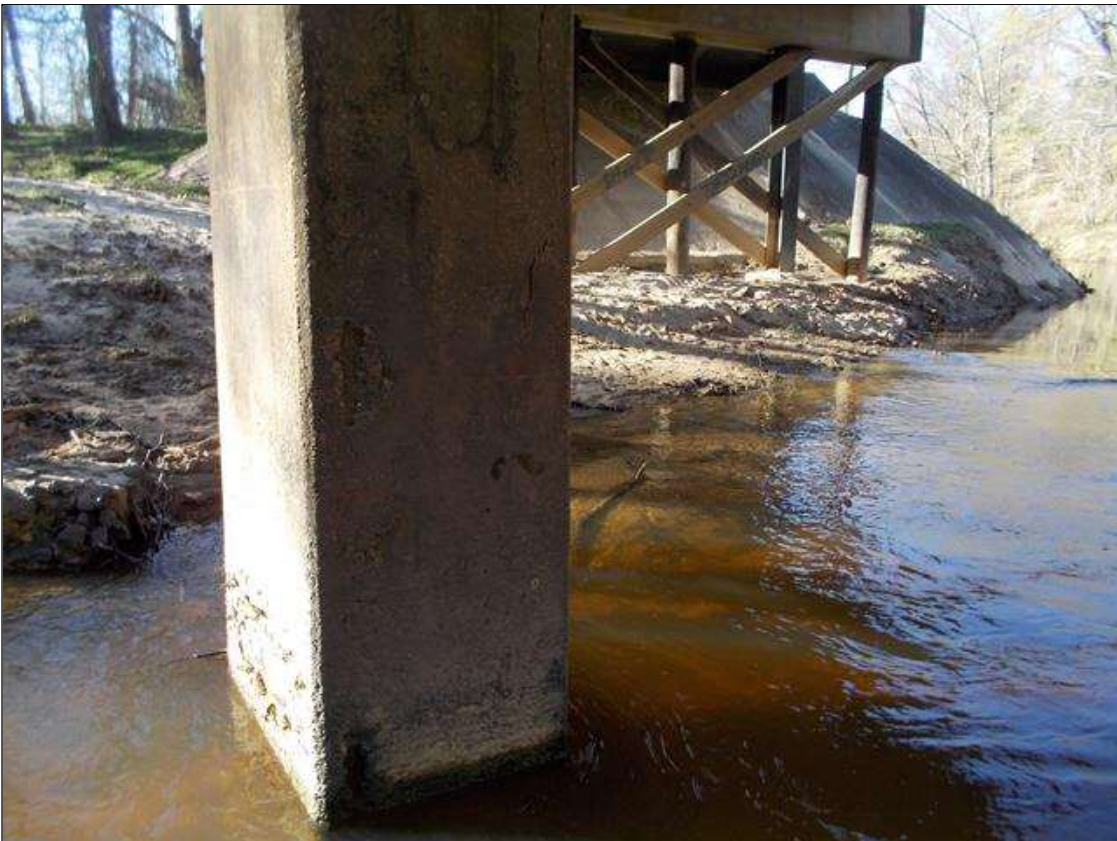
Bent 2 Pile 2: 20" X 1" X 1" SPALL WITH EXPOSED REINFORCING, WITH SECTION LOSS, SPAN 2 FACE, 4' FROM WATER SURFACE. (PRIORITY MAINTENANCE)

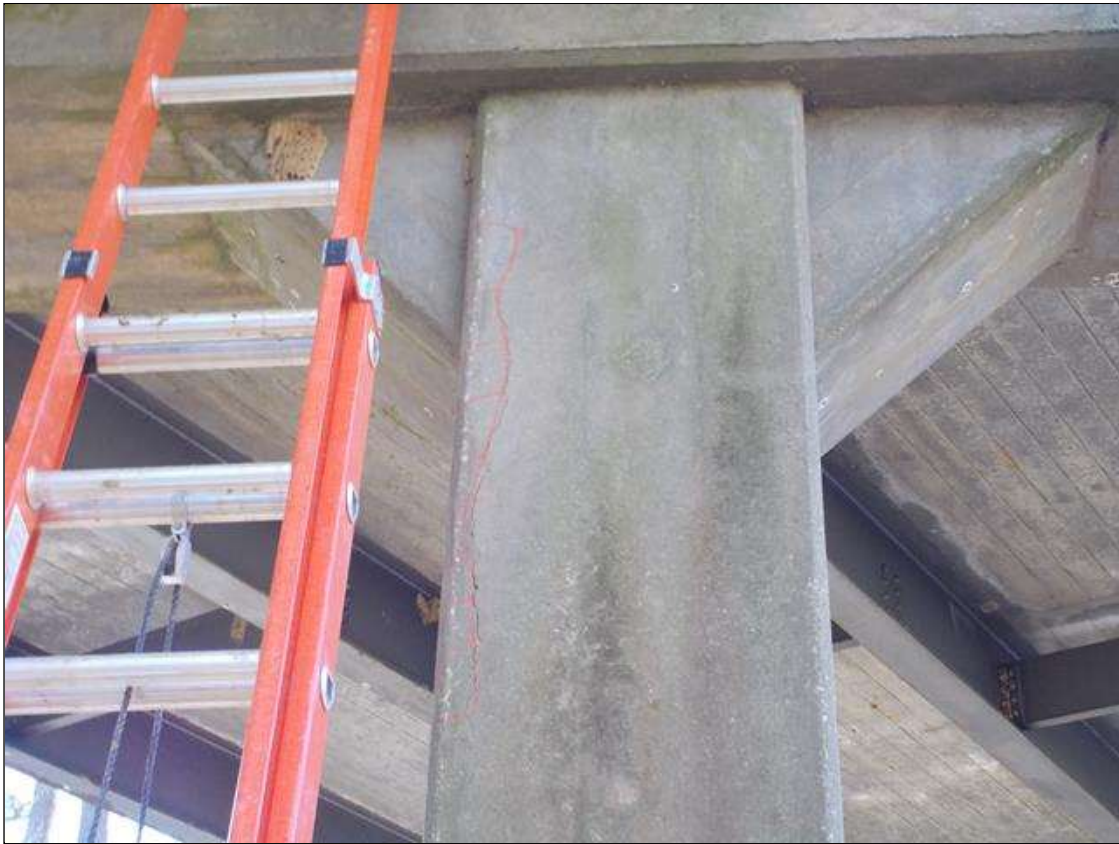
Bent 2 Pile 2 : 7" X 4" X 1/2" SPALL WITH EXPOSED REINFORCING, SPAN 3 FACE, DOWNSTREAM SIDE, 5' FROM WATER SURFACE. (PRIORITY MAINTENANCE)

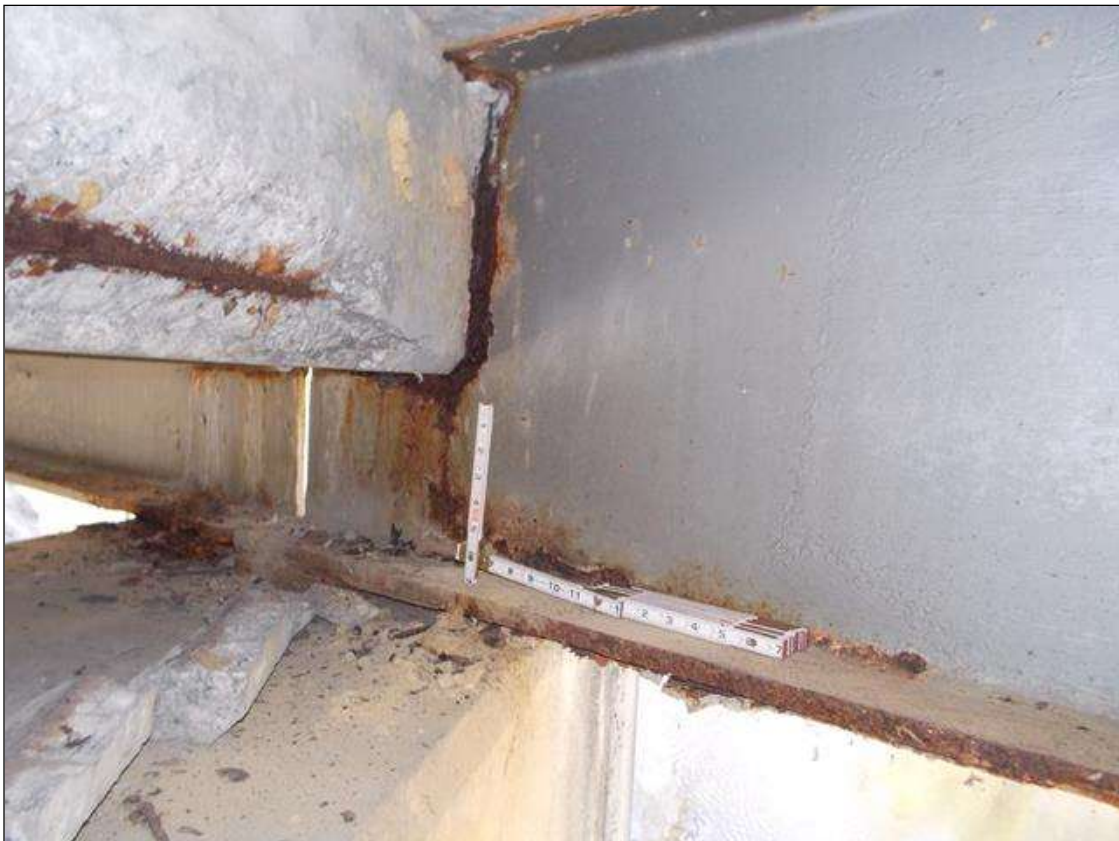
Bent 2 Pile 2: 36" X 6" X 2" CORNER DELAMINATION, SPAN 3 FACE, 2' FROM TOP OF COLUMN.

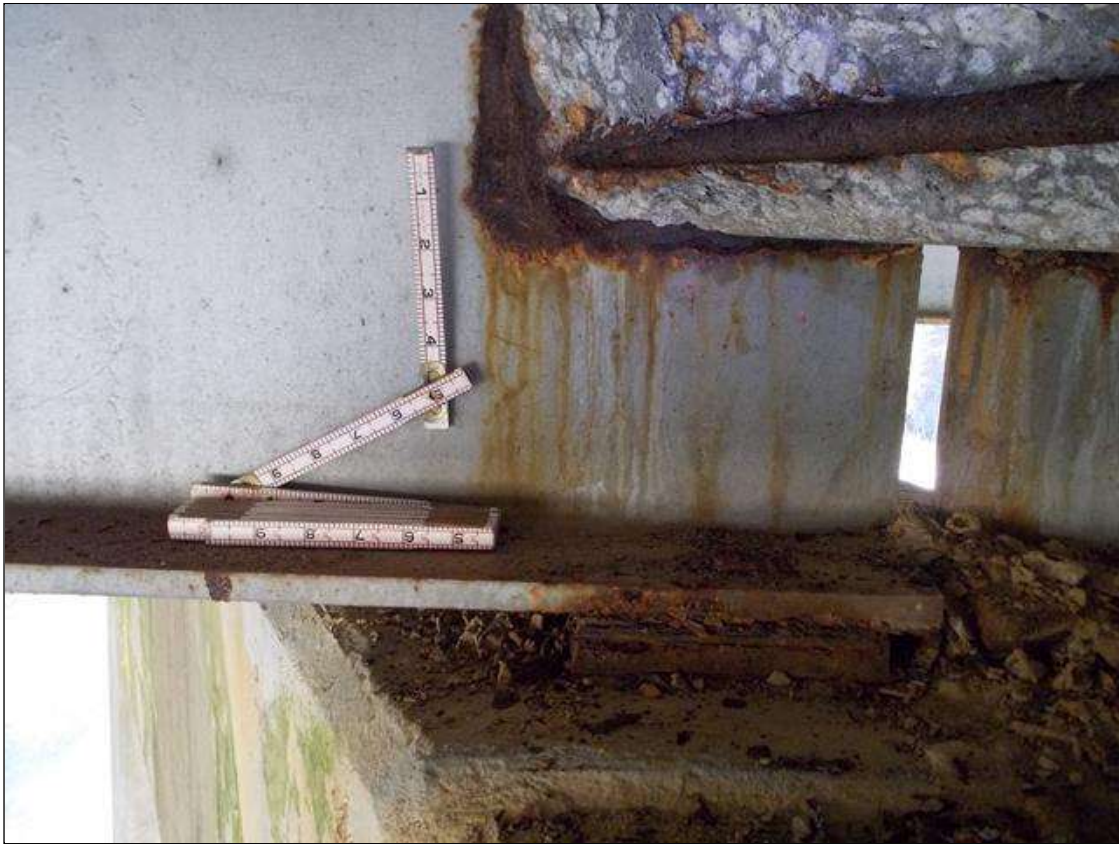
Span 3 Beam 1: 1' RUST STAINING WITH NO SECTION LOSS, WEB AT BENT 2 DIAPHRAGM.

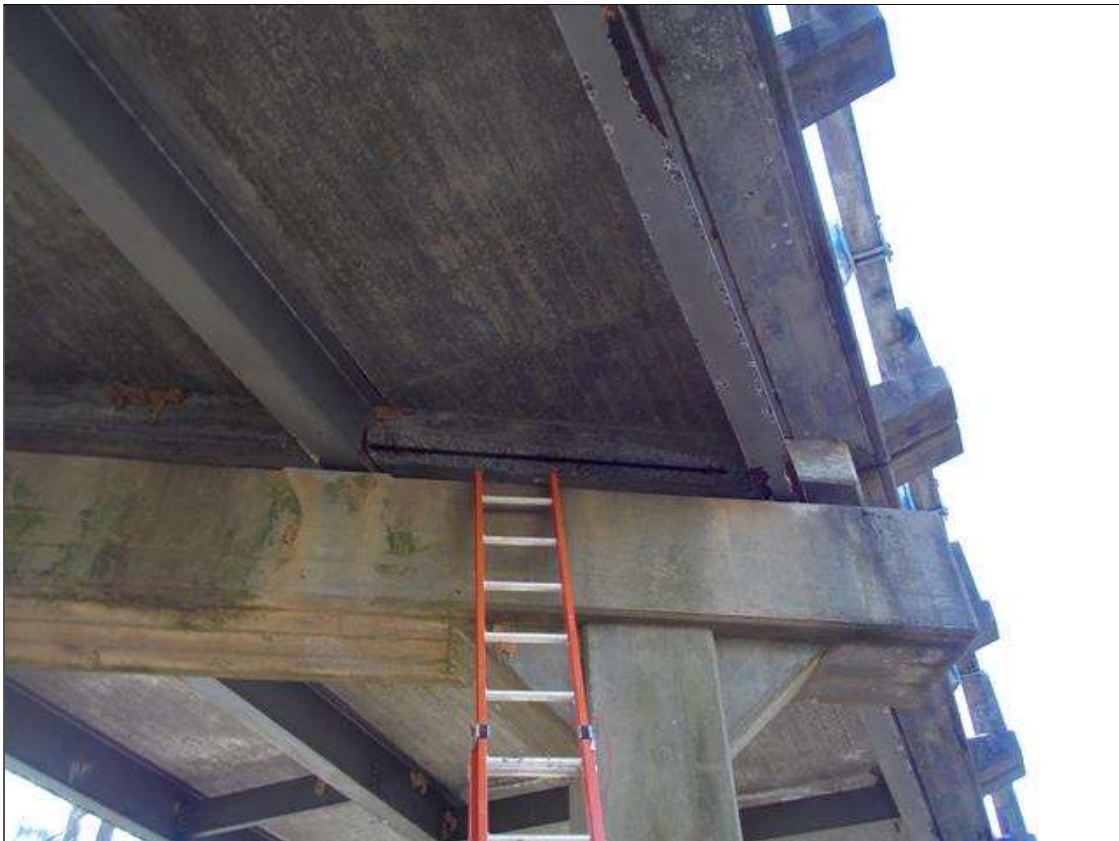
Span 3 Beam 2: 1' RUST SCALE WITH SECTION LOSS, 0.44" REMAINING, WEB AT BENT 2 DIAPHRAGM (PRIORITY MAINTENANCE).

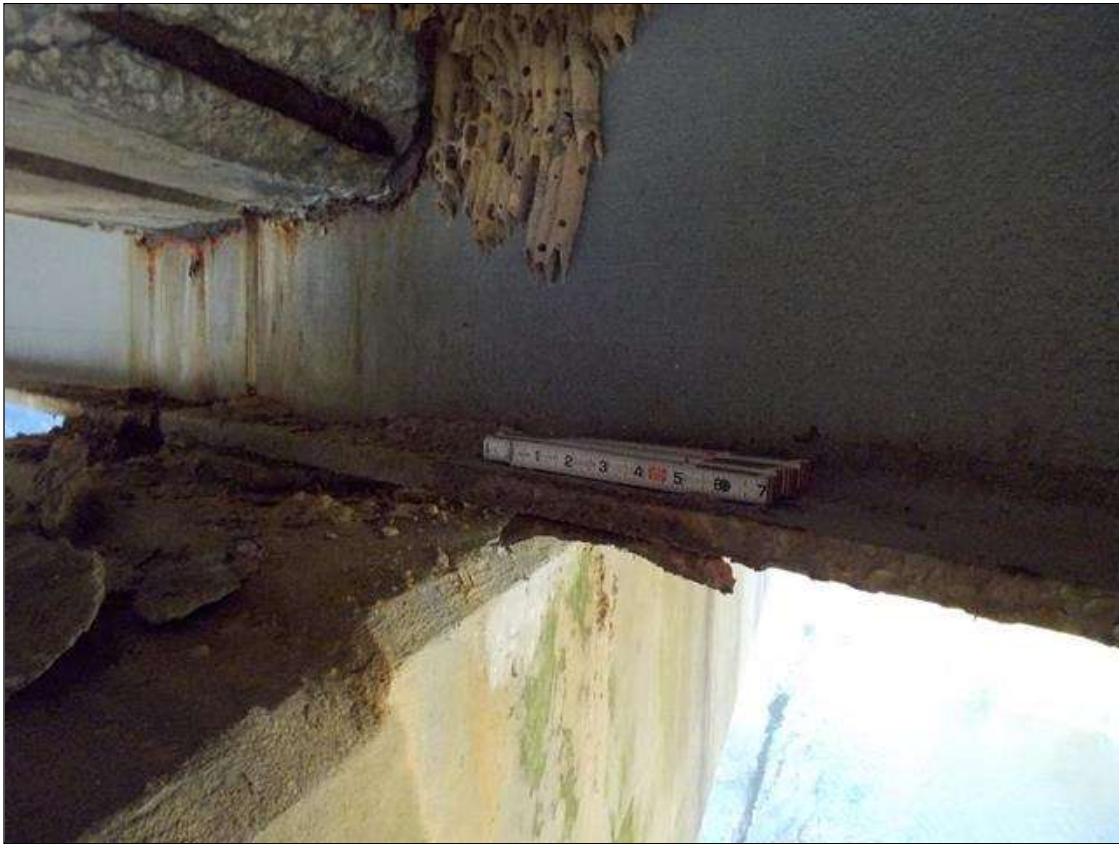
Superstructure: 8' X 6" X 1" SPALL WITH EXPOSED REINFORCING, END DIAPHRAGM, SPAN 3, BAY 1, OVER BENT 2.

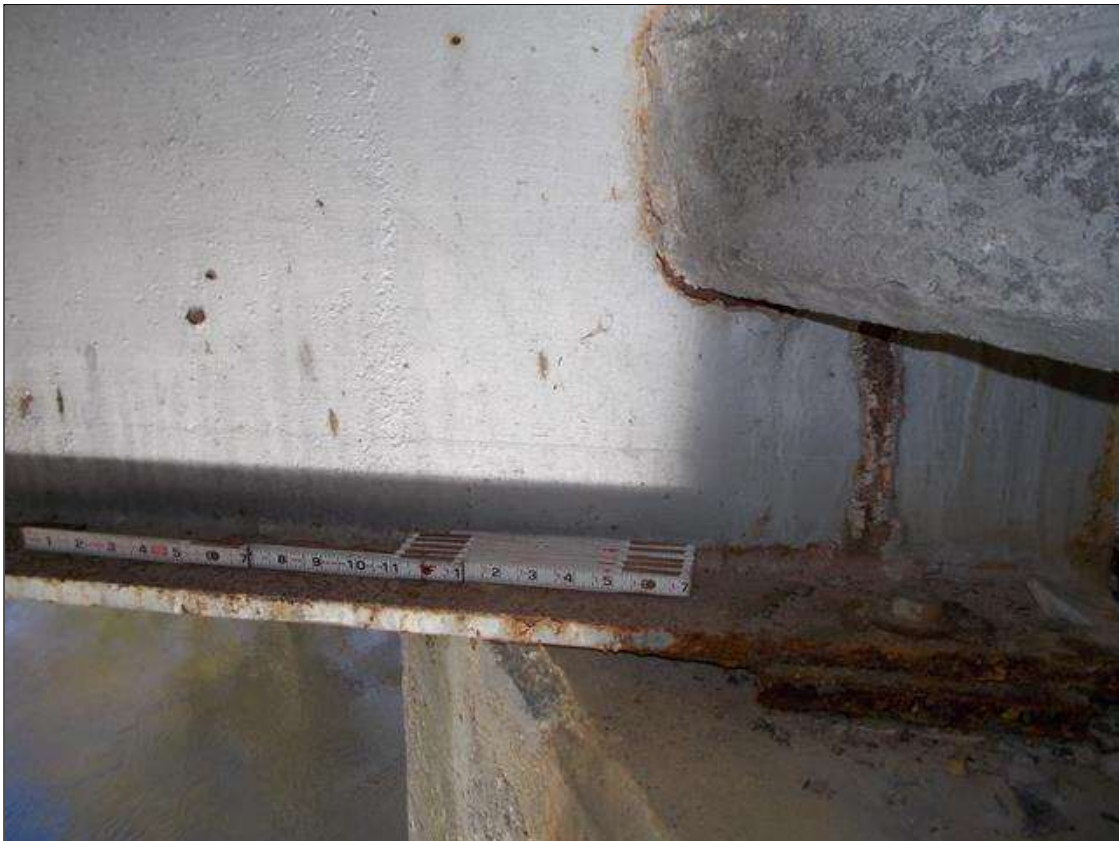
Span 3 Beam 4: 2' RUST SCALE WITH SECTION LOSS, 0.55" REMAINING, BOTTOM FLANGE, AT BENT 2 BEARING (PRIORITY MAINTENANCE).

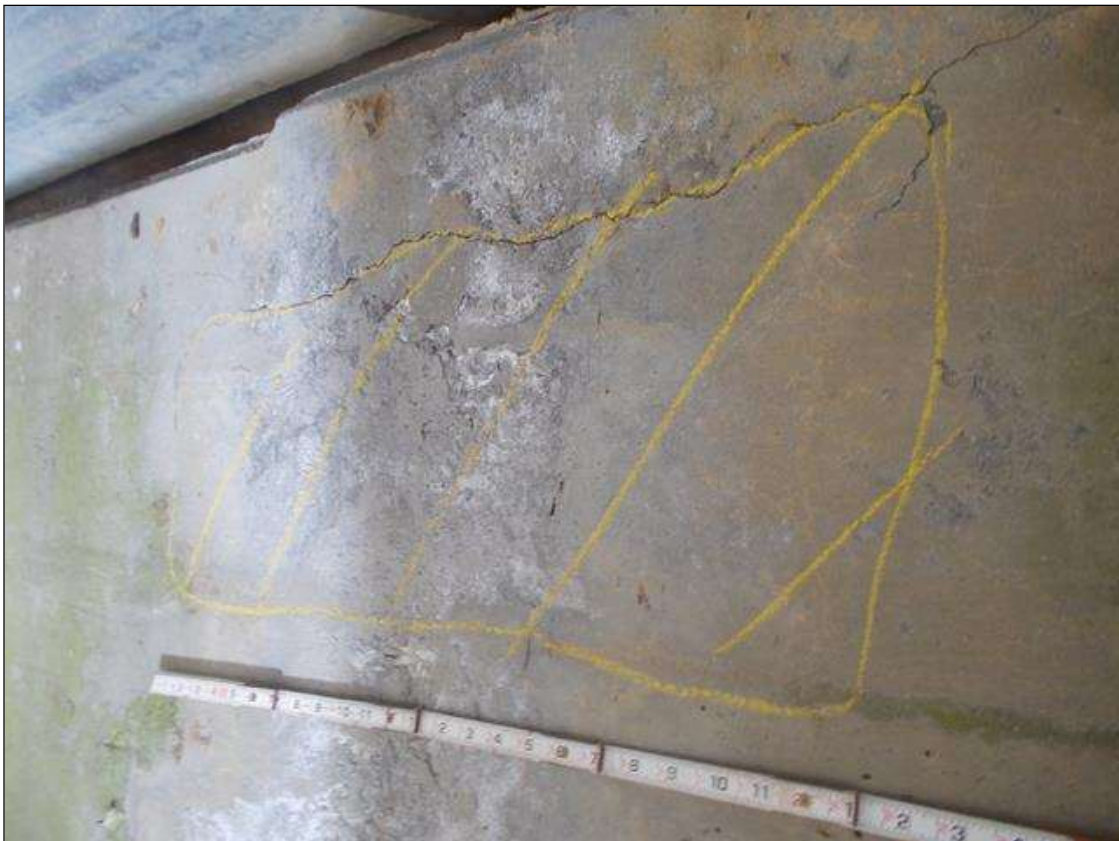
Bent 3 Cap : 4' X 1/32" CRACK, BENEATH BAY 1, SPAN 3 FACE.

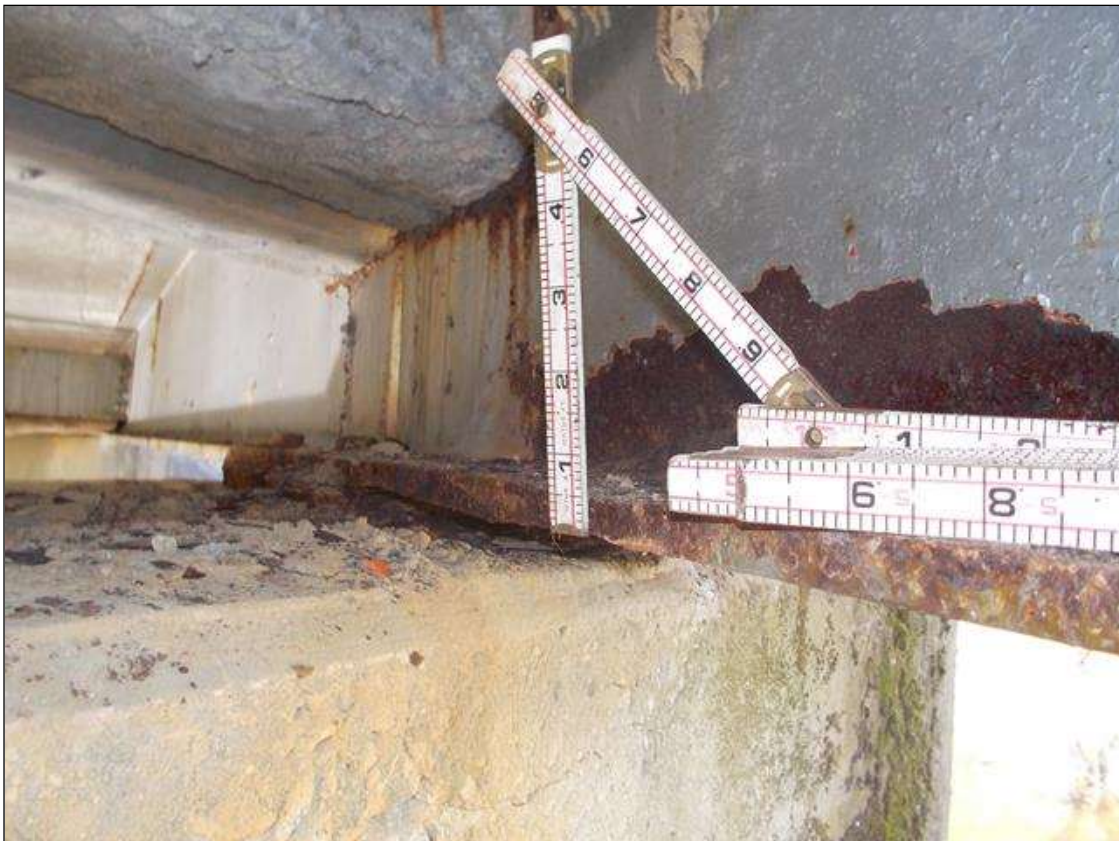
Span 3 Beam 3: 5' SHALLOW PITTING, BOTTOM FLANGE, MEASURED FROM BENT 3.

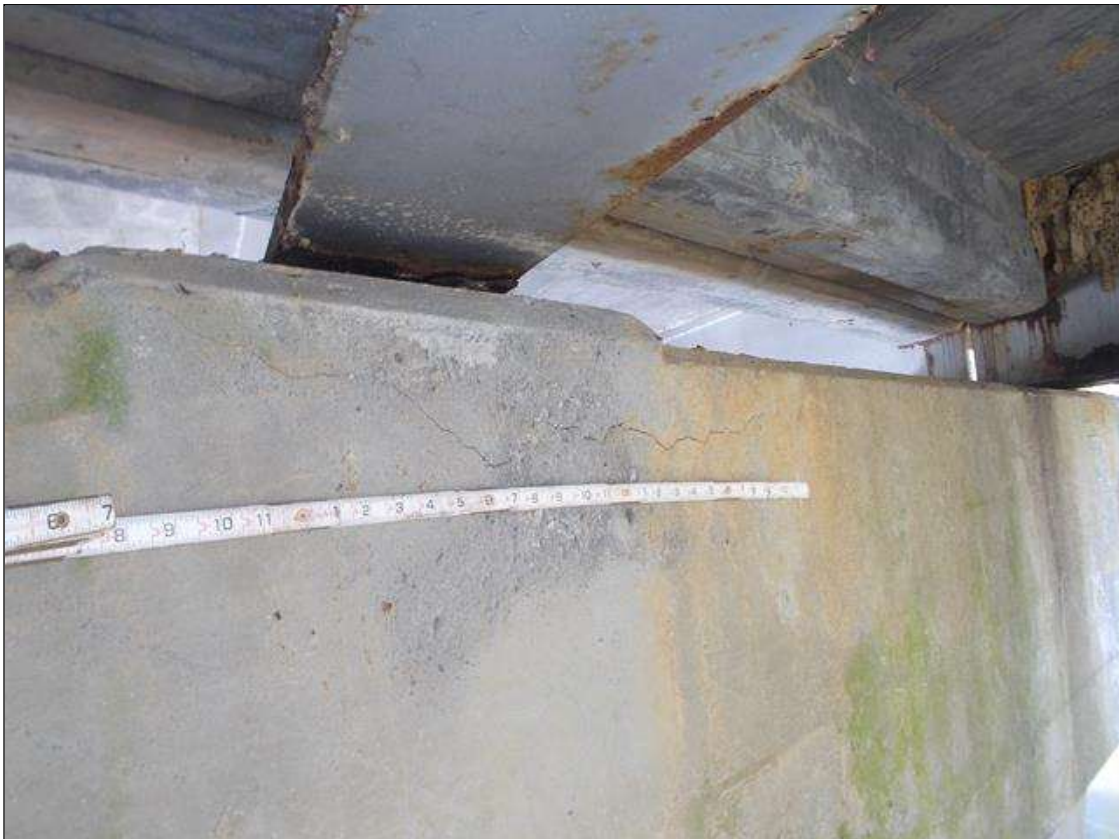
Bent 3 Cap : 2' X 1/64" VERTICAL CRACKS AT 12" CENTERS WITH 1/64" LONGITUDINAL CRACKS, BENEATH BEAM 1, SPAN 4 FACE.

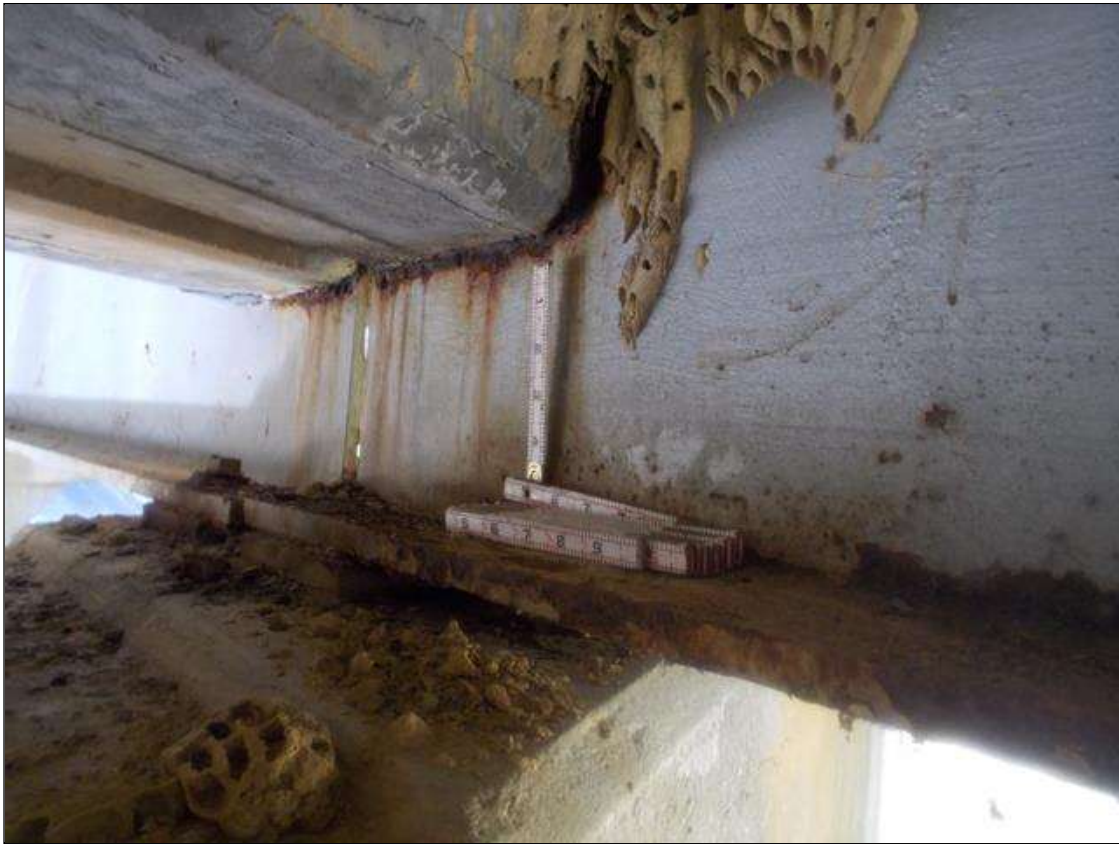
Bent 3 Cap : 2' X 1/32" LONGITUDINAL CRACK, BENEATH BEAM 2, SPAN 4 FACE.

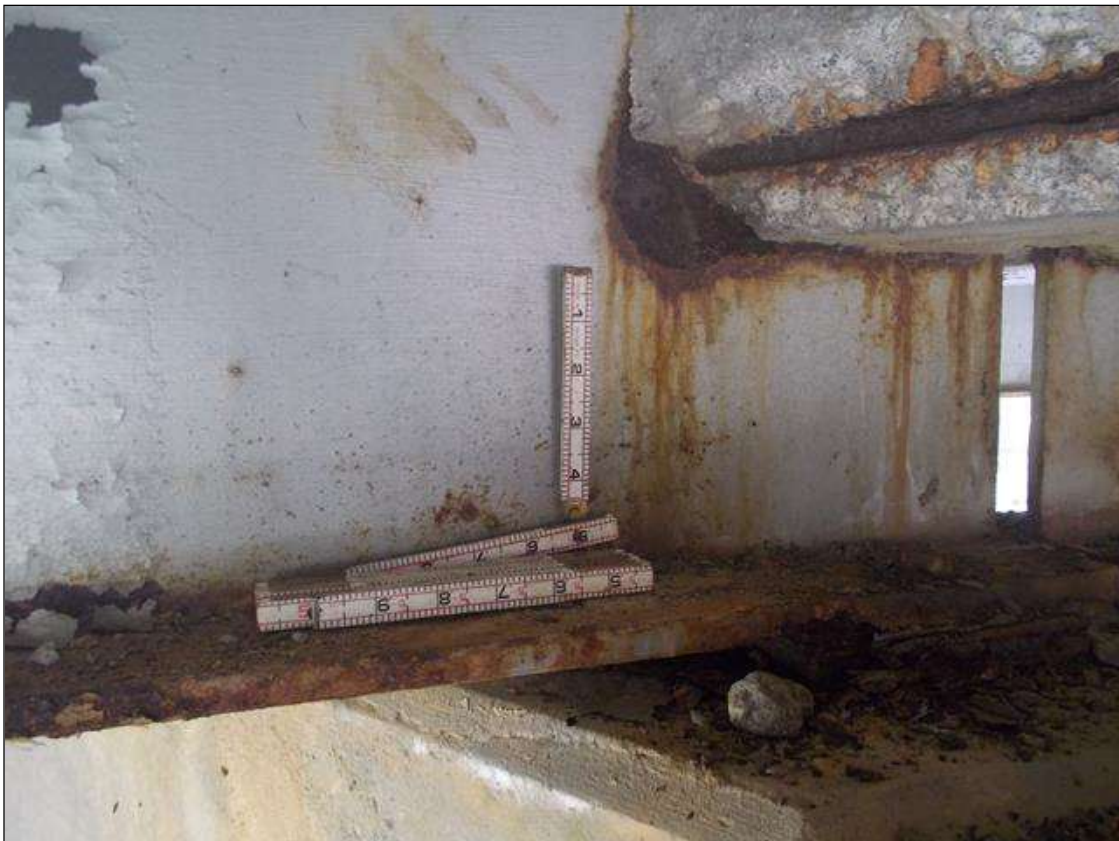
Span 4 Beam 2: 1' RUST SCALING, BOTTOM FLANGE, BENT 3 BEARING.

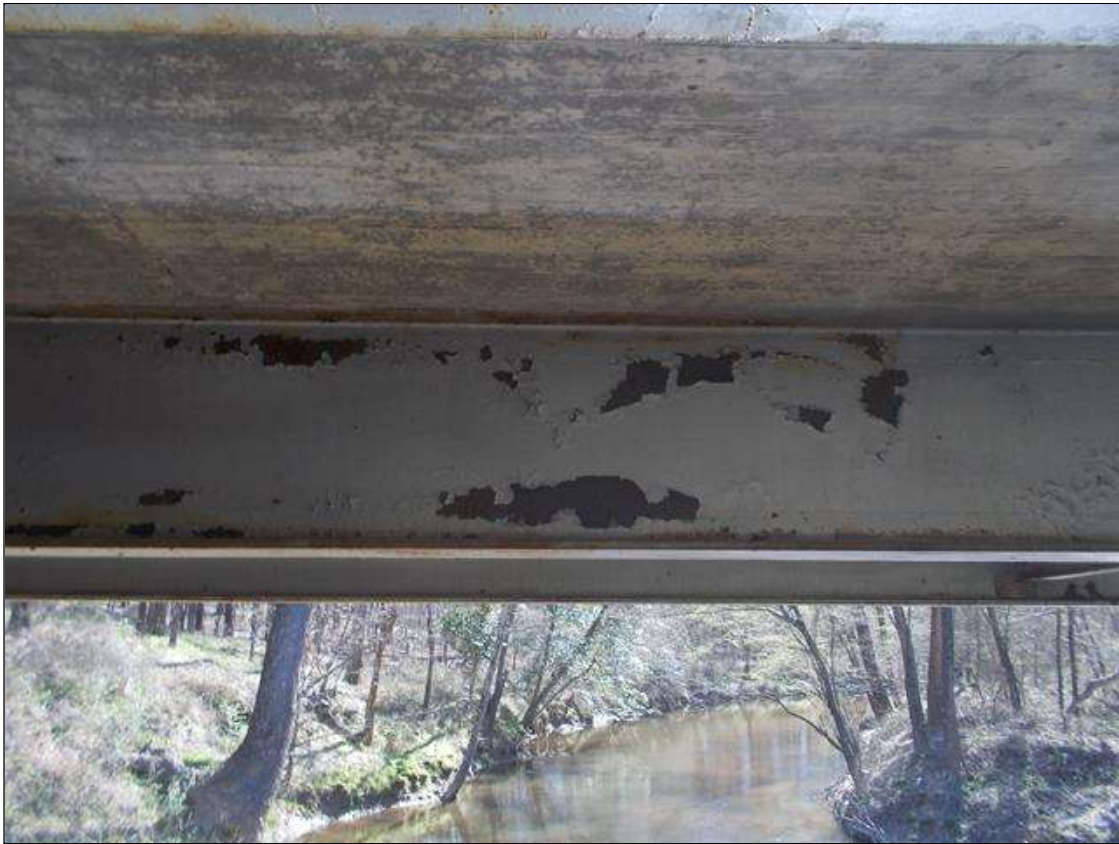
Span 4 Beam 3: 1' RUST SCALE WITH SECTION LOSS, 0.44" REMAINING, WEB AT BENT 3 DIAPHRAGM (PRIORITY MAINTENANCE).

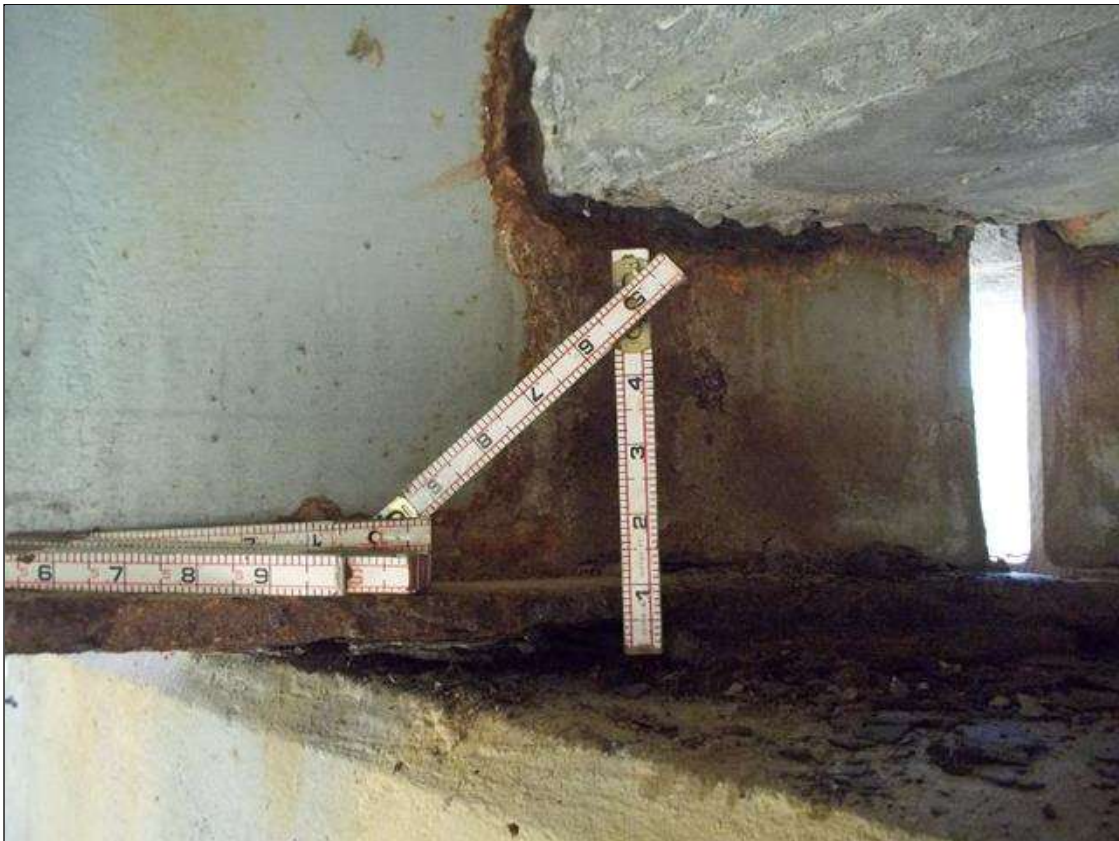
Span 4 Beam 4: 1' RUST SCALE WITH SECTION LOSS, 0.45" REMAINING, BOTTOM FLANGE AND WEB, AT BENT 3 BEARING (PRIORITY MAINTENANCE).

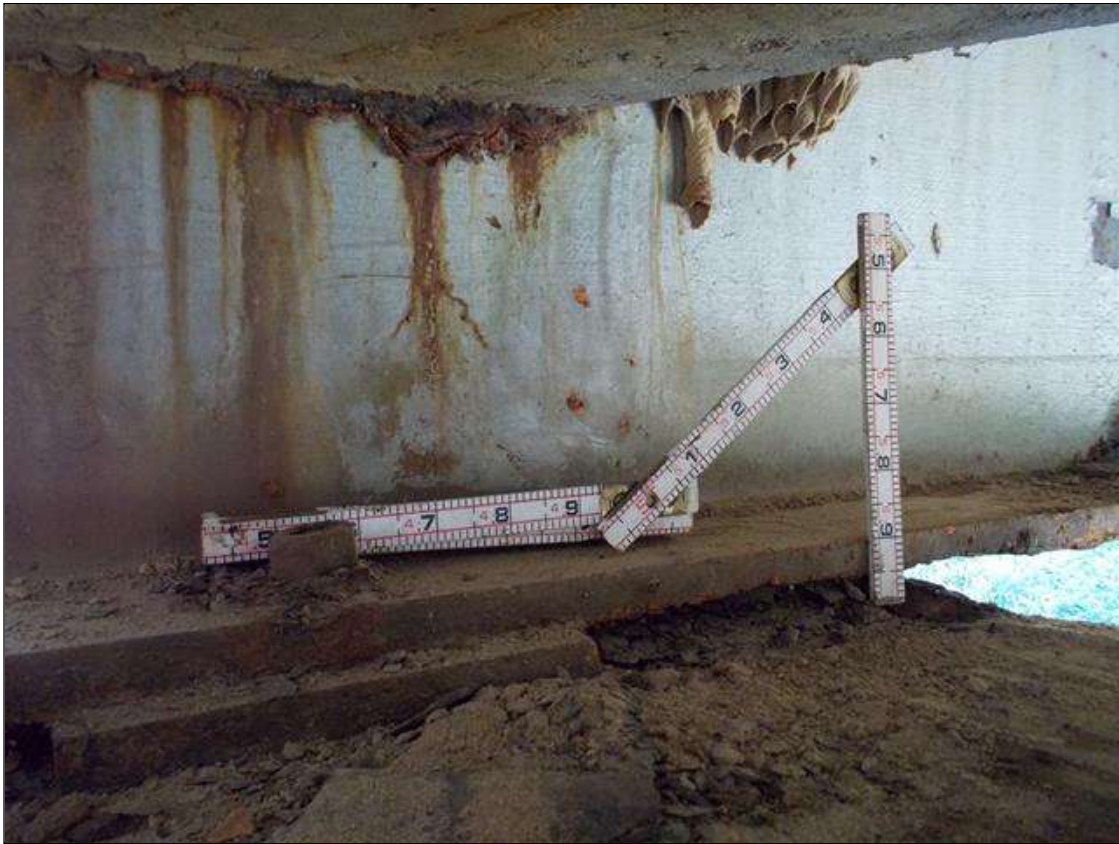
Span 4 Beam 1: 1' RUST SCALE WITH SECTION LOSS, 0.5" REMAINING, BOTTOM FLANGE AT BENT 4 BEARING (PRIORITY MAINTENANCE).

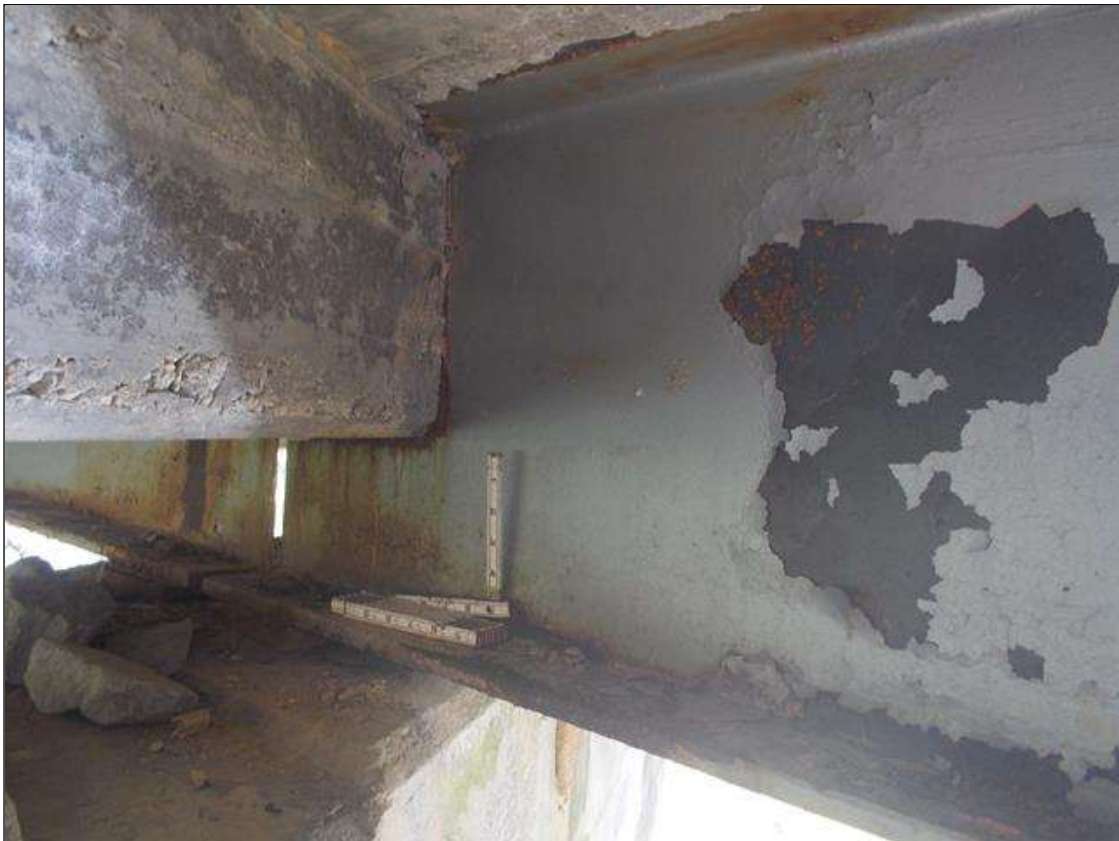
Span 5 Beam 1: 1' RUST SCALE WITH SECTION LOSS, 0.5" REMAINING, BOTTOM FLANGE, AT BENT 4 BEARING (PRIORITY MAINTENANCE).

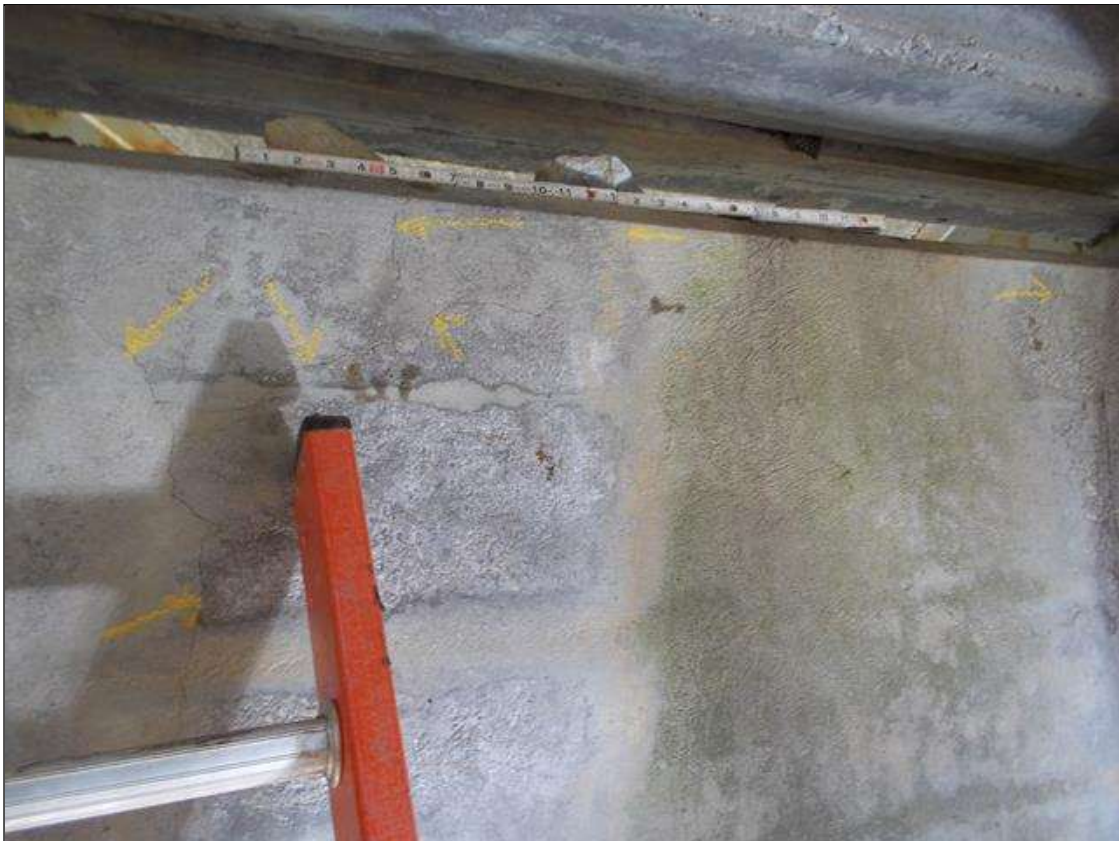
Bent 4 Cap : 48" TRANSVERSE HAIRLINE CRACKS , 42" ON CENTER, SPAN 4 FACE, WITH 12" LONGITUDINAL HAIRLINE CRACK, TOP FACE.

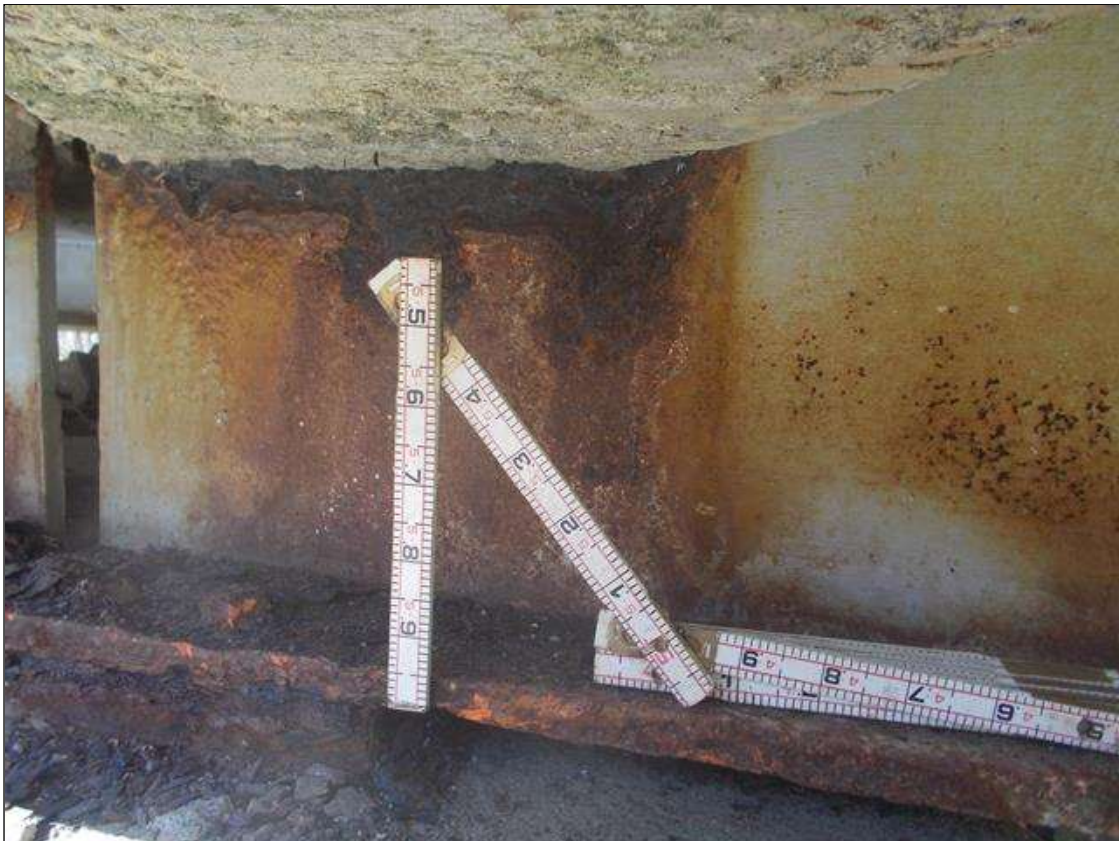
Span 4 Beam 4: 1' RUST SCALE WITH SECTION LOSS, 0.3" REMAINING, BOTTOM FLANGE AND WEB, AT BENT 4 BEARING (PRIORITY MAINTENANCE).

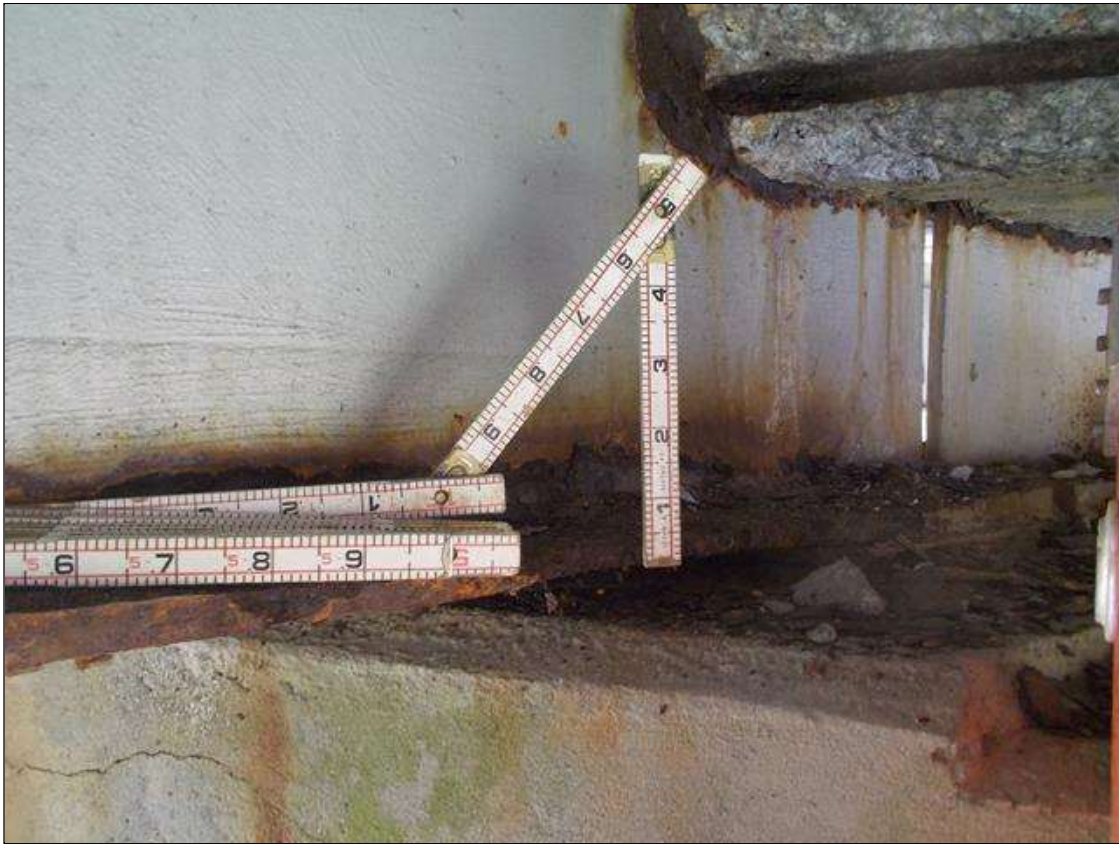
Span 5 Beam 4: 1' RUST SCALE WITH SECTION LOSS, 0.4" REMAINING, BOTTOM FLANGE AND WEB, AT BENT 4 BEARING (PRIORITY MAINTENANCE).

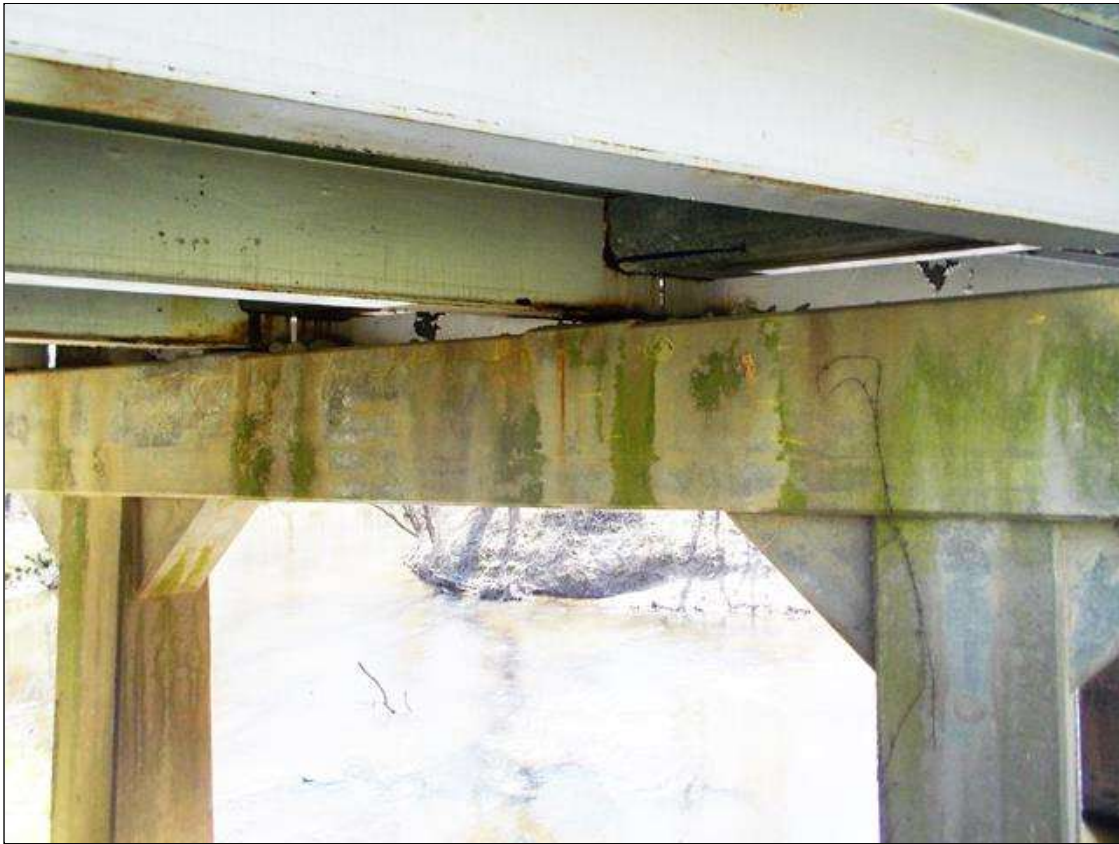
Span 5 Beam 2: 2' RUST SCALING, BOTTOM FLANGE AND WEB, 1/16" SECTION LOSS WEB AT BENT 4 DIAPHRAGM, 0.15" REMAINING UPSTREAM BOTTOM FLANGE TAPERING TO 0.5" REMAINING DOWNSTREAM BOTTOM FLANGE, AT BENT 4 BEARING (PRIORITY MAINTENANCE ).

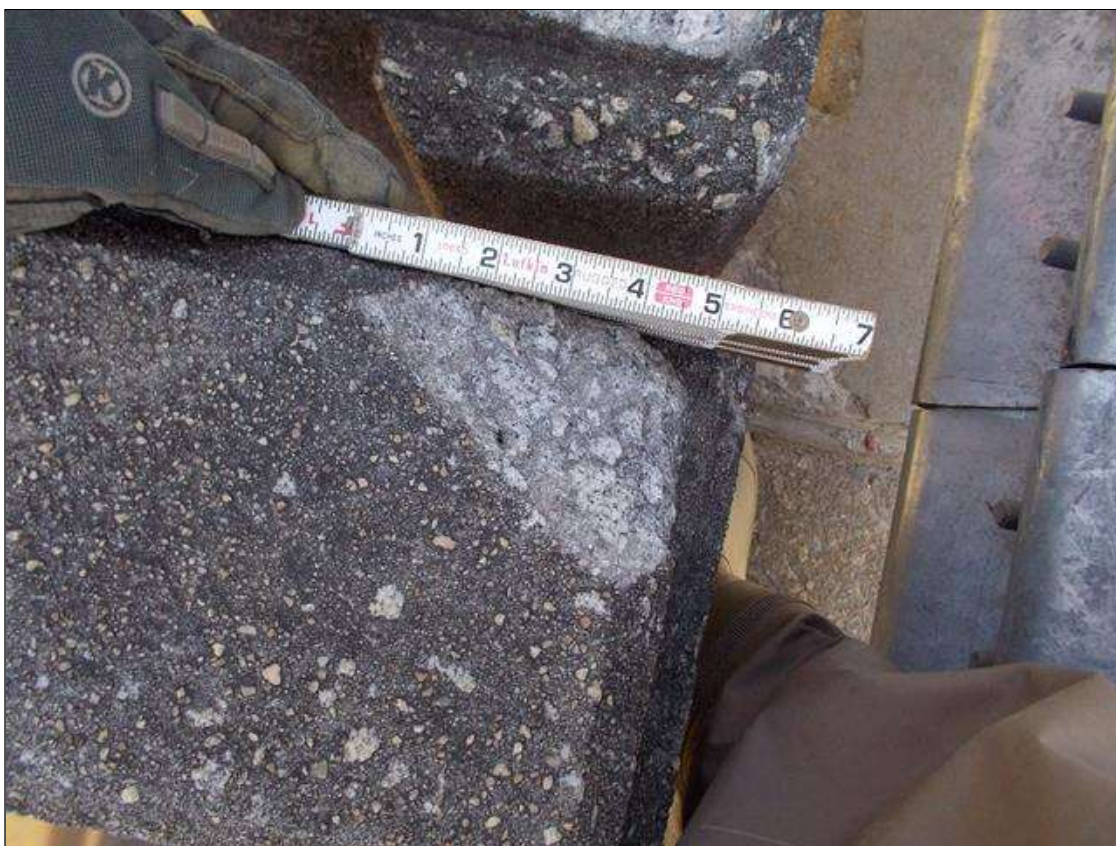
Span 3 Left Bridge Rail: 7" X 7" X 3/4" SPALL, TOP OF POST 5.

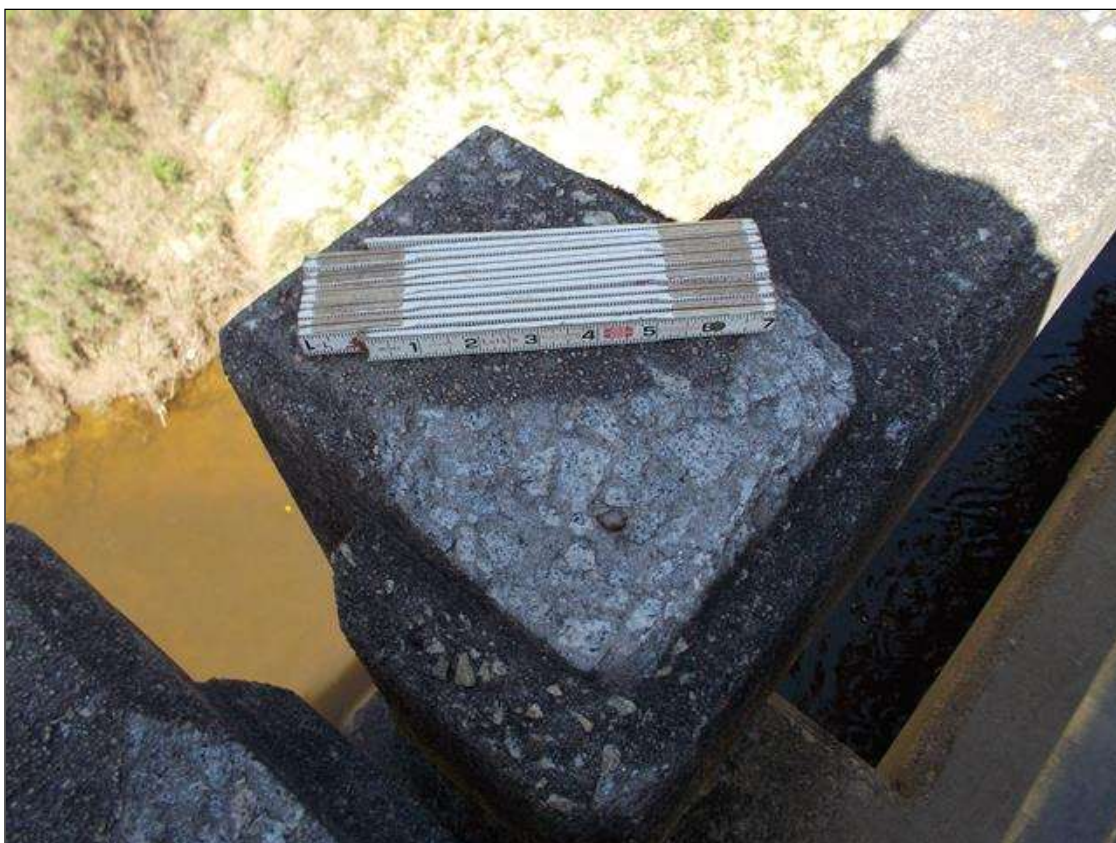
Span 3 Left Bridge Rail: 3" X 3" X 2" CORNER SPALL, POST 6.

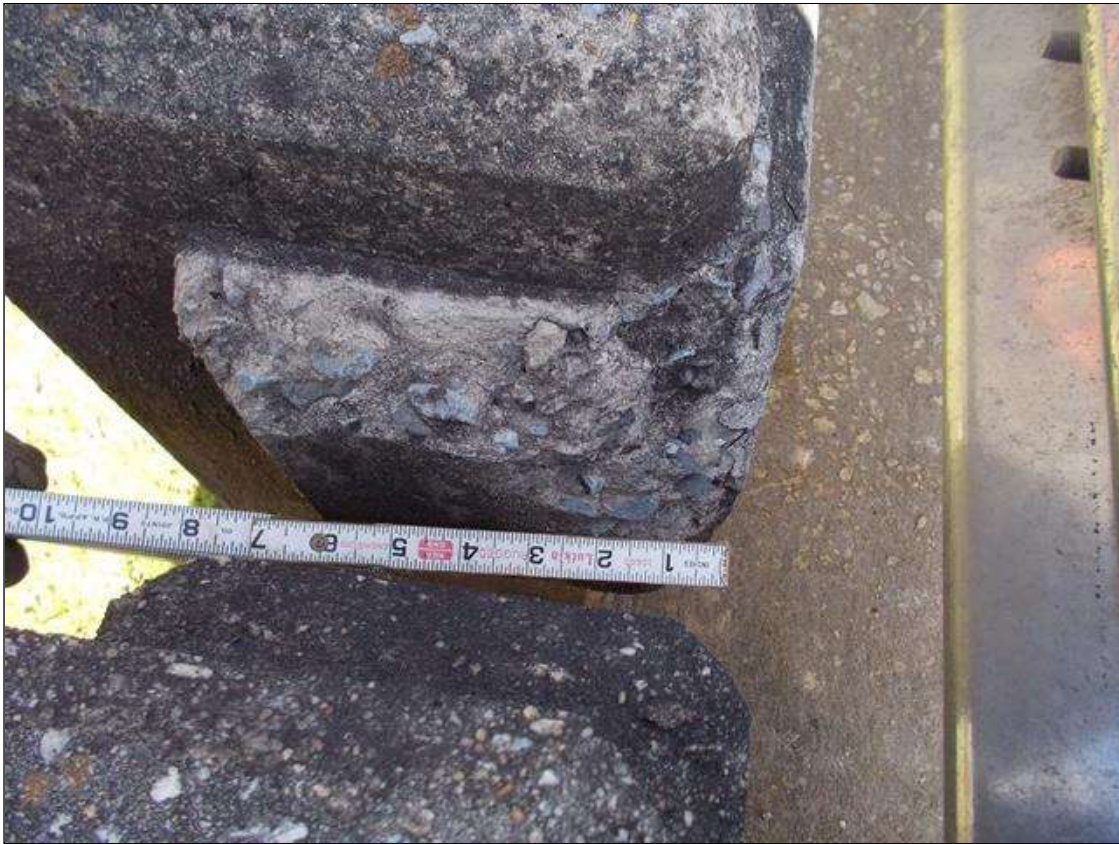
Span 4 Left Bridge Rail: 8" X 4" X 2.5" CORNER SPALL WITH EXPOSED REINFORCING, POST 1.

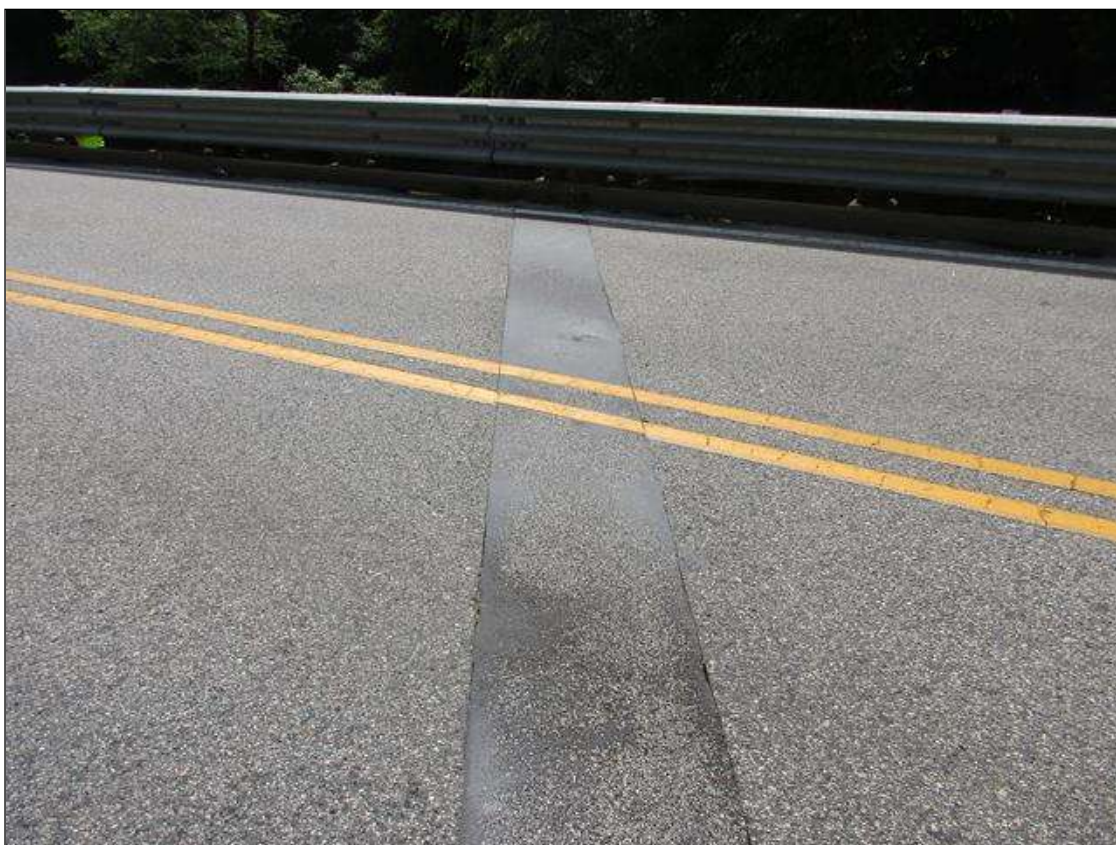
CRACK IN ASPHALT WEARING SURFACE OVER END BENT 1, LOOKING WEST
