NC DEPARTMENT OF TRANSPORTATION  
DIVISION OF HIGHWAYS  
BRIDGE MANAGEMENT UNIT

# BRIDGE INSPECTION REPORT

INSPECTION TYPE: Routine Inspection

COUNTY JOHNSTON BRIDGE NUMBER 500216 INSPECTION CYCLE 2 YRS  
ROUTE SR2143 ACROSS LITTLE BUFFALO CREEK M.P. 0

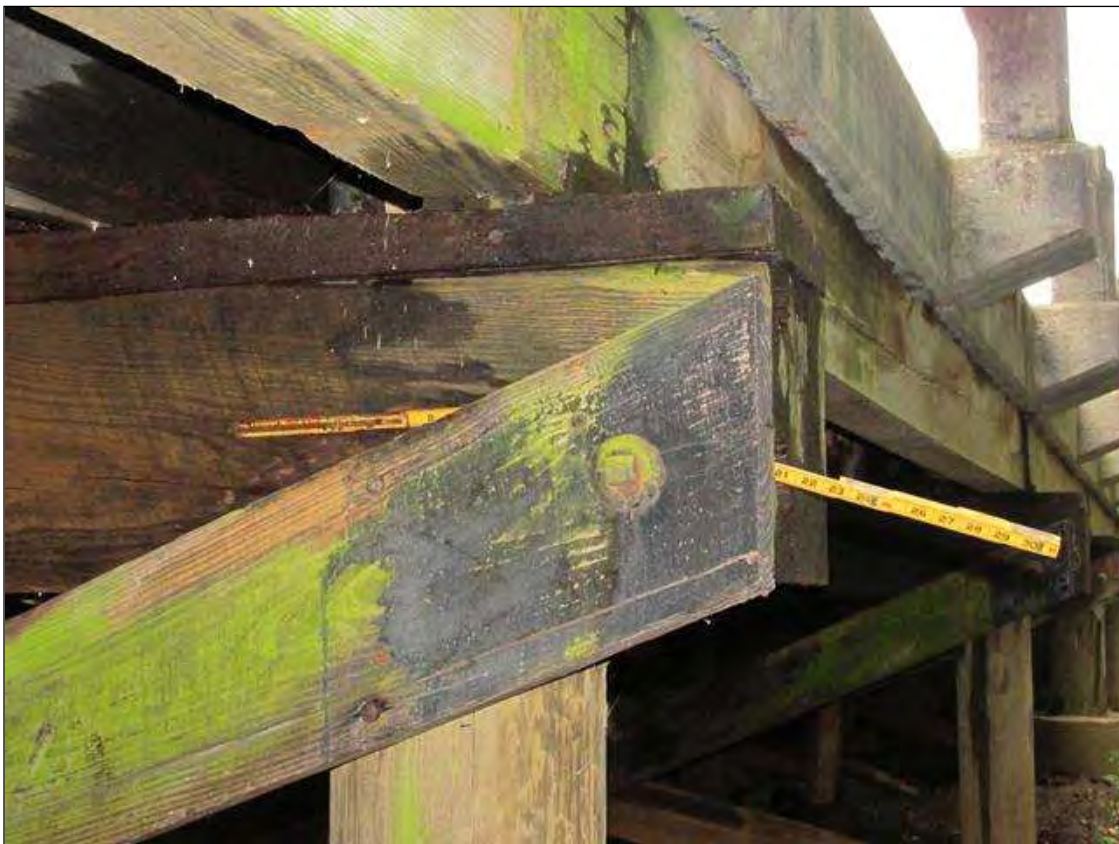
| MMS Code | Description of Function | Unit | Quantity | Remarks | Est. Cost |
|---|---|---|---|---|---|
| 3344 | Repair / Replace Timber Substructure Components | LF | 2 <del>TSE</del> | THE LEFT END OF BENT 4 CAP IS DECAYED 2 IN. DIAMETER X 7 IN. DEEP AND DECAYED 4 IN. DIAMETER EXTENDING 21 IN. INTO THE SPAN 5 SIDE FACE 4 IN. HIGH X 2 IN. DEEP BEHIND THE CROSSBRACE CONNECTION OVER PILE 1. THERE IS A 1/4 WIDE SPLIT IN THE AREA OF DECAY 2 IN. DEEP IN THE SPAN 5 SIDE. | |

DECAY LEFT END AND SPAN 5 SIDE OF BENT 4 CAP PRIORITY MAINTENANCE ISSUED

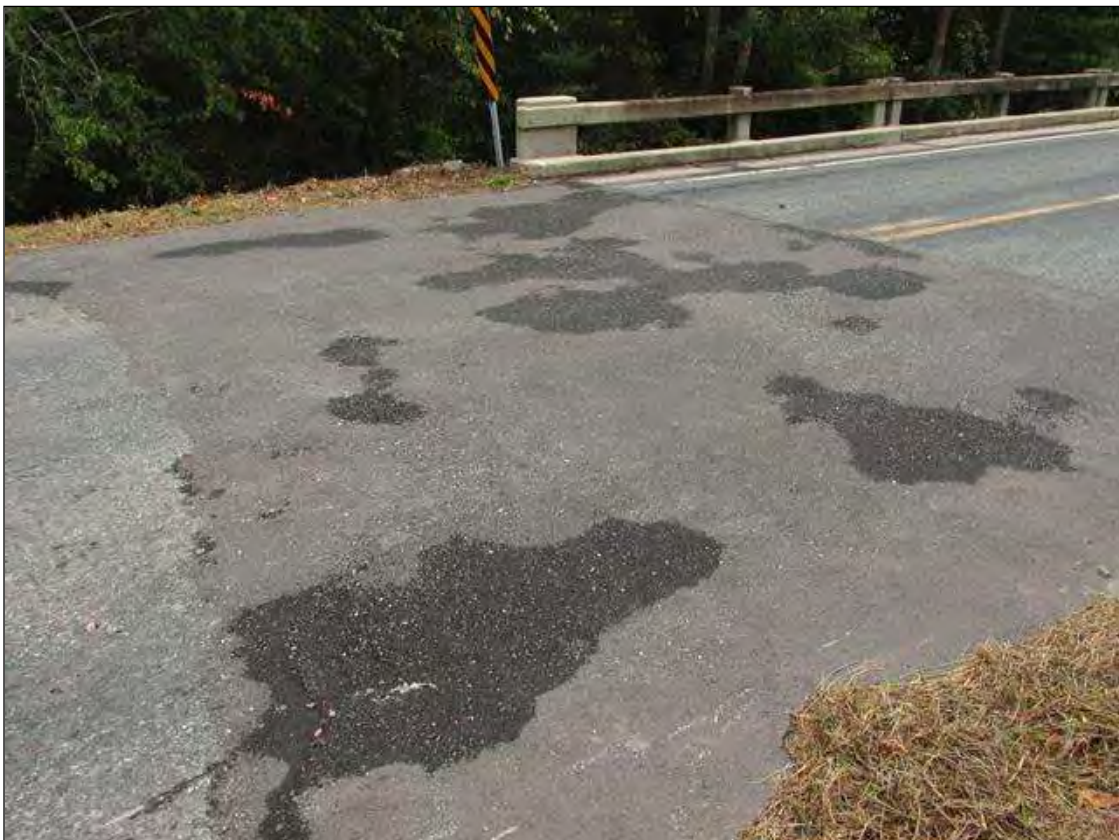
APPROACH 1 PATCHED

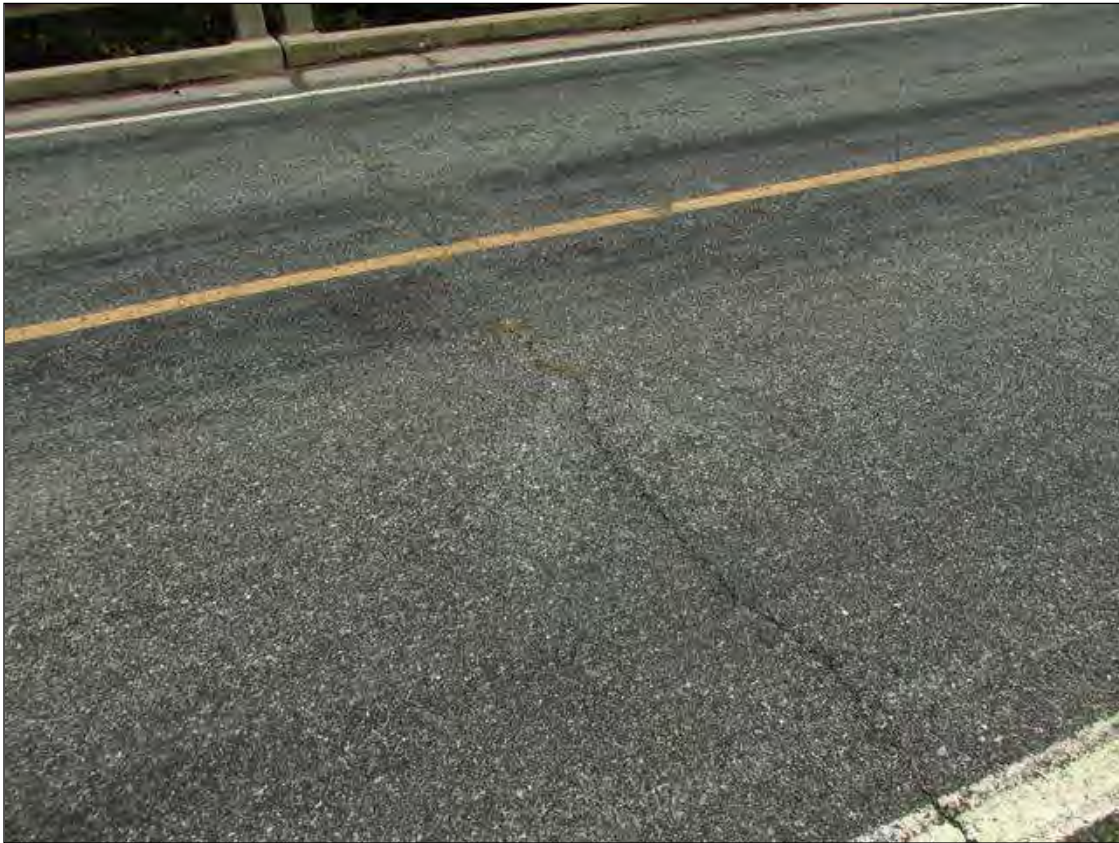
| 1 | G | WEARING SURFACE<br>TRANSVERSE CRACK IN ASPHALT OVER EXPANSION JOINTS AT INTERIOR BENTS. | |

TRANSVERSE CRACK IN WEARING SURFACE OVER BENT 1

| MMS Code | Description of Function | Unit | Quantity | Remarks | Est. Cost |
|---|---|---|---|---|---|
| 2816 | Asphalt Surface Repair or Replacement | SY | 150 | APPROACH 2 CRACKED SETTLED. ASPHALT OVER EXPANSION JOINTS CRACKED. | |

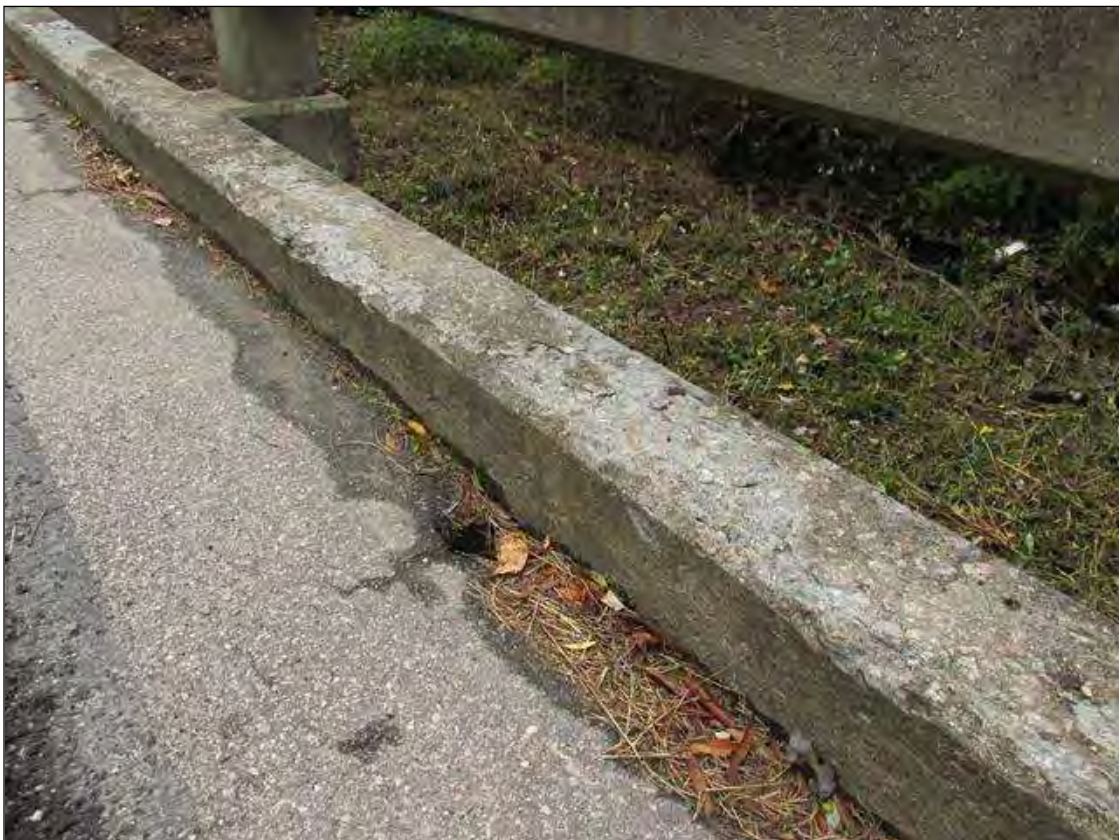
| 4 | F | CURBS<br>SCALING WITH EXPOSED COARSE AGGREGATE AND HAIRLINE MAP CRACKS IN<br>FACES .<br>SPAN 2<br>RIGHT SIDE TOP OF CURB SCALED AND SPALLED 3/4 IN. DEEP THE FULL LENGTH<br>OF SPAN. | |

DELAMINATION ALONG THE RIGHT SIDE CURB IN SPAN 2

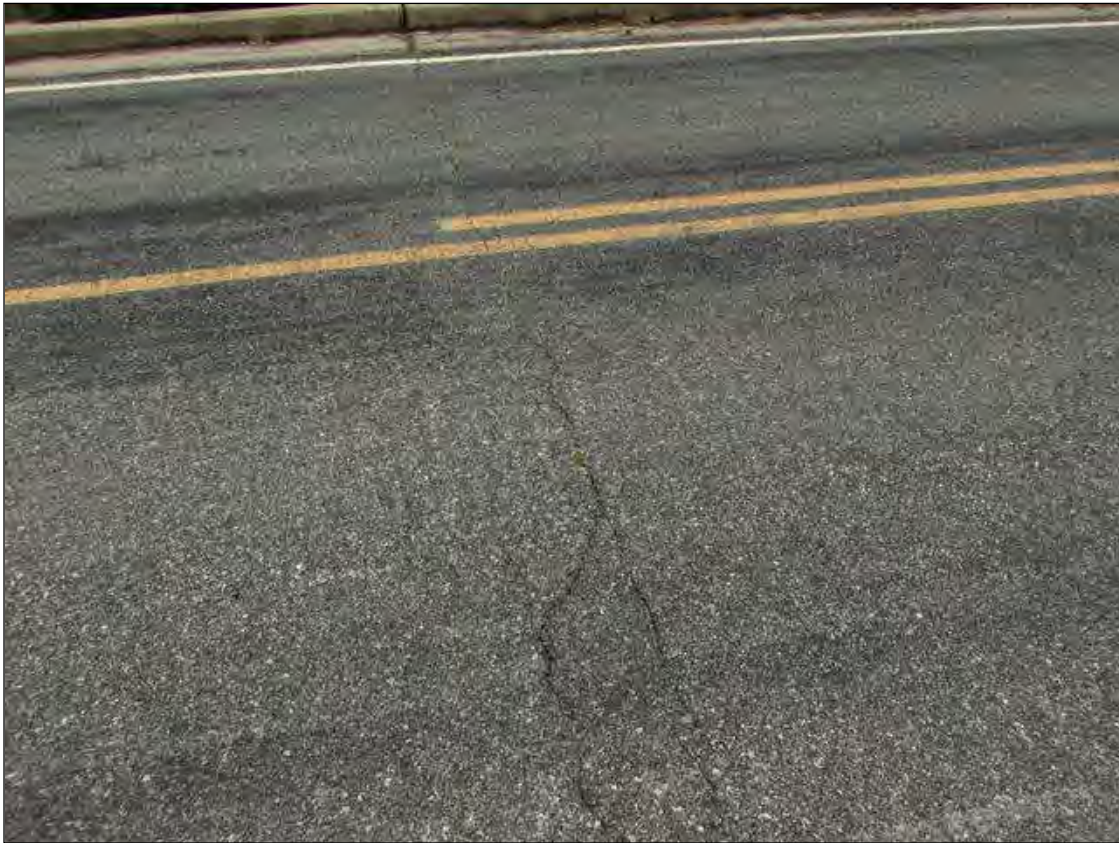
TRANSVERSE CRACK IN WEARING SURFACE OVER BENT 2

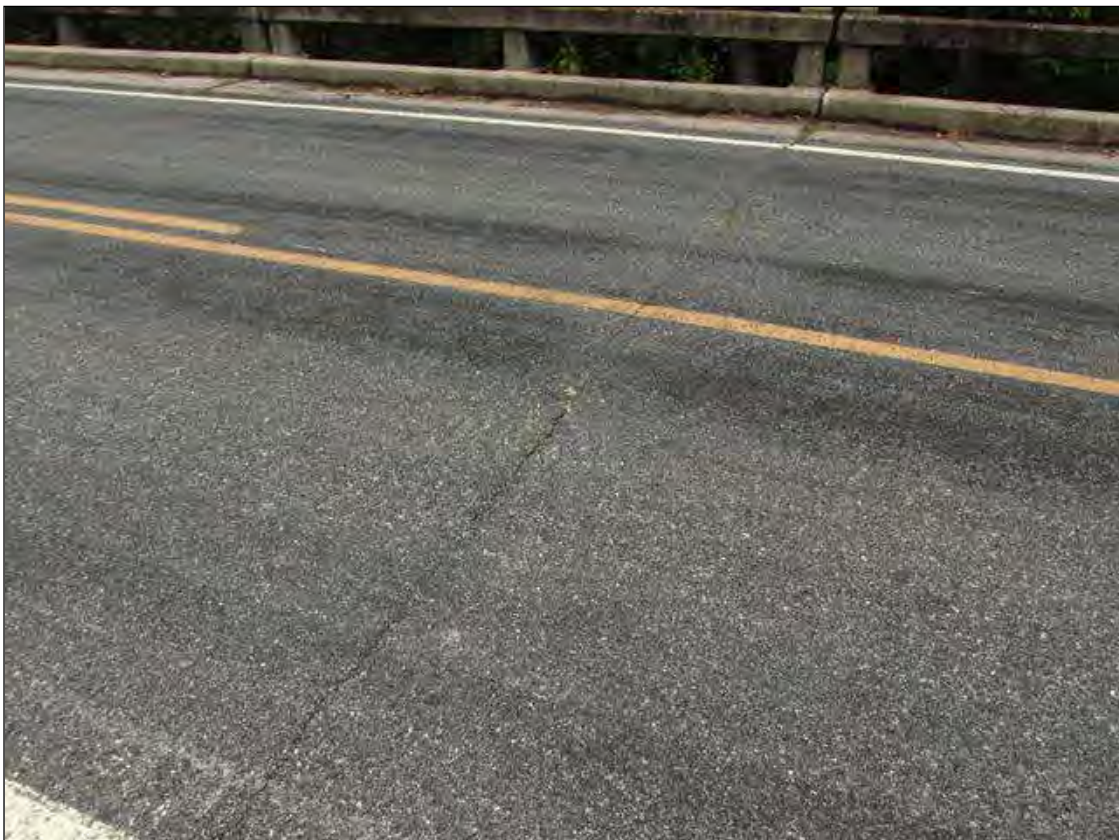
TRANSVERSE CRACK IN WEARING SURFACE OVER BENT 3

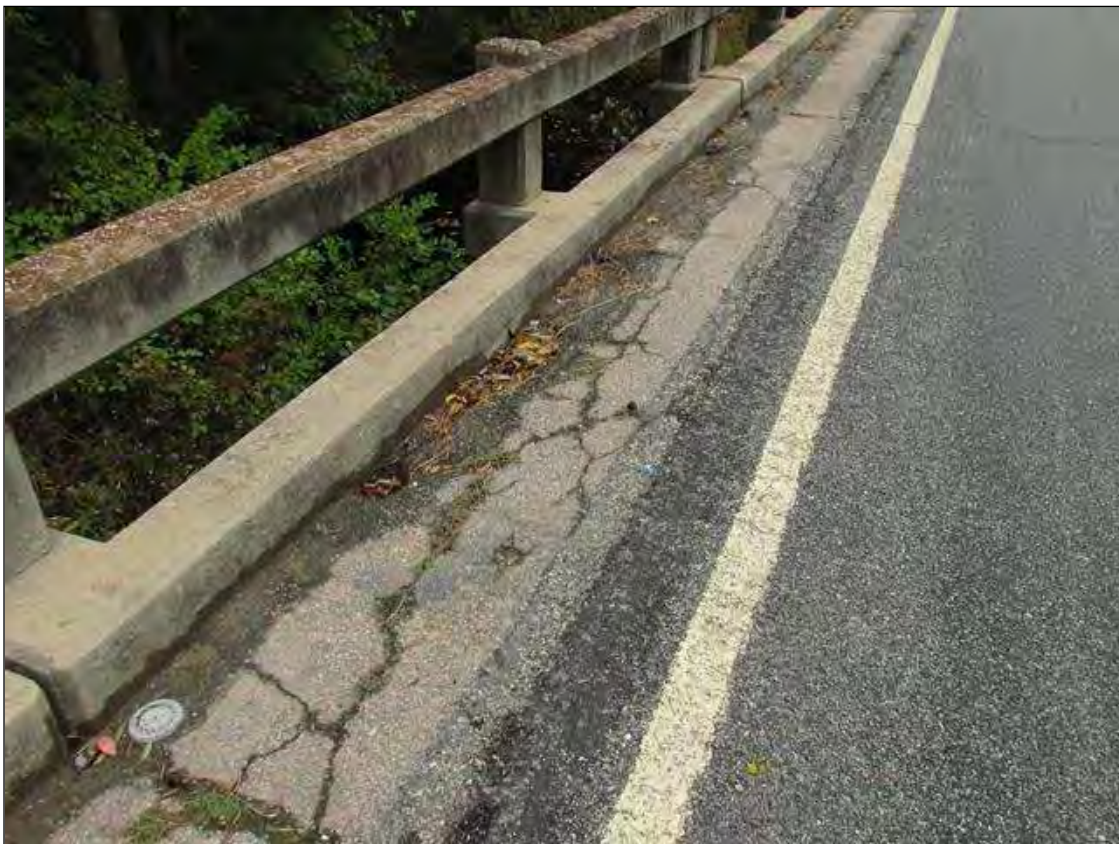
MAP CRACKING IN IN THE LEFT SIDE SHOULDER ASPHALT IN SPAN 3

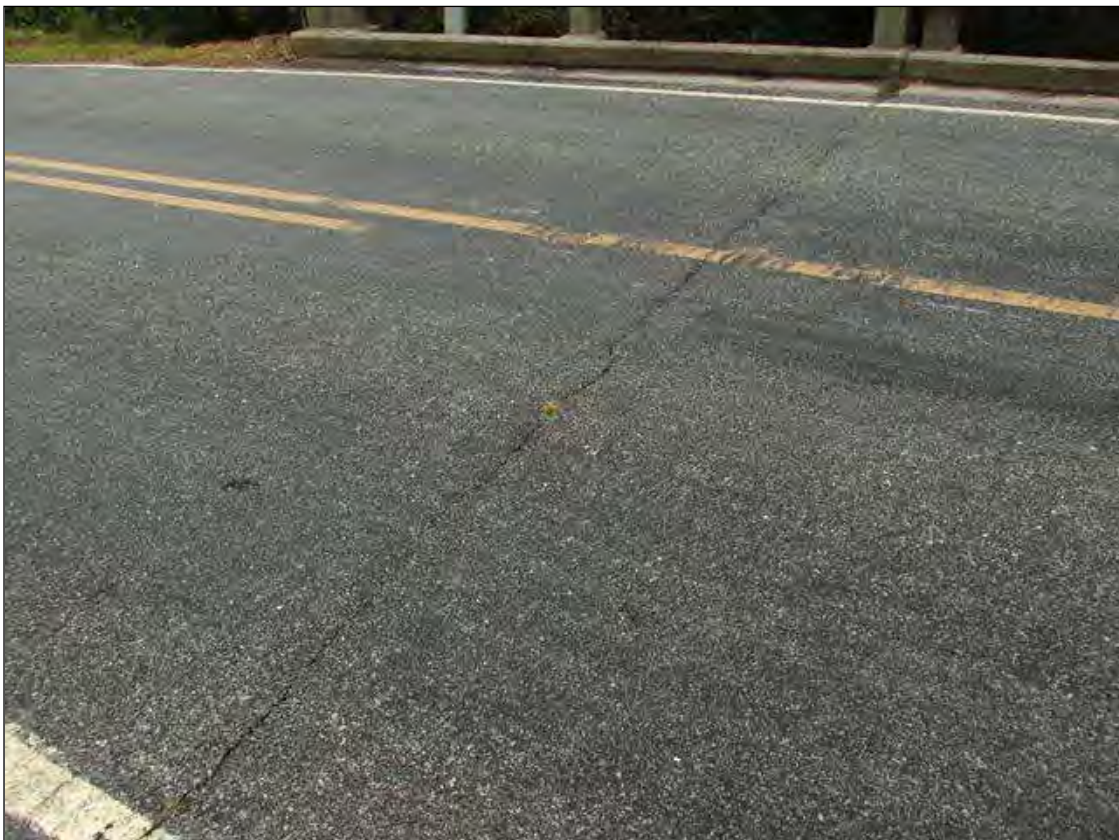
TRANSVERSE CRACK IN WEARING SURFACE OVER BENT 3

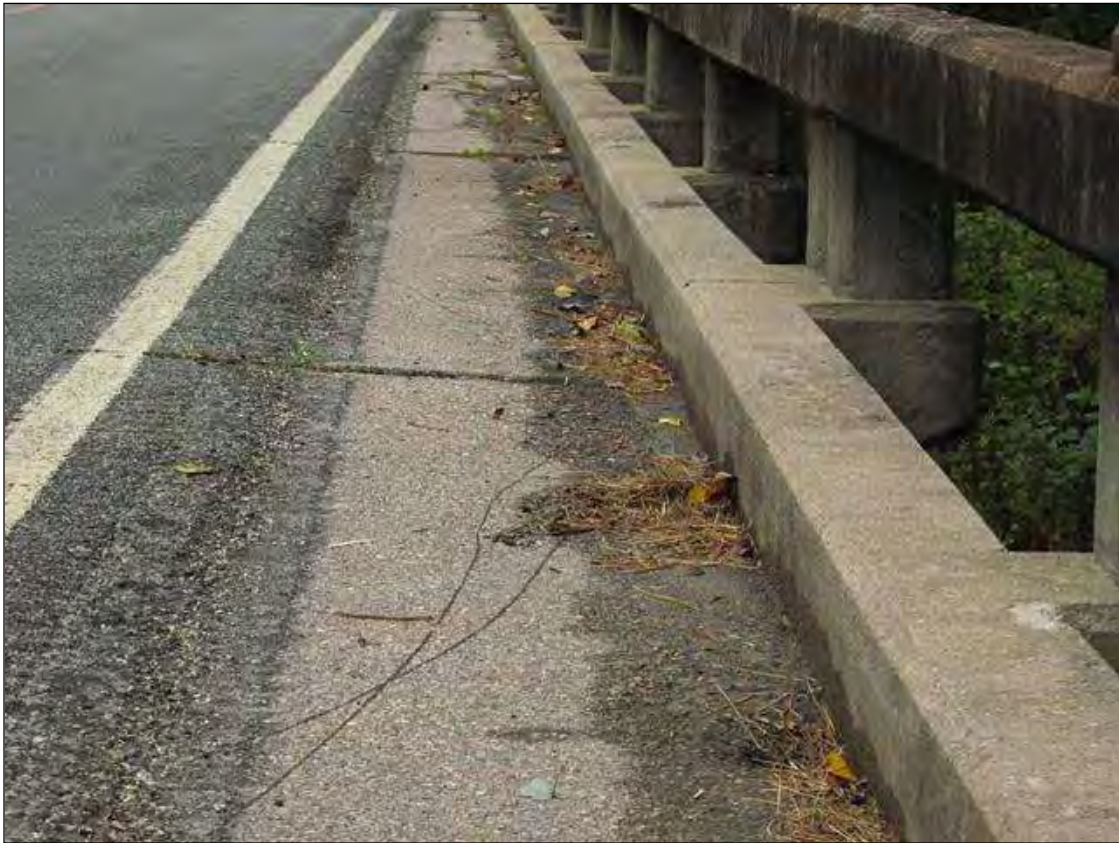
DEBRIS AND VEGETATION ALONG CURBLINES

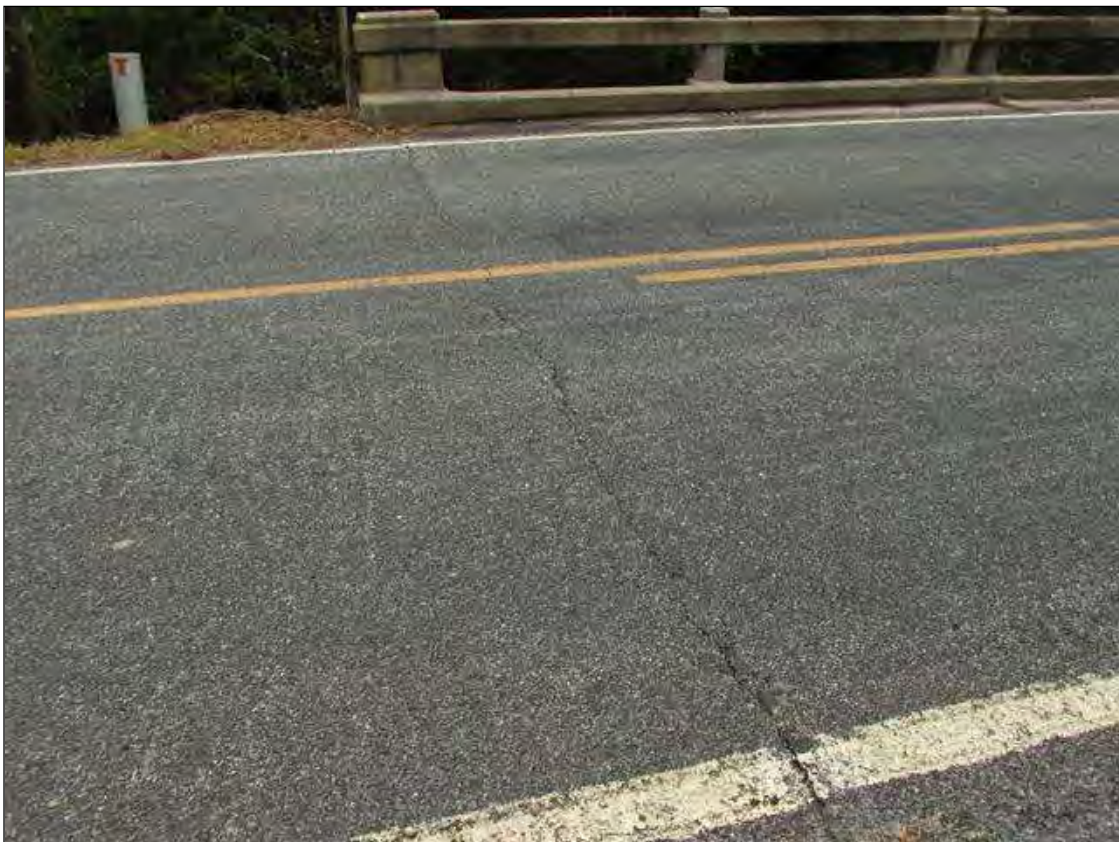
TRANSVERSE CRACK IN WEARING SURFACE OVER END BENT 2

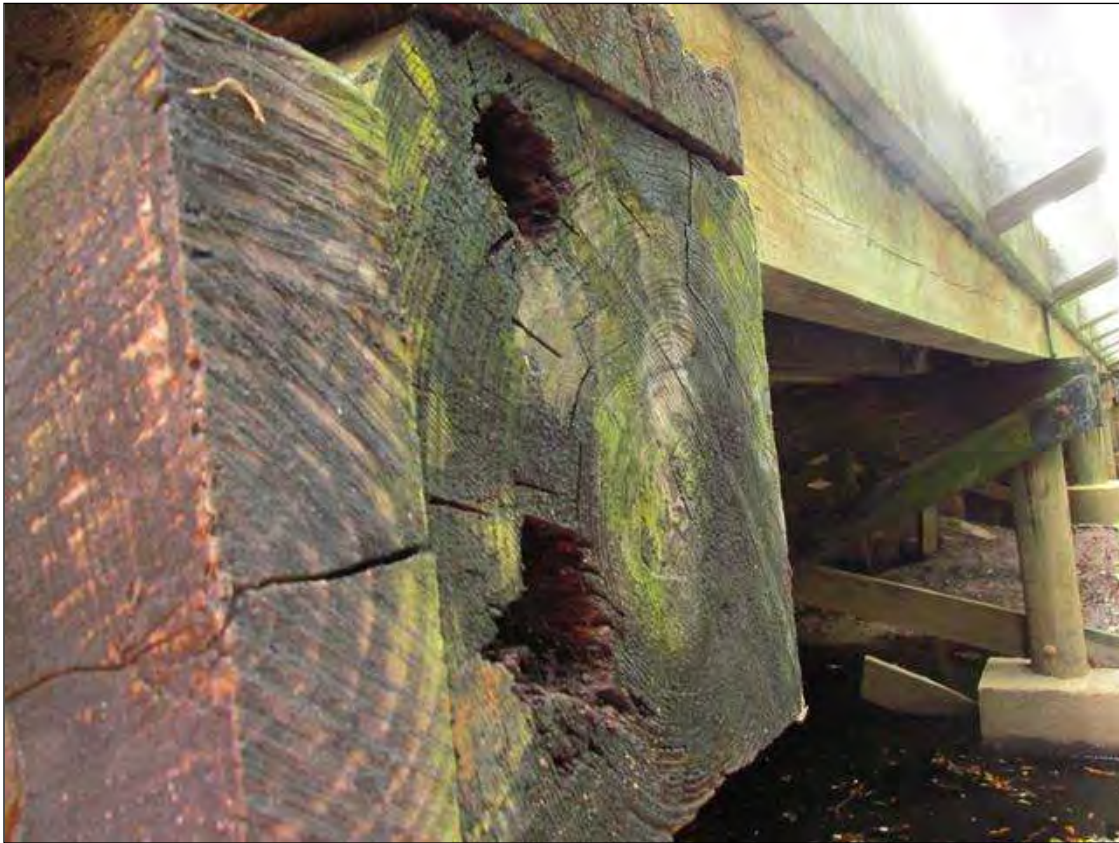
2 SPOTS OF DECAY IN THE LEFT END OF CAP AT BENT 4

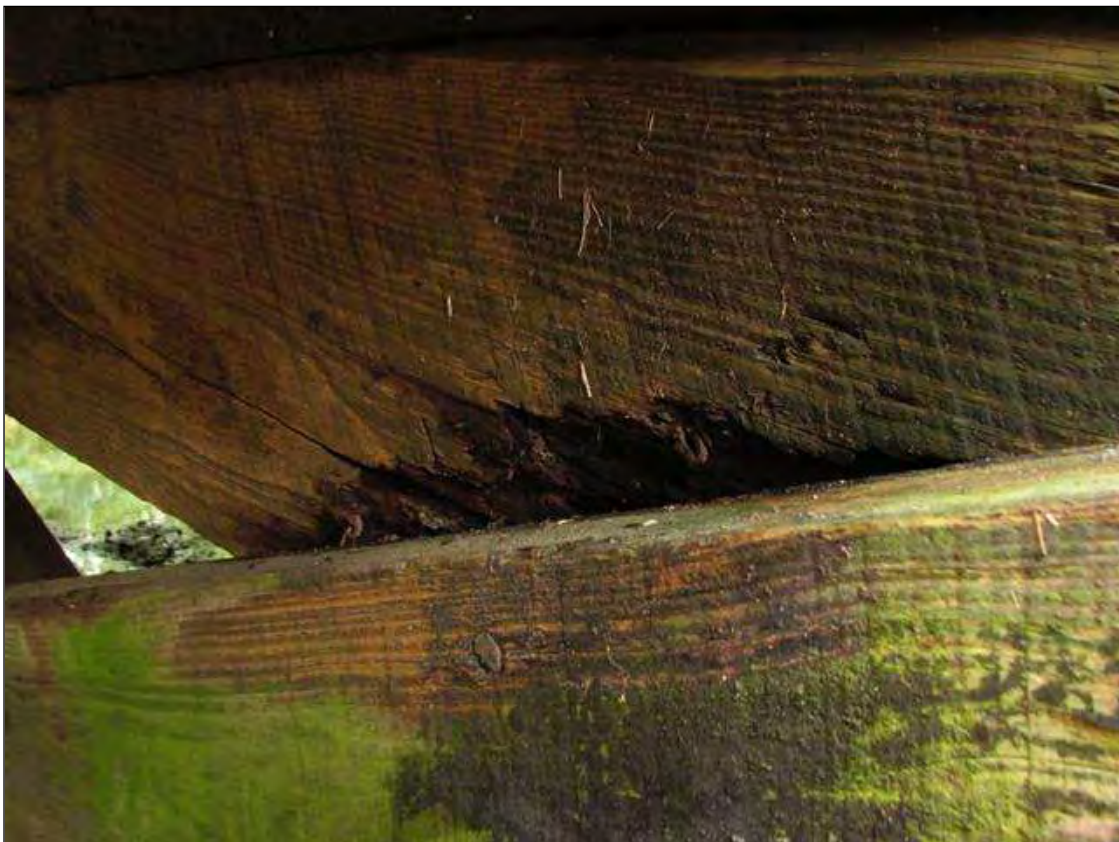
DECAY IN FACE OF CAP AT BENT 4 SPAN 5 SIDE BEHIND CROSSBRACE UNDER BAY 1

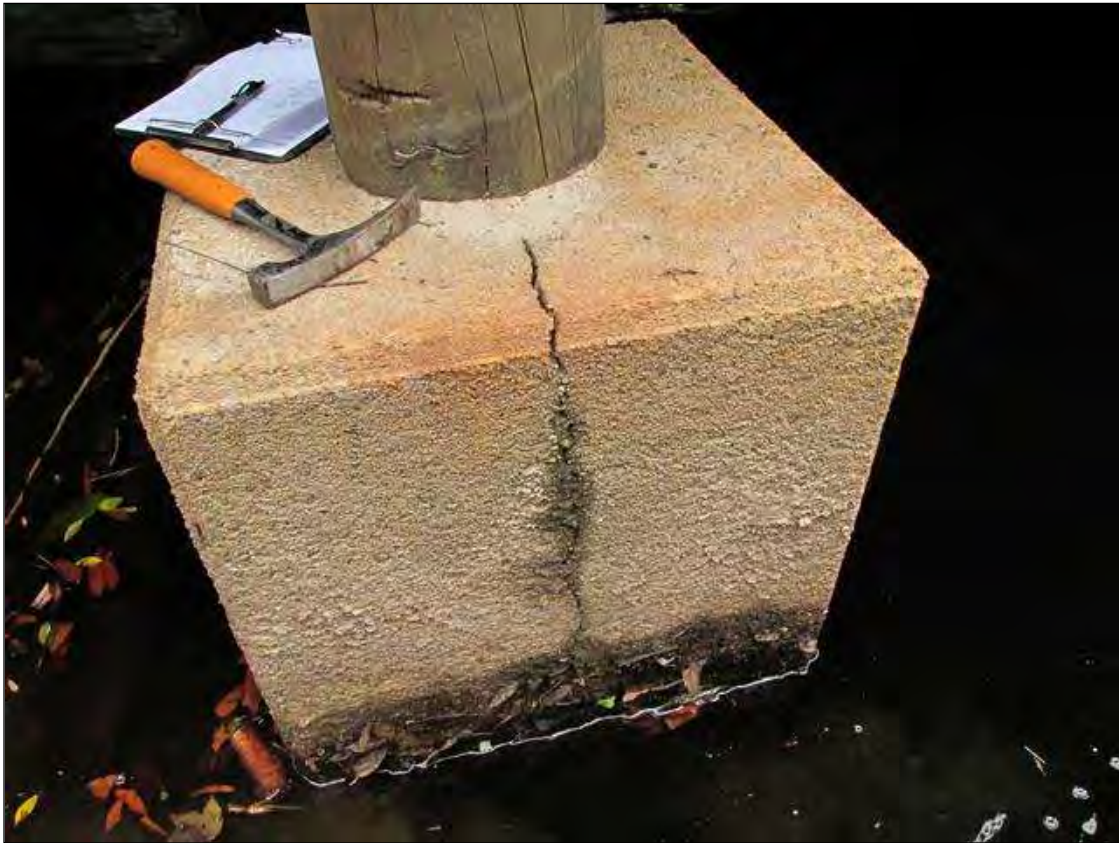
VERTICAL CRACKS IN CONCRETE ENCASEMENTS THROUGHOUT STRUCTURE

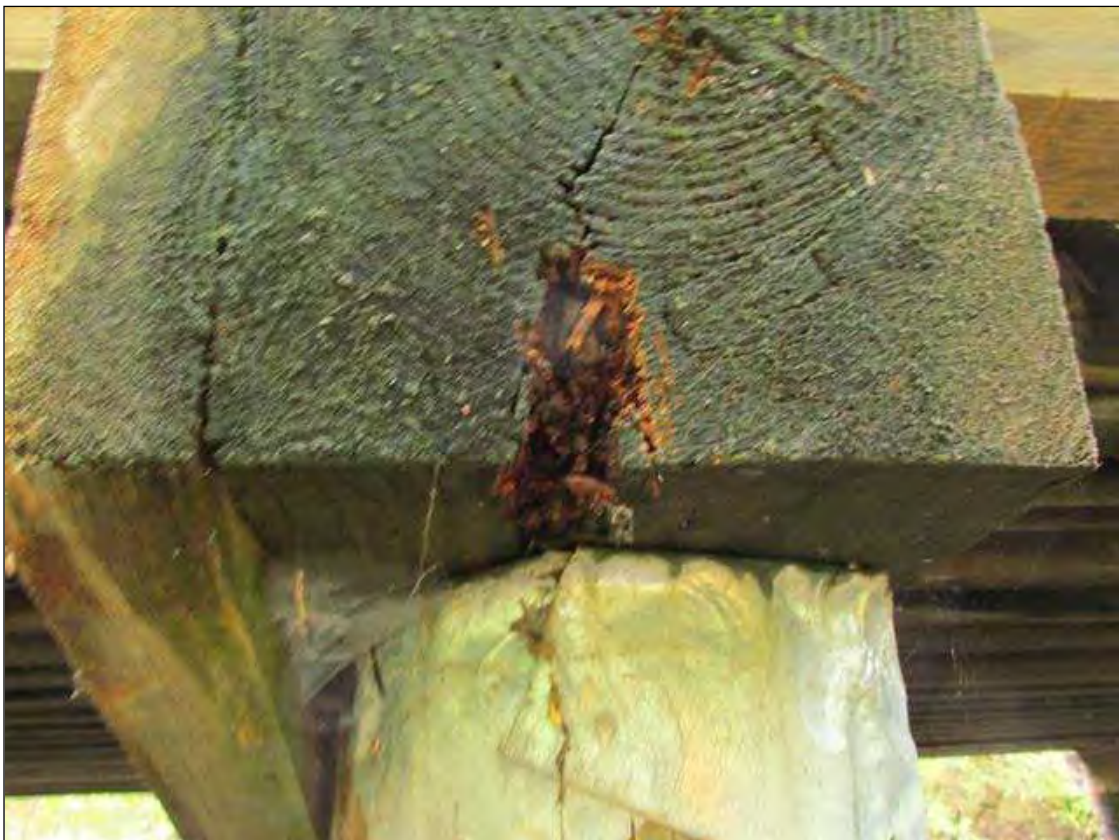
DECAY IN LEFT END OF CAP AT BENT 2

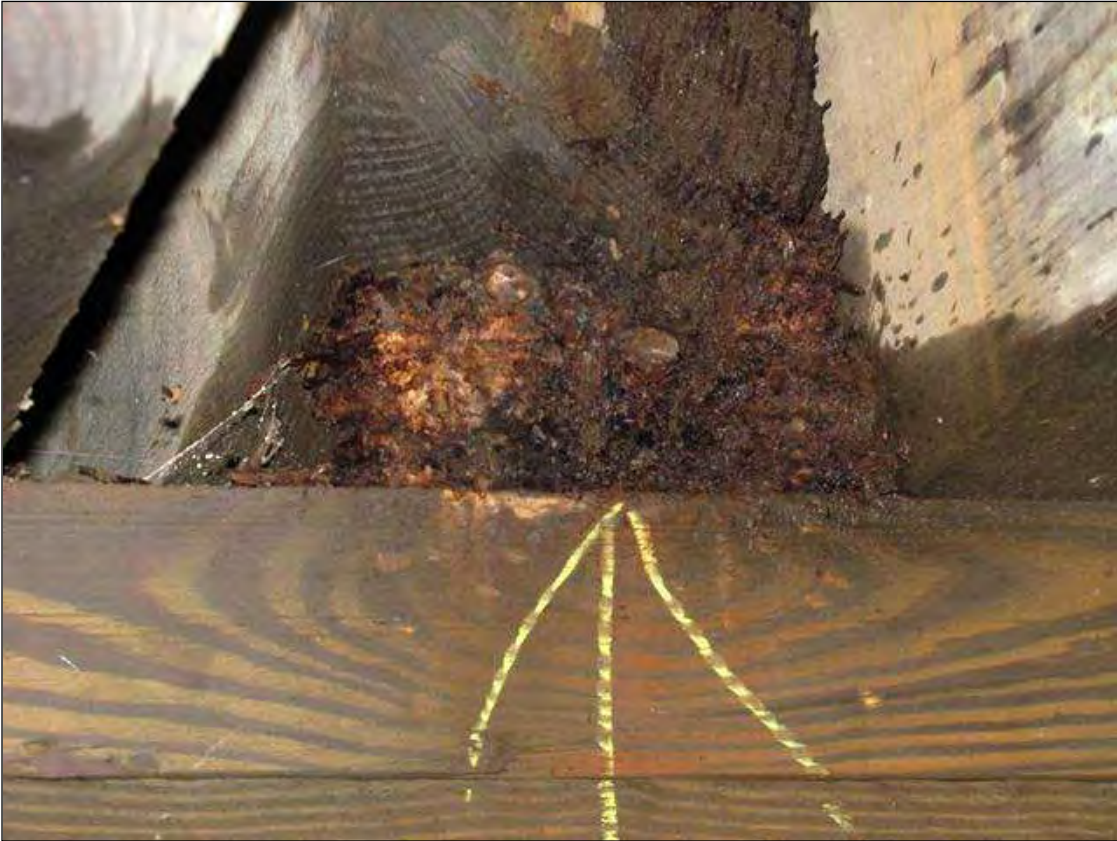
2 IN. HIGH X 1/2 IN. DEEP DECAY AT THE END OF JOIST 5 IN SPAN 3 OVER BENT 2

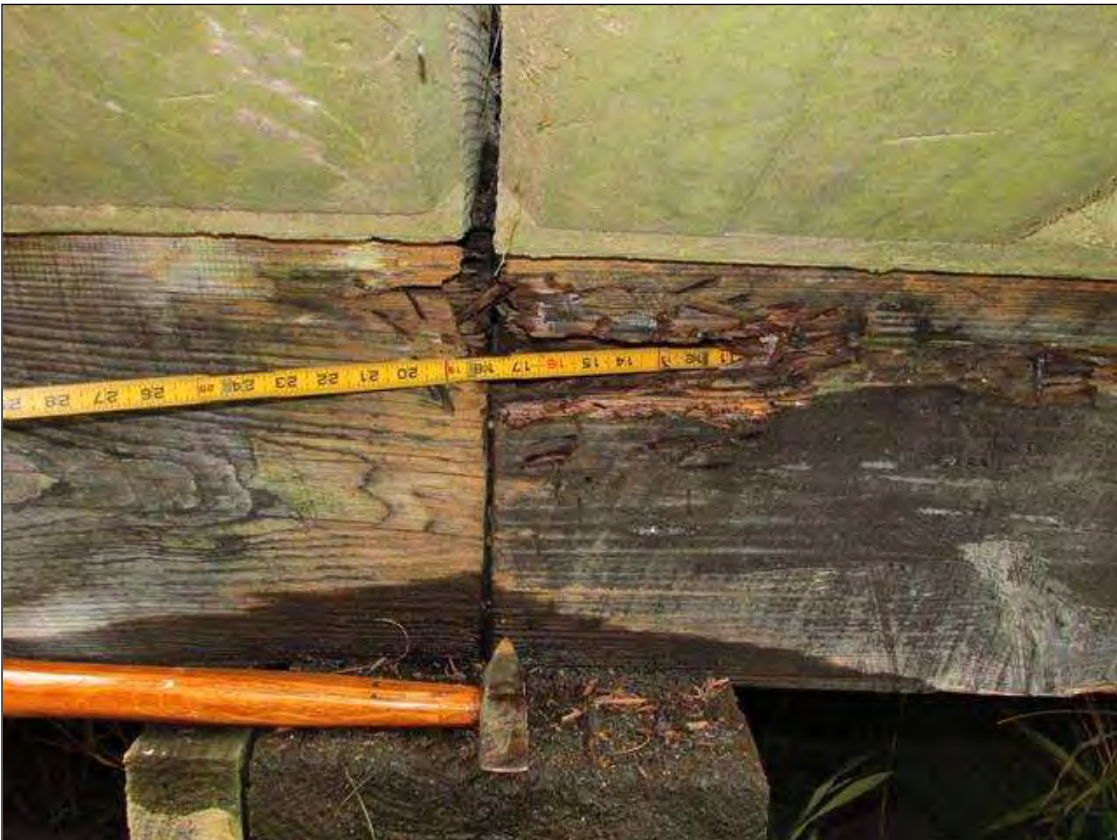
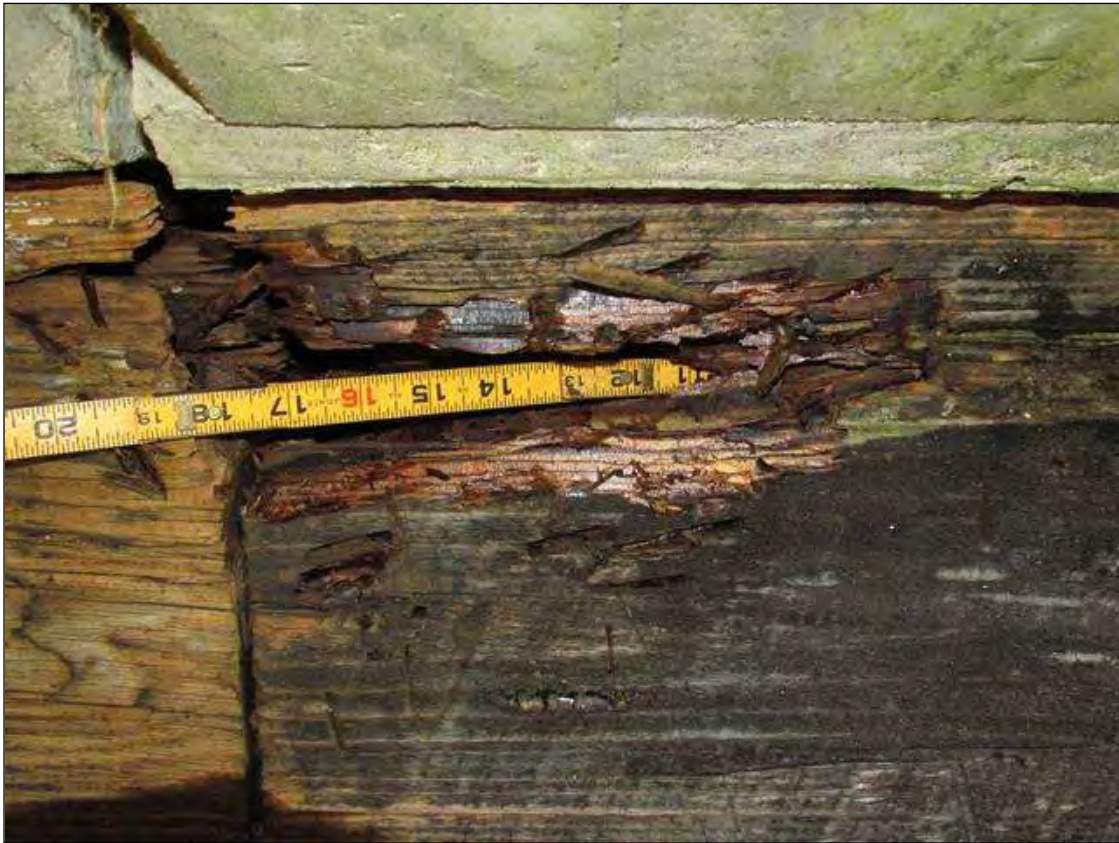
| MMS Code | Description of Function | Unit | Quantity | Remarks | Est. Cost |
|---|---|---|---|---|---|
| 3304 | Maintain/Replace Timber Superstructure Components | LF | 1 | JOIST 19 SPAN 3 AT BENT 2 IS DECAYED IN THE END - 4 IN. WIDE X 5 IN. HIGH X 18 IN. LONG. | |

DECAY IN JOIST 19 IN SPAN 3 AT BENT 2 - PHOTO 1 OF 2 - PRIORITY MAINTENANCE ISSUED

DECAY IN JOIST 19 IN SPAN 3 AT BENT 2 - PHOTO 2 OF 2 - PRIORITY MAINTENANCE ISSUED

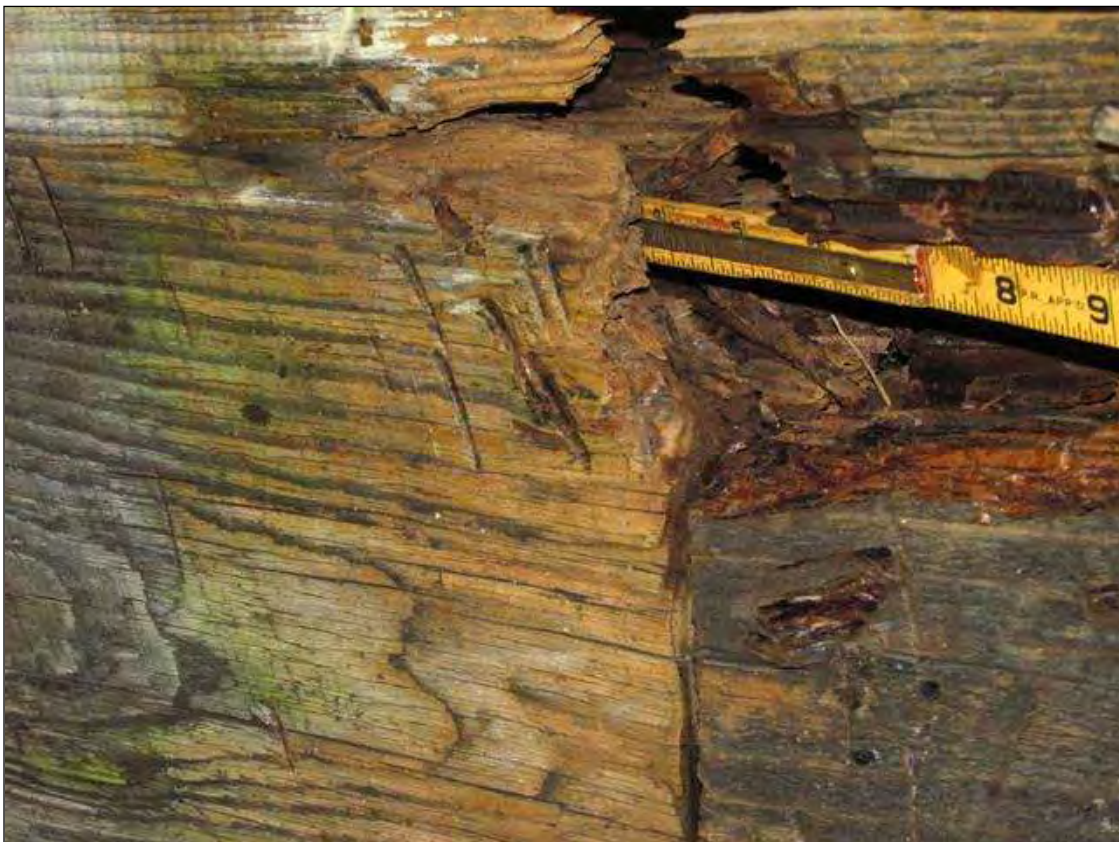
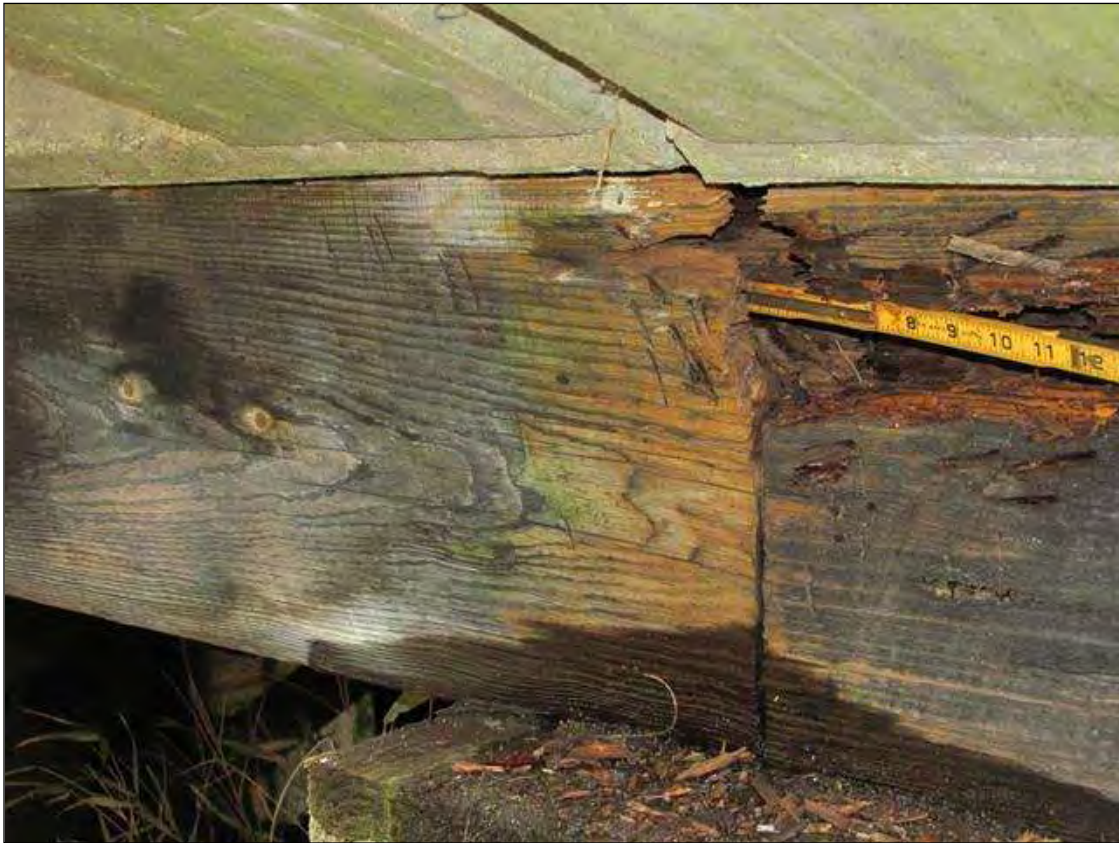
| MMS Code | Description of Function | Unit | Quantity | Remarks | Est. Cost |
|---|---|---|---|---|---|
| 3304 | Maintain/Replace Timber Superstructure Components | LF | 1<br>12/31/13 | JOIST 19 SPAN 2 AT BENT 2 IS DECAYED IN THE END - 3 IN. WIDE X 4 IN. HIGH X 6 IN. LONG. | |

DECAY IN JOIST 19 IN SPAN 2 AT BENT 2 - PHOTO 1 OF 2 - PRIORITY MAINTENANCE ISSUED

DECAY IN JOIST 19 IN SPAN 2 AT BENT 2 - PHOTO 2 OF 2 - PRIORITY MAINTENANCE ISSUED

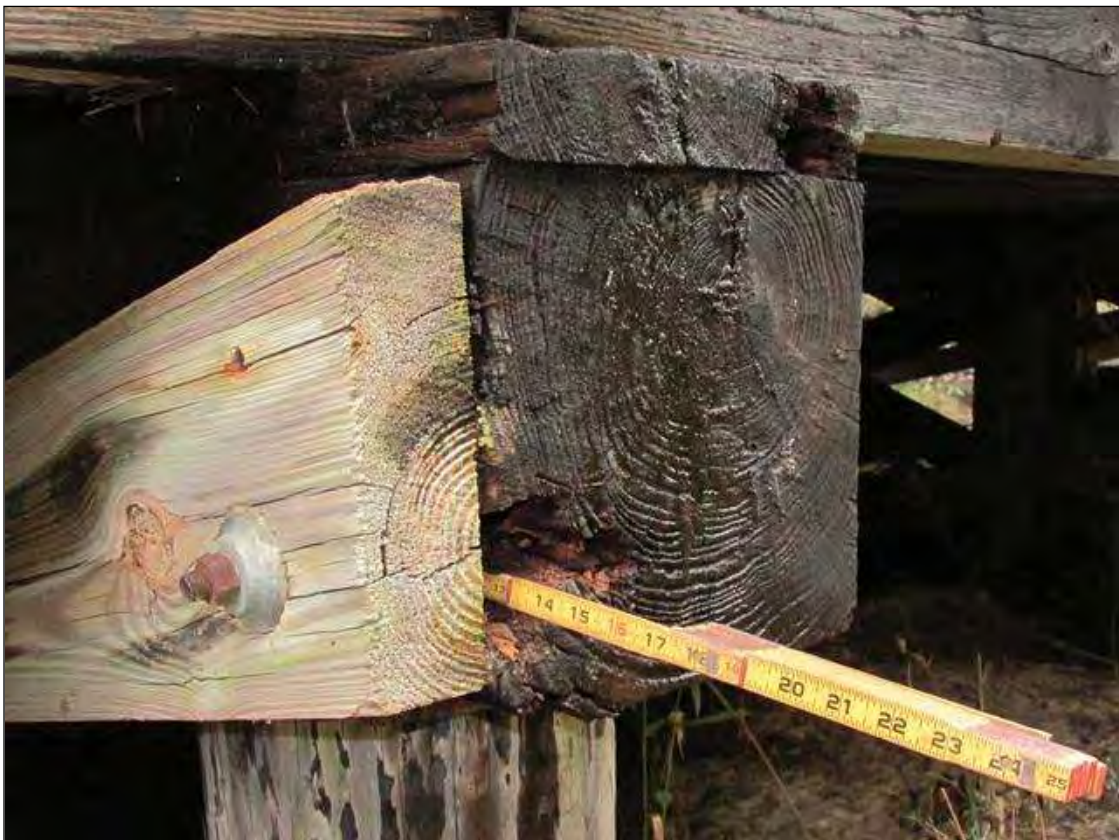
| MMS Code | Description of Function | Unit | Quantity | Remarks | Est. Cost |
|---|---|---|---|---|---|
| 3344 | Repair / Replace Timber Substructure Components | LF | 2 | RIGHT END OF BENT 1 CAP DECAYED 5 IN. WIDE X 4 IN. HIGH X 14 IN. LONG IN THE BOTTOM CORNER. RIGHT END OF BENT 1 CROWNSTRIP DECAYED 2 IN. WIDE X 2 IN. HIGH X 7 IN. LONG. | |

DECAY IN RIGHT END OF CAP AT BENT 1 PRIORITY MAINTENANCE ISSUED

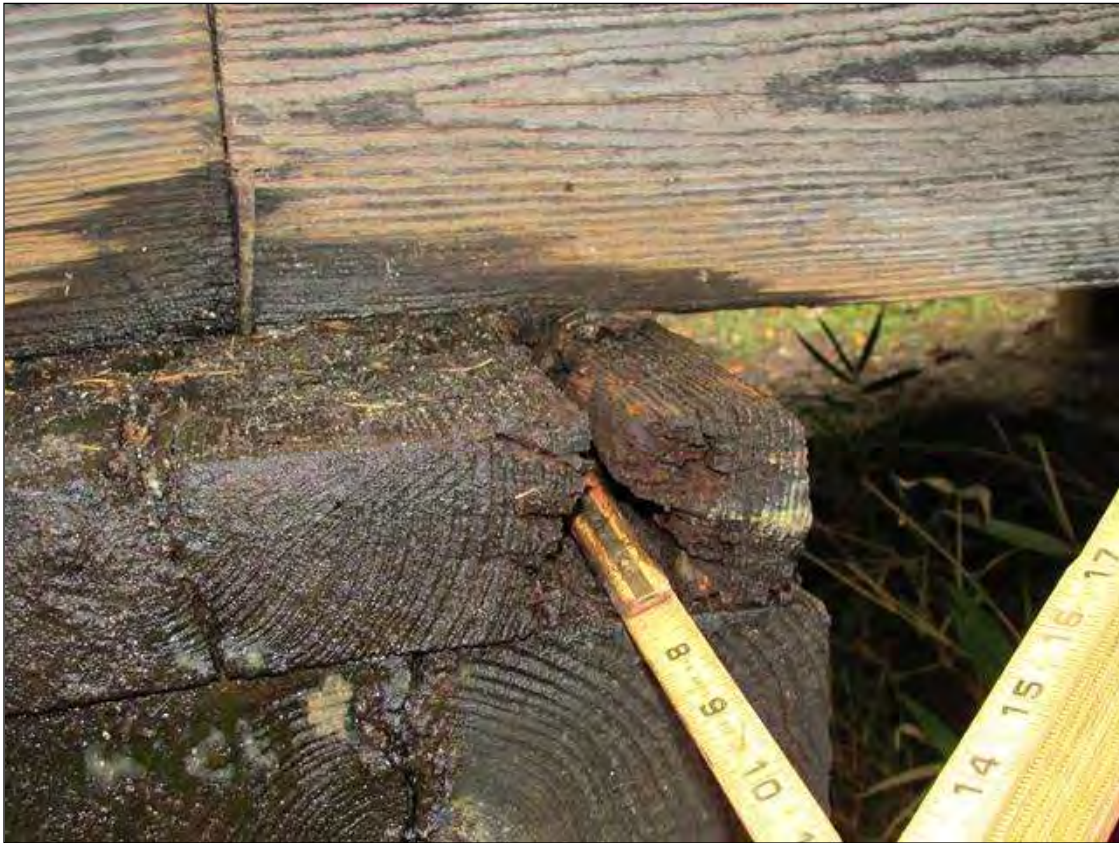
DECAY IN RIGHT END OF CROWNSTRIP AT BENT 1

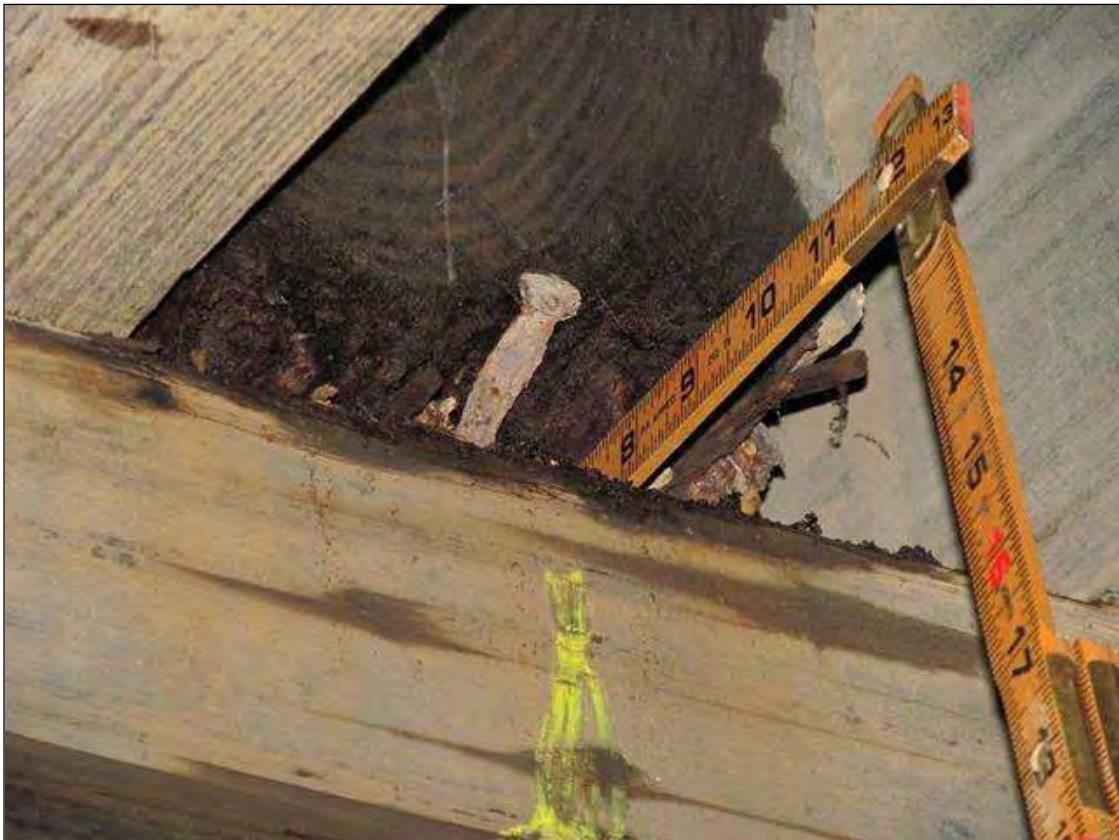
| MMS Code | Description of Function | Unit | Quantity | Remarks | Est. Cost |
|---|---|---|---|---|---|
| 3304 | Maintain/Replace Timber Superstructure Components | LF | 1 <del>TSE</del> | JOIST 9 SPAN 2 AT BENT 1 END IS DECAYED IN THE BEARING AREA 6 IN. WIDE X 2 IN. HIGH X 8 IN. LONG. | |

DECAY IN THE END OF JOIST 9 IN SPAN 2 AT BENT 1 - PRIORITY MAINTENANCE ISSUED

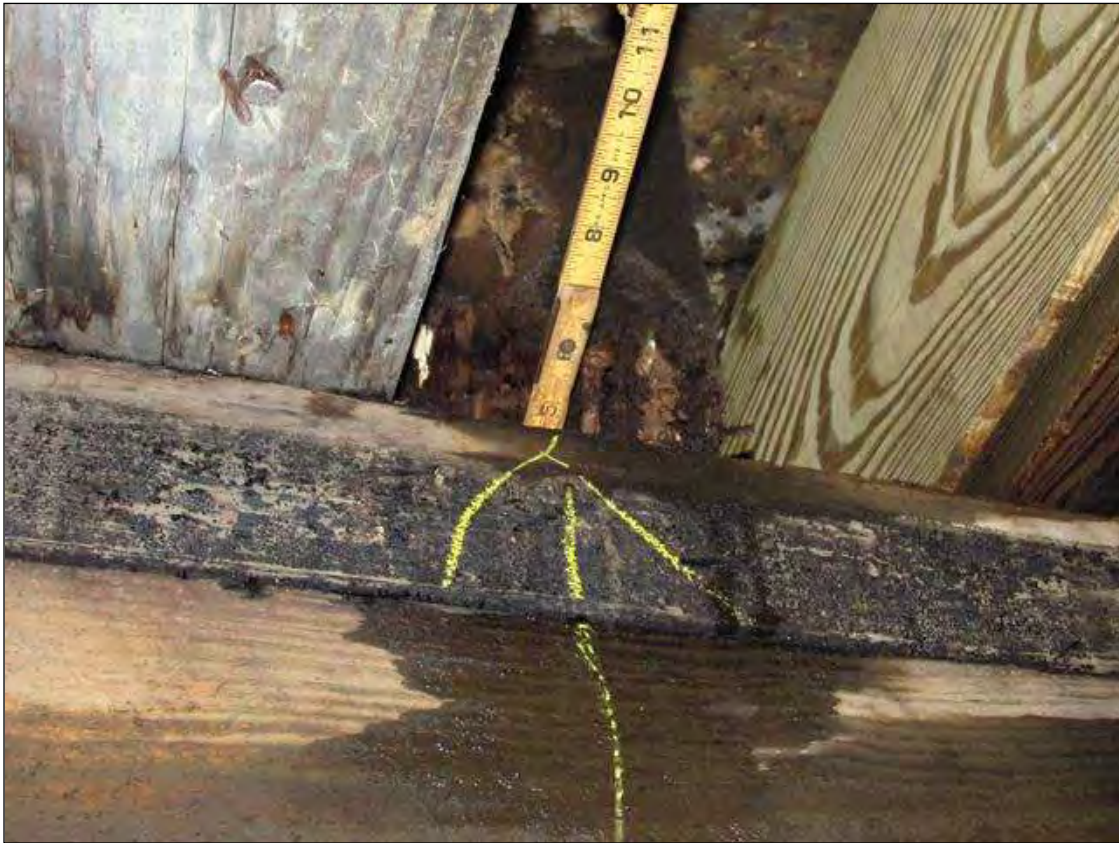
| MMS Code | Description of Function | Unit | Quantity | Remarks | Est. Cost |
|---|---|---|---|---|---|
| 3304 | Maintain/Replace Timber Superstructure Components | LF | 1 | JOIST 15 SPAN 2 AT BENT 1 IS DECAYED IN THE BEARING AREA 6 IN. WIDE X 3 IN HIGH X 5 IN. LONG. | |

DECAY IN THE END AND BOTTOM OF JOIST 15 IN SPAN 2 AT BENT 1 - PRIORITY MAINTENANCE ISSUED
