NC DEPARTMENT OF TRANSPORTATION  
DIVISION OF HIGHWAYS  
BRIDGE MANAGEMENT UNIT

# BRIDGE INSPECTION REPORT

INSPECTION TYPE: Routine Inspection

COUNTY JOHNSTON BRIDGE NUMBER 500216 INSPECTION CYCLE 2 YRS  
ROUTE SR2143 ACROSS LITTLE BUFFALO CREEK M.P. 0

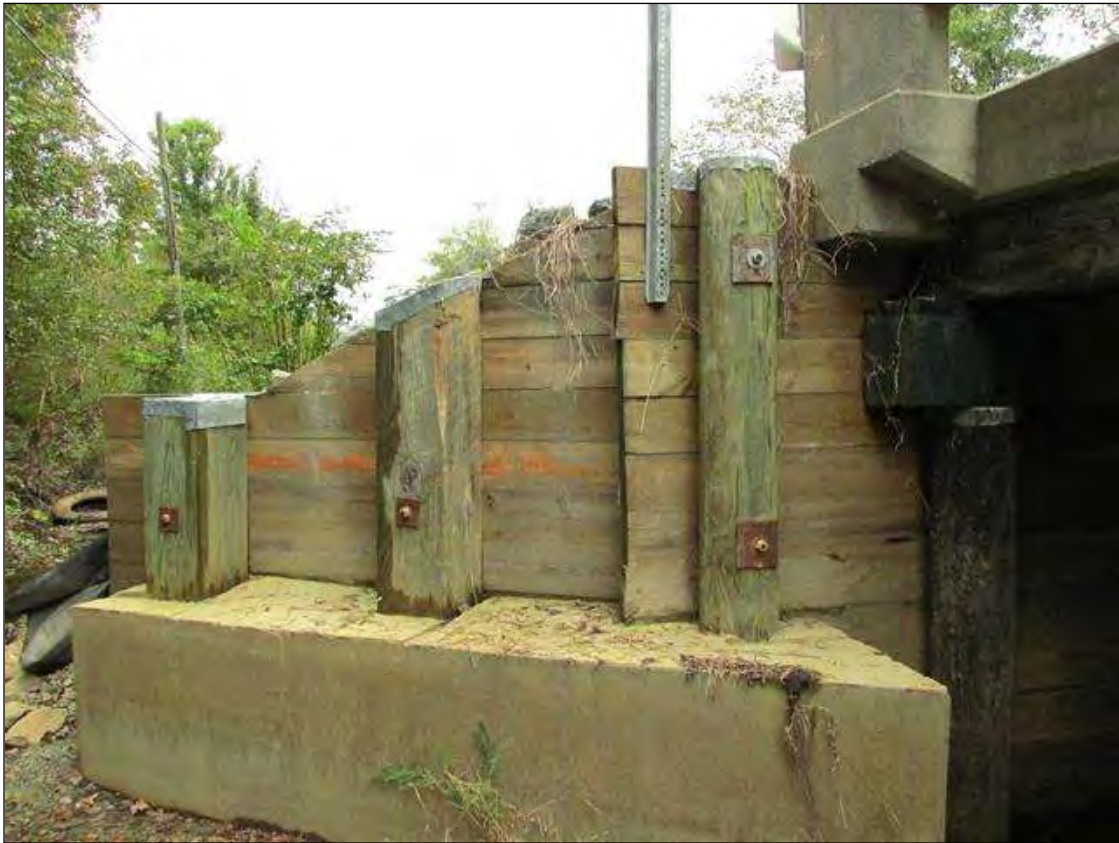
RIGHT SIDE WINGWALL AT END BENT 1 REPLACED - LEFT SIDE WINGWALL SIMILAR

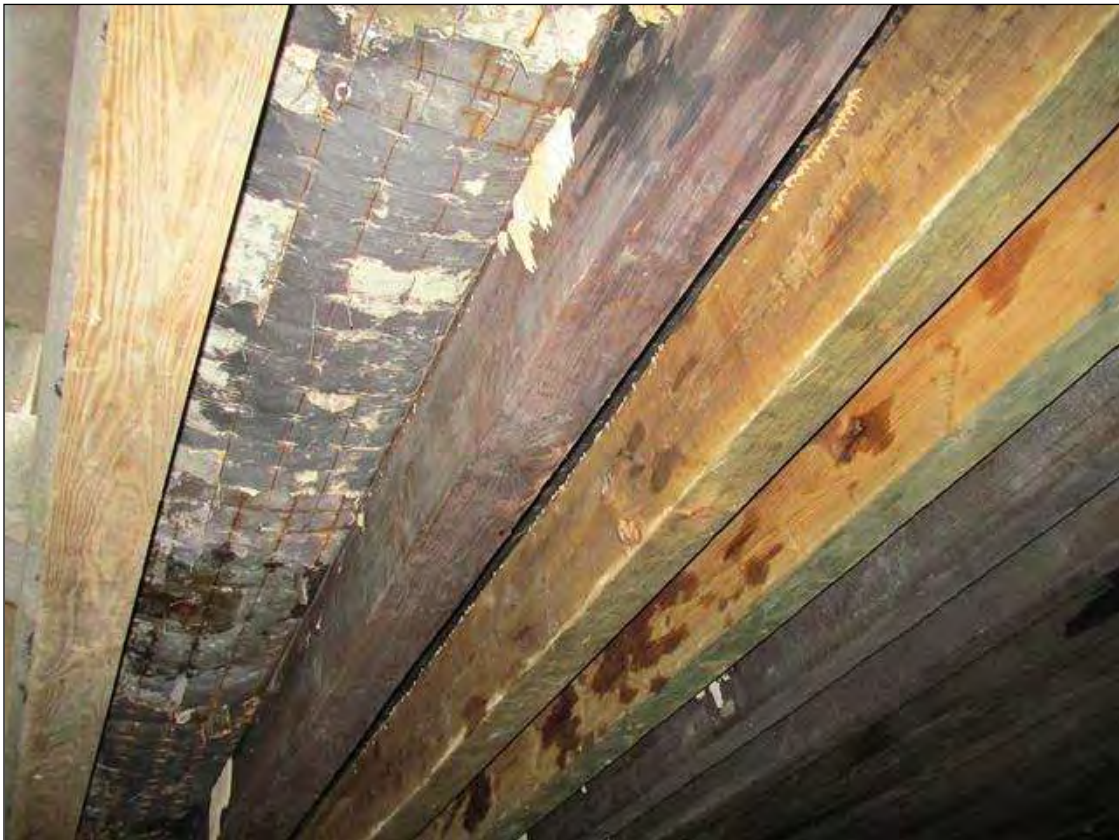
JOISTS 1, 3 AND 4 IN SPAN 5 HAVE BEEN REPLACED SINCE LAST INSPECTION

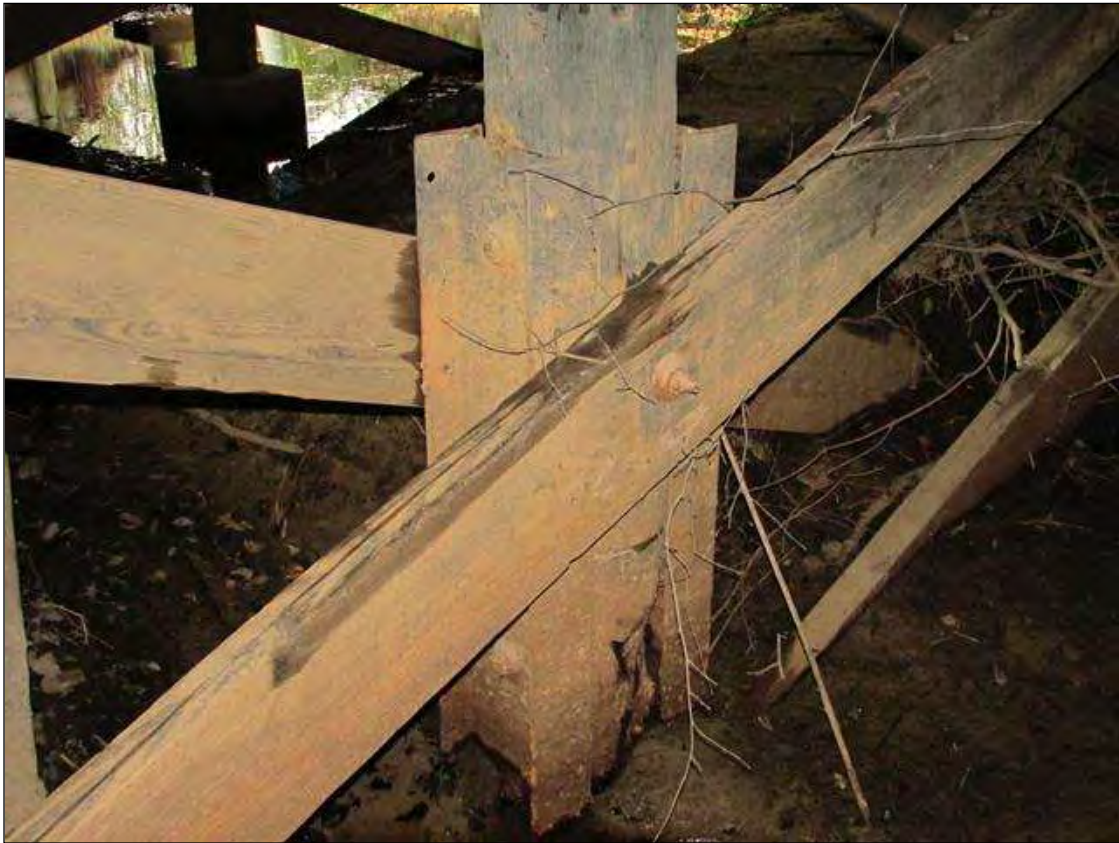
PILE 2 AT BENT 2 SPLICED WITH I-BEAMS

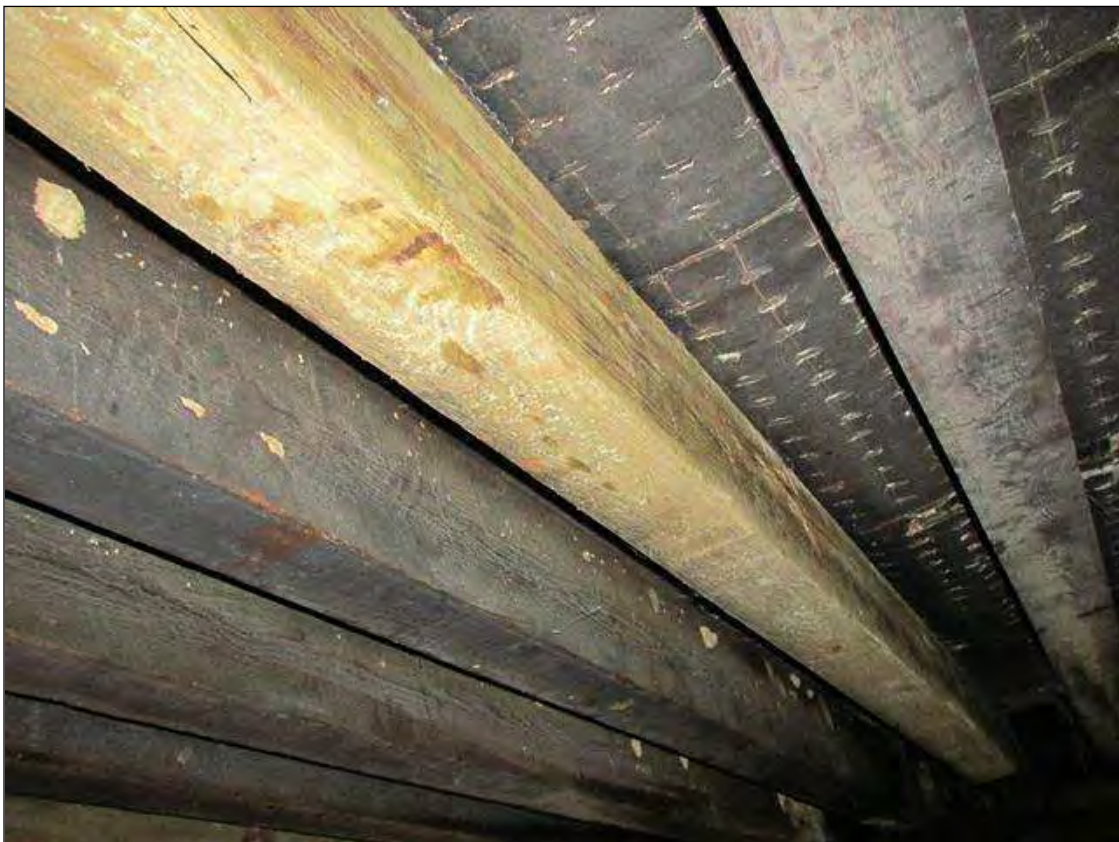
JOIST 5 IN SPAN 1 HAS BEEN REPLACED SINCE LAST INSPECTION - JOISTS 11 AND 15 SIMILAR
