# Structure Safety Report

## Routine Element Inspection

COUNTY: JOHNSTON STRUCTURE NUMBER: 500231 FREQUENCY: 24 MONTHSFACILITY CARRIED: SR2159 MILE POST: \_\_\_\_\_LOCATION: 0.3 MI SE JCT SR2110FEATURE INTERSECTED: LITTLE BUFFALO CREEKLATITUDE: 35° 38' 51.97" LONGITUDE: 78° 10' 41.48"SUPERSTRUCTURE: PPC CHANNELS (BMD-13)SUBSTRUCTURE: EBTS&IBT:PPC CAP/TIM.PILES @ 5"9 CTS.SPANS: 2@30"☐ FRACTURE CRITICAL ☐ TEMPORARY SHORING ☐ SCOUR CRITICAL ☐ SCOUR PLAN OF ACTIONPRESENT CONDITION: Fair INSPECTION DATE: 09/11/2014POSTED SV: 23 POSTED TTST: 26OTHER SIGNS PRESENT: 4 Delineators

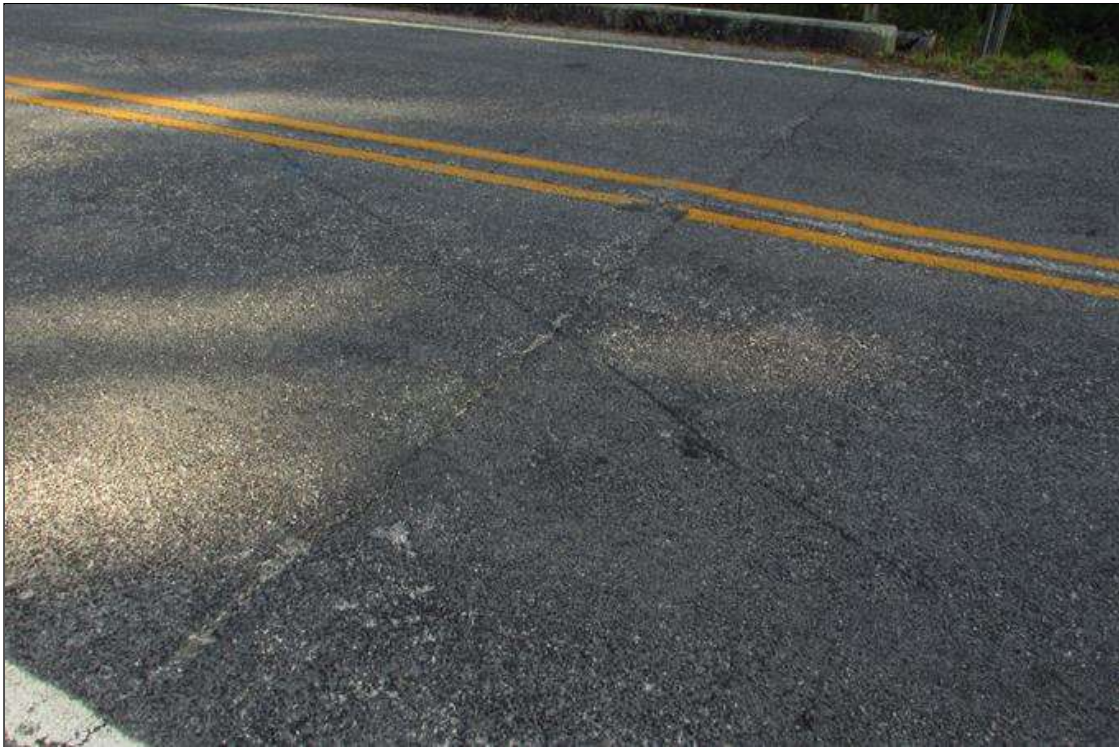
48 Square Feet of Crack (Wearing Surface): Width of more than 0.05 in. or spacing of less than 1.0 ft. Over end bent 1 and bent 1.

24 Square Feet of Crack (Wearing Surface): Width of more than 0.05 in. or spacing of less than 1.0 ft. at end bent 2

TRANSVERSE CRACK IN WEARING SURFACE OVER END BENT 1 - SIMILAR AT END BENT 2

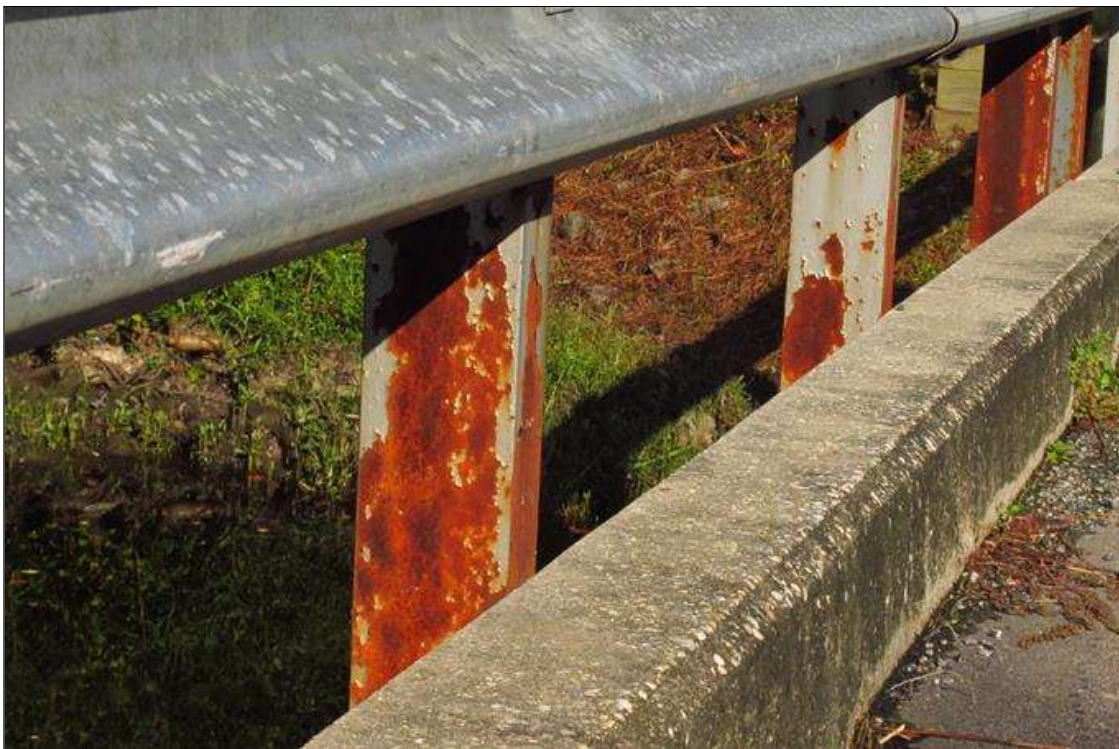
6 Square Feet of Corrosion: Freckled rust. Corrosion of the steel has initiated on posts.

18 Square Feet of Effectiveness (Steel Protective Coatings): Failed; no protection of the underlying metal on posts.

PROTECTIVE SYSTEM FAILING THROUGHOUT GUARDRAIL POSTS WITH SURFACE RUST TO EXPOSED STEEL

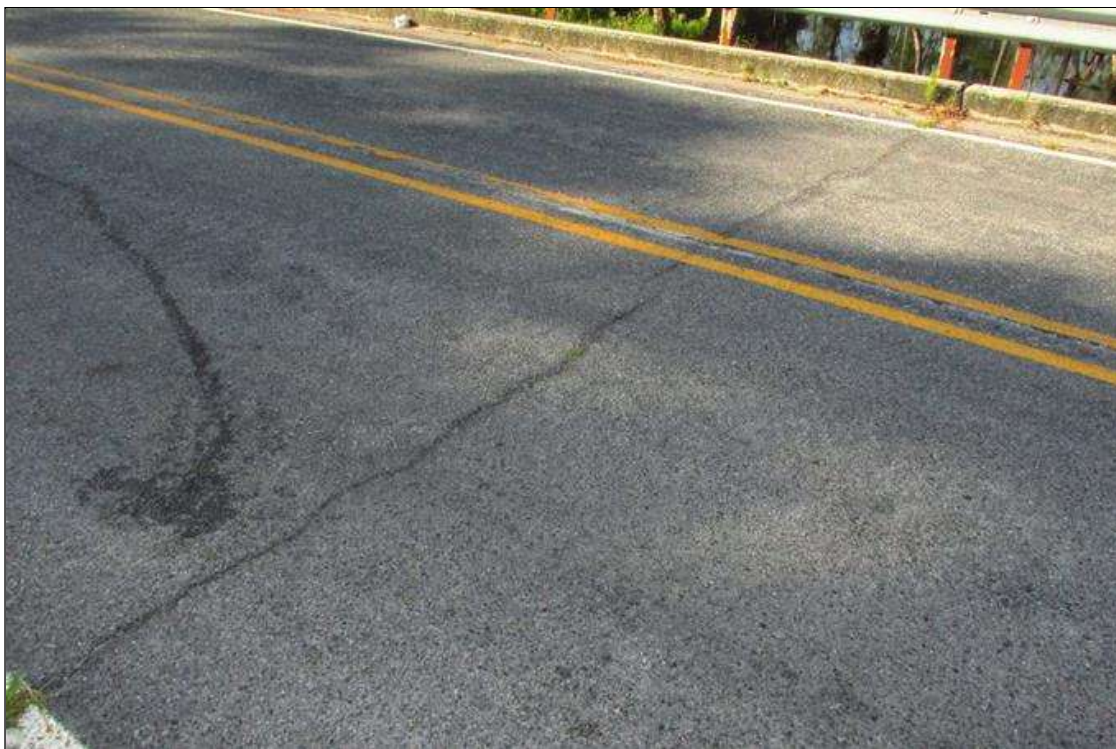
TRANSVERSE CRACK IN WEARING SURFACE OVER THE INTERIOR BENT

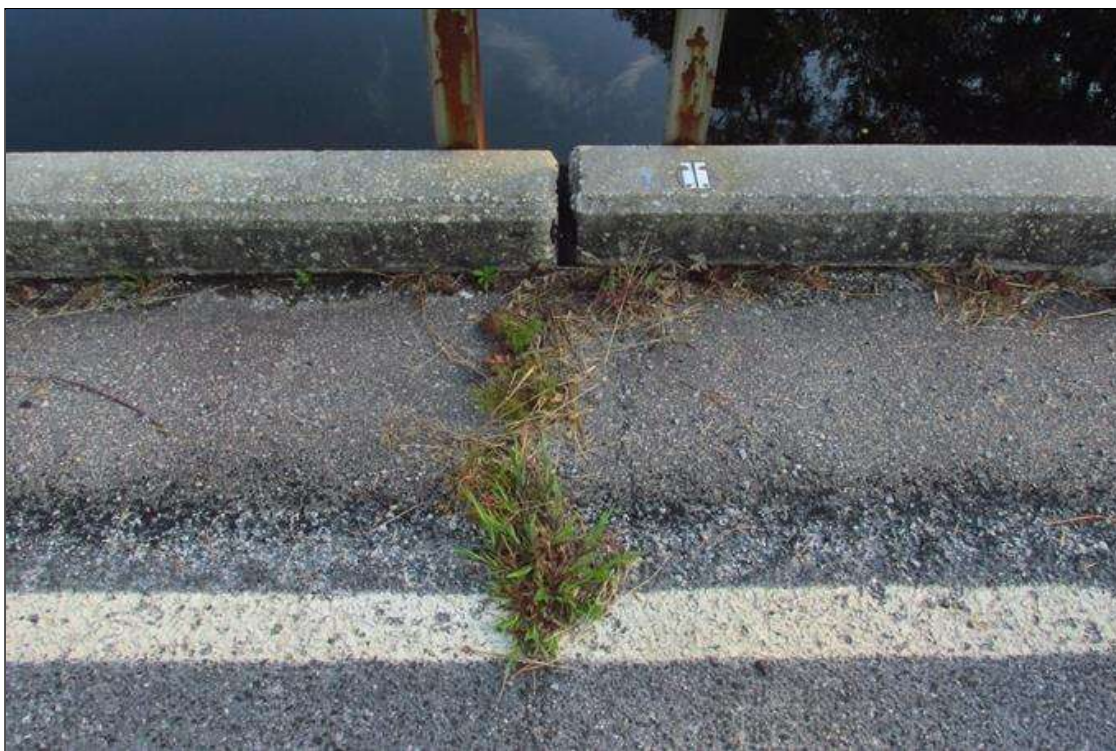
VEGETATION GROWTH IN TRANSVERSE CRACK OVER THE INTERIOR BENT

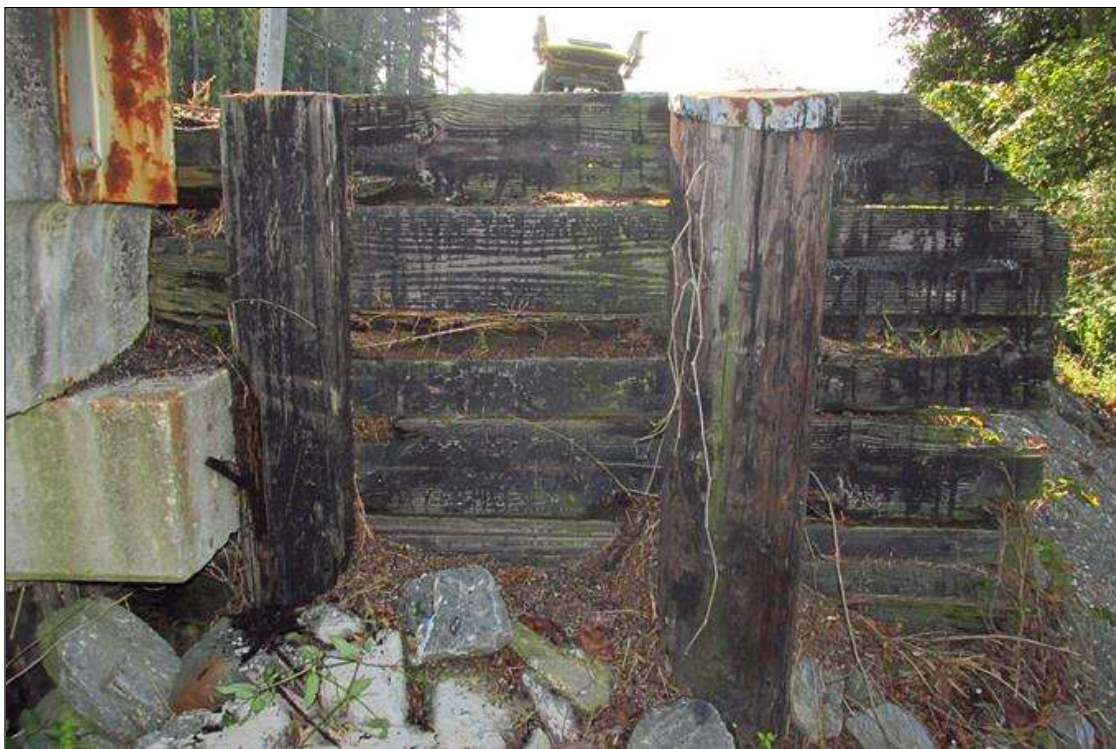
20 Feet of Decay: left ends decayed back 5 ft. Bulkhead board # 2 decayed from pile 1 to pile 3 with exposed fill in spots. Vertical braces at left and right side decayed through. Right ends decayed back 2 ft.

LEFT EXTERIOR BULKHEAD BOARDS DECAYED THROUGHOUT AT END BENT 1 - PHOTO 1 OF 2

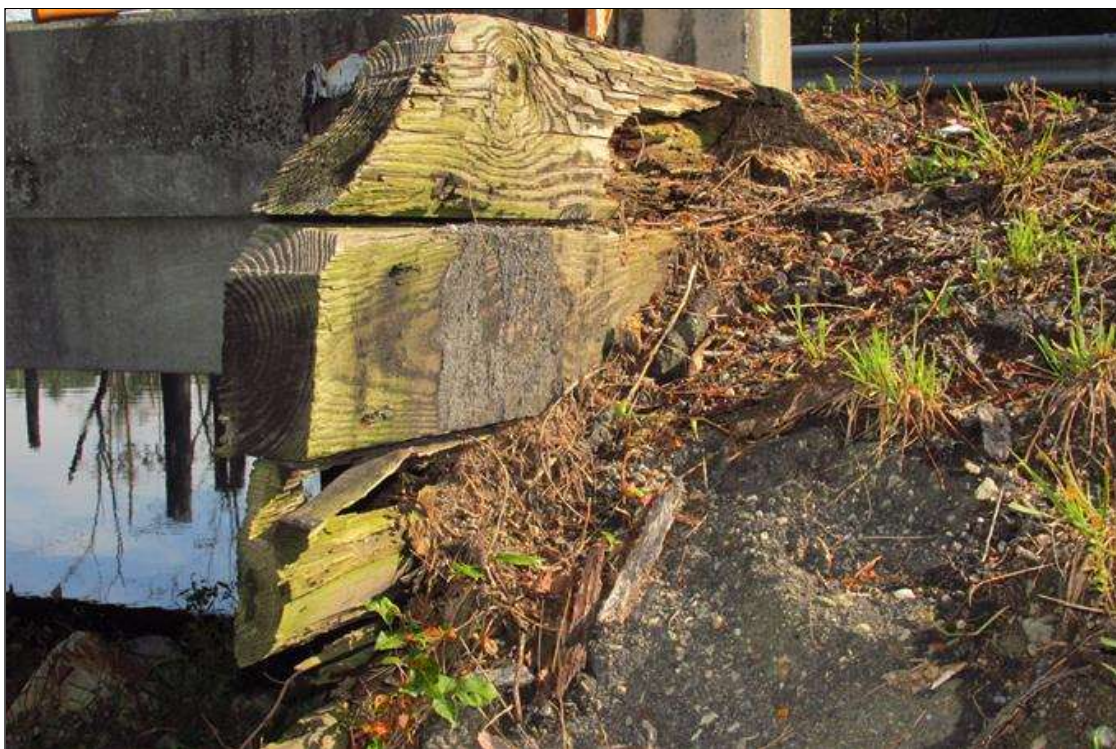
LEFT EXTERIOR BULKHEAD BOARDS DECAYED THROUGHOUT AT END BENT 1 - PHOTO 2 OF 2

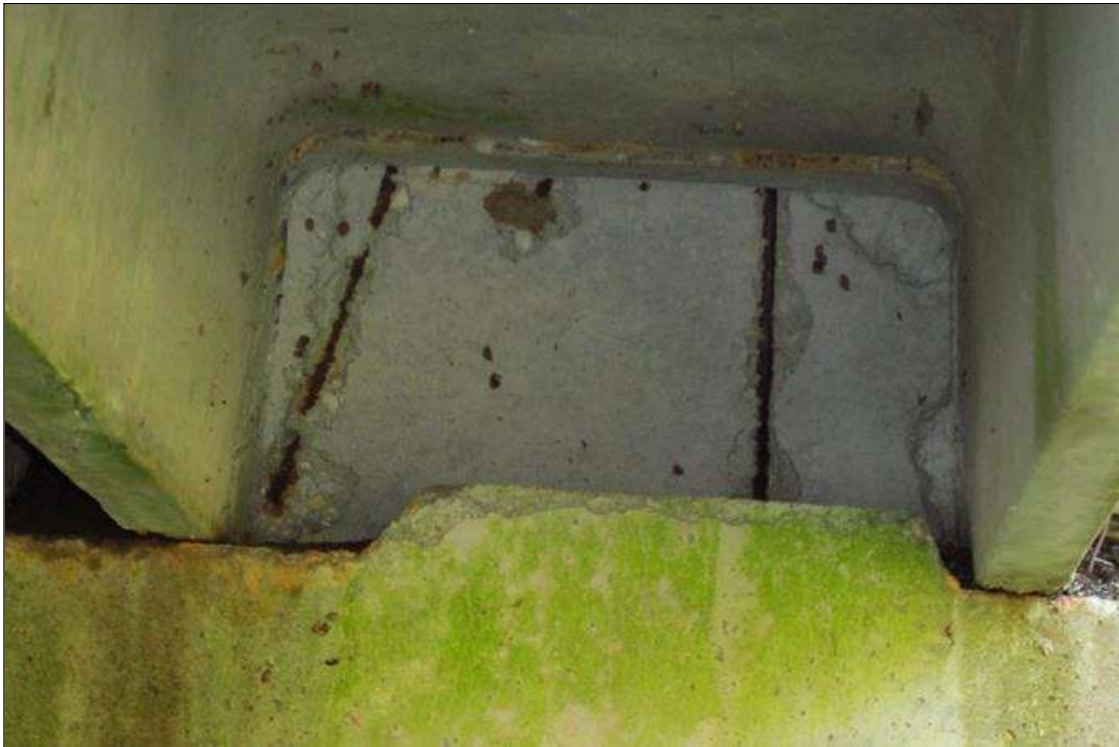
RANDOM SPALLS WITH EXPOSED REBAR THROUGHOUT END DIAPHRAGMS

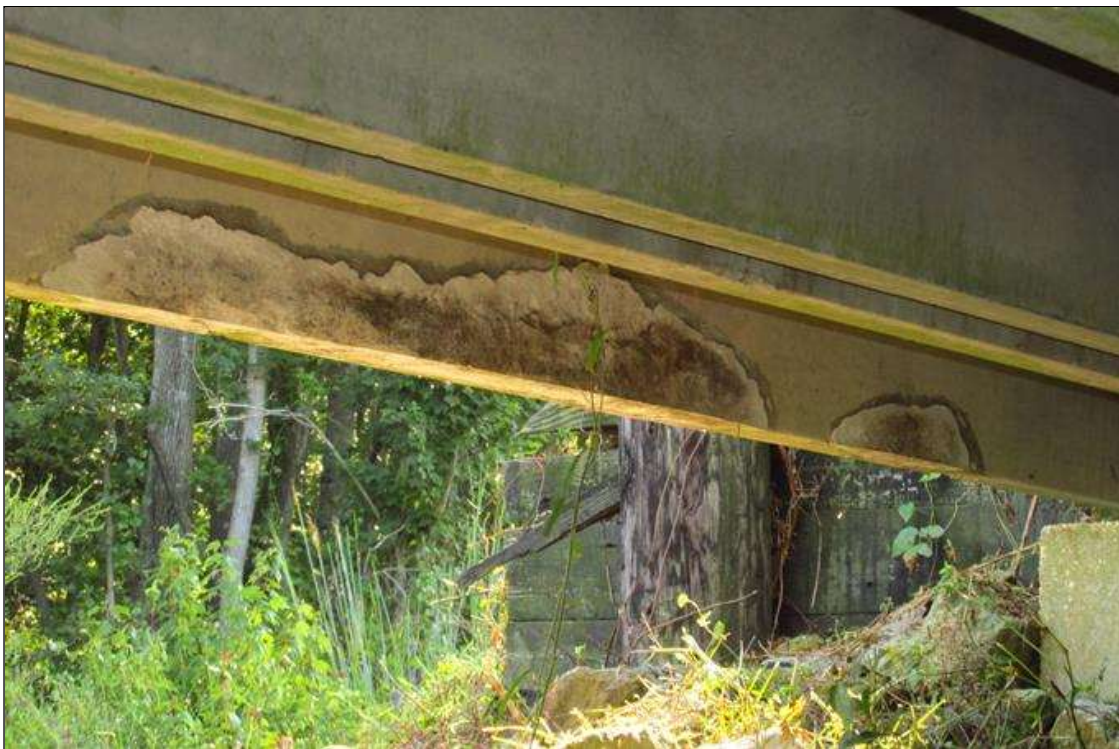
5 Feet of Patched Area: Patched area that is sound 5 ft. long in left leg near end bent 1.

REPAIR PATCH IN THE RIGHT LEG OF CHANNEL BEAM NO.10 IN SPAN 1

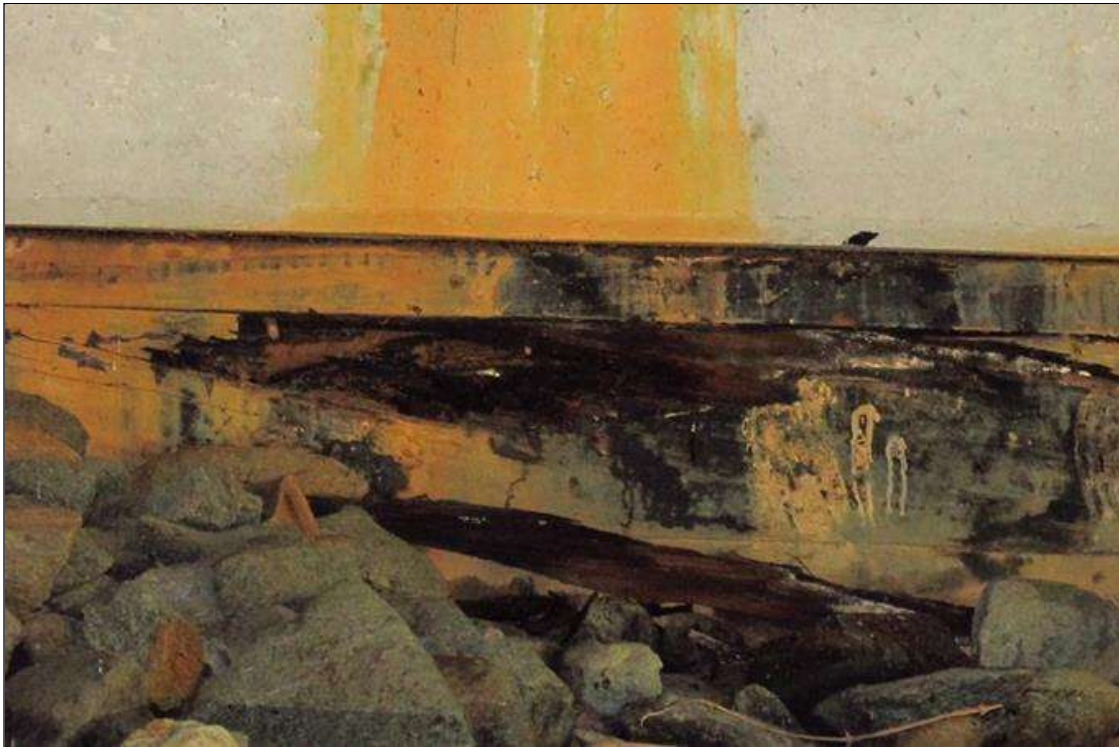
DECAY IN BULKHEAD BOARDS BETWEEN PILES 2 & 3 AT END BENT 1 - SIMILAR BETWEEN PILE 1 & PILE 2

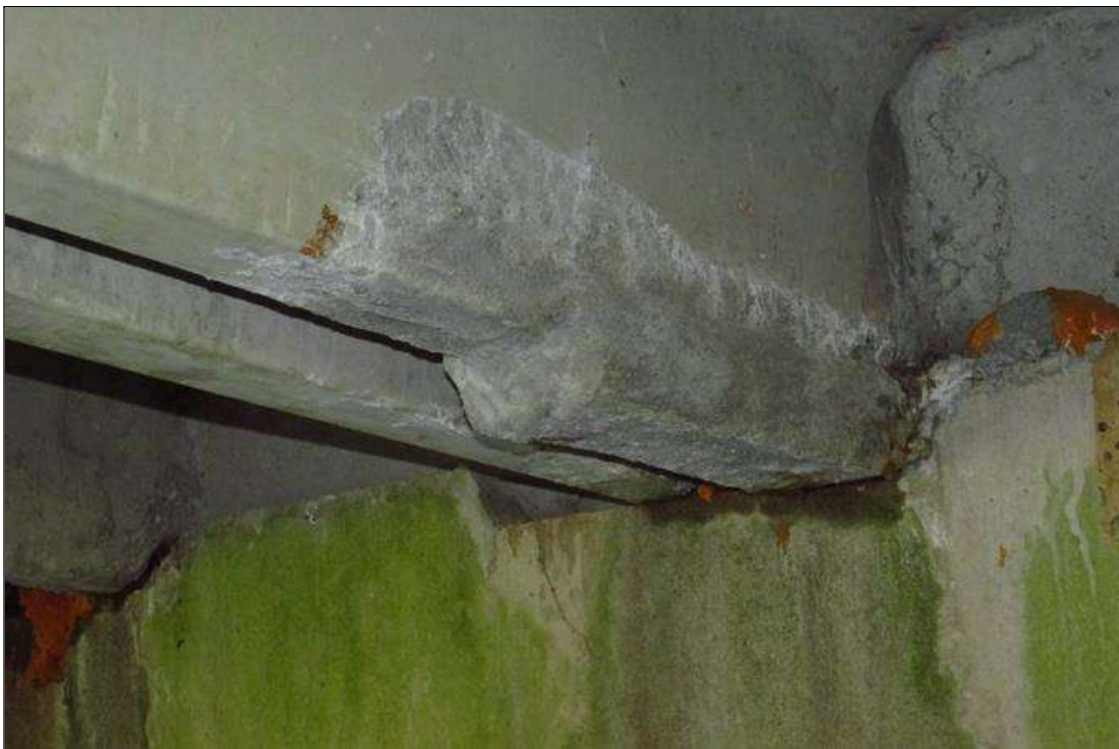
2 Feet of Delamination/Spall/Patched Area: Patched area that is sound in left leg at bent 1.

SPALL REPAIR IN THE LEFT LEG IN CHANNEL BEAM NO.3 IN SPAN 1 AT BENT 1

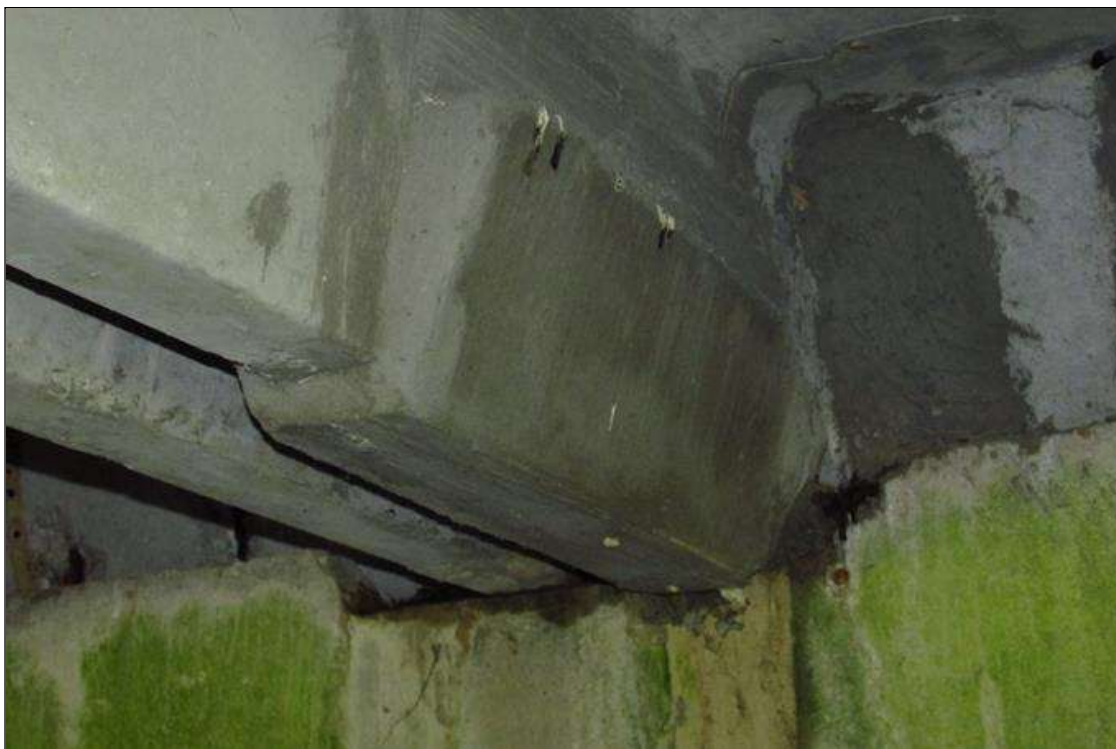
2 Feet of Delamination/Spall/Patched Area: Patched area that is sound in left leg at bent 1.

SPALL REPAIR IN THE LEFT LEG OF CHANNEL BEAM NO.5 IN SPAN 1 AT BENT 1

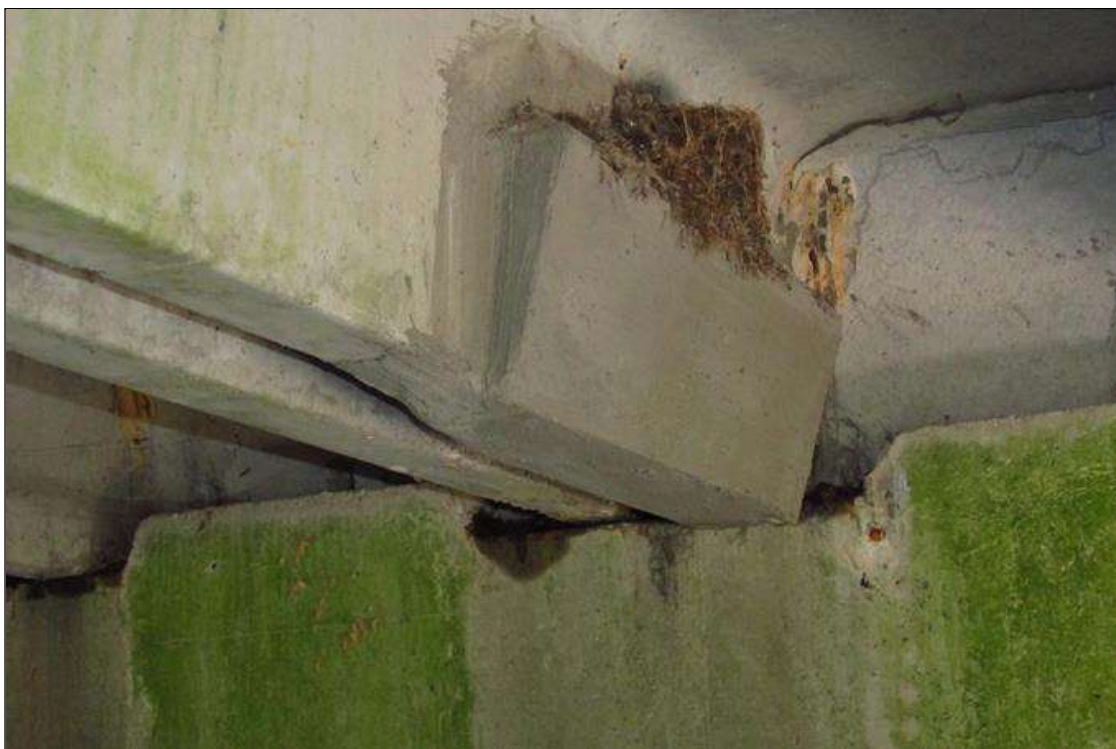
2 Feet of Delamination/Spall/Patched Area: Patched area that is sound in left leg at bent 1.

SPALL REPAIR IN THE LEFT LEG OF CHANNEL BEAM NO.8 IN SPAN 1 AT BENT 1

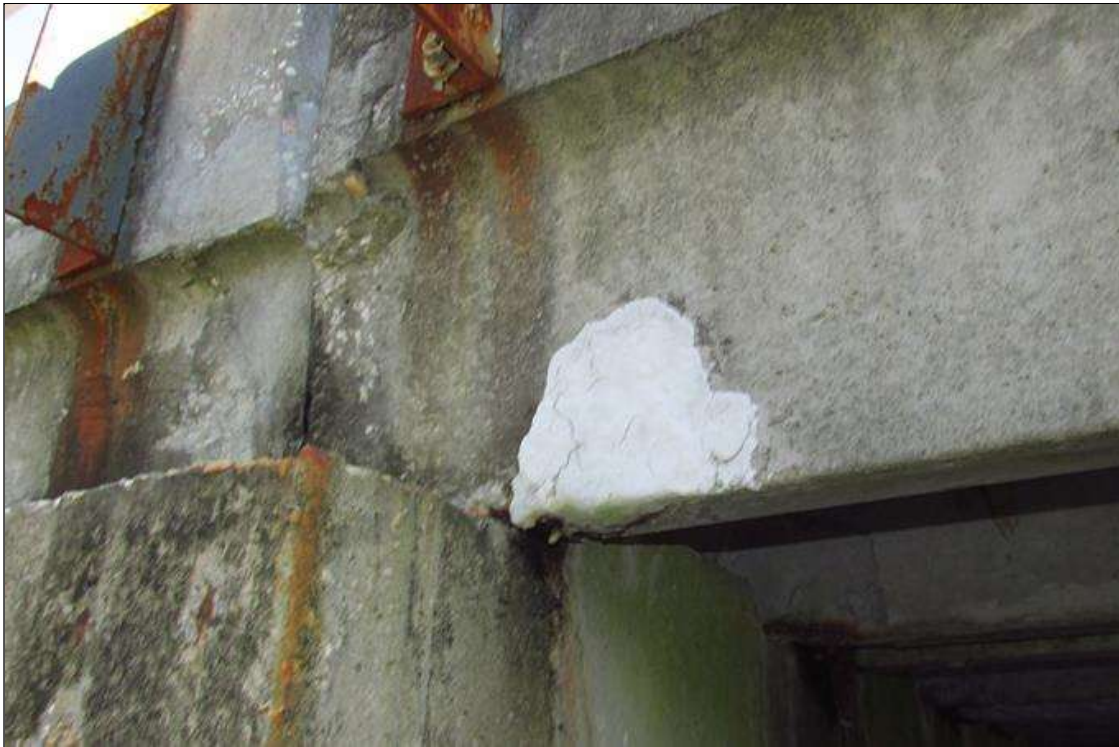
1 Feet of Patched Area: Patched area that is sound in left leg at bent 1.

PATCH REPAIR IN THE LEFT LEG OF CHANNEL BEAM NO.1 IN SPAN 1 OVER BENT 1

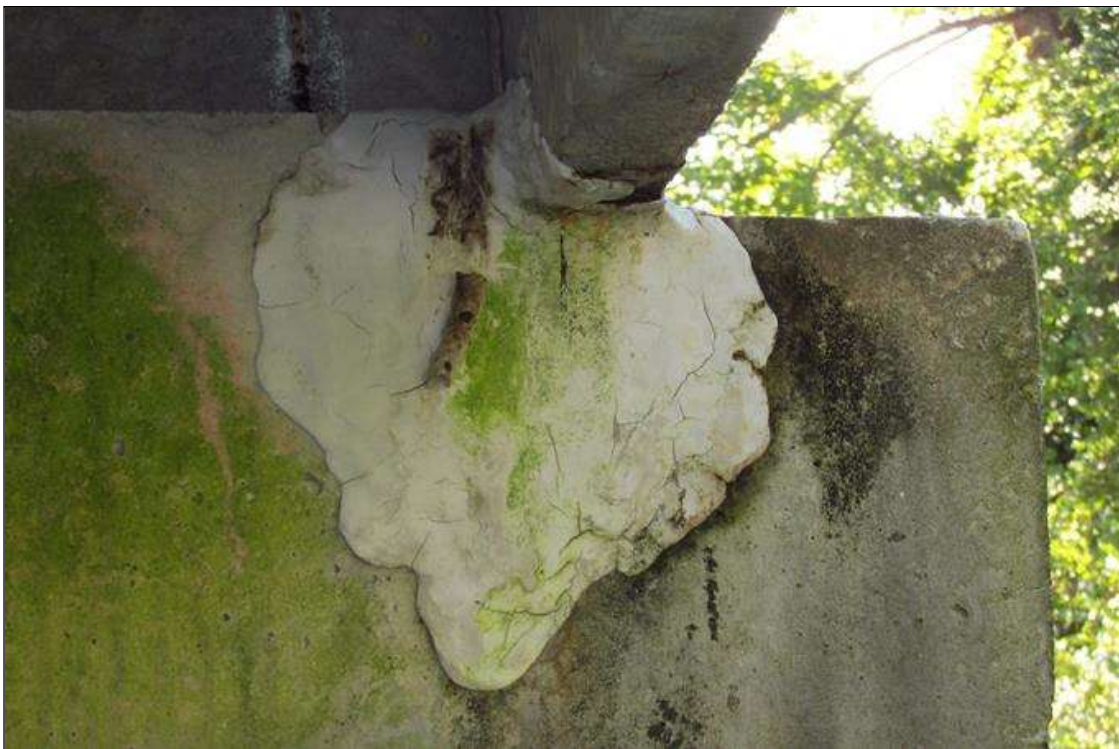
PATCH REPAIR IN FACE OF CAP AT BENT 1 SPAN 2 SIDE UNDER THE LEFT LEG OF CHANNEL BEAM NO.1

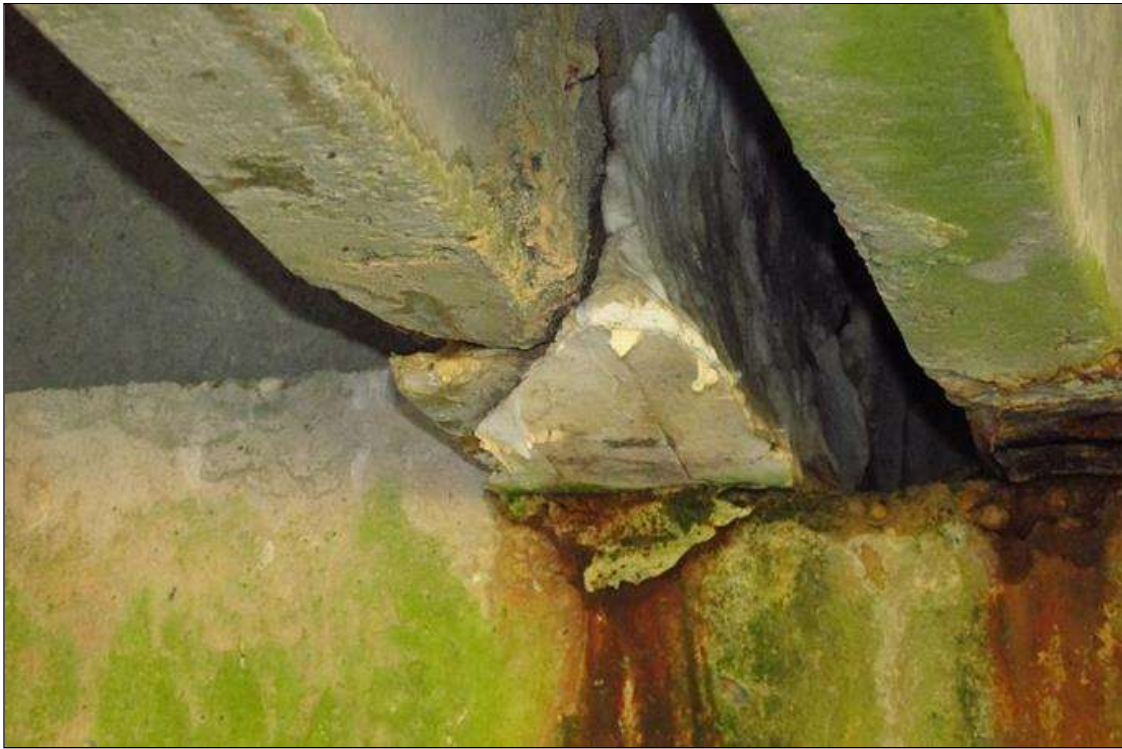
1 Feet of Delamination/Patched Area: Patched area that is unsound with 1/4 wide crack.

PATCH REPAIR IN THE LEFT LEG OF CHANNEL BEAM NO.2 IN SPAN 2 AT BENT 1
