NC DEPARTMENT OF TRANSPORTATION  
DIVISION OF HIGHWAYS  
STRUCTURE MANAGEMENT UNIT

## Structure Safety Report

### Routine Element Inspection - Contract

COUNTY: JOHNSTON STRUCTURE NUMBER: 500243 FREQUENCY: 24 MONTHS

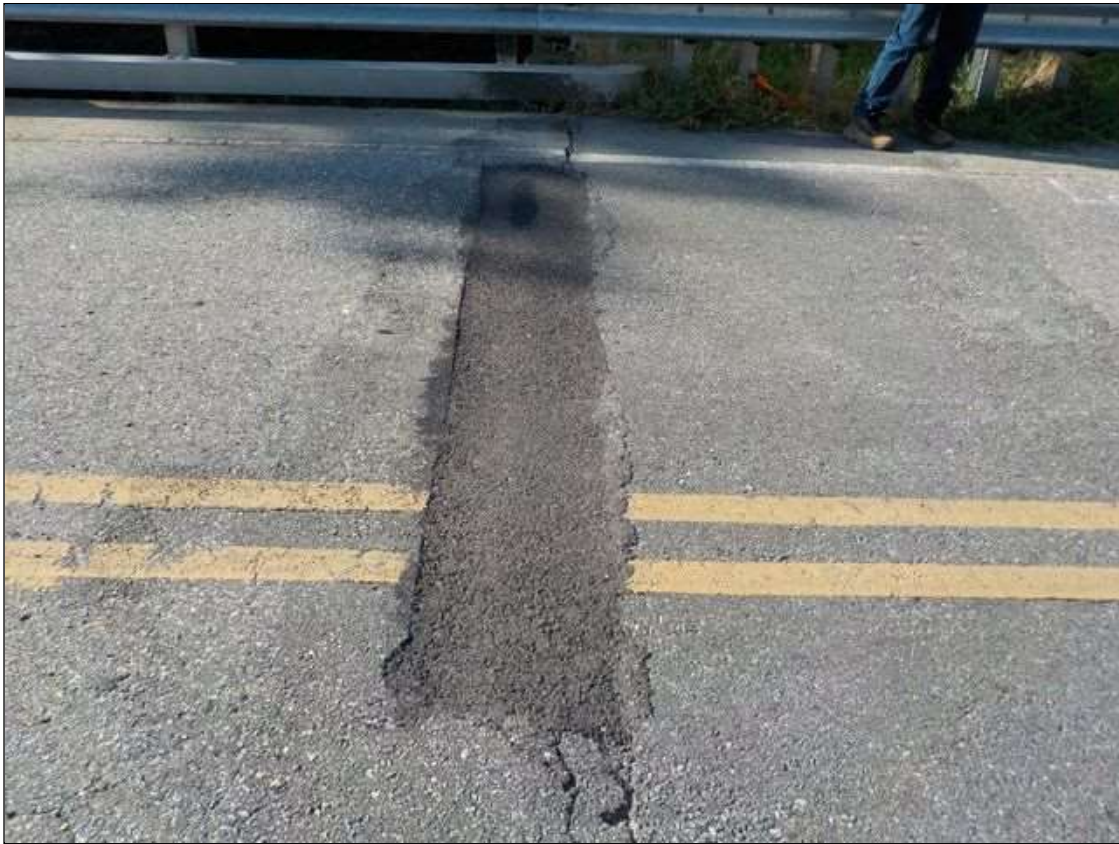
10' WIDE X 1'-6" SOUND PATCH IN THE EASTBOUND LANE ALONG THE END BENT 1 JOINT  
10' WIDE X 7" LONG AREA OF DELAMINATED ASPHALT IN THE WESTBOUND LANE ALONG THE END BENT 1 JOINT  
FULL LENGTH X 1/4" WIDE LONGITUDINAL CRACKS IN THE WESTBOUND LANE AT GREATER THAN 3' SPACING  
6' LONG X 1/8" WIDE TRANSVERSE CRACKS AT 1'-3' CENTERS THROUGHOUT THE SPAN

Span 1 Wearing Surface: 10' WIDE X 1'-6" SOUND PATCH IN THE EASTBOUND LANE

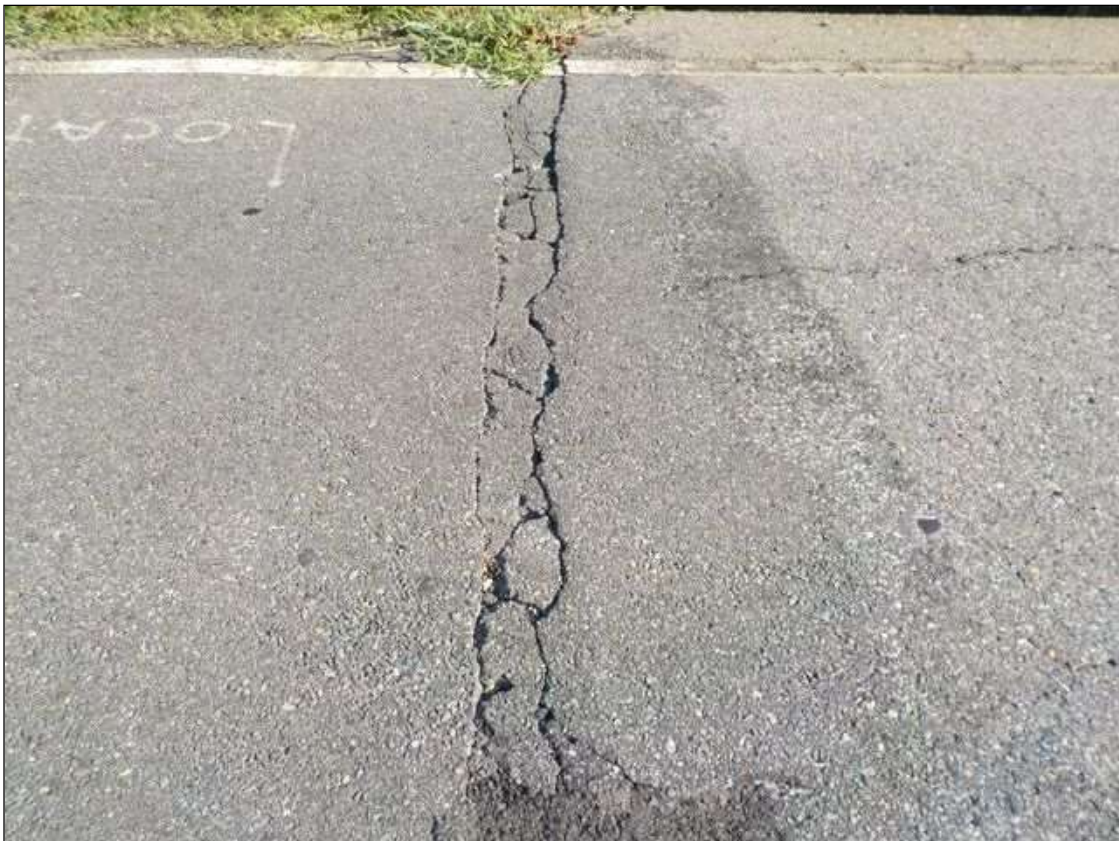
Span 1 Wearing Surface: 10' WIDE X 7" LONG AREA OF DELAMINATED ASPHALT IN THE WESTBOUND LANE  
ALONG THE END BENT 1 JOINT

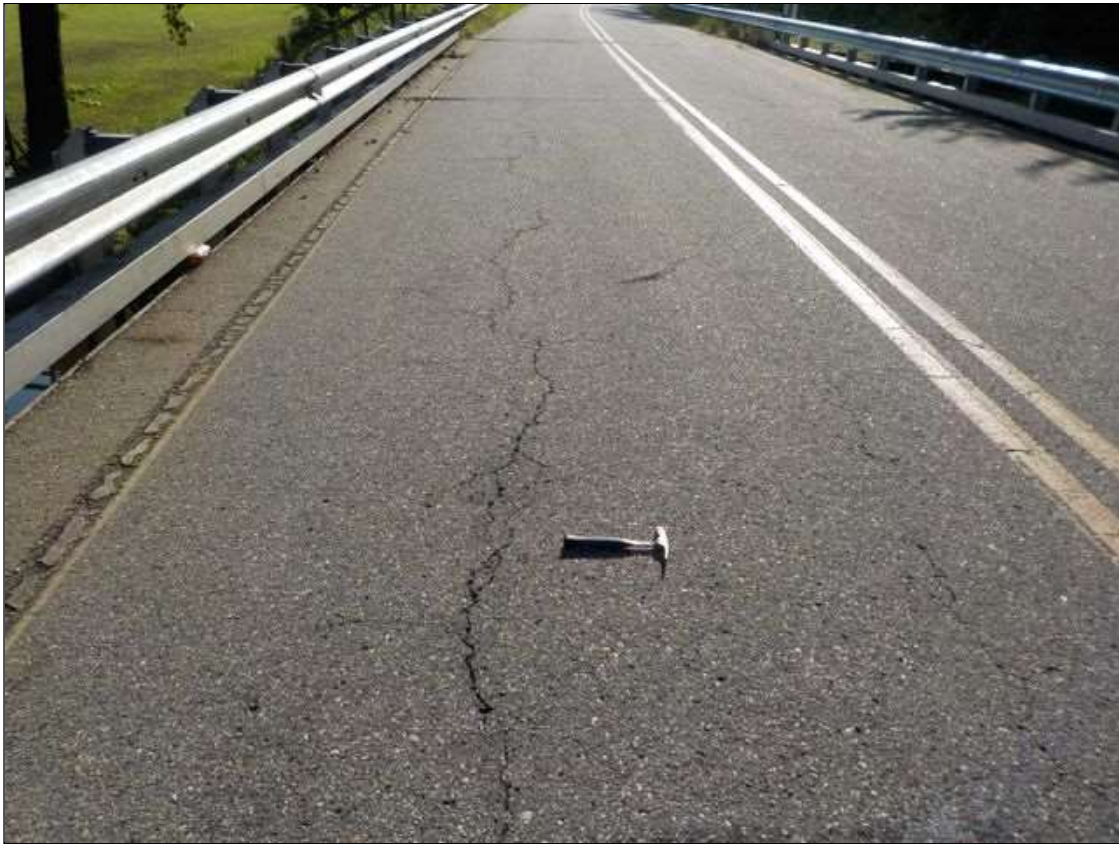
Span 1 Wearing Surface: FULL LENGTH X 1/4" WIDE LONGITUDINAL CRACKS IN THE WESTBOUND LANE AT GREATER THAN 3' SPACING

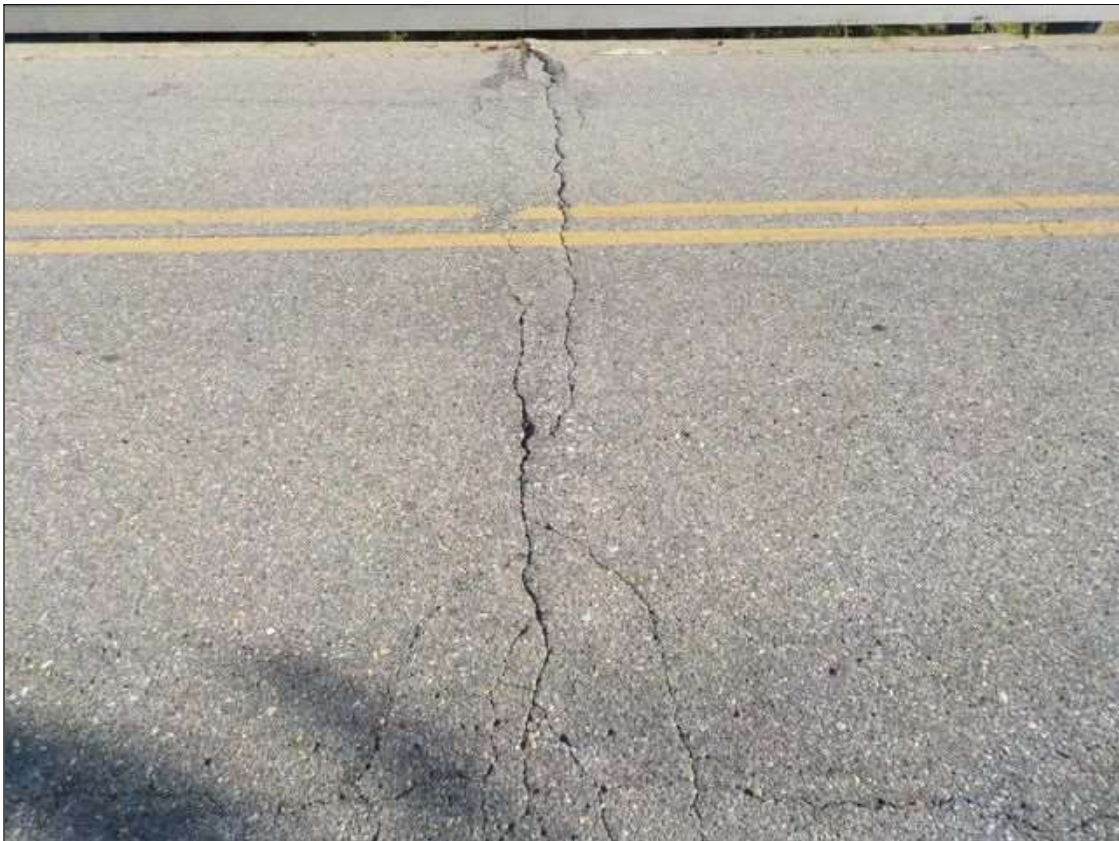
FULL LENGTH X 1/4" WIDE LONGITUDINAL CRACKS IN THE WESTBOUND LANE AT GREATER THAN 3' SPACING  
 24' WIDE X 2' LONG AREA OF DELAMINATED ASPHALT ALONG THE BENT 1 JOINT  
 6' LONG X 1/8" WIDE TRANSVERSE CRACKS AT 1'-3' CENTERS THROUGHOUT THE SPAN  
 2'-0" WIDE X 2'-0" SOUND PATCH IN THE WESTBOUND LANE ALONG THE END BENT 2 JOINT  
 10' LONG X 1/4" WIDE TRANSVERSE CRACK IN THE EASTBOUND LANE ALONG THE END BENT 2 JOINT

Span 2 Wearing Surface: 24' WIDE X 2' LONG AREA OF DELAMINATED ASPHALT ALONG THE BENT 1 JOINT

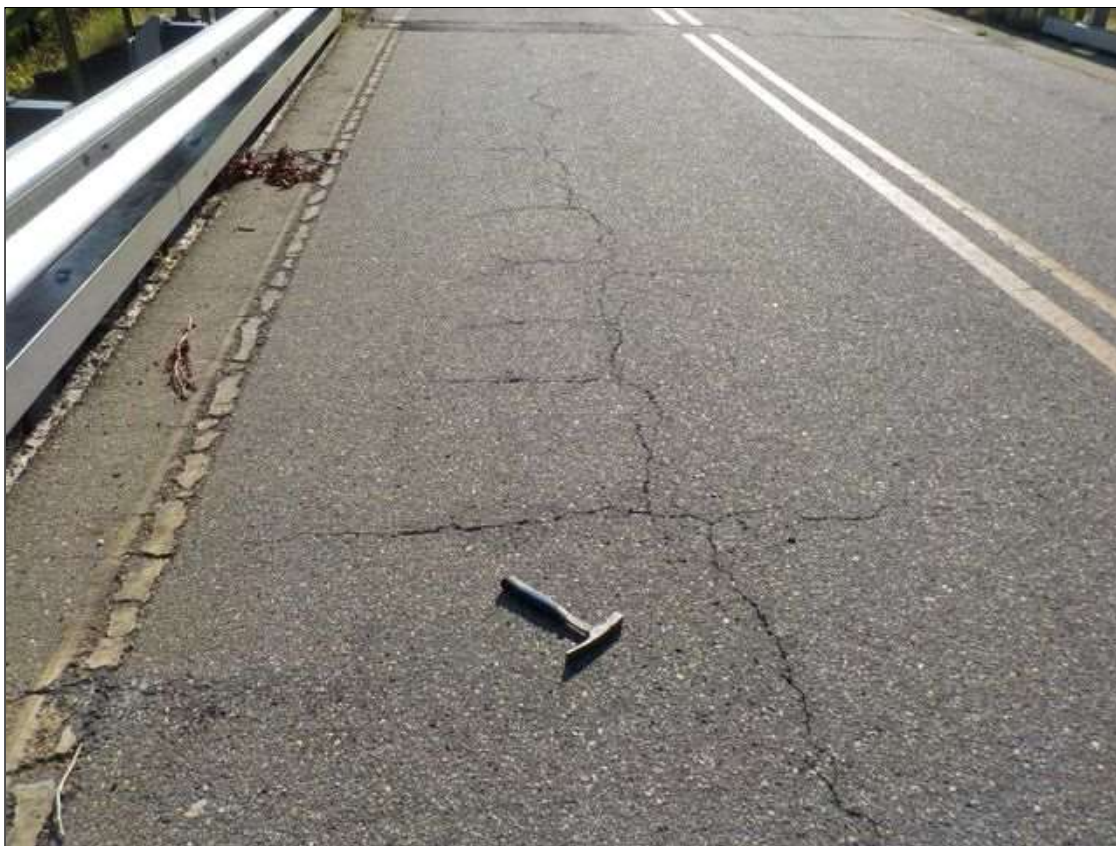
Span 2 Wearing Surface: 6' LONG X 1/8" WIDE TRANSVERSE CRACKS AT 1'-3' CENTERS THROUGHOUT THE SPAN

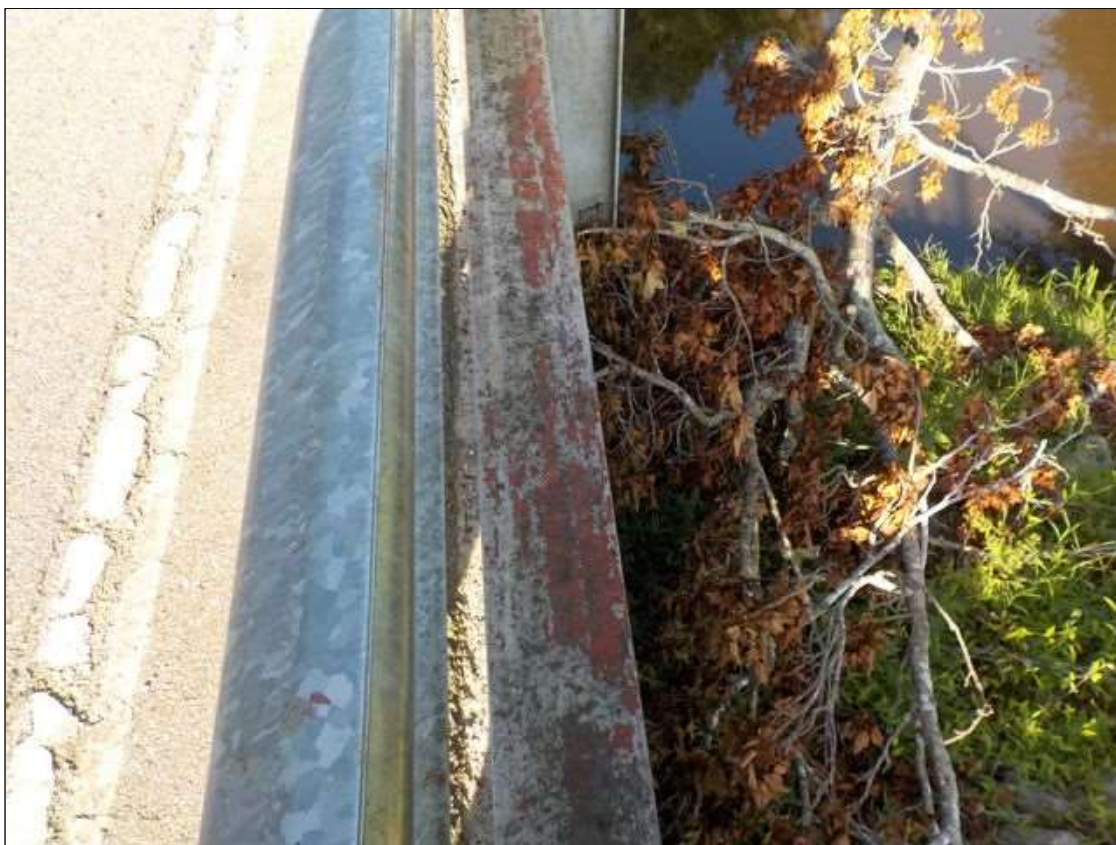
Span 2 Left Bridge Rail: PEELING PAINT THROUGHOUT THE CURB

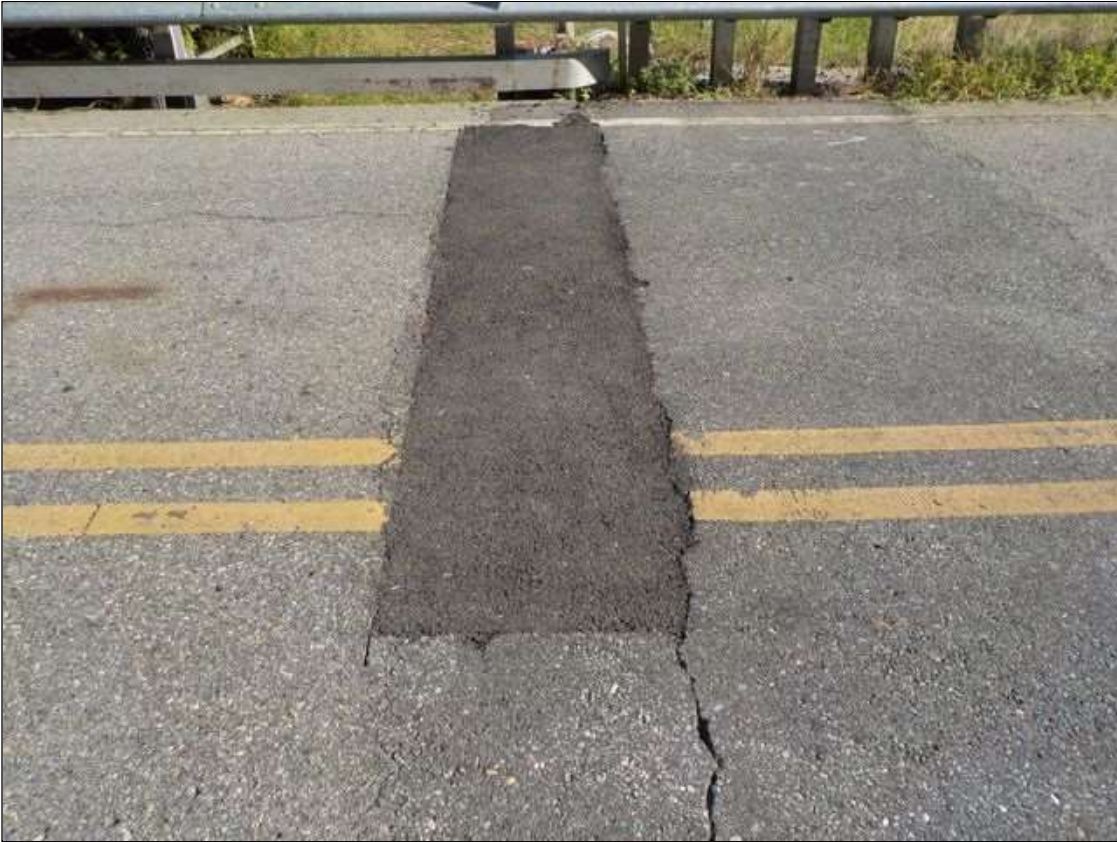
Span 2 Wearing Surface: 2'-0" WIDE X 2'-0" SOUND PATCH IN THE WESTBOUND LANE ALONG THE END BENT 2 JOINT

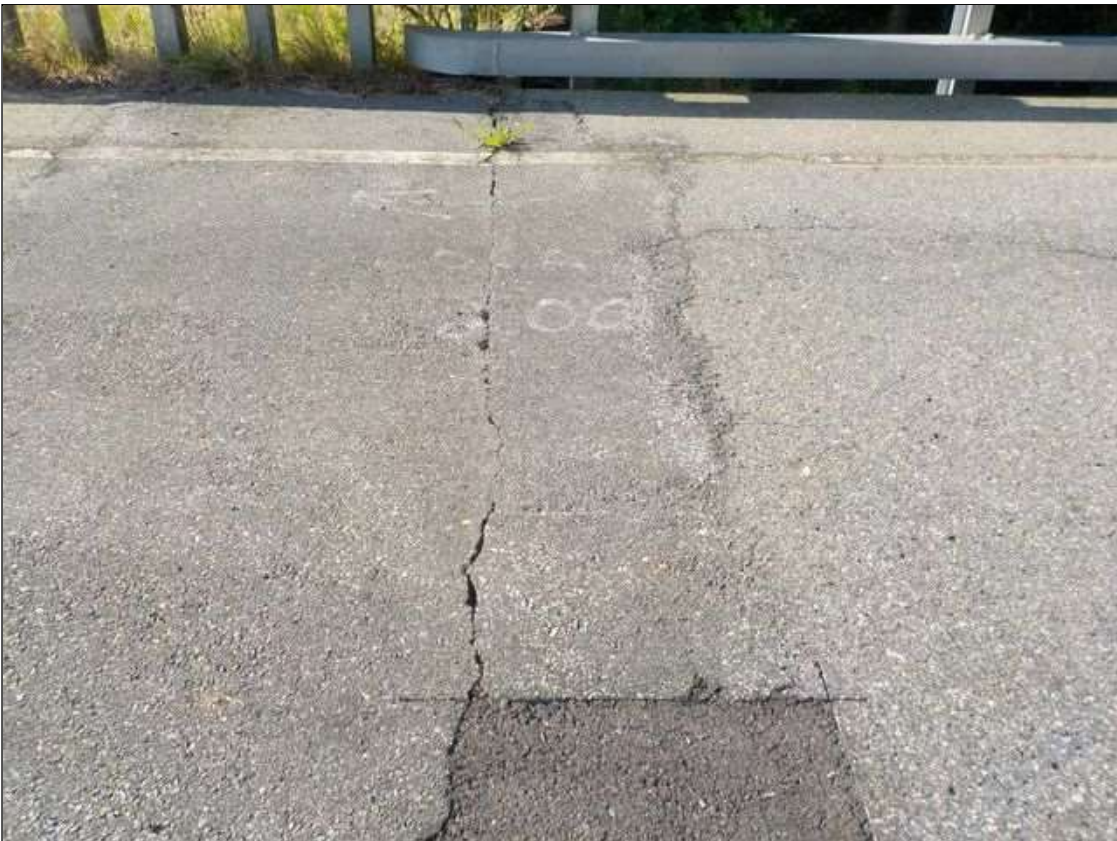
Span 2 Wearing Surface: 10' LONG X 1/4" WIDE TRANSVERSE CRACK IN THE EASTBOUND LANE ALONG THE END BENT 2 JOINT

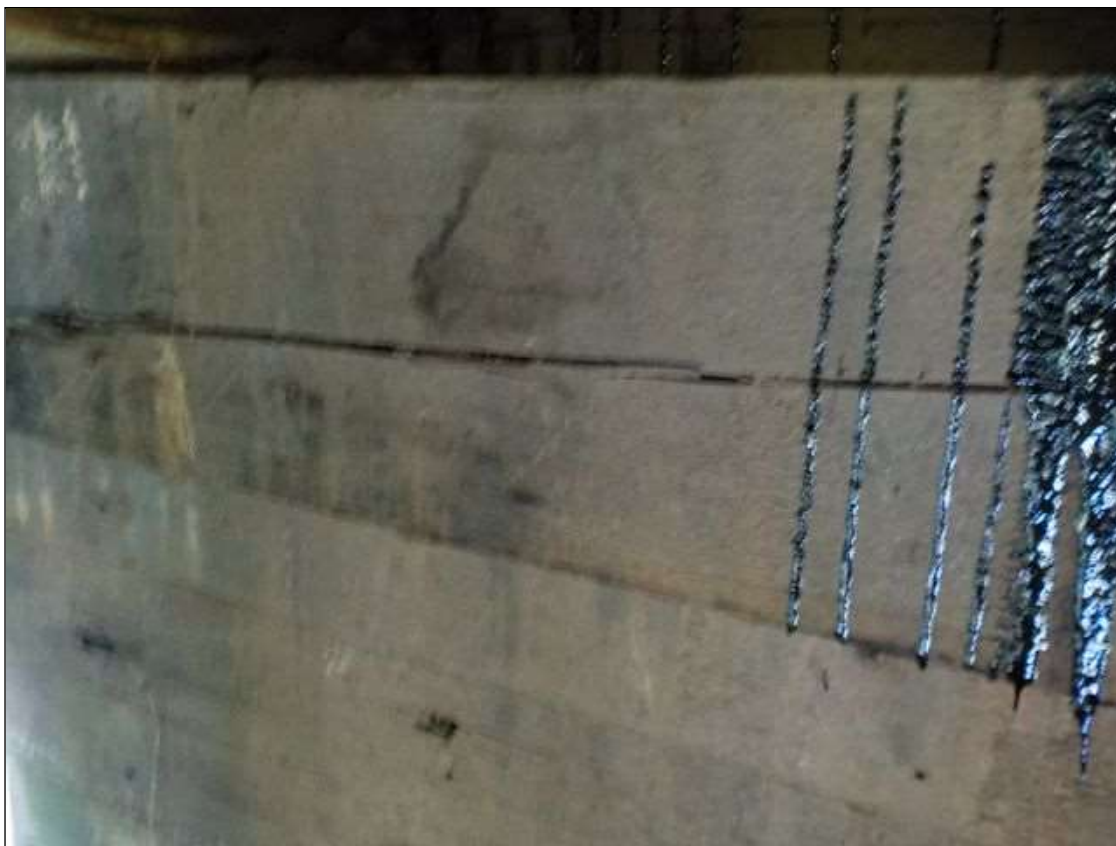
| 4' LONG X UP TO 1/4" WIDE HORIZONTAL CRACK IN THE EAST FACE BETWEEN PILES 2 AND 3 | | | | | | | | | | | | |

End Bent 1 Cap : 4' LONG X UP TO 1/4" WIDE HORIZONTAL CRACK IN THE EAST FACE BETWEEN PILES 2 AND 3

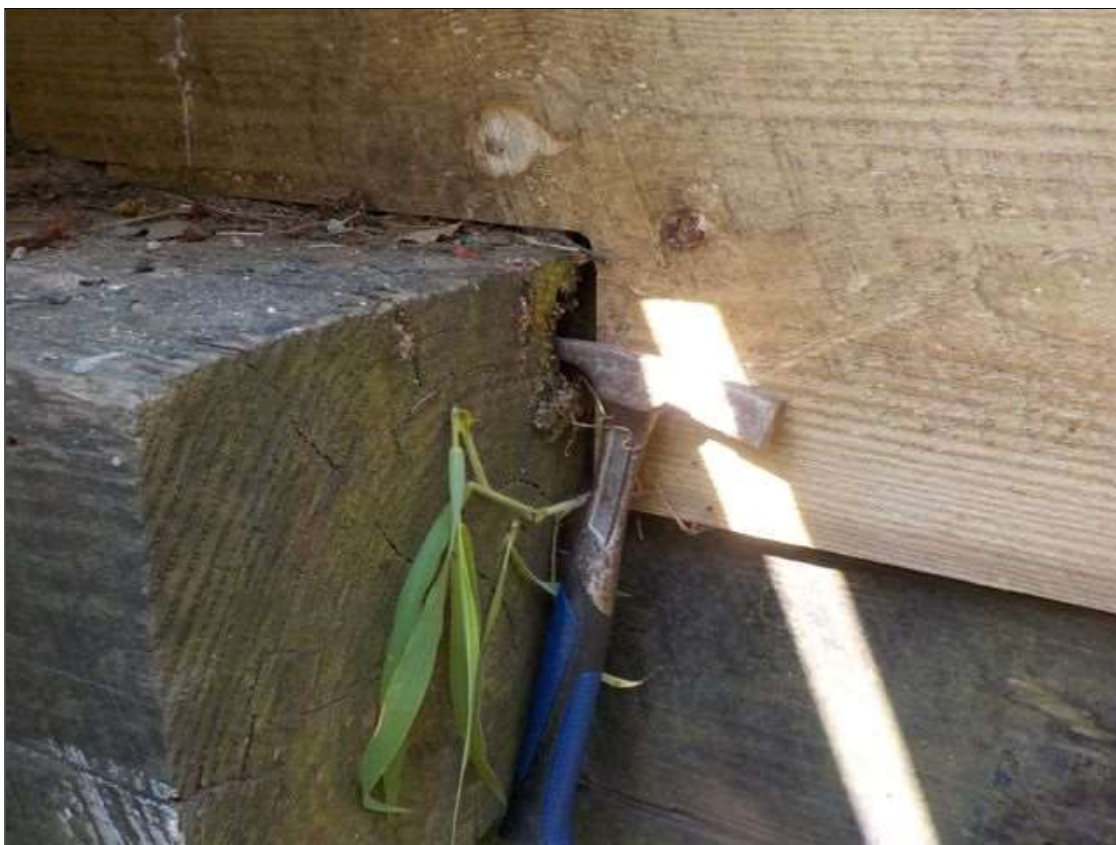
| 2 1/2" WIDE X 3" HIGH X 2" DEEP AREA OF DECAY AT THE NORTH END | | | | | | | | | | | | |

End Bent 1 Cap : 2 1/2" WIDE X 3" HIGH X 2" DEEP AREA OF DECAY AT THE NORTH END

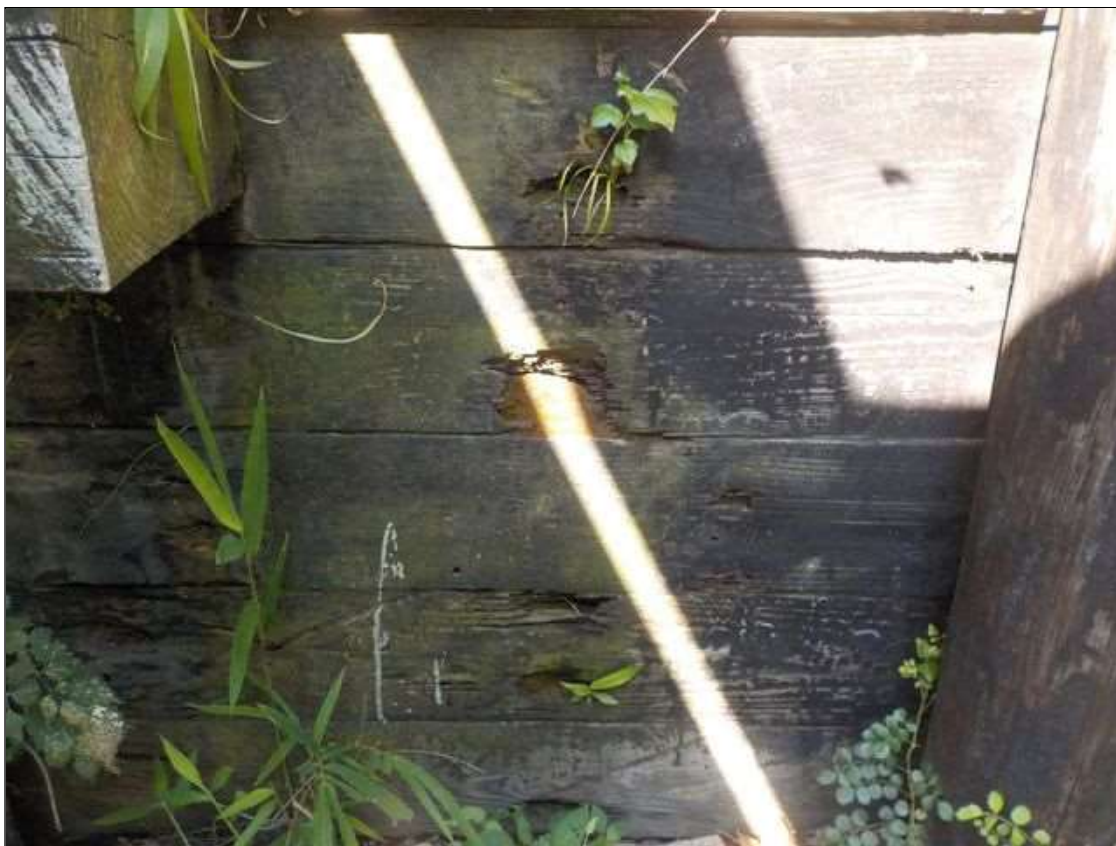
| End Bent 1 | Row 1 | Abutments | 1 |
|---|---|---|---|
| 1'-0" LONG X 1'-8" HIGH X 3" DEEP AREA OF DECAY AT THE NORTH END | | | |

End Bent 1 Abutment/Backwall : 1'-0" LONG X 1'-8" HIGH X 3" DEEP AREA OF DECAY AT THE NORTH END

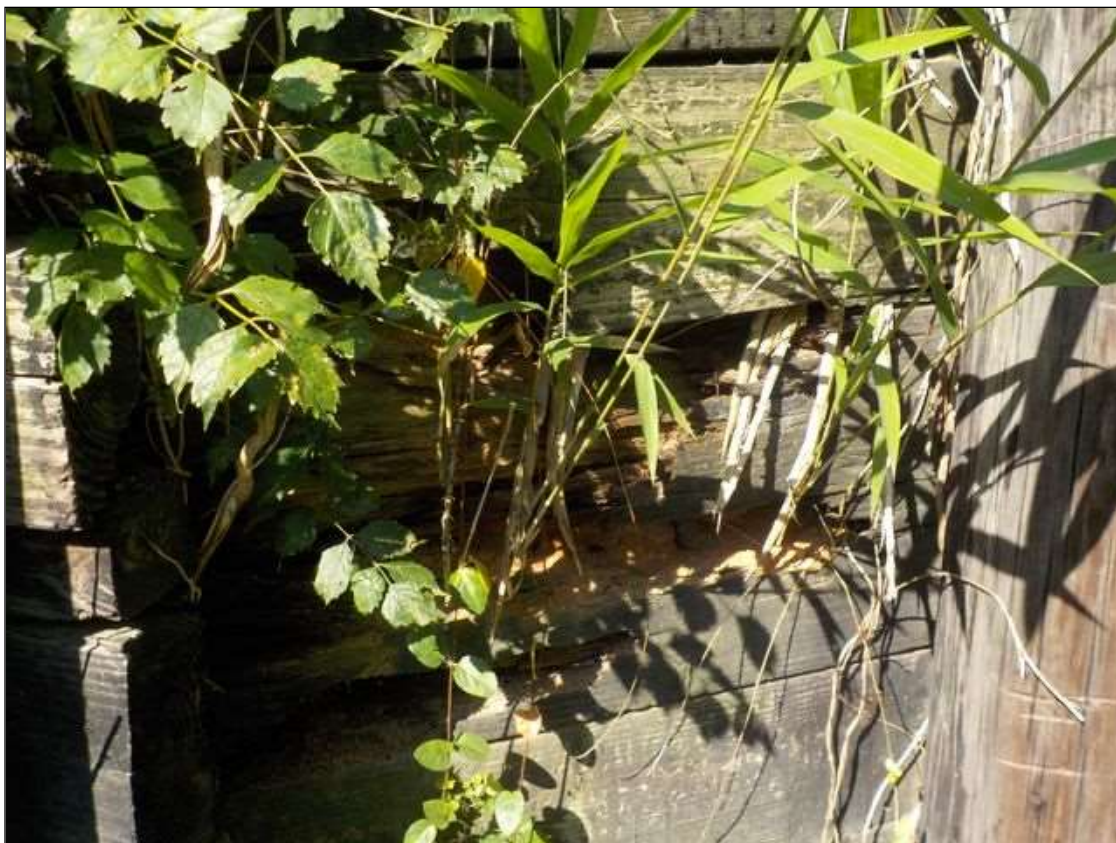
| End Bent 1 | Row 1 | Abutments | 1 |
|---|---|---|---|
| 11' LONG X 2' HIGH X 3" DEEP AREA OF DECAY AT THE NORTH END | | | |

End Bent 1 Abutment/Backwall : 11' LONG X 2' HIGH X 3" DEEP AREA OF DECAY AT THE NORTH END

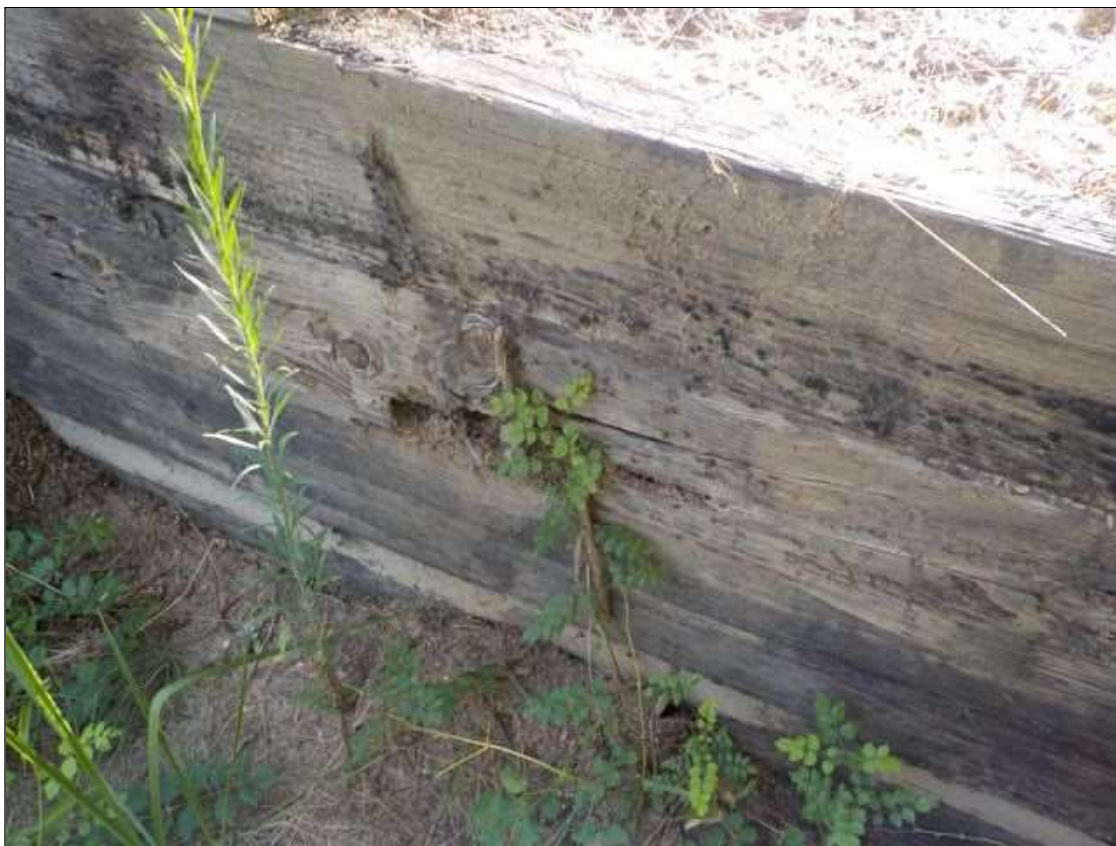
| End Bent 2 | Row 1 | Abutments | 1 |
|---|---|---|---|
| 1'-6" LONG X 6" HIGH X 3 1/2" DEEP AREA OF DECAY WITH EXPOSED FILL AT THE SOUTH END<br>4' LONG X 10" HIGH X 3 1/2" DEEP DECAYED AREA AT THE NORTH END | | | |

End Bent 2 Abutment/Backwall : 1'-6" LONG X 6" HIGH X 3 1/2" DEEP AREA OF DECAY WITH EXPOSED FILL AT THE SOUTH END

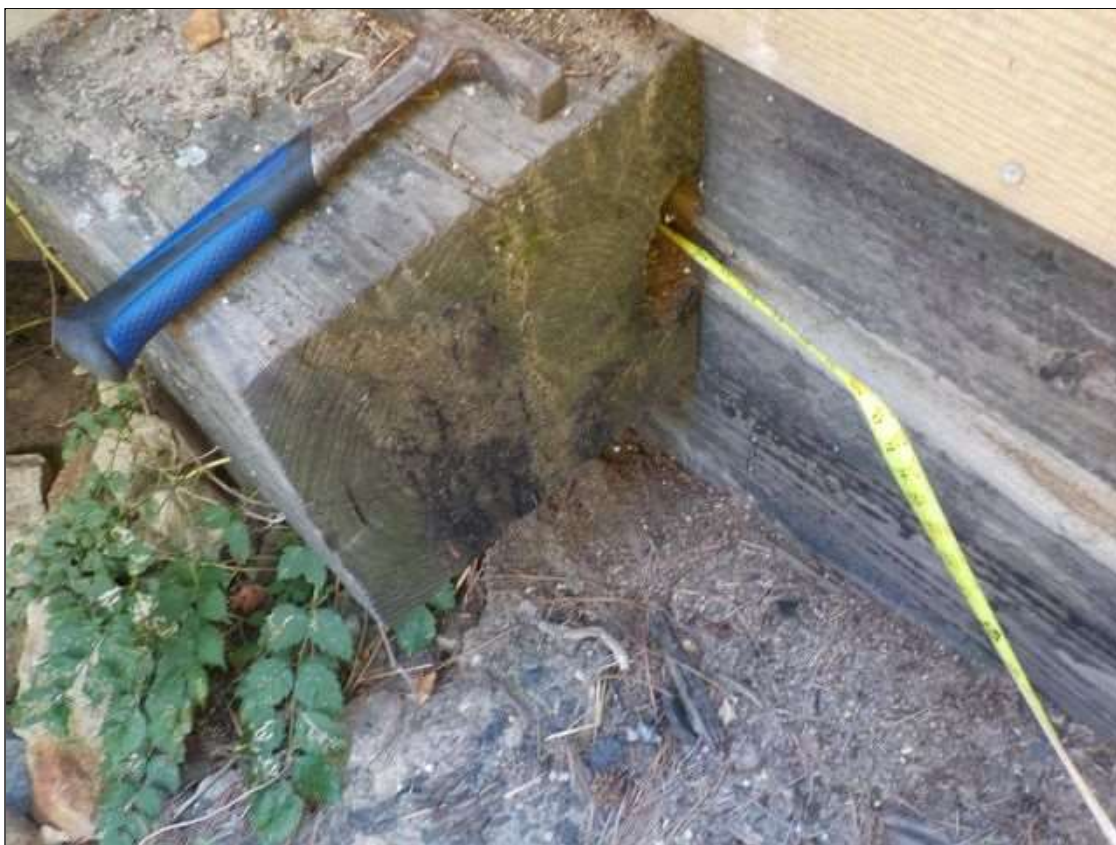
| 10" DEEP X 2 1/2" WIDE X 5" HIGH AREA OF DECAY IN THE SOUTH END | | | | | | | | | | | | |

End Bent 2 Cap : 10" DEEP X 2 1/2" WIDE X 5" HIGH AREA OF DECAY IN THE SOUTH END

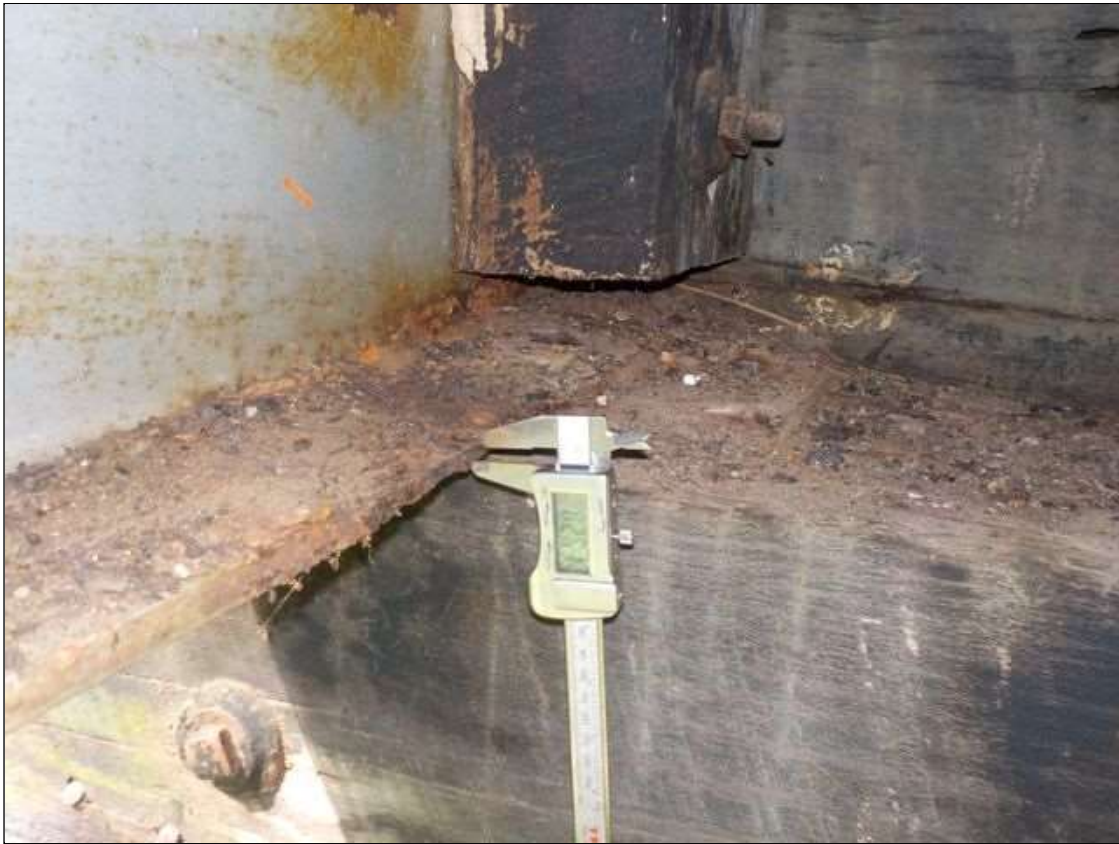
1'-6" LONG X UP TO 8" WIDE AREA OF UP TO 5/16" SECTION LOSS IN THE BOTTOM FLANGE AT END BENT 1  
 5" WIDE X 1'-6" HIGH X 8" LONG TIMBER BLOCK REPAIR BOLTED TO THE WEB AT END BENT 1  
 SURFACE RUST IN THE FLANGES AND WEB THROUGHOUT THE FULL LENGTH OF THE BEAM WITH 20% PAINT LOSS

Span 1 Beam 8: 1'-6" LONG X UP TO 8" WIDE AREA OF UP TO 5/16" SECTION LOSS IN THE BOTTOM FLANGE AT END BENT 1

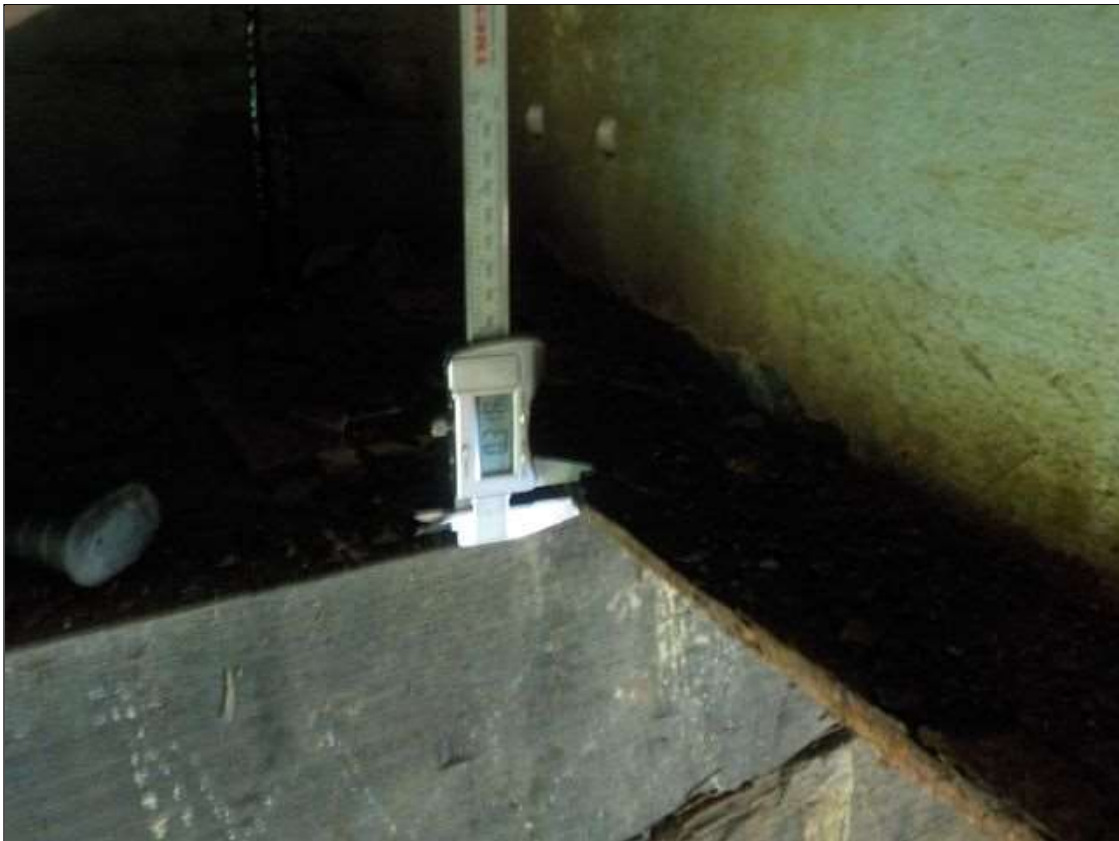
1'-8" LONG X UP TO 8" WIDE AREA OF UP TO 3/8" SECTION LOSS IN THE BOTTOM FLANGE AT END BENT 1  
 SURFACE RUST AND PEELING PAINT THROUGHOUT THE INTERMEDIATE DIAPHRAGMS  
 SURFACE RUST IN THE FLANGES AND WEB THROUGHOUT THE FULL LENGTH OF THE BEAM WITH 20% PAINT LOSS

Span 1 Beam 7: 1'-8" LONG X UP TO 8" WIDE AREA OF UP TO 3/8" SECTION LOSS IN THE BOTTOM FLANGE AT END BENT 1

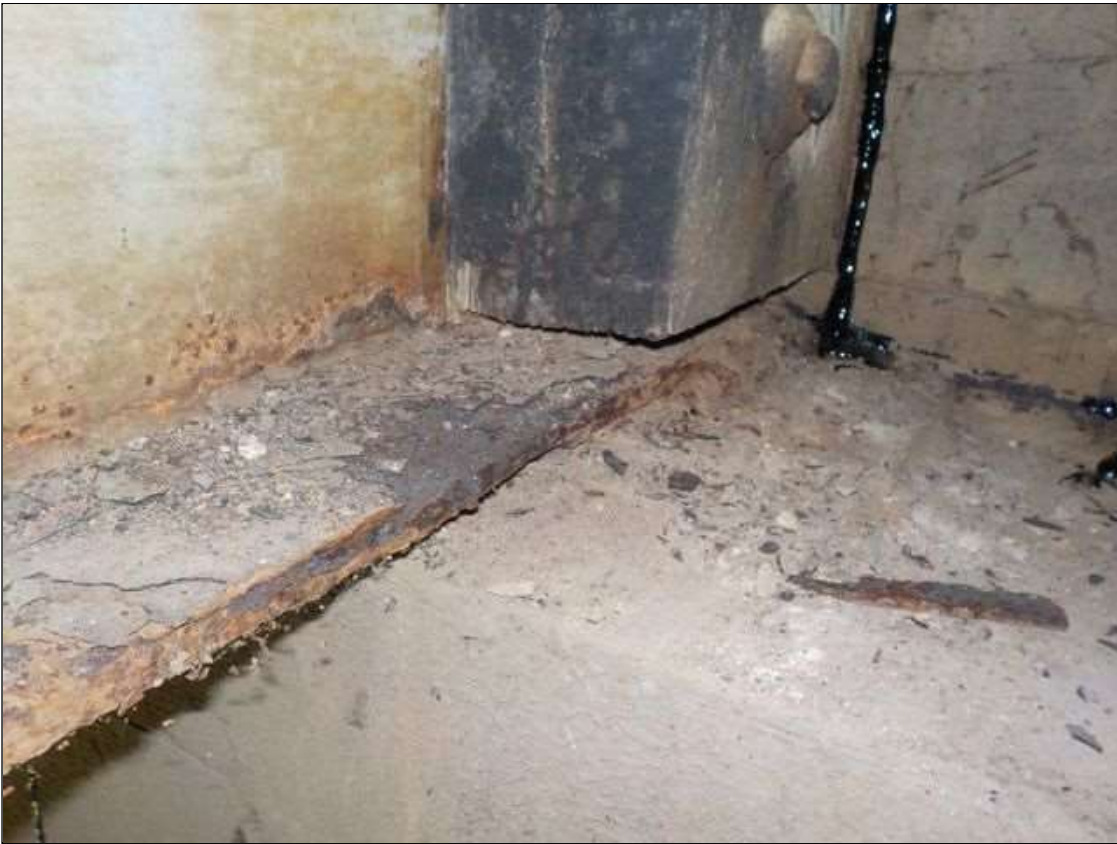
1'-6" LONG X UP TO 8" WIDE AREA OF UP TO 1/4" SECTION LOSS IN THE BOTTOM FLANGE AT END BENT 1  
 3'-0" LONG X UP TO 8" WIDE AREA OF UP TO 3/16" SECTION LOSS IN THE BOTTOM FLANGE AT BENT 1  
 5" WIDE X 1'-6" HIGH X 8" LONG TIMBER BLOCK REPAIR BOLTED TO THE WEB AT END BENT 1  
 SURFACE RUST AND PEELING PAINT THROUGHOUT THE INTERMEDIATE DIAPHRAGMS  
 SURFACE RUST IN THE FLANGES AND WEB THROUGHOUT THE FULL LENGTH OF THE BEAM WITH 20% PAINT LOSS

Span 1 Beam 6: 1'-6" LONG X UP TO 8" WIDE AREA OF UP TO 1/4" SECTION LOSS IN THE BOTTOM FLANGE AT  
END BENT 1

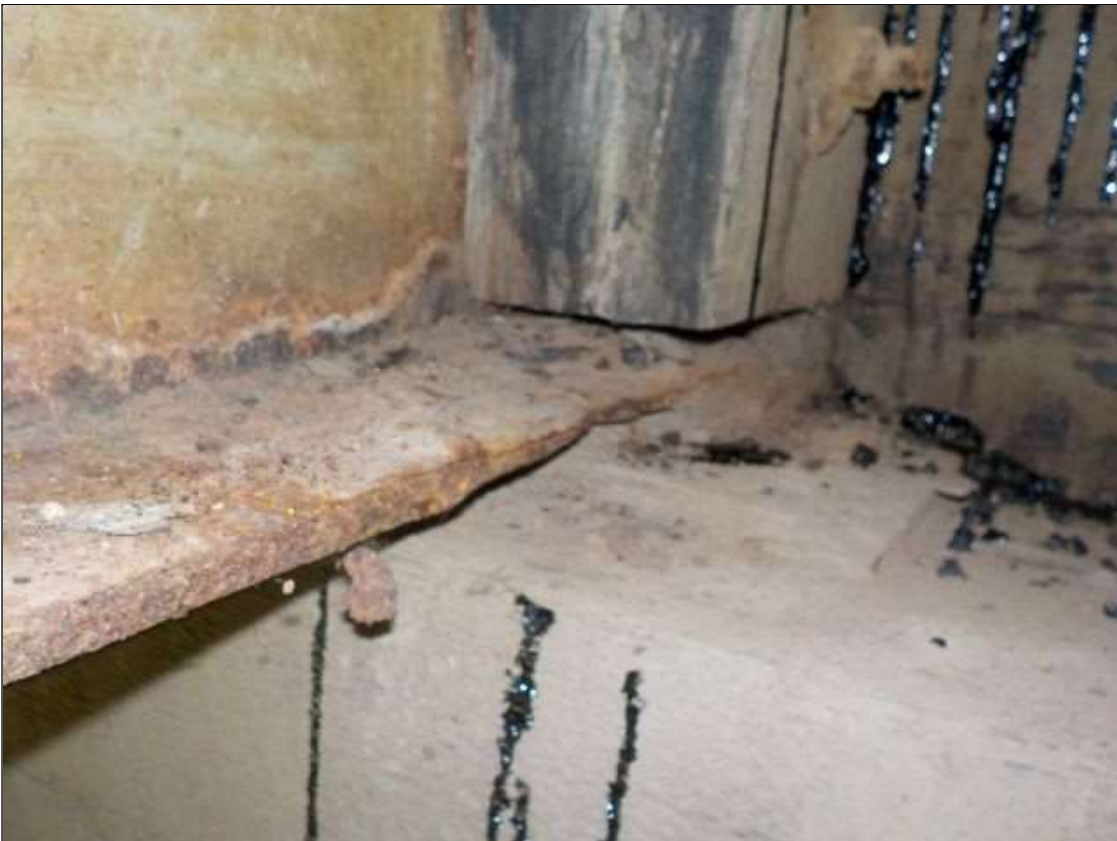
1'-6" LONG X UP TO 8" WIDE AREA OF UP TO 1/2" SECTION LOSS IN THE BOTTOM FLANGE AT END BENT 1  
1'-6" LONG X UP TO 8" WIDE AREA OF UP TO 3/16" SECTION LOSS IN THE BOTTOM FLANGE OF BEAM 5 IN SPAN 1, 1'-6" FROM BENT 1  
5" WIDE X 1'-6" HIGH X 8" LONG TIMBER BLOCK REPAIR BOLTED TO THE WEB AT END BENT 1  
SURFACE RUST AND PEELING PAINT THROUGHOUT THE INTERMEDIATE DIAPHRAGMS  
SURFACE RUST IN THE FLANGES AND WEB THROUGHOUT THE FULL LENGTH OF THE BEAM WITH 20% PAINT LOSS

Span 1 Beam 5: 1'-6" LONG X UP TO 8" WIDE AREA OF UP TO 1/2" SECTION LOSS IN THE BOTTOM FLANGE AT  
END BENT 1

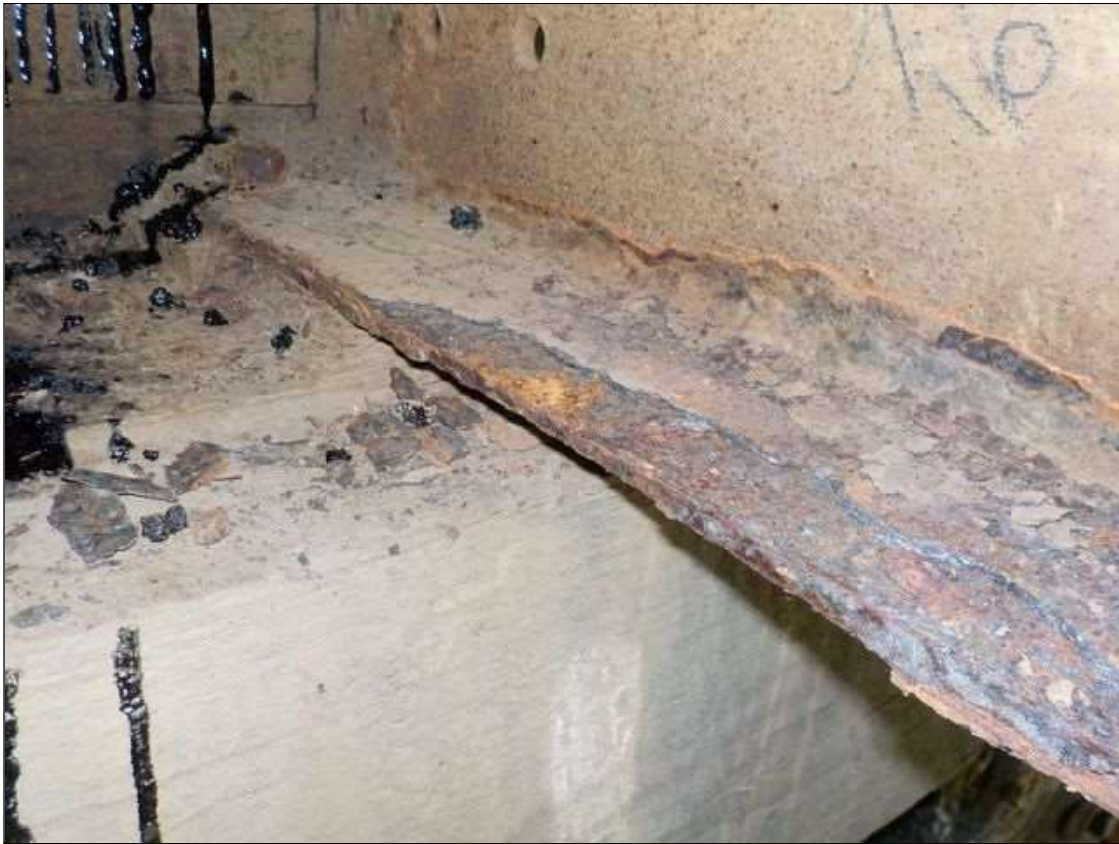
2'-6" LONG X UP TO 8" WIDE AREA OF UP TO 7/16" SECTION LOSS IN THE BOTTOM FLANGE AT END BENT 1  
SURFACE RUST AND PEELING PAINT THROUGHOUT THE INTERMEDIATE DIAPHRAGMS  
SURFACE RUST IN THE FLANGES AND WEB THROUGHOUT THE FULL LENGTH OF THE BEAM WITH 20% PAINT LOSS

Span 1 Beam 4: 2'-6" LONG X UP TO 8" WIDE AREA OF UP TO 7/16" SECTION LOSS IN THE BOTTOM FLANGE AT END BENT 1

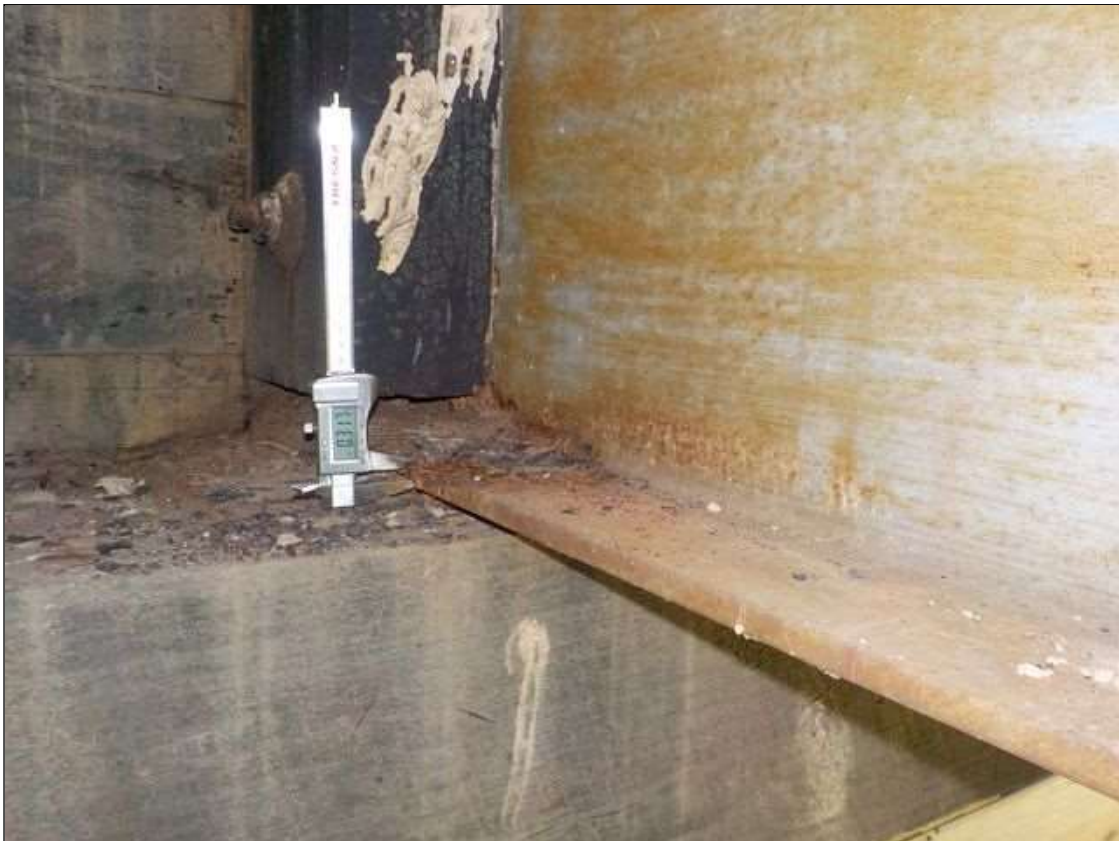
1'-0" LONG X UP TO 8" WIDE AREA OF UP TO 5/16" SECTION LOSS IN THE BOTTOM FLANGE AT END BENT 1  
5" WIDE X 1'-6" HIGH X 8" LONG TIMBER BLOCK REPAIR BOLTED TO THE WEB AT END BENT 1  
SURFACE RUST AND PEELING PAINT THROUGHOUT THE INTERMEDIATE DIAPHRAGMS  
SURFACE RUST IN THE FLANGES AND WEB THROUGHOUT THE FULL LENGTH OF THE BEAM WITH 20% PAINT LOSS

Span 1 Beam 3: 1'-0" LONG X UP TO 8" WIDE AREA OF UP TO 5/16" SECTION LOSS IN THE BOTTOM FLANGE AT END BENT 1

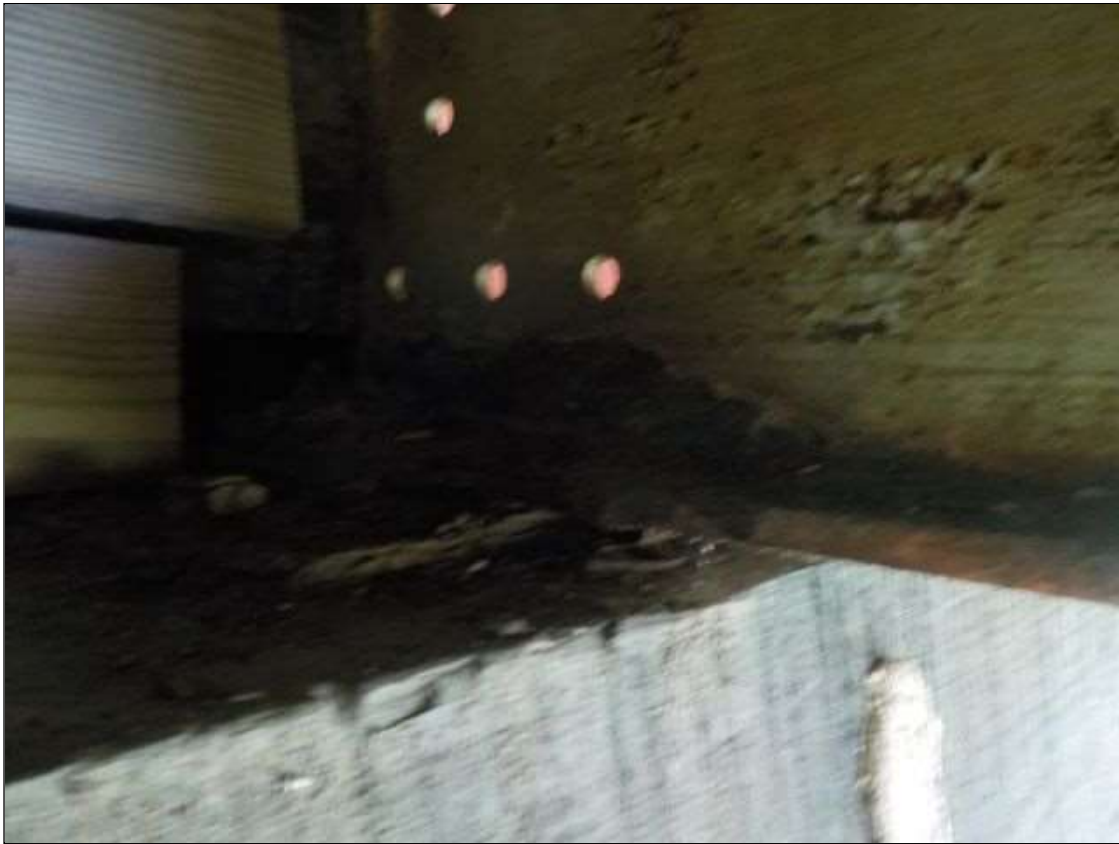
1'-0" LONG X UP TO 8" WIDE AREA OF UP TO 3/16" SECTION LOSS IN THE BOTTOM FLANGE AT END BENT 1  
SURFACE RUST AND PEELING PAINT THROUGHOUT THE INTERMEDIATE DIAPHRAGMS  
SURFACE RUST IN THE FLANGES AND WEB THROUGHOUT THE FULL LENGTH OF THE BEAM WITH 20% PAINT LOSS

Span 1 Beam 2: 1'-0" LONG X UP TO 8" WIDE AREA OF UP TO 3/16" SECTION LOSS IN THE BOTTOM FLANGE AT END BENT 1

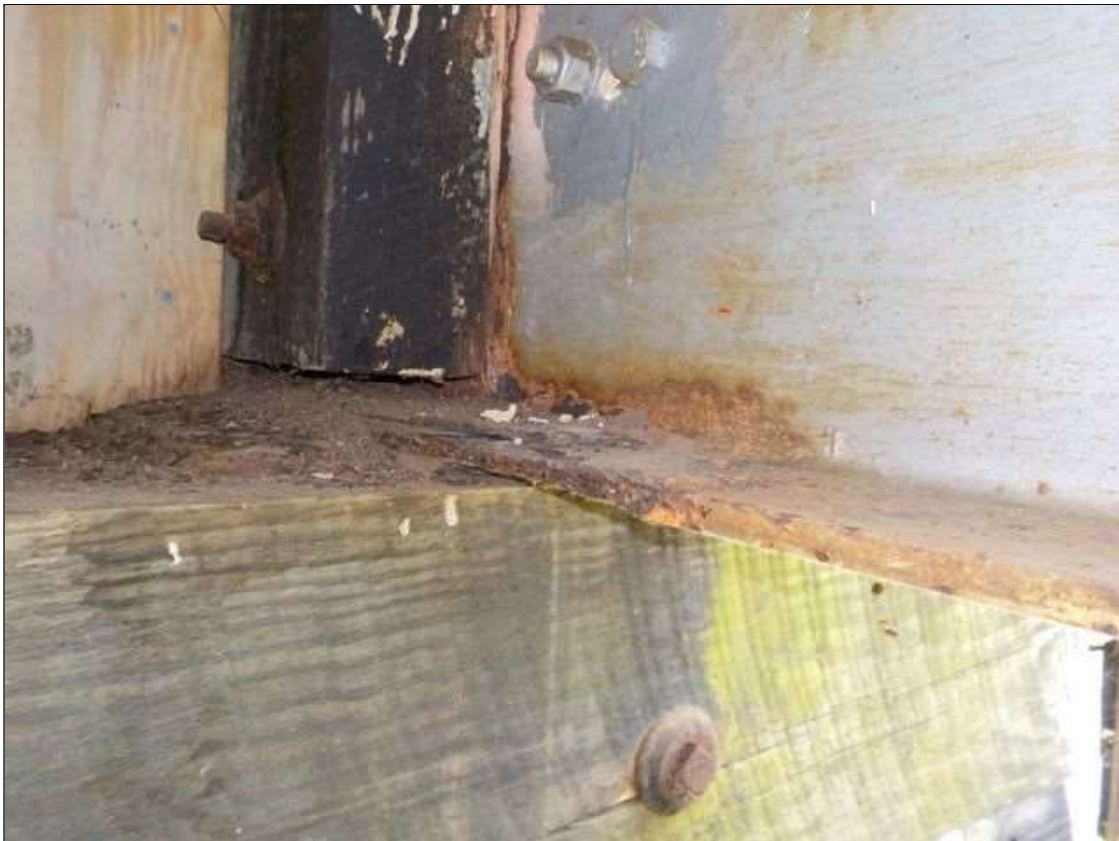
1'-6" LONG X UP TO 8" WIDE AREA OF UP TO 5/16" SECTION LOSS IN THE BOTTOM FLANGE AND 2" HIGH X 1'-6" LONG AREA OF 1/16" SECTION LOSS IN THE WEB AT END BENT 1  
5" WIDE X 1'-6" HIGH X 8" LONG TIMBER BLOCK REPAIR BOLTED TO THE WEB AT END BENT 1  
SURFACE RUST AND PEELING PAINT THROUGHOUT THE INTERMEDIATE DIAPHRAGMS  
SURFACE RUST IN THE FLANGES AND WEB THROUGHOUT THE FULL LENGTH OF THE BEAM WITH 20% PAINT LOSS

Span 1 Beam 1: 1'-6" LONG X UP TO 8" WIDE AREA OF UP TO 5/16" SECTION LOSS IN THE BOTTOM FLANGE AND 2" HIGH X 1'-6" LONG AREA OF 1/16" SECTION LOSS IN THE WEB AT END BENT 1
