NC DEPARTMENT OF TRANSPORTATION  
DIVISION OF HIGHWAYS  
STRUCTURE MANAGEMENT UNIT

## Structure Safety Report

### Routine Element Inspection - Contract

COUNTY: JOHNSTON STRUCTURE NUMBER: 500243 FREQUENCY: 24 MONTHS

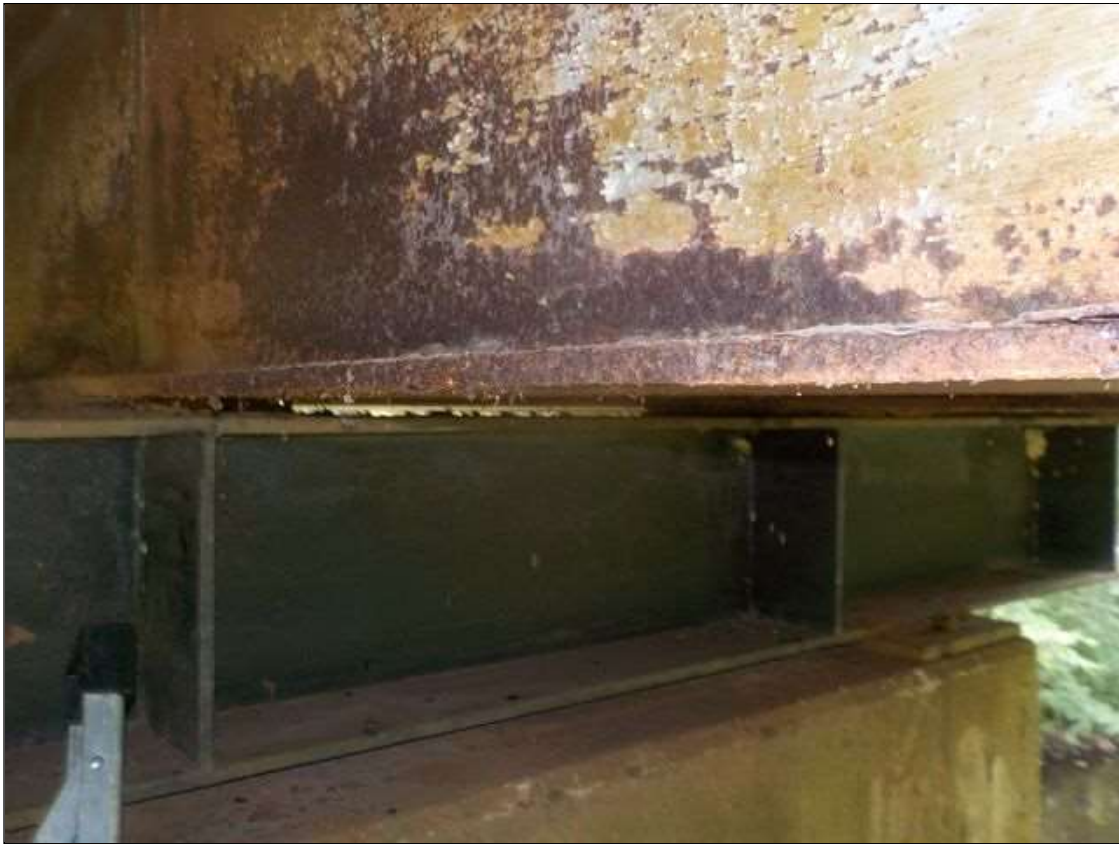
1'-6" LONG X UP TO 8" WIDE AREA OF UP TO 1/4" SECTION LOSS IN THE BOTTOM FLANGE AT END BENT 1  
 3'-0" LONG X UP TO 8" WIDE AREA OF UP TO 3/16" SECTION LOSS IN THE BOTTOM FLANGE AT BENT 1  
 5" WIDE X 1'-6" HIGH X 8" LONG TIMBER BLOCK REPAIR BOLTED TO THE WEB AT END BENT 1  
 SURFACE RUST AND PEELING PAINT THROUGHOUT THE INTERMEDIATE DIAPHRAGMS  
 SURFACE RUST IN THE FLANGES AND WEB THROUGHOUT THE FULL LENGTH OF THE BEAM WITH 20% PAINT LOSS

Span 1 Beam 6: 3'-0" LONG X UP TO 8" WIDE AREA OF UP TO 3/16" SECTION LOSS IN THE BOTTOM FLANGE AT BENT 1

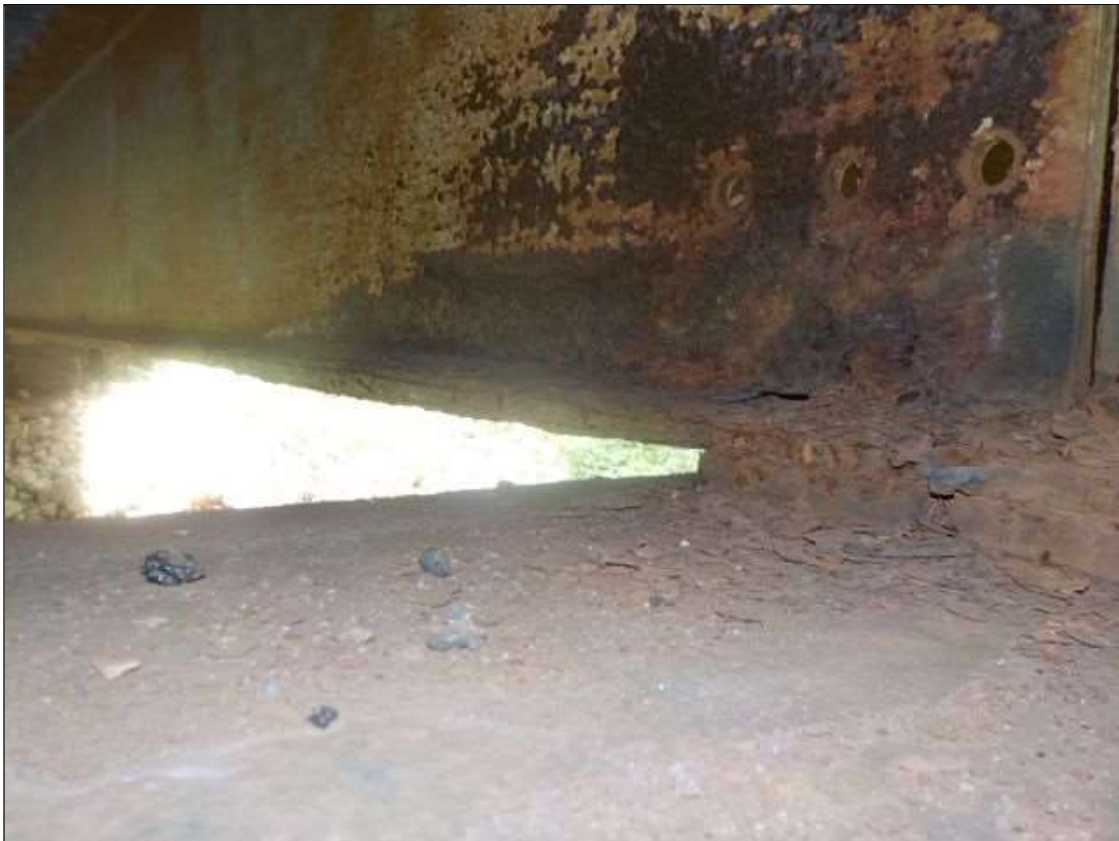
3'-0" LONG X UP TO 8" WIDE AREA OF UP TO 1/4" SECTION LOSS IN THE BOTTOM FLANGE OF BEAM 6 IN SPAN 2 AT BENT 1  
 1'-0" LONG X UP TO 8" WIDE AREA OF UP TO 3/8" SECTION LOSS IN THE BOTTOM FLANGE OF BEAM 6 AT END BENT 2  
 5" WIDE X 1'-6" HIGH X 8" LONG TIMBER BLOCK REPAIR BOLTED TO THE WEB AT END BENT 1  
 SURFACE RUST AND PEELING PAINT THROUGHOUT THE INTERMEDIATE DIAPHRAGMS  
 SURFACE RUST IN THE FLANGES AND WEB THROUGHOUT THE FULL LENGTH OF THE BEAM WITH 20% PAINT LOSS

Span 2 Beam 6: 3'-0" LONG X UP TO 8" WIDE AREA OF UP TO 1/4" SECTION LOSS IN THE BOTTOM FLANGE OF BEAM 6 IN SPAN 2 AT BENT 1

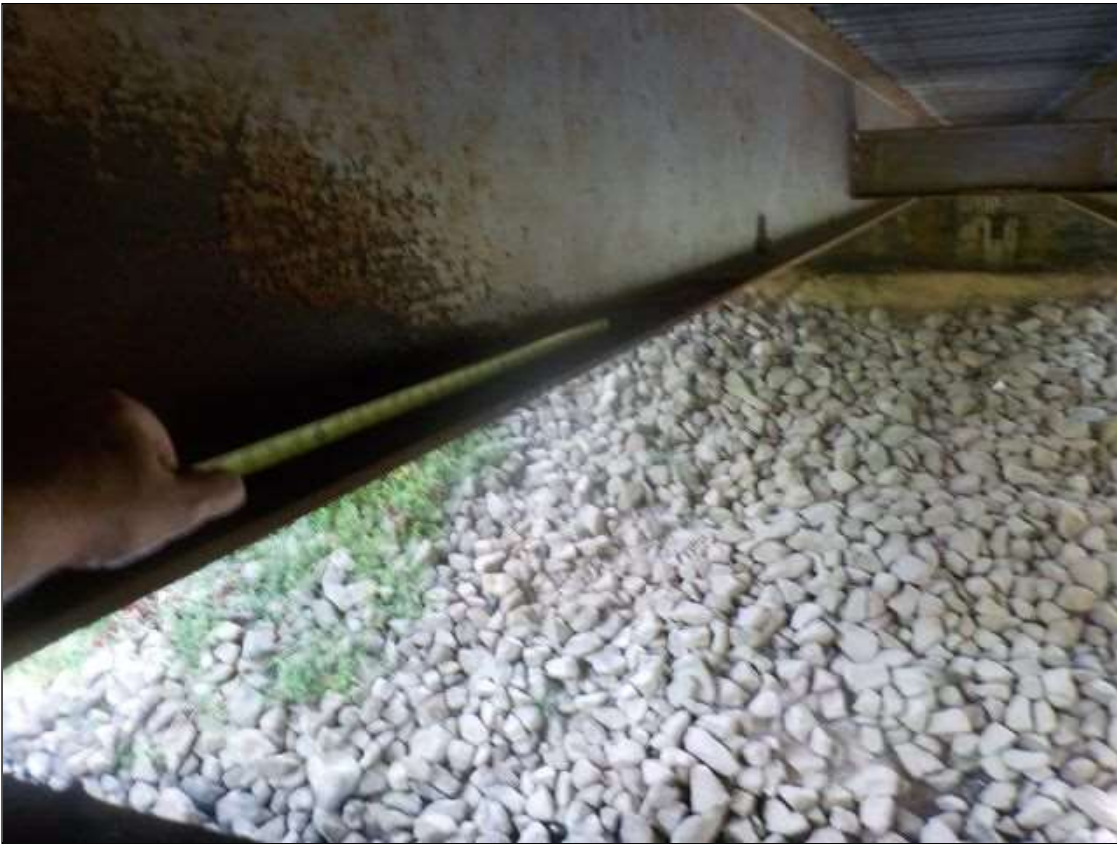
2'-0" LONG X UP TO 8" WIDE AREA OF UP TO 3/16" SECTION LOSS IN THE BOTTOM FLANGE OF BEAM 5 IN SPAN 2 AT BENT 1  
 5" WIDE X 1'-6" HIGH X 8" LONG TIMBER BLOCK REPAIR BOLTED TO THE WEB AT END BENT 1  
 SURFACE RUST AND PEELING PAINT THROUGHOUT THE INTERMEDIATE DIAPHRAGMS  
 SURFACE RUST IN THE FLANGES AND WEB THROUGHOUT THE FULL LENGTH OF THE BEAM WITH 20% PAINT LOSS

Span 2 Beam 5: 2'-0" LONG X UP TO 8" WIDE AREA OF UP TO 3/16" SECTION LOSS IN THE BOTTOM FLANGE OF BEAM 5 IN SPAN 2 AT BENT 1

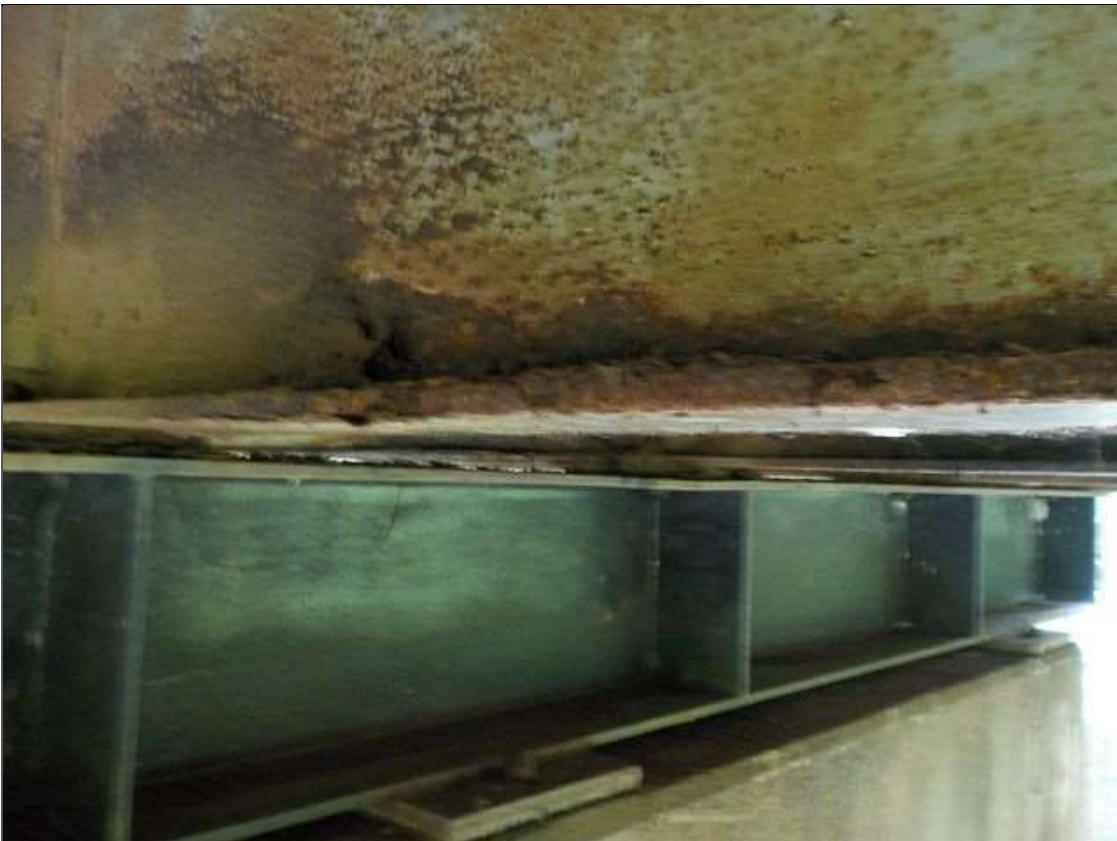
1'-6" LONG X UP TO 8" WIDE AREA OF UP TO 1/2" SECTION LOSS IN THE BOTTOM FLANGE AT END BENT 1  
1'-6" LONG X UP TO 8" WIDE AREA OF UP TO 3/16" SECTION LOSS IN THE BOTTOM FLANGE OF BEAM 5 IN SPAN 1, 1'-6" FROM BENT 1  
5" WIDE X 1'-6" HIGH X 8" LONG TIMBER BLOCK REPAIR BOLTED TO THE WEB AT END BENT 1  
SURFACE RUST AND PEELING PAINT THROUGHOUT THE INTERMEDIATE DIAPHRAGMS  
SURFACE RUST IN THE FLANGES AND WEB THROUGHOUT THE FULL LENGTH OF THE BEAM WITH 20% PAINT LOSS

Span 1 Beam 5: 1'-6" LONG X UP TO 8" WIDE AREA OF UP TO 3/16" SECTION LOSS IN THE BOTTOM FLANGE OF BEAM 5 IN SPAN 1, 1'-6" FROM BENT 1

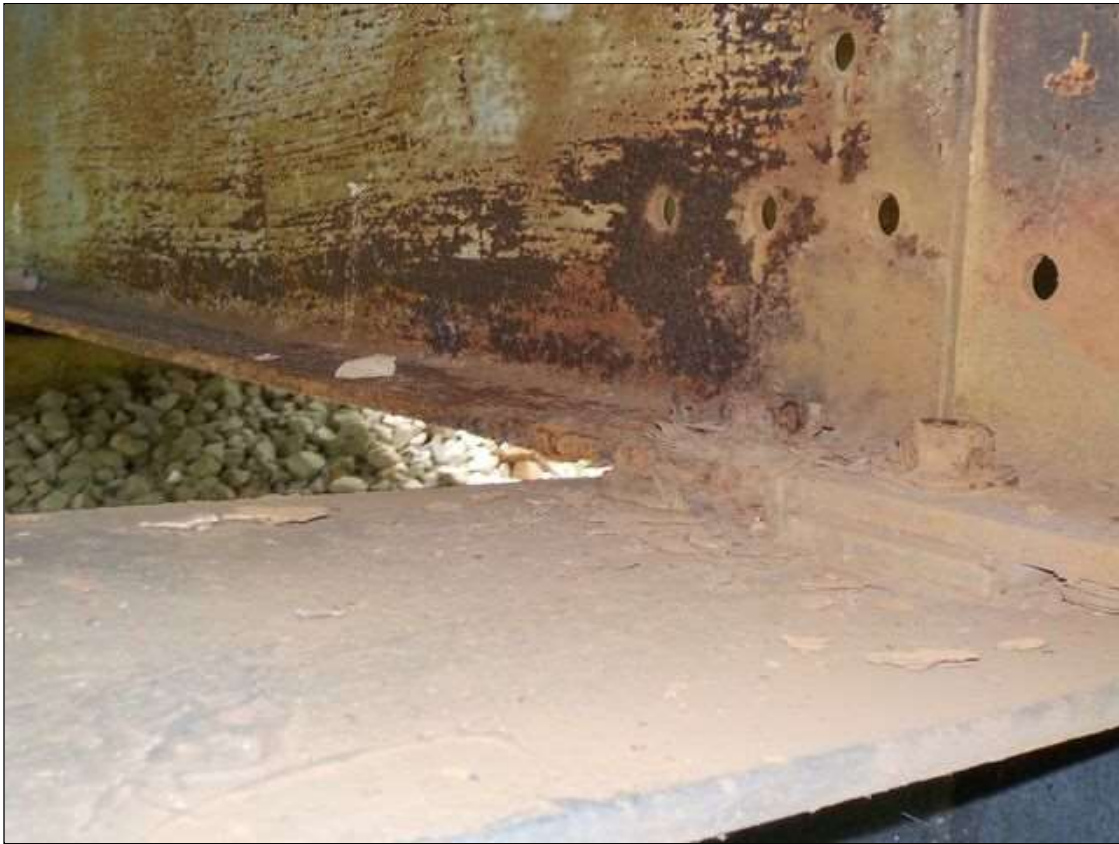
6" LONG X UP TO 8" WIDE AREA OF UP TO 3/16" SECTION LOSS IN THE BOTTOM FLANGE OF BEAM 2 IN SPAN 2 AT BENT 1  
 SURFACE RUST AND PEELING PAINT THROUGHOUT THE INTERMEDIATE DIAPHRAGMS  
 SURFACE RUST IN THE FLANGES AND WEB THROUGHOUT THE FULL LENGTH OF THE BEAM WITH 20% PAINT LOSS

Span 2 Beam 2: 6" LONG X UP TO 8" WIDE AREA OF UP TO 3/16" SECTION LOSS IN THE BOTTOM FLANGE OF BEAM 2 IN SPAN 2 AT BENT 1

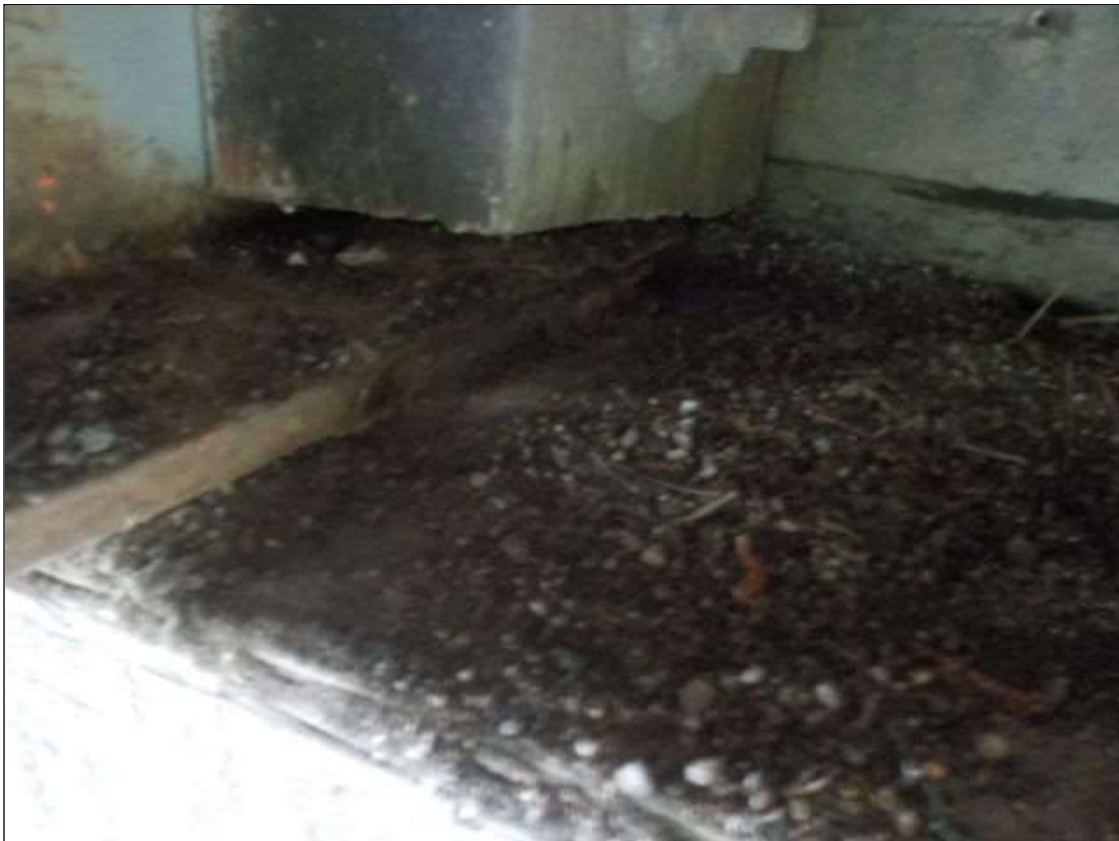
2'-0" LONG X UP TO 8" WIDE AREA OF UP TO 5/16" SECTION LOSS IN THE BOTTOM FLANGE OF BEAM 1 IN SPAN 2, 2' FROM BENT 1  
 5" WIDE X 1'-6" HIGH X 8" LONG TIMBER BLOCK REPAIR BOLTED TO THE WEB AT END BENT 1  
 SURFACE RUST AND PEELING PAINT THROUGHOUT THE INTERMEDIATE DIAPHRAGMS  
 SURFACE RUST IN THE FLANGES AND WEB THROUGHOUT THE FULL LENGTH OF THE BEAM WITH 20% PAINT LOSS

Span 2 Beam 1: 2'-0" LONG X UP TO 8" WIDE AREA OF UP TO 5/16" SECTION LOSS IN THE BOTTOM FLANGE OF BEAM 1 IN SPAN 2, 2' FROM BENT 1

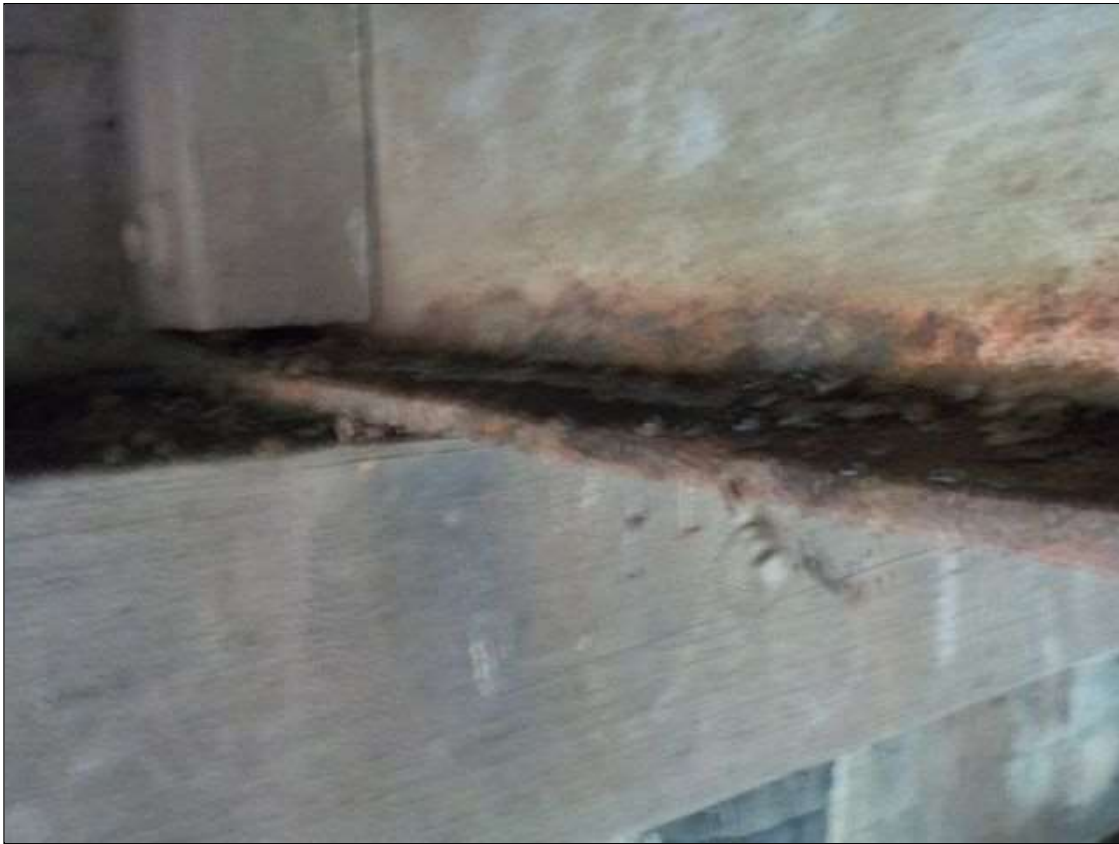
1'-0" LONG X UP TO 8" WIDE AREA OF UP TO 3/16" SECTION LOSS IN THE BOTTOM FLANGE OF BEAM 3 IN SPAN 2 AT END BENT 2  
 5" WIDE X 1'-6" HIGH X 8" LONG TIMBER BLOCK REPAIR BOLTED TO THE WEB AT END BENT 1  
 SURFACE RUST AND PEELING PAINT THROUGHOUT THE INTERMEDIATE DIAPHRAGMS  
 SURFACE RUST IN THE FLANGES AND WEB THROUGHOUT THE FULL LENGTH OF THE BEAM WITH 20% PAINT LOSS

Span 2 Beam 3: 1'-0" LONG X UP TO 8" WIDE AREA OF UP TO 3/16" SECTION LOSS IN THE BOTTOM FLANGE OF BEAM 3 IN SPAN 2 AT END BENT 2

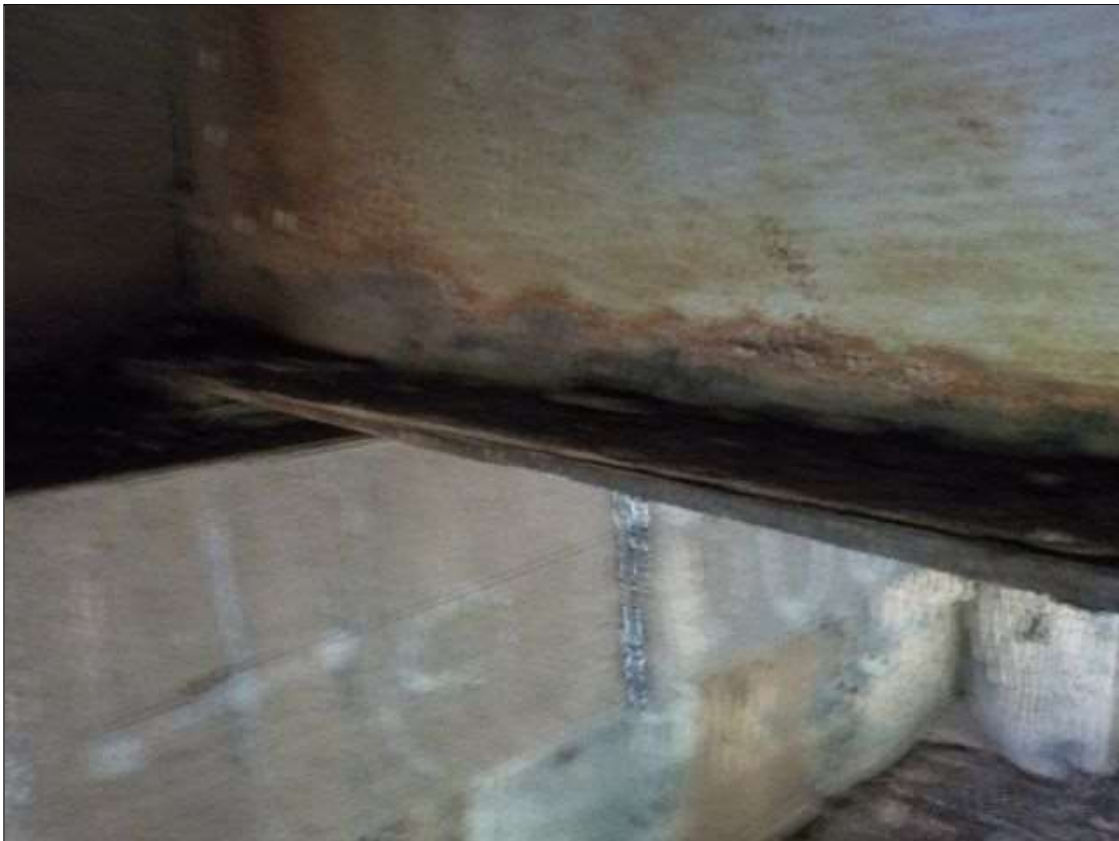
2'-0" LONG X UP TO 8" WIDE AREA OF UP TO 3/8" SECTION LOSS IN THE BOTTOM FLANGE AND 2" HIGH X 2' LONG AREA OF 1/16" SECTION LOSS IN THE WEB OF BEAM 4 AT END BENT 2  
 SURFACE RUST AND PEELING PAINT THROUGHOUT THE INTERMEDIATE DIAPHRAGMS  
 SURFACE RUST IN THE FLANGES AND WEB THROUGHOUT THE FULL LENGTH OF THE BEAM WITH 20% PAINT LOSS

Span 2 Beam 4: 2'-0" LONG X UP TO 8" WIDE AREA OF UP TO 3/8" SECTION LOSS IN THE BOTTOM FLANGE AND 2" HIGH X 2' LONG AREA OF 1/16" SECTION LOSS IN THE WEB OF BEAM 4 AT END BENT 2

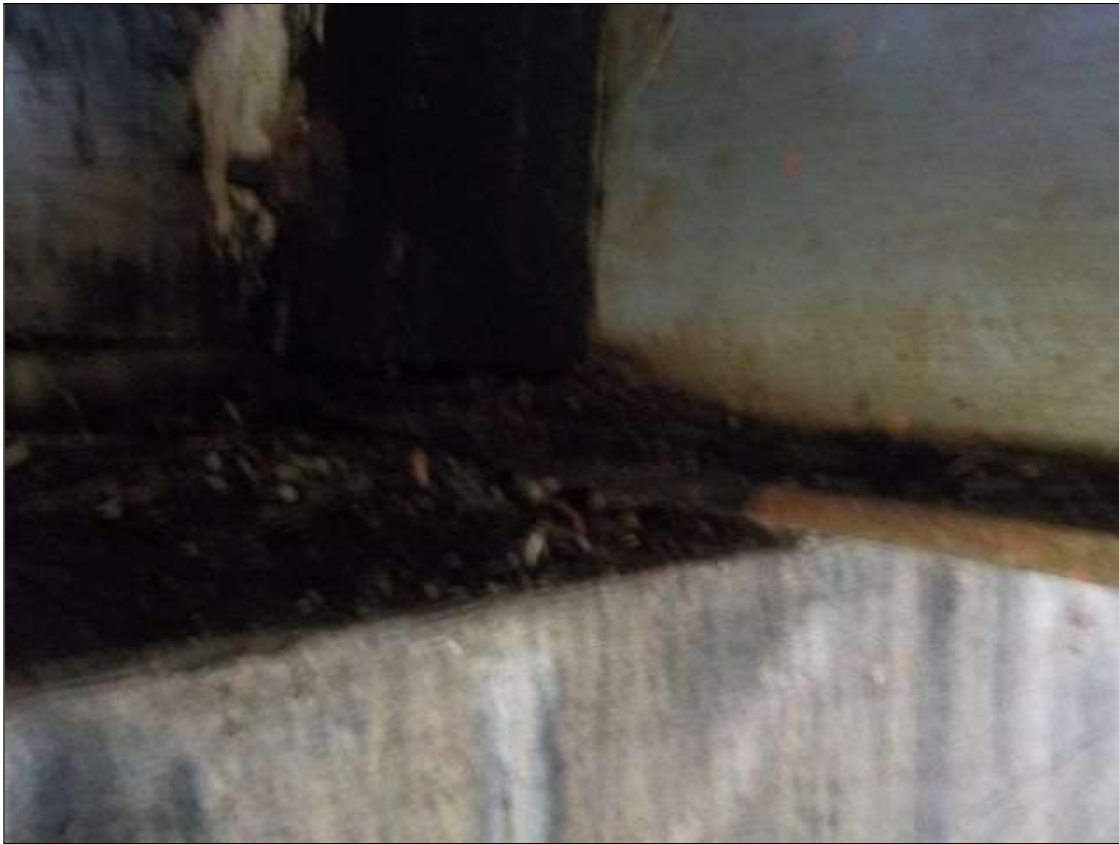
Span 2 Beam 6: 1'-0" LONG X UP TO 8" WIDE AREA OF UP TO 3/8" SECTION LOSS IN THE BOTTOM FLANGE OF BEAM 6 AT END BENT 2

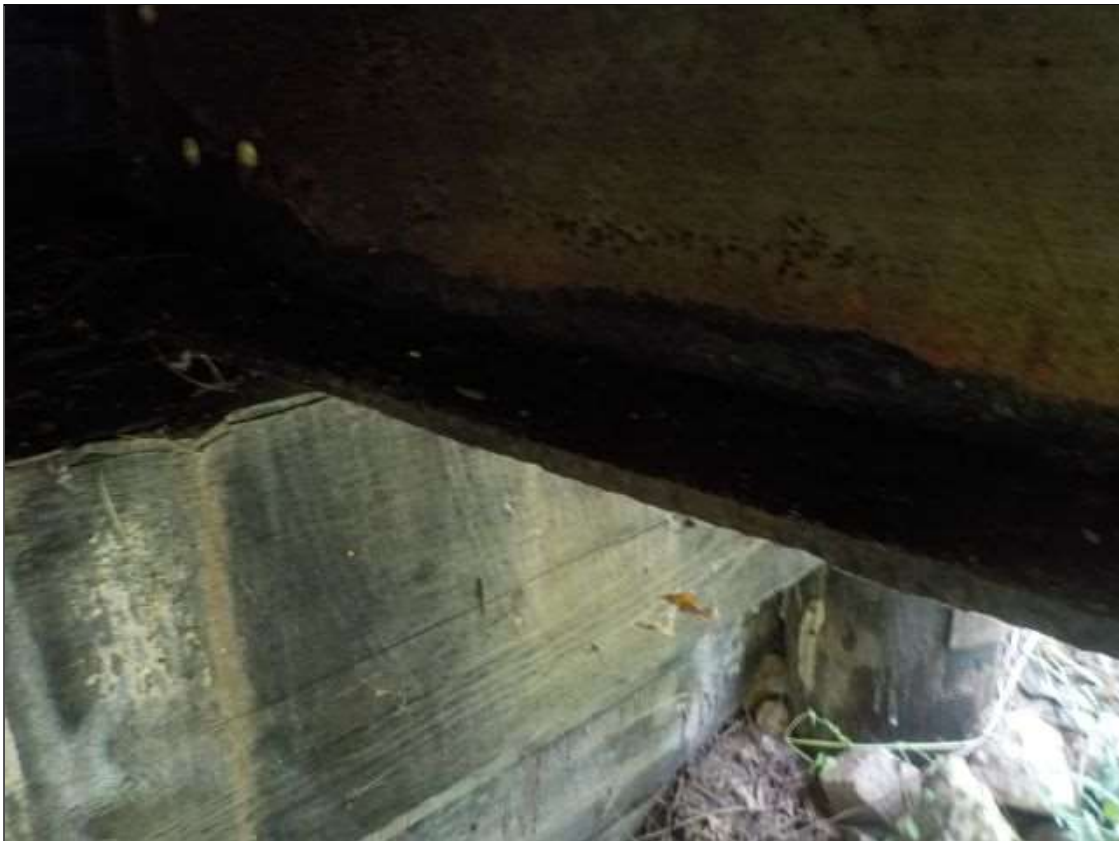
Span 2 Beam 7: 3'-0" LONG X UP TO 8" WIDE AREA OF UP TO 5/16" SECTION LOSS IN THE BOTTOM FLANGE OF BEAM 7 AT END BENT 2

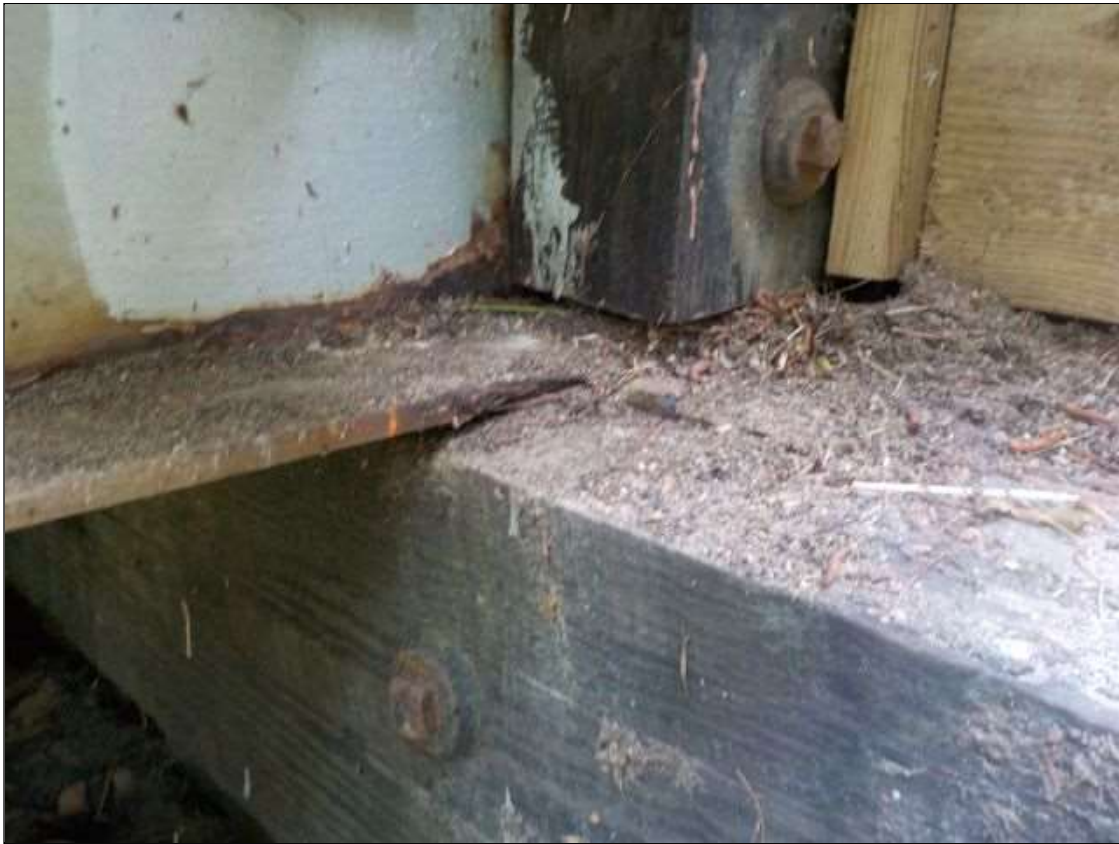
Span 2 Beam 8: 1'-0" LONG X UP TO 8" WIDE AREA OF UP TO 1/4" SECTION LOSS IN THE BOTTOM FLANGE OF BEAM 8 AT END BENT 2

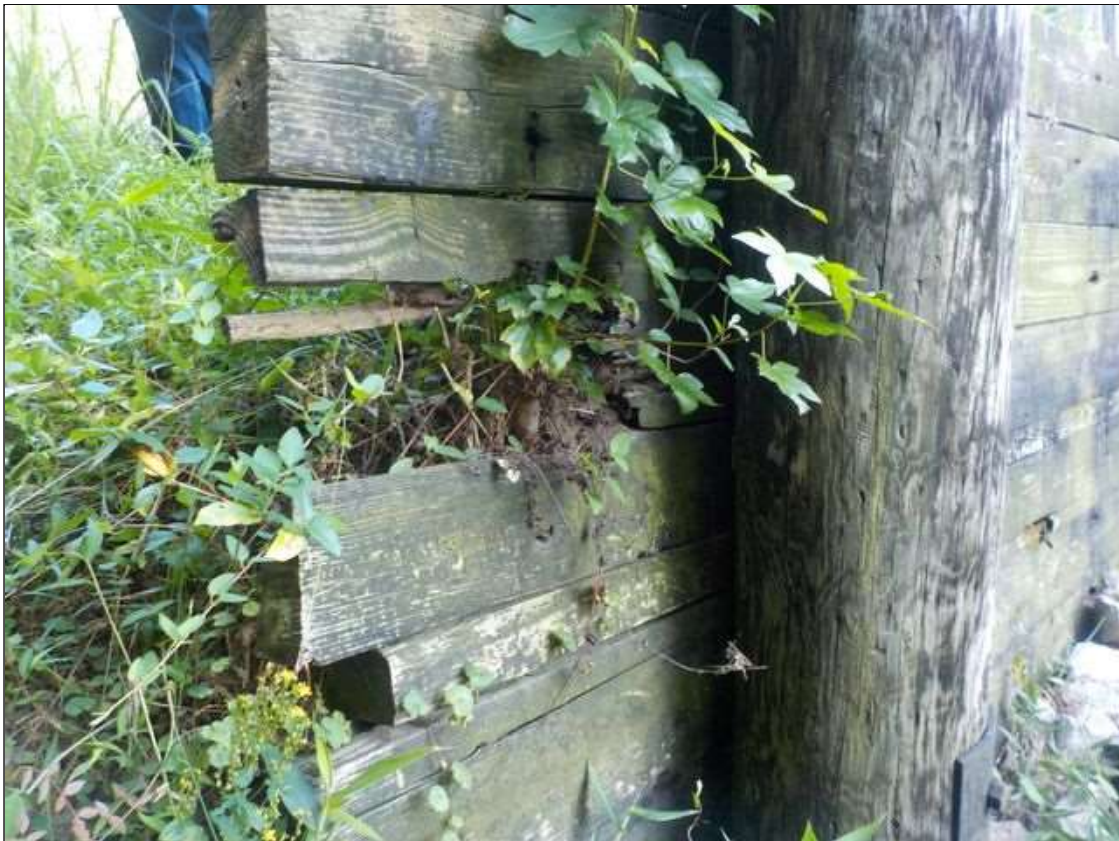
| End Bent 1 | Row 1 | Abutments | 1 |
|---|---|---|---|
| 2' LONG X 10" HIGH X 3 1/2" DEEP DECAYED AREA AT THE SOUTH END | | | |

End Bent 1 Abutment/Backwall : 2' LONG X 10" HIGH X 3 1/2" DEEP DECAYED AREA AT THE SOUTH END

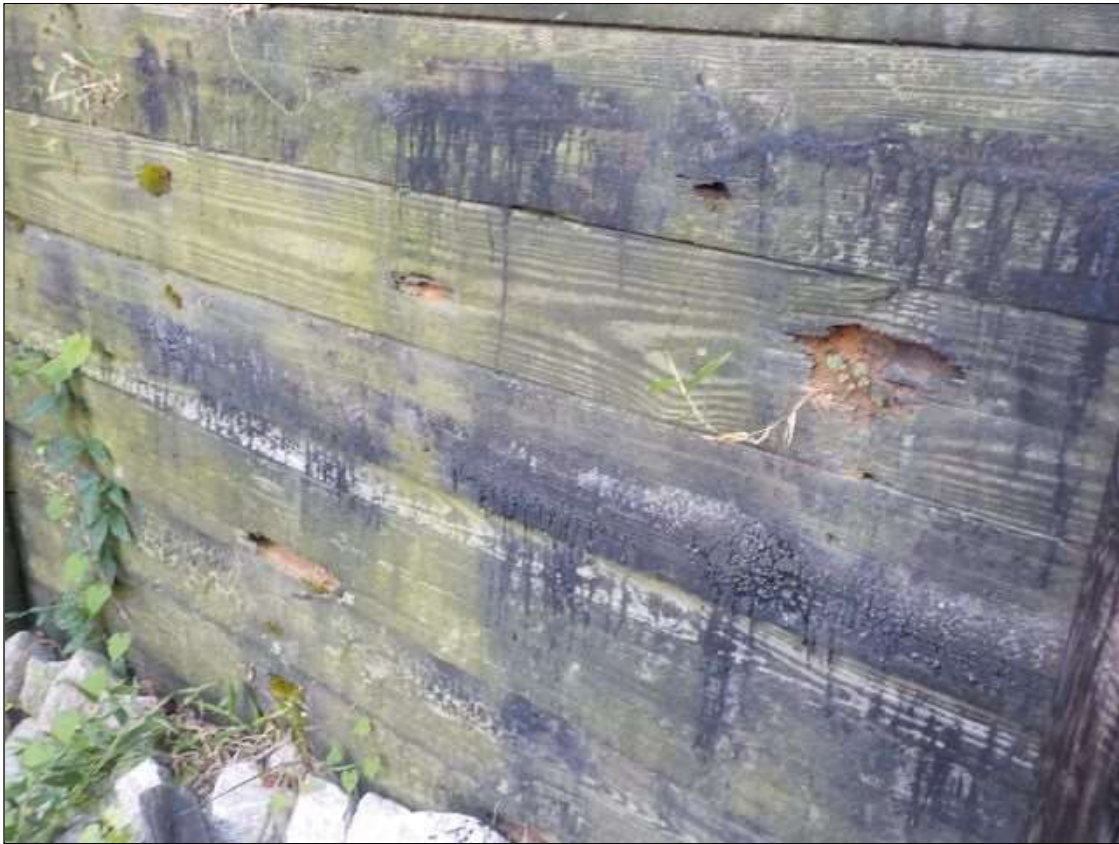
| End Bent 1 | Row 1 | Abutments | 1 |
|---|---|---|---|
| 2' LONG X 4" HIGH X 3 1/2" DEEP DECAYED AREA AT THE SOUTH END BETWEEN THE SOLDIER PILES | | | |

End Bent 1 Abutment/Backwall : 2' LONG X 4" HIGH X 3 1/2" DEEP DECAYED AREA AT THE SOUTH END  
BETWEEN THE SOLDIER PILES

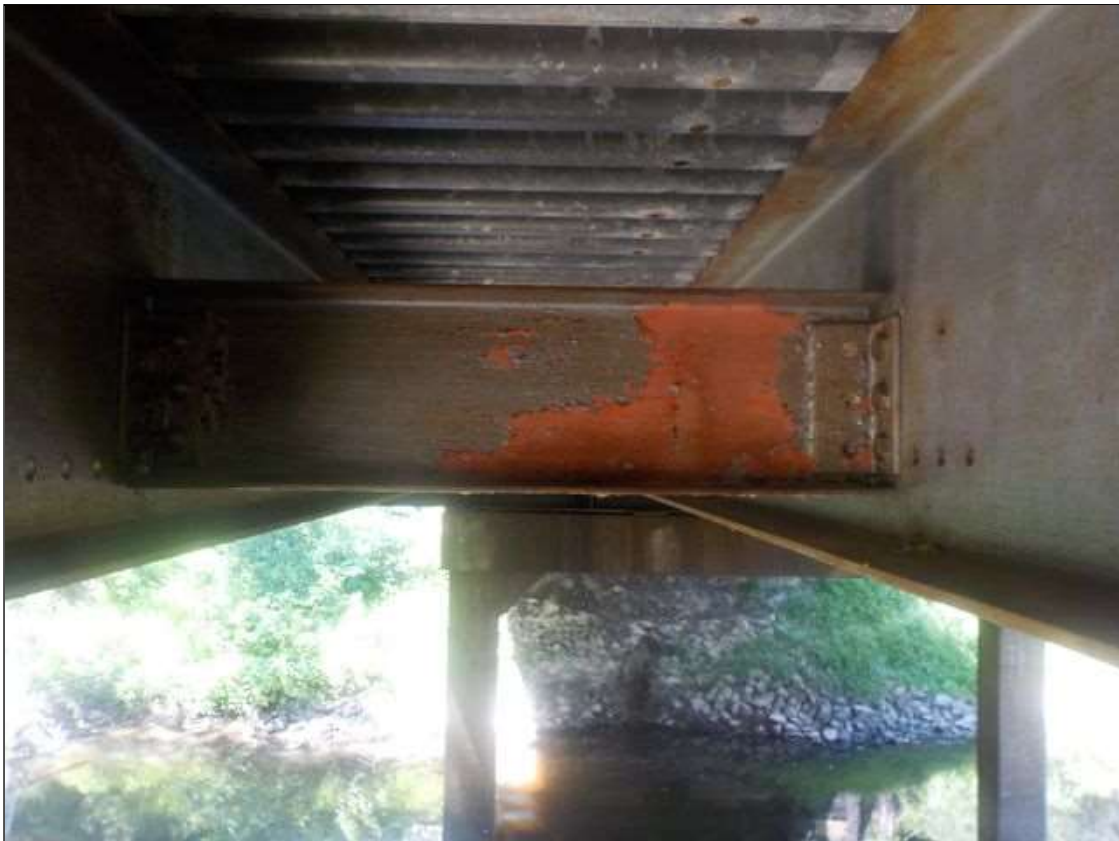
SURFACE RUST AND PEELING PAINT THROUGHOUT THE INTERMEDIATE DIAPHRAGMS IN BAY 6 OF SPAN 2  
(OTHERS SIMILAR)

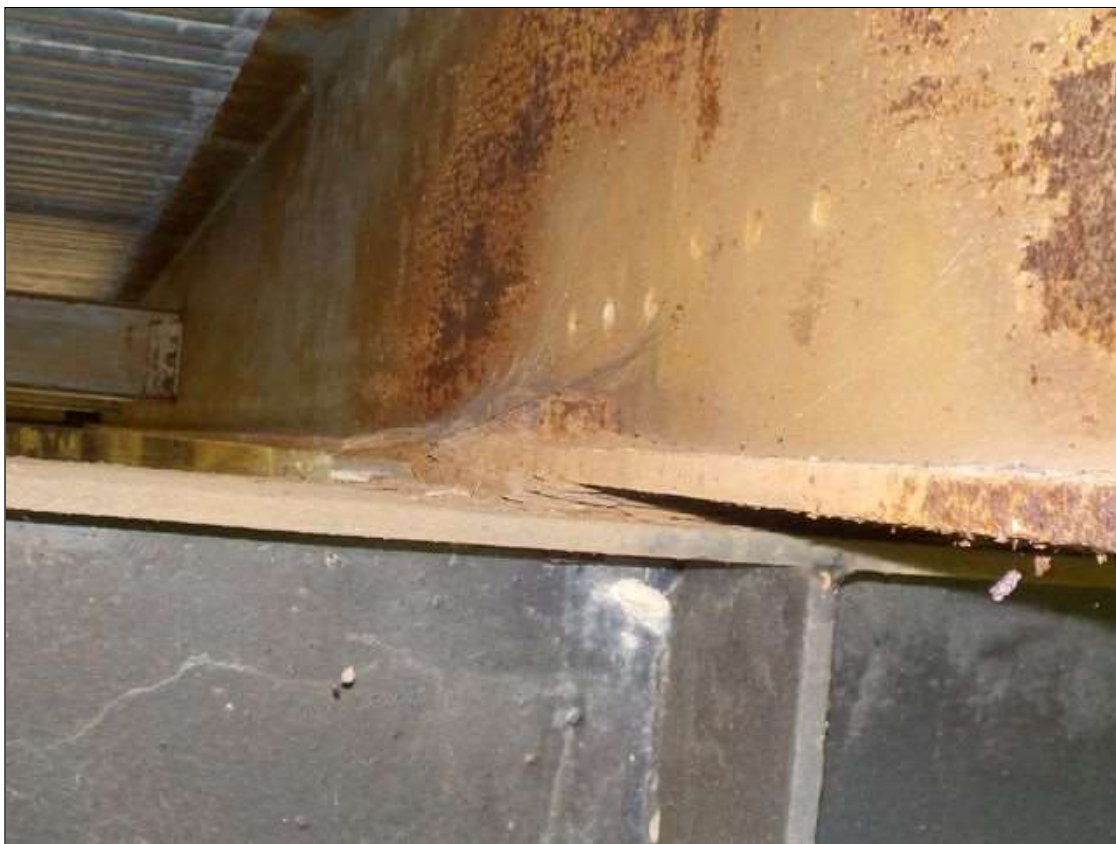
DELAMINATED ANCHOR BOLTS ON BEAM 7 AT BENT 1 (OTHERS SIMILAR)

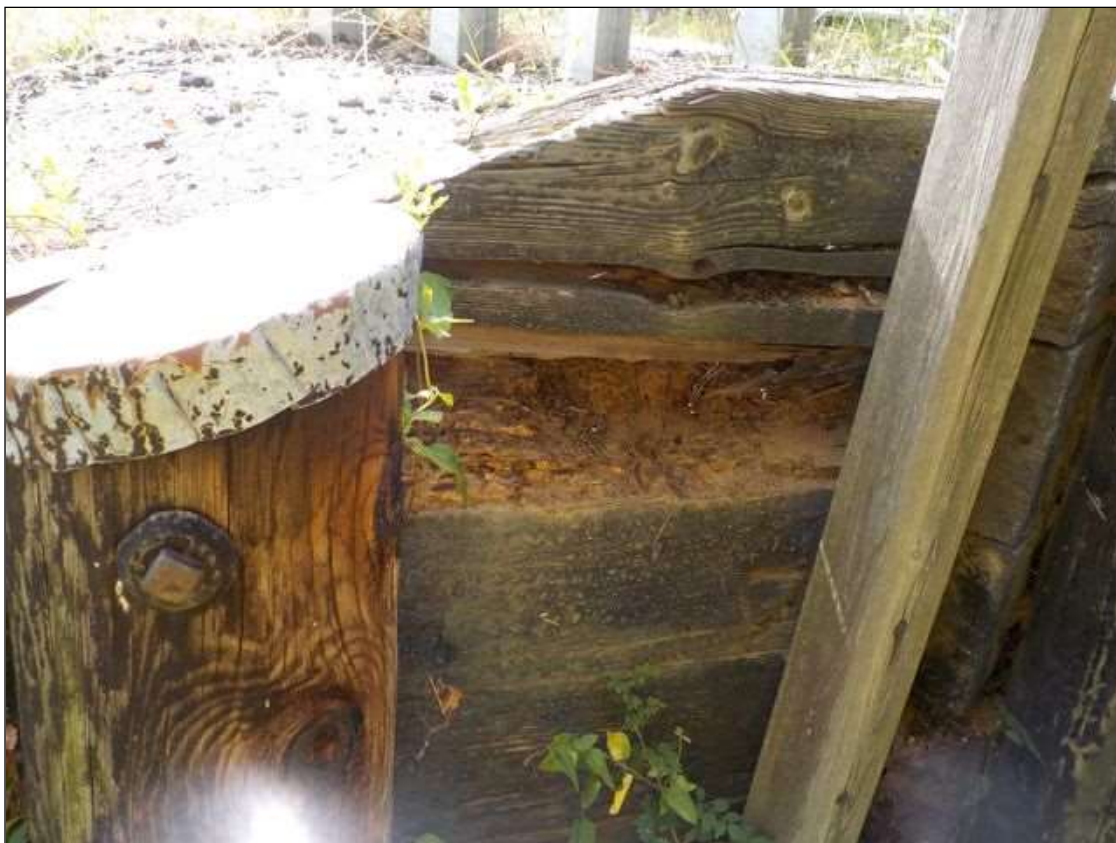
| End Bent 2 | Row 1 | Abutments | 1 |
|---|---|---|---|
| 1'-6" LONG X 6" HIGH X 3 1/2" DEEP AREA OF DECAY WITH EXPOSED FILL AT THE SOUTH END<br>4' LONG X 10" HIGH X 3 1/2" DEEP DECAYED AREA AT THE NORTH END | | | |

End Bent 2 Abutment/Backwall : 4' LONG X 10" HIGH X 3 1/2" DEEP DECAYED AREA AT THE NORTH END

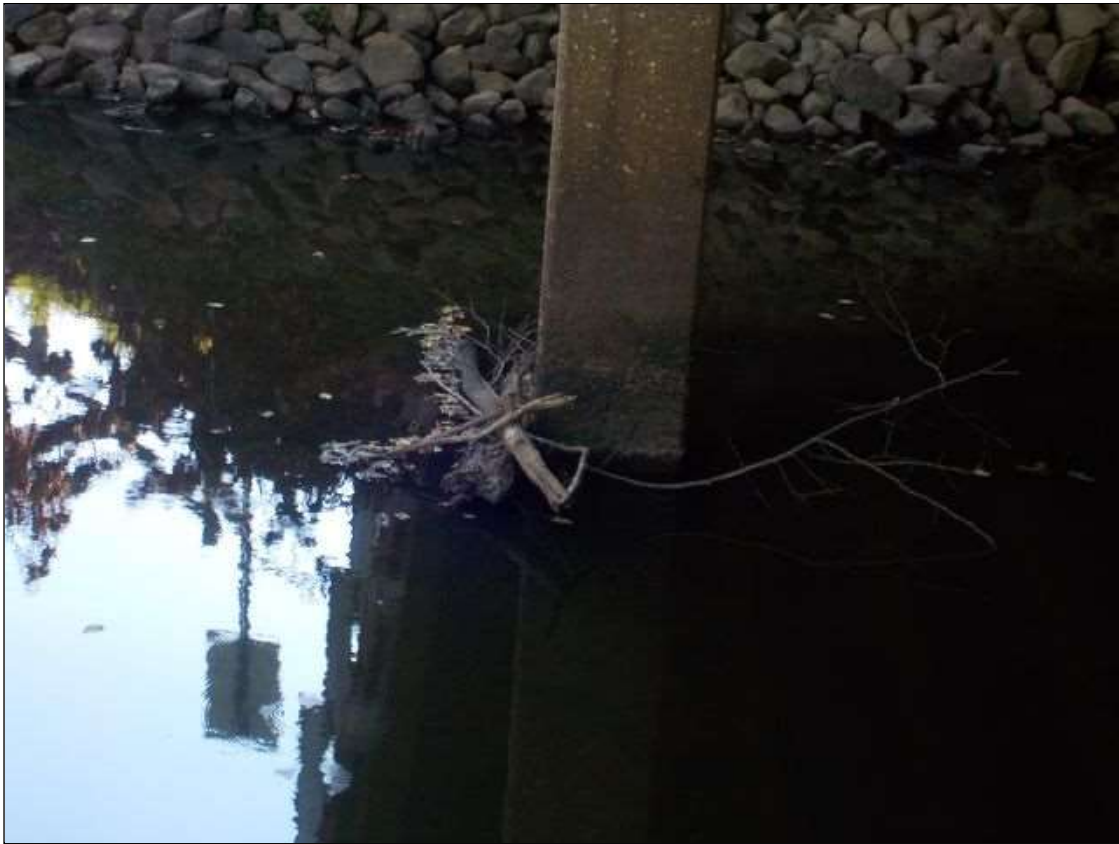
**Details** DRIFT ALONG THE UPSTREAM SIDE OF COLUMN 1 OF BENT 1

DRIFT ALONG THE UPSTREAM SIDE OF COLUMN 1 OF BENT 1

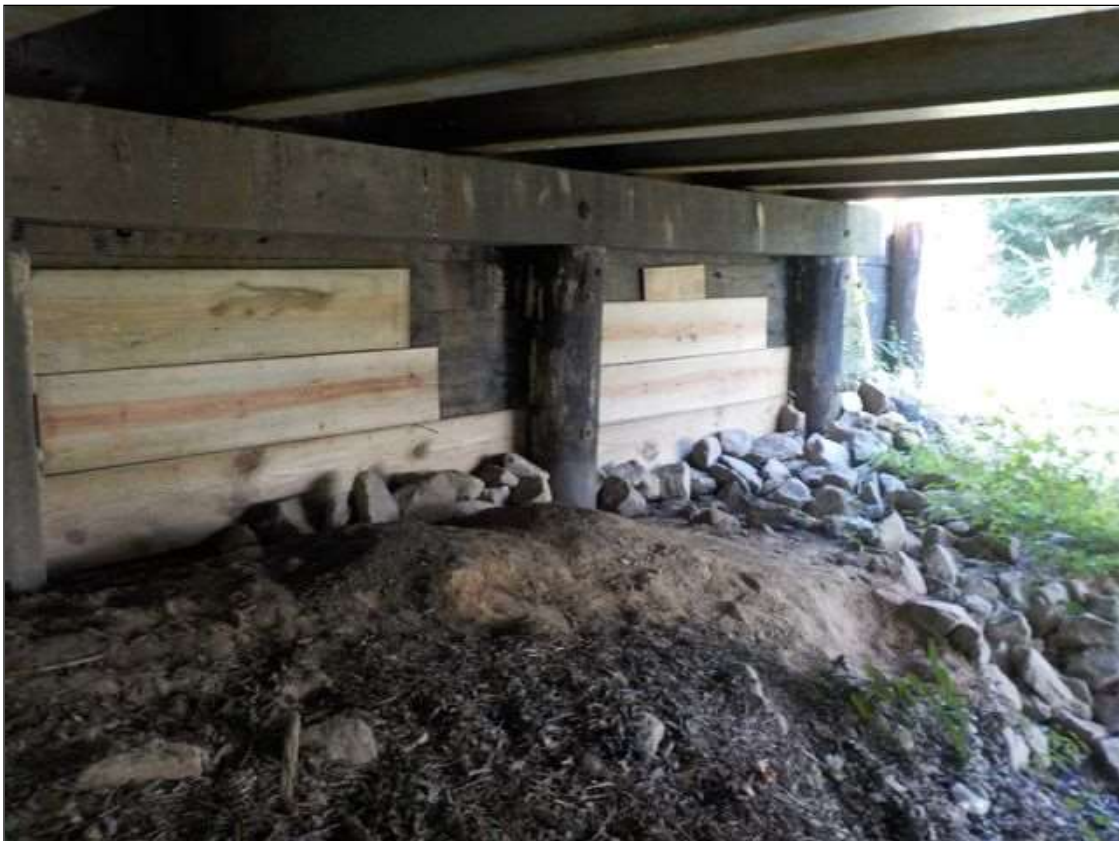
TEMPORARY REPAIR TO THE END BENT 1 BULKHEAD BETWEEN PILES 1 AND 3
