NC DEPARTMENT OF TRANSPORTATION  
DIVISION OF HIGHWAYS  
STRUCTURE MANAGEMENT UNIT

## Structure Safety Report

### Routine Element Inspection

COUNTY: JOHNSTON STRUCTURE NUMBER: 500432 FREQUENCY: 24 MONTHS

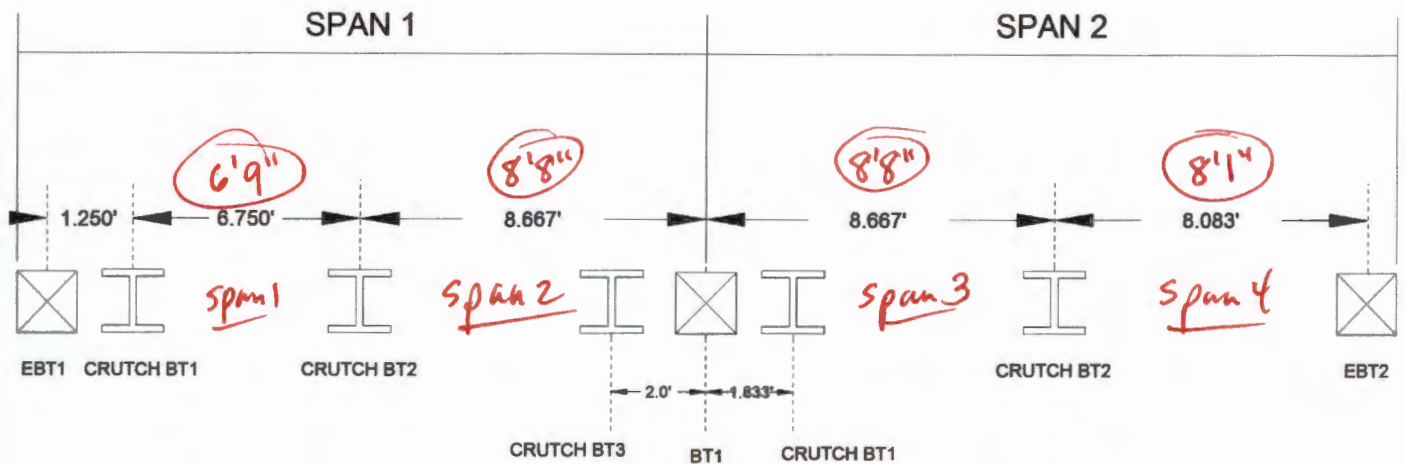
10" X 10" STEEL H-PILES AT EBT1, BT1, BT2A, BT2B, BT3

Was 2 spans:  
Now 4 spans w/ crutch bts.  
MH 11-19-2015

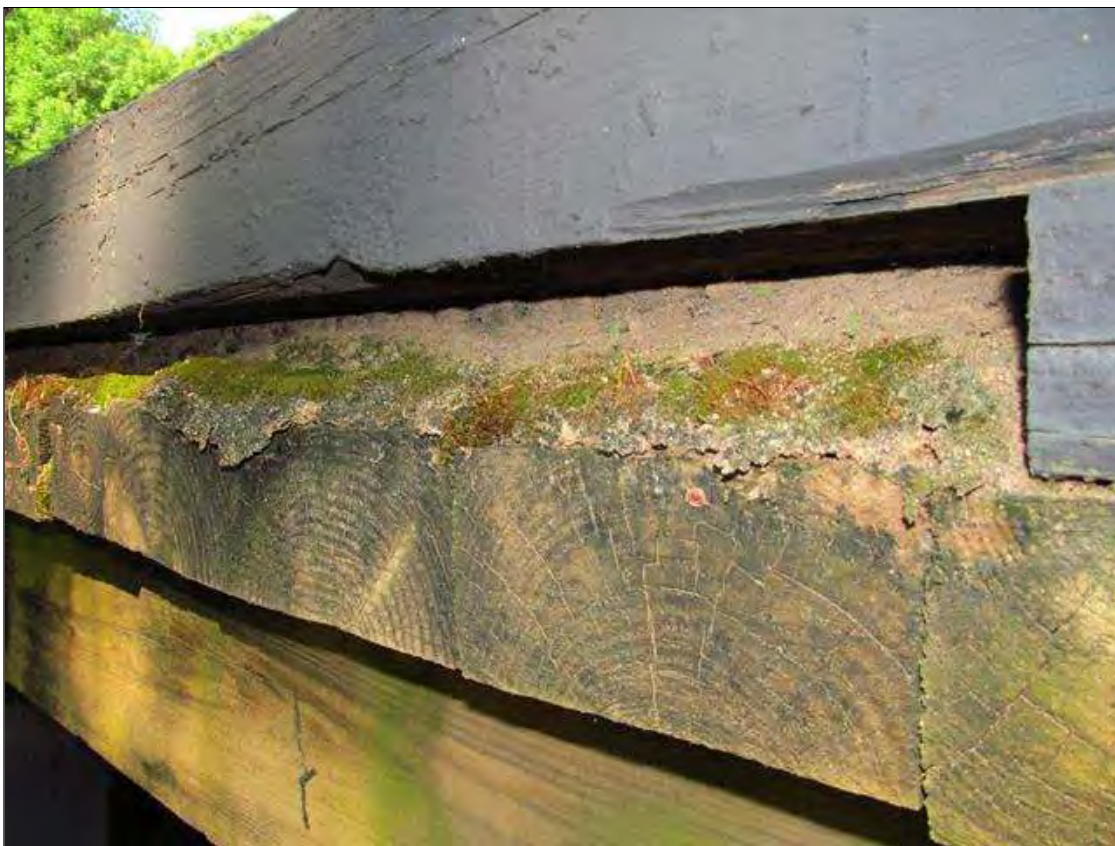
Dirt buildup between wheelguard and deck boards - Full length of each span

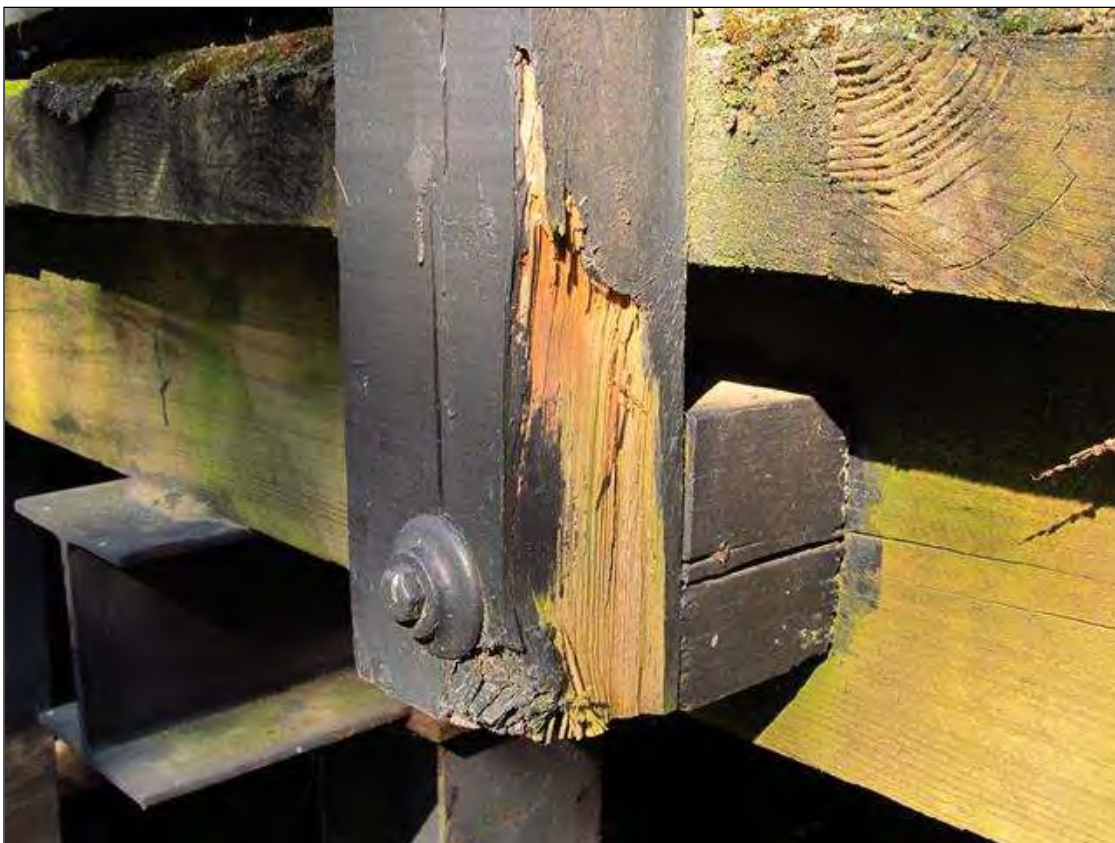
1 Foot of Decay/Section Loss in Post No.3. Affects 10% or more of the member but does not warrant structural review.  
17 Feet of Check/Shake: Penetrates 5%-50% of the thickness of the member and not in a tension zone.  
1 Square Foot of Effectiveness at Post No.3. Metalized coating is missing.  
11 Square Feet of Effectiveness along wheel-guard. Tar coating is missing.

Split-off in the post No.3 along the Right side of Span 2

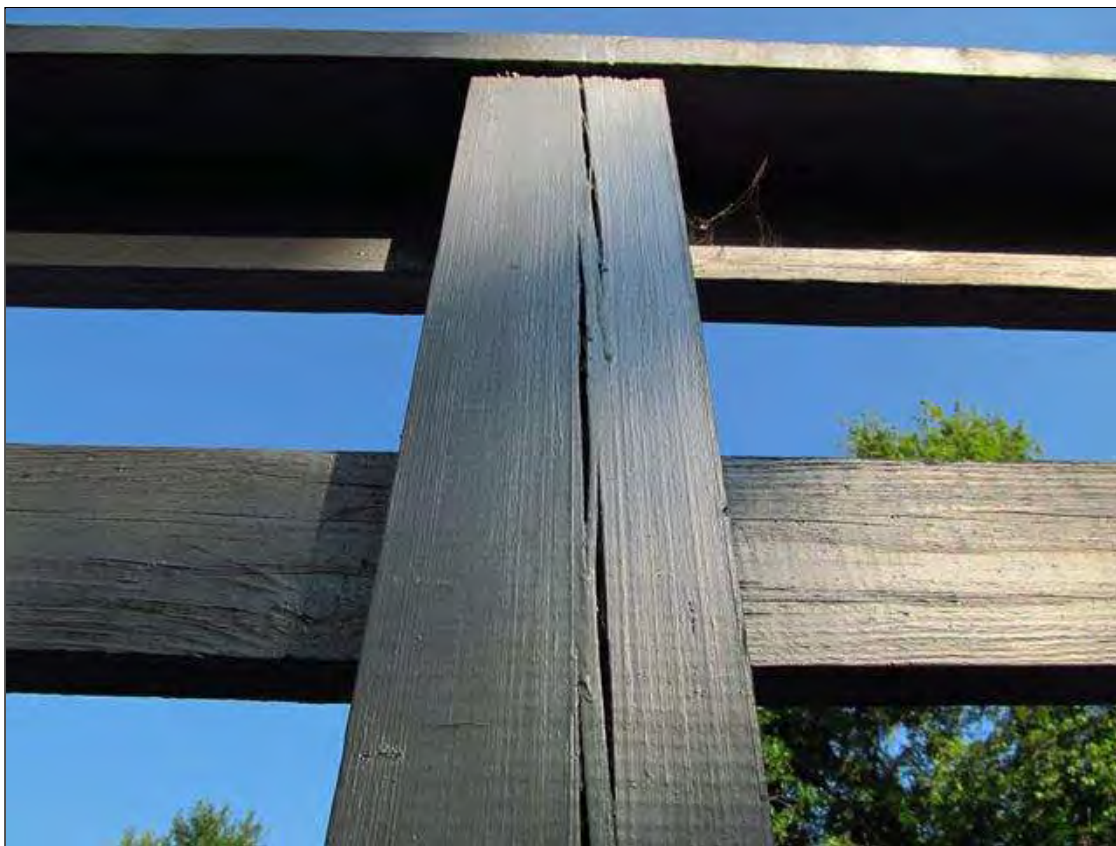
Random vertical checking throughout guardrail posts

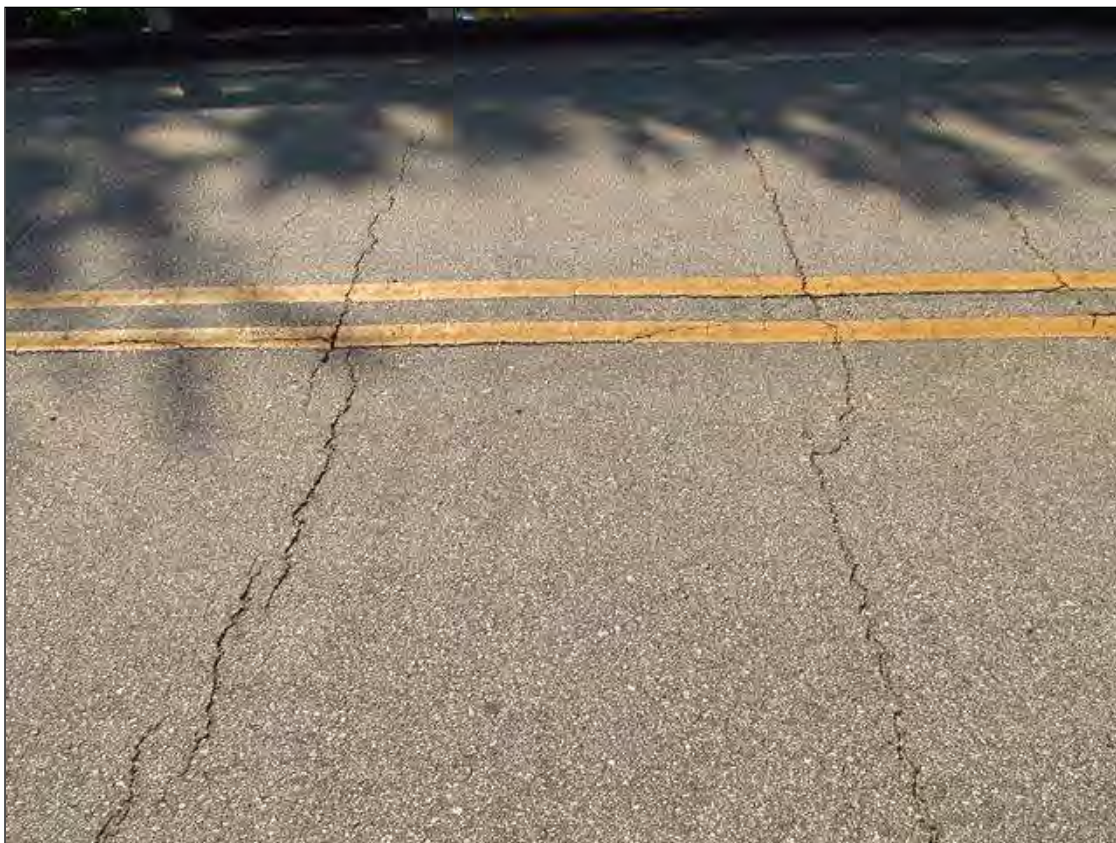
67 Square Feet of transverse Cracking (Wearing Surface): Width of more than 0.05 in. or spacing of less than 1.0 ft.

Transverse cracking throughout Asphalt wearing surface

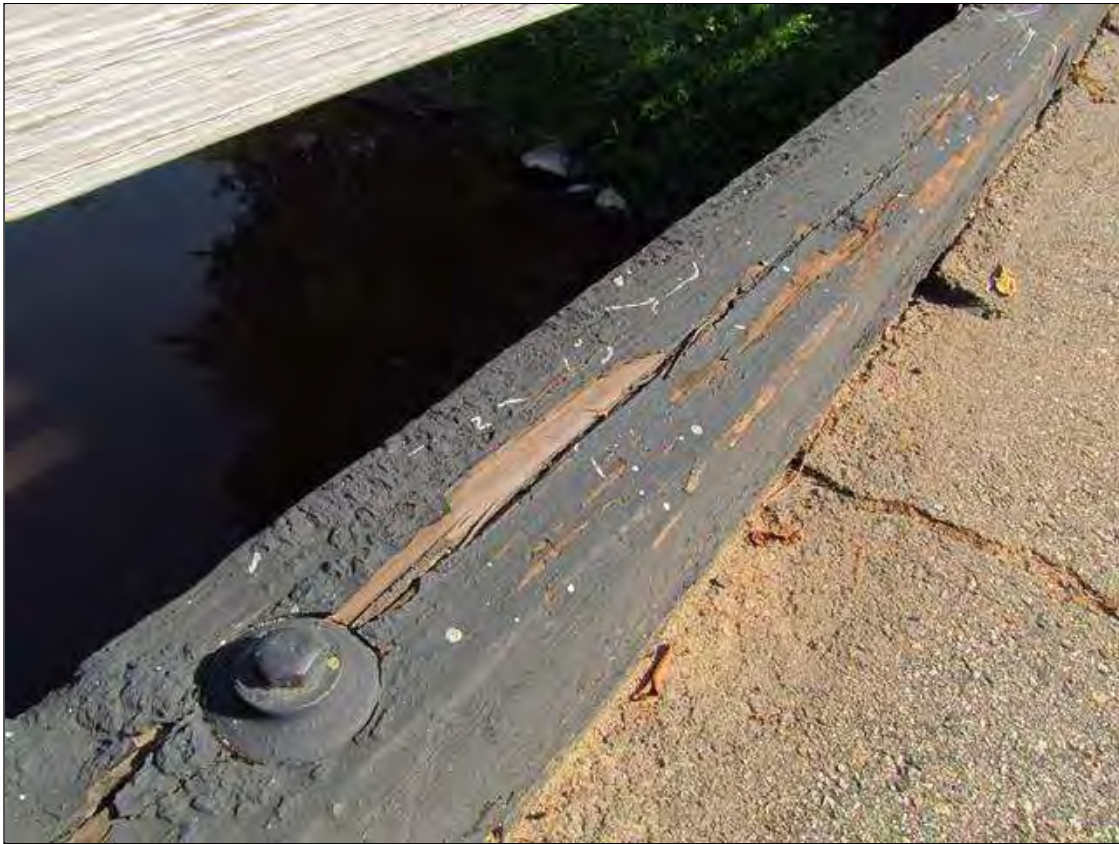
Longitudinal checking along wheelguards

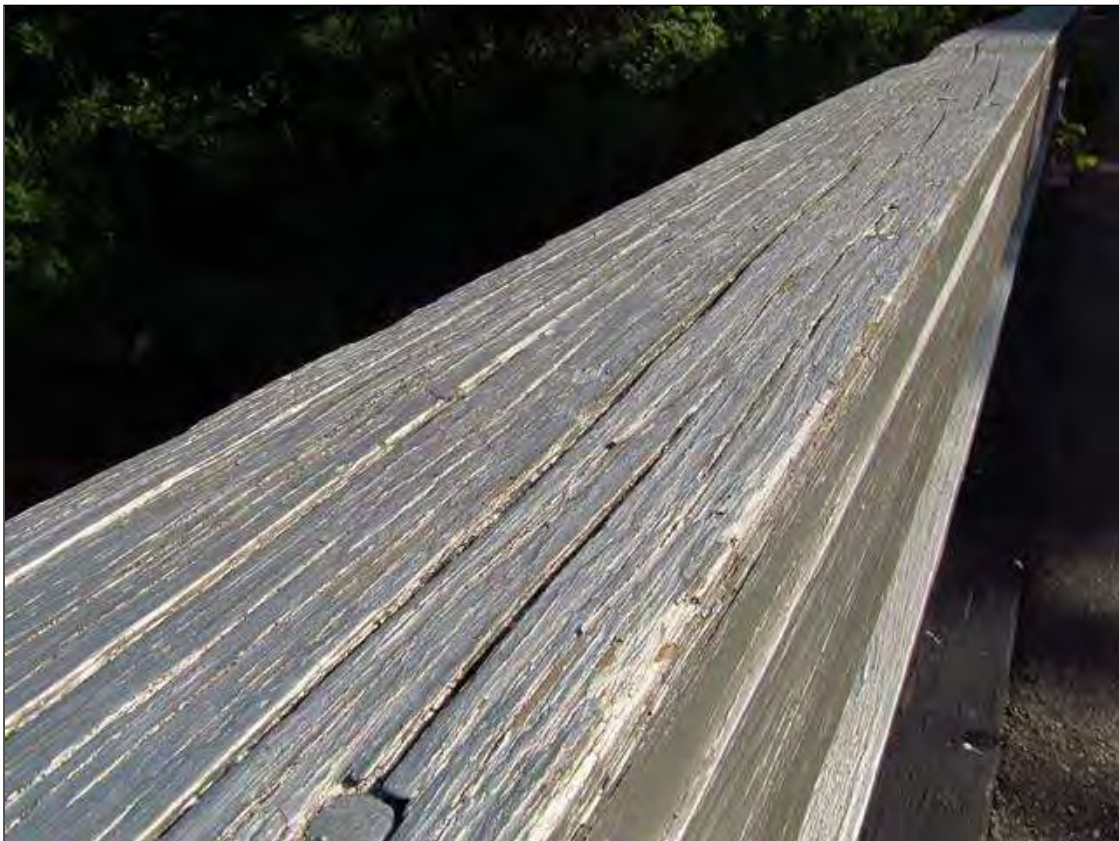
Longitudinal checking along top rail of guardrails

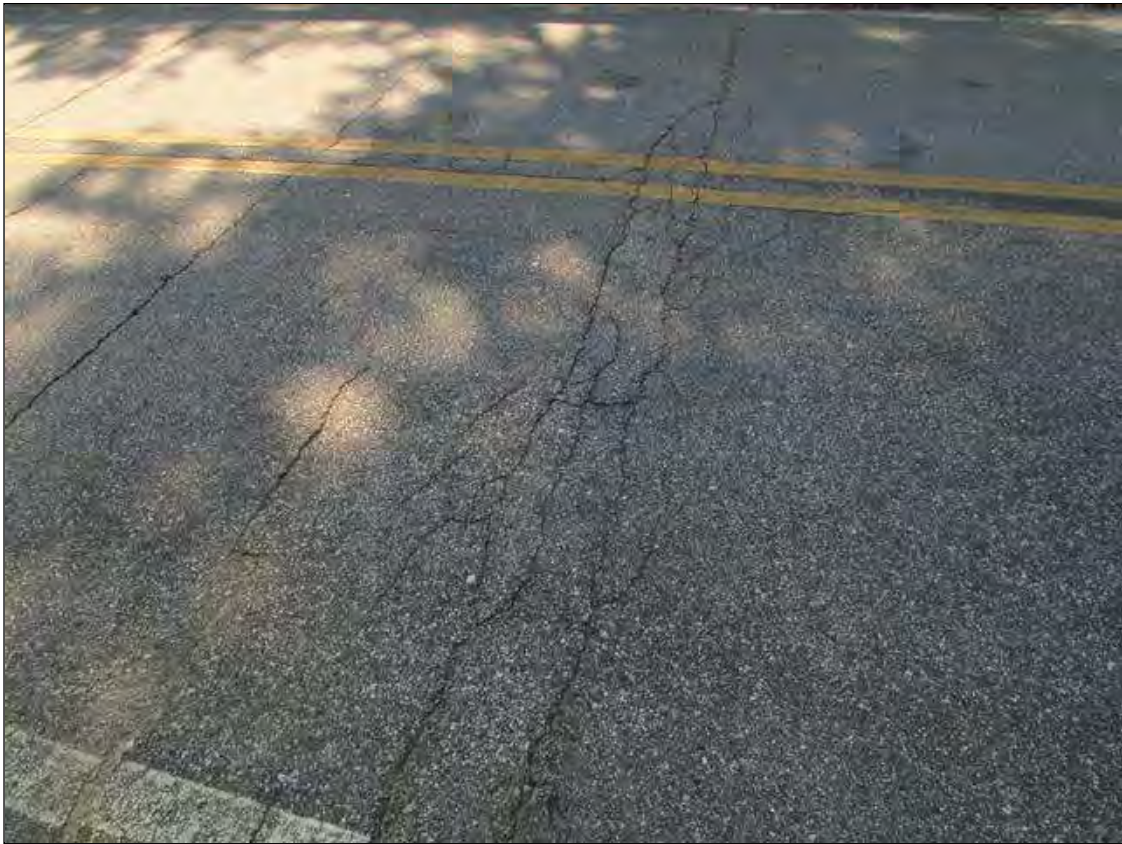
19 Square Feet of Cracking over End Bent 1 (Wearing Surface): Width of more than 0.05 in. or spacing of less than 1.0 ft.

Cracking in Wearing surface over End Bent 1

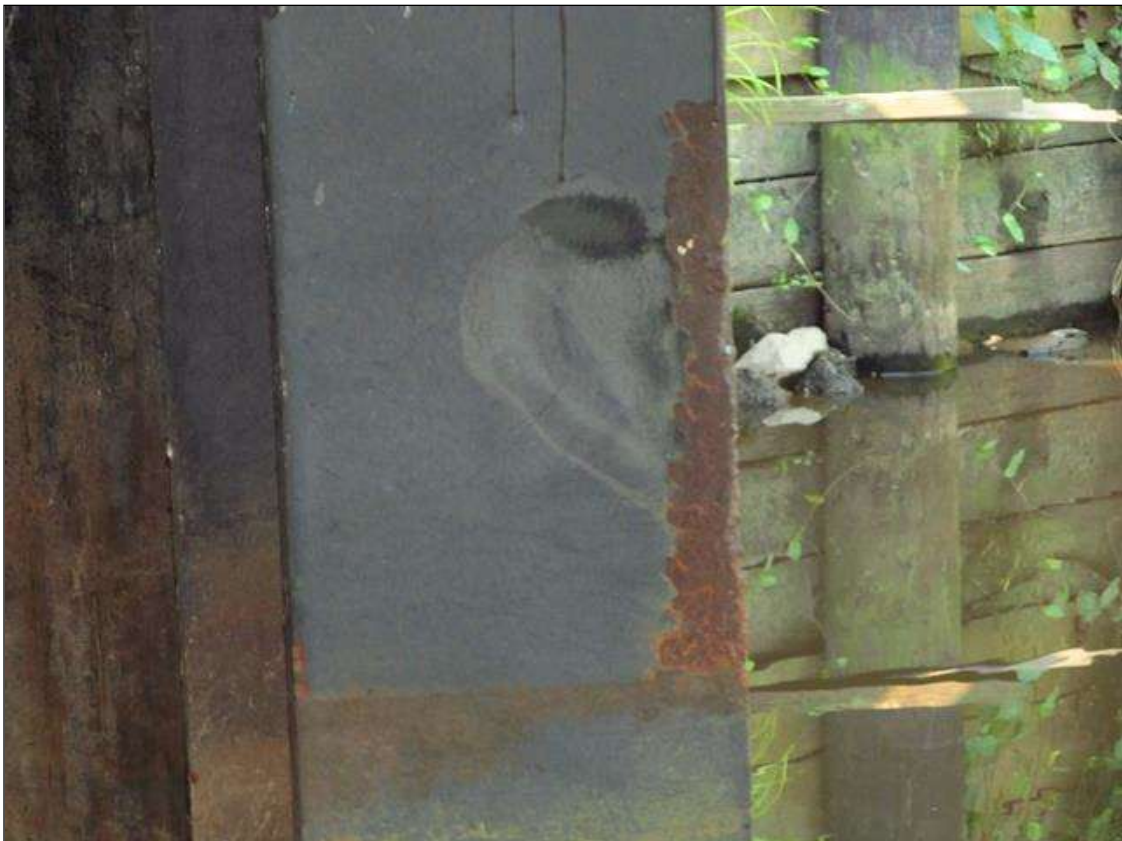
Spots of Peeling paint with Surface rust to exposed steel throughout crutch piles

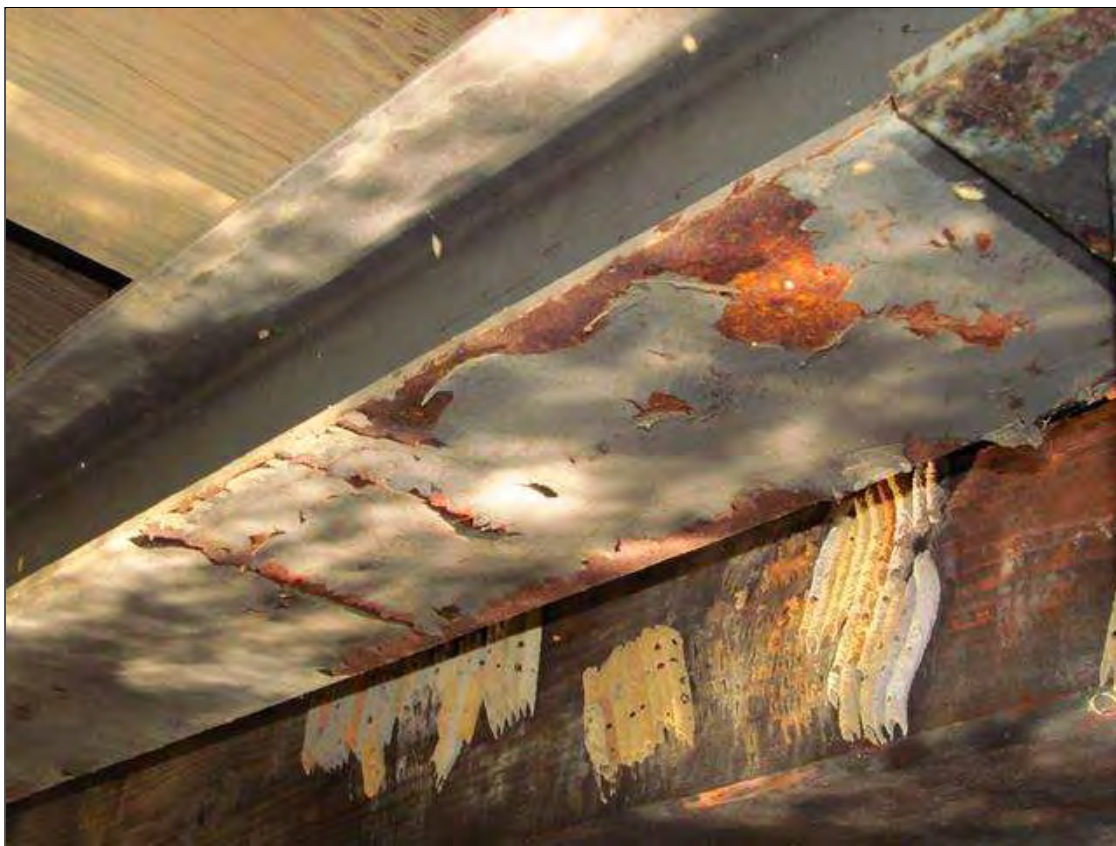
Peeling paint with Surface rust to exposed steel in random spots along crutch caps

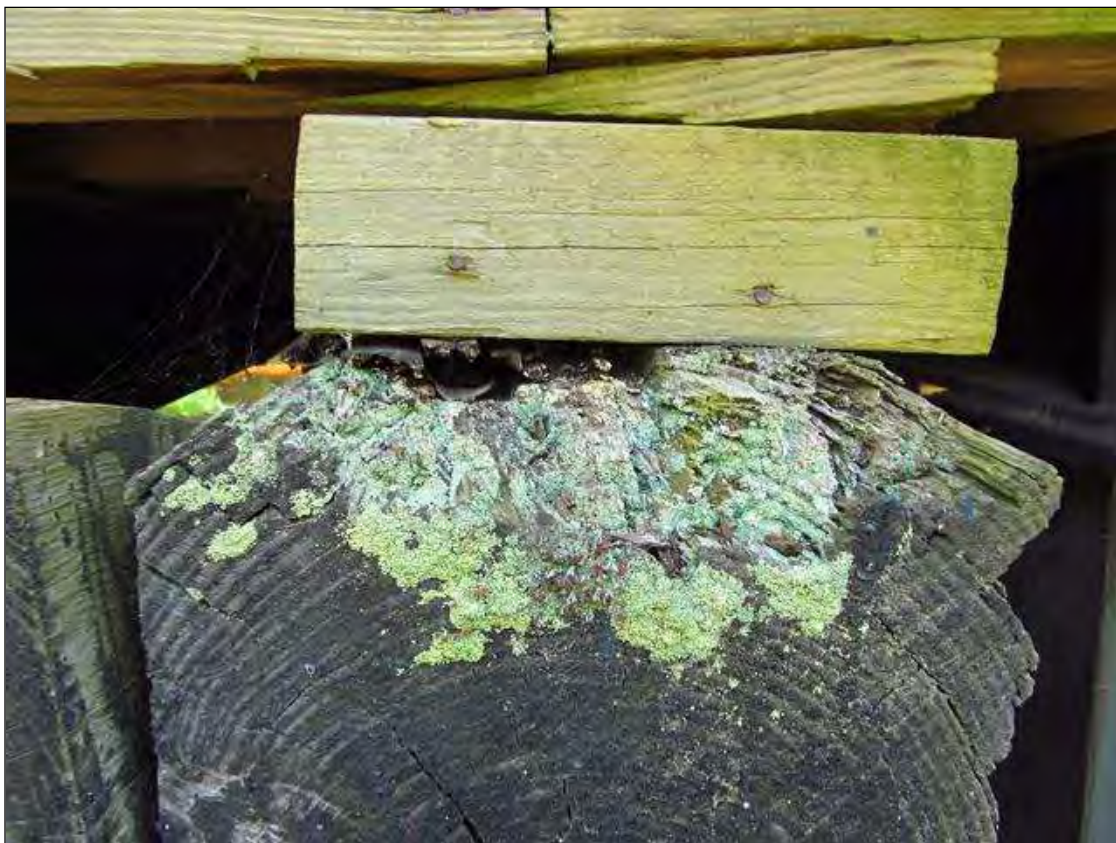
Decay in left End of cap at Bent 1

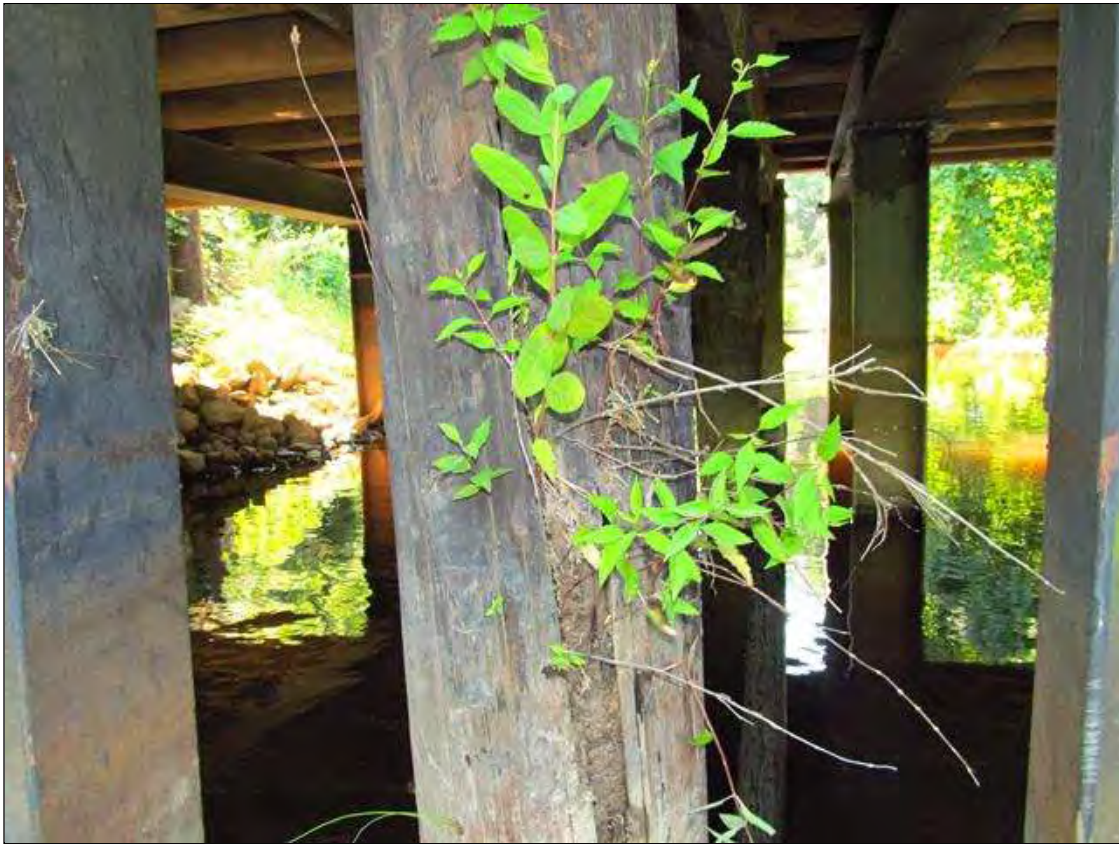
Decay and Delamination in the Left side of Pile 1 from waterline to cap

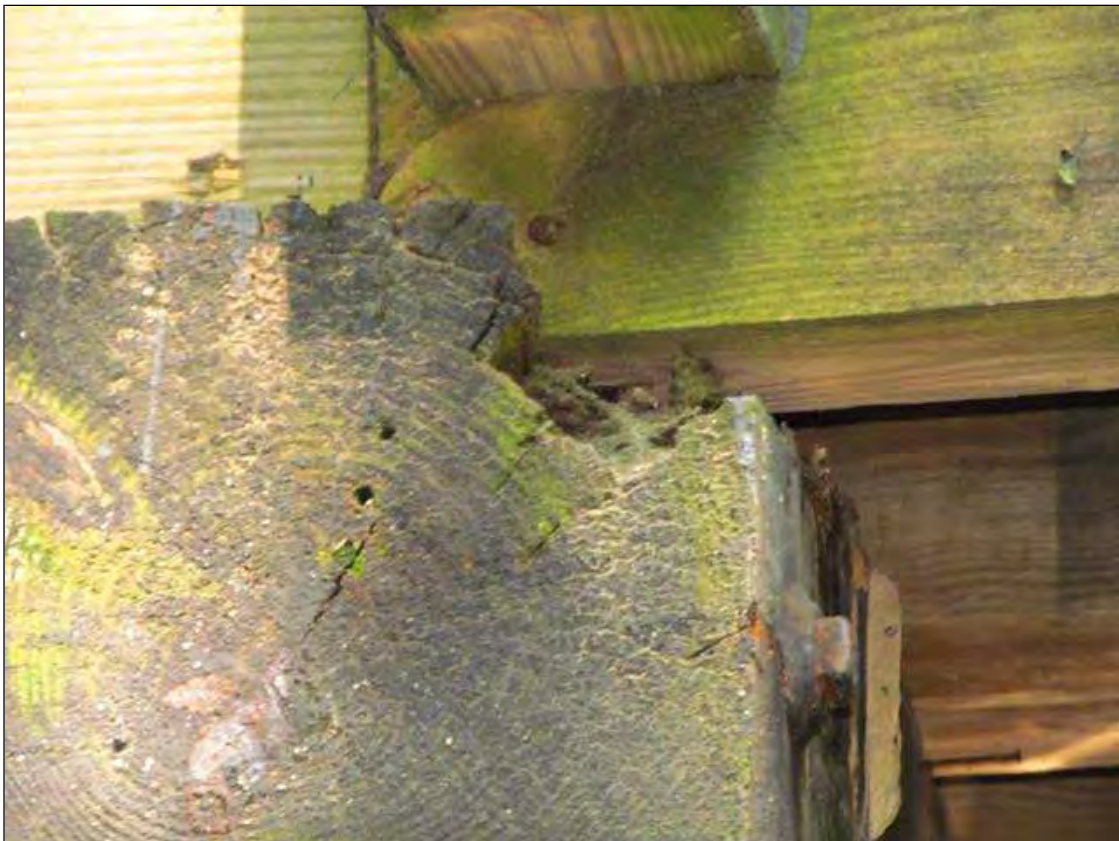
Decay in right End of cap at Bent 1

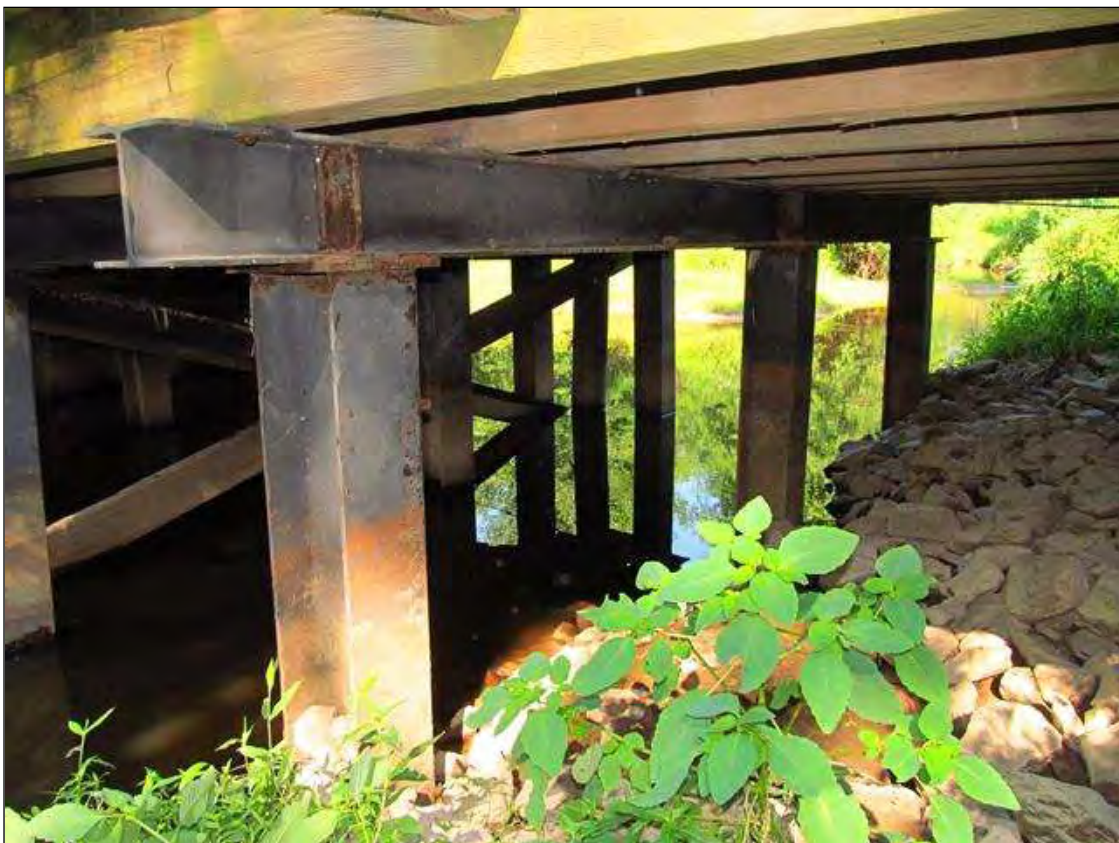
Crutch bent at midspan of span 2 - other crutch bents similar

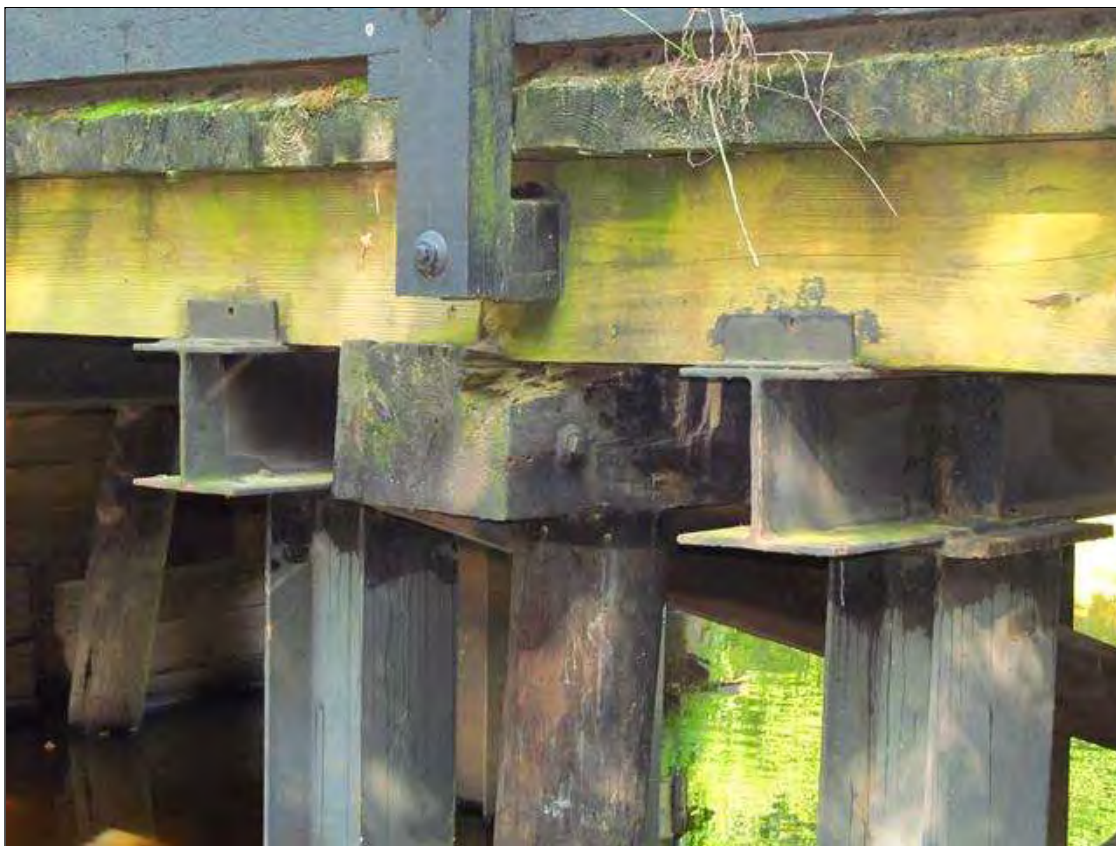
Right End of cap at Bent 1 and Adjacent crutch bents

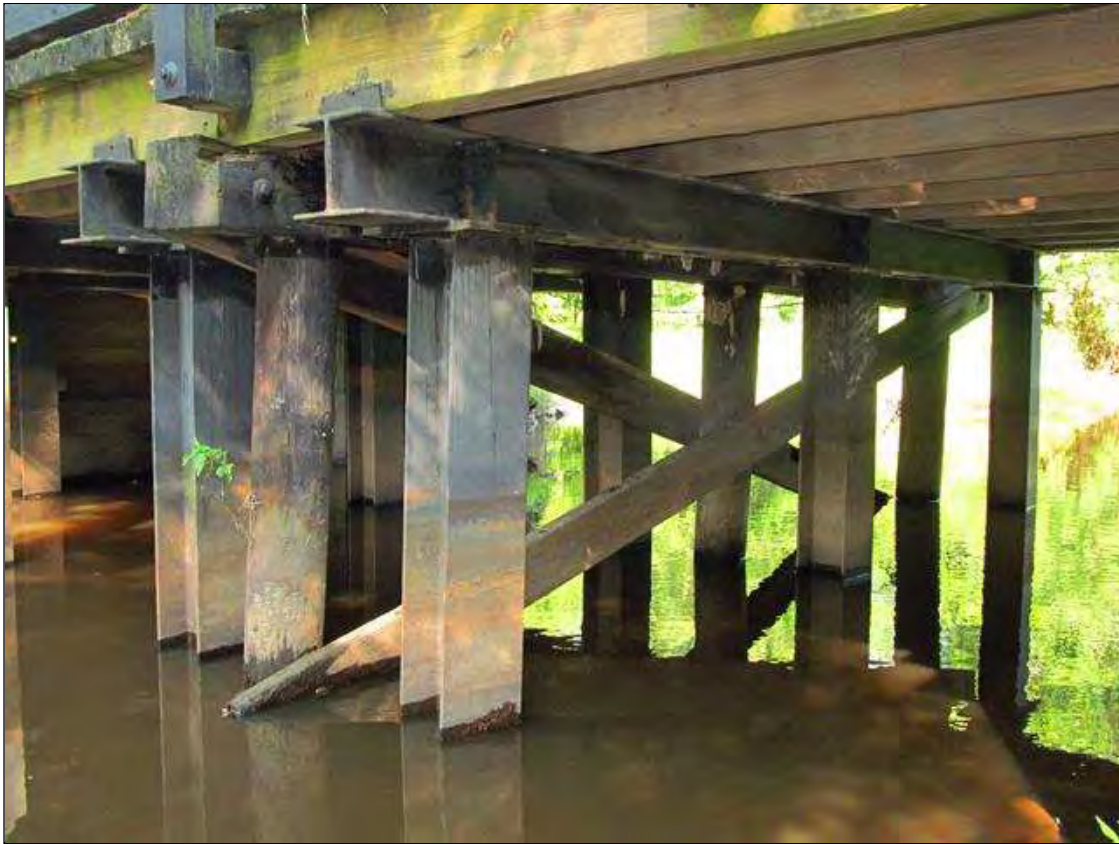
Crutch bent at Span 2 side of Bent 1

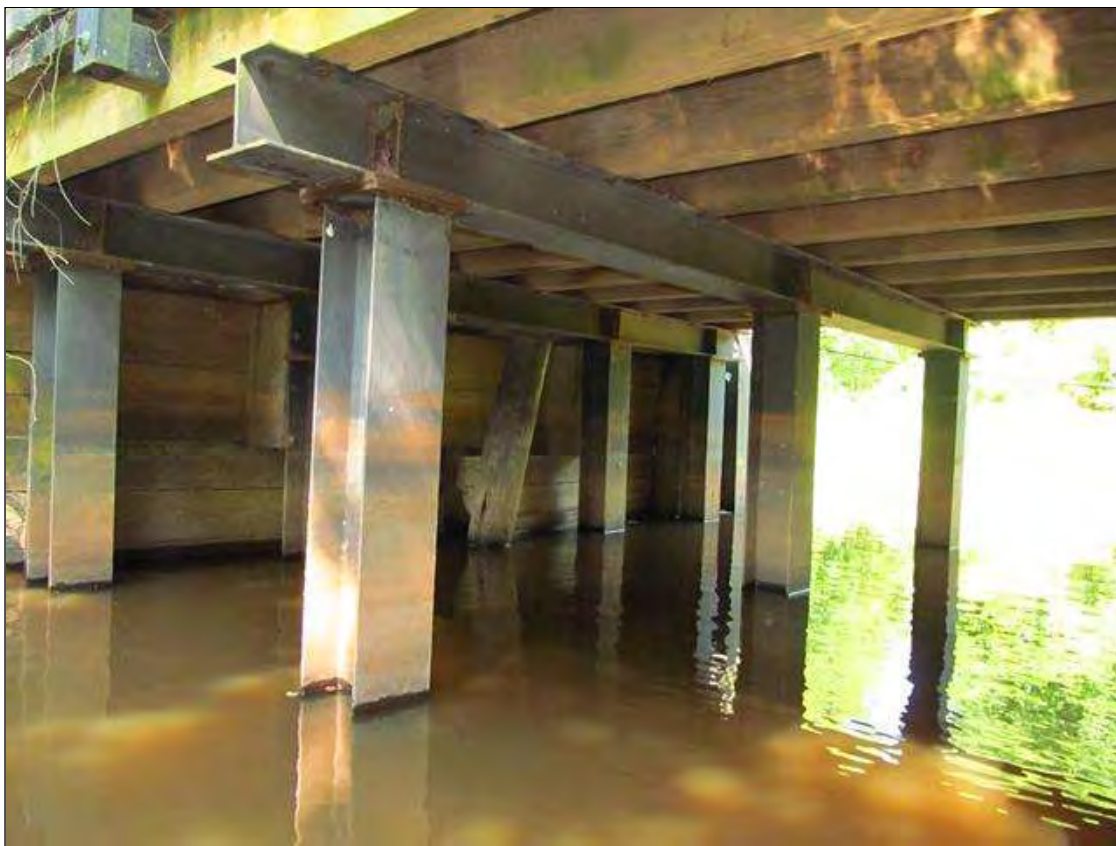
Crutch bent at mid-span of Span 1
