NC DEPARTMENT OF TRANSPORTATION  
DIVISION OF HIGHWAYS  
STRUCTURE MANAGEMENT UNIT

## Structure Safety Report

### Routine Element Inspection

COUNTY: WAYNE STRUCTURE NUMBER: 950133 FREQUENCY: 24 MONTHS

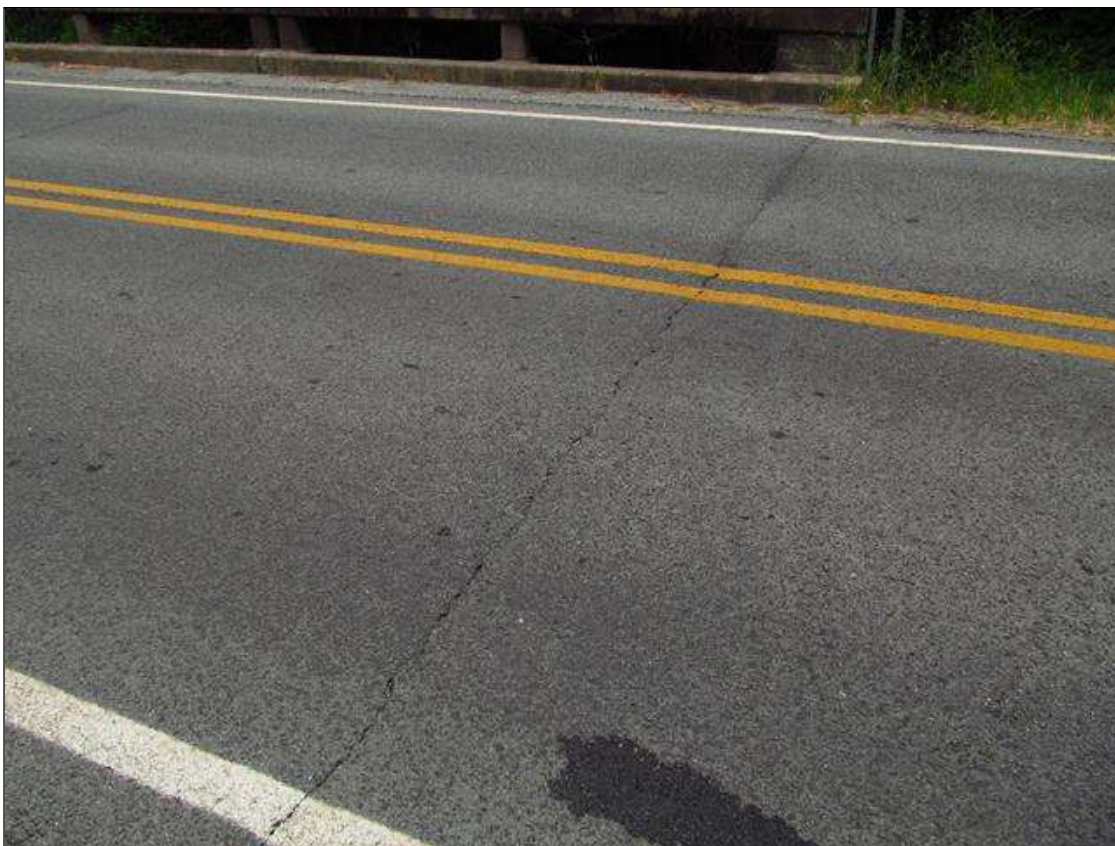
47 Square Feet of Cracking over the Interior bent and End Bent 2. Width of more than 0.05 in. or spacing of less than 1.0 ft.

Transverse crack in Wearing surface over End Bent 2

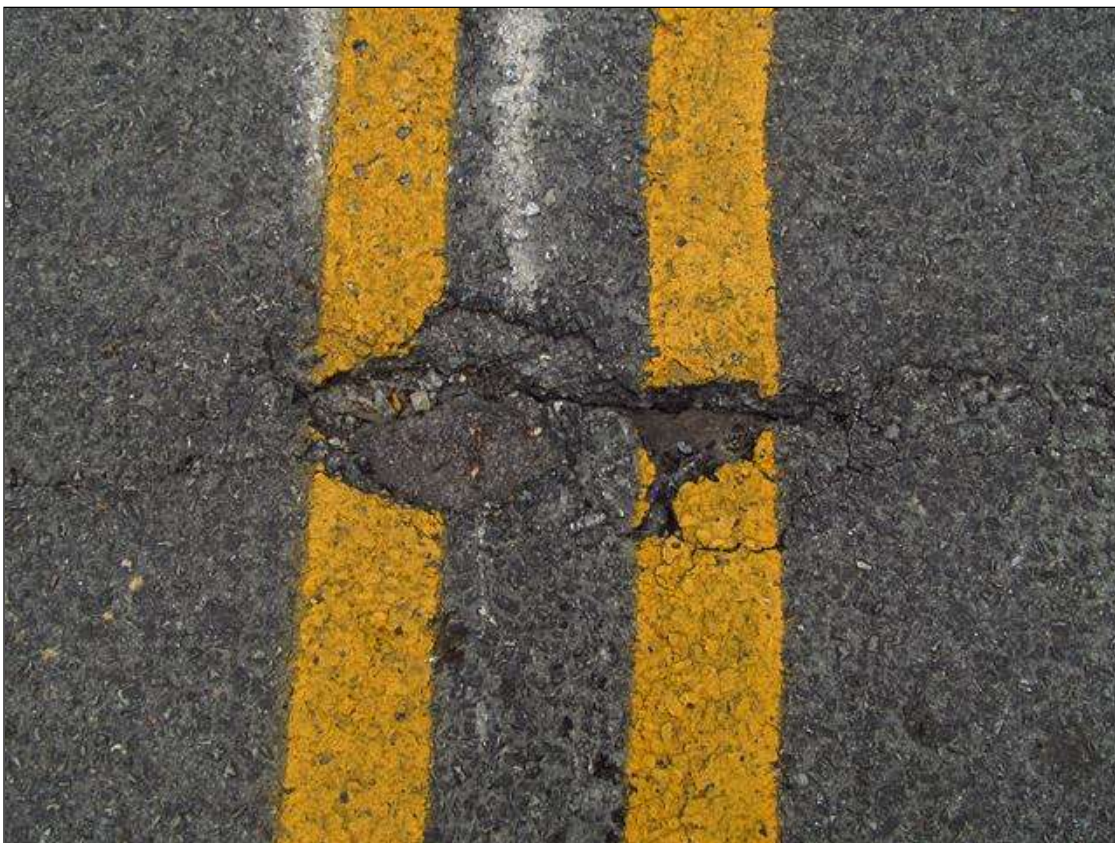
Asphalt wearing surface cracked and settled at the centerline of Bent 1

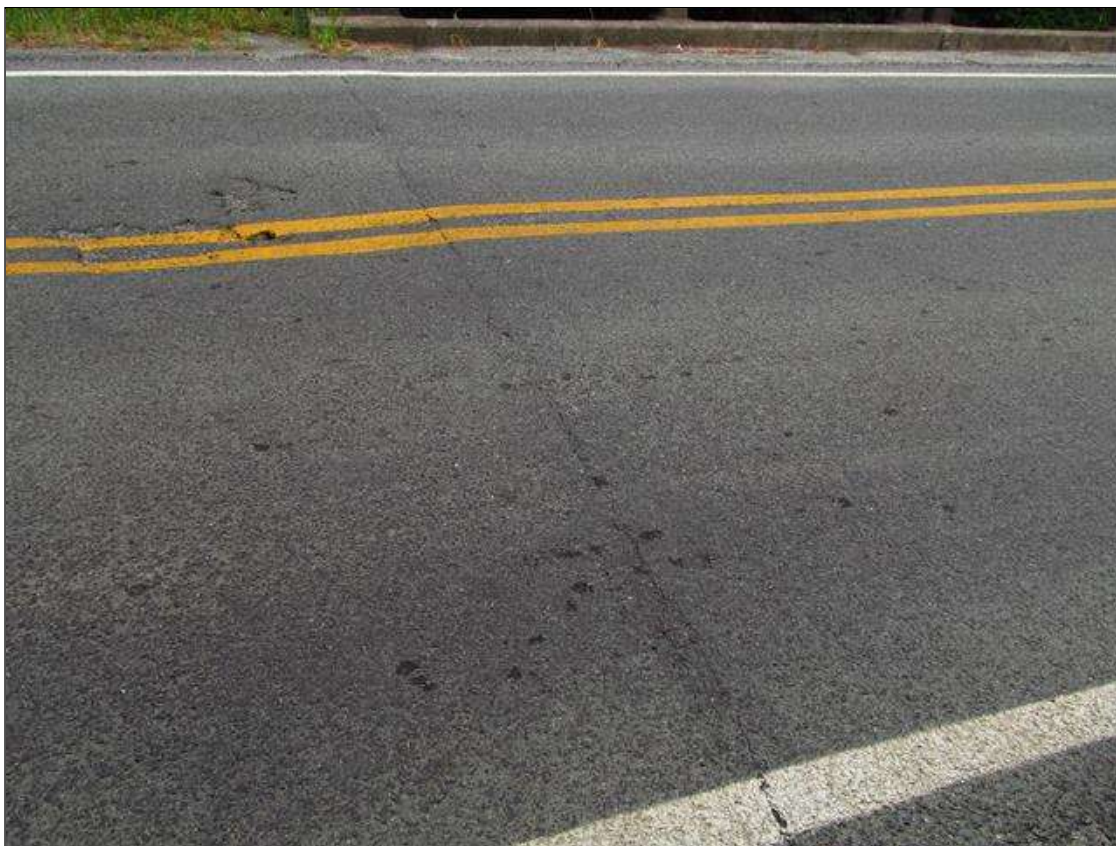
24 Square Feet of Cracking over End Bent 1. Width of more than 0.05 in. or spacing of less than 1.0 ft.

Transverse crack in Wearing surface over End Bent 1

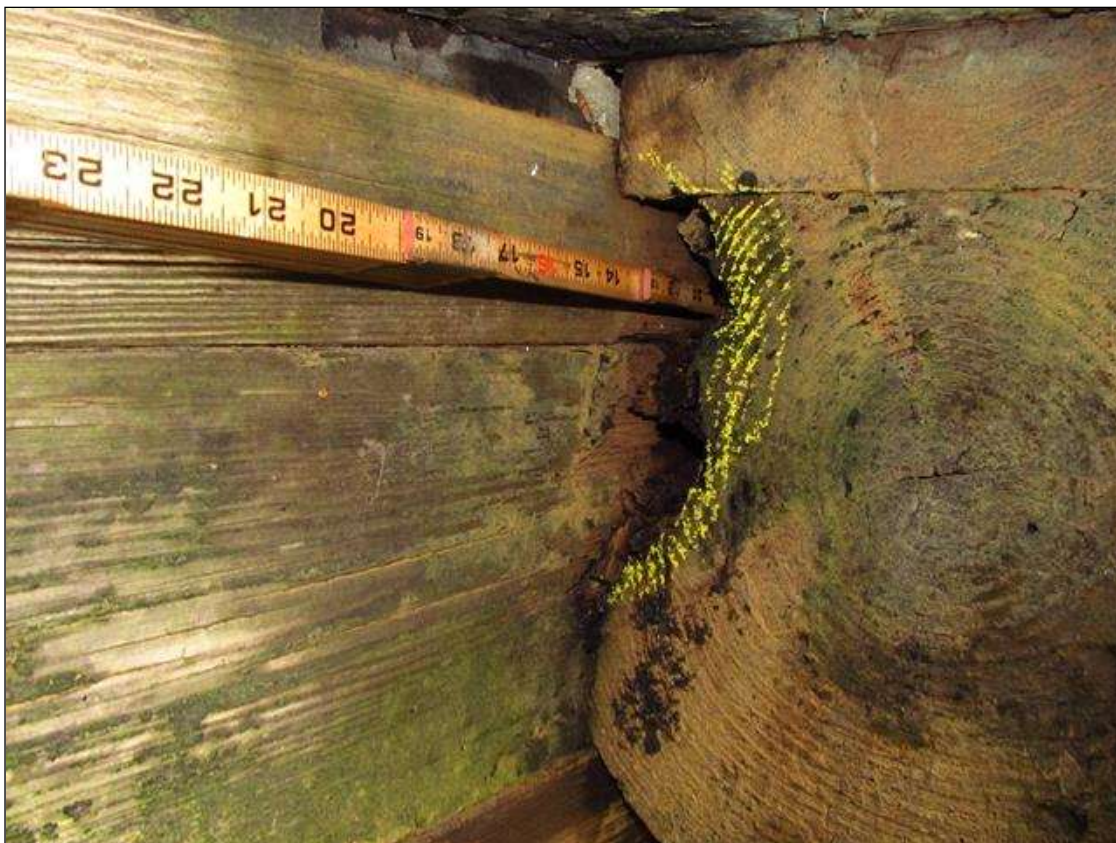
Decay in left End of cap at End Bent 2

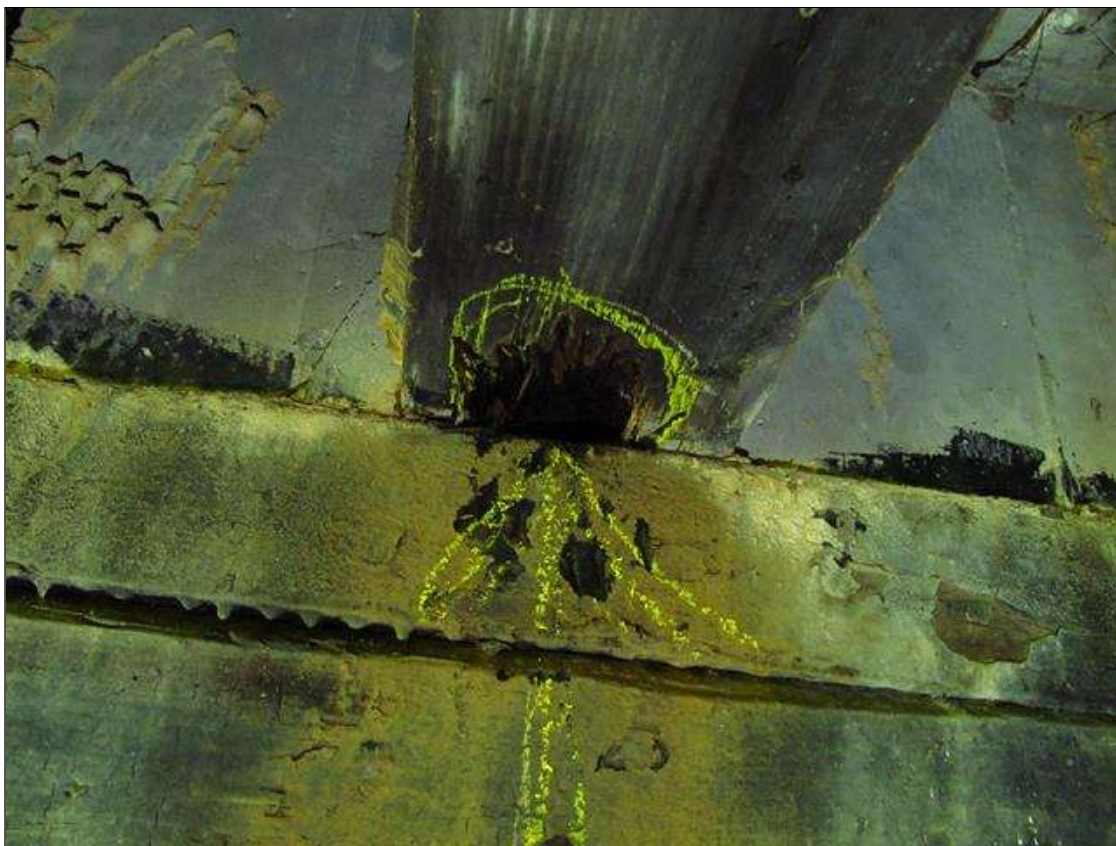
Decay in the bottom of Joist No.6 at End Bent 2

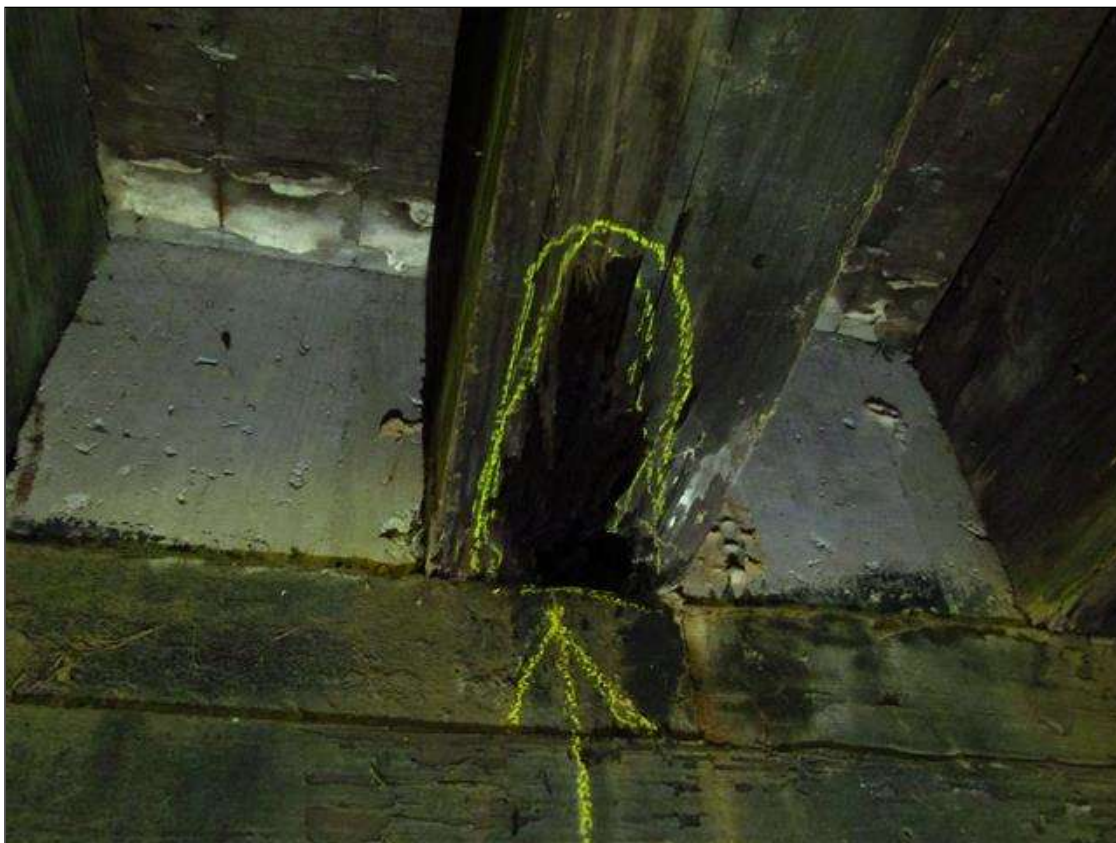
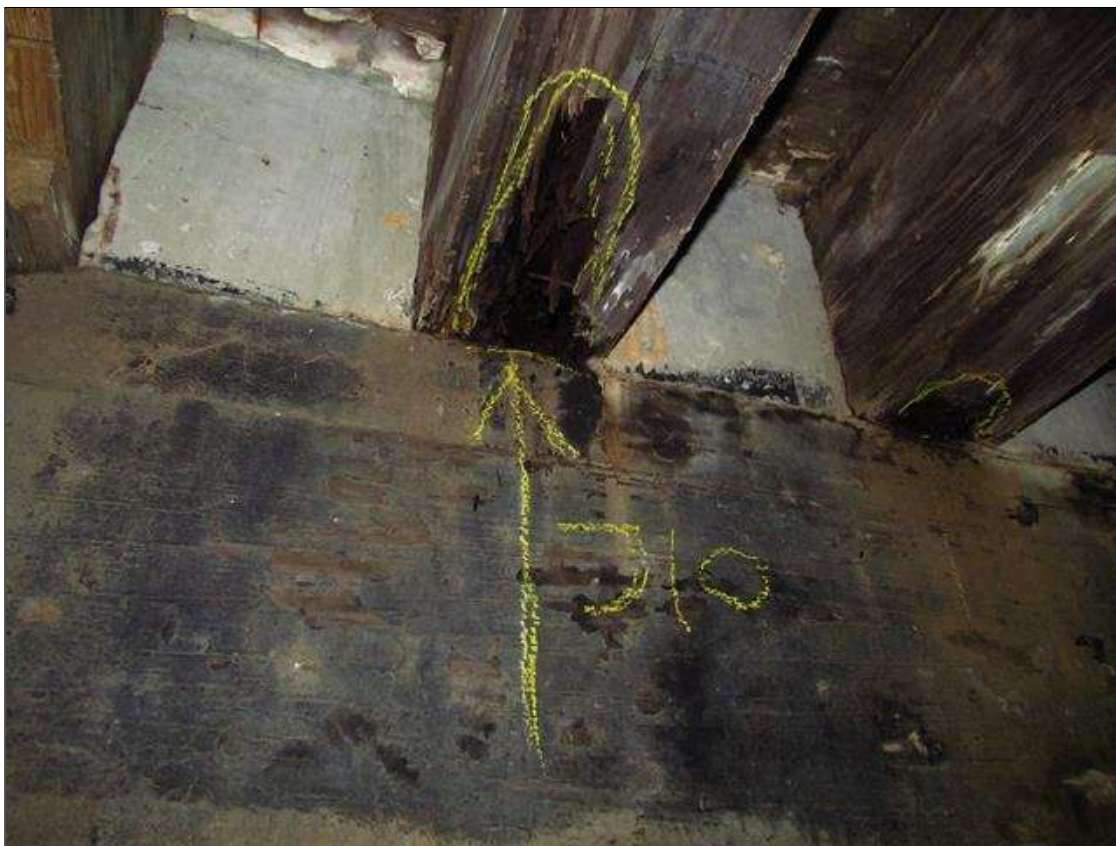
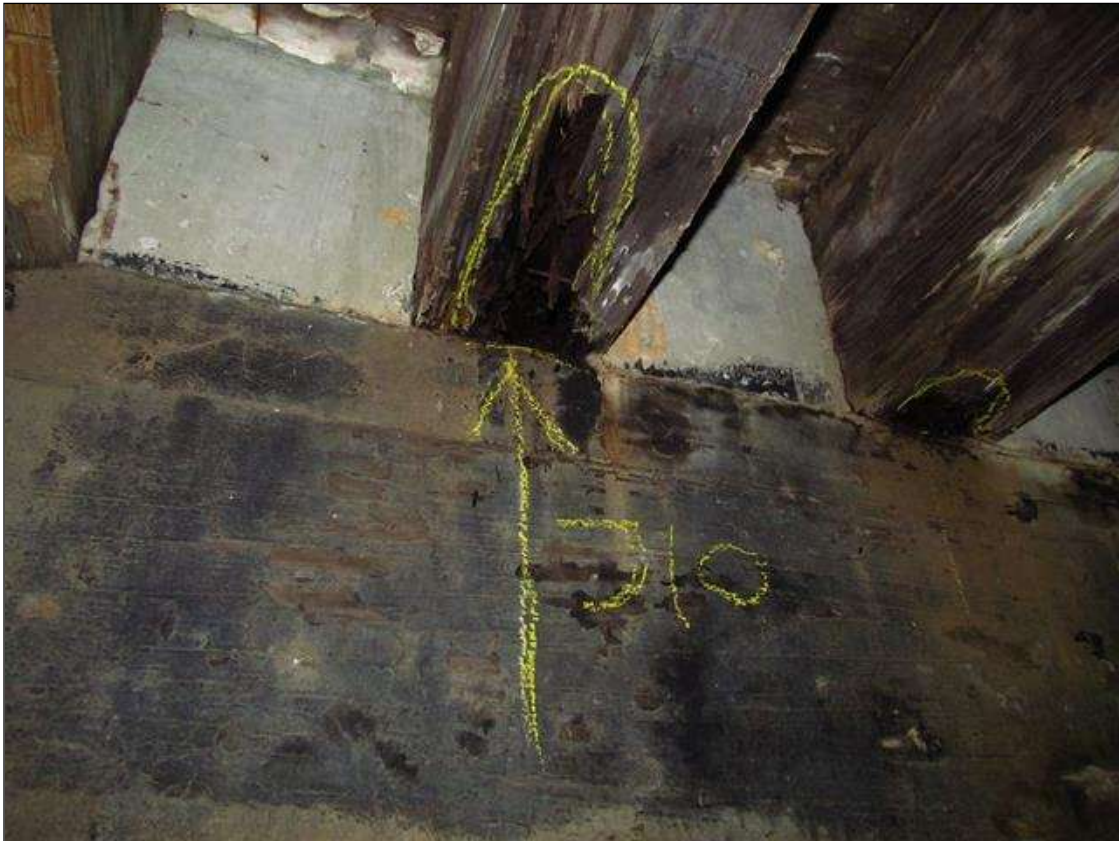
The bottom of joist is decayed 2 1/2 in high x 4 in wide x 21 in long over end bent 2 cap. priority maintenance issued

Decay in the Bottom of Joist No.10 at End Bent 2 (Priority maintenance issued)

Decay in bottom of joist 10 span 2 at end bent 2 photo 2

DECAY IN BOTTOM OF JOIST 10 SPAN 2 OVER END BENT 2 PHOTO 2

| MMS Code | Description of Function | Unit | Quantity | Remarks | Est. Cost |
|---|---|---|---|---|---|
| 3304 | Maintain/Replace Timber Superstructure Components | LF | <del>2</del> | JOIST 10 SPAN 2 IS DECAYED IN THE BOTTOM OF THE JOIST IN THE BEARING AREA OVER END BENT 2 CAP 21" LONG X 4" WIDE X 2.5" DEEP | |

| MMS Code | MMS Description | Quantity |
|---|---|---|
| JOIST 10 SPAN 2 IS DECAYED IN THE BOTTOM OF THE JOIST IN THE BEARING AREA OVER END BENT 2<br>CAP 21" LONG X 4" WIDE X 2.5" DEEP | | |

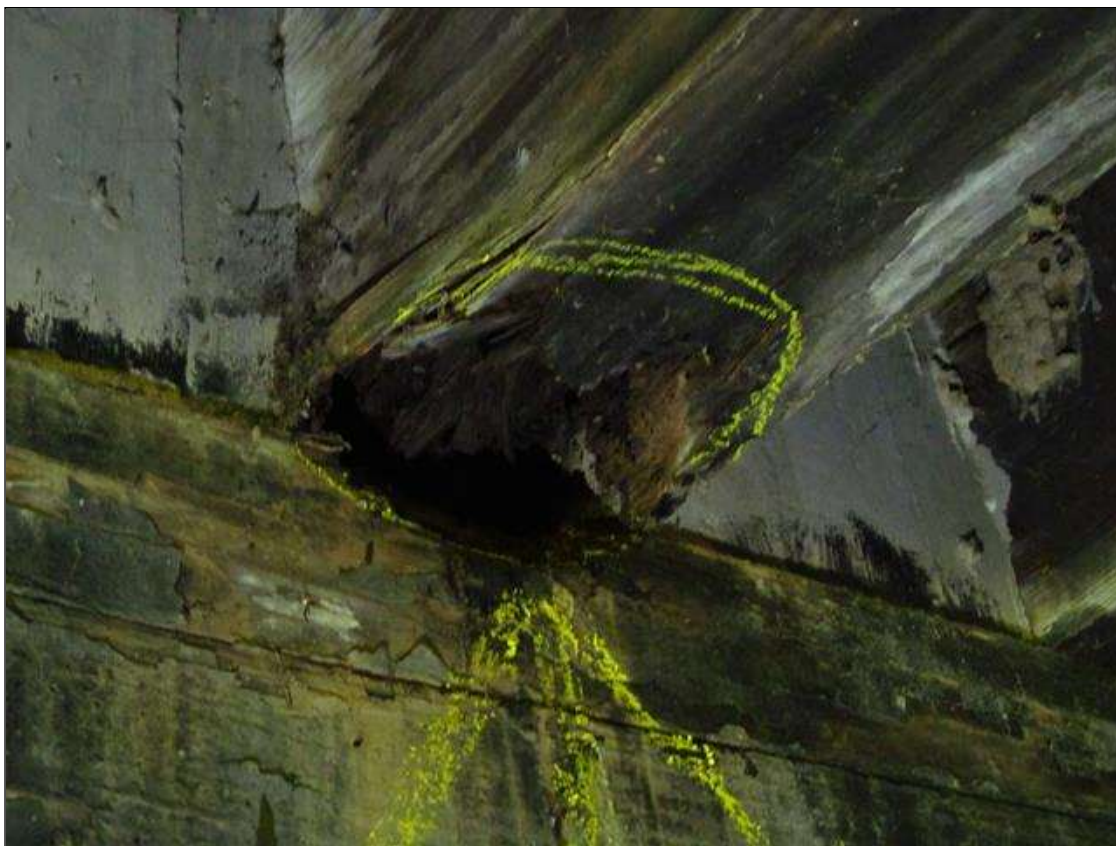
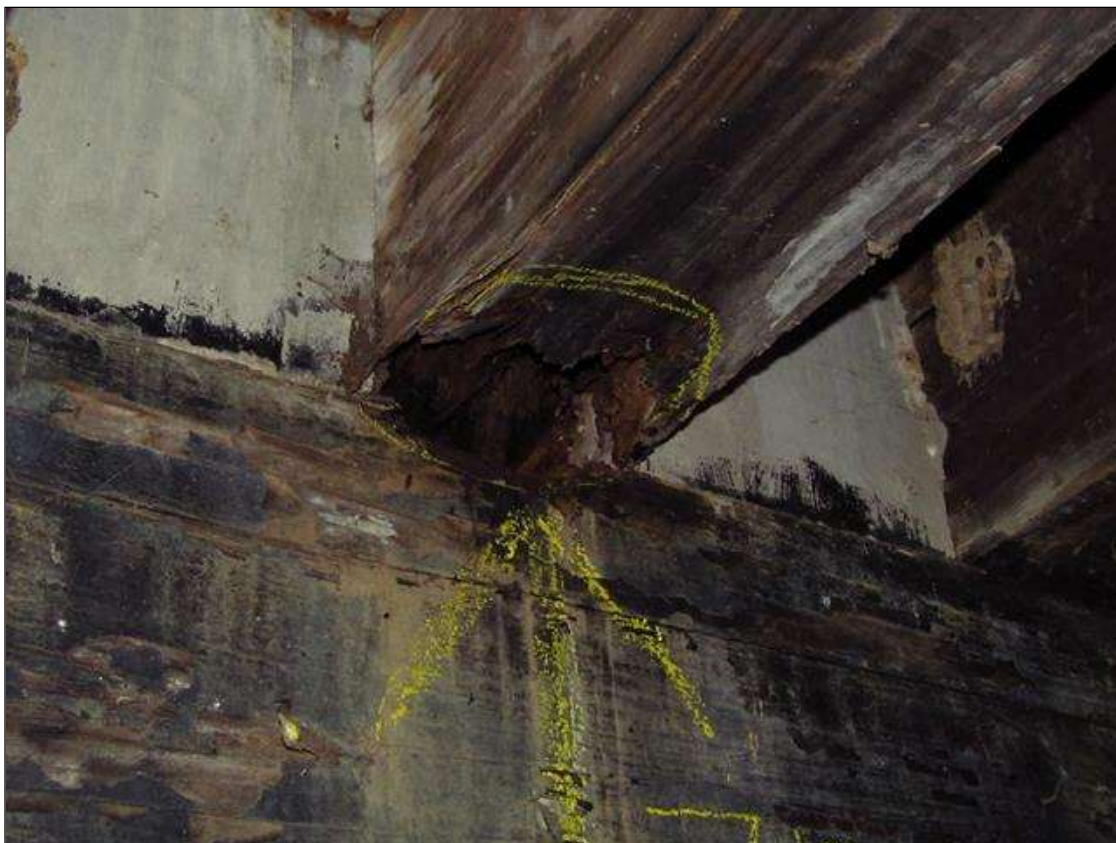
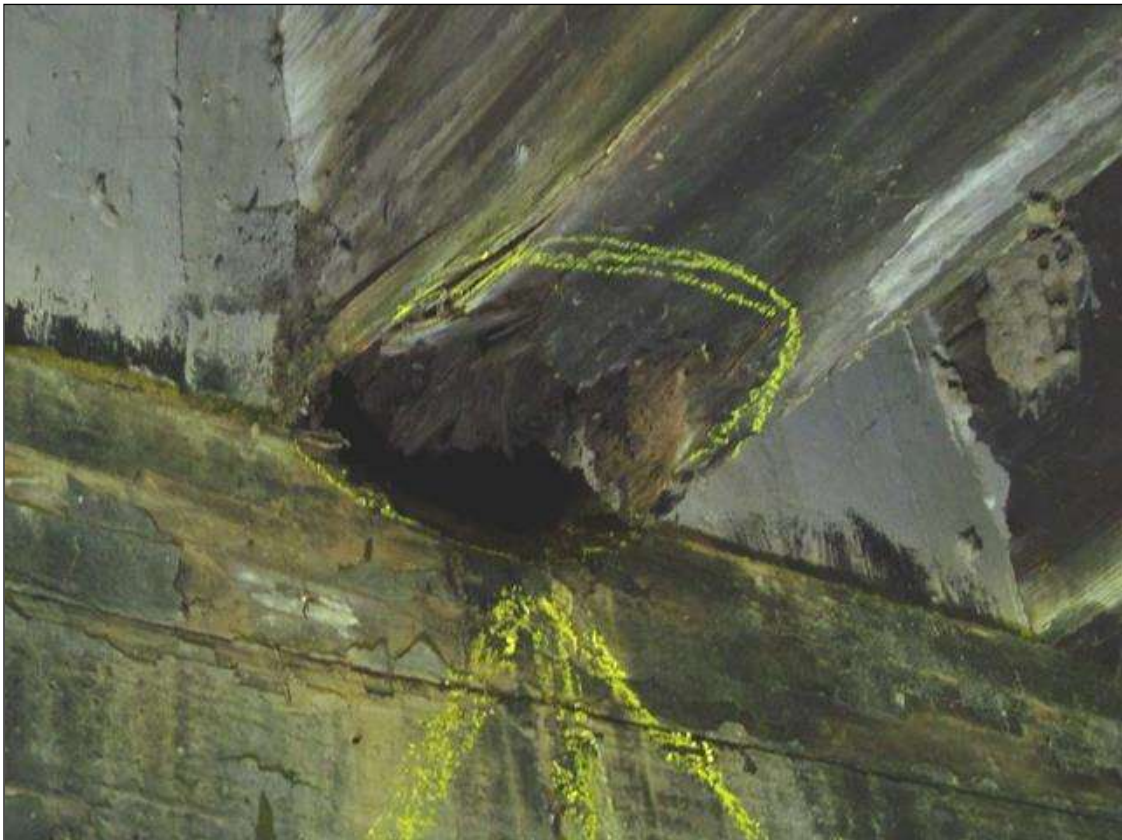
The bottom of joist 13 is decayed 6 in wide x 3 in high x 17 in long over end bent 2 cap. priority maintenance issued

Decay in the bottom of Joist No.13 at End Bent 2 (Priority maintenance issued)

Decay in bottom of joist 13 span 2 at end bent 2 photo 2

DECAY 17" LONG X 6" WIDE X 3" DEEP IN THE BOTTOM OF JOIST NO.13 OVER END BENT 2.

| MMS Code | Description of Function | Unit | Quantity | Remarks | Est. Cost |
|---|---|---|---|---|---|
| 3304 | Maintain/Replace Timber Superstructure Components | LF | <del>2</del> | JOIST 13 SPAN 2 IS DECAYED IN THE BOTTOM OF THE JOIST IN THE BEARING AREA OVER END BENT 2 17" LONG X 6" WIDE X 3" DEEP. | |

| MMS Code | MMS Description | Quantity |
|---|---|---|
| JOIST 13 SPAN 2 IS DECAYED IN THE BOTTOM OF THE JOIST IN THE BEARING AREA OVER END BENT 2<br>17" LONG X 6" WIDE X 3" DEEP. | | |

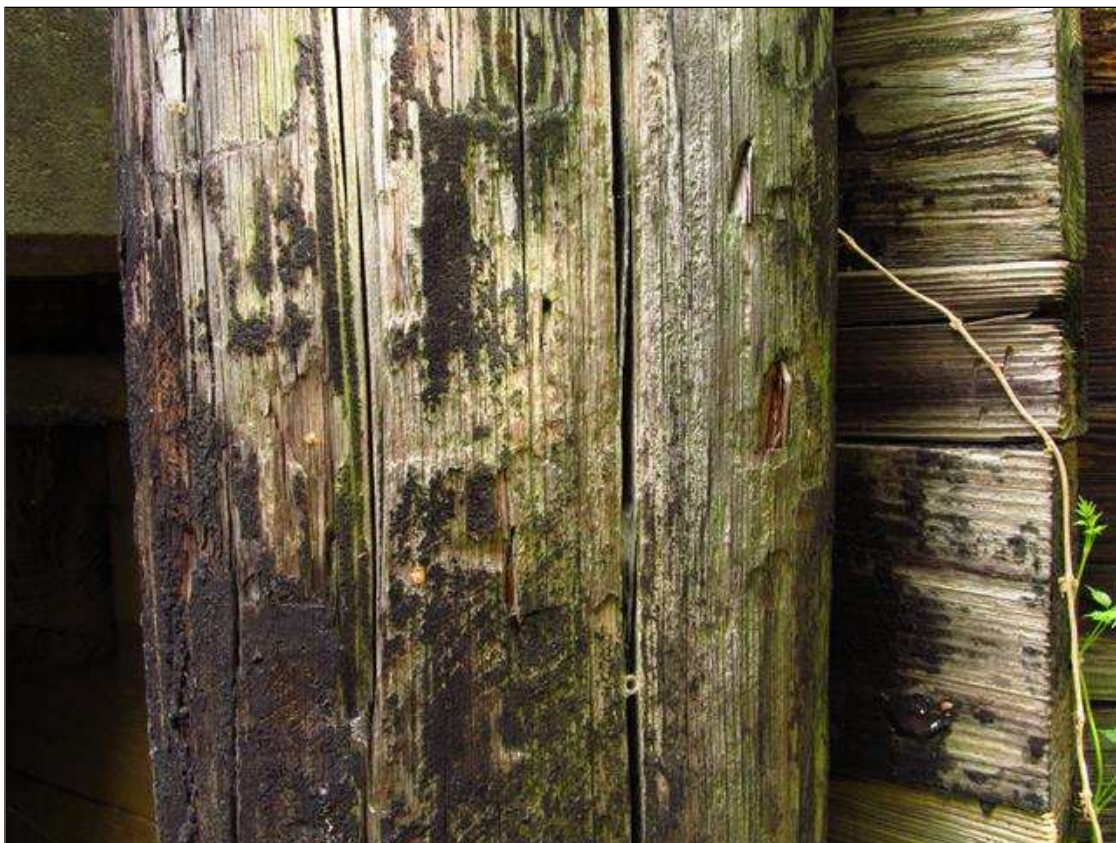
Vertical checks throughout all timber piles

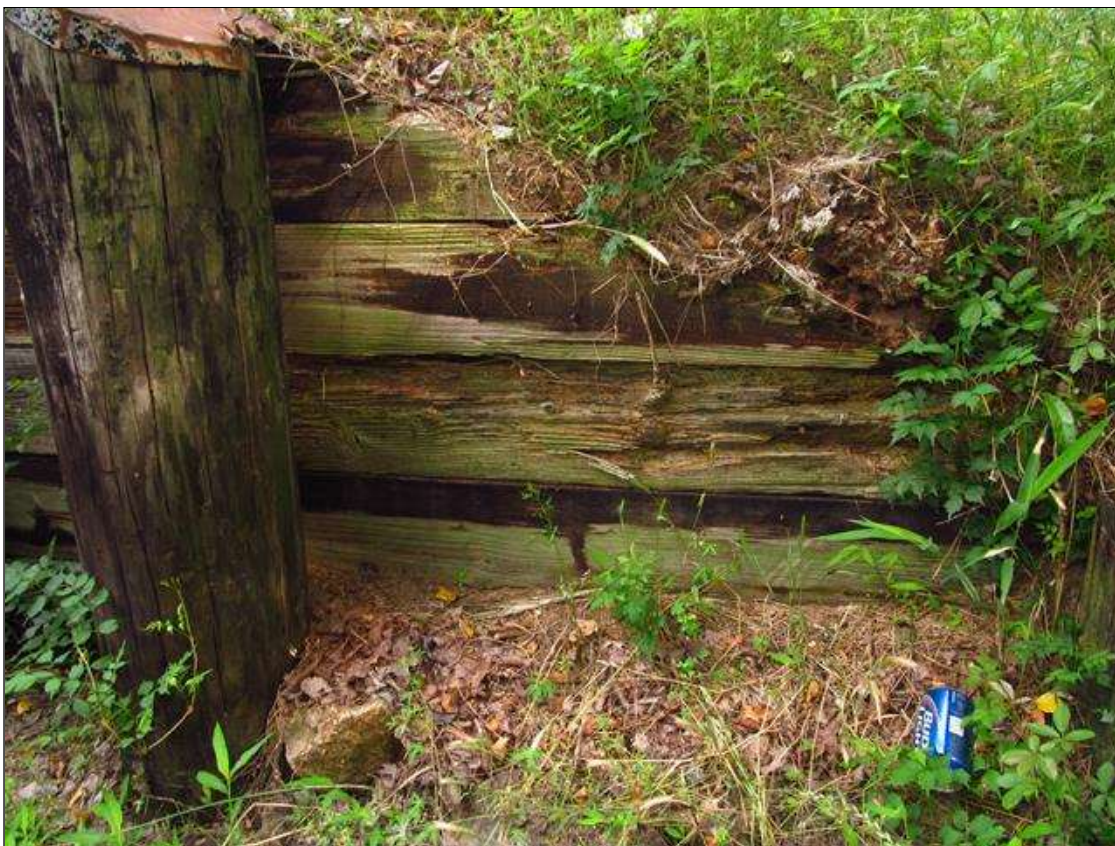
- 20 Feet of Check/Shake in bulkhead piles and bulkhead boards : Penetrates 5%-50% of the thickness of teh member and not in a tension zone.  
3 Feet of Decay 1 in deep in top bulkhead board at right side of end bent 2.

Decay in the Right side Wingwall boards at End Bent 2

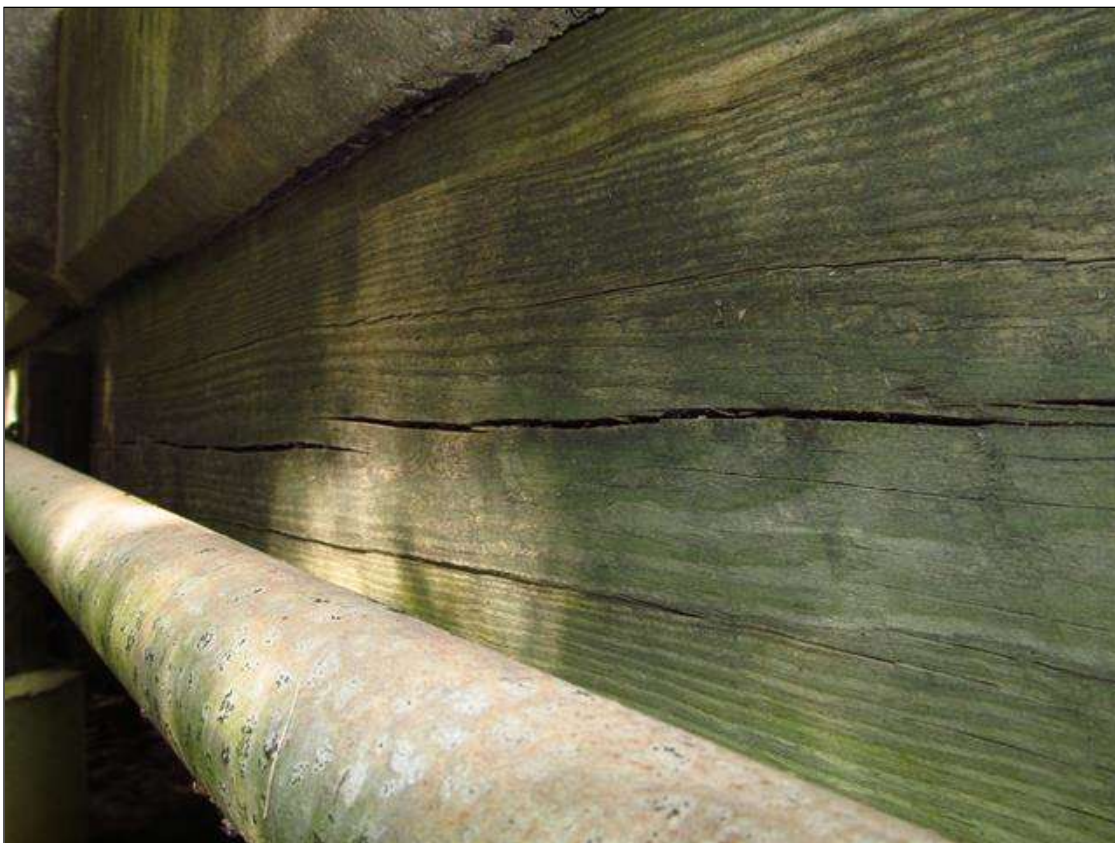
Longitudinal checks throughout timber Joists

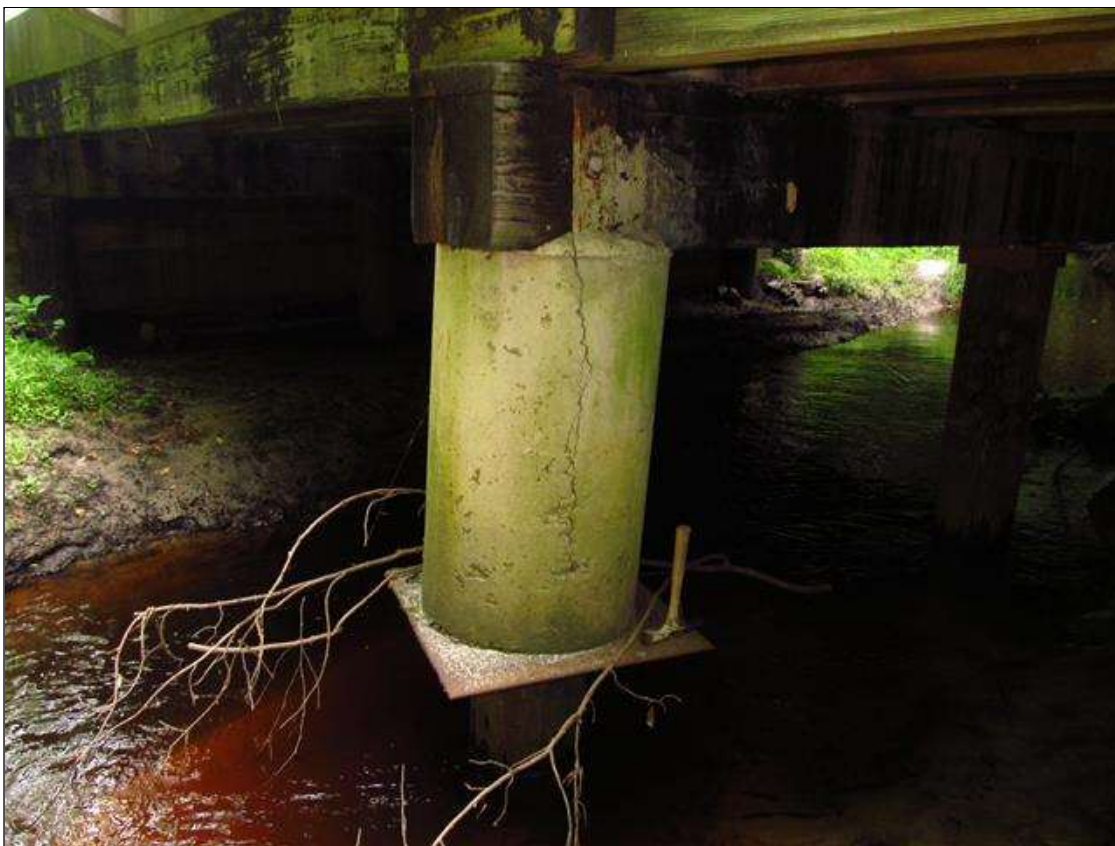
Pile 4 @ E-Bent 1 and Pile 1 @ Int-Bent 1 Encased with Concrete. Temp Repair  
Pile 4 @ Int Bent 1 Encased with Concrete. 11/27/14

Temporary pile repairs throughout structure

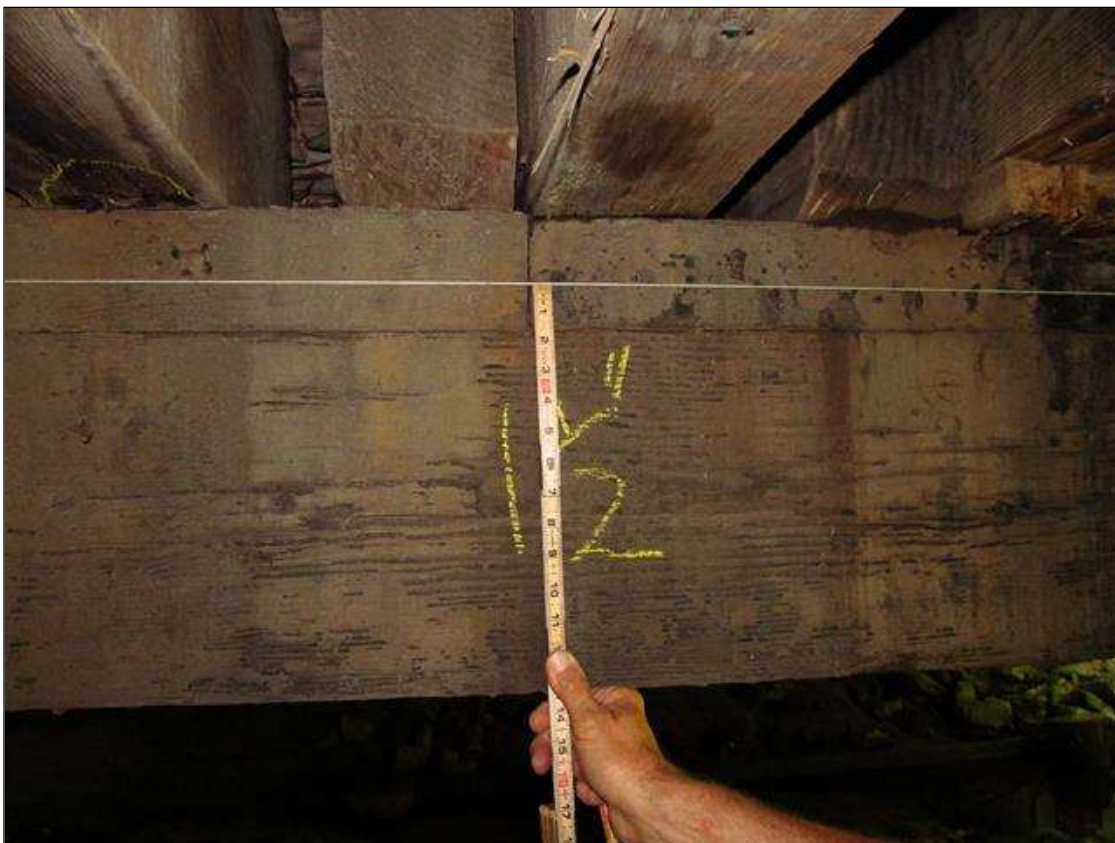
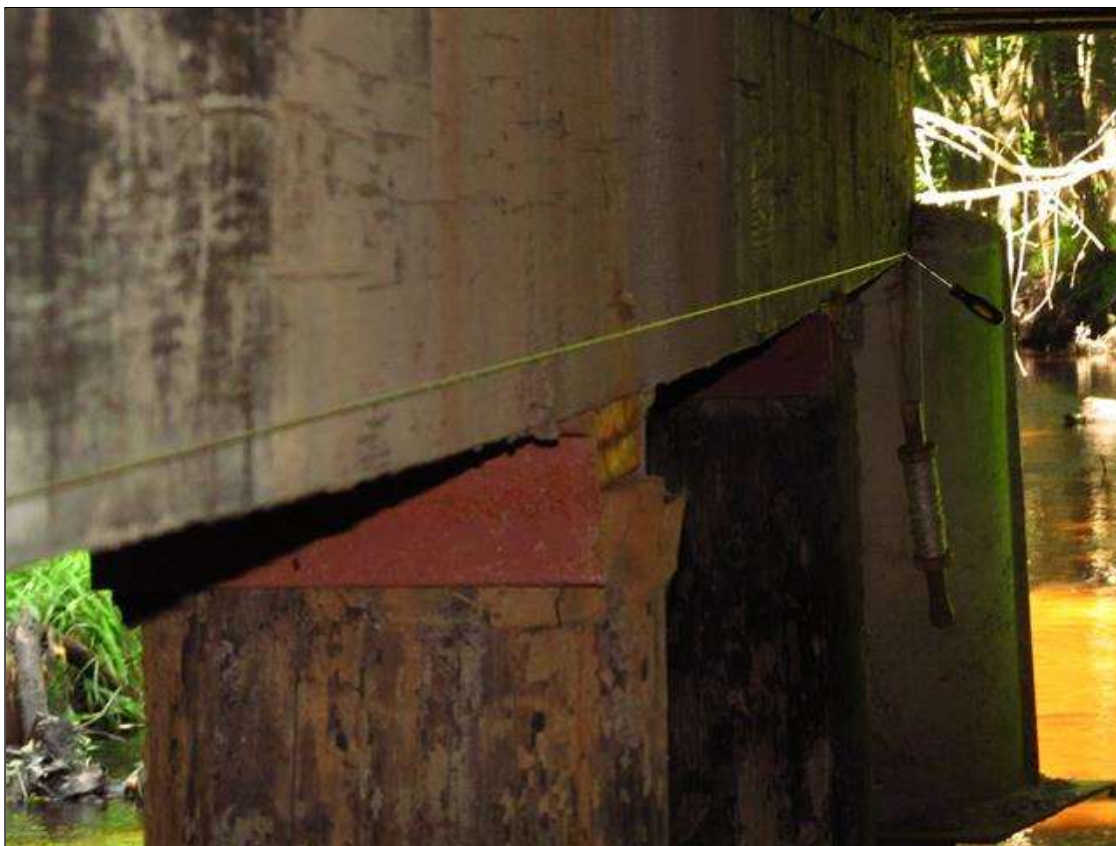
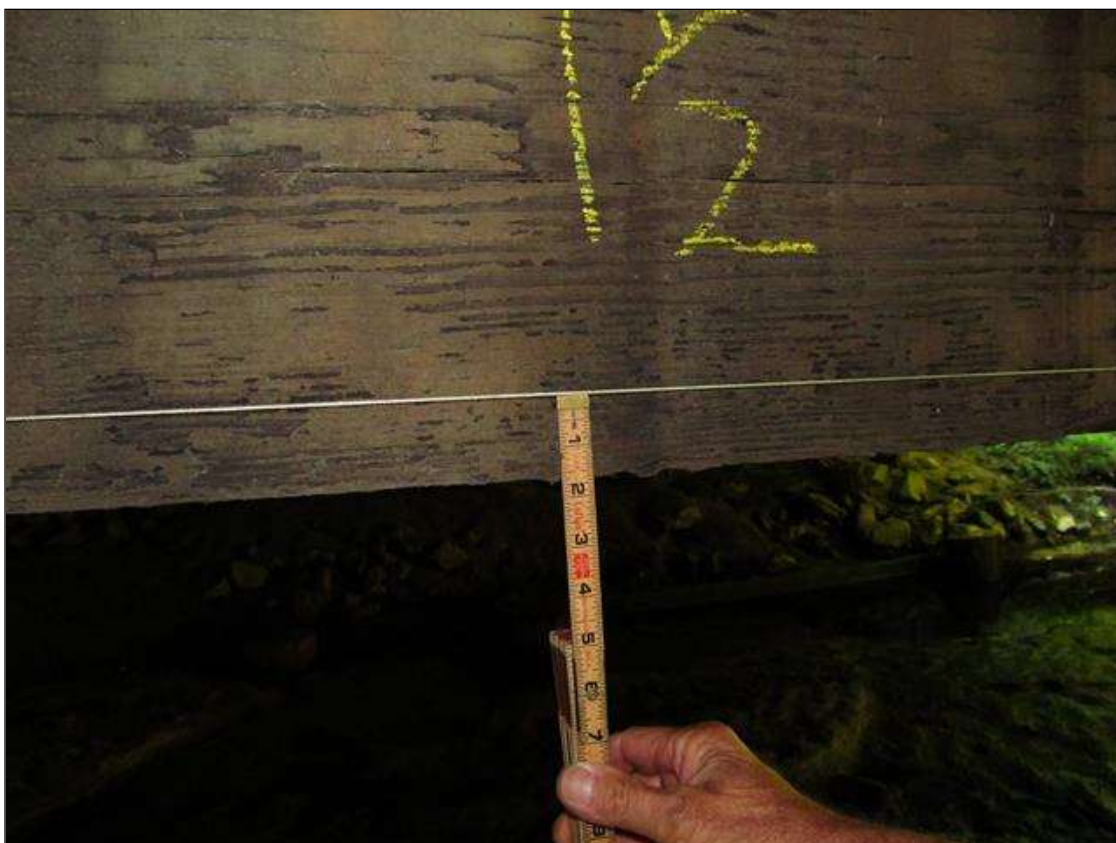
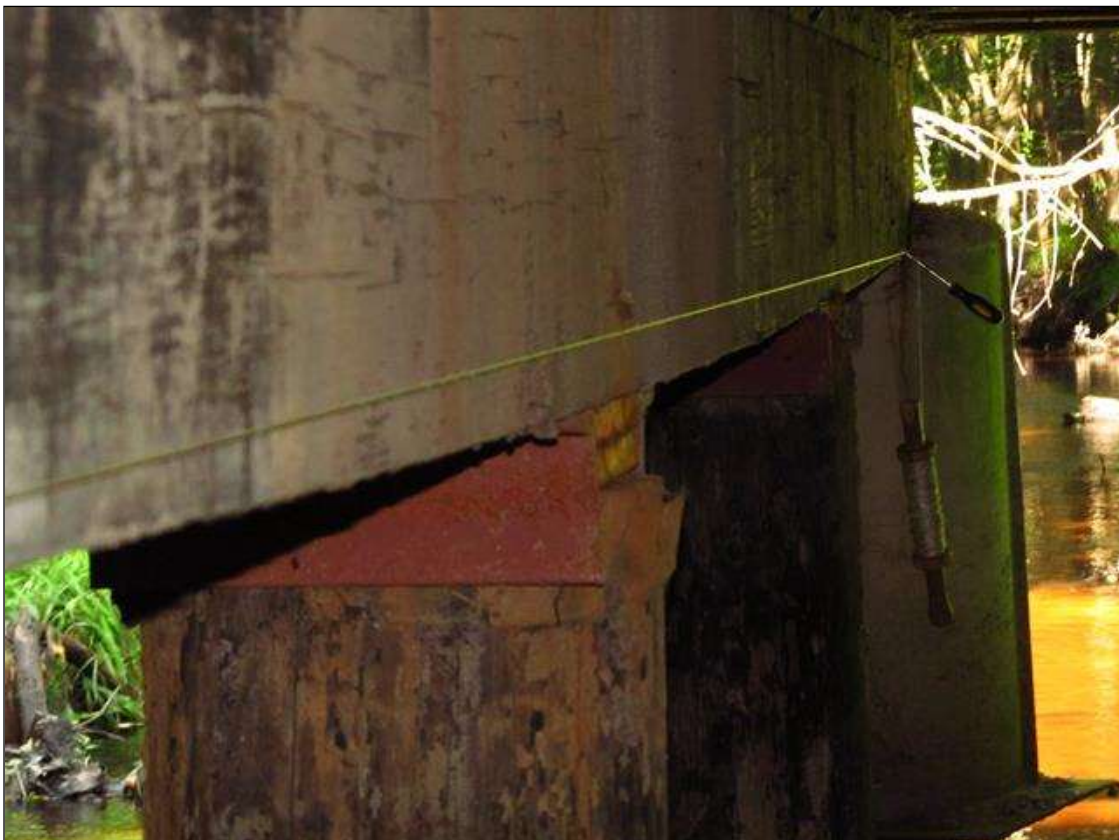
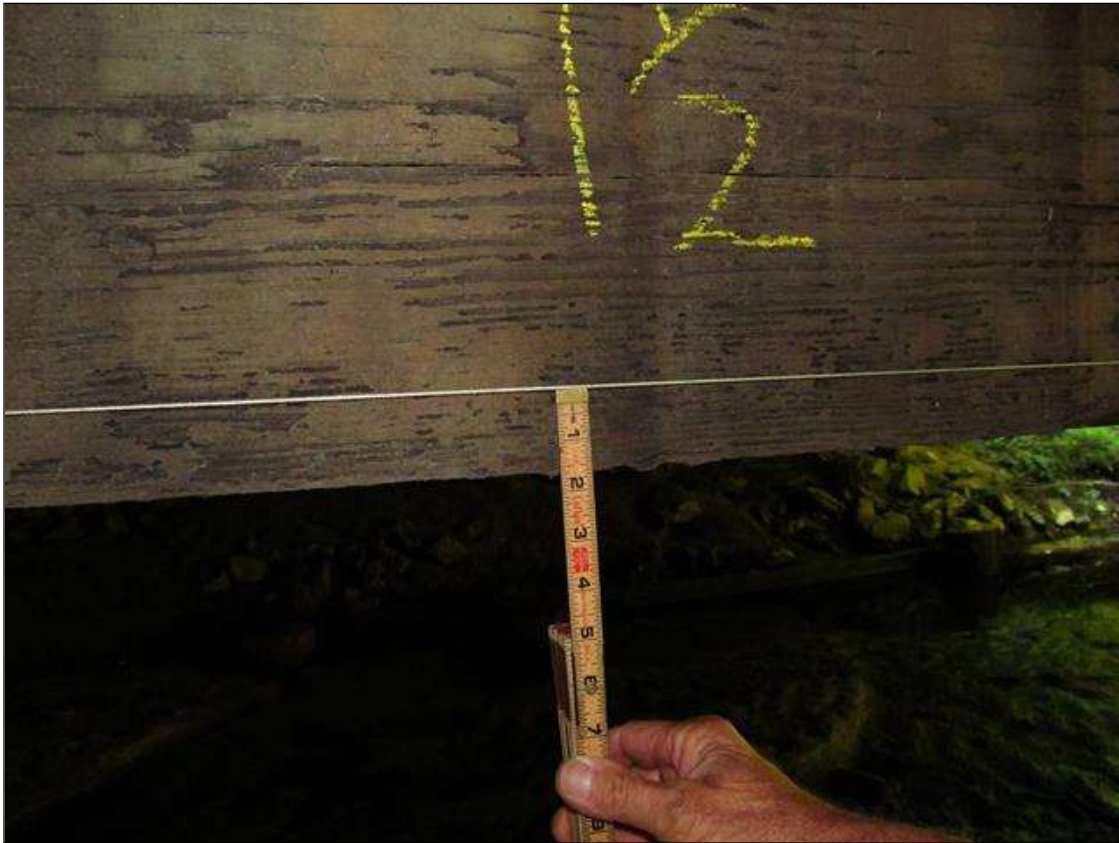
Cap was previously sagged 2.5 in at the middle of the cap. Repairs have been made with shims on piles 2 & 3. Piles appear to have settled since repair and is presently sagged 1.5 in at the middle. priority maintenance issued

Interior bent cap is sagging 1.5" at centerline

sag in bent 1 cap

sag in bent 1 cap photo 2

SAG IN BENT 1 CAP

| MMS Code | Description of Function | Unit | Quantity | Remarks | Est. Cost |
|---|---|---|---|---|---|
| 3344 | Repair / Replace Timber Substructure Components | LF | <del>13</del> | PILES 2 AND 3 OF BENT 1 HAVE SETTLED. CAP IS SAGGED 1.5 INCHES AT MIDSPAN. | |

| MMS Code | MMS Description | Quantity |
|---|---|---|
| PILES 2 AND 3 OF BENT 1 HAVE SETTLED. CAP IS SAGGED 1.5 INCHES AT MIDSPAN. | | |

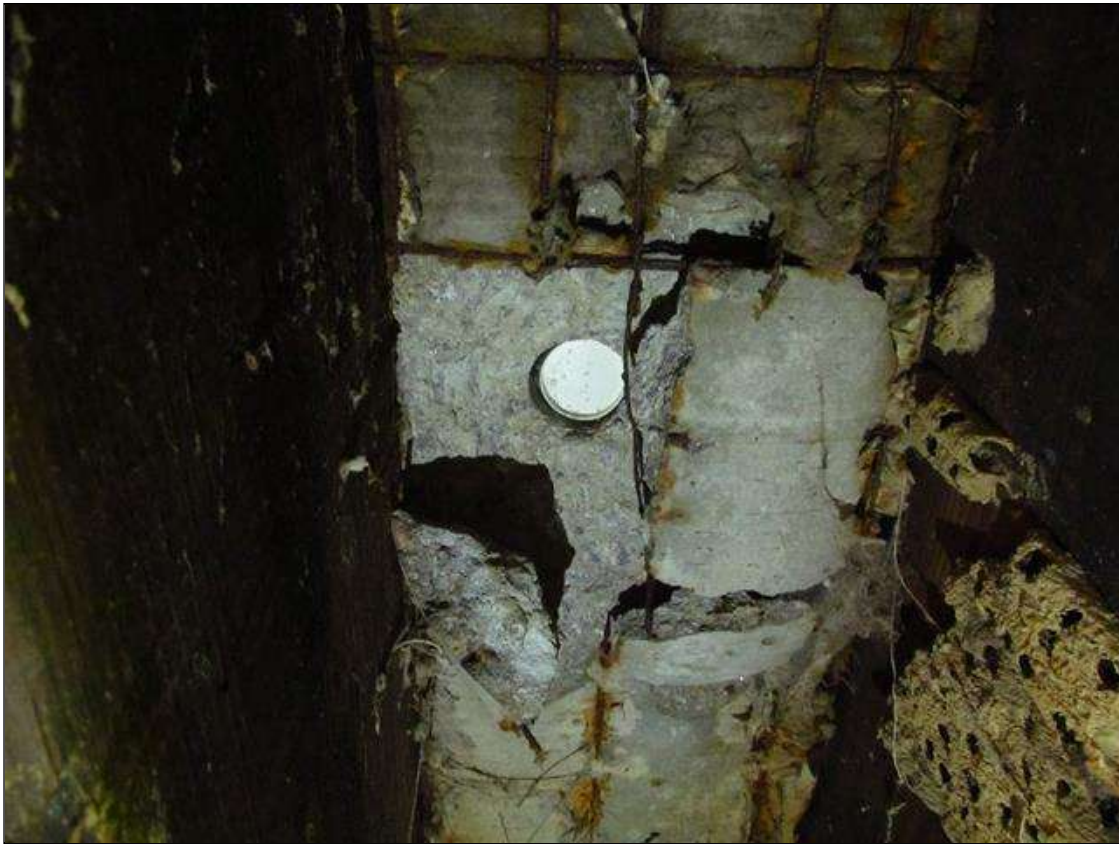
4 Square Feet of 6 in diameter spalls in bottom of deck where holes were drilled for lifting deck.

Spall in Bottom of deck Span 2 bay 14, other bays have similar spalls due to lifting of spans for repair

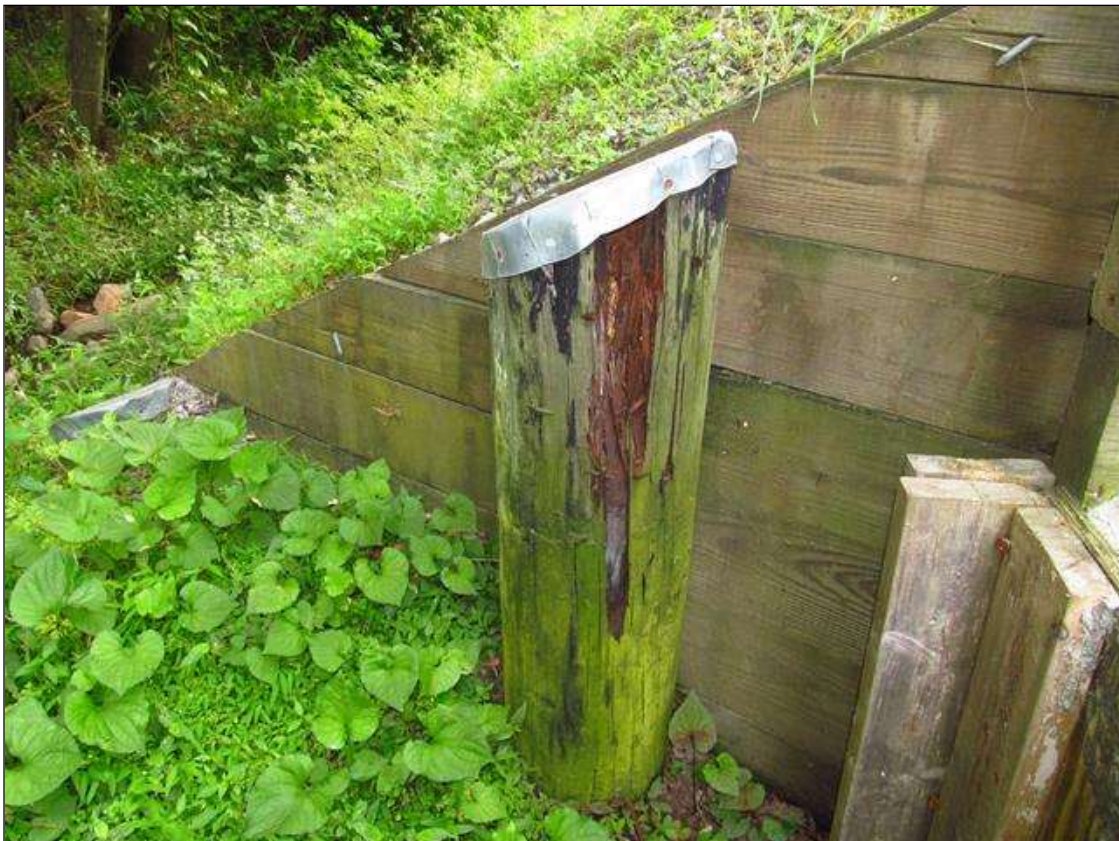
| Details | End bent 1<br>Right wingwall pile is decay in the center with at 1 in shell remaining.<br>End bent 2<br>Left tall wingwall pile is decayed in the center with a 2 in shell remaining. | | | | | |

Decay in the Right side Wingwall pile at End Bent 1

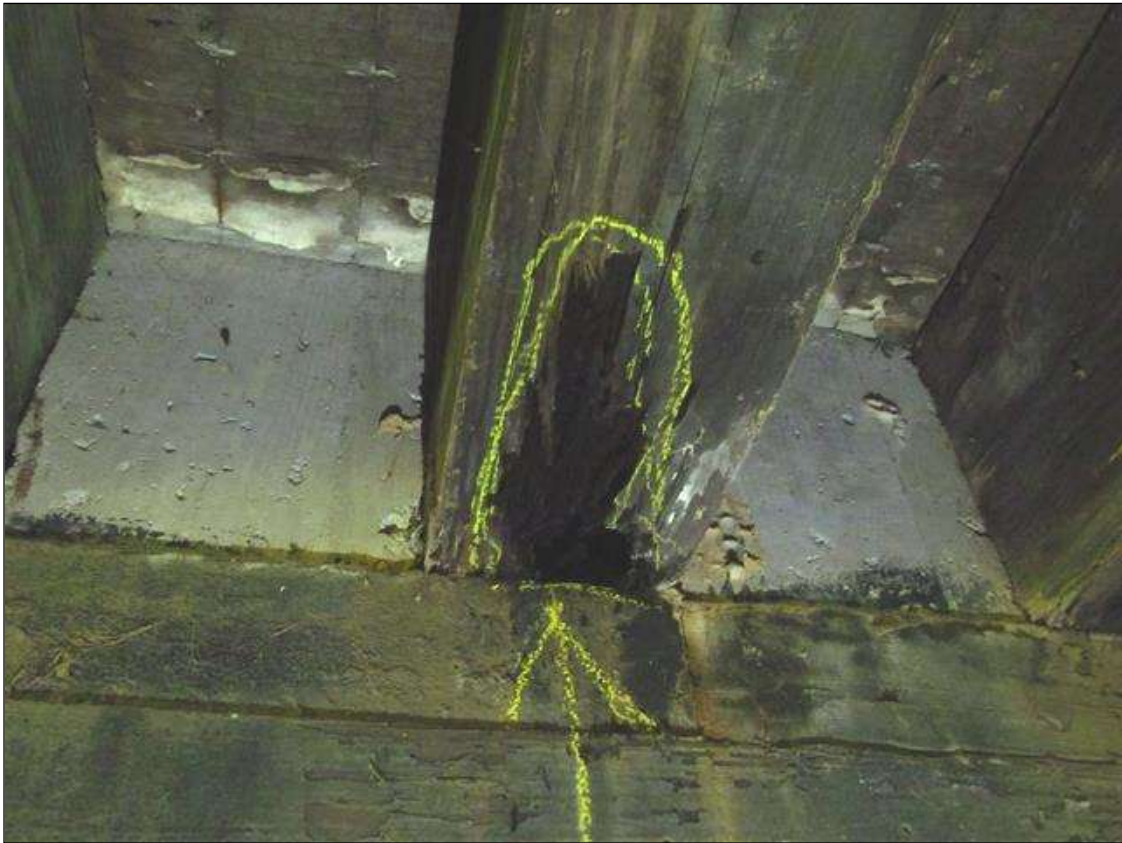
DECAY 21" LONG X 4" WIDE X 2.5" DEEP IN THE BOTTOM OF JOIST NO.11 OVER END BENT 2.
