NC DEPARTMENT OF TRANSPORTATION  
DIVISION OF HIGHWAYS  
BRIDGE MANAGEMENT UNIT

# BRIDGE INSPECTION REPORT

INSPECTION TYPE: Routine Inspection

COUNTY COLUMBUS BRIDGE NUMBER 230068 INSPECTION CYCLE 2 YRS  
ROUTE NC214 ACROSS GREEN SWAMP M.P. 0

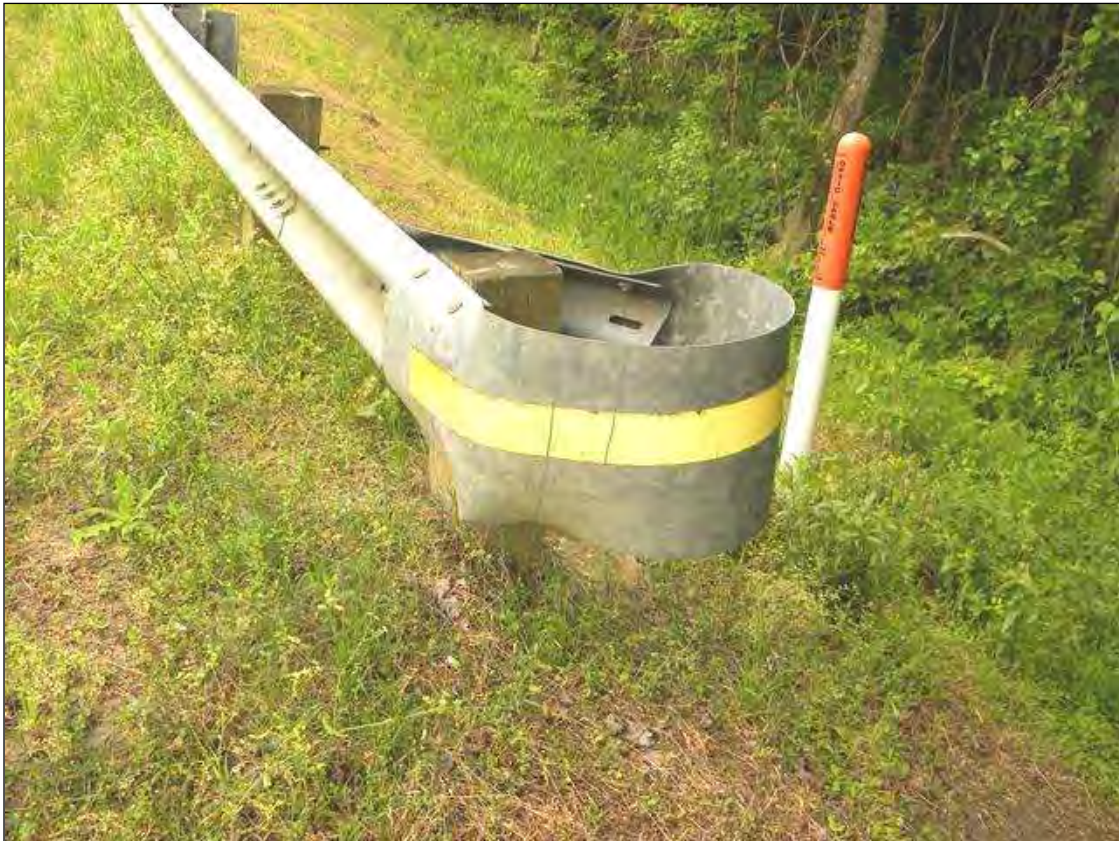
DAMAGED GUARDRAIL END TERMINAL AT SOUTHWEST CORNER

| MMS Code | Description of Function | Unit | Quantity | Remarks | Est. Cost |
|---|---|---|---|---|---|
| 3120 | Repair/Maintain Barriers | LF | 2 | DAMAGED GUARDRAIL END TERMINAL AT SOUTHWEST CORNER | |

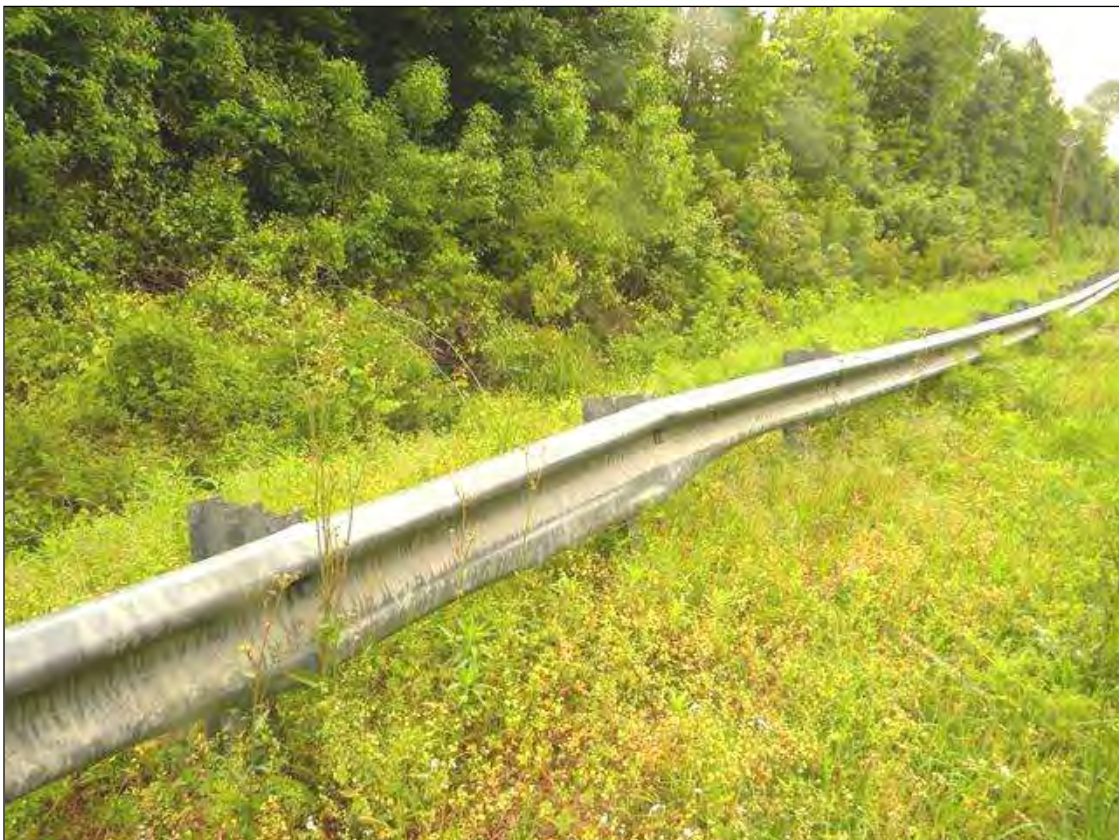
DAMAGED GUARDRAIL SECTION IN THE NORTHWEST CORNER

| MMS Code | Description of Function | Unit | Quantity | Remarks | Est. Cost |
|---|---|---|---|---|---|
| 3120 | Repair/Maintain Barriers | LF | 20 | DAMAGED GUARDRAIL SECTION IN THE NORTHWEST CORNER | |

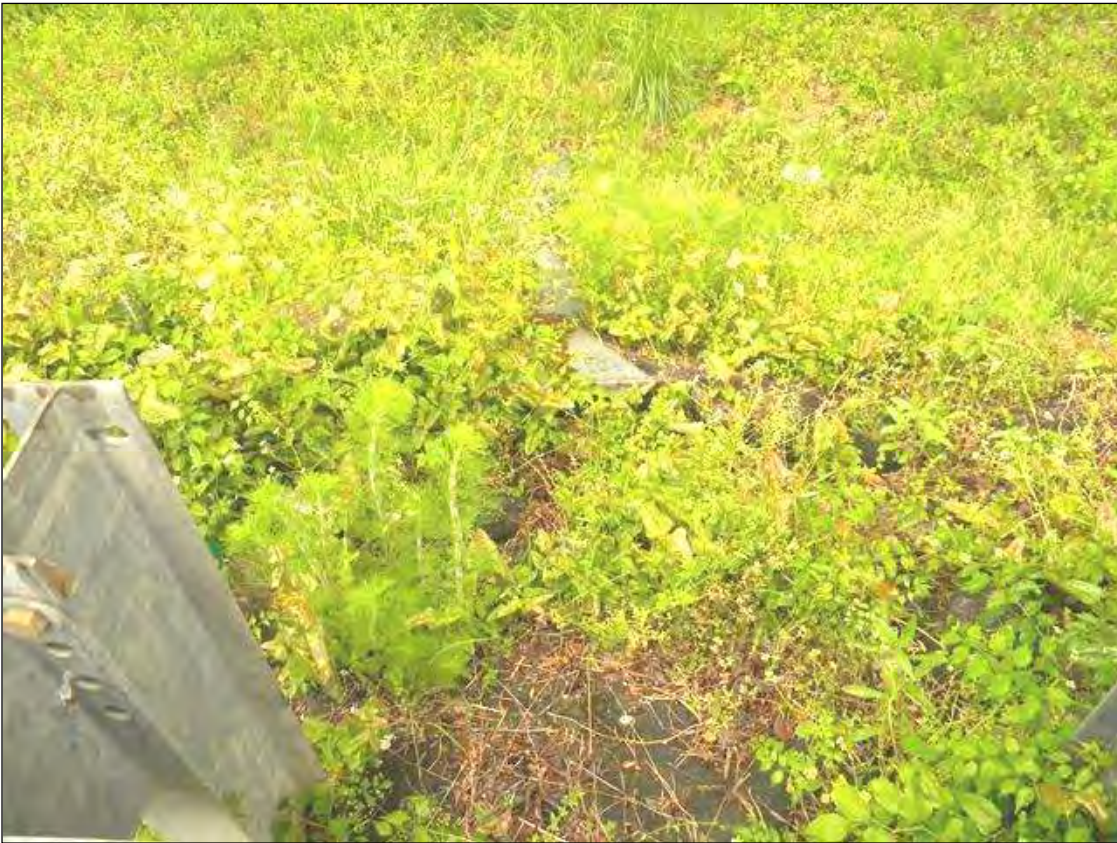
APPROACH DRAIN BLOCKED BY DEBRIS IN THE SOUTHWEST CORNER

| MMS Code | Description of Function | Unit | Quantity | Remarks | Est. Cost |
|---|---|---|---|---|---|
| 3332 | Maint Drainage System - Bridge | LF | 10 | APPROACH DRAIN BLOCKED BY DEBRIS IN THE SOUTHWEST CORNER | |

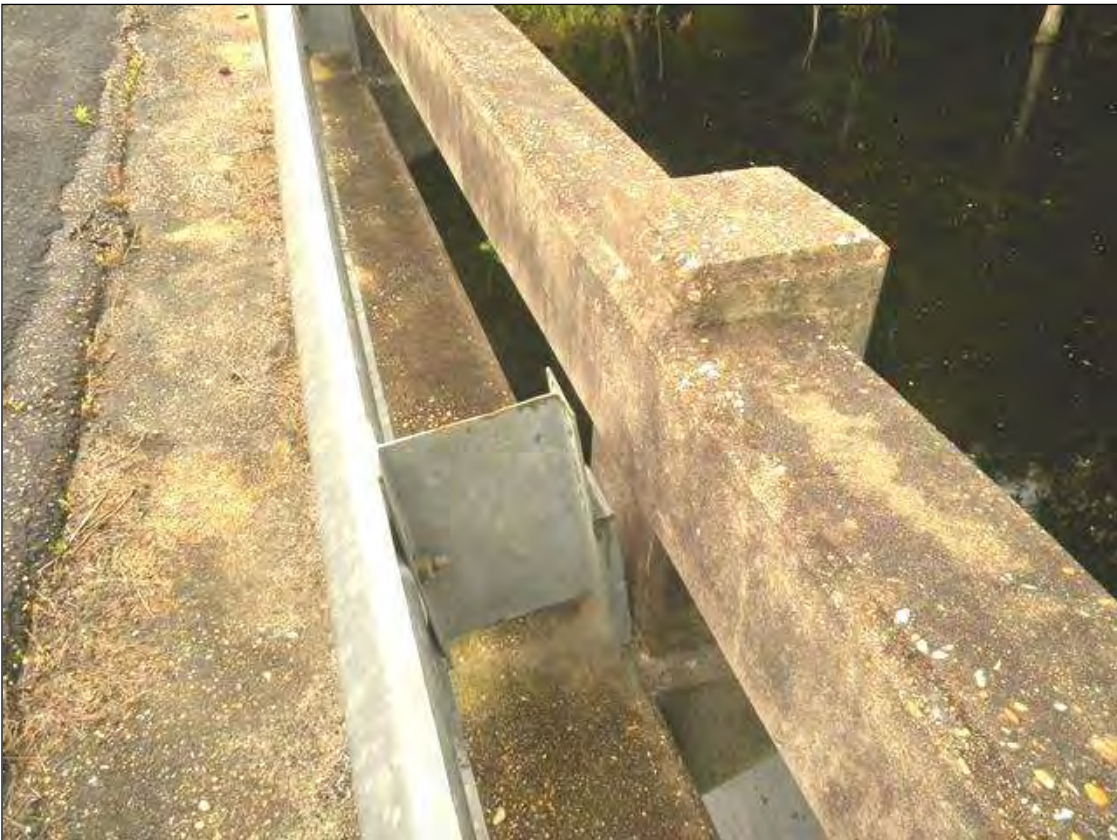
LOOSE GUARDRAIL CONNECTIONS AT SOUTHWEST CORNER, SIMILAR AT NORTHWEST CORNER

| MMS Code | Description of Function | Unit | Quantity | Remarks | Est. Cost |
|---|---|---|---|---|---|
| 3120 | Repair/Maintain Barriers | LF | 4 | LOOSE GUARDRAIL CONNECTIONS AT SOUTHWEST CORNER, SIMILAR AT NORTHWEST CORNER | |

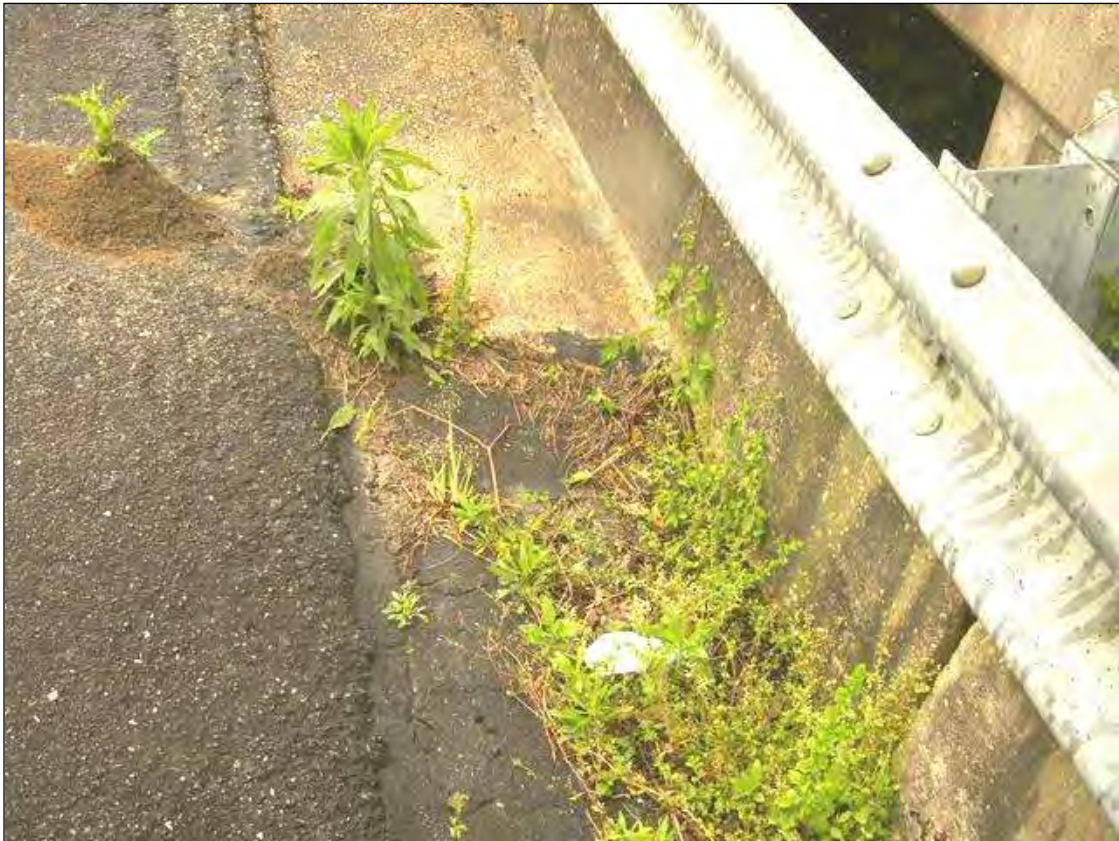
WEST APPROACH ASPHALT WEARING SURFACE IS SETTLED 3" AT SOUTHWEST CORNER

| MMS Code | Description of Function | Unit | Quantity | Remarks | Est. Cost |
|---|---|---|---|---|---|
| 2816 | Asphalt Surface Repair or Replacement | SY | 2 | WEST APPROACH ASPHALT WEARING SURFACE IS SETTLED 3" AT SOUTHWEST CORNER | |

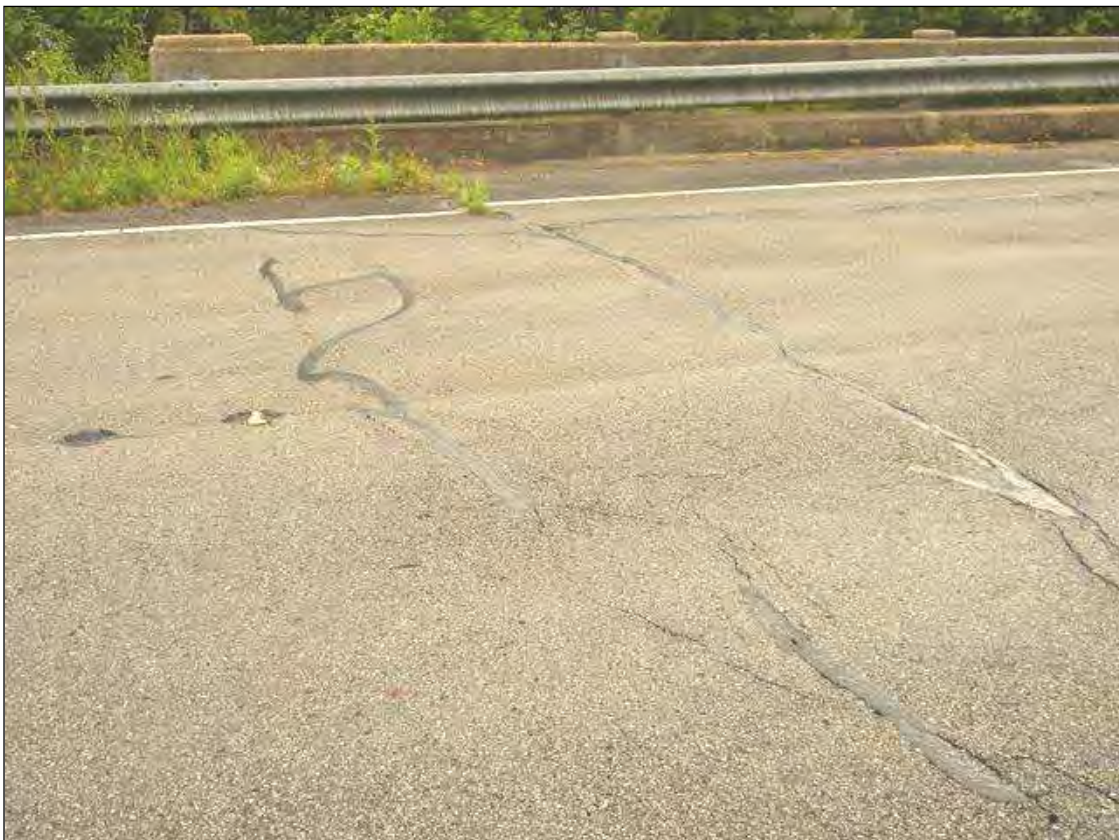
SEALED CRACKING IN WEST APPROACH ASPHALT WEARING SURFACE

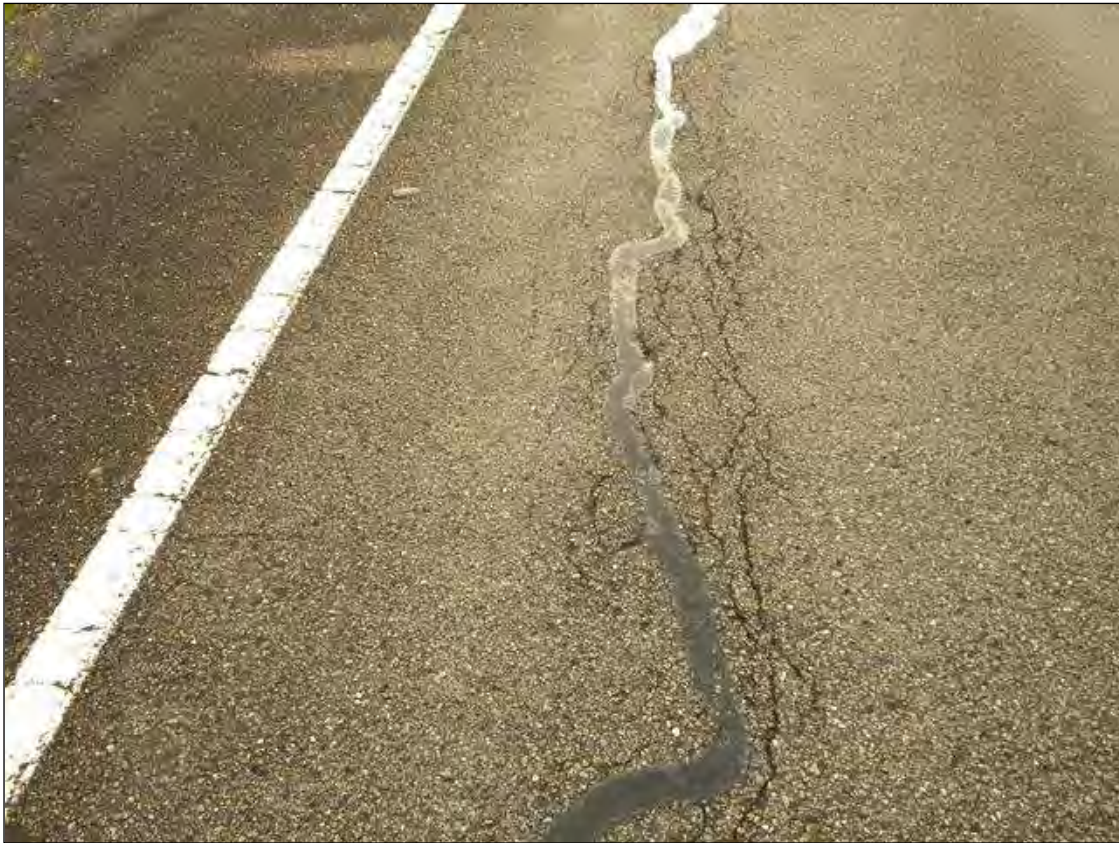
SEALED LONGITUDINAL CRACKS IN SPAN 1, WEST BOUND LANE

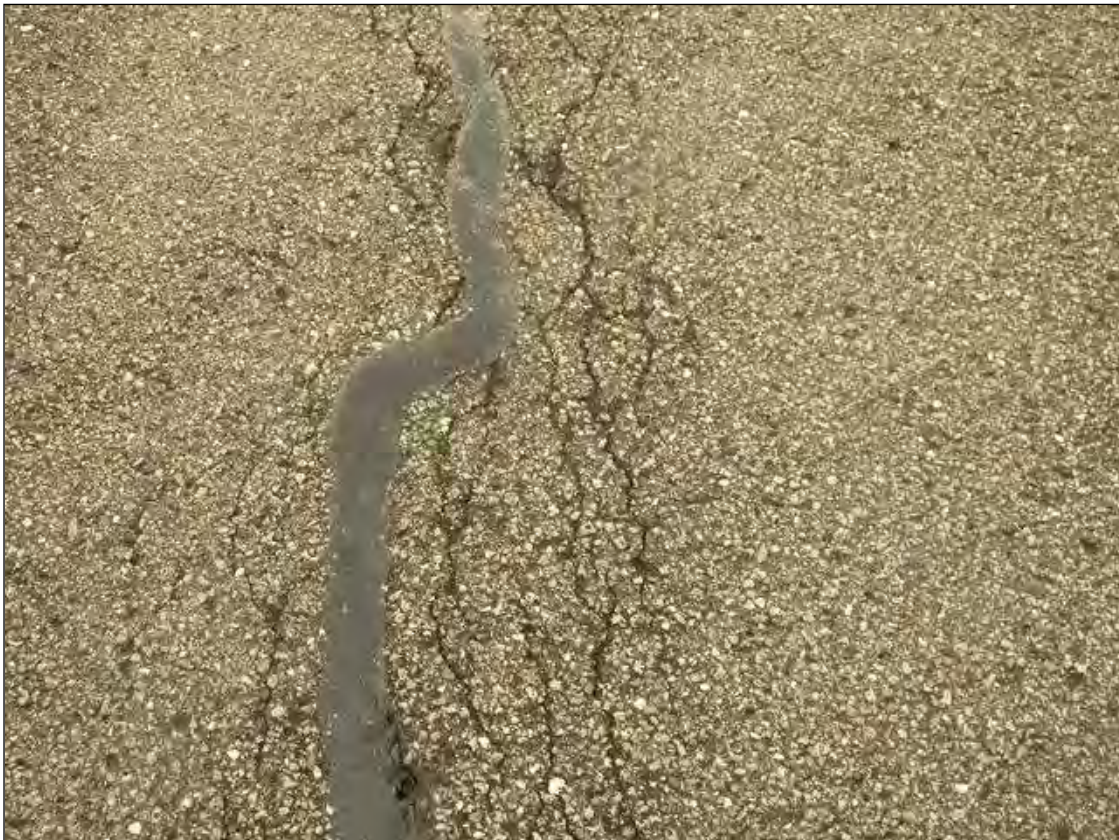
1/8" WIDE LONGITUDINAL CRACKS IN SPAN 1 ASPHALT WEARING SURFACE, IN BOTH LANES, ALL SPANS ARE SIMILAR

| MMS Code | Description of Function | Unit | Quantity | Remarks | Est. Cost |
|---|---|---|---|---|---|
| 2816 | Asphalt Surface Repair or Replacement | SY | 4 | 1/8" WIDE LONGITUDINAL CRACKS IN SPAN 1 ASPHALT WEARING SURFACE , IN BOTH LANES, ALL SPANS ARE SIMILAR | |

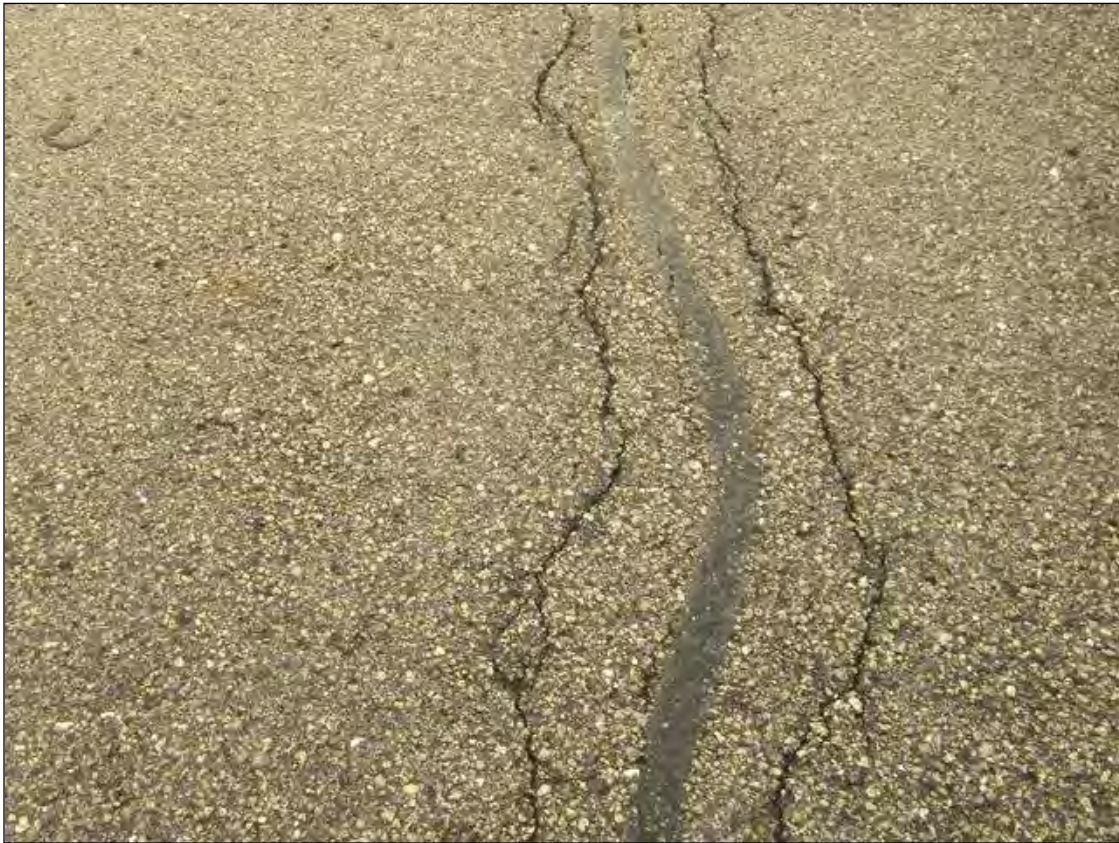
LONGITUDINAL CRACKS IN SPAN 1 EAST BOUND LANE

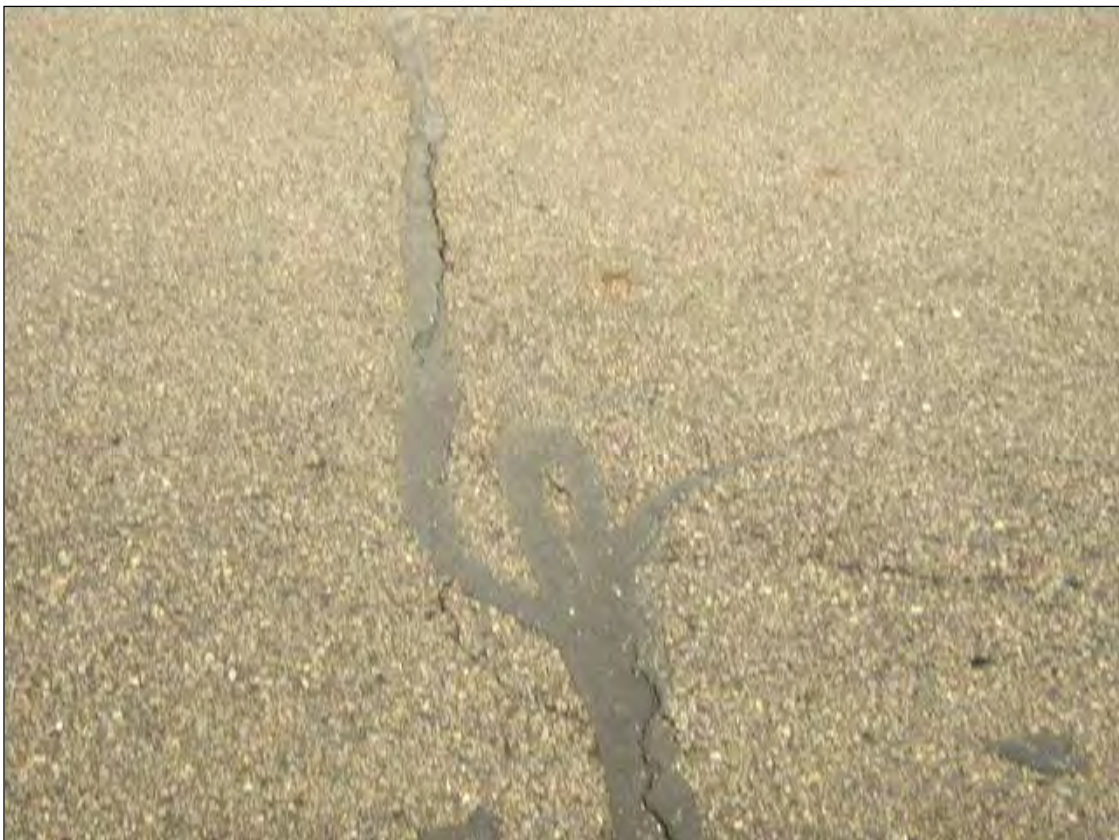
SEALED TRANSVERSE CRACK IN ASPHALT WEARING SURFACE OVER BENT 1 JOINT

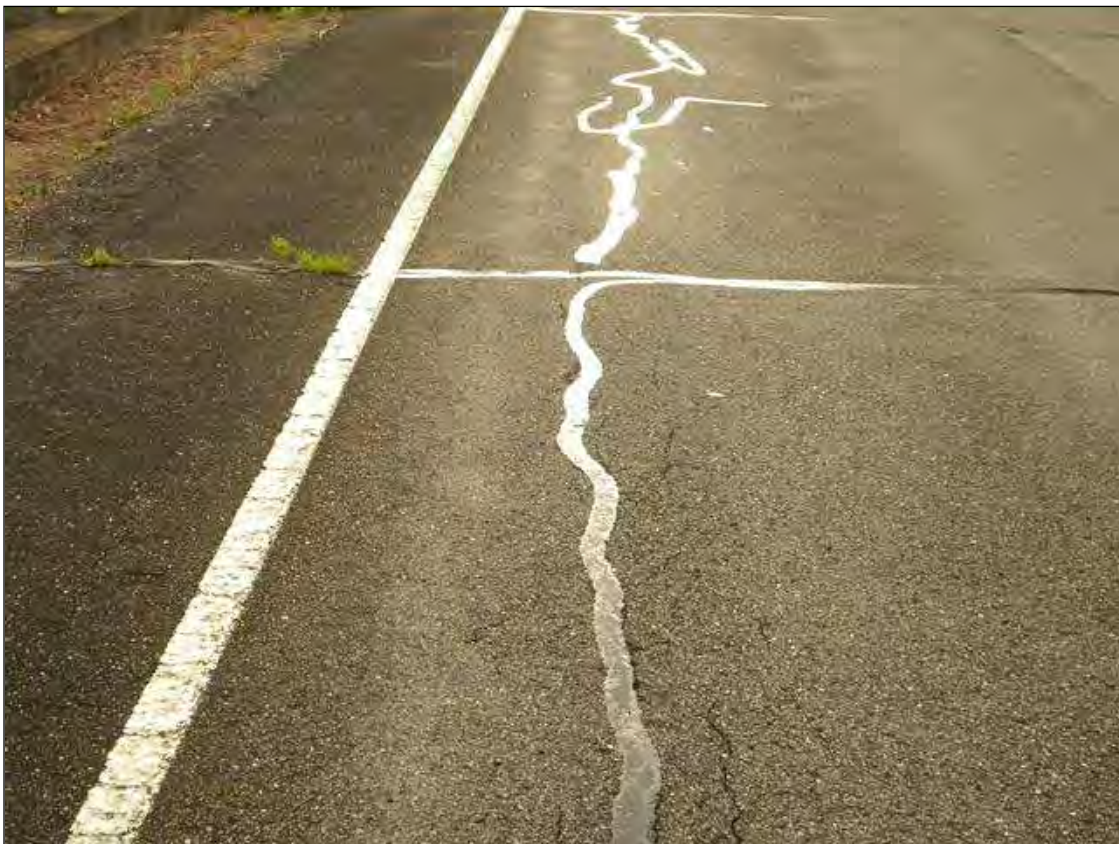
SEALED LONGITUDINAL CRACKS IN SPANS 2 AND 3

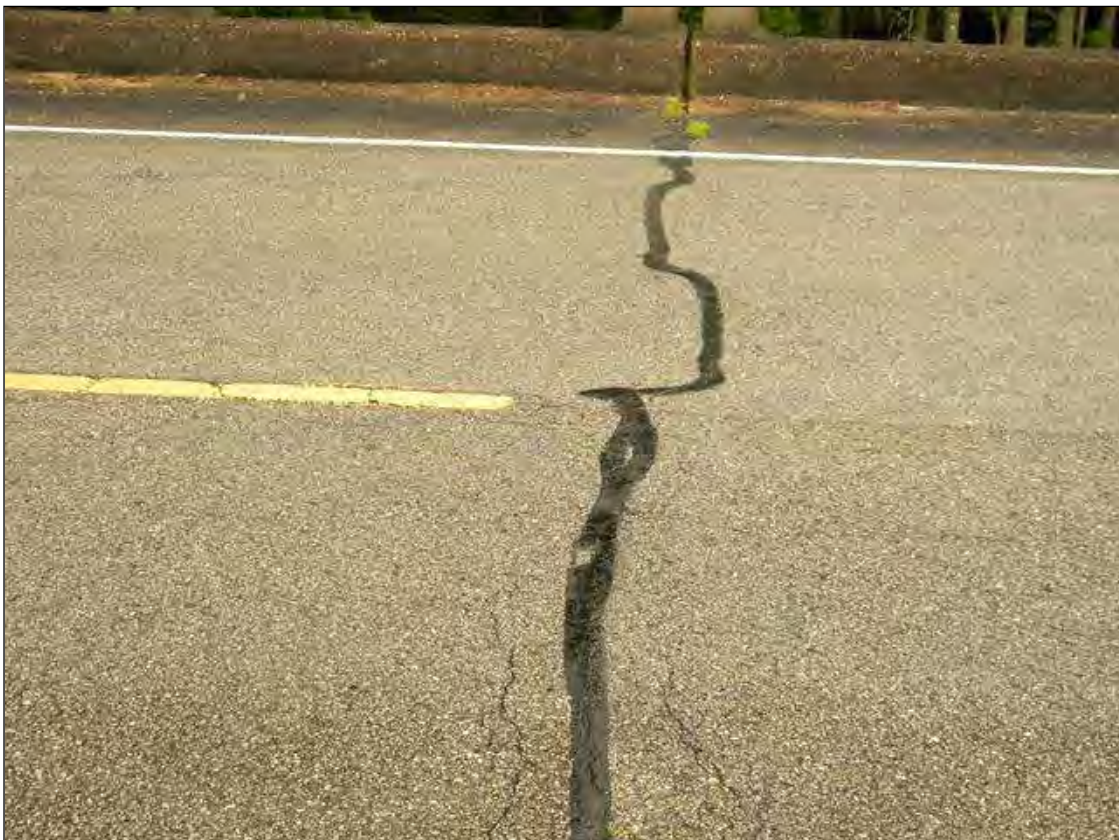
SEALED TRANSVERSE CRACK IN ASPHALT WEARING SURFACE OVER BENT 2 JOINT

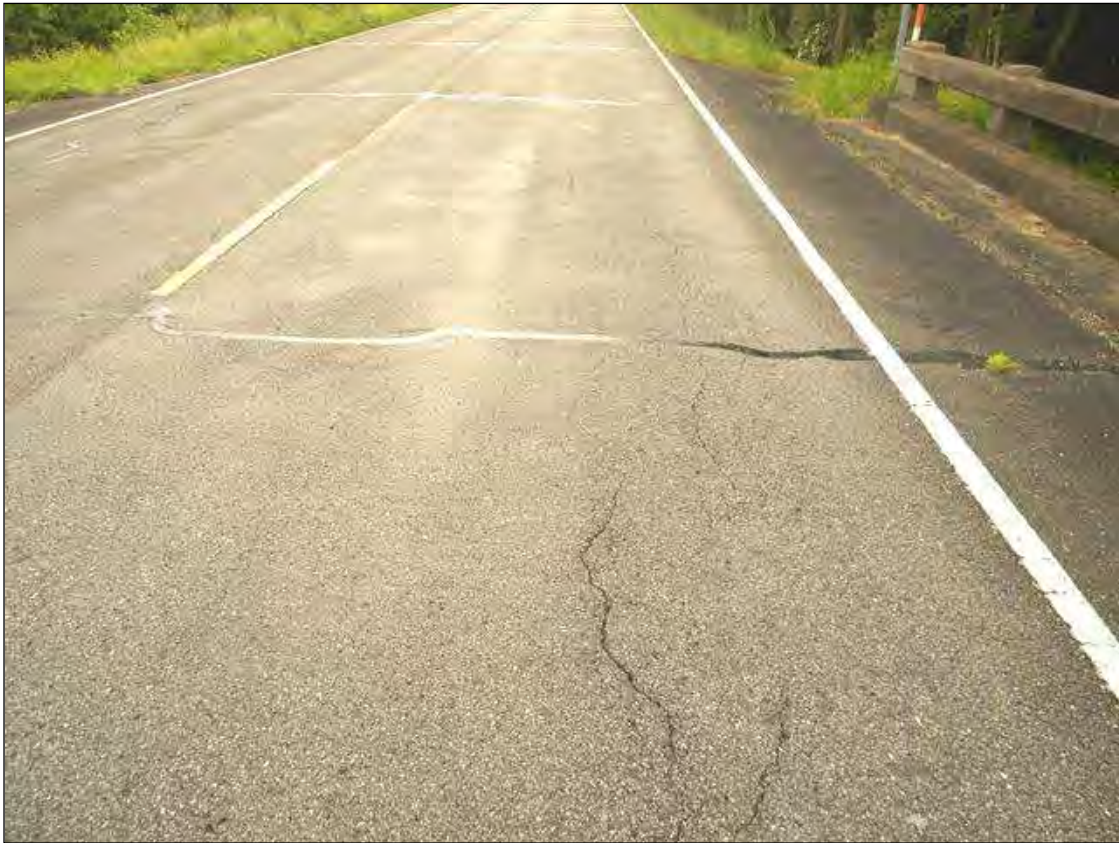
1/16" TO 1/8" LONGITUDINAL CRACKS IN SPANS 2 AND 3 IN THE EAST BOUND LANE

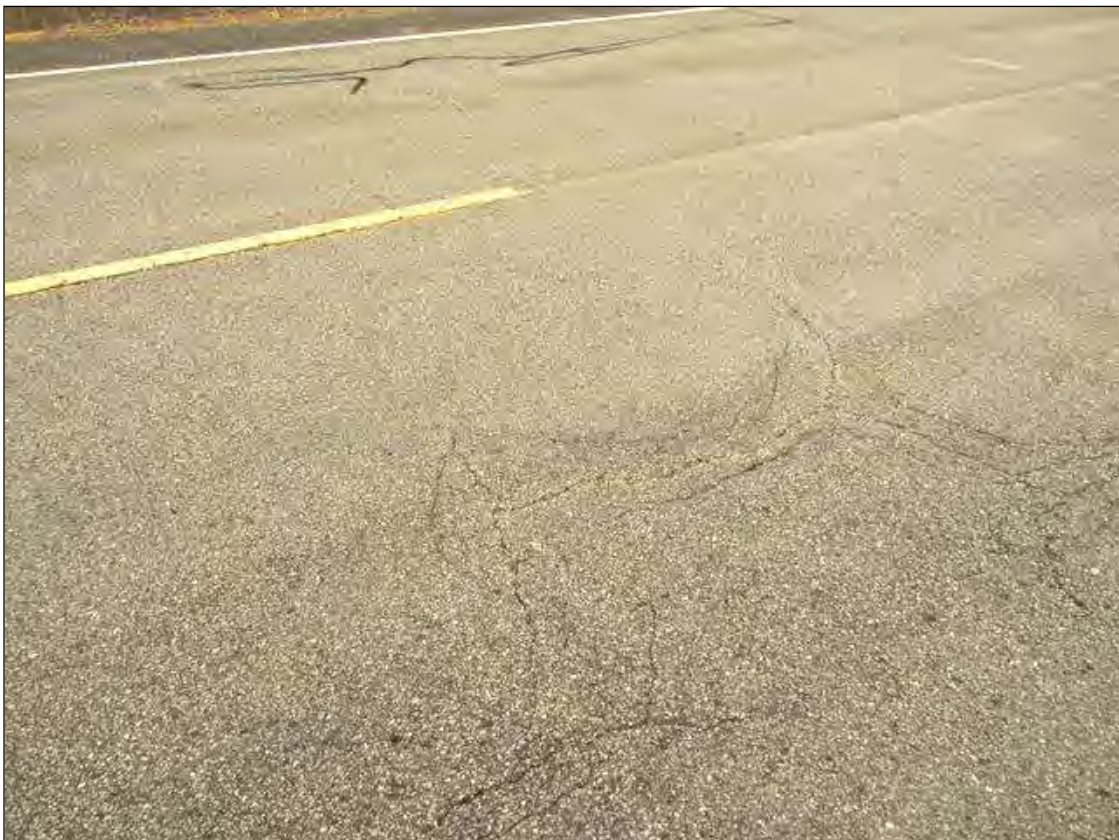
1/8" MAP CRACKING IN SPAN 3 EAST BOUND LANE

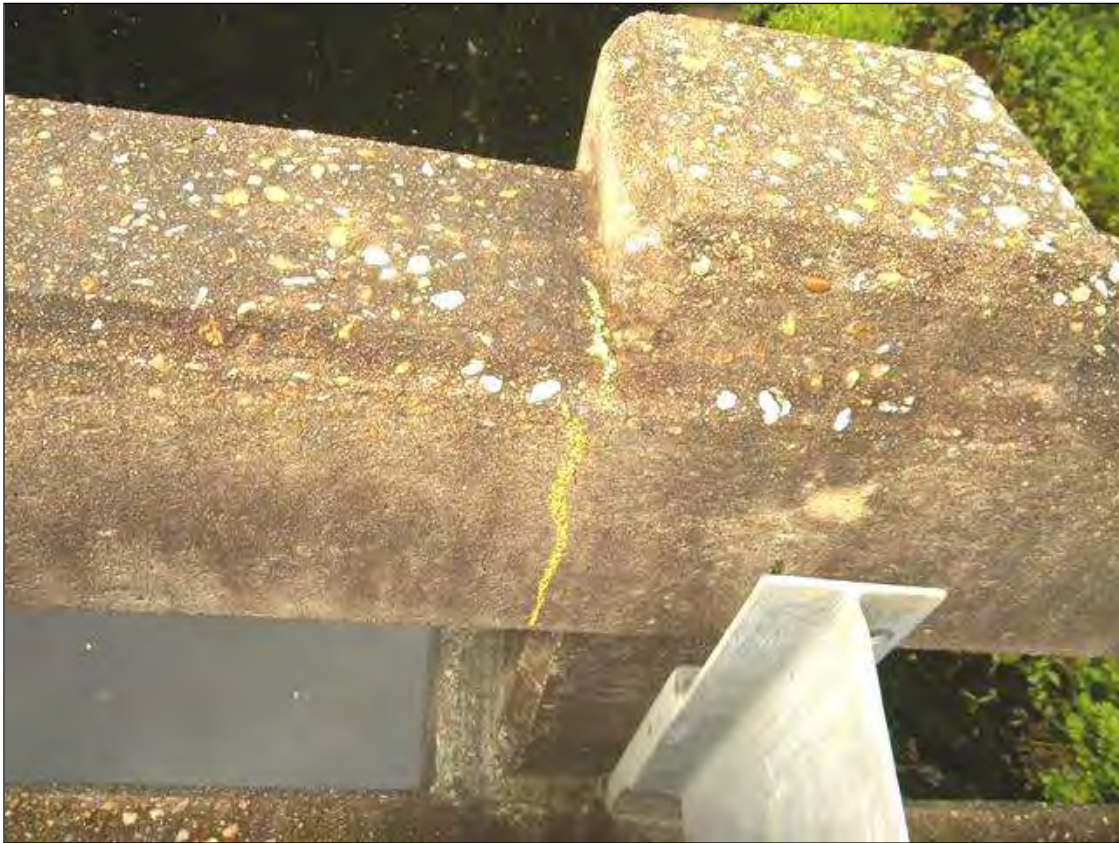
| Bridge I&A Form 1(82)H<br>State of North Carolina<br>Dept. of Transportation<br>Division of Highways | | <h1>FIELD INSPECTION REPORT</h1> <p><u>Bridge Inspection &amp; Analysis</u></p> | |
|---|---|---|--|
| 3a | G | ( RC RAILS ) THERE IS A HAIRLINE TRANSVERSE CRACK IN RIGHT RAIL BAR IN SPAN 1 AT POST 3. (PHOTO) | |

HAIRLINE TRANSVERSE CRACK IN RIGHT RAIL BAR IN SPAN 1 AT POST 3

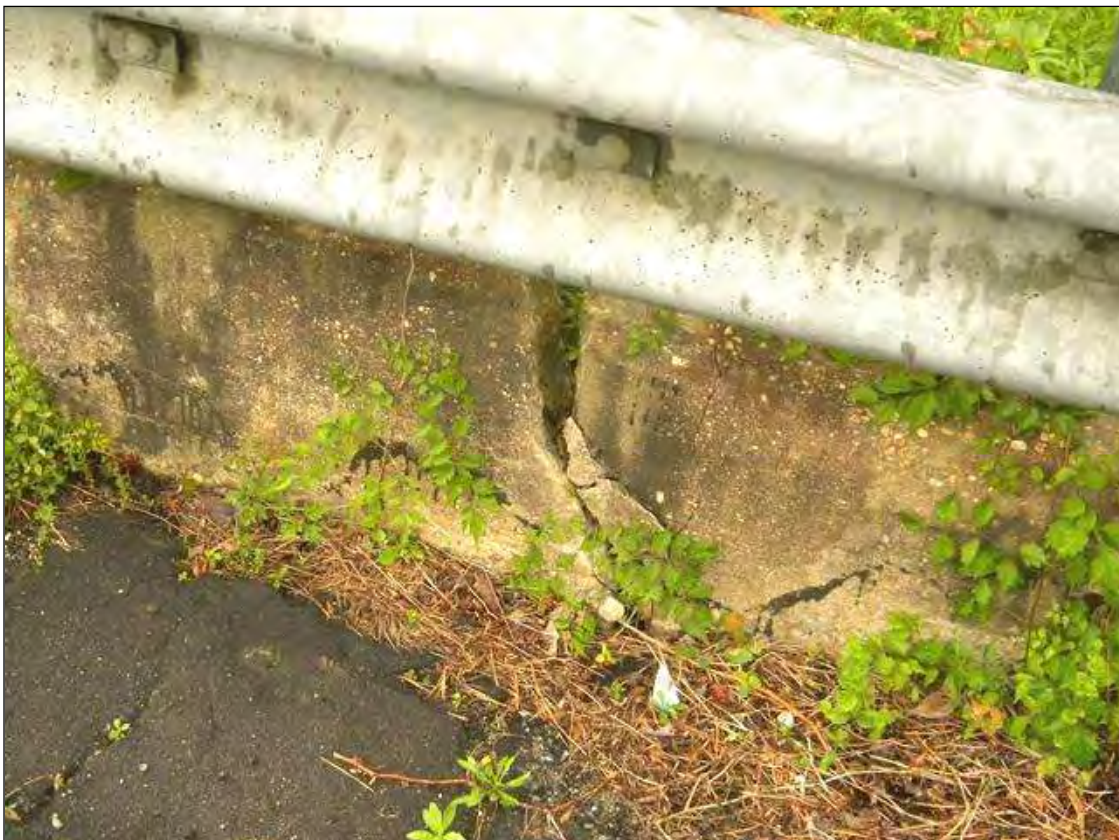
SOUTHWEST CORNER APPROACH CURB CRACKED, SIMILAR AT NORTHWEST CORNER

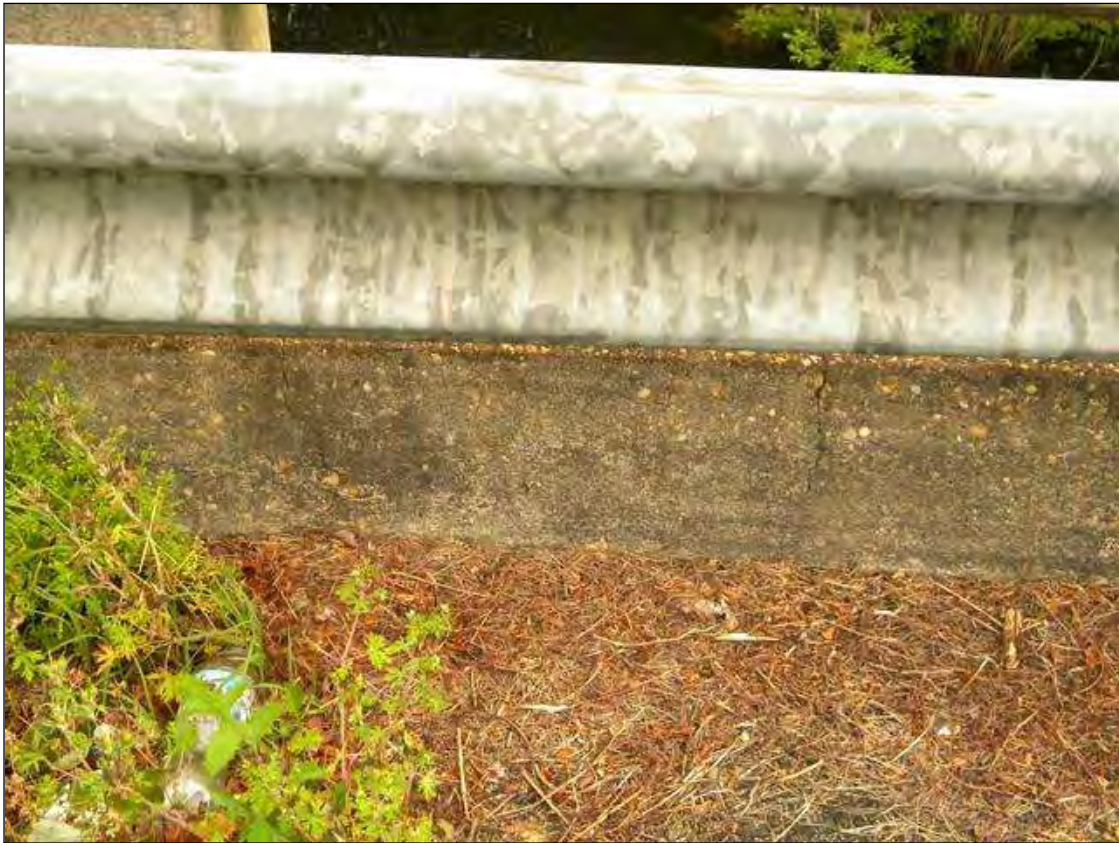
LEFT CURB HAS HAIRLINE VERTICAL CRACKS IN SPAN 1 UNDER GUARDRAIL

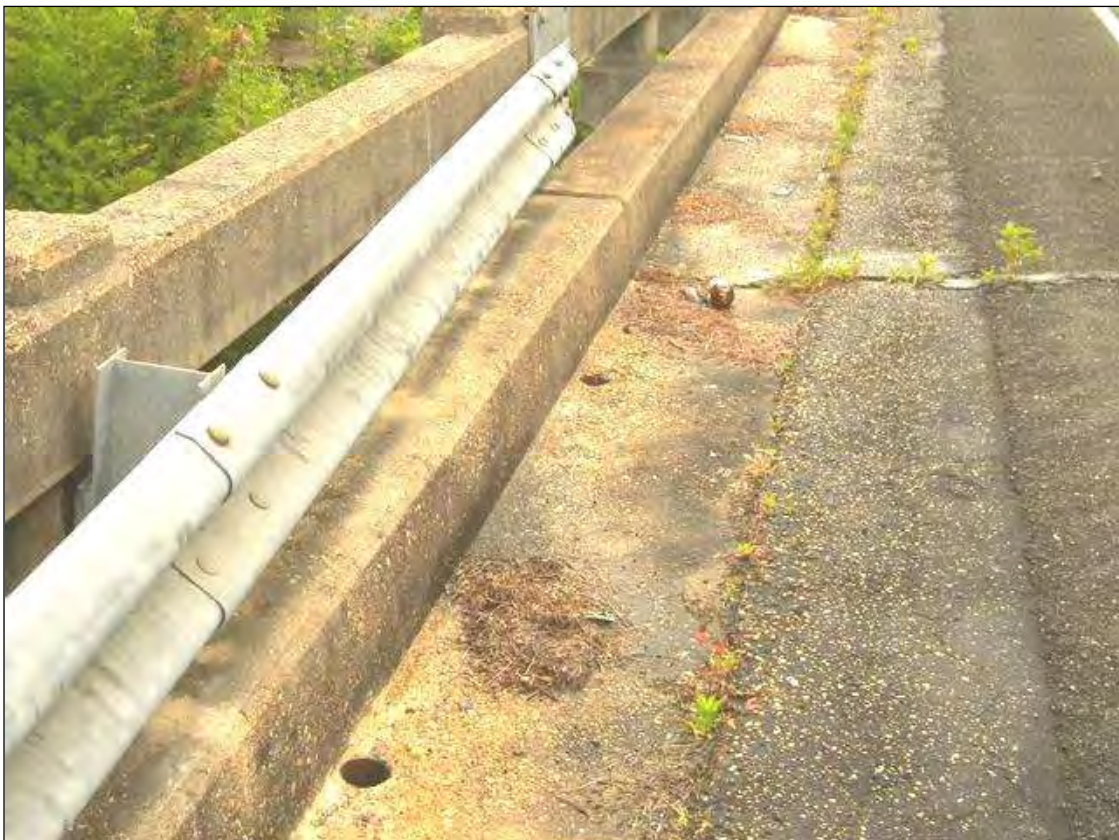
| Bridge I&A Form 1(82)H<br>State of North Carolina<br>Dept. of Transportation<br>Division of Highways | | <h1>FIELD INSPECTION REPORT</h1> <p><u>Bridge Inspection &amp; Analysis</u></p> | |
|---|---|---|--|
| 7 | G | ( DECK DEBRIS ) THERE IS SCATTERED DEBRIS AND VEGETATION ALONG BOTH CURBS. (PHOTO) | |

SCATTERED DEBRIS ALONG BOTH CURBS

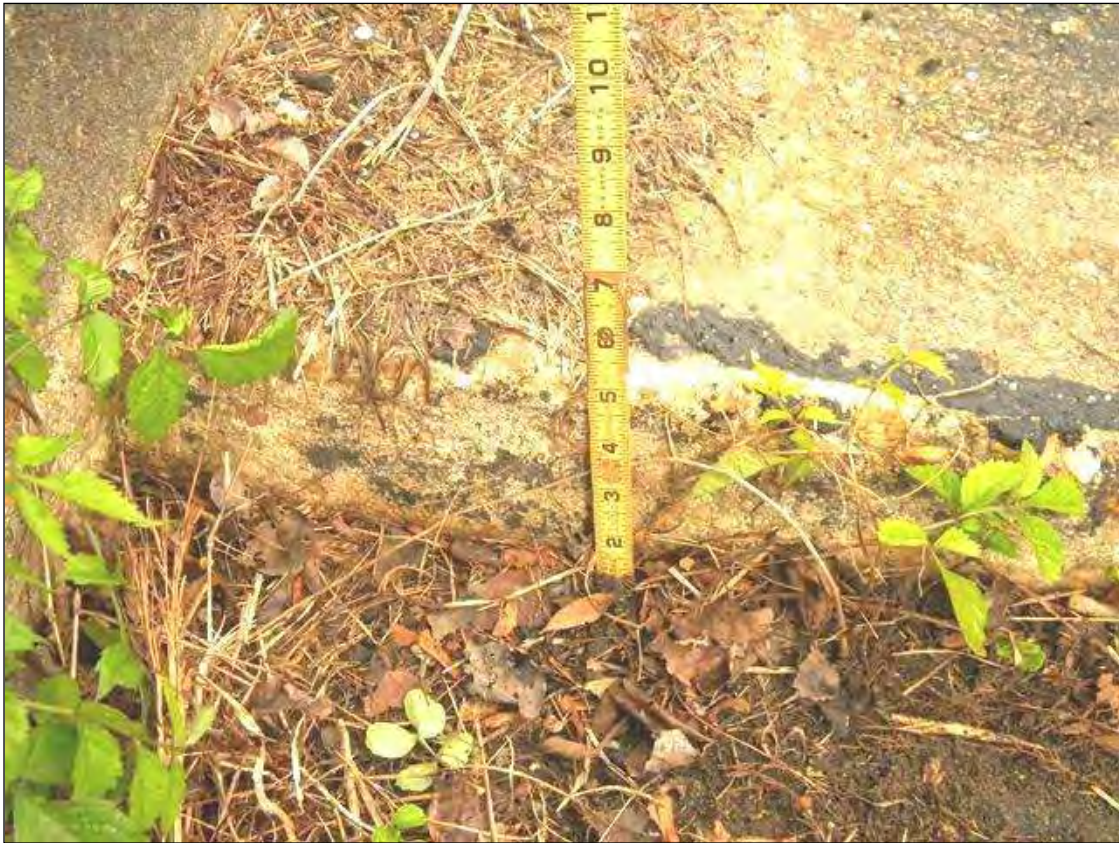
EAST APPROACH RIGHT SHOULDER IS SETTLED 5"

| MMS Code | Description of Function | Unit | Quantity | Remarks | Est. Cost |
|---|---|---|---|---|---|
| 2816 | Asphalt Surface Repair or Replacement | SY | 2 | EAST APPROACH RIGHT SHOULDER IS SETTLED 5" | |

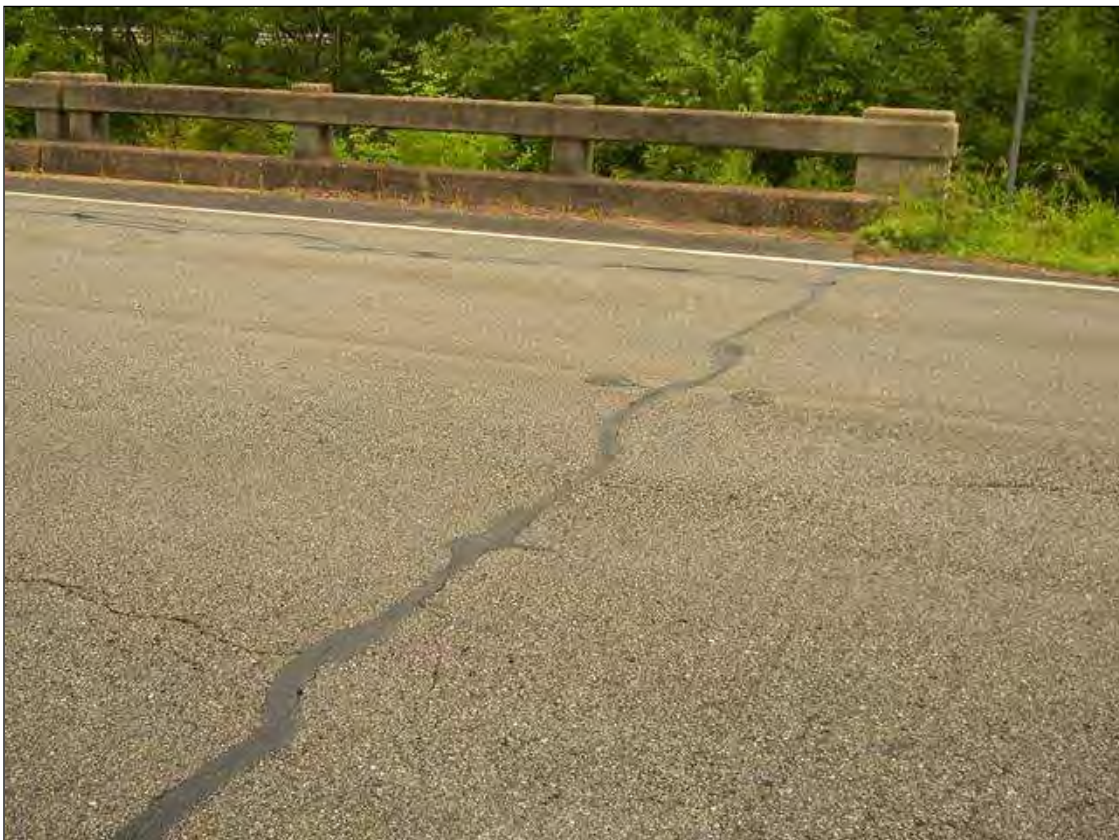
SEALED CRACKING IN THE EAST APPROACH ASPHALT WEARING SURFACE

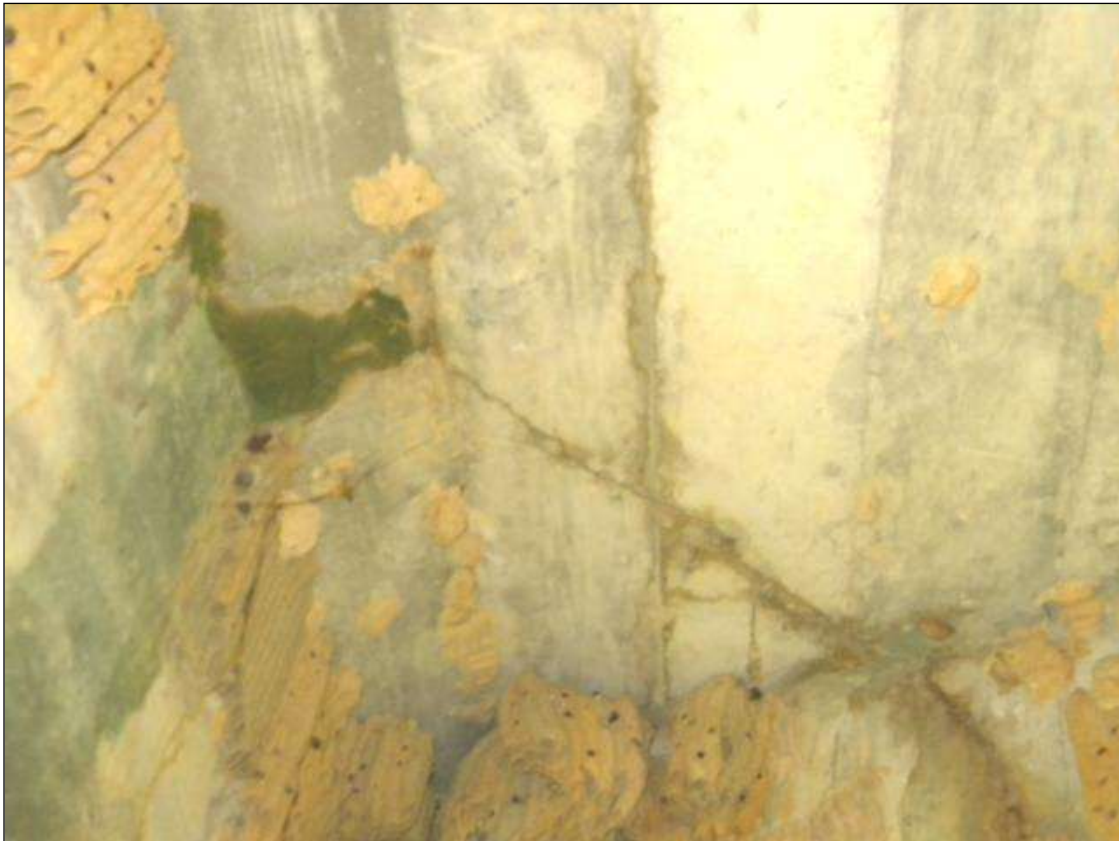
| Bridge I&A Form 1(82)H<br>State of North Carolina<br>Dept. of Transportation<br>Division of Highways | | <h1>FIELD INSPECTION REPORT</h1> <p><u>Bridge Inspection &amp; Analysis</u></p> | |
|---|---|---|--|
| 2a | F | ( RC DECK ) THE DECK UNDERSIDE HAS AREAS OF EFFLORESCENCE.<br><br>THERE IS A HAIRLINE DIAGONAL CRACK IN DECK UNDERSIDE AT SPAN 1, BAY 5 AT ABUTMENT 1. (PHOTO) | |

HAIRLINE DIAGONAL CRACK IN SPAN 1 UNDERSIDE IN BAY 5 AT ABUTMENT 1

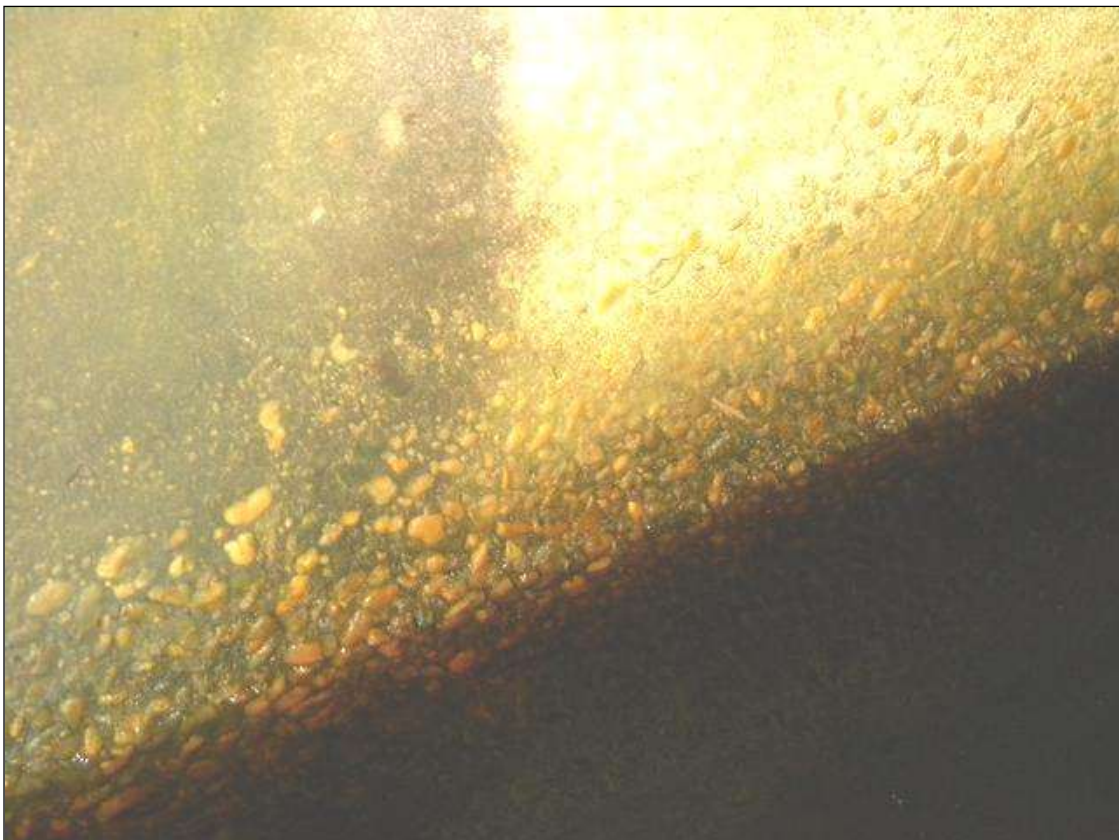
| 36b | G | ( BREAST WALLS ) THERE IS EXPOSED AGGREGATE IN ABUTMENT 1 BREASTWALL. THIS IS SIMILAR AT ABUTMENT 2. (PHOTO) | |

EXPOSED AGGREGATE IN ABUTMENT 1 BREASTWALL, SIMILAR AT ABUTMENT 2

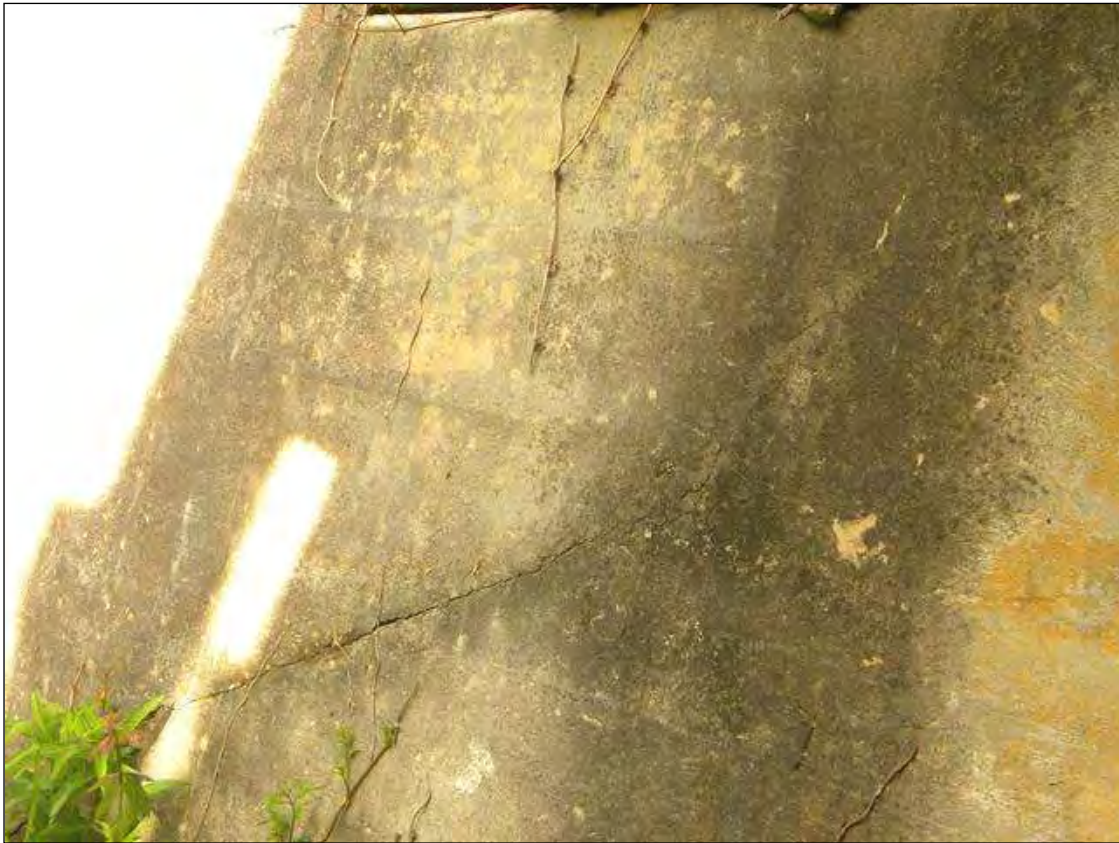
| 36d | F | ( CONC. RETAINING WALLS ) THERE IS A 1/16" DIAGONAL CRACK IN WINGWALL AT SOUTHWEST CORNER. (PHOTO) | |

1/16" DIAGONAL CRACK IN WINGWALL AT SOUTHWEST CORNER
