NC DEPARTMENT OF TRANSPORTATION  
DIVISION OF HIGHWAYS  
BRIDGE MANAGEMENT UNIT

# BRIDGE INSPECTION REPORT

INSPECTION TYPE: Routine Inspection

COUNTY COLUMBUS BRIDGE NUMBER 230068 INSPECTION CYCLE 2 YRS  
ROUTE NC214 ACROSS GREEN SWAMP M.P. 0

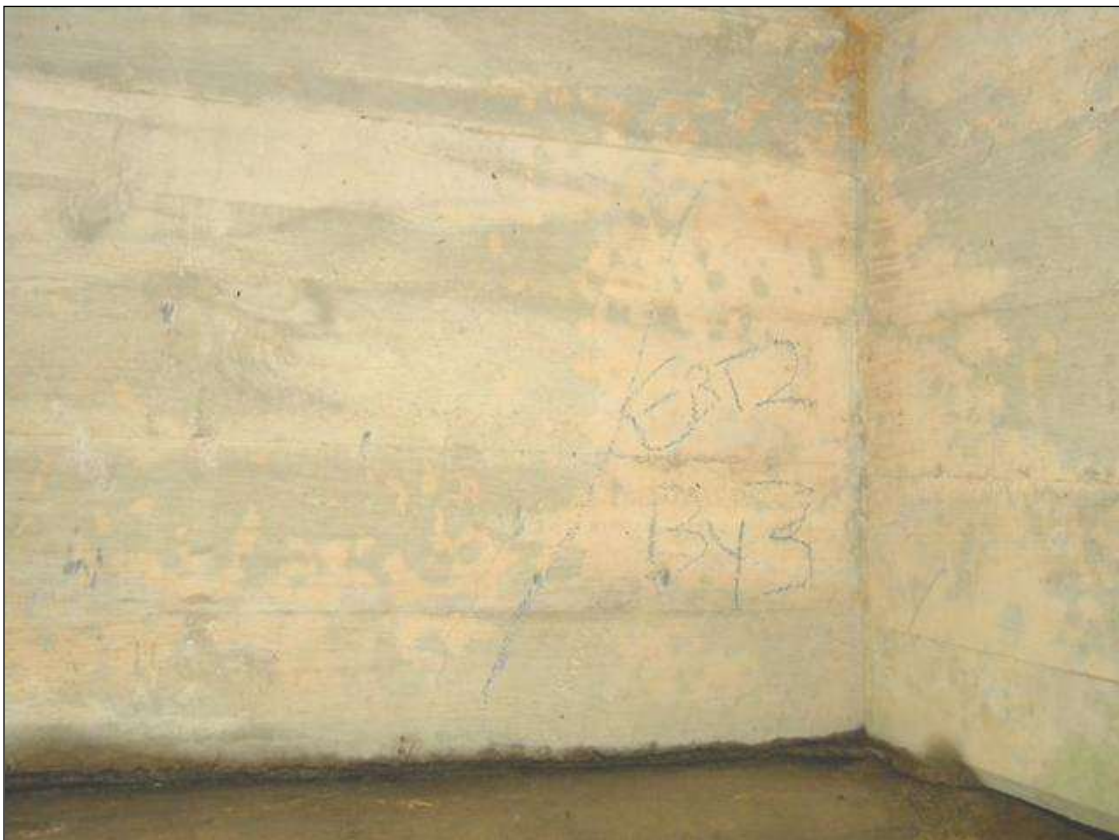
| | | THE ABUTMENT 2 CURTAIN WALL HAS A HAIRLINE VERTICAL CRACK IN BAY 3. (PHOTO) | |

HAIRLINE VERTICAL CRACK IN ABUTMENT 2 CURTAIN WALL AT BAY 3

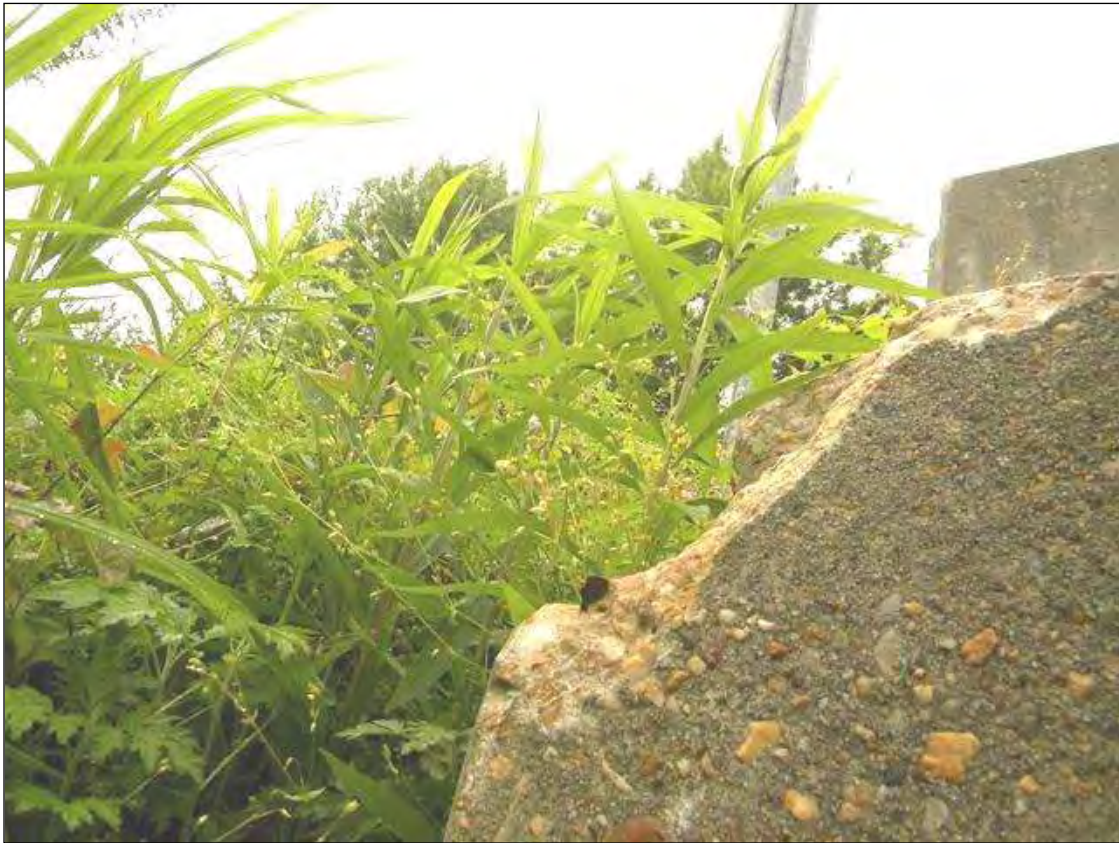
| | | THE NORTHEAST CORNER EXTERIOR CURTAIN WALL IS SPALLED 6" HIGH X 5" WIDE X UP TO 4" DEEP. (PHOTO) | |

NORTHEAST CORNER EXTERIOR CURTAIN WALL SPALLED 6" HIGH X 5" WIDE X UP TO 4" DEEP

| MMS Code | Description of Function | Unit | Quantity | Remarks | Est. Cost |
|---|---|---|---|---|---|
| 3348 | Maintain Concrete Substructure Components | LF | 1 | NORTHEAST CORNER EXTERIOR CURTAIN WALL SPALLED 6" HIGH X 5" WIDE X UP TO 4" DEEP | |
