NC DEPARTMENT OF TRANSPORTATION  
DIVISION OF HIGHWAYS  
STRUCTURE MANAGEMENT UNIT

## Structure Safety Report

### Routine Element Inspection

COUNTY: COLUMBUS STRUCTURE NUMBER: 230068 FREQUENCY: 24 MONTHS

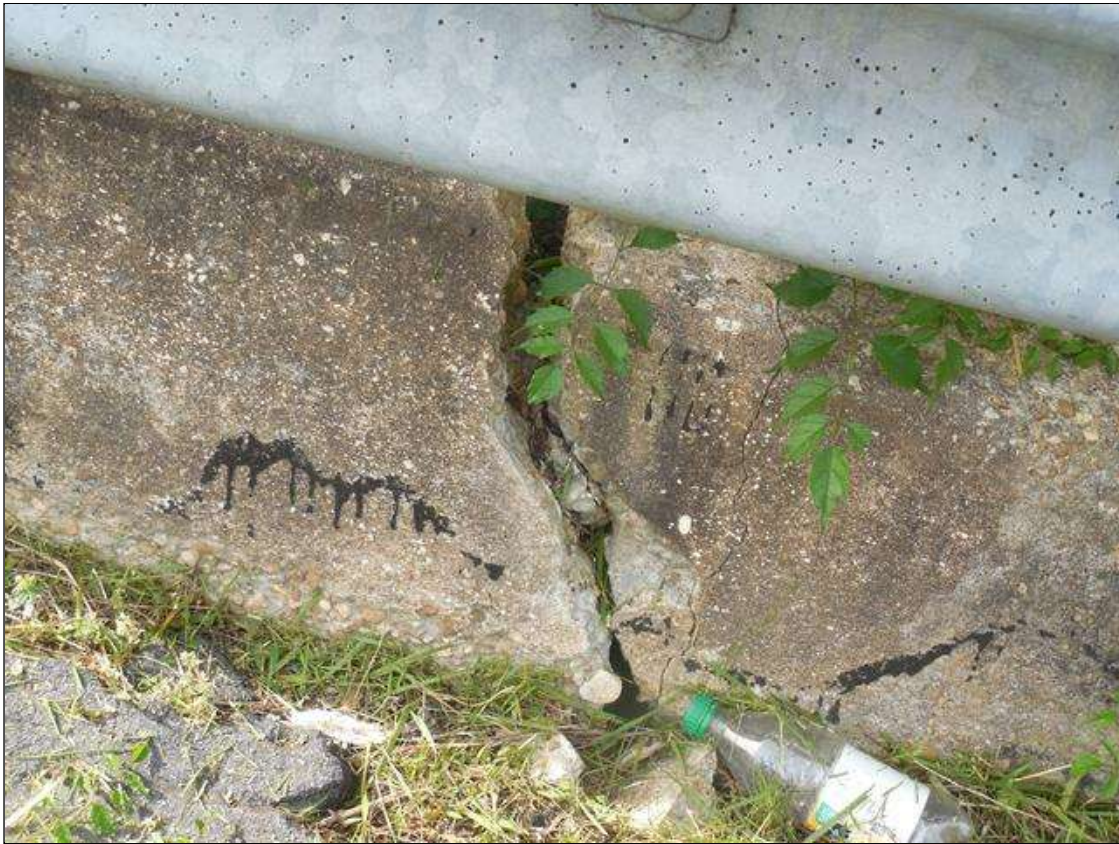
| Details | APPROACH CURB CRACKED AT SOUTHWEST CORNER 2FT. MAINTENANCE (PHOTO # 7243 ) | | | |

APPROACH CURB CRACKED AT SOUTHWEST CORNER 2FT. MAINTENANCE (PHOTO # 7243 )

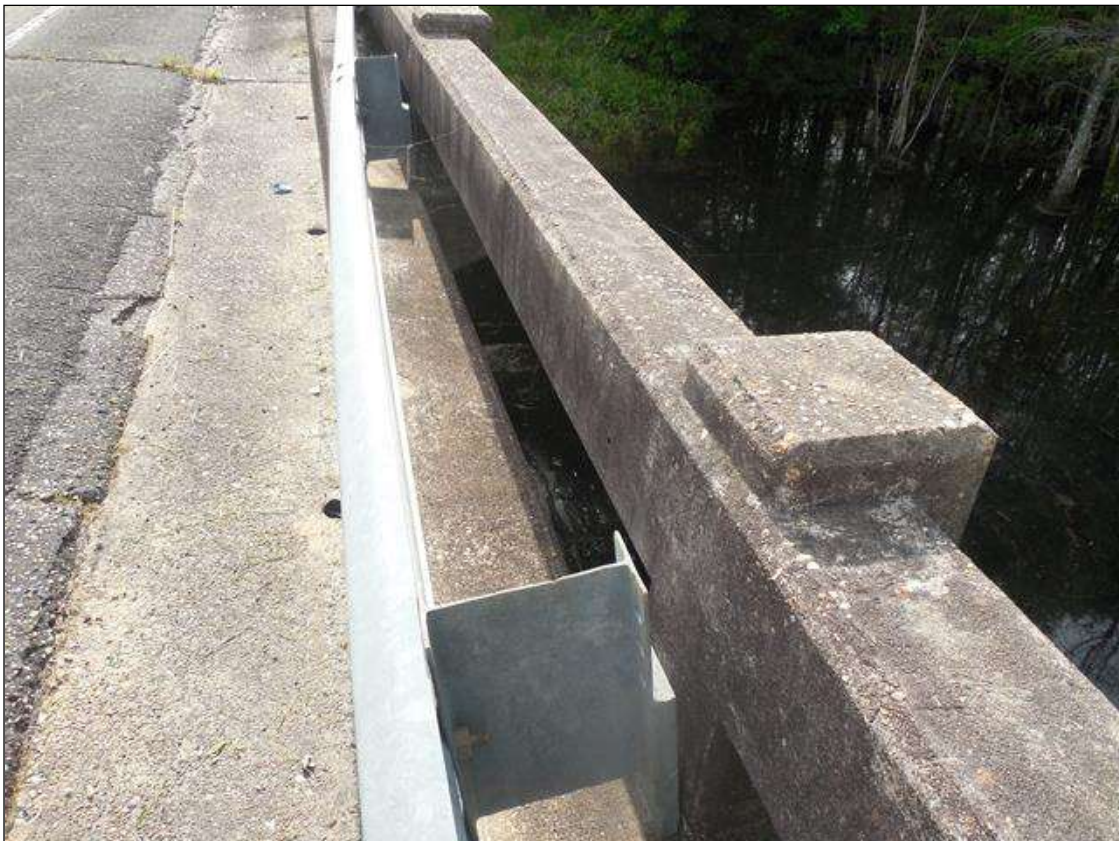
GUARDRAIL SPACERS IN SOUTHWEST CORNER NOT ATTACHED TO BRIDGE RAIL ( PHOTO # 7244 ) 2 FT. MAINTENANCE

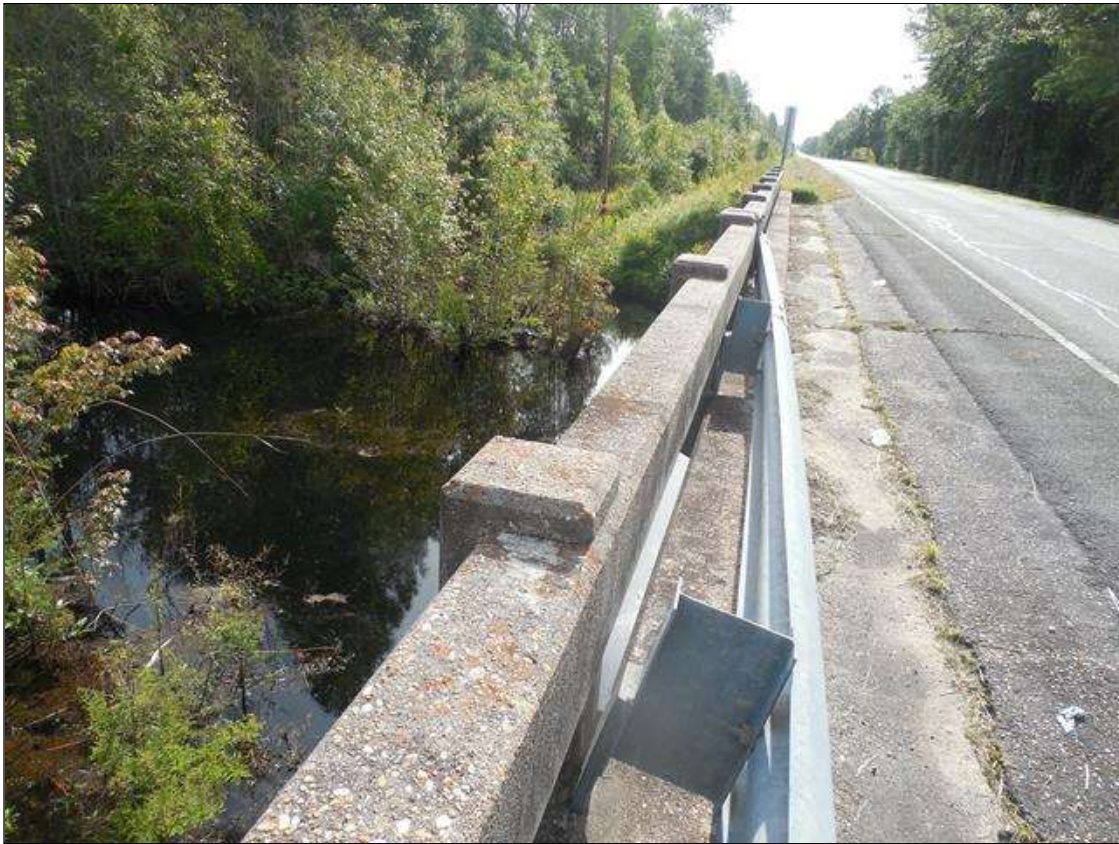
NORTHWEST CORNER GUARDRAIL SPACERS NOT ATTACHED TO BRIDGE RAIL ( PHOTO # 7250 ) 2 FT. MAINTENANCE

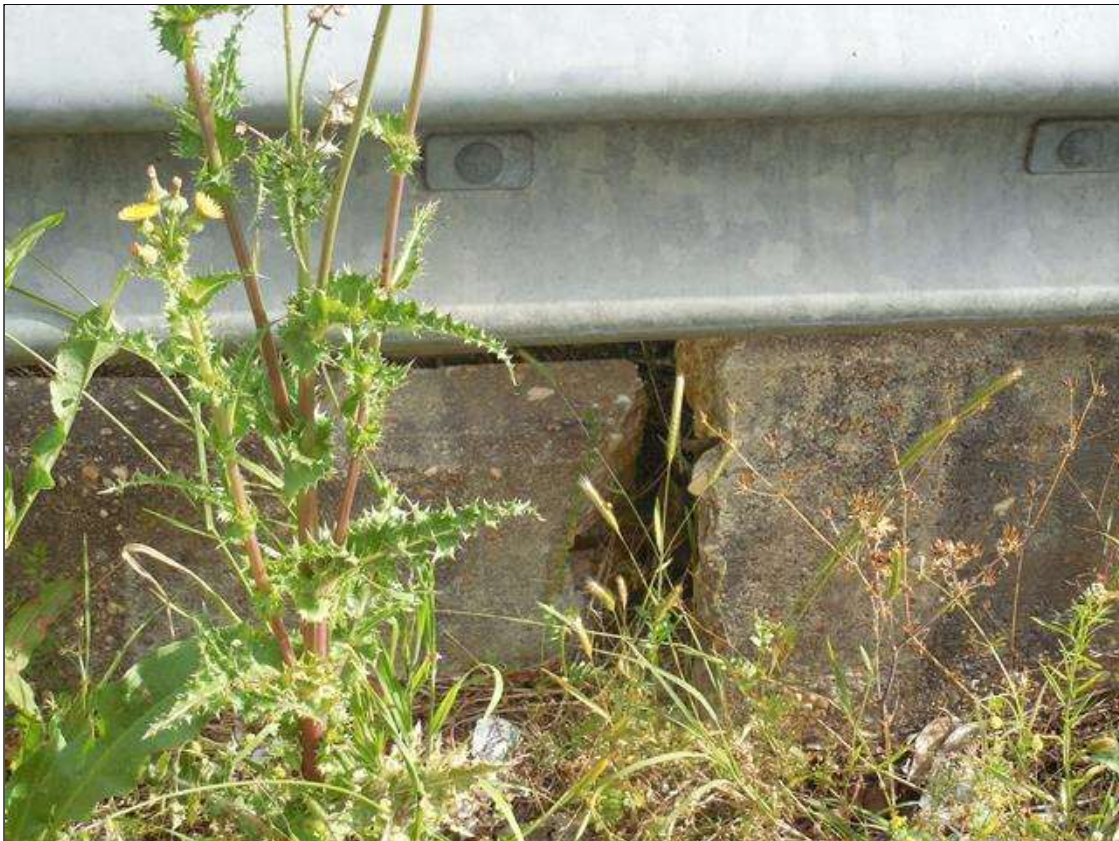
| | NORTHWEST CORNER APPROACH CURB CRACKED , NOT ATTACHED AND MOVED NORTH 6" (PHOTO # 7251 ) MAINTENANCE 10 FT. | | | |

NORTHWEST CORNER APPROACH CURB CRACKED , NOT ATTACHED AND MOVED NORTH 6" (PHOTO # 7251 ) MAINTENANCE 10 FT.

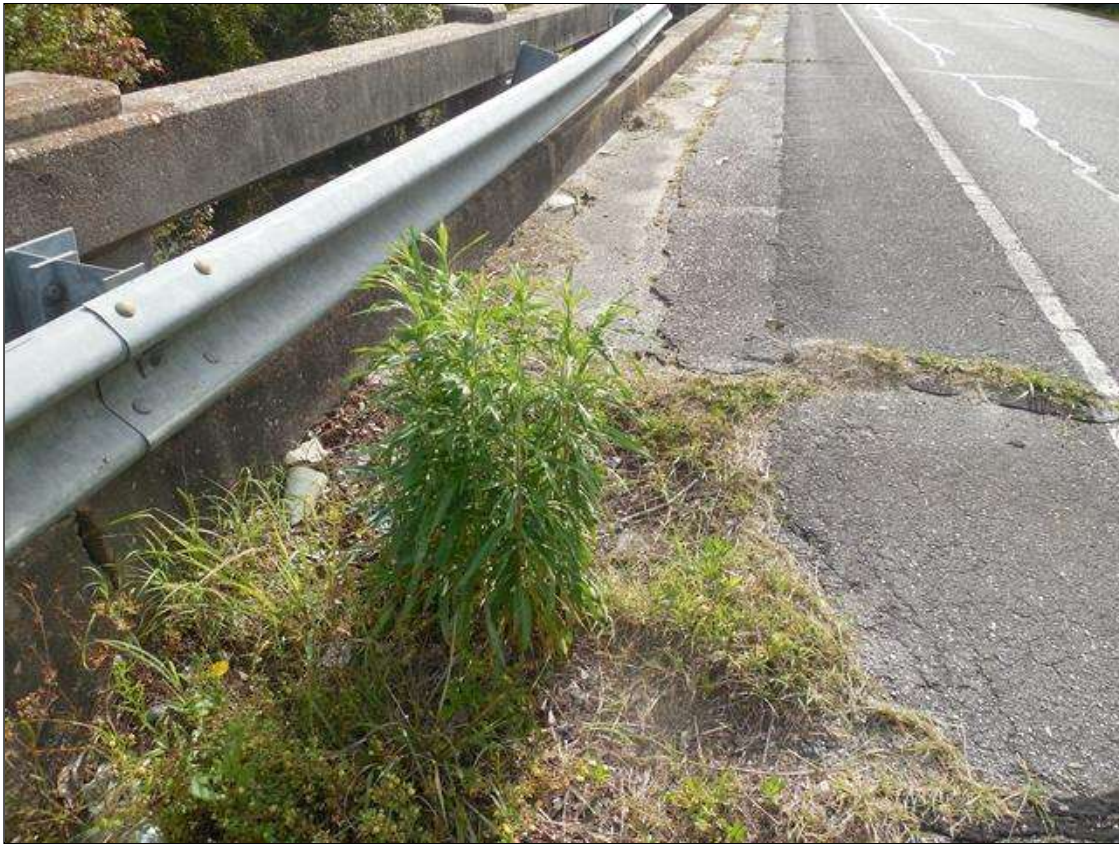
NORTHWEST CORNER APPROACH SETTLED 4" IN LEFT SHOULDER (PHOTO # 7252 ) 9 SQ. FT.  
MAINTENANCE

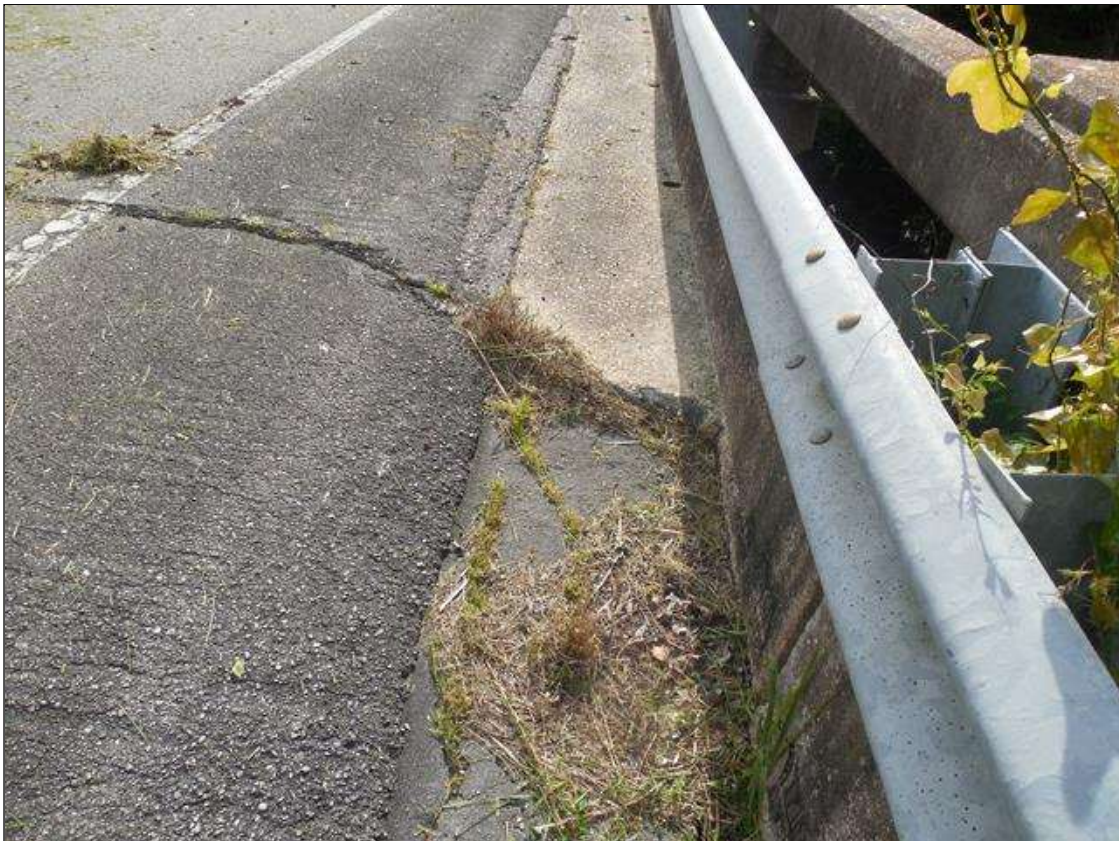
SOUTHWEST CORNER APPROACH SETTLED 4" IN RIGHT SHOULDER ( PHOTO # 7253 ) 9 SQ. FT.  
MAINTENANCE

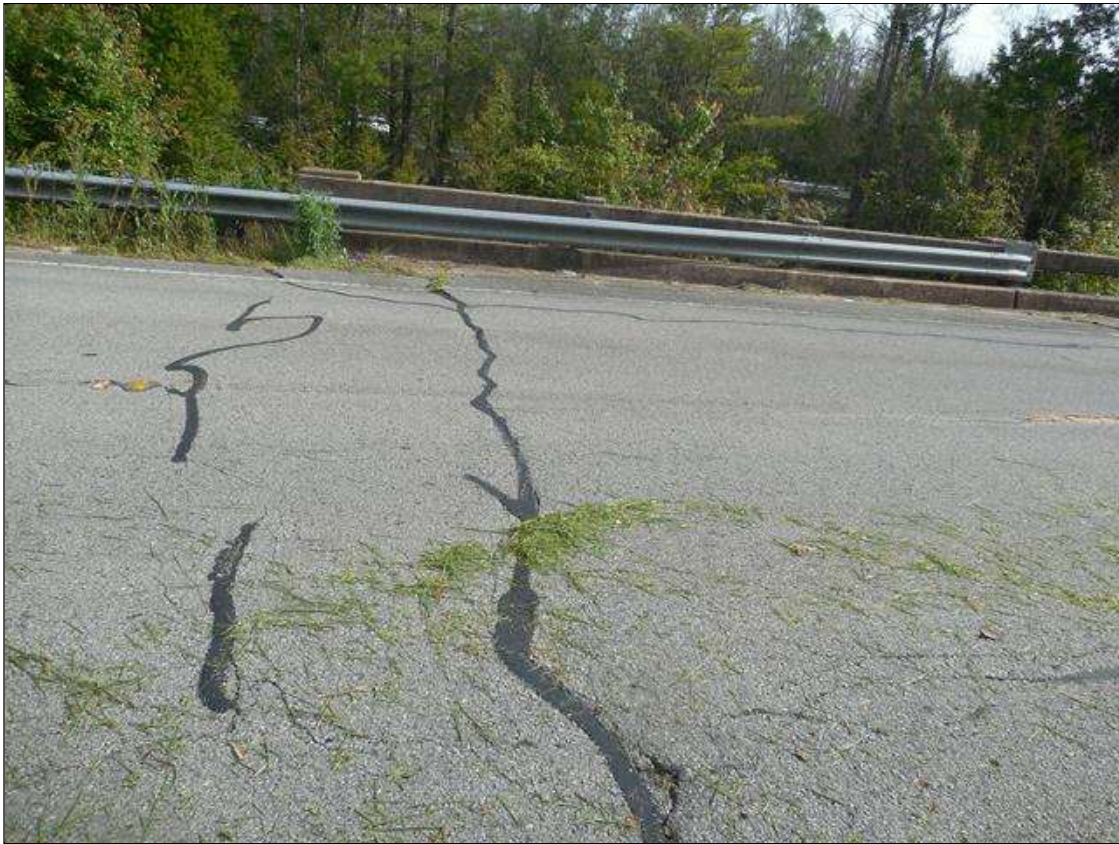
34 Square Feet of Delamination/Spall/Patched Area/Pothole (Wearing Surfaces): Delaminated. Spall less than 1 in. deep or less than 6 in. diameter. Patched area that is sound. Partial depth pothole. SEALED TRANSVERSE CRACK OVER ABUTMENT 1

Span 1 Wearing Surface: 34 Square Feet of Delamination/Spall/Patched Area/Pothole (Wearing Surfaces):  
Delaminated. Spall less than 1 in. deep or less than 6 in. diameter. Patched area that is sound. Partial depth pothole.  
SEALED TRANSVERSE CRACK OVER ABUTMENT 1

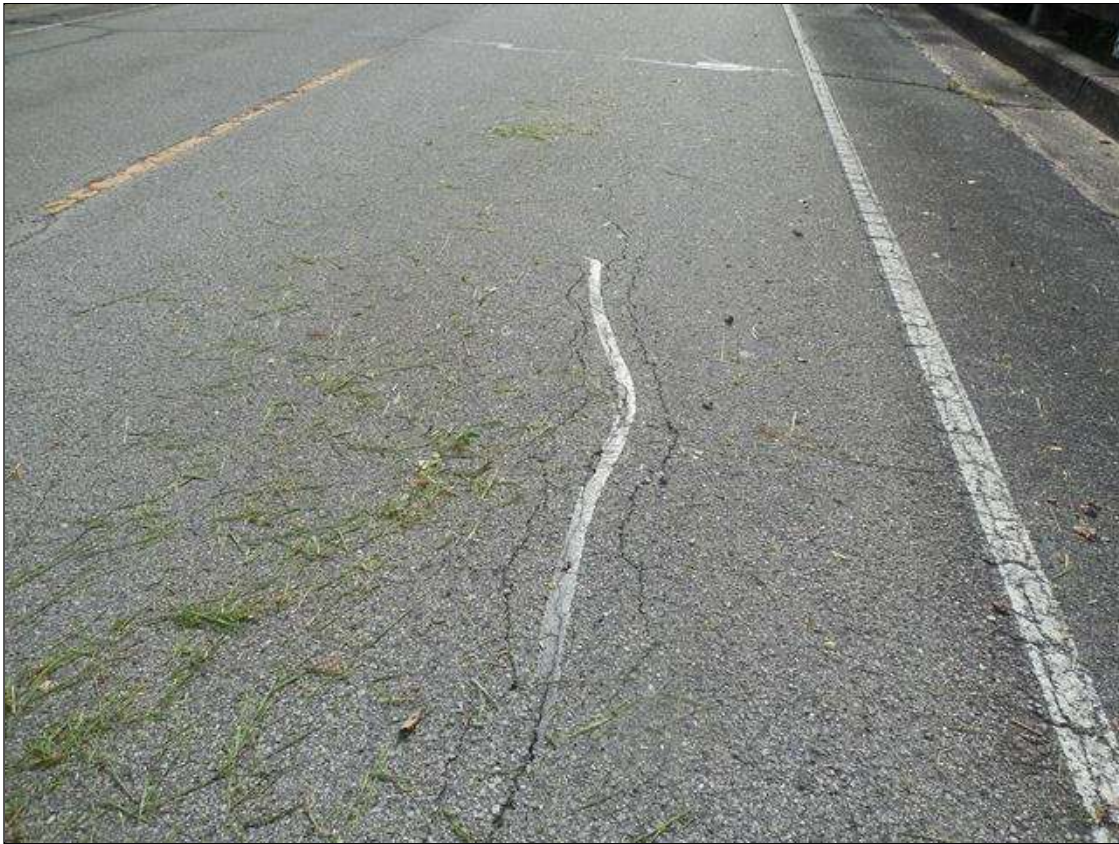
30 Square Feet of Crack (Wearing Surface): Width of more than 0.05 in. or spacing of less than 1.0 ft. 2- 15' LONG X 1/8" WIDE LONGITUDINAL CRACKS IN EAST BOUND LANE

Span 1 Wearing Surface: 30 Square Feet of Crack (Wearing Surface): Width of more than 0.05 in. or spacing of less than 1.0 ft. 2- 15' LONG X 1/8" WIDE LONGITUDINAL CRACKS IN EAST BOUND LANE

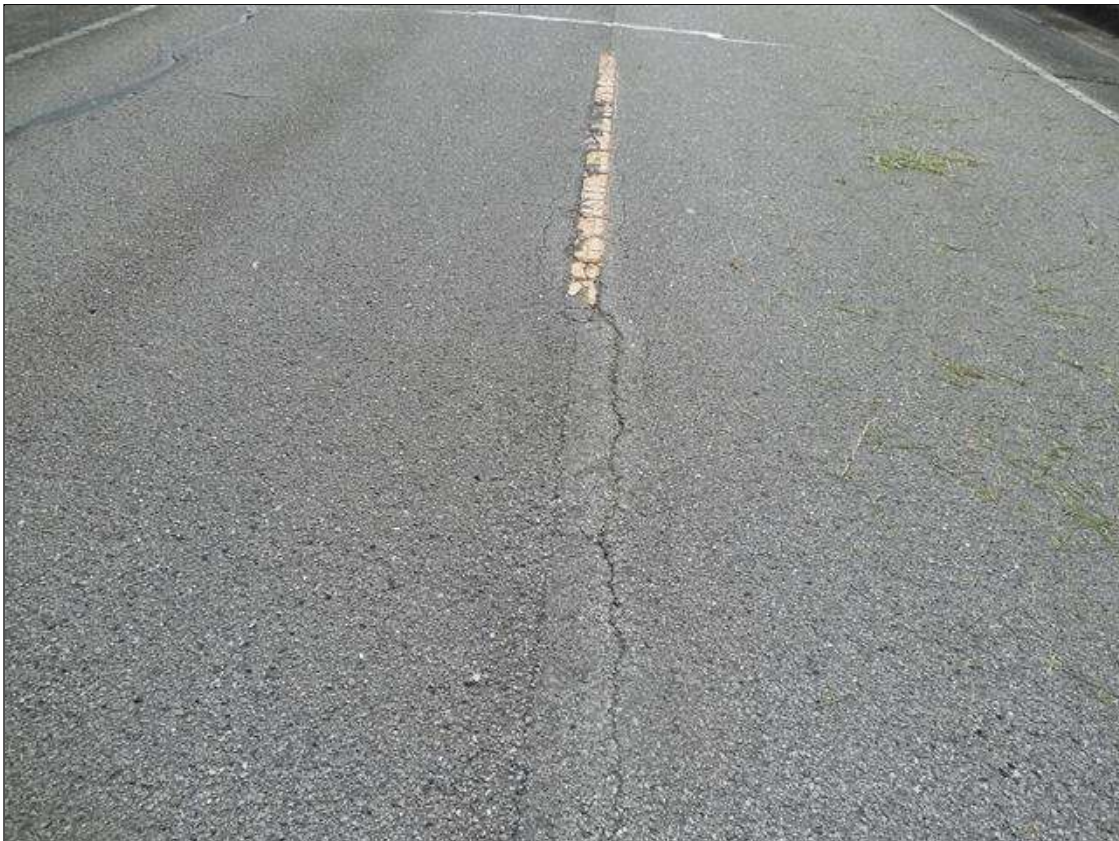
20 Square Feet of Crack (Wearing Surface): Width of more than 0.05 in. or spacing of less than 1.0 ft. 1/4" WIDE LONGITUDINAL CRACK AT CENTERLINE

Span 1 Wearing Surface: 20 Square Feet of Crack (Wearing Surface): Width of more than 0.05 in. or spacing of less than 1.0 ft. 1/4" WIDE LONGITUDINAL CRACK AT CENTERLINE

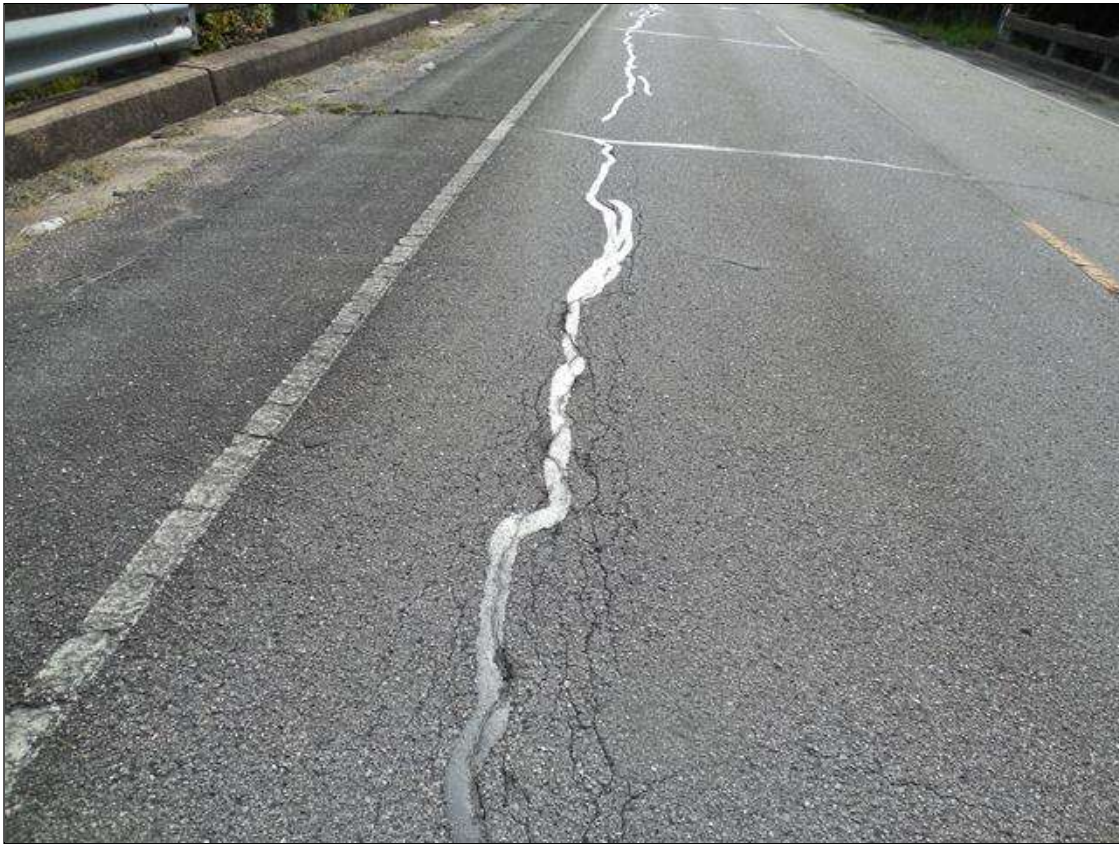
25 Square Feet of Crack (Wearing Surface): Width of more than 0.05 in. or spacing of less than 1.0 ft. 1/8" WIDE LONGITUDINAL CRACK IN WEST BOUND LANE

Span 1 Wearing Surface: 25 Square Feet of Crack (Wearing Surface): Width of more than 0.05 in. or spacing of less than 1.0 ft. 1/8" WIDE LONGITUDINAL CRACK IN WEST BOUND LANE

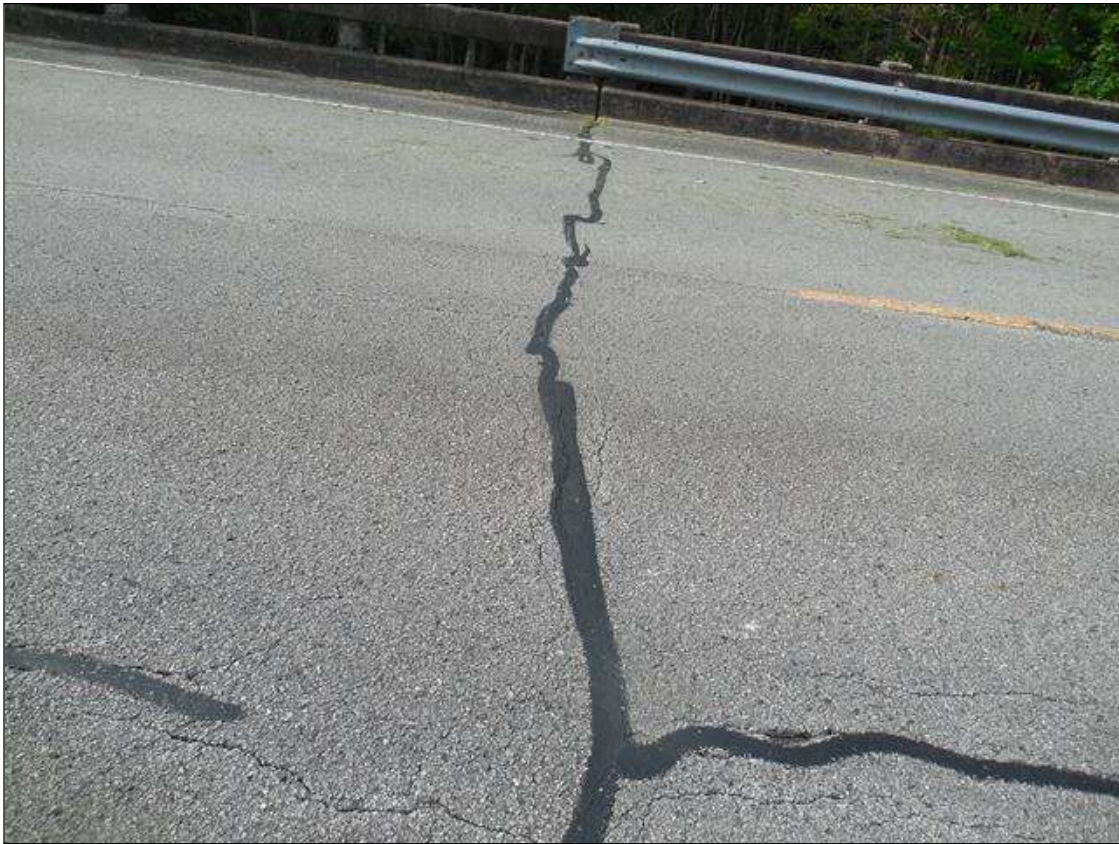
34 Square Feet of Delamination/Spall/Patched Area/Pothole (Wearing Surfaces): Delaminated. Spall less than 1 in. deep or less than 6 in. diameter. Patched area that is sound. Partial depth pothole. SEALED TRANSVERSE CRACK OVER BENT 1

Span 1 Wearing Surface: 34 Square Feet of Delamination/Spall/Patched Area/Pothole (Wearing Surfaces):  
Delaminated. Spall less than 1 in. deep or less than 6 in. diameter. Patched area that is sound. Partial depth pothole.  
SEALED TRANSVERSE CRACK OVER BENT 1

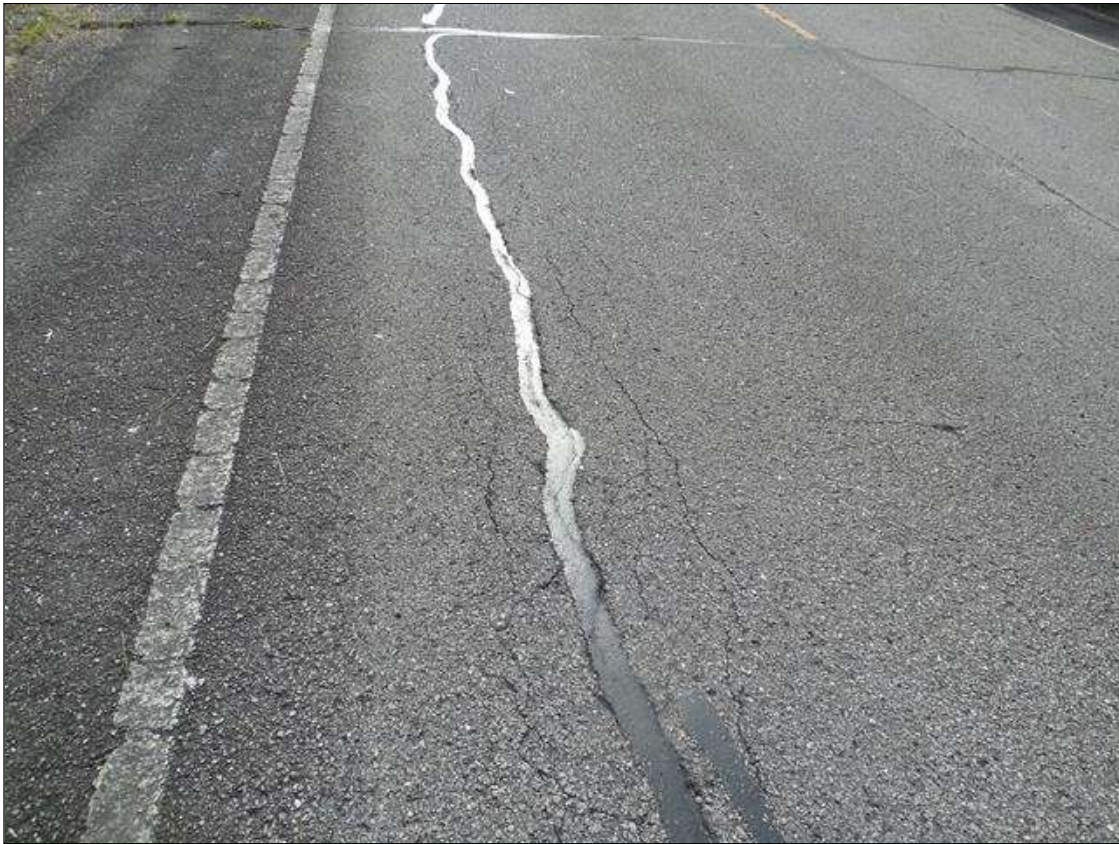
25 Square Feet of Crack (Wearing Surface): Width of more than 0.05 in. or spacing of less than 1.0 ft. 1/8" WIDE LONGITUDINAL CRACK IN WEST BOUND LANE

Span 2 Wearing Surface: 25 Square Feet of Crack (Wearing Surface): Width of more than 0.05 in. or spacing of less than 1.0 ft. 1/8" WIDE LONGITUDINAL CRACK IN WEST BOUND LANE

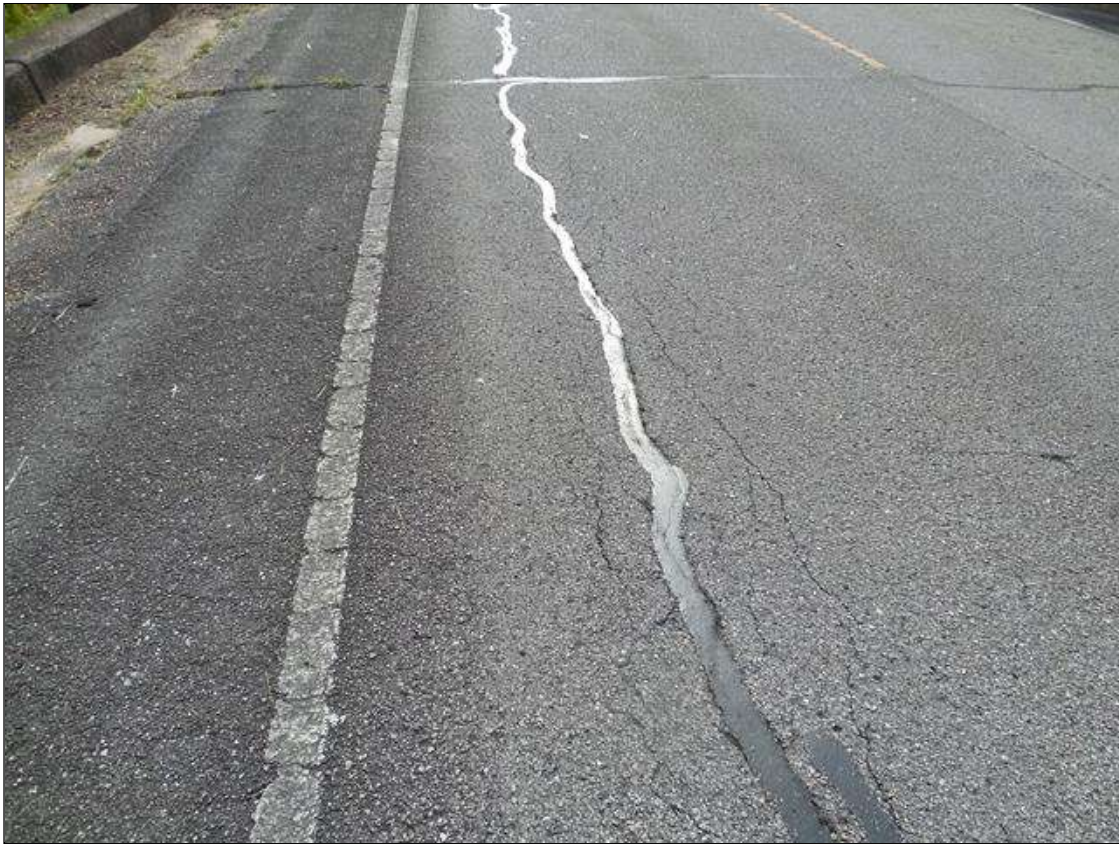
25 Square Feet of Delamination/Spall/Patched Area/Pothole (Wearing Surfaces): Delaminated. Spall less than 1 in. deep or less than 6 in. diameter. Patched area that is sound. Partial depth pothole. SEALED CRACKS IN WEST BOUND LANE

Span 2 Wearing Surface: 25 Square Feet of Delamination/Spall/Patched Area/Pothole (Wearing Surfaces):  
Delaminated. Spall less than 1 in. deep or less than 6 in. diameter. Patched area that is sound. Partial depth pothole.  
SEALED CRACKS IN WEST BOUND LANE

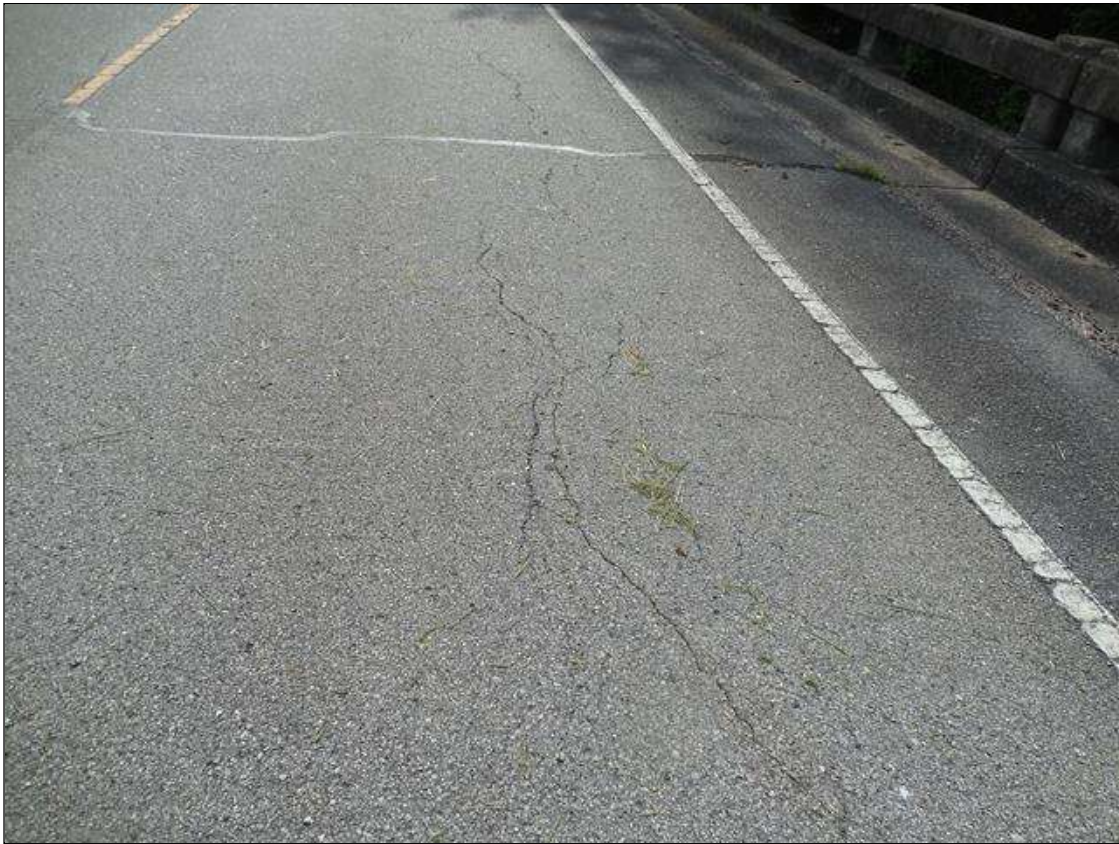
25 Square Feet of Crack (Wearing Surface): Width of more than 0.05 in. or spacing of less than 1.0 ft. 1/8" WIDE LONGITUDINAL CRACK IN EAST BOUND LANE

Span 2 Wearing Surface: 25 Square Feet of Crack (Wearing Surface): Width of more than 0.05 in. or spacing of less than 1.0 ft. 1/8" WIDE LONGITUDINAL CRACK IN EAST BOUND LANE

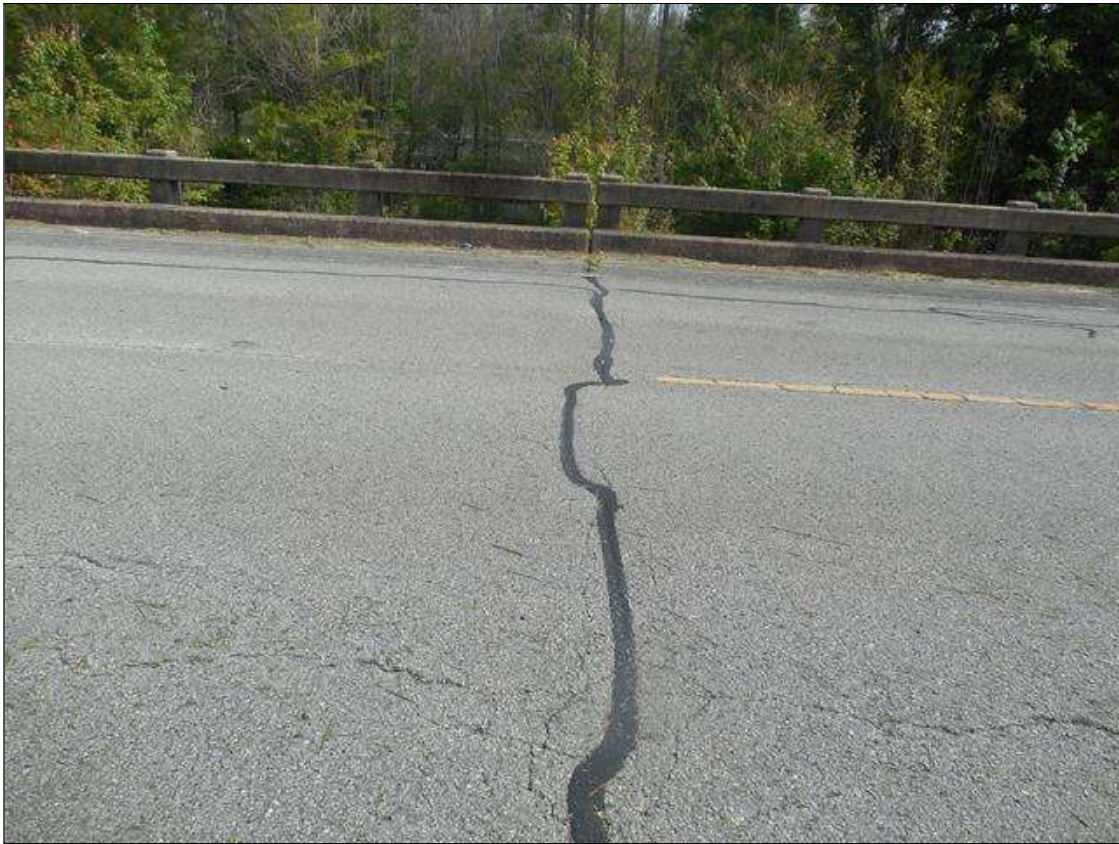
34 Square Feet of Delamination/Spall/Patched Area/Pothole (Wearing Surfaces): Delaminated. Spall less than 1 in. deep or less than 6 in. diameter. Patched area that is sound. Partial depth pothole. SEALED TRANSVERSE CRACK OVER BENT 2

Span 2 Wearing Surface: 34 Square Feet of Delamination/Spall/Patched Area/Pothole (Wearing Surfaces):  
Delaminated. Spall less than 1 in. deep or less than 6 in. diameter. Patched area that is sound. Partial depth pothole.  
SEALED TRANSVERSE CRACK OVER BENT 2

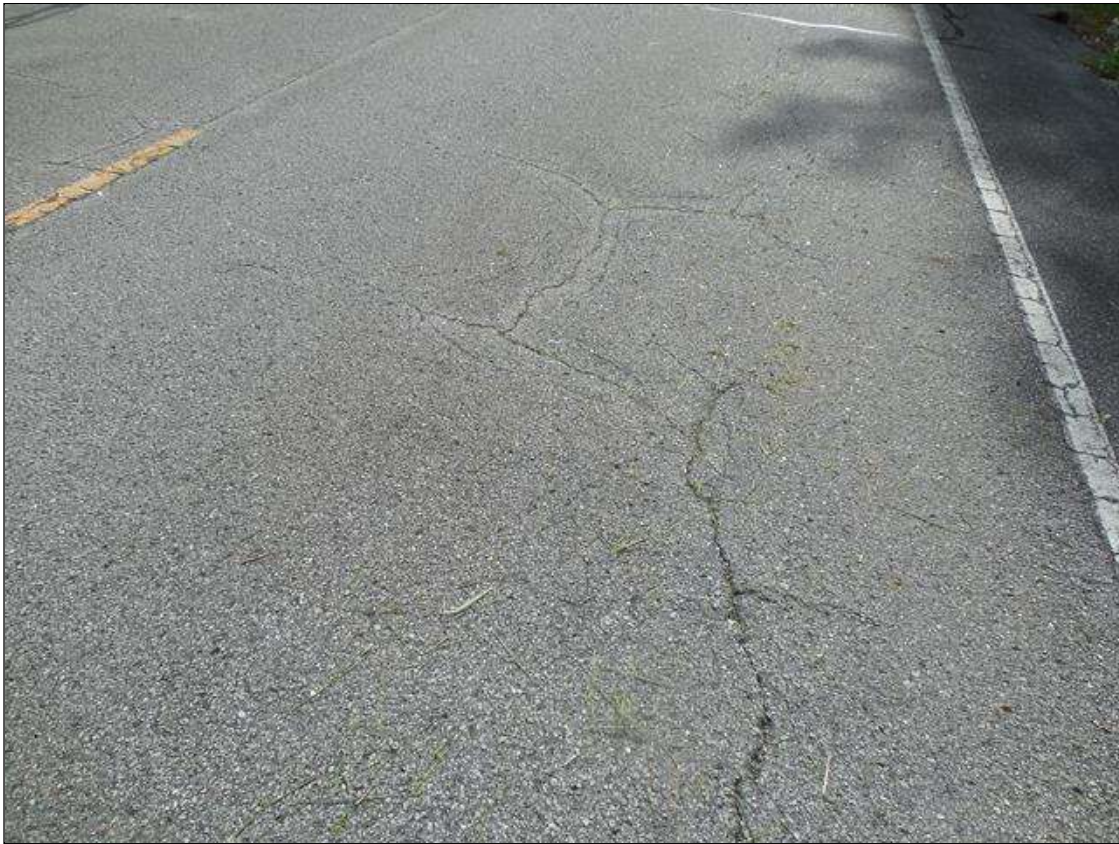
45 Square Feet of Crack (Wearing Surface): Width of more than 0.05 in. or spacing of less than 1.0 ft. 1/8" CRACKING IN EAST BOUND LANE

Span 3 Wearing Surface: 45 Square Feet of Crack (Wearing Surface): Width of more than 0.05 in. or spacing of less than 1.0 ft. 1/8" CRACKING IN EAST BOUND LANE

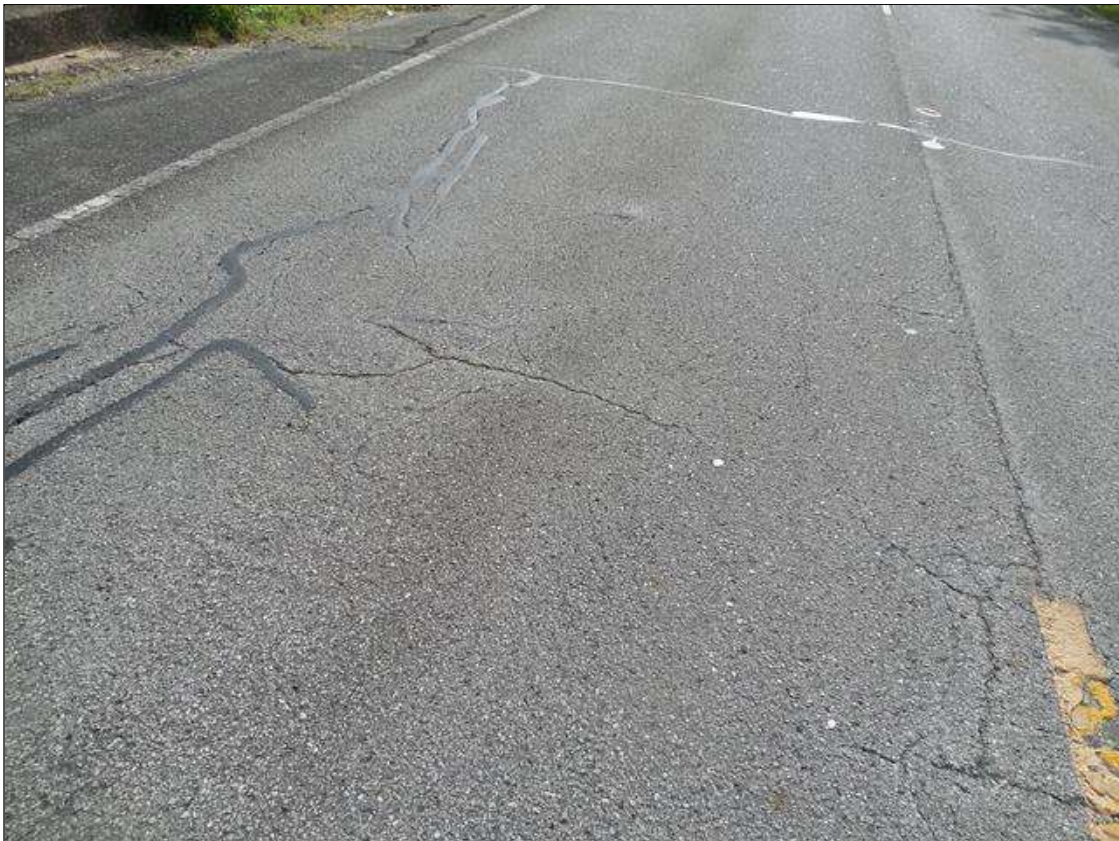
30 Square Feet of Crack (Wearing Surface): Width of more than 0.05 in. or spacing of less than 1.0 ft. 1/8" WIDE CRACKING IN WEST BOUND LANE

Span 3 Wearing Surface: 30 Square Feet of Crack (Wearing Surface): Width of more than 0.05 in. or spacing of less than 1.0 ft. 1/8" WIDE CRACKING IN WEST BOUND LANE

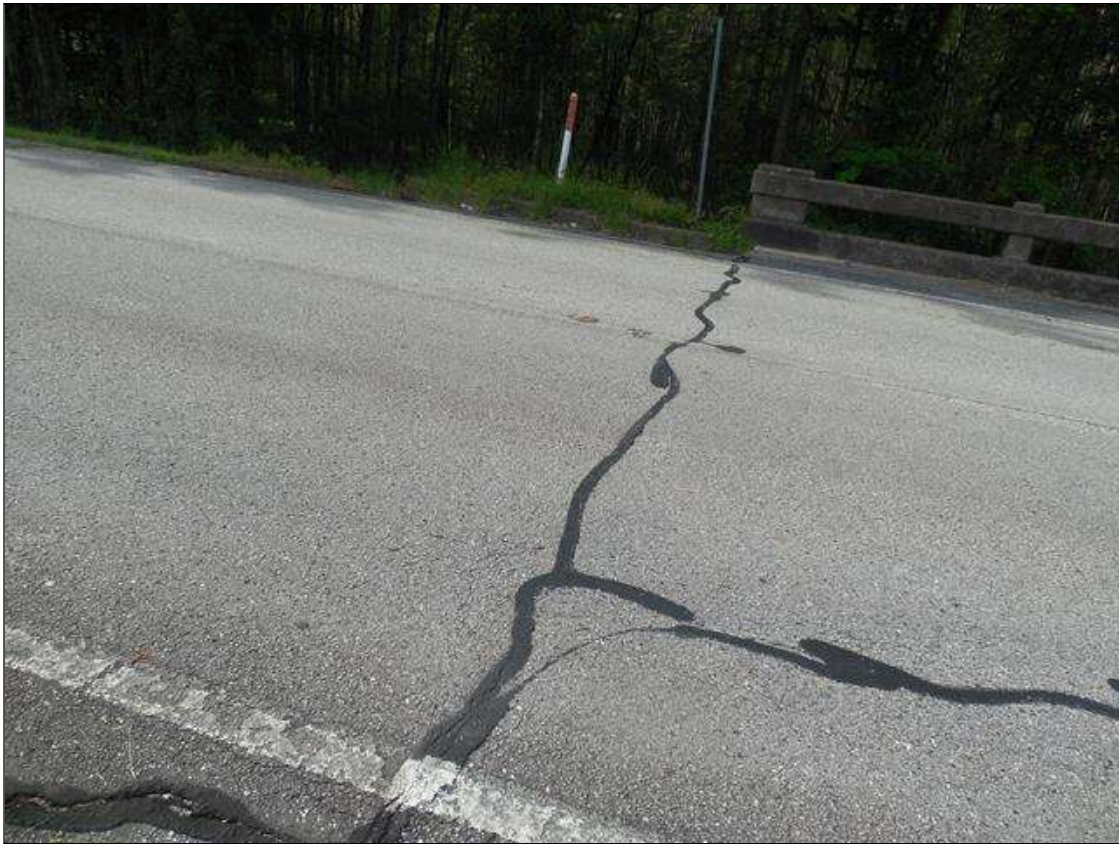
34 Square Feet of Delamination/Spall/Patched Area/Pothole (Wearing Surfaces): Delaminated. Spall less than 1 in. deep or less than 6 in. diameter. Patched area that is sound. Partial depth pothole. SEALED TRANSVERSE CRACK OVER END BENT 2

Span 3 Wearing Surface: 34 Square Feet of Delamination/Spall/Patched Area/Pothole (Wearing Surfaces):  
Delaminated. Spall less than 1 in. deep or less than 6 in. diameter. Patched area that is sound. Partial depth pothole.  
SEALED TRANSVERSE CRACK OVER END BENT 2

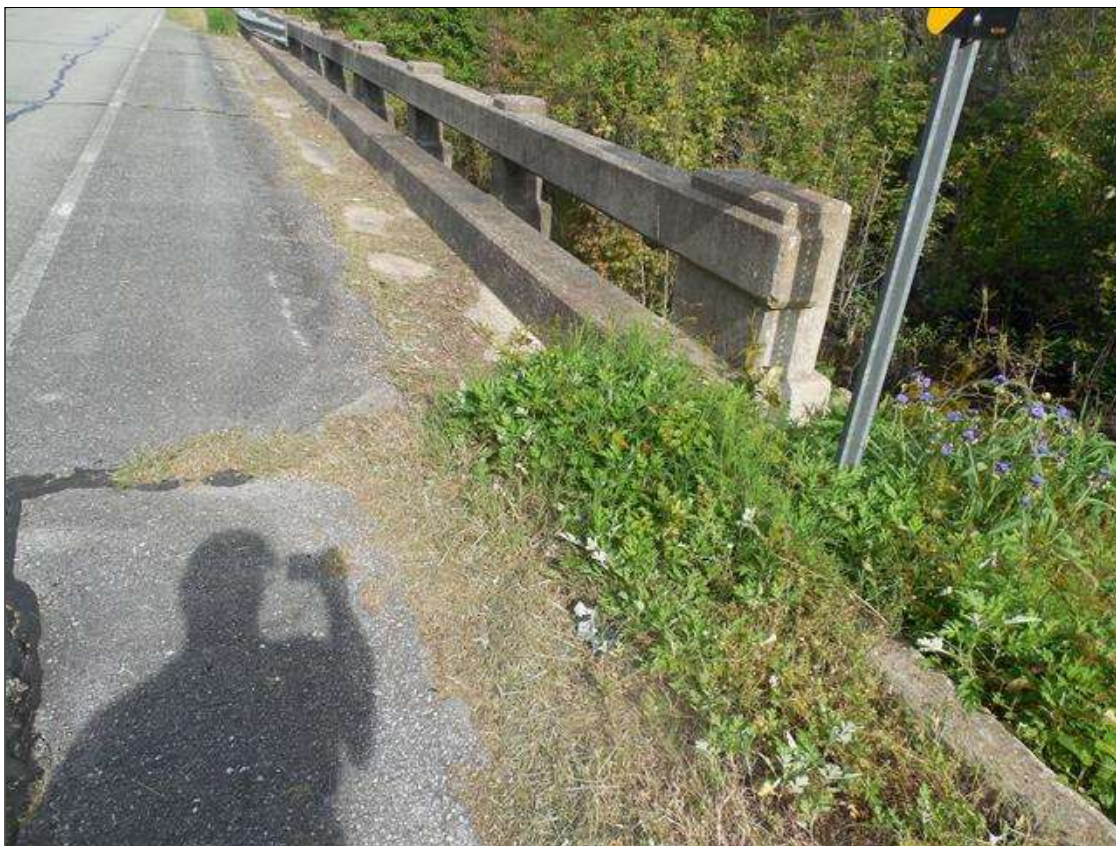
NORTHEAST CORNER APPROACH SHOULDER SETTLED 5" ( PHOTO # 7268 ) 9 SQ. FT. MAINTENANCE

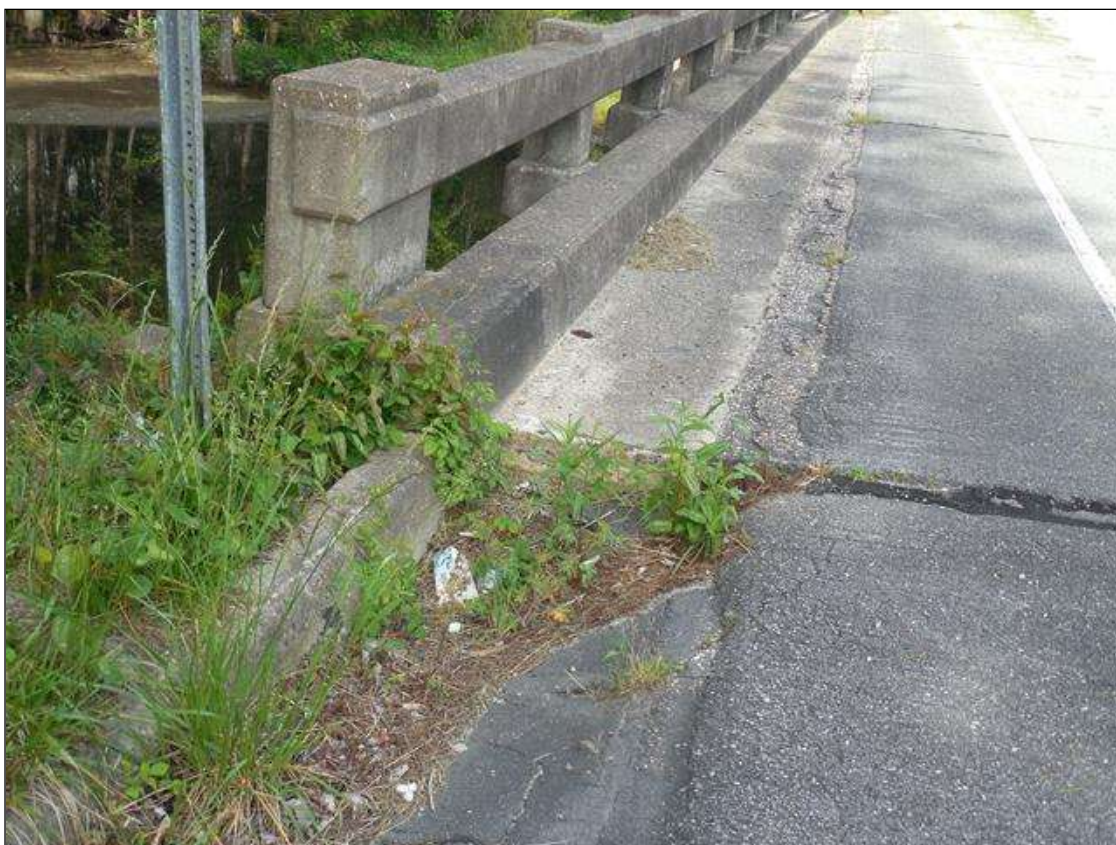
SOUTHWEST CORNER APPROACH SHOULDER SETTLED 8" ( PHOTO # 7270 ) 9 SQ. FT. MAINTENANCE

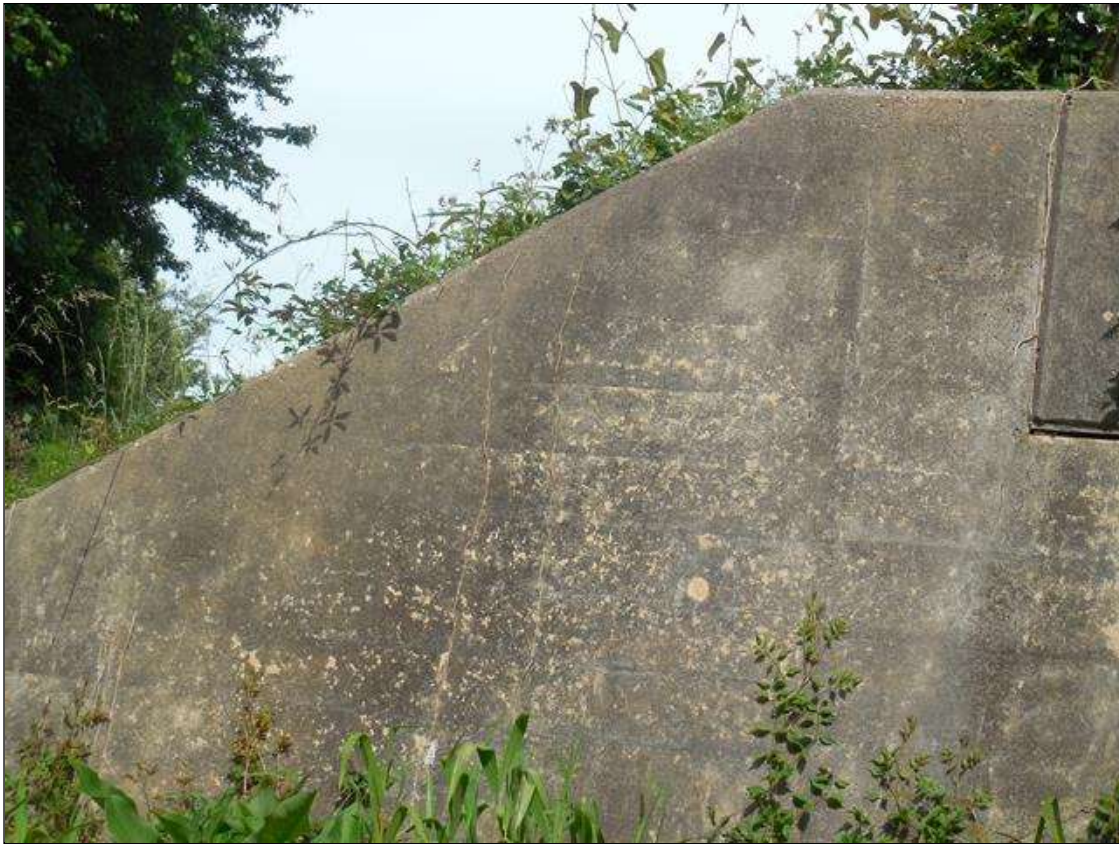
10 Feet of Cracking (RC and Other): Width greater than 0.05 in. or spacing of less than 1 ft. 10' OF HAIRLINE MAP  
CRACKING IN ABUTMENT 1 WING AT SOUTHWEST CORNER

| Details | 10' OF HAIRLINE MAP CRACKING IN ABUTMENT 1 WING AT SOUTHWEST CORNER | | | |

End Bent 1 Abutment/Backwall : 10 Feet of Cracking (RC and Other): Width greater than 0.05 in. or spacing of less than 1 ft. 10' OF HAIRLINE MAP CRACKING IN ABUTMENT 1 WING AT SOUTHWEST CORNER

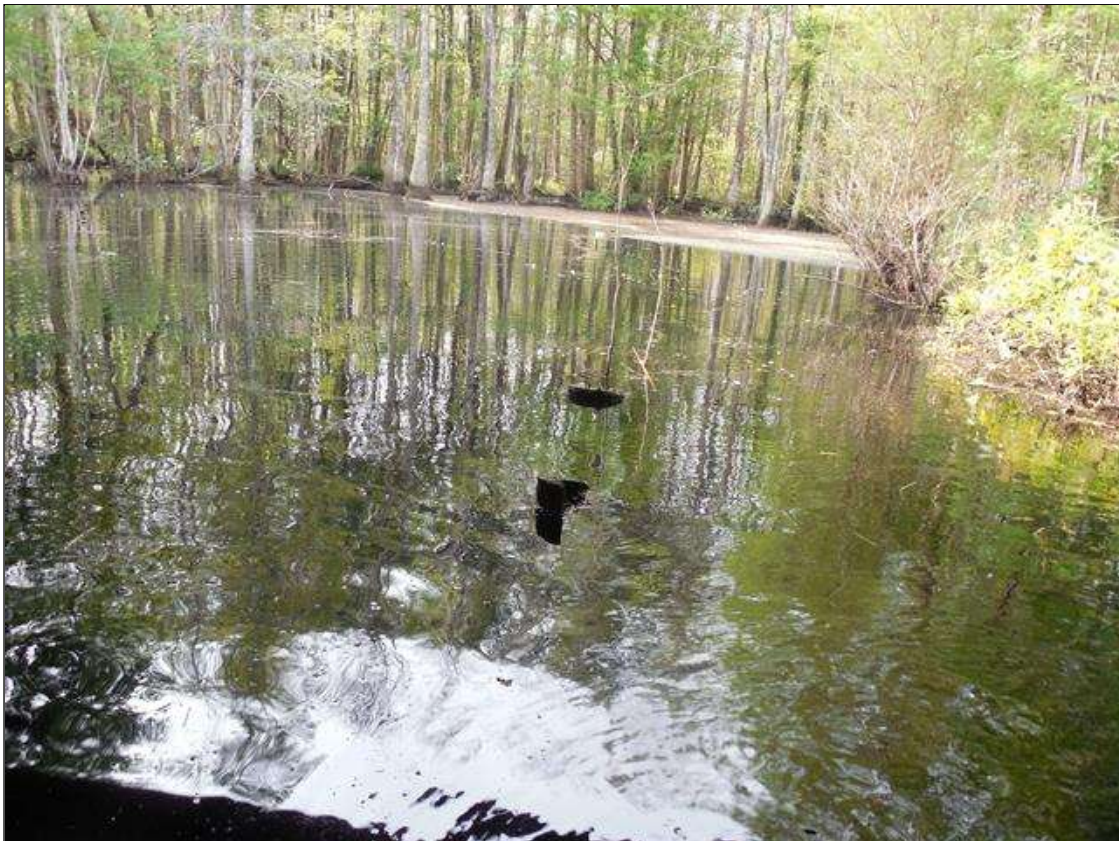
CUT OFF PILES IN SPAN 1 WATERWAY
