NC DEPARTMENT OF TRANSPORTATION  
DIVISION OF HIGHWAYS  
STRUCTURE MANAGEMENT UNIT

## Structure Safety Report

### Routine Element Inspection

COUNTY: COLUMBUS STRUCTURE NUMBER: 230068 FREQUENCY: 24 MONTHS

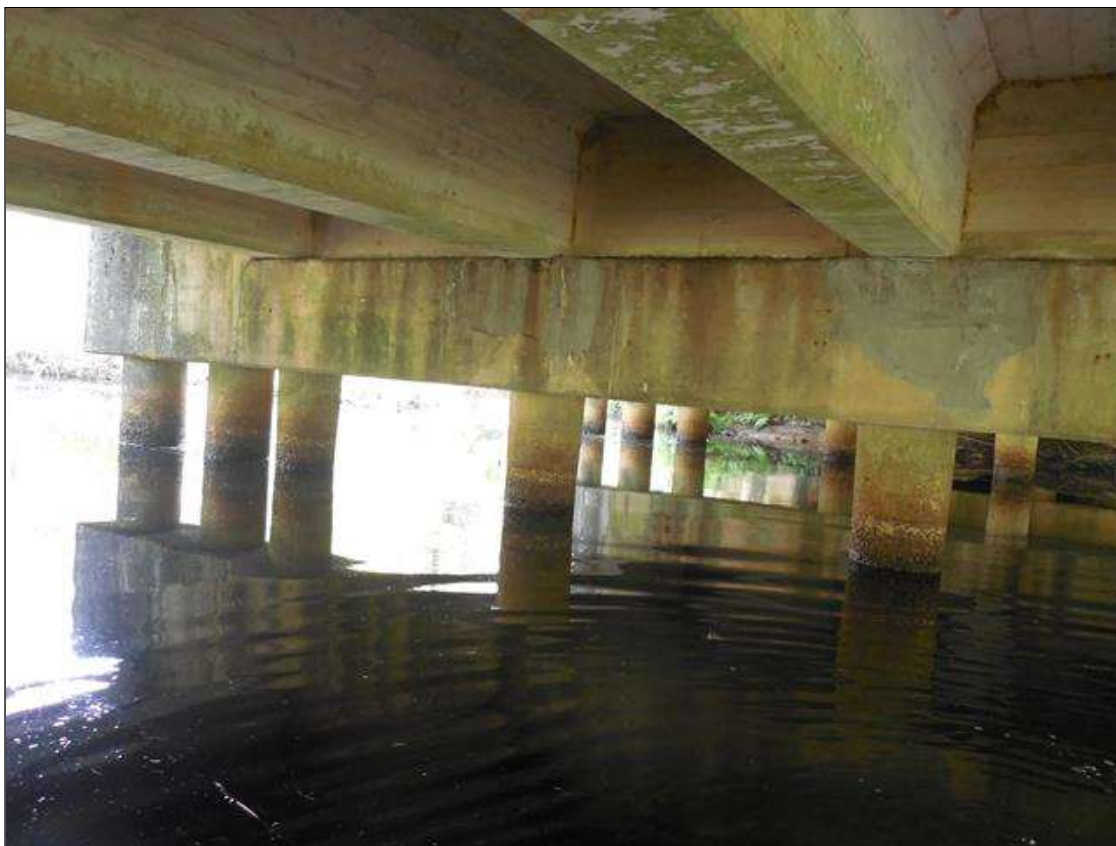
ALL TIMBER PILES AT BENT 1 ARE ENCASED IN CONCRETE (PHOTO # 7277 )

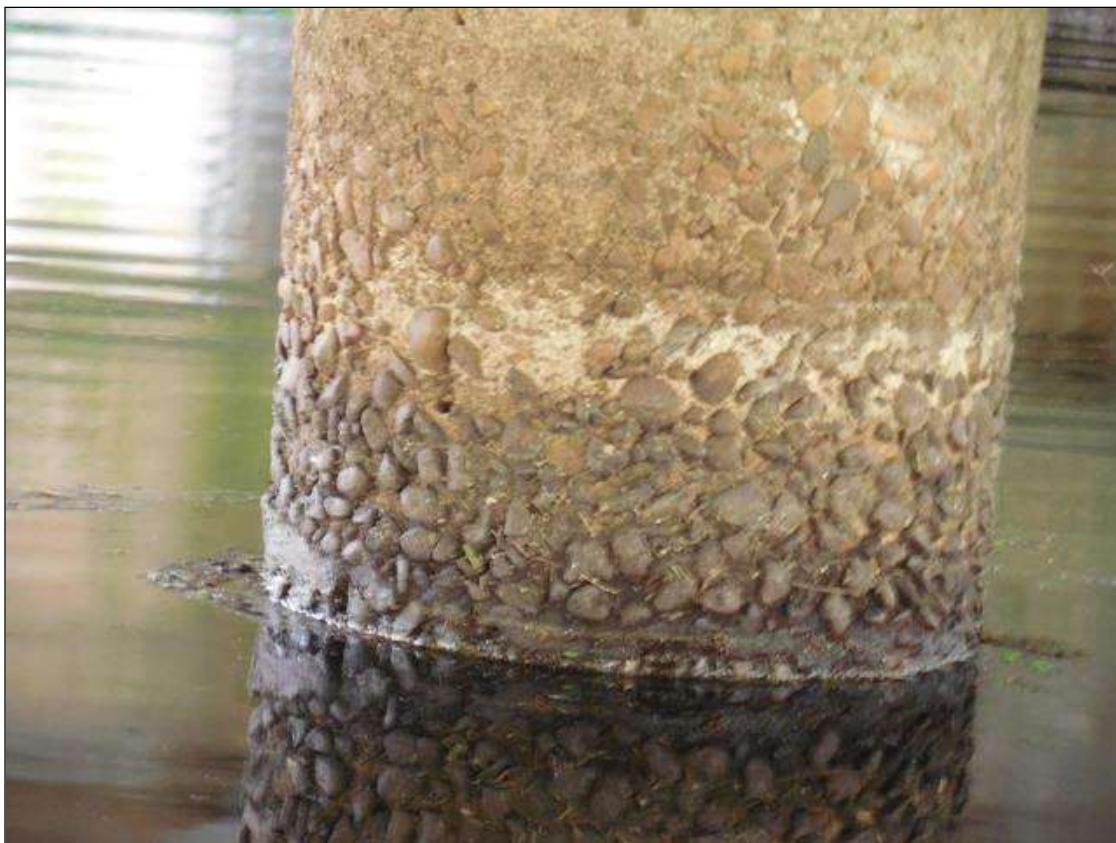
PLANS INDICATE CONCRETE ENCASED TIMBER PILES  
 HORIZONTAL CRACK TO 1/16"(6" ABOVE W/L)  
 COARSE AGGREGATE EXPOSED TO 1/4" WITH RANDOM POP-OUTS TO 1" DEEP  
 WATER DEPTH - 2"  
 PILES AT BENT 1 ENCASEMENT HAS SCALING WITH EXPOSED AGGREGATE, ALL PILES ARE SIMILAR (PHOTO # 7278 )

PILE 5 AT BENT 1 ENCASEMENT HAS SCALING WITH EXPOSED AGGREGATE, ALL PILES ARE SIMILAR (PHOTO # 7278 )

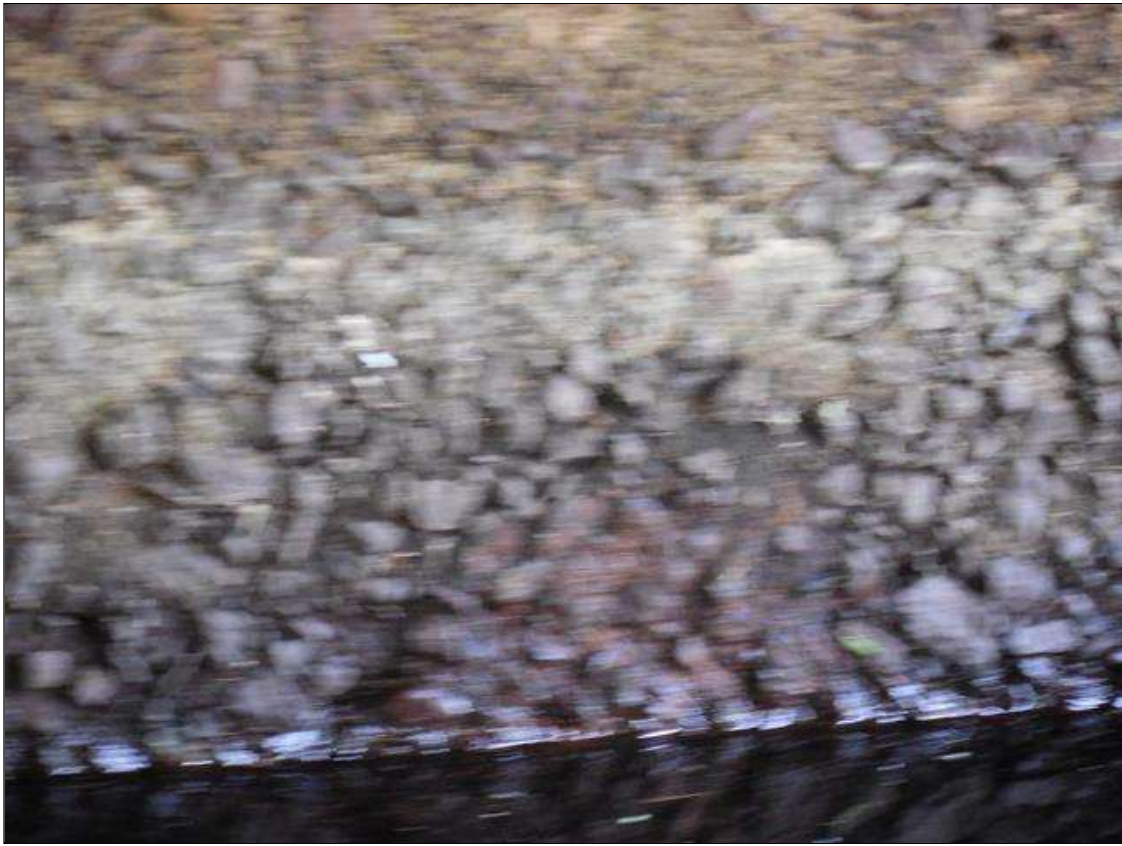
ABUTMENT 1 WALL HAS SCALING WITH EXPOSED AGGREGATE 2' HIGH (PHOTO # 7279 )  
ABUTMENT 1 WINGWALL HAS 5' LONG X 1/8" WIDE DIAGONAL CRACK AT NORTHWEST CORNER ( PHOTO # 7280 )

ABUTMENT 1 WALL HAS SCALING WITH EXPOSED AGGREGATE 2' HIGH (PHOTO # 7279 )

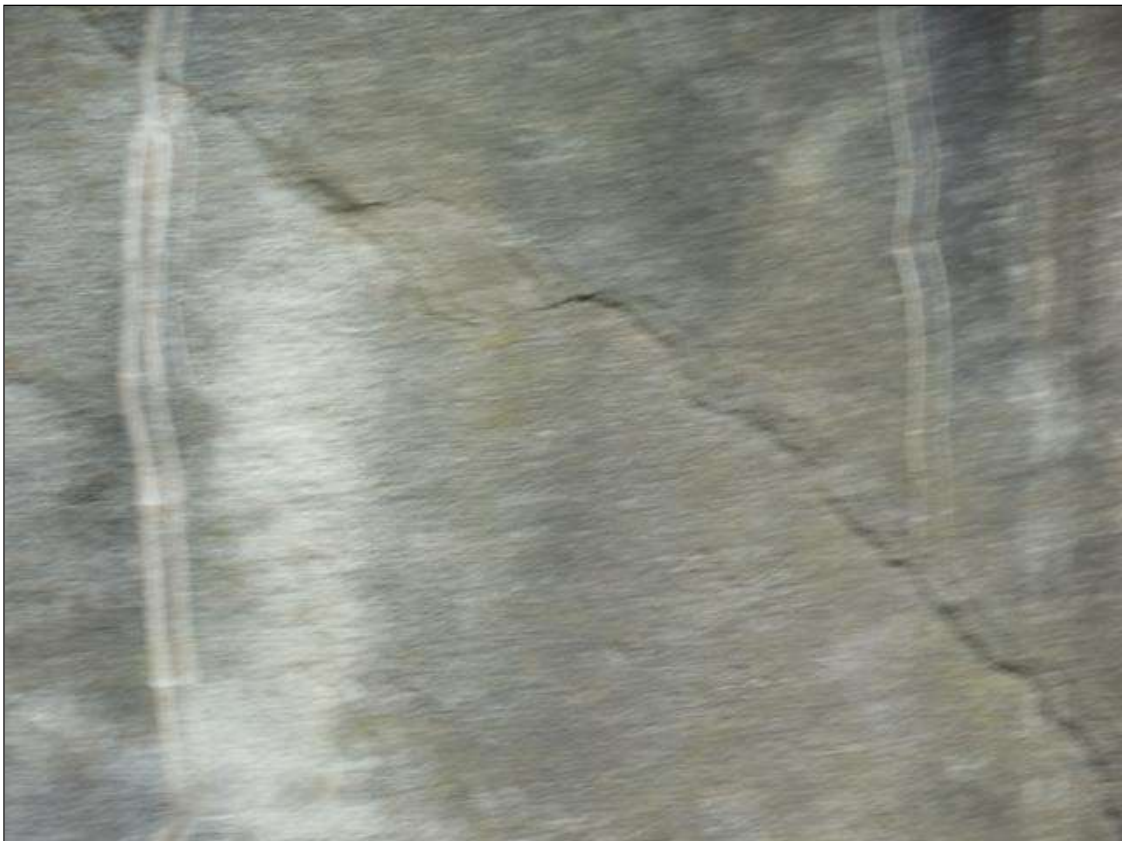
ABUTMENT 1 WINGWALL HAS 5' LONG X 1/8" WIDE DIAGONAL CRACK AT NORTHWEST CORNER ( PHOTO # 7280 )

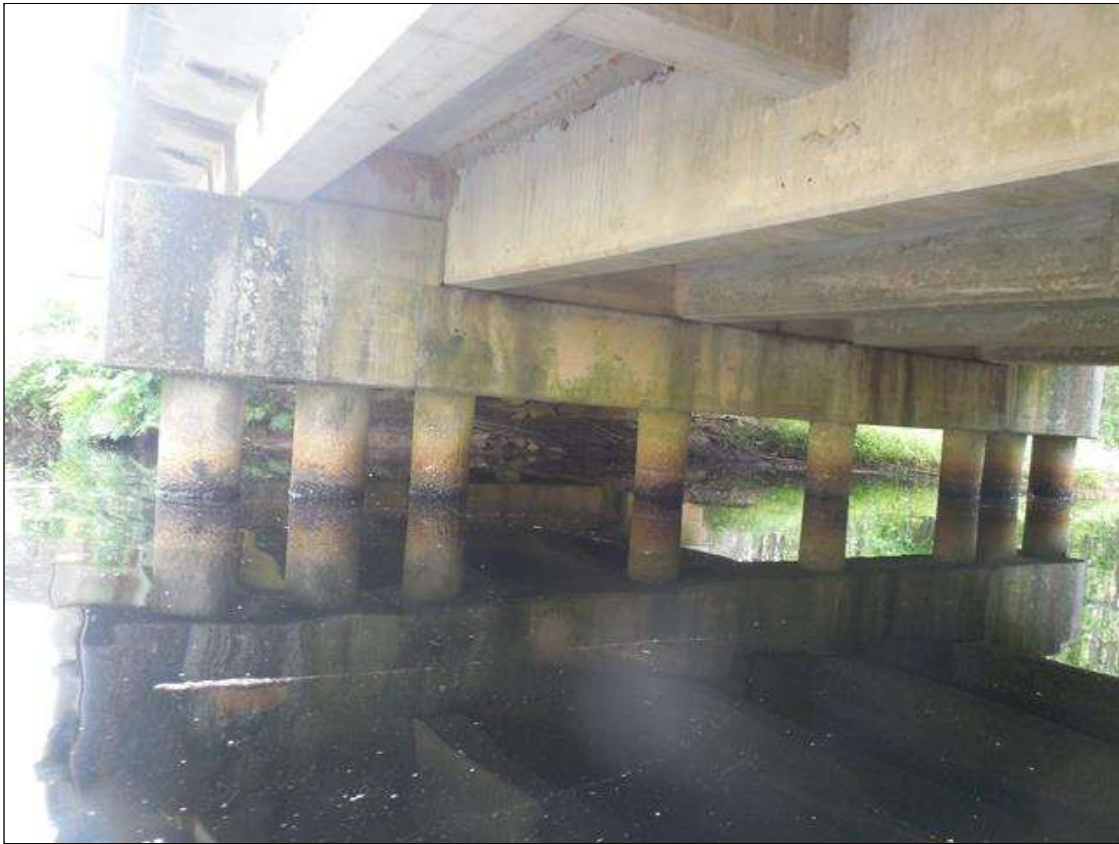
ALL PILES AT BENT 2 ARE FULLY ENCASED IN CONCRETE, NOT VISIBLE (PHOTO # 7283 )

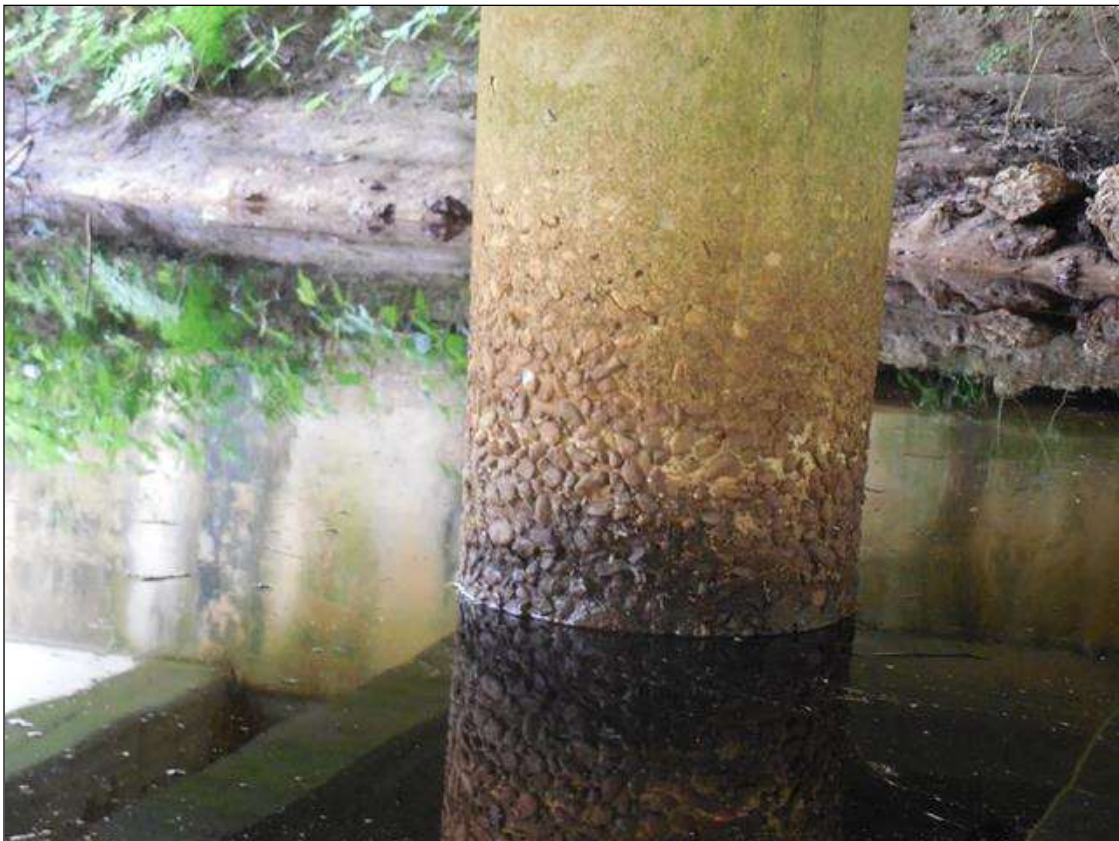
PLANS INDICATE CONCRETE ENCASED TIMBER PILES  
COARSE AGGREGATE EXPOSED TO 1/4" WITH RANDOM POP-OUTS TO 1" DEEP  
1/8" HORIZONTAL CRACK X FULL CIRCUMFERENCE NOTED ABOVE W/L  
WATER DEPTH - 0.8"  
PILES AT BENT 2 ENCASEMENT IS SCALING WITH EXPOSED AGGREGATE, ALL PILES ARE SIMILAR (PHOTO # 7287 )  
PILE 8 AT BENT 2 HAS A 1/8" CRACK IN CONCRETE ENCASEMENT ( PHOTO # 7291 )

PILE 4 AT BENT 2 ENCASEMENT IS SCALING WITH EXPOSED AGGREGATE, ALL PILES ARE SIMILAR (PHOTO # 7287 )

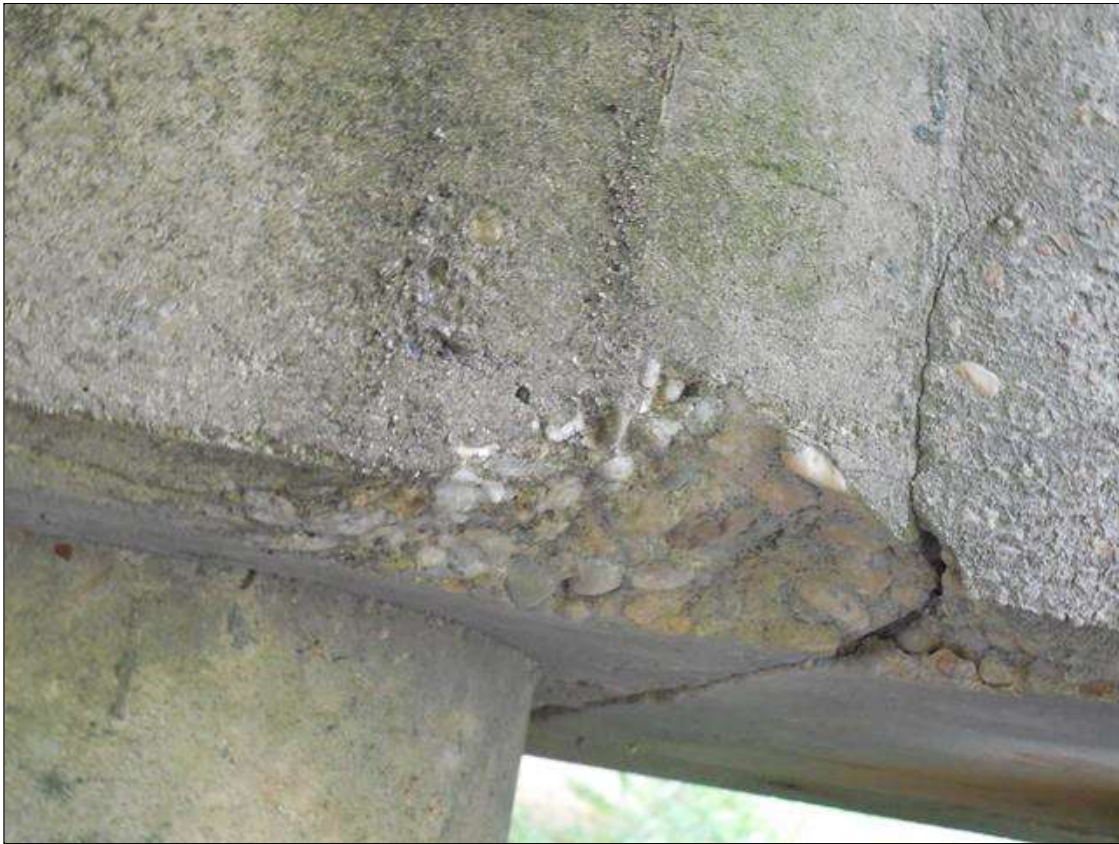
1 Feet of Delamination/Spall/Patched Area: Spall greater than 1 inch deep or greater than 6 inches in diameter. Patched area that is unsound or showing distress. Condition does not warrant structural Review SPALL 11" WIDE X 3" HIGH X 6" DEEP ON SPAN 2 FACE OVER PILE 6

Bent 2 Cap : 1 Feet of Delamination/Spall/Patched Area: Spall greater than 1 inch deep or greater than 6 inches in diameter. Patched area that is unsound or showing distress. Condition does not warrant structural Review SPALL 11" WIDE X 3" HIGH X 6" DEEP ON SPAN 2 FACE OVER PILE 6

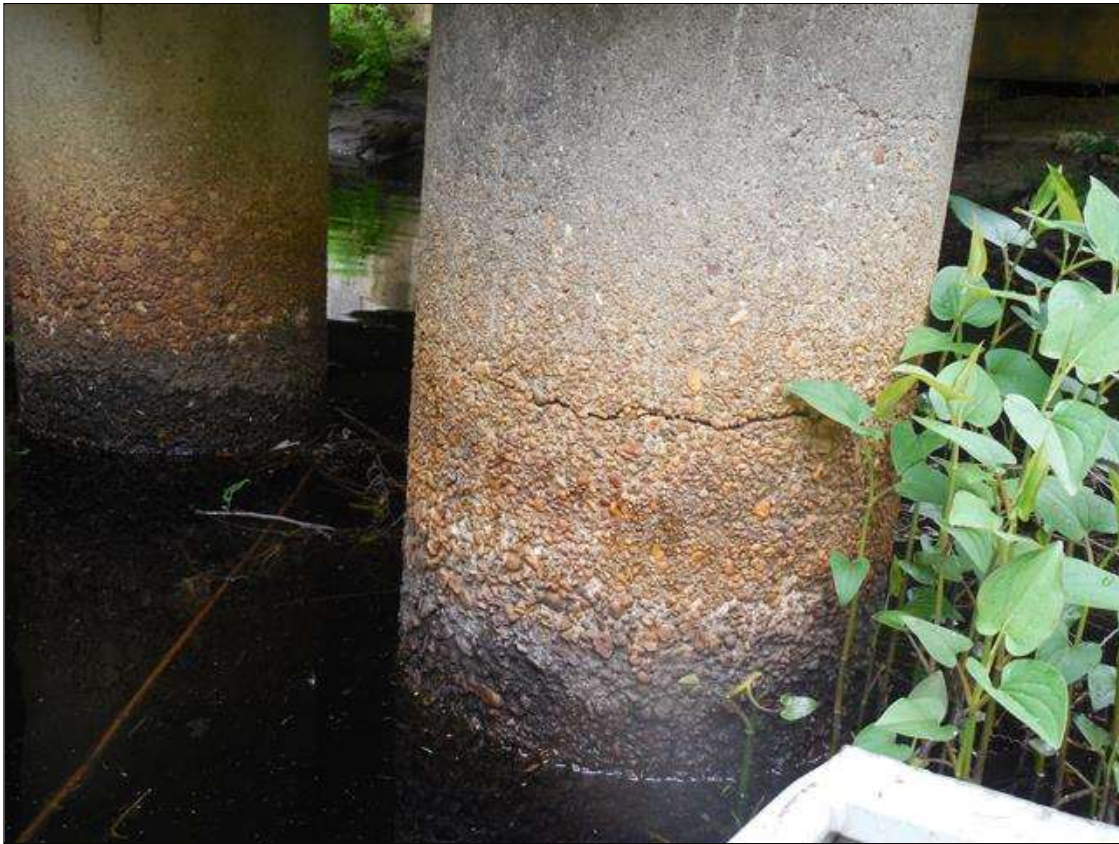
PILE 8 AT BENT 2 HAS A 1/8" CRACK IN CONCRETE ENCASEMENT ( PHOTO # 7291 )

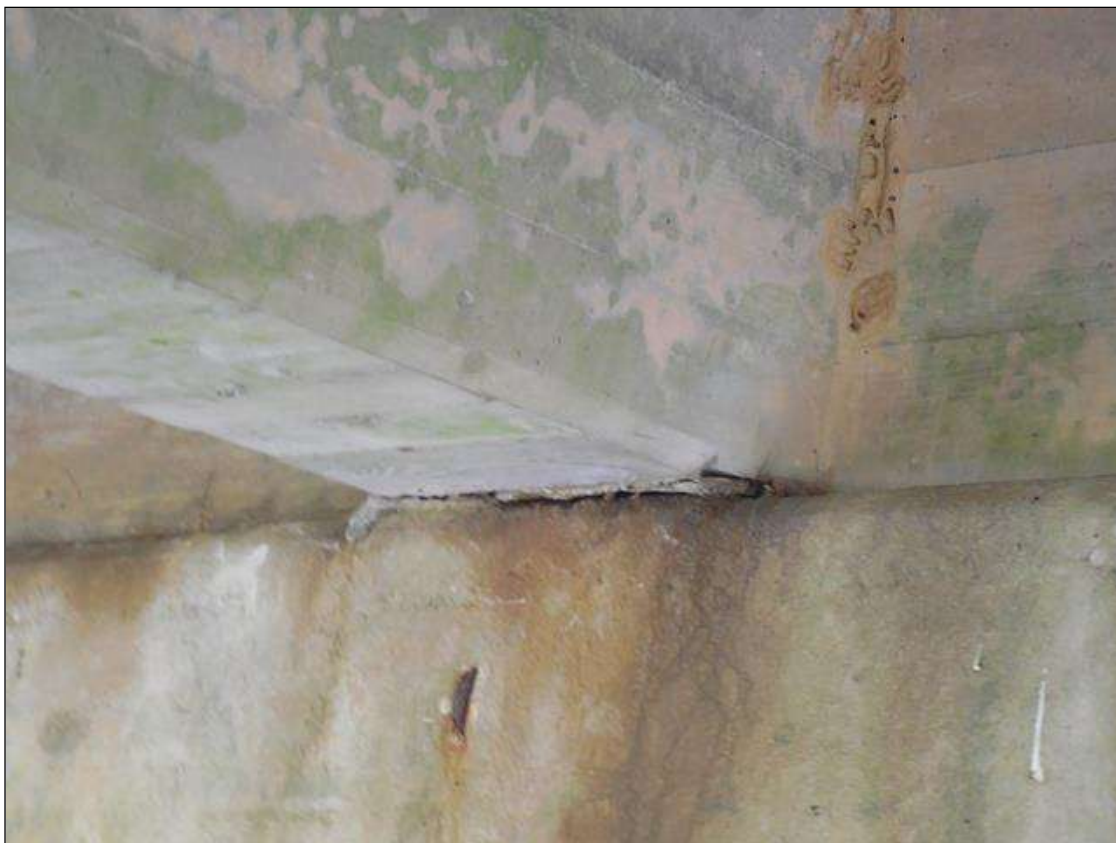
NO BEARINGS ARE VISIBLE ( PHOTO # 7289 )
