# Structure Safety Report

## 4 Year Underwater Element Inspection

COUNTY: COLUMBUS STRUCTURE NUMBER: 230077 FREQUENCY: 48 MONTHS

FEATURE INTERSECTED: GREEN SWAMP

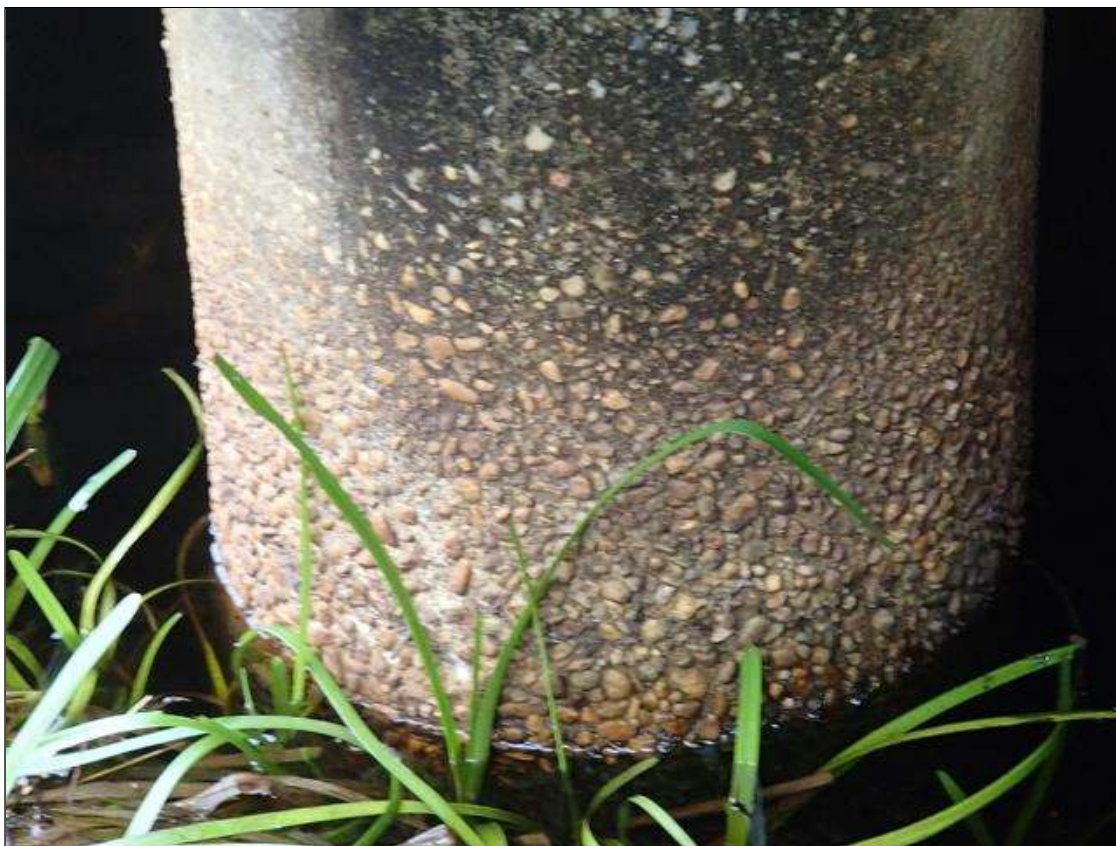
COARSE AGGREGATES EXPOSED

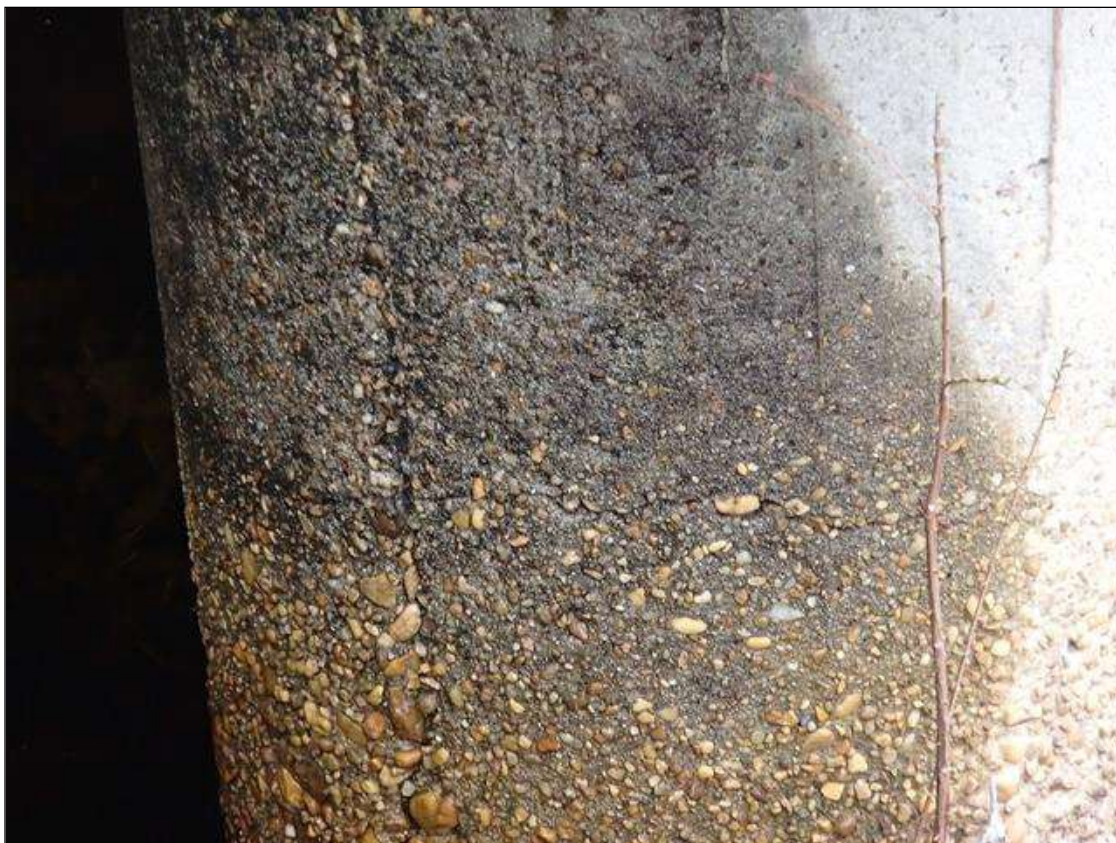
PLANS INDICATE CONCRETE ENCASED TIMBER PILES.  
COARSE AGGREGATE EXPOSED TO 1/2" WITH RANDOM POP-OUTS AND VOIDS.  
H/L - 1/16" VERTICAL CRACK AND A H/L - 1/32" HORIZONTAL CRACK.

BENT 1,P-8 HORIZONTAL CRACK

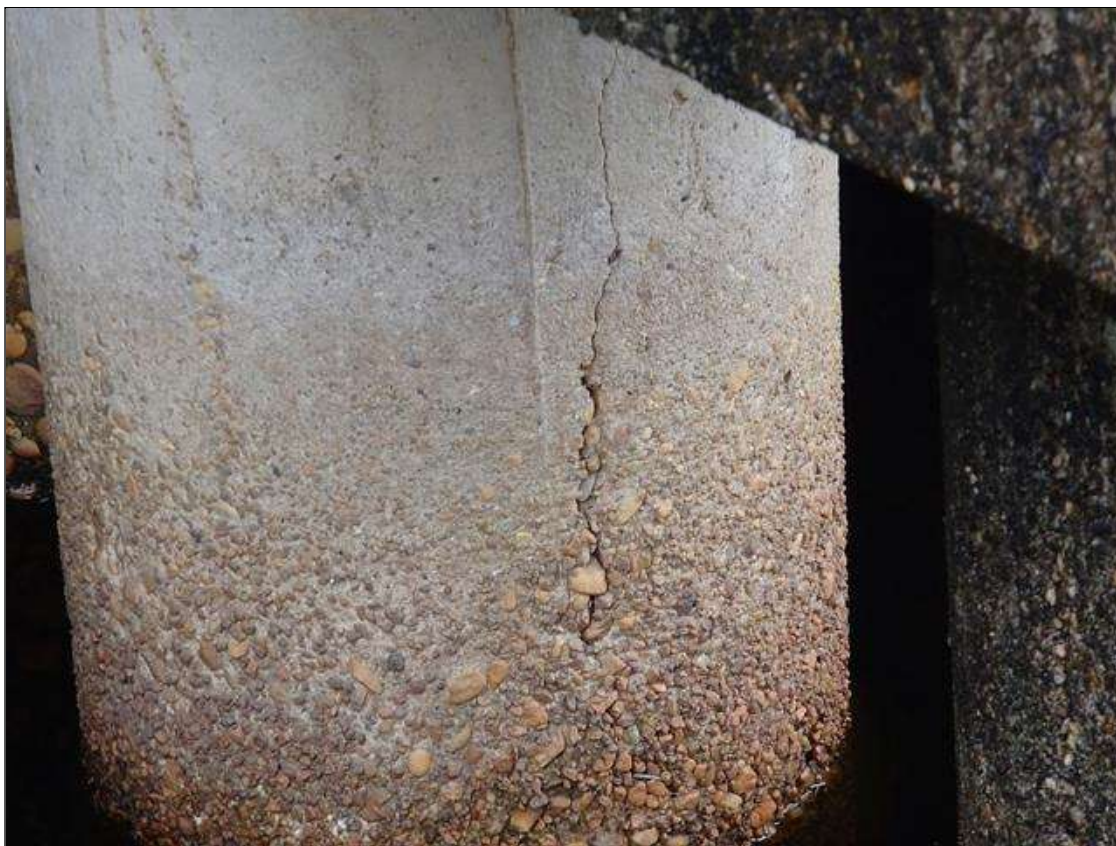
| PLANS INDICATE CONCRETE ENCASED TIMBER PILES.<br>COARSE AGGREGATE EXPOSED TO 1/2" WITH RANDOM POP-OUTS AND VOIDS.<br>VERTICAL H/L - 1/8" CRACK ON THE WEST QUADRANT. | | | | | | | | | | |

BENT 1,P-7 VERTICAL CRACK

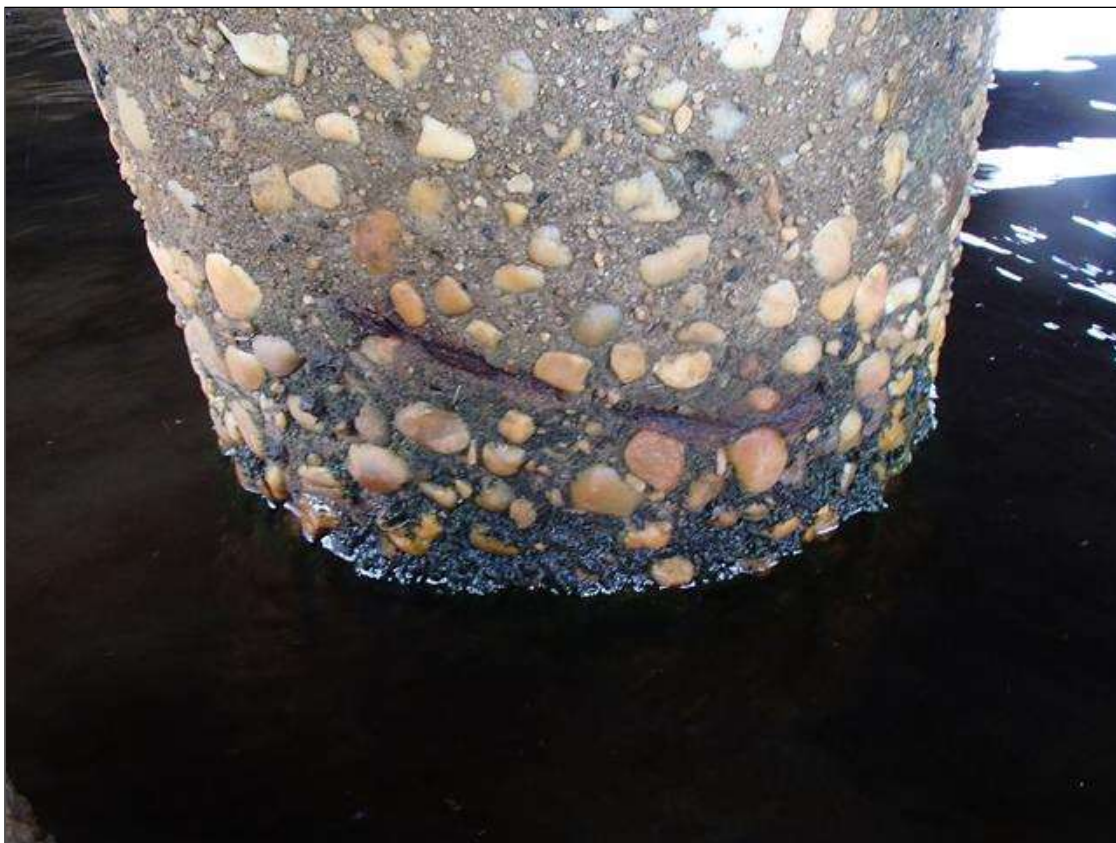
BENT 1,P-1 STEEL REINFORCING WIRE EXPOSED
