# Structure Safety Report

## Routine Element Inspection

COUNTY: COLUMBUS STRUCTURE NUMBER: 230383 FREQUENCY: 24 MONTHSFACILITY CARRIED: US74 & 76 WBL MILE POST: 255.6LOCATION: 1.8 MI.E. OF JCT.SR1740FEATURE INTERSECTED: FRIAR SWAMPLATITUDE: 34° 19' 20.54" LONGITUDE: 78° 28' 9.54"SUPERSTRUCTURE: PPC CORED SLABSUBSTRUCTURE: EBT&IBTS:RC CAP ON PPC PILESSPANS: 1@36';1@35';1@36'☐ FRACTURE CRITICAL ☐ TEMPORARY SHORING ☐ SCOUR CRITICAL ☐ SCOUR PLAN OF ACTIONPRESENT CONDITION: Good INSPECTION DATE: 07/12/2016POSTED SV: Not Posted POSTED TTST: Not PostedOTHER SIGNS PRESENT: NONE

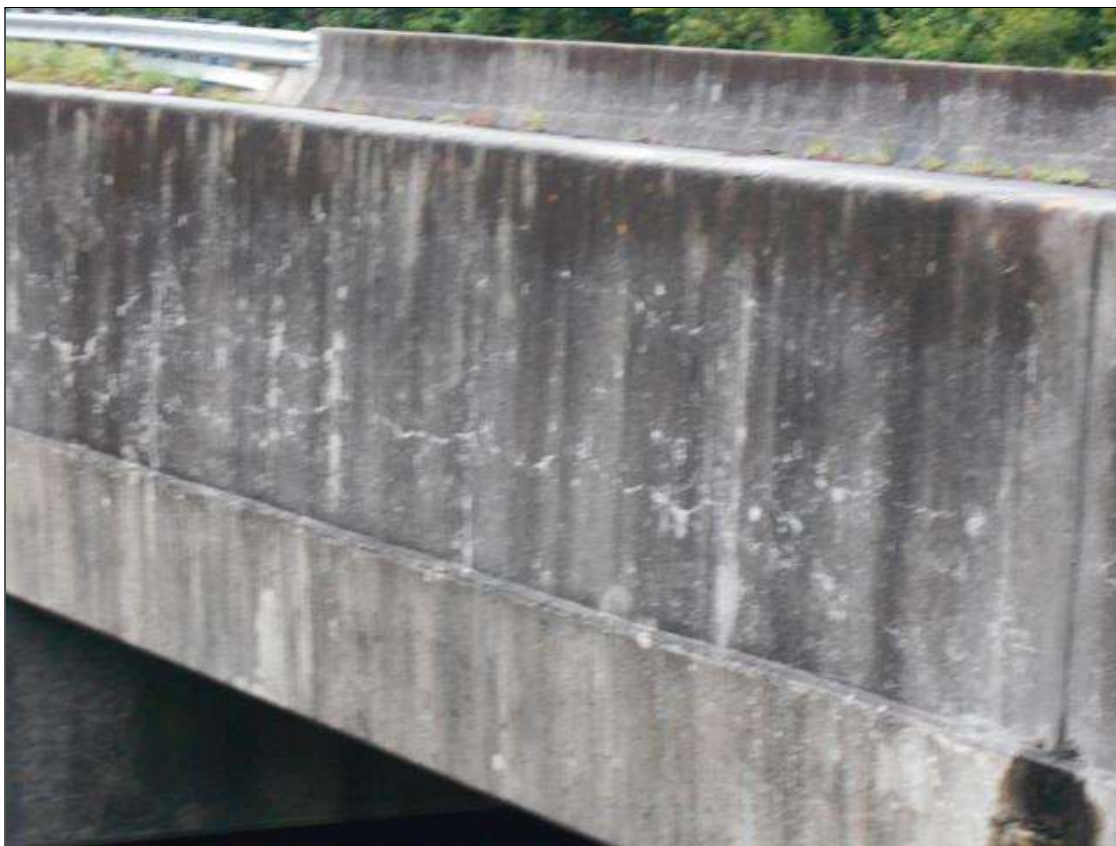
| Element Number | Defect Type | Defect Description | CS | CS Qty | Maint Qty |
|---|---|---|---|---|---|
| 331 | Cracking (RC and Other) | HAIRLINE MAP CRACKING ON EXTERIOR SIDE OF RAIL | 2 | 18 | Feet |

Span 1 Left Bridge Rail: HAIRLINE MAP CRACKING ON EXTERIOR SIDE OF RAIL

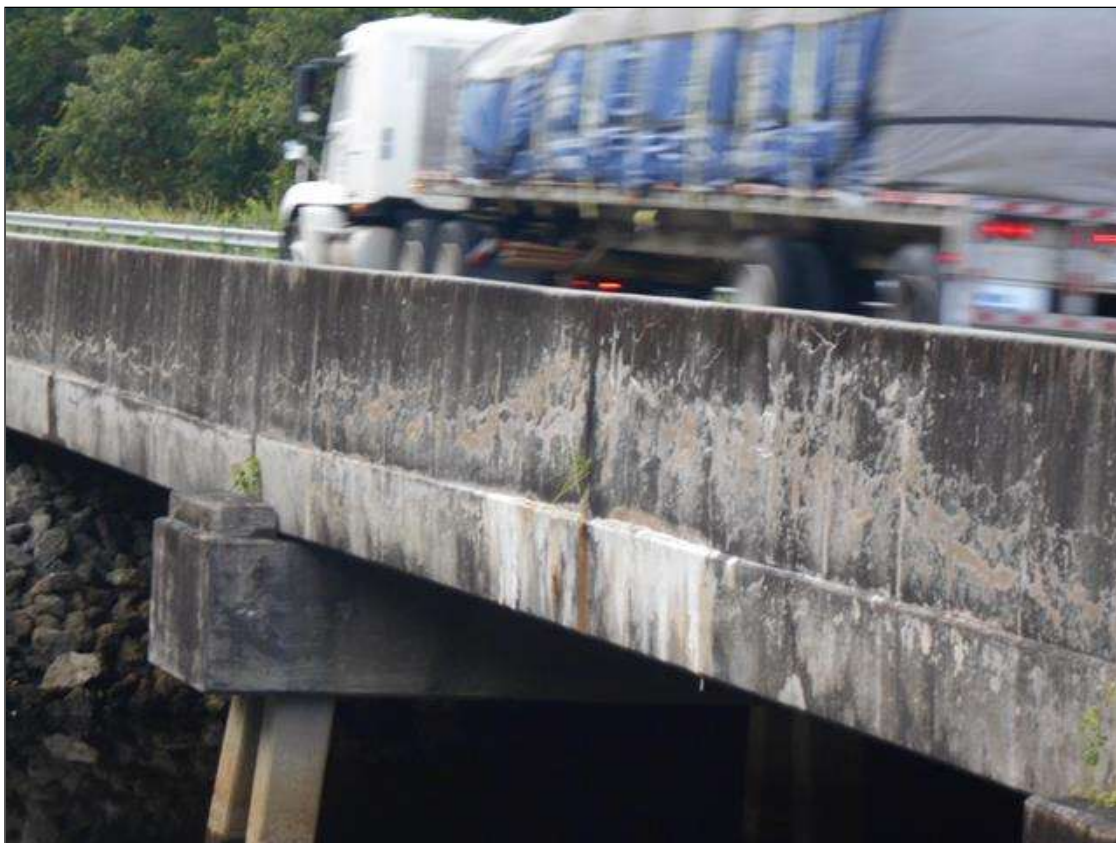
| Element Number | Defect Type | Defect Description | CS | CS Qty | Maint Qty |
|---|---|---|---|---|---|
| 331 | Cracking (RC and Other) | HAIRLINE MAP CRACKING ON EXTERIOR SIDE OF RAIL | 2 | 17 | Feet |

Span 2 Left Bridge Rail: HAIRLINE MAP CRACKING ON EXTERIOR SIDE OF RAIL

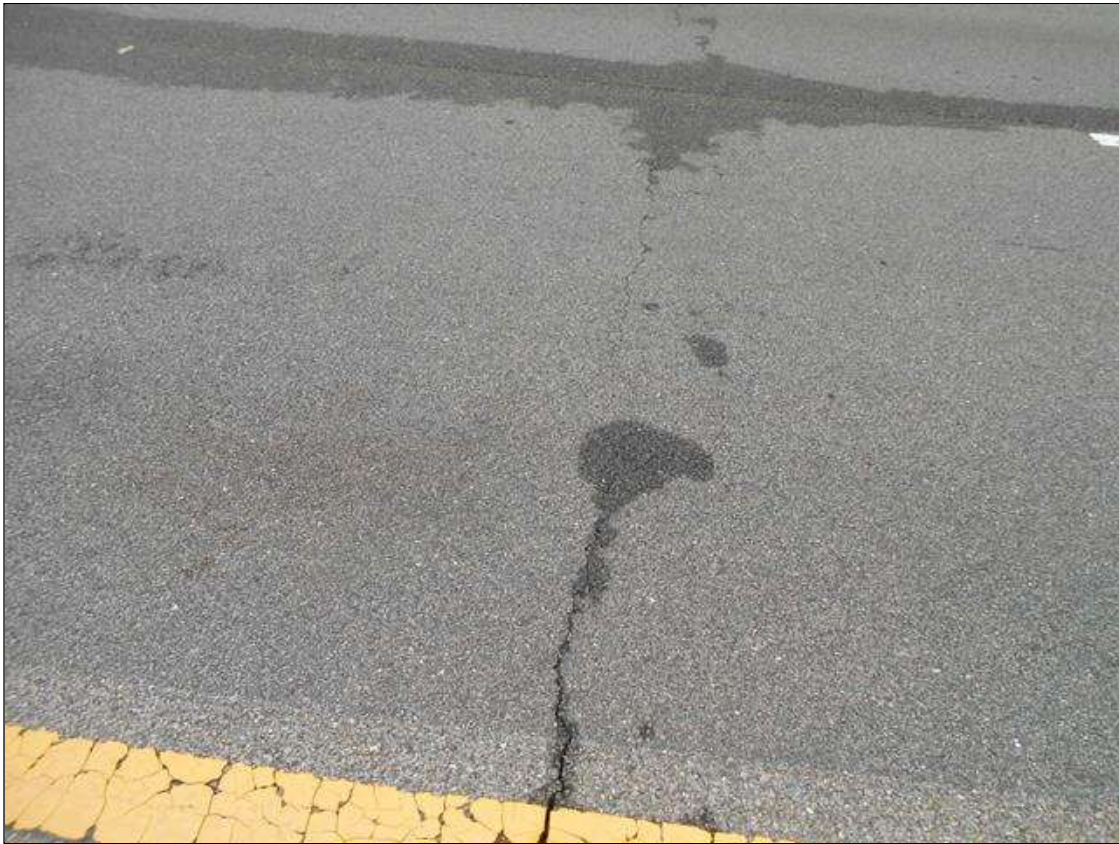
| Element Number | Defect Type | Defect Description | CS | CS Qty | Maint Qty | |
|---|---|---|---|---|---|---|
| 510 | Crack (Wearing Surface) | 1/16" WIDE TRANSVERSE CRACK OVER END BENT 1 | 2 | 36 | 36 | Square Feet |

Span 1 Wearing Surface: 1/16" WIDE TRANSVERSE CRACK OVER END BENT 1

| MMS Code | Element Name | Defect Name | Recommended Quantity |
|---|---|---|---|
| 2816 | Wearing Surface | Crack (Wearing Surface) | 108 Square Feet |

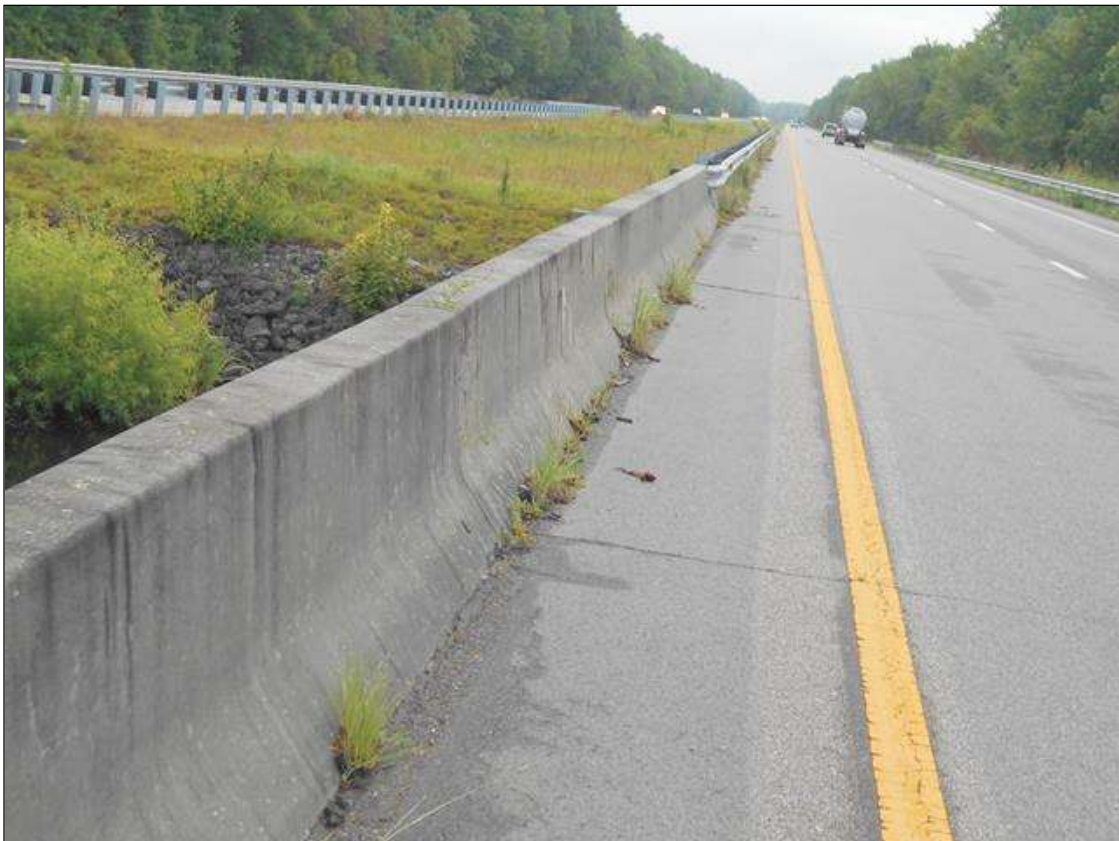
| Details | DEBRIS AND VEGETATION ALONG LEFT RAIL | | | | | |

DEBRIS AND VEGETATION ALONG LEFT RAIL

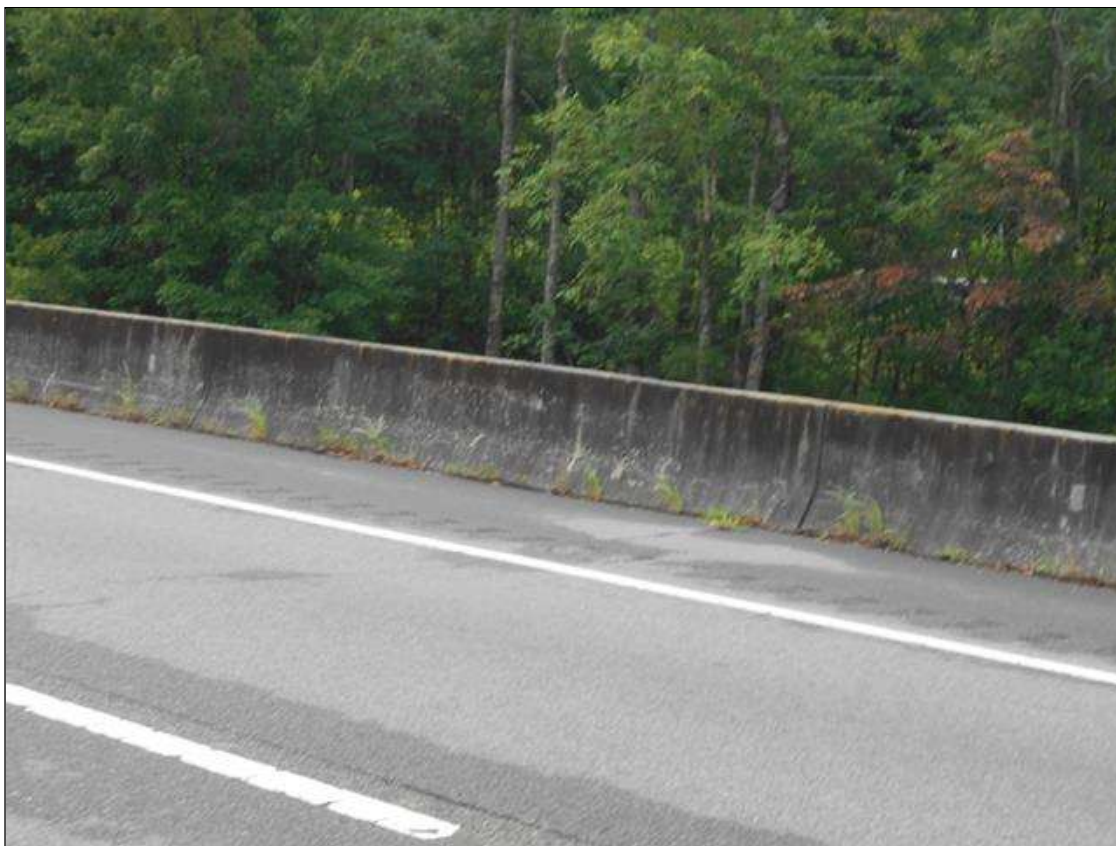
| | DEBRIS AND VEGETATION ALONG RIGHT RAIL | | | | | |

DEBRIS AND VEGETATION ALONG RIGHT RAIL

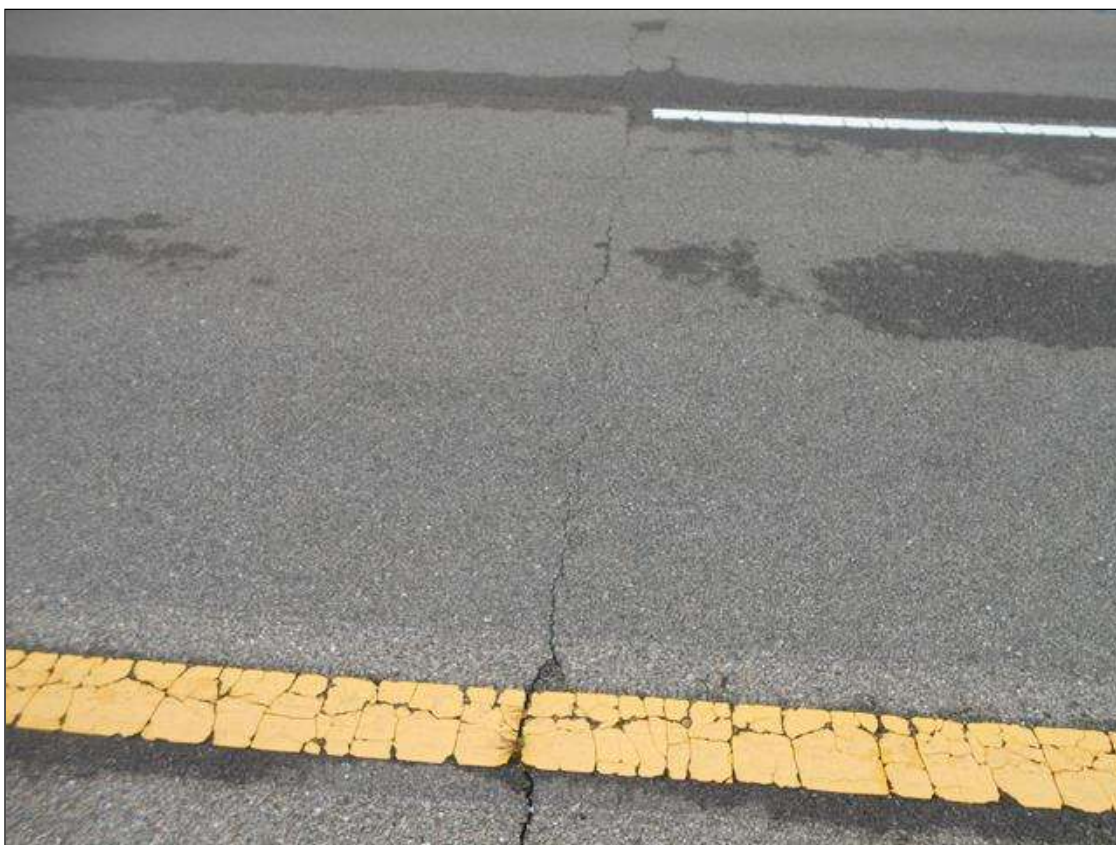
| Element Number | Defect Type | Defect Description | CS | CS Qty | Maint Qty | |
|---|---|---|---|---|---|---|
| 510 | Crack (Wearing Surface) | 1/8" WIDE TRANSVERSE CRACK OVER BENT 1 | 3 | 36 | 36 | Square Feet |

Span 1 Wearing Surface: 1/8" WIDE TRANSVERSE CRACK OVER BENT 1

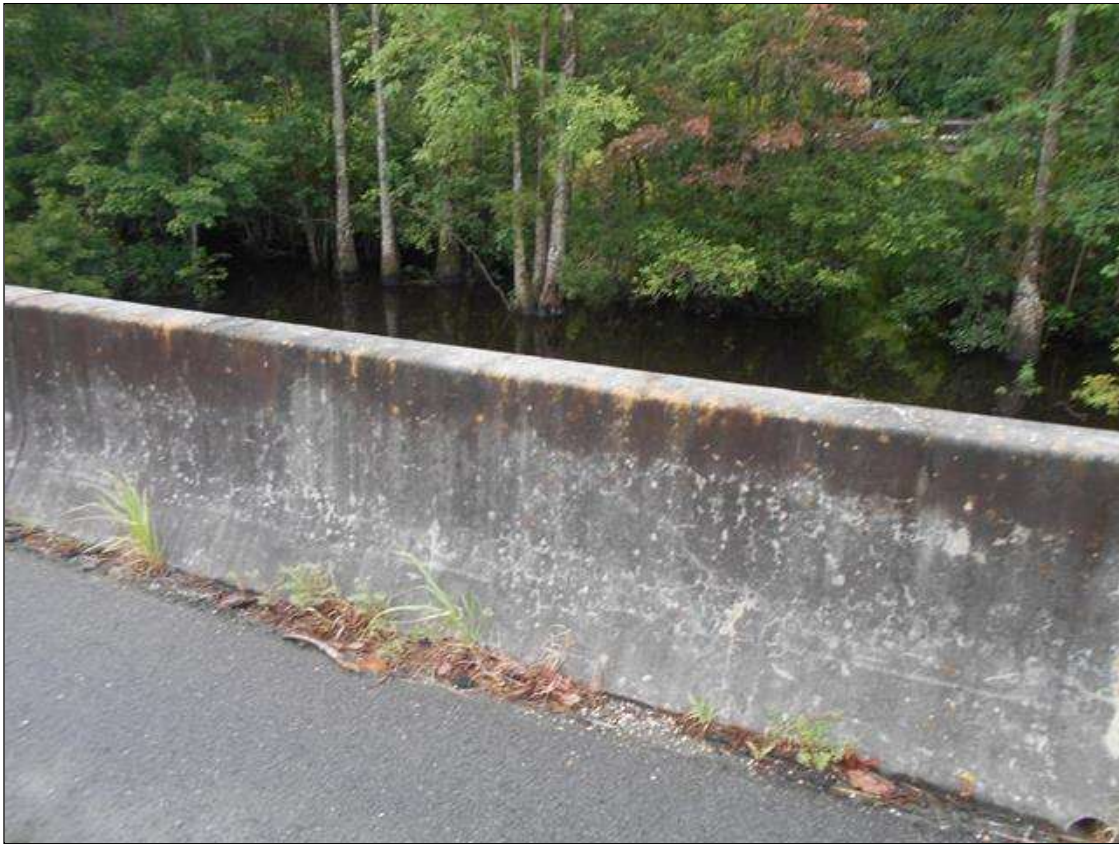
| Element Number | Defect Type | Defect Description | CS | CS Qty | Maint Qty | |
|---|---|---|---|---|---|---|
| 331 | Cracking (RC and Other) | HAIRLINE MAP CRACKING | 2 | 35 | | Feet |

Span 2 Right Bridge Rail: HAIRLINE MAP CRACKING

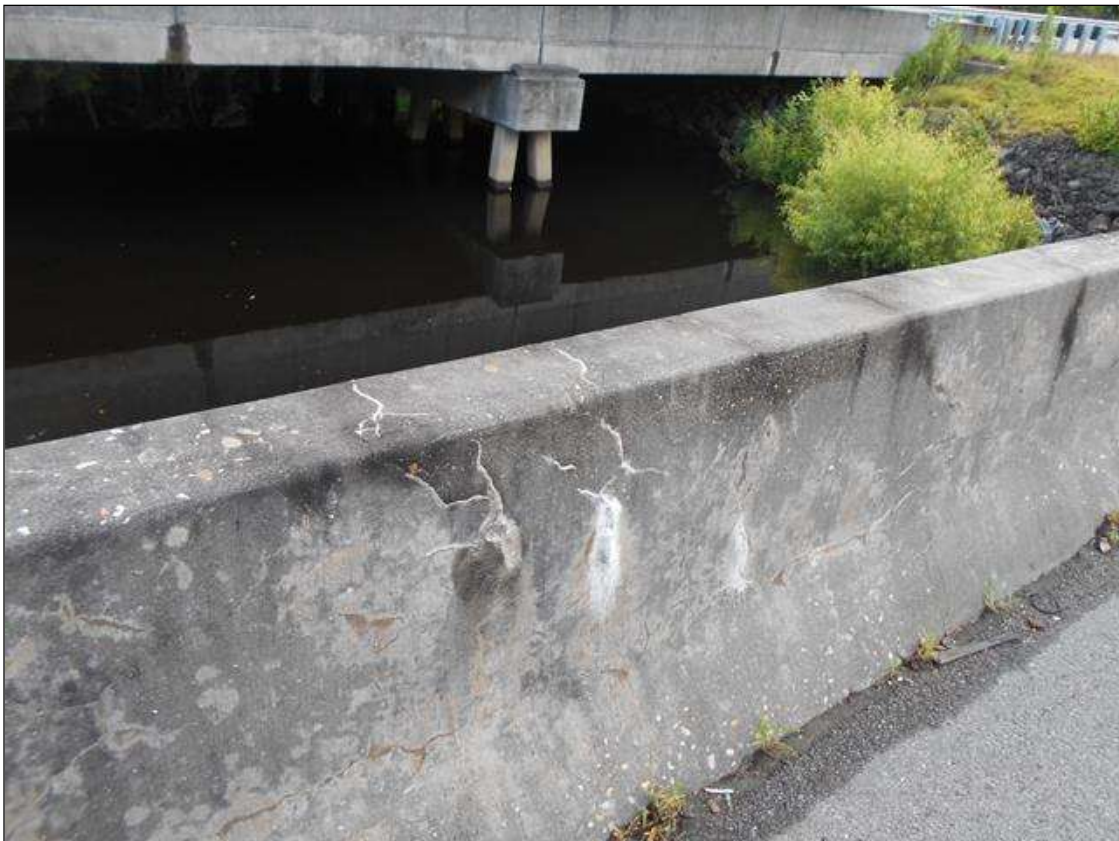
| Element Number | Defect Type | Defect Description | CS | CS Qty | Maint Qty |
|---|---|---|---|---|---|
| 331 | Cracking (RC and Other) | HAIRLINE MAP CRACKING | 2 | 18 | Feet |

Span 2 Left Bridge Rail: HAIRLINE MAP CRACKING

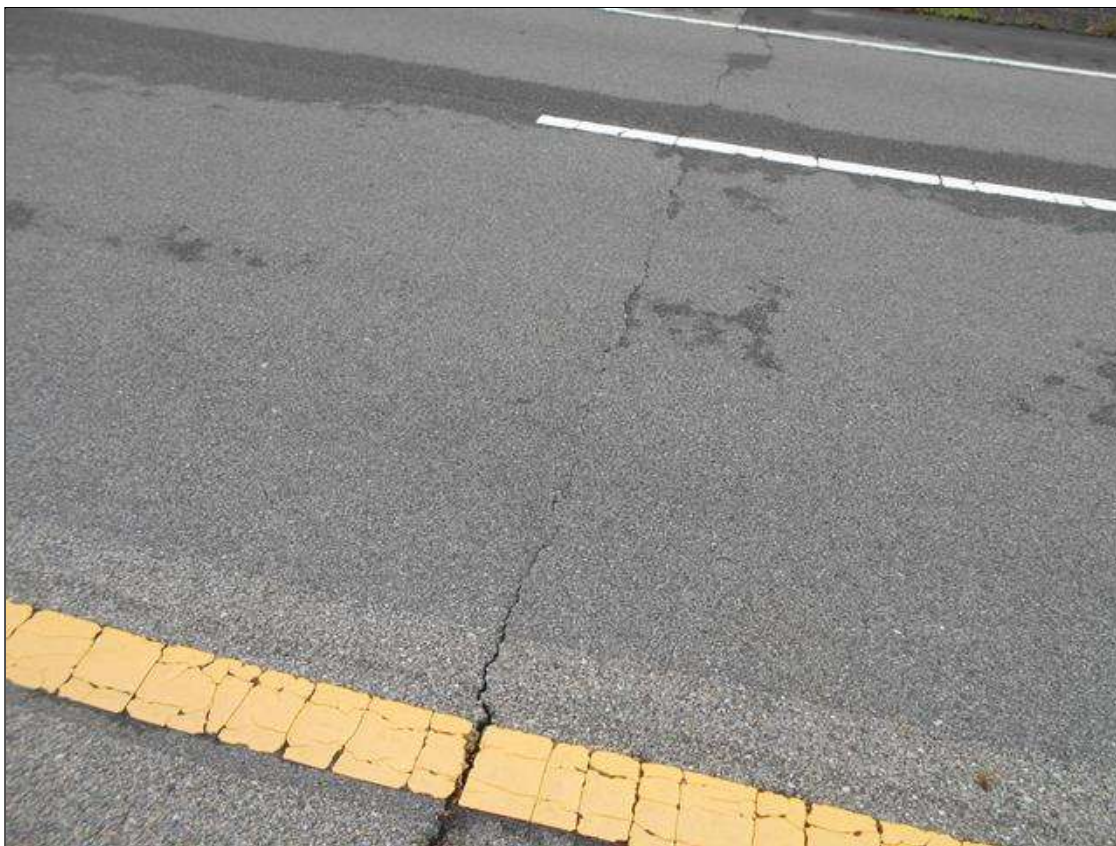
| Element Number | Defect Type | Defect Description | CS | CS Qty | Maint Qty |
|---|---|---|---|---|---|
| 510 | Crack (Wearing Surface) | 1/8" WIDE TRANSVERSE CRACK OVER BENT 2 | 3 | 36 | Square Feet |

Span 2 Wearing Surface: 1/8" WIDE TRANSVERSE CRACK OVER BENT 2

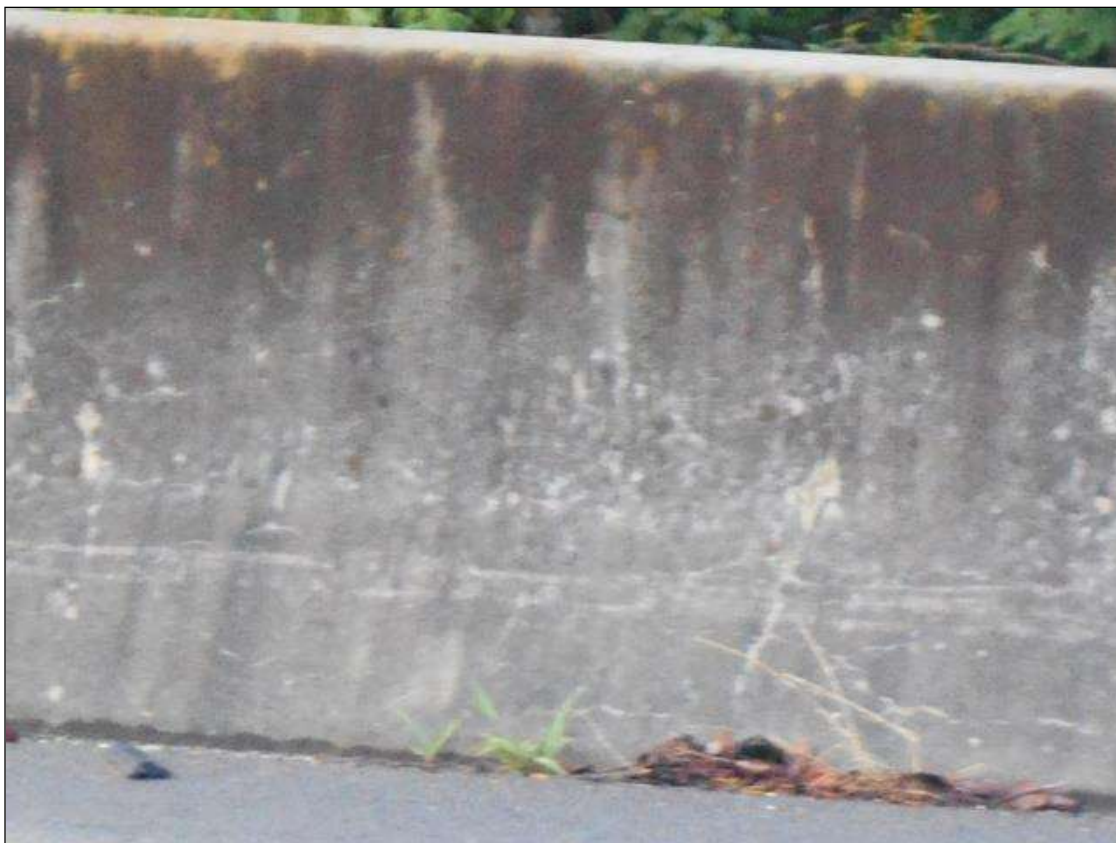
| Element Number | Defect Type | Defect Description | CS | CS Qty | Maint Qty | |
|---|---|---|---|---|---|---|
| 331 | Cracking (RC and Other) | HAIRLINE MAP CRACKING | 2 | 36 | | Feet |

Span 3 Right Bridge Rail: HAIRLINE MAP CRACKING

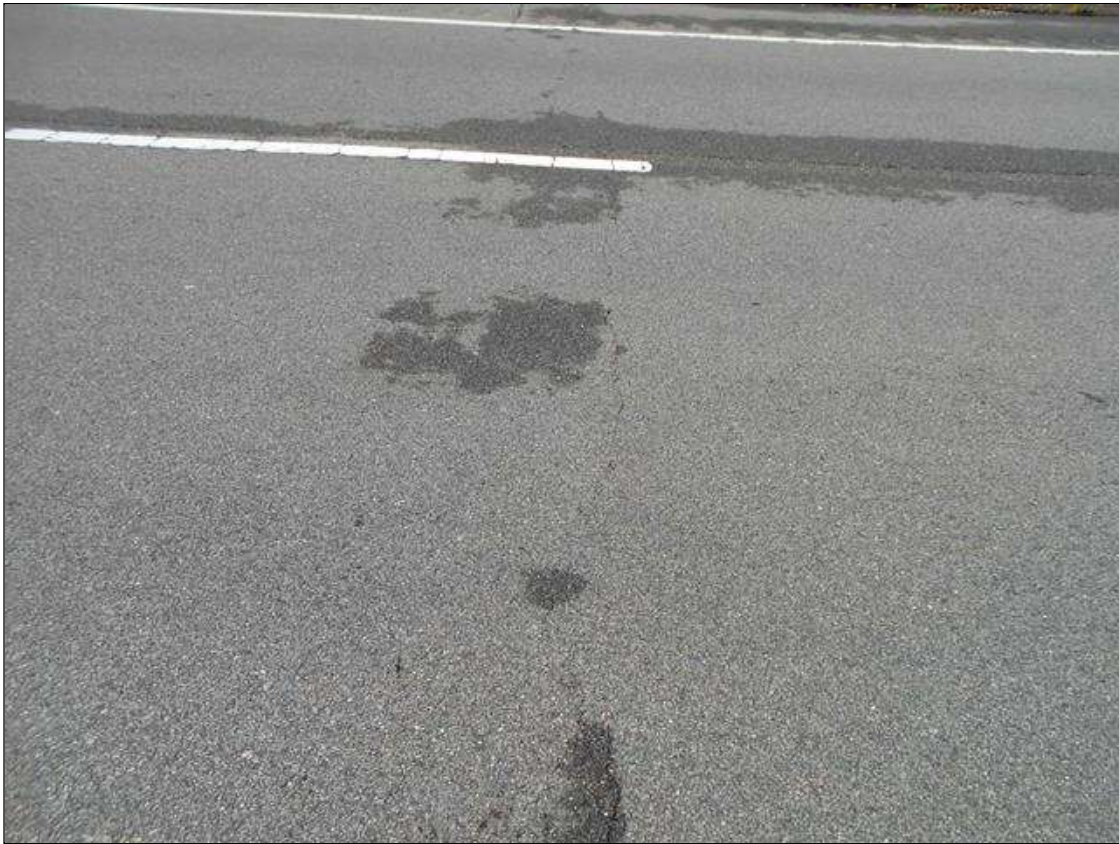
| Element Number | Defect Type | Defect Description | CS | CS Qty | Maint Qty | |
|---|---|---|---|---|---|---|
| 510 | Crack (Wearing Surface) | 1/16" WIDE TRANSVERSE CRACK OVER END BENT 2 | 2 | 36 | 36 | Square Feet |

Span 3 Wearing Surface: 1/16" WIDE TRANSVERSE CRACK OVER END BENT 2

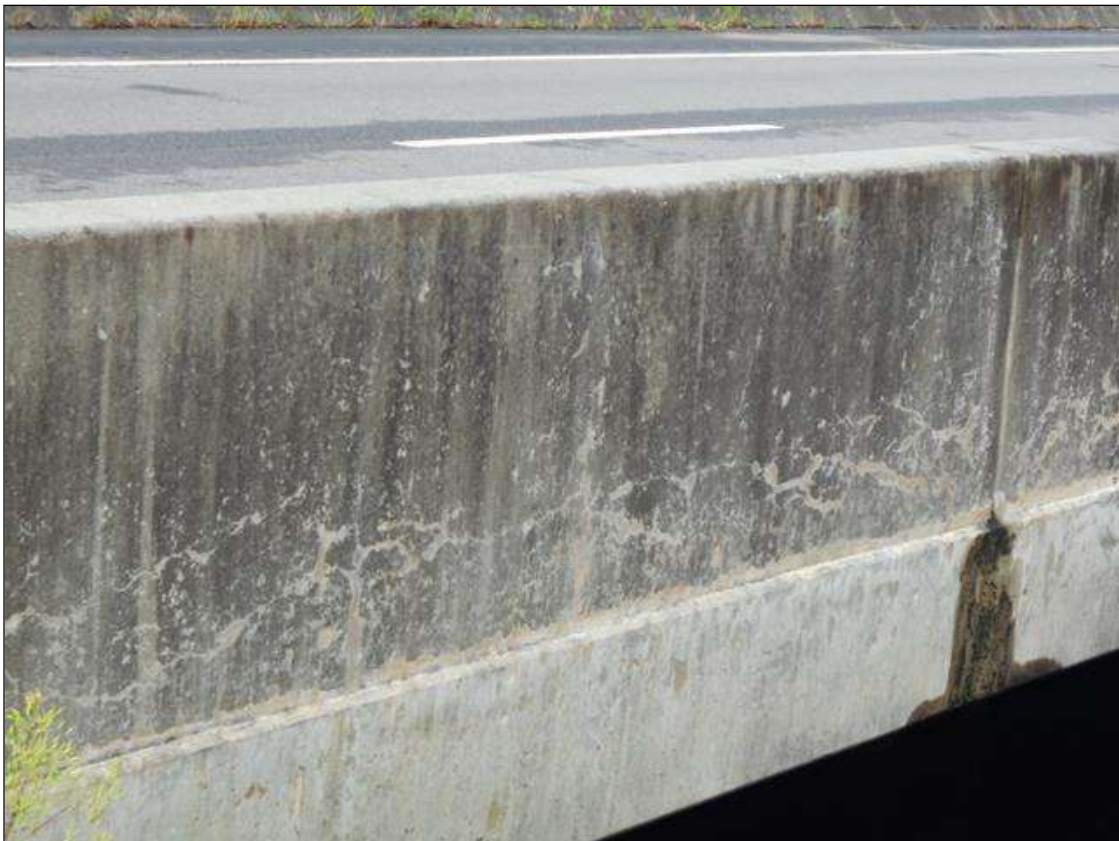
| Element Number | Defect Type | Defect Description | CS | CS Qty | Maint Qty | |
|---|---|---|---|---|---|---|
| 331 | Cracking (RC and Other) | HAIRLINE MAP CRACKING ON EXTERIOR SIDE | 2 | 36 | | Feet |

Span 3 Left Bridge Rail: HAIRLINE MAP CRACKING ON EXTERIOR SIDE
