## Structure Safety Report

### Routine Element Inspection - Contract

COUNTY: CUMBERLAND STRUCTURE NUMBER: 250045 FREQUENCY: 24 MONTHS

FEATURE INTERSECTED: SOUTH RIVER

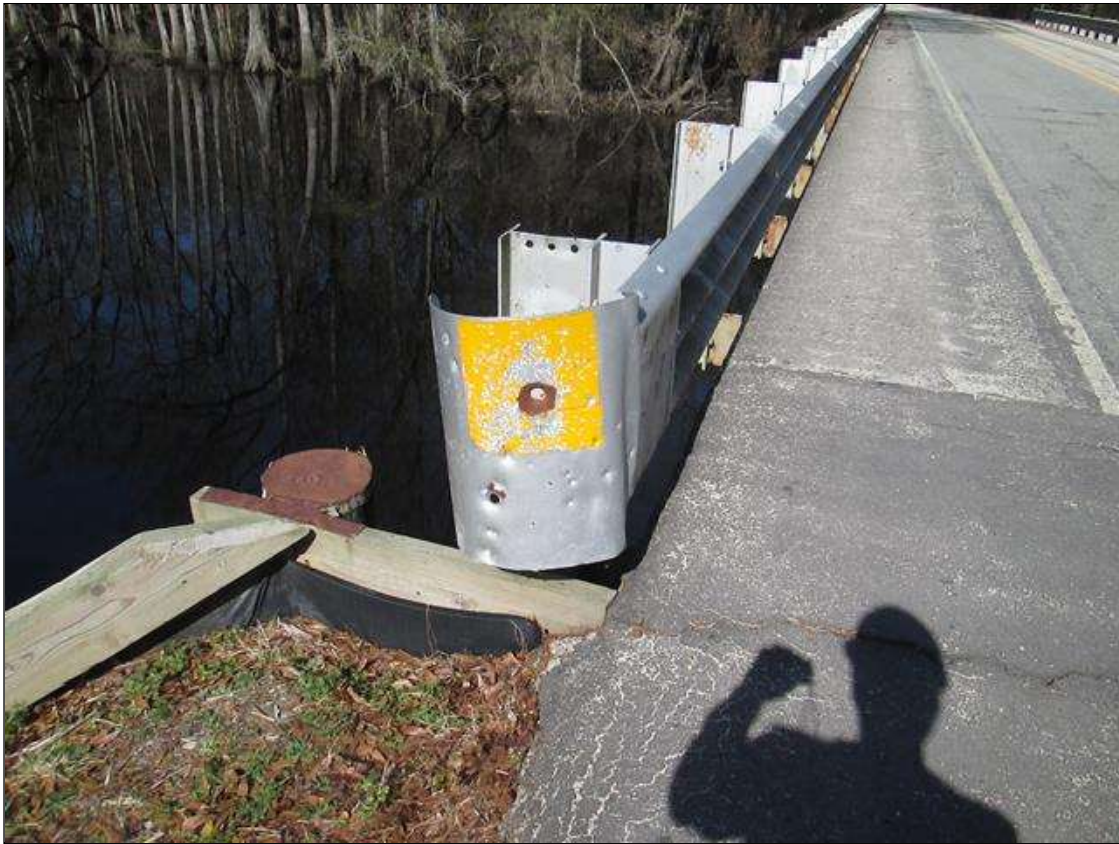
Damaged guardrail end treatment.

DAMAGED GUARDRAIL END TREATMENT ON ALL 4 CORNERS

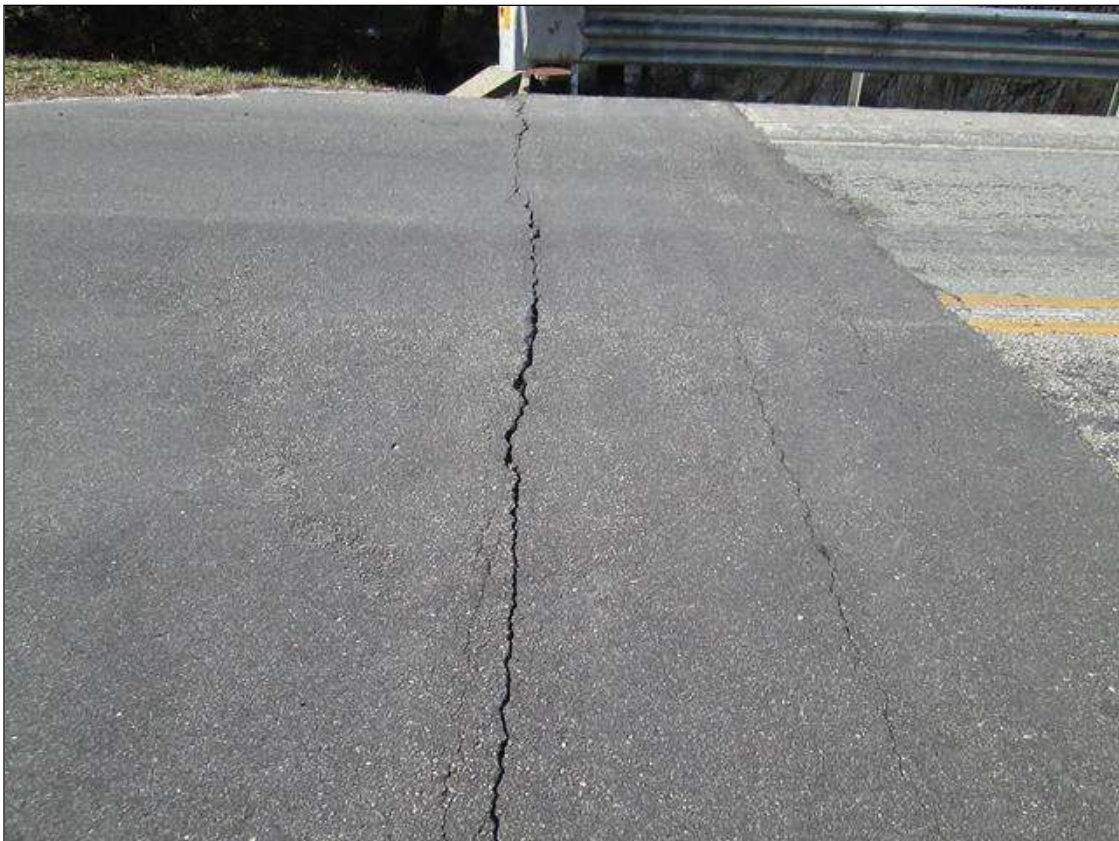
0.50" crack in wearing surface over End Bent 1.

0.5" CRACK IN ASPHALT WEARING SURFACE OVER END BENT 1 WITH UP TO 0.5" SETTLEMENT OF APPROACH ROADWAY

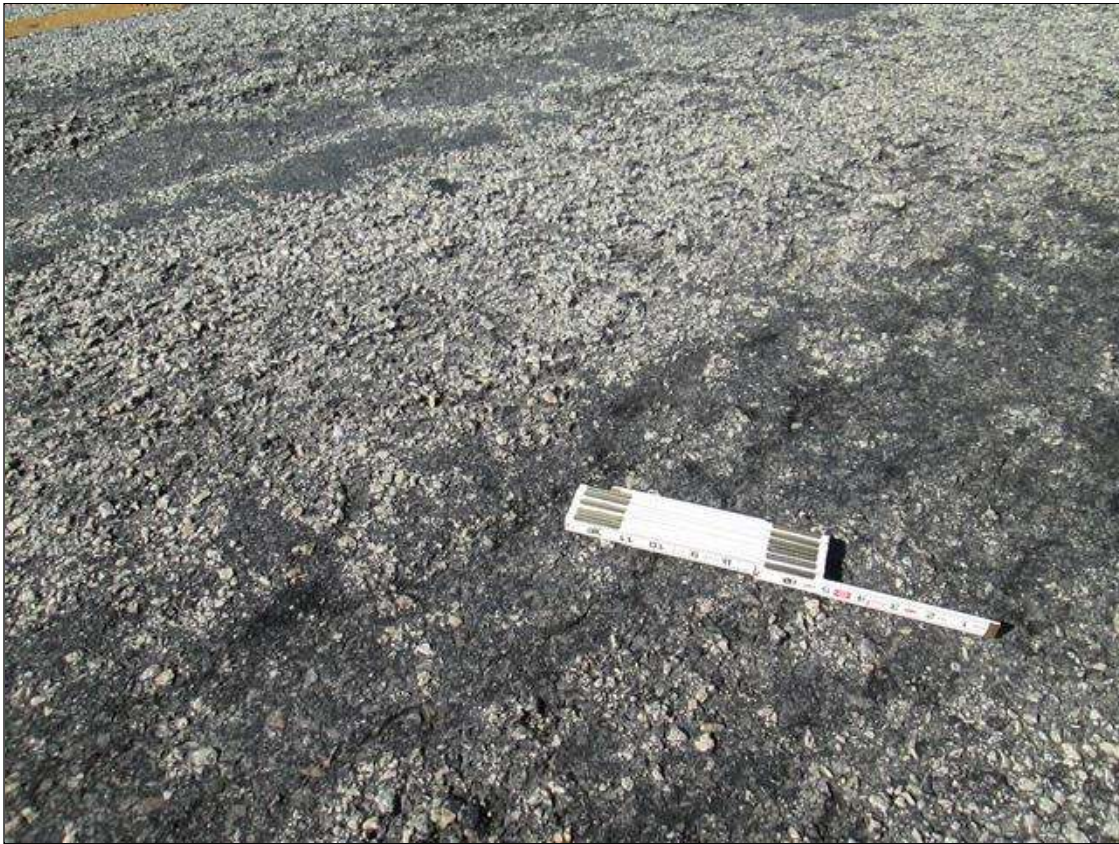
Surface of wearing surface weathered and scaled with exposed coarse aggregate in all spans.

SURFACE OF ASPHALT WEARING SURFACE WEATHERED AND SCALED WITH EXPOSED COARSE AGGREGATE IN ALL SPANS

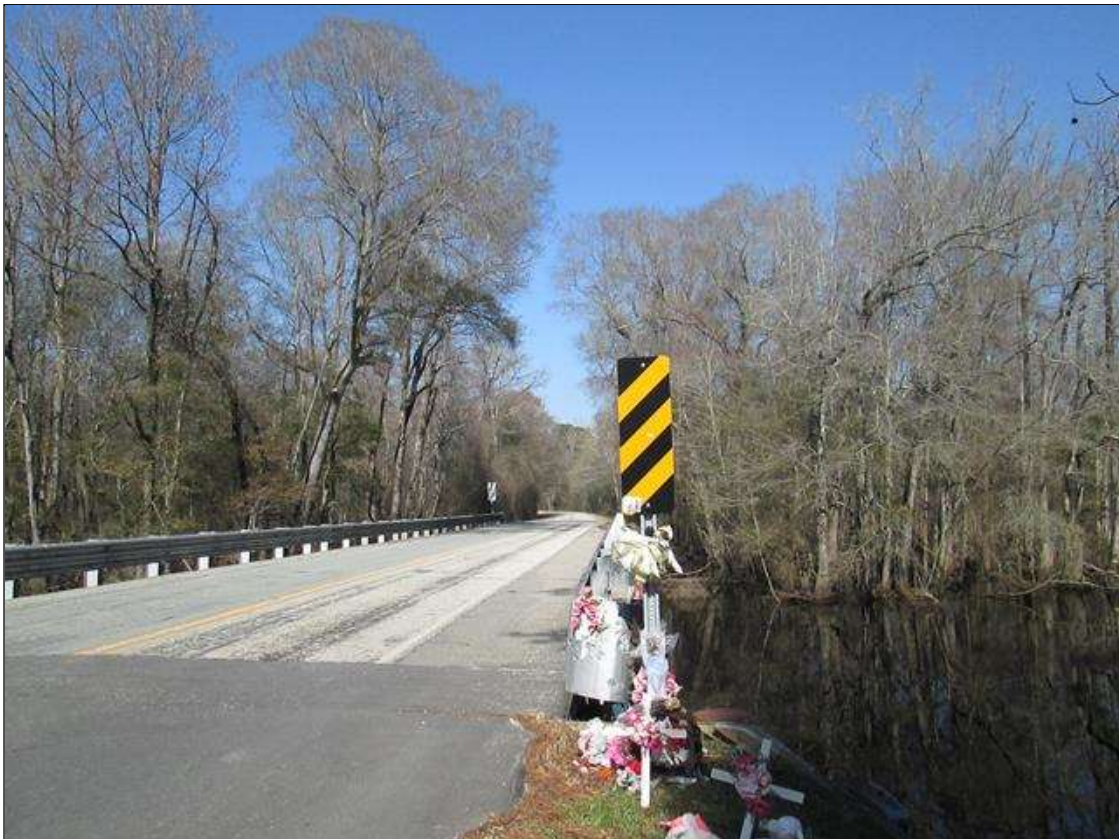
NO WEIGHT LIMIT SIGN ON SOUTH APPROACH

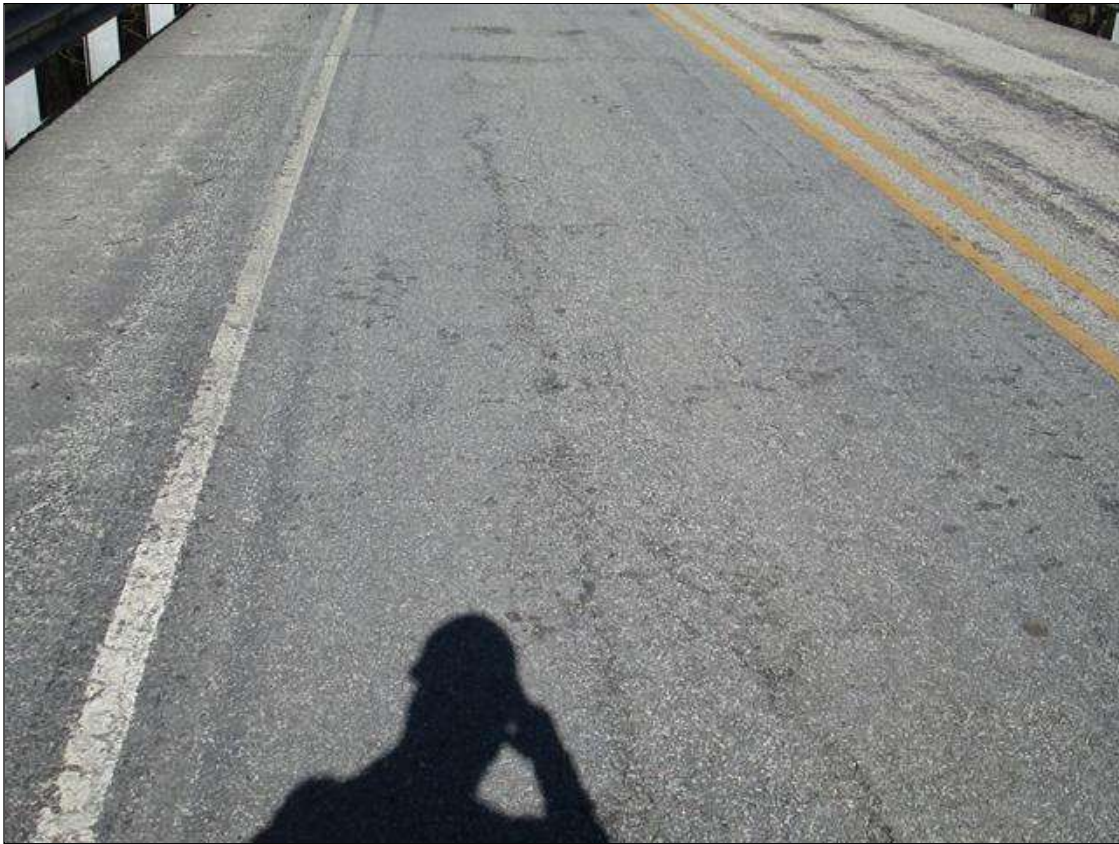
0.125" long cracks in southbound lane of span.

0.125" LONGITUDINAL CRACKS IN SOUTHBOUND LANE OF SPAN 1

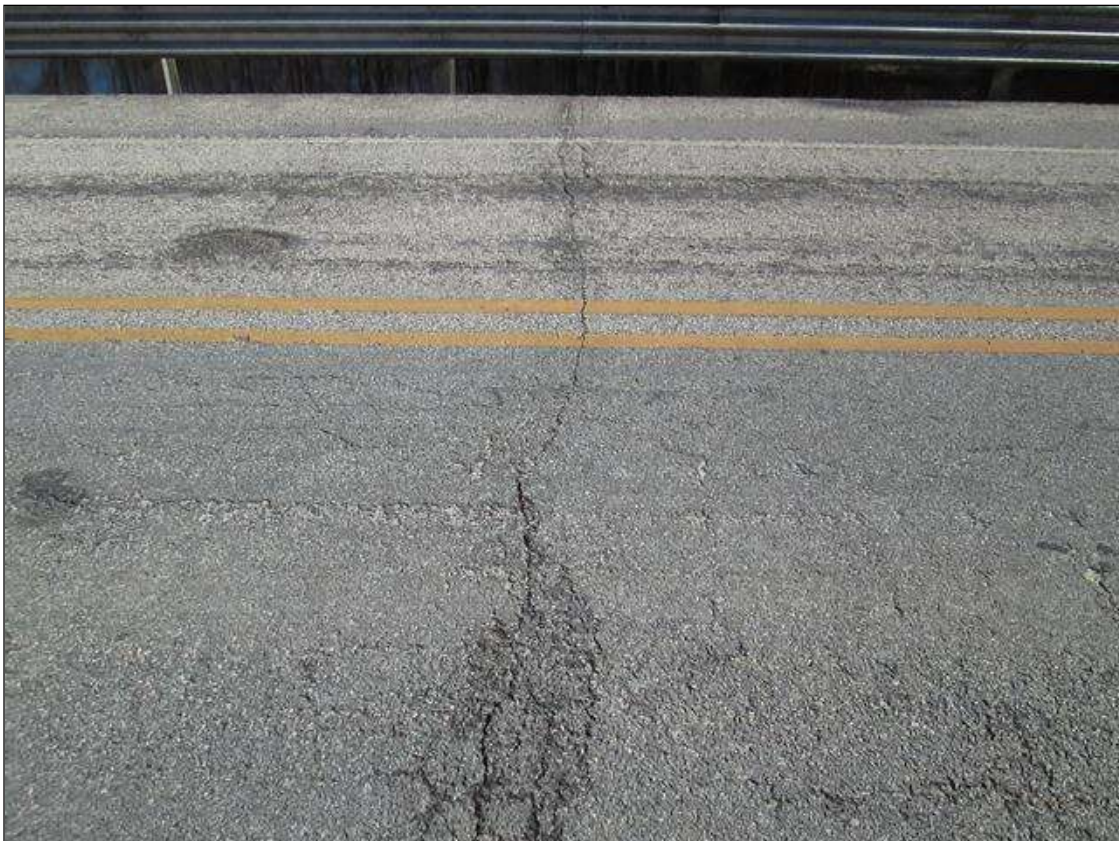
0.25" crack in wearing surface over Bent 1.

0.25" crack in wearing surface over Bent 2.

0.25" crack in wearing surface over Bent 3.

0.25" crack in wearing surface over Bent 4.

0.25" crack in wearing surface over Bent 5.

0.25" CRACK IN ASPHALT WEARING SURFACE OVER ALL INTERIOR BENTS

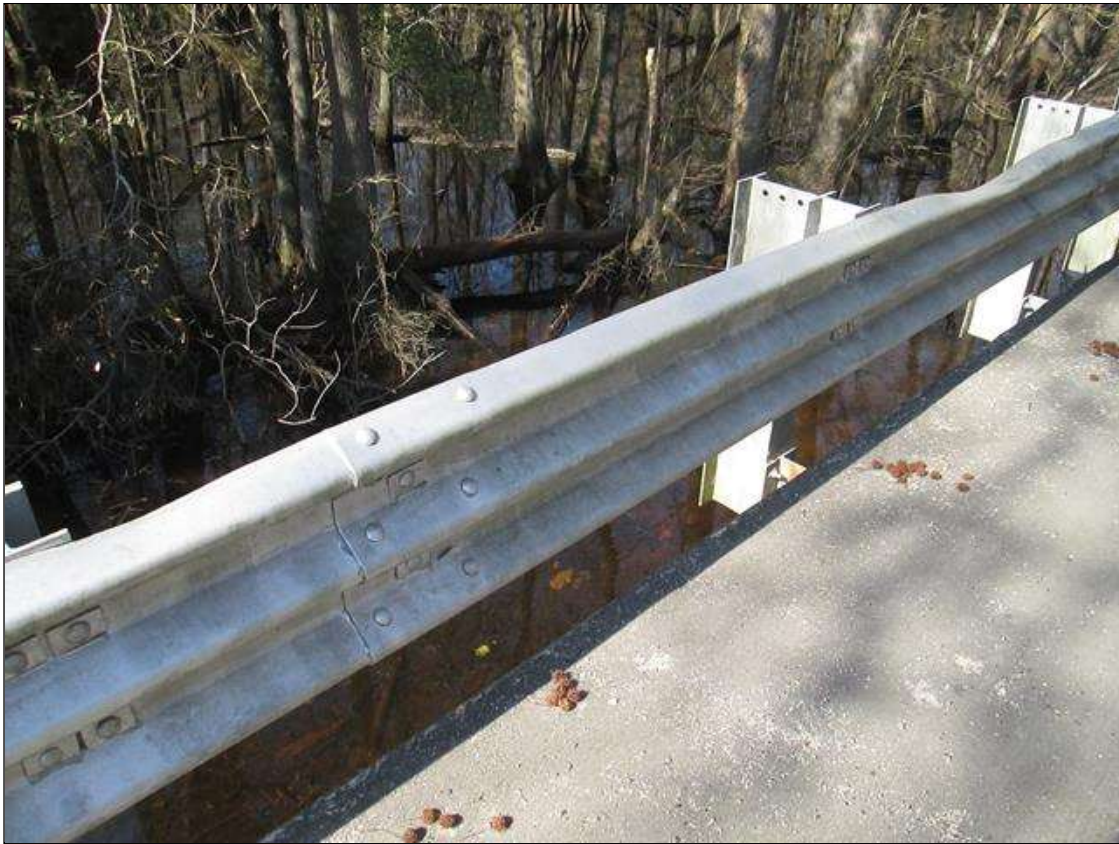
15' of barrier has impact damage.

IMPACT DAMAGE TO 15' SECTION OF LEFT BARRIER IN SPAN 4

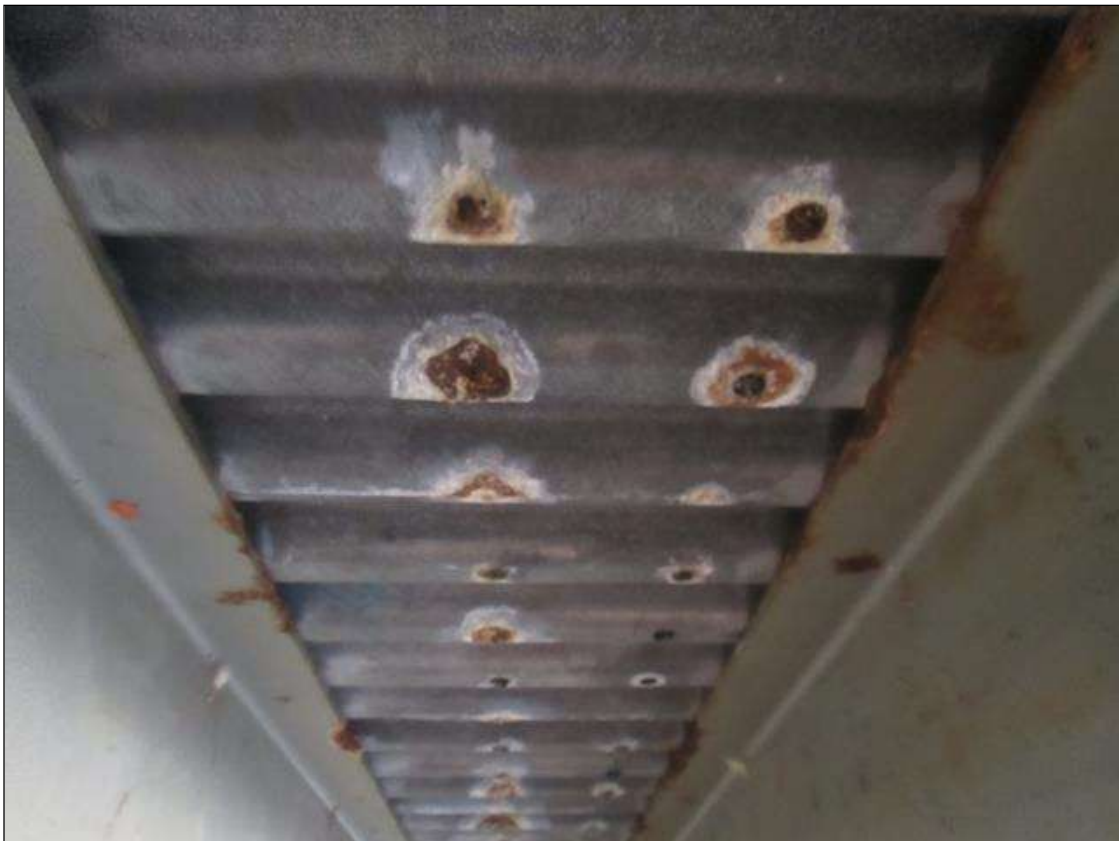
Surface rust throughout steel deck around drainage holes.

SURFACE RUST THROUGHOUT STEEL DECKING AROUND DRAINAGE HOLES

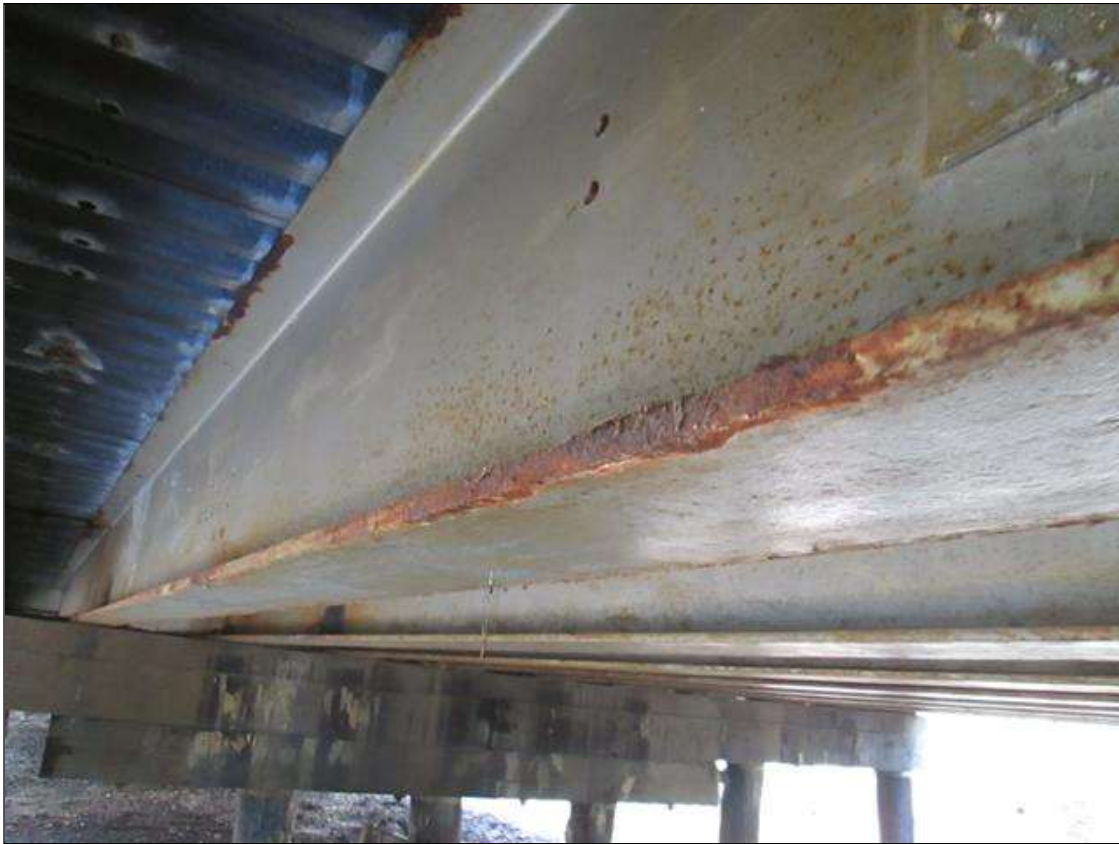
SURFACE RUST ON BOTTOM FLANGES OF BEAMS THROUGHOUT

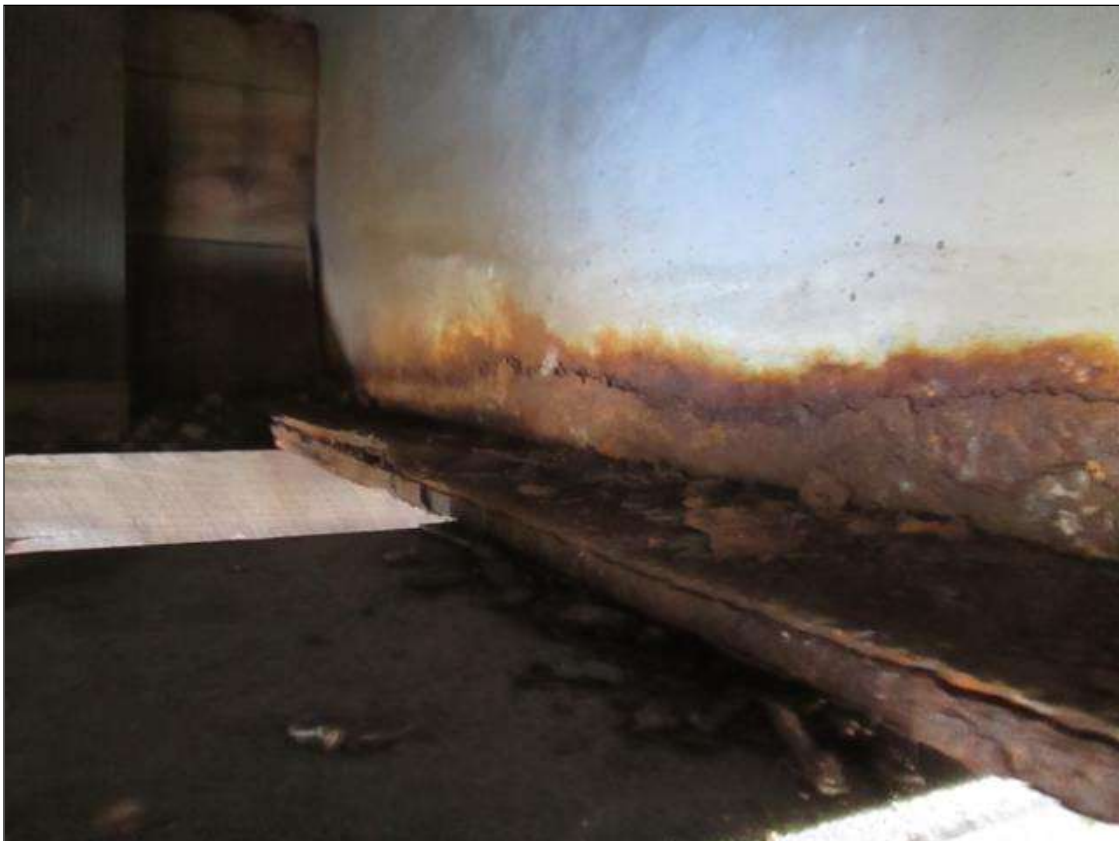
Beam has corrosion for 4' near end bent 1 with up to 0.125" section loss in bottom flange and bottom 3" of web.

BEAM 8 AT END BENT 1 HAS CORROSION WITH UP TO 0.125" SECTION LOSS FOR 4' IN BOTTOM FLANGE AND BOTTOM 3" OF WEB

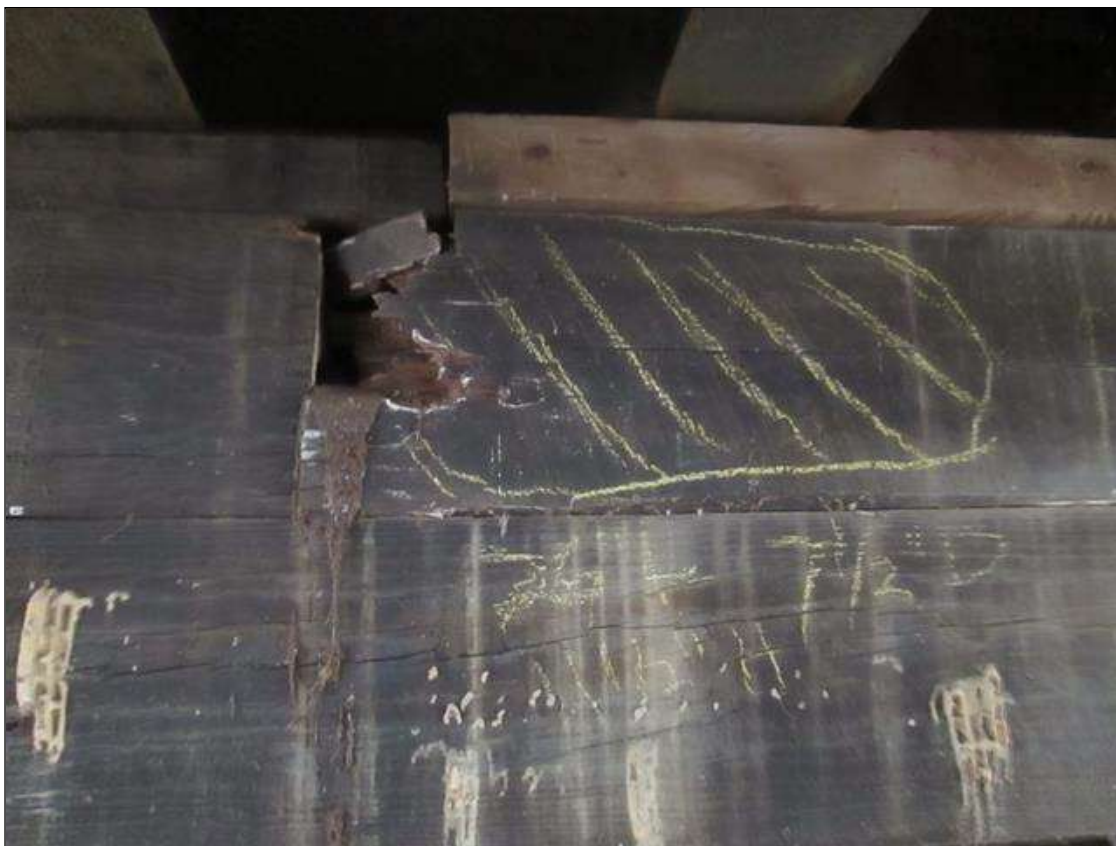
| End Bent 2 | Row 1 | Caps | 2 | | | | | | | | | |
|---|---|---|---|---|---|---|---|---|---|---|---|---|
| 3' x 1' area of decay in original bent cap under beam 8. | | | | | | | | | | | | |

3' X 1' AREA OF DECAY IN ORIGINAL END BENT 2 CAP UNDER BEAM 8

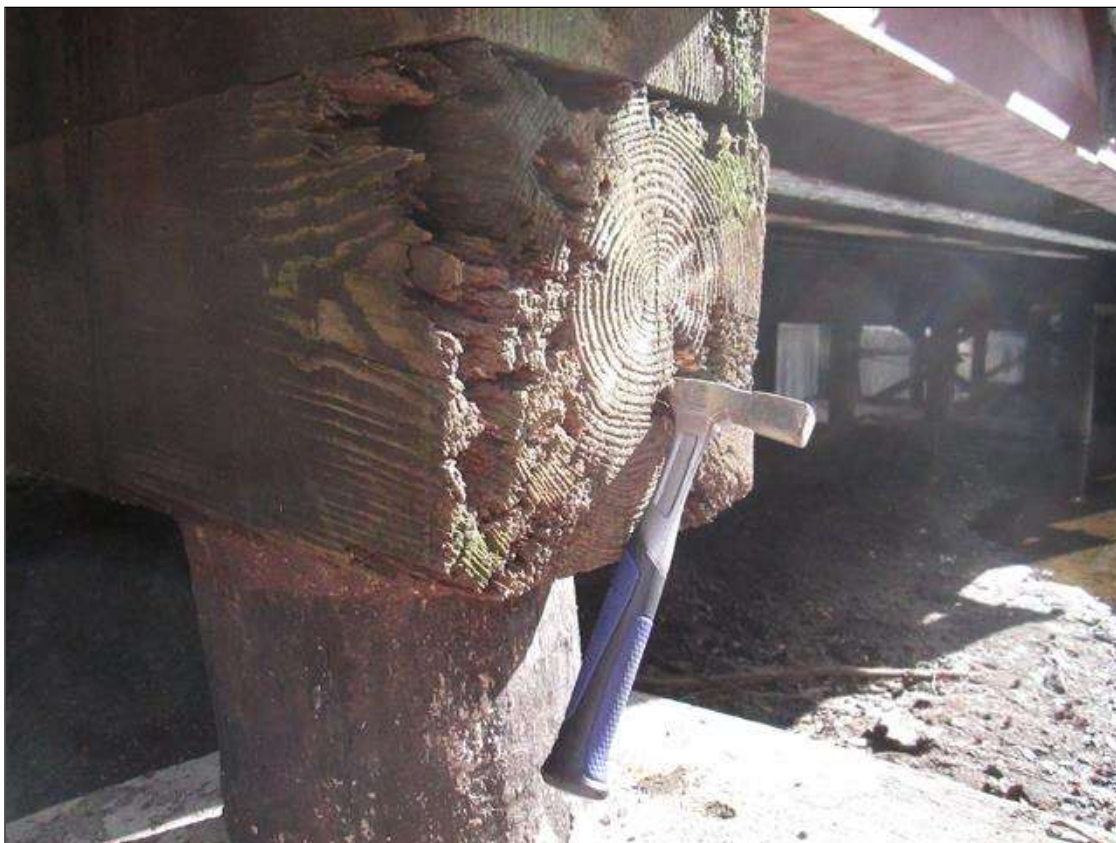
| 8" Decay in end of cap. | | | | | | | | | | | | |

8" DEEP DECAY IN BOTH ENDS OF BENT 4 CAP

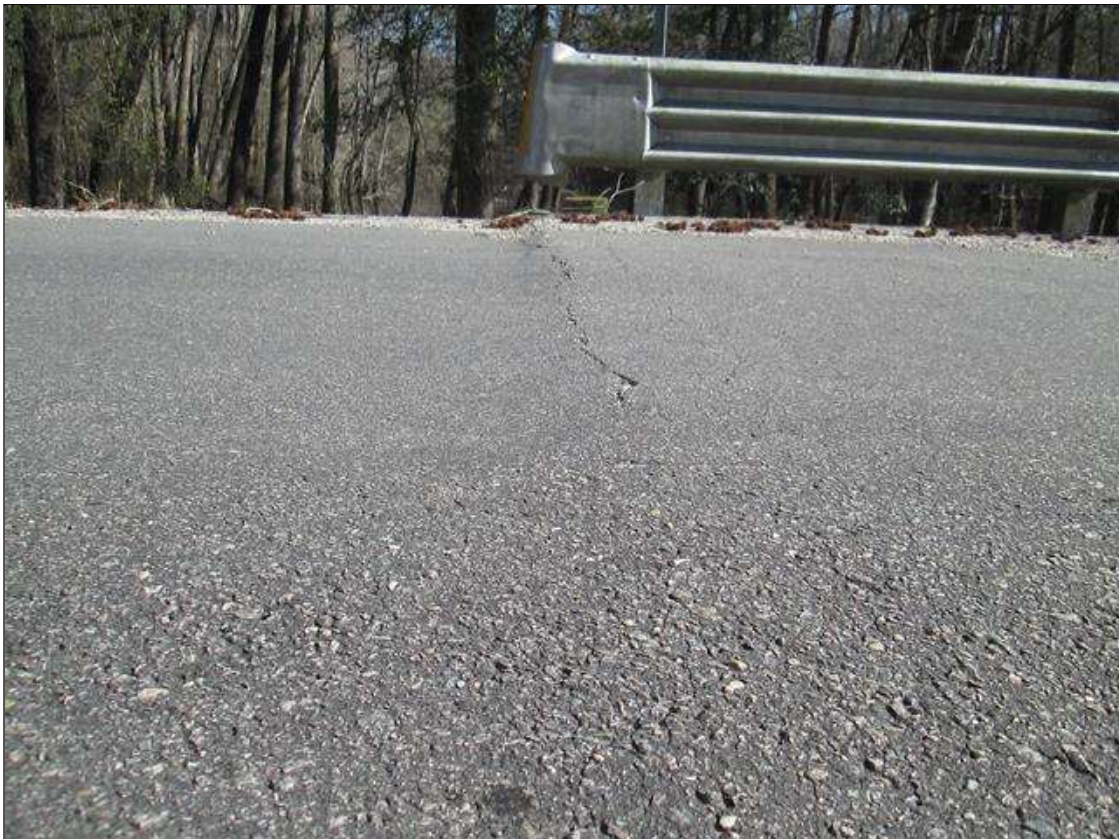
0.125" CRACK WITH UP TO 0.5" SETTLEMENT IN NORTH APPROACH

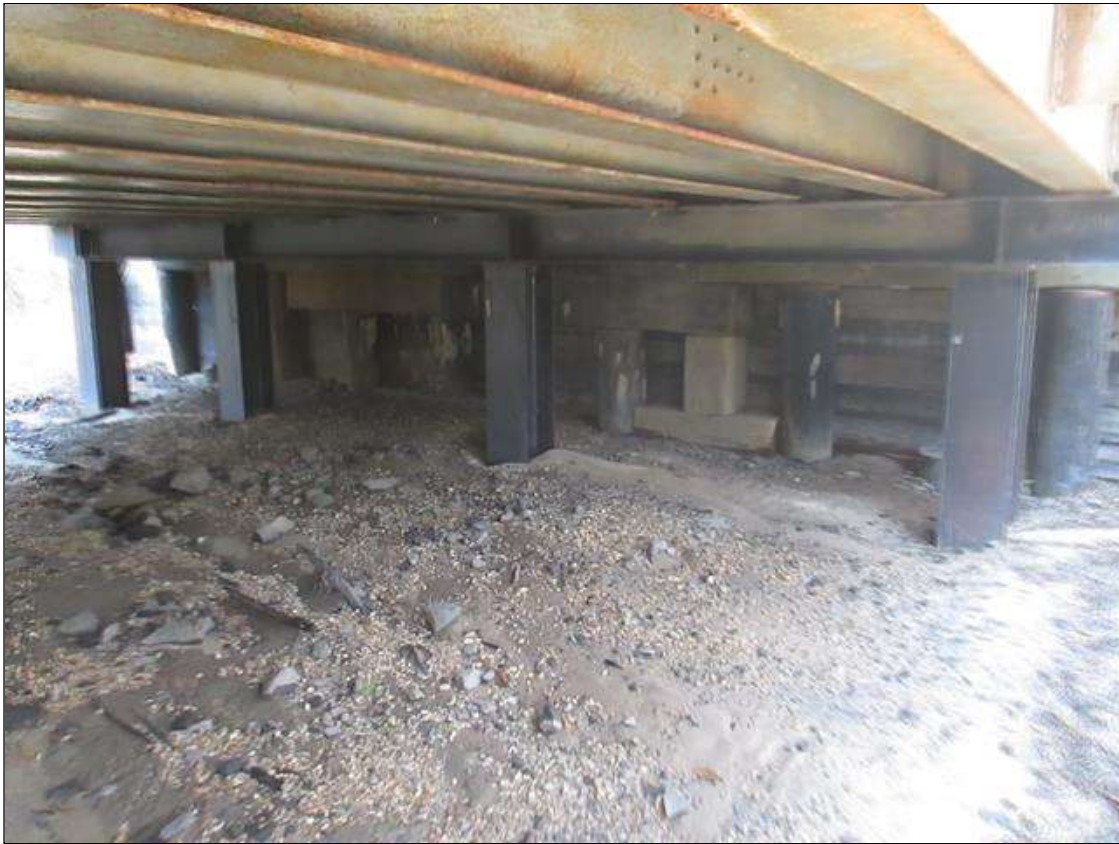
END BENT 2 WITH ADDED CRUTCH BENT

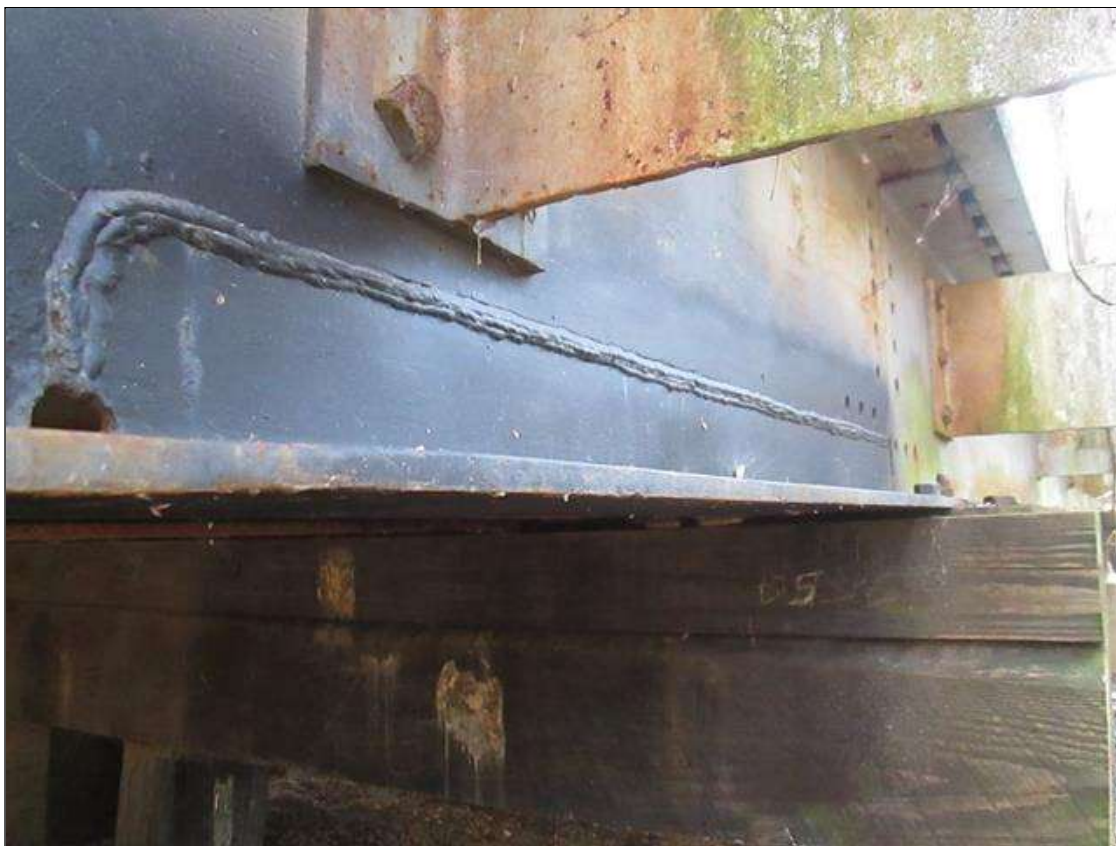
Web of beam over Bent 5 repaired.

REPAIR TO BEAM 1 WEB OVER BENT 5 IN SPAN 6

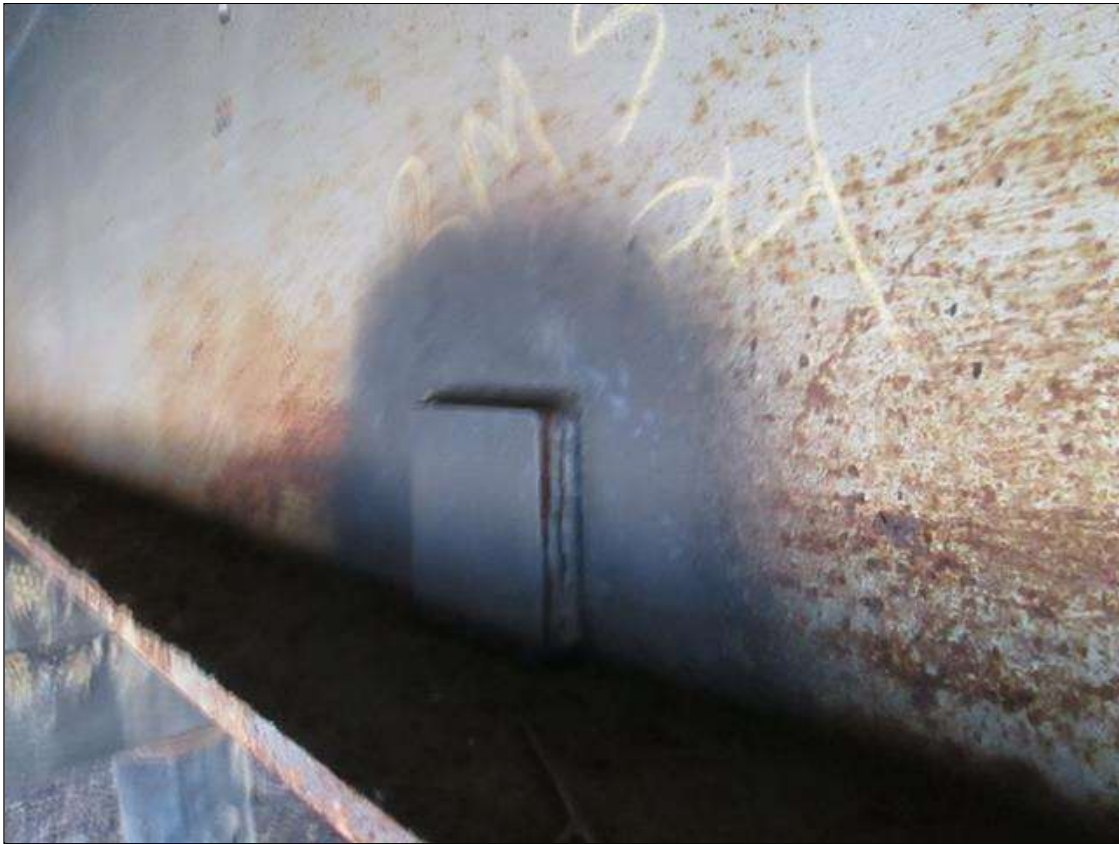
Beam repaired in 1 location.

Beam repaired in 2 locations.

REPAIR TO BEAM 5 IN SPAN 4 (2 LOCATIONS. SIMILAR REPAIR TO BEAM 4 IN SPAN 4)

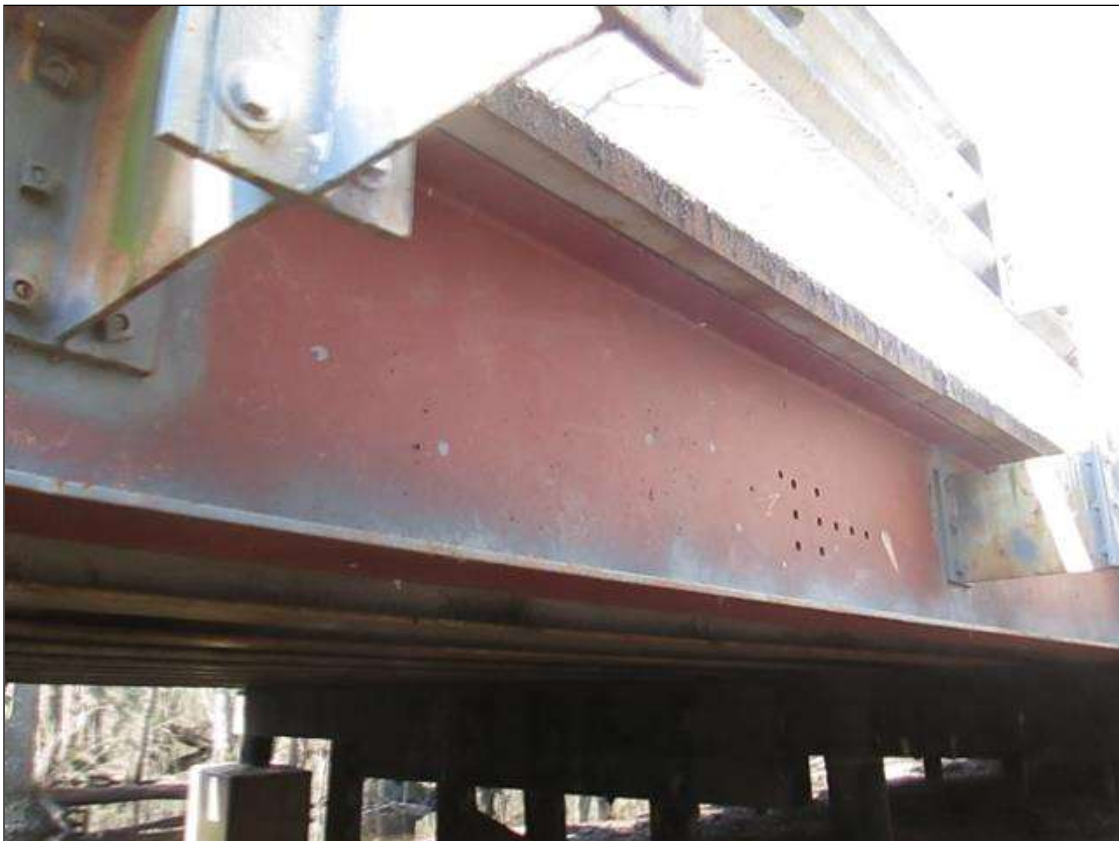
Beam has been replaced.

BEAMS 1 AND 13 REPLACED IN SPAN 4

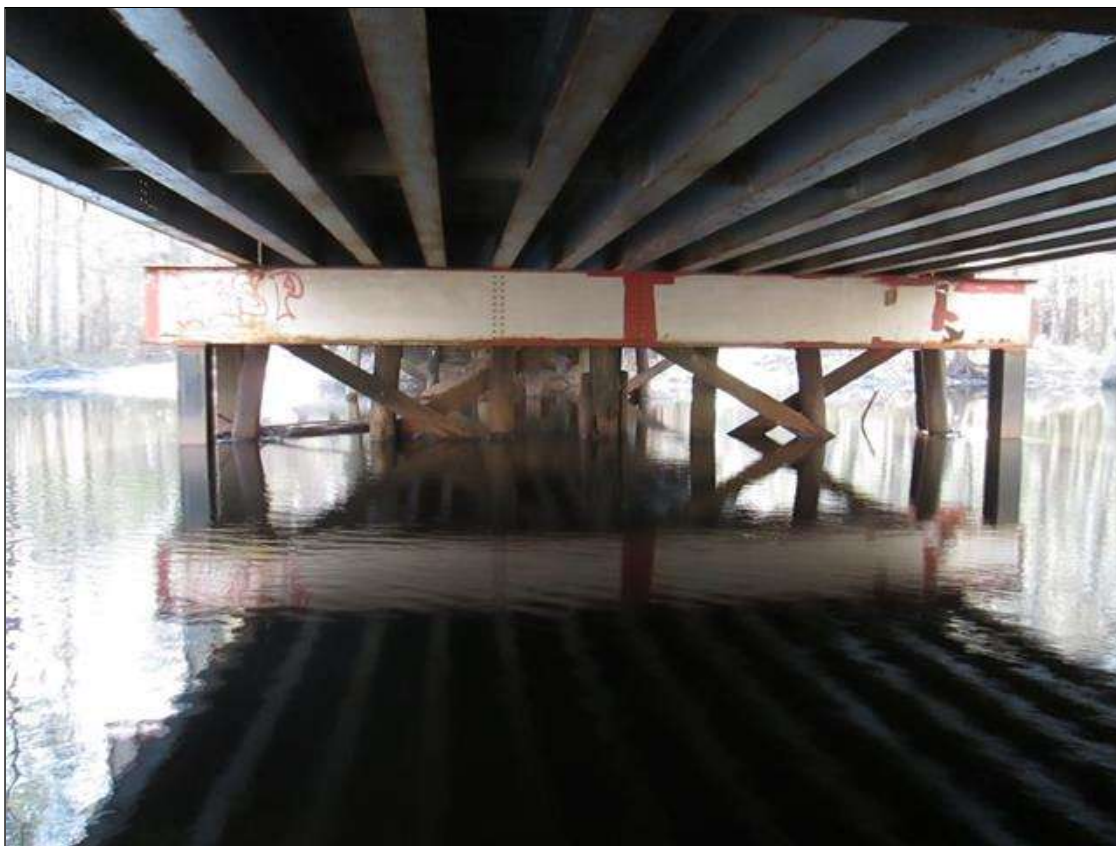
BENT 2 LOOKING SOUTH WITH CRUTCH BENTS ON BOTH SIDES

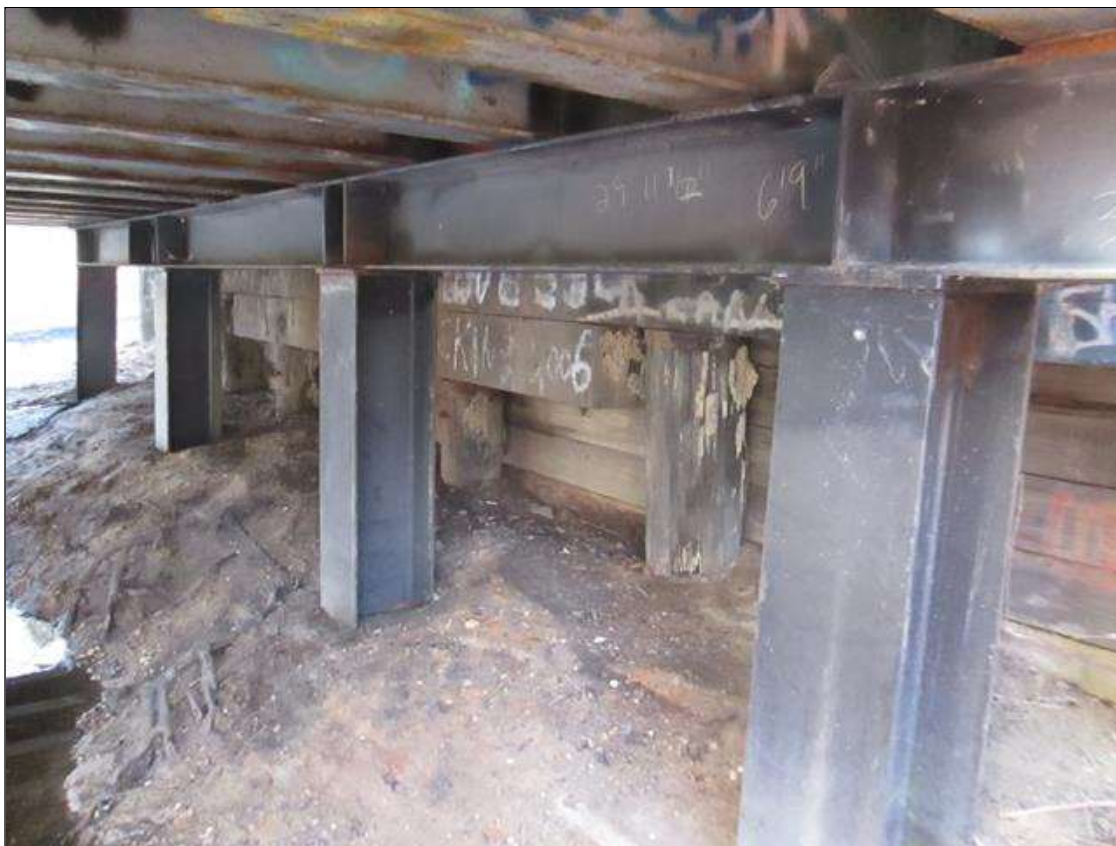
END BENT 1 WITH ADDED CRUTCH BENT

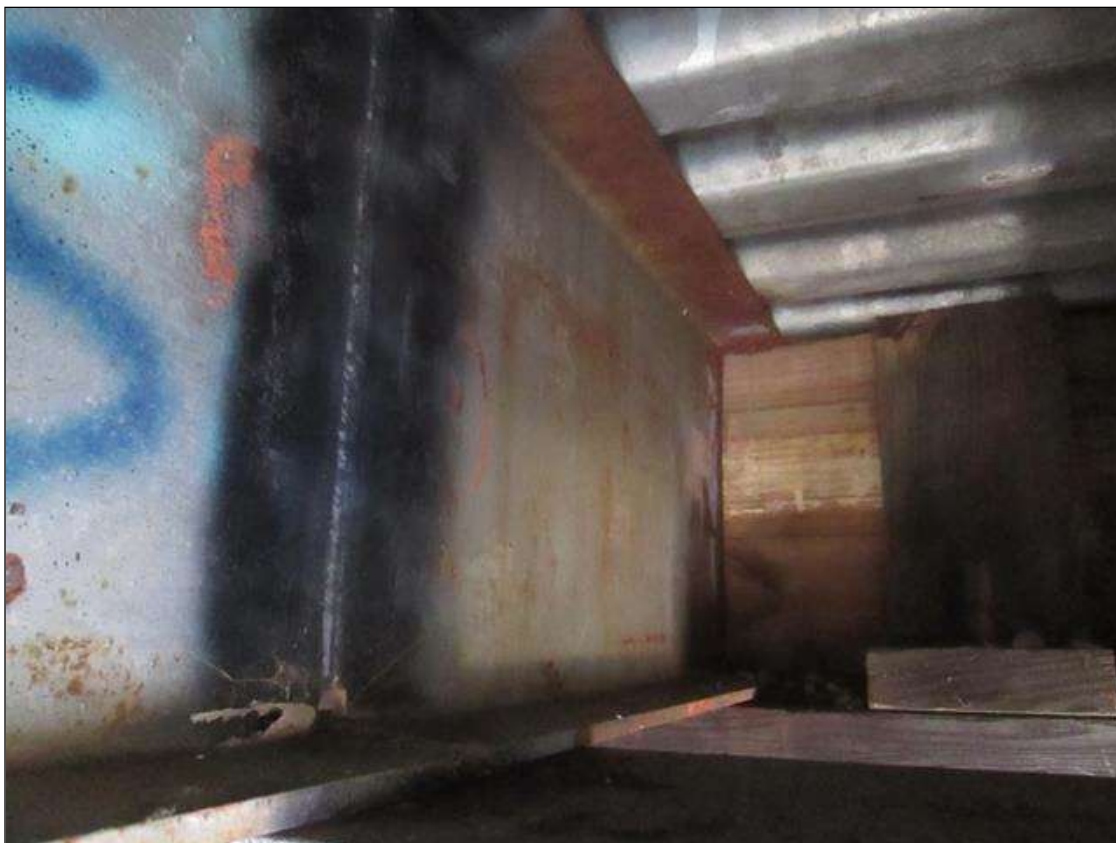
End of beam at End Bent 1 replaced.

END OF BEAM 3 REPLACED AT END BENT 1 (SIMILAR REPAIR TO BEAMS 4 AND 9 AT END BENT 1)

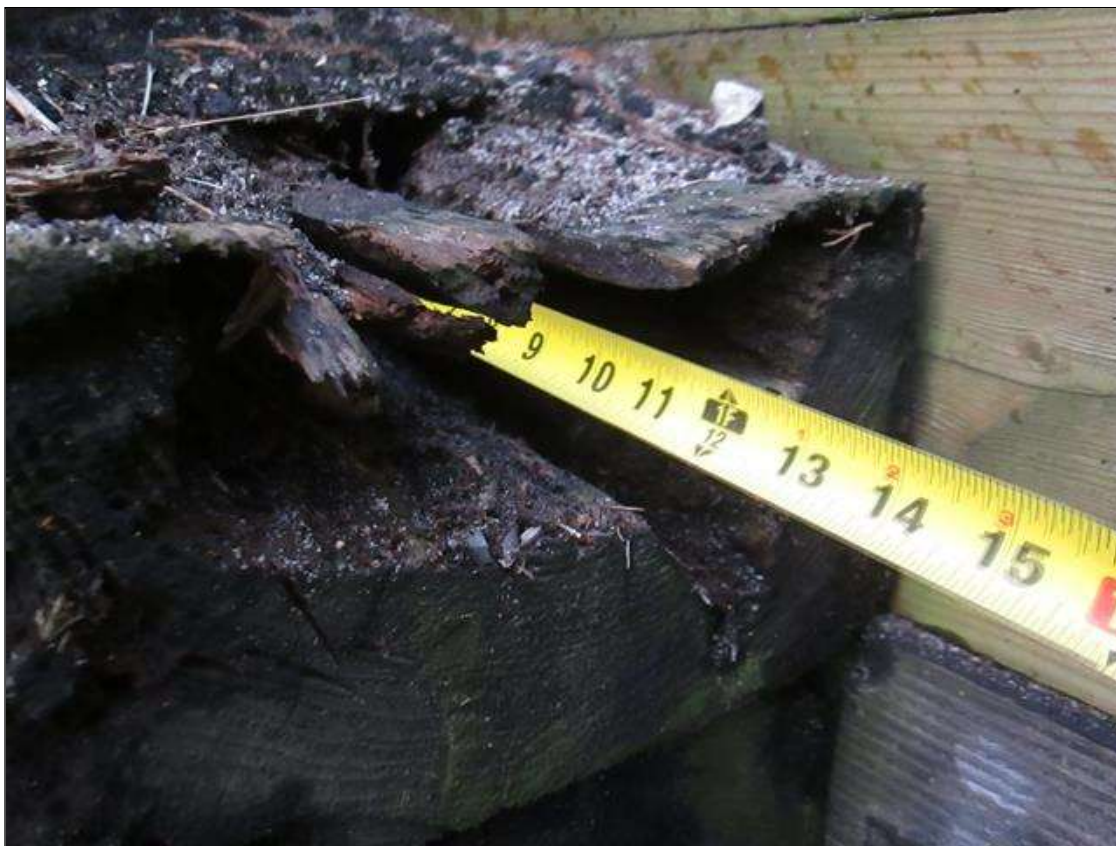
| End Bent 1 | Row 1 | Caps | 2 | | | | | | | | |
|---|---|---|---|---|---|---|---|---|---|---|---|
| 12" deep decay in west end of crown strip of original bent cap. | | | | | | | | | | | |

12" DEEP DECAY TO WEST END OF CROWN STRIP OF ORIGINAL END BENT 1
