NC DEPARTMENT OF TRANSPORTATION  
DIVISION OF HIGHWAYS  
STRUCTURE MANAGEMENT UNIT

## Structure Safety Report

### Routine Element Inspection - Contract

COUNTY: DAVIDSON STRUCTURE NUMBER: 280055 FREQUENCY: 24 MONTHS  
FACILITY CARRIED: NC47 MILE POST: \_\_\_\_\_  
LOCATION: 0.3 MI. W. JCT. SR2346  
FEATURE INTERSECTED: FLAT SWAMP CREEK  
LATITUDE: 35° 41' 11" LONGITUDE: 80° 9' 5.13"  
SUPERSTRUCTURE: REINFORCED CONCRETE DECK ON I-BEAMS  
SUBSTRUCTURE: E.BENTS:RC CAP ON TIMBER PILES,INT.BENTS:2COL.RC POST & BEAM  
SPANS: 3@30'1"  
☐ FRACTURE CRITICAL ☐ TEMPORARY SHORING ☐ SCOUR CRITICAL ☐ SCOUR PLAN OF ACTION  
PRESENT CONDITION: Poor INSPECTION DATE: 01/07/2016  
POSTED SV: 22 POSTED TTST: 29  
OTHER SIGNS PRESENT: 4 DELINEATORS

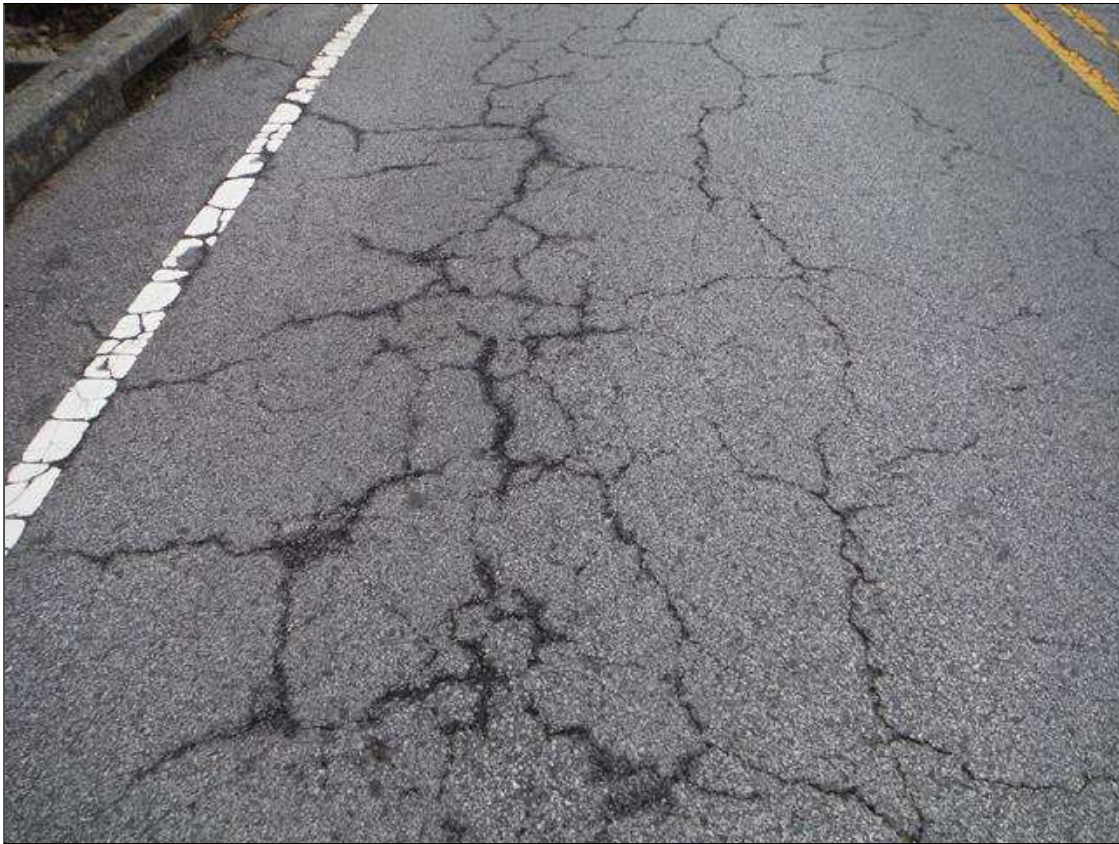
600 SF. OF ALLIGATOR CRACKING

Span 1 Wearing Surface: 600 SF. OF ALLIGATOR CRACKING

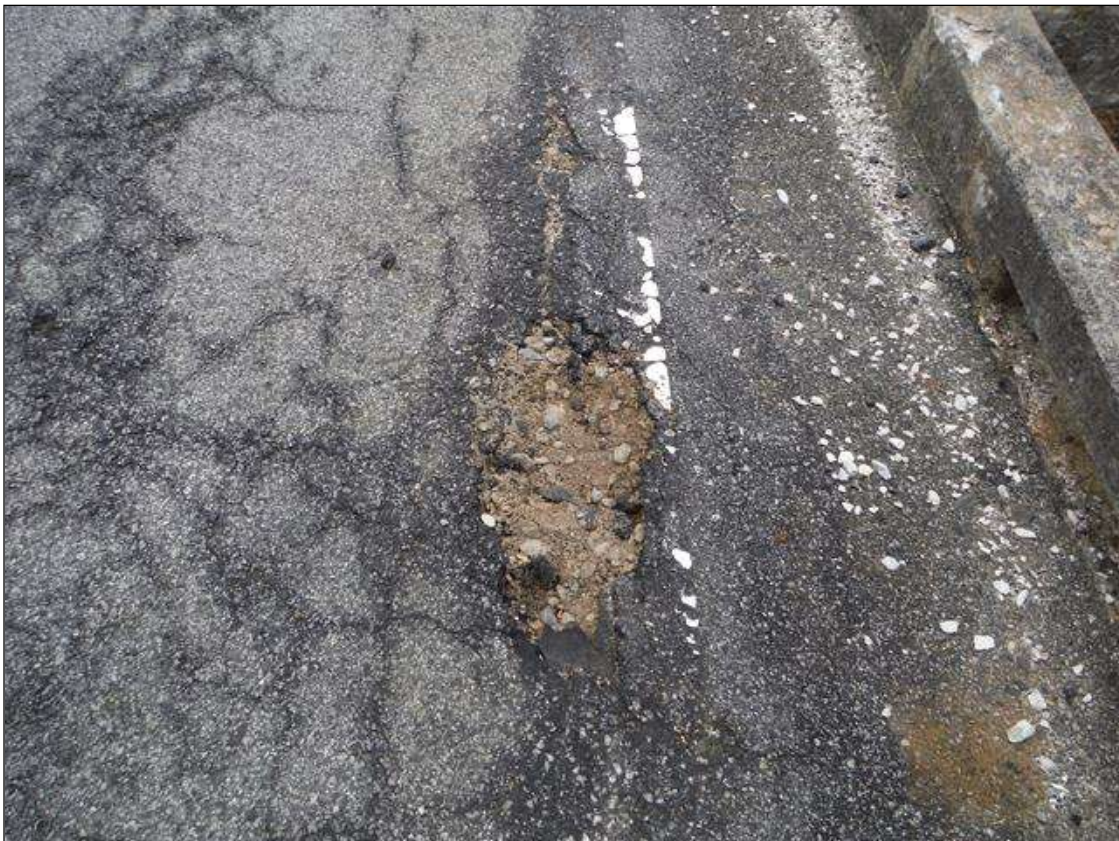
24" X 10" X FULL DEPTH POTHOLE IN EASTBOUND LANE, 3 FT. FROM BENT 1  
 600 SF. OF ALLIGATOR CRACKING

Span 2 Wearing Surface: 24" X 10" X FULL DEPTH POTHOLE IN EASTBOUND LANE, 3 FT. FROM BENT 1

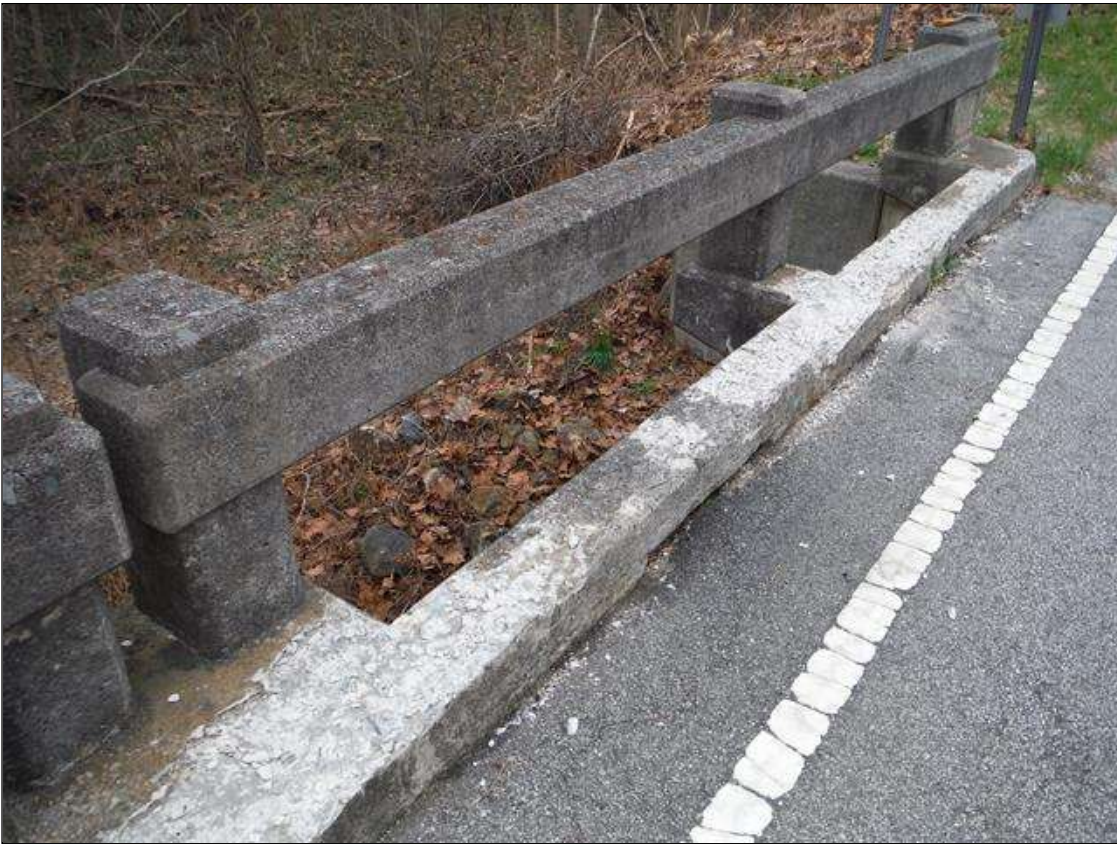
Span 3 Left Bridge Rail: 17 FT. X 7" X 1/4" DEEP AREA OF SCALING IN CURB NEAR MID SPAN

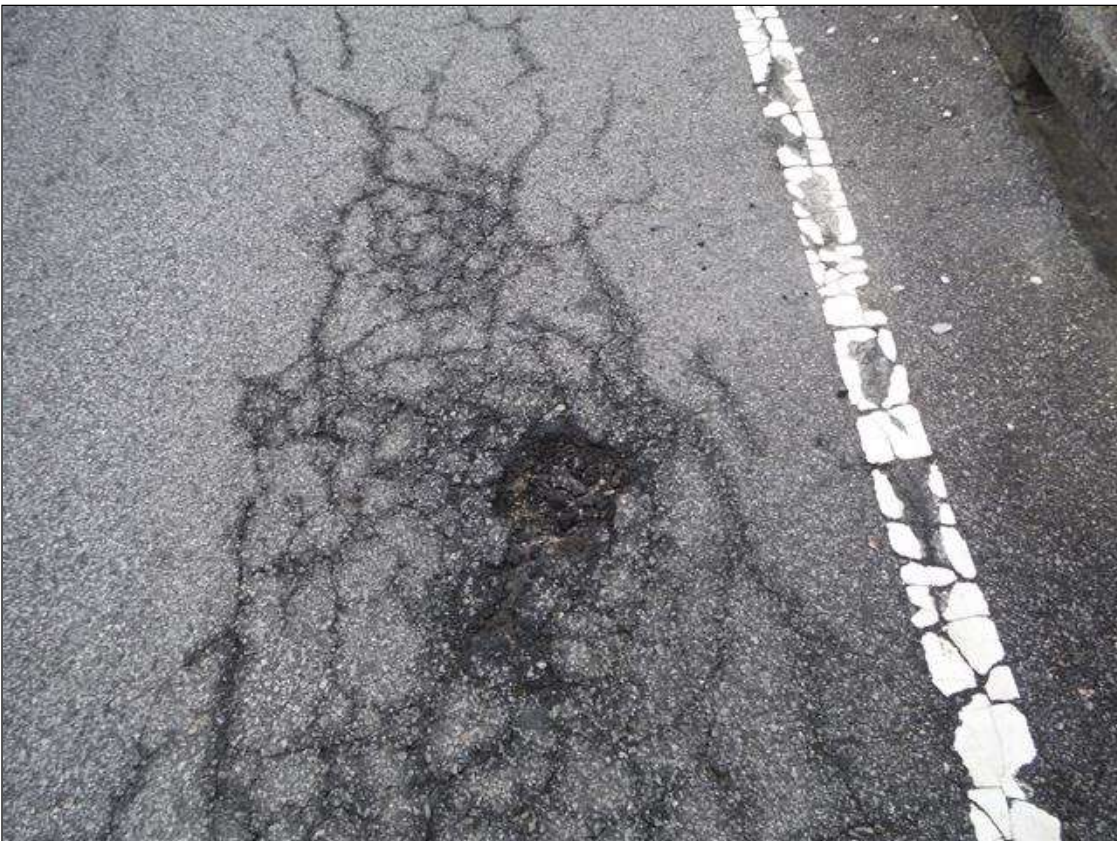
600 SF. OF ALLIGATOR CRACKING  
 8" DIAMETER X FULL DEPTH POTHOLE IN EAST BOUND LANE 5 FT. FROM END BENT 2

Span 3 Wearing Surface: 8" DIAMETER X FULL DEPTH POT HOLE IN EAST BOUND LANE 5 FT. FROM END BENT

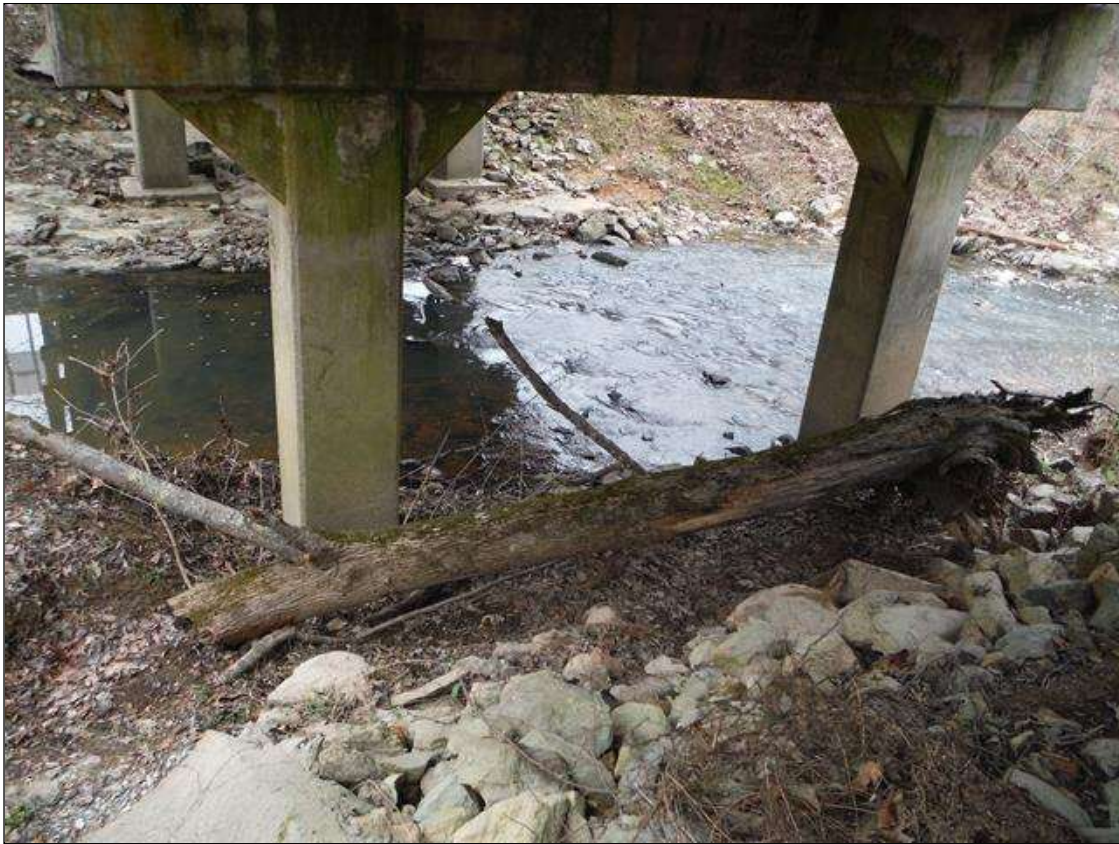
| Item | Drift | Grade | P | Maint Code | 3366 | Qty. | 40 |
|---|---|---|---|---|---|---|---|
| Details | 14" DIAMETER TREE AND DEBRIS UNDER SPAN 1<br>20 CY OF DRIFT 200 FT. DOWNSTREAM OF BRIDGE | | | | | | |

14" DIAMETER TREE AND DEBRIS UNDER SPAN 1

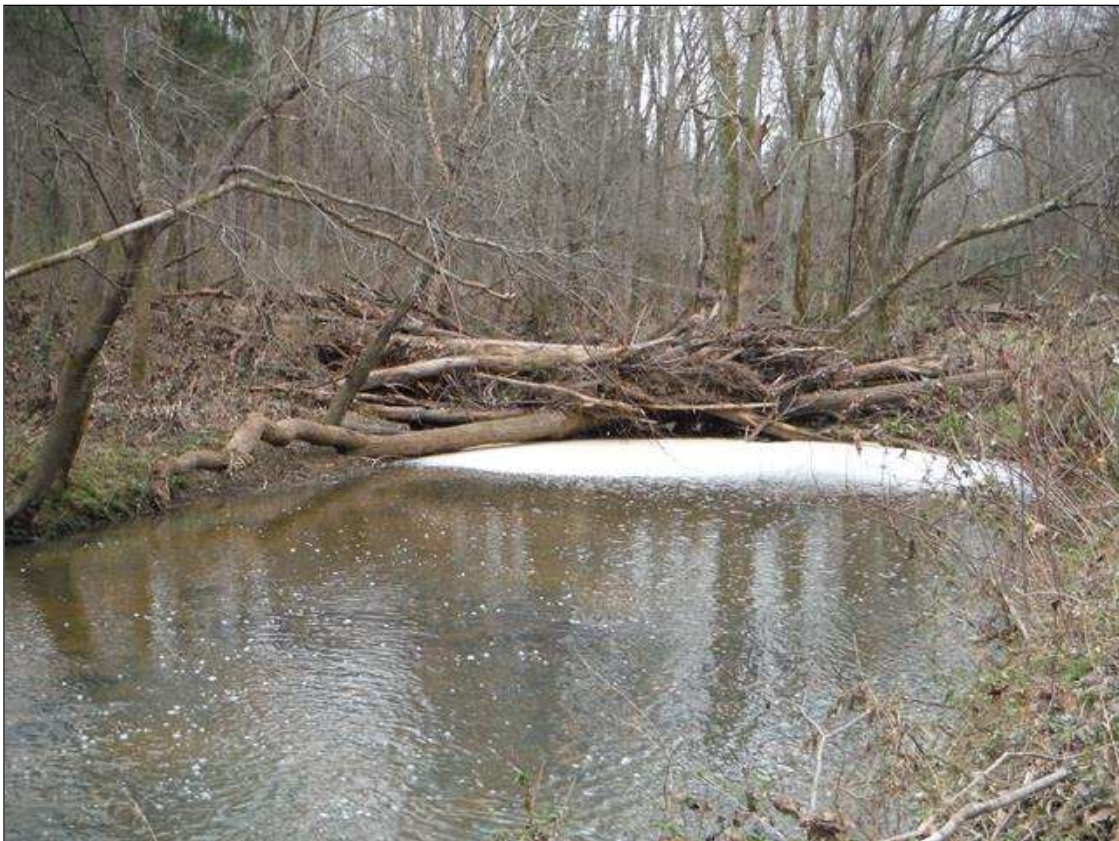
20 CY OF DRIFT 200 FT. DOWNSTREAM OF BRIDGE

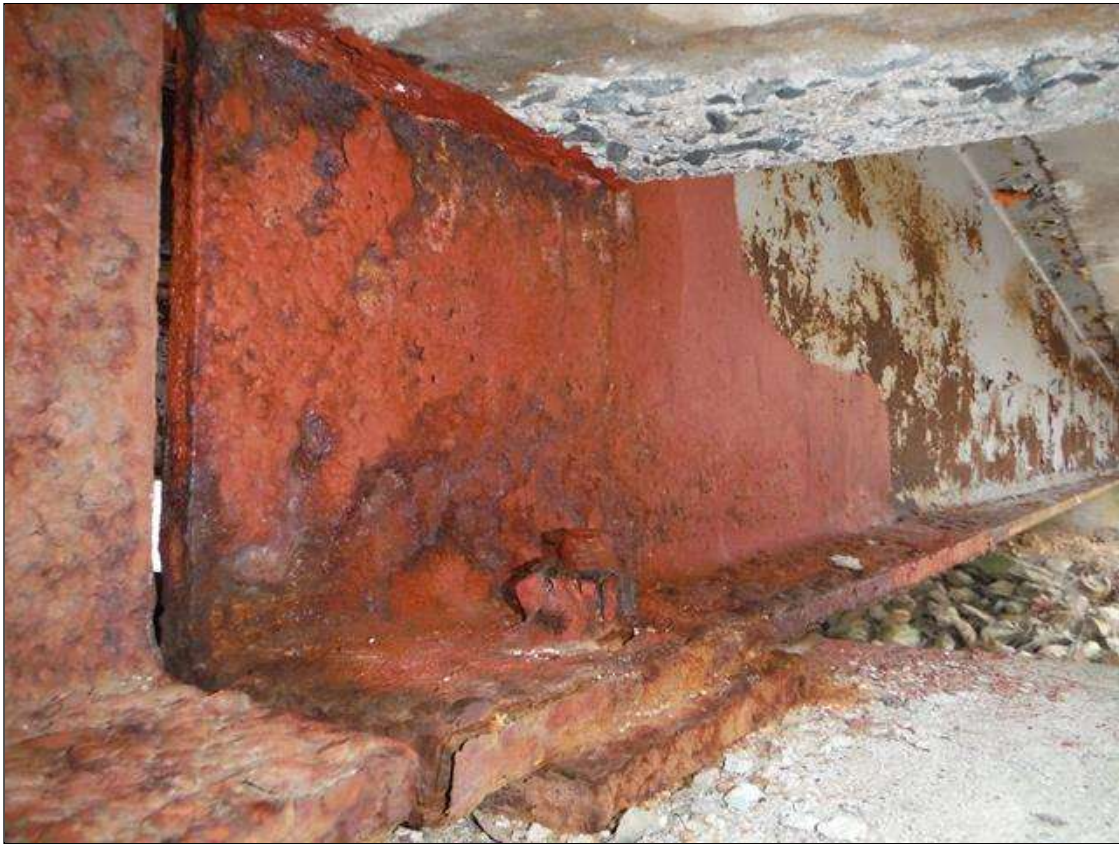
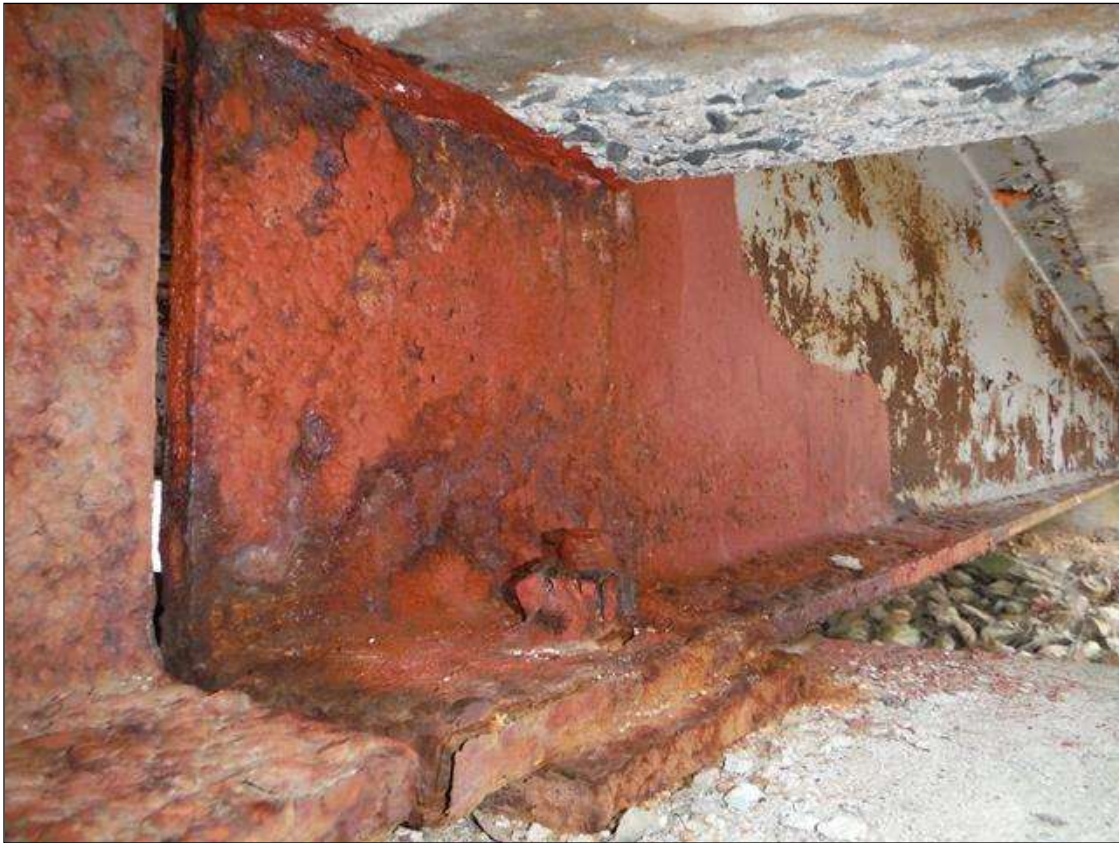
| Item | Priority | Maintenance Issued | Grade | Y | Maint Code | Qty. | 0 |
|---|---|---|---|---|---|---|---|
| Details | Span 1 Beam 1: | 2 FT. OF CORROSION WITH 1/2" REMAINING SECTION IN BOTTOM FLANGE AND PAINTED OVER PITTING 1/16" DEEP IN WEB AT BENT 1 | | | | | |

Span 1 Beam 1: 2 FT. OF CORROSION WITH 1/2" REMAINING SECTION IN BOTTOM FLANGE AND PAINTED OVER PITTING 1/16" DEEP IN WEB AT BENT 1

SPAN 1 BEAM 1: 2 FT. OF CORROSION WITH 1/2" REMAINING SECTION IN BOTTOM FLANGE AND PAINTED OVER PITTING 1/16" DEEP IN WEB AT BENT 1

| MMS Code | Description of Function | Unit | Quantity | Remarks | Est. Cost |
|---|---|---|---|---|---|
| 3314 | Maintain Steel Superstructure Components | LF | 2 | Span 1 Beam 1: 2 FT. OF CORROSION WITH 1/2" REMAINING SECTION IN BOTTOM FLANGE AND PAINTED OVER PITTING 1/16" DEEP IN WEB AT BENT 1 | |

| MMS Code | MMS Description | Quantity |
|---|---|---|
| Span 1 Beam 1: 2 FT. OF CORROSION WITH 1/2" REMAINING SECTION IN BOTTOM FLANGE AND PAINTED OVER PITTING 1/16" DEEP IN WEB AT BENT 1 | | |

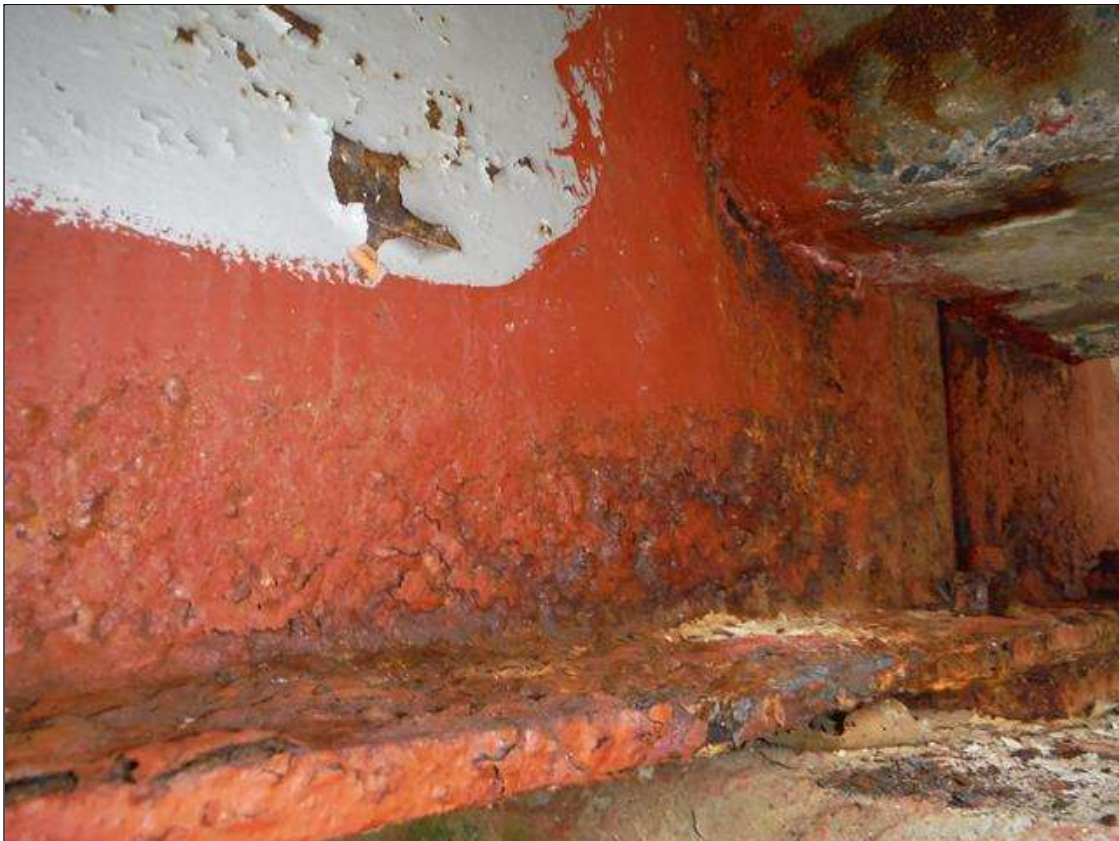
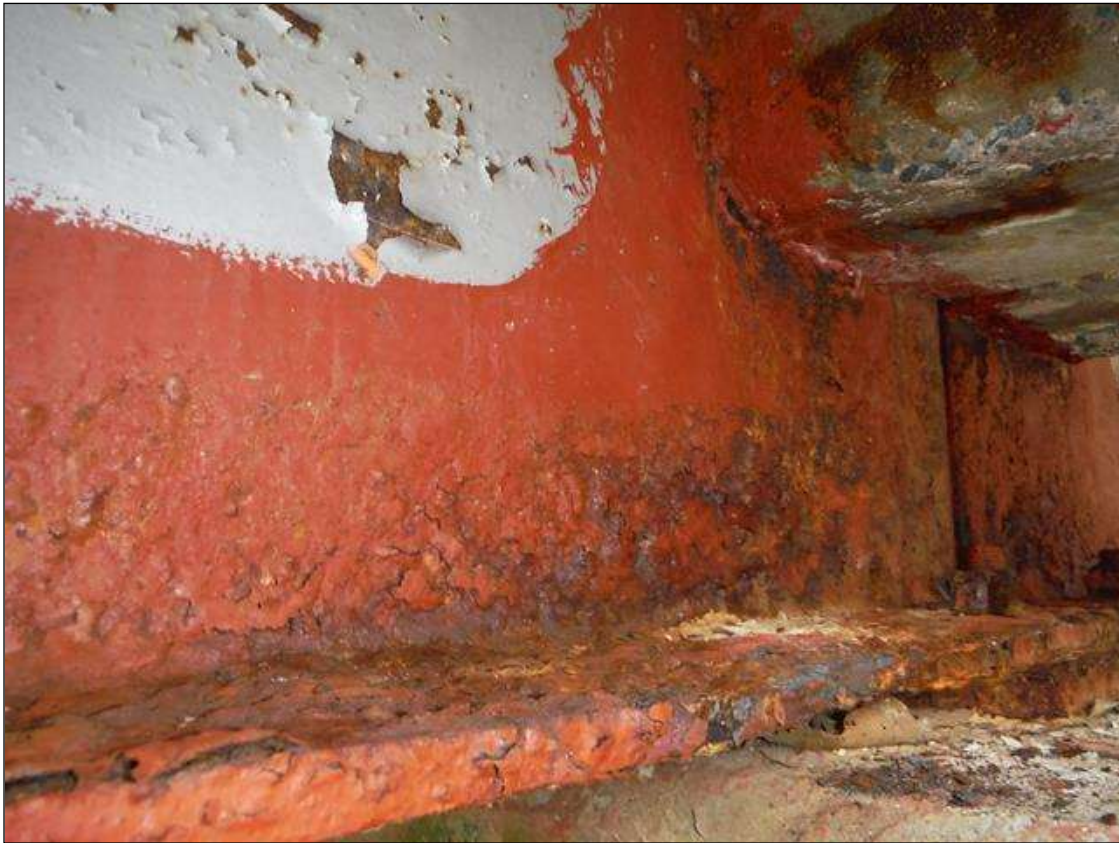
| Item | Priority | Maintenance Issued | Grade | Y | Maint Code | Qty. | 0 |
|---|---|---|---|---|---|---|---|
| | Span 2 Beam 1: | 2 FT. OF CORROSION WITH 1/2" REMAINING SECTION IN BOTTOM FLANGE AND PAINTED OVER PITTING 1/16" DEEP IN WEB AT BENT 1 | | | | | |

Span 2 Beam 1: 2 FT. OF CORROSION WITH 1/2" REMAINING SECTION IN BOTTOM FLANGE AND PAINTED OVER PITTING 1/16" DEEP IN WEB AT BENT 1

SPAN 2 BEAM 1: 2 FT. OF CORROSION WITH 1/2" REMAINING SECTION IN BOTTOM FLANGE AND PAINTED OVER PITTING 1/16" DEEP IN WEB AT BENT 1

| MMS Code | Description of Function | Unit | Quantity | Remarks | Est. Cost |
|---|---|---|---|---|---|
| 3314 | Maintain Steel Superstructure Components | LF | 2 | Span 2 Beam 1: 2 FT. OF CORROSION WITH 1/2" REMAINING SECTION IN BOTTOM FLANGE AND PAINTED OVER PITTING 1/16" DEEP IN WEB AT BENT 1 | |

| MMS Code | MMS Description | Quantity |
|---|---|---|
| Span 2 Beam 1: 2 FT. OF CORROSION WITH 1/2" REMAINING SECTION IN BOTTOM FLANGE AND PAINTED OVER PITTING 1/16" DEEP IN WEB AT BENT 1 | | |

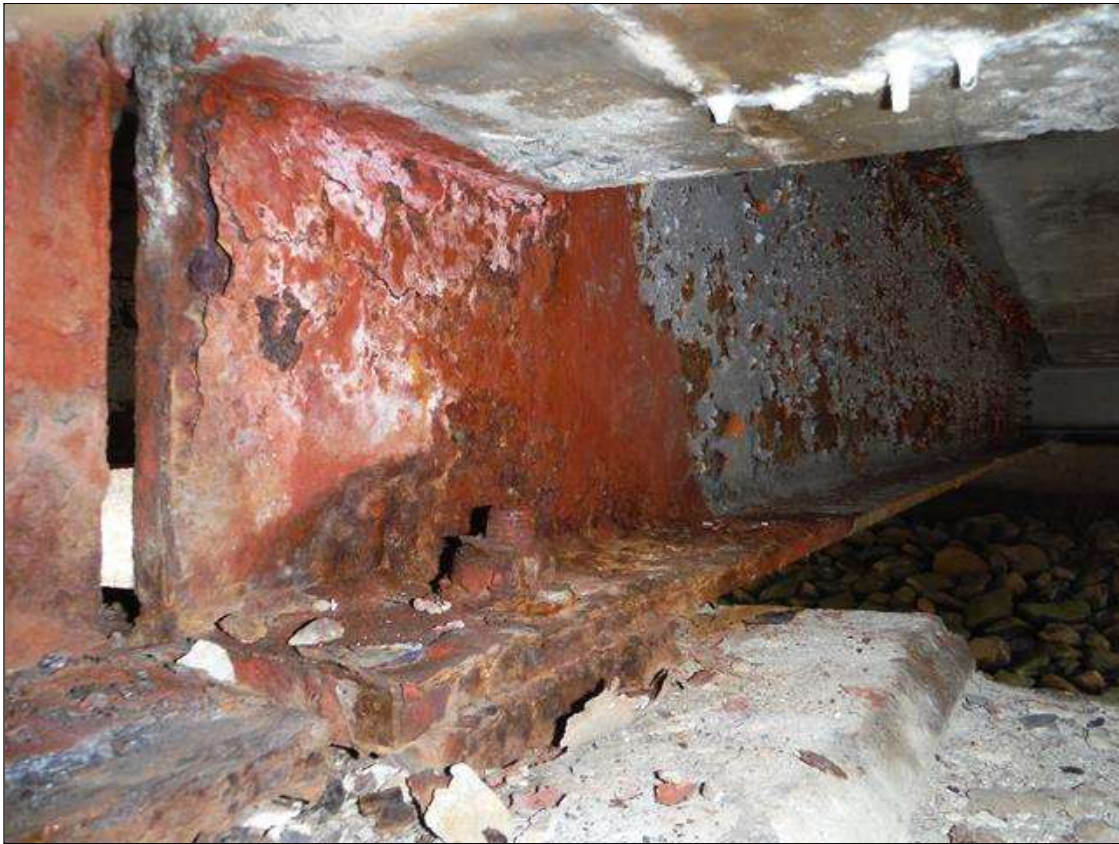
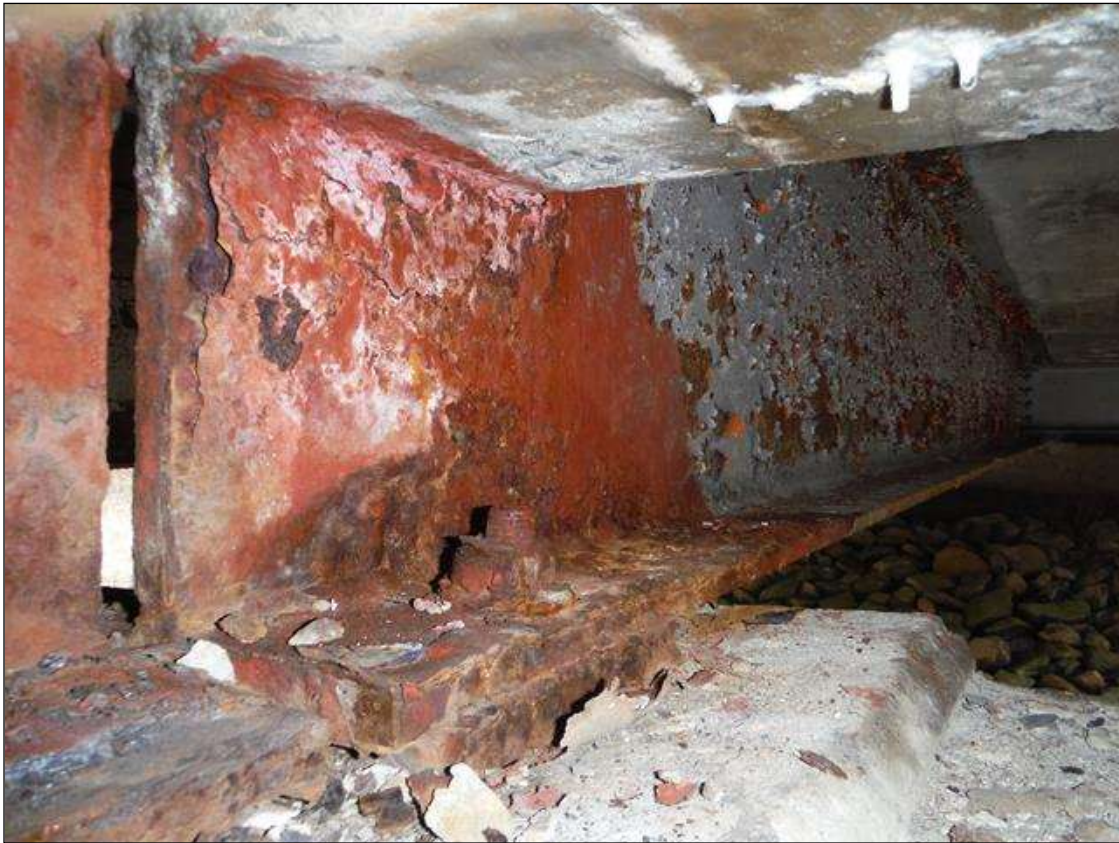
| Item | Priority | Maintenance Issued | Grade | Y | Maint Code | Qty. | 0 |
|---|---|---|---|---|---|---|---|
| | Span 1 Beam 2: | 2 FT. OF CORROSION WITH 1/2" REMAINING SECTION IN BOTTOM FLANGE AND PAINTED OVER PITTING 1/16" DEEP IN WEB AT BENT 1 | | | | | |

Span 1 Beam 2: 2 FT. OF CORROSION WITH 1/2" REMAINING SECTION IN BOTTOM FLANGE AND PAINTED OVER PITTING 1/16" DEEP IN WEB AT BENT 1

SPAN 1 BEAM 2: 2 FT. OF CORROSION WITH 1/2" REMAINING SECTION IN BOTTOM FLANGE AND PAINTED OVER PITTING 1/16" DEEP IN WEB AT BENT 1

| MMS Code | Description of Function | Unit | Quantity | Remarks | Est. Cost |
|---|---|---|---|---|---|
| 3314 | Maintain Steel Superstructure Components | LF | 2 | Span 1 Beam 2: 2 FT. OF CORROSION WITH 1/2" REMAINING SECTION IN BOTTOM FLANGE AND PAINTED OVER PITTING 1/16" DEEP IN WEB AT BENT 1 | |

| MMS Code | MMS Description | Quantity |
|---|---|---|
| Span 1 Beam 2: 2 FT. OF CORROSION WITH 1/2" REMAINING SECTION IN BOTTOM FLANGE AND PAINTED OVER PITTING 1/16" DEEP IN WEB AT BENT 1 | | |

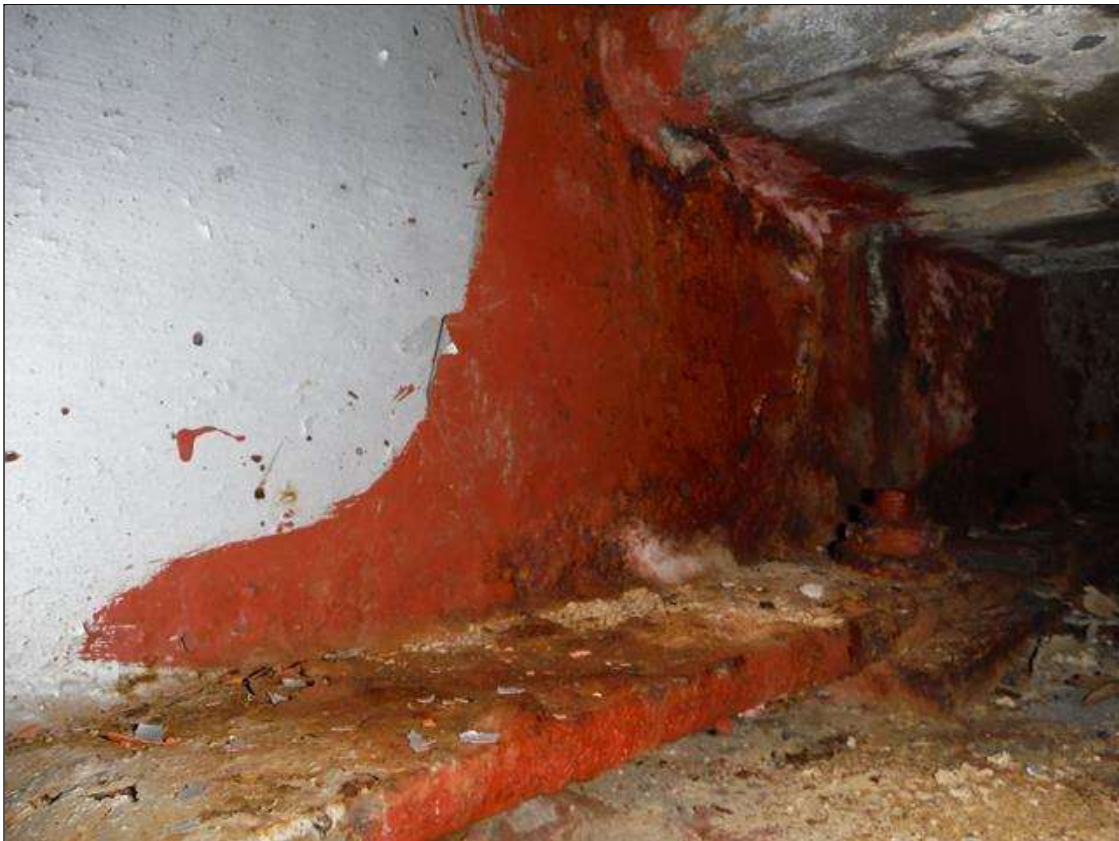
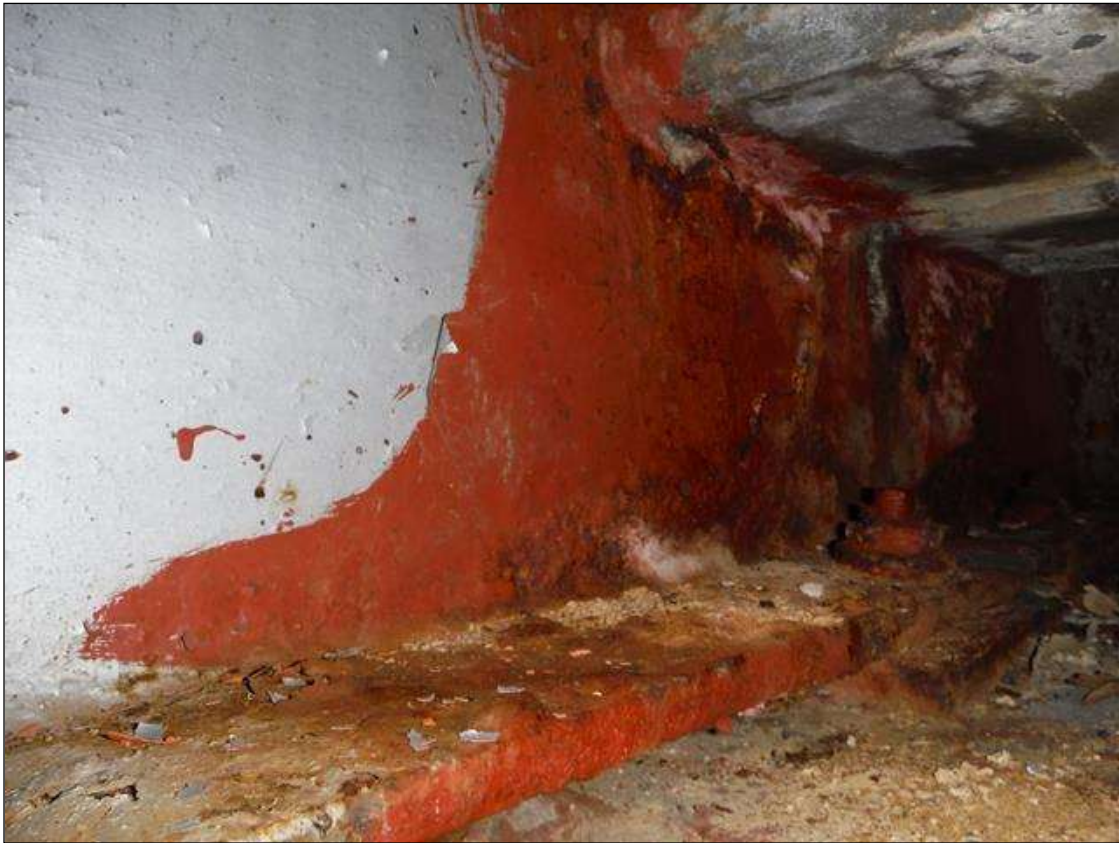
| Item | Priority | Maintenance Issued | Grade | Y | Maint Code | Qty. | 0 |
|---|---|---|---|---|---|---|---|
| | Span 2 Beam 2: | 2 FT. OF CORROSION WITH 1/2" REMAINING SECTION IN BOTTOM FLANGE AND PAINTED OVER PITTING 1/16" DEEP IN WEB AT BENT 1 | | | | | |

Span 2 Beam 2: 2 FT. OF CORROSION WITH 1/2" REMAINING SECTION IN BOTTOM FLANGE AND PAINTED OVER PITTING 1/16" DEEP IN WEB AT BENT 1

SPAN 2 BEAM 2: 2 FT. OF CORROSION WITH 1/2" REMAINING SECTION IN BOTTOM FLANGE AND PAINTED OVER PITTING 1/16" DEEP IN WEB AT BENT 1

| MMS Code | Description of Function | Unit | Quantity | Remarks | Est. Cost |
|---|---|---|---|---|---|
| 3314 | Maintain Steel Superstructure Components | LF | 2 | Span 2 Beam 2: 2 FT. OF CORROSION WITH 1/2" REMAINING SECTION IN BOTTOM FLANGE AND PAINTED OVER PITTING 1/16" DEEP IN WEB AT BENT 1 | |

| MMS Code | MMS Description | Quantity |
|---|---|---|
| Span 2 Beam 2: 2 FT. OF CORROSION WITH 1/2" REMAINING SECTION IN BOTTOM FLANGE AND PAINTED OVER PITTING 1/16" DEEP IN WEB AT BENT 1 | | |

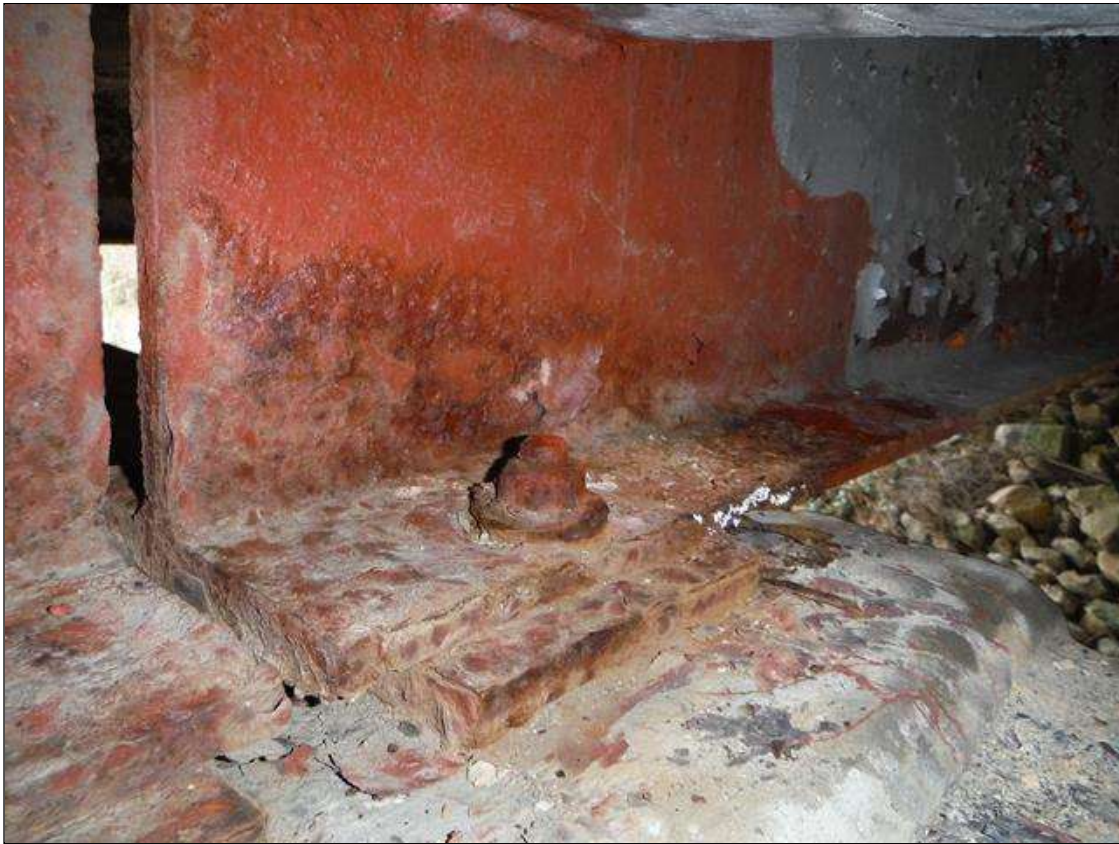
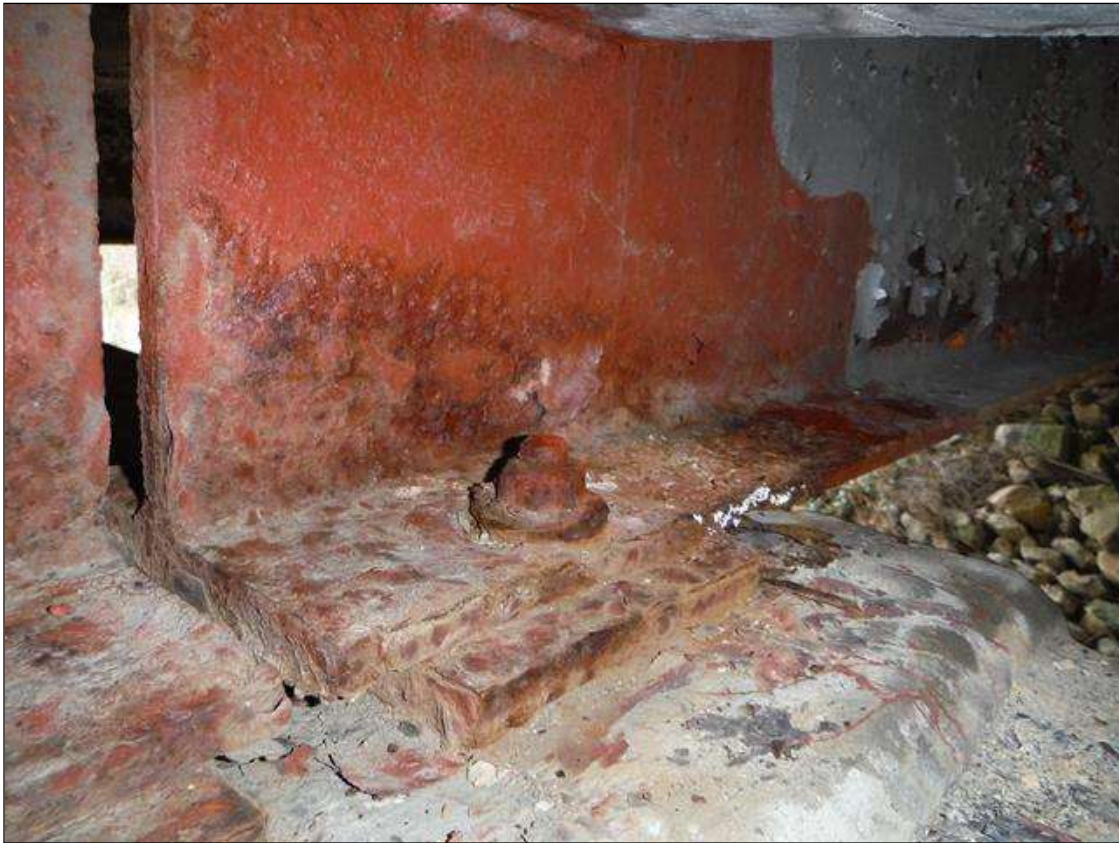
| Item | Priority | Maintenance Issued | Grade | Y | Maint Code | Qty. | 0 |
|---|---|---|---|---|---|---|---|
| | Span 1 Beam 3: | 2 FT. OF CORROSION WITH 3/8" REMAINING SECTION IN BOTTOM FLANGE AND PAINTED OVER PITTING 1/16" DEEP IN WEB AT BENT 1 | | | | | |

Span 1 Beam 3: 2 FT. OF CORROSION WITH 3/8" REMAINING SECTION IN BOTTOM FLANGE AND PAINTED OVER PITTING 1/16" DEEP IN WEB AT BENT 1

SPAN 1 BEAM 3: 2 FT. OF CORROSION WITH 3/8" REMAINING SECTION IN BOTTOM FLANGE AND PAINTED OVER PITTING 1/16" DEEP IN WEB AT BENT 1

| MMS Code | Description of Function | Unit | Quantity | Remarks | Est. Cost |
|---|---|---|---|---|---|
| 3314 | Maintain Steel Superstructure Components | LF | 2 | Span 1 Beam 3: 2 FT. OF CORROSION WITH 3/8" REMAINING SECTION IN BOTTOM FLANGE AND PAINTED OVER PITTING 1/16" DEEP IN WEB AT BENT 1 | |

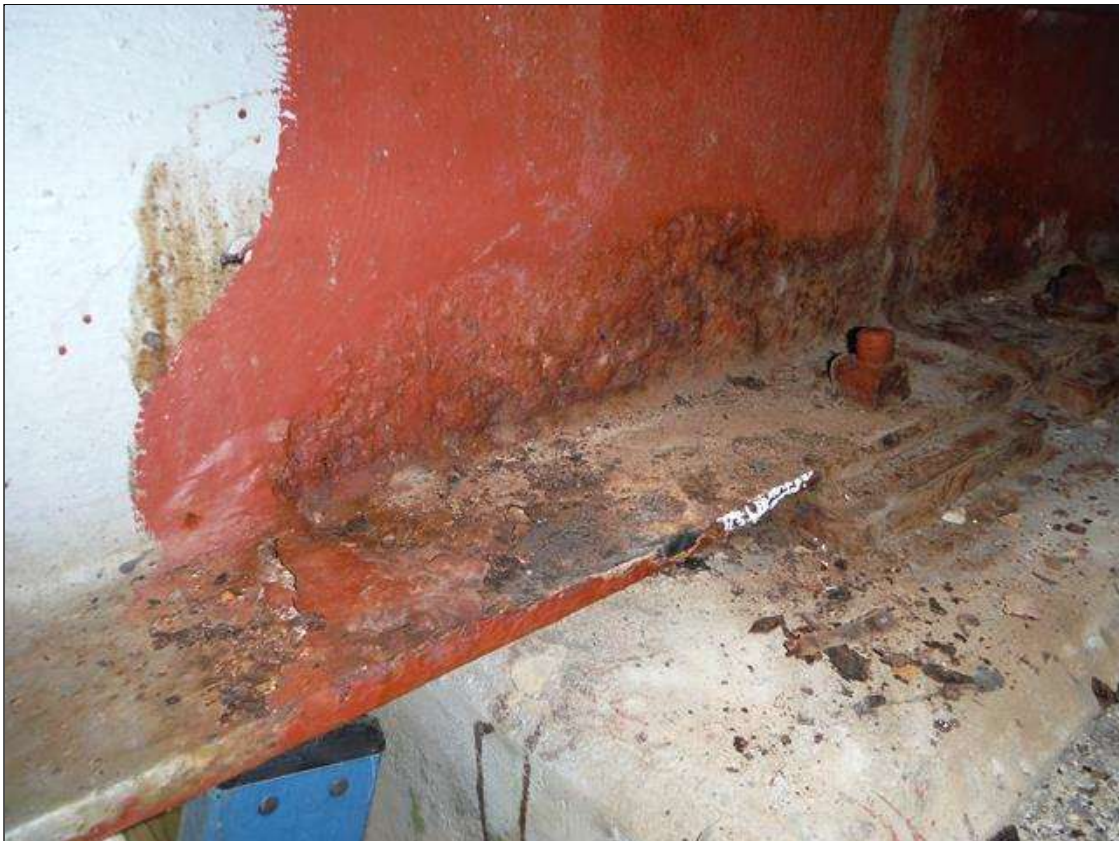
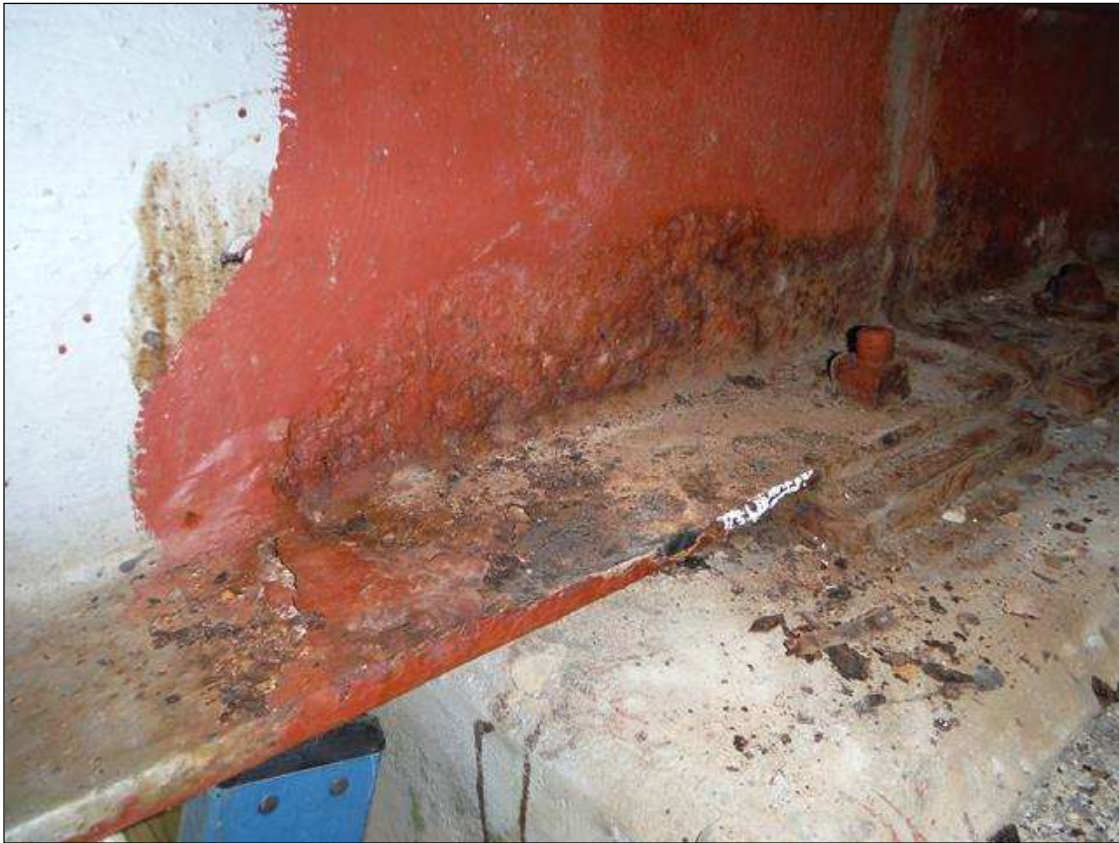
| Item | Priority | Maintenance Issued | Grade | Y | Maint Code | Qty. | 0 |
|---|---|---|---|---|---|---|---|
| | Span 2 Beam 3: | 2 FT. OF CORROSION WITH 3/8" REMAINING SECTION IN BOTTOM FLANGE AND PAINTED OVER PITTING 1/16" DEEP IN WEB AT BENT 1 | | | | | |

Span 2 Beam 3: 2 FT. OF CORROSION WITH 3/8" REMAINING SECTION IN BOTTOM FLANGE AND PAINTED OVER PITTING 1/16" DEEP IN WEB AT BENT 1

SPAN 2 BEAM 3: 2 FT. OF CORROSION WITH 3/8" REMAINING SECTION IN BOTTOM FLANGE AND PAINTED OVER PITTING 1/16" DEEP IN WEB AT BENT 1

| MMS Code | Description of Function | Unit | Quantity | Remarks | Est. Cost |
|---|---|---|---|---|---|
| 3314 | Maintain Steel Superstructure Components | LF | 2 | Span 2 Beam 3: 2 FT. OF CORROSION WITH 3/8" REMAINING SECTION IN BOTTOM FLANGE AND PAINTED OVER PITTING 1/16" DEEP IN WEB AT BENT 1 | |

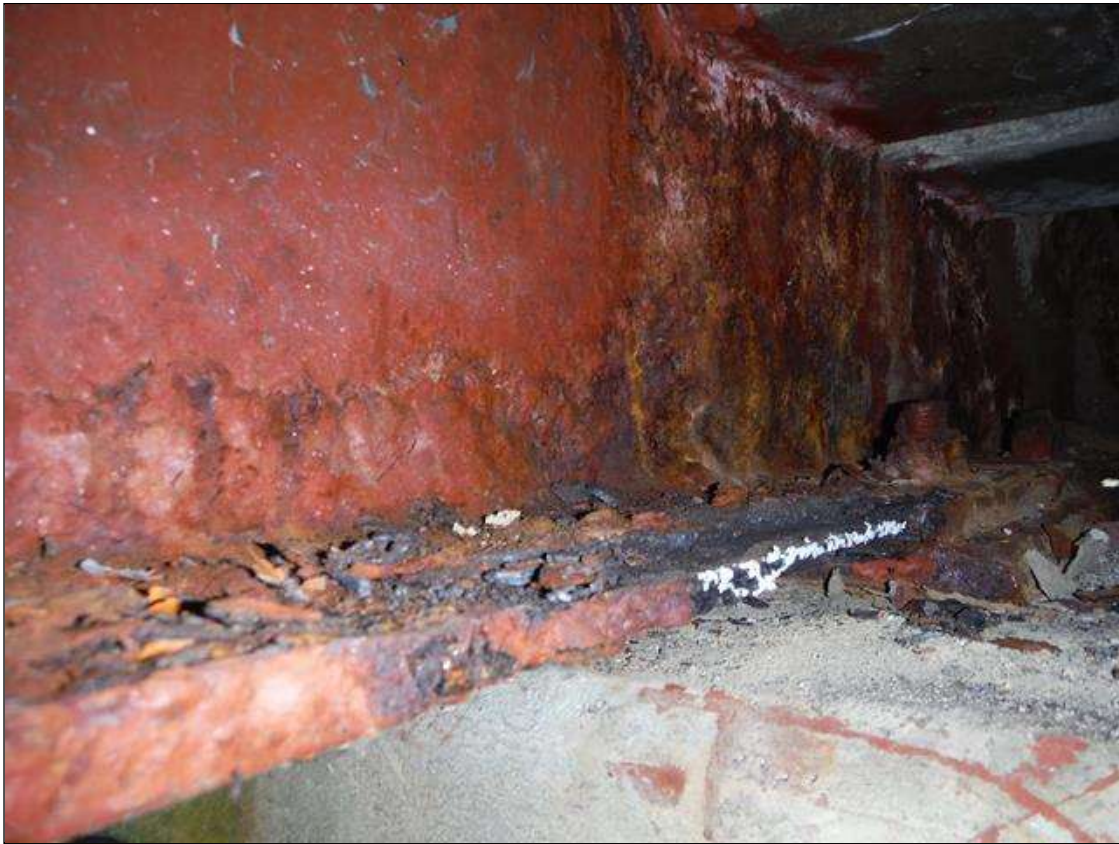
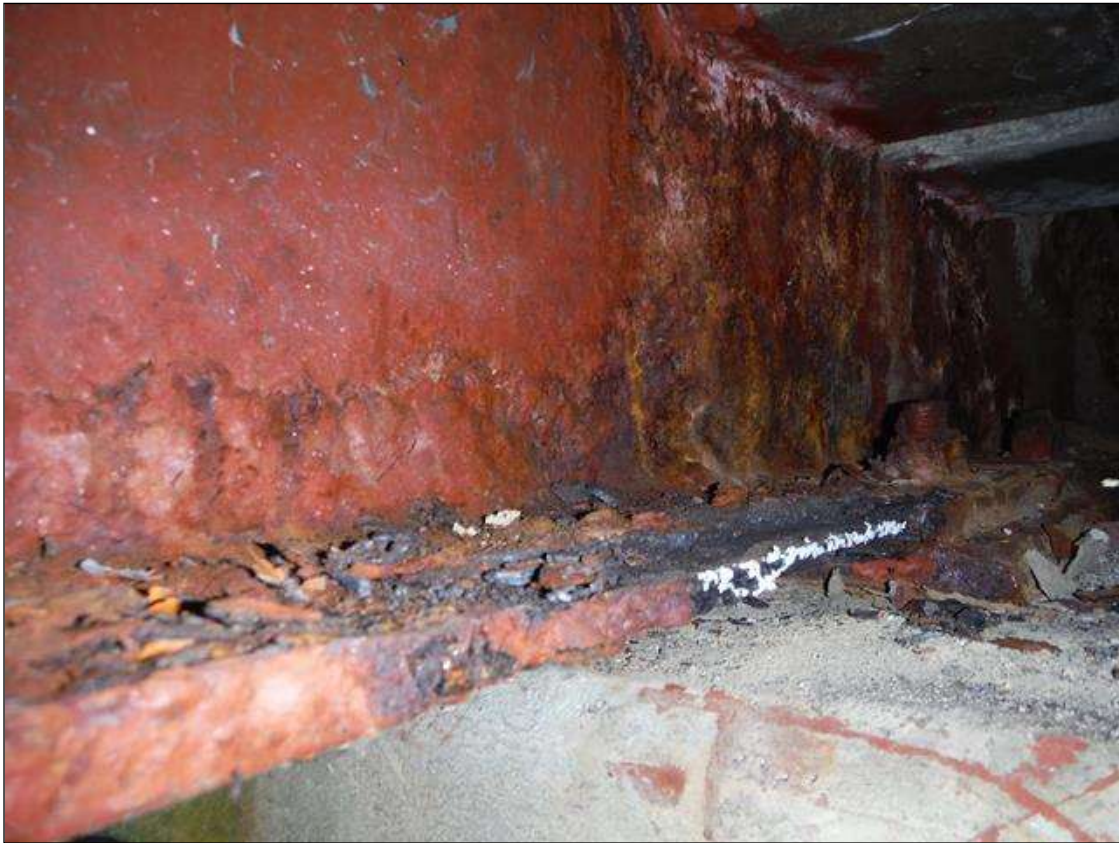
| Item | Priority | Maintenance Issued | Grade | Y | Maint Code | Qty. | 0 |
|---|---|---|---|---|---|---|---|
| | Span 2 Beam 4: | 2 FT. OF CORROSION WITH 1/4" REMAINING SECTION IN BOTTOM FLANGE AND PAINTED OVER PITTING 1/16" DEEP IN WEB AT BENT 1 | | | | | |

Span 2 Beam 4: 2 FT. OF CORROSION WITH 1/4" REMAINING SECTION IN BOTTOM FLANGE AND PAINTED OVER PITTING 1/16" DEEP IN WEB AT BENT 1

SPAN 2 BEAM 4: 2 FT. OF CORROSION WITH 1/4" REMAINING SECTION IN BOTTOM FLANGE AND PAINTED OVER PITTING 1/16" DEEP IN WEB AT BENT 1

| MMS Code | Description of Function | Unit | Quantity | Remarks | Est. Cost |
|---|---|---|---|---|---|
| 3314 | Maintain Steel Superstructure Components | LF | 2 | Span 2 Beam 4: 2 FT. OF CORROSION WITH 1/4" REMAINING SECTION IN BOTTOM FLANGE AND PAINTED OVER PITTING 1/16" DEEP IN WEB AT BENT 1 | |
