NC DEPARTMENT OF TRANSPORTATION  
DIVISION OF HIGHWAYS  
STRUCTURE MANAGEMENT UNIT

## Structure Safety Report

### Routine Element Inspection - Contract

COUNTY: DAVIDSON STRUCTURE NUMBER: 280055 FREQUENCY: 24 MONTHS  
FACILITY CARRIED: NC47 MILE POST: \_\_\_\_\_  
LOCATION: 0.3 MI. W. JCT. SR2346  
FEATURE INTERSECTED: FLAT SWAMP CREEK  
LATITUDE: 35° 41' 11" LONGITUDE: 80° 9' 5.13"  
SUPERSTRUCTURE: REINFORCED CONCRETE DECK ON I-BEAMS  
SUBSTRUCTURE: E.BENTS:RC CAP ON TIMBER PILES,INT.BENTS:2COL.RC POST & BEAM  
SPANS: 3@30'1"  
☐ FRACTURE CRITICAL ☐ TEMPORARY SHORING ☐ SCOUR CRITICAL ☐ SCOUR PLAN OF ACTION  
PRESENT CONDITION: Poor INSPECTION DATE: 01/07/2016  
POSTED SV: 22 POSTED TTST: 29  
OTHER SIGNS PRESENT: 4 DELINEATORS

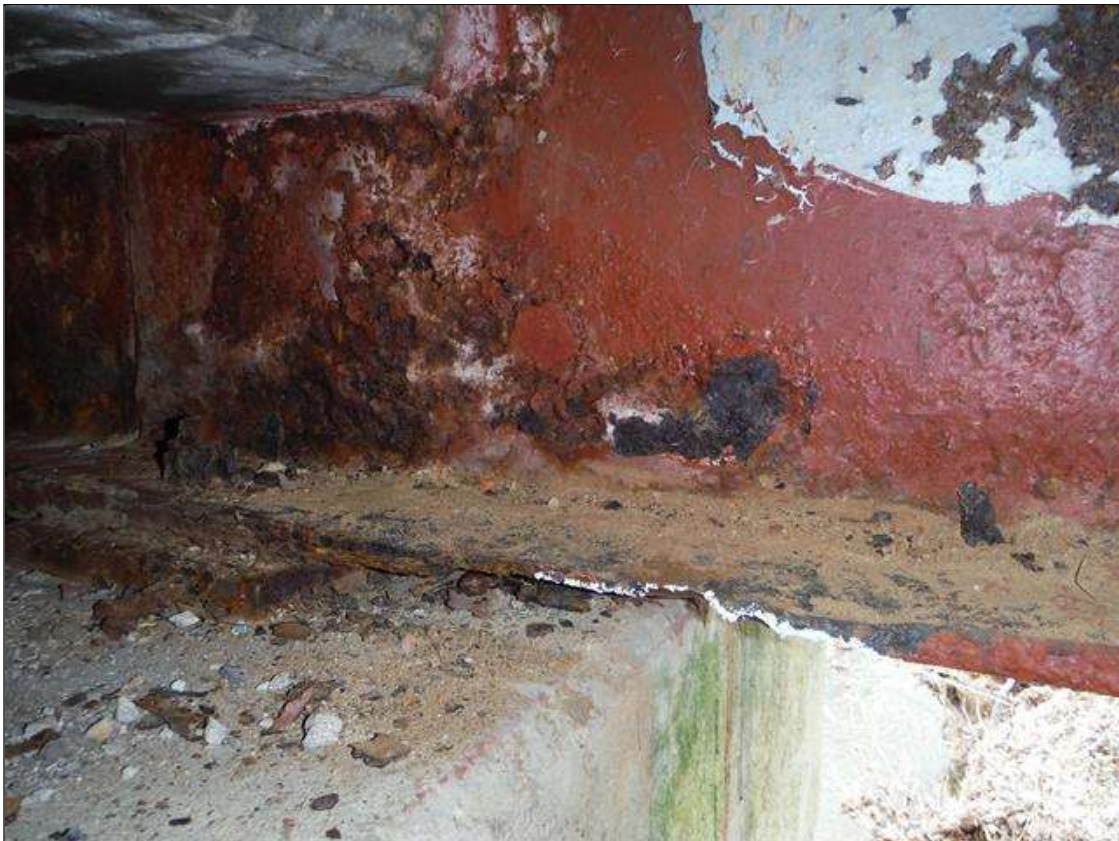
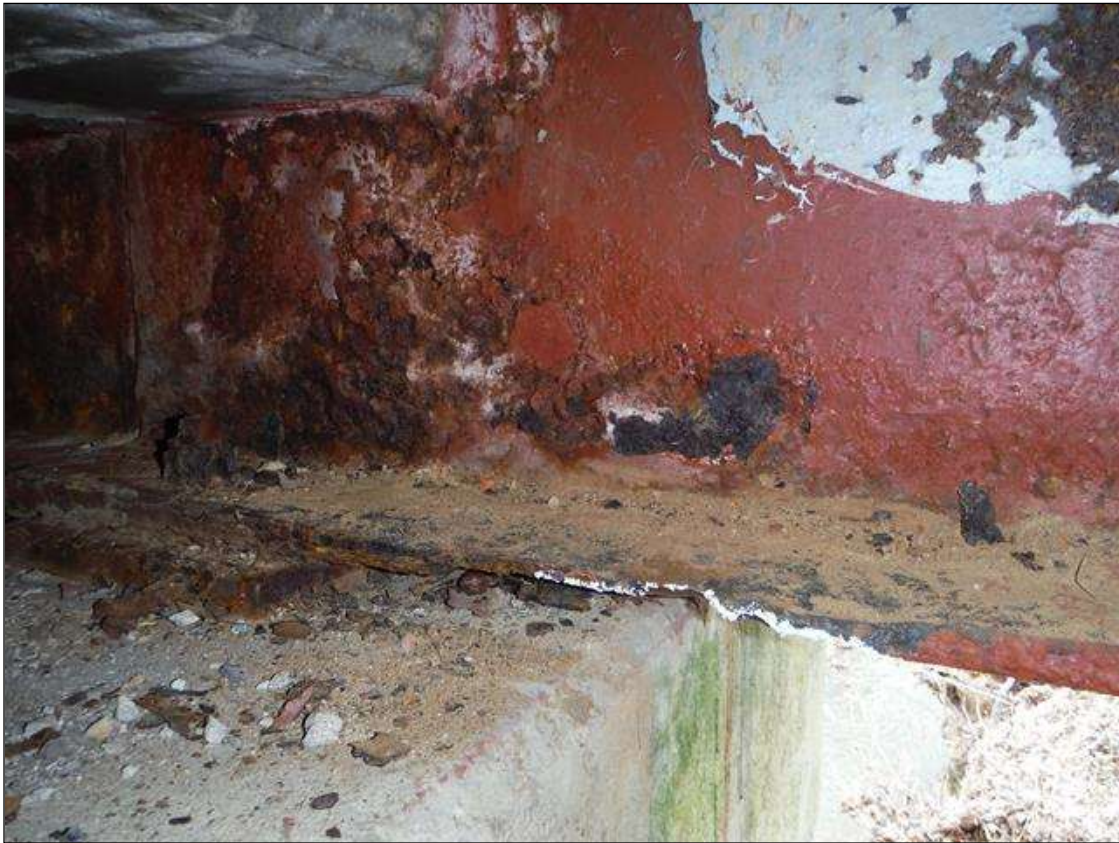
| Item | Priority | Maintenance Issued | Grade | Y | Maint Code | Qty. | 0 |
|---|---|---|---|---|---|---|---|
| | Span 1 Beam 4: | 2 FT. OF CORROSION WITH BOTTOM FLANGE TO KNIFES EDGE AND PAINTED OVER PITTING 1/16" DEEP IN WEB AT BENT 1 | | | | | |

Span 1 Beam 4: 2 FT. OF CORROSION WITH BOTTOM FLANGE TO KNIFES EDGE AND PAINTED OVER PITTING 1/16" DEEP IN WEB AT BENT 1

SPAN 1 BEAM 4: 2 FT. OF CORROSION WITH BOTTOM FLANGE TO KNIFES EDGE AND PAINTED OVER  
PITTING 1/16" DEEP IN WEB AT BENT 1

| MMS Code | Description of Function | Unit | Quantity | Remarks | Est. Cost |
|---|---|---|---|---|---|
| 3314 | Maintain Steel Superstructure Components | LF | 2 | Span 1 Beam 4: 2 FT. OF CORROSION WITH BOTTOM FLANGE TO KNIFES EDGE AND PAINTED OVER PITTING 1/16" DEEP IN WEB AT BENT 1 | |

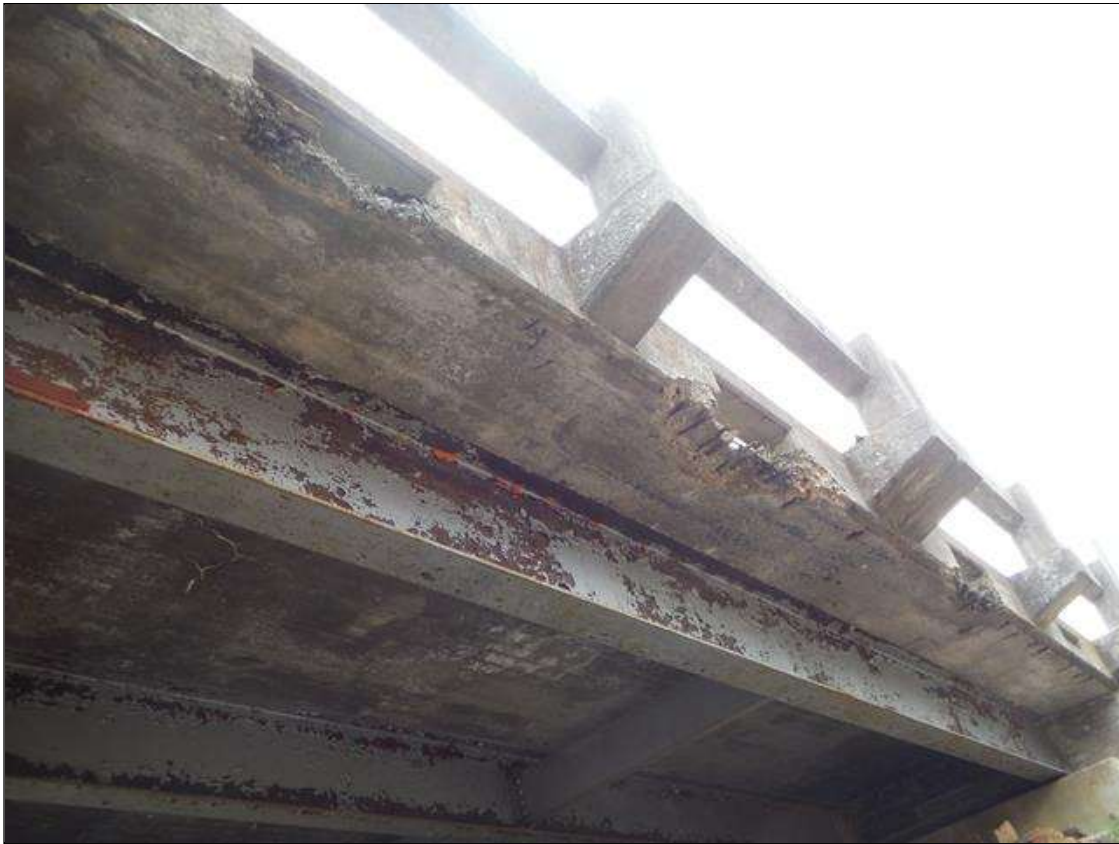
Span 3 Deck: 24" X 6" X 4" DEEP, 48" X 6" X 12" DEEP AND 24" X 6" X 6" DEEP SPALLS WITH EXPOSED REBAR IN BOTTOM OF DECK EAST OVERHANG

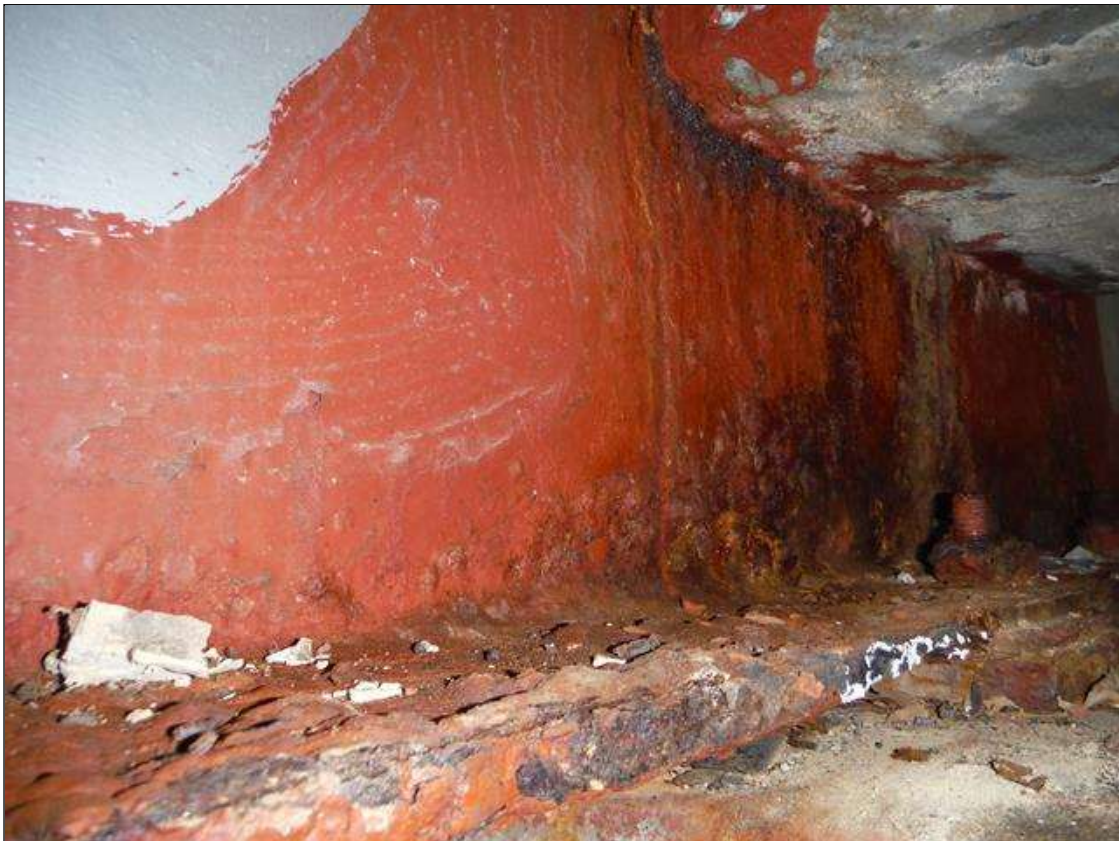
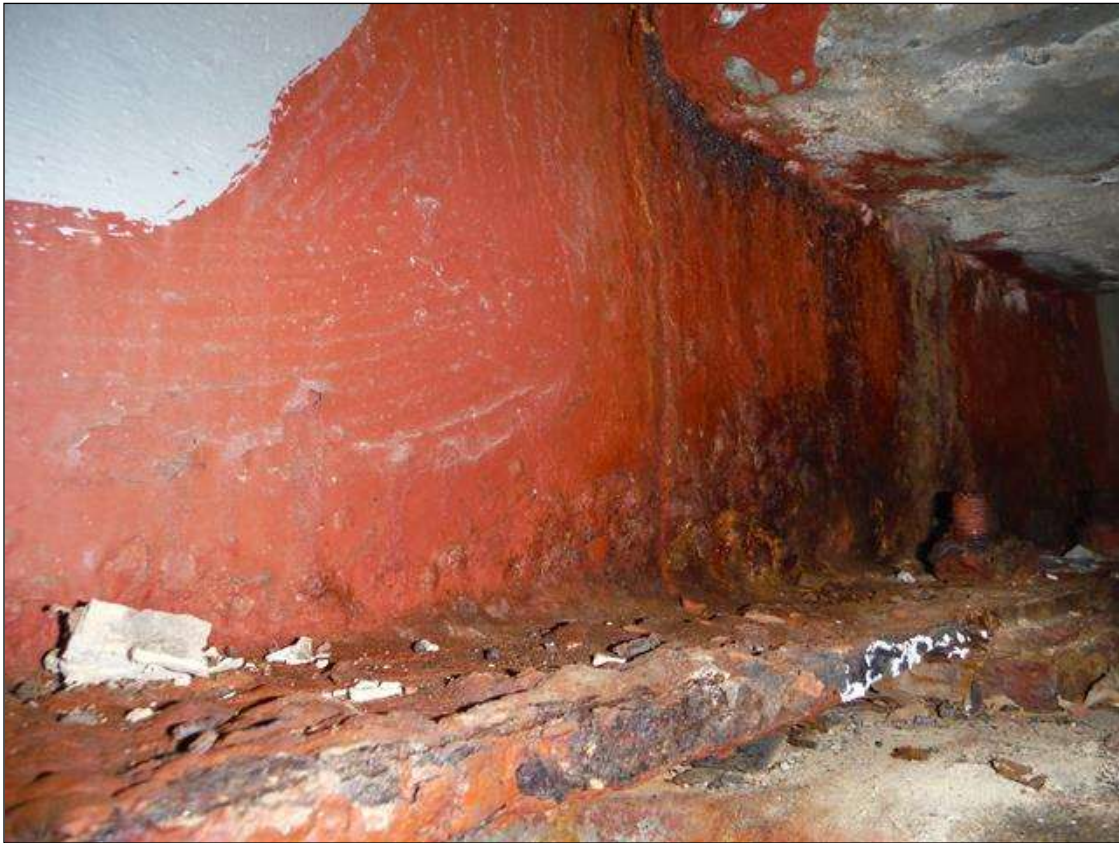
| Item | Priority | Maintenance Issued | Grade | Y | Maint Code | Qty. | 0 |
|---|---|---|---|---|---|---|---|
| | Span 2 Beam 2: | 2 FT. OF CORROSION WITH 1/4" REMAINING SECTION IN BOTTOM FLANGE AND PAINTED OVER PITTING 1/16" DEEP IN WEB AT BENT 2 | | | | | |

Span 2 Beam 2: 2 FT. OF CORROSION WITH 1/4" REMAINING SECTION IN BOTTOM FLANGE AND PAINTED OVER PITTING 1/16" DEEP IN WEB AT BENT 2

SPAN 2 BEAM 2: 2 FT. OF CORROSION WITH 1/4" REMAINING SECTION IN BOTTOM FLANGE AND PAINTED OVER PITTING 1/16" DEEP IN WEB AT BENT 2

| MMS Code | Description of Function | Unit | Quantity | Remarks | Est. Cost |
|---|---|---|---|---|---|
| 3314 | Maintain Steel Superstructure Components | LF | 2 | Span 2 Beam 2: 2 FT. OF CORROSION WITH 1/4" REMAINING SECTION IN BOTTOM FLANGE AND PAINTED OVER PITTING 1/16" DEEP IN WEB AT BENT 2 | |

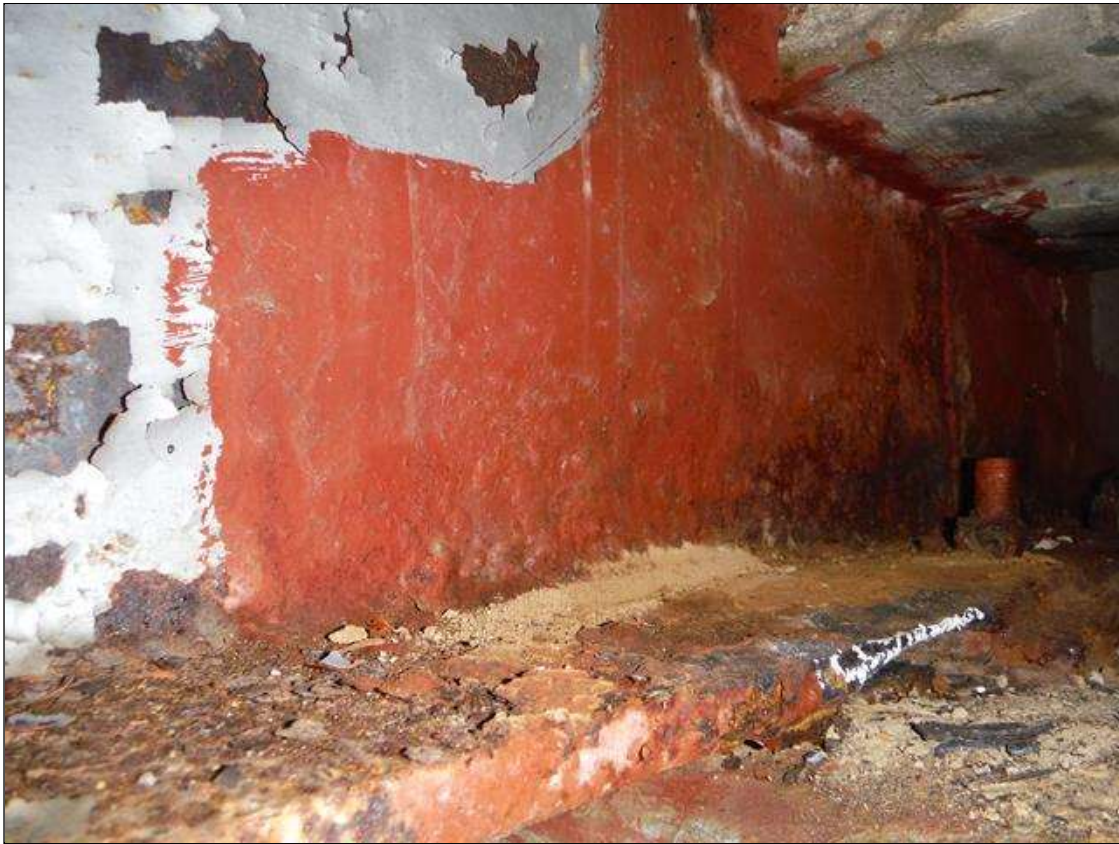
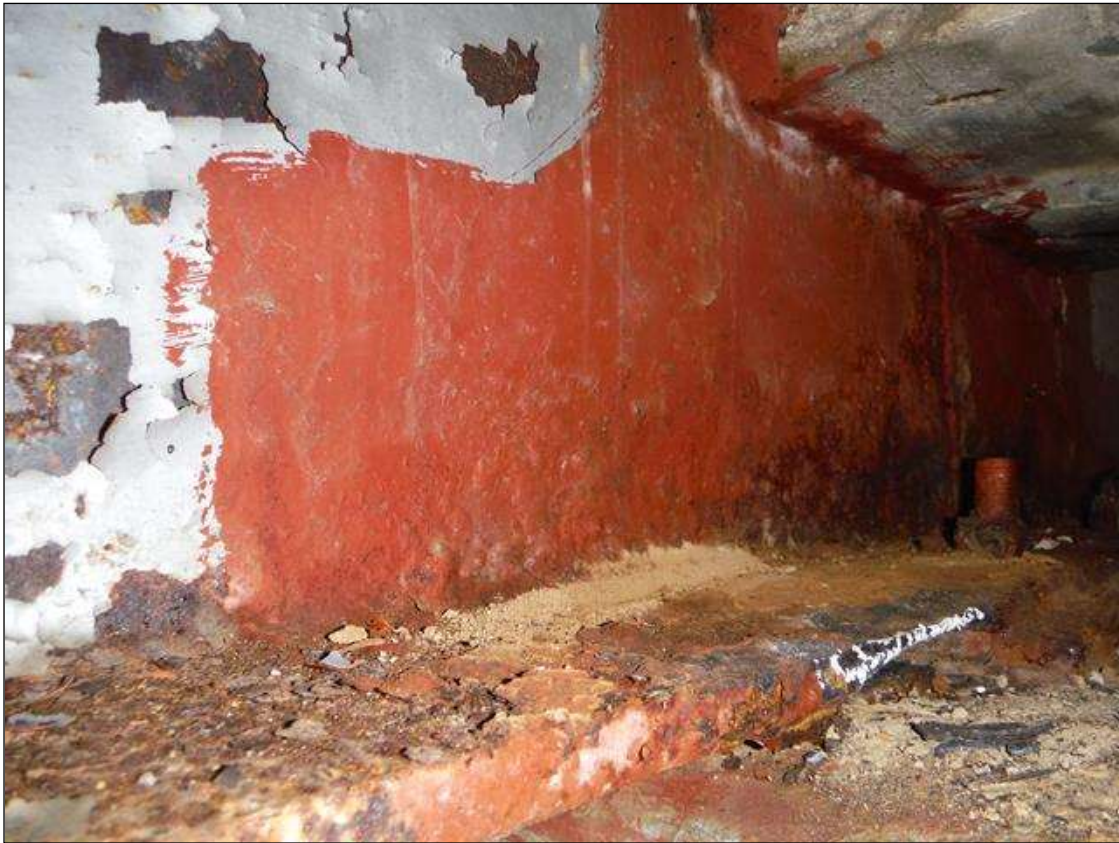
| Item | Priority | Maintenance Issued | Grade | Y | Maint Code | Qty. | 0 |
|---|---|---|---|---|---|---|---|
| | Span 2 Beam 1: | 2 FT. OF CORROSION WITH 1/4" REMAINING SECTION IN BOTTOM FLANGE AND PAINTED OVER PITTING 1/16" DEEP IN WEB AT BENT 2 | | | | | |

Span 2 Beam 1: 2 FT. OF CORROSION WITH 1/4" REMAINING SECTION IN BOTTOM FLANGE AND PAINTED OVER PITTING 1/16" DEEP IN WEB AT BENT 2

SPAN 2 BEAM 1: 2 FT. OF CORROSION WITH 1/4" REMAINING SECTION IN BOTTOM FLANGE AND PAINTED OVER PITTING 1/16" DEEP IN WEB AT BENT 2

| MMS Code | Description of Function | Unit | Quantity | Remarks | Est. Cost |
|---|---|---|---|---|---|
| 3314 | Maintain Steel Superstructure Components | LF | 2 | Span 2 Beam 1: 2 FT. OF CORROSION WITH 1/4" REMAINING SECTION IN BOTTOM FLANGE AND PAINTED OVER PITTING 1/16" DEEP IN WEB AT BENT 2 | |

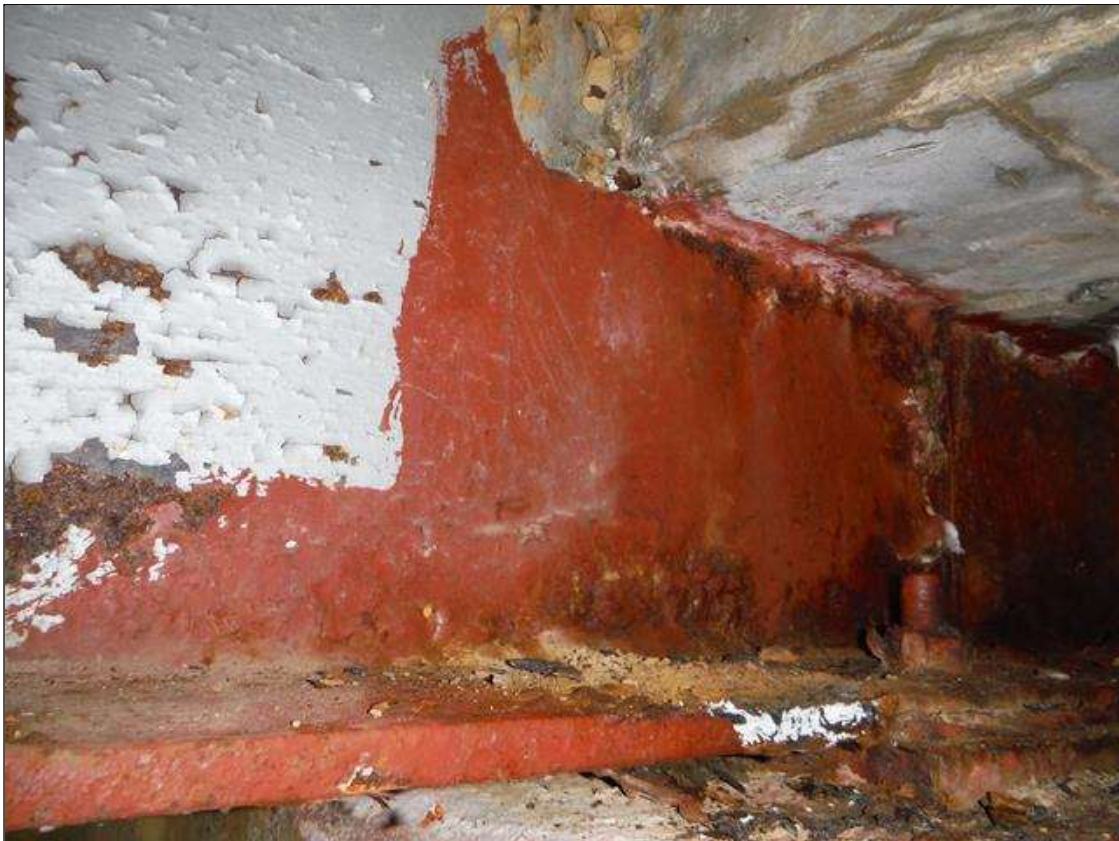
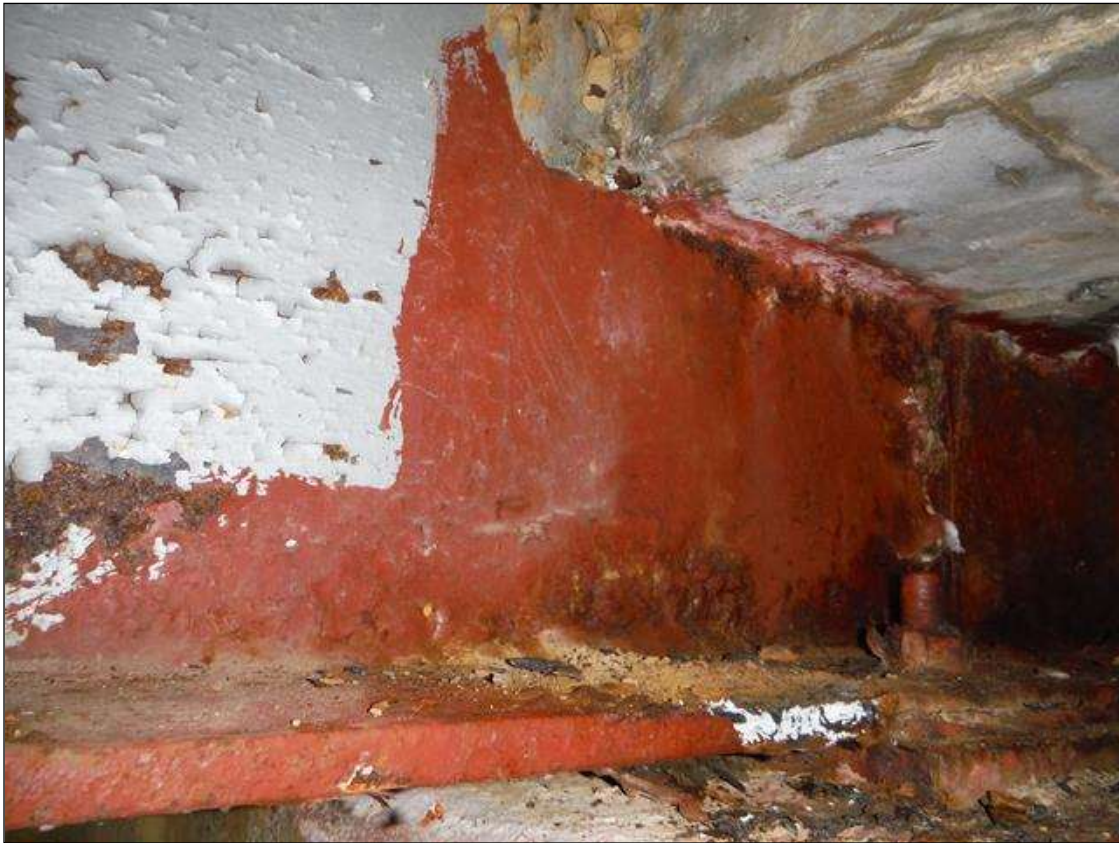
| Item | Priority | Maintenance Issued | Grade | Y | Maint Code | Qty. | 0 |
|---|---|---|---|---|---|---|---|
| | Span 2 Beam 3: | 2 FT. OF CORROSION WITH 1/2" REMAINING SECTION IN BOTTOM FLANGE AND PAINTED OVER PITTING 1/16" DEEP IN WEB AT BENT 2 | | | | | |

Span 2 Beam 3: 2 FT. OF CORROSION WITH 1/2" REMAINING SECTION IN BOTTOM FLANGE AND PAINTED OVER PITTING 1/16" DEEP IN WEB AT BENT 2

SPAN 2 BEAM 3: 2 FT. OF CORROSION WITH 1/2" REMAINING SECTION IN BOTTOM FLANGE AND PAINTED OVER PITTING 1/16" DEEP IN WEB AT BENT 2

| MMS Code | Description of Function | Unit | Quantity | Remarks | Est. Cost |
|---|---|---|---|---|---|
| 3314 | Maintain Steel Superstructure Components | LF | 2 | Span 2 Beam 3: 2 FT. OF CORROSION WITH 1/2" REMAINING SECTION IN BOTTOM FLANGE AND PAINTED OVER PITTING 1/16" DEEP IN WEB AT BENT 2 | |

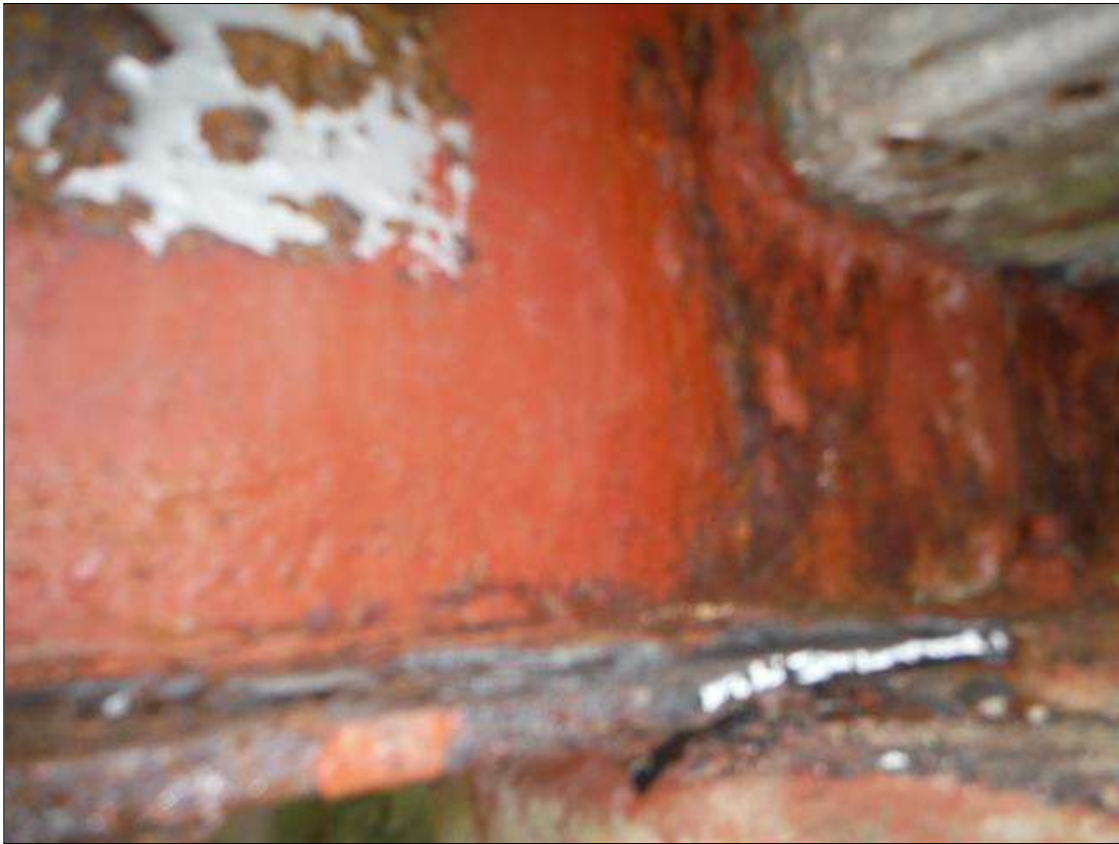
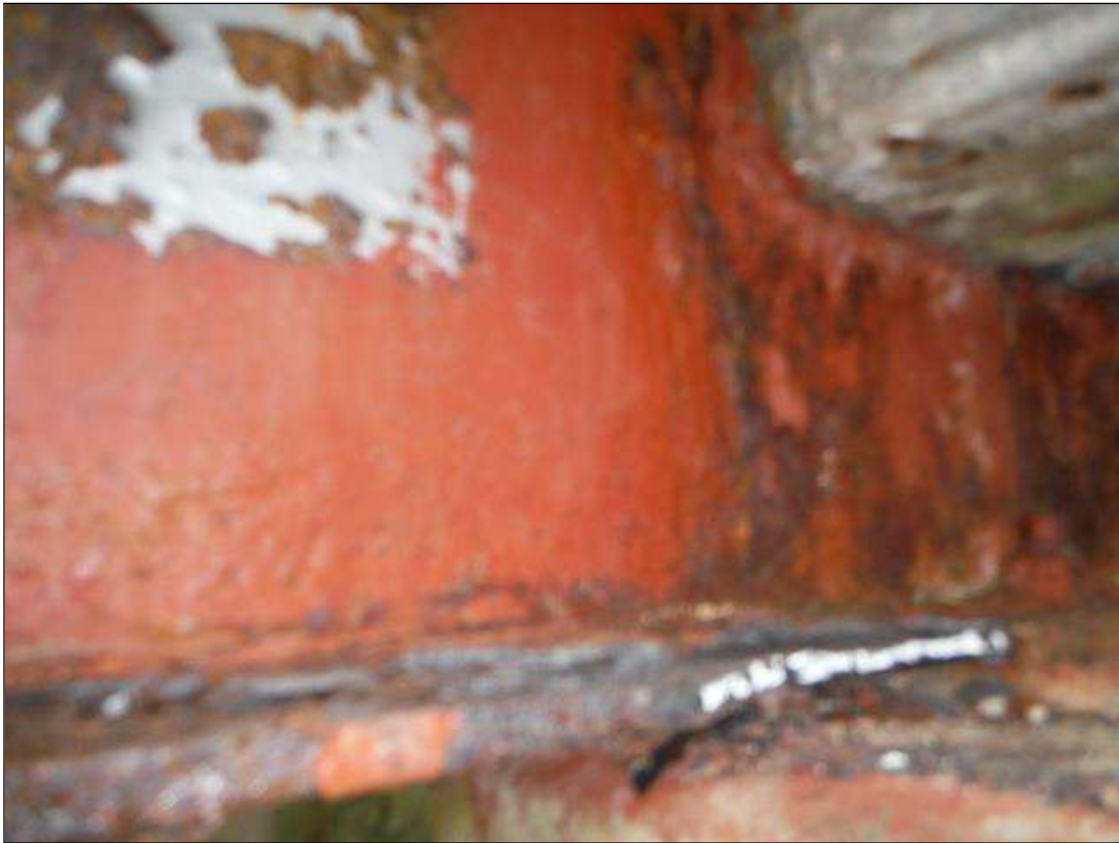
| Item | Priority | Maintenance Issued | Grade | Y | Maint Code | Qty. | 0 |
|---|---|---|---|---|---|---|---|
| | Span 2 Beam 4: | 2 FT. OF CORROSION WITH 1/4" REMAINING SECTION IN BOTTOM FLANGE AND PAINTED OVER PITTING 1/16" DEEP IN WEB AT BENT 2 | | | | | |

Span 2 Beam 4: 2 FT. OF CORROSION WITH 1/4" REMAINING SECTION IN BOTTOM FLANGE AND PAINTED OVER PITTING 1/16" DEEP IN WEB AT BENT 2

SPAN 2 BEAM 4: 2 FT. OF CORROSION WITH 1/4" REMAINING SECTION IN BOTTOM FLANGE AND PAINTED OVER PITTING 1/16" DEEP IN WEB AT BENT 2

| MMS Code | Description of Function | Unit | Quantity | Remarks | Est. Cost |
|---|---|---|---|---|---|
| 3314 | Maintain Steel Superstructure Components | LF | 2 | Span 2 Beam 4: 2 FT. OF CORROSION WITH 1/4" REMAINING SECTION IN BOTTOM FLANGE AND PAINTED OVER PITTING 1/16" DEEP IN WEB AT BENT 2 | |

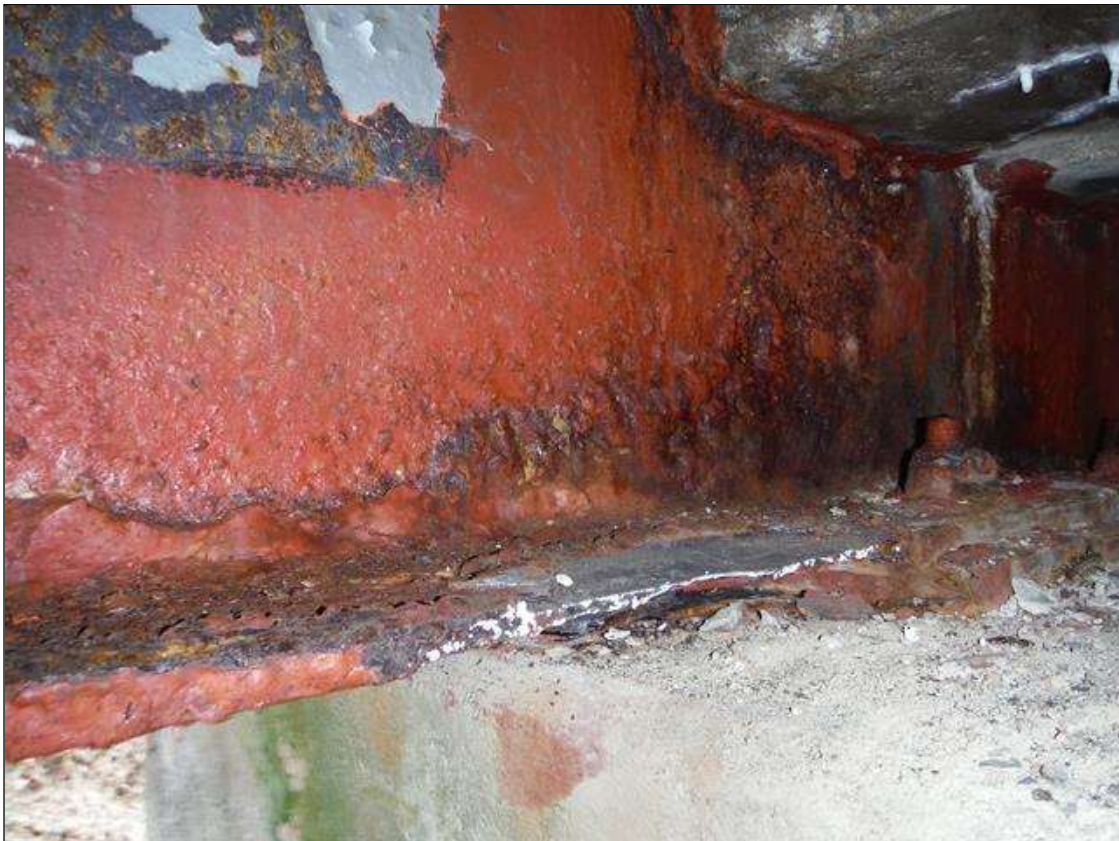
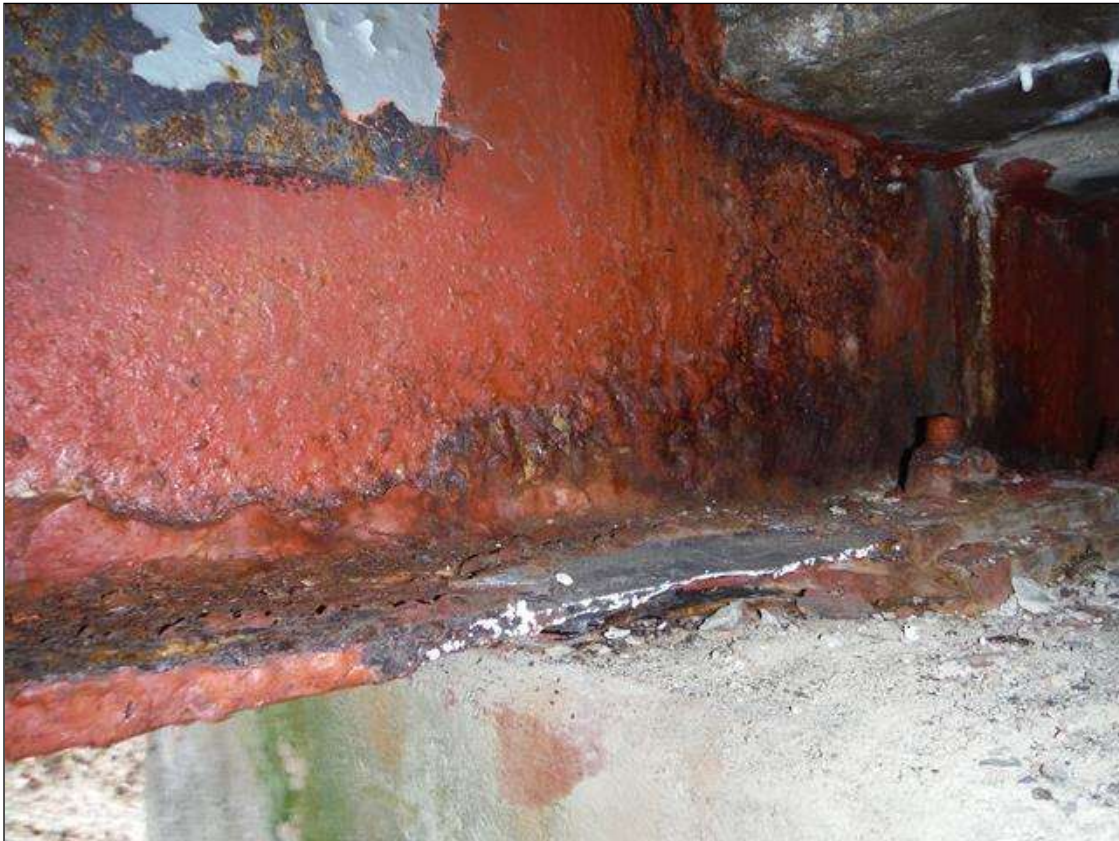
| Item | Priority | Maintenance Issued | Grade | Y | Maint Code | Qty. | 0 |
|---|---|---|---|---|---|---|---|
| | Span 3 Beam 4: | 2 FT. OF CORROSION WITH BOTTOM FLANGE TO KNIFES EDGE AND PAINTED OVER PITTING 1/16" DEEP IN WEB AT BENT 2 | | | | | |

Span 3 Beam 4: 2 FT. OF CORROSION WITH BOTTOM FLANGE TO KNIFES EDGE AND PAINTED OVER PITTING 1/16" DEEP IN WEB AT BENT 2

SPAN 3 BEAM 4: 2 FT. OF CORROSION WITH BOTTOM FLANGE TO KNIFES EDGE AND PAINTED OVER  
PITTING 1/16" DEEP IN WEB AT BENT 2

| MMS Code | Description of Function | Unit | Quantity | Remarks | Est. Cost |
|---|---|---|---|---|---|
| 3314 | Maintain Steel Superstructure Components | LF | 2 | Span 3 Beam 4: 2 FT. OF CORROSION WITH BOTTOM FLANGE TO KNIFES EDGE AND PAINTED OVER PITTING 1/16" DEEP IN WEB AT BENT 2 | |

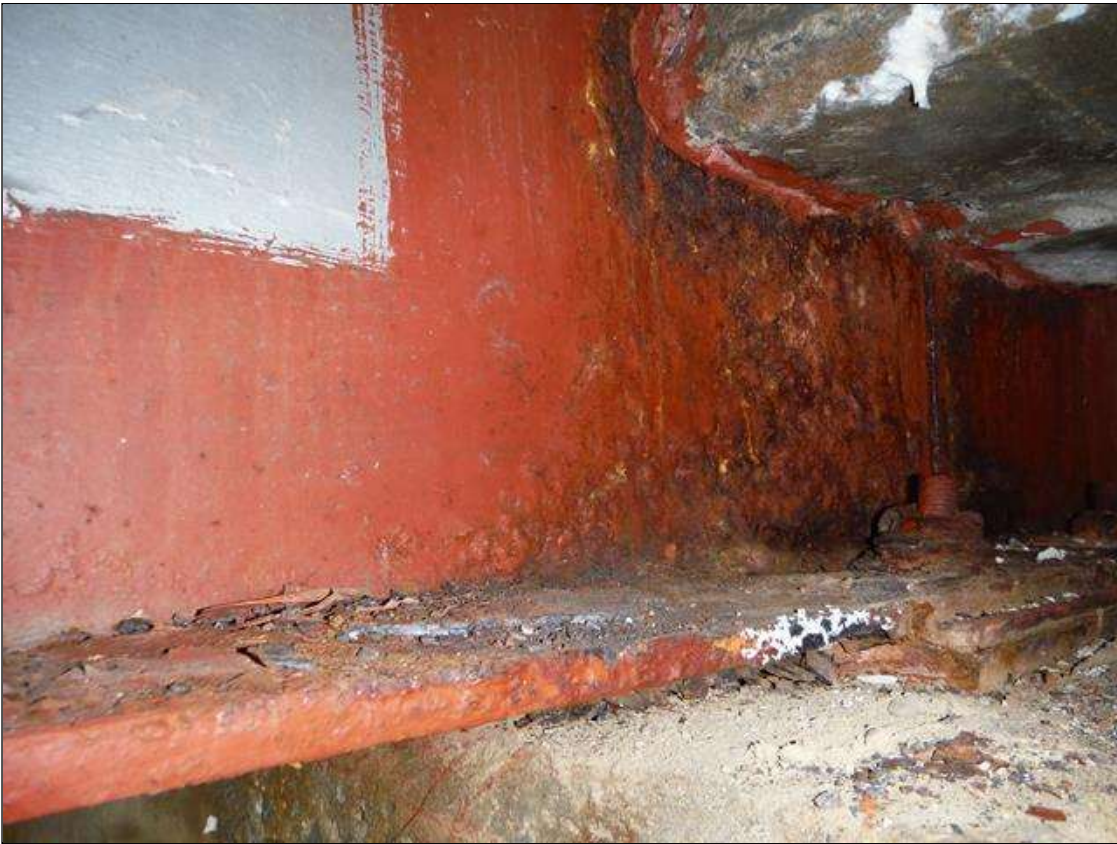
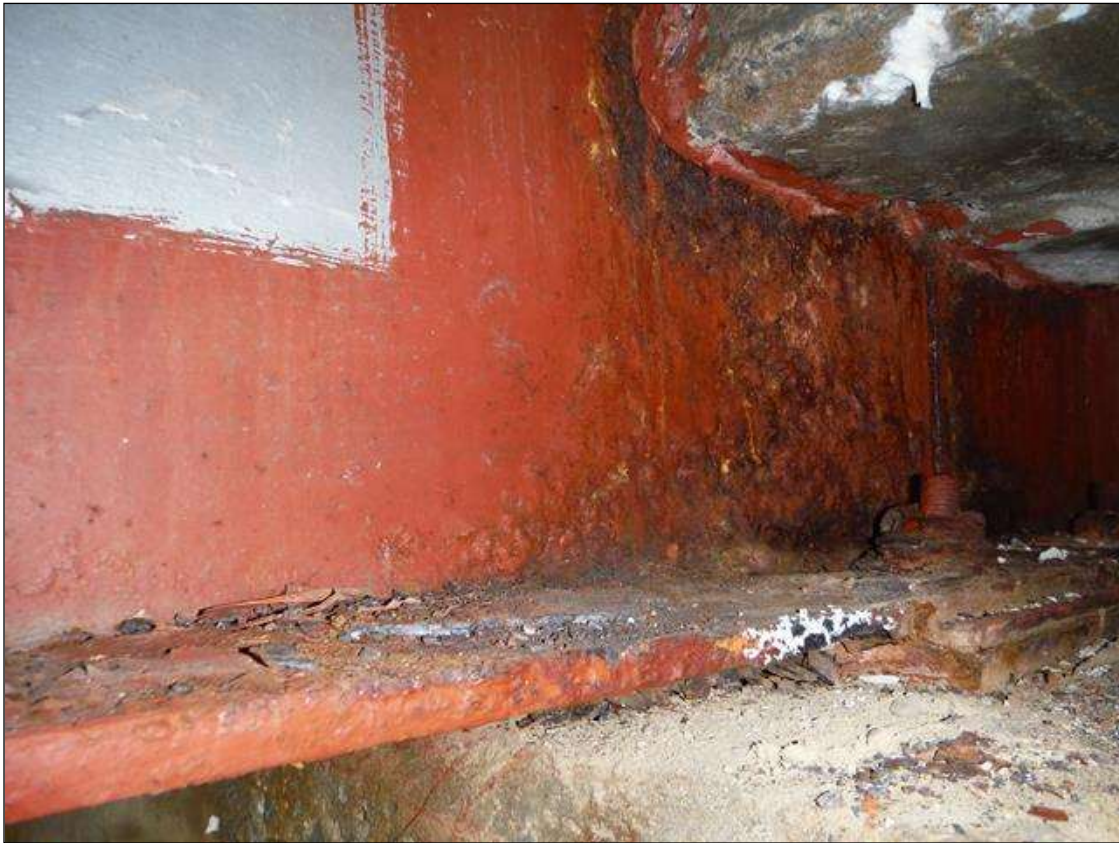
| Item | Priority | Maintenance Issued | Grade | Y | Maint Code | Qty. | 0 |
|---|---|---|---|---|---|---|---|
| | Span 3 Beam 3: | 2 FT. OF CORROSION WITH 1/2" REMAINING SECTION IN BOTTOM FLANGE AND PAINTED OVER PITTING 1/16" DEEP IN WEB AT BENT 2 | | | | | |

Span 3 Beam 3: 2 FT. OF CORROSION WITH 1/2" REMAINING SECTION IN BOTTOM FLANGE AND PAINTED OVER PITTING 1/16" DEEP IN WEB AT BENT 2

SPAN 3 BEAM 3: 2 FT. OF CORROSION WITH 1/2" REMAINING SECTION IN BOTTOM FLANGE AND PAINTED OVER PITTING 1/16" DEEP IN WEB AT BENT 2

| MMS Code | Description of Function | Unit | Quantity | Remarks | Est. Cost |
|---|---|---|---|---|---|
| 3314 | Maintain Steel Superstructure Components | LF | 2 | Span 3 Beam 3: 2 FT. OF CORROSION WITH 1/2" REMAINING SECTION IN BOTTOM FLANGE AND PAINTED OVER PITTING 1/16" DEEP IN WEB AT BENT 2 | |

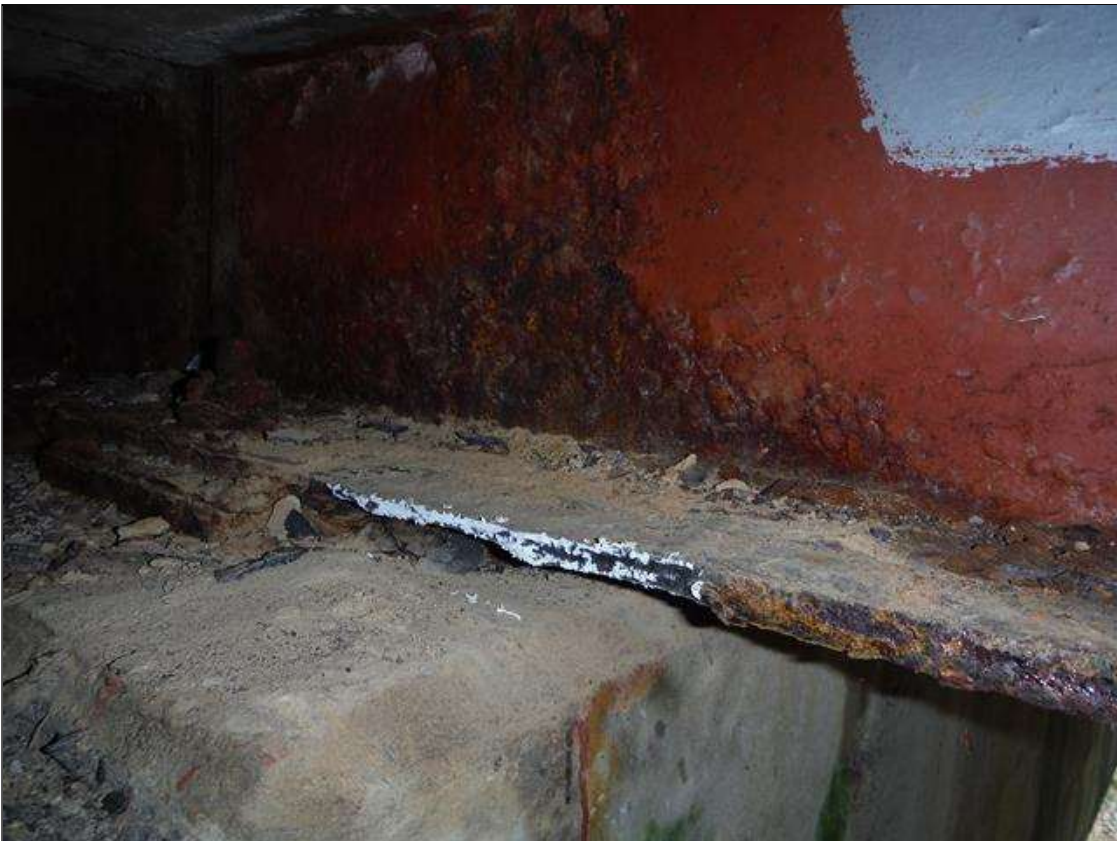
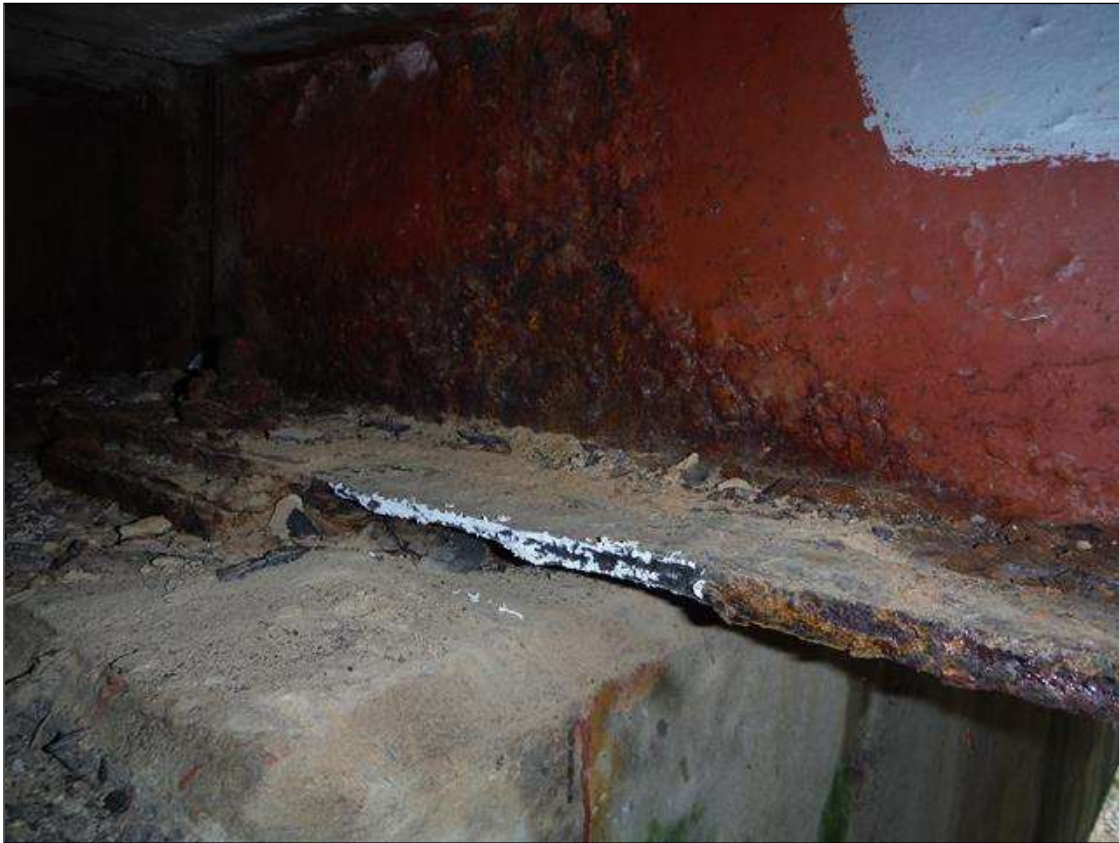
| Item | Priority | Maintenance Issued | Grade | Y | Maint Code | Qty. | 0 |
|---|---|---|---|---|---|---|---|
| | Span 3 Beam 2: | 2 FT. OF CORROSION WITH 1/4" REMAINING SECTION IN BOTTOM FLANGE AND PAINTED OVER PITTING 1/16" DEEP IN WEB AT BENT 2 | | | | | |

Span 3 Beam 2: 2 FT. OF CORROSION WITH 1/4" REMAINING SECTION IN BOTTOM FLANGE AND PAINTED OVER PITTING 1/16" DEEP IN WEB AT BENT 2

SPAN 3 BEAM 2: 2 FT. OF CORROSION WITH 1/4" REMAINING SECTION IN BOTTOM FLANGE AND PAINTED OVER PITTING 1/16" DEEP IN WEB AT BENT 2

| MMS Code | Description of Function | Unit | Quantity | Remarks | Est. Cost |
|---|---|---|---|---|---|
| 3314 | Maintain Steel Superstructure Components | LF | 2 | Span 3 Beam 2: 2 FT. OF CORROSION WITH 1/4" REMAINING SECTION IN BOTTOM FLANGE AND PAINTED OVER PITTING 1/16" DEEP IN WEB AT BENT 2 | |

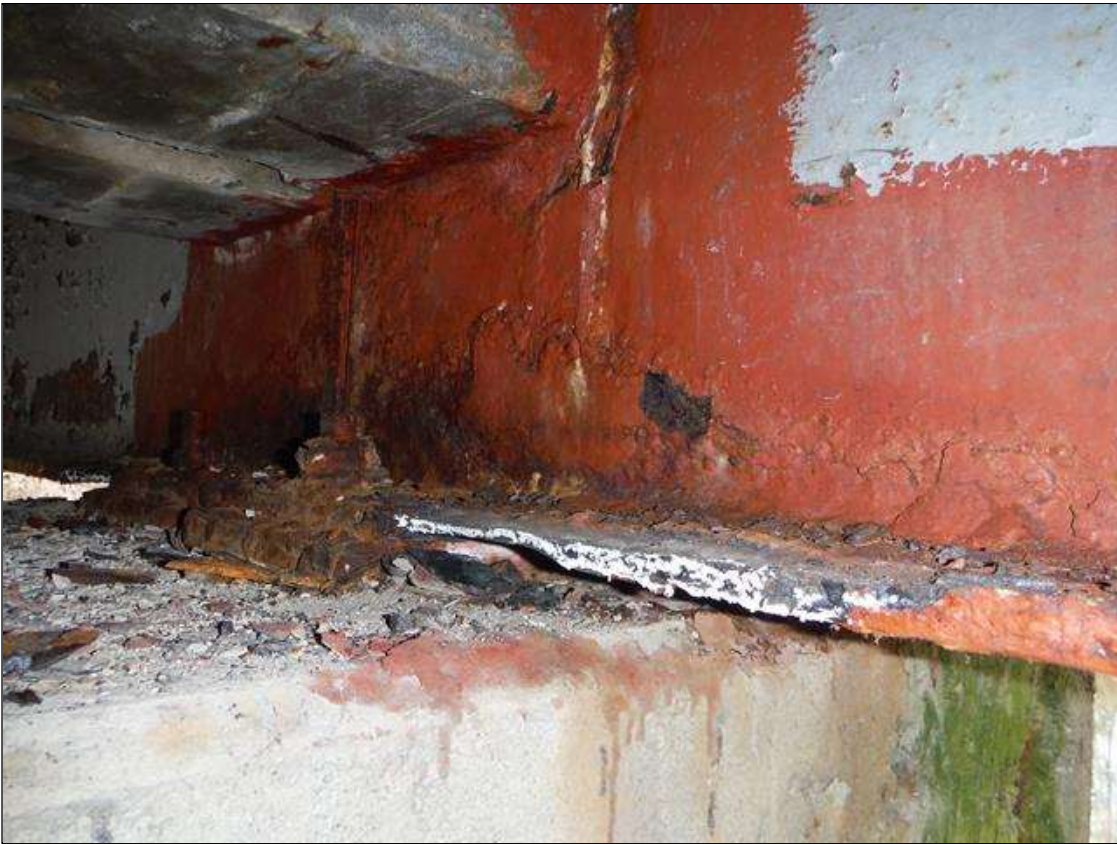
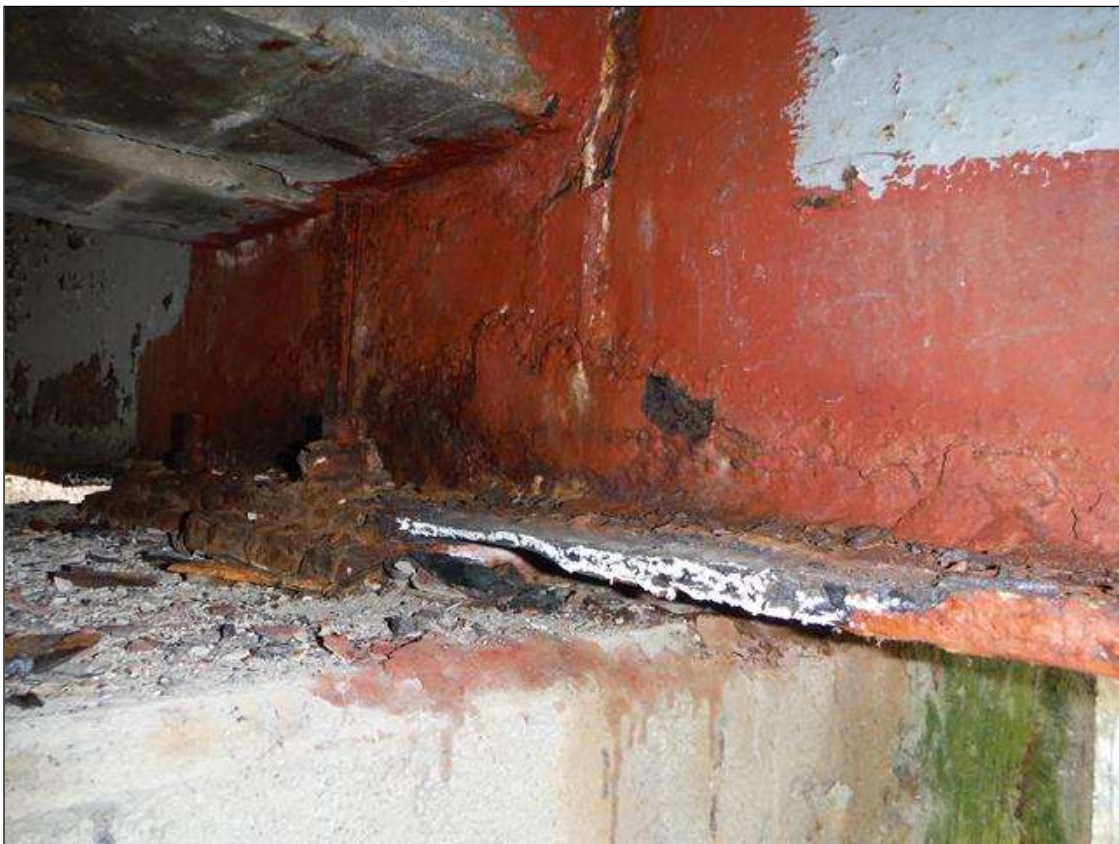
| Item | Priority | Maintenance Issued | Grade | Y | Maint Code | Qty. | 0 |
|---|---|---|---|---|---|---|---|
| | Span 3 Beam 1: | 2 FT. OF CORROSION WITH BOTTOM FLANGE TO KNIFES EDGE AND PAINTED OVER PITTING 1/16" DEEP IN WEB AT BENT 2 | | | | | |

Span 3 Beam 1: 2 FT. OF CORROSION WITH BOTTOM FLANGE TO KNIFES EDGE AND PAINTED OVER PITTING 1/16" DEEP IN WEB AT BENT 2

SPAN 3 BEAM 1: 2 FT. OF CORROSION WITH BOTTOM FLANGE TO KNIFES EDGE AND PAINTED OVER  
PITTING 1/16" DEEP IN WEB AT BENT 2

| MMS Code | Description of Function | Unit | Quantity | Remarks | Est. Cost |
|---|---|---|---|---|---|
| 3314 | Maintain Steel Superstructure Components | LF | 2 | Span 3 Beam 1: 2 FT. OF CORROSION WITH BOTTOM FLANGE TO KNIFES EDGE AND PAINTED OVER PITTING 1/16" DEEP IN WEB AT BENT 2 | |

| MMS Code | MMS Description | Quantity |
|---|---|---|
| Span 3 Beam 1: 2 FT. OF CORROSION WITH BOTTOM FLANGE TO KNIFES EDGE AND PAINTED OVER PITTING 1/16" DEEP IN WEB AT BENT 2 | | |

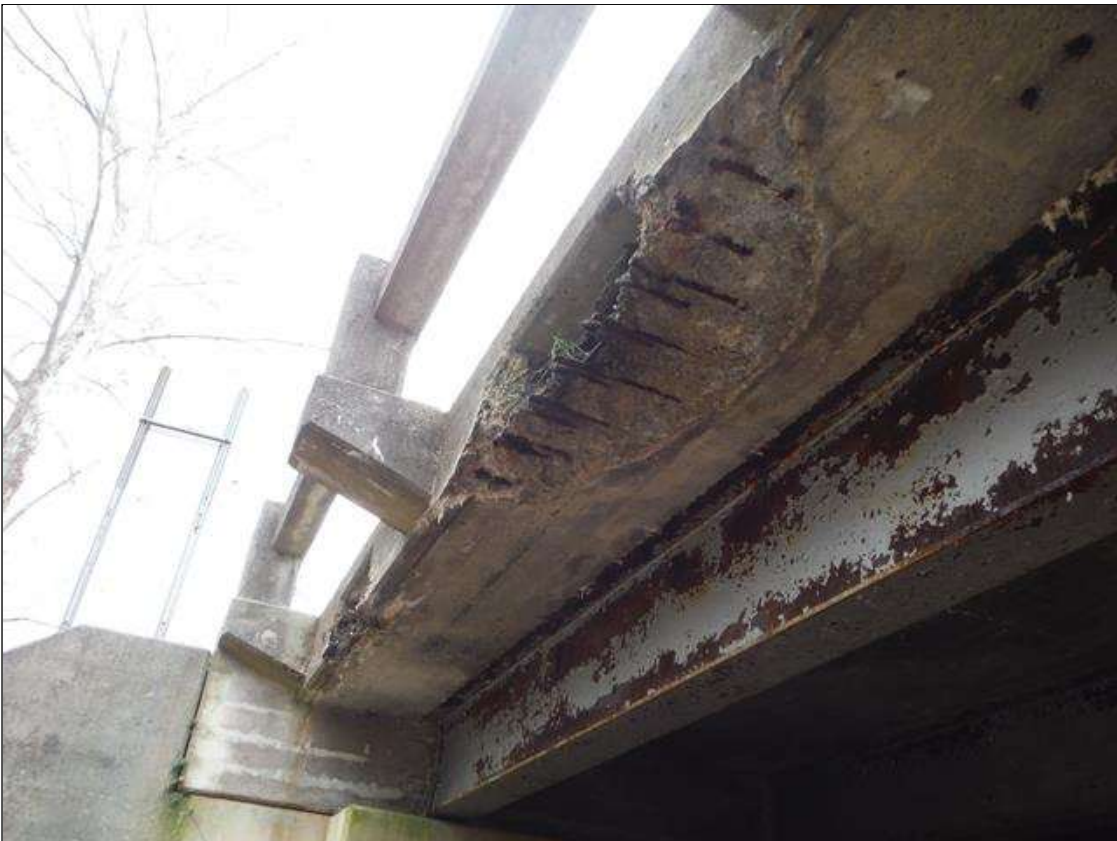
Span 3 Deck: 72" X 18" X 6" DEEP AND 24" X 4" X 3" DEEP SPALLS WITH EXPOSED REBAR IN BOTTOM OF DECK NORTH OVERHANG
