NC DEPARTMENT OF TRANSPORTATION  
DIVISION OF HIGHWAYS  
STRUCTURE MANAGEMENT UNIT

## Structure Safety Report

### Routine Element Inspection - Contract

COUNTY: DAVIDSON STRUCTURE NUMBER: 280082 FREQUENCY: 24 MONTHS

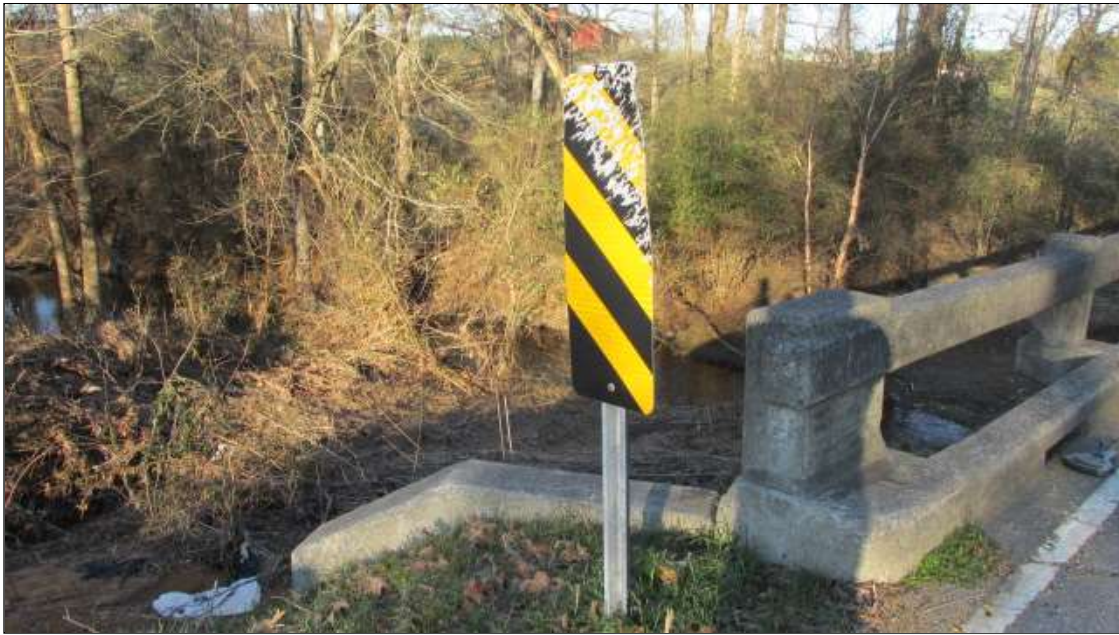
DAMAGED SOUTHEAST DELINEATOR

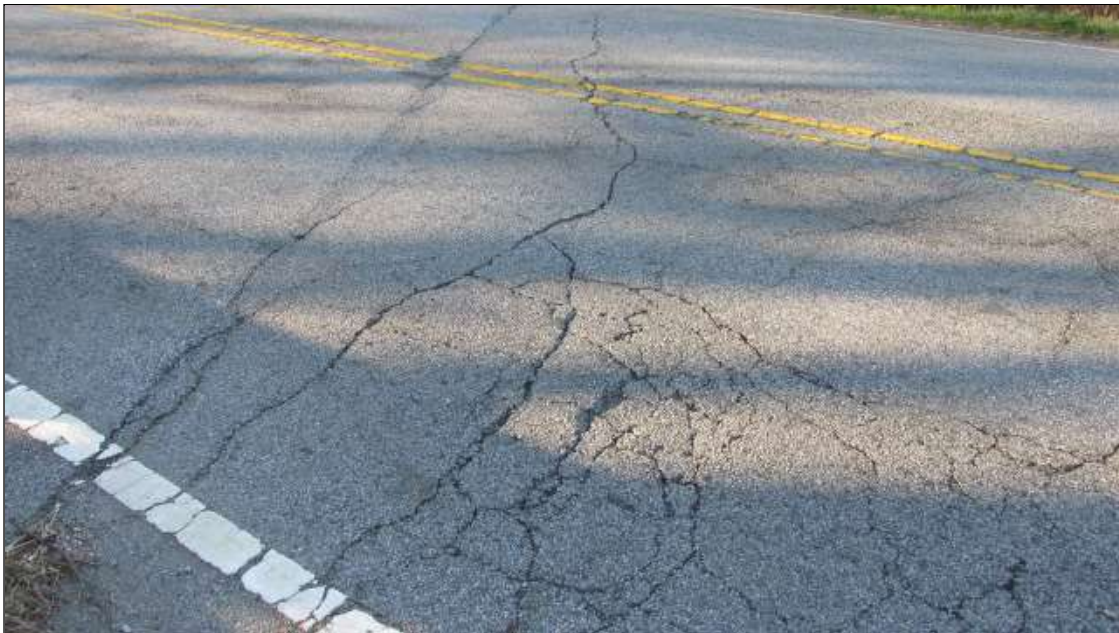
| <b>Details</b> | CRACKING AND MINOR SETTLEMENT AT EACH BRIDGE APPROACH |

1" MAXIMUM SETTLEMENT AND CRACKING IN WEST APPROACH

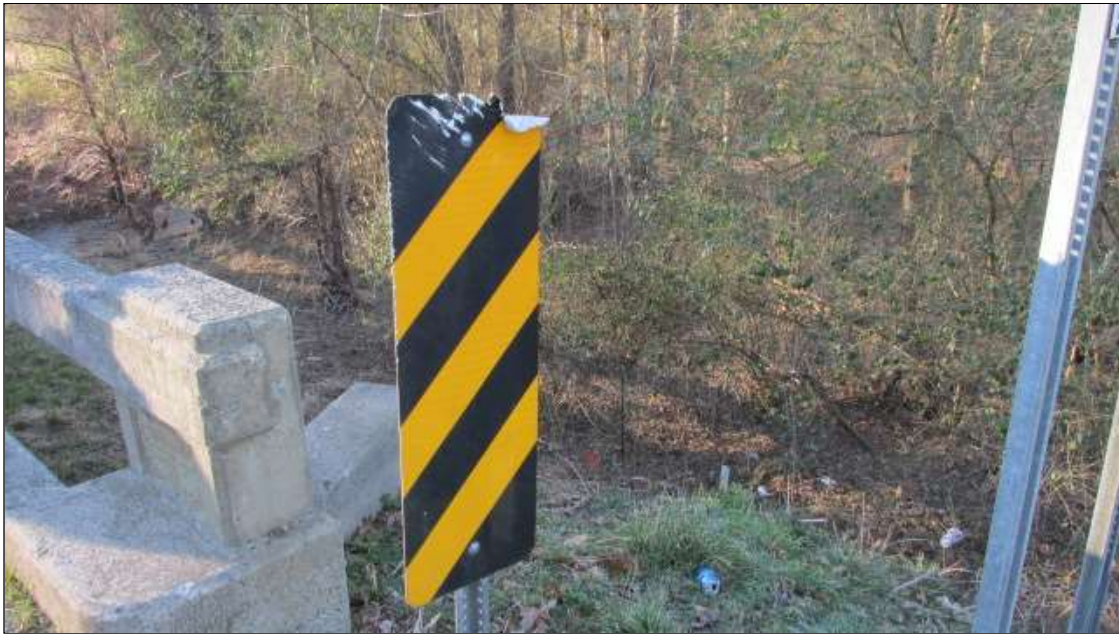
DAMAGED NORTHWEST DELINEATOR

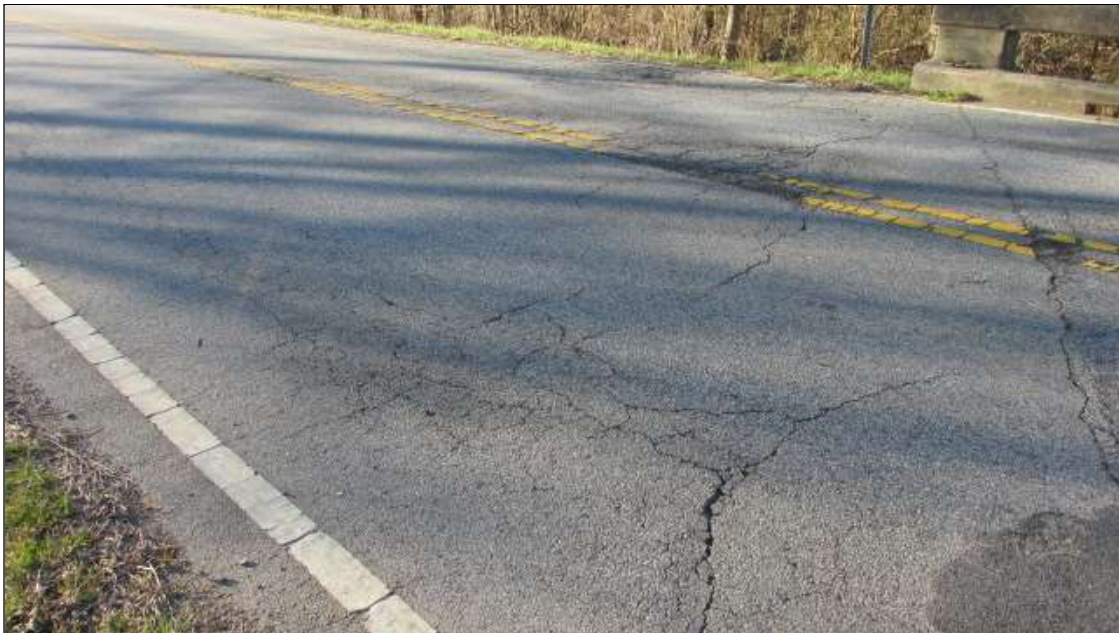
MINOR SETTLEMENT AND CRACKING IN EAST APPROACH

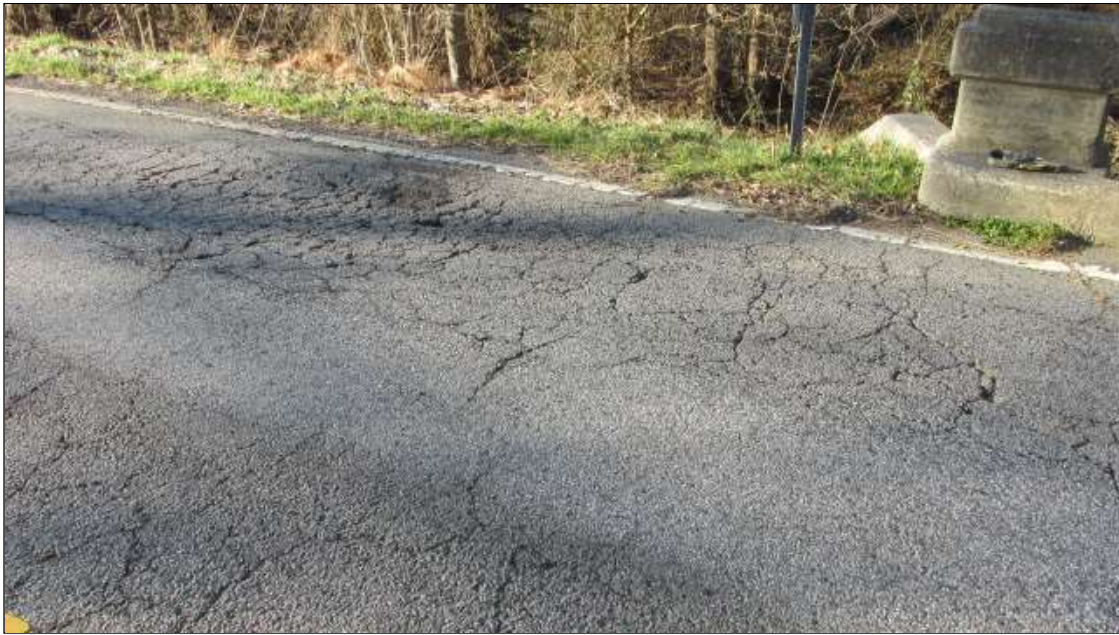
CRACKING AND DEVELOPING POTHOLE IN EAST BOUND LANE OF EAST APPROACH-80 SQUARE FEET

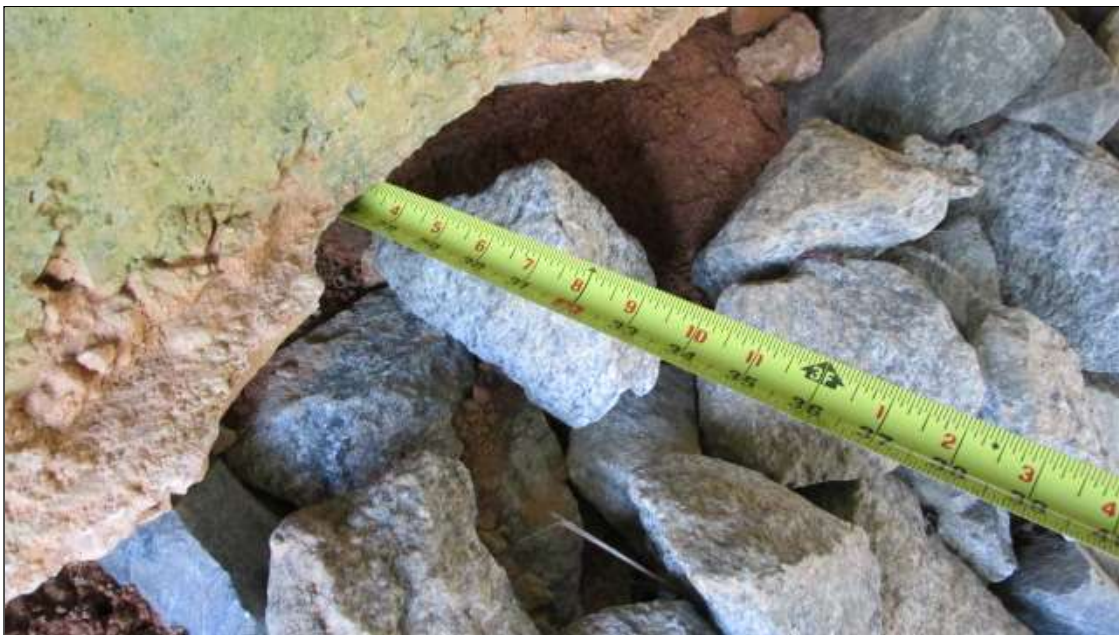
| <b>Details</b> | SLOPE SETTLEMENT AT END BENT 1 (15' L X 2.5' W X 6" D) AT SOUTH HALF<br>SLOPE SETTLEMENT AT END BENT 2 (2' L X 2.5' W X 3" D) AT NORTH FACE<br>SLOPE SETTLEMENT AT NORTHEAST WING (2' L X 1' W X 3" D) |

SLOPE SETTLEMENT 2.5' X 6" AT END BENT 1 - 15 FEET

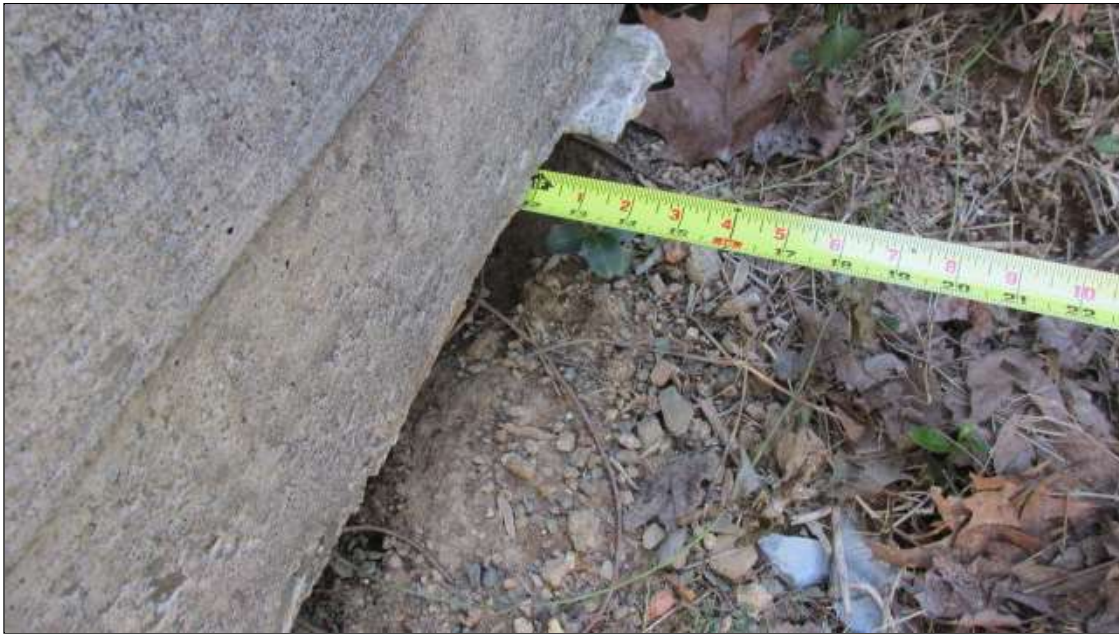
1' DEEP UNDERMINE 2' LONG X 3" HIGH AT NORTHEAST WING

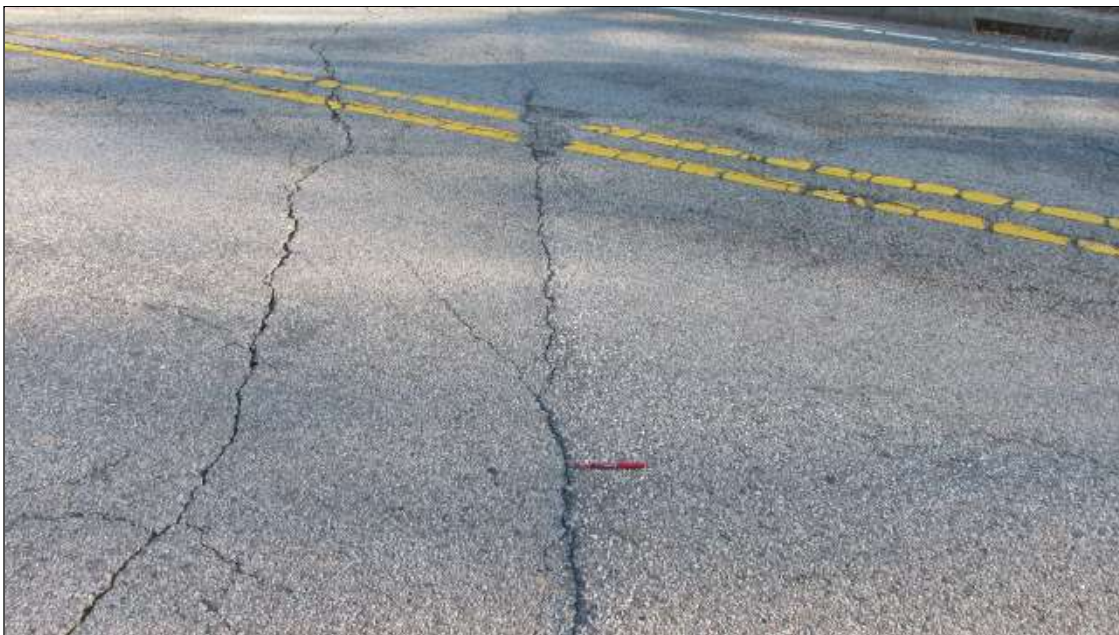
1/8" CRACKING ALONG END BENT 1 FILL FACE  
MINOR MAP CRACKING COVERING ENTIRE SPAN

Span 1 Wearing Surface: 1/8" CRACKING ALONG END BENT 1 FILL FACE

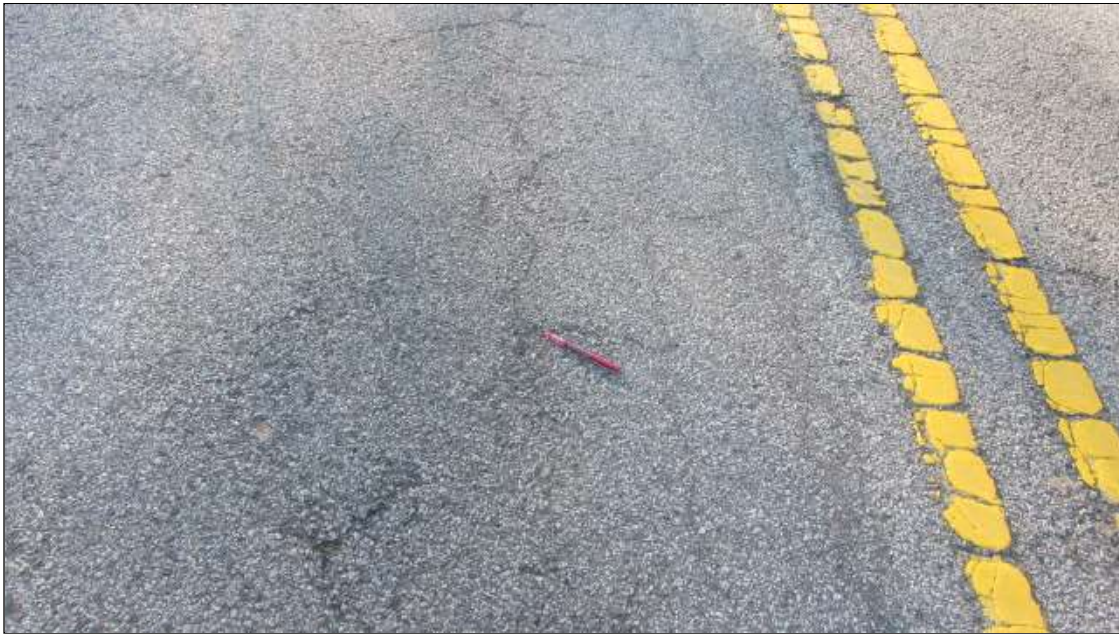
Span 1 Wearing Surface: MINOR MAP CRACKING COVERING ENTIRE SPAN

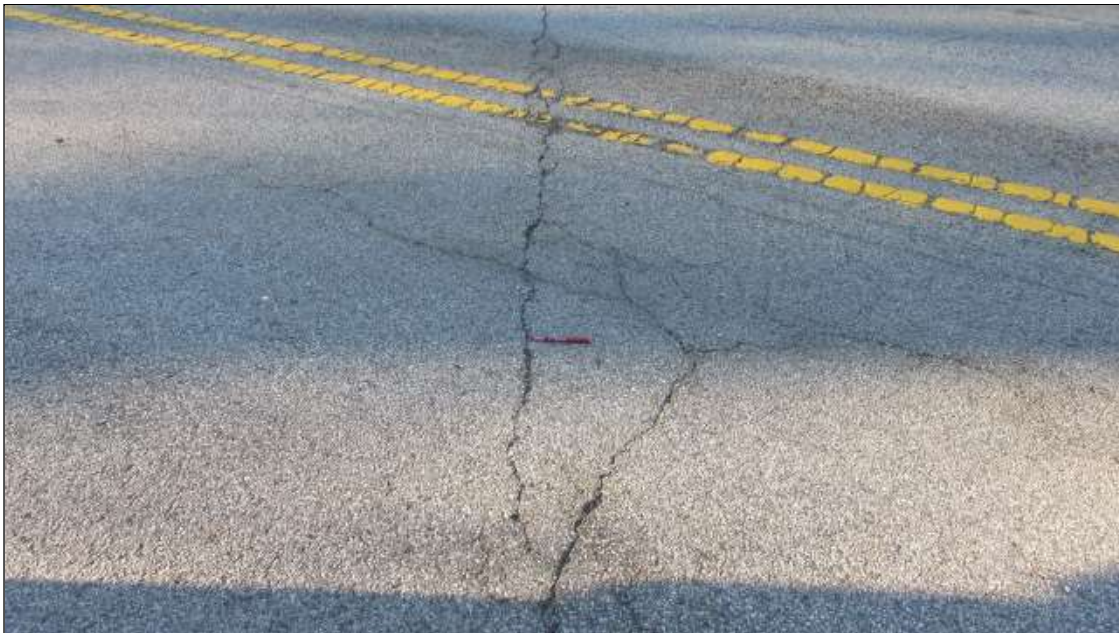
1/8" CRACKING ALONG BENT 1

Span 2 Wearing Surface: 1/8" CRACKING ALONG BENT 1

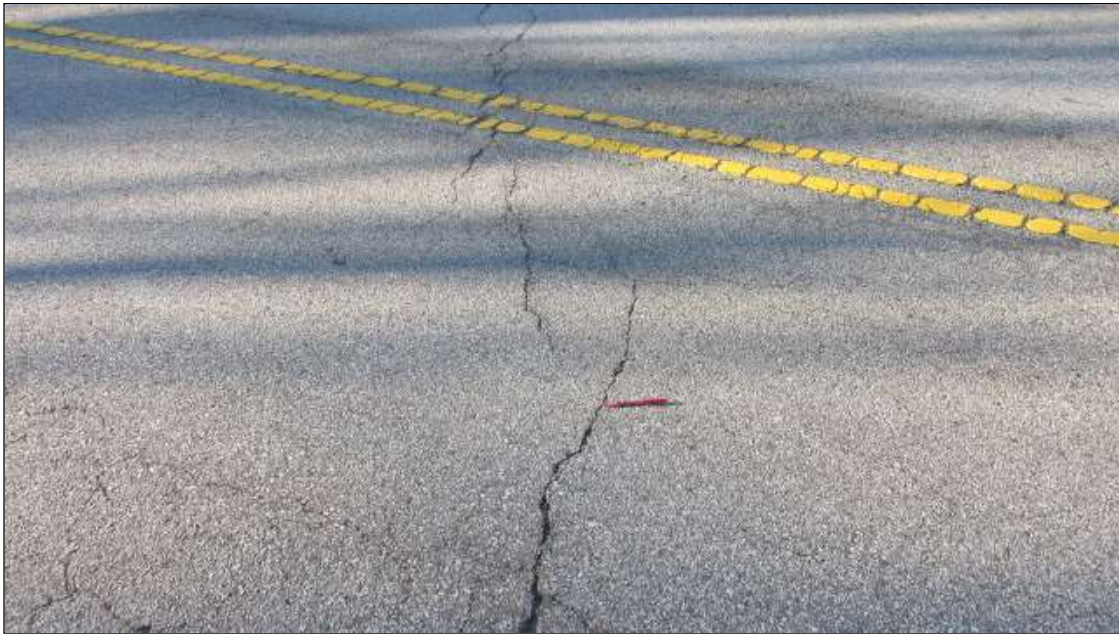
1/8" CRACKING ALONG BENT 2  
 1/8" CRACKING ALONG END BENT 2 FILL FACE  
 MINOR MAP CRACKING ALONG ENTIRE SPAN

Span 3 Wearing Surface: 1/8" CRACKING ALONG BENT 2

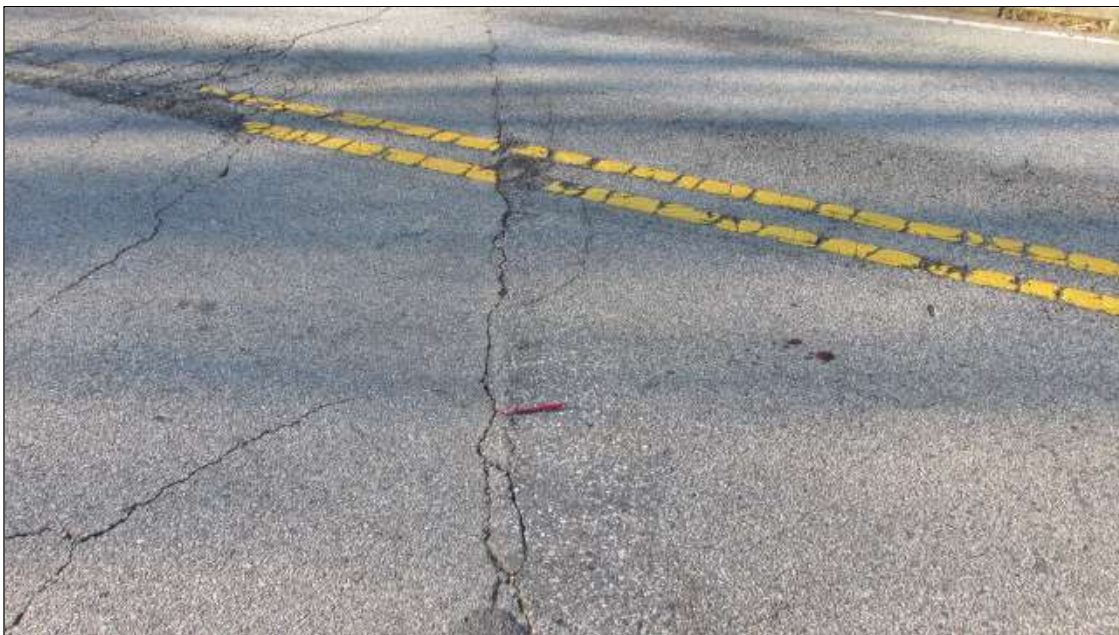
Span 3 Wearing Surface: 1/8" CRACKING ALONG END BENT 2 FILL FACE

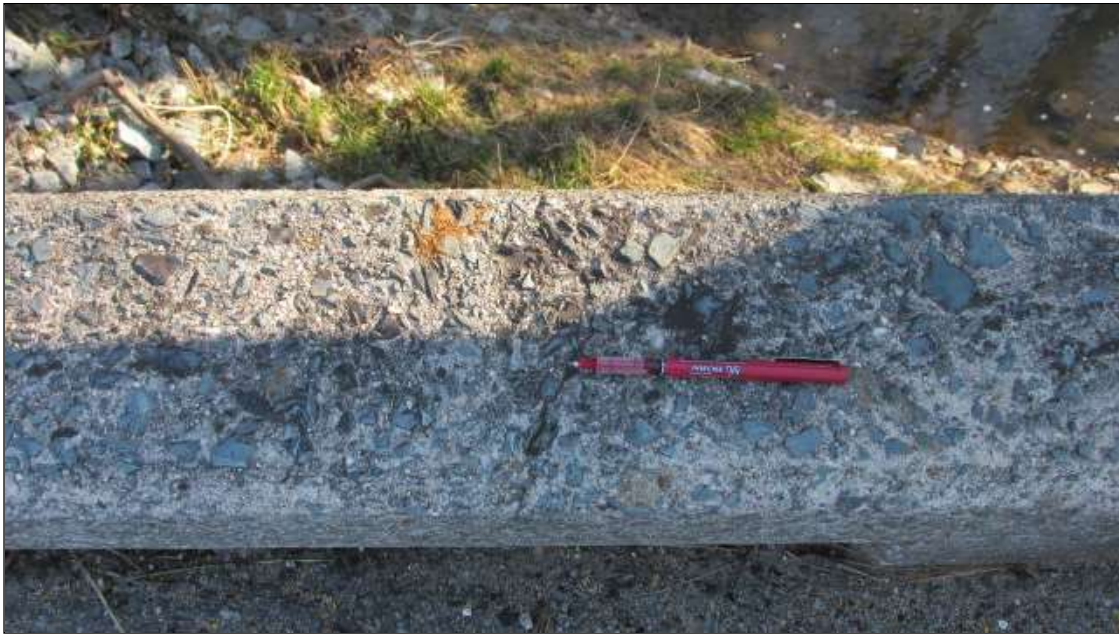
3/64" CRACKING IN CURB AND DRAIN #2  
SURFACE SCALING ALONG ENTIRE RAIL

Span 1 Left Bridge Rail: 3/64" CRACKING IN CURB AND DRAIN #2

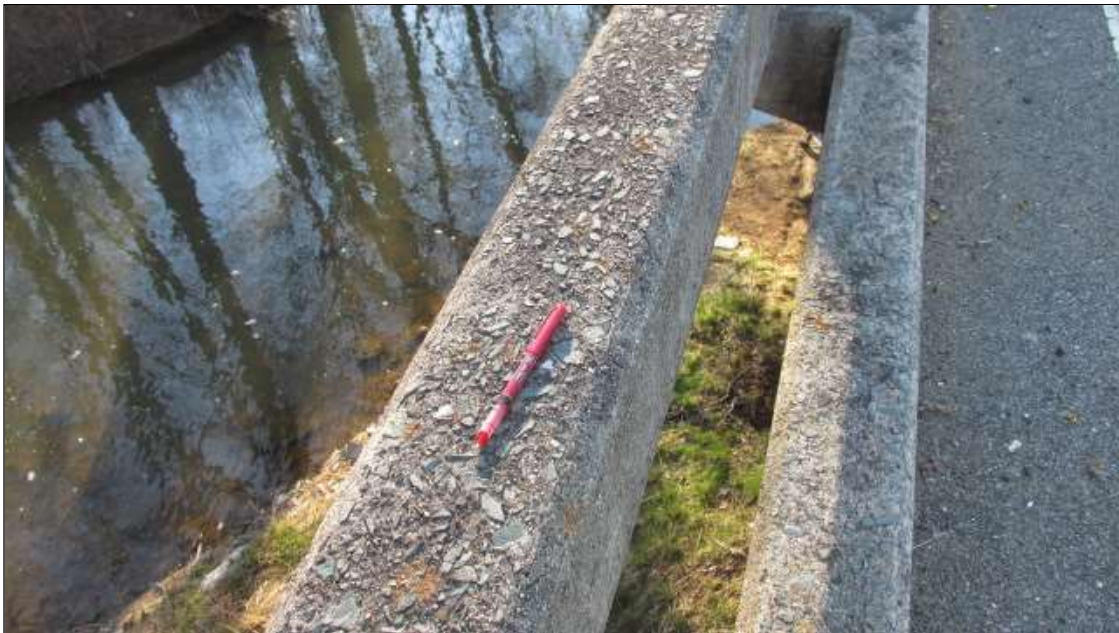
Span 1 Left Bridge Rail: SURFACE SCALING ALONG ENTIRE RAIL

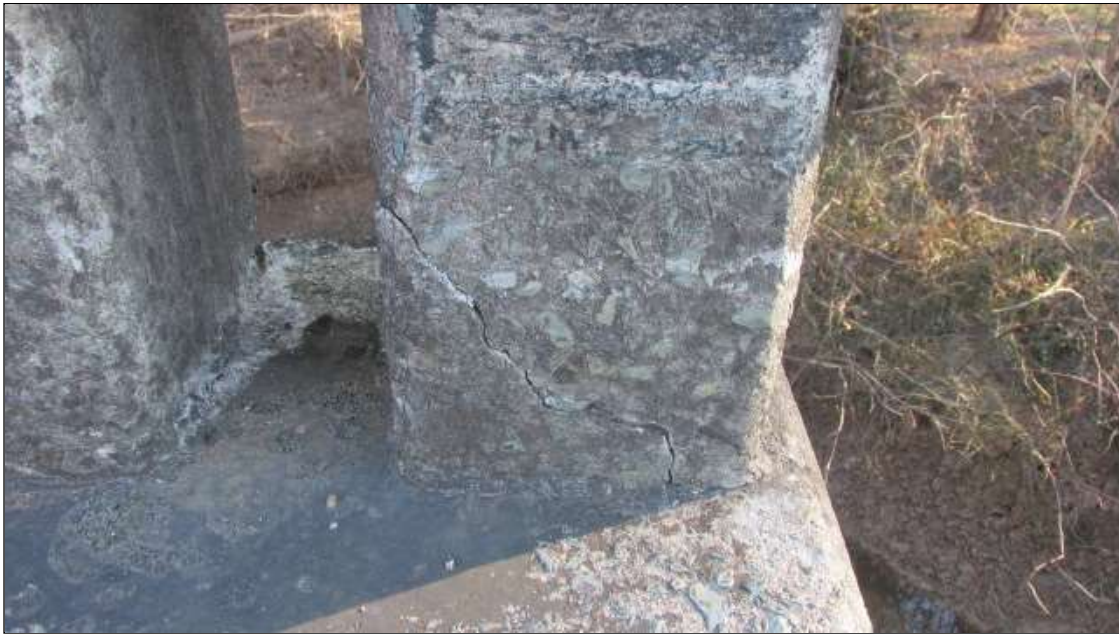
1/32" CRACK IN POST 4

Span 2 Left Bridge Rail: 1/32" CRACK IN POST 4

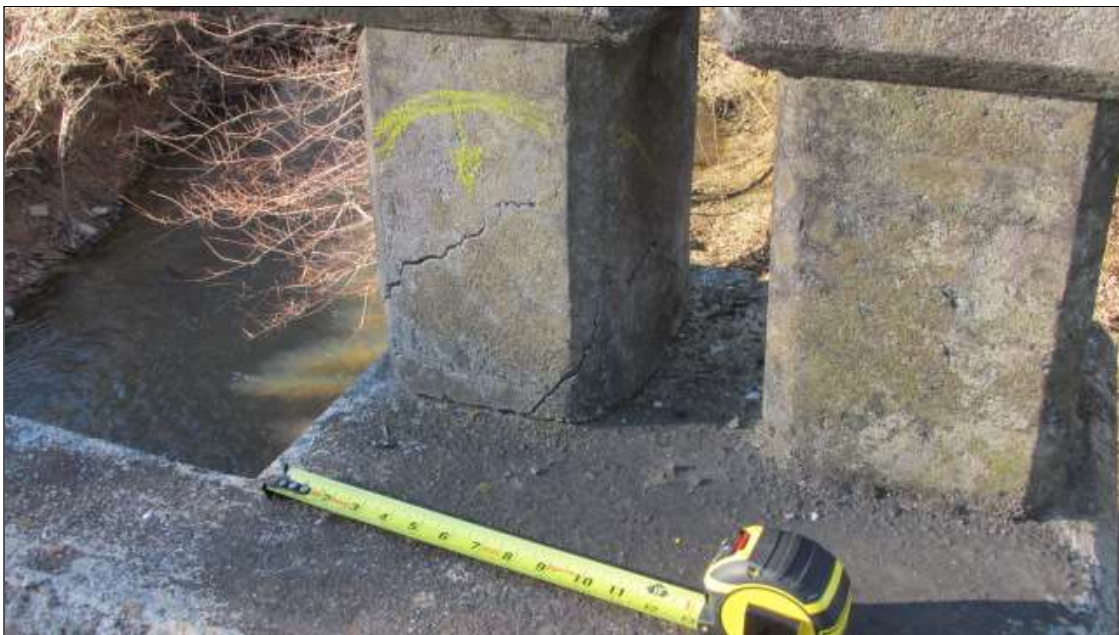
1/16" CRACKING IN POST 4

Span 2 Right Bridge Rail: 1/16" CRACKING IN POST 4

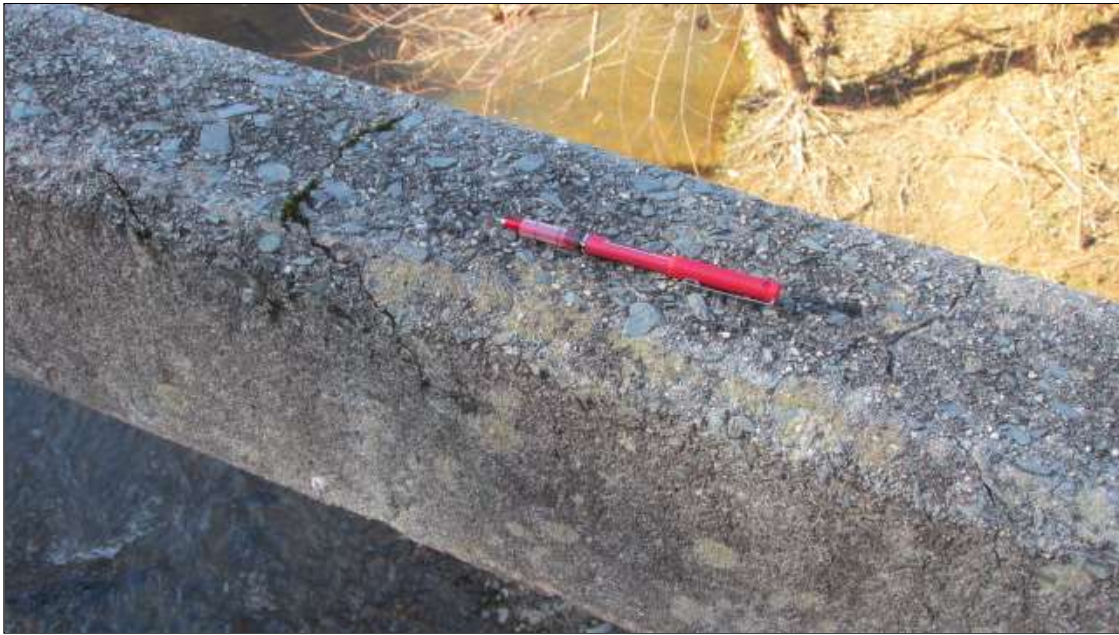
1/32" CRACK BETWEEN POST 4 AND 5

Span 2 Right Bridge Rail: 1/32" CRACK BETWEEN POST 4 AND 5

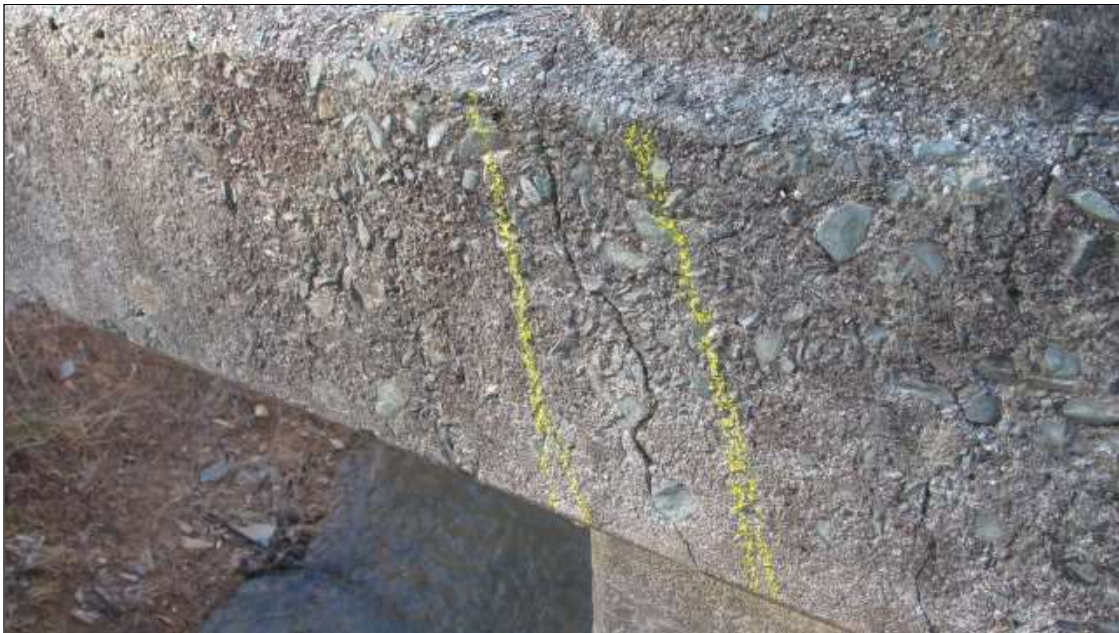
1/32" CRACK AT POST 5

Span 2 Right Bridge Rail: 1/32" CRACK AT POST 5

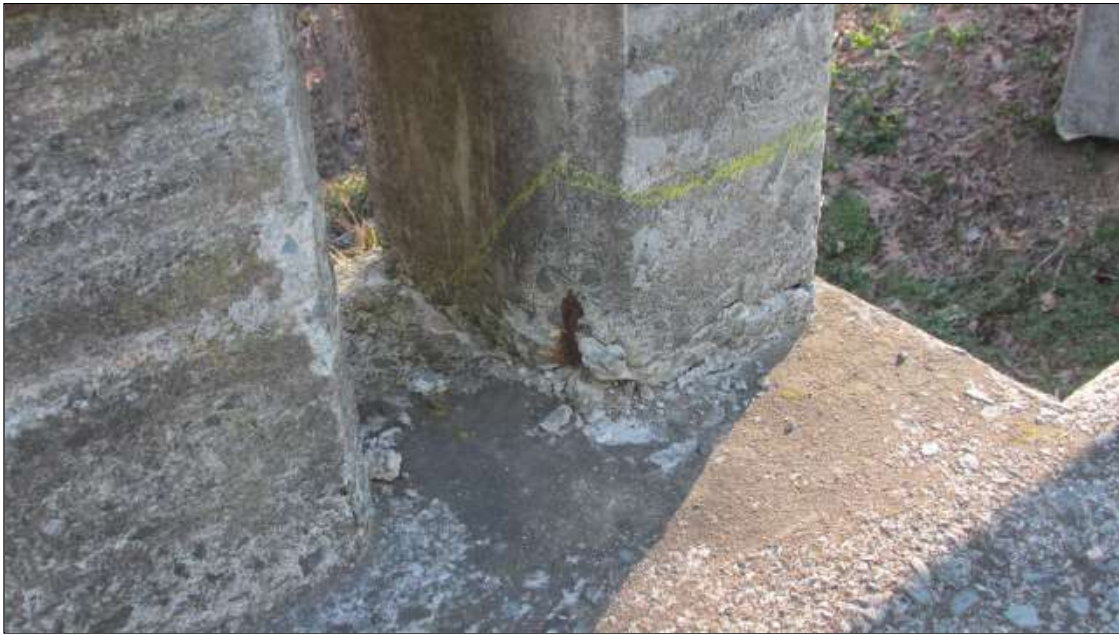
SPALLING WITH EXPOSED REBAR IN POST 4  
 1/32" CRACK IN POST 5  
 SURFACE SCALING ALONG ENTIRE RAIL

Span 3 Left Bridge Rail: SPALLING WITH EXPOSED REBAR IN POST 4

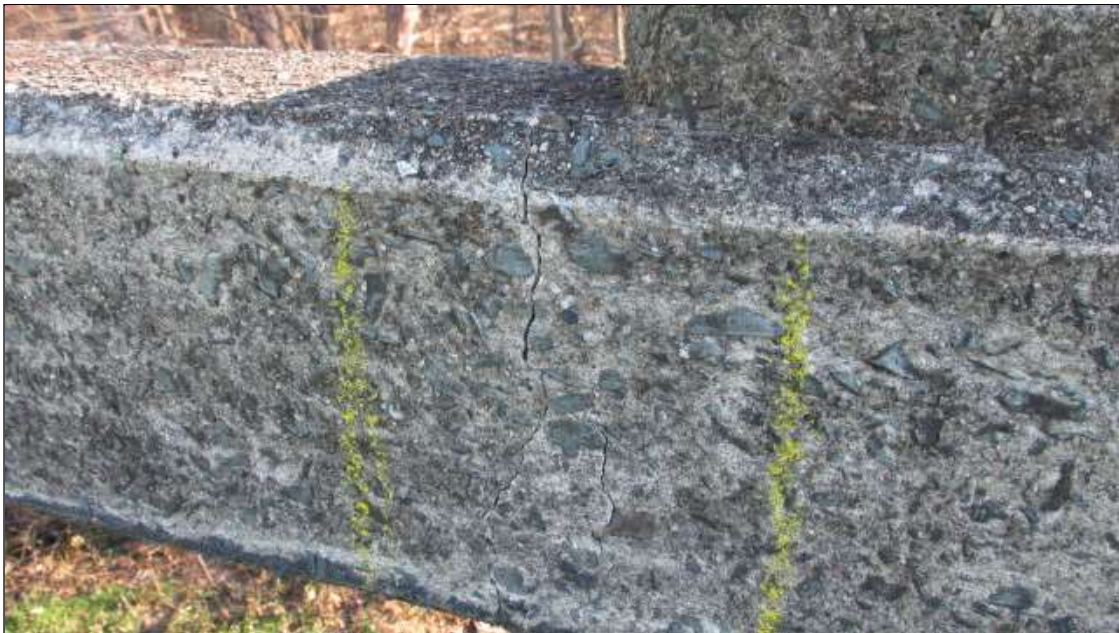
Span 3 Left Bridge Rail: 1/32" CRACK IN POST 5

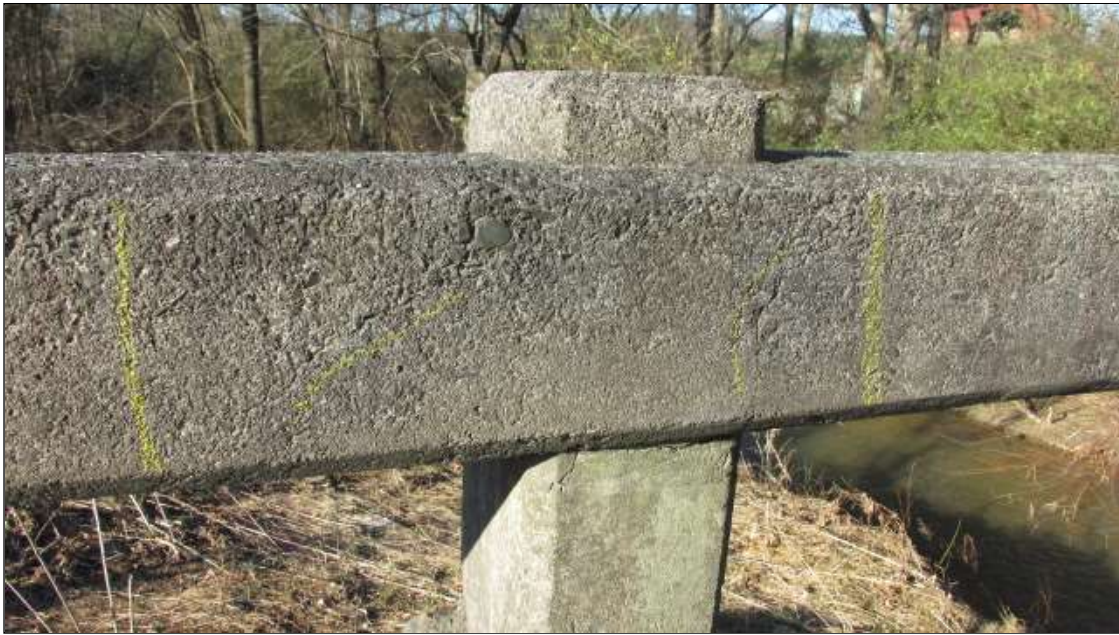
1/32" CRACK IN POST 5  
 SURFACE SCALING ALONG ENTIRE RAIL

Span 3 Right Bridge Rail: 1/32" CRACK IN POST 5

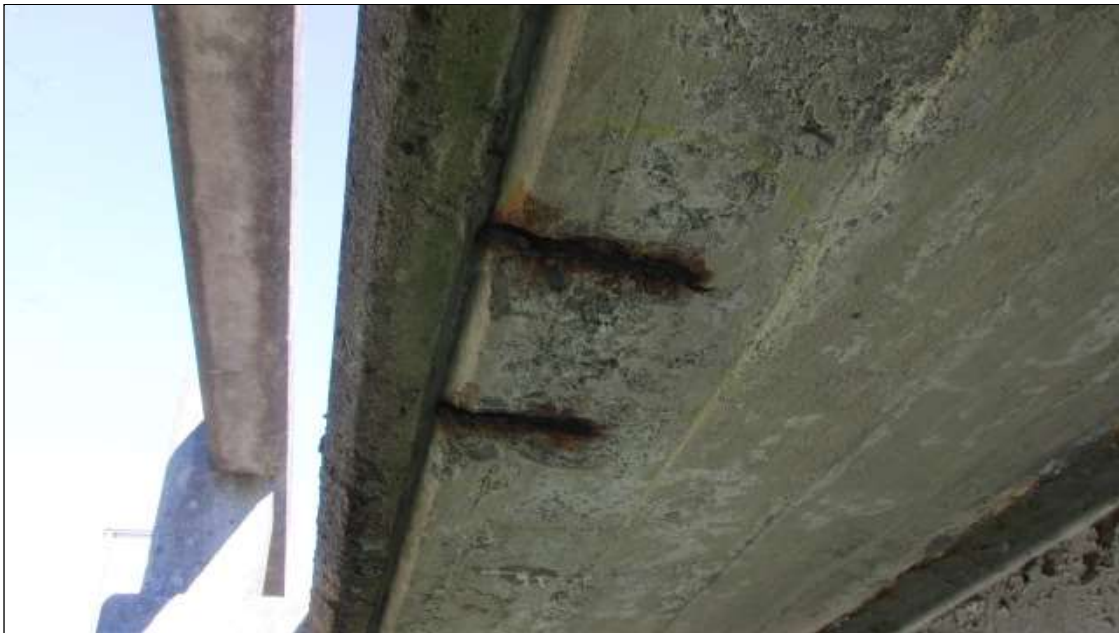
Span 1 Deck: 6" DIAMETER X .5" DEEP POPOUTS IN EACH OVERHANG

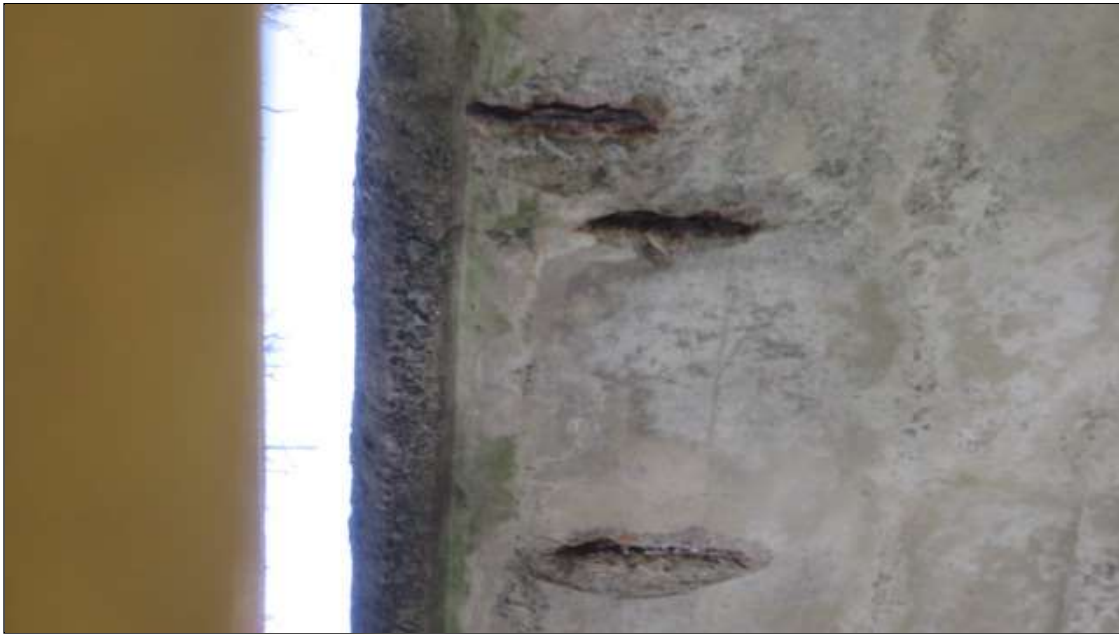
Span 2 Deck: 6" DIAMETER X .5" DEEP POPOUTS IN EACH OVERHANG

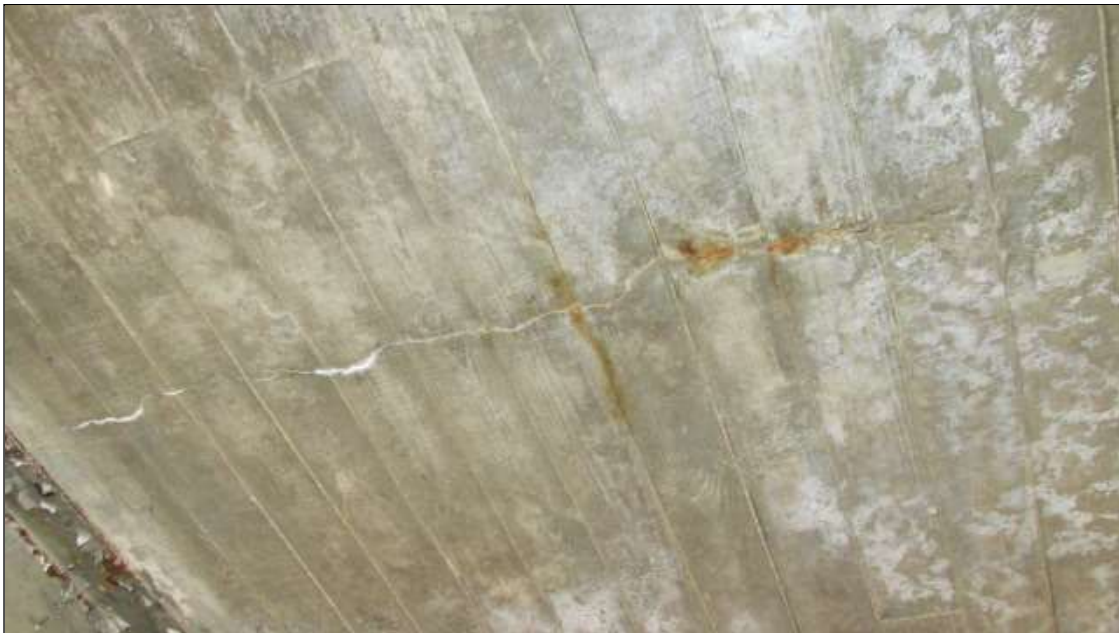
TRANSVERSE CRACKING WITH LIGHT EFFLORESCENCE AND RUST STAINING IN BAY 1 NEAR END BENT 2  
 TRANSVERSE CRACKING IN BAY 2 NEAR END BENT 2  
 6" DIAMETER X .5" DEEP POPOUTS IN EACH OVERHANG

Span 3 Deck: TRANSVERSE CRACKING WITH LIGHT EFFLORESCENCE AND RUST STAINING IN BAY 1 NEAR  
END BENT 2

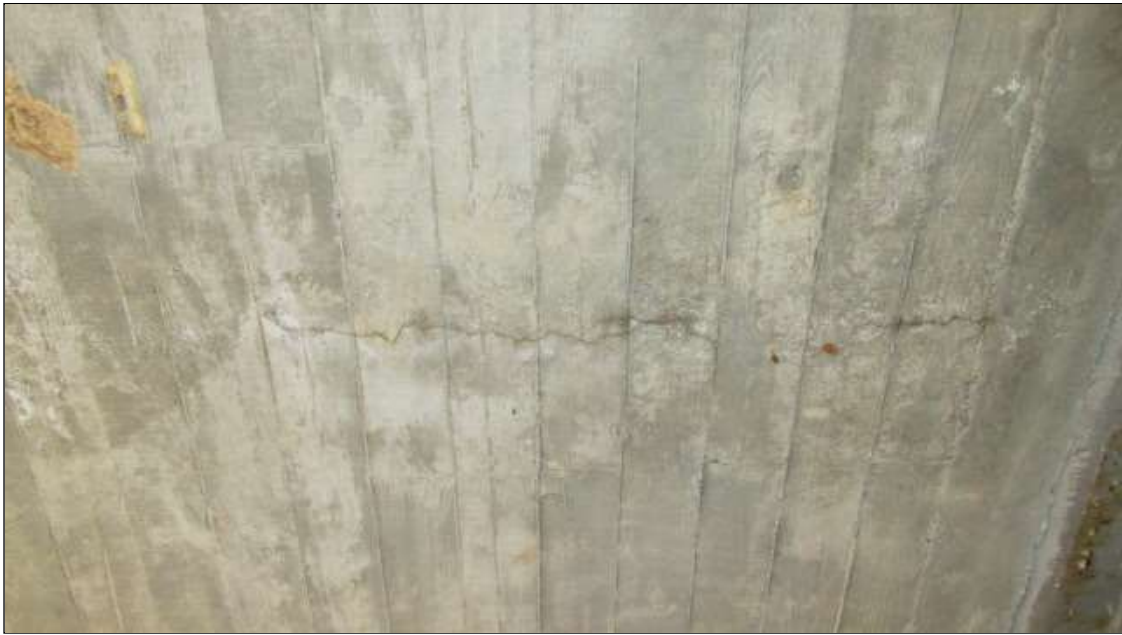
Span 3 Deck: TRANSVERSE CRACKING IN BAY 2 NEAR END BENT 2

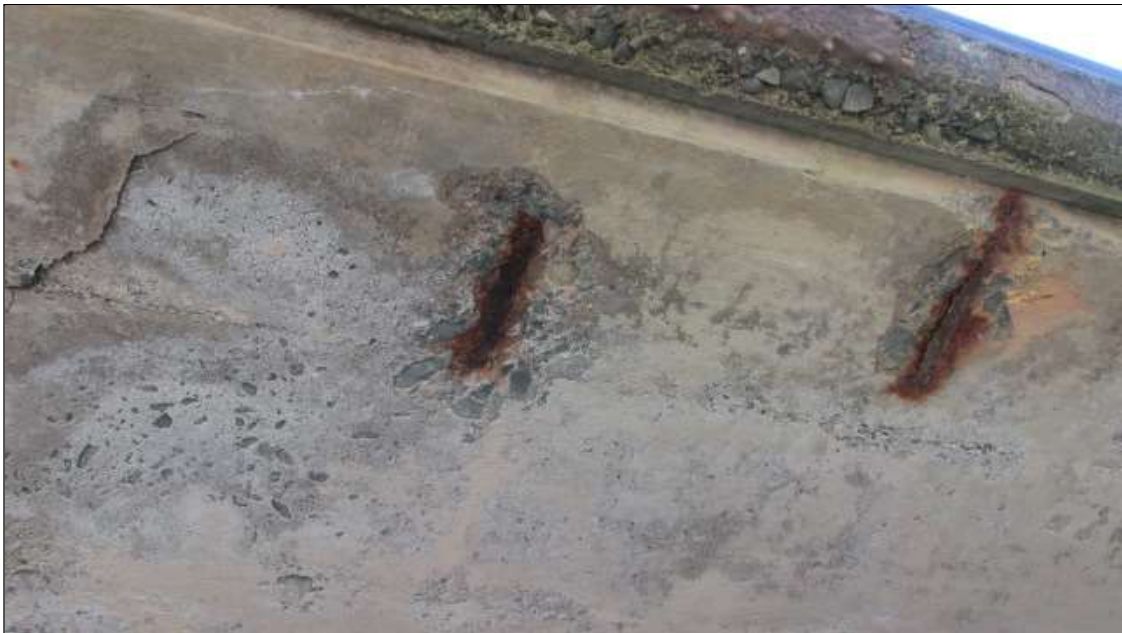
Span 3 Deck: 6" DIAMETER X .5" DEEP POPOUTS IN EACH OVERHANG

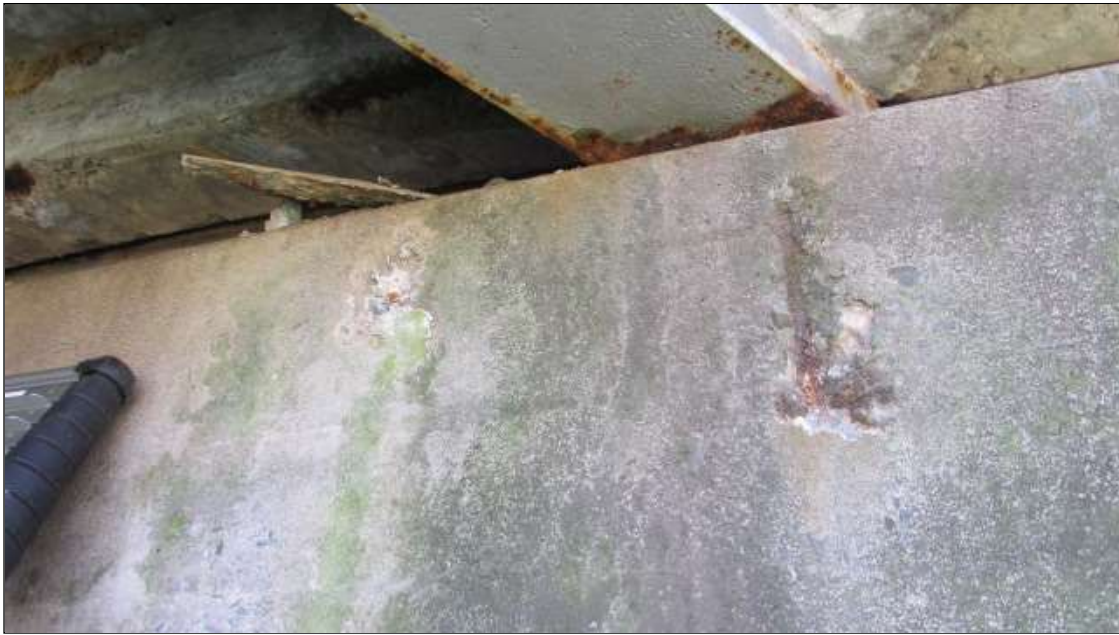
| 12" X 4" X 1" DEEP SPALL WITH EXPOSED REBAR ON WEST FACE AT GIRDER 4 | | | | | | | | | | | | |

Bent 1 Cap : 12" X 4" X 1" DEEP SPALL WITH EXPOSED REBAR ON WEST FACE AT GIRDER 4

| MMS Code | Description of Function | Unit | Quantity | Remarks | Est. Cost |
|---|---|---|---|---|---|
| 3348 | Maintain Concrete Substructure Components | LF | 1 | 12" X 4" X 1" DEEP SPALL WITH EXPOSED REBAR ON WEST FACE AT GIRDER 4 ON BENT 1 | |

| MMS Code | MMS Description | Quantity |
|---|---|---|
| 12" X 4" X 1" DEEP SPALL WITH EXPOSED REBAR ON WEST FACE AT GIRDER 4 ON BENT 1 | | |

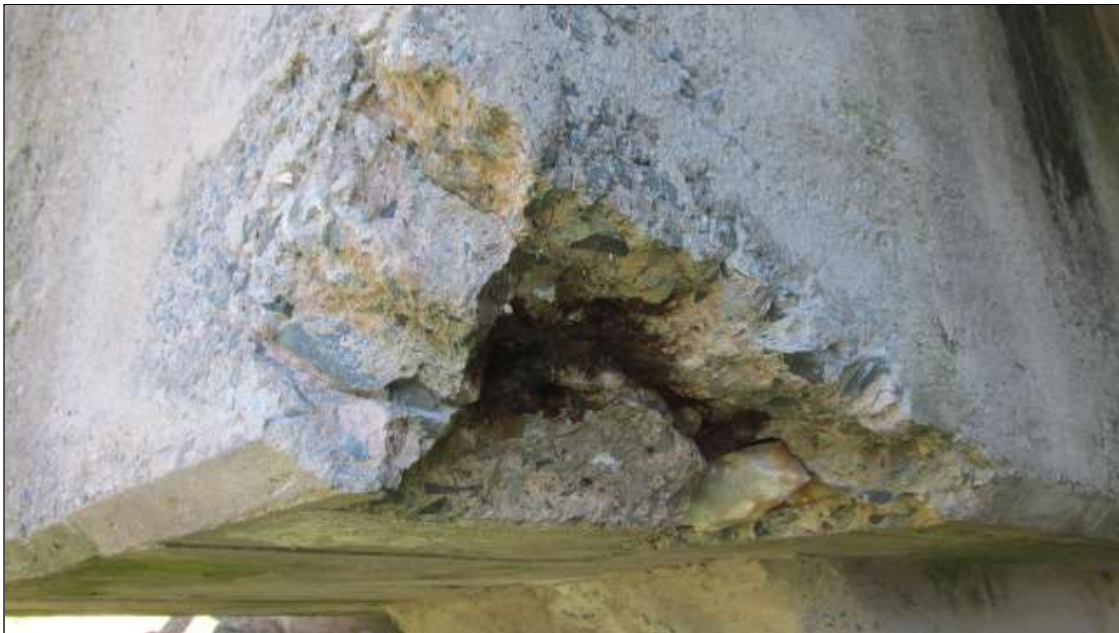
| 12" X 6" X 2" DEEP CORNER SPALL ON EAST FACE ON SOUTH END | | | | | | | | | | | | |

Bent 1 Cap : 12" X 6" X 2" DEEP CORNER SPALL ON EAST FACE ON SOUTH END

| MMS Code | Description of Function | Unit | Quantity | Remarks | Est. Cost |
|---|---|---|---|---|---|
| 3348 | Maintain Concrete Substructure Components | LF | 1 | 12" X 6" X 2" DEEP CORNER SPALL WITH EXPOSED REBAR ON EAST FACE OF BENT 1 AT SOUTH END | |

| MMS Code | MMS Description | Quantity |
|---|---|---|
| 12" X 6" X 2" DEEP CORNER SPALL WITH EXPOSED REBAR ON EAST FACE OF BENT 1 AT SOUTH END | | |

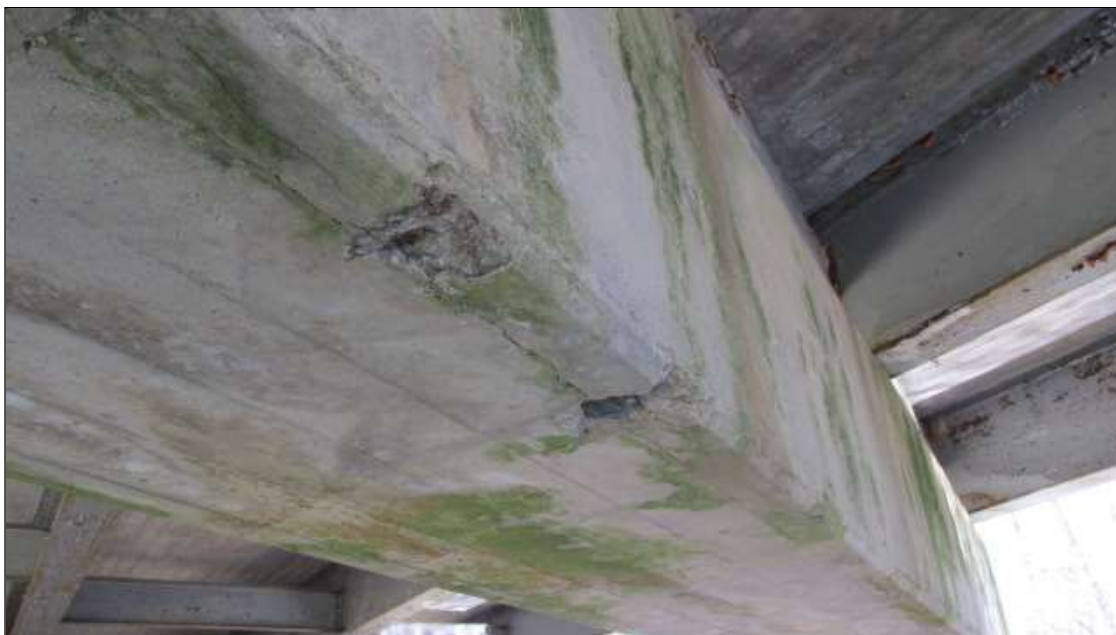
| 3/64" CORNER CRACKING AT EACH BOTTOM CORNER | | | | | | | | | | | | |

Bent 1 Cap : 3/64" CORNER CRACKING AT EACH BOTTOM CORNER

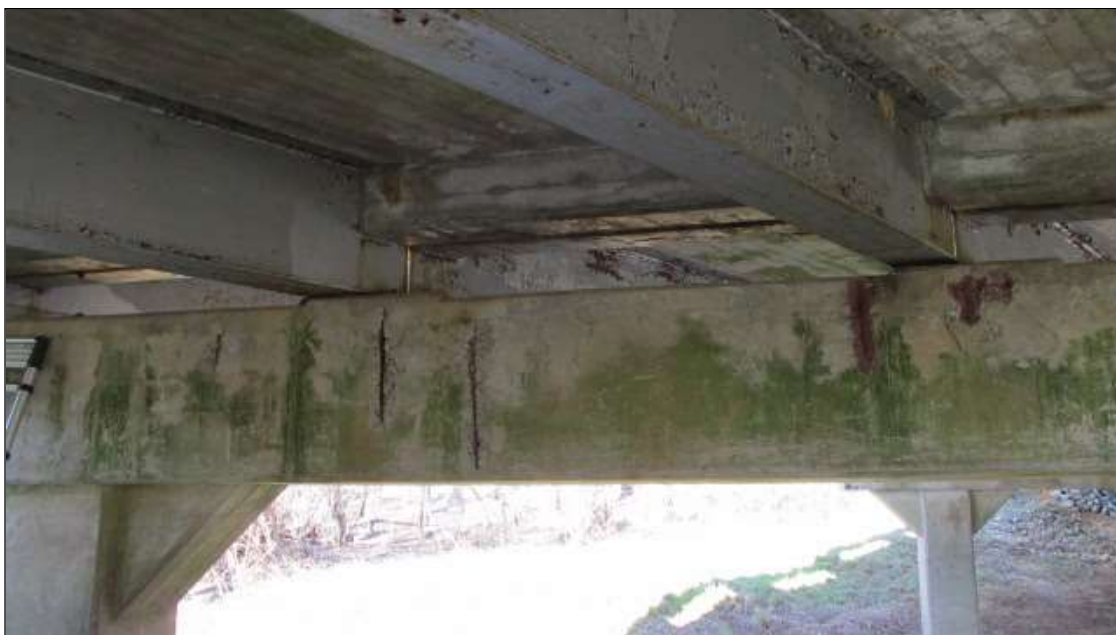
| SPALLING ON EAST FACE WITH EXPOSED STEEL | | | | | | | | | | | | |

Bent 2 Cap : SPALLING ON EAST FACE

| MMS Code | Description of Function | Unit | Quantity | Remarks | Est. Cost |
|---|---|---|---|---|---|
| 3348 | Maintain Concrete Substructure Components | LF | 10 | SPALLING WITH EXPOSED REBAR ON EAST FACE OF BENT 2 CAP | |

| MMS Code | MMS Description | Quantity |
|---|---|---|
| SPALLING WITH EXPOSED REBAR ON EAST FACE OF BENT 2 CAP | | |

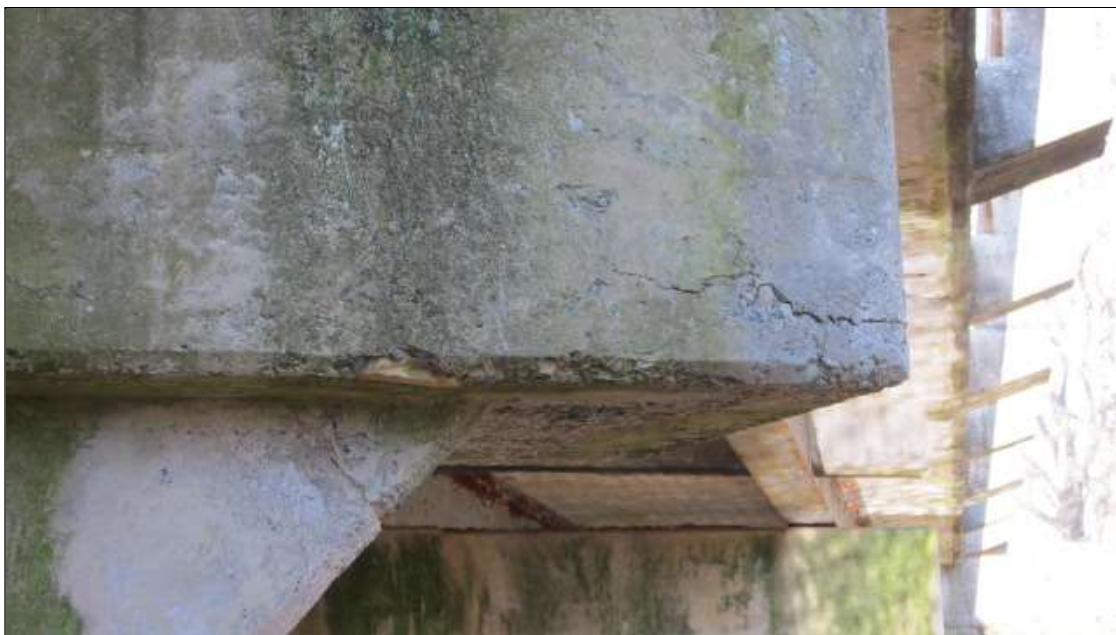
| 3/64" CORNER CRACKING ON TOP AND BOTTOM ON EAST FACE | | | | | | | | | | | | |

Bent 2 Cap : 3/64" CORNER CRACKING ON TOP AND BOTTOM ON EAST FACE
