NC DEPARTMENT OF TRANSPORTATION  
DIVISION OF HIGHWAYS  
STRUCTURE MANAGEMENT UNIT

## Structure Safety Report

### Routine Element Inspection - Contract

COUNTY: DAVIDSON STRUCTURE NUMBER: 280082 FREQUENCY: 24 MONTHS

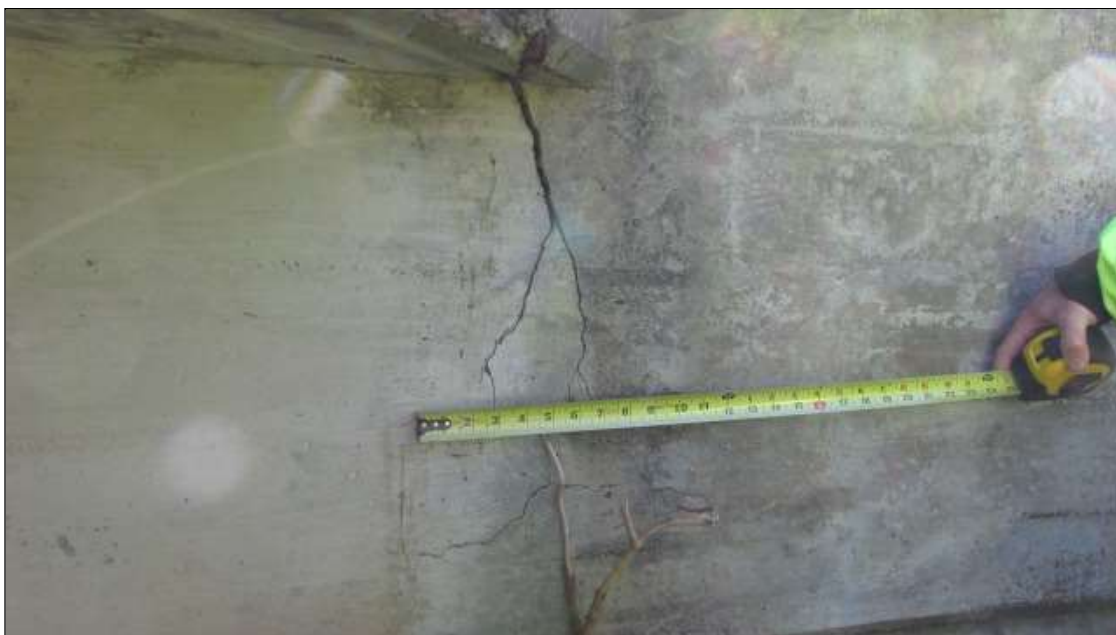
| 1/8" CRACKING AT SOUTHEAST WING | | | | | | | | | | | | |

Bent 2 Cap : 1/8" CRACKING ON SOUTHEAST WING

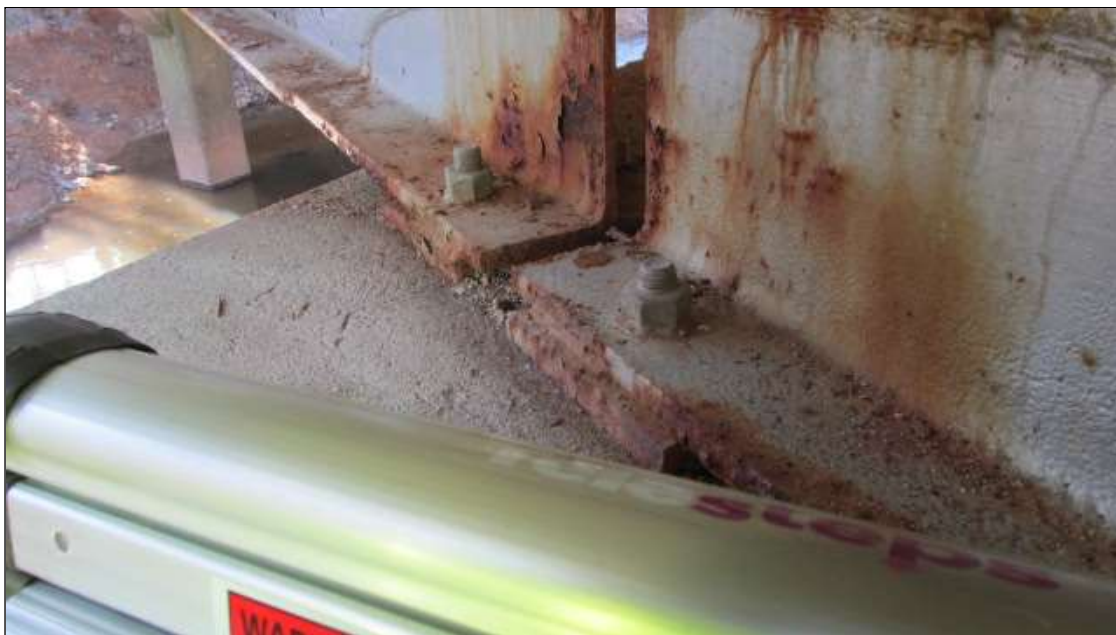
SURFACE RUSTING AT ENDS OVER BENTS  
SURFACE RUSTING ALONG ENTIRE GIRDER SPAN

Span 1 Beam 1: SURFACE RUSTING AT ENDS OVER BENTS

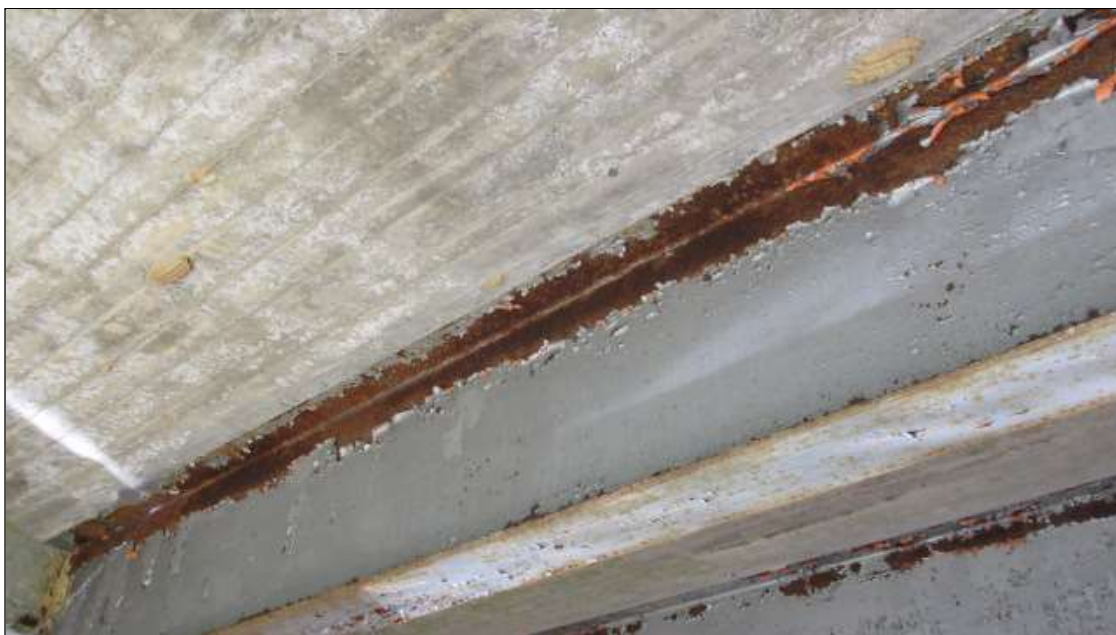
SURFACE RUSTING AT ENDS OVER BENTS  
SURFACE RUSTING ALONG ENTIRE GIRDER SPAN

Span 1 Beam 2: SURFACE RUSTING ALONG ENTIRE GIRDER SPAN

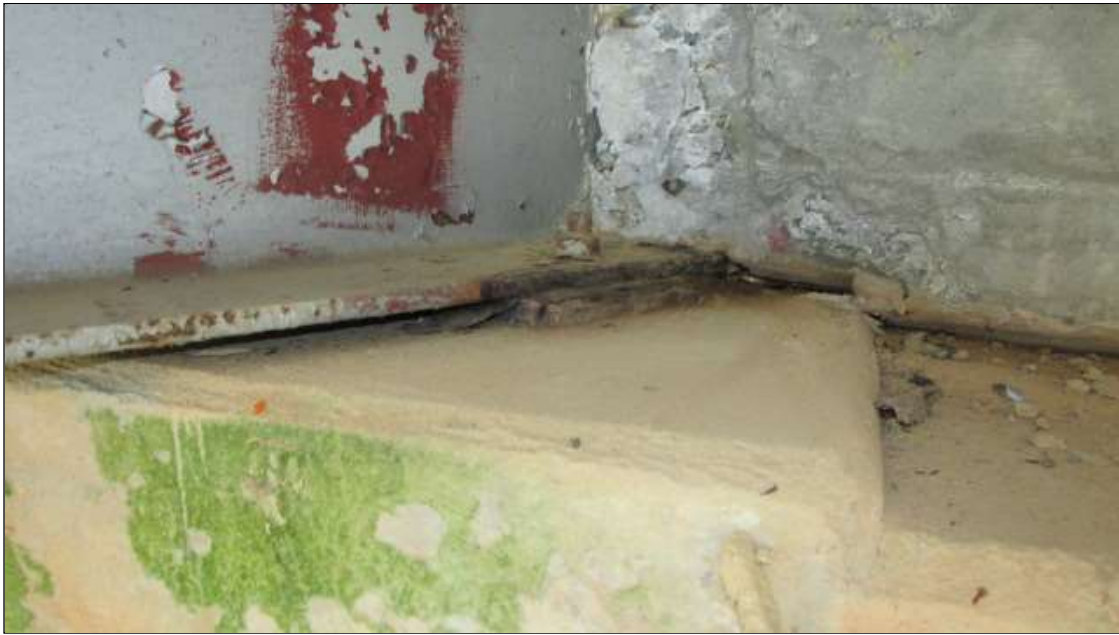
Span 1 Beam 3 Near Bearing : BEARINGS SHOW RUST WITH FLAKING SECTION LOSS

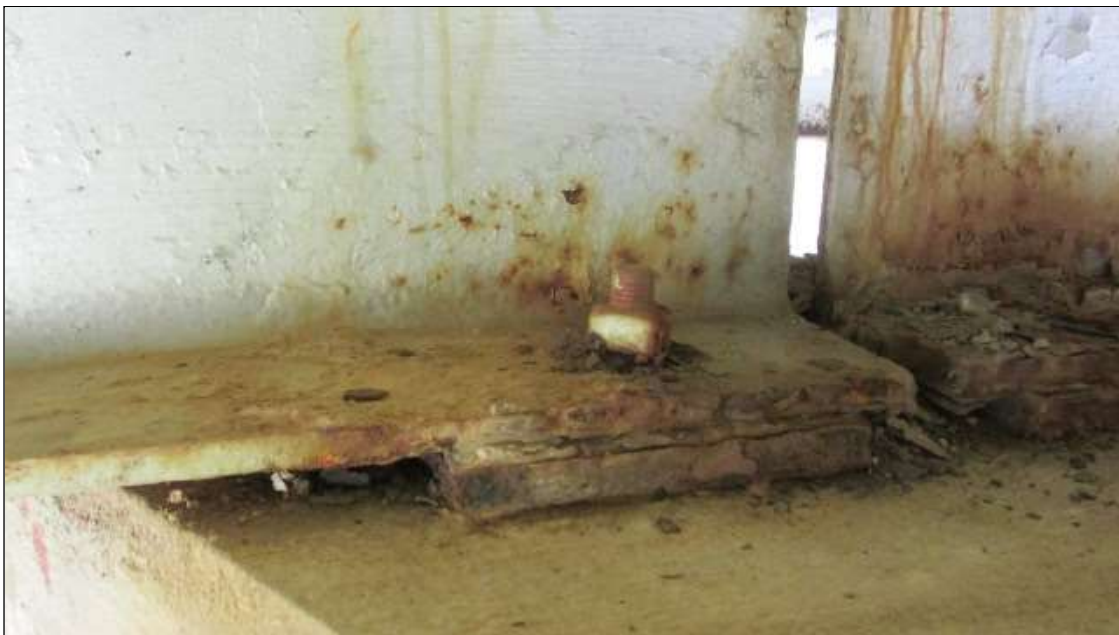
Span 1 Beam 3 Far Bearing : BEARINGS SHOW RUST WITH FLAKING SECTION LOSS

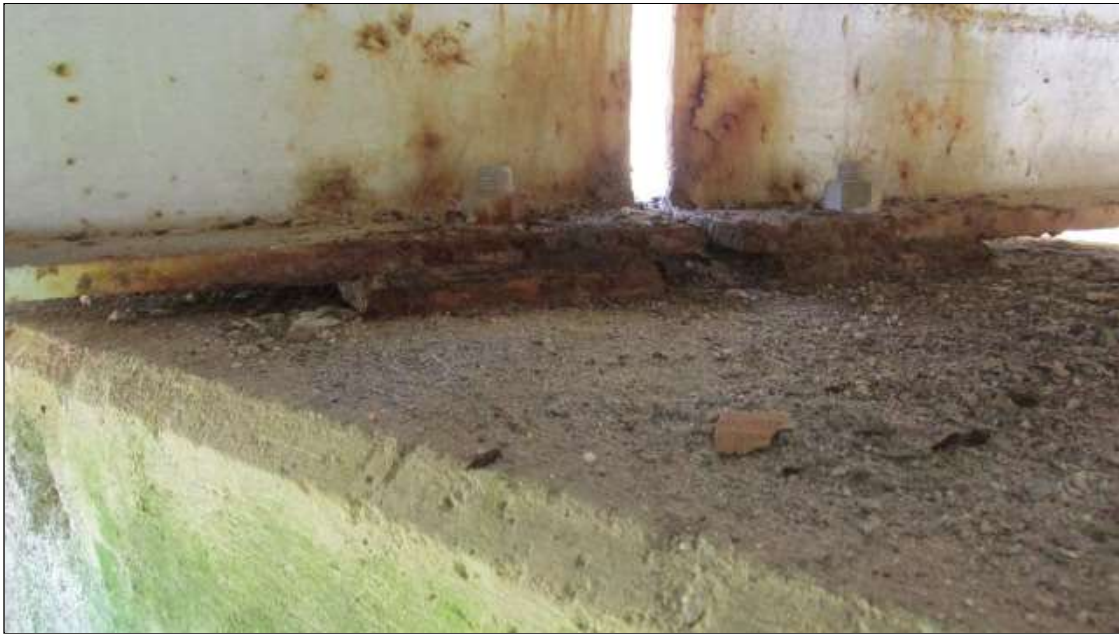
Span 2 Beam 4 Near Bearing : BEARINGS SHOW RUST WITH FLAKING SECTION LOSS

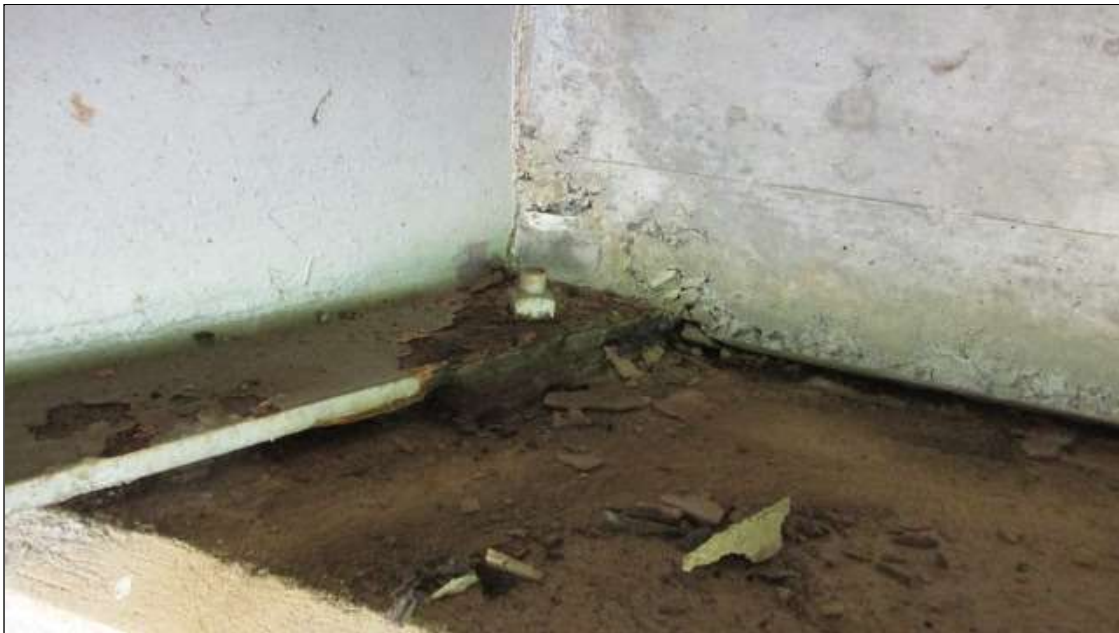
Span 3 Beam 1 Far Bearing : BEARINGS SHOW RUST WITH FLAKING SECTION LOSS

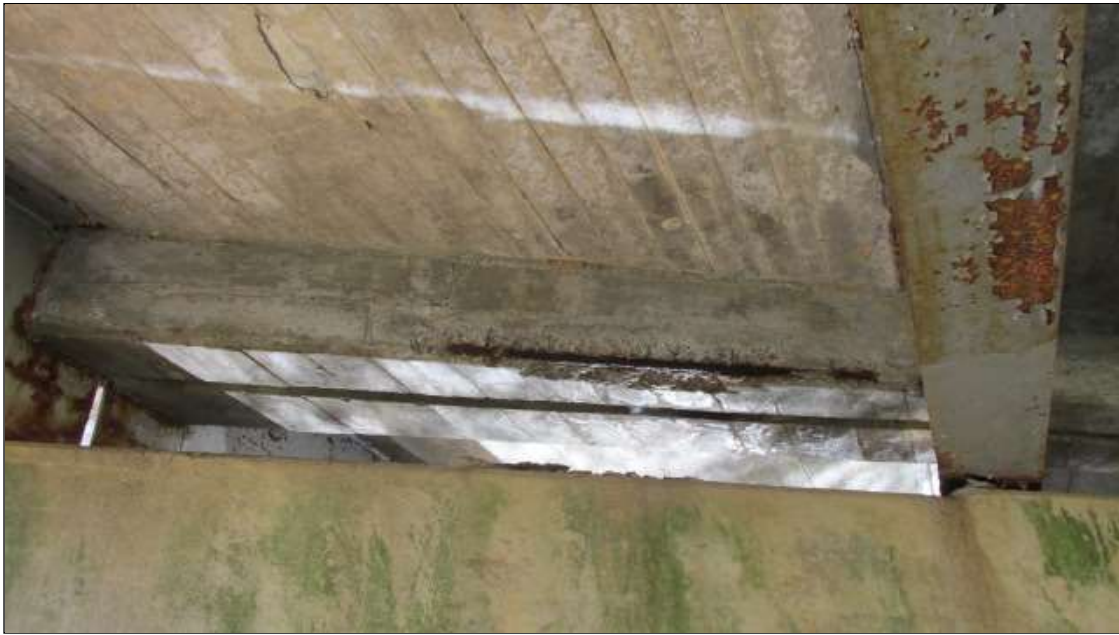
SPALLED END DIAPHRAGM-BAY 1-SPAN 1 AT BENT 1 (36" L X 6" X 1.5" D)

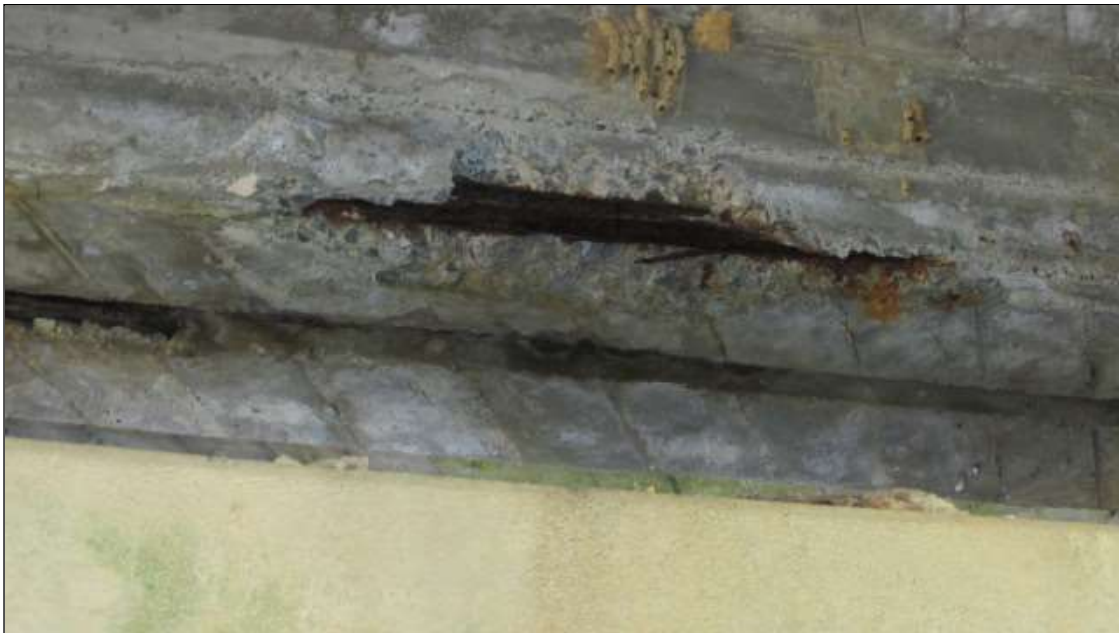
SPALLED END DIAPHRAGM-BAY 2-SPAN 1 AT BENT 1 (24" L X 6" X 1.5" D)

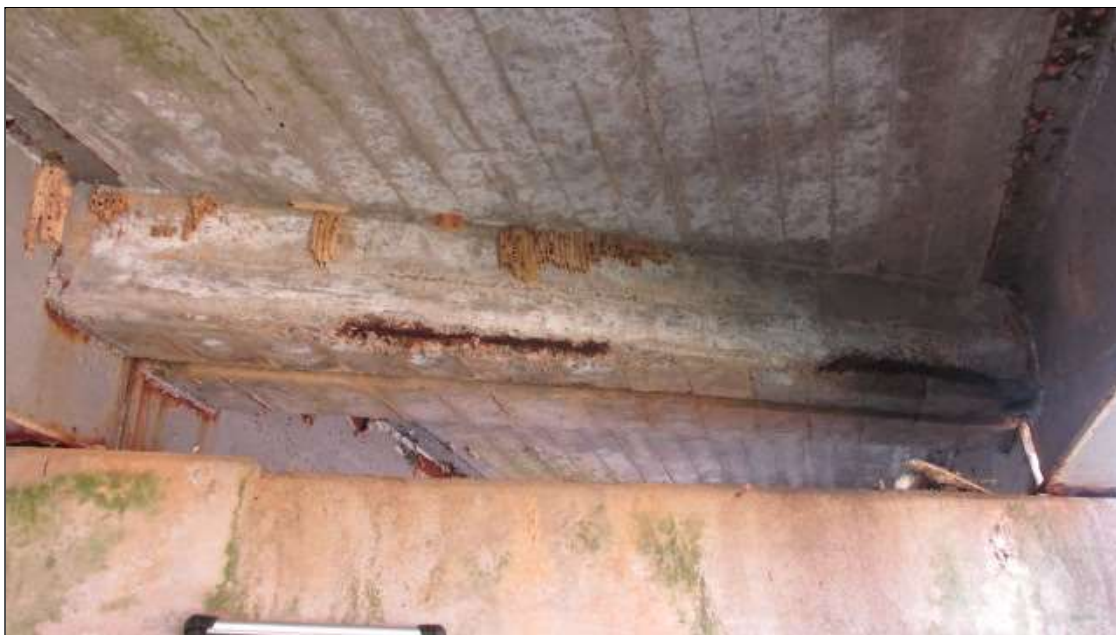
SPALLED END DIAPHRAGM-BAY 3-SPAN 1 AT BENT 1 (24" L X 6" X 1.5" D)

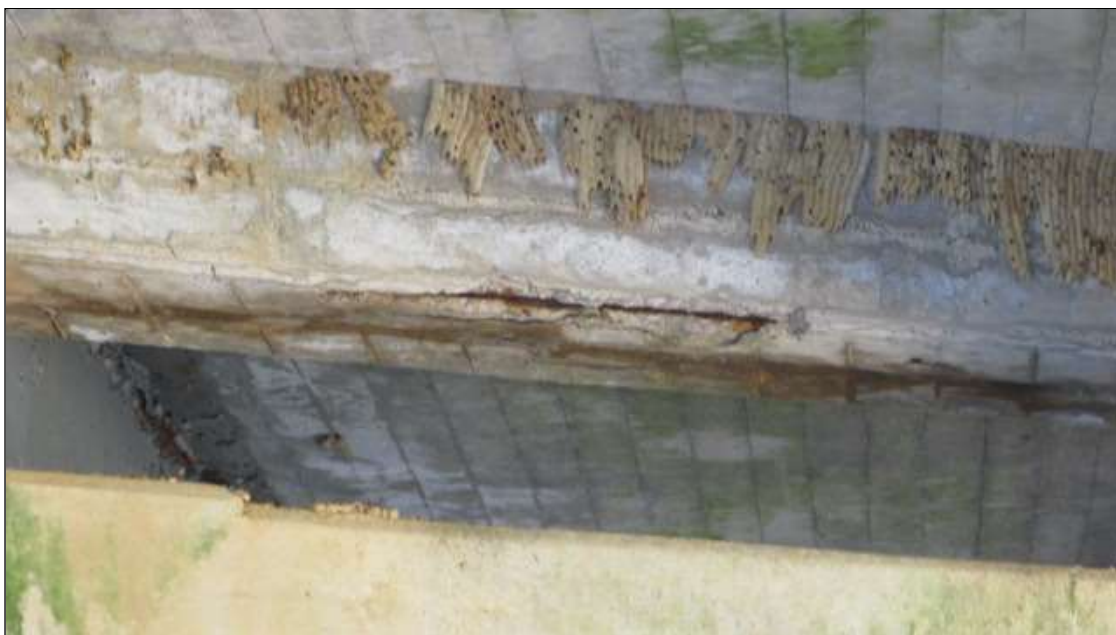
SPALLED END DIAPHRAGM-BAY 2-SPAN 2 AT BENT 2 (36" L X 6" X 1.5" D)

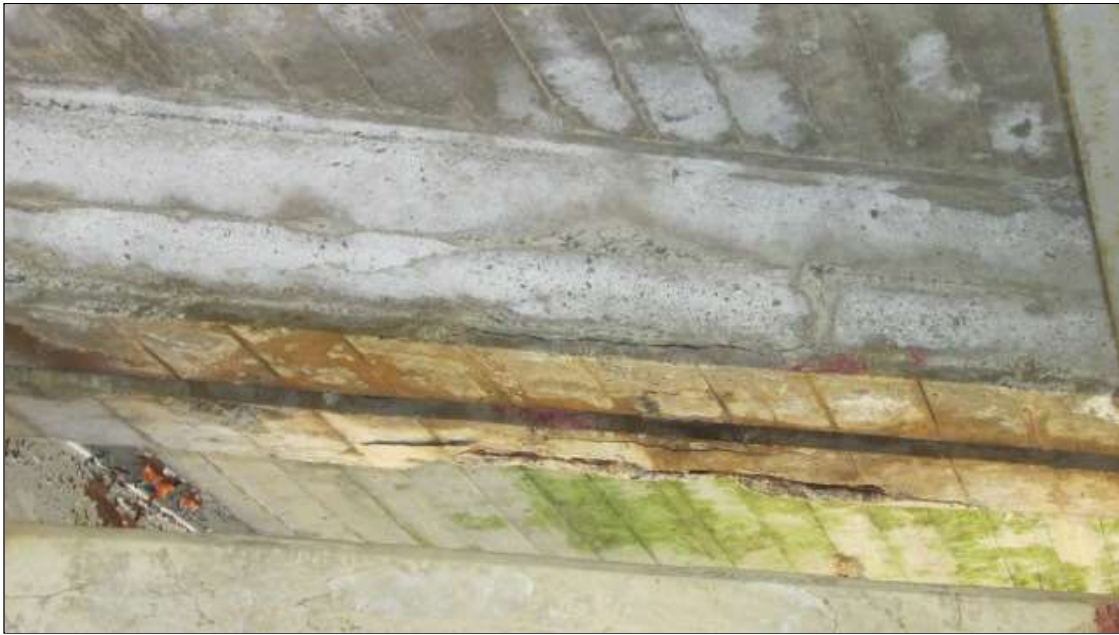
CRACKED END DIAPHRAGM- BAY 2- SPAN 3 AT BENT 2

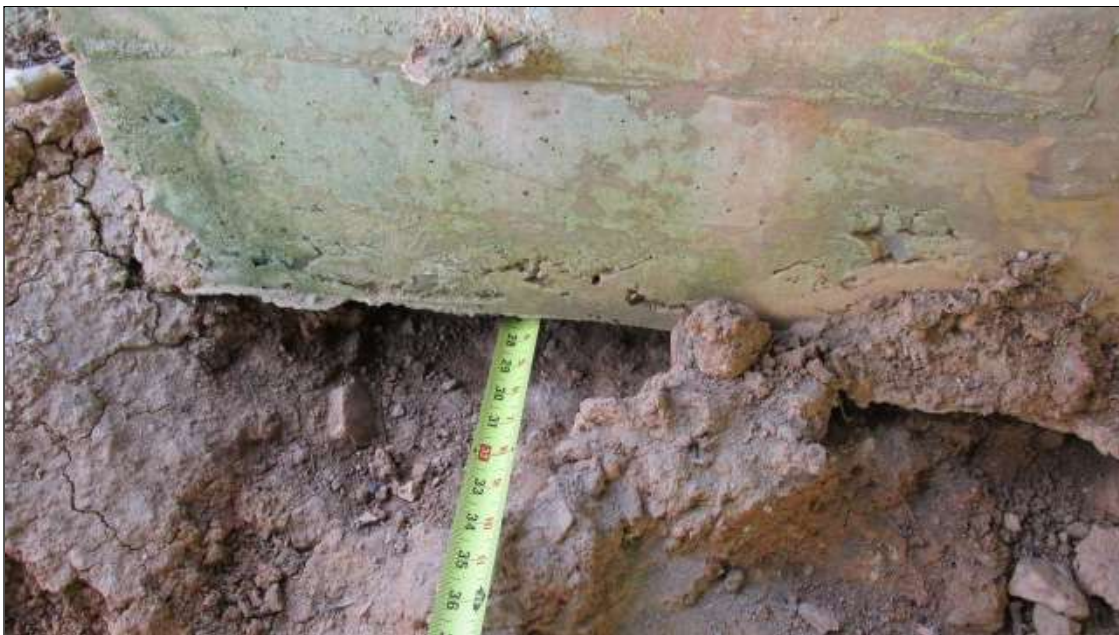
| <b>Details</b> | SLOPE SETTLEMENT AT END BENT 1 (15' L X 2.5' W X 6" D) AT SOUTH HALF<br>SLOPE SETTLEMENT AT END BENT 2 (2' L X 2.5' W X 3" D) AT NORTH FACE<br>SLOPE SETTLEMENT AT NORTHEAST WING (2' L X 1' W X 3" D) |

SLOPE SETTLEMENT 2' LONG X 2.5' UNDER X 3" HIGH AT NORTH END OF END BENT 2

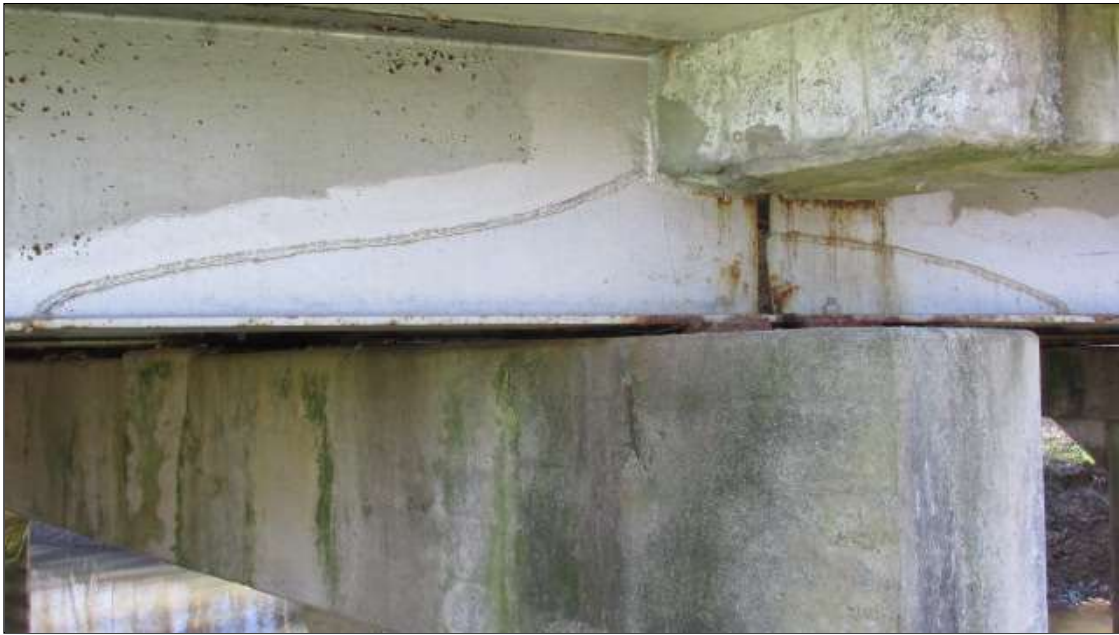
EXTERIOR GIRDERS OVER EACH BENT HAVE WEB AND BOTTOM FLANGE REPAIRS

TYPICAL EXTERIOR GIRDER REPAIR

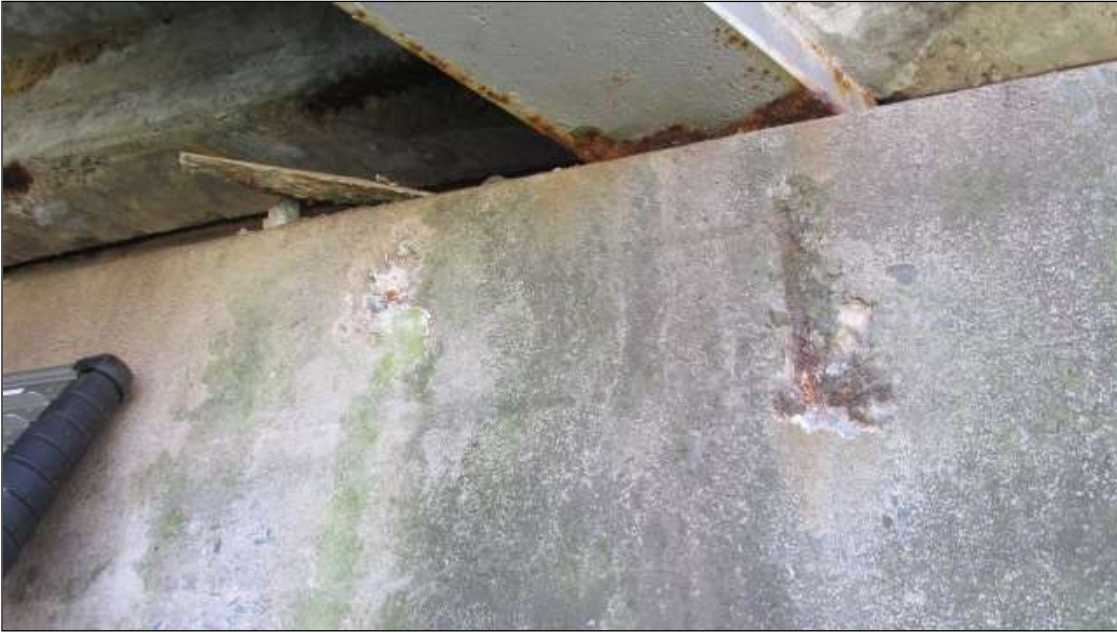
12" X 4" X 1" DEEP SPALL WITH EXPOSED REBAR ON WEST FACE AT GIRDER 4 ON BENT 1

| MMS Code | Description of Function | Unit | Quantity | Remarks | Est. Cost |
|---|---|---|---|---|---|
| 3348 | Maintain Concrete Substructure Components | LF | 1 | 12" X 4" X 1" DEEP SPALL WITH EXPOSED REBAR ON WEST FACE AT GIRDER 4 ON BENT 1 | |

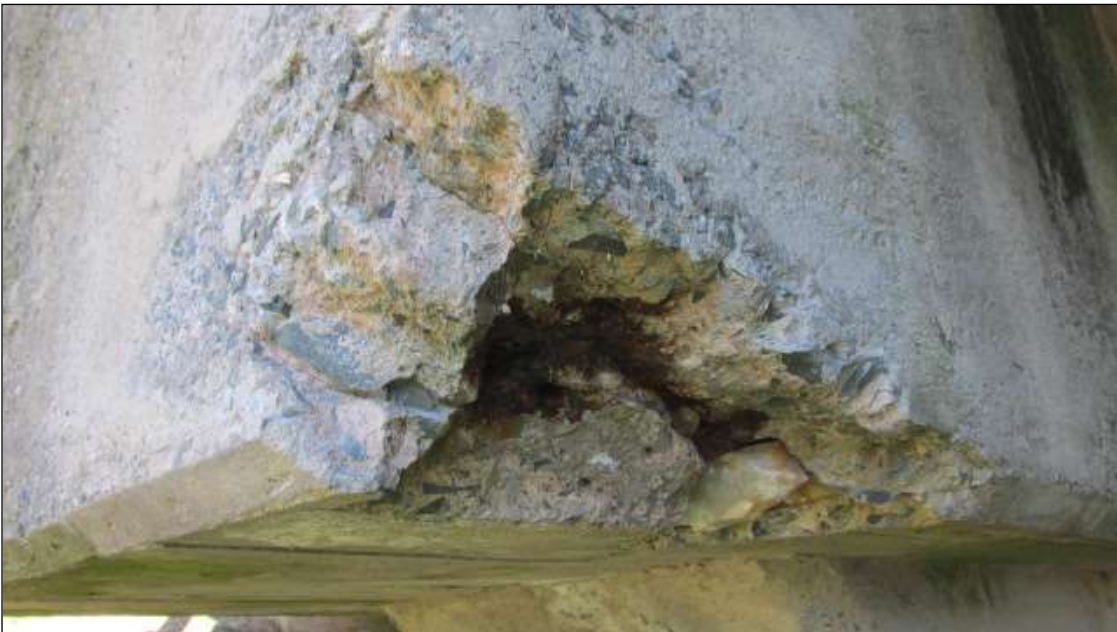
12" X 6" X 2" DEEP CORNER SPALL WITH EXPOSED REBAR ON EAST FACE OF BENT 1 AT SOUTH END

| MMS Code | Description of Function | Unit | Quantity | Remarks | Est. Cost |
|---|---|---|---|---|---|
| 3348 | Maintain Concrete Substructure Components | LF | 1 | 12" X 6" X 2" DEEP CORNER SPALL WITH EXPOSED REBAR ON EAST FACE OF BENT 1 AT SOUTH END | |

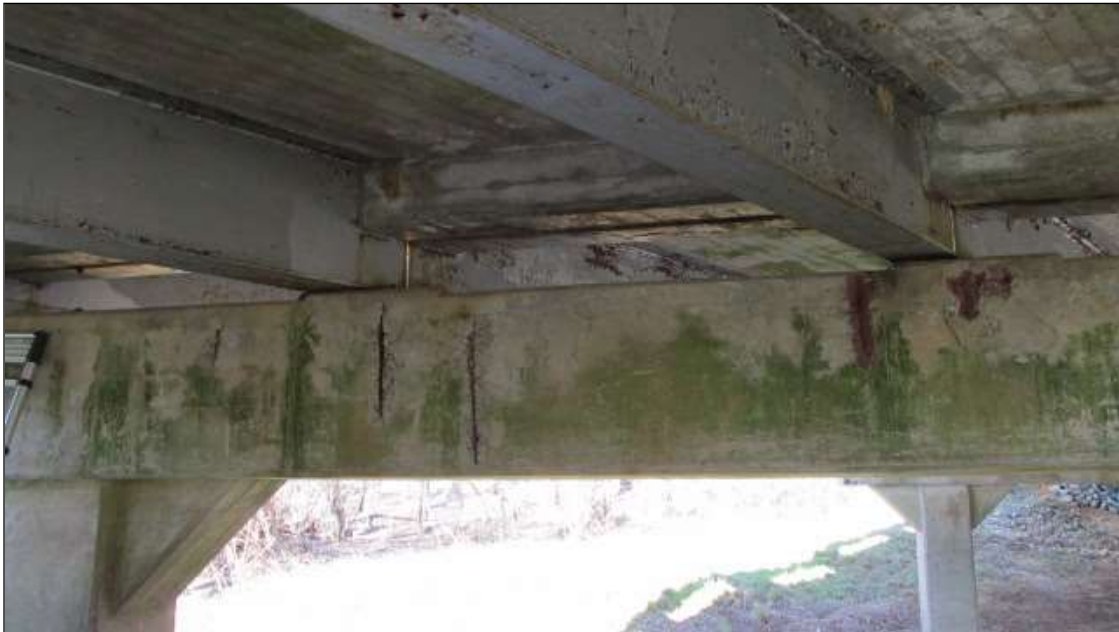
SPALLING WITH EXPOSED REBAR ON EAST FACE OF BENT 2 CAP

| MMS Code | Description of Function | Unit | Quantity | Remarks | Est. Cost |
|---|---|---|---|---|---|
| 3348 | Maintain Concrete Substructure Components | LF | 10 | SPALLING WITH EXPOSED REBAR ON EAST FACE OF BENT 2 CAP | |
