NC DEPARTMENT OF TRANSPORTATION

# Structure Safety Report

## Routine Element Inspection

COUNTY: DAVIE STRUCTURE NUMBER: 290050 FREQUENCY: 24 MONTHSFACILITY CARRIED: SR1411 MILE POST: LOCATION: 0.3 MI. S. JCT. SR1435FEATURE INTERSECTED: DUTCHMANS CREEKLATITUDE: 35° 59' 0.31" LONGITUDE: 80° 34' 48.81"SUPERSTRUCTURE: REINFORCED CONCRETE DECK ON I-BEAMSSUBSTRUCTURE: END & INT.BENTS:RC CAP ON PRECAST PRESTRESSED CONCRETE PILESSPANS: 5@30'0"☐ FRACTURE CRITICAL ☐ TEMPORARY SHORING ☐ SCOUR CRITICAL ☒ SCOUR PLAN OF ACTIONPRESENT CONDITION: Fair INSPECTION DATE: 11/17/2014POSTED SV: 39 POSTED TTST: Not PostedOTHER SIGNS PRESENT: (4) DELINEATORS

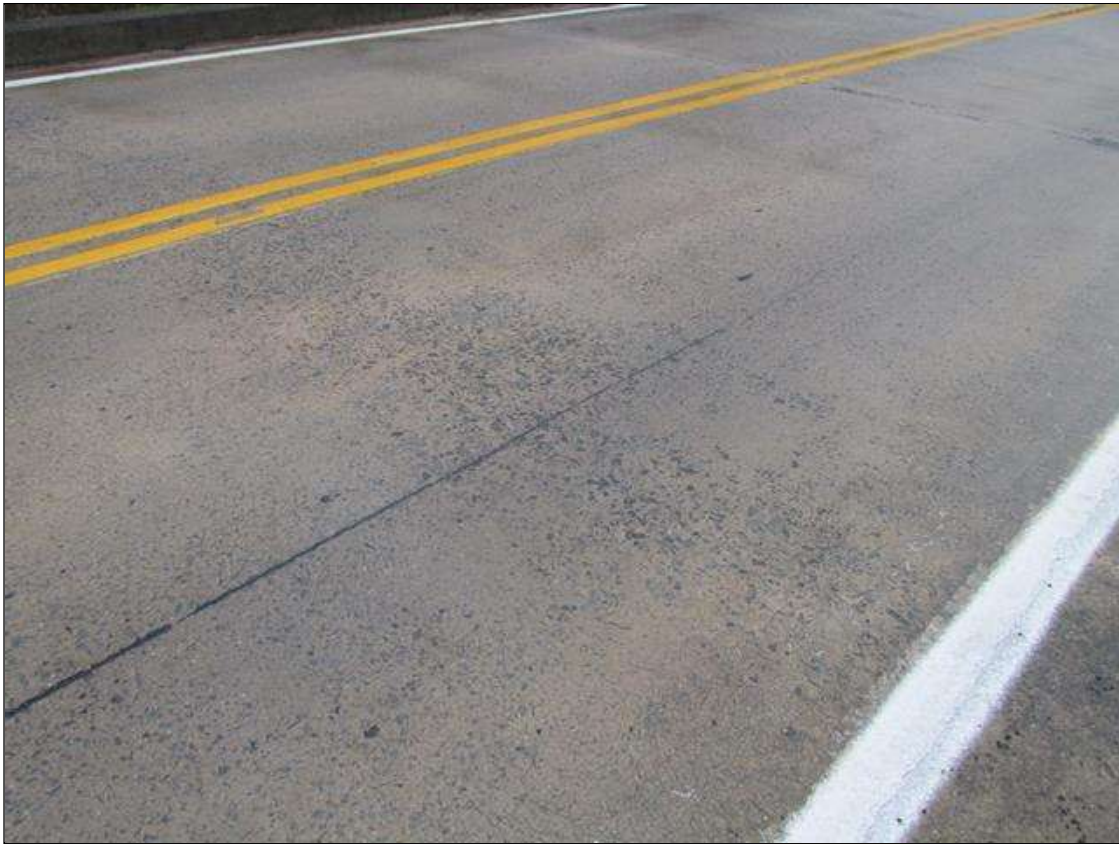
Span 1 Deck: 200 Square Feet of Abrasion/Wear (PSC/RC): Abrasion or wearing has exposed coarse aggregate but the aggregate remains secure in the concrete. IN RANDOM AREAS

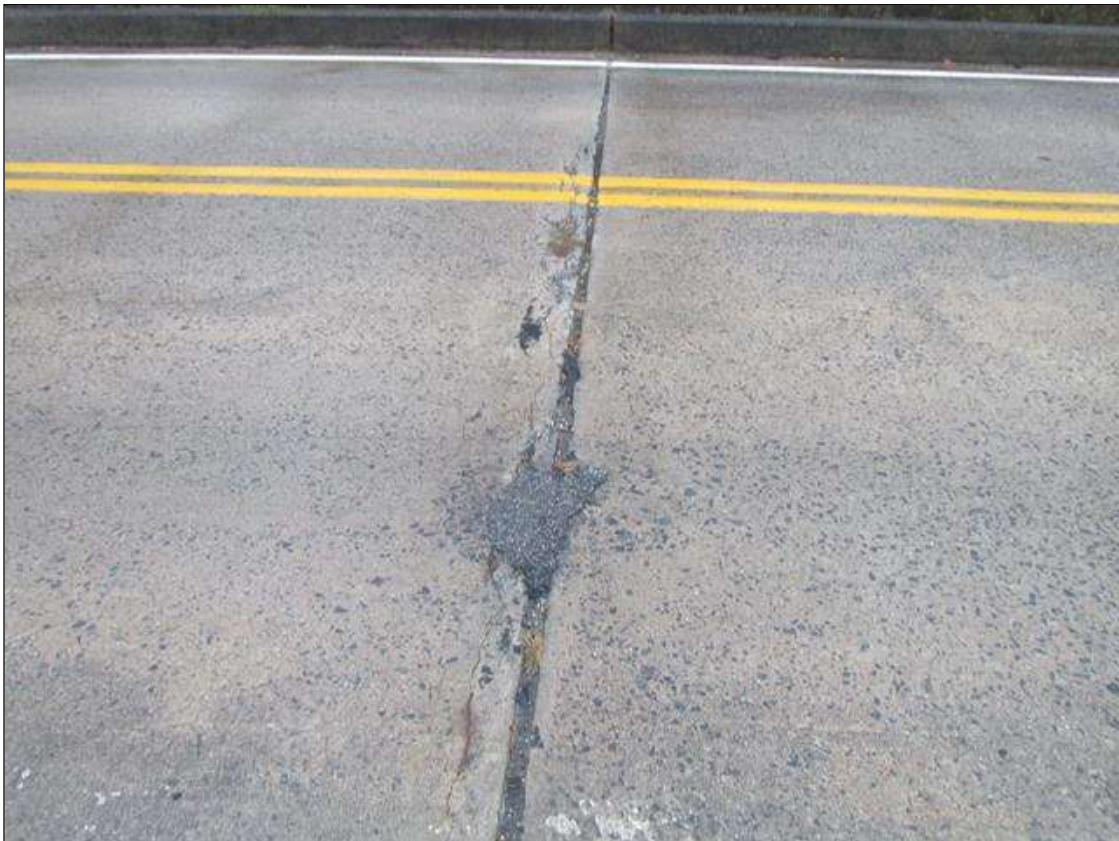
Span 1 Deck: 25 Square Feet of Cracking (RC and Other): Width greater than 0.05 in. or spacing of less than 1 ft. AT PIER 1 JOINT

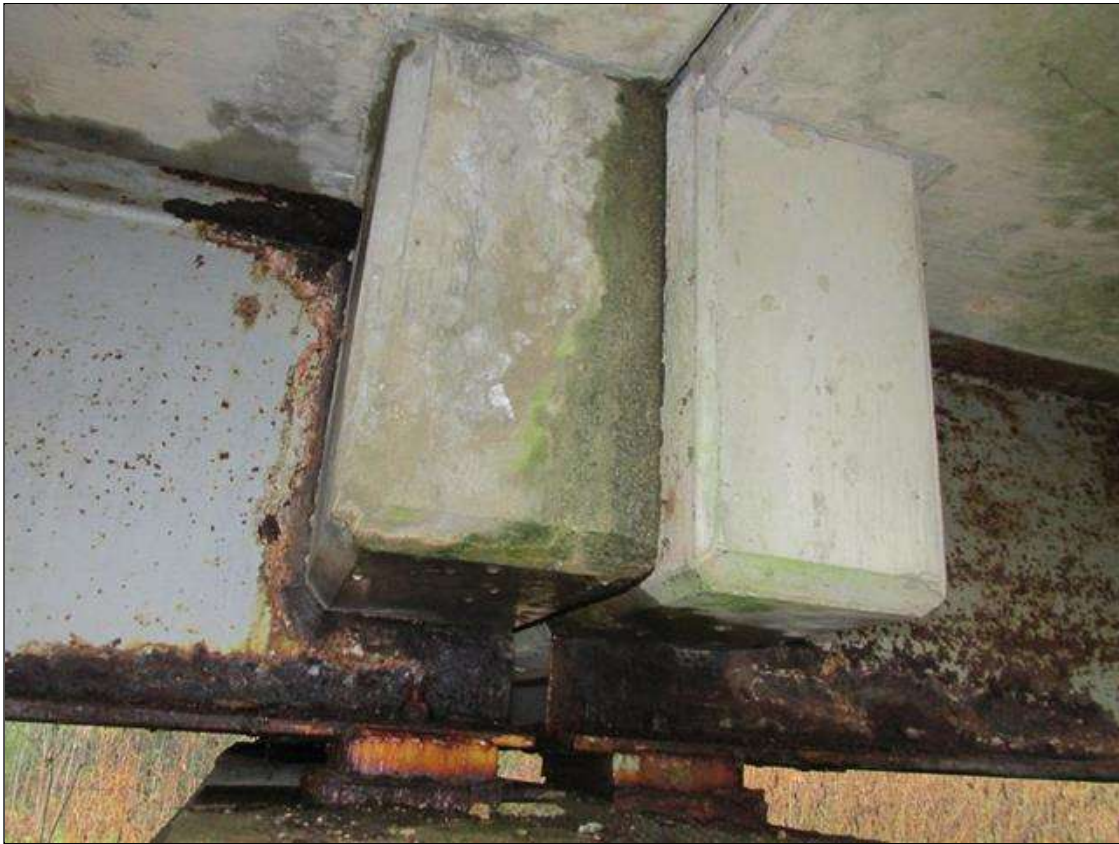
Span 5 Beam 1: 2 Feet of Corrosion: Section loss is evident or pack rust is present but does not warrant structural review. RUST AND SCALE WITH UP TO 3/16 IN SECTION LOSS.

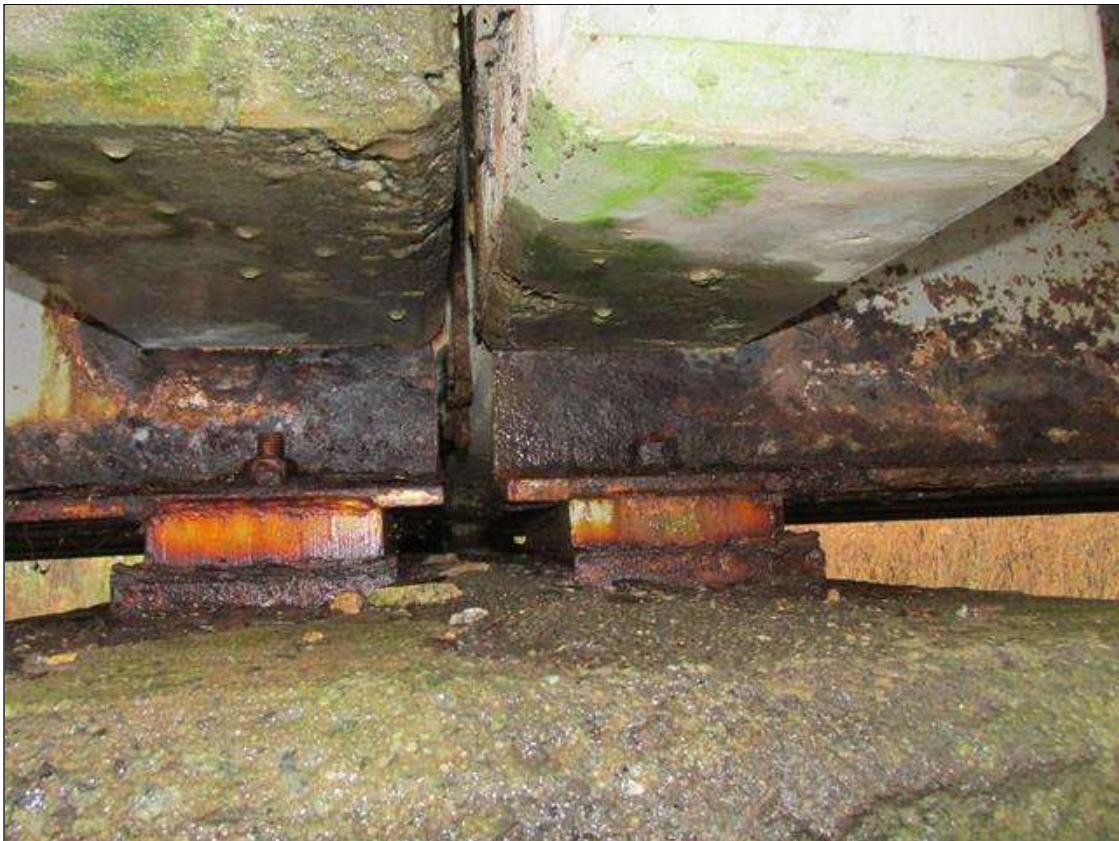
Span 5 Beam 1 Near Bearing : 1 Each of Corrosion: Freckled rust. Corrosion of the steel has initiated.
