NC DEPARTMENT OF TRANSPORTATION

# Structure Safety Report

## Routine Element Inspection

COUNTY: DAVIE STRUCTURE NUMBER: 290078 FREQUENCY: 24 MONTHS

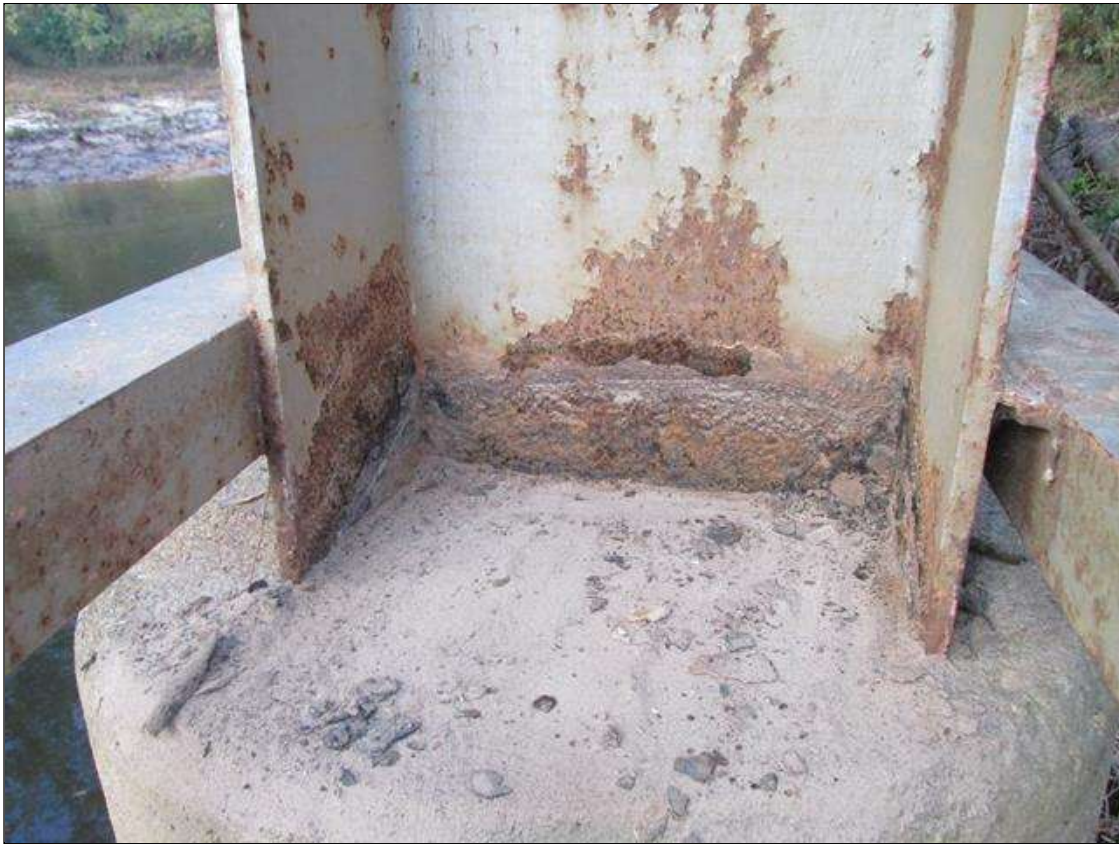
| Columns | | | | | | | | | | | |
|---|---|---|---|---|---|---|---|---|---|---|---|
| 1 Each of Corrosion: Freckled Rust. Corrosion of the steel has initiated. RUST AND SCALE AT THE ENCASEMENT | | | | | | | | | | | |

Bent 3 Pile 4: 1 Each of Corrosion: Freckled Rust. Corrosion of the steel has initiated. RUST AND SCALE AT THE ENCASEMENT

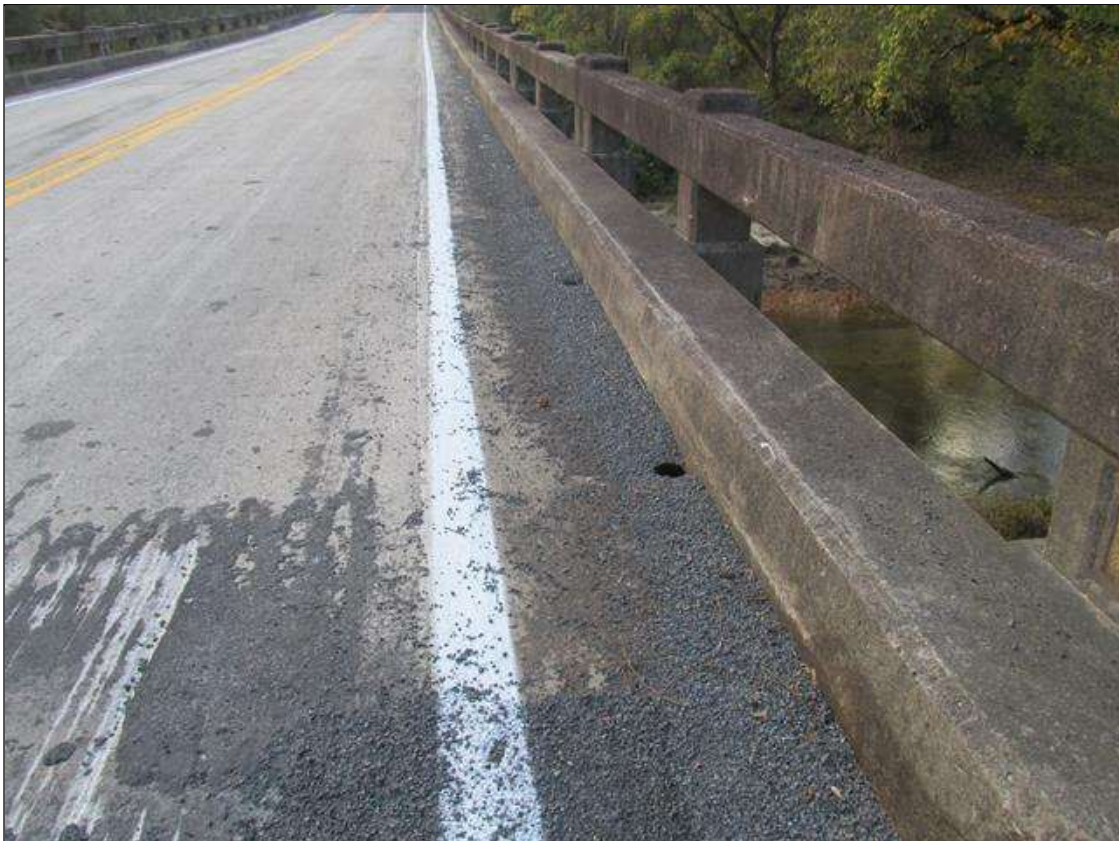
DECK DEBRIS ON BOTH GUTTER LINES UP TO 1 FT. W x 3 IN DEEP FULL LENGTH

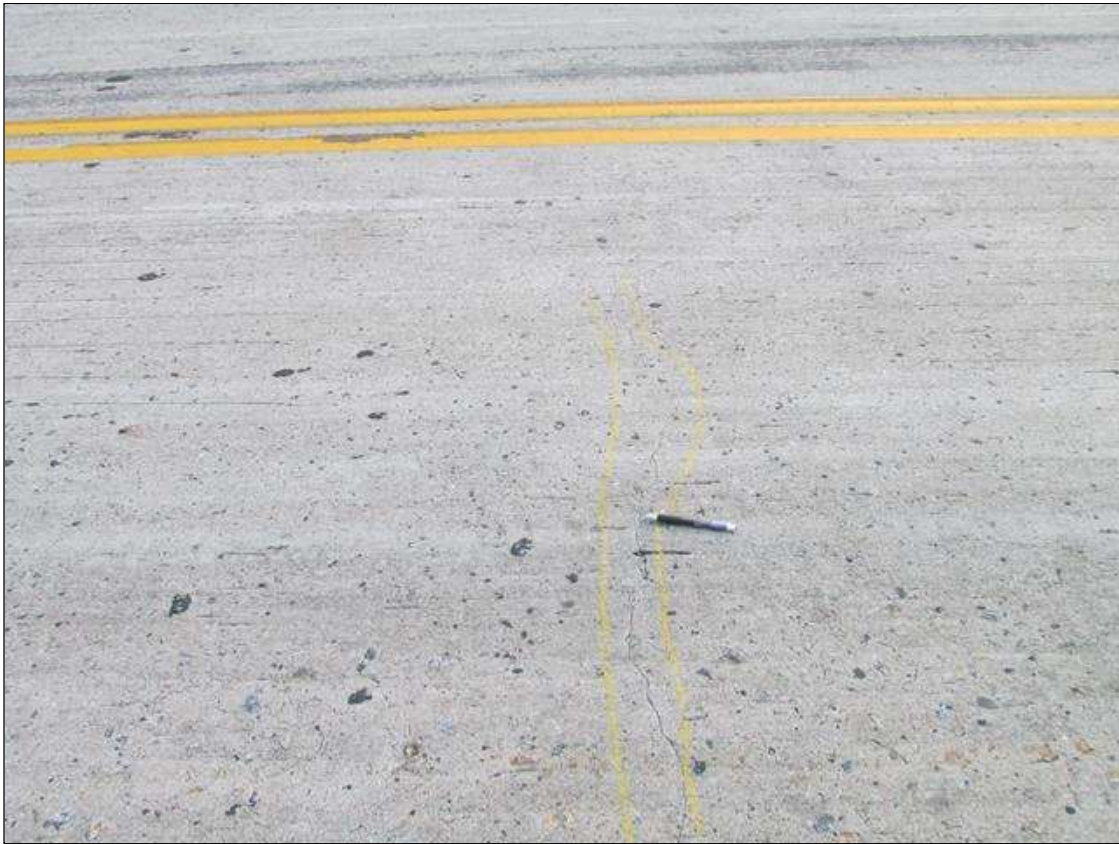
100 Square Feet of Cracking (RC and Other): Width 0.012-0.05 in. or spacing of 1.0-3.0 ft. RANDOM AREAS OF CRACKING  
200 Square Feet of Abrasion/Wear (PSC/RC): Abrasion or wearing has exposed coarse aggregate but the aggregate remains secure in the concrete.RANDOM AREAS

Span 4 Deck: 100 Square Feet of Cracking (RC and Other): Width 0.012-0.05 in. or spacing of 1.0-3.0 ft. RANDOM AREAS OF CRACKING

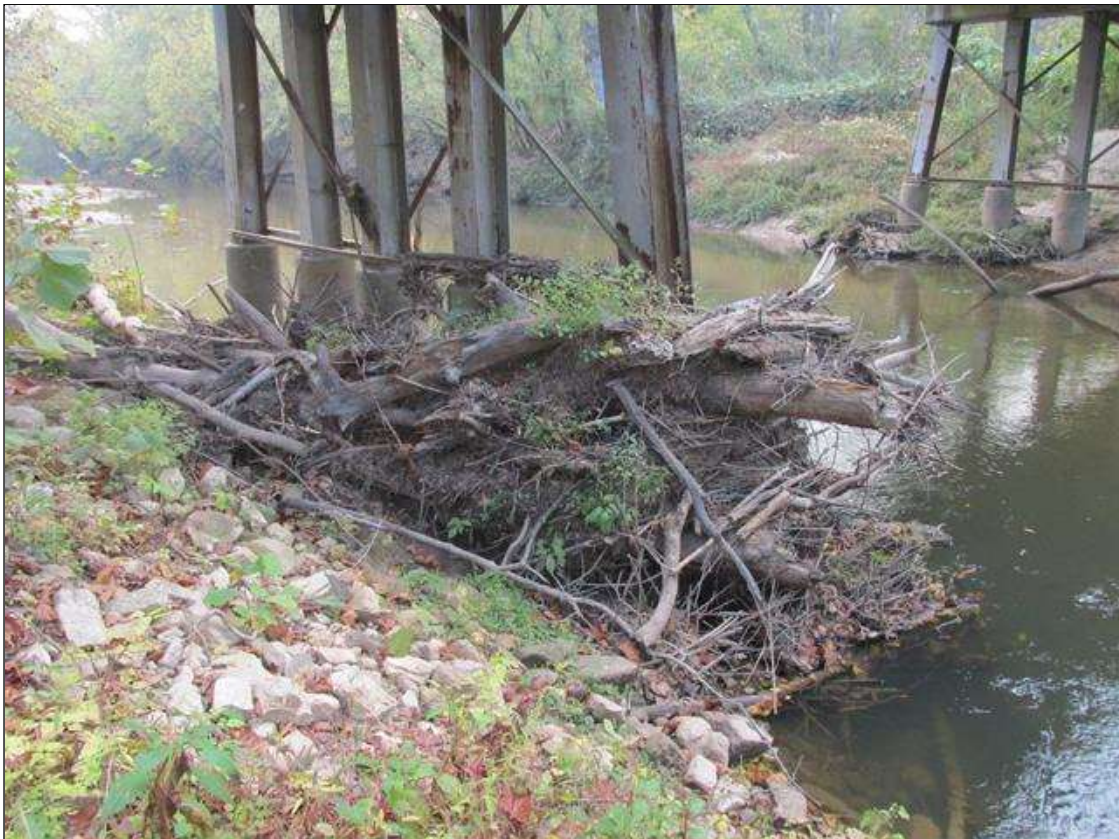
DRIFT AT PIER 3 UP TO 8FT. W x 8FT. DEEP x 40 FT. LONG PRIORITY MAINTENANCE

| MMS Code | MMS Description | Quantity |
|---|---|---|
| DRIFT AT PIER 3 8FT. W X 8 FT. H X 40 FT. LONG PRIORITY MAINTENANCE | | |

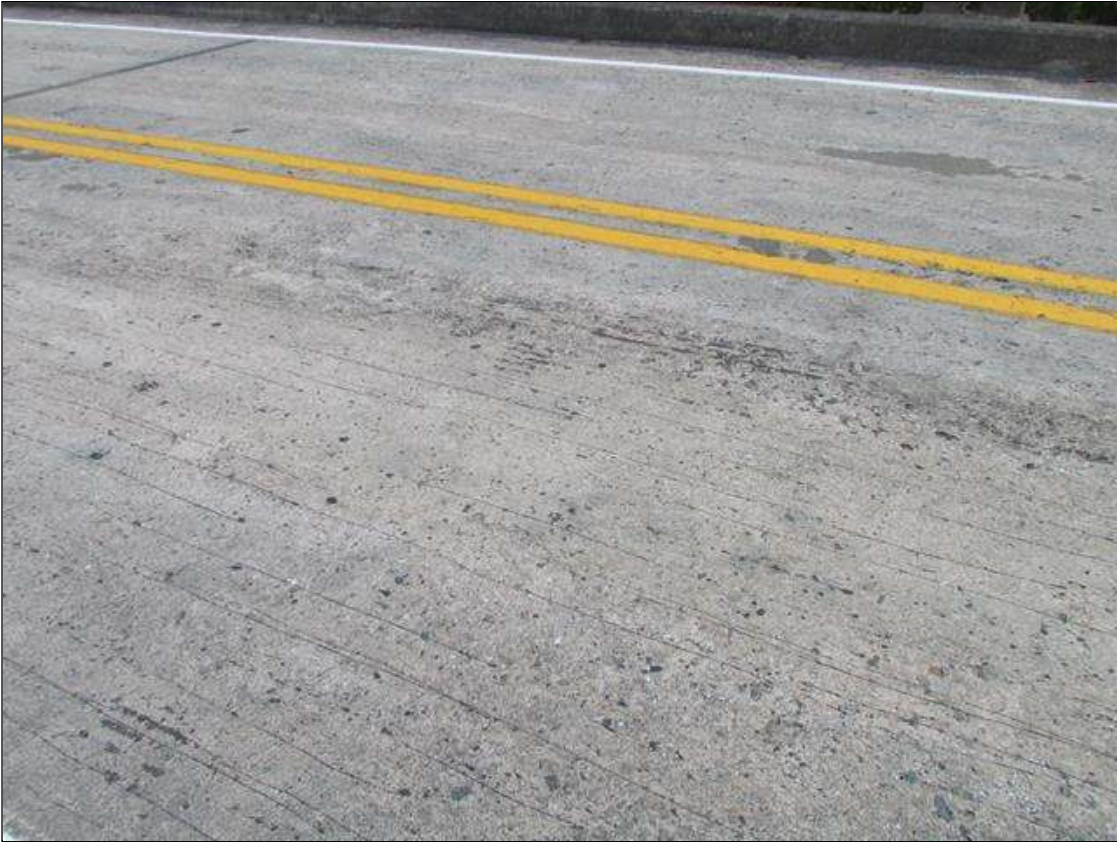
200 Square Feet of Abrasion/Wear (PSC/RC): Abrasion or wearing has exposed coarse aggregate but the aggregate remains secure in the concrete. IN RANDOM AREAS

Span 1 Deck: 200 Square Feet of Abrasion/Wear (PSC/RC): Abrasion or wearing has exposed coarse aggregate but the aggregate remains secure in the concrete. IN RANDOM AREAS

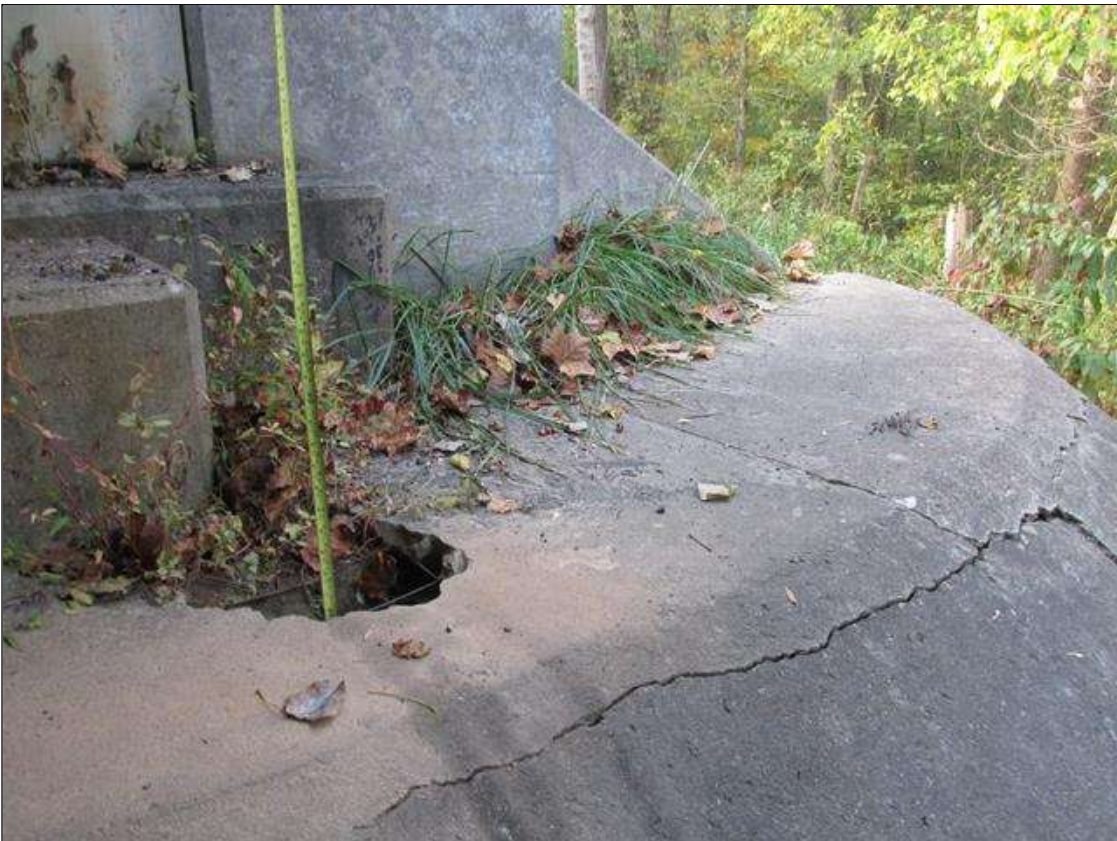
**Details** S.W. SLOPE PROTECTION HOLE UP TO 18 IN DIA x 1FT. DEEP. WITH CRACKING

S.W. SLOPE PROTECTION HOLE UP TO 18 IN DIA x 1FT. DEEP. WITH CRACKING

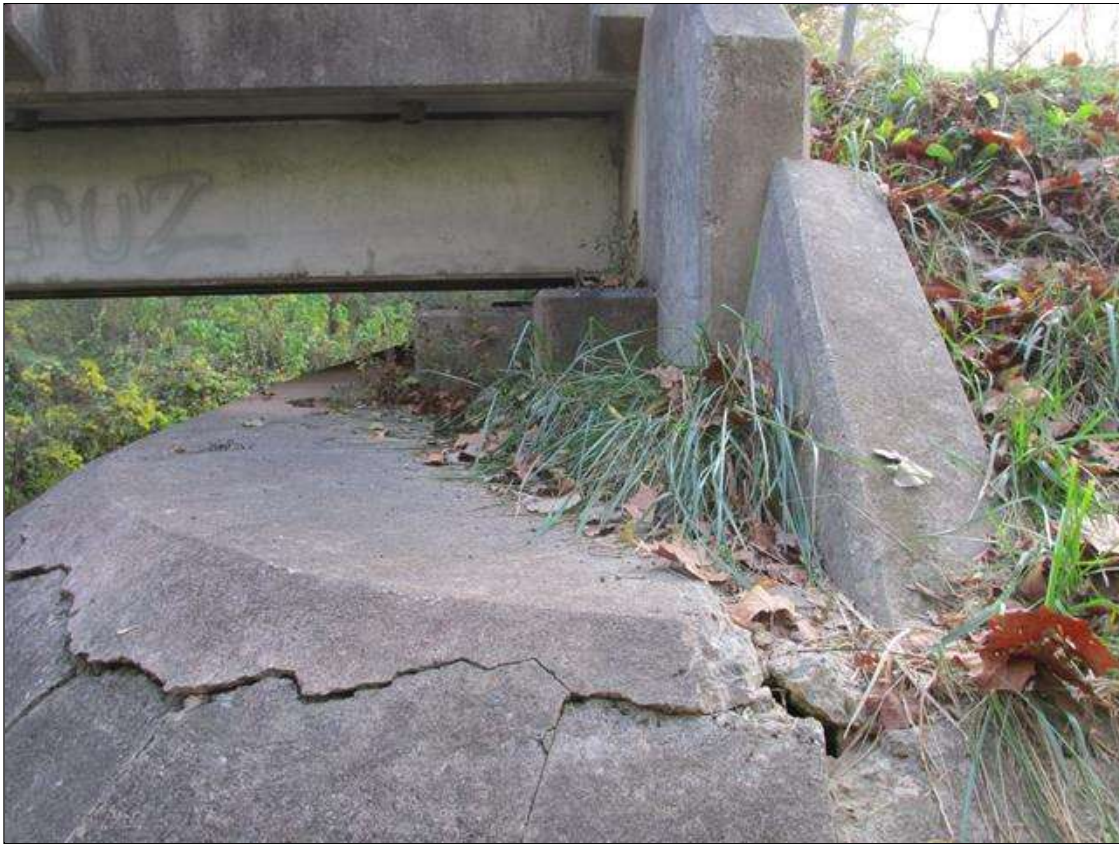
S.W. WING WALL LEANING AT TOP UP TO 6 IN.

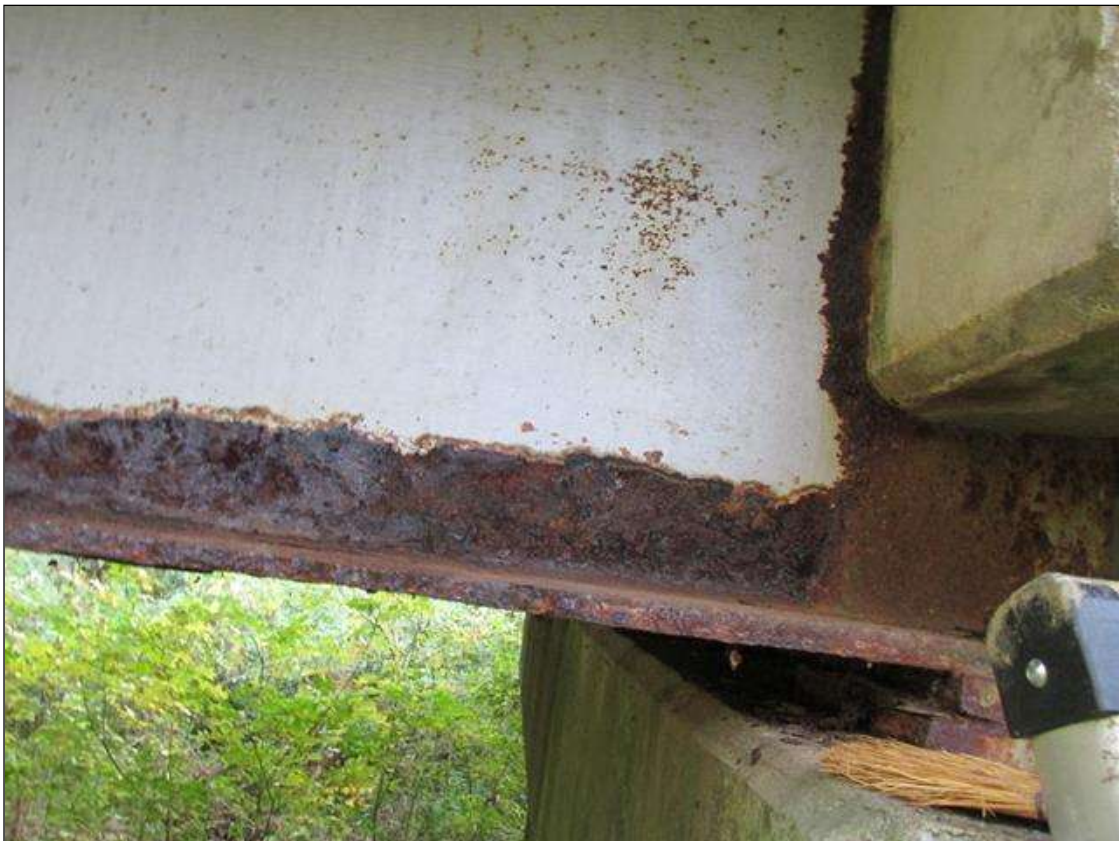
4 Feet of Corrosion: Section loss is evident or pack rust is present but does not warrant structural review. UP TO 1/8 IN SECTION LOSS UP IN BOTTOM FLANGE AND LOWER WEB

Span 2 Beam 1: 4 Feet of Corrosion: Section loss is evident or pack rust is present but does not warrant structural review. UP TO 1/8 IN SECTION LOSS UP IN BOTTOM FLANGE AND LOWER WEB

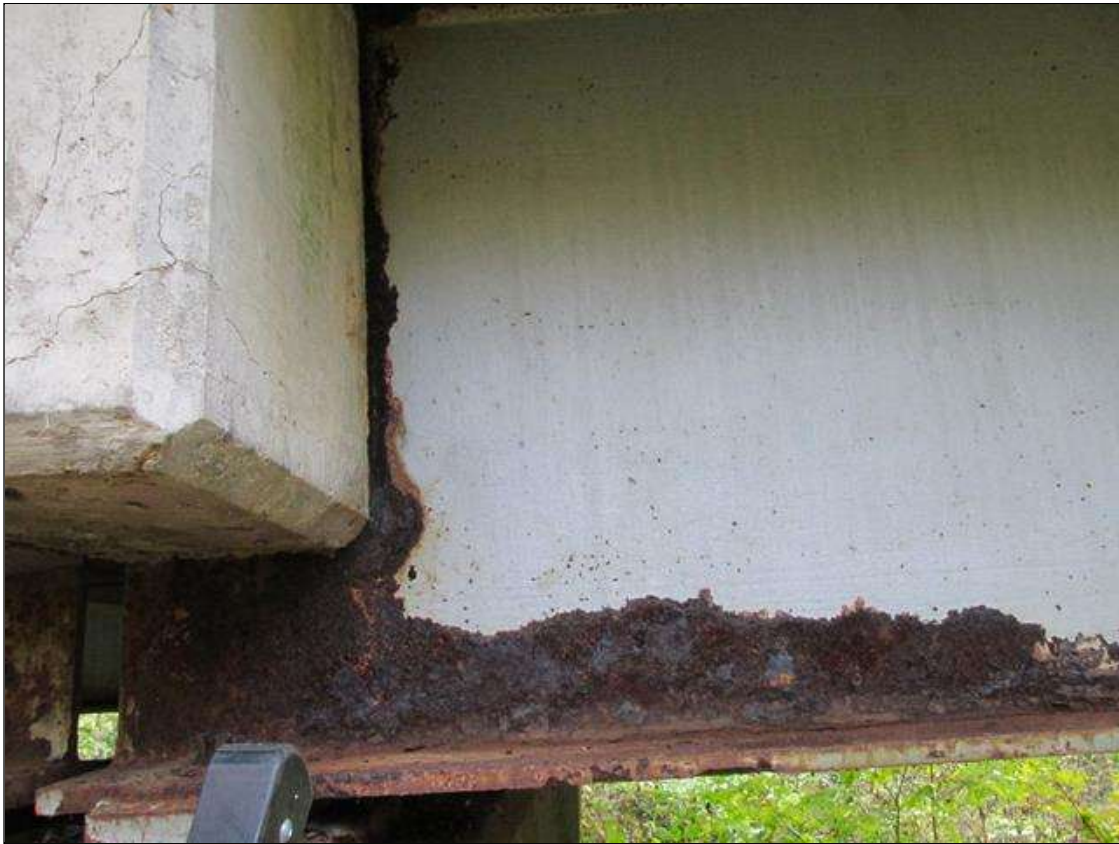
4 Feet of Corrosion: Section loss is evident or pack rust is present but does not warrant structural review.UP TO 1/8 IN LOSS IN WEB AND LOWER FLANGE

Span 1 Beam 1: 4 Feet of Corrosion: Section loss is evident or pack rust is present but does not warrant structural review. UP TO 1/8 IN LOSS IN WEB AND LOWER FLANGE

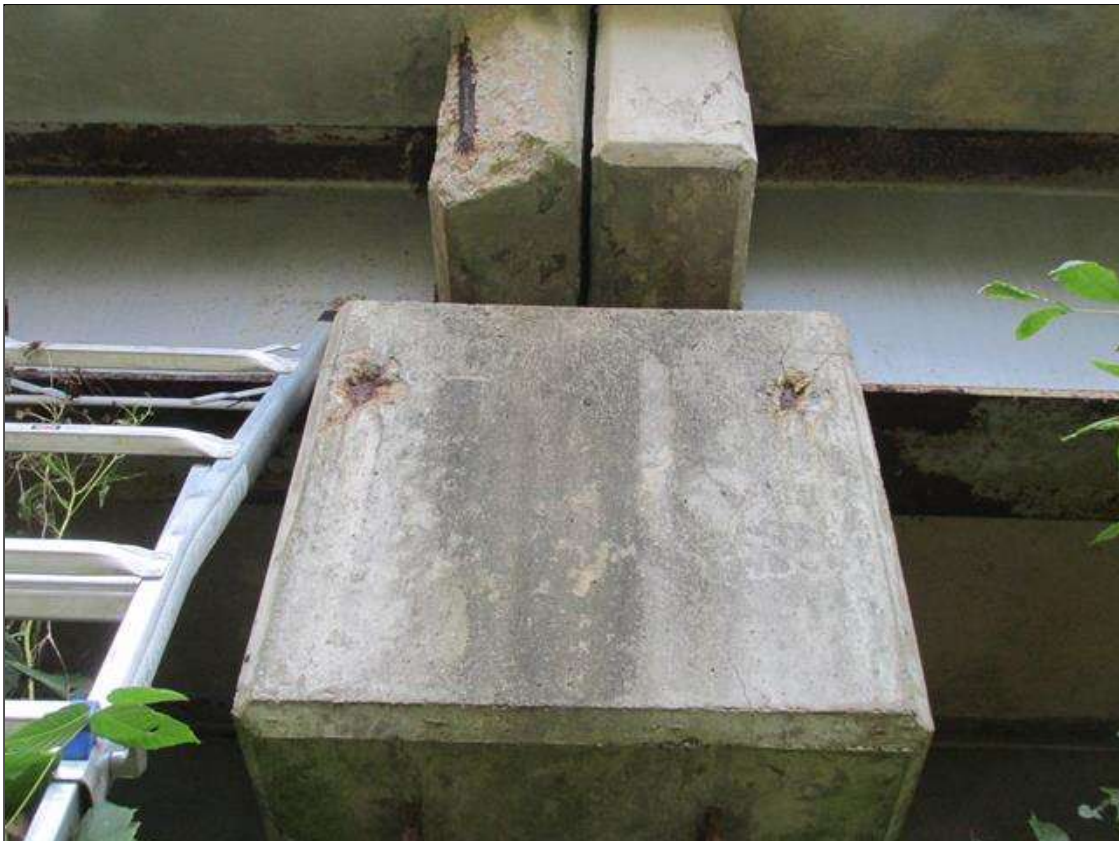
2 Feet of Cracking (RC and Other): Width 0.012-0.05 in. or spacing of 1.0-3.0 ft. CRACKING IN THE LEFT END OF PIER

Bent 1 Cap : 2 Feet of Cracking (RC and Other): Width 0.012-0.05 in. or spacing of 1.0-3.0 ft. CRACKING IN THE LEFT END OF PIER

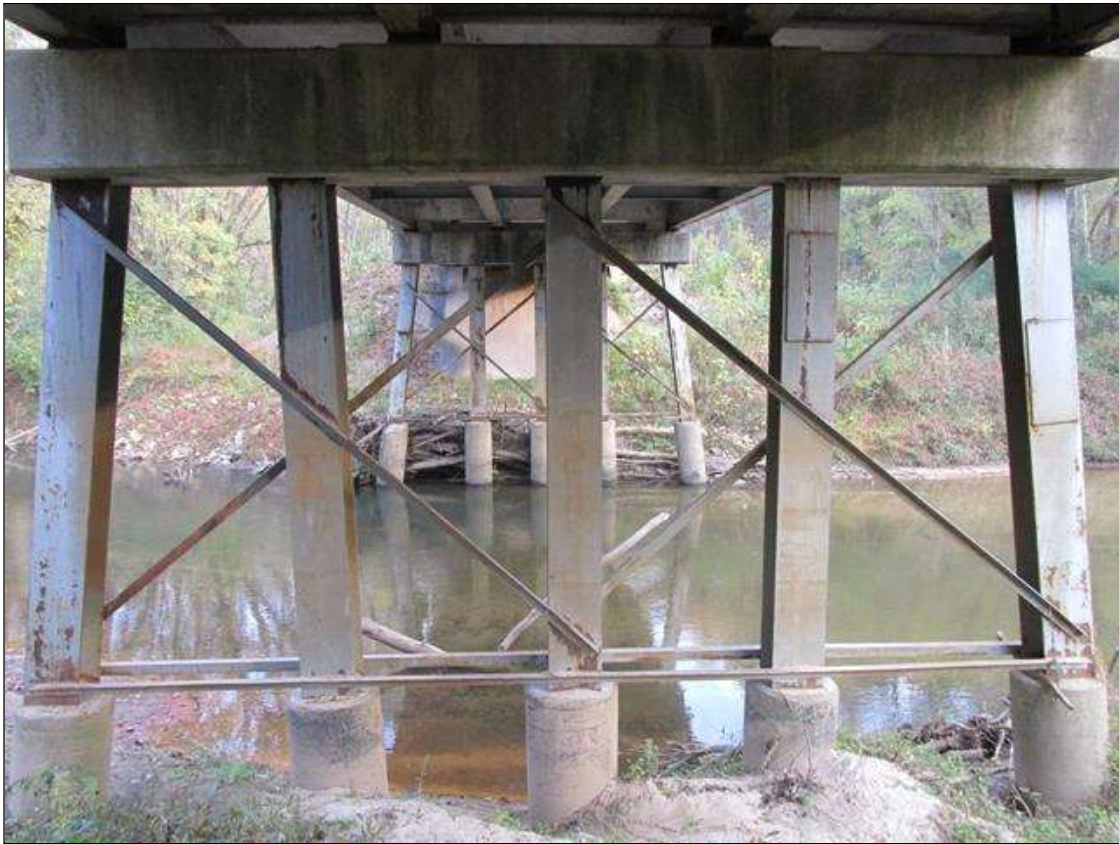
Bent 2 Pile 1: 1 Each of Corrosion: Freckled Rust. Corrosion of the steel has initiated.

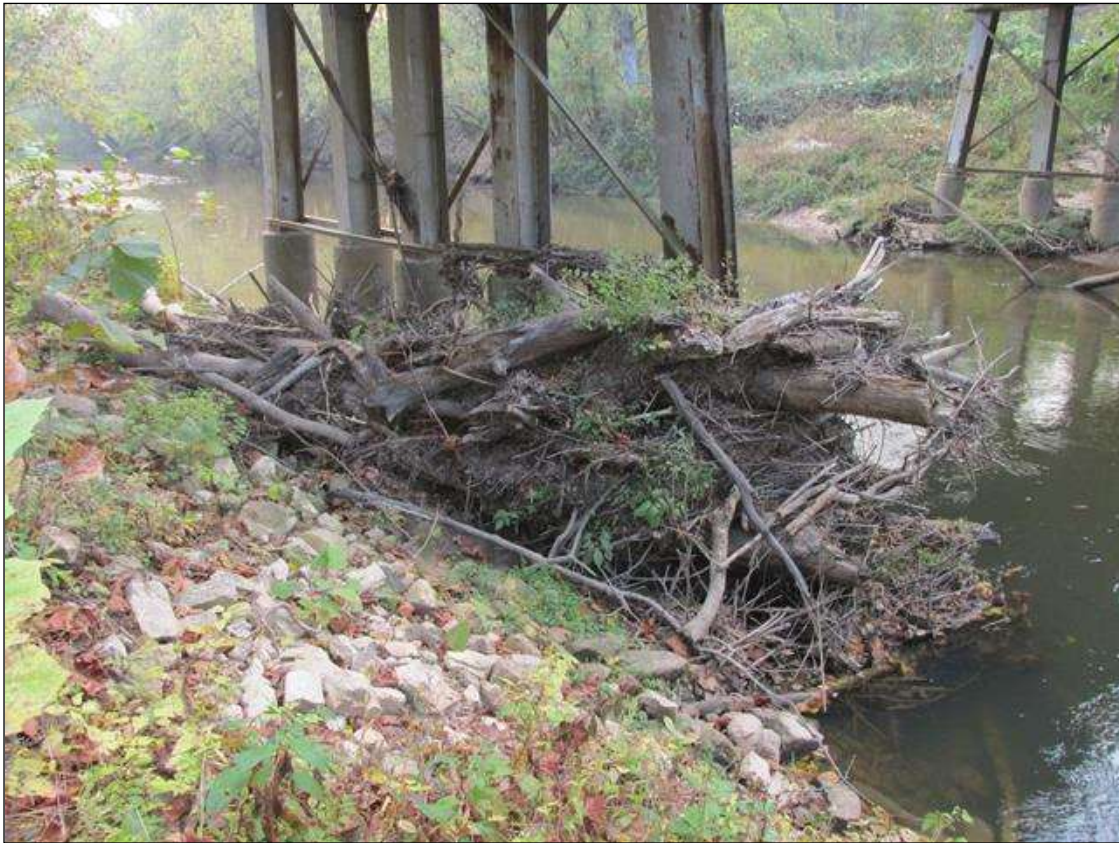
DRIFT AT PIER 3 8FT. W X 8 FT. H X 40 FT. LONG PRIORITY MAINTENANCE
