NC DEPARTMENT OF TRANSPORTATION  
DIVISION OF HIGHWAYS  
STRUCTURE MANAGEMENT UNIT

## Structure Safety Report

### Routine Element Inspection

COUNTY: ROWAN STRUCTURE NUMBER: 790061 FREQUENCY: 24 MONTHS

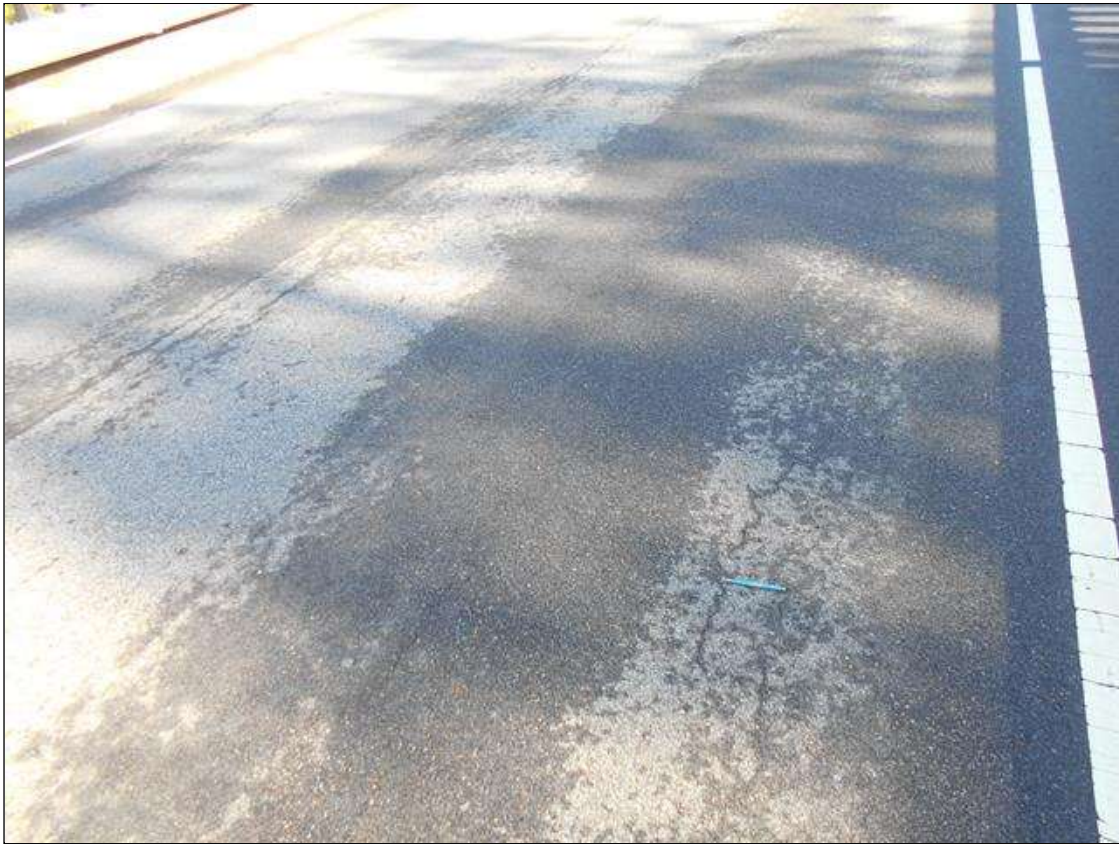
300 Square Feet of Cracking (RC and Other): Width 0.012-0.05 in. or spacing of 1.0-3.0 ft. AWS HAS SCATTERED H/L CRACKING.

SPAN 1 AWS H/L MAP CRACKING

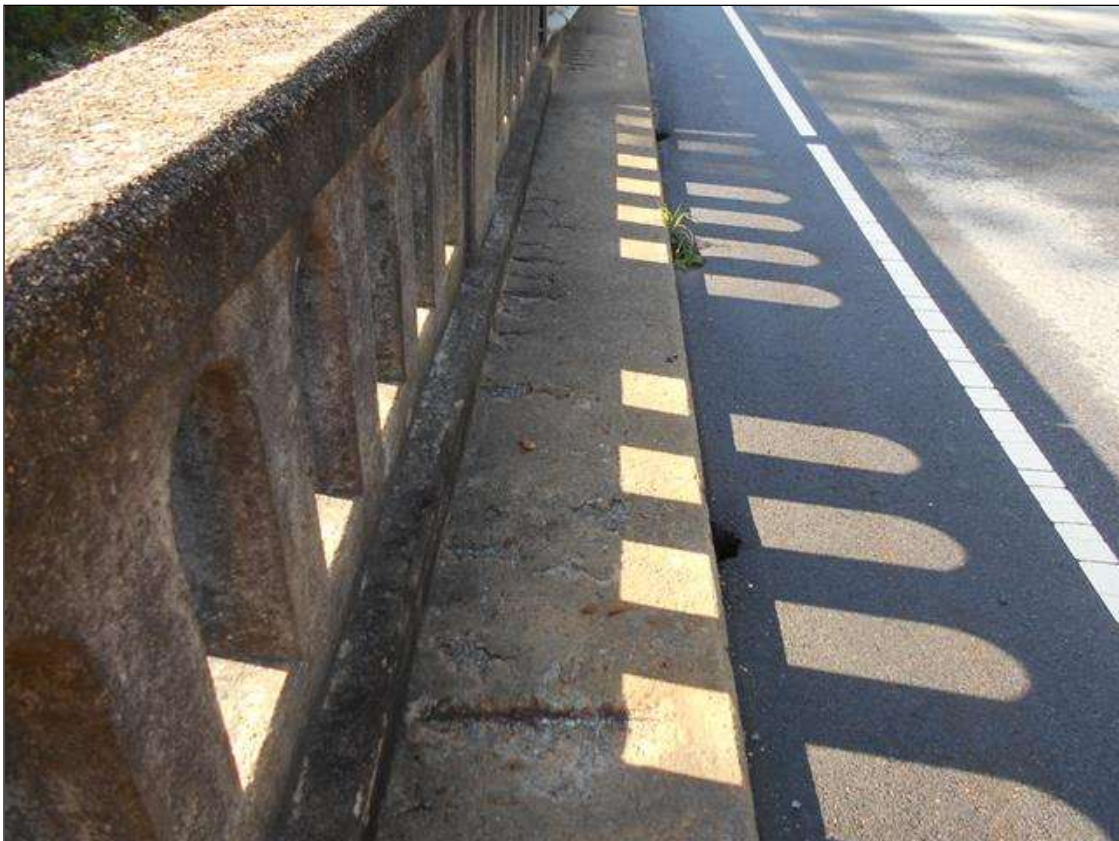
SPAN 1 RT. CONCRETE CURB AREAS OF SCALING AND POP-OFFS WITH EXPOSED REBAR: 1/2 IN. DEEP X 2 IN. WIDE X 12 IN. LONG

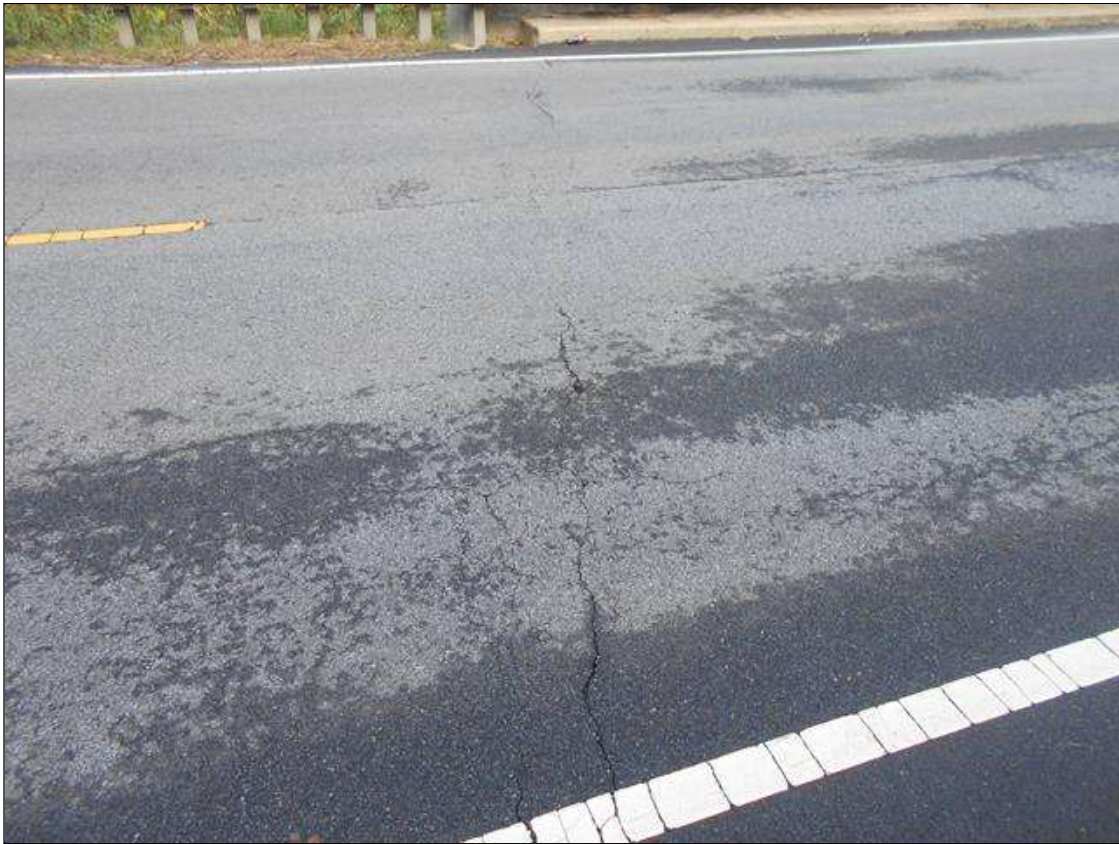
40 Square Feet of Crack (Wearing Surface): Width of more than 0.05 in. or spacing of less than 1.0 ft. AWS HAS 1/8 IN. WIDE TRANSVERSE CRACK ABOVE ABUT. 1.

SPAN 1 AWS HAS 1/8 IN. WIDE TRANSVERSE CRACK ABOVE ABUT. 1.

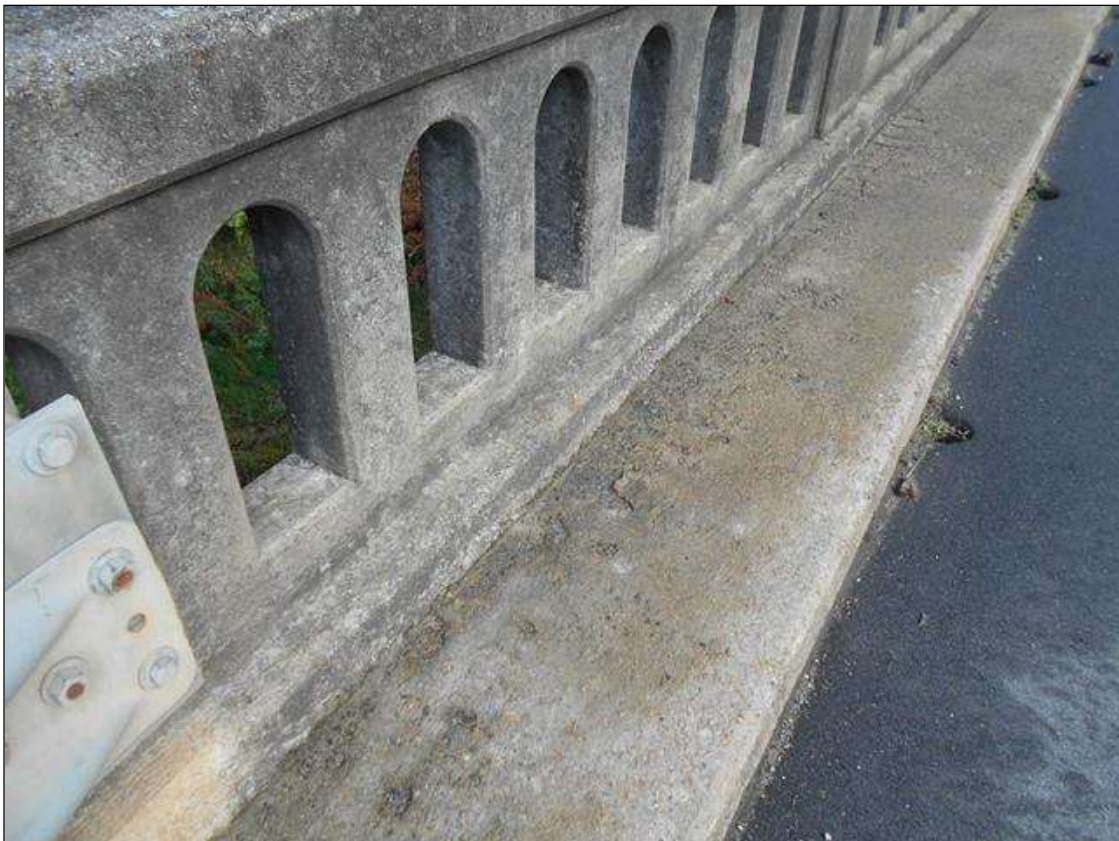
SPAN 1 LT. CONCRETE CURB AREAS OF SCALING AND POP-OFFS WITH EXPOSED REBAR: 1/2 IN. DEEP X 2 IN. WIDE X 12 IN. LONG

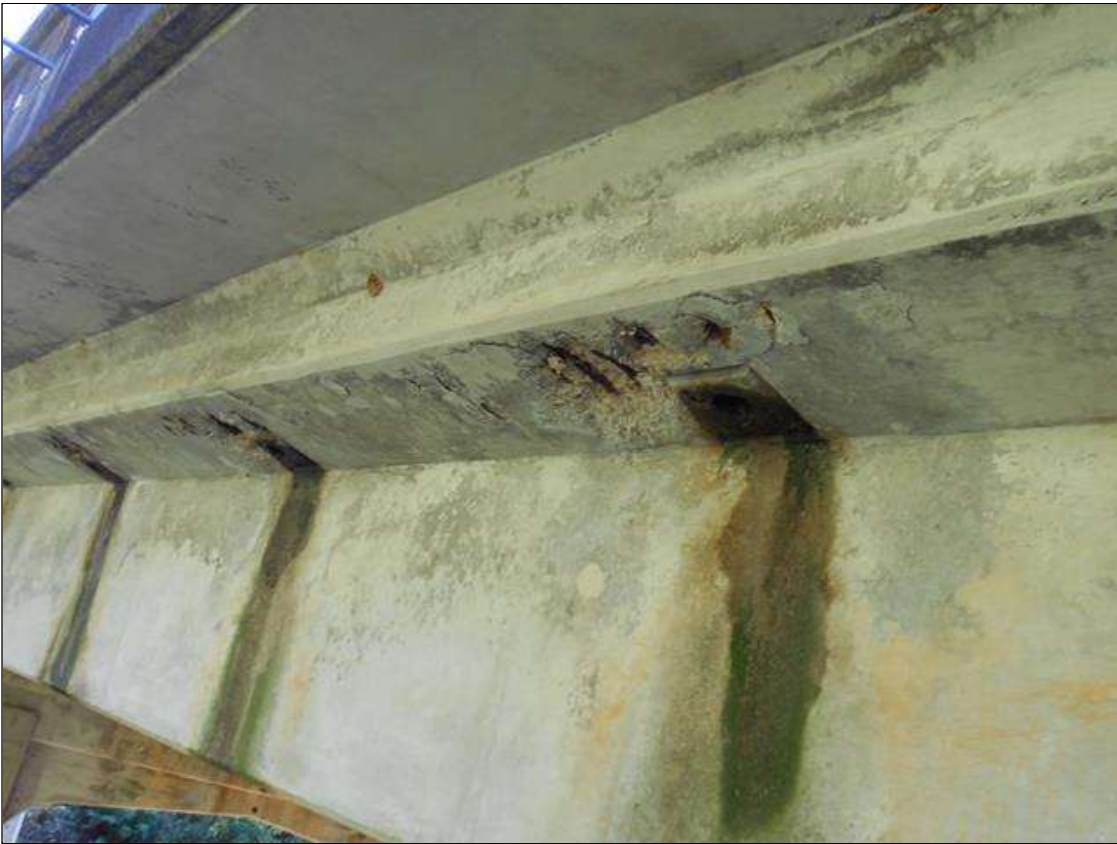
SPAN 1 LT. OVERHANG HAS A FEW 1 IN. DEEP SPALLS WITH EXPOSED REBAR AROUND DRAIN HOLES

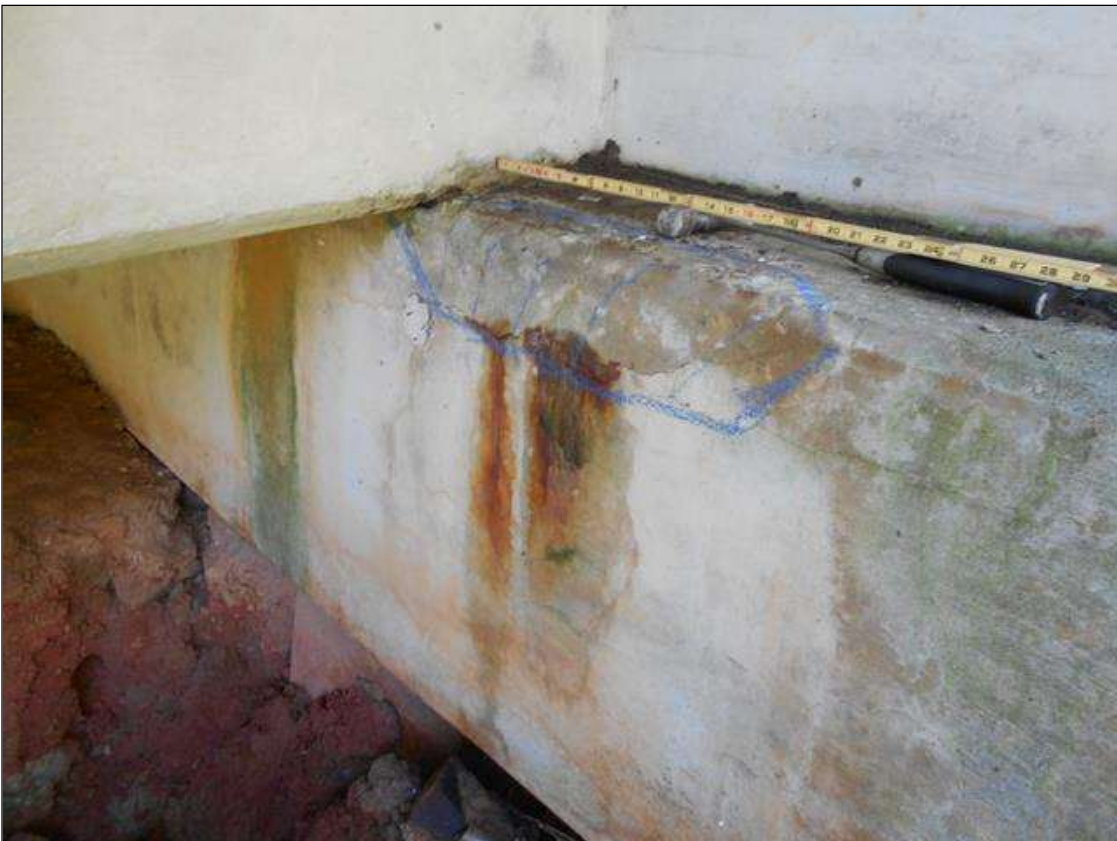
ABUT. 1 CAP HAS 1/16 IN. CRACKS AND DELAMINATION AT SEAT 1, 2 FT. LONG X 5 IN. HIGH X 4 IN. WIDE. MOISTURE SEEPING FROM CRACKS WITH RUST STAINS.

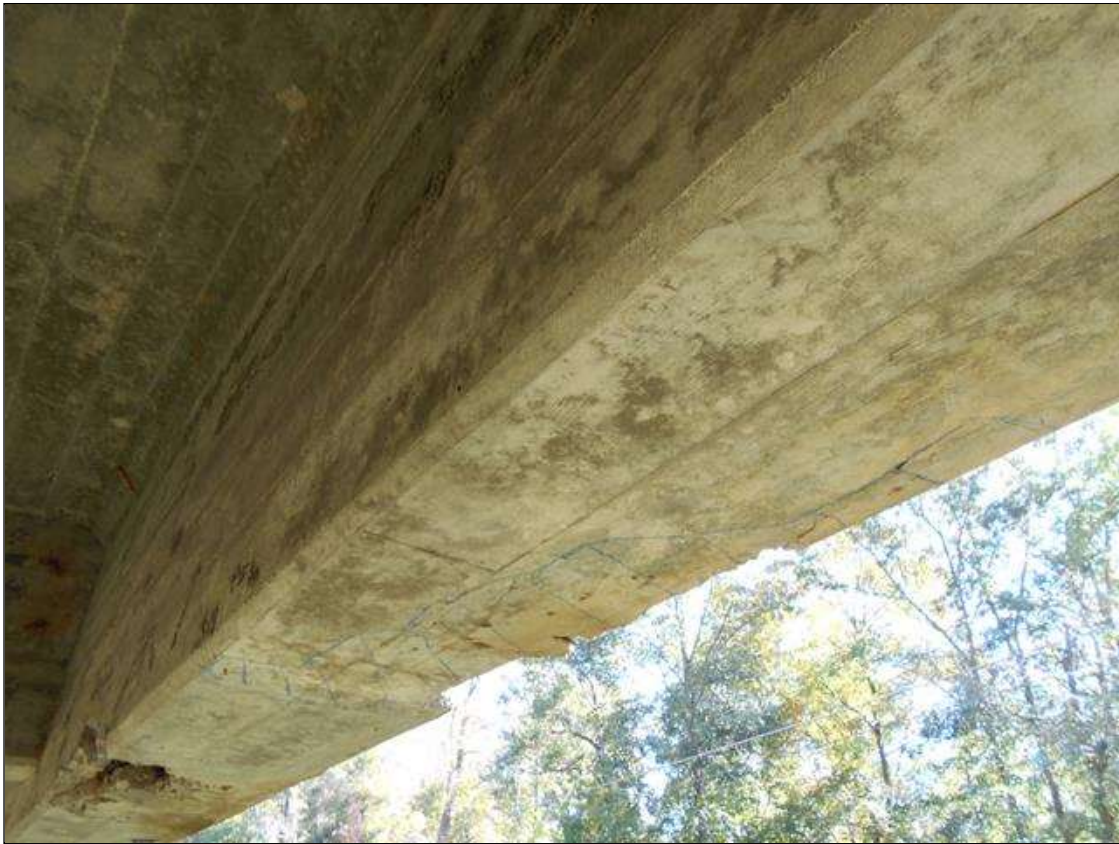
8 Feet of Delamination/Spall/Patched Area: Spall greater than 1 in. deep or greater than 6 in. diameter. Patched area that is unsound or showing distress. Does not warrant structural review. 15 FT. FROM ABUT. 1, CORNER SPALL WITH EXPOSED REBAR AT BOTTOM, 3 FT. LONG X 3 IN. DEEP X 3 IN. HIGH. PRIORITY MAINTENANCE.

SPAN 1, GIRDER 4, 15 FT. FROM ABUT. 1, CRACKS, DELAMINATION AND CORNER SPALL WITH EXPOSED REBAR AT BOTTOM, 3 FT. LONG X 3 IN. DEEP X 3 IN. HIGH. PRIORITY MAINTENANCE.

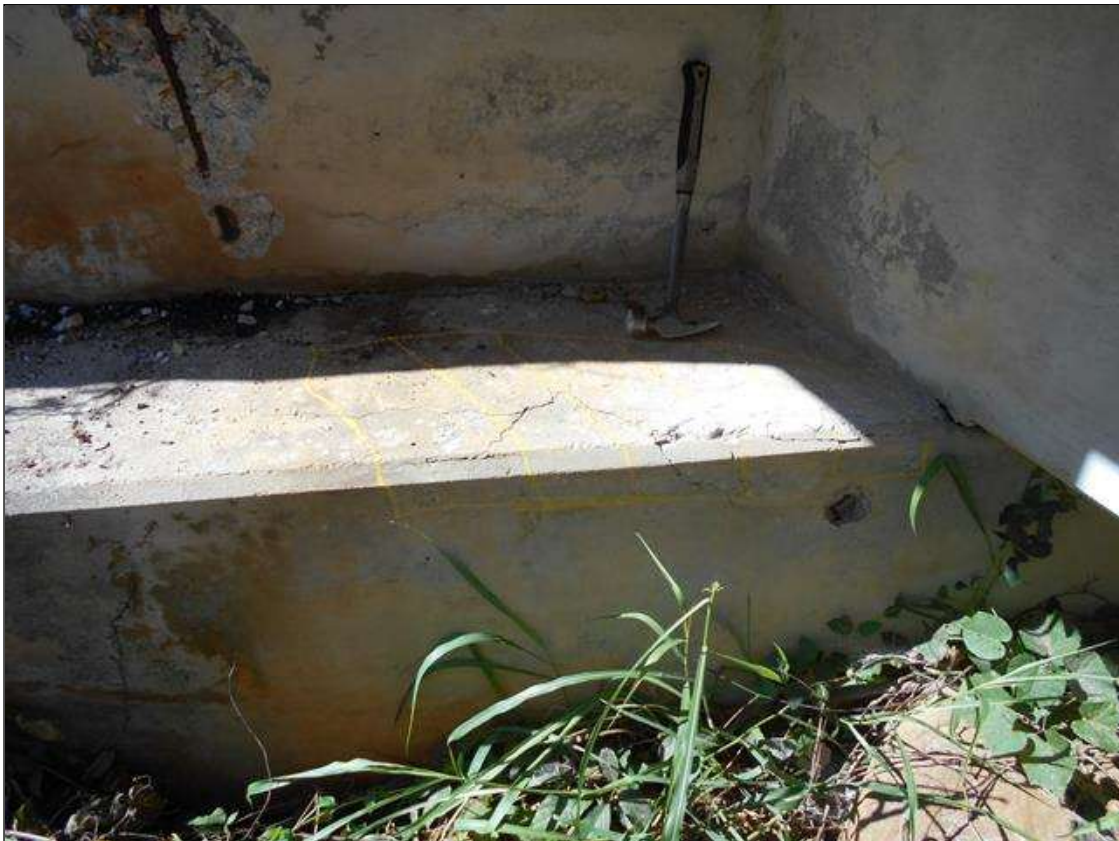
ABUT 1 CAP, AT SEAT 4, TOP OF CAP HAS 1/16 IN. CRACKS AND DELAMINATION, 2 FT. LONG X 14 IN. WIDE X 3 IN. HIGH.

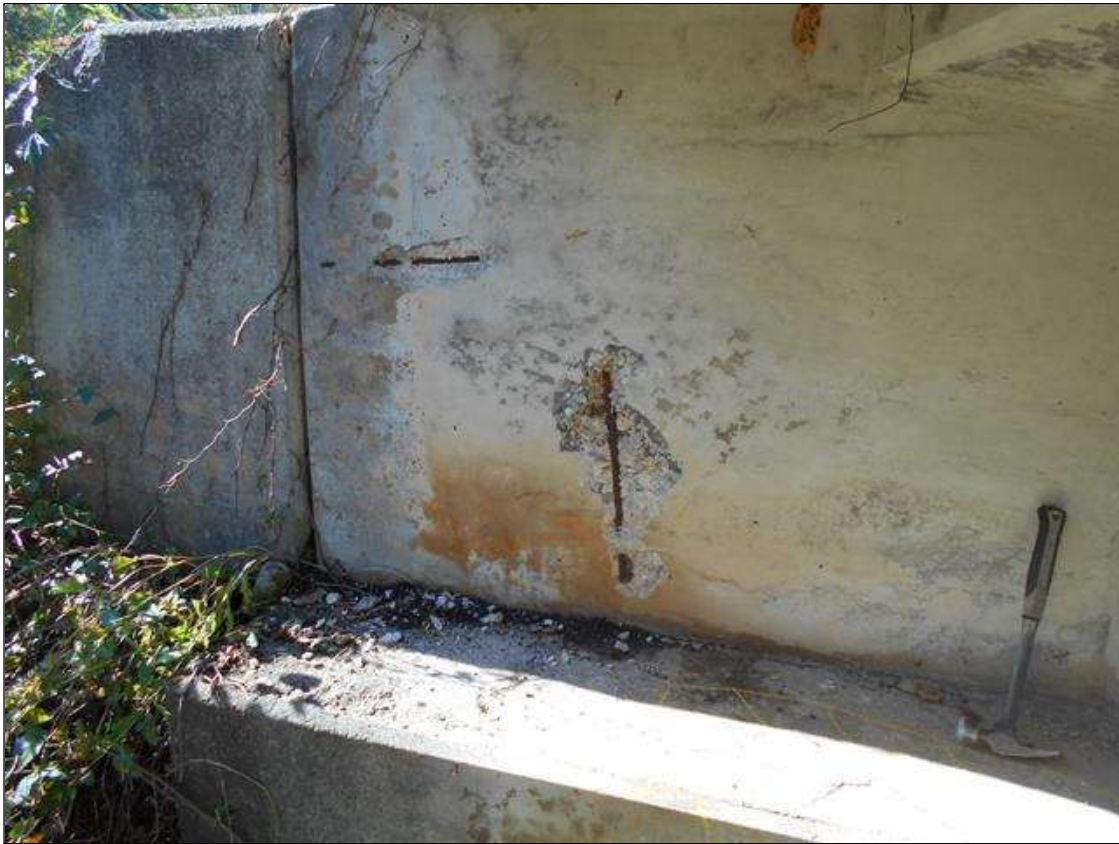
SPAN 1 CURTAIN WALL AT ABUT. 1 RT. END HAS 1/2 IN. DEEP POP-OFFS WITH EXPOSED REBAR UP TO 6 IN. WIDE X 14 IN. HIGH.

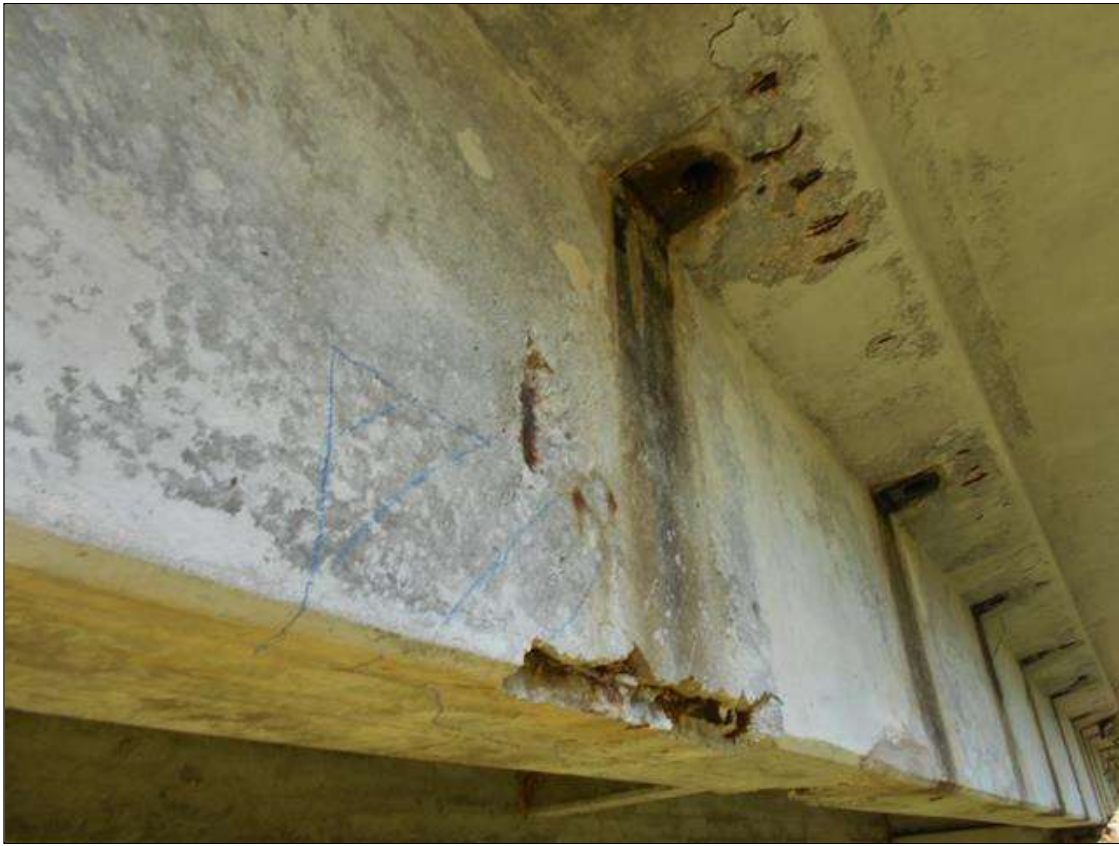
15 FT. FROM ABUT. 1, CRACKS AND DELAMINATION TO UNDERSIDE AND EAST FACE, 5 FT. LONG X 1 FT. HIGH X 3 IN. TO 14 IN. WIDE.

SPAN 1, GIRDER 4, 15 FT. FROM ABUT. 1, CRACKS, DELAMINATION 5FT. LONG X 1 FT. HIGH X 3 IN. TO 14 IN. WIDE, 5 IN. DIA. X 1/2 IN. DEEP POP-OFF ON EAST FACE AND A CORNER SPALL WITH EXPOSED REBAR AT BOTTOM, 3 FT. LONG X 3 IN. DEEP X 3 IN. HIGH. PRIORITY MAINTENANCE.

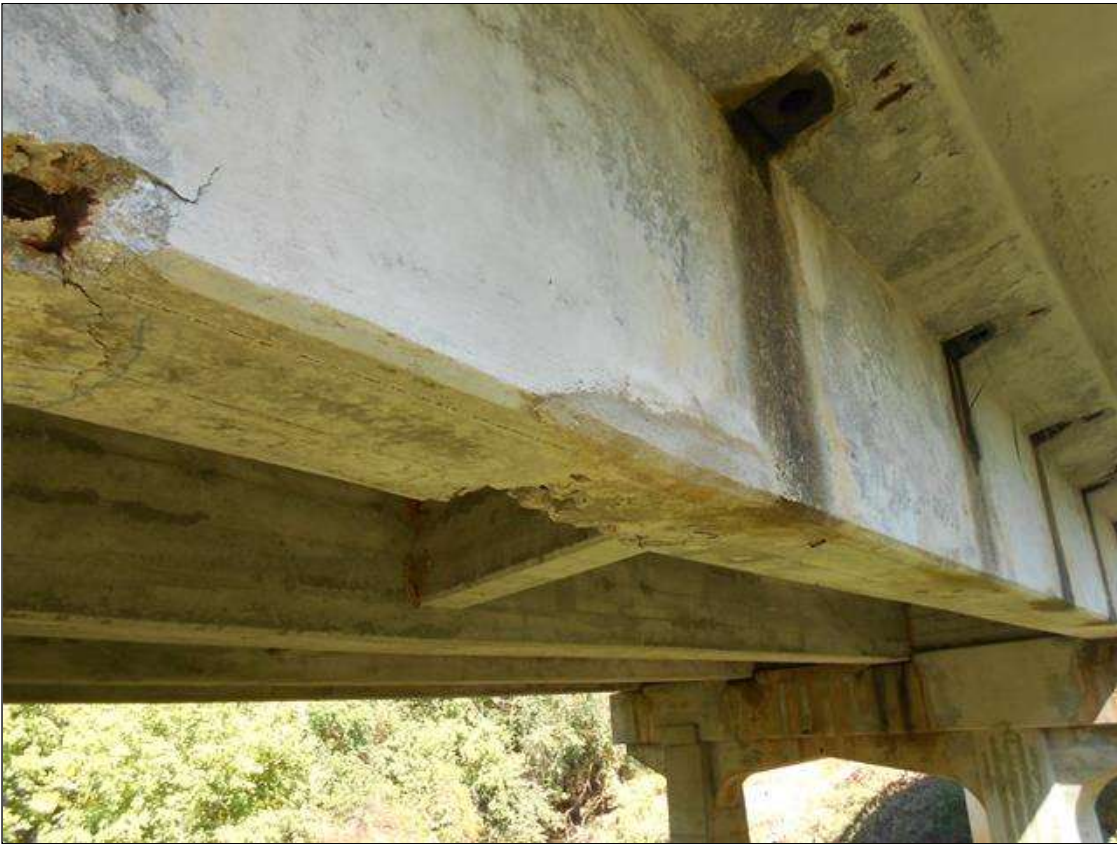
22 FT. FROM ABUT 1 PATCH TO CORNER SPALL AT BOTTOM RT. 2 FT. LONG X 3 IN. HIGH.

SPAN 1, GIRDER 4, 22 FT. FROM ABUT 1 PATCH TO CORNER SPALL AT BOTTOM.

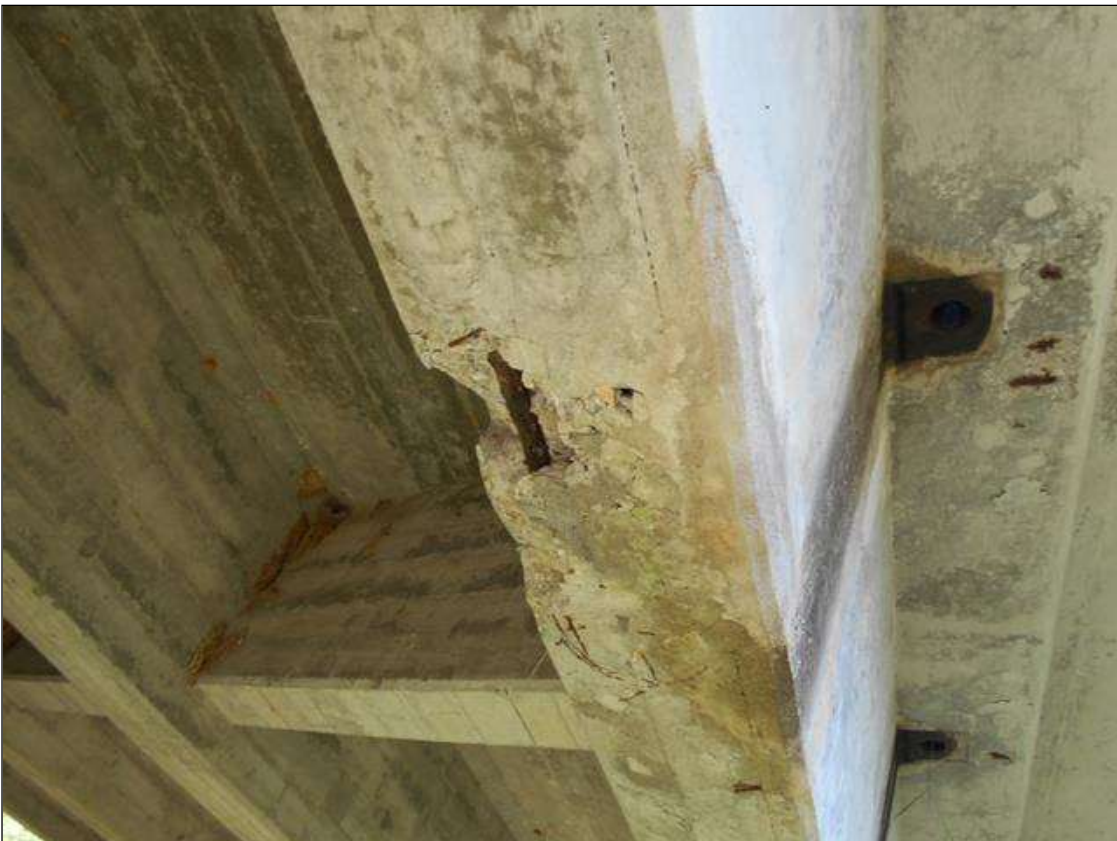
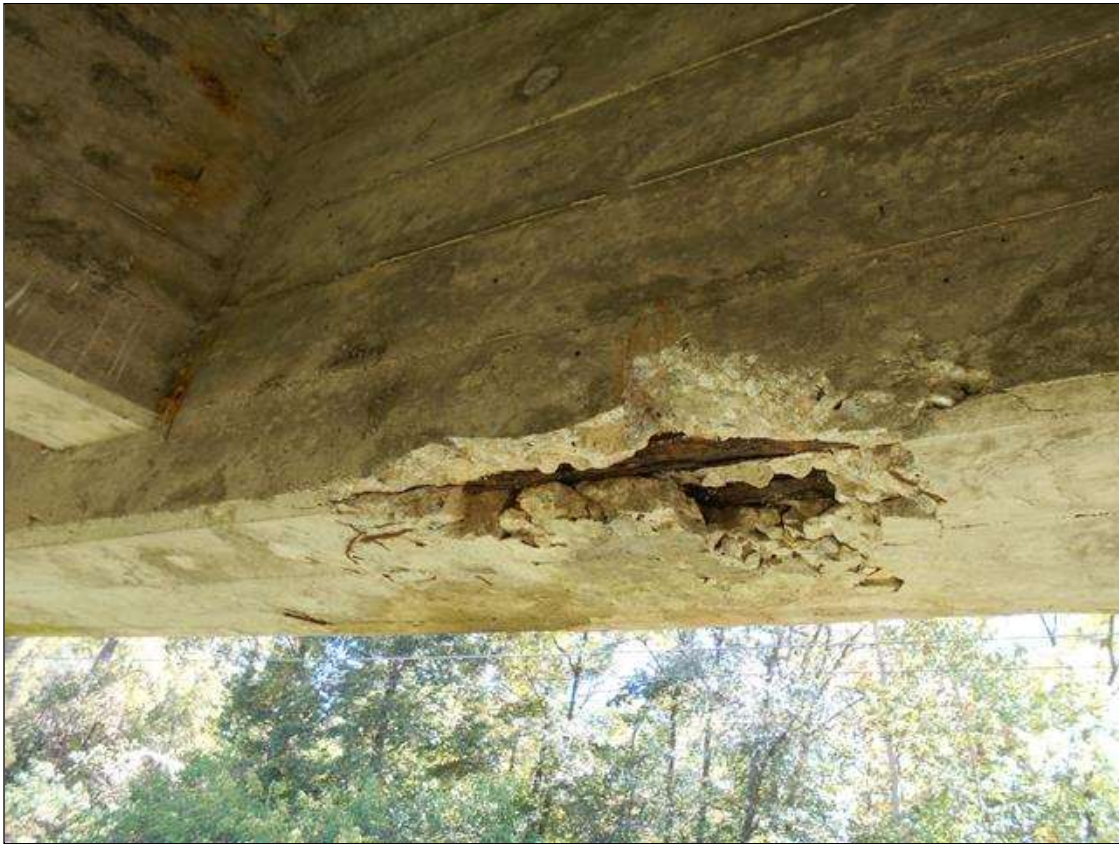
22 FT. FROM ABUT 1 SPALL WITH EXPOSED REBAR AND DELAMINATION TO BOTTOM 14 IN. WIDE X 2 FT. LONG X 3 IN. DEEP. EXPOSED REBAR HAS 1/8 IN. SECTION LOSS. PRIORITY MAINTENANCE.

SPAN 1, GIRDER 4, 22 FT. FROM ABUT 1 SPALL WITH EXPOSED REBAR AND DELAMINATION TO BOTTOM 14. IN WIDE X 2 FT. LONG X 3 IN. DEEP. EXPOSED REBAR HAS 1/8 IN. SECTION LOSS. PRIORITY MAINTENANCE.

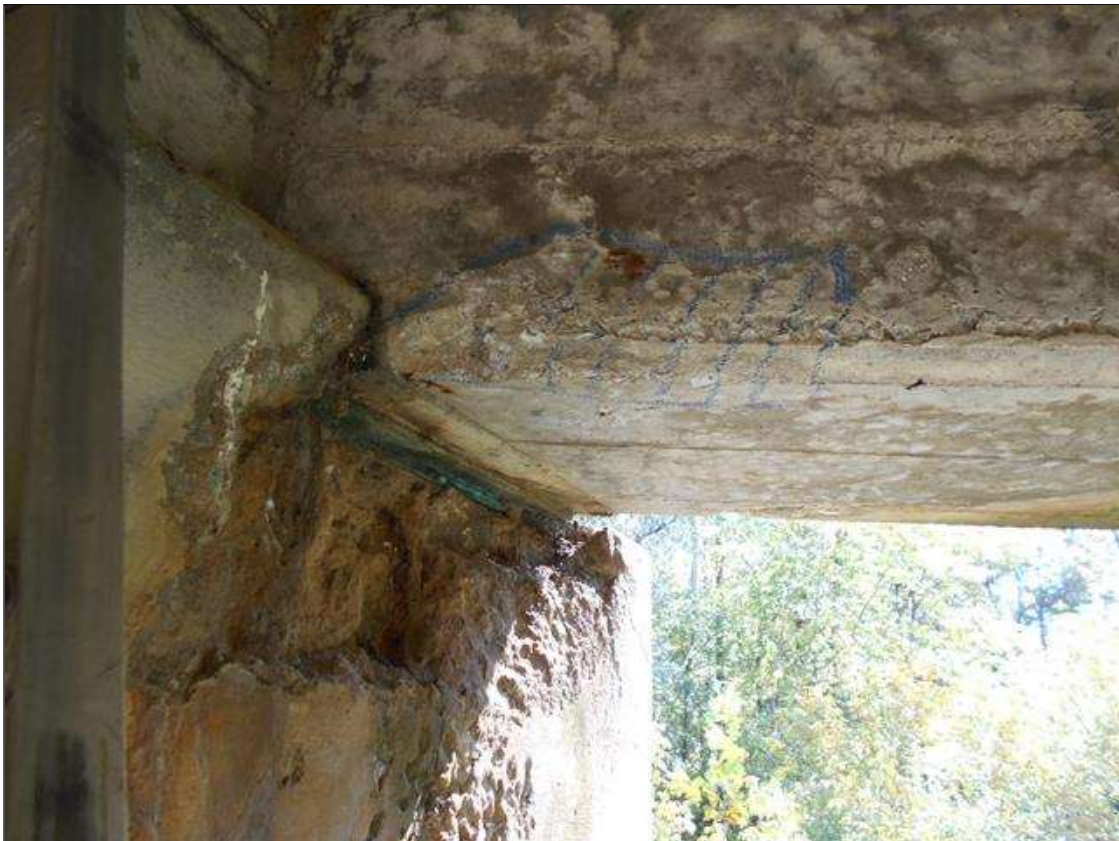
4 Feet of Delamination/Spall/Patched Area: Delaminated. Spall 1 in. or less deep or 6 in. or less in diameter. Patched area that is sound. AT PIER 1, LT. BOTTOM CORNER HAS 1/16 IN. CRACKS AND DELAMINATION 14 IN. LONG X 4 IN. HIGH X 3 IN. WIDE. BEARING PLATES EXPOSED AT PIER 1 DUE TO SPALL IN CAP UNDER THIS SEAT.

SPAN 1, GIRDER 4 AT PIER 1, LT. BOTTOM CORNER HAS 1/16 IN. CRACKS AND DELAMINATION 14 IN. LONG X 4 IN. HIGH X 3 IN. DEEP.

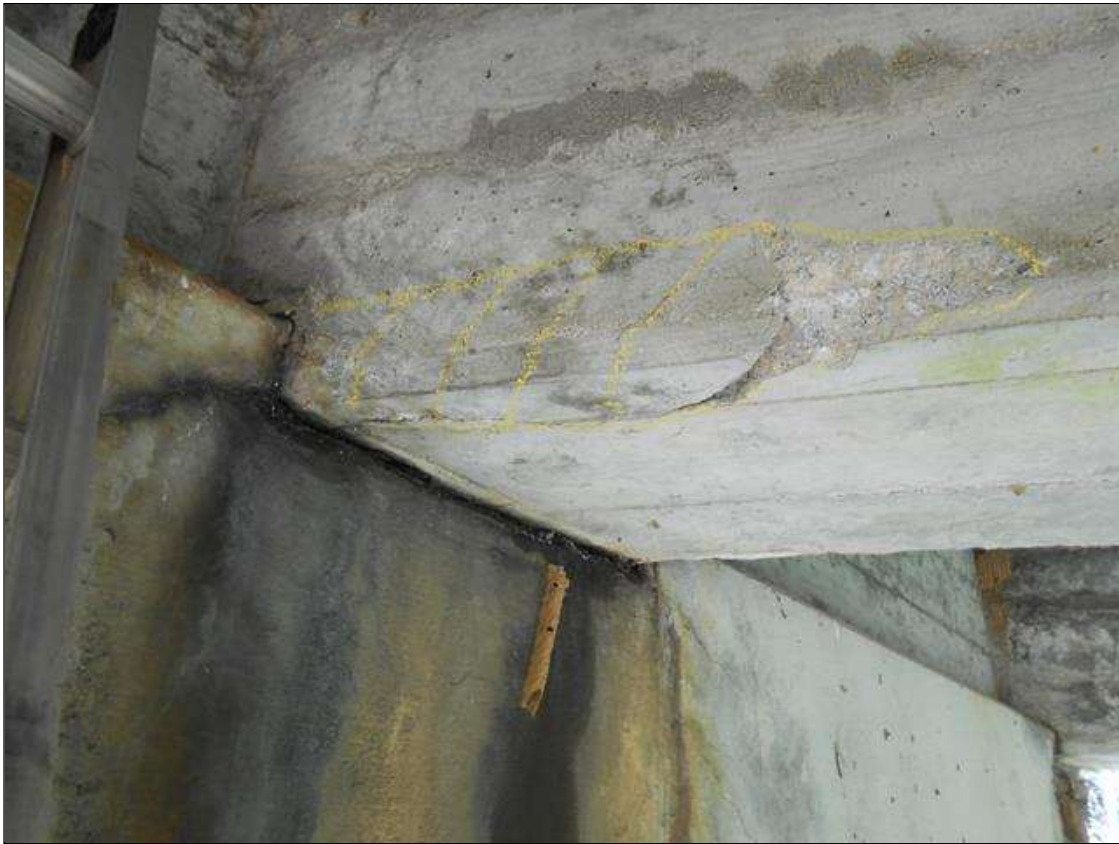
2 Feet of Delamination/Spall/Patched Area: Delaminated. Spall 1 in. or less deep or 6 in. or less in diameter. Patched area that is sound. AT PIER 1, LT. BOTTOM CORNER HAS 1/16 IN. CRACKS AND DELAMINATION 18 IN. LONG X 3 IN. HIGH X 3 IN.

Span 1 Beam 3: 2 Feet of Delamination/Spall/Patched Area: Delaminated. Spall 1 in. or less deep or 6 in. or less in diameter. Patched area that is sound. AT PIER 1, LT. BOTTOM CORNER HAS 1/16 IN. CRACKS AND DELAMINATION 18 IN. LONG X 3 IN. HIGH X 3 IN. DEEP.

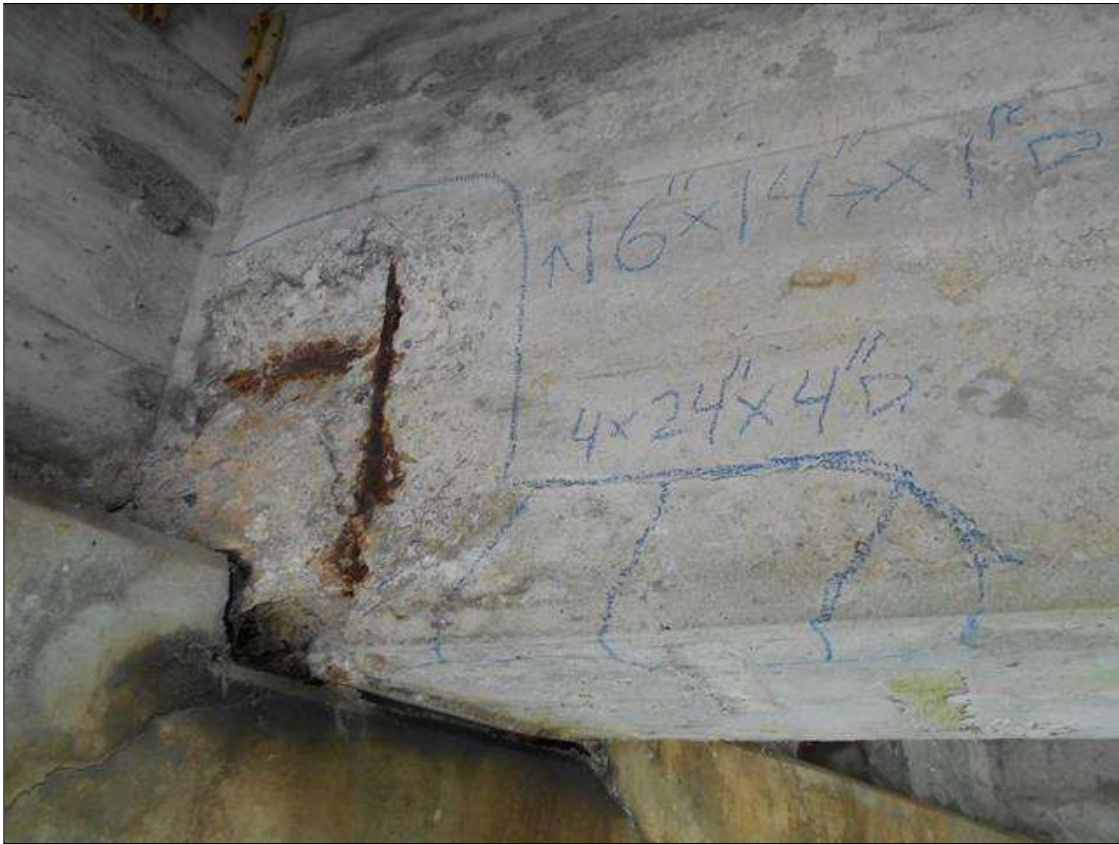
2 Feet of Delamination/Spall/Patched Area: Spall greater than 1 in. deep or greater than 6 in. diameter. Patched area that is unsound or showing distress. Does not warrant structural review. AT PIER 1, LT. FACE HAS SPALL WITH EXPOSED VERTICAL REBAR 12 IN. HIGH X 12 IN. LONG X 1 IN. DEEP ALSO DELAMINATION ON BOTH SIDES AT BOTTOM CORNERS 2 FT. LONG X 4 IN. DEEP X 4 IN. HIGH.

Span 1 Beam 2: 2 Feet of Delamination/Spall/Patched Area: Spall greater than 1 in. deep or greater than 6 in. diameter. Patched area that is unsound or showing distress. Does not warrant structural review. AT PIER 1, LT. FACE HAS SPALL WITH EXPOSED VERTICAL REBAR 12 IN. HIGH X 12 IN. LONG X 1 IN. DEEP ALSO DELAMINATION ON BOTH SIDES AT BOTTOM CORNERS 2 FT. LONG X 4 IN. DEEP X 4 IN. HIGH.

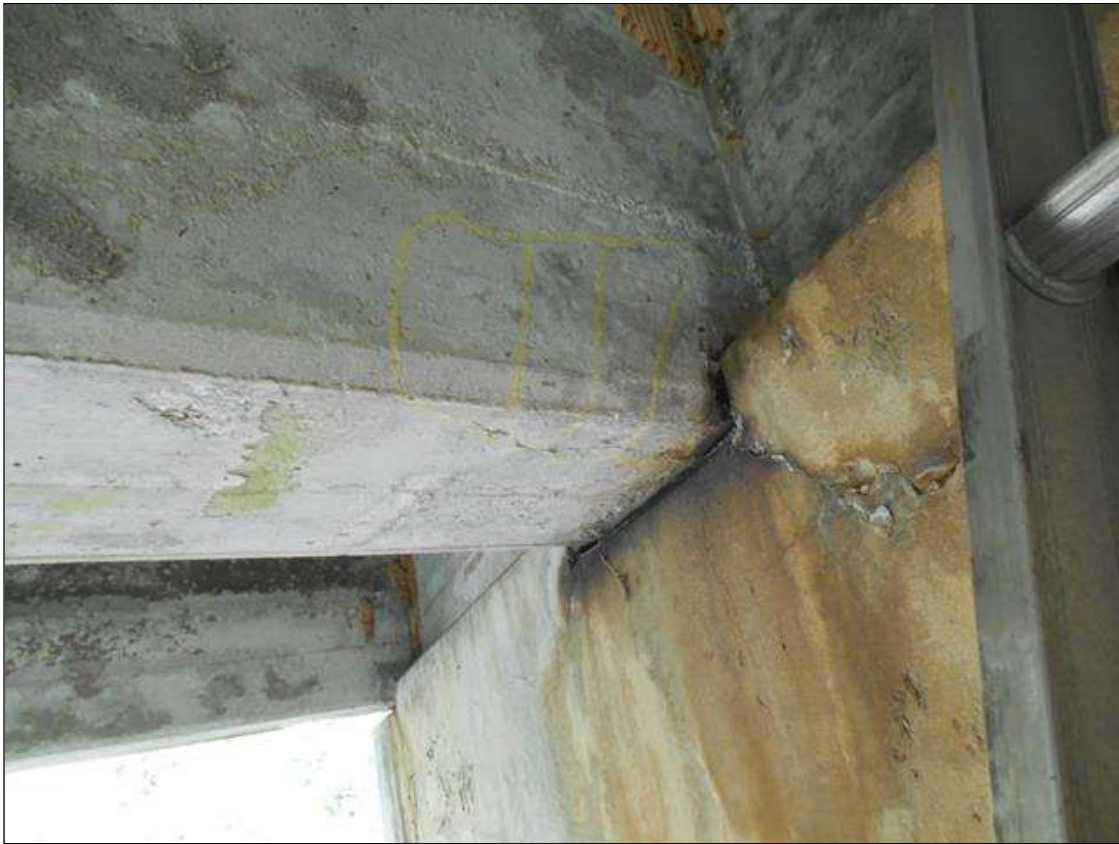
SPAN 1 GIRDER 2 AT PIER 1 BOTTOM RT. CORNER HAS 1/16 IN. CRACKS AND DELAMINATION 18 IN. LONG X 6 IN. HIGH X 4 IN. DEEP.

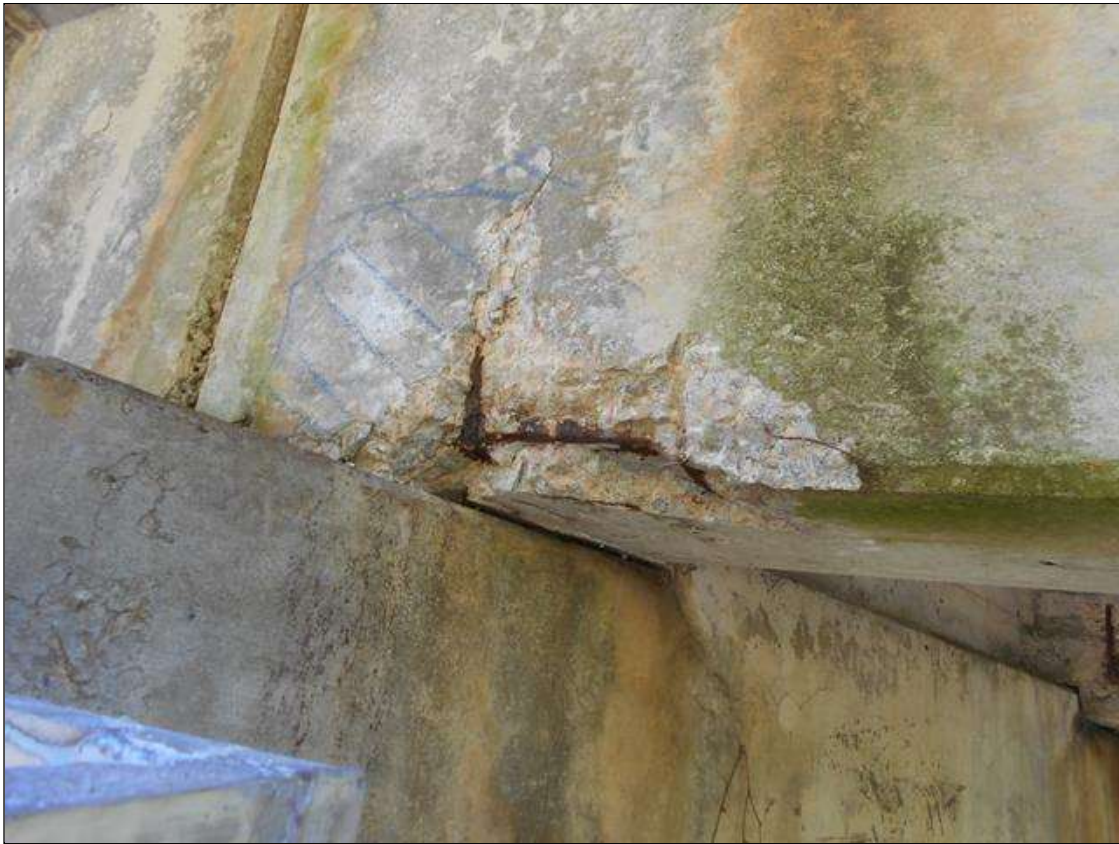
3 Feet of Delamination/Spall/Patched Area: Spall greater than 1 in. deep or greater than 6 in. diameter. Patched area that is unsound or showing distress. Does not warrant structural review. AT PIER 1, LT. BOTTOM CORNER HAS SPALL WITH EXPOSED REBAR 3 IN. DEEP X 6 IN. HIGH X 12 IN. LONG ALSO DELAMINATION ABOVE PIER 16 IN. HIGH X 16 IN. LONG.

Span 1 Beam 1: 3 Feet of Delamination/Spall/Patched Area: Spall greater than 1 in. deep or greater than 6 in. diameter. Patched area that is unsound or showing distress. Does not warrant structural review. AT PIER 1, LT. BOTTOM CORNER HAS SPALL WITH EXPOSED REBAR 3 IN. DEEP X 6 IN. HIGH X 12 IN. LONG ALSO DELAMINATION ABOVE PIER 16 IN. HIGH X 16 IN. LONG.

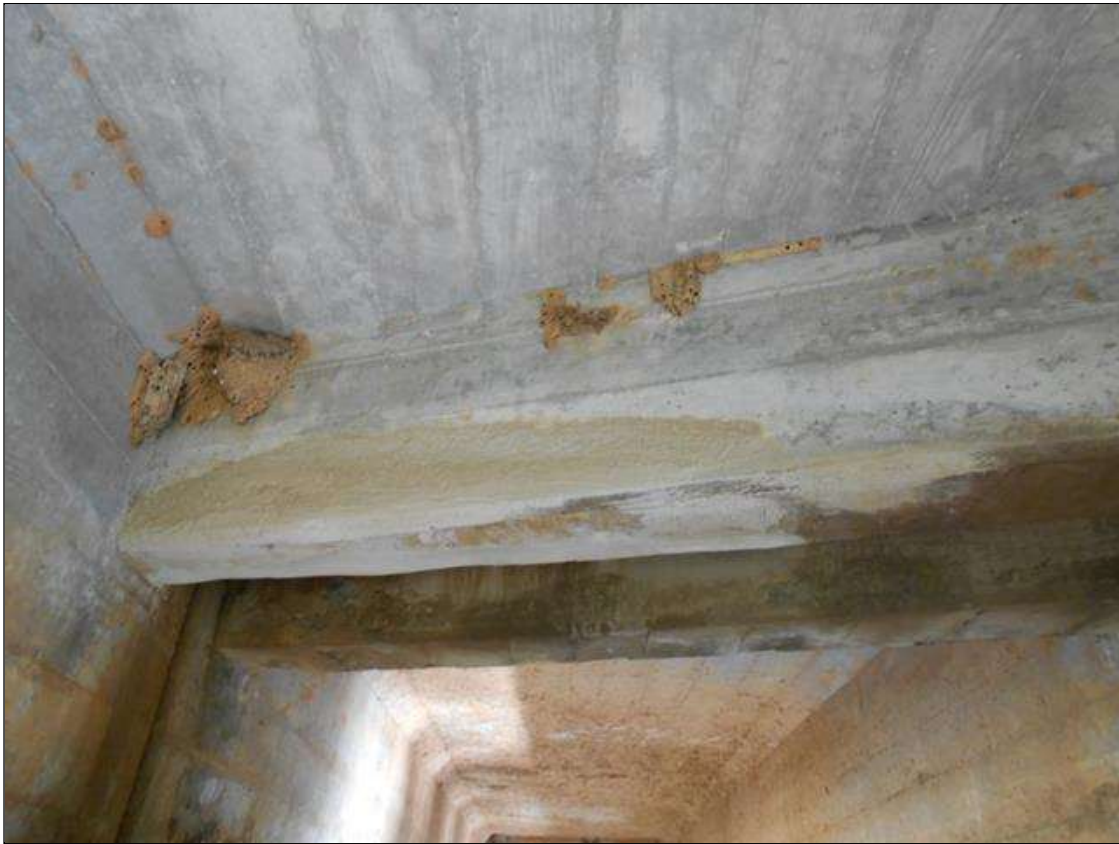
SPAN 2 BAY 2 CURTAIN WALL AT PIER 2 HAS CONCRETE PATCH THAT IS SOUND.

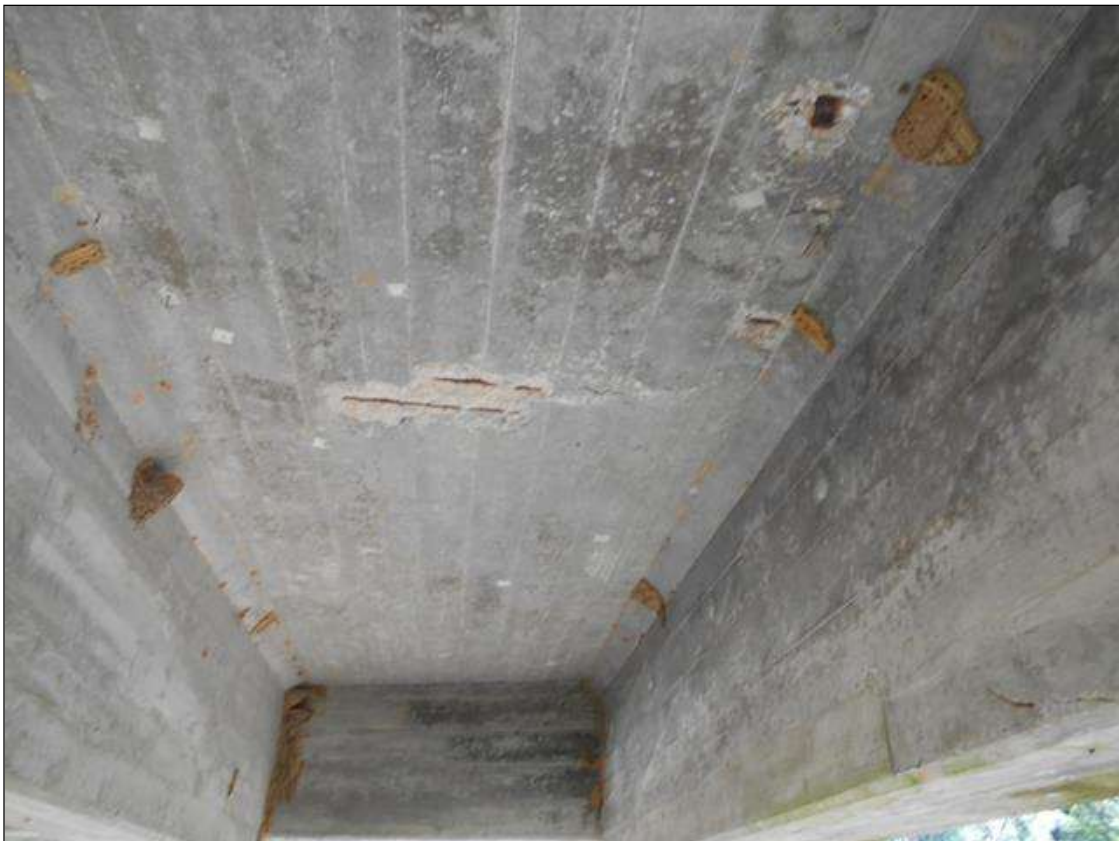
BOTH OVERHANGS HAVE FEW 1 IN. DEEP X 12 IN. SQUARE SPALLS WITH EXPOSED REBAR AROUND DRAIN HOLES. UNDERSIDE OF DECK, BAY 3, 15 FT. FROM PIER 1 SPALL WITH EXPOSED REBAR 1 IN. DEEP X 2 FT. WIDE X 1 FT. LONG.

SPAN 2, UNDERSIDE OF DECK, BAY 3, 15 FT. FROM PIER 1 SPALLS WITH EXPOSED REBAR 1 IN. DEEP X 2 FT. WIDE X 1 FT. LONG.

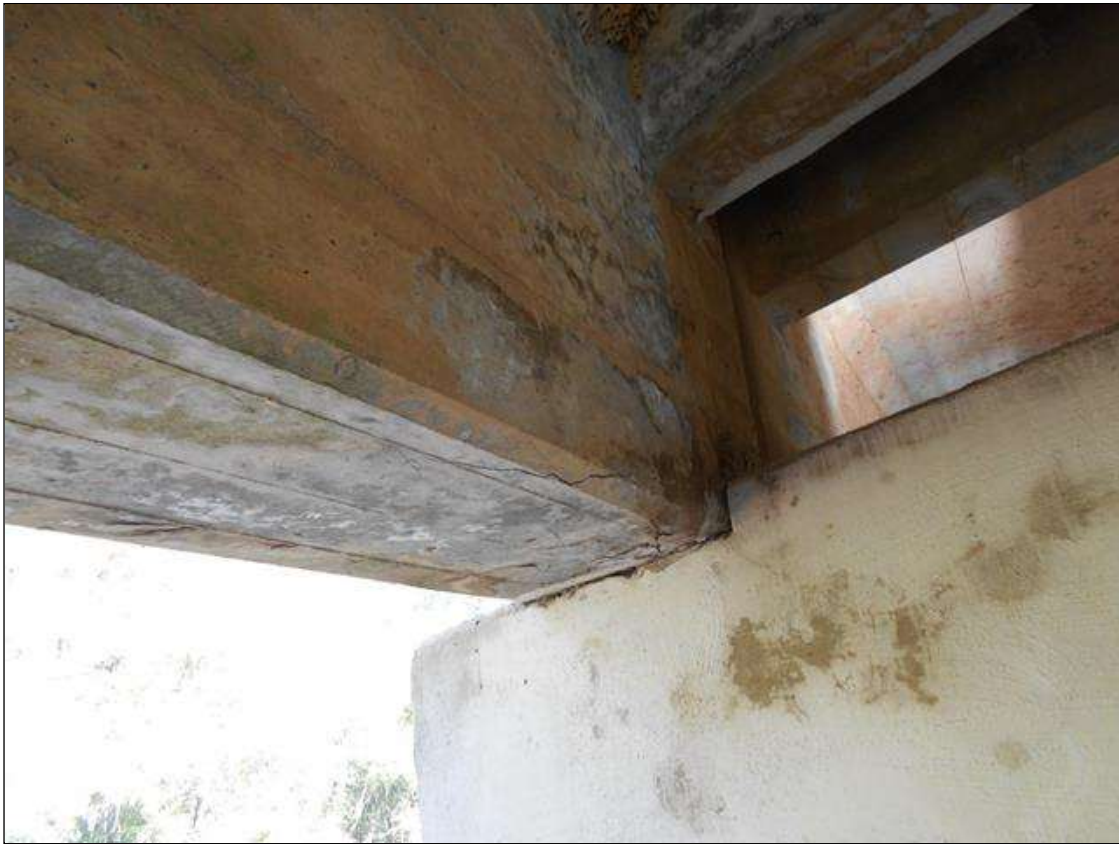
AT PIER 2, BOTTOM RT. CORNER HAS 1/8 IN. CRACKS AND DELAMINATION 3 IN. HIGH X 20 IN. LONG X 4 IN. WIDE.

SPAN 2, GIRDER 1, AT PIER 2 BOTTOM RT. CORNER HAS 1/8 IN. CRACKS AND DELAMINATION 3 IN. HIGH X 20 IN. LONG X 4 IN. WIDE.

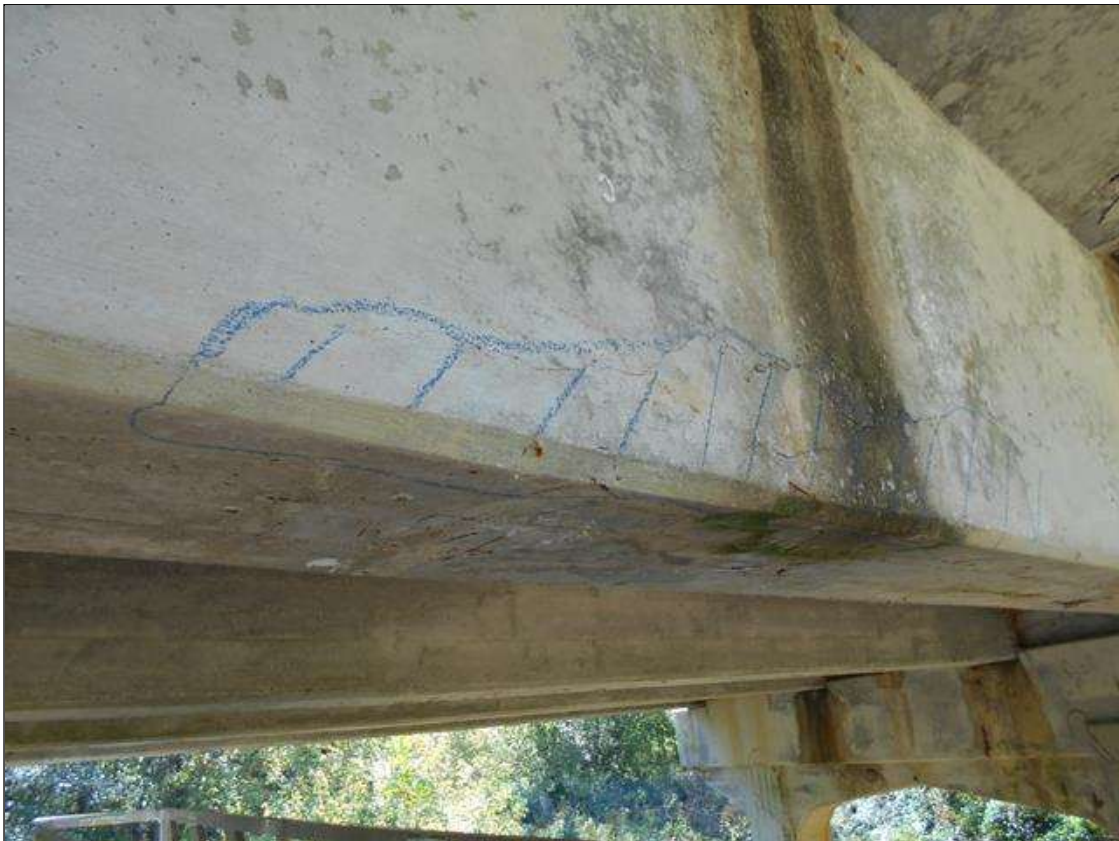
7 Feet of Delamination/Spall/Patched Area: Spall greater than 1 in. deep or greater than 6 in. diameter. Patched area that is unsound or showing distress. Does not warrant structural review. 16 FT. FROM PIER 2, LT. BOTTOM CORNER 1/16 IN. CRACKS AND DELAMINATION UP TO 1 FT. HIGH X 5 FT. LONG X 4 IN. WIDE.

SPAN 2, GIRDER 1, 16 FT. FROM PIER 2, LT. BOTTOM CORNER 1/16 IN. CRACKS AND DELAMINATION UP TO 1 FT. HIGH X 5 FT. LONG X 4 IN. WIDE.
