NC DEPARTMENT OF TRANSPORTATION  
DIVISION OF HIGHWAYS  
STRUCTURE MANAGEMENT UNIT

## Structure Safety Report

### Routine Element Inspection

COUNTY: ROWAN STRUCTURE NUMBER: 790061 FREQUENCY: 24 MONTHS

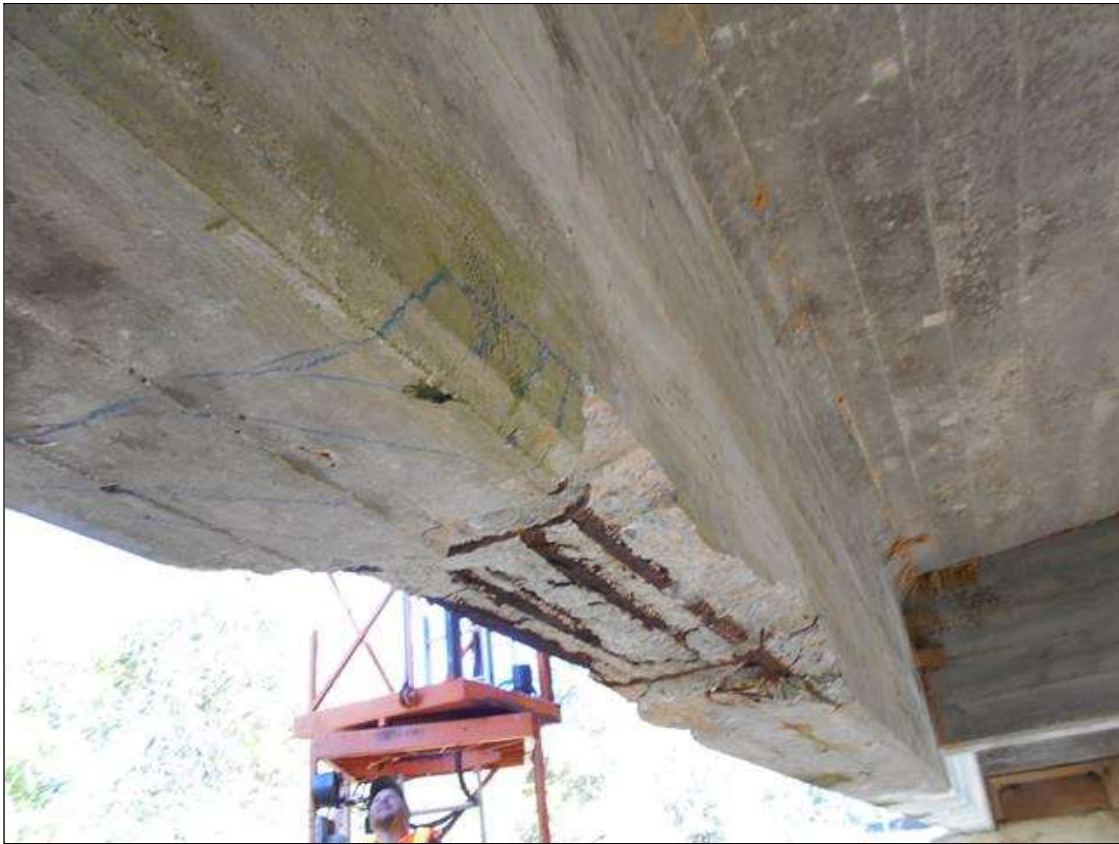
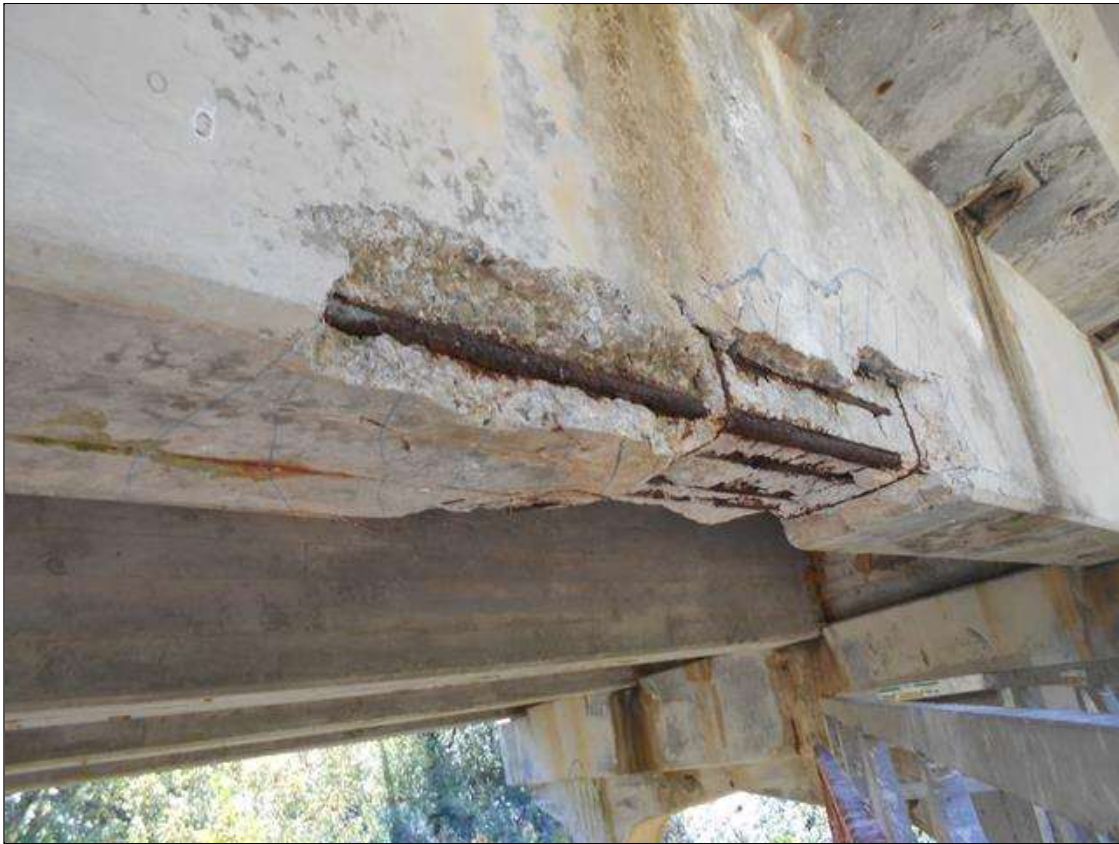
9 FT. FROM PIER 1, BOTTOM OF GIRDER HAS DELAMINATION AND SPALL WITH SEVERAL EXPOSED AND DETERIORATING PIECES OF MAIN REBAR, FULL WIDTH X 6 FT. LONG X 3 IN. DEEP. CONCRETE ON LEFT FACE HERE IS UNSOUND UP TO 16 IN. HIGH. PRIORITY MAINTENANCE.

SPAN 2, GIRDER 1, 9 FT. FROM PIER 1, BOTTOM OF GIRDER HAS DELAMINATION AND SPALL WITH SEVERAL EXPOSED AND DETERIORATING PIECES OF MAIN REBAR, FULL WIDTH X 6 FT. LONG X 3 IN. DEEP. CONCRETE ON LEFT FACE HERE IS UNSOUND UP TO 16 IN. HIGH. PRIORITY MAINTENANCE.

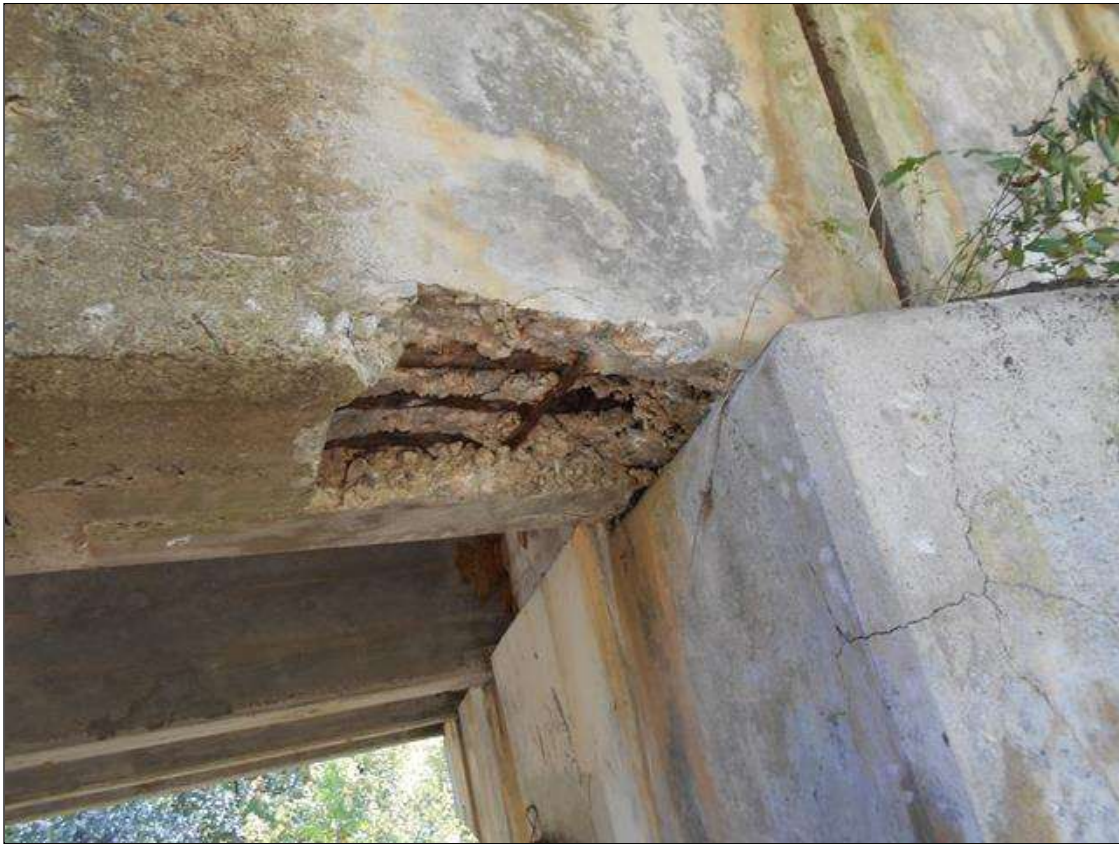
AT PIER 1, BOTTOM OF GIRDER HAS SPALL WITH SEVERAL EXPOSED MAIN REBAR PIECES 18 IN. LONG X 12 IN. WIDE X 4 IN. DEEP. PRIORITY MAINTENANCE.

SPAN 2, GIRDER 1 AT PIER 1, BOTTOM OF GIRDER HAS SPALL WITH SEVERAL EXPOSED MAIN REBAR PIECES 18 IN. LONG X 12 IN. WIDE X 4 IN. DEEP. PRIORITY MAINTENANCE.

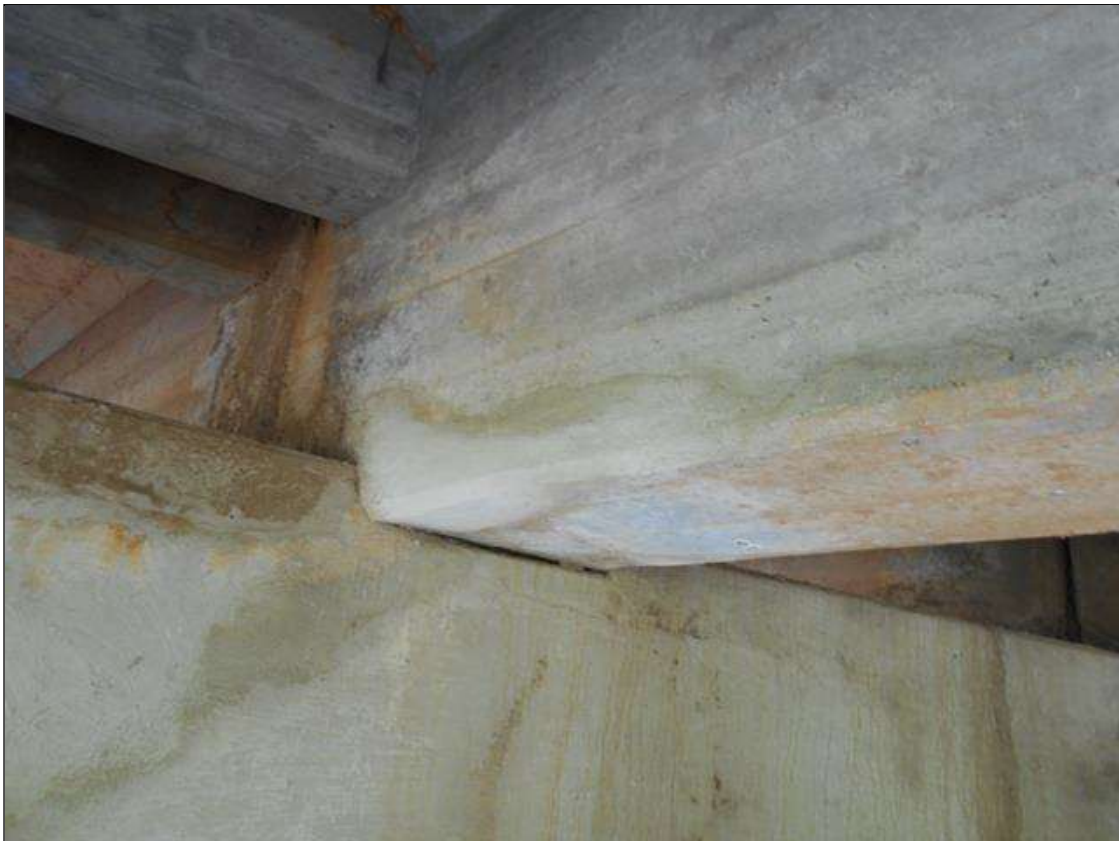
SPAN 2, GIRDER 2, AT PIER 2, PATCH TO SPALL ON LT. BOTTOM CORNER 20 IN. LONG X 5 IN. HIGH.

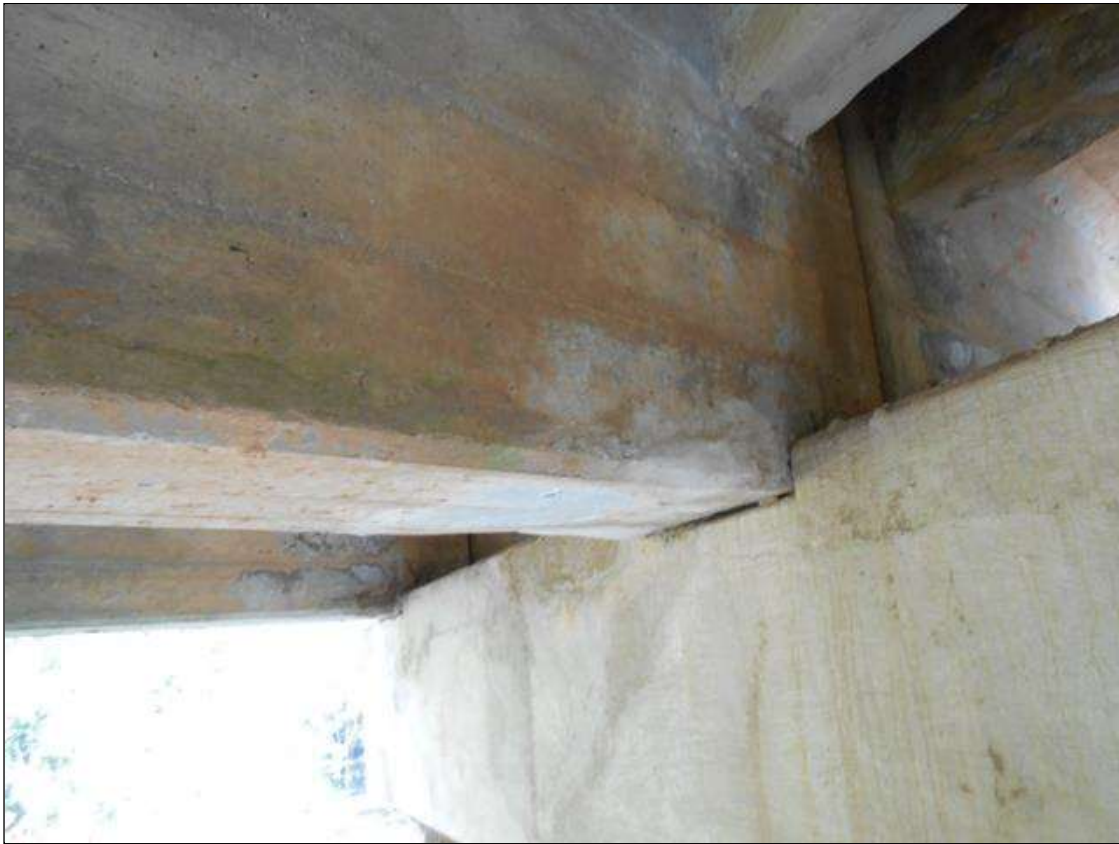
2 Feet of Delamination/Spall/Patched Area: Delaminated. Spall 1 in. or less deep or 6 in. or less in diameter. Patched area that is sound. AT PIER 2, SOUND PATCHES TO SPALLS ON BOTH BOTTOM CORNERS 20 IN. LONG X 5 IN. HIGH.

SPAN 2, GIRDER 2, AT PIER 2, PATCH TO SPALL ON RT. BOTTOM CORNER 20 IN. LONG X 5 IN. HIGH.

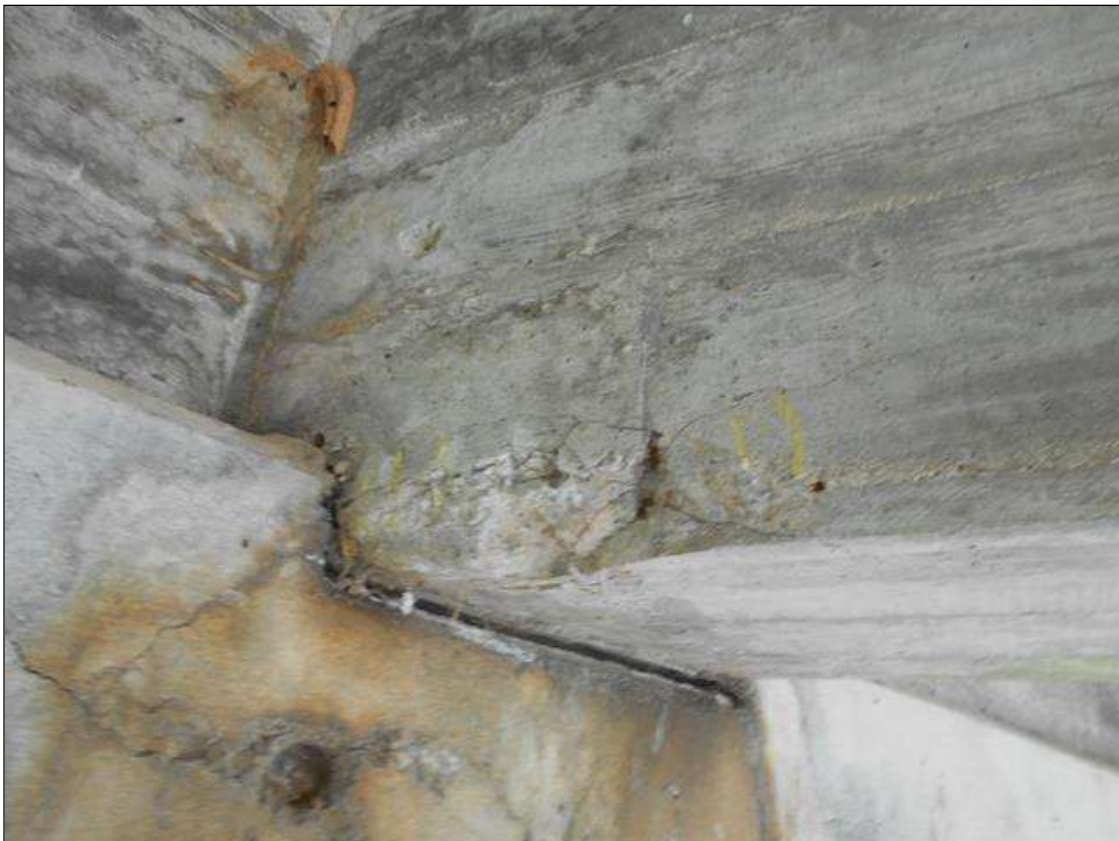
1 Feet of Delamination/Spall/Patched Area: Spall greater than 1 in. deep or greater than 6 in. diameter. Patched area that is unsound or showing distress. Does not warrant structural review. AT PIER 1, RT. BOTTOM CORNER HAS 1/16 IN. CRACKS AND DELAMINATION 12 IN. LONG X 3 IN. DEEP X 3 IN. HIGH.

SPAN 2, GIRDER 2, AT PIER 1, RT. BOTTOM CORNER HAS 1/16 IN. CRACKS AND DELAMINATION 12 IN. LONG X 3 IN. DEEP X 3 IN. HIGH.

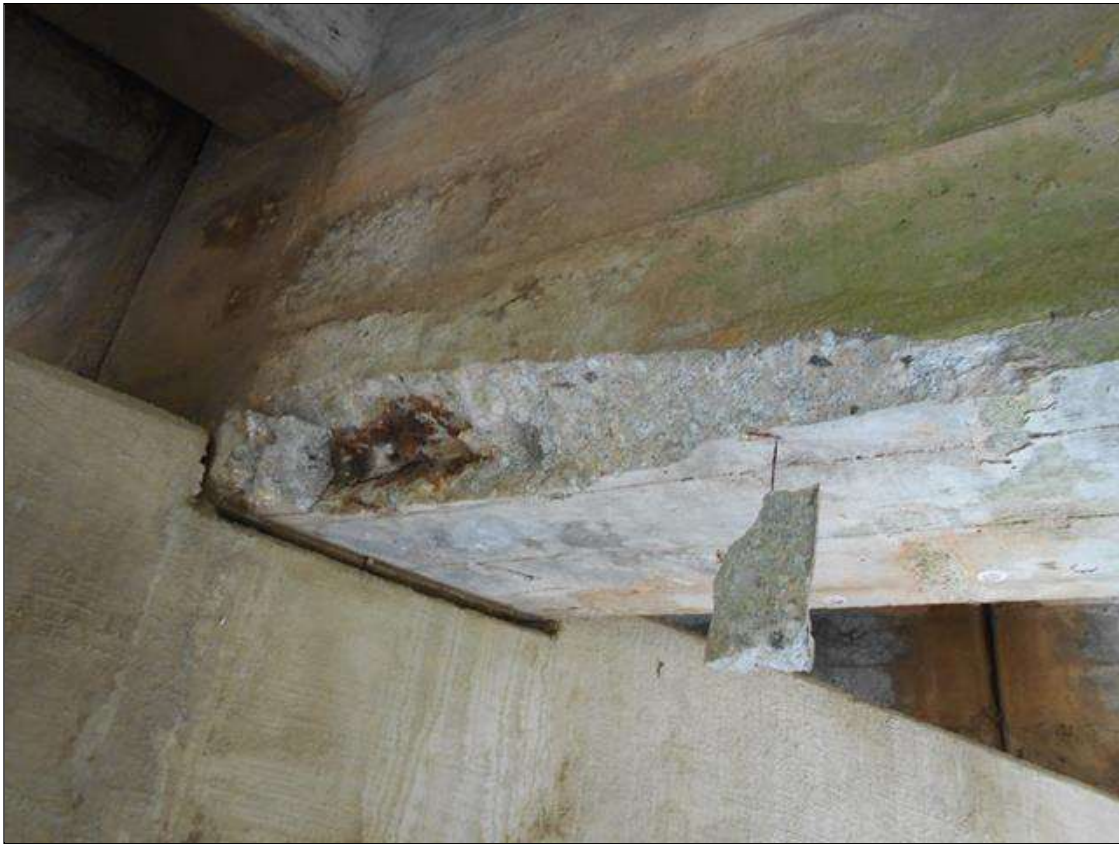
2 Feet of Delamination/Spall/Patched Area: Spall greater than 1 in. deep or greater than 6 in. diameter. Patched area that is unsound or showing distress. Does not warrant structural review. AT PIER 2, LT. BOTTOM CORNER HAS SPALL WITH EXPOSED REBAR 20 IN. LONG X 5 IN. HIGH UP TO 3 IN. DEEP.

Span 2 Beam 3: 2 Feet of Delamination/Spall/Patched Area: Spall greater than 1 in. deep or greater than 6 in. diameter. Patched area that is unsound or showing distress. Does not warrant structural review. AT PIER 2, LT. BOTTOM CORNER HAS SPALL WITH EXPOSED REBAR 20 IN. LONG X 5 IN. HIGH UP TO 3 IN. DEEP.

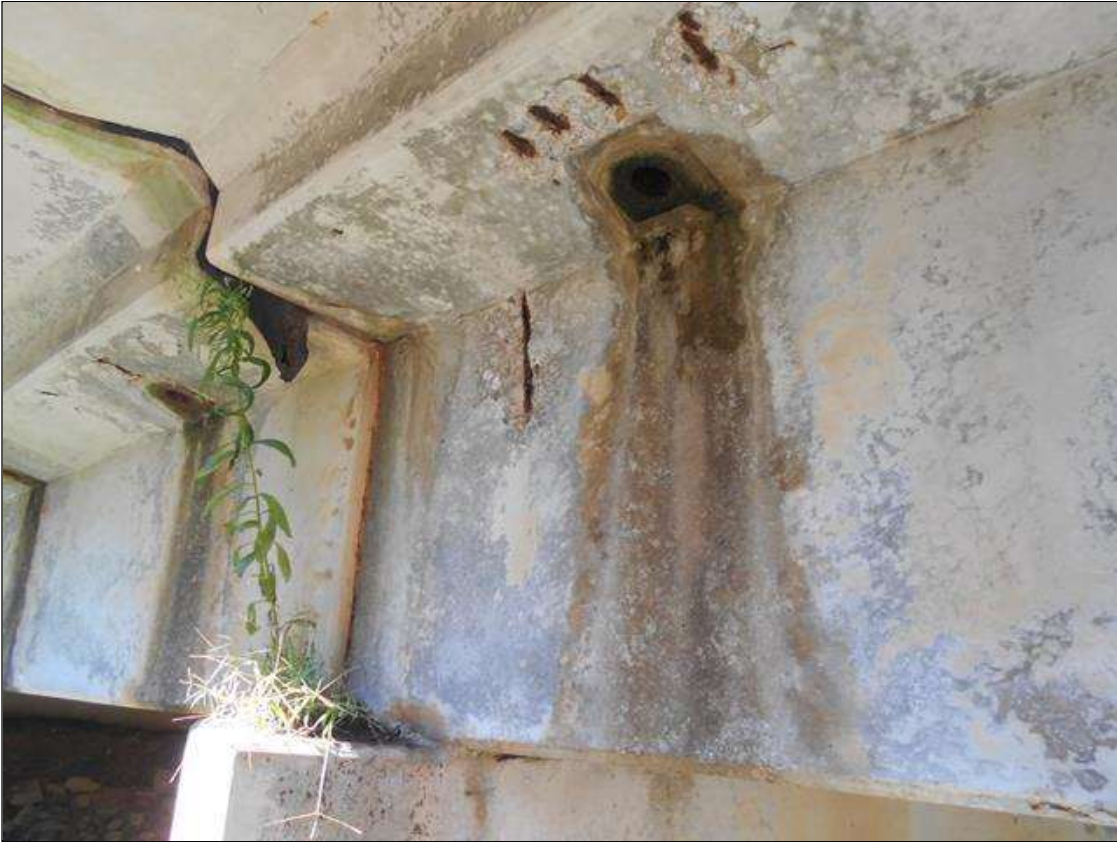
1 Feet of Delamination/Spall/Patched Area: Delaminated. Spall 1 in. or less deep or 6 in. or less in diameter. Patched area that is sound. AT PIER 1, 1 IN. DEEP POP-OFF WITH EXPOSED REBAR 4 IN. LONG X 12 IN. HIGH.

SPAN 2, GIRDER 4, AT PIER 1, RT. SIDE HAS 1 IN. DEEP POP-OFF 4 IN. LONG X 12 IN. HIGH.

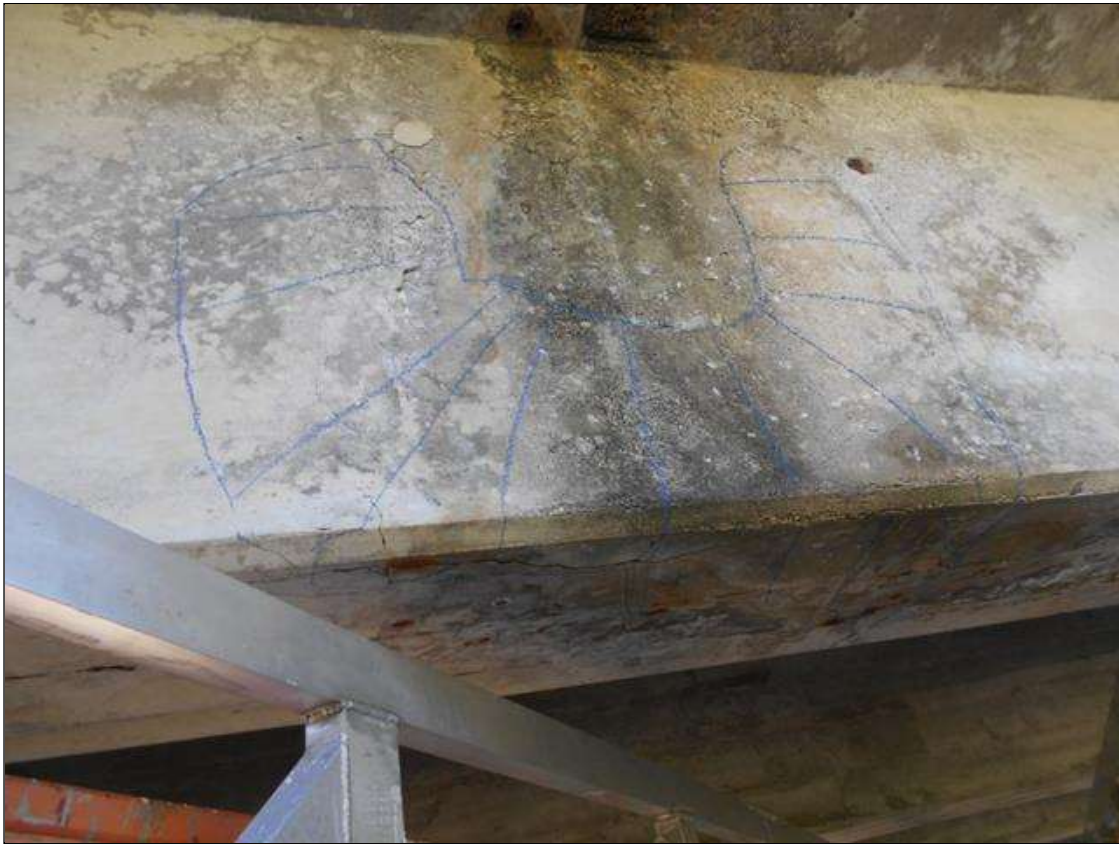
4 FT. FROM PIER 3, LEFT SIDE AND BOTTOM OF GIRDER HAS 1/16 IN. CRACKS AND DELAMINATION 3 FT. LONG X 1 FT. WIDE X 15 IN. TO 30 IN. HIGH.

SPAN 3, GIRDER 1, 4 FT. FROM PIER 3, LEFT SIDE AND BOTTOM OF GIRDER HAS 1/16 IN. CRACKS AND DELAMINATION 3 FT. LONG X 1 FT. WIDE X 15 IN. TO 30 IN. HIGH.

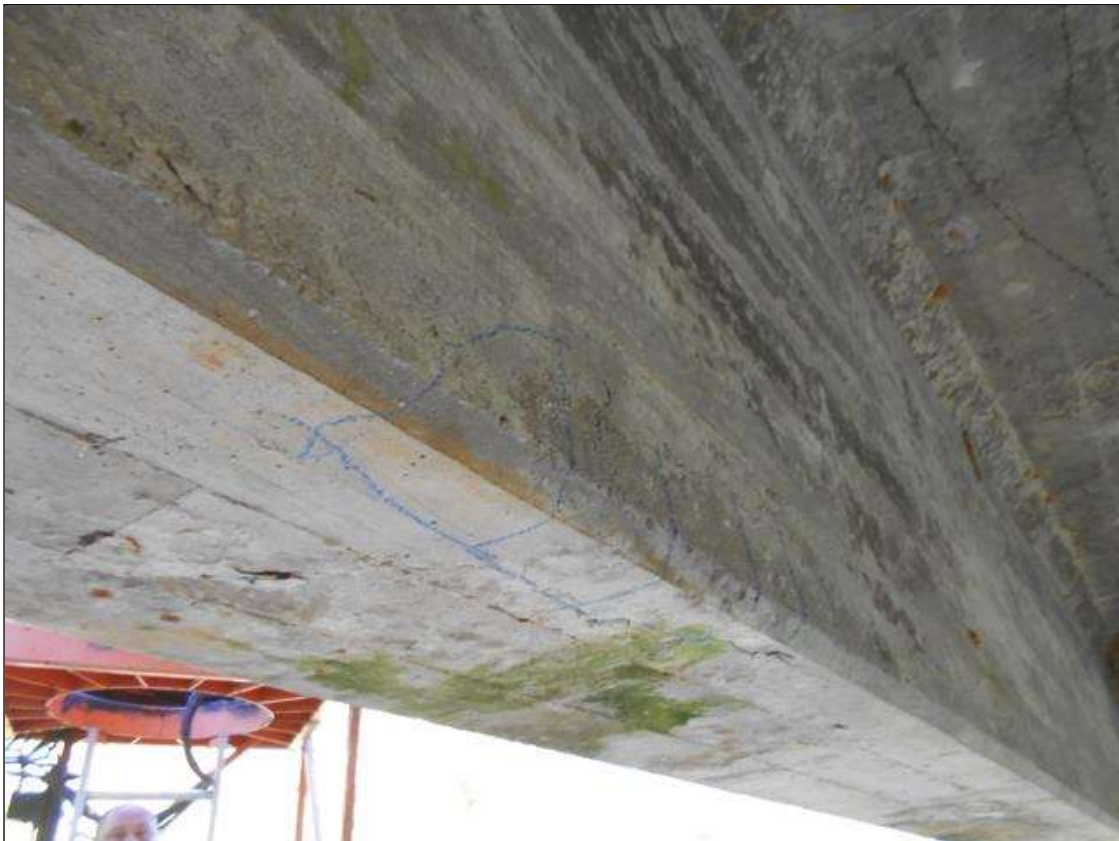
SPAN 3, GIRDER 1, 16 FT. FROM PIER 3, RT. BOTTOM CORNER OF GIRDER HAS 1/16 IN. CRACKS AND DELAMINATION 20 IN. LONG X 4 IN. WIDE X 3 IN. HIGH.

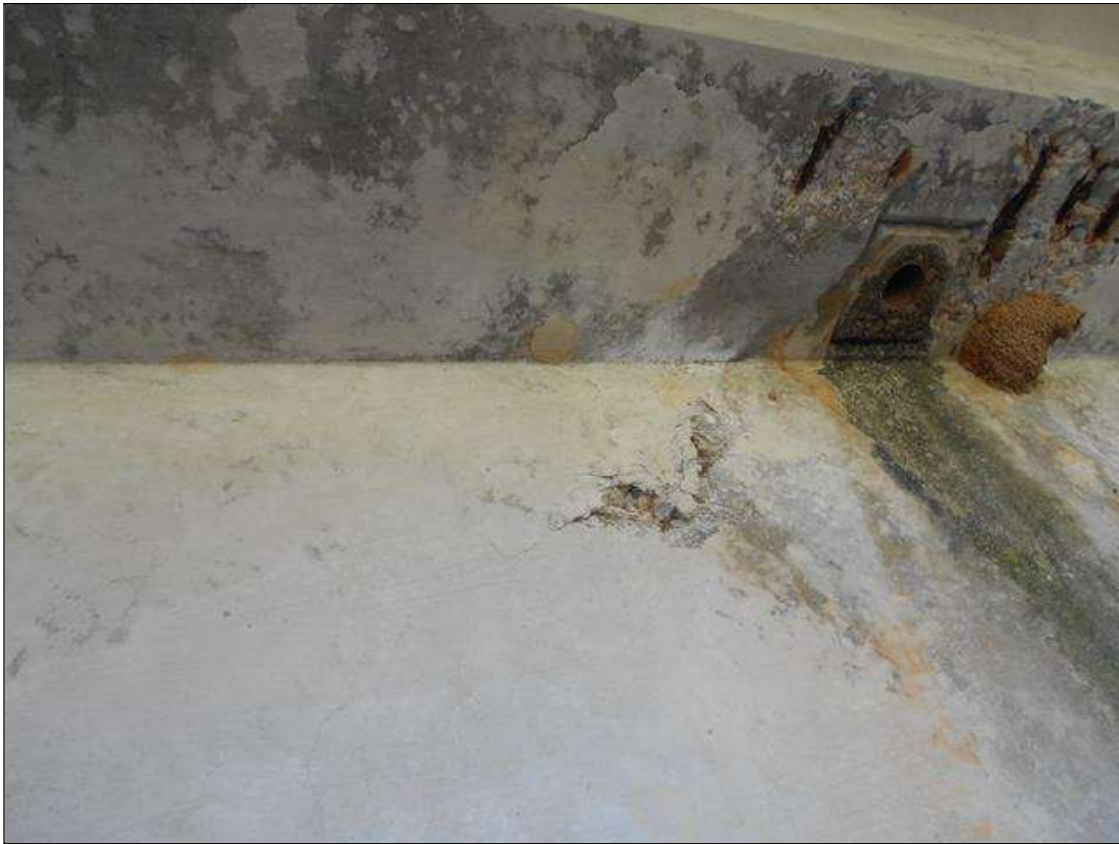
SPAN 3, GIRDER 1, 18 FT. FROM PIER 3, LT. SIDE HAS DELAMINATION 1 FT. DIA. X 1/2 IN. DEEP.

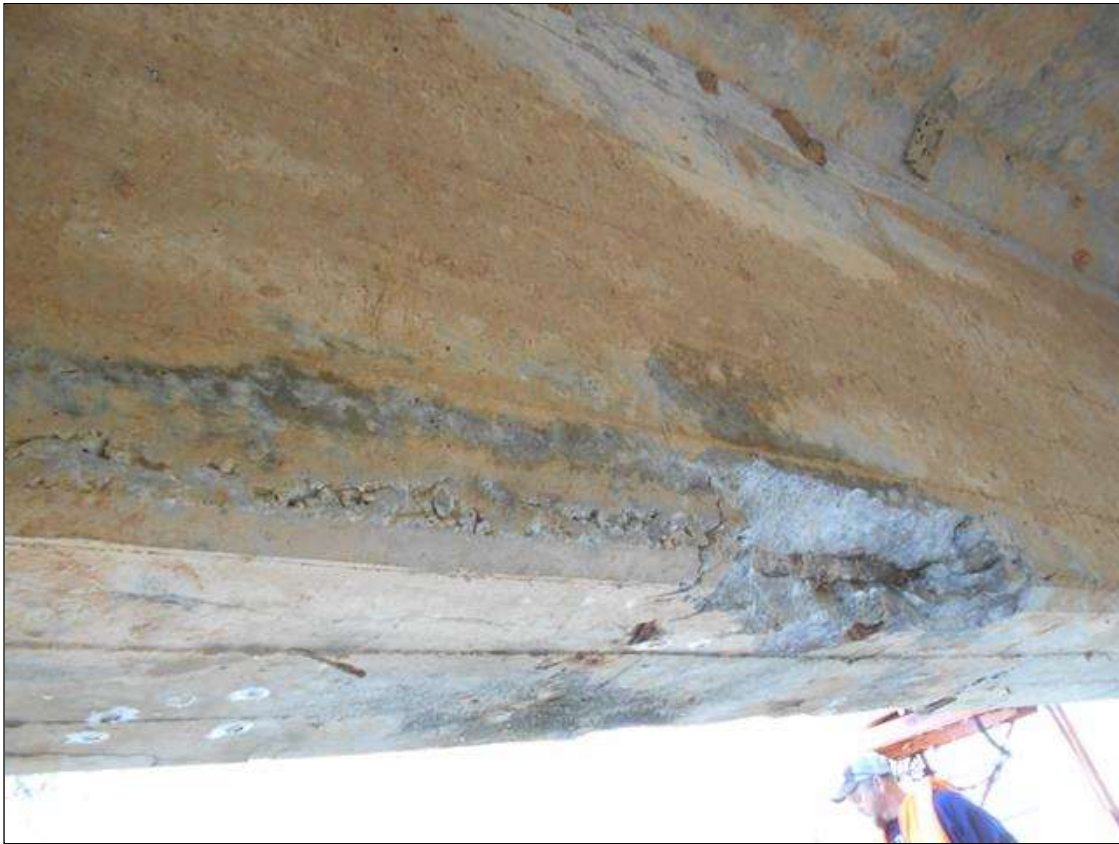
SPAN 3, GIRDER 1, 19 FT. FROM PIER 2, RT. BOTTOM CORNER HAS 1/16 IN. CRACKS WITH DELAMINATION 2 FT. LONG, AND A SPALL WITH EXPOSED REBAR 3 IN. DEEP X 3 IN. HIGH X 1 FT. LONG. PRIORITY MAINTENANCE.

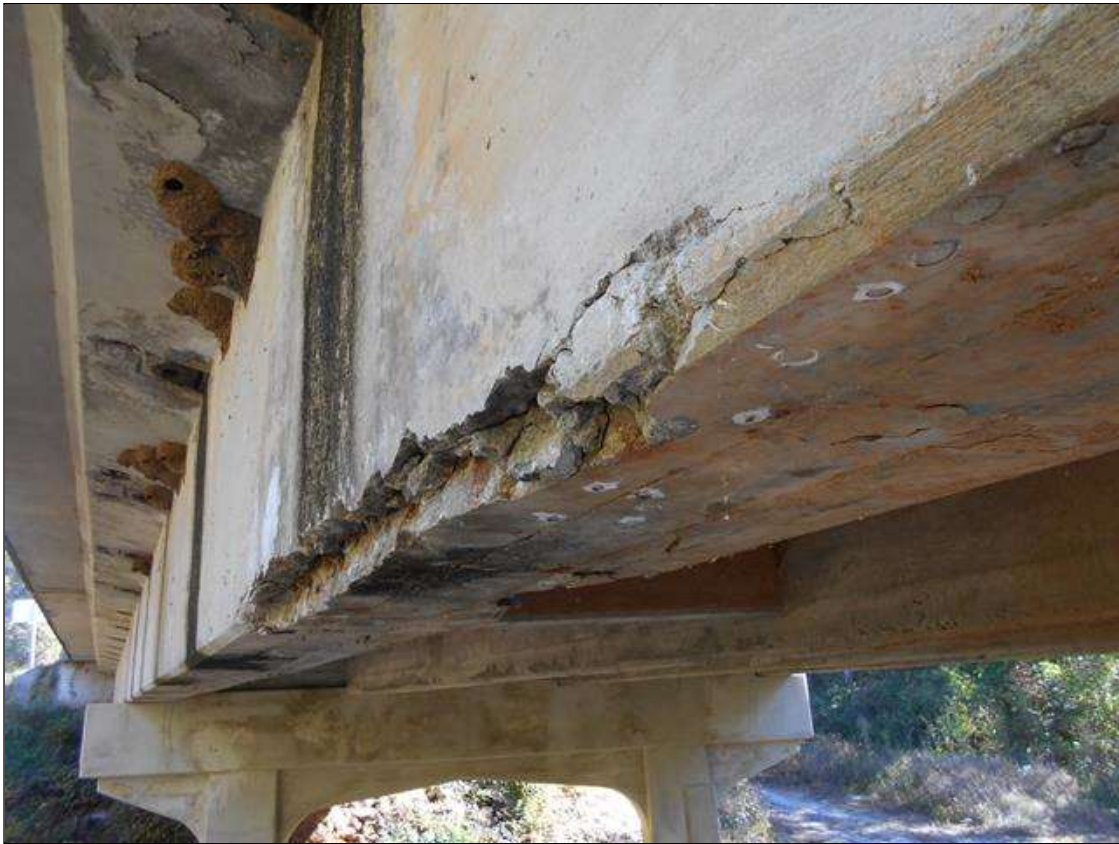
SPAN 3, GIRDER 1, 15 FT. FROM PIER 2, LT. BOTTOM CORNER HAS SPALL WITH EXPOSED REBAR 3 IN. DEEP X 3 IN. HIGH X 5 FT. LONG. PRIORITY MAINTENANCE.

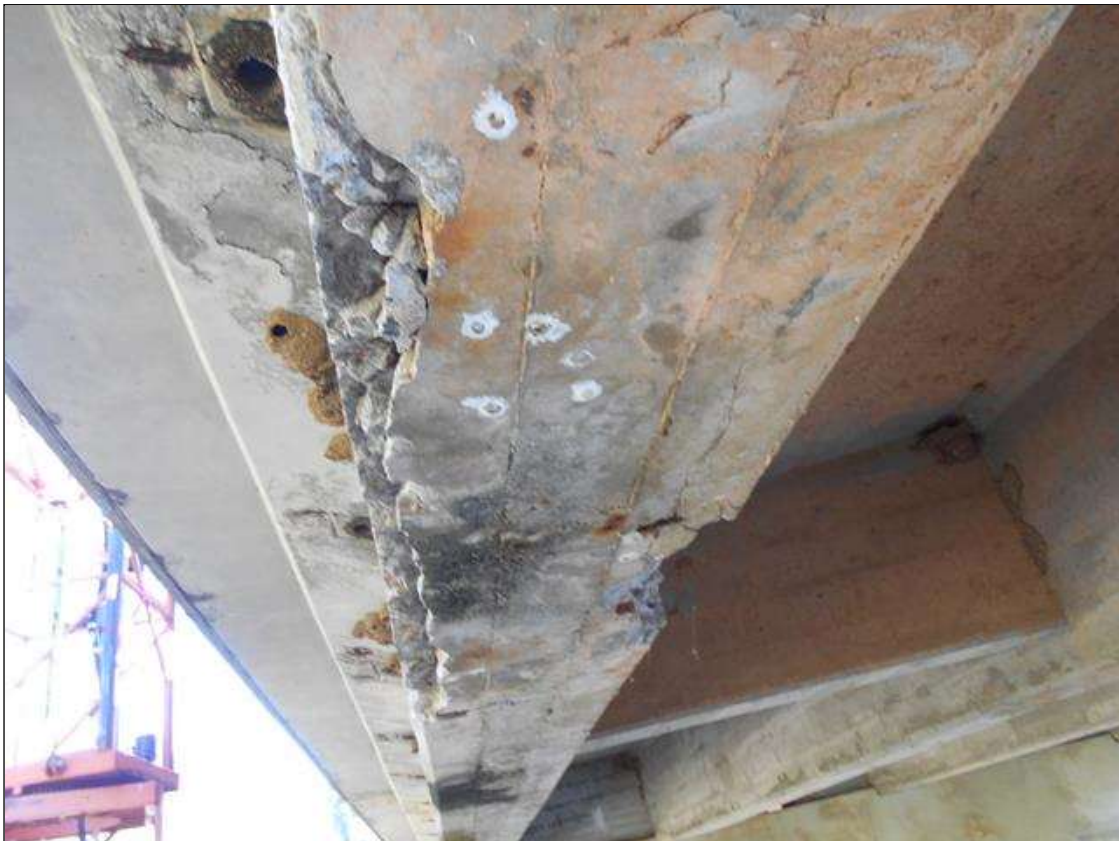
5 Feet of Delamination/Spall/Patched Area: Spall greater than 1 in. deep or greater than 6 in. diameter. Patched area that is unsound or showing distress. Does not warrant structural review. 15 FT. FROM PIER 2, BOTTOM CORNERS HAVE SPALLS

WITH EXPOSED REBAR, 1/16 IN. CRACKS AND DELAMINATION 3 IN. DEEP X 3 IN. HIGH X 5 FT. LONG. PRIORITY MAINTENANCE.

SPAN 3, GIRDER 1, 15 FT. FROM PIER 2, BOTTOM CORNERS HAVE SPALLS WITH EXPOSED MAIN REBAR 3 IN. DEEP X 3 IN. HIGH X UP TO 5 FT. LONG. PRIORITY MAINTENANCE.

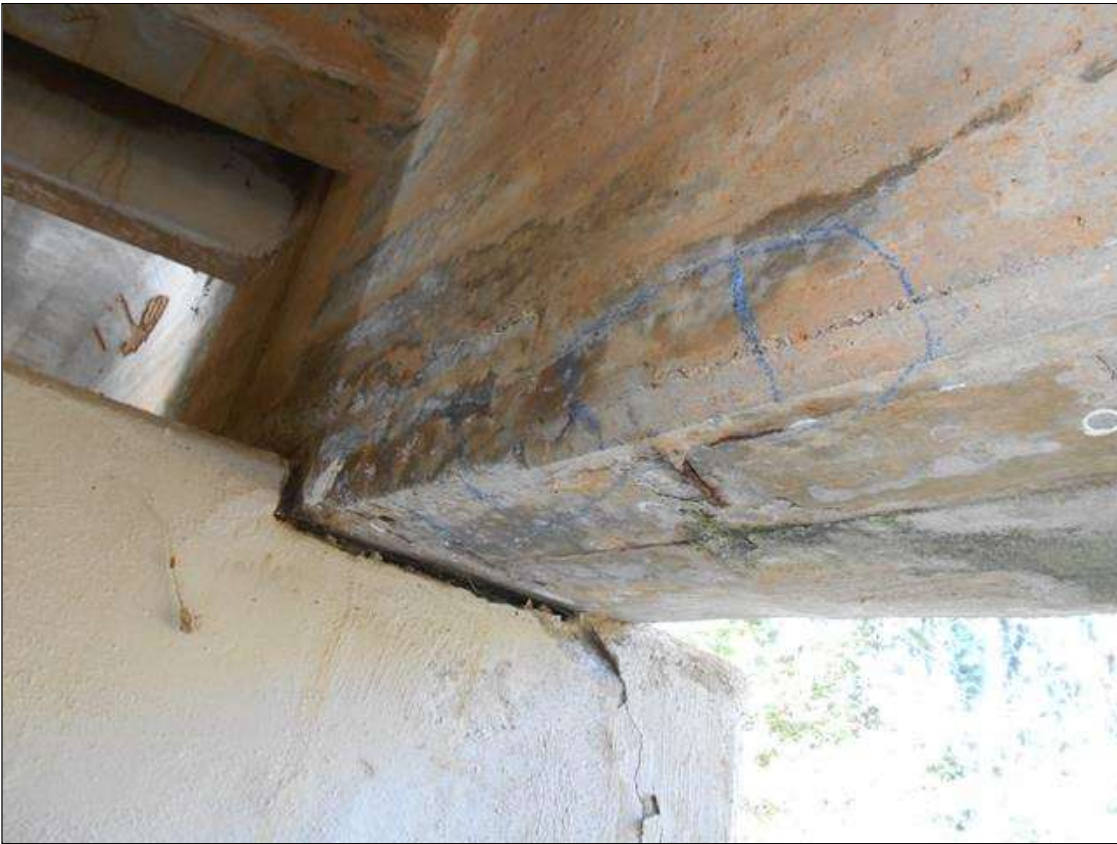
SPAN 3, GIRDER 1, AT PIER 2 RT. BOTTOM CORNER 1/16 IN. CRACKS WITH DELAMINATION 4 IN. HIGH X 3 FT. LONG X 4 IN. WIDE.

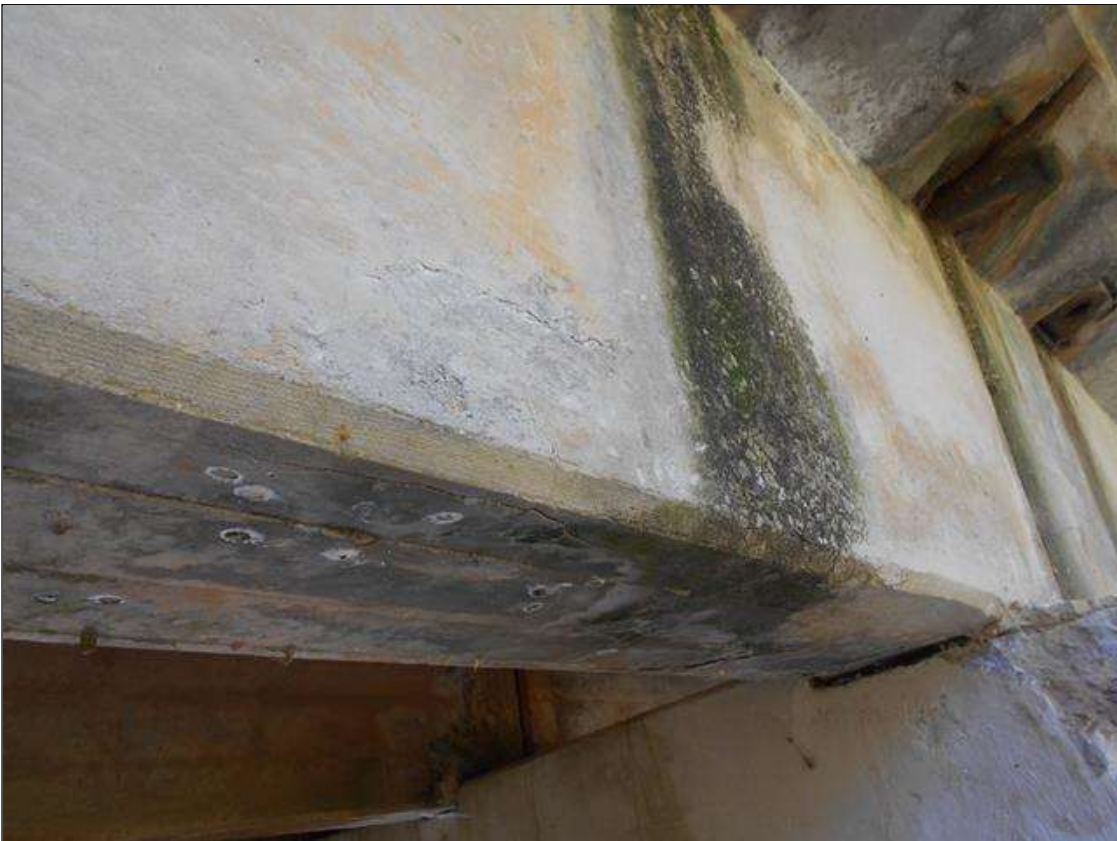
SPAN 3, GIRDER 1, AT PIER 2 LT. BOTTOM CORNER HAS SOUND PATCH TO SPALL 18 IN. LONG X 3 IN. HIGH X 3 IN. WIDE.

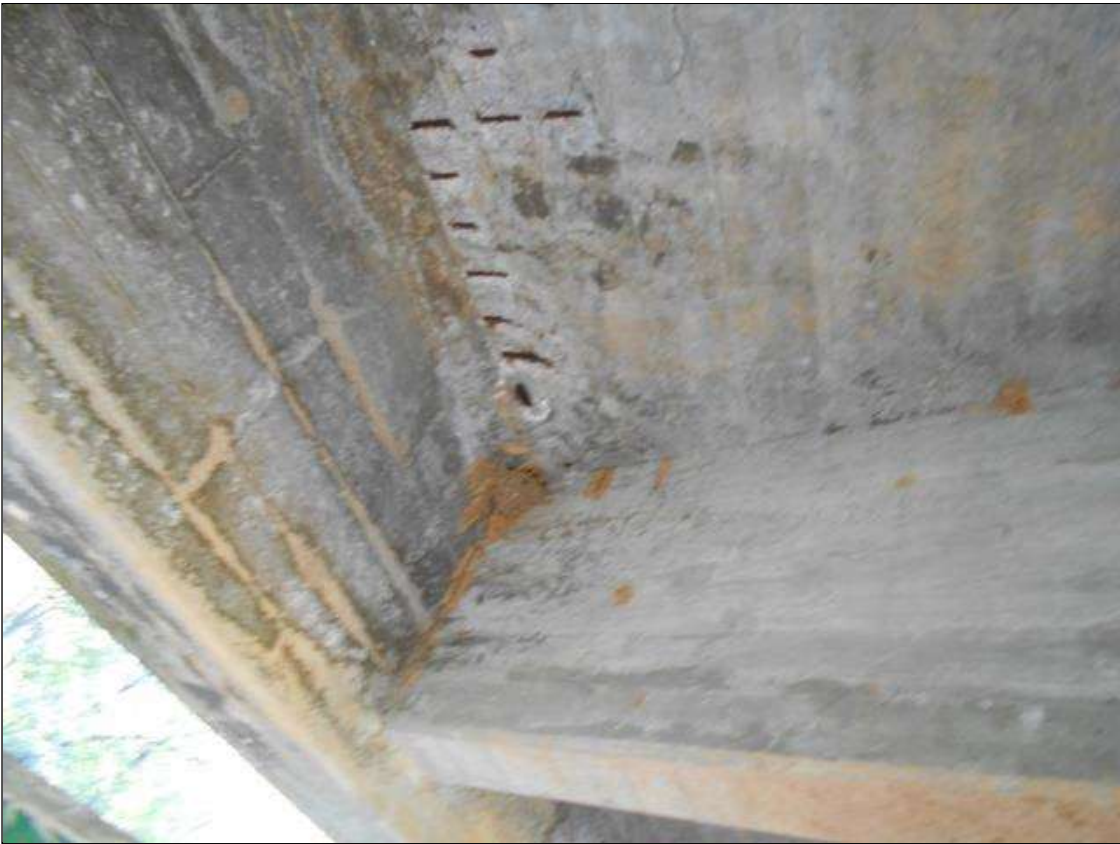
12 Square Feet of Delamination/Spall: Spall greater than 1 in. deep or greater than 6 in. in diameter. Does not warrant structural review.  
BOTH OVERHANGS HAVE FEW 1 IN. DEEP X 12 IN. SQUARE SPALLS WITH EXPOSED REBAR AROUND DRAIN HOLES. UNDERSIDE OF DECK, BAY 3, AT 1/2 PT. SPALLS WITH EXPOSED REBAR 1 IN. DEEP X 2 FT. WIDE X 3 FT. LONG.

SPAN 3, UNDERSIDE OF DECK, BAY 3, AT 1/2 PT. SPALLS WITH EXPOSED REBAR 1 IN. DEEP X 2 FT. WIDE X 3 FT. LONG.

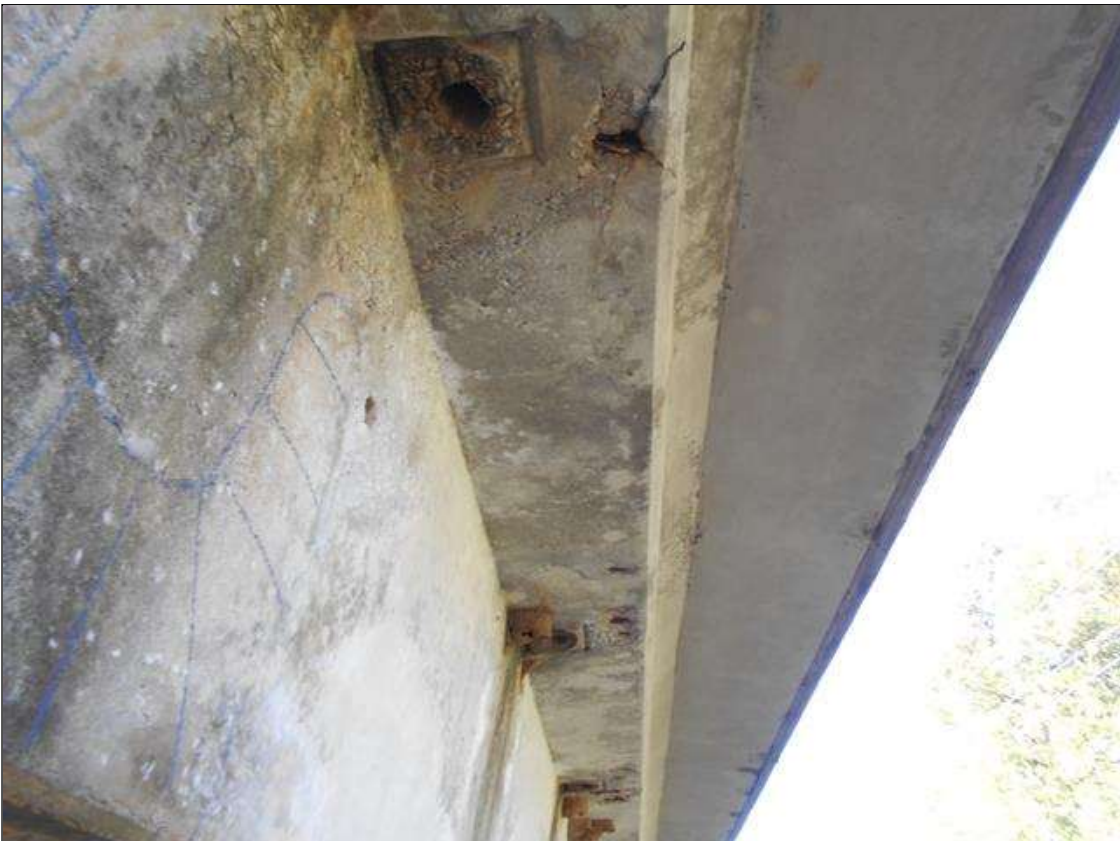
SPAN 3, BOTH OVERHANGS HAVE SPALLS WITH EXPOSED REBAR AND DELAMINATION AROUND DRAIN HOLES.

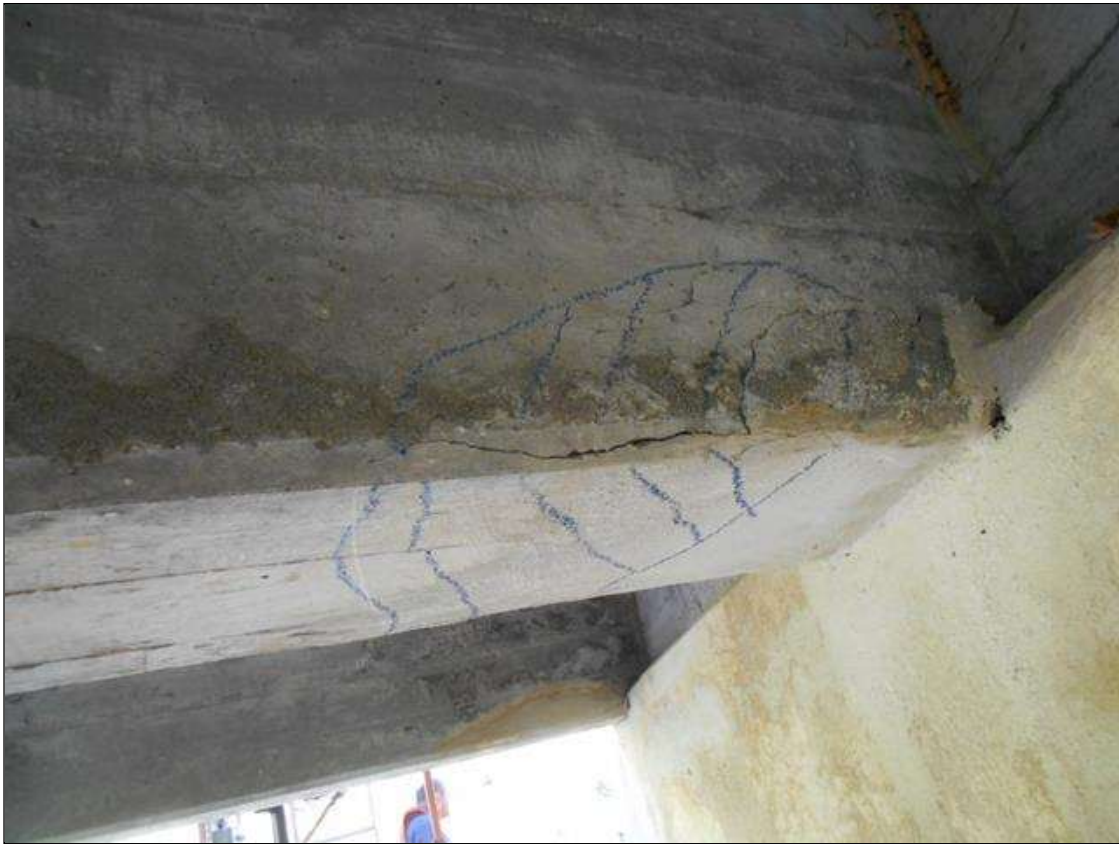
SPAN 3, GIRDER 2 AT PIER 3 HAS A CONCRETE PATCH AND 1/8 IN. CRACK AND DELAMINATION IN BOTTOM RT. SIDE 5 IN. HIGH X 18 IN. LONG X 17 IN. WIDE ACROSS THE BOTTOM.

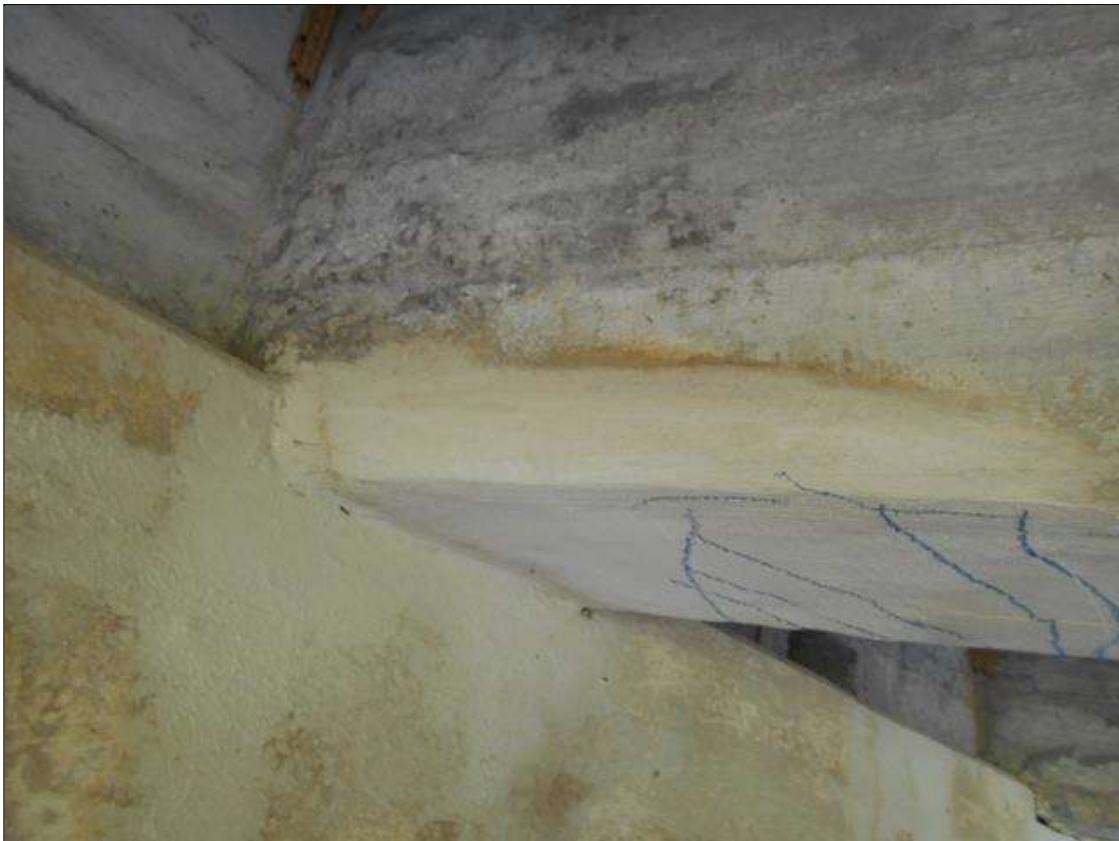
SPAN 3, GIRDER 2, AT PIER 3 LT SIDE HAS PATCH, 30 IN. LONG X 5 IN. HIGH, TO BOTTOM WITH DELAMINATION IN UNDERSIDE.

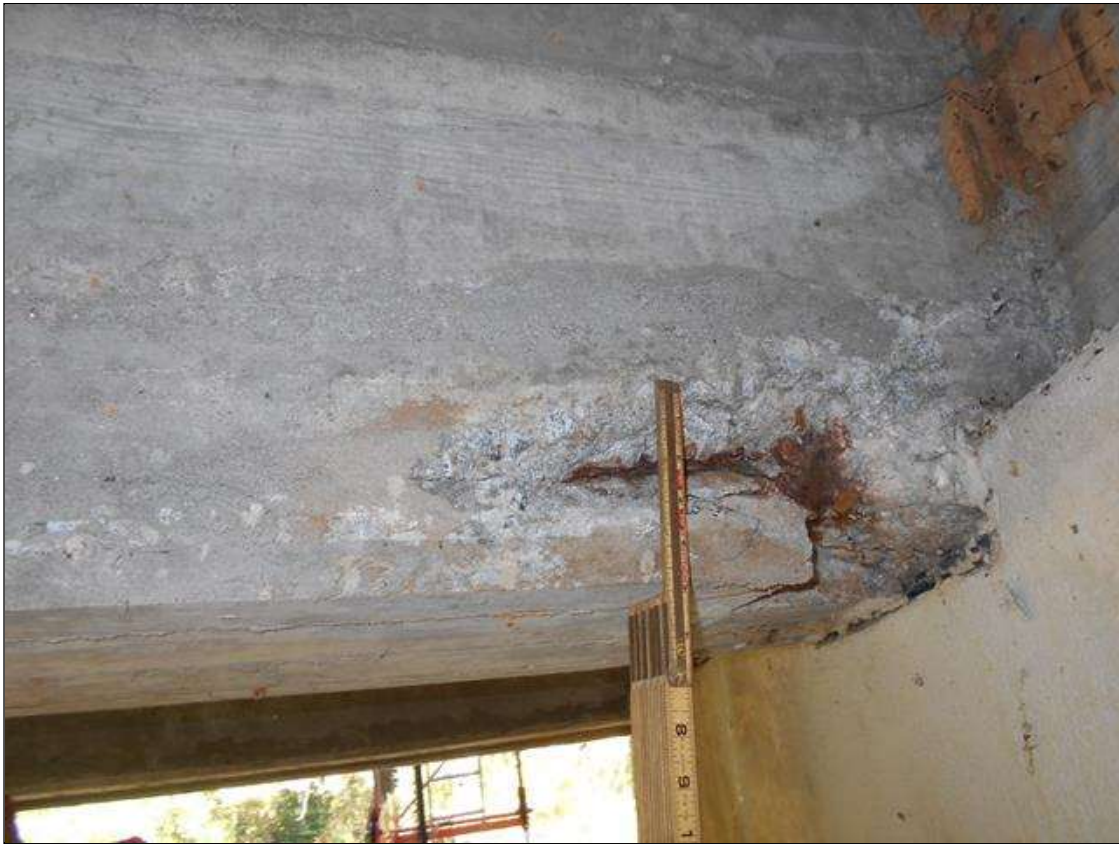
SPAN 3, GIRDER 3, AT PIER 3, BOTTOM OF GIRDER HAS DELAMINATION 2 FT. LONG X FULL WIDTH X 5 IN. HIGH, AND A SPALL WITH EXPOSED REBAR ON RT. SIDE AT BOTTOM, 5 IN. HIGH X 12 IN. LONG X 1 IN. TO 3 IN. DEEP.

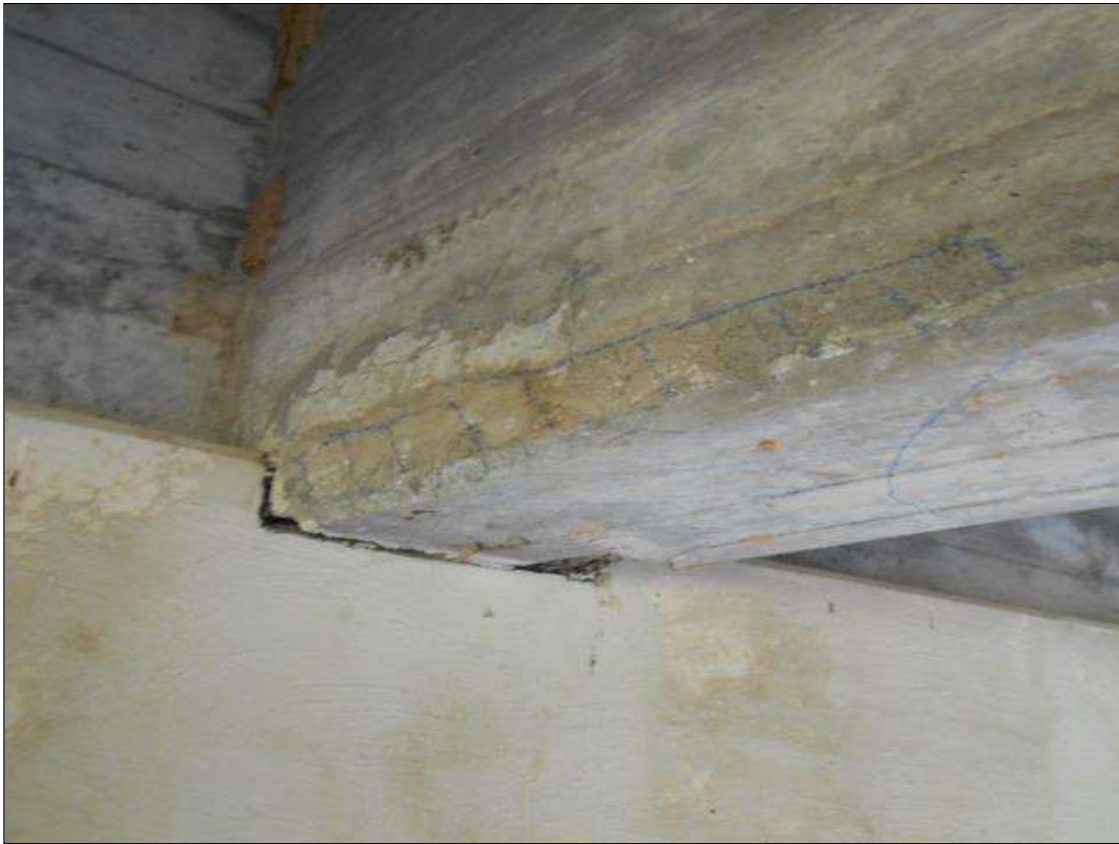
SPAN 3, GIRDER 3, AT PIER 3, BOTTOM OF GIRDER HAS DELAMINATION 2 FT. LONG X FULL WIDTH X 5 IN. HIGH. LT. SIDE SHOWN HERE.

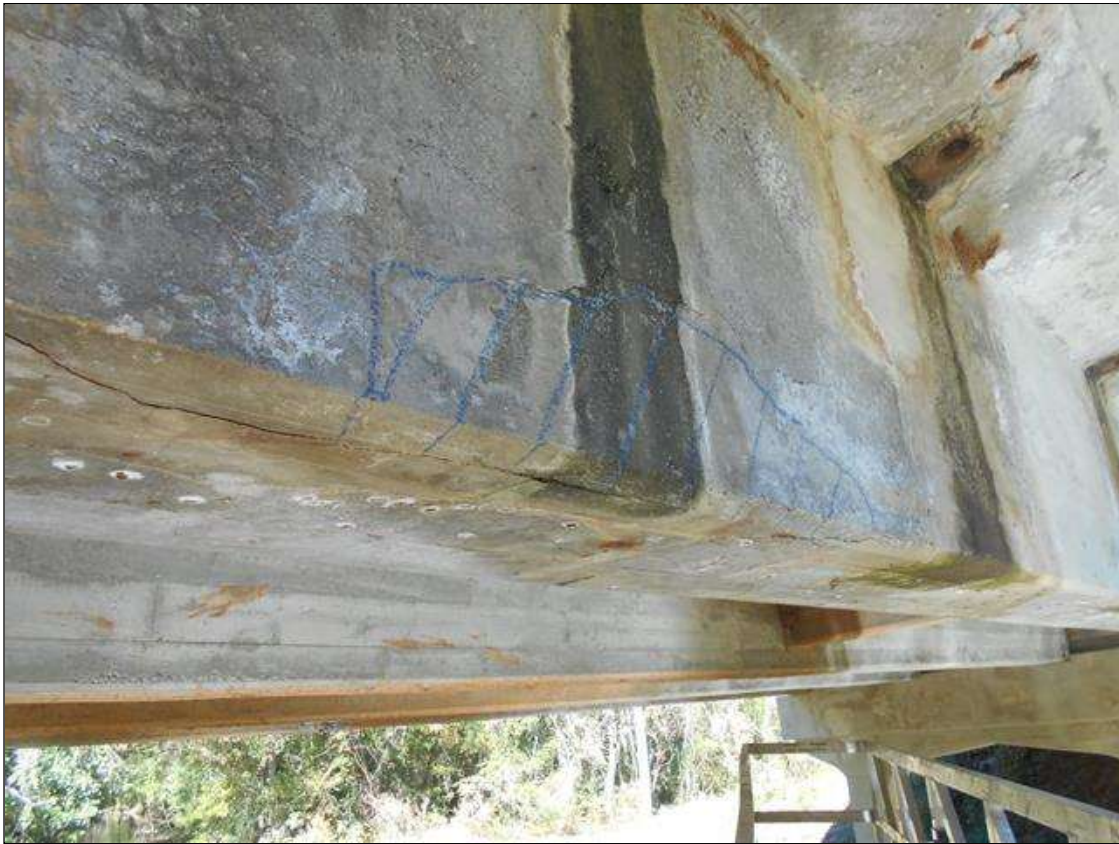
Span 3 Beam 4: 5 Feet of Cracking (RC and Other): Width greater than 0.05 in. or spacing of less than 1 ft. 10 FT. FROM PIER 2, BOTTOM RT. SIDE OF GIRDER HAS 1/16 IN. TO 1/8 IN. WIDE LONGITUDINAL CRACKS WITH DELAMINATION 12 IN. HIGH X 4 FT. LONG X 3 IN. WIDE AT BOTTOM.
