NC DEPARTMENT OF TRANSPORTATION  
DIVISION OF HIGHWAYS  
STRUCTURE MANAGEMENT UNIT

## Structure Safety Report

### Routine Element Inspection

COUNTY: ROWAN STRUCTURE NUMBER: 790061 FREQUENCY: 24 MONTHS

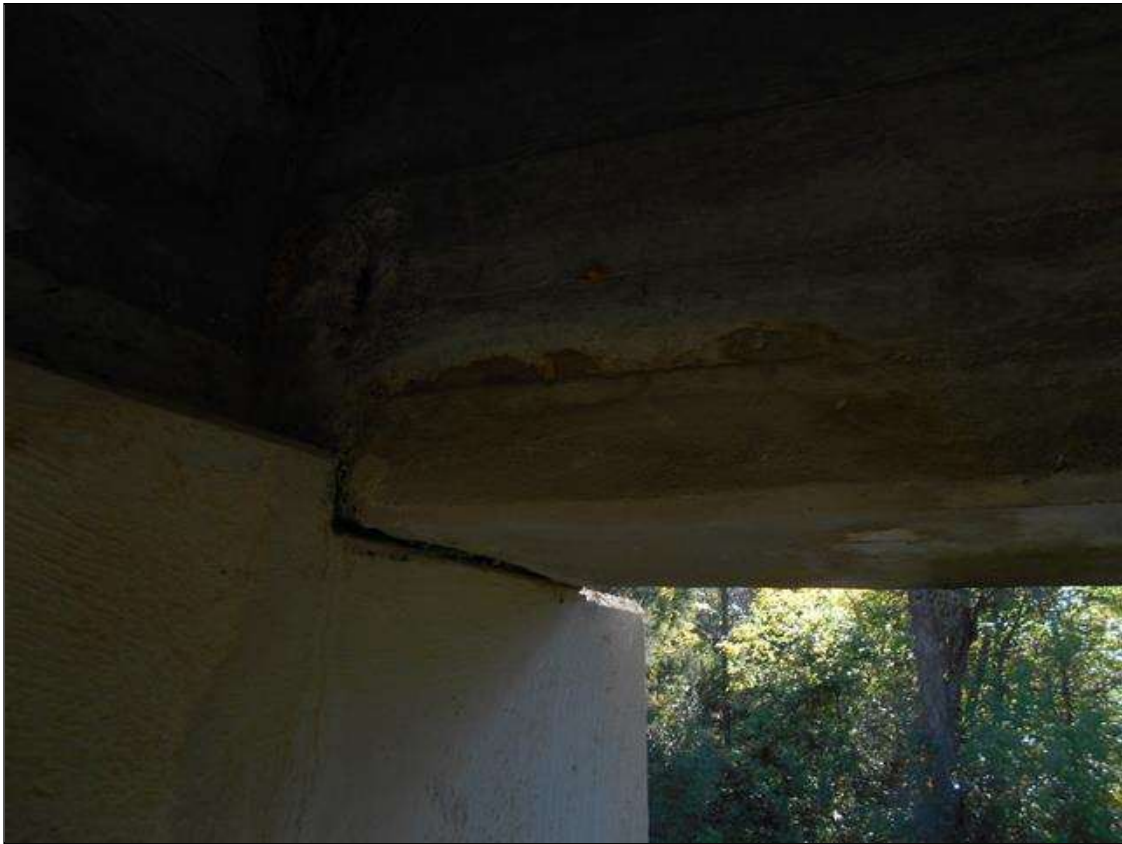
SPAN 3, GIRDER 3, AT PIER 3, BOTTOM 5 IN. OF GIRDER HAS A SOUND CONCRETE PATCH, FULL WIDTH X 30 IN. LONG. POP-OFF WITH EXPOSED VERTICAL. REBAR ON LT. FACE AT PIER 3, 6 IN. DIA. X 1 IN. DEEP.

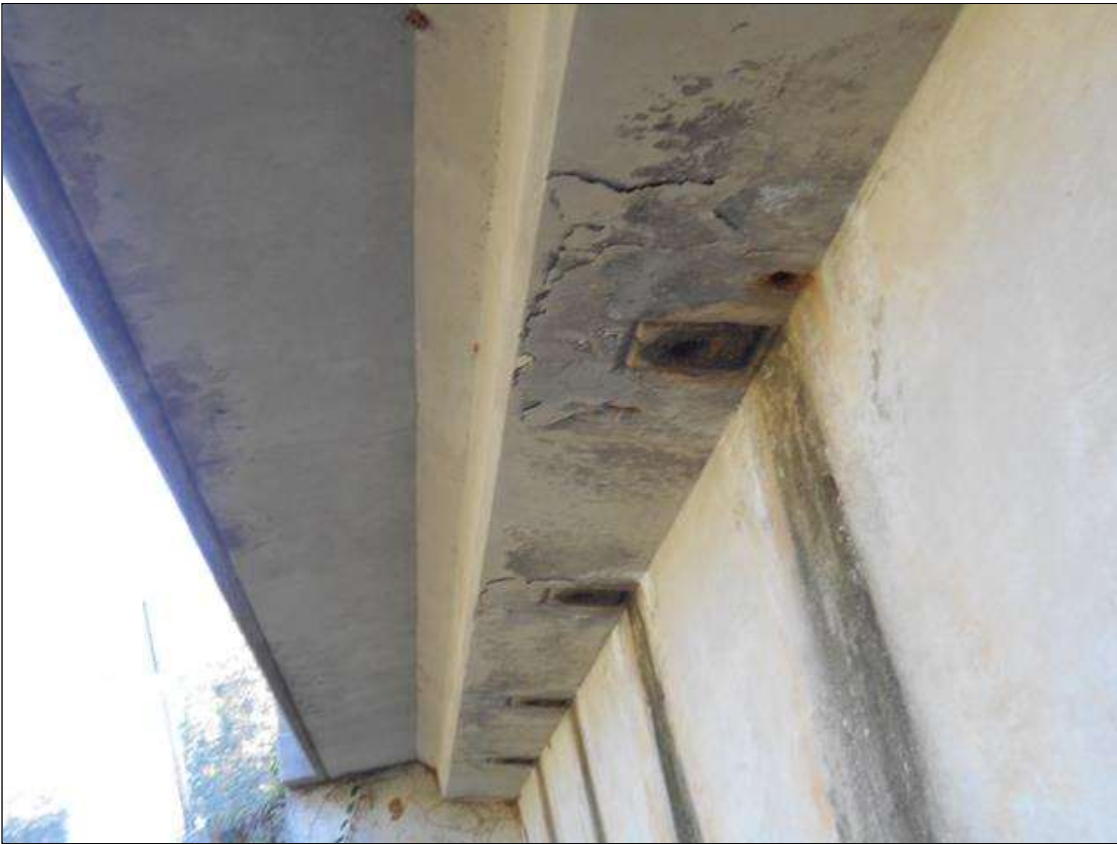
SPAN 4, LT. OVERHANG AREAS OF CRACKS AND DELAMINATION UP TO 1 FT. DIA. AROUND SEVERAL DRAIN HOLES.

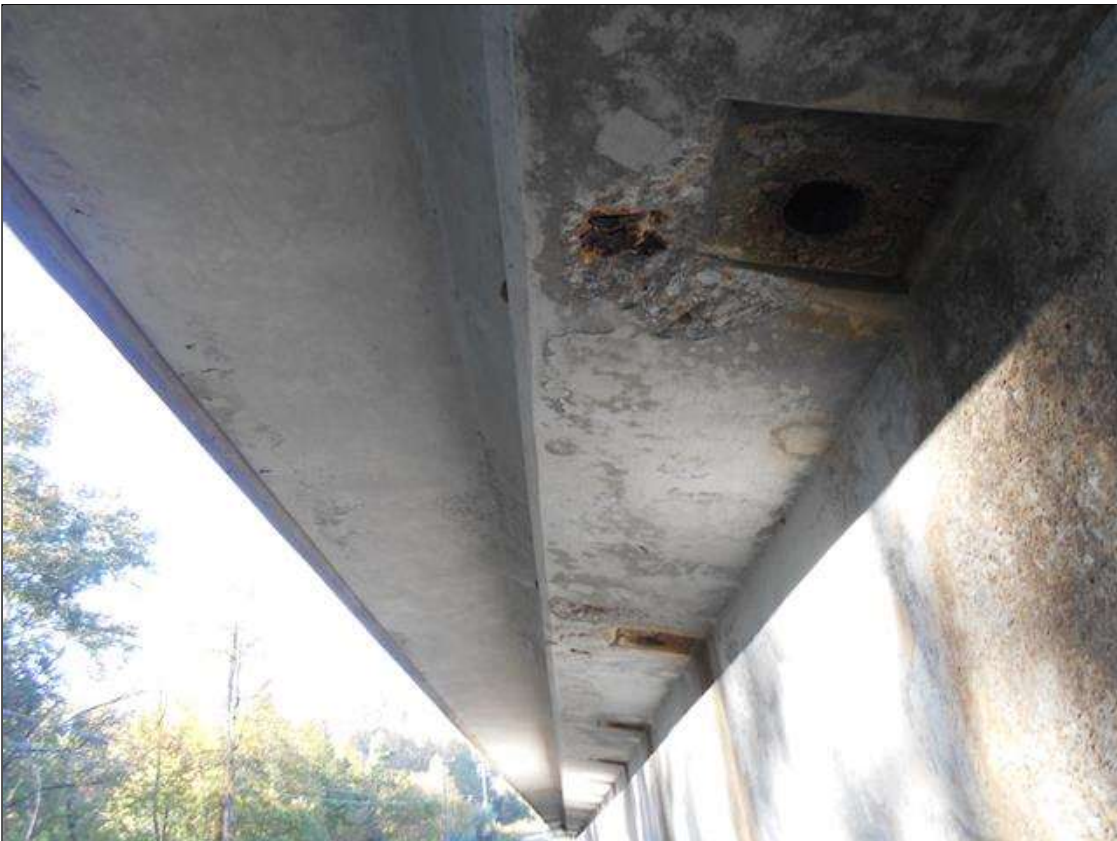
SPAN 4, RT. OVERHANG HAS FEW 1 IN. DEEP X 6 IN. DIA. POP-OFFS W/ EXPOSED REBAR AND AREAS OF CRACKS AND DELAMINATION UP TO 8 IN. DIA. AROUND SEVERAL DRAIN HOLES.

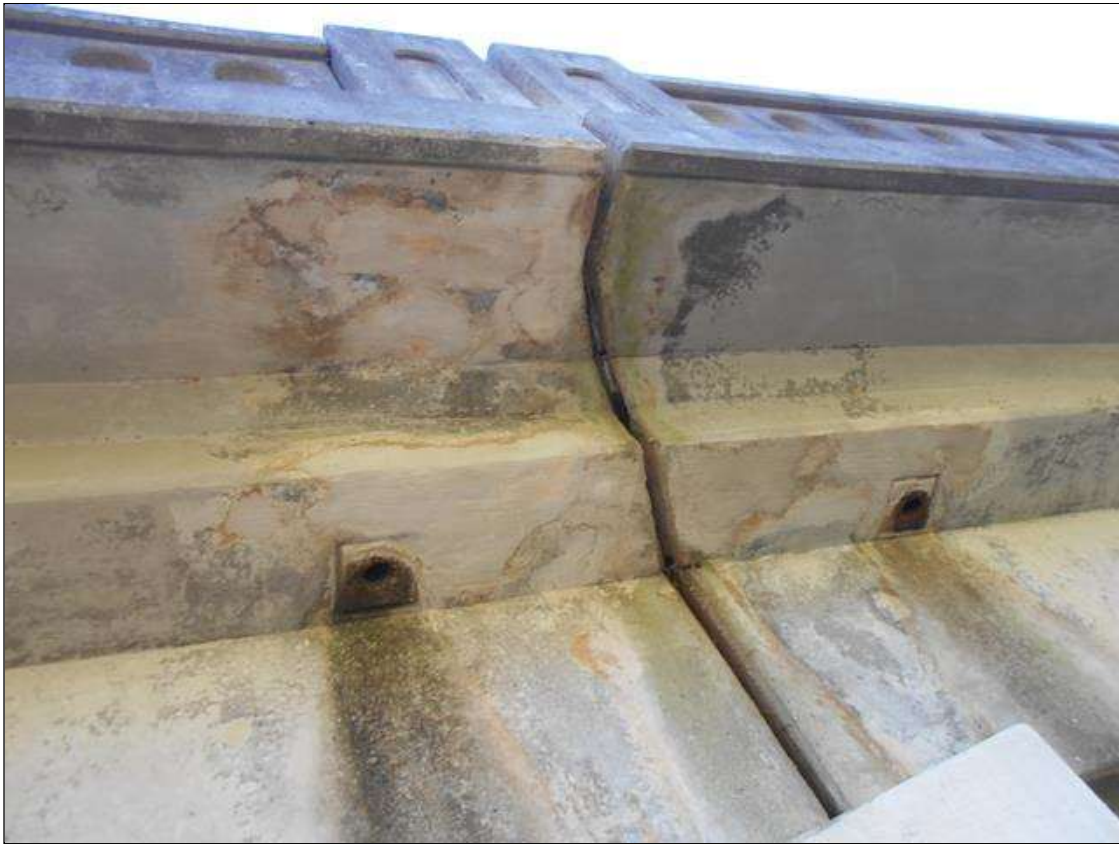
SPAN 4 LT. OVERHANG, NEAR PIER 3, HAS REPAIR TO SPALLS WITH CONCRETE PATCHES 3 FT. LONG X 2 FT. WIDE.

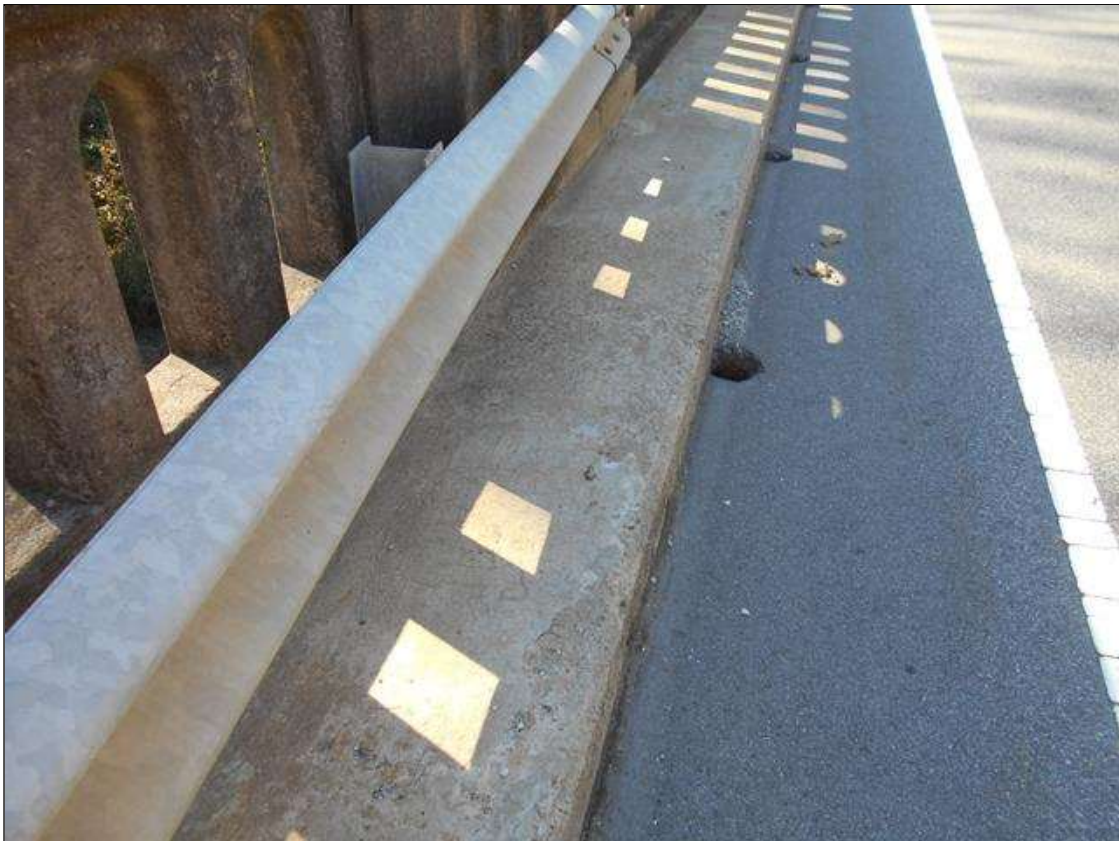
SPAN 4 DECK, RT. CURB HAS UP TO 1/2 IN. DETERIORATION AND CONCRETE PATCHES WITH H/L CRACKS.

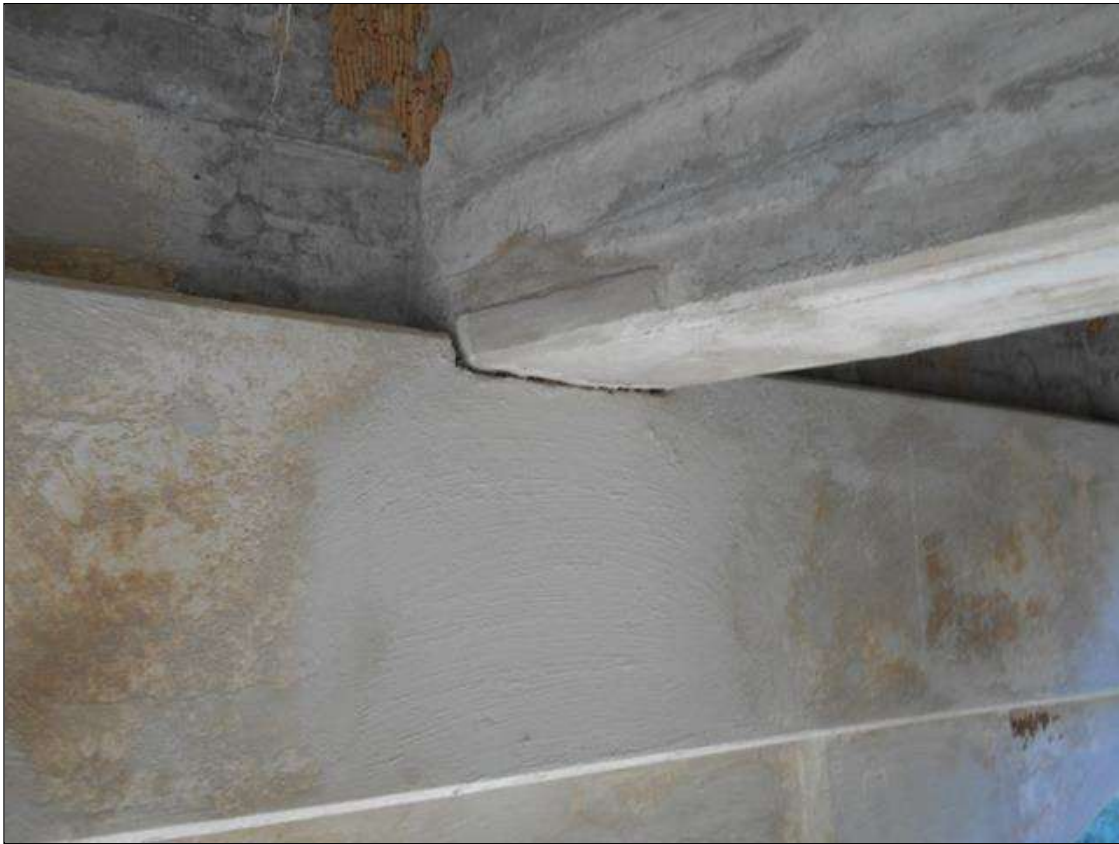
SPAN 4, GIRDER 2 AT PIER 3, HAS CONCRETE PATCH TO BOTTOM OF GIRDER, 3 IN. H X FULL WIDTH X 1 FT. LONG. RT. SIDE SHOWN.

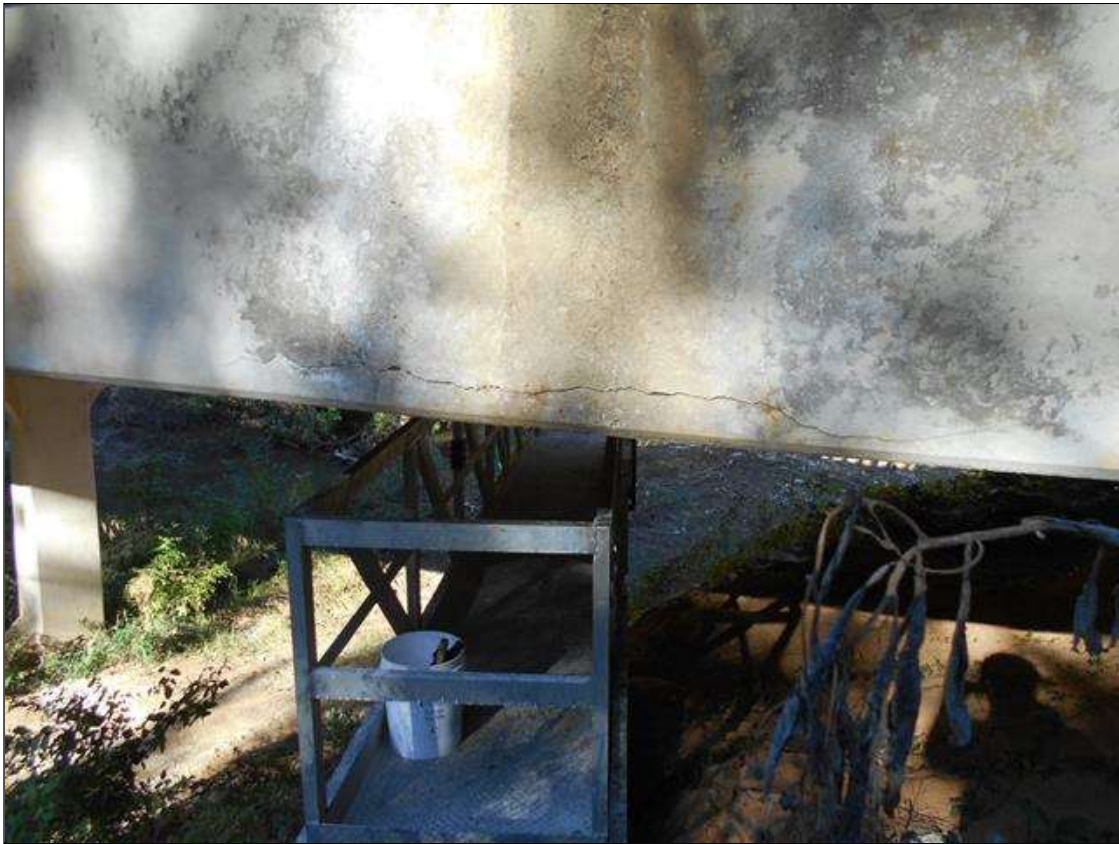
SPAN 4, GIRDER 4, 16 FT. FROM ABUT 2, BOTTOM OF GIRDER HAS 1/8 IN. CRACKS AND DELAMINATION, 3 IN. H X FULL WIDTH X 5 FT. LONG. RT. SIDE SHOWN.

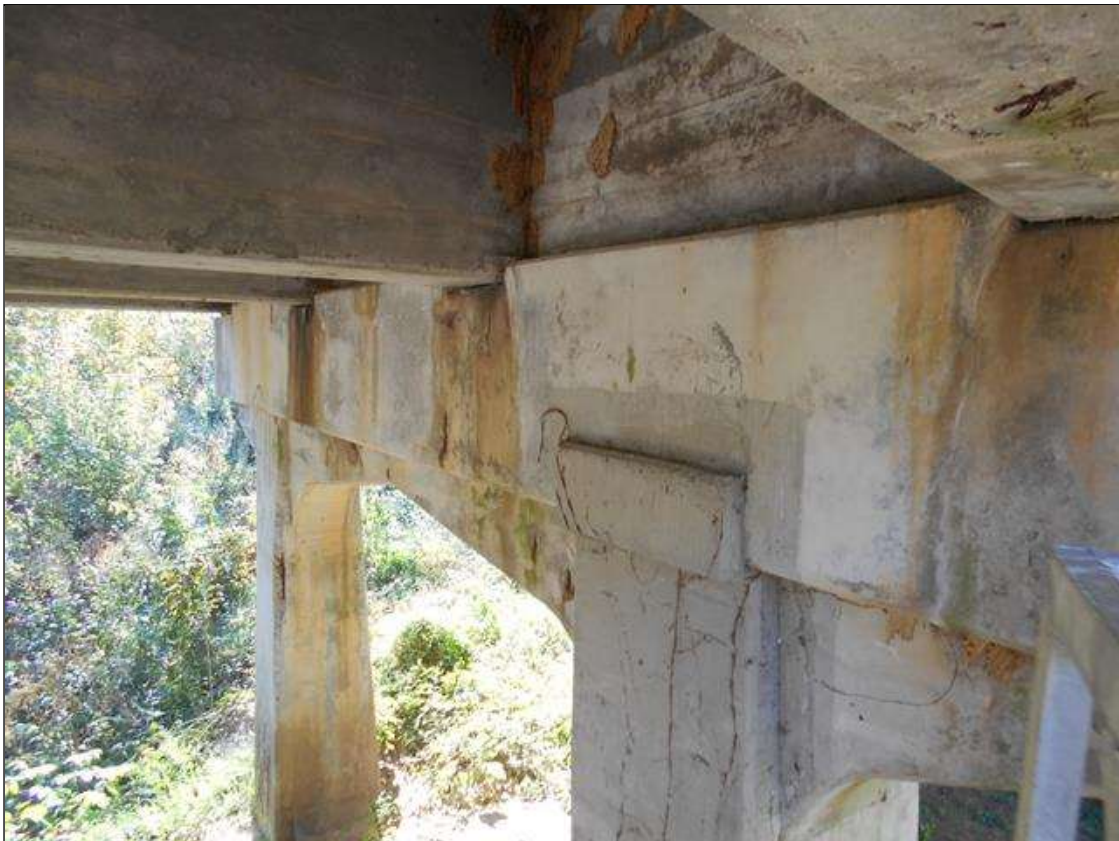
PIER 1, NORTH SIDE, CONCRETE PATCHING ON BOTTOM OF CAP AT COLUMN 1, 2.5FT. L X 1 FT. H.

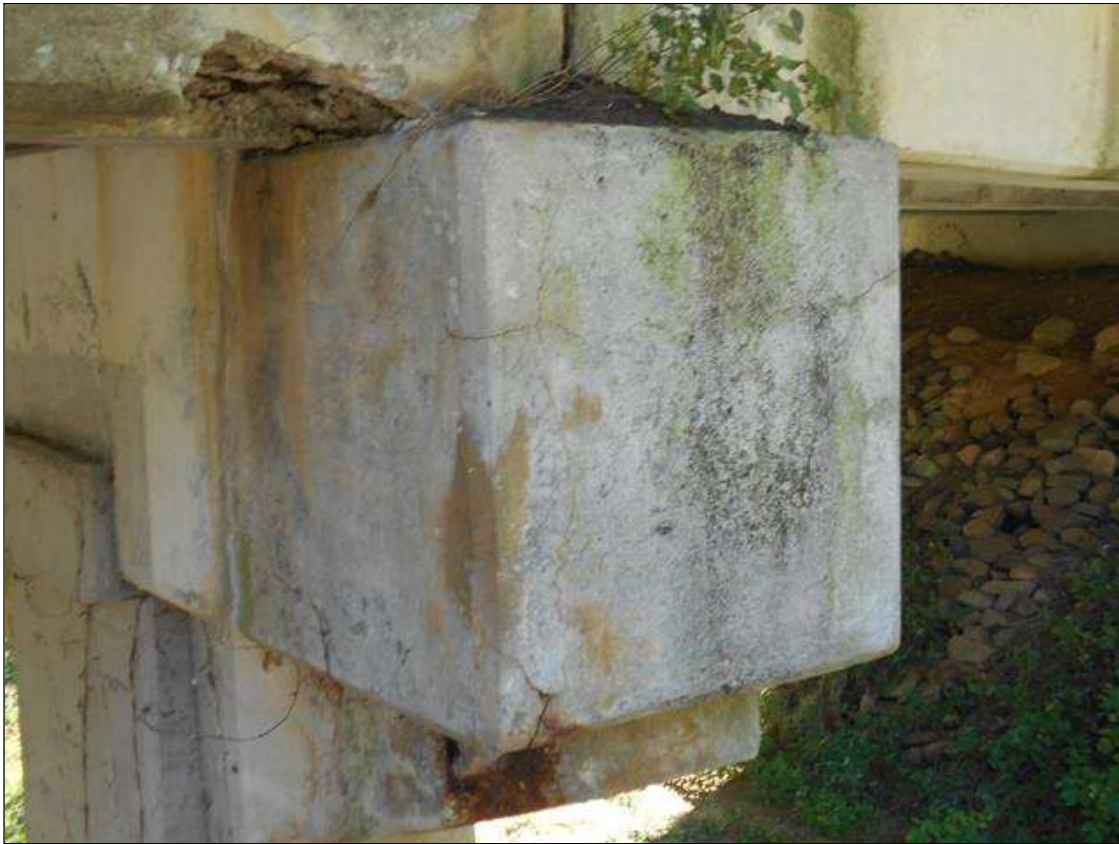
PIER 1 LT. END OF CAP HAS 1/32 IN. MAP CRACKING

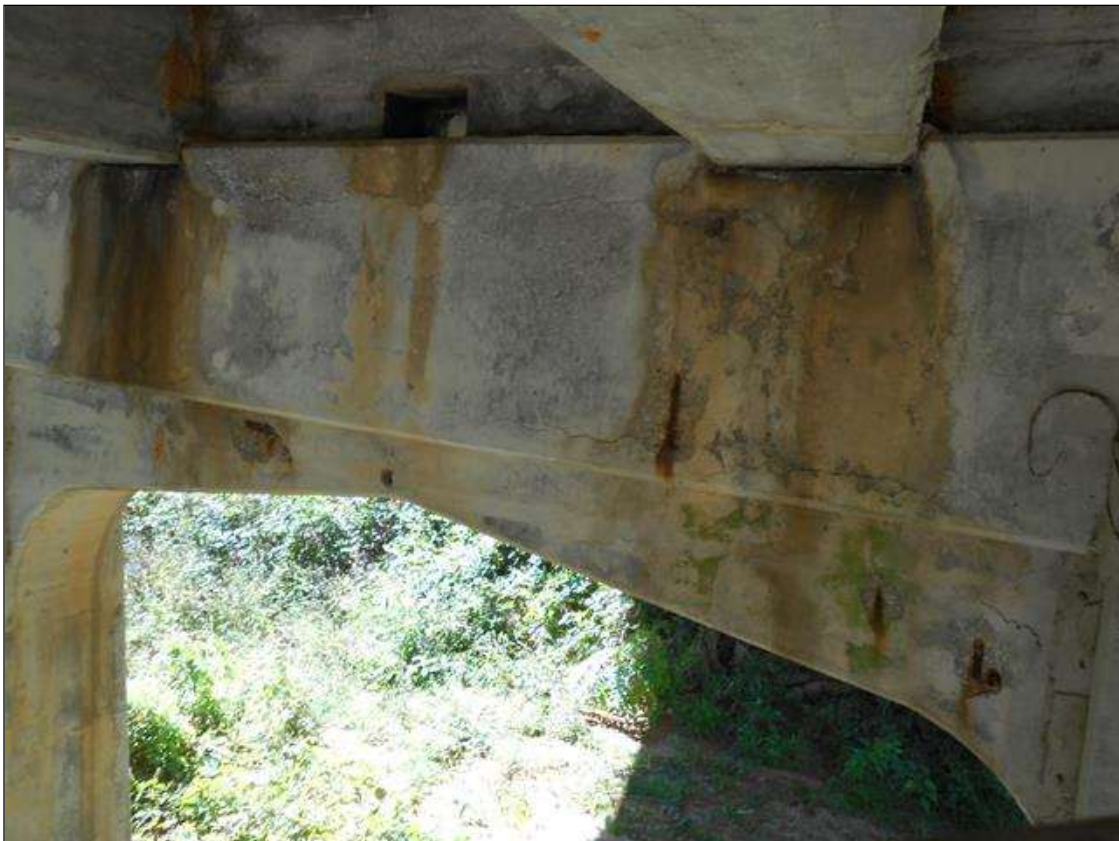
PIER 1 CAP, NORTH FACE 1/16 IN. CRACKS THROUGHOUT WITH SEVERAL SCATTERED 1/2 IN. DEEP POP-OFFS UP TO 6 IN. DIA.

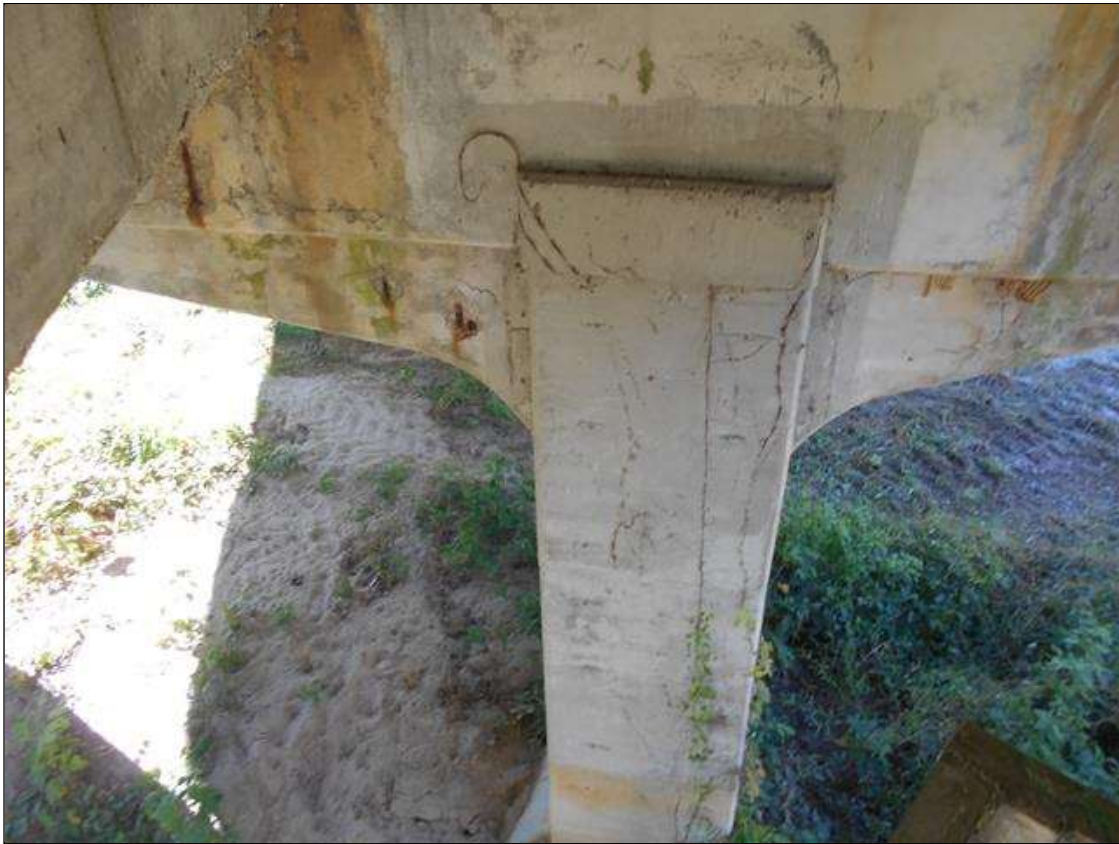
PIER 1 NORTH SIDE, COLUMN 1 HAS CONCRETE PATCHING FULL CIRCUMFERENCE X 10 FT. LONG.

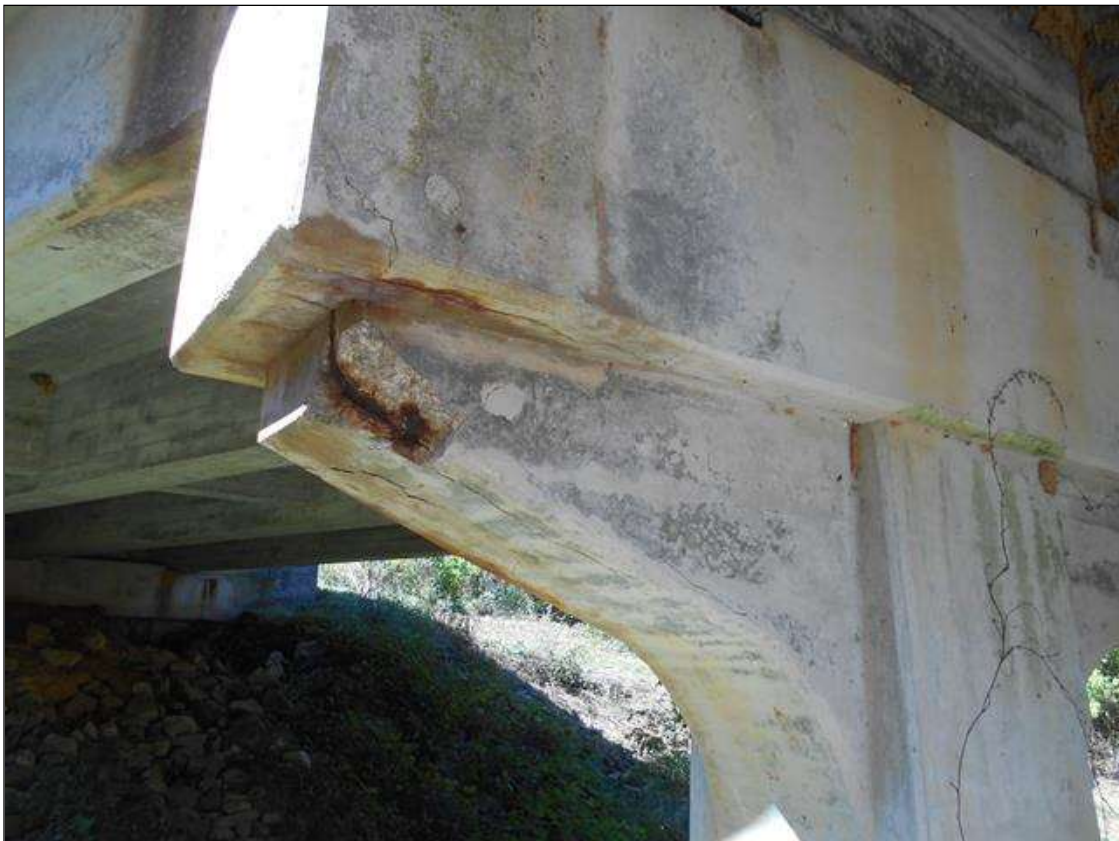
PIER 1, RIGHT END, NORTH FACE, END OF KNEE BRACE TO CAP HAS SPALL WITH EXPOSED REBAR, 10 IN. L X 8 IN. H X 3 IN. DEEP. AND 1/8 IN. CRACKS WITH DELAMINATION.

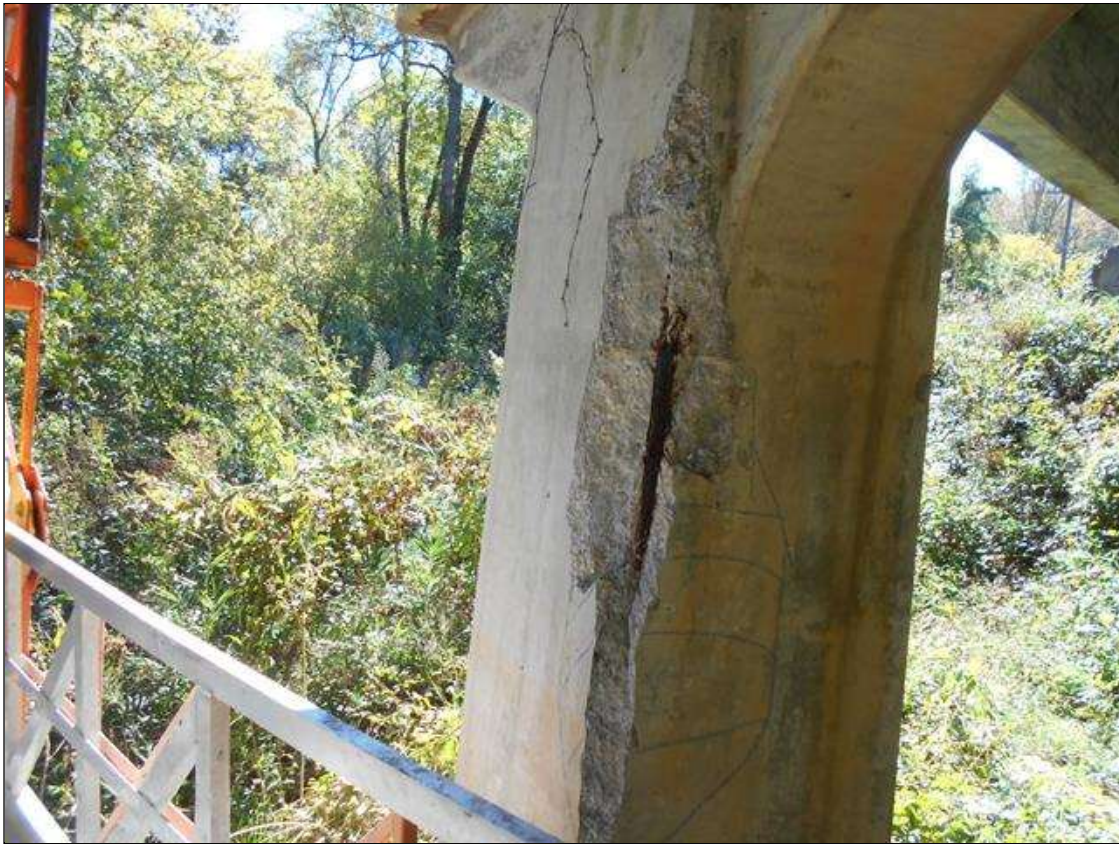
PIER 1 COLUMN 2, N W CORNER SPALL WITH EXPOSED REBAR 7 FT. H X 4 IN. DEEP X 1 FT. W., AND DELAMINATION. PRIORITY MAINTENANCE.

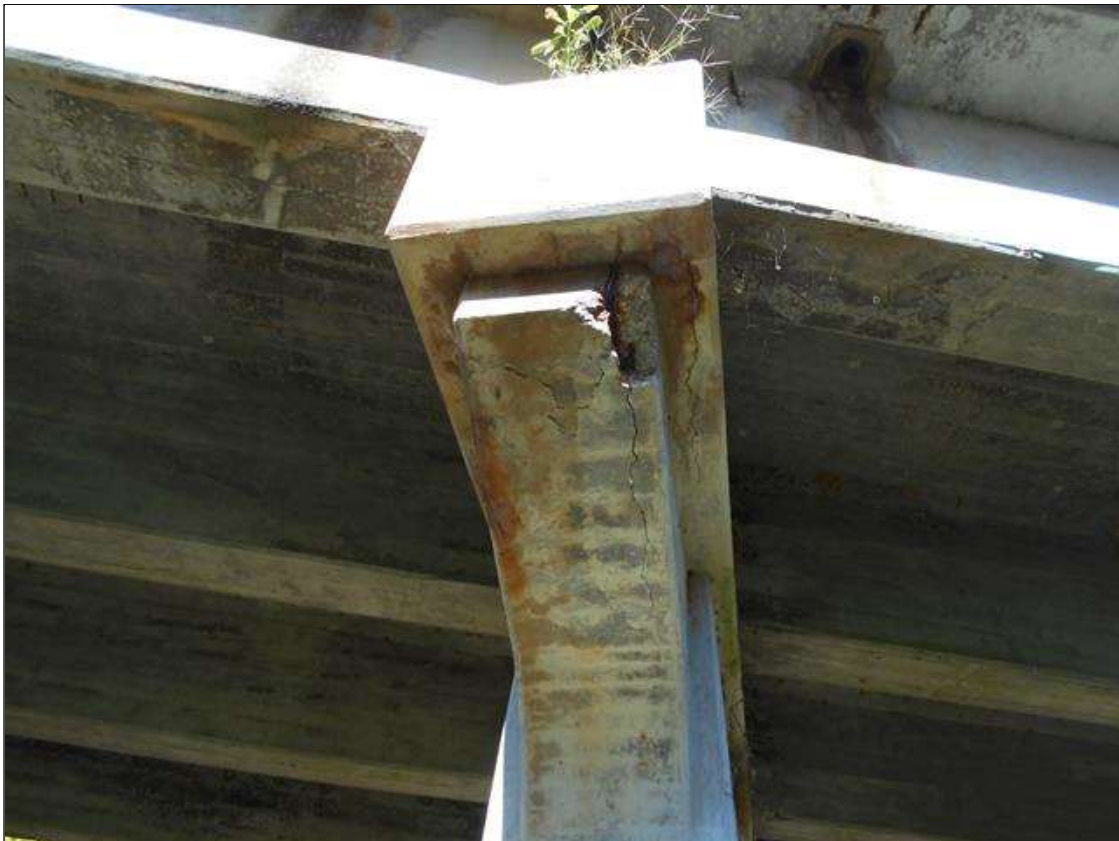
PIER 1 CAP, RIGHT END, END OF KNEE BRACE HAS SPALL WITH EXPOSED REBAR, 10 IN. L X 8 IN. H X 3 IN. DEEP. AND 1/8 IN. CRACKS WITH DELAMINATION.

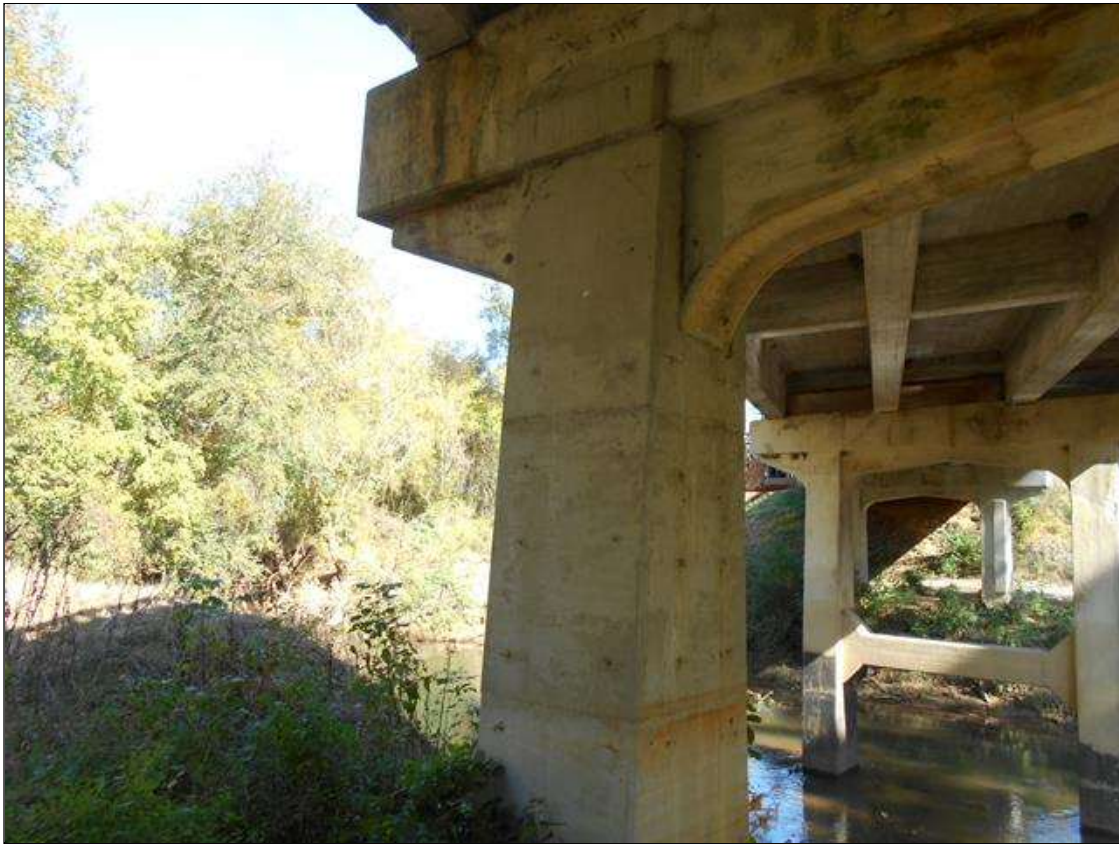
PIER 1 COLUMN 1 HAS CONCRETE PATCHING FULL CIRCUMFERENCE X 10 FT. L.

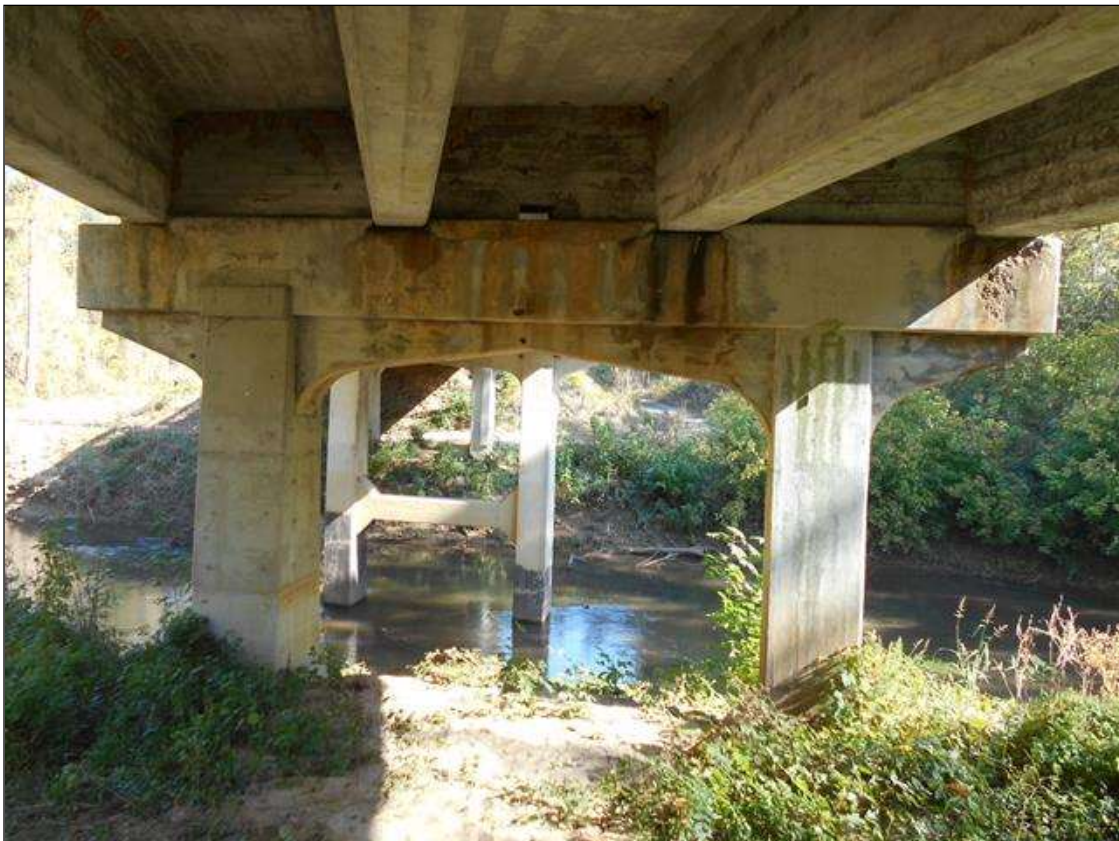
PIER 1, SOUTH SIDE, CAP HAS 1/16 IN. TO 1/8 IN. CRACKS THROUGHOUT WITH CONCRETE PATCH BETWEEN SEATS 3 AND 4.

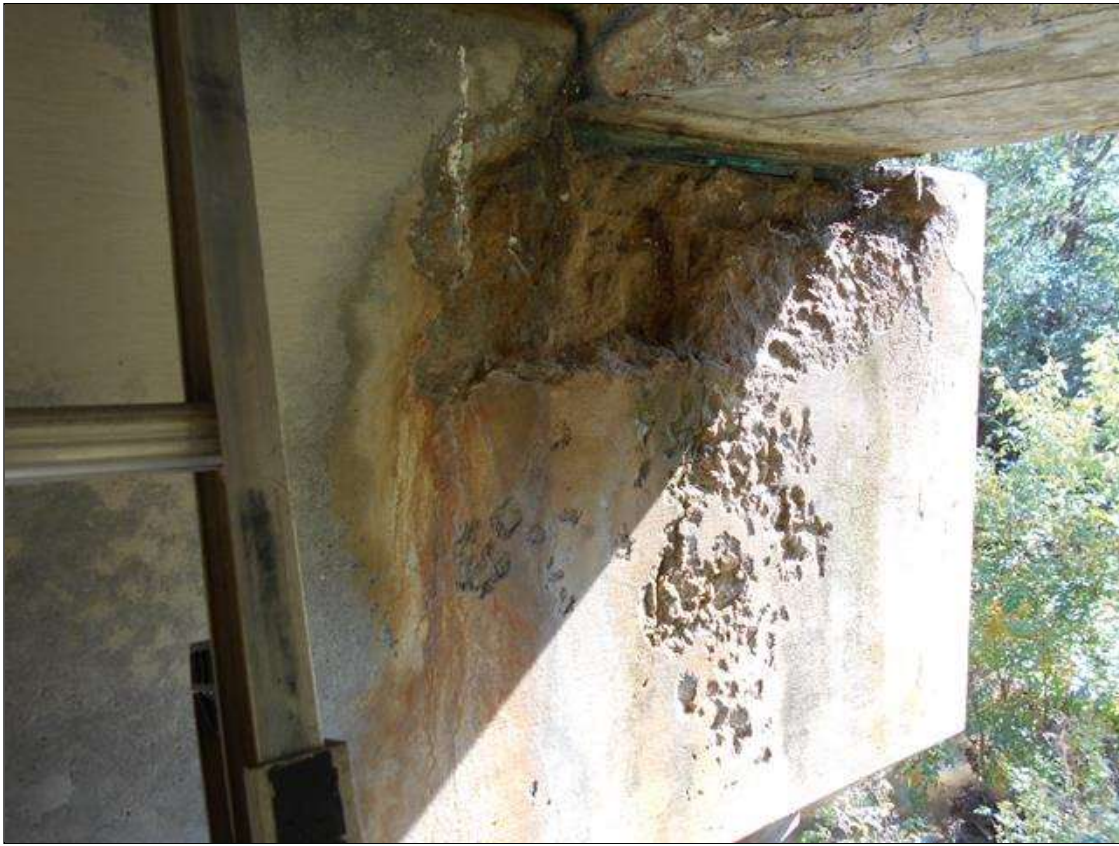
PIER 1 CAP, SOUTH FACE, AT SEAT 4, AREA OF 1/2 IN. DEEP DETERIORATION AND SPALL 3 IN. DEEP X 2 FT. L X 10 IN. H, WITH EXPOSED REBAR 4 IN. LONG WITH SECTION LOSS. SEAT 4 BEARING PLATE EDGE EXPOSED WITHOUT BEARING LOSS.

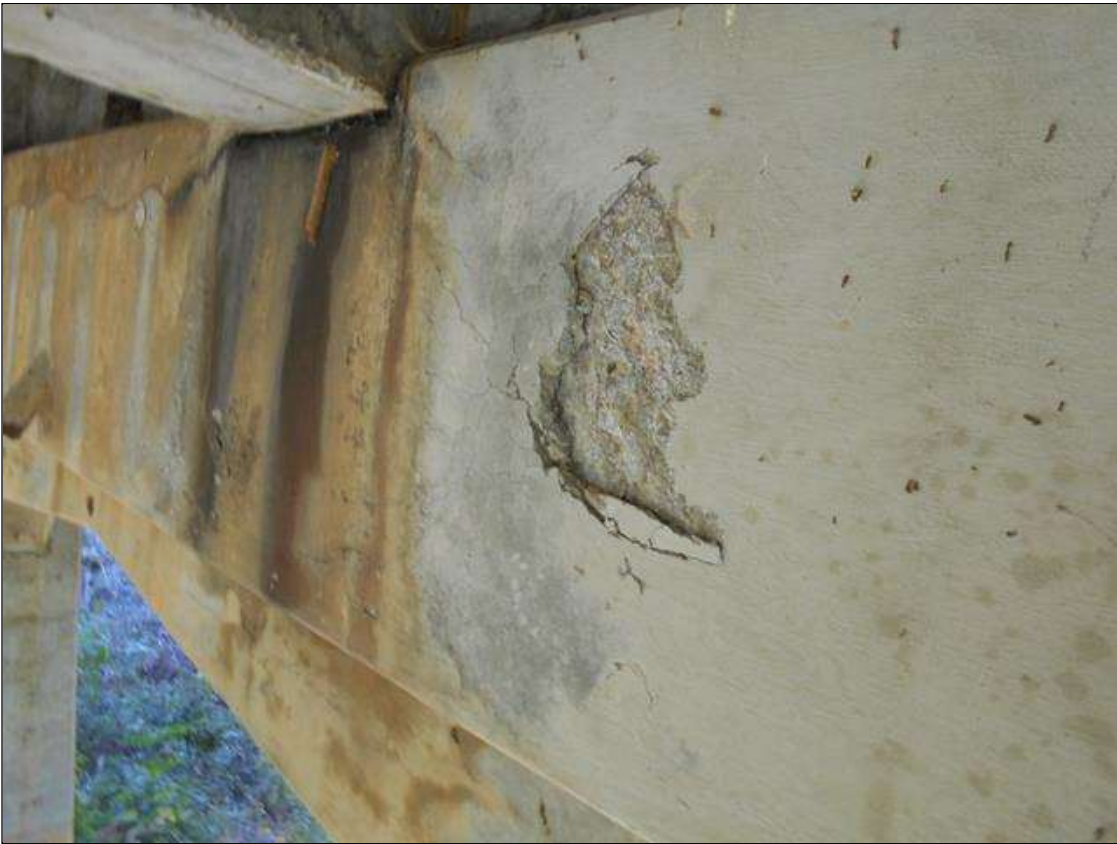
PIER 1 CAP, SOUTH FACE BETWEEN SEATS 3 & 4, UNSOUND CONCRETE PATCH WITH H/L CRACKS, DELAMINATION 20 IN. DIA., & SPALL 3/4 IN. DEEP.

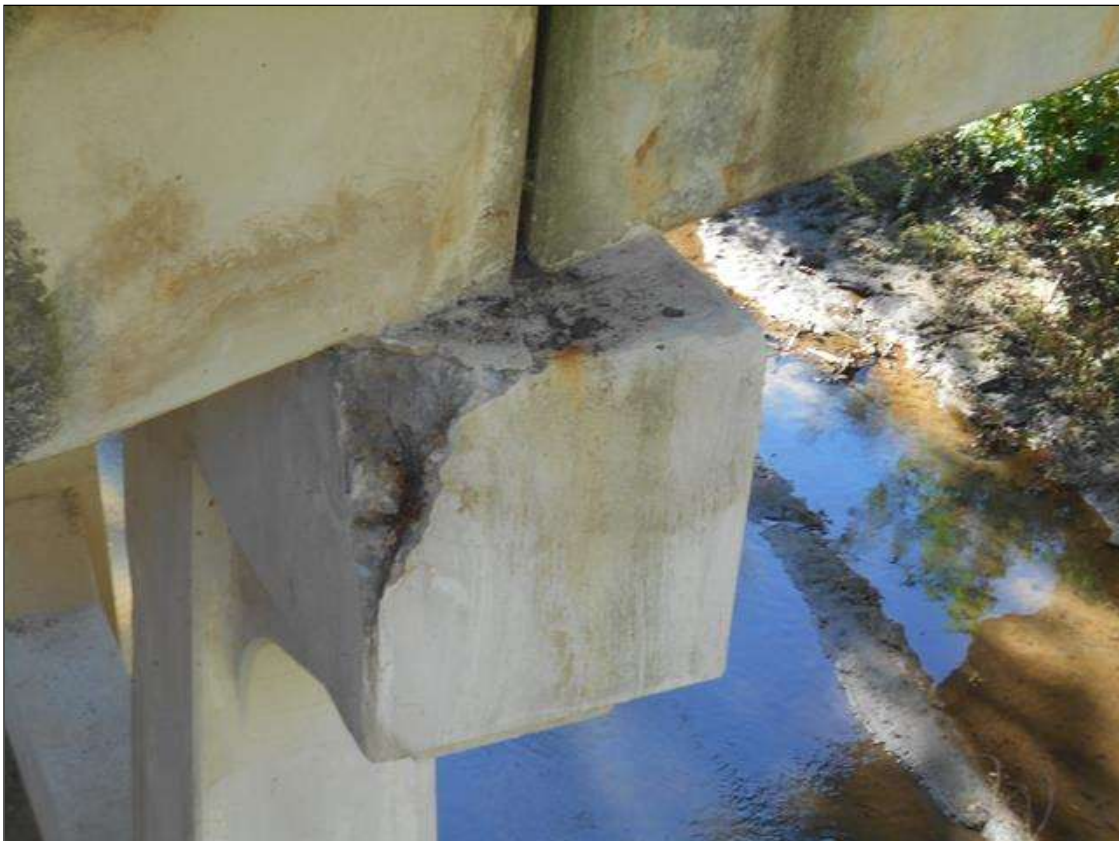
PIER 2 CAP LEFT END, N W CORNER, SPALL WITH EXPOSED REBAR 4 IN. D X 20 IN. H X 1 FT. LONG.

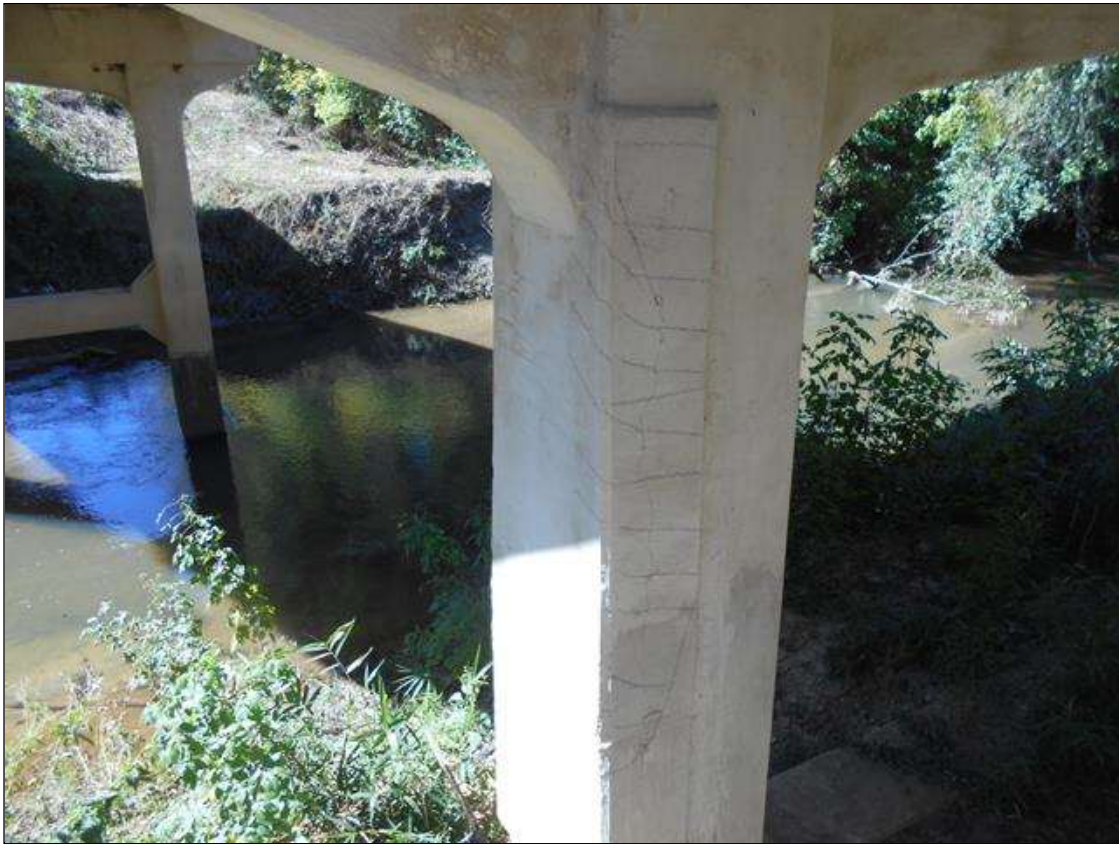
PIER 3 COLUMN 2 REPAIR TO EAST SIDE OF COLUMN WITH 1/8 IN. CRACKS AND DELAMINATION ON N E CORNER.

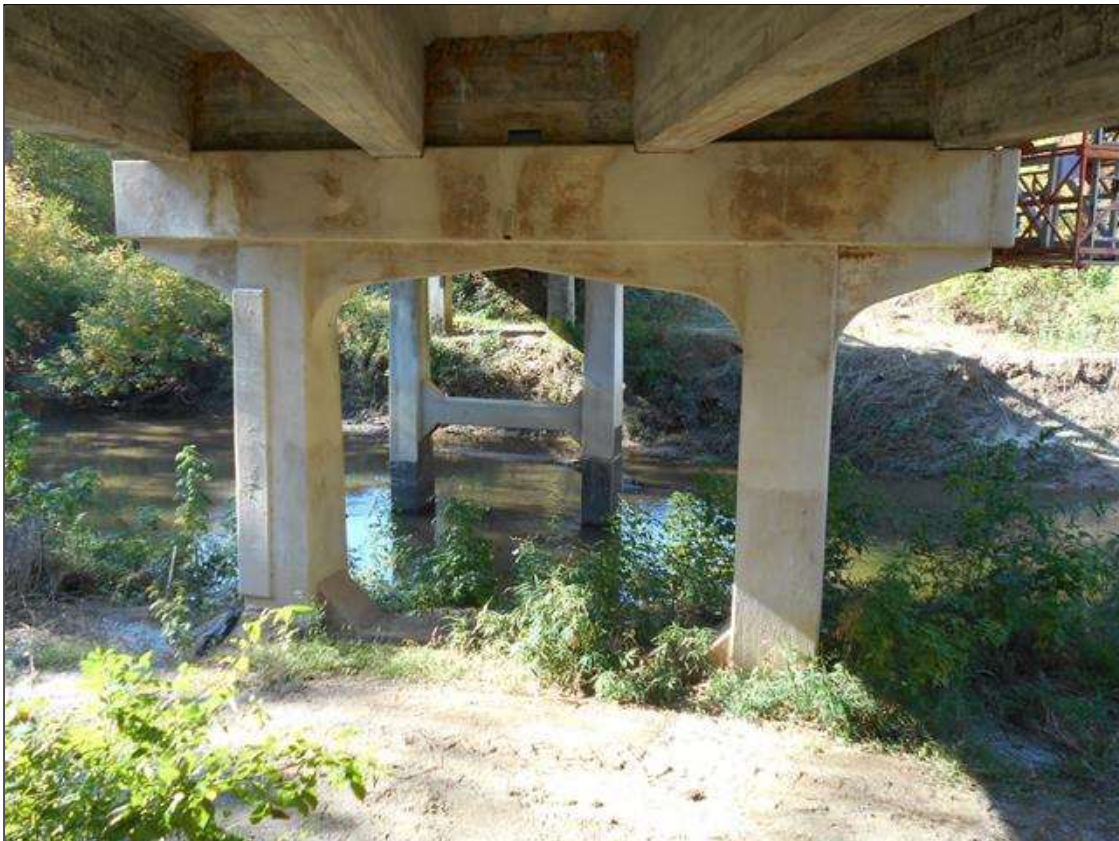
PIER 3 CAP NORTH FACE SOUND CONCRETE PATCHES BELOW ALL SEATS.

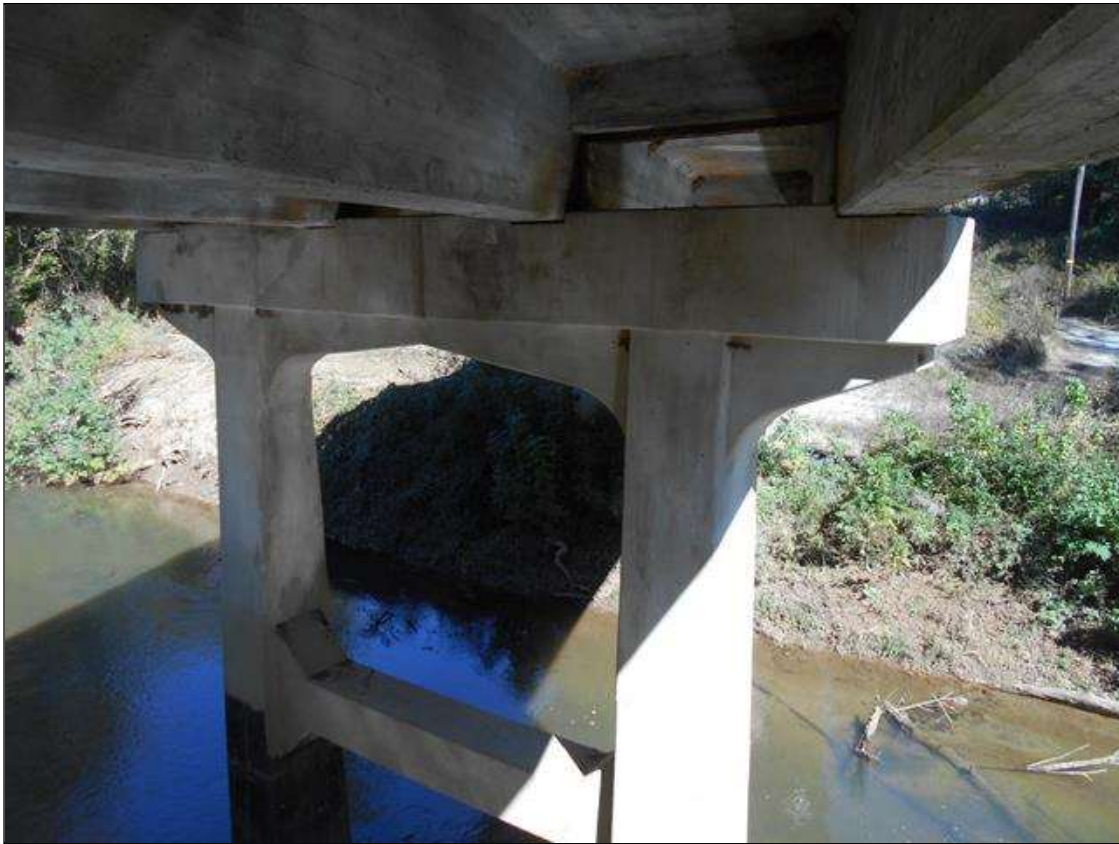
PIER 2 SOUTH SIDE, REPAIR TO SPALLS BETWEEN SEATS 1 AND 2 WITH CONCRETE PATCHES TO CAP.

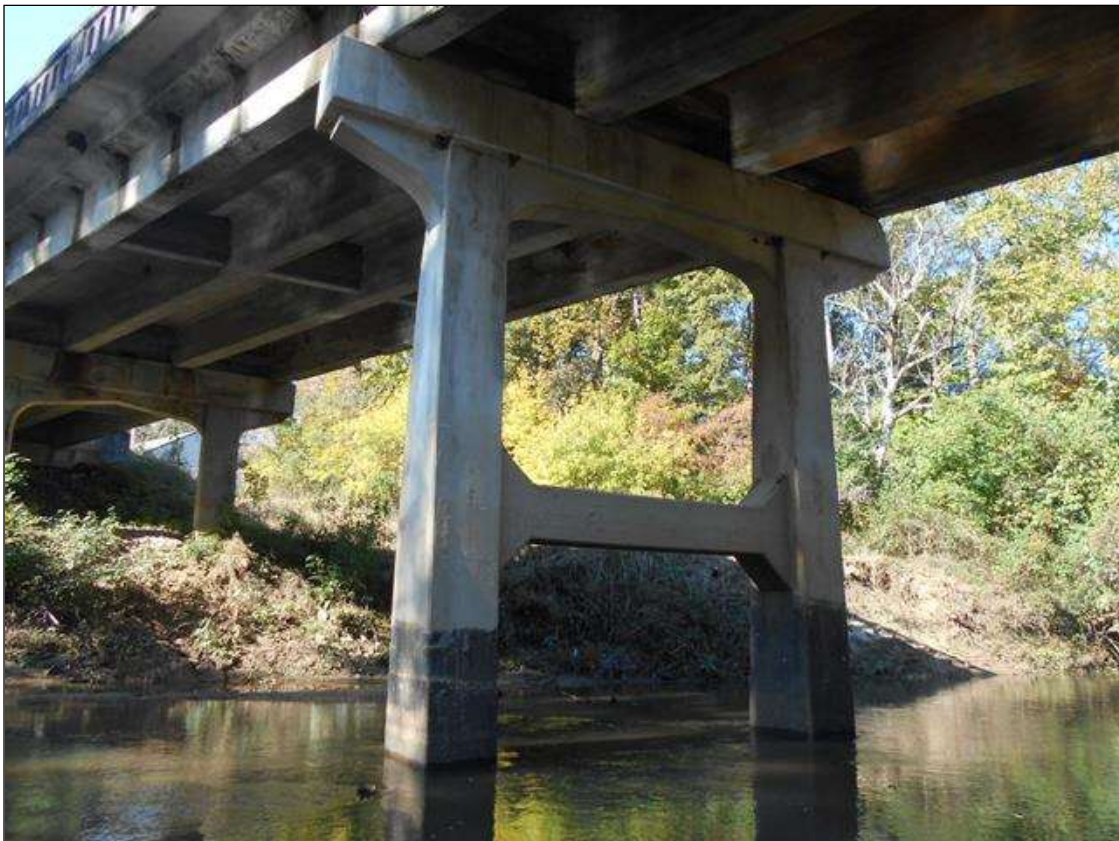
PIER 2, COLUMN 2 REPAIR TO SPALLS ON EAST SIDE WITH CONCRETE PATCH.
