NC DEPARTMENT OF TRANSPORTATION  
DIVISION OF HIGHWAYS  
STRUCTURE MANAGEMENT UNIT

## Structure Safety Report

### Routine Element Inspection

COUNTY: ROWAN STRUCTURE NUMBER: 790061 FREQUENCY: 24 MONTHS

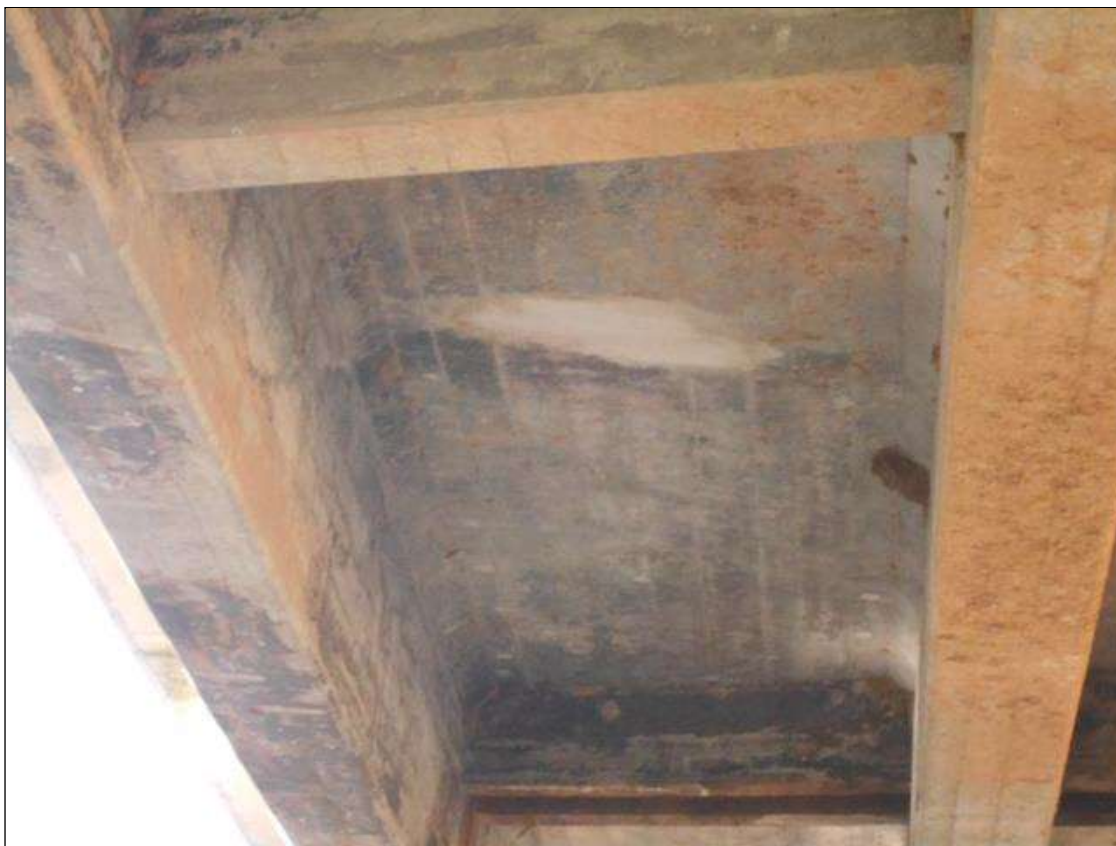
21 Square Feet of Delamination/Spall: Delaminated. Spall 1 in. or less deep or 6 in. or less in diameter. BOTH OVERHANGS HAVE SEVERAL 1/2 IN. DEEP X 6 IN. DIA. POP-OFFS WITH EXPOSED REBAR AROUND DRAIN HOLES. BOTH CONCRETE CURBS HAVE AREAS OF SCALING AND PATCHES. SPAN 3, DECK UNDERSIDE CONCRETE PATCH TO SPALL IN BAY 3, NEAR 1/2 PT.

SPAN 3, DECK UNDERSIDE CONCRETE PATCH TO SPALL IN BAY 3, NEAR 1/2 PT.
