NC DEPARTMENT OF TRANSPORTATION  
DIVISION OF HIGHWAYS  
STRUCTURE MANAGEMENT UNIT

## Structure Safety Report

### Routine Element Inspection - Contract

COUNTY: ROWAN STRUCTURE NUMBER: 790063 FREQUENCY: 24 MONTHS

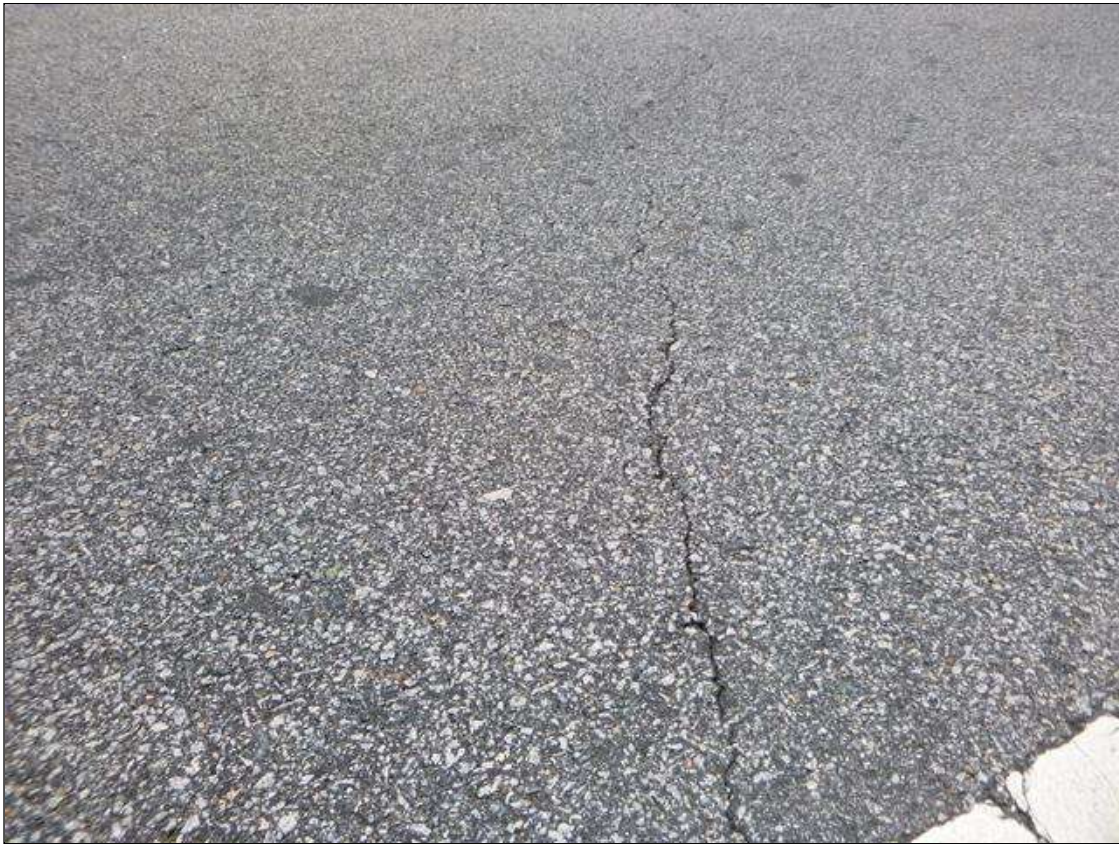
30' TRANSVERSE CRACK UP TO 1/8" IN ASPHALT WEARING SURFACE, OVER END BENT 1.

Span 1 Wearing Surface: 30' TRANSVERSE CRACK UP TO 1/8", OVER END BENT 1.

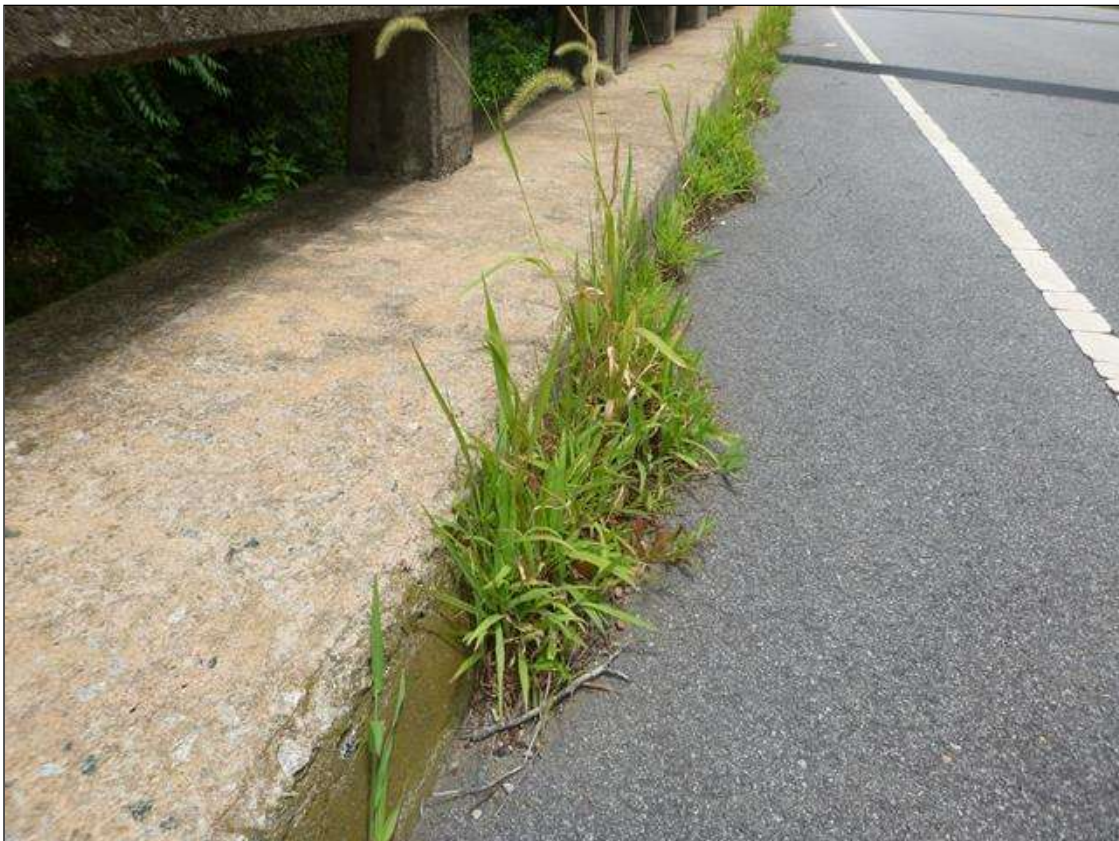
Deck Debris: VEGETATION GROWTH ALONG BOTH CURBS.

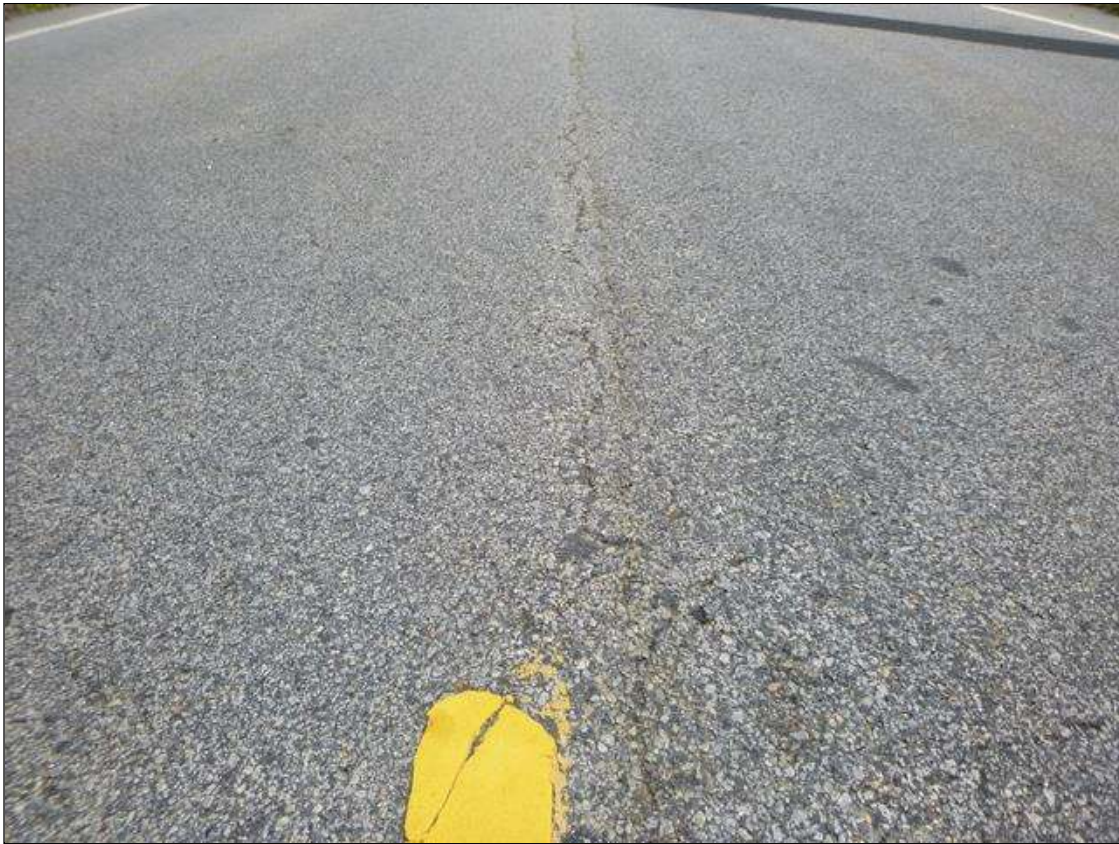
40' LONGITUDINAL CRACK UP TO 1/8" AT CENTERLINE.

Span 1 Wearing Surface: 40' LONGITUDINAL CRACK UP TO 1/8" AT CENTERLINE.

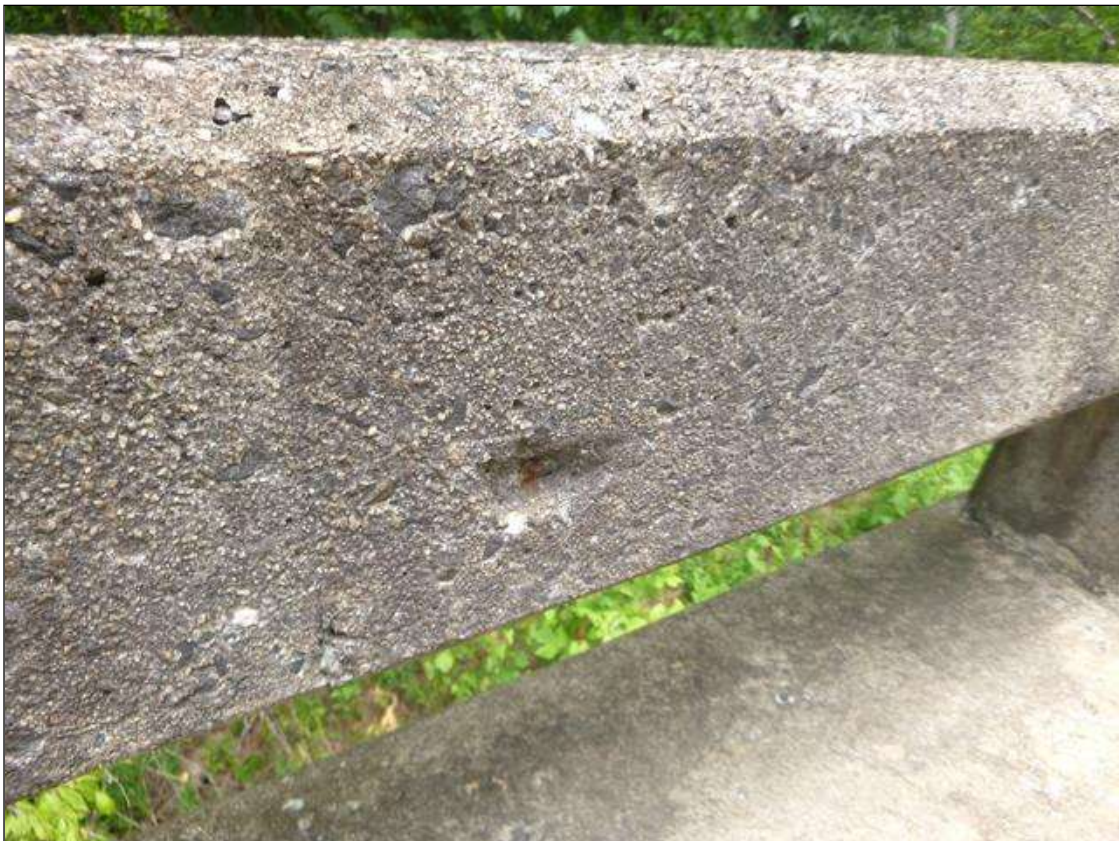
Span 1 Left Bridge Rail: (7) 2" DIAMETER X 1/2" POP OUTS WITH EXPOSED REINFORCING, INSIDE FACE OF RAIL AT RANDOM.

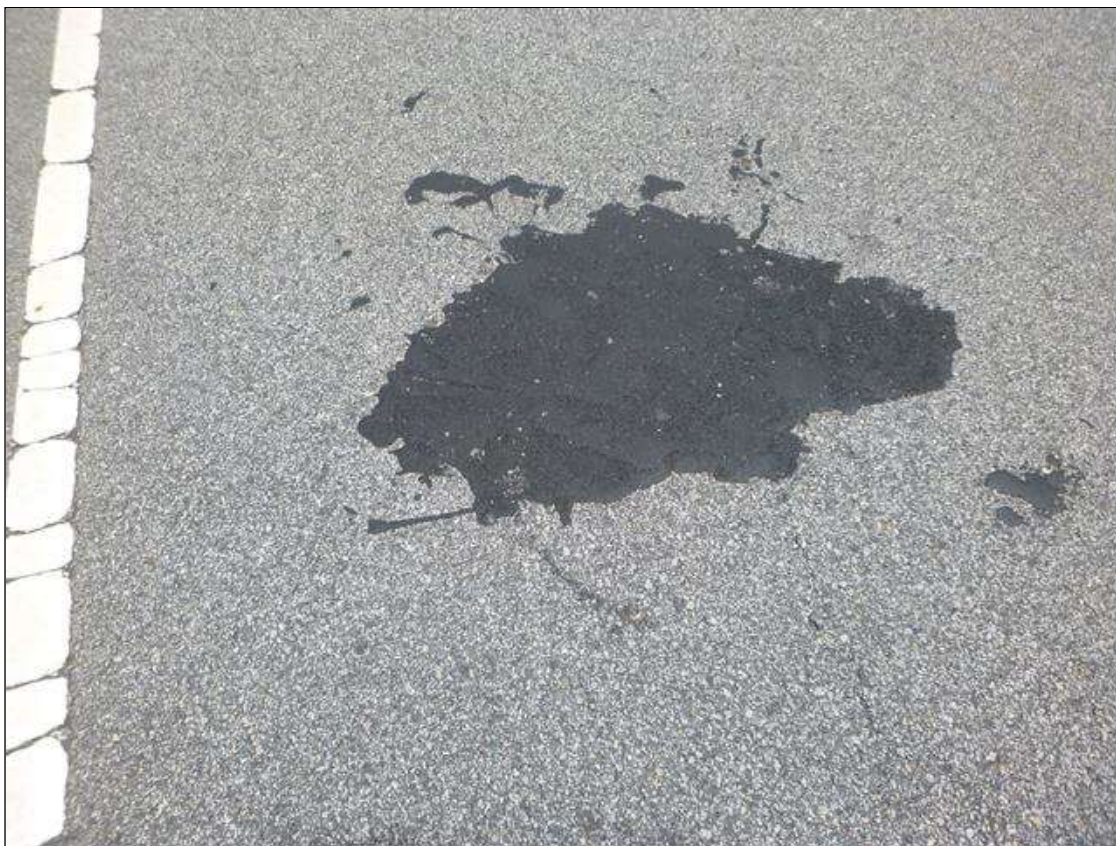
Span 3 Wearing Surface: 2' X 3' ASPHALT PATCH, 2' FROM LEFT FOG LINE, 18' FROM BENT 2.

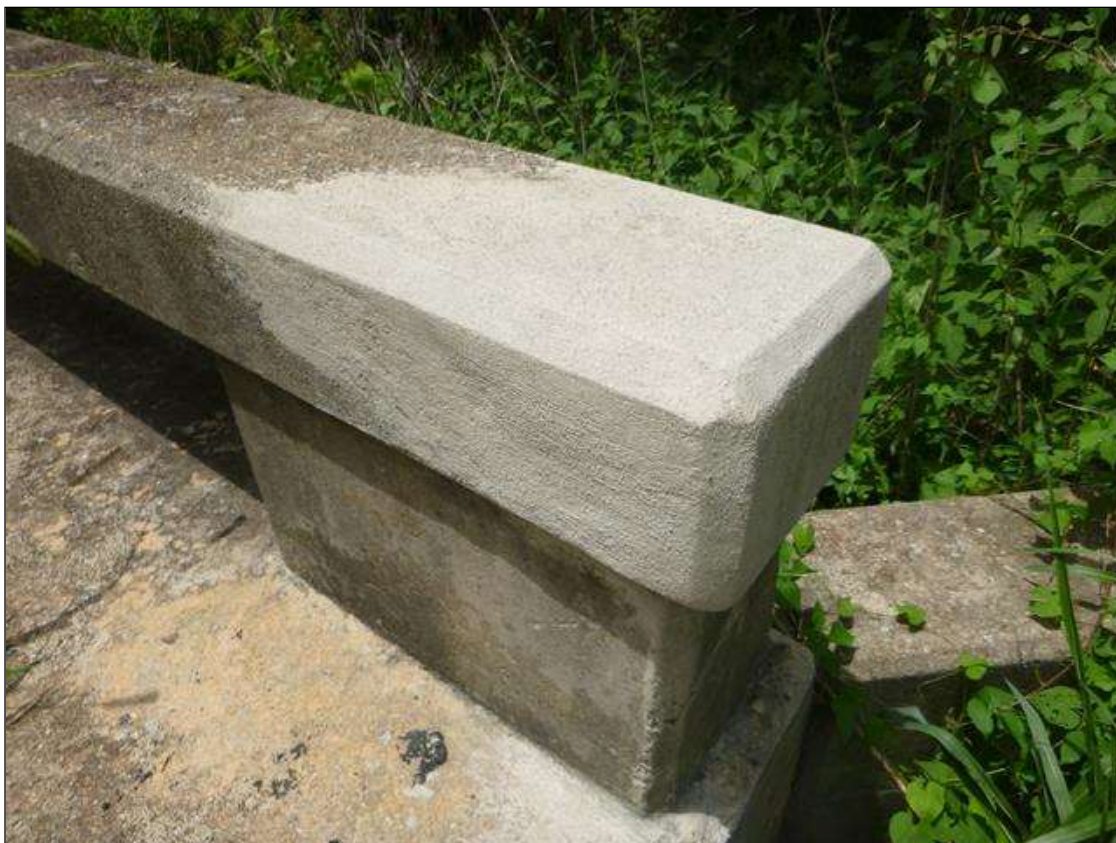
Span 3 Left Bridge Rail: 21" X 10" X 8" TEMPORARY REPAIR TO EAST END OF BRIDGE RAIL, AT END BENT 2.

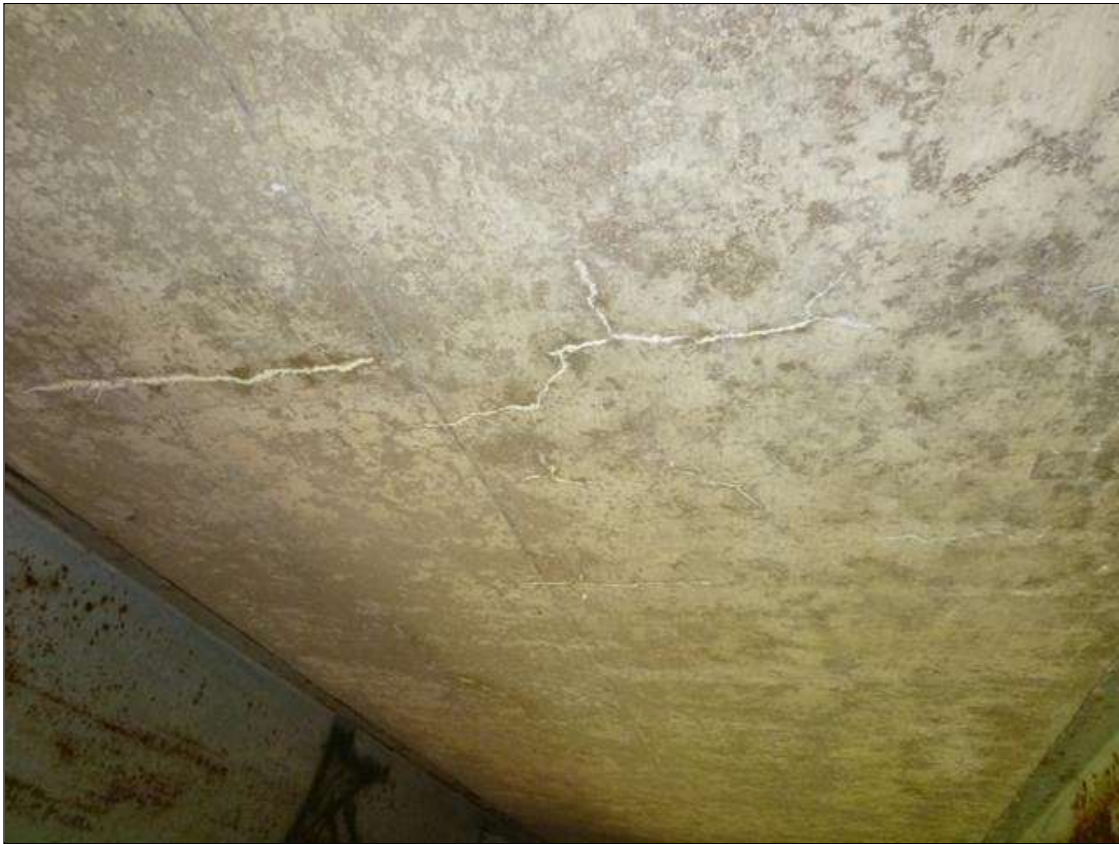
Span 3 Deck: 8 SQ FT OF HAIRLINE MAP CRACKING WITH EFFLORESCENCE, UNDERSIDE OF DECK, BAY 1, 10' FROM BENT 2.

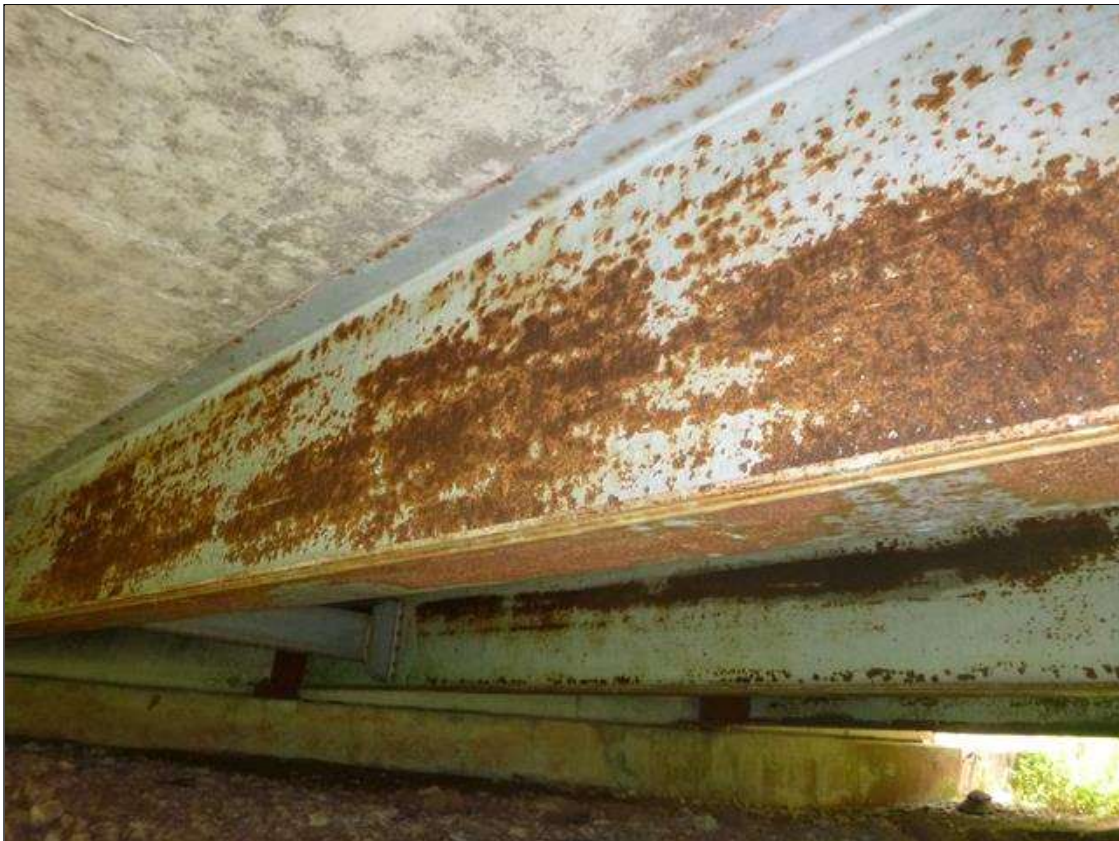
Span 3 Beam 2: CORROSION ON UP TO 50% OF BEAM SURFACE AT RANDOM THROUGHOUT, EXCEPT PAINTED ENDS.

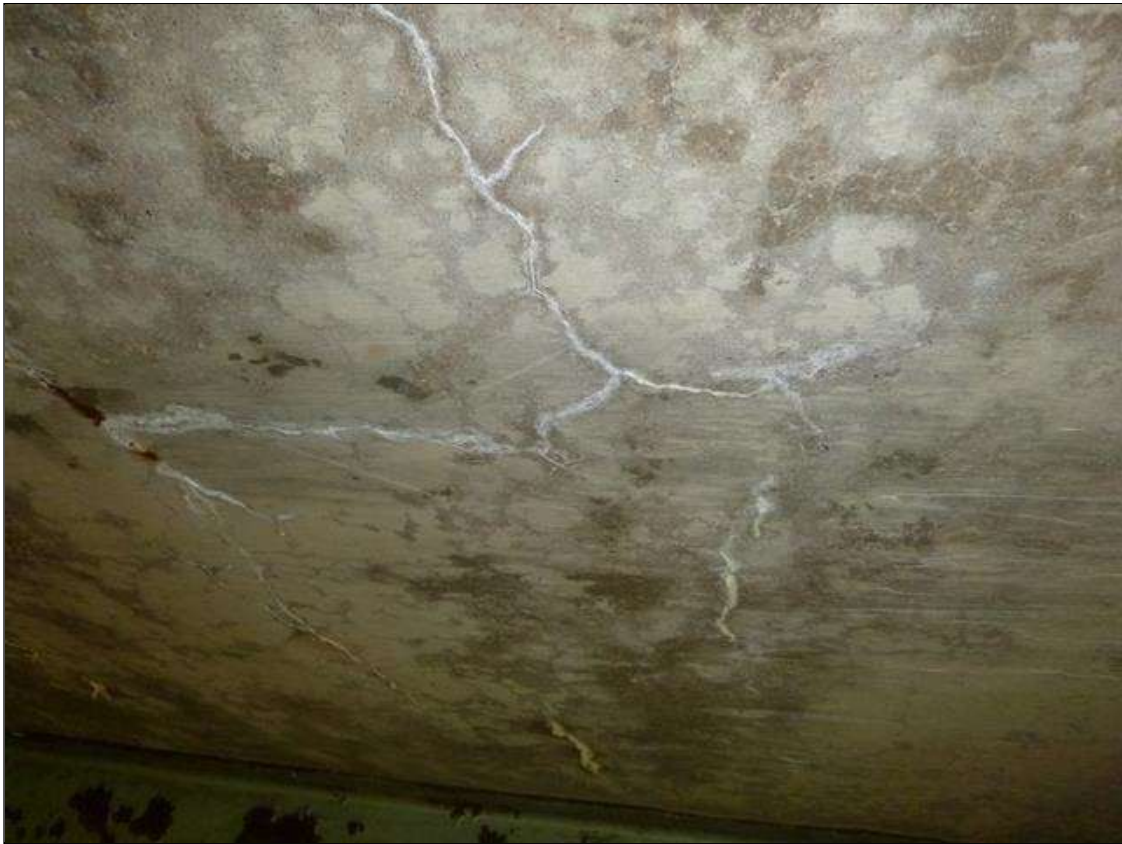
Span 3 Deck: 40 SQ FT OF HAIRLINE MAP CRACKING WITH EFFLORESCENCE STALACTITES, UNDERSIDE OF DECK, BAY 3, 10' FROM BENT 2.

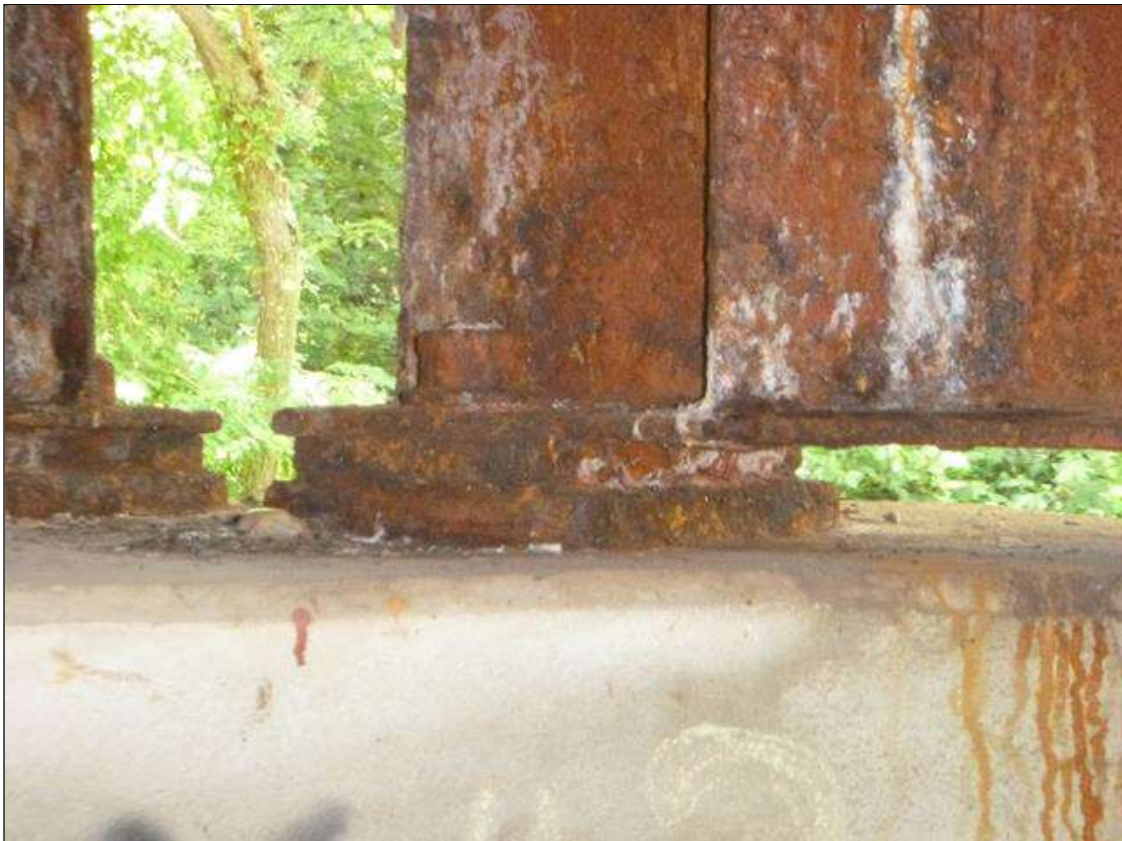
CORROSION ON NEAR BEARING ASSEMBLY WITH RUST BLOOM.

Span 3 Beam 1 Near Bearing : CORROSION ON NEAR BEARING ASSEMBLY WITH RUST BLOOM.

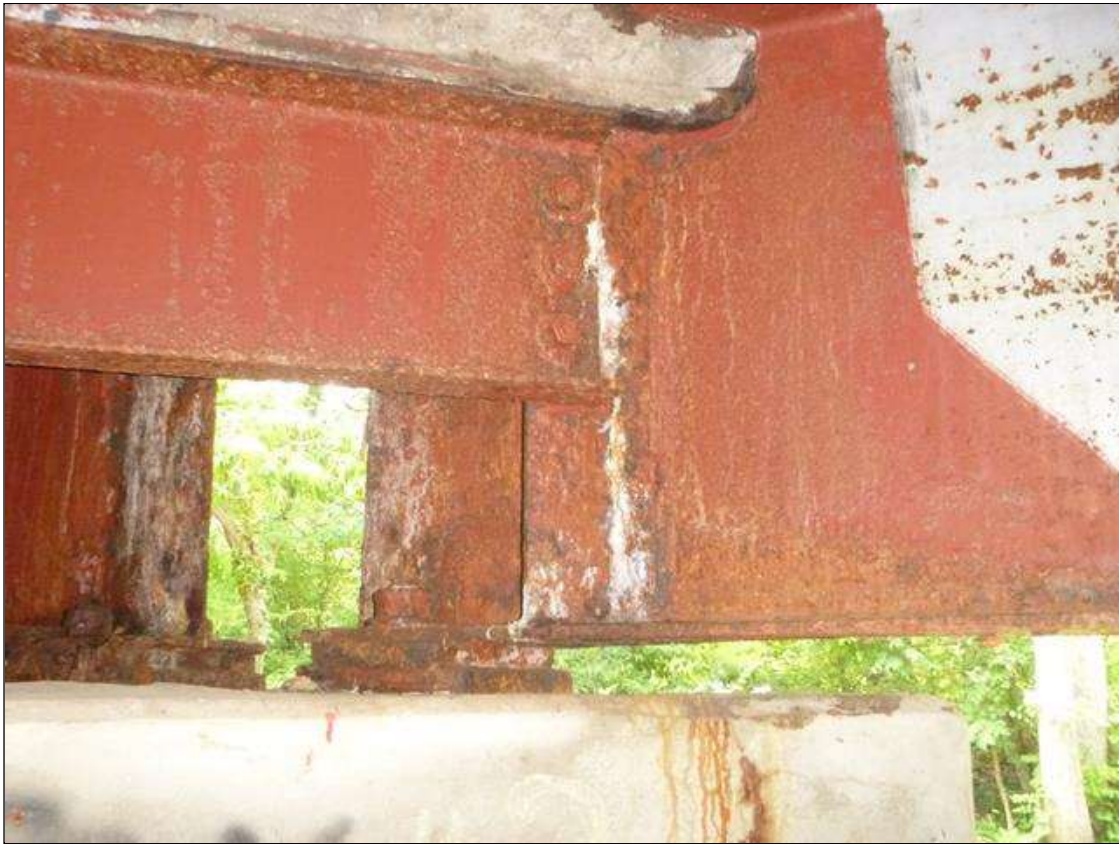
Span 3 Beam 1: 16" OF CORROSION ON WEB AND BEARING STIFFENER, EFFLORESCENCE ACCUMULATION FROM DECK ABOVE, AT NEAR BEARING.

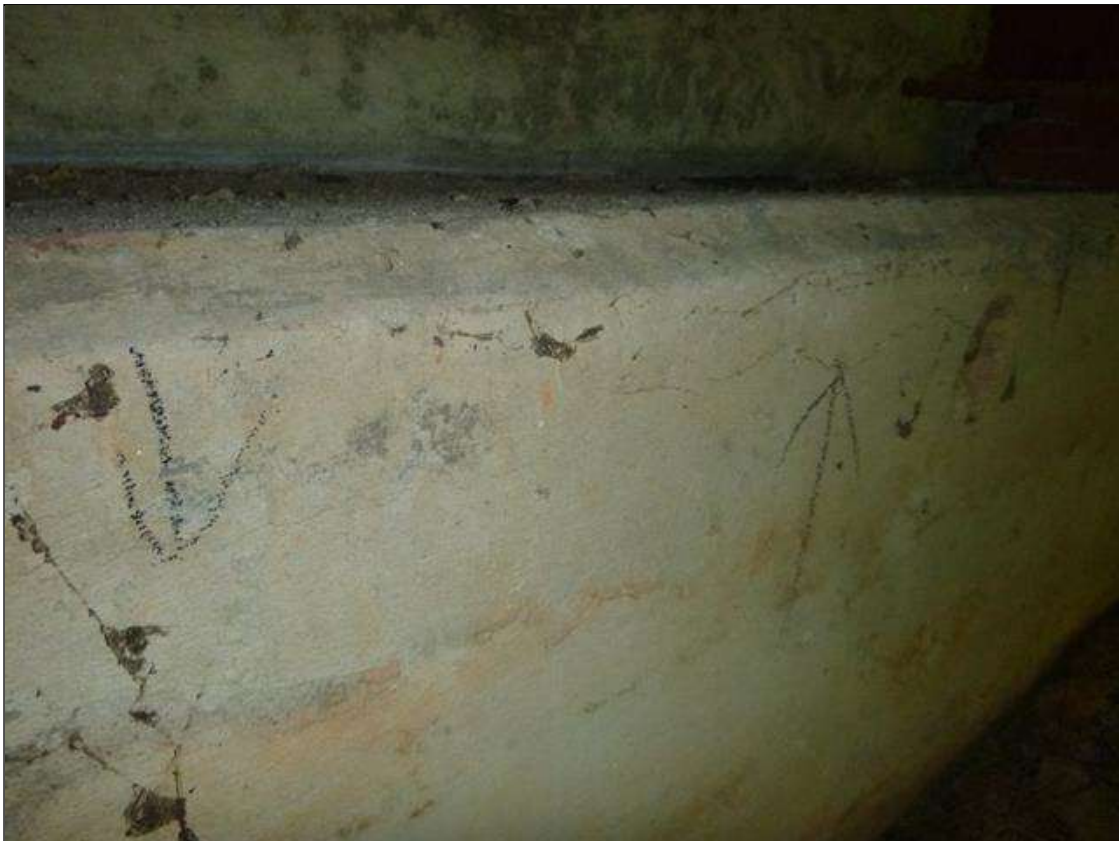
13' HORIZONTAL CRACK UP TO 0.06", FACE OF CAP, BEGINNING UNDER MIDDLE OF BAY 1, EXTENDING INTO BAY 2.

End Bent 2 Cap : 13' CRACK UP TO 0.06", FACE OF CAP, BEGINNING UNDER MIDDLE OF BAY 1, EXTENDING INTO BAY 2.

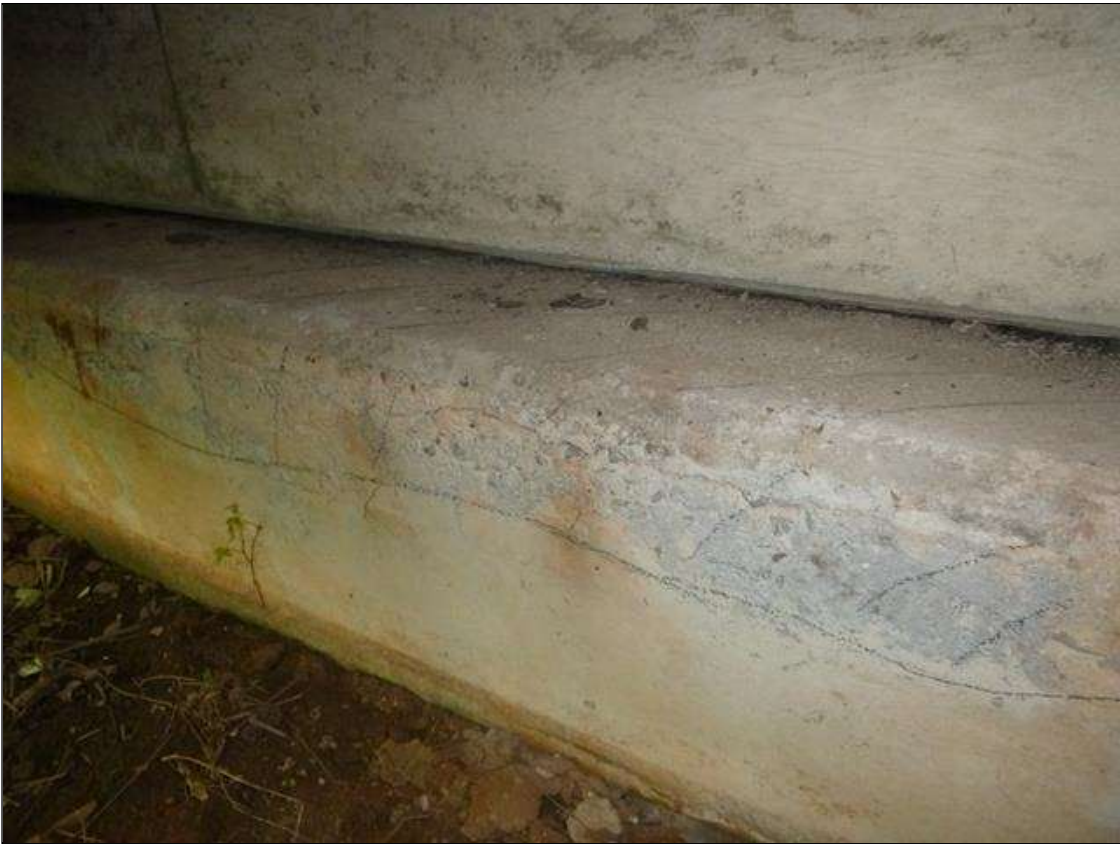
End Bent 2 Cap : 5'-6" X 10" X 6" DELAMINATION, TOP CORNER, BELOW BAY 1, 1' FROM BEAM 1.

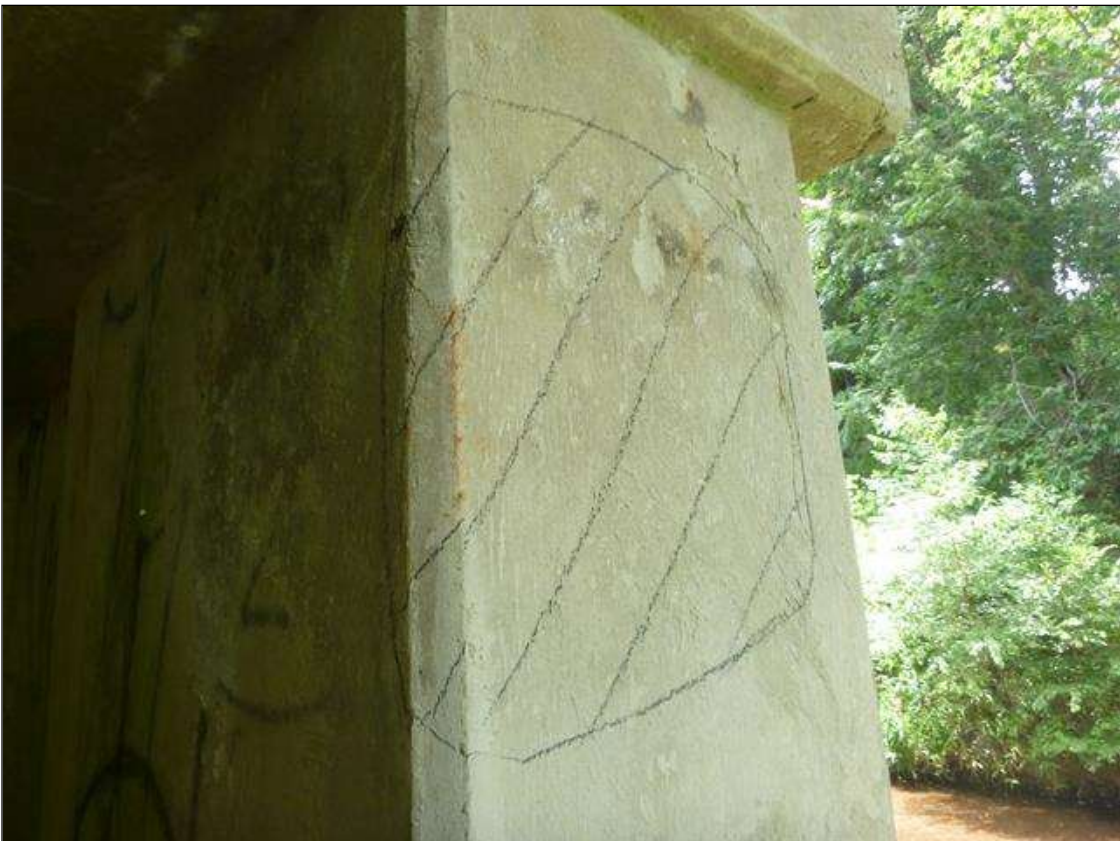
Bent 2 Pile 1: 20" X 18" X 3" CORNER DELAMINATION, NORTH FACE OF COLUMN ADD ON, 1' BELOW BOTTOM OF CAP.

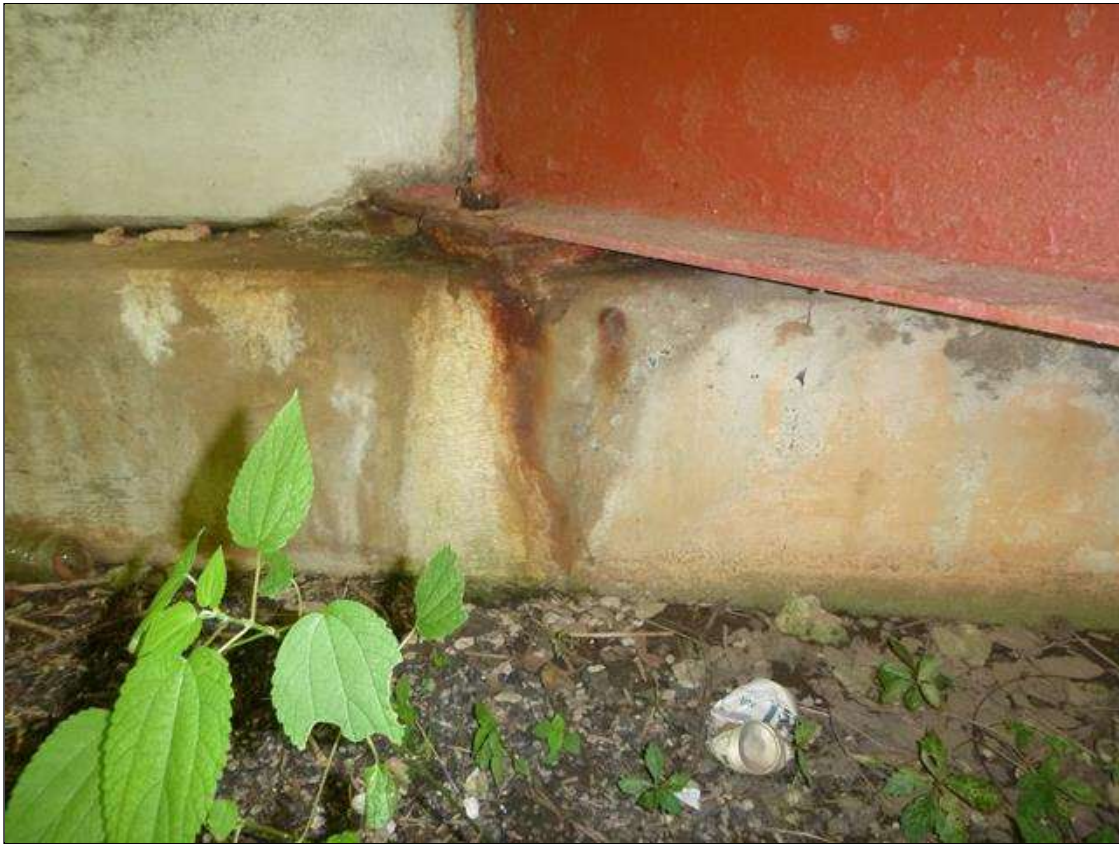
CORROSION ON FAR BEARING ASSEMBLY UP TO 50%, WITH RUST STAINING AND EFFLORESCENCE ON CAP BELOW.

Span 3 Beam 1 Far Bearing : CORROSION ON FAR BEARING ASSEMBLY UP TO 50%, WITH RUST STAINING AND EFFLORESCENCE ON CAP BELOW.

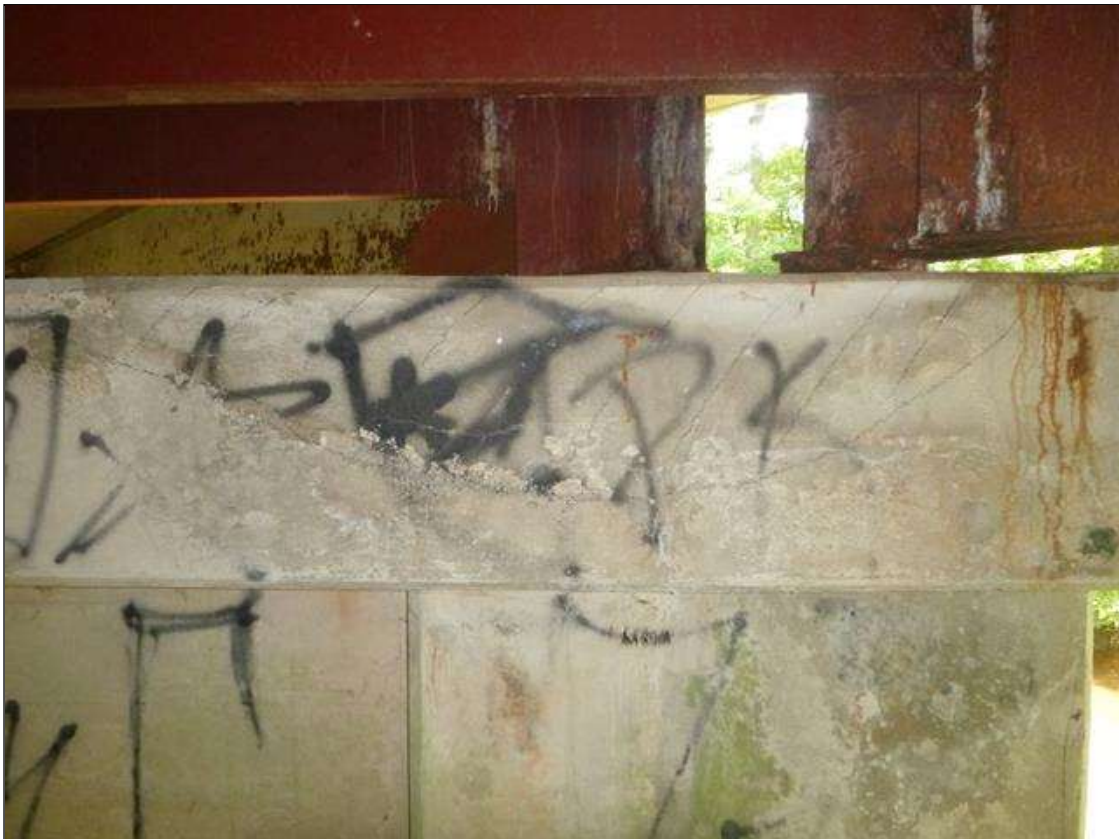
Bent 2 Cap : 5' X 1' DELAMINATION, EAST FACE, BEGINNING UNDER BEAM 1 BEARING ASSEMBLY.

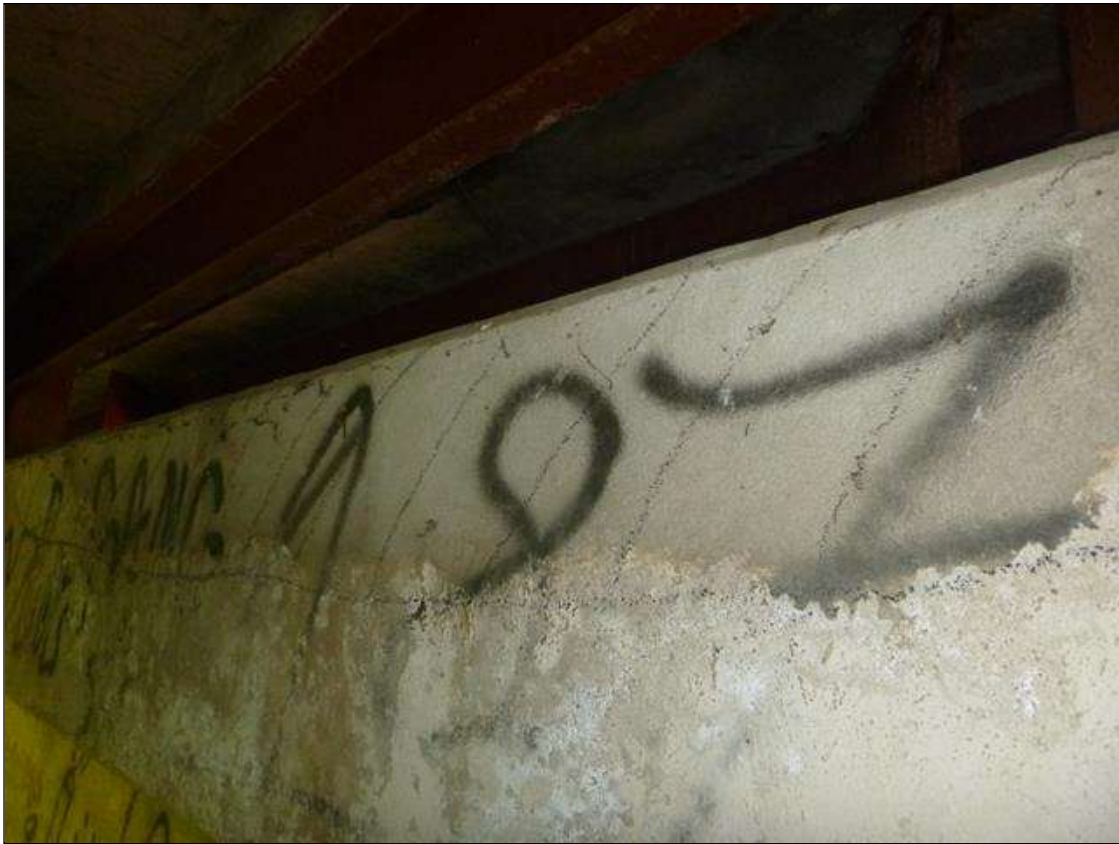
7'-6" X 9" DELAMINATION OF TEMPORARY REPAIR, EAST FACE OF CAP, BELOW BAY 2.

Bent 2 Cap : 7'-6" X 9" DELAMINATION OF TEMPORARY REPAIR, EAST FACE OF CAP, BELOW BAY 2.

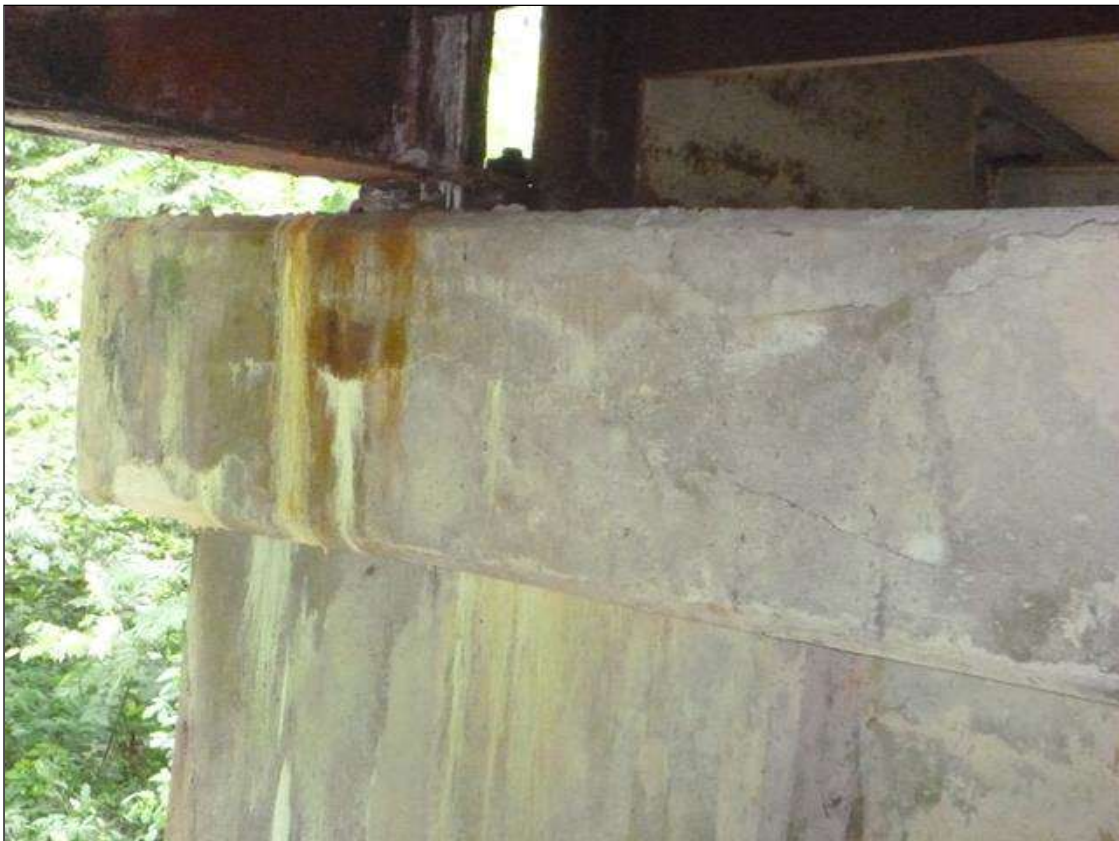
6' X 9" DELAMINATION, WITH RUST STAINING AND EFFLORESCENCE LEAKAGE, EAST FACE OF CAP, BELOW BAY 3, BEGINNING UNDER BEAM 4 BEARING ASSEMBLY.

Bent 2 Cap : 6' X 9" DELAMINATION WITH RUST STAINING AND EFFLORESCENCE LEAKAGE, EAST FACE OF CAP, BELOW BAY 3, BEGINNING UNDER BEAM 4 BEARING ASSEMBLY.

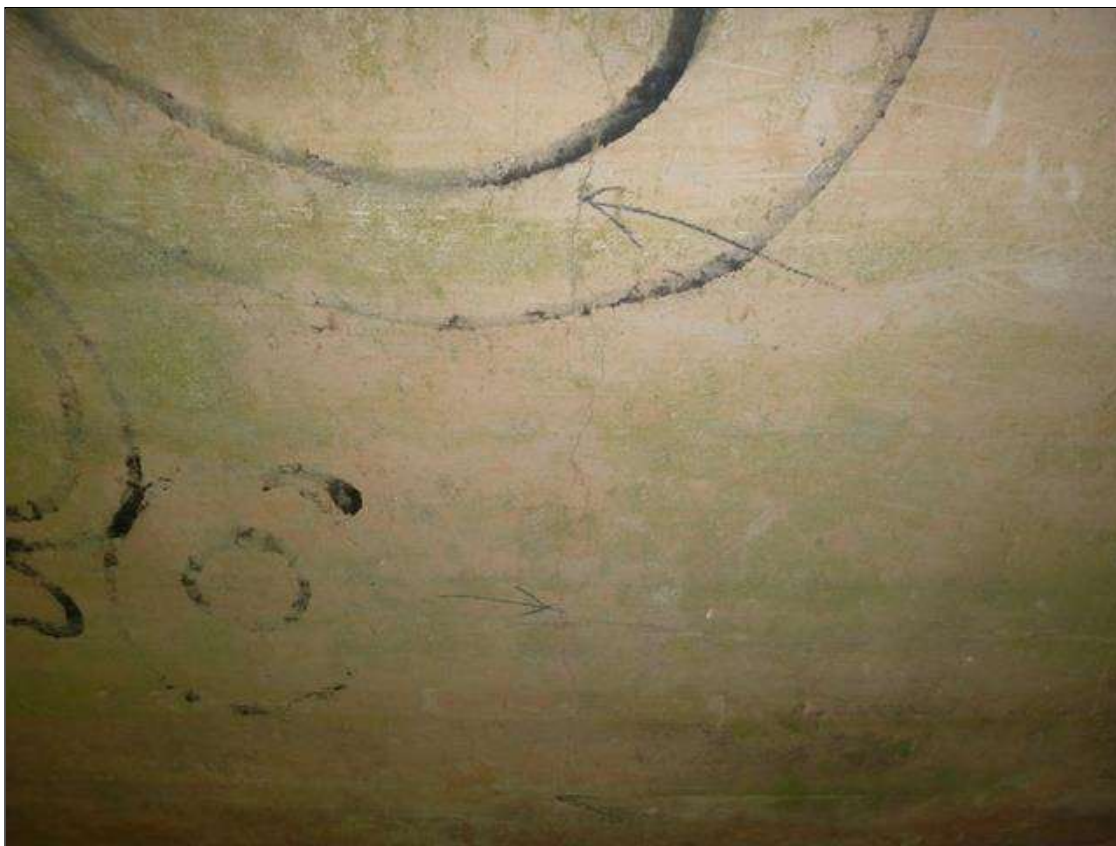
5' VERTICAL CRACK UP TO 0.03", EAST FACE OF PIER WALL, CENTERED BELOW BAY 2.

Bent 2 Pile 2: 5' VERTICAL CRACK UP TO 0.03", EAST FACE OF PIER WALL, CENTERED BELOW BAY 2.

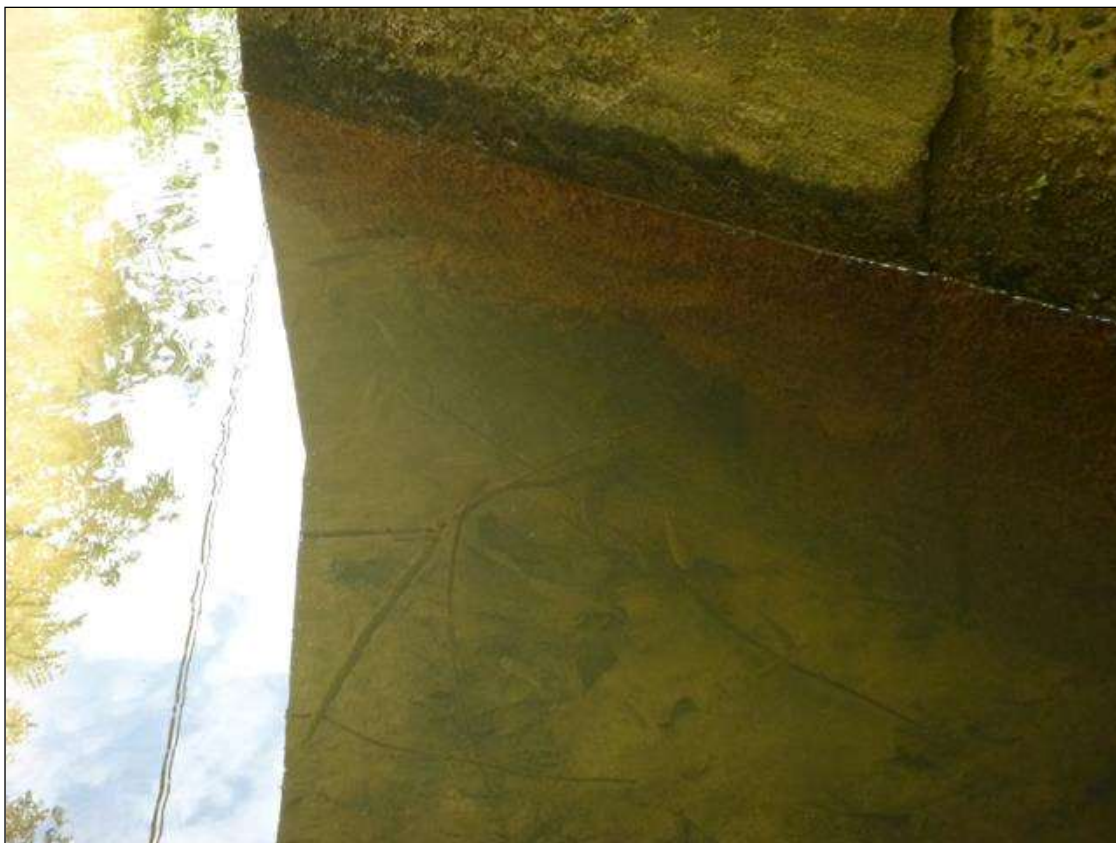
Scour: 2' X 3'-4" AREA BELOW SOUTH END OF BENT 2 PIER ADDITION IS COMPLETELY UNDERMINED.

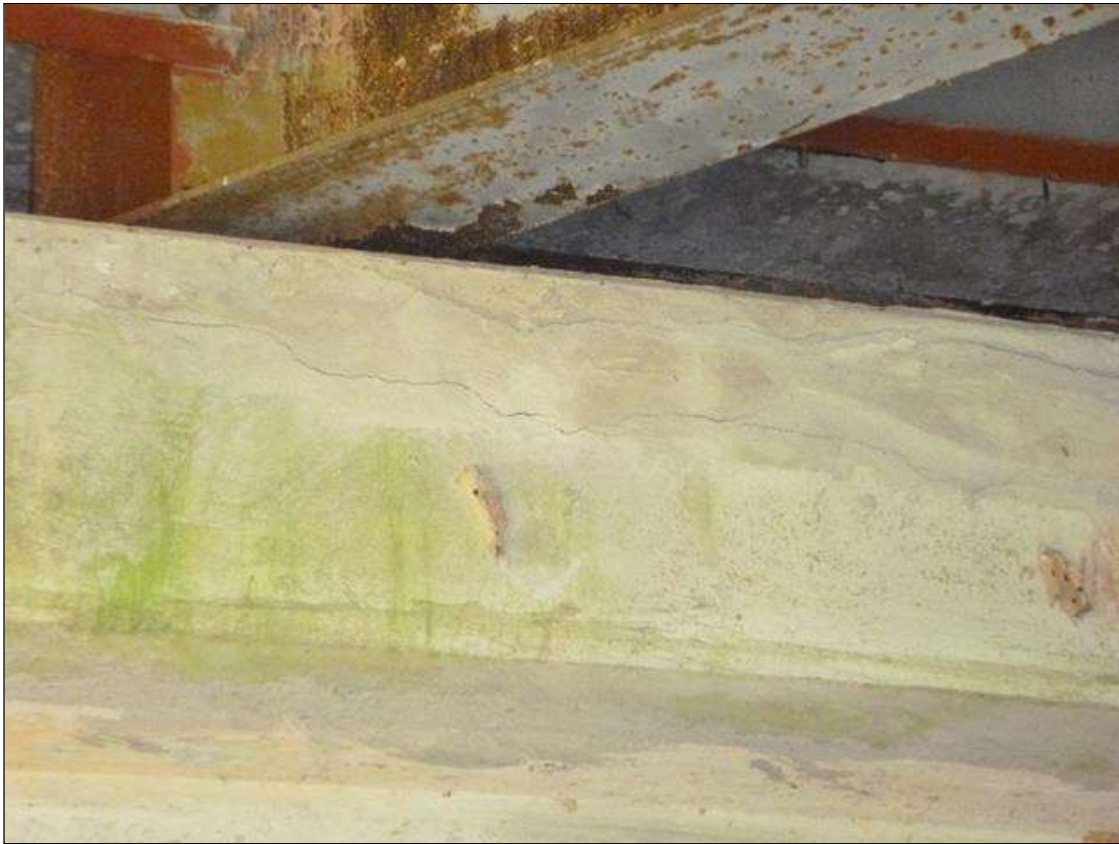
Bent 2 Cap : 6' X 9" DELAMINATION, WEST FACE OF CAP, BELOW BEAM 2.

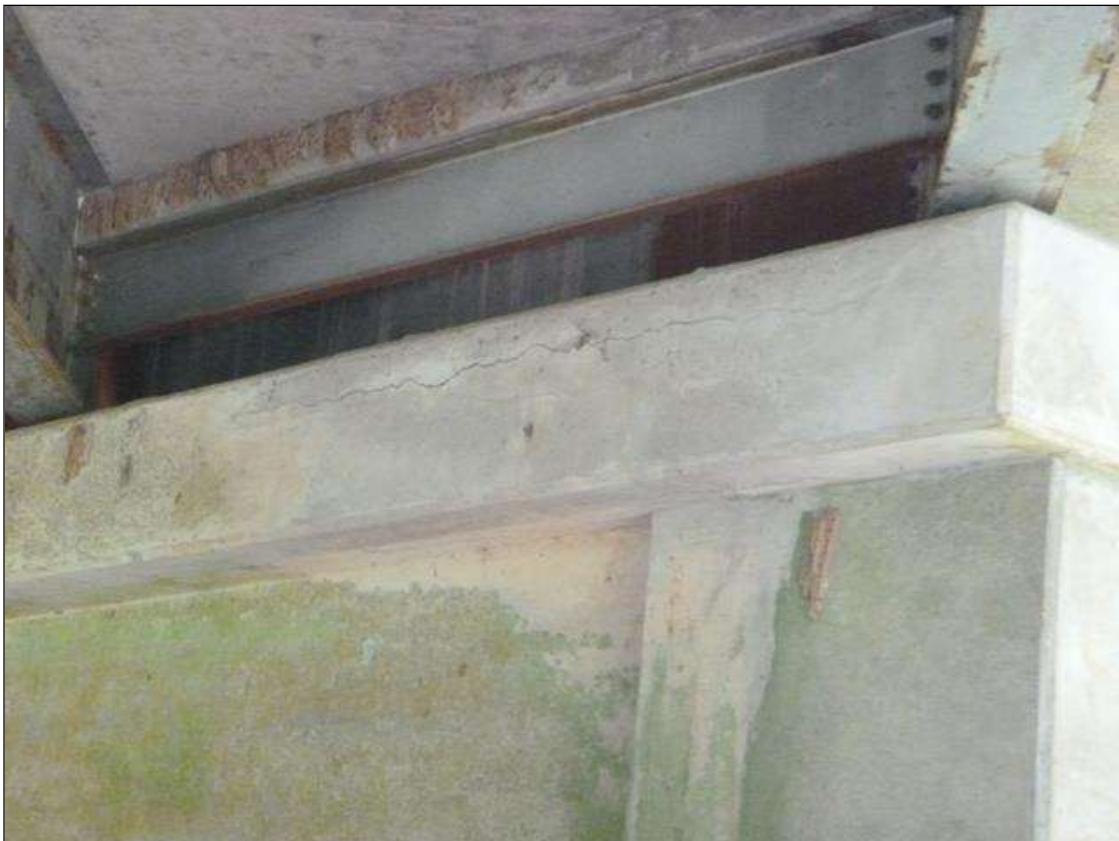
8' HORIZONTAL CRACK UP TO 0.06", EAST FACE, BEGINNING AT NORTH END OF CAP.

Bent 1 Cap : 8' HORIZONTAL CRACK UP TO 0.06", EAST FACE, BEGINNING AT NORTH END OF CAP.

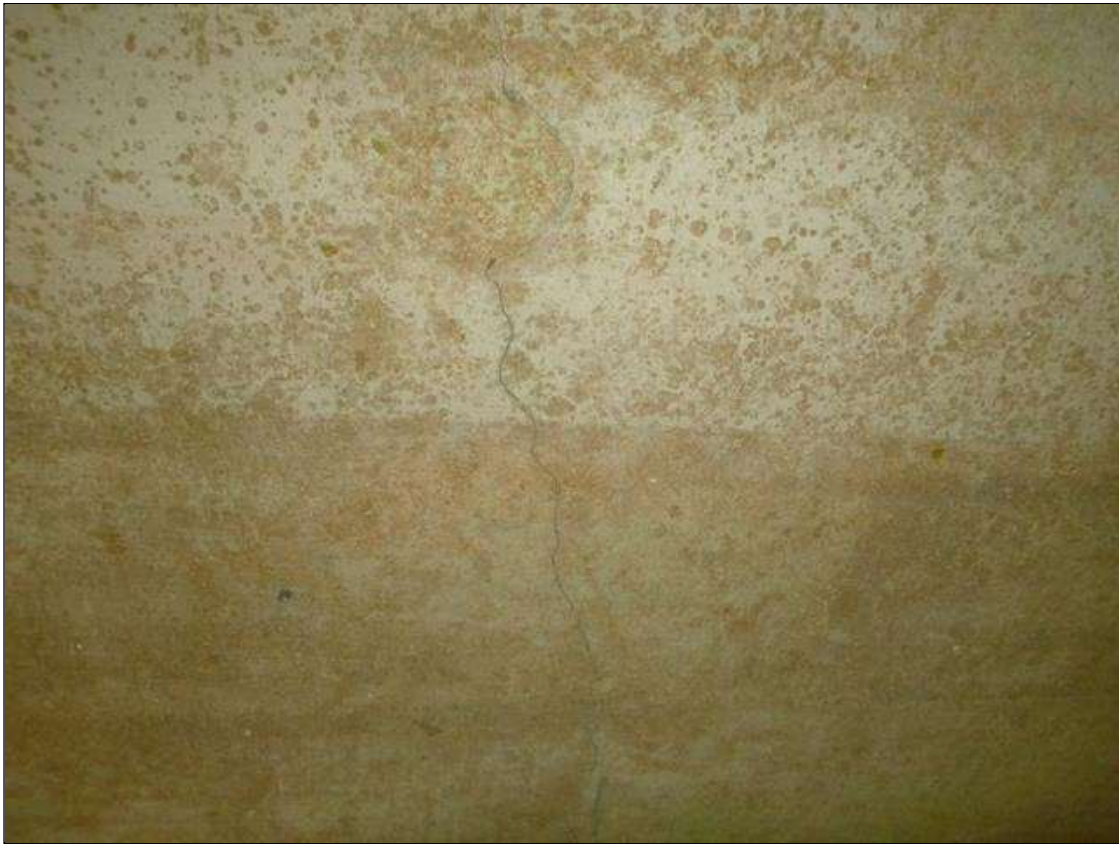
3' VERTICAL CRACK UP TO 0.04", WEST FACE OF PIER WALL, BELOW BEAM 2.

Bent 1 Pile 2: 3' VERTICAL CRACK UP TO 0.04", WEST FACE, BELOW BEAM 2.
