NC DEPARTMENT OF TRANSPORTATION  
DIVISION OF HIGHWAYS  
STRUCTURE MANAGEMENT UNIT

## Structure Safety Report

### Routine Element Inspection - Contract

COUNTY: ROWAN STRUCTURE NUMBER: 790063 FREQUENCY: 24 MONTHS

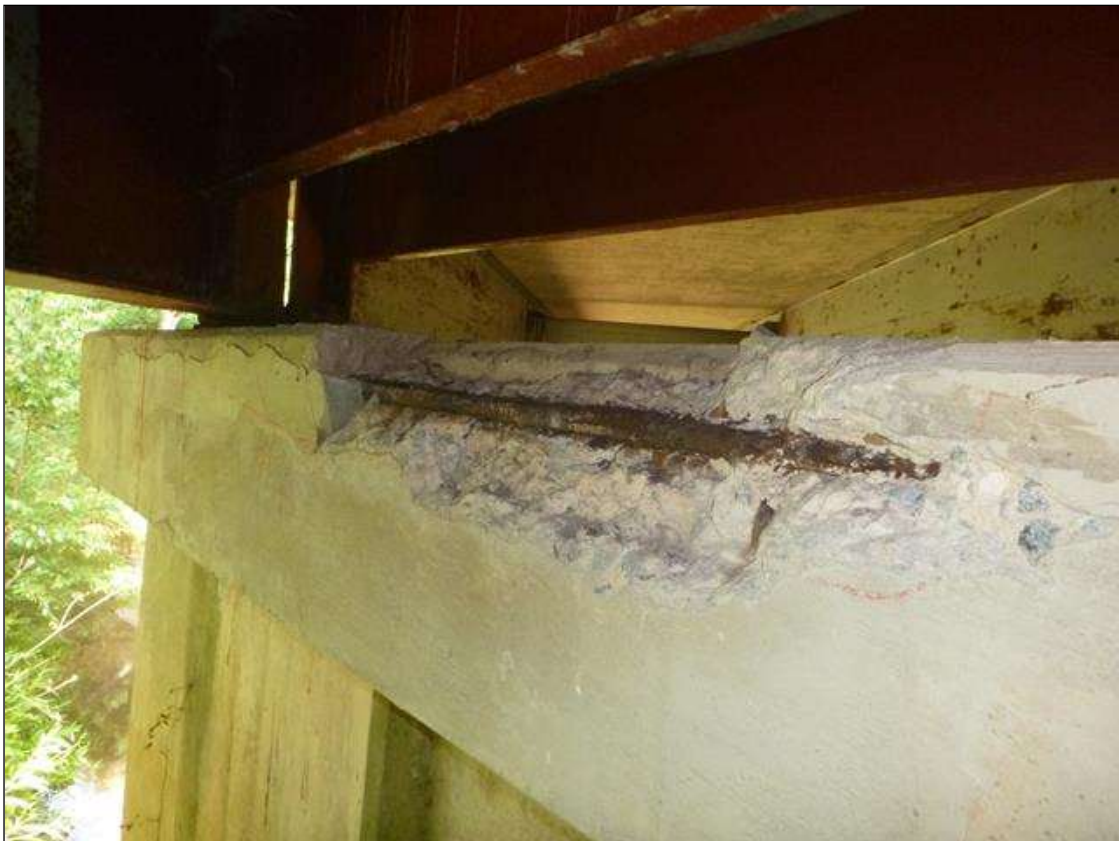
8' X 8" X 9" DELAMINATION/SPALL WITH EXPOSED REINFORCING, WEST FACE, BEGINNING UNDER BEAM 1 BEARING ASSEMBLY. (PM)

Bent 1 Cap : 8' X 8" X 9" DELAMINATION/SPALL WITH EXPOSED REINFORCING, WEST FACE, BEGINNING UNDER BEAM 1 BEARING ASSEMBLY. (PM)

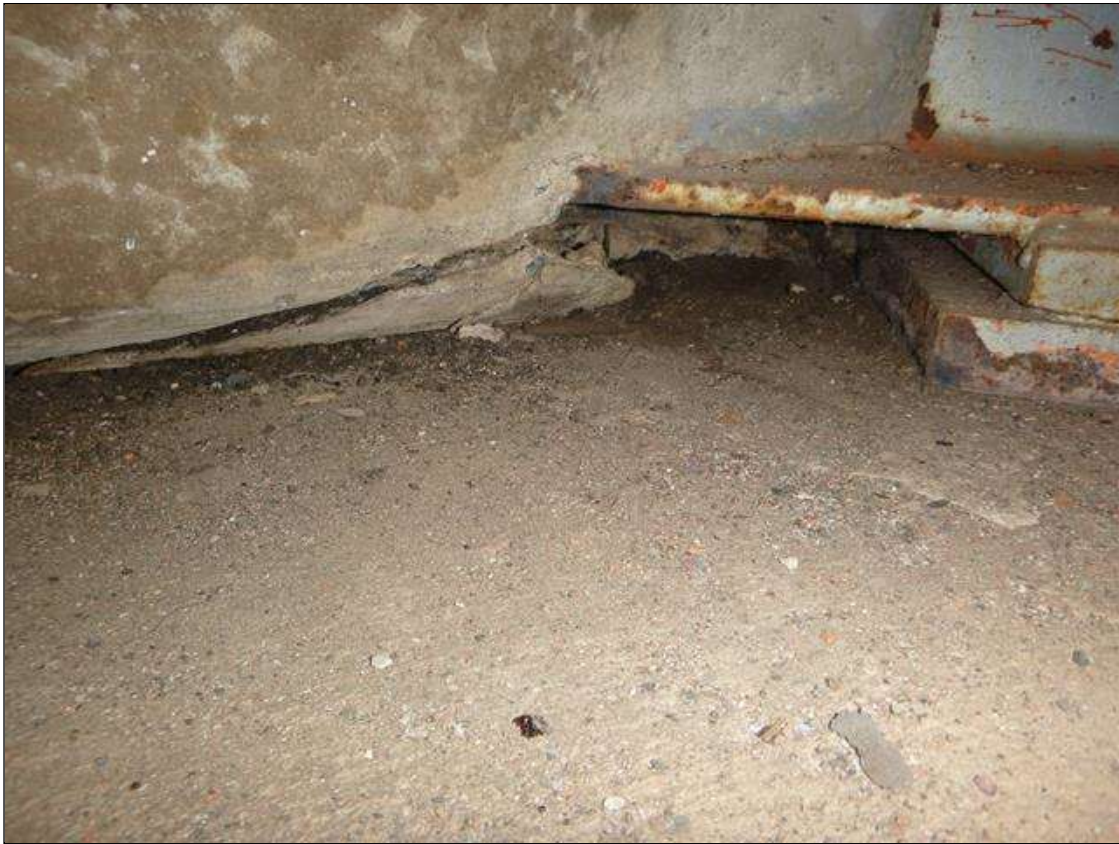
12" X 3" X 3" SPALL, FACE OF CURTAIN WALL, SOUTH SIDE OF BEAM 1.

End Bent 2 Abutment/Backwall : 12" X 3" X 3" SPALL, FACE OF CURTAIN WALL, SOUTH SIDE OF BEAM 1.

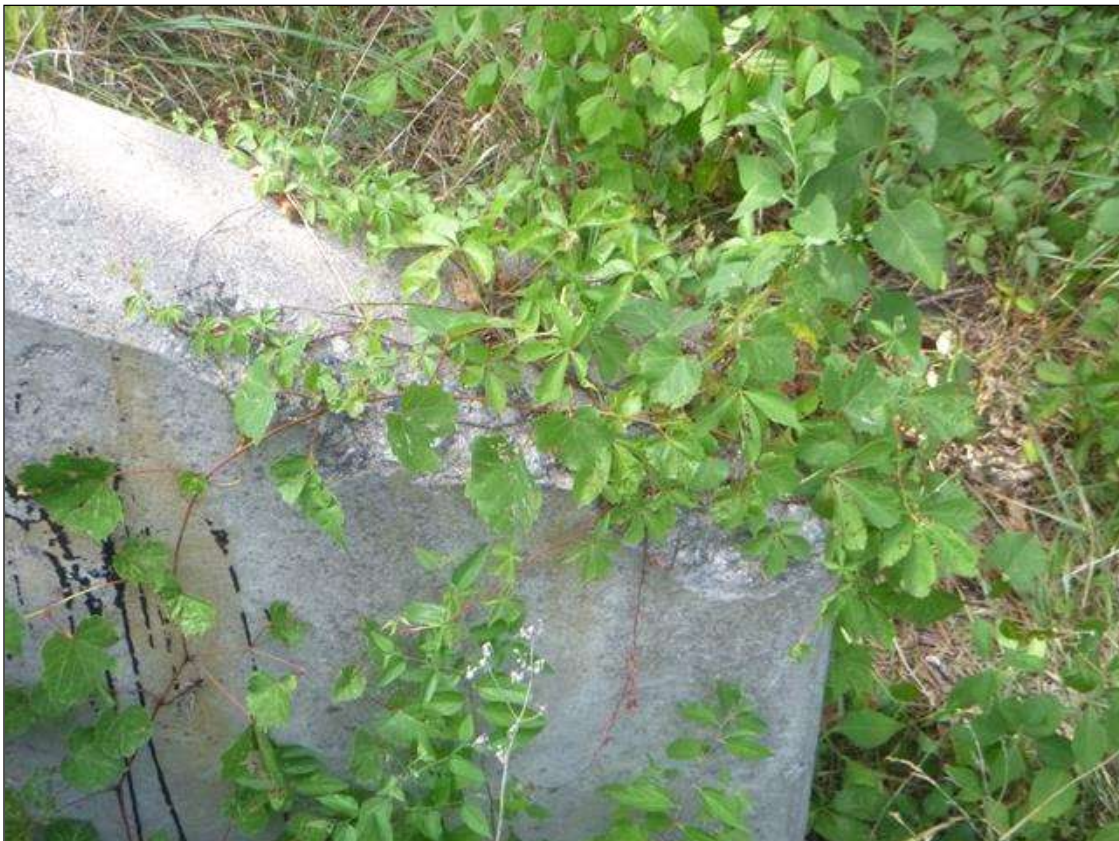
32" X 6" X 4" SPALL, TOP CORNER OF NORTHWEST WINGWALL.

Wingwalls: 32" X 6" X 4" SPALL, TOP CORNER OF NORTHWEST WINGWALL.

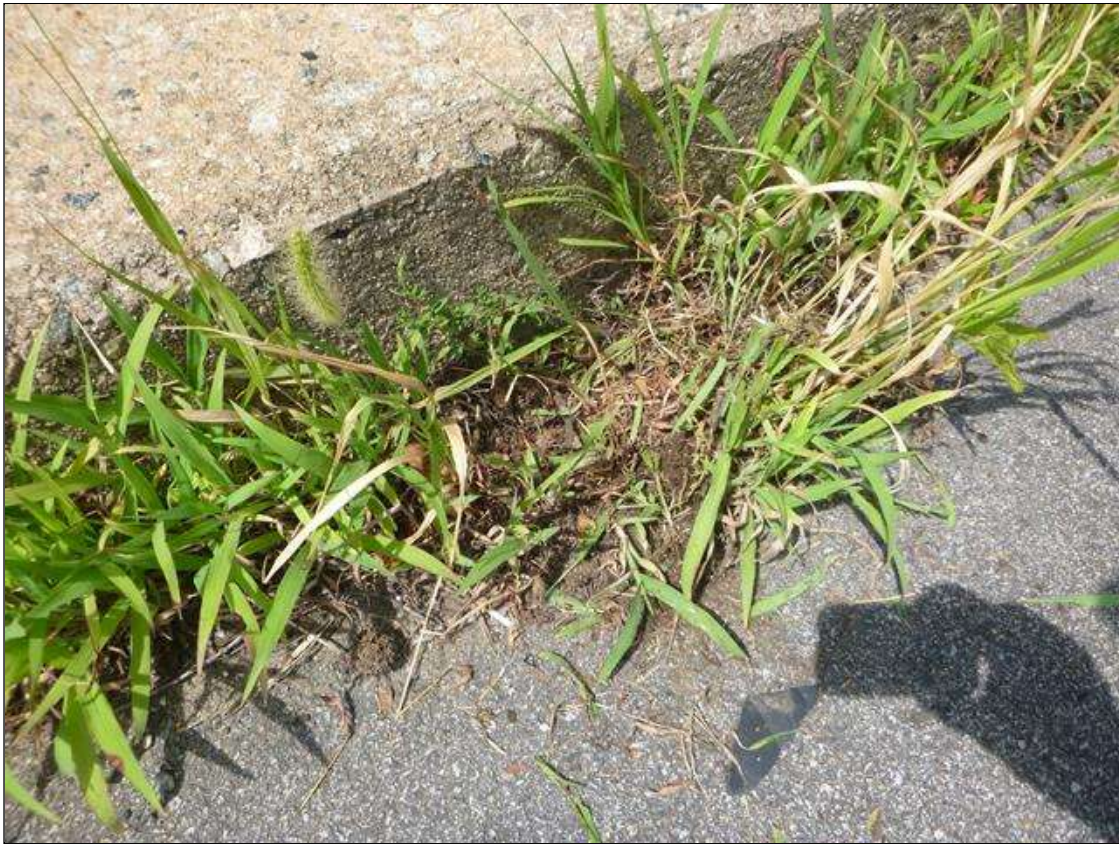
Drainage System: 100% OF DRAINS ARE CLOGGED BY VEGETATION GROWTH.

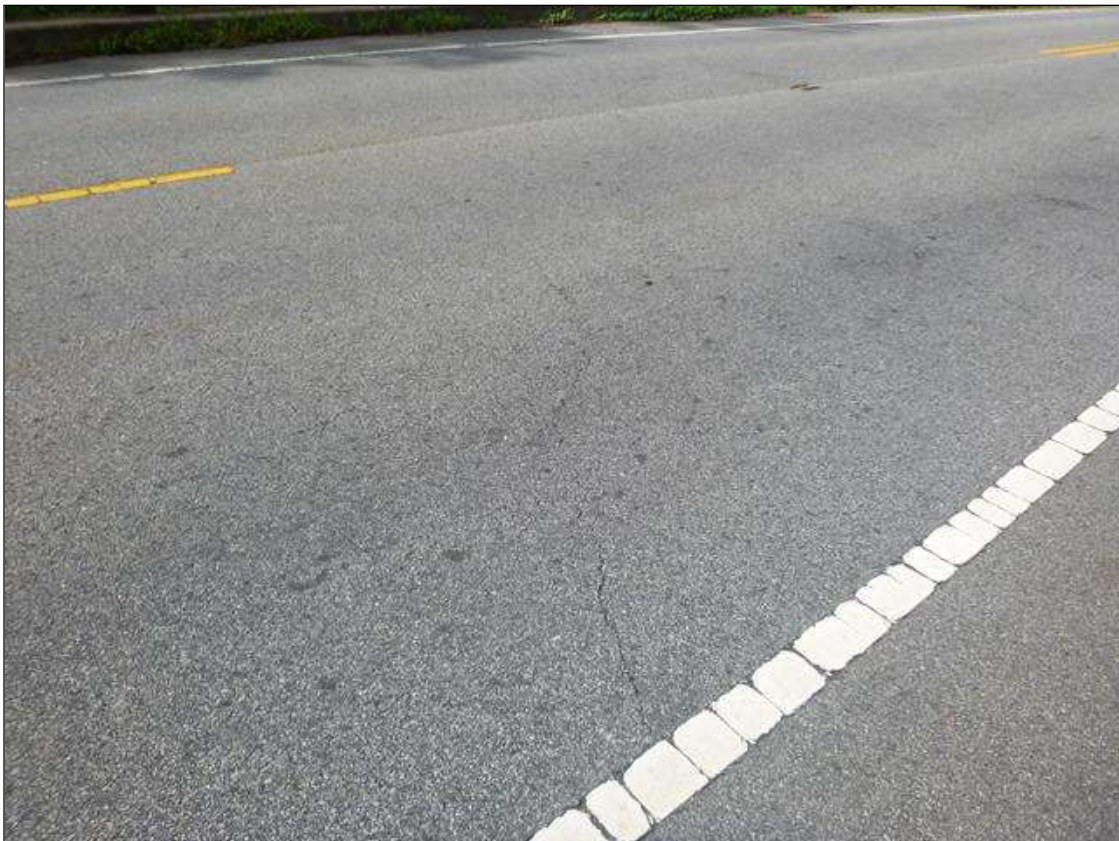
CRACK IN ASPHALT WEARING SURFACE OVER END BENT 1, LOOKING SOUTH

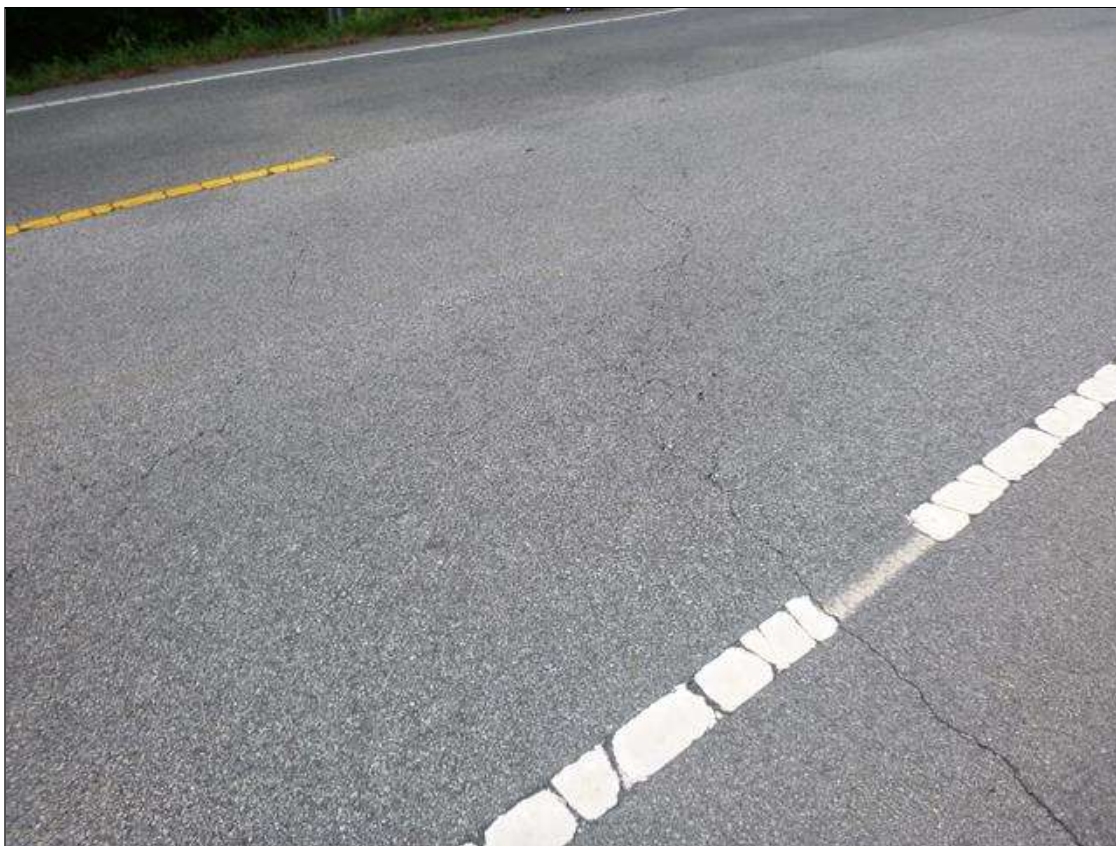
CRACK IN ASPHALT WEARING SURFACE OVER END BENT 2, LOOKING SOUTH
