NC DEPARTMENT OF TRANSPORTATION  
DIVISION OF HIGHWAYS  
STRUCTURE MANAGEMENT UNIT

## Structure Safety Report

### Routine Element Inspection - Contract

COUNTY: AVERY STRUCTURE NUMBER: 050047 FREQUENCY: 24 MONTHS

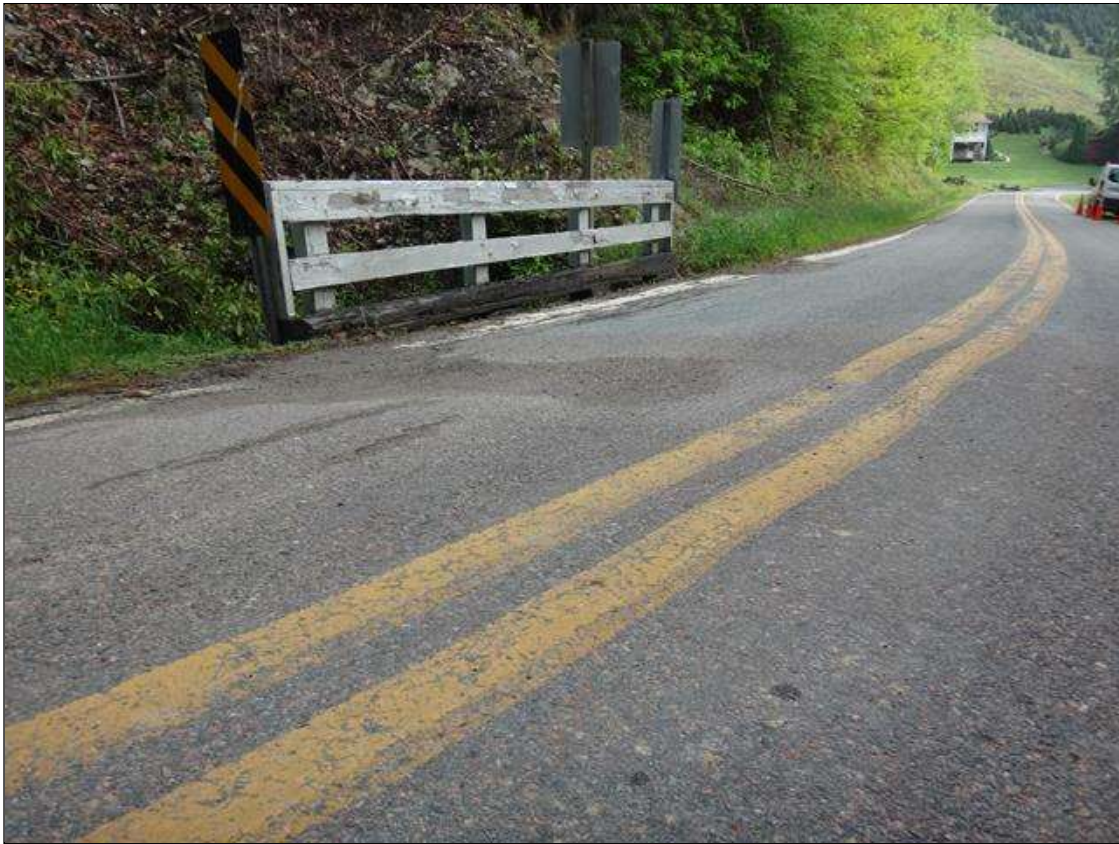
rutting in both lanes (up to 4in)  
 5 Square Feet of Delamination/Spall/Patched Area/Pothole (Wearing Surfaces): Delaminated. Spall 1 in. deep or greater or 6 in. diameter or greater. Patched area that is unsound or showing distress. Full depth pothole.. East shoulder at north approach, settlement (4in)  
 dropoff at both curbs (6in x full length)  
 30 Square Feet of Crack (Wearing Surface): Width of more than 0.05 in. or spacing of less than 1.0 ft.. Left shoulder Multiple longitudinal cracks (1/4 in x full length)

Span 1 Wearing Surface: rutting in both lanes (up to 4in)

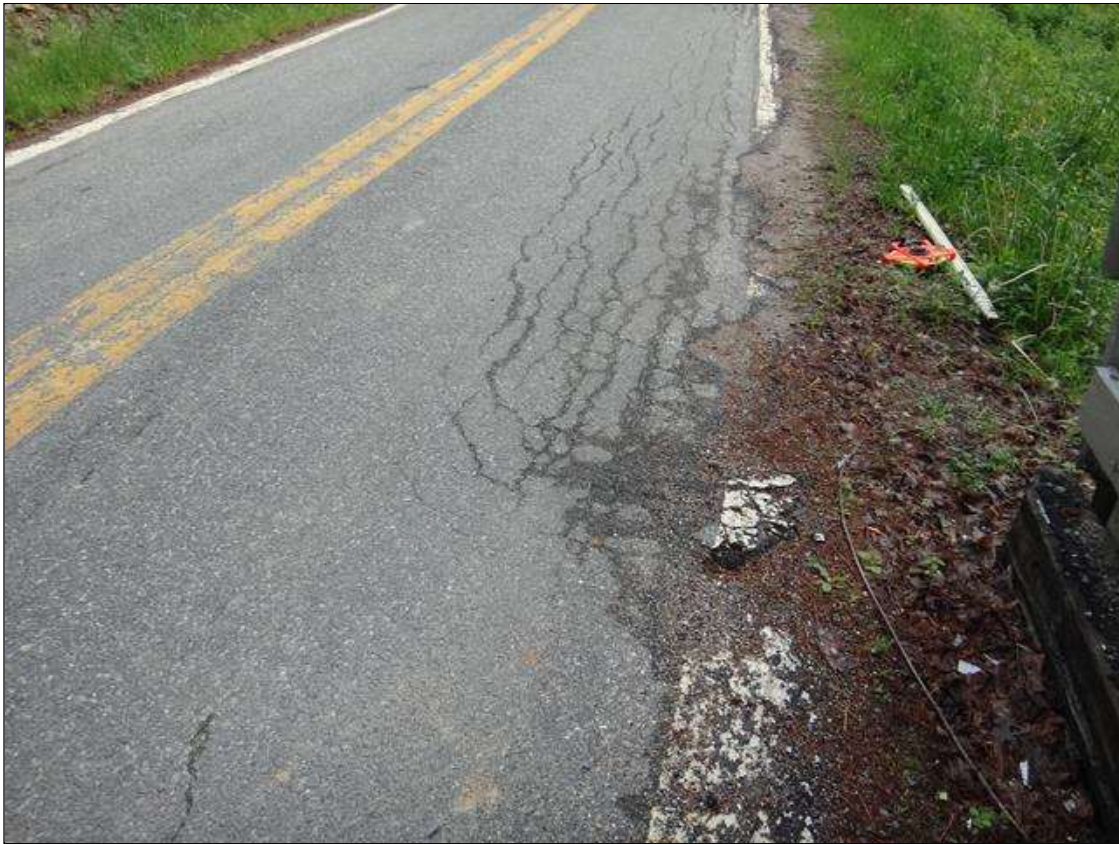
Span 1 Wearing Surface: 5 Square Feet of Delamination/Spall/Patched Area/Pothole (Wearing Surfaces): Spall 1 in. deep or greater or 6 in. diameter or greater. Patched area that is unsound or showing distress. Full depth pothole. East shoulder at north approach, settlement (4in)

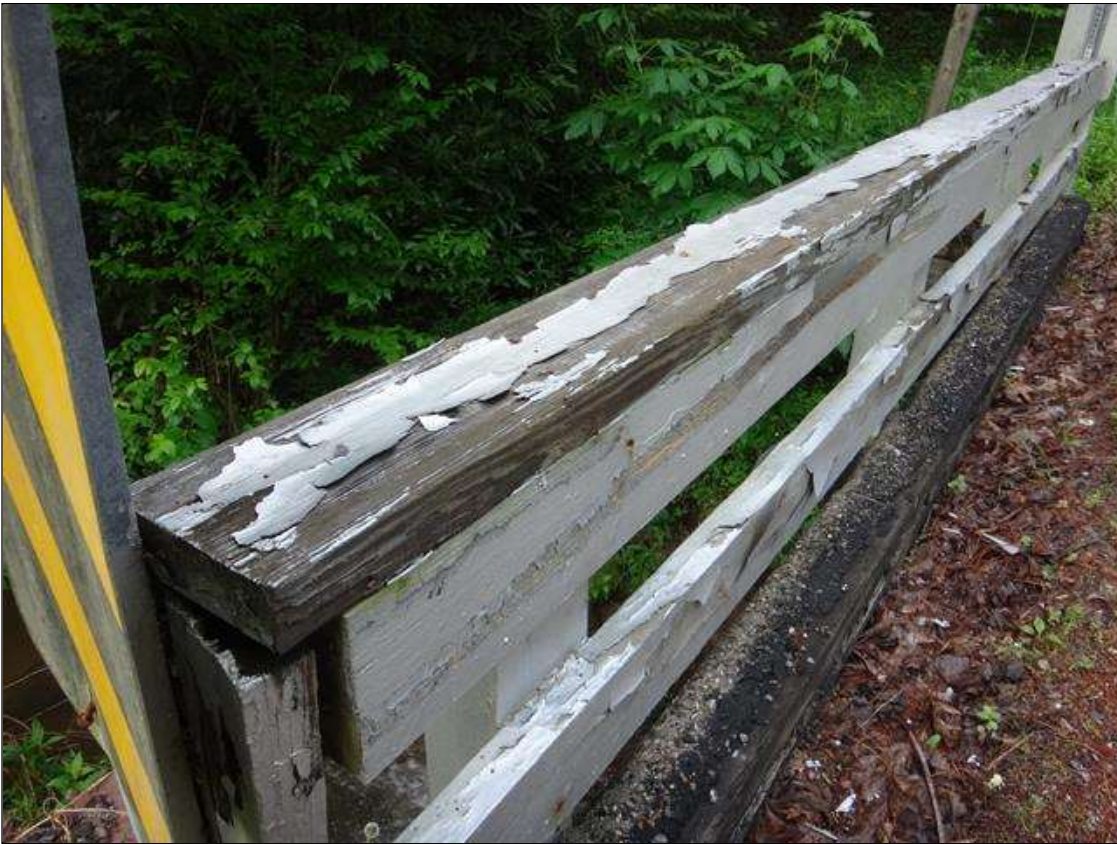
40 Square Feet of Peeling/Bubbling/Cracking: paint peeling and exposure of timber.  
 17 Feet of Check/Shake: Penetrates 5%-50% of the thickness of the member and not in a tension zone. Curb, checks (1/8 in x full length)  
 4 Feet of Split/Delamination (Timber): Length equal to or greater than the member depth but does not require structural review.  
 Outrigger split (4 locations)

Span 1 Right Bridge Rail: 40 Square Feet of Peeling/Bubbling/Cracking: paint peeling and exposure of timber.

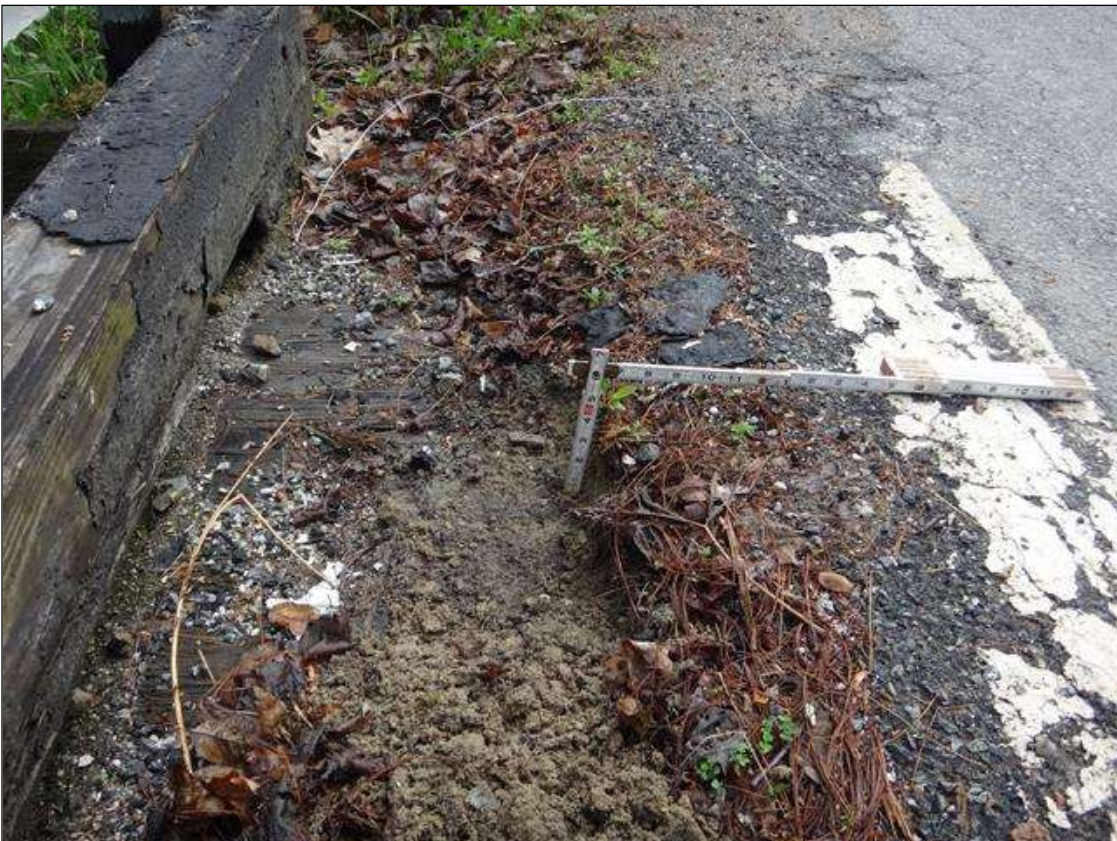
Span 1 Wearing Surface: dropoff at both curbs (6in x full length)

| MMS Code | Description of Function | Unit | Quantity | Remarks | Est. Cost |
|---|---|---|---|---|---|
| 2816 | Asphalt Surface Repair or Replacement | SY | 4 | SPAN 1 ASPHALT WEARING SURFACE, DROPOFF AT BOTH CURBS (6IN X FULL LENGTH) | |

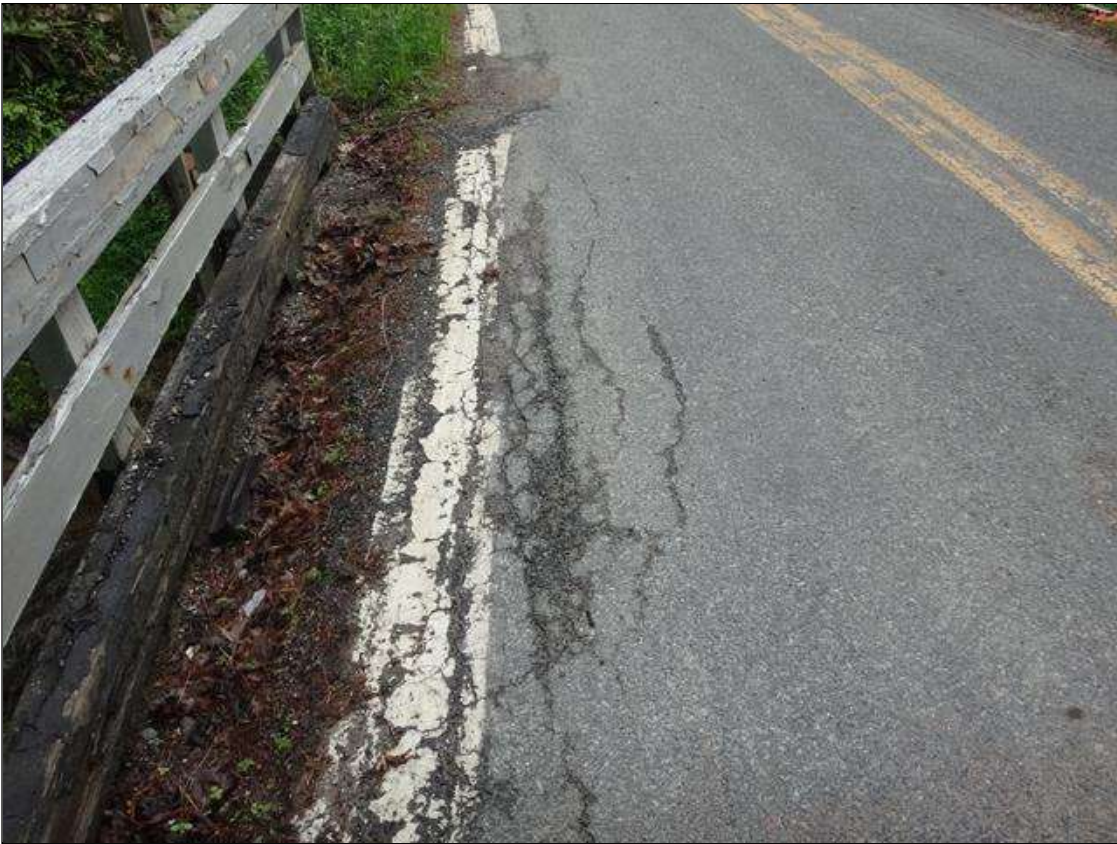
Span 1 Wearing Surface: 30 Square Feet of Crack (Wearing Surface): Width of more than 0.05 in. or spacing of less than 1.0 ft.. Left shoulder Multiple longitudinal cracks (1/4 in x full length)

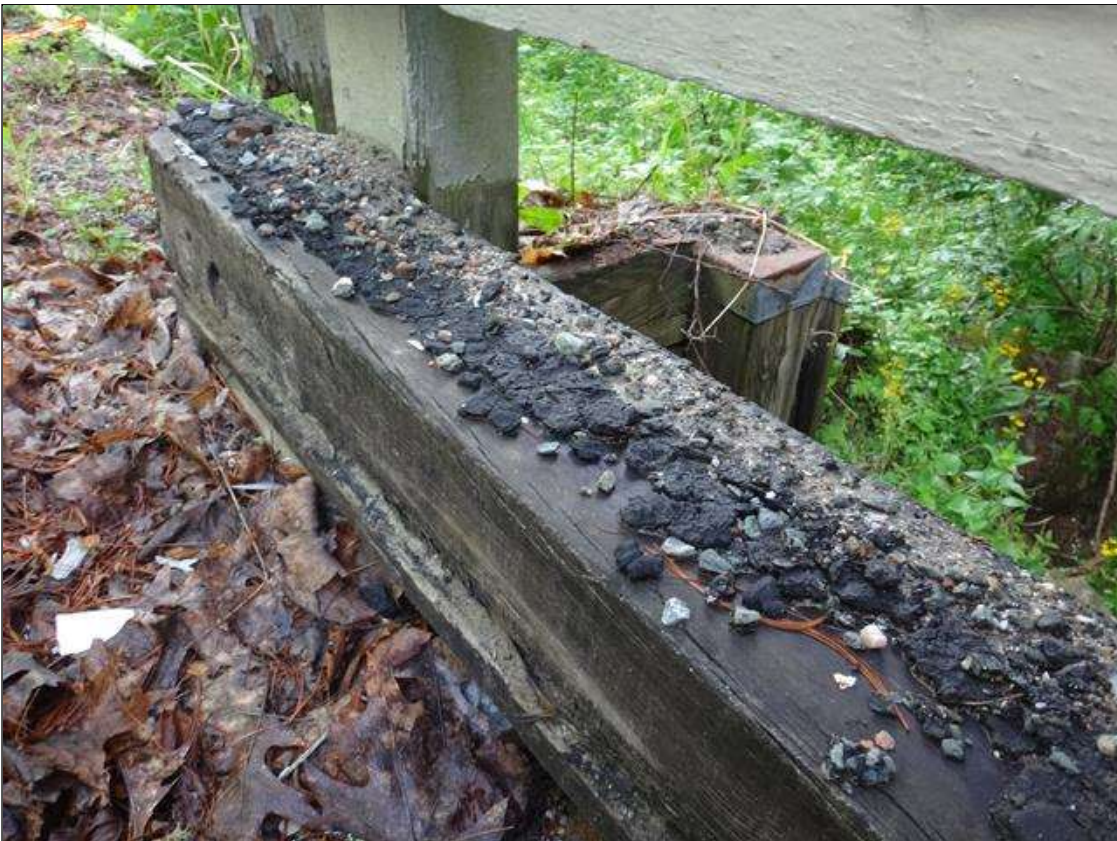
Span 1 Right Bridge Rail: 17 Feet of Check/Shake: Penetrates 5%-50% of the thickness of the member and not in a tension zone. Curb, checks (1/8 in x full length)

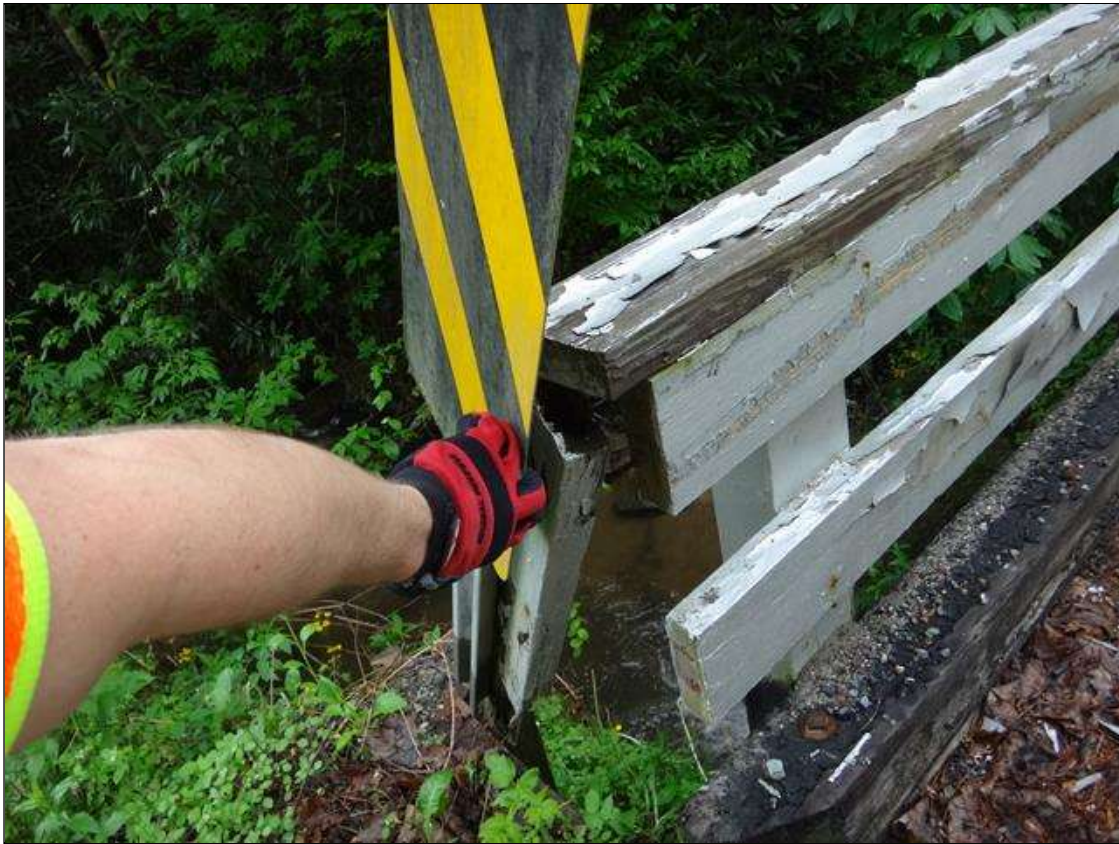
40 Square Feet of Peeling/Bubbling/Cracking: paint peeling and exposure of timber.  
 17 Feet of Check/Shake: Penetrates 5%-50% of the thickness of the member and not in a tension zone. Curb, checks (1/8 in x full length)  
 1 Feet of Connection: The condition warrants a structural review to determine the effect on strength or serviceability of the element or bridge; OR a structural review has been completed and the defects impact strength or serviceability of the element or bridge. north end post single point attachment, includes delineator

Span 1 Right Bridge Rail: 1 Feet of Connection: The condition warrants a structural review to determine the effect on strength or serviceability of the element or bridge; OR a structural review has been completed and the defects impact strength or serviceability of the element or bridge. north end post single point attachment, includes delineator

| MMS Code | MMS Description | Quantity |
|---|---|---|
| SPAN 1 RIGHT BRIDGE RAIL NORTH END POST SINGLE POINT ATTACHMENT INCLUDES DELINEATOR | | |

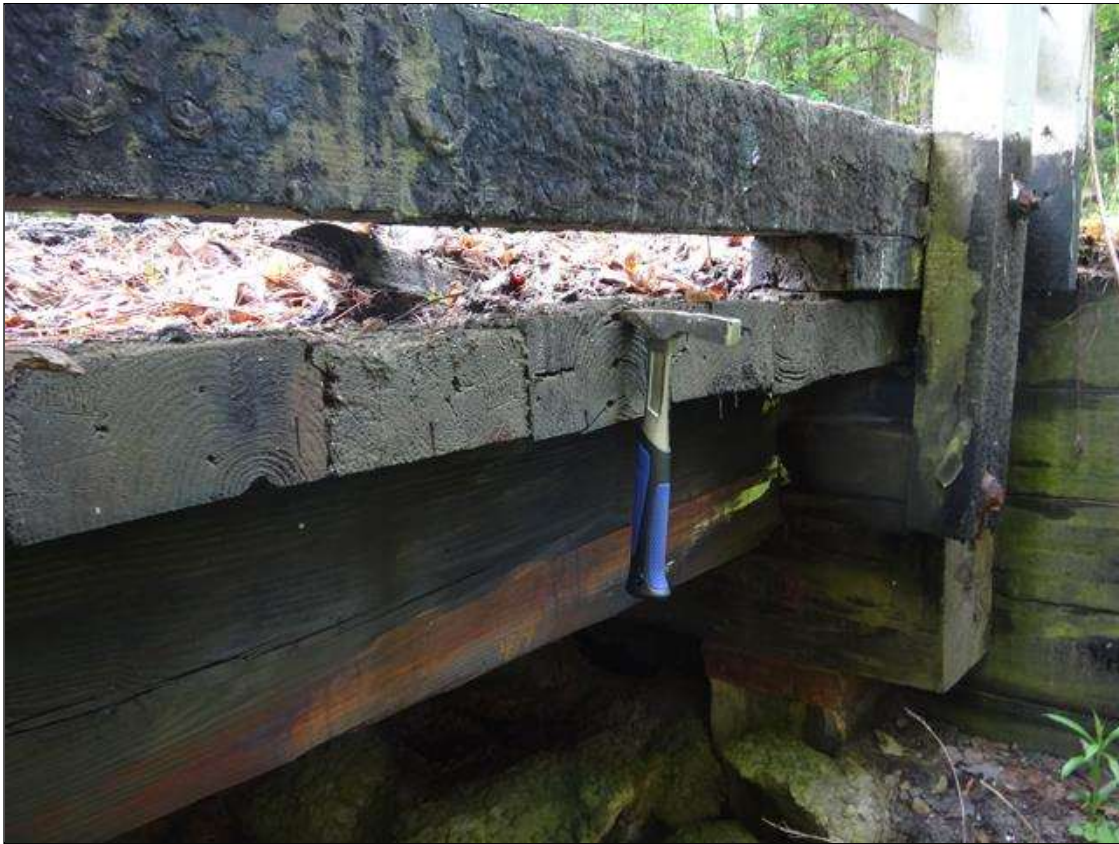
32 Square Feet of Check/Shake: Penetrates 5% - 50% of the thickness of the member and not in a tension zone. board ends wet/soft with shakes at random, both ends (full length)

Span 1 Deck: 32 Square Feet of Check/Shake: Penetrates 5% - 50% of the thickness of the member and not in a tension zone. board ends wet/soft with shakes at random, both ends (full length)

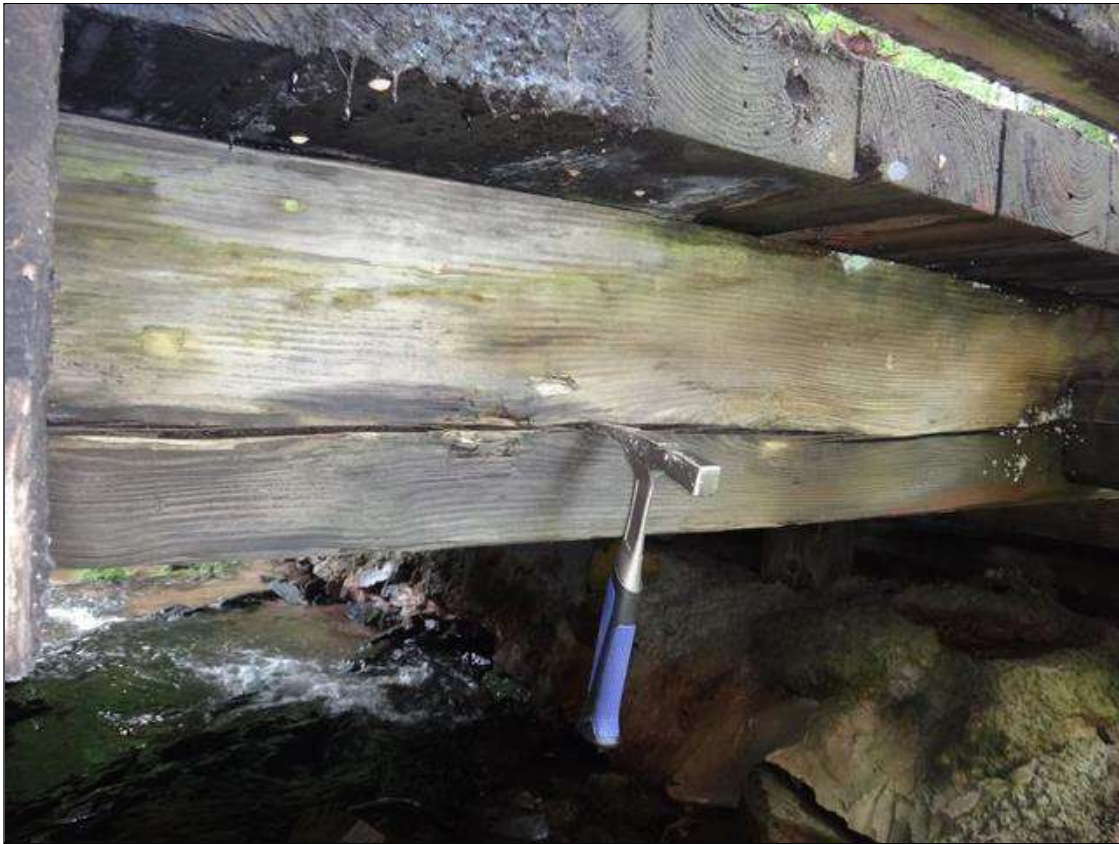
17 Feet of Split/Delamination (Timber): The condition warrants a structural review to determine the effect on strength or serviceability of the element or bridge; OR a structural review has been completed and the defects impact strength or serviceability of the element or bridge. Split at mid height (full length)  
 2 Feet of Decay/Section Loss: Affects less than 10% of the member section. at end bent 1, decay (2ft x 3in)

Span 1 Beam 1: 17 Feet of Split/Delamination (Timber): The condition warrants a structural review to determine the effect on strength or serviceability of the element or bridge; OR a structural review has been completed and the defects impact strength or serviceability of the element or bridge. Split at mid height (full length)

| MMS Code | Description of Function | Unit | Quantity | Remarks | Est. Cost |
|---|---|---|---|---|---|
| 3304 | Maintain/Replace Timber Superstructure Components | LF | 17 | SPAN 1 BEAM 1 MID HEIGHT AT MIDSPAN, SPLIT (FULL LENGTH X UP TO 1/4IN) | |

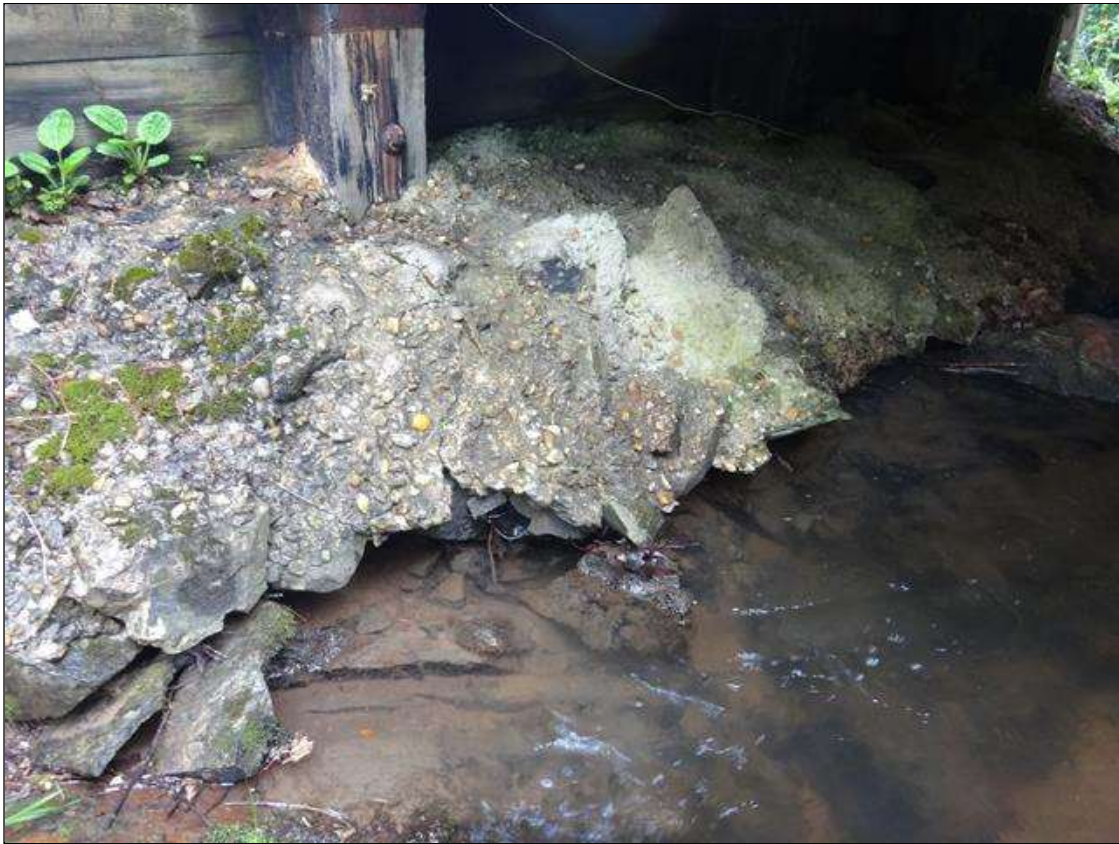
end bent 2 slope protection undermined (8in deep x 2ft x 15 ft)

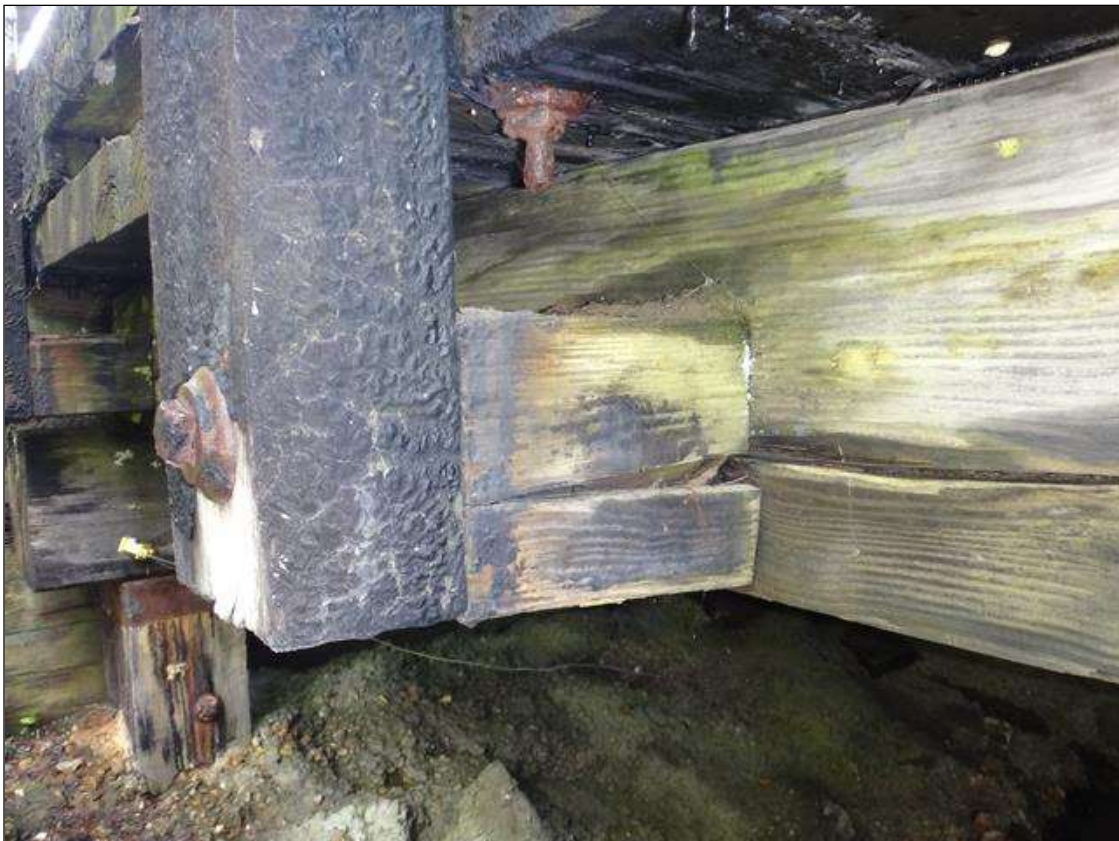
Span 1 Left Bridge Rail: 4 Feet of Split/Delamination (Timber): Length equal to or greater than the member depth but does not require structural review. Outrigger split (4 locations)

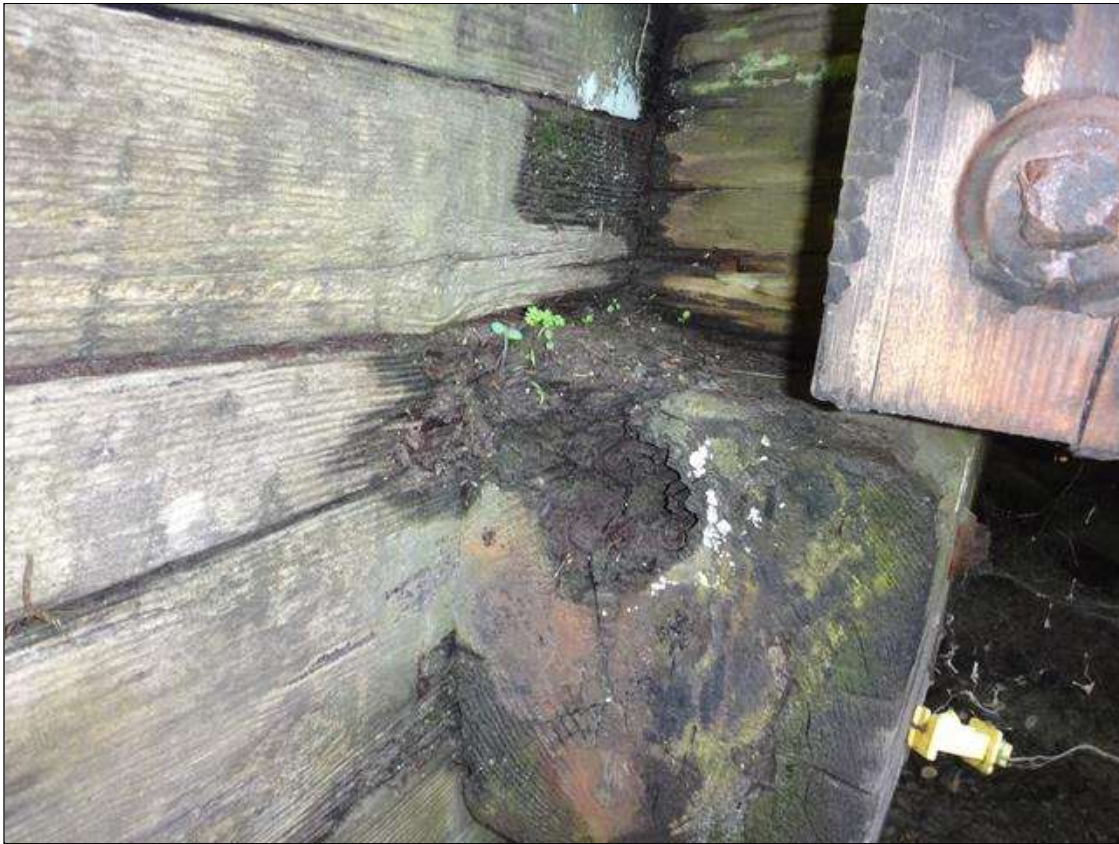
1 Feet of Decay/Section Loss: Affects less than 10% of the member section. left end, decay (4in x 3in)  
20 Feet of Check/Shake: Penetrates 5%-50% of the thickness of the memeber and not in a tension zone. checks (up to 1/16in) at random

End Bent 2 Cap : 1 Feet of Decay/Section Loss: Affects less than 10% of the member section. left end, decay (4in x 3in)

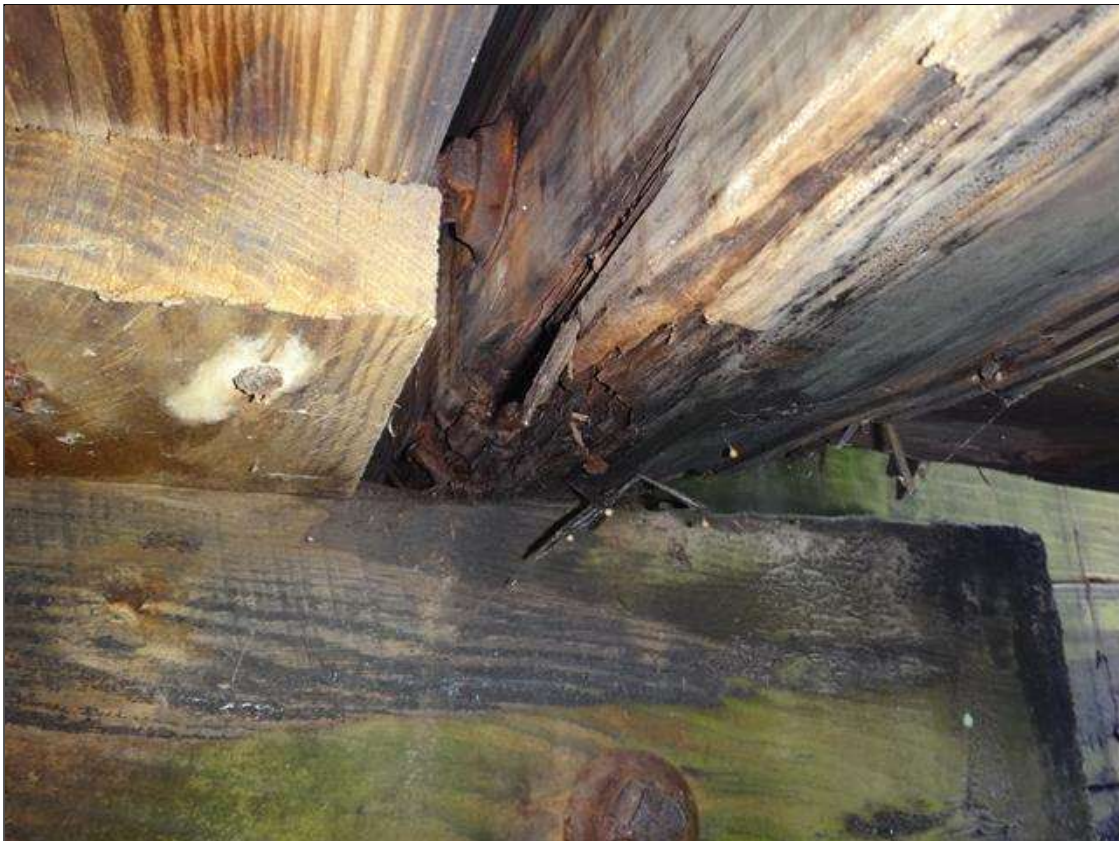
Span 1 Beam 1: 2 Feet of Decay/Section Loss: Affects less than 10% of the member section. at end bent 1, decay (2ft x 3in)

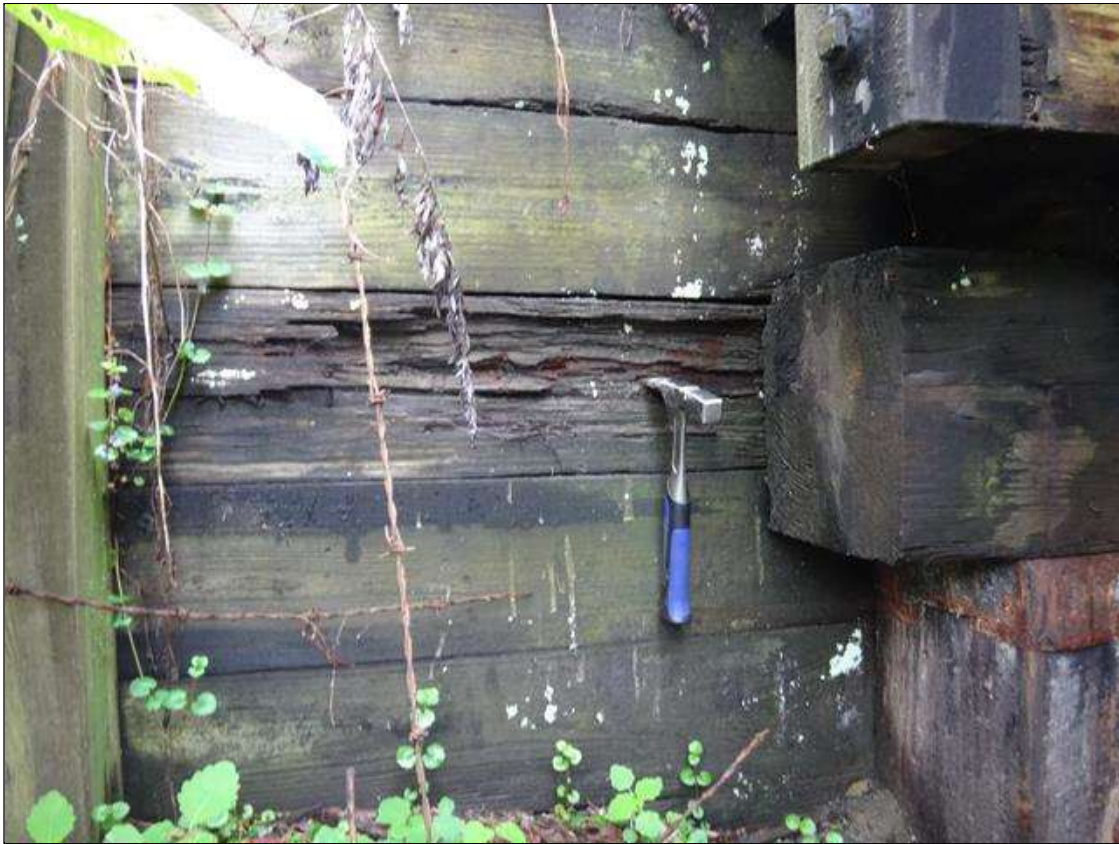
3 Feet of Decay/Section Loss: Affects 10% or more of the member but does not warrant structural review. timber board at east end, decay (3ft x 8in x 1.5in)

End Bent 1 Abutment/Backwall : 3 Feet of Decay/Section Loss: Affects 10% or more of the member but does not warrant structural review. timber board at east end, decay (3ft x 8in x 1.5in)

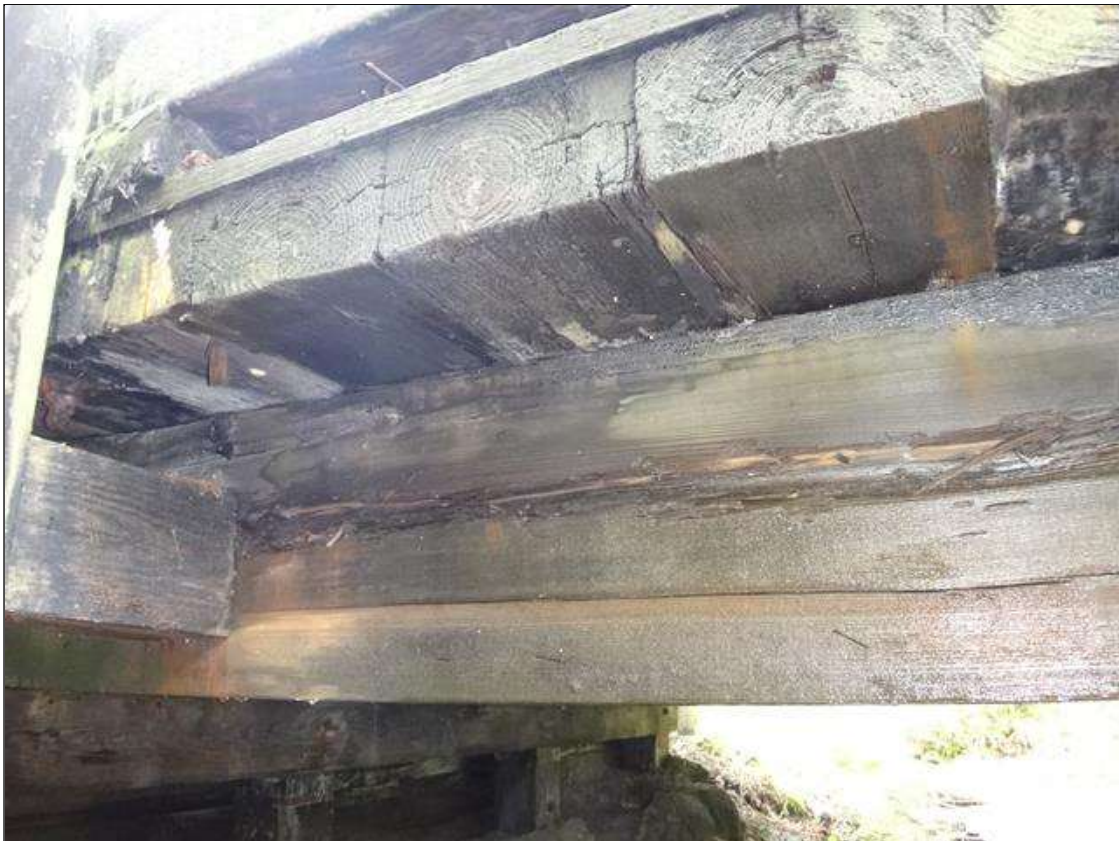
6 Feet of Decay/Section Loss: Affects 10% or more of the member but does not warrant structural review. at midspan, decay (6ft x 2in x 1in) on mid-height

Span 1 Beam 19: 6 Feet of Decay/Section Loss: Affects 10% or more of the member but does not warrant structural review. at midspan, decay (6ft x 2in x 1in) on mid-height

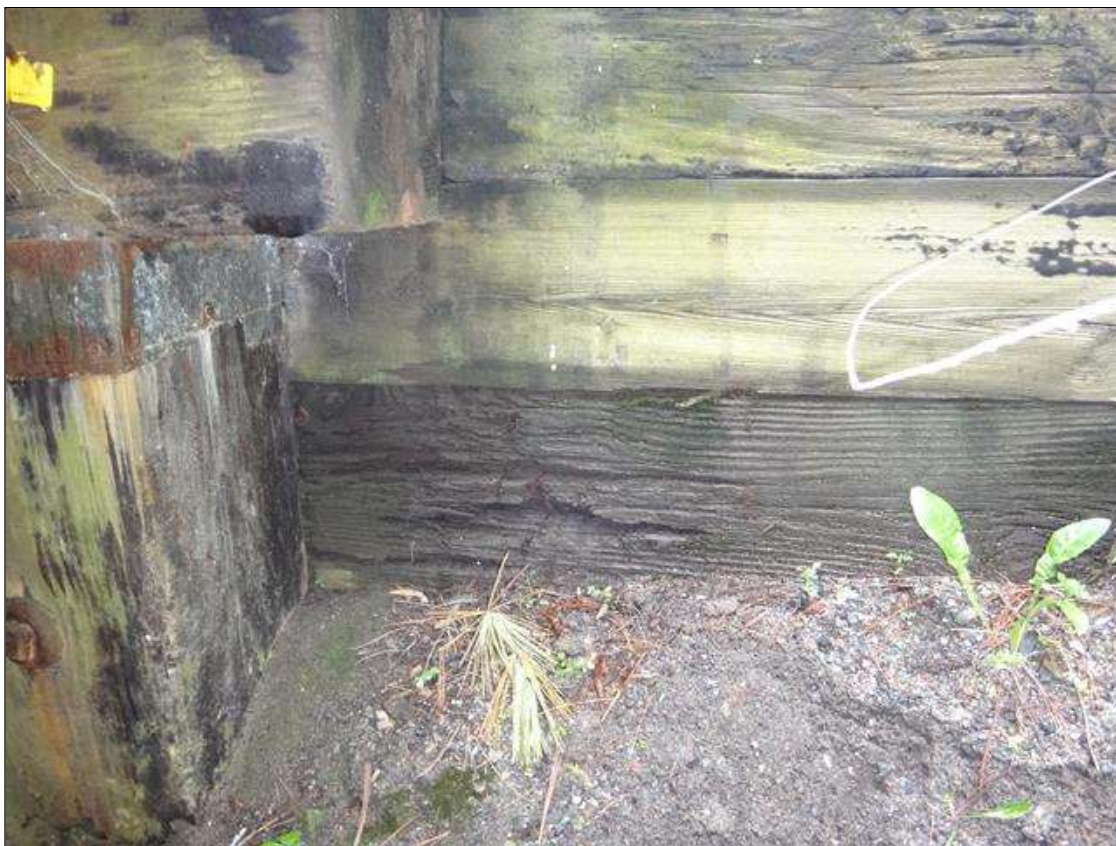
1 Feet of Decay/Section Loss: Affects less than 10% of the member section. bottom board at east end, decay (1ft x 1ft x 1in)

End Bent 2 Abutment/Backwall : 1 Feet of Decay/Section Loss: Affects less than 10% of the member section. bottom board at east end, decay (1ft x 1ft x 1in)

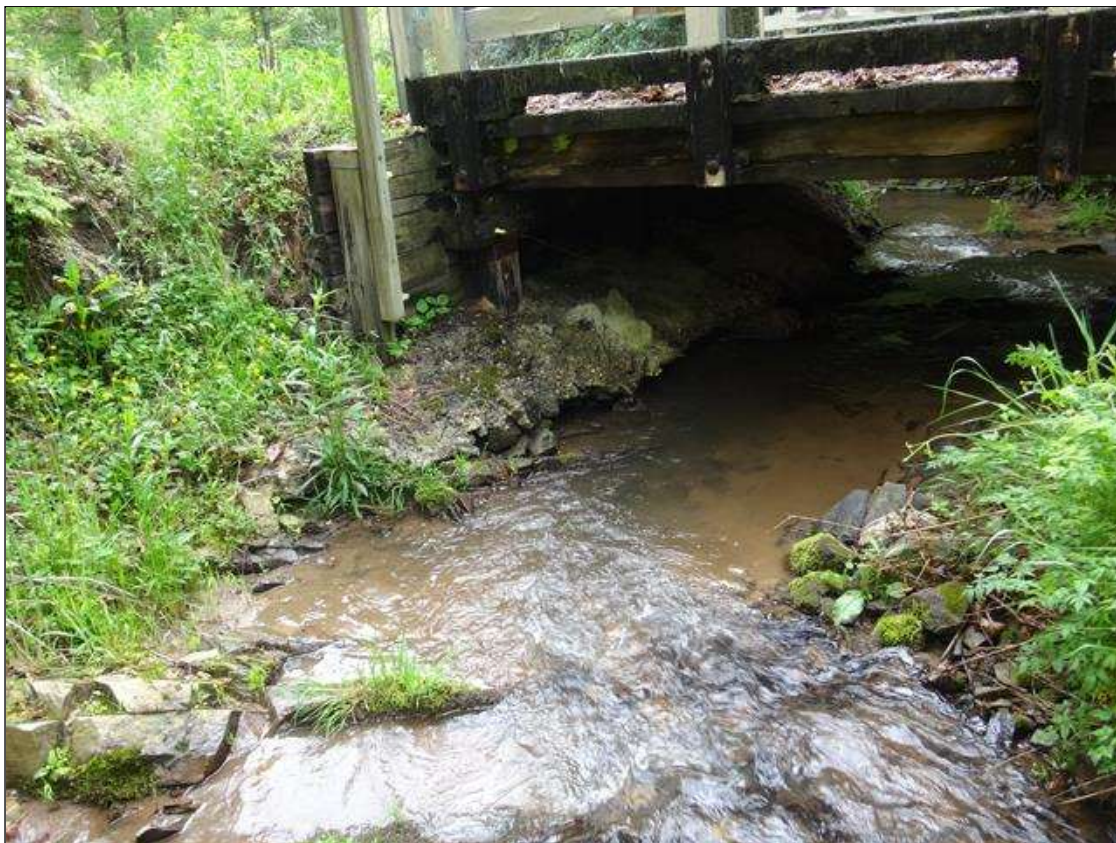
streamflow directed towards end bent 2

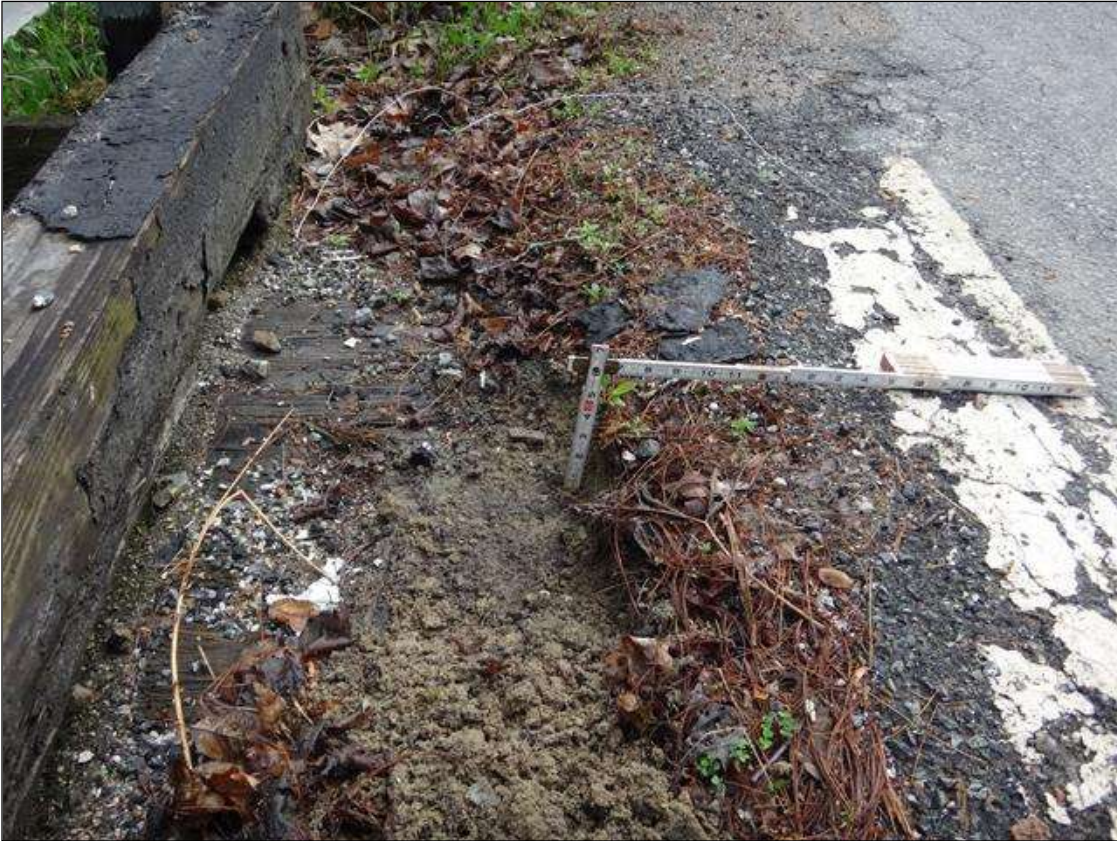
SPAN 1 WEARING SURFACE, DROPOFF AT BOTH CURBS (6IN X FULL LENGTH)

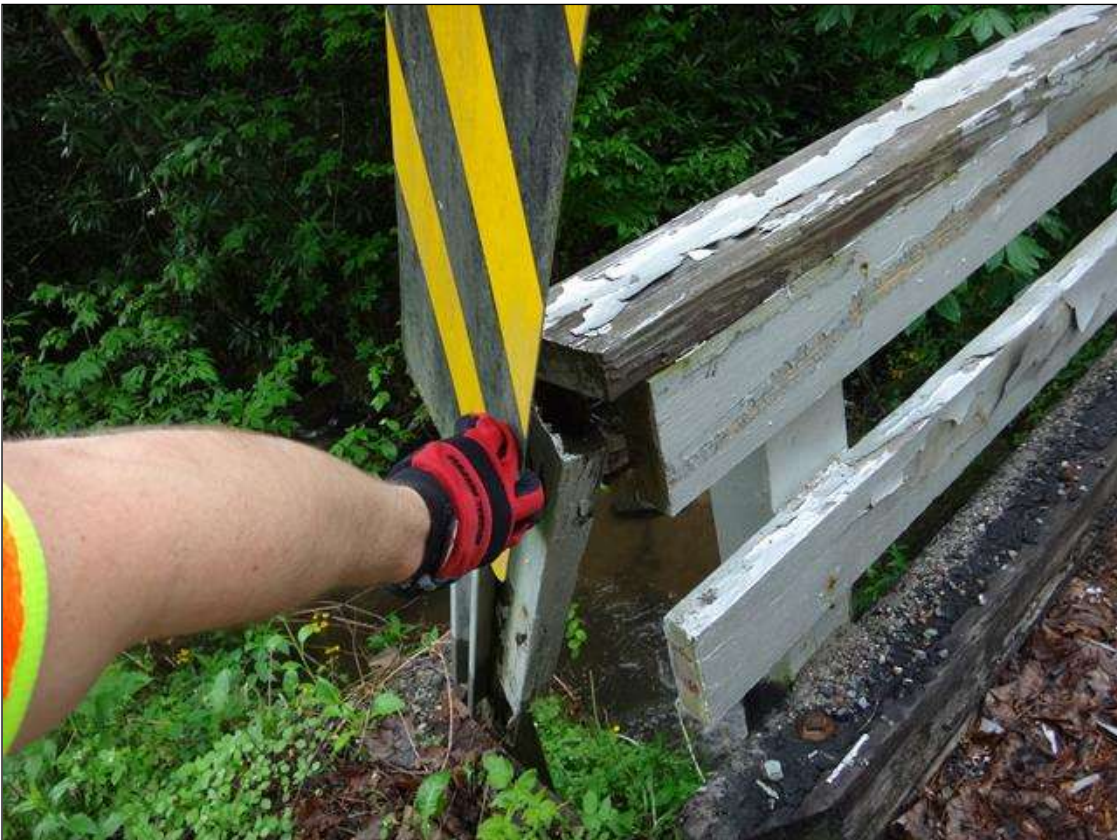
SPAN 1 RIGHT BRIDGE RAIL NORTH END POST SINGLE POINT ATTACHMENT INCLUDES DELINEATOR, DETACHED

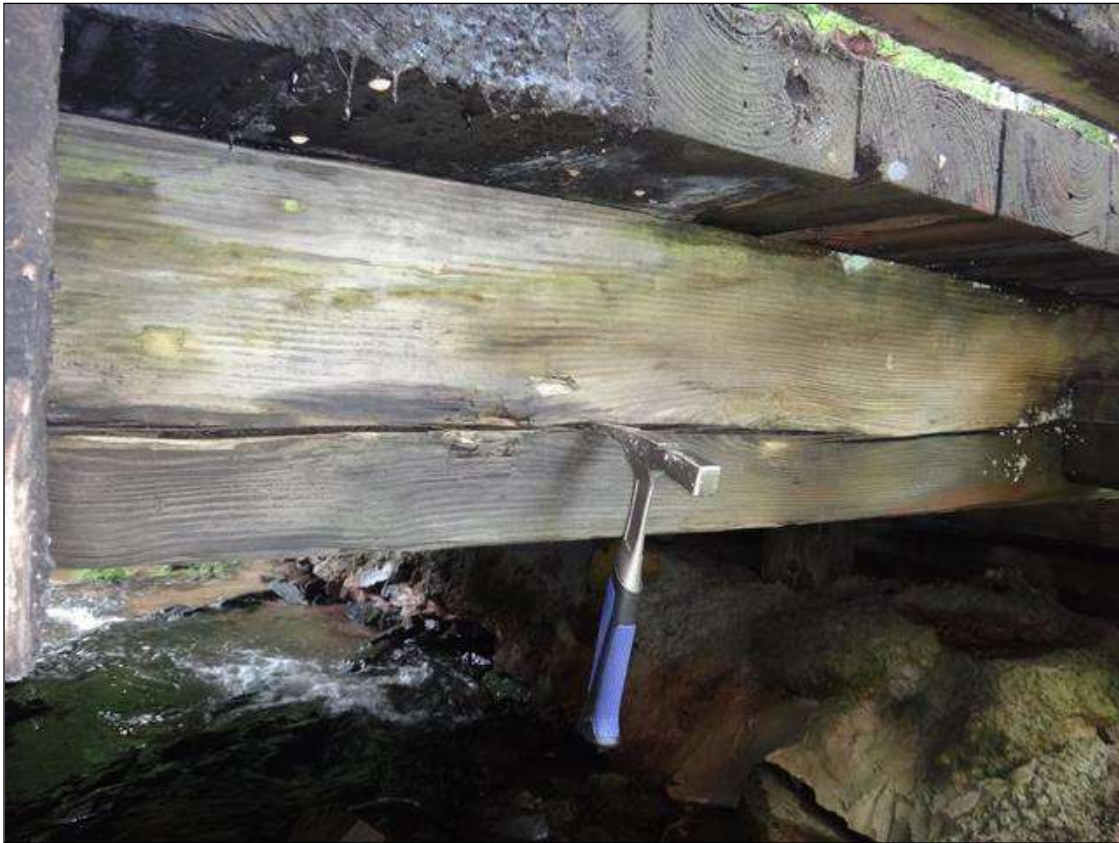
SPAN 1 BEAM 1 MID HEIGHT AT MIDSPAN, SPLIT (FULL LENGTH X UP TO 1/4IN)
