NC DEPARTMENT OF TRANSPORTATION  
DIVISION OF HIGHWAYS  
BRIDGE MANAGEMENT UNIT

# BRIDGE INSPECTION REPORT

COUNTY WATAUGA BRIDGE NUMBER 940046 INSPECTION CYCLE 0 YRS

SR1351 (CASTLE FORD RD)

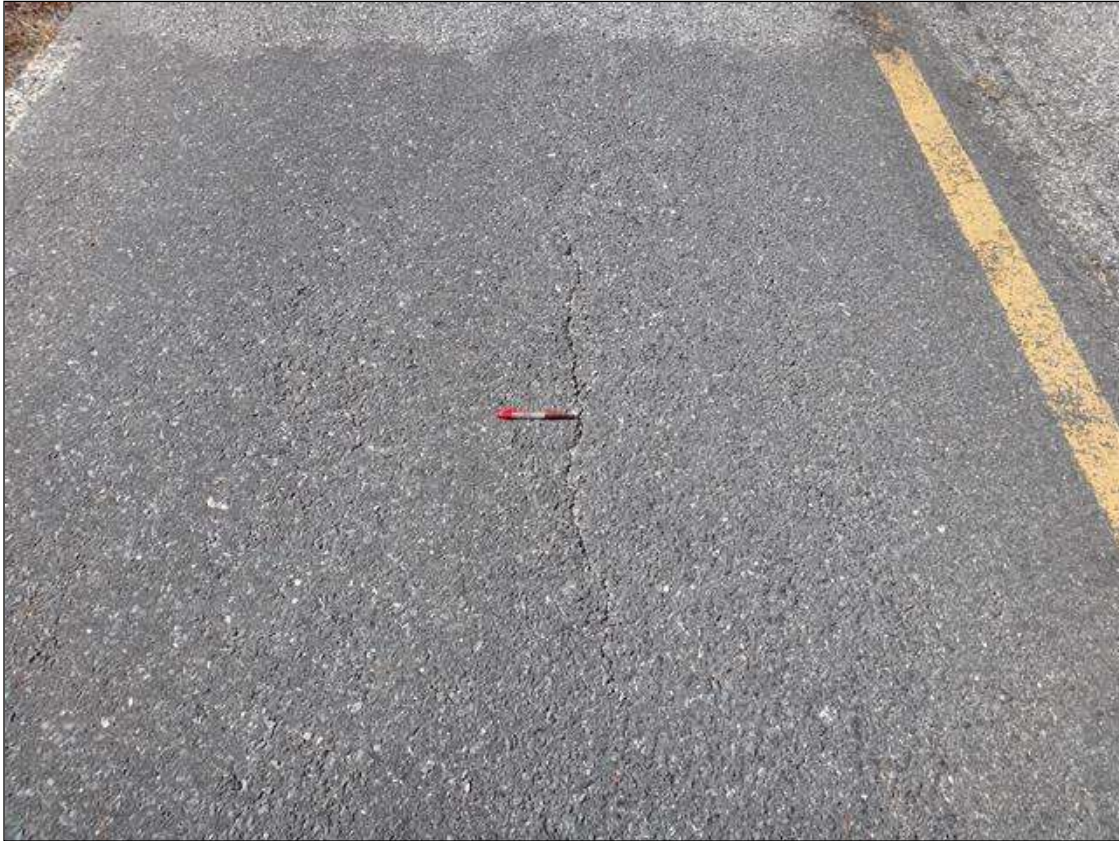
EAST APPROACH EASTBOUND LANE, LONGITUDINAL CRACK (3FT X 1/8IN WIDE) WITH RUTTING IN WHEELPATHS

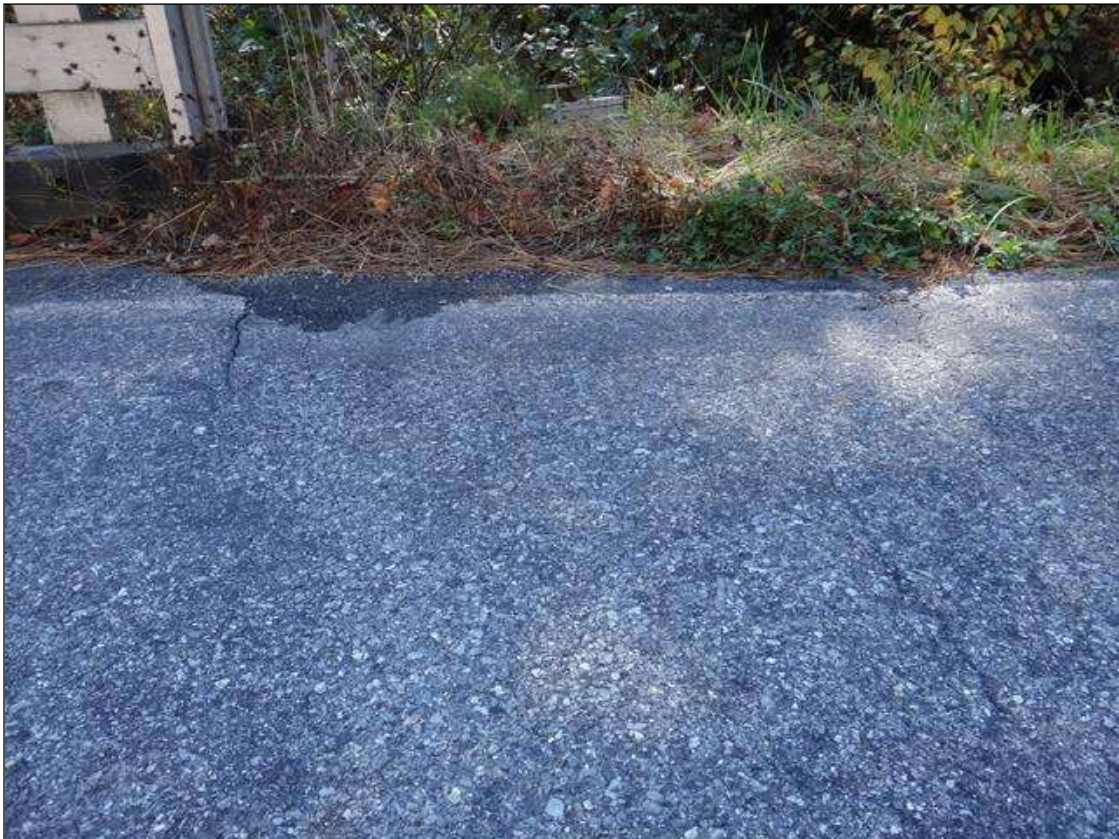
WEST APPROACH EASTBOUND LANE, SETTLEMENT (UP TO 1-1/2IN) WITH ADJACENT CRACK

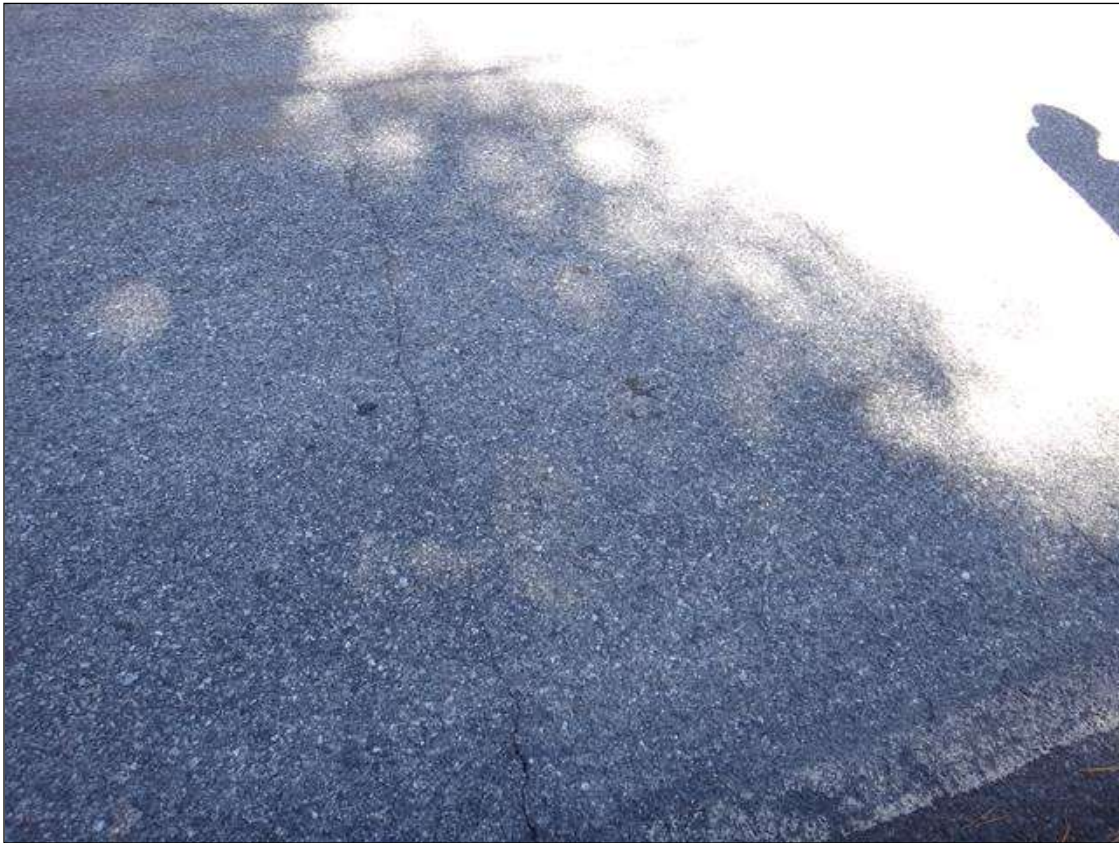
ASPHALT WEARING SURFACE OVER STRUCTURE, PARTIAL WIDTH TRANSVERSE CRACKS (UP TO 1/8IN WIDE)

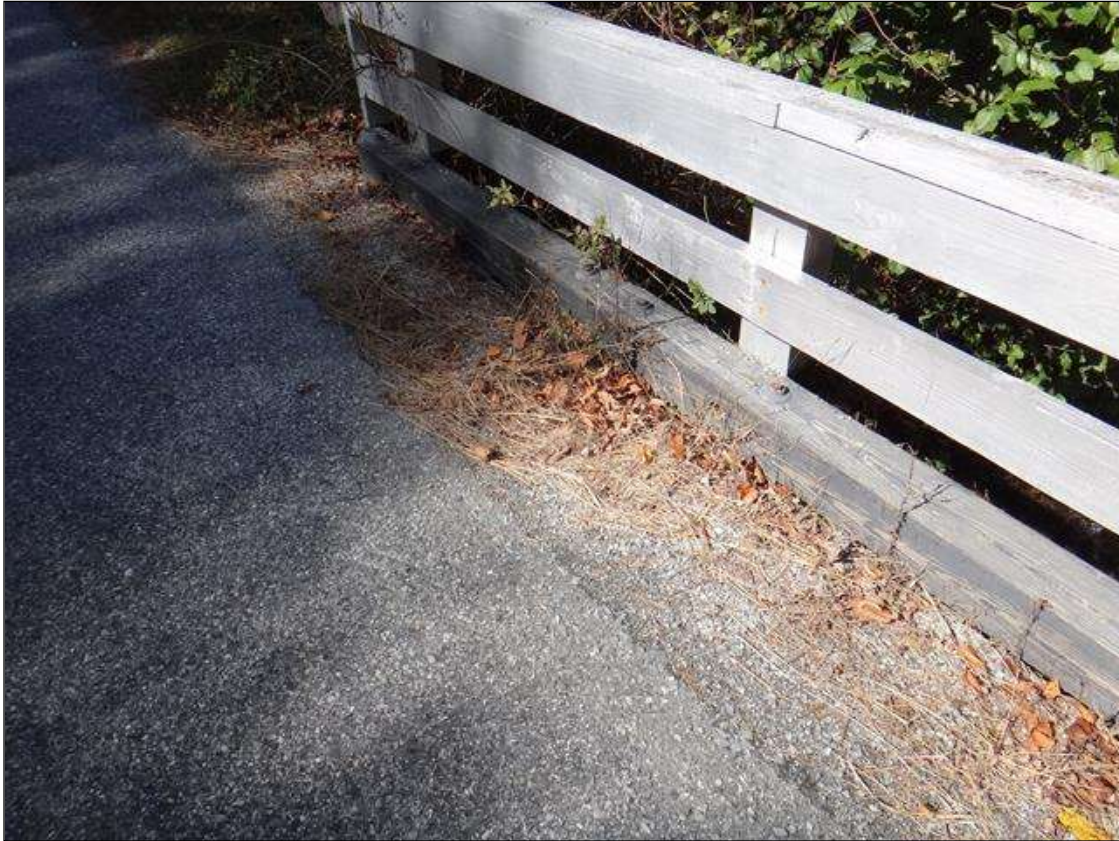
NORTH SHOULDER OVER STRUCTURE, LOOSE GRAVEL WITH VEGETATION GROWTH AND DEBRIS  
BLOCKING SCUPPERS

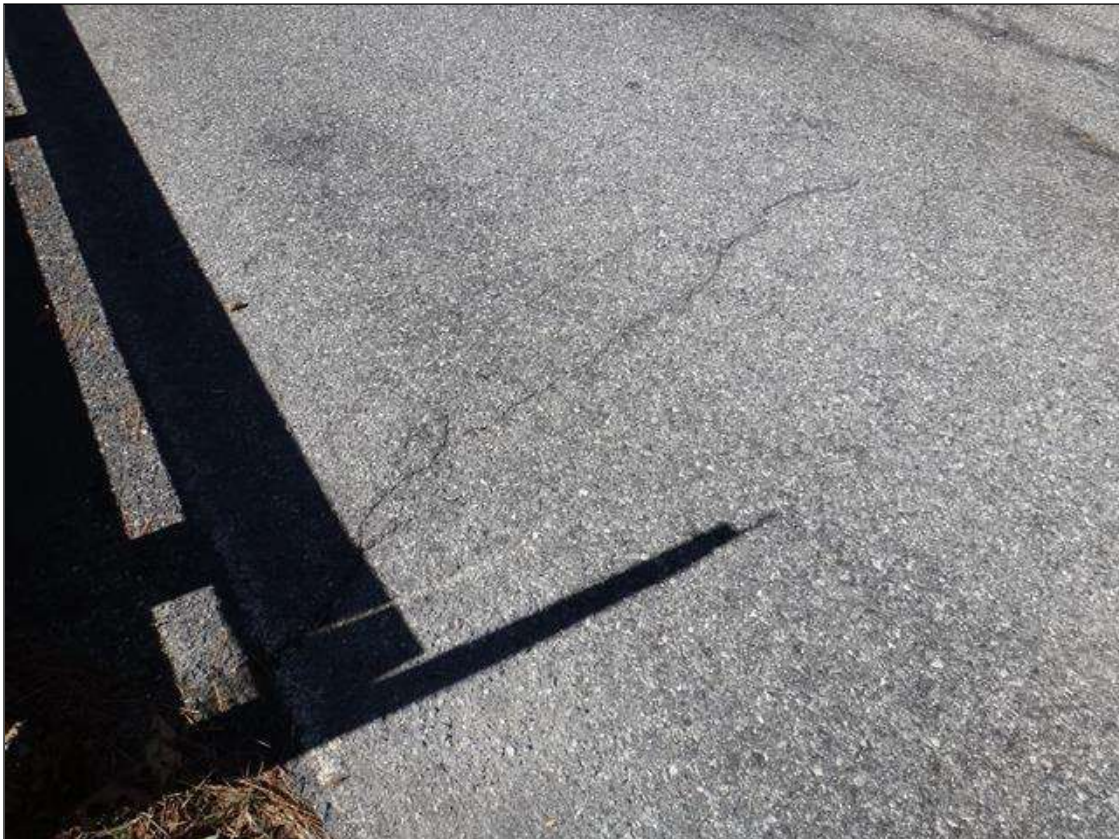
ASPHALT WEARING SURFACE AT EAST APPROACH EASTBOUND LANE/ABUTMENT 1, TRANSVERSE CRACK

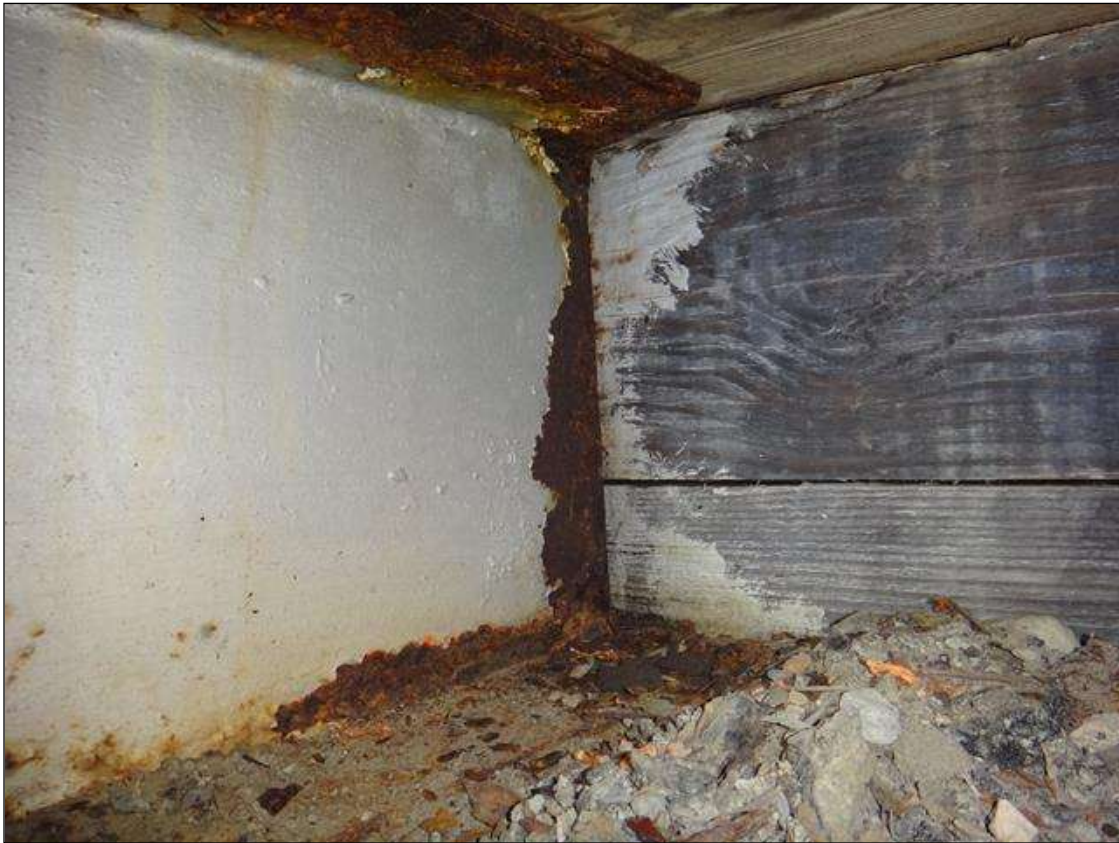
BEAM 2 AT ABUTMENT 1, SECTION LOSS AT WEB (UP TO 10%)

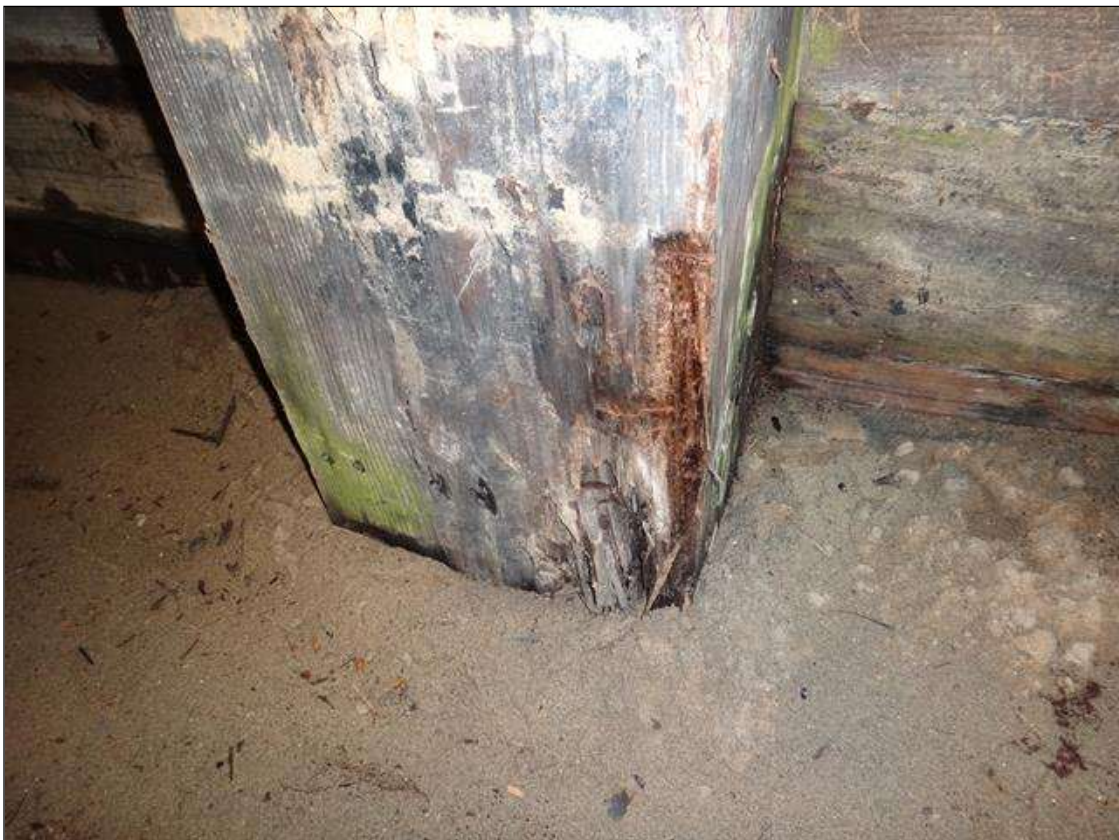
PILE 2 AT ABUTMENT 1, DECAY (LOWER 1FT), SOFT AND WET

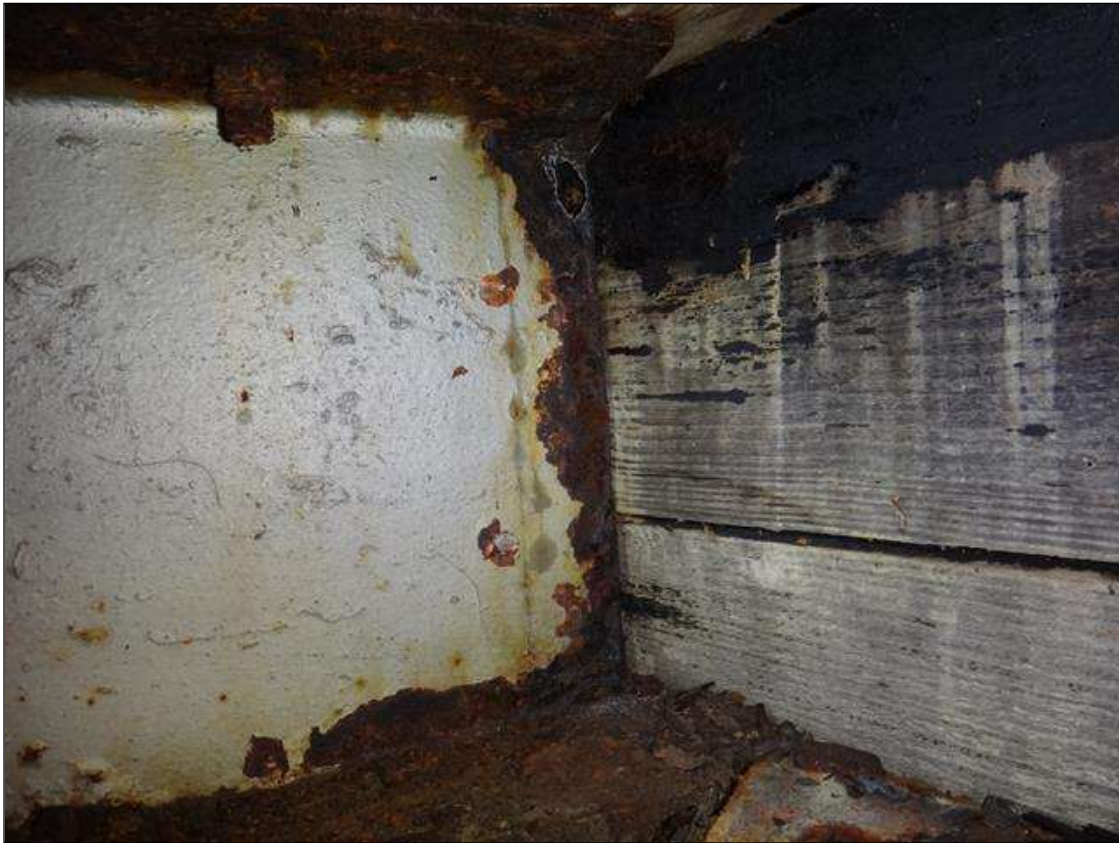
| MMS Code | MMS Description | Quantity |
|---|---|---|
| BEAM 5 AT ABUTMENT 1, SECTION LOSS AT WEB (80%) WITH CORROSION HOLE (1IN X 3/4IN), TOP FLANGE AND BOTTOM FLANGE (UP TO 10%) | | |

(PM) BEAM 5 AT ABUTMENT 1, SECTION LOSS AT WEB (80%) WITH CORROSION HOLE (1IN X 3/4IN), TOP FLANGE AND BOTTOM FLANGE (UP TO 10%)

| MMS Code | Description of Function | Unit | Quantity | Remarks | Est. Cost |
|---|---|---|---|---|---|
| 3314 | Maintain Steel Superstructure Components | LF | 10 | BEAM 5 AT ABUTMENT 1, SECTION LOSS AT WEB (80%) WITH CORROSION HOLE (1IN X 3/4IN), TOP FLANGE AND BOTTOM FLANGE (UP TO 10%)<br><br>BEAM 5 AT MIDSPAN, SECTION LOSS AT BOTTOM FLANGE (TO KNIFE EDGING) WITH TWO (2) PINHOLES AND TOP FLANGE (25%)<br><br>BEAM 5 AT ABUTMENT 2, SECTION LOSS AT WEB (50%) AND BOTTOM FLANGE (40%) AT EDGE OF CAP | |

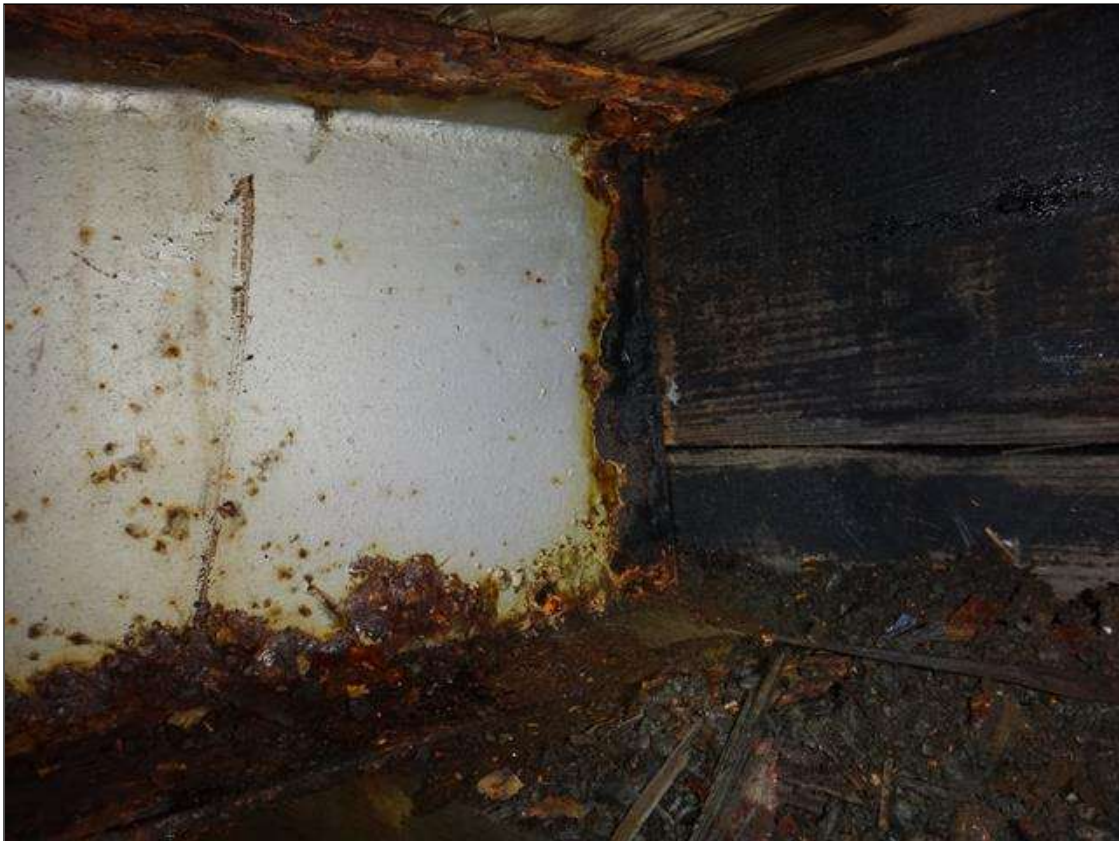
(PM) BEAM 6 AT ABUTMENT 1, SECTION LOSS AT WEB (60%), TOP FLANGE AND BOTTOM FLANGE (30%)

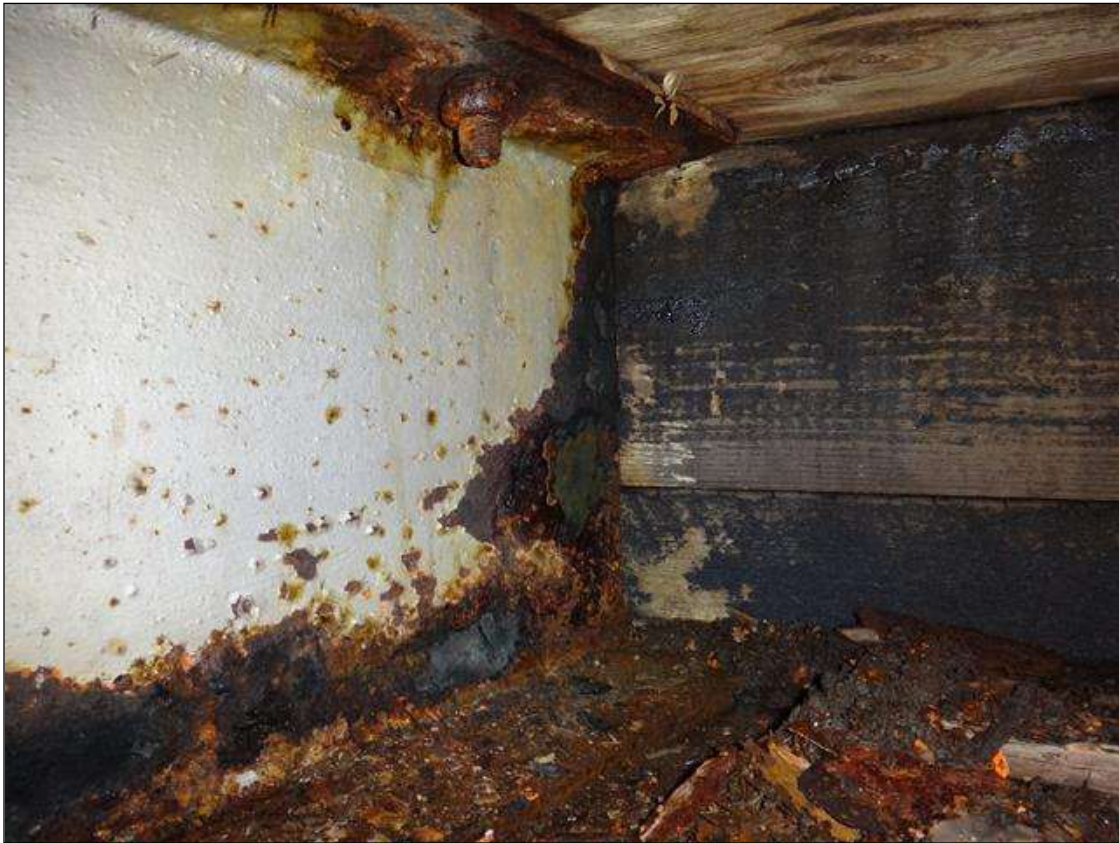
(PM) BEAM 7 AT ABUTMENT 1, SECTION LOSS AT WEB (UP TO 30%)

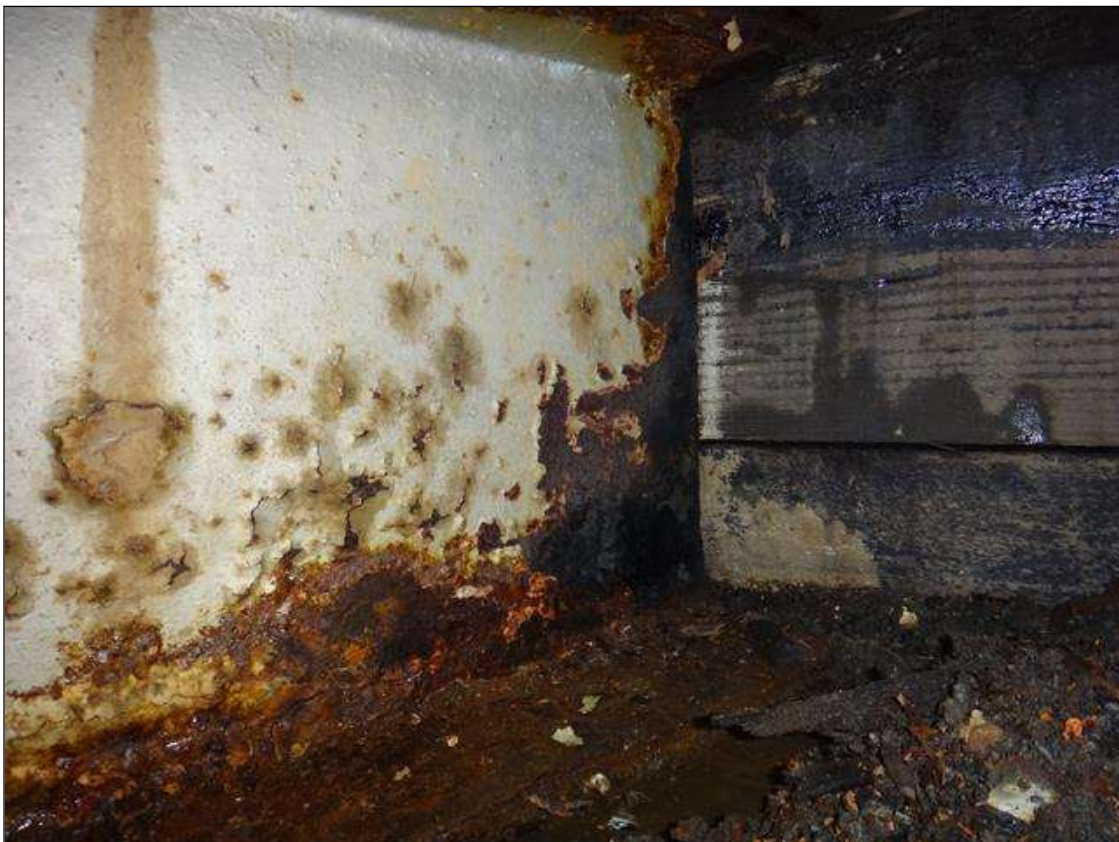
(PM) BEAM 8 AT ABUTMENT 1, SECTION LOSS AT WEB (UP TO 30%)

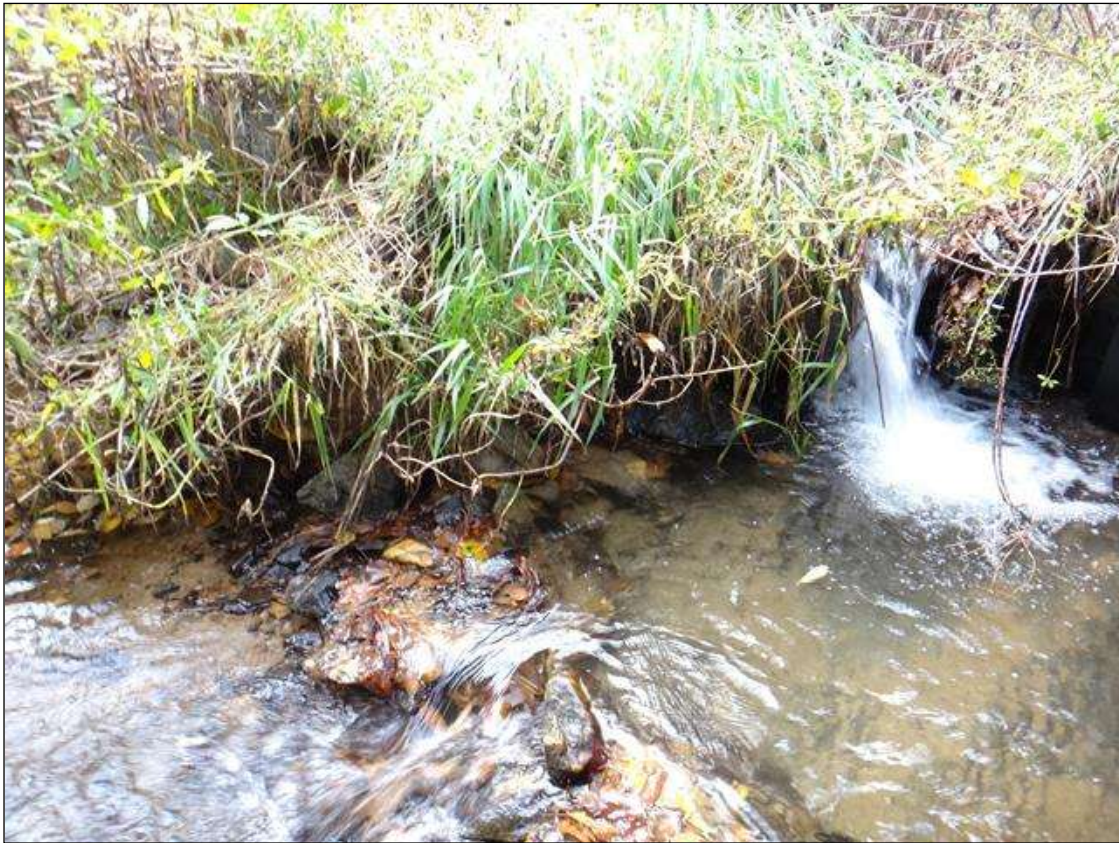
DOWNSTREAM WEST BANK, BANK EROSION (20FT LONG X 2FT HIGH)

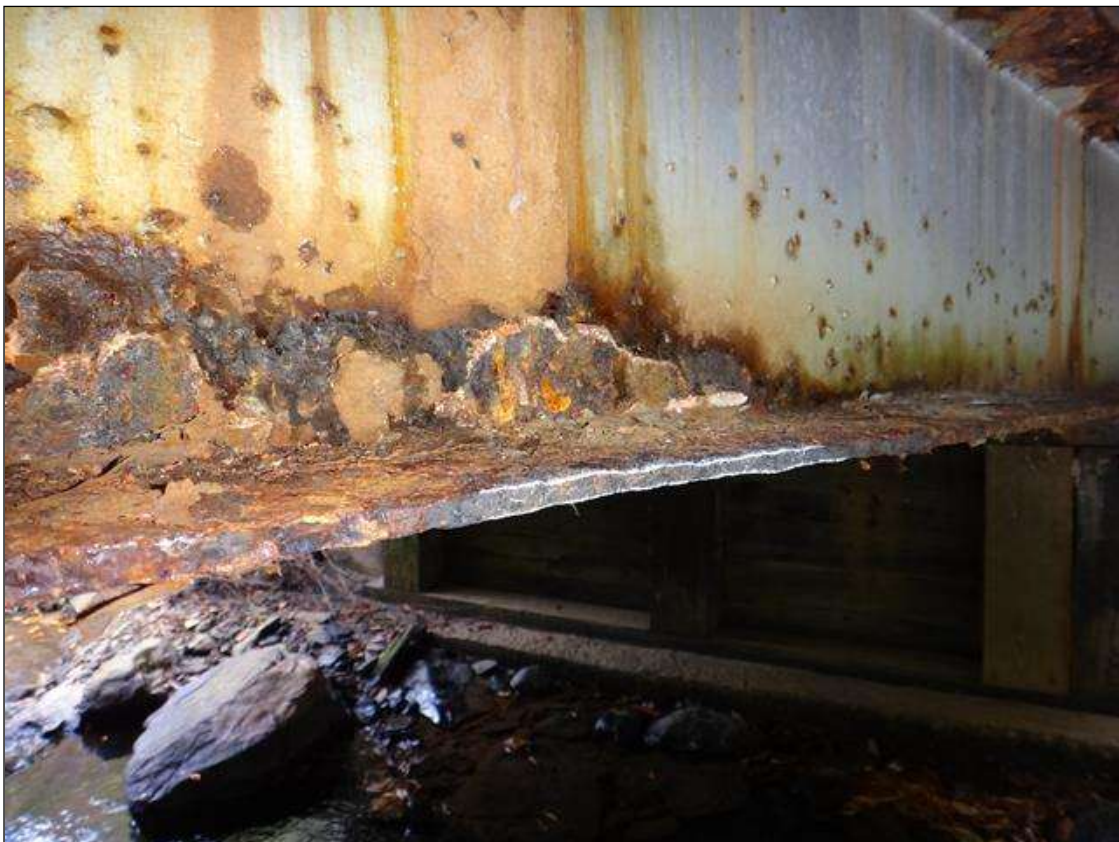
(PM) BEAM 7 AT MIDSPAN, SECTION LOSS AT BOTTOM FLANGE (25%) AND TOP FLANGE (20%)

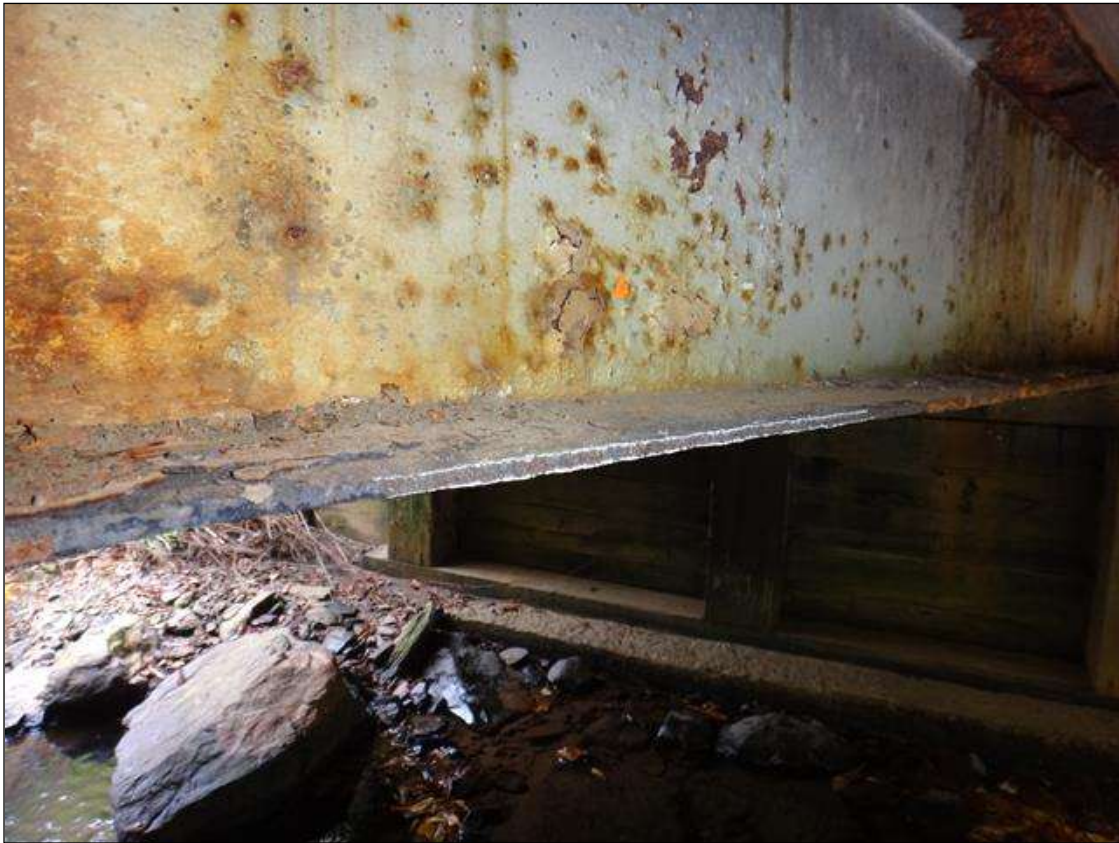
(PM) BEAM 6 AT MIDSPAN, SECTION LOSS AT BOTTOM FLANGE (40%) AND TOP FLANGE (20%)

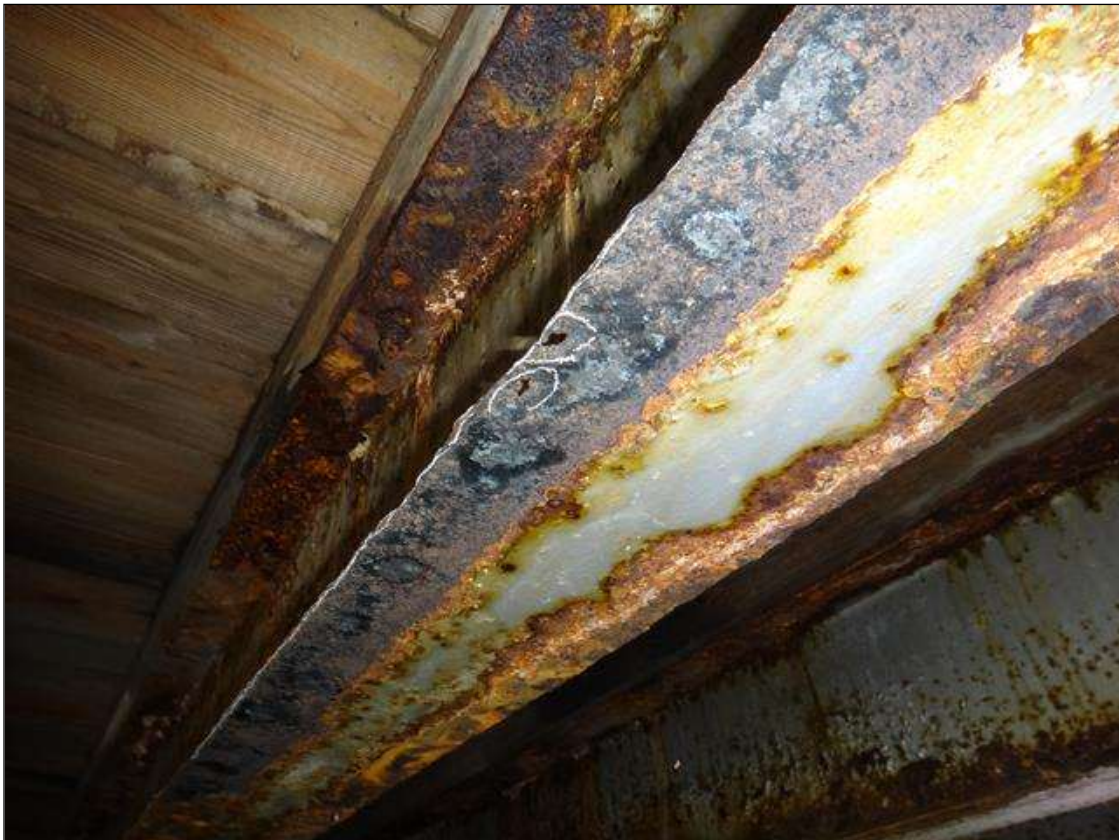
(PM) BEAM 5 AT MIDSPAN, SECTION LOSS AT BOTTOM FLANGE (TO KNIFE EDGING) WITH TWO (2) PINHOLES AND TOP FLANGE (25%)

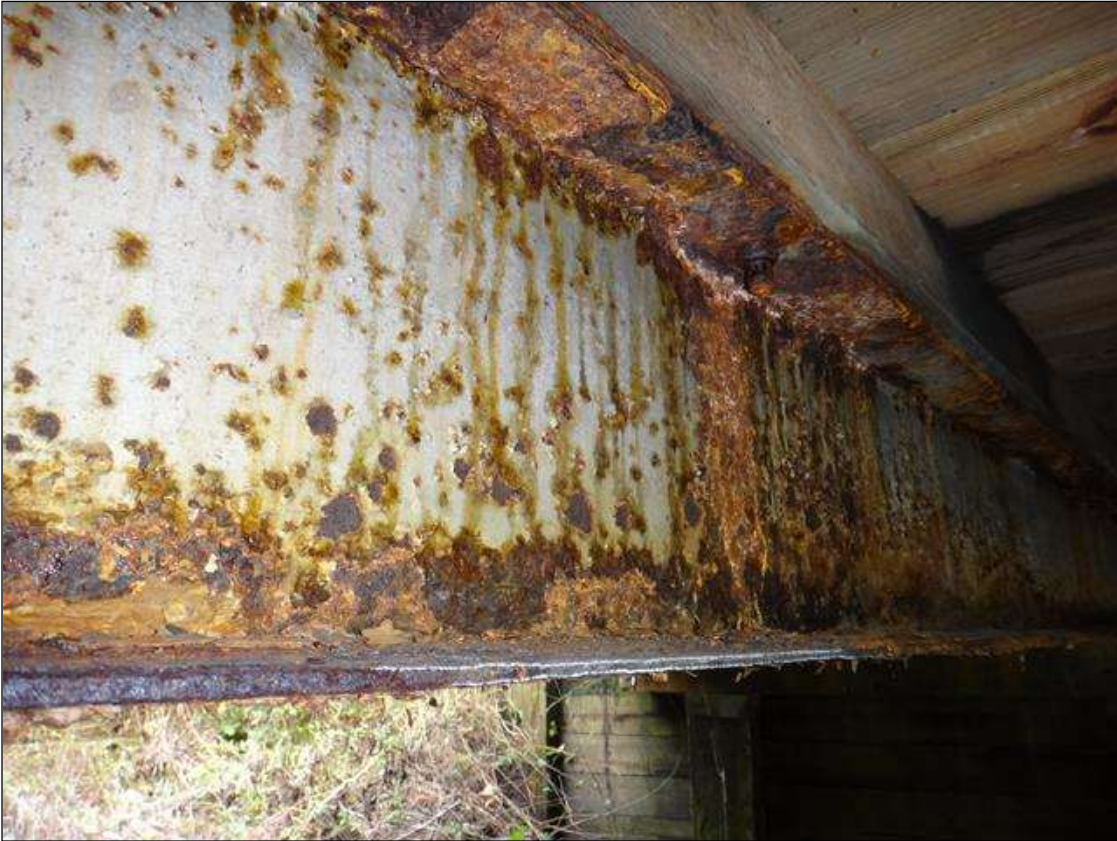
(PM) BEAM 4 AT MIDSPAN, SECTION LOSS AT BOTTOM FLANGE (50%) AND TOP FLANGE (20%)

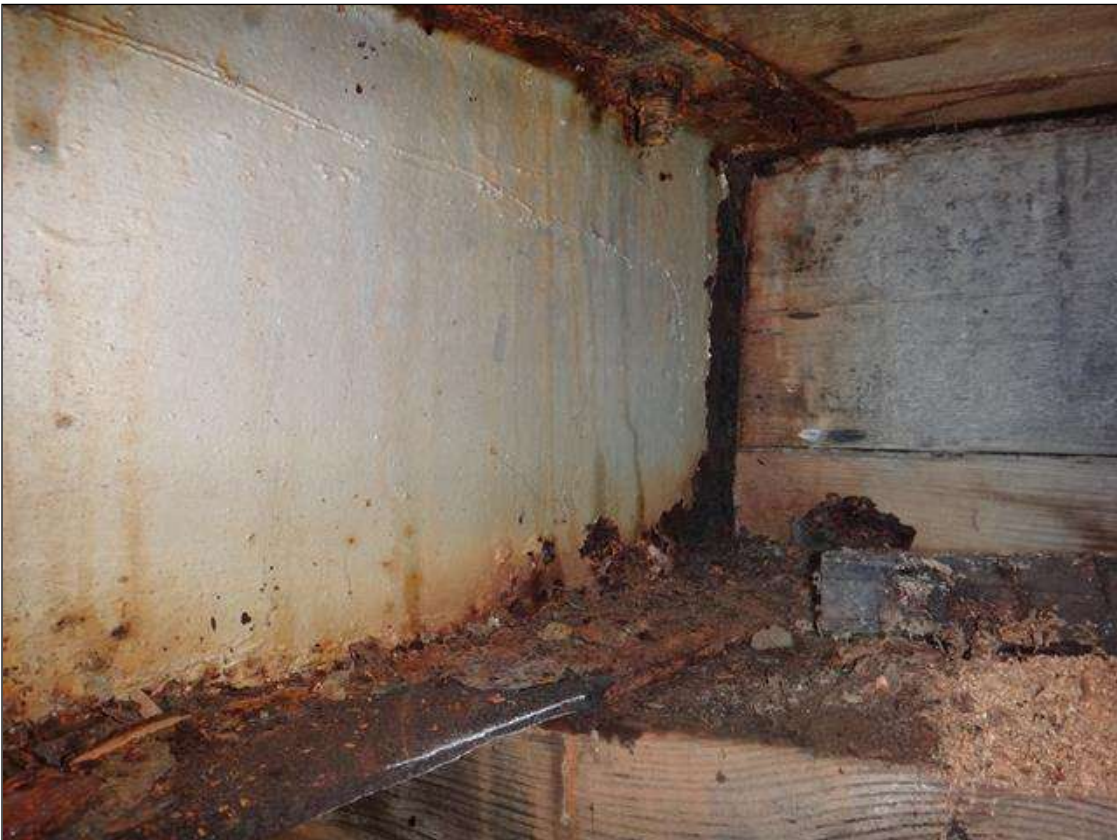
(PM) BEAM 3 AT ABUTMENT 2, SECTION LOSS AT WEB (35%) AND BOTTOM FLANGE (50%) AT EDGE OF CAP

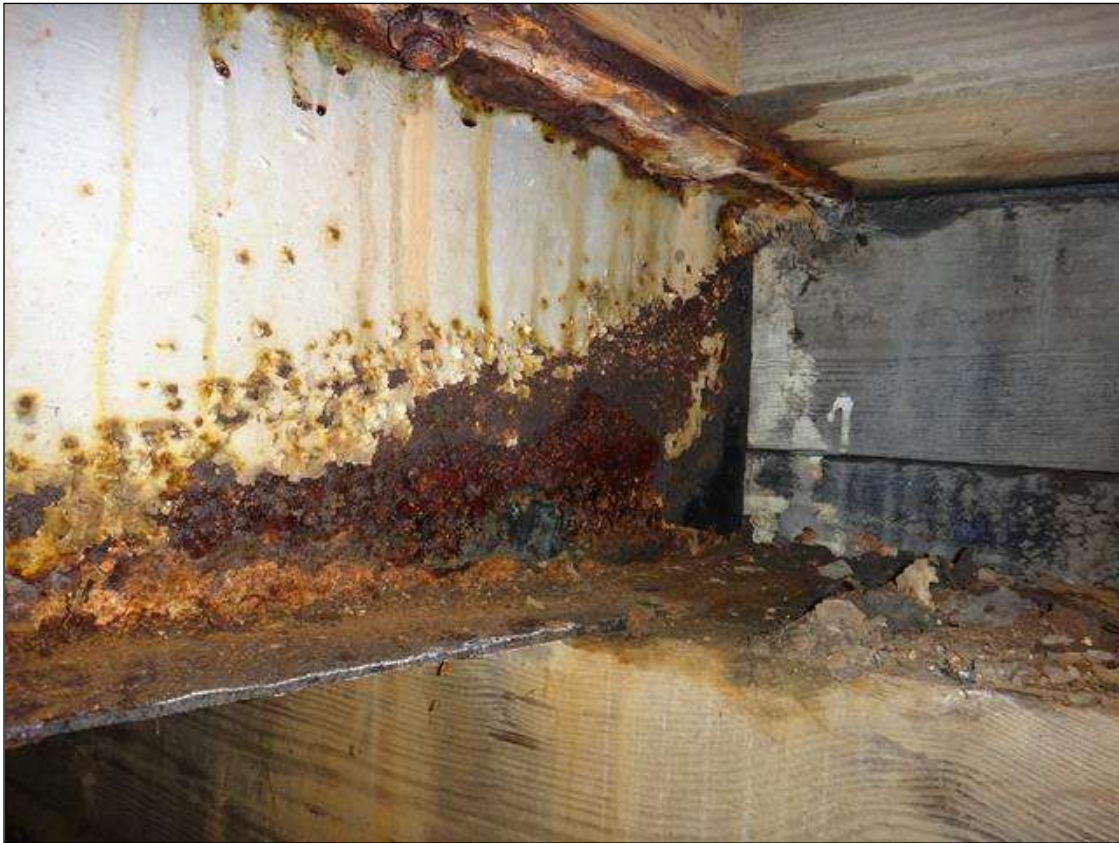
(PM) BEAM 7 AT ABUTMENT 2, SECTION LOSS AT WEB (25%) AND BOTTOM FLANGE (50%) AT EDGE OF CAP

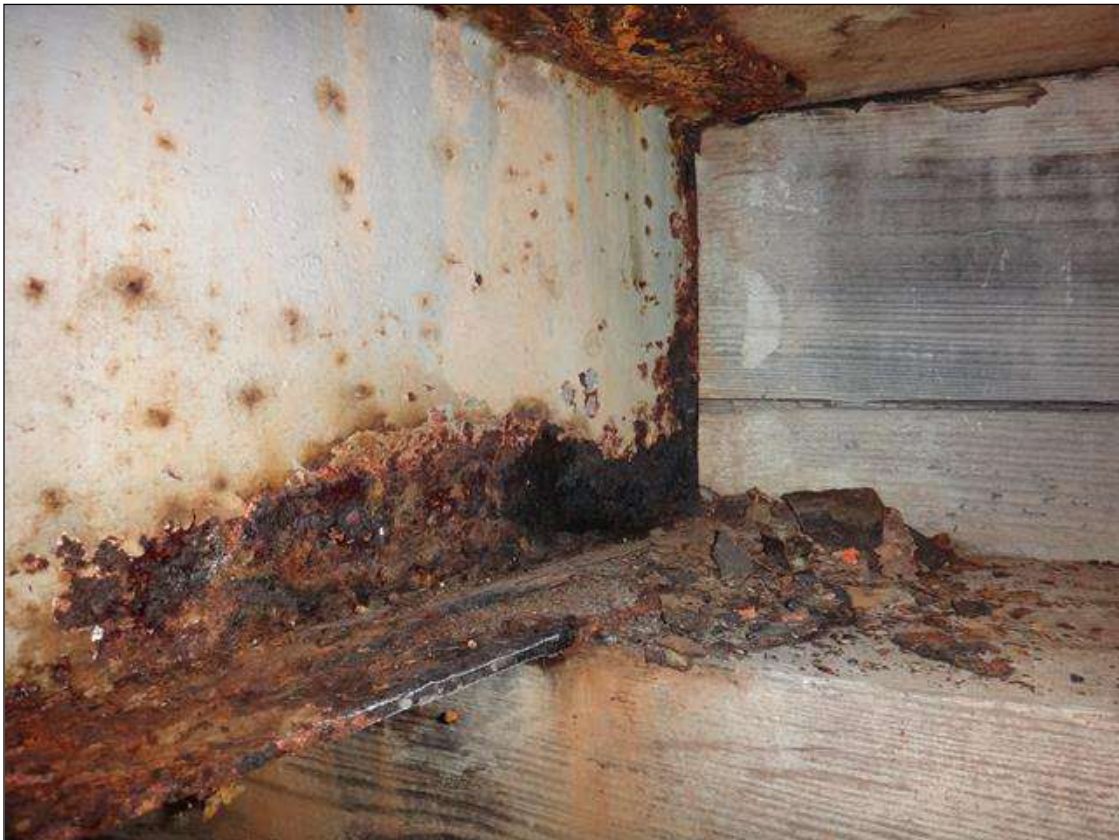
(PM) BEAM 5 AT ABUTMENT 2, SECTION LOSS AT WEB (50%) AND BOTTOM FLANGE (40%) AT EDGE OF CAP

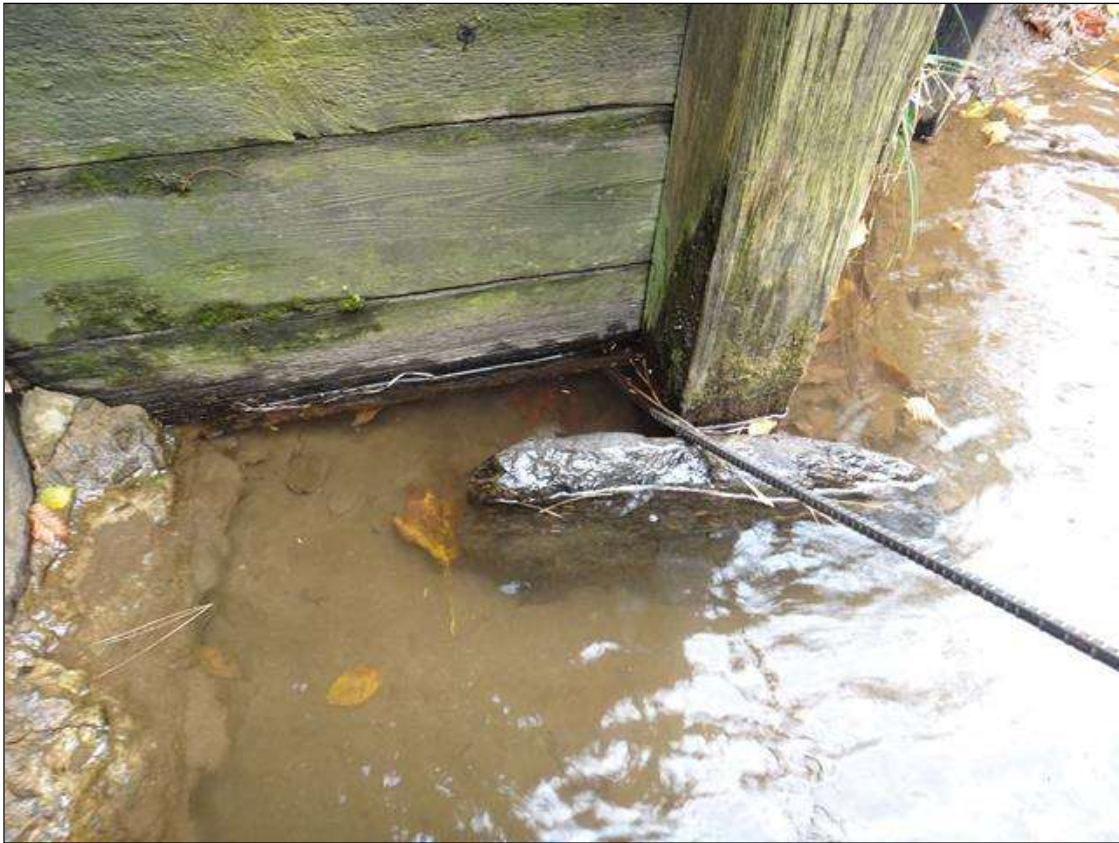
ABUTMENT 2 AT SOUTH END, FOOTING EXPOSED WITH SCOUR UNDERMINING BULKHEAD (2FT X 12IN)

| MMS Code | Description of Function | Unit | Quantity | Remarks | Est. Cost |
|---|---|---|---|---|---|
| 3344 | Repair / Replace Timber Substructure Components | LF | 4 | END BENT 2 BULKHEAD UNDERMINING | |

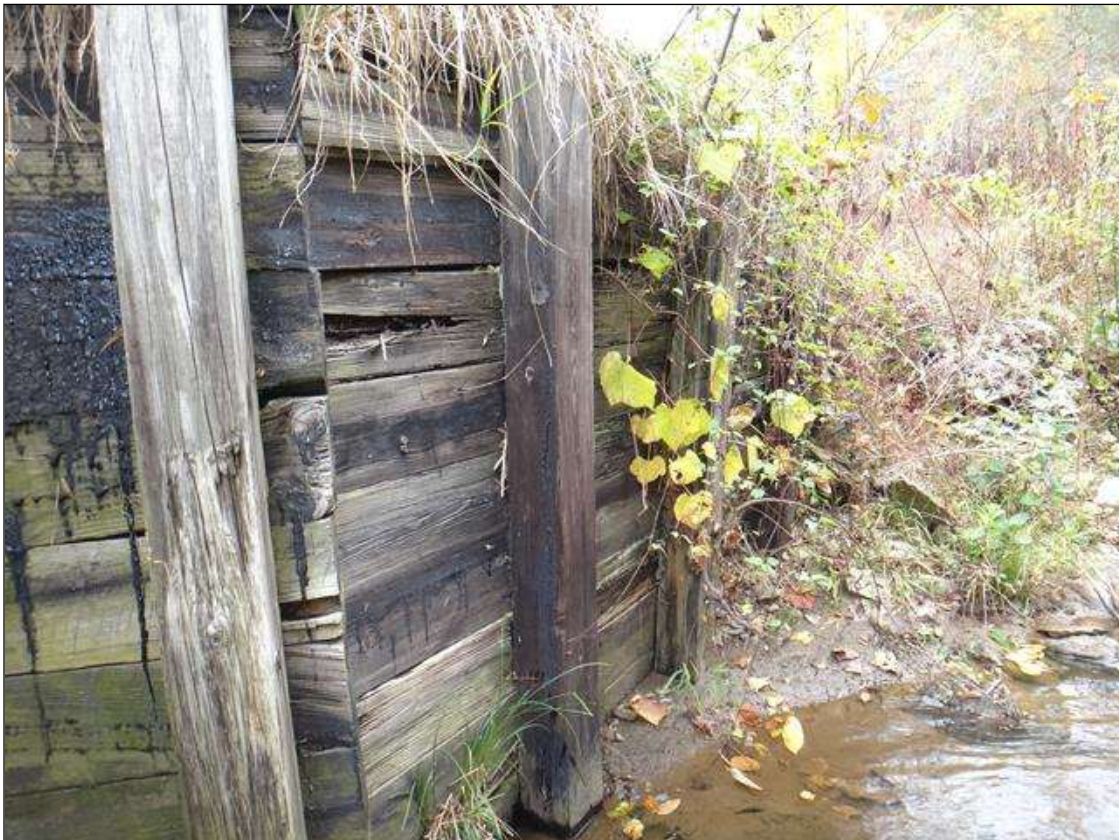
SOUTHEAST WINGWALL, ROTATED OUTWARD AT THE TOP (8IN) WITH DECAYED BOARDS

| MMS Code | Description of Function | Unit | Quantity | Remarks | Est. Cost |
|---|---|---|---|---|---|
| 3346 | Repair / Maintain Timber Wings & Blkhds | SF | 25 | NORTHEAST AND SOUTHEAST WINGWALL DECAYED AND ROTATED | |

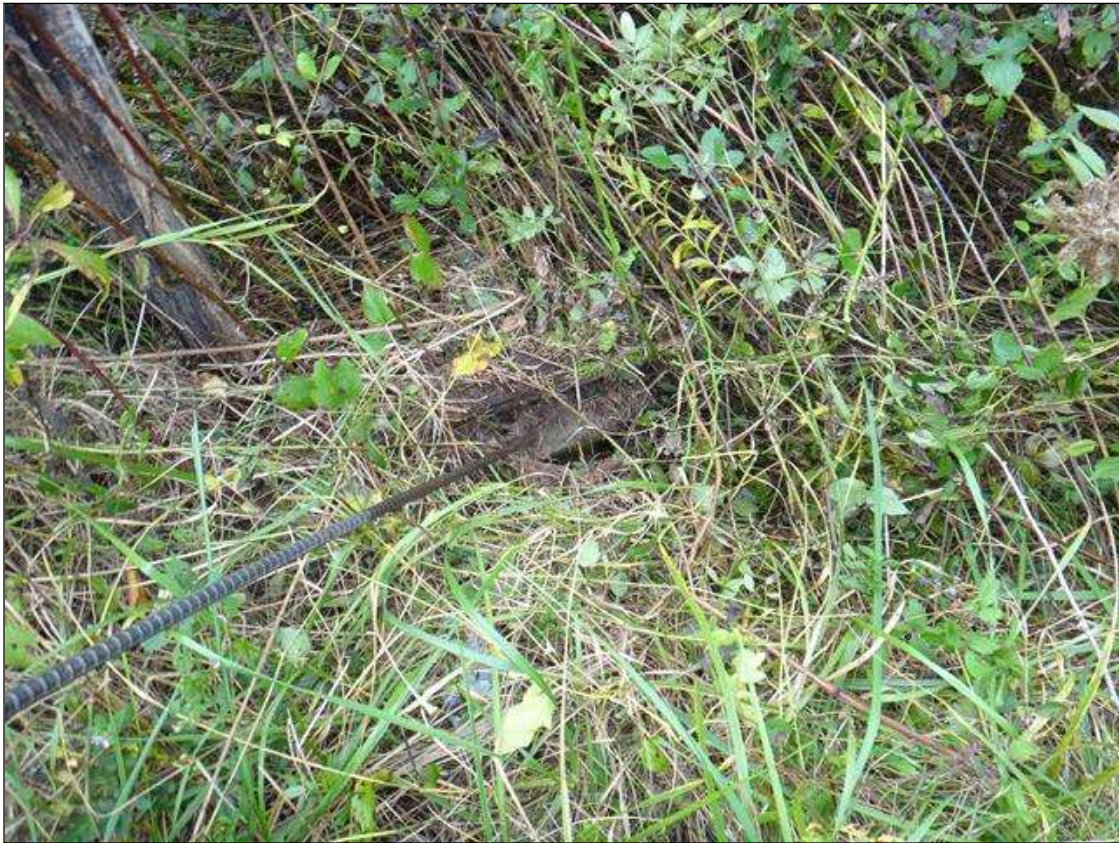
NORTHEAST WINGWALL, DECAYED TOP BOARD WITH SECTION LOSS EROSION (2FT X 2FT X 4FT DEEP)
