NC DEPARTMENT OF TRANSPORTATION  
DIVISION OF HIGHWAYS  
STRUCTURE MANAGEMENT UNIT

## Structure Safety Report

### Routine Element Inspection

COUNTY: WATAUGA STRUCTURE NUMBER: 940047 FREQUENCY: 24 MONTHS

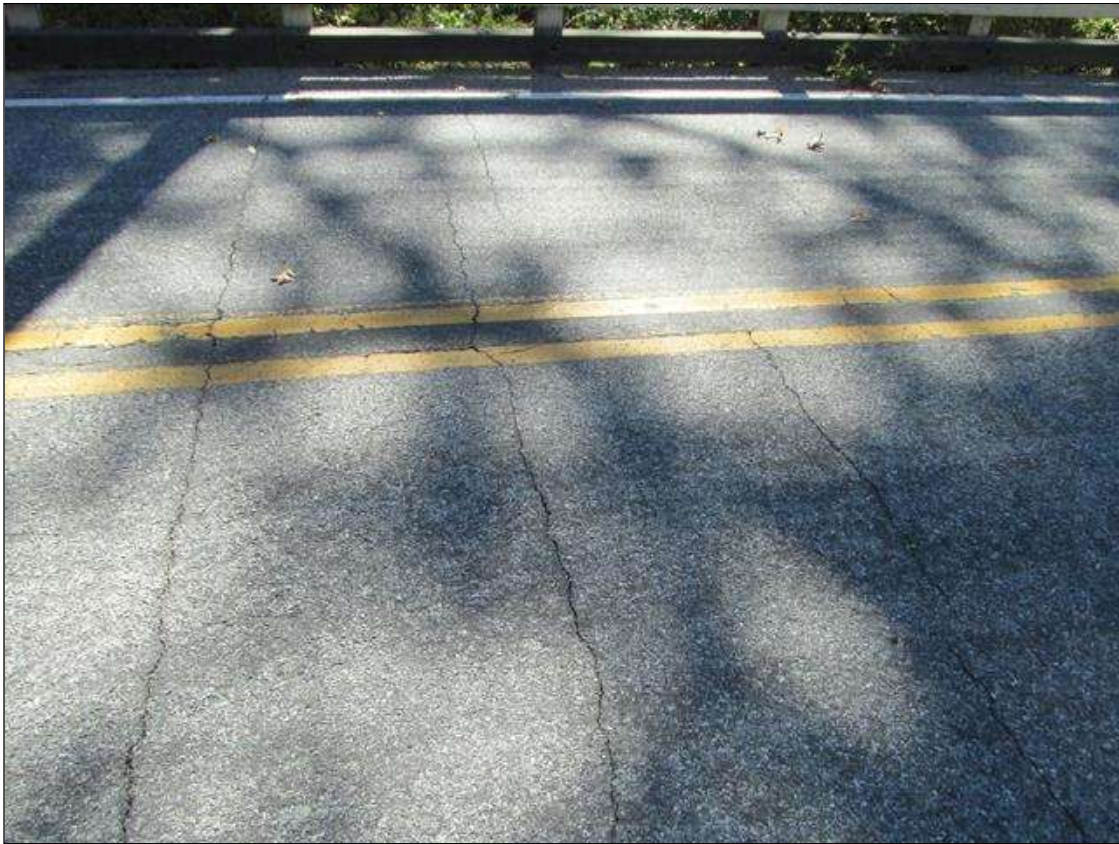
523 Square Feet of Crack (Wearing Surface): Width of more than 0.05 in. or spacing of less than 1.0 ft. TRANSVERSE CRACKS ALONG DECK BOARDS

Span 1 Wearing Surface: 523 Square Feet of Crack (Wearing Surface): Width of more than 0.05 in. or spacing of less than 1.0 ft. TRANSVERSE CRACKS ALONG DECK BOARDS

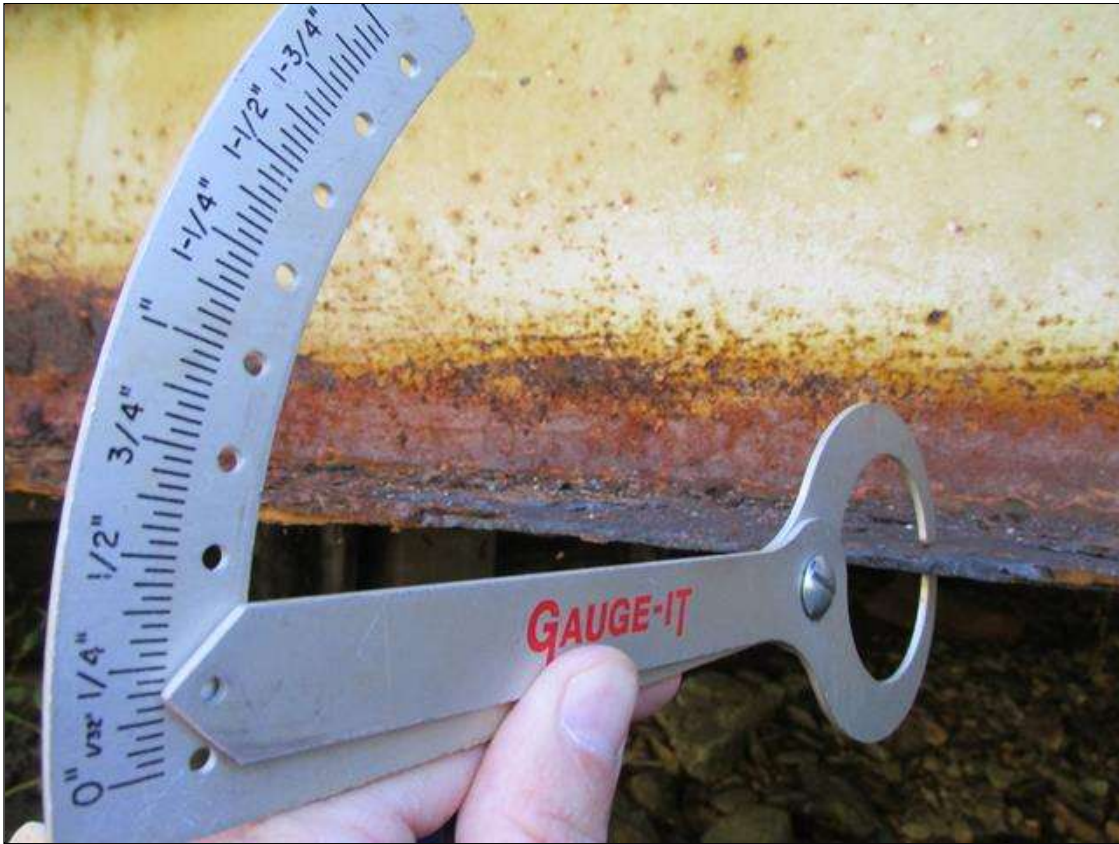
25 Feet of Corrosion: Section loss is evident or pack rust is present but does not warrant structural review. BEAM (1) CORROSION FULL LENGTH ALONG TOP AND BOTTOM FLANGES WITH (+/- 3/16") LOSS OF SECTION AND (+/- 3/16") REMAINING SECTION.

50 Square Feet of Effectiveness (Steel Protective Coatings): Failed; no protection of the underlying metal. CORROSION FULL LENGTH ALONG TOP AND BOTTOM FLANGES WITH (+/- 3/16") LOSS OF SECTION AND (+/- 3/16") REMAINING SECTION.

Span 1 Beam 1: 25 Feet of Corrosion: Section loss is evident or pack rust is present but does not warrant structural review. CORROSION FULL LENGTH ALONG TOP AND BOTTOM FLANGES WITH (+/- 3/16") LOSS OF SECTION AND (+/- 3/16") REMAINING SECTION.

| MMS Code | Description of Function | Unit | Quantity | Remarks | Est. Cost |
|---|---|---|---|---|---|
| 3314 | Maintain Steel Superstructure Components | LF | 25 | BEAM (1) CORROSION FULL LENGTH ALONG TOP AND BOTTOM FLANGES WITH (+/- 3/16") LOSS OF SECTION AND (+/- 3/16") REMAINING SECTION. | |

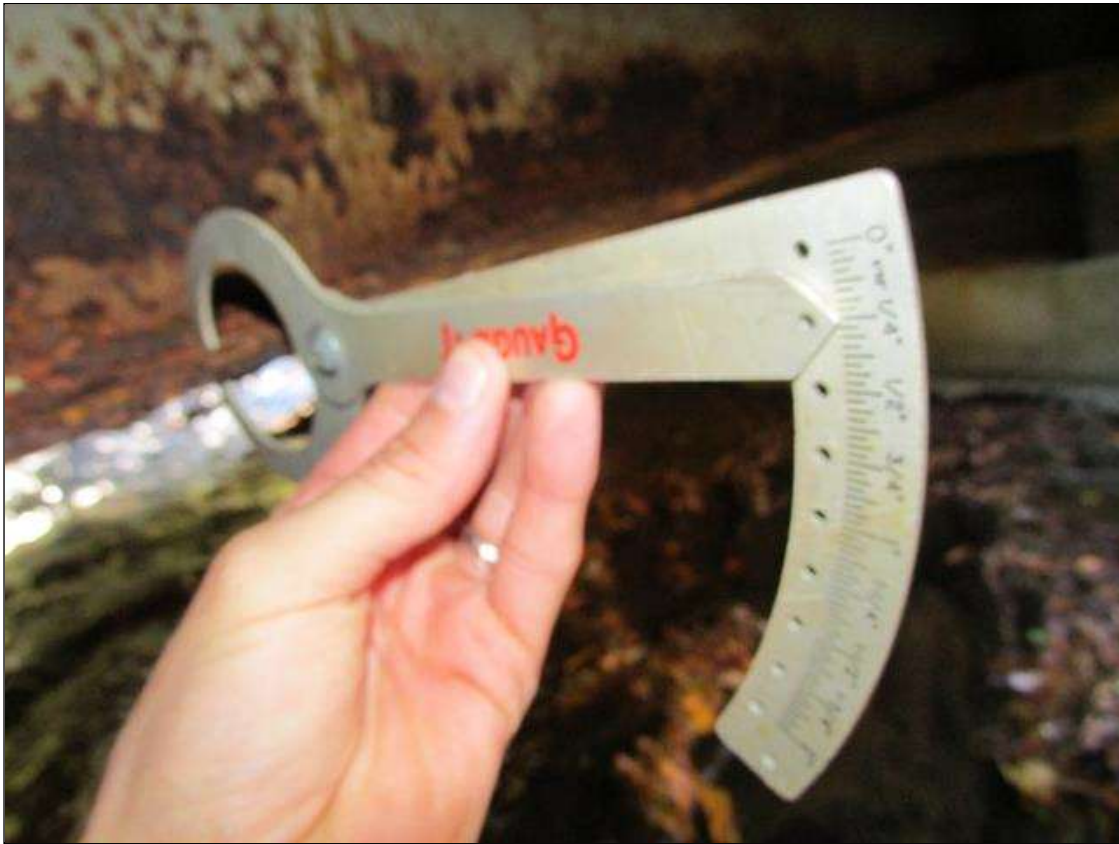
25 Feet of Corrosion: Section loss is evident or pack rust is present but does not warrant structural review. BEAM (2) CORROSION FULL LENGTH ALONG TOP AND BOTTOM FLANGES WITH (+/- 1/8") LOSS OF SECTION AND (+/- 1/4") REMAINING SECTION.

50 Square Feet of Effectiveness (Steel Protective Coatings): Failed; no protection of the underlying metal. BEAM (2) CORROSION FULL LENGTH ALONG TOP AND BOTTOM FLANGES WITH (+/- 1/8") LOSS OF SECTION AND (+/- 1/4") REMAINING SECTION.

Span 1 Beam 2: 25 Feet of Corrosion: Section loss is evident or pack rust is present but does not warrant structural review. BEAM (2) CORROSION FULL LENGTH ALONG TOP AND BOTTOM FLANGES WITH (+/- 1/8") LOSS OF SECTION AND (+/- 1/4") REMAINING SECTION.

| MMS Code | Description of Function | Unit | Quantity | Remarks | Est. Cost |
|---|---|---|---|---|---|
| 3314 | Maintain Steel Superstructure Components | LF | 25 | BEAM (2) CORROSION FULL LENGTH ALONG TOP AND BOTTOM FLANGES WITH (+/- 1/8") LOSS OF SECTION AND (+/- 1/4") REMAINING SECTION. | |

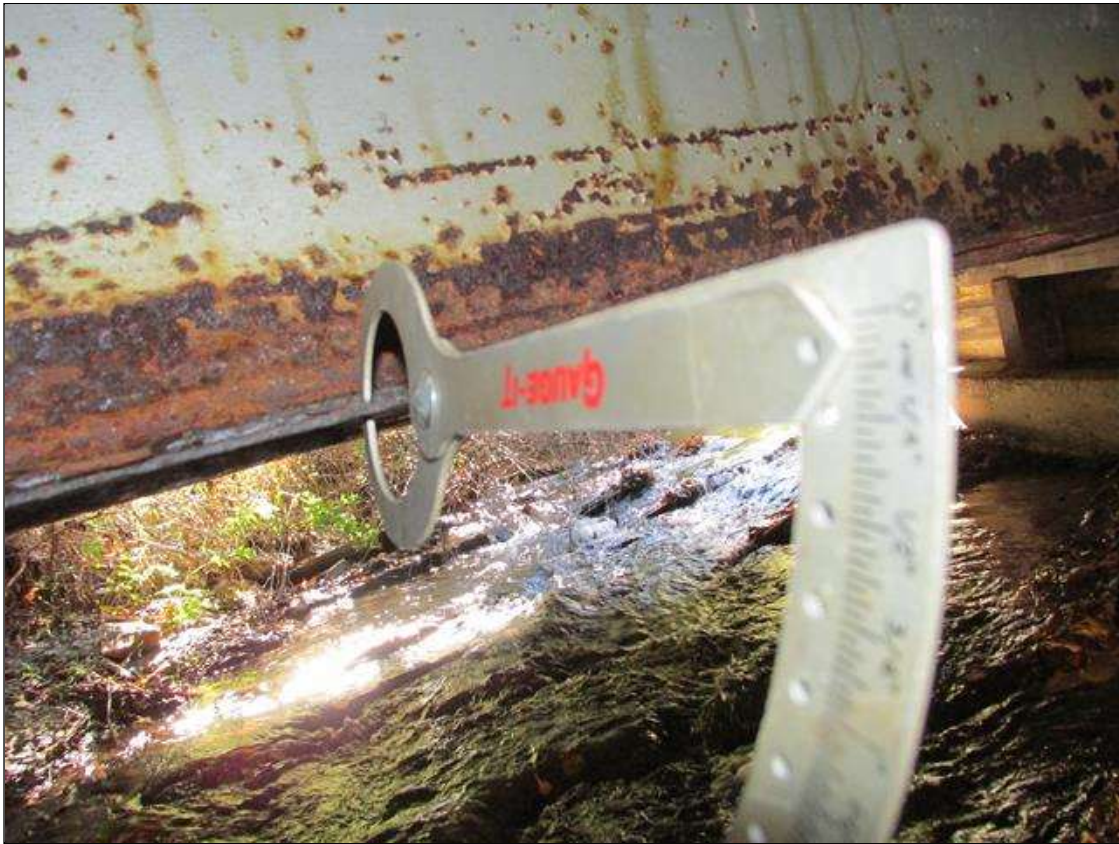
25 Feet of Corrosion: Section loss is evident or pack rust is present but does not warrant structural review. BEAM (3) CORROSION FULL LENGTH ALONG TOP AND BOTTOM FLANGES WITH (+/- 5/16") LOSS OF SECTION AND (+/- 1/16") REMAINING SECTION.

50 Square Feet of Effectiveness (Steel Protective Coatings): Failed; no protection of the underlying metal. BEAM (3) CORROSION FULL LENGTH ALONG TOP AND BOTTOM FLANGES WITH (+/- 5/16") LOSS OF SECTION AND (+/- 1/16") REMAINING SECTION.

Span 1 Beam 3: 25 Feet of Corrosion: Section loss is evident or pack rust is present but does not warrant structural review. BEAM (3) CORROSION FULL LENGTH ALONG TOP AND BOTTOM FLANGES WITH (+/- 5/16") LOSS OF SECTION AND (+/- 1/16") REMAINING SECTION.

| MMS Code | Description of Function | Unit | Quantity | Remarks | Est. Cost |
|---|---|---|---|---|---|
| 3314 | Maintain Steel Superstructure Components | LF | 25 | BEAM (3) CORROSION FULL LENGTH ALONG TOP AND BOTTOM FLANGES WITH (+/- 5/16") LOSS OF SECTION AND (+/- 1/16") REMAINING SECTION. | |

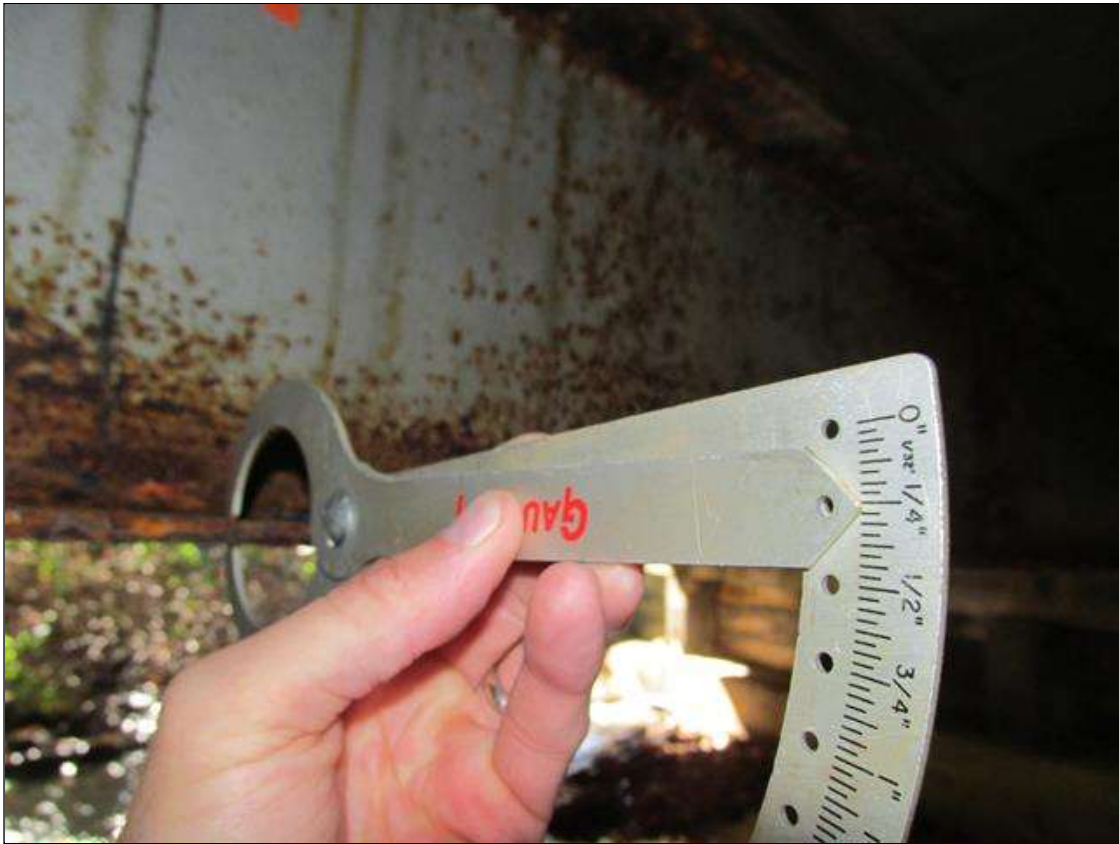
25 Feet of Corrosion: Section loss is evident or pack rust is present but does not warrant structural review. BEAM (4) CORROSION FULL LENGTH ALONG TOP AND BOTTOM FLANGES WITH (+/- 1/8") LOSS OF SECTION AND (+/- 1/4") REMAINING SECTION.

50 Square Feet of Effectiveness (Steel Protective Coatings): Failed; no protection of the underlying metal. BEAM (4) CORROSION FULL LENGTH ALONG TOP AND BOTTOM FLANGES WITH (+/- 1/8") LOSS OF SECTION AND (+/- 1/4") REMAINING SECTION.

Span 1 Beam 4: 25 Feet of Corrosion: Section loss is evident or pack rust is present but does not warrant structural review. BEAM (4) CORROSION FULL LENGTH ALONG TOP AND BOTTOM FLANGES WITH (+/- 1/8") LOSS OF SECTION AND (+/- 1/4") REMAINING SECTION.

| MMS Code | Description of Function | Unit | Quantity | Remarks | Est. Cost |
|---|---|---|---|---|---|
| 3314 | Maintain Steel Superstructure Components | LF | 25 | BEAM (4) CORROSION FULL LENGTH ALONG TOP AND BOTTOM FLANGES WITH (+/- 1/8") LOSS OF SECTION AND (+/- 1/4") REMAINING SECTION. | |

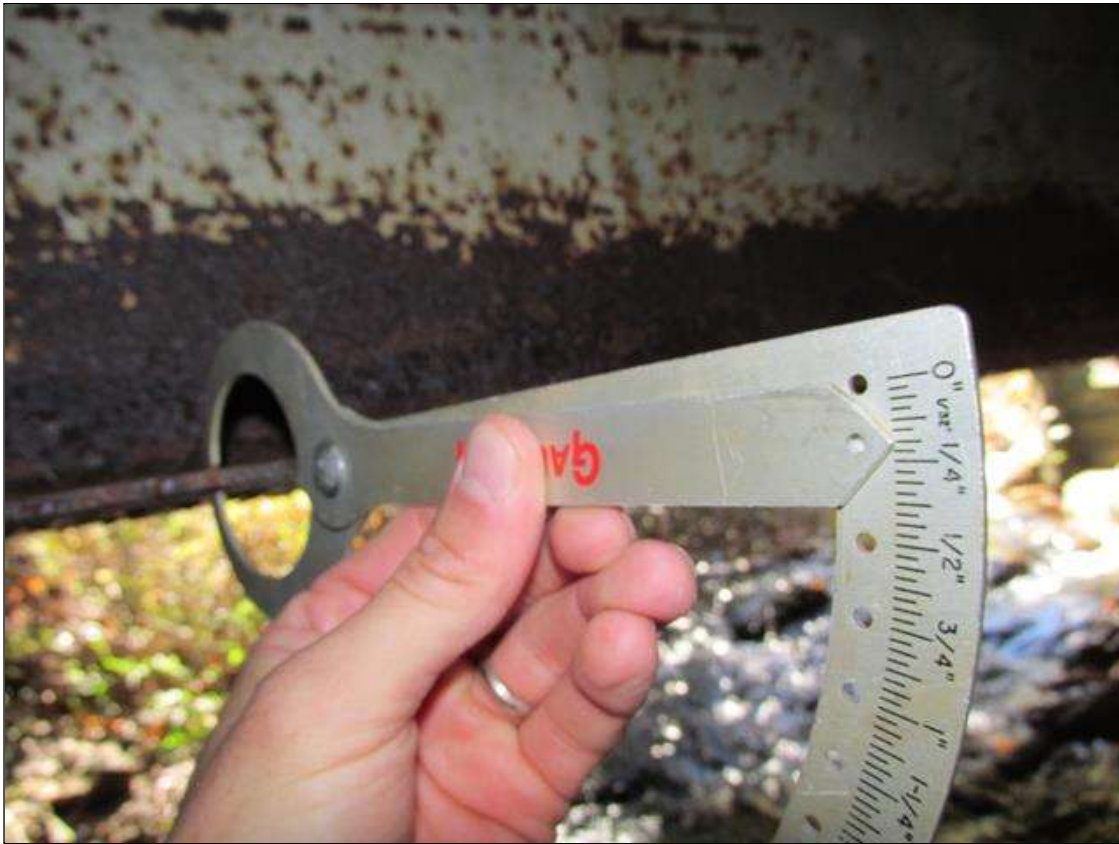
25 Feet of Corrosion: Section loss is evident or pack rust is present but does not warrant structural review. BEAM (5) CORROSION FULL LENGTH ALONG TOP AND BOTTOM FLANGES WITH (+/- 3/16") LOSS OF SECTION AND (+/- 3/16")

50 Square Feet of Effectiveness (Steel Protective Coatings): Failed; no protection of the underlying metal. BEAM (5)  
CORROSION FULL LENGTH ALONG TOP AND BOTTOM FLANGES WITH (+/- 3/16") LOSS OF SECTION AND (+/- 3/16")  
REMAINING SECTION.

Span 1 Beam 5: 25 Feet of Corrosion: Section loss is evident or pack rust is present but does not warrant structural review. BEAM (5) CORROSION FULL LENGTH ALONG TOP AND BOTTOM FLANGES WITH (+/- 3/16") LOSS OF SECTION AND (+/- 3/16") REMAINING SECTION.

| MMS Code | Description of Function | Unit | Quantity | Remarks | Est. Cost |
|---|---|---|---|---|---|
| 3314 | Maintain Steel Superstructure Components | LF | 25 | BEAM (5) CORROSION FULL LENGTH ALONG TOP AND BOTTOM FLANGES WITH (+/- 3/16") LOSS OF SECTION AND (+/- 3/16") REMAINING SECTION. | |

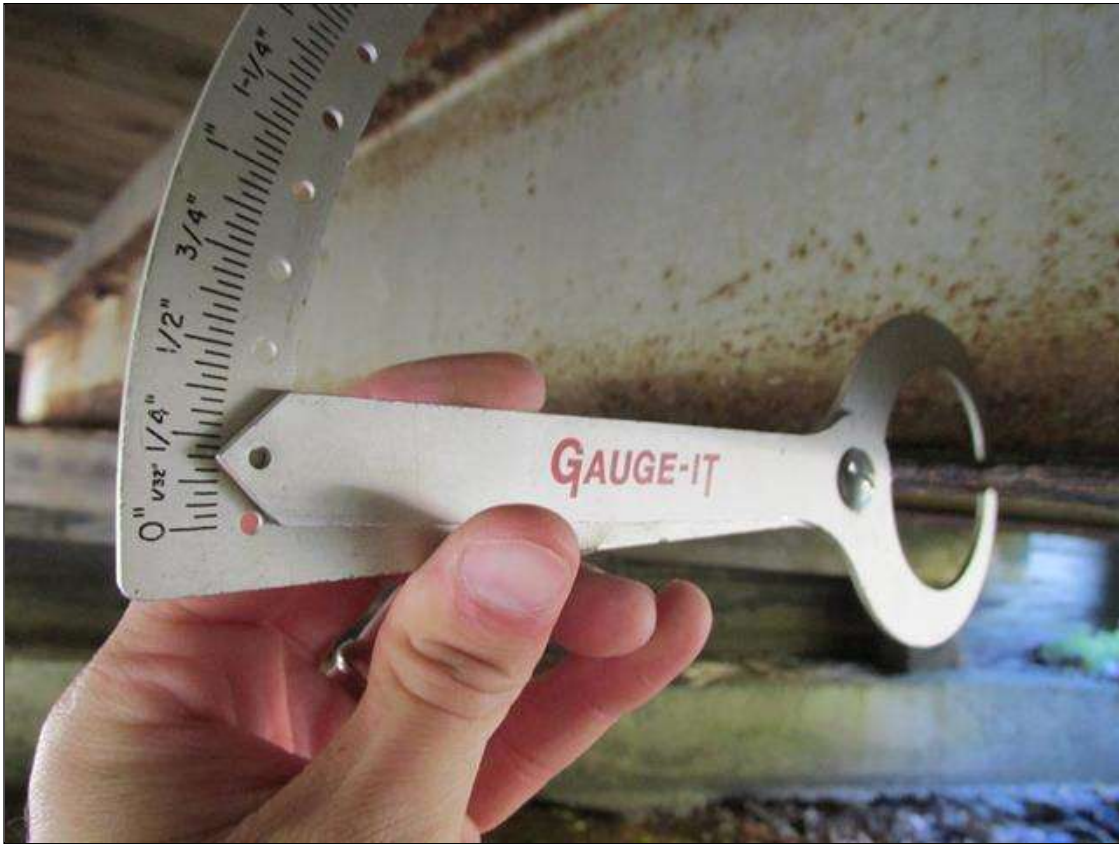
25 Feet of Corrosion: Section loss is evident or pack rust is present but does not warrant structural review. BEAM (6)  
CORROSION FULL LENGTH ALONG TOP AND BOTTOM FLANGES WITH (+/- 3/16") LOSS OF SECTION AND (+/- 3/16")  
REMAINING SECTION.

50 Square Feet of Effectiveness (Steel Protective Coatings): Failed; no protection of the underlying metal. BEAM (6)  
CORROSION FULL LENGTH ALONG TOP AND BOTTOM FLANGES WITH (+/- 3/16") LOSS OF SECTION AND (+/- 3/16")  
REMAINING SECTION.

Span 1 Beam 6: 25 Feet of Corrosion: Section loss is evident or pack rust is present but does not warrant structural review. BEAM (6) CORROSION FULL LENGTH ALONG TOP AND BOTTOM FLANGES WITH (+/- 3/16") LOSS OF SECTION AND (+/- 3/16") REMAINING SECTION.

| MMS Code | Description of Function | Unit | Quantity | Remarks | Est. Cost |
|---|---|---|---|---|---|
| 3314 | Maintain Steel Superstructure Components | LF | 25 | BEAM (6) CORROSION FULL LENGTH ALONG TOP AND BOTTOM FLANGES WITH (+/- 3/16") LOSS OF SECTION AND (+/- 3/16") REMAINING SECTION. | |

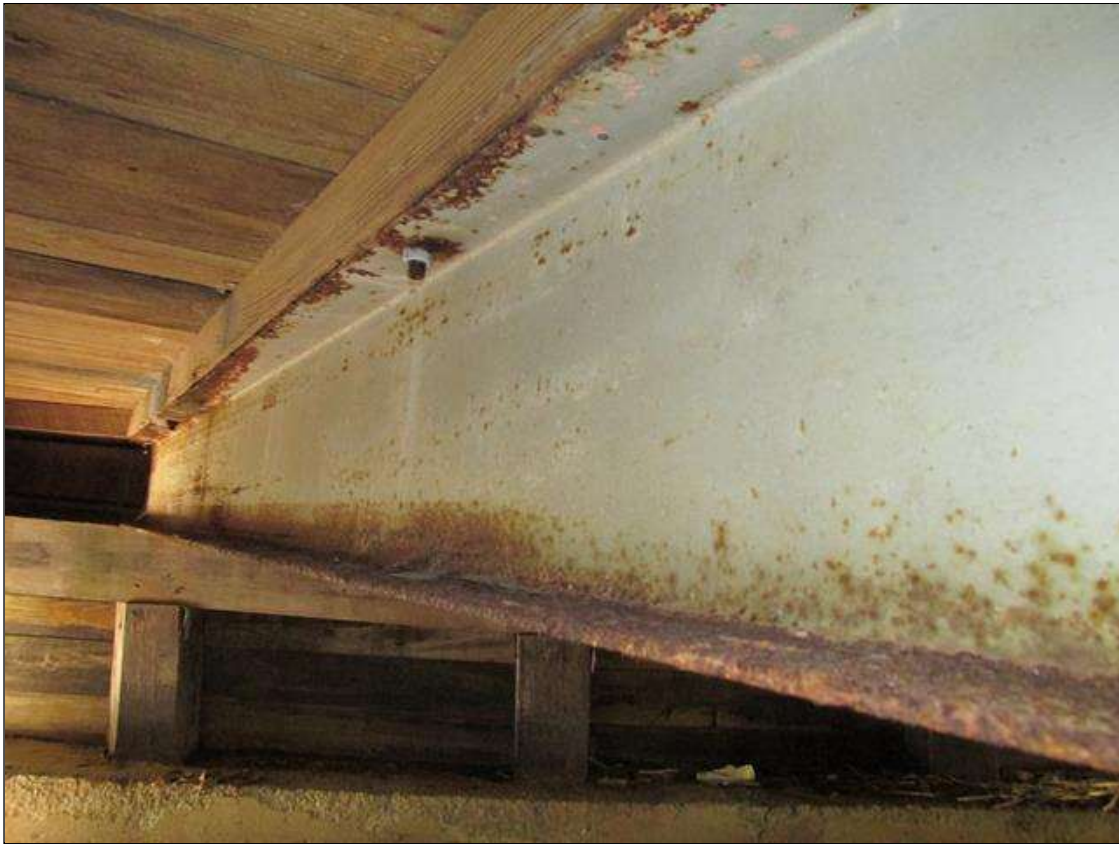
25 Feet of Corrosion: Section loss is evident or pack rust is present but does not warrant structural review. CORROSION FULL  
LENGTH ALONG TOP AND BOTTOM FLANGES WITH NO MEASURABLE SECTION LOSS AT THIS TIME.

50 Square Feet of Effectiveness (Steel Protective Coatings): Failed; no protection of the underlying metal. CORROSION FULL  
LENGTH ALONG TOP AND BOTTOM FLANGES WITH NO MEASURABLE SECTION LOSS AT THIS TIME.

Span 1 Beam 7: 25 Feet of Corrosion: Section loss is evident or pack rust is present but does not warrant structural review. CORROSION FULL LENGTH ALONG TOP AND BOTTOM FLANGES WITH NO MEASURABLE SECTION LOSS AT THIS TIME.

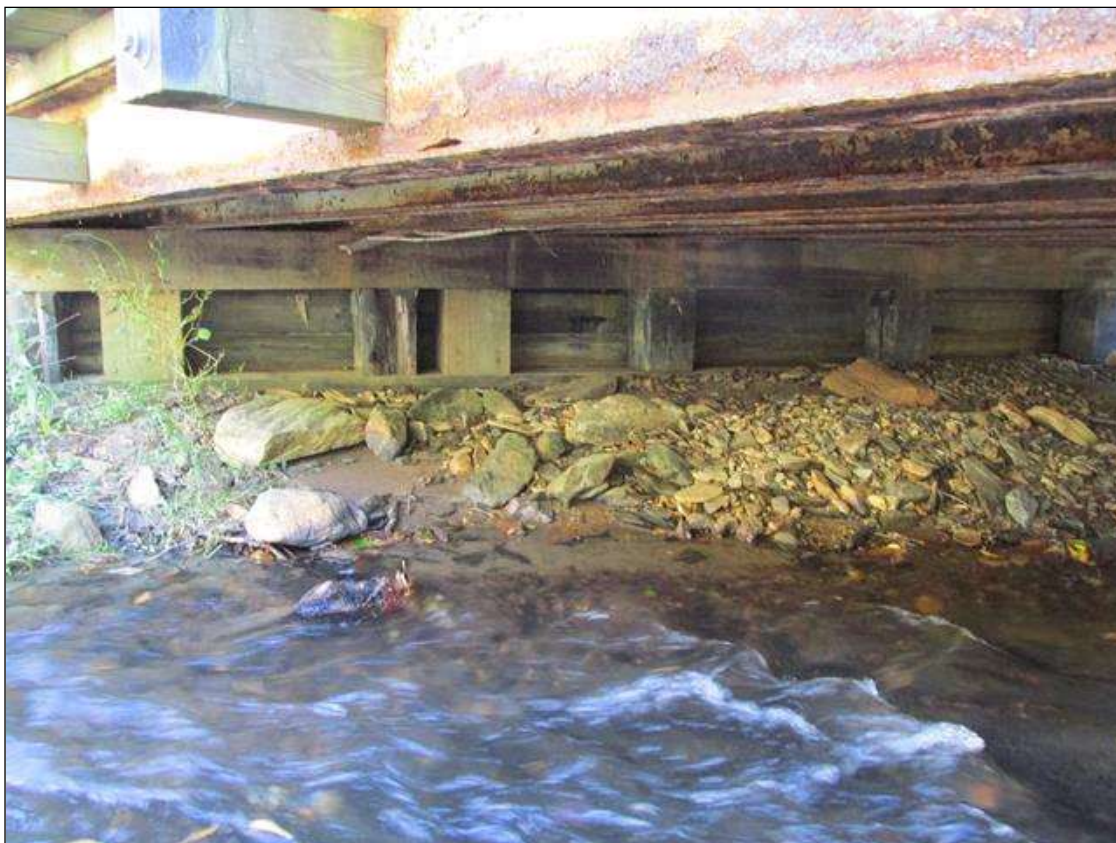
ABUTMENT B

**Details** ABUT. (B) SILL EXPOSED

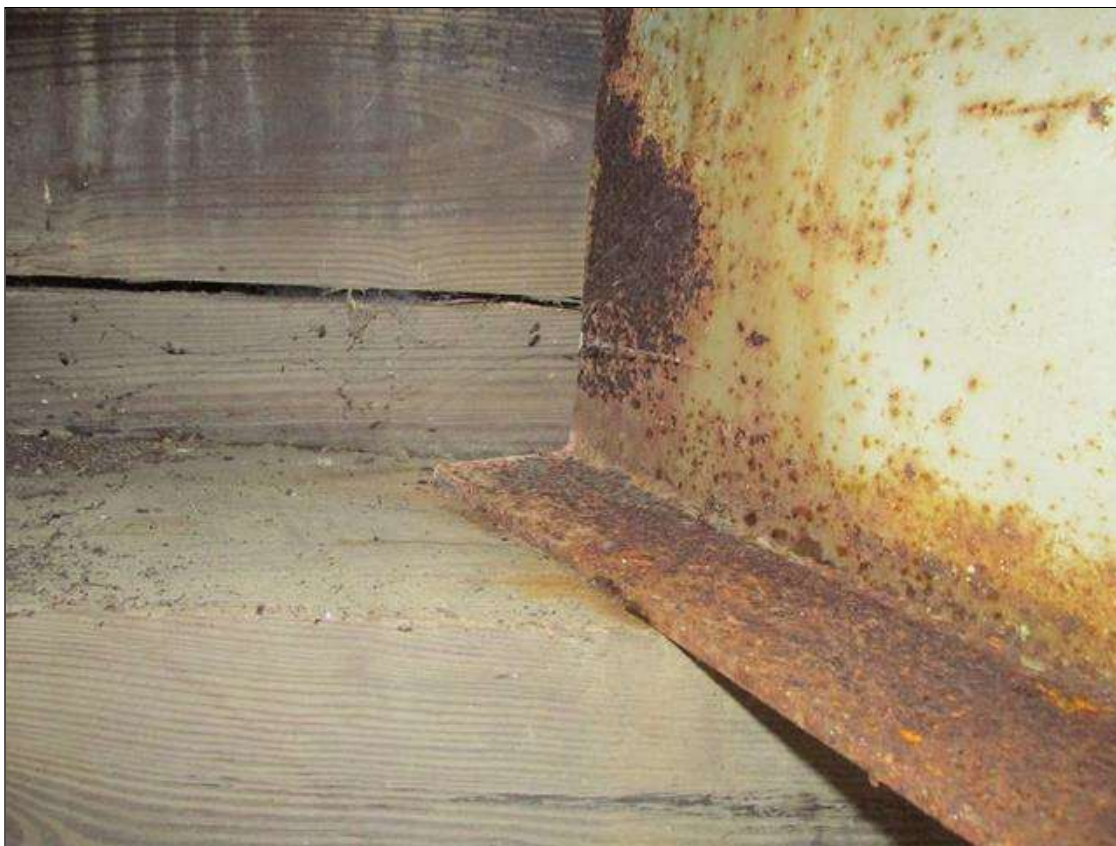
NO BEARINGS

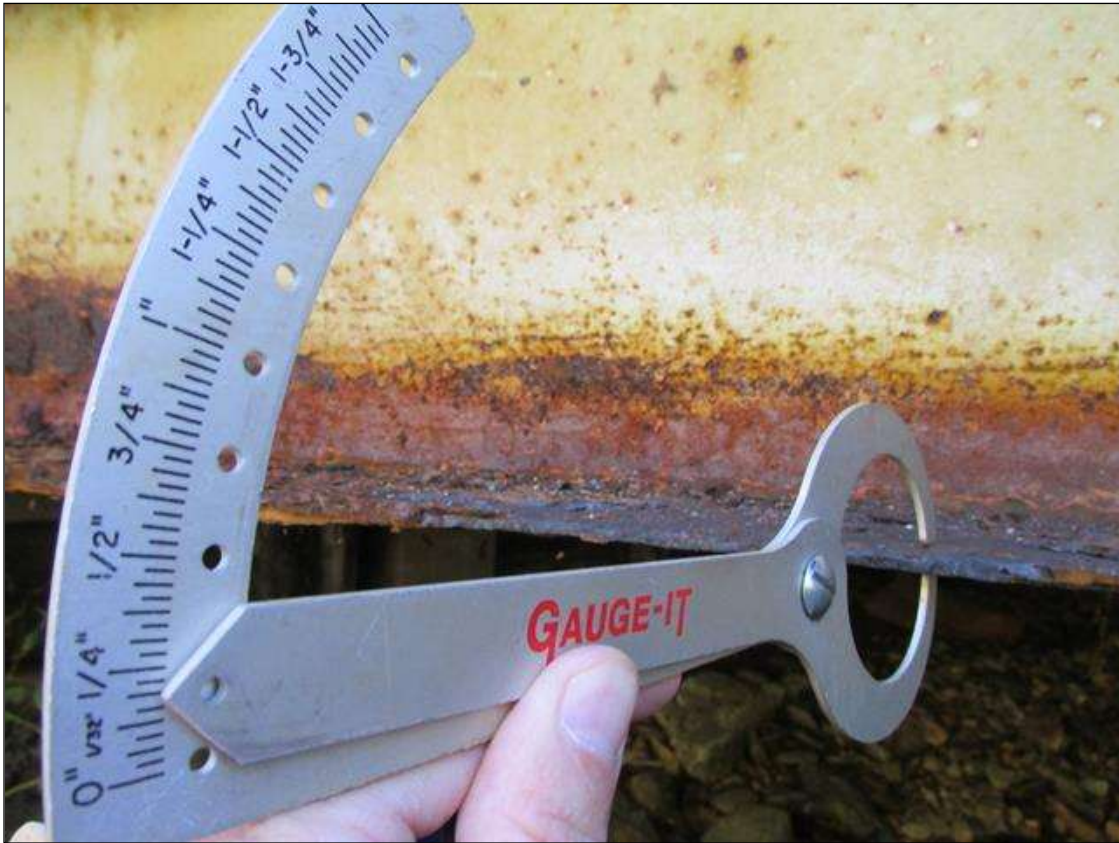
BEAM (1) CORROSION FULL LENGTH ALONG TOP AND BOTTOM FLANGES WITH (+/- 3/16") LOSS OF SECTION AND (+/- 3/16") REMAINING SECTION.

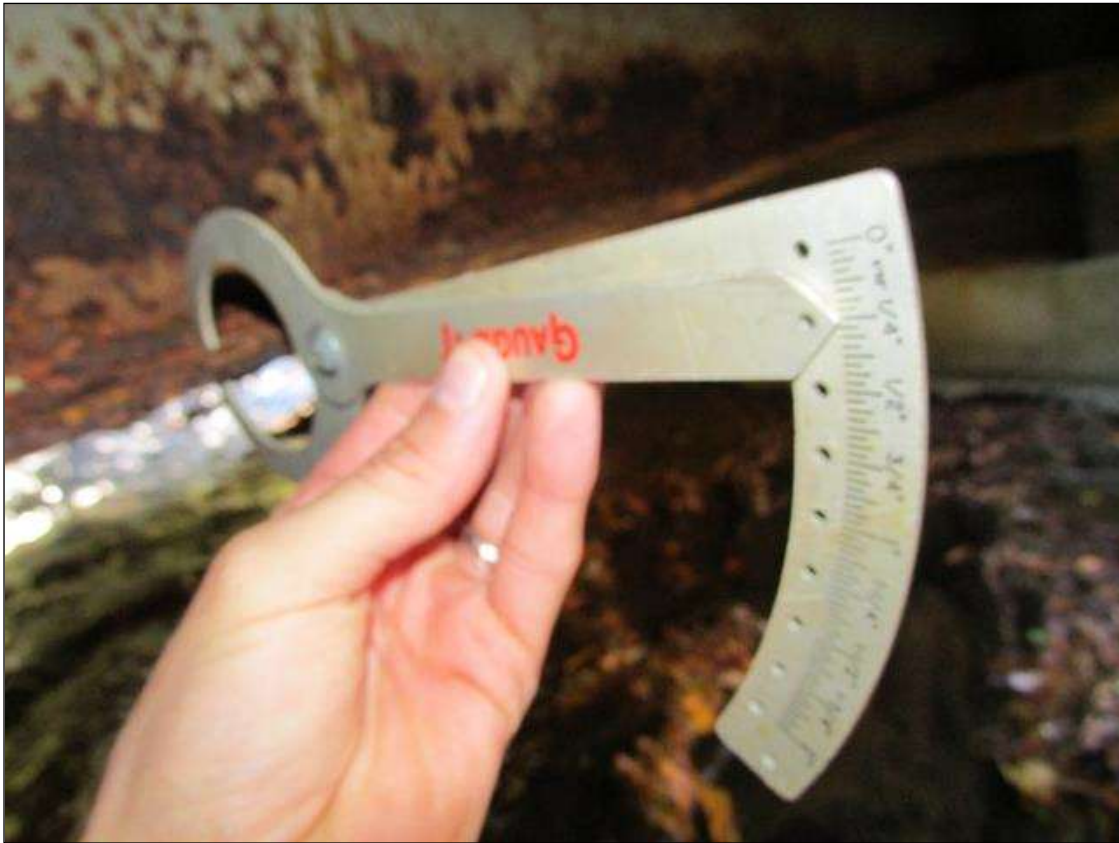
BEAM (2) CORROSION FULL LENGTH ALONG TOP AND BOTTOM FLANGES WITH (+/- 1/8") LOSS OF SECTION AND (+/- 1/4") REMAINING SECTION.

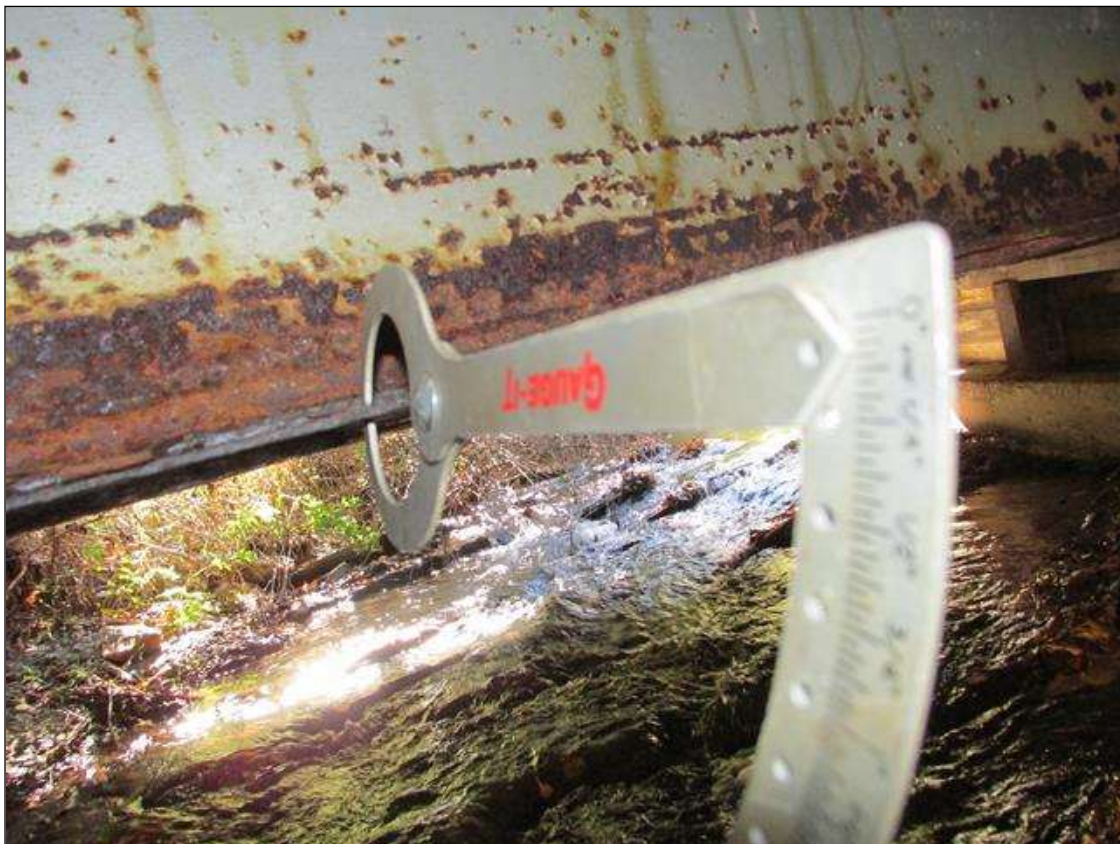
BEAM (3) CORROSION FULL LENGTH ALONG TOP AND BOTTOM FLANGES WITH (+/- 5/16") LOSS OF SECTION AND (+/- 1/16") REMAINING SECTION.

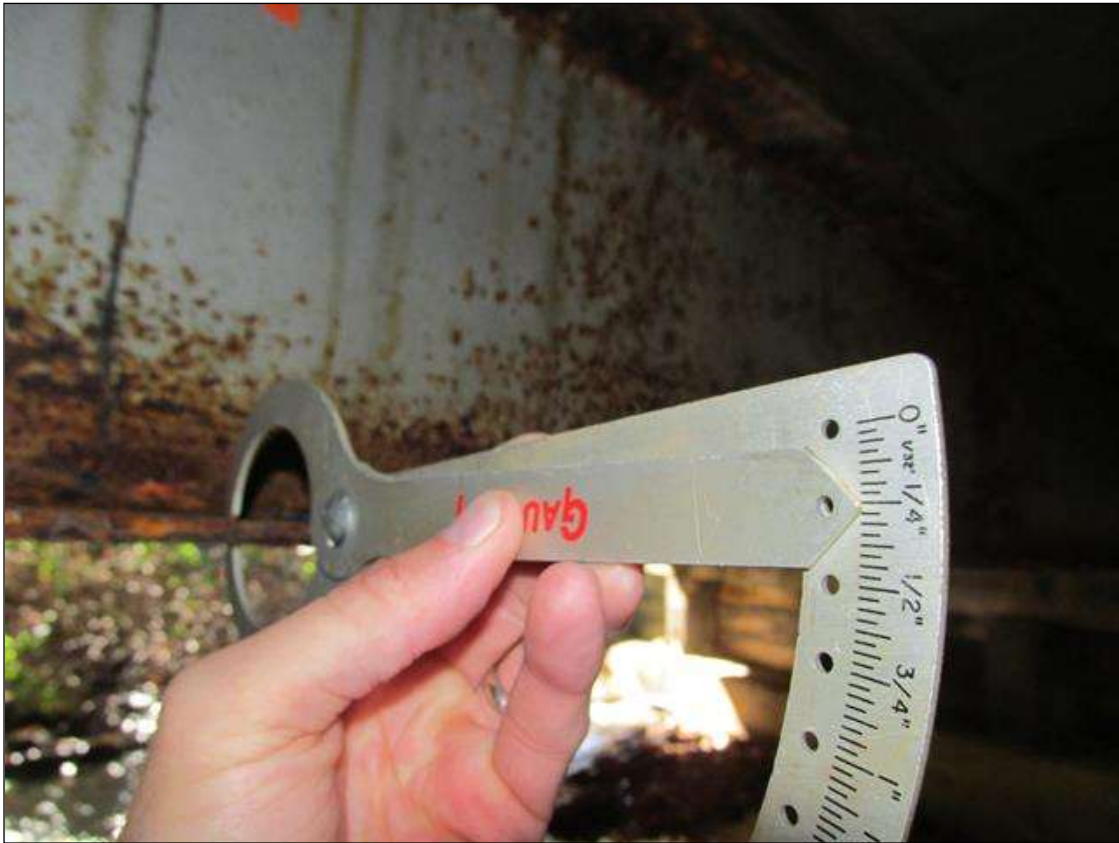
BEAM (4) CORROSION FULL LENGTH ALONG TOP AND BOTTOM FLANGES WITH (+/- 1/8") LOSS OF SECTION AND (+/- 1/4") REMAINING SECTION.

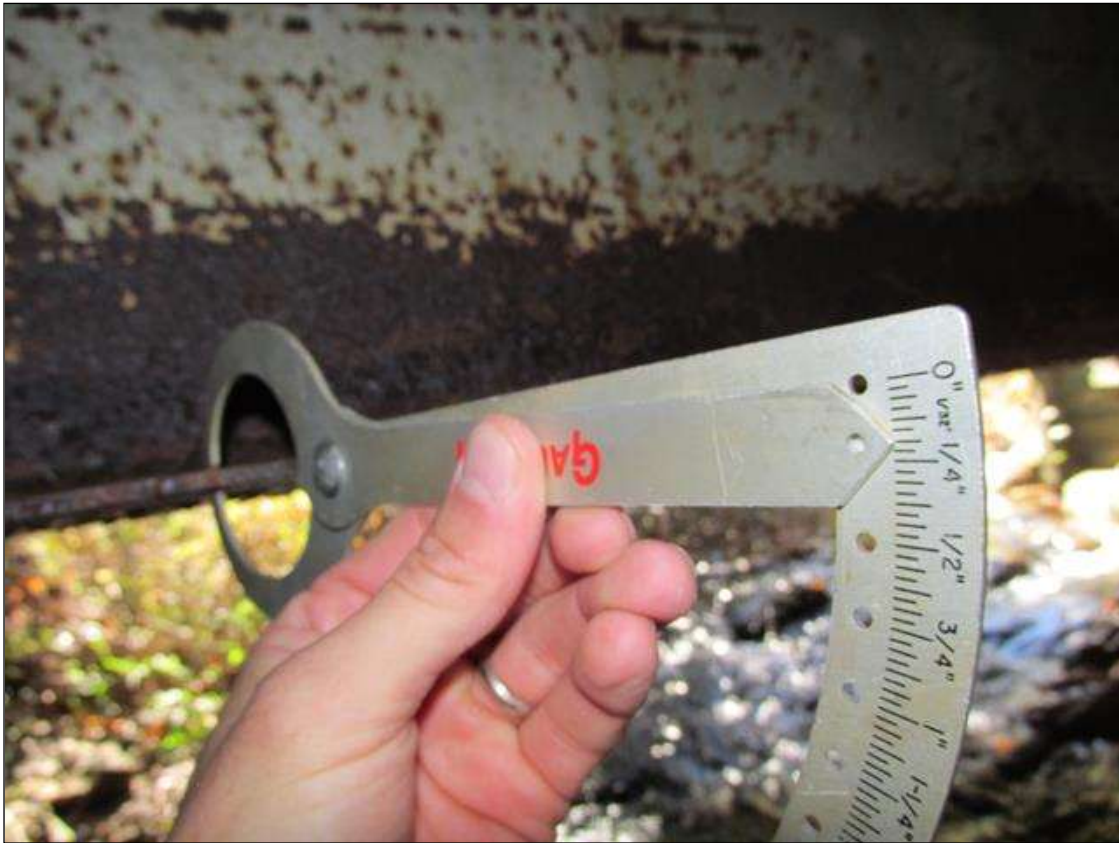
BEAM (5) CORROSION FULL LENGTH ALONG TOP AND BOTTOM FLANGES WITH (+/- 3/16") LOSS OF SECTION AND (+/- 3/16") REMAINING SECTION.

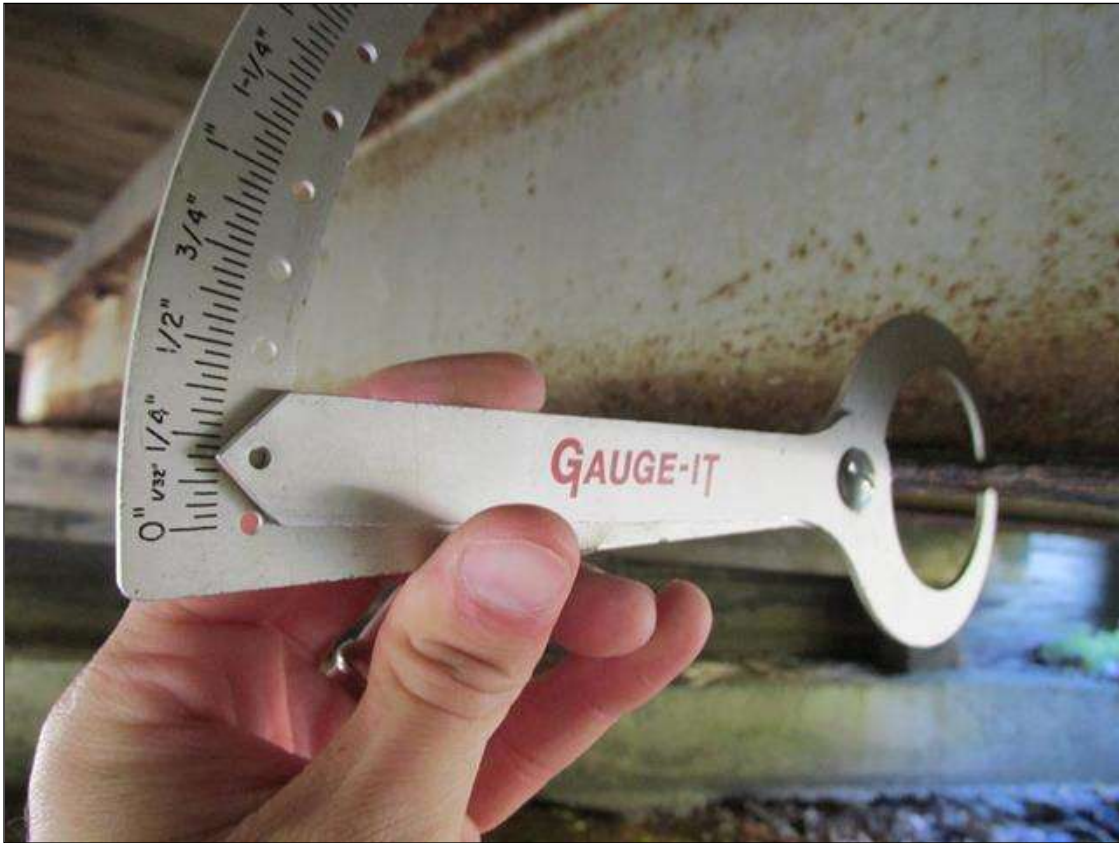
BEAM (6) CORROSION FULL LENGTH ALONG TOP AND BOTTOM FLANGES WITH (+/- 3/16") LOSS OF SECTION AND (+/- 3/16") REMAINING SECTION.
