NC DEPARTMENT OF TRANSPORTATION  
DIVISION OF HIGHWAYS  
STRUCTURE MANAGEMENT UNIT

## Structure Safety Report

### Routine Element Inspection

COUNTY: WATAUGA STRUCTURE NUMBER: 940048 FREQUENCY: 24 MONTHS

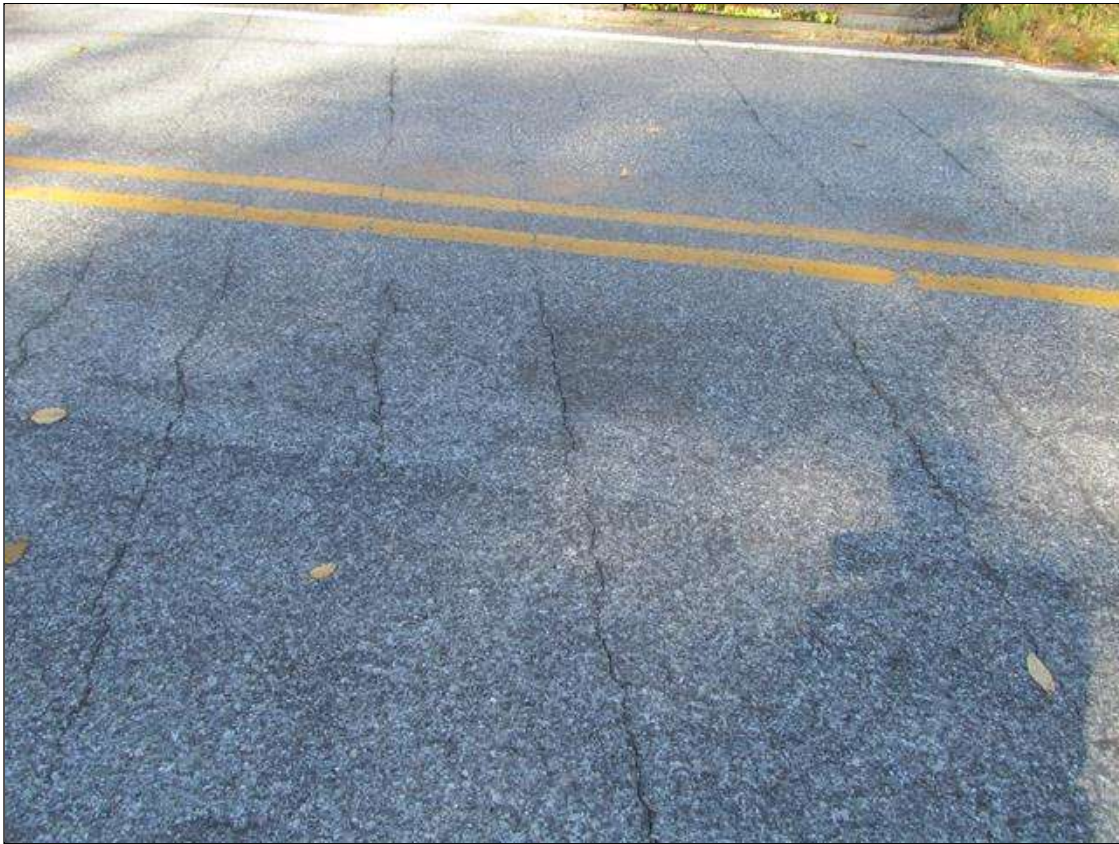
372 Square Feet of Crack (Wearing Surface): Width of more than 0.05 in. or spacing of less than 1.0 ft. TRANSVERSE CRACKS ALONG DECK BOARDS

Span 1 Wearing Surface: 372 Square Feet of Crack (Wearing Surface): Width of more than 0.05 in. or spacing of less than 1.0 ft. TRANSVERSE CRACKS ALONG DECK BOARDS

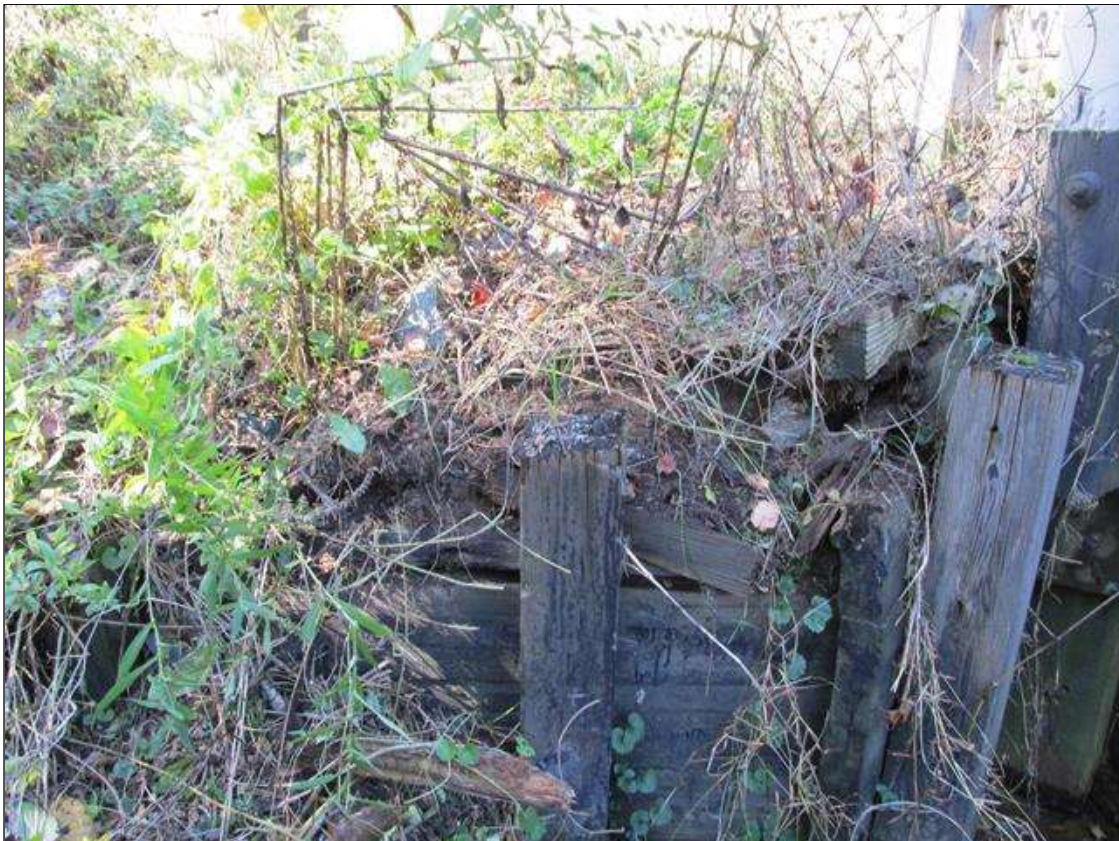
Details SOUTH WEST WING TOP (3) BOARDS DECAYED (+/- 15 SF) WITH LOSS OF FILL.

SOUTH WEST WING TOP (3) BOARDS DECAYED (+/- 15 SF) WITH LOSS OF FILL.

| MMS Code | Description of Function | Unit | Quantity | Remarks | Est. Cost |
|---|---|---|---|---|---|
| 3346 | Repair / Maintain Timber Wings & Blkhds | SF | 10 | SOUTH WEST WING TOP (3) BOARDS DECAYED (+/- 15 SF) WITH LOSS OF FILL. | |

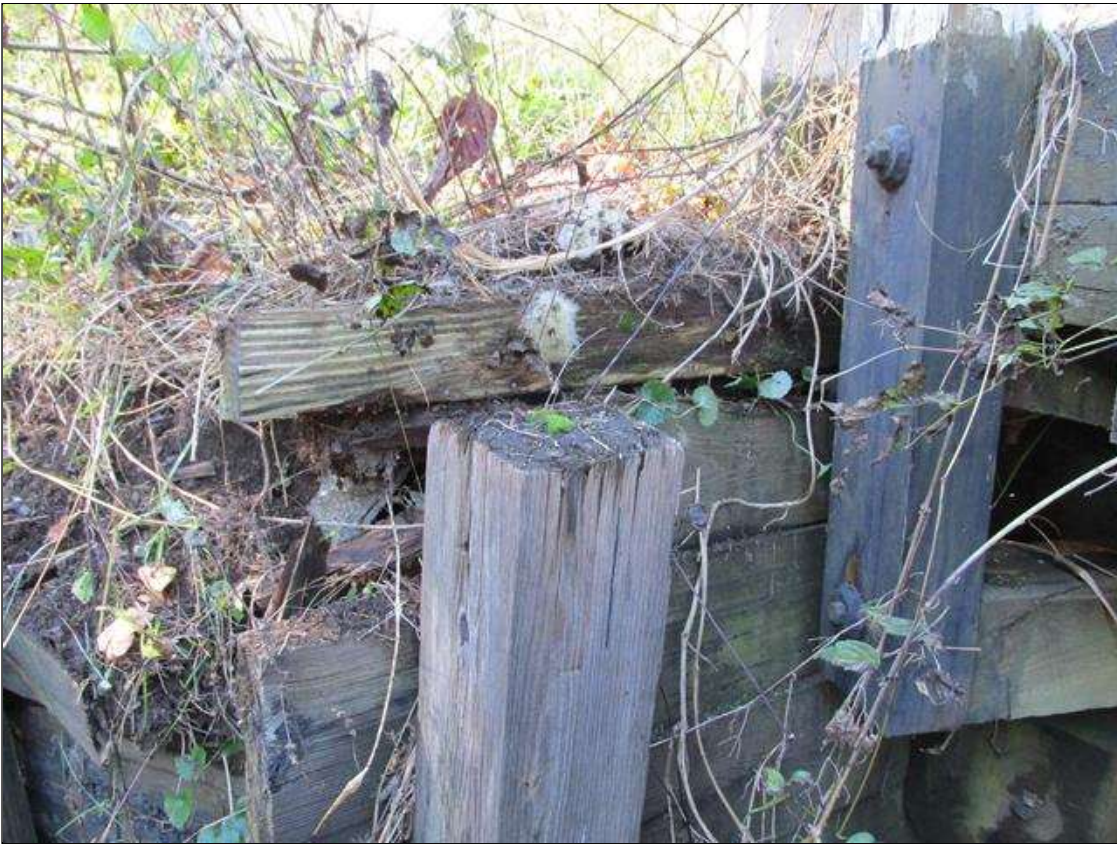
3 Feet of Decay/Section Loss: Affects 10% or more of the member but does not warrant structural review. RIGHT END ABUT.  
(A) TIMBER BULKHEAD TOP (2) BOARDS DECAYED (+/- 6 SF)

End Bent 1 Abutment/Backwall : 3 Feet of Decay/Section Loss: Affects 10% or more of the member but does not warrant structural review. RIGHT END ABUT. (A) TIMBER BULKHEAD TOP (2) BOARDS DECAYED (+/- 6 SF)

| MMS Code | Description of Function | Unit | Quantity | Remarks | Est. Cost |
|---|---|---|---|---|---|
| 3346 | Repair / Maintain Timber Wings & Blkhds | SF | 6 | RIGHT END ABUT. (A) TIMBER BULKHEAD TOP (2) BOARDS DECAYED (+/- 6 SF) | |

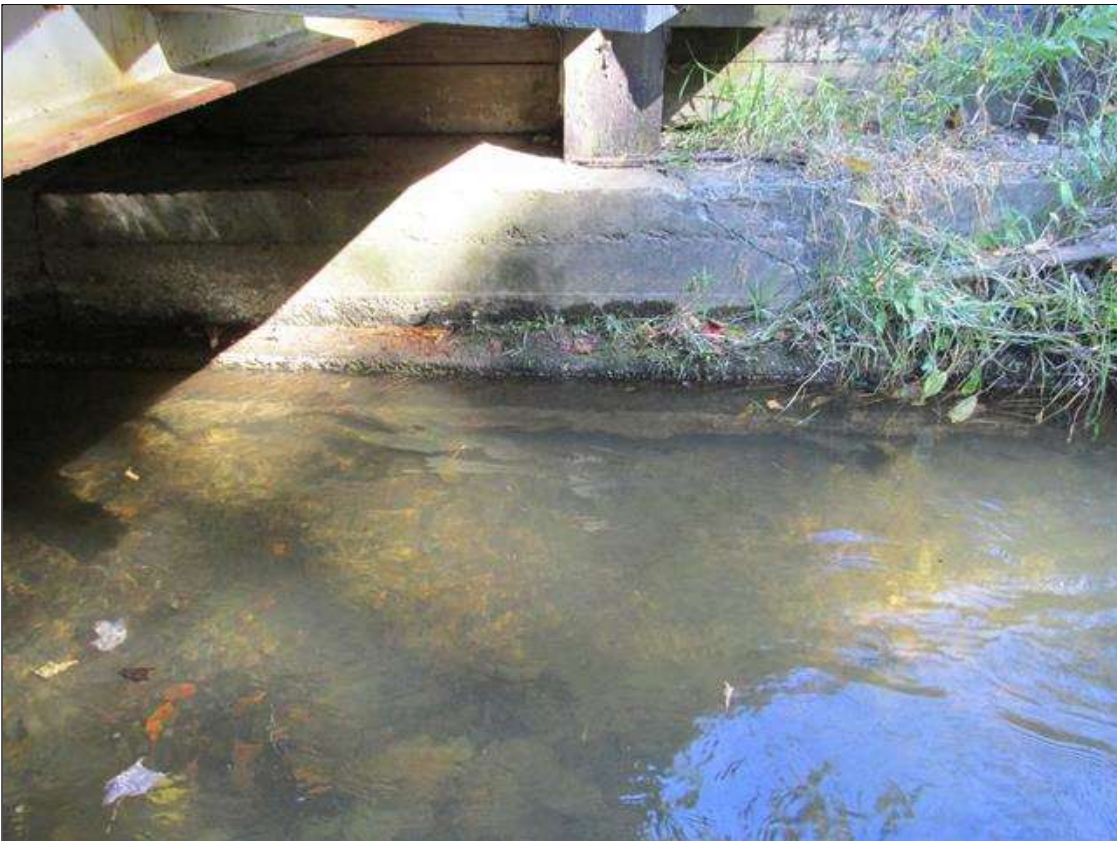
Details RIGHT END ABUTMENT B (R.C.) ENCASEMENT UNDERMINED (+/- 10 LF X 6" D X 1' PROBES)

RIGHT END ABUTMENT B (R.C.) ENCASEMENT UNDERMINED (+/- 10 LF X 6" D X 1' PROBES)

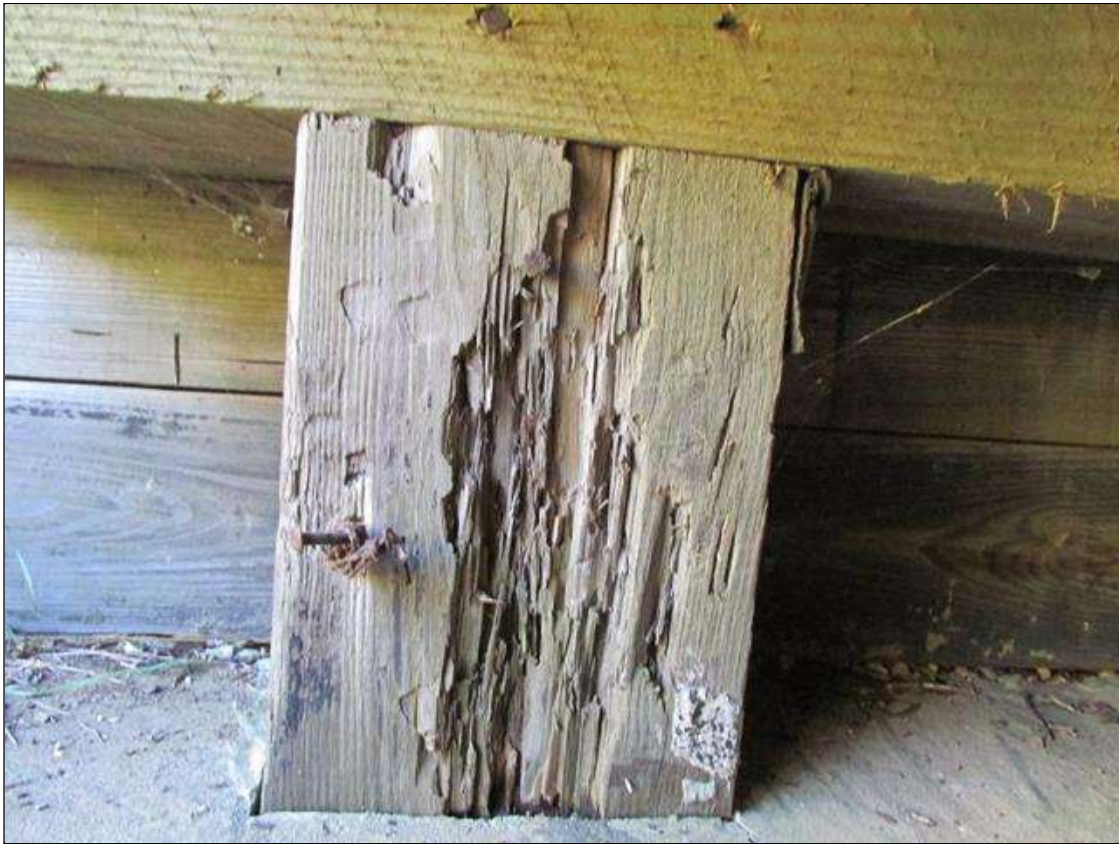
1 Each of Decay/Section Loss: Affects less than 10% of the member section. ABUT. (B) POST (1) WEST FACE DECAYED (+/- 1' H X 5" W X 1" D)

End Bent 2 Pile 1: 1 Each of Decay/Section Loss: Affects less than 10% of the member section. ABUT. (B) POST (1)  
WEST FACE DECAYED (+/- 1' H X 5" W X 1" D)

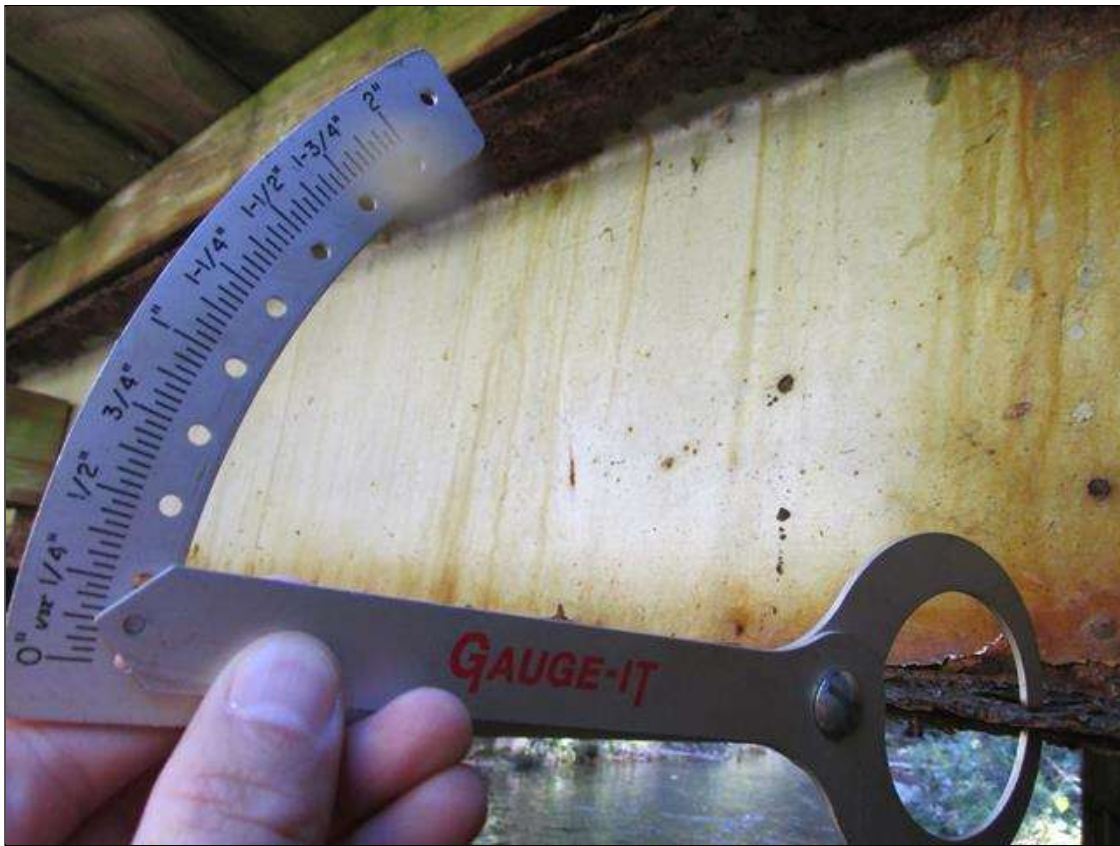
18 Feet of Corrosion: Section loss is evident or pack rust is present but does not warrant structural review. CORROSION F/L ALONG TOP FLANGES AND (+/- 10 LF) ALONG BOTTOM FLANGES FROM ABUT. (A) BEAM END WITH (+/- 1/4") LOSS AND (+/- 1/8") REMAINING SECTION

36 Square Feet of Effectiveness (Steel Protective Coatings): Failed; no protection of the underlying metal. CORROSION F/L ALONG TOP FLANGES AND (+/- 10 LF) ALONG BOTTOM FLANGES FROM ABUT. (A) BEAM END WITH (+/- 1/4") LOSS AND (+/- 1/8") REMAINING SECTION

Span 1 Beam 1: 18 Feet of Corrosion: Section loss is evident or pack rust is present but does not warrant structural review. CORROSION F/L ALONG TOP FLANGES AND (+/- 10 LF) ALONG BOTTOM FLANGES FROM ABUT. (A) BEAM END WITH (+/- 1/4") LOSS AND (+/- 1/8") REMAINING SECTION

| MMS Code | Description of Function | Unit | Quantity | Remarks | Est. Cost |
|---|---|---|---|---|---|
| 3314 | Maintain Steel Superstructure Components | LF | 18 | CORROSION F/L ALONG TOP FLANGES AND (+/- 10 LF) ALONG BOTTOM FLANGES FROM ABUT. (A) BEAM END WITH (+/- 1/4") LOSS AND (+/- 1/8") REMAINING SECTION | |

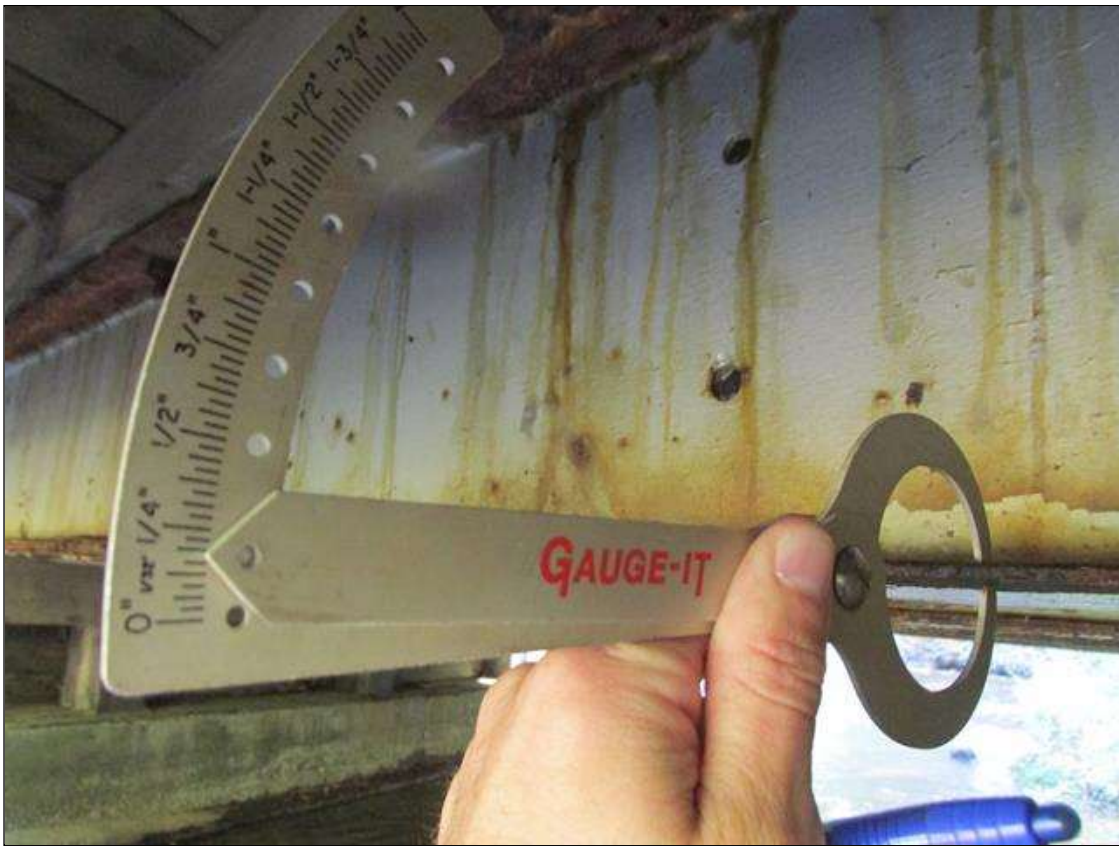
18 Feet of Corrosion: Section loss is evident or pack rust is present but does not warrant structural review. CORROSION F/L ALONG TOP FLANGES AND (+/- 12 LF) ALONG BOTTOM FLANGES FROM ABUT. (A) BEAM END WITH (+/- 3/16") LOSS AND (+/- 3/16") REMAINING SECTION

36 Square Feet of Effectiveness (Steel Protective Coatings): Failed; no protection of the underlying metal. CORROSION F/L ALONG TOP FLANGES AND (+/- 12 LF) ALONG BOTTOM FLANGES FROM ABUT. (A) BEAM END WITH (+/- 3/16") LOSS AND (+/- 3/16") REMAINING SECTION

Span 1 Beam 2: 18 Feet of Corrosion: Section loss is evident or pack rust is present but does not warrant structural review. CORROSION F/L ALONG TOP FLANGES AND (+/- 12 LF) ALONG BOTTOM FLANGES FROM ABUT. (A) BEAM END WITH (+/- 3/16") LOSS AND (+/- 3/16") REMAINING SECTION

| MMS Code | Description of Function | Unit | Quantity | Remarks | Est. Cost |
|---|---|---|---|---|---|
| 3314 | Maintain Steel Superstructure Components | LF | 18 | CORROSION F/L ALONG TOP FLANGES AND (+/- 12 LF) ALONG BOTTOM FLANGES FROM ABUT. (A) BEAM END WITH (+/- 3/16") LOSS AND (+/- 3/16") REMAINING SECTION | |

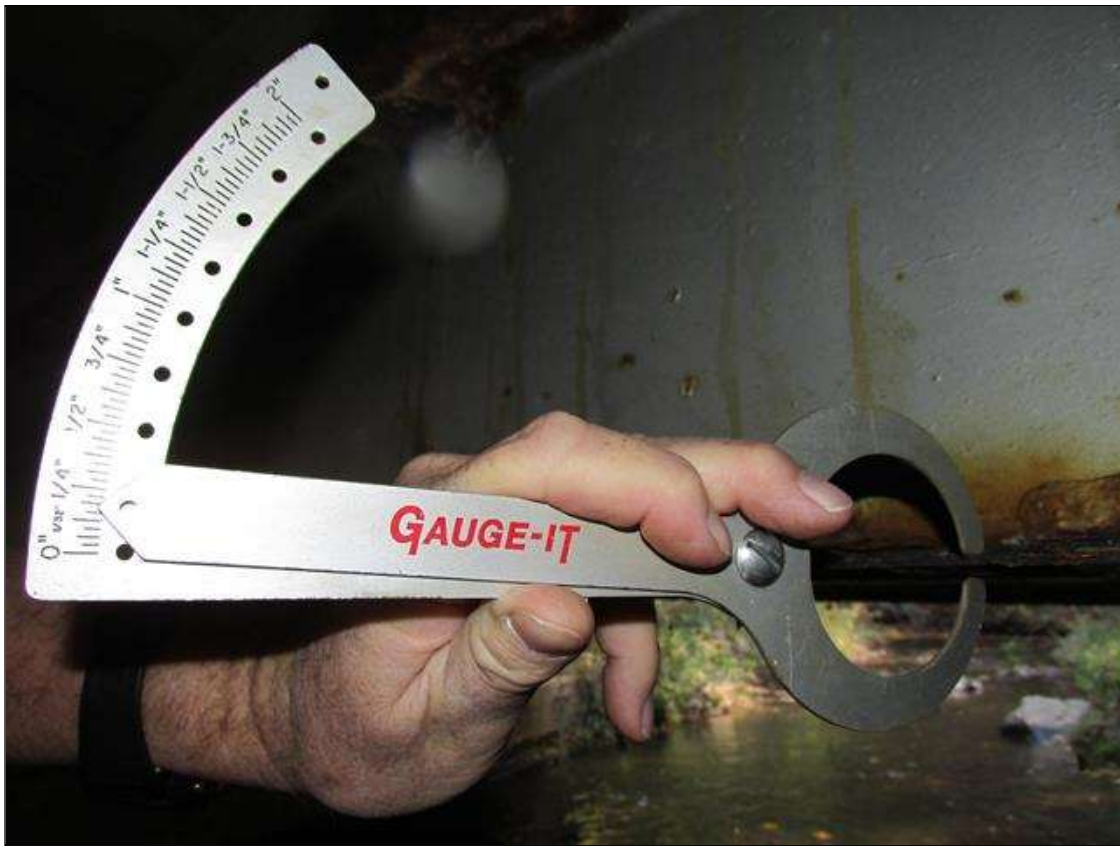
18 Feet of Corrosion: Section loss is evident or pack rust is present but does not warrant structural review. BEAM (3) CORROSION F/L ALONG TOP FLANGES AND (+/- 10 LF) ALONG BOTTOM FLANGES FROM ABUT. (A) BEAM END WITH (+/- 3/16") LOSS AND (+/- 3/16") REMAINING SECTION

36 Square Feet of Effectiveness (Steel Protective Coatings): Failed; no protection of the underlying metal. BEAM (3) CORROSION F/L ALONG TOP FLANGES AND (+/- 10 LF) ALONG BOTTOM FLANGES FROM ABUT. (A) BEAM END WITH (+/- 3/16") LOSS AND (+/- 3/16") REMAINING SECTION

Span 1 Beam 3: 18 Feet of Corrosion: Section loss is evident or pack rust is present but does not warrant structural review. BEAM (3) CORROSION F/L ALONG TOP FLANGES AND (+/- 10 LF) ALONG BOTTOM FLANGES FROM ABUT. (A) BEAM END WITH (+/- 3/16") LOSS AND (+/- 3/16") REMAINING SECTION

| MMS Code | Description of Function | Unit | Quantity | Remarks | Est. Cost |
|---|---|---|---|---|---|
| 3314 | Maintain Steel Superstructure Components | LF | 18 | BEAM (3) CORROSION F/L ALONG TOP FLANGES AND (+/- 10 LF) ALONG BOTTOM FLANGES FROM ABUT. (A) BEAM END WITH (+/- 3/16") LOSS AND (+/- 3/16") REMAINING | |

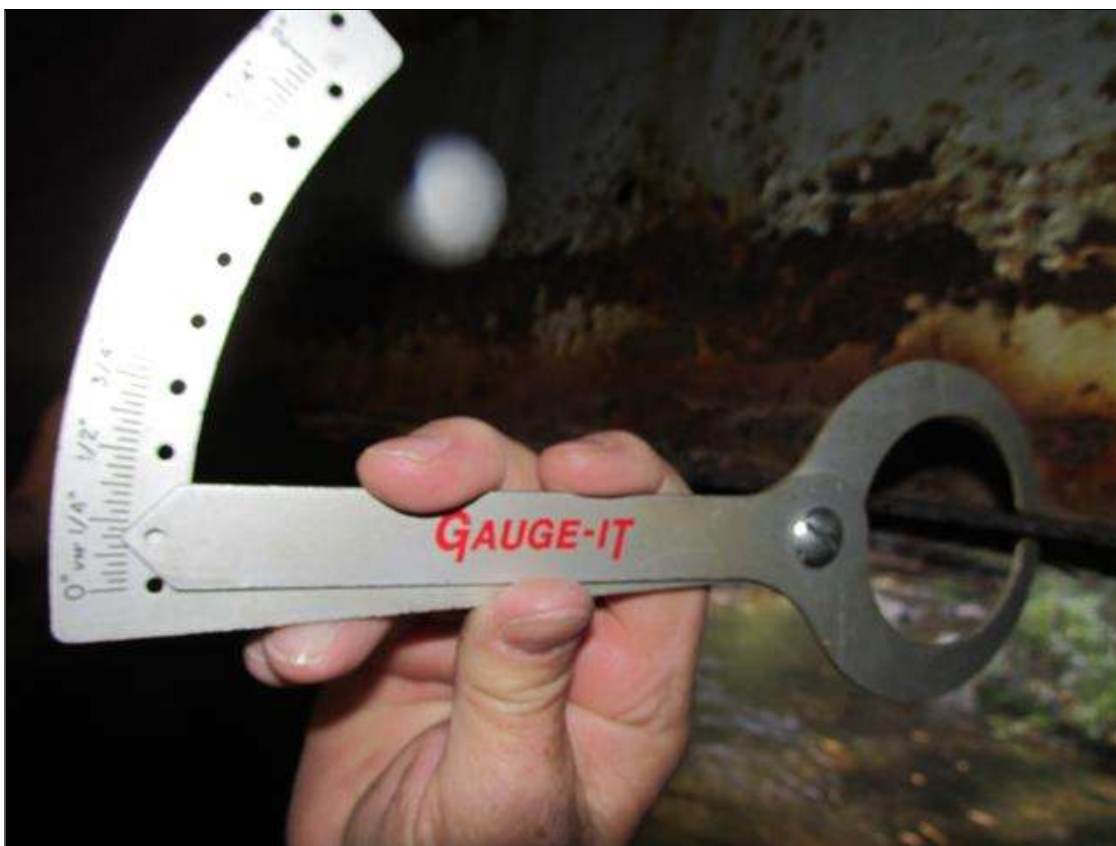
18 Feet of Corrosion: Section loss is evident or pack rust is present but does not warrant structural review. BEAM (4) CORROSION F/L ALONG TOP AND BOTTOM FLANGES WITH (+/- 3/16") LOSS AND (+/- 3/16") REMAINING SECTION

36 Square Feet of Effectiveness (Steel Protective Coatings): Failed; no protection of the underlying metal. BEAM (4) CORROSION F/L ALONG TOP AND BOTTOM FLANGES WITH (+/- 3/16") LOSS AND (+/- 3/16") REMAINING SECTION

Span 1 Beam 4: 18 Feet of Corrosion: Section loss is evident or pack rust is present but does not warrant structural review. BEAM (4) CORROSION F/L ALONG TOP AND BOTTOM FLANGES WITH (+/- 3/16") LOSS AND (+/- 3/16") REMAINING SECTION

| MMS Code | Description of Function | Unit | Quantity | Remarks | Est. Cost |
|---|---|---|---|---|---|
| 3314 | Maintain Steel Superstructure Components | LF | 18 | BEAM (4) CORROSION F/L ALONG TOP AND BOTTOM FLANGES WITH (+/- 3/16") LOSS AND (+/- 3/16") REMAINING SECTION | |

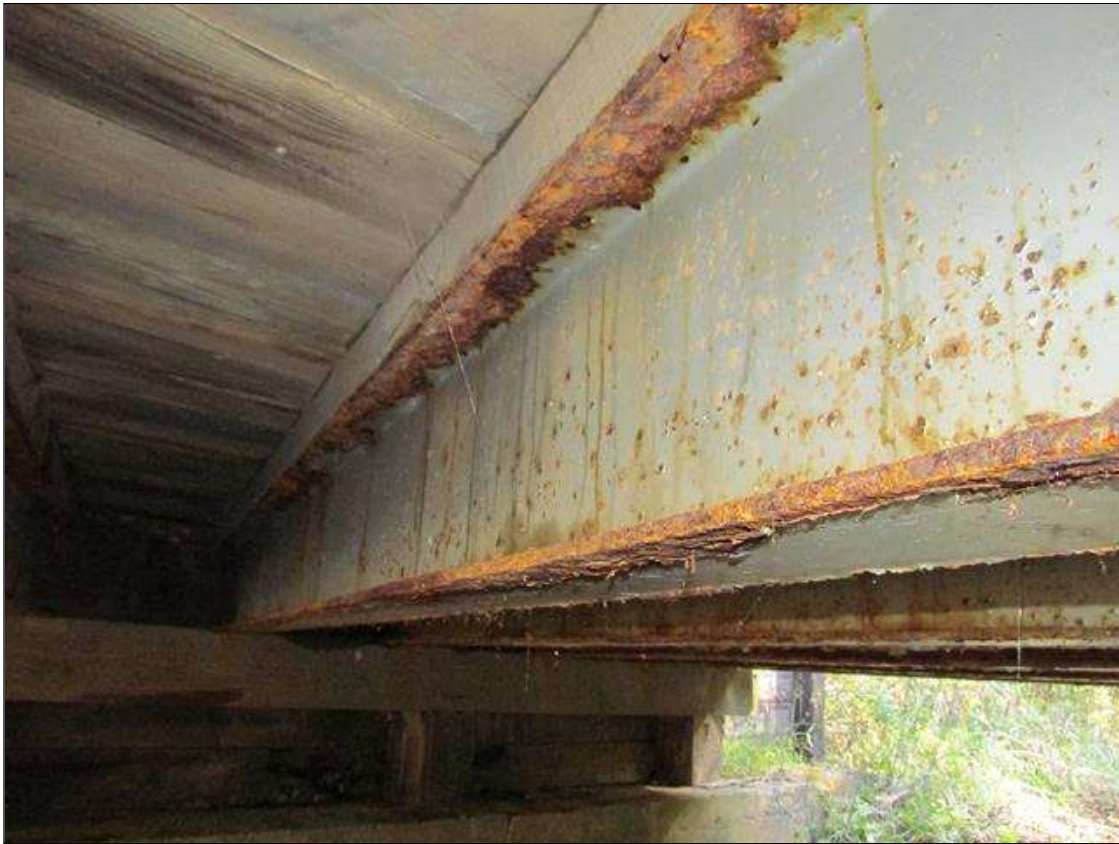
18 Feet of Corrosion: Section loss is evident or pack rust is present but does not warrant structural review. CORROSION F/L ALONG TOP AND BOTTOM FLANGES WITH NO MEASURABLE SECTION LOSS AT THIS TIME

36 Square Feet of Effectiveness (Steel Protective Coatings): Failed; no protection of the underlying metal. CORROSION F/L

## ALONG TOP AND BOTTOM FLANGES WITH NO MEASURABLE SECTION LOSS AT THIS TIME

Span 1 Beam 5: 18 Feet of Corrosion: Section loss is evident or pack rust is present but does not warrant structural review. CORROSION F/L ALONG TOP AND BOTTOM FLANGES WITH NO MEASURABLE SECTION LOSS AT THIS TIME

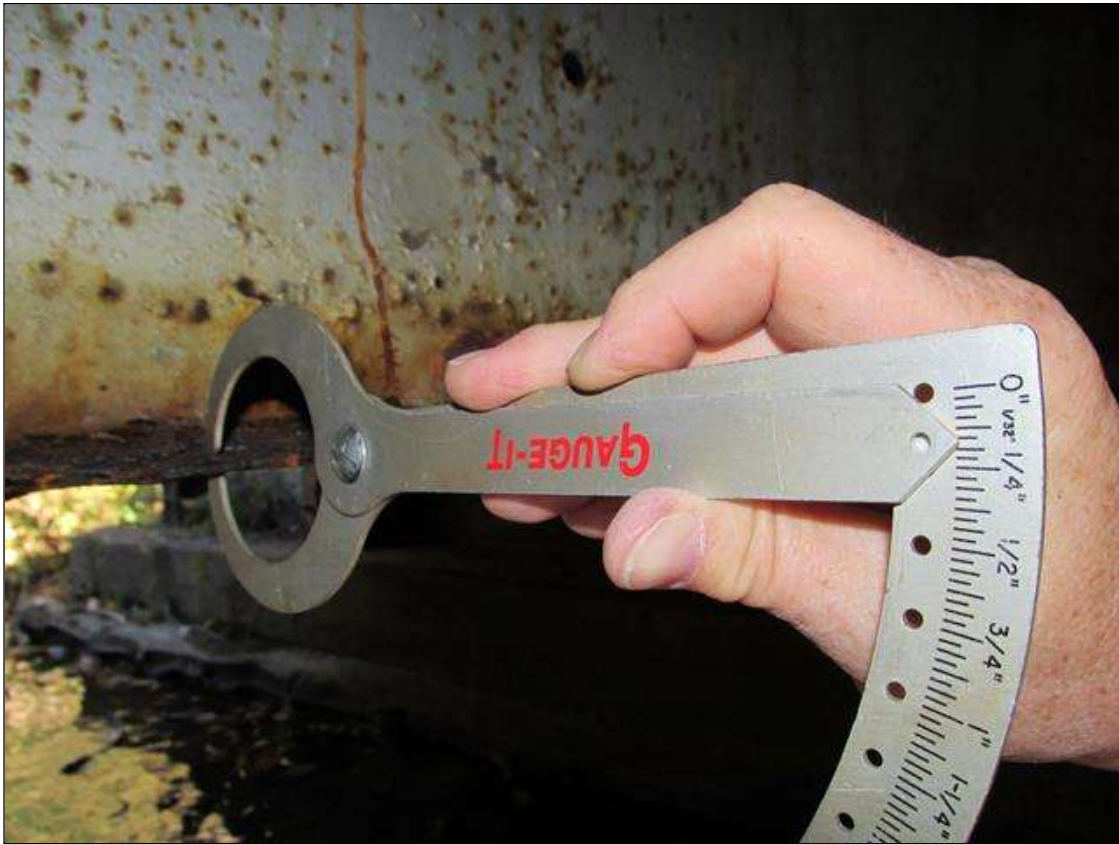
18 Feet of Corrosion: Section loss is evident or pack rust is present but does not warrant structural review. BEAM (6)  
CORROSION F/L ALONG TOP AND BOTTOM FLANGES WITH (+/- 3/16") LOSS AND (+/- 3/16") REMAINING SECTION

36 Square Feet of Effectiveness (Steel Protective Coatings): Failed; no protection of the underlying metal. BEAM (6)  
CORROSION F/L ALONG TOP AND BOTTOM FLANGES WITH (+/- 3/16") LOSS AND (+/- 3/16") REMAINING SECTION

Span 1 Beam 6: 18 Feet of Corrosion: Section loss is evident or pack rust is present but does not warrant structural review. BEAM (6) CORROSION F/L ALONG TOP AND BOTTOM FLANGES WITH (+/- 3/16") LOSS AND (+/- 3/16") REMAINING SECTION

| MMS Code | Description of Function | Unit | Quantity | Remarks | Est. Cost |
|---|---|---|---|---|---|
| 3314 | Maintain Steel Superstructure Components | LF | 18 | BEAM (6) CORROSION F/L ALONG TOP AND BOTTOM FLANGES WITH (+/- 3/16") LOSS AND (+/- 3/16") REMAINING SECTION | |

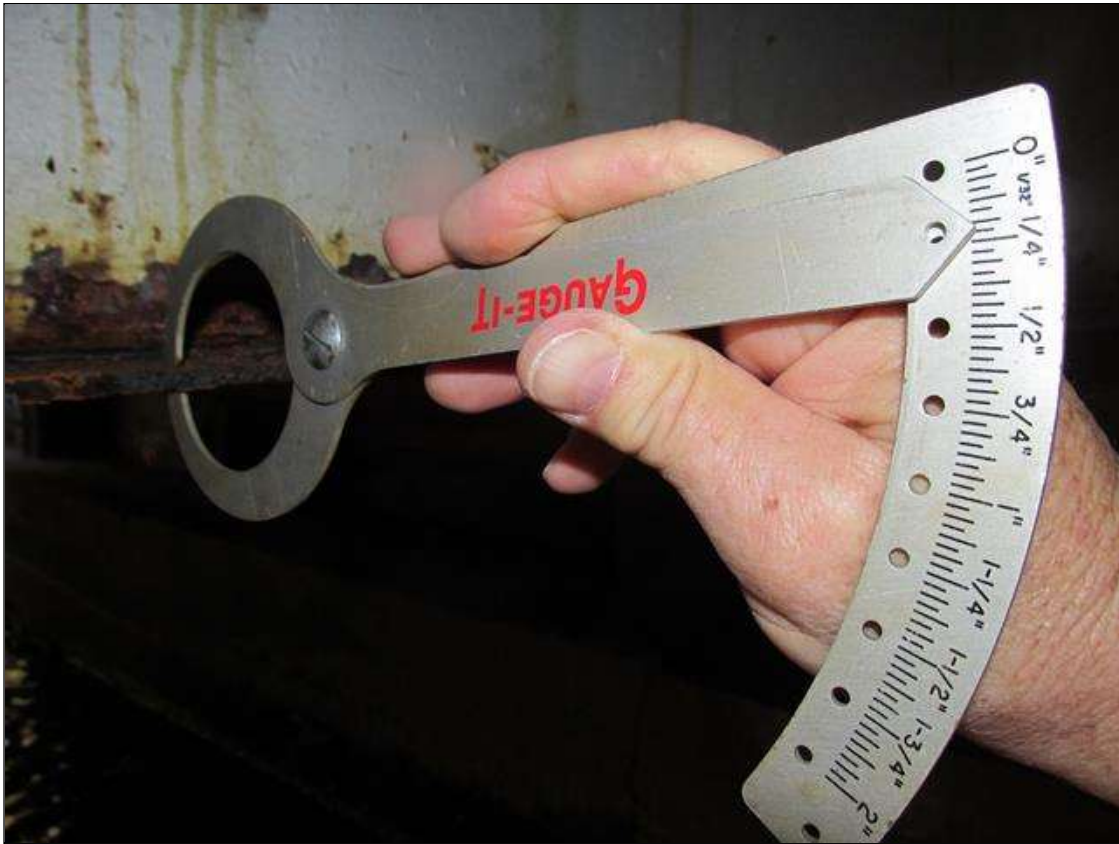
18 Feet of Corrosion: Section loss is evident or pack rust is present but does not warrant structural review. BEAM (8)  
CORROSION F/L ALONG TOP AND BOTTOM FLANGES WITH (+/- 3/16") LOSS AND (+/- 3/16") REMAINING SECTION

36 Square Feet of Effectiveness (Steel Protective Coatings): Failed; no protection of the underlying metal. BEAM (8)  
CORROSION F/L ALONG TOP AND BOTTOM FLANGES WITH (+/- 3/16") LOSS AND (+/- 3/16") REMAINING SECTION

Span 1 Beam 8: 18 Feet of Corrosion: Section loss is evident or pack rust is present but does not warrant structural review. BEAM (8) CORROSION F/L ALONG TOP AND BOTTOM FLANGES WITH (+/- 3/16") LOSS AND (+/- 3/16") REMAINING SECTION

| MMS Code | Description of Function | Unit | Quantity | Remarks | Est. Cost |
|---|---|---|---|---|---|
| 3314 | Maintain Steel Superstructure Components | LF | 18 | BEAM (8) CORROSION F/L ALONG TOP AND BOTTOM FLANGES WITH (+/- 3/16") LOSS AND (+/- 3/16") REMAINING SECTION | |

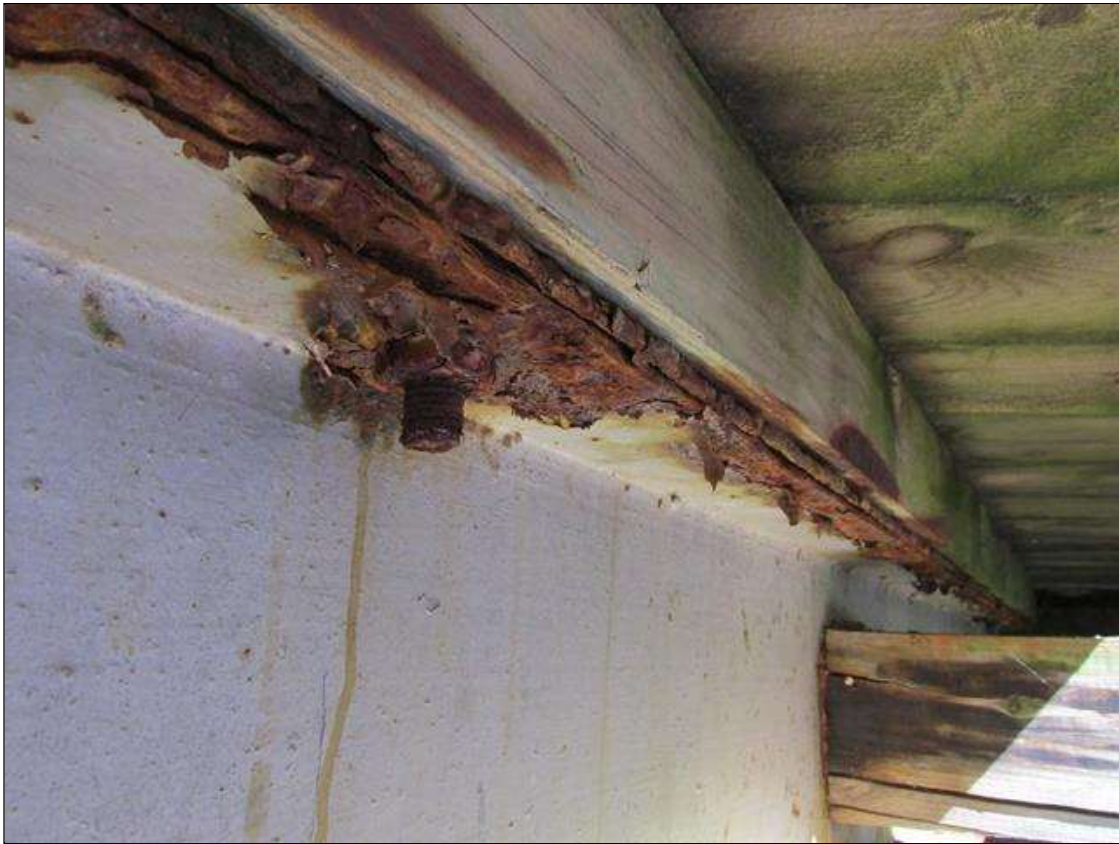
18 Feet of Corrosion: Section loss is evident or pack rust is present but does not warrant structural review. BEAM (9)  
CORROSION F/L ALONG TOP FLANGES WITH (+/- 3/16") LOSS AND (+/- 3/16") REMAINING SECTION

18 Square Feet of Effectiveness (Steel Protective Coatings): Failed; no protection of the underlying metal. BEAM (9)  
CORROSION F/L ALONG TOP FLANGES WITH (+/- 3/16") LOSS AND (+/- 3/16") REMAINING SECTION

Span 1 Beam 9: 18 Feet of Corrosion: Section loss is evident or pack rust is present but does not warrant structural review. BEAM (9) CORROSION F/L ALONG TOP FLANGES WITH (+/- 3/16") LOSS AND (+/- 3/16") REMAINING SECTION

| MMS Code | Description of Function | Unit | Quantity | Remarks | Est. Cost |
|---|---|---|---|---|---|
| 3314 | Maintain Steel Superstructure Components | LF | 18 | BEAM (9) CORROSION F/L ALONG TOP FLANGES WITH (+/- 3/16") LOSS AND (+/- 3/16") REMAINING SECTION | |

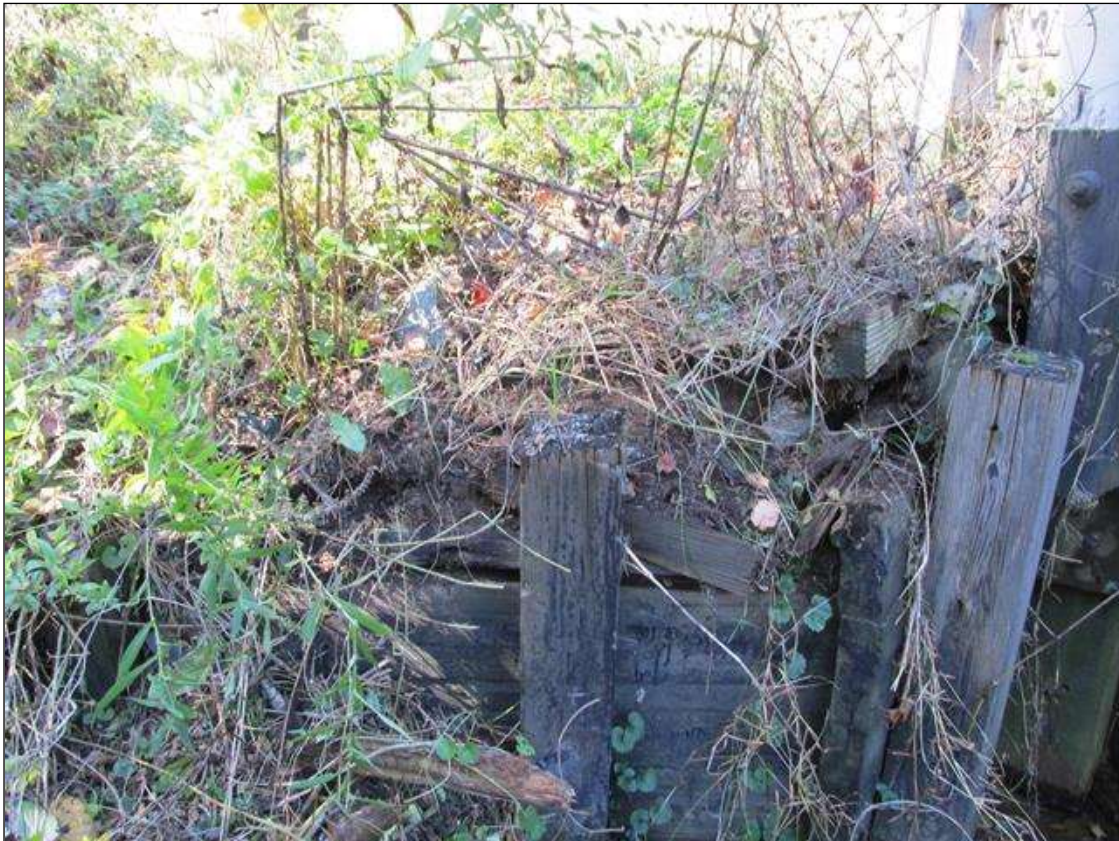
SOUTH WEST WING TOP (3) BOARDS DECAYED (+/- 15 SF) WITH LOSS OF FILL.

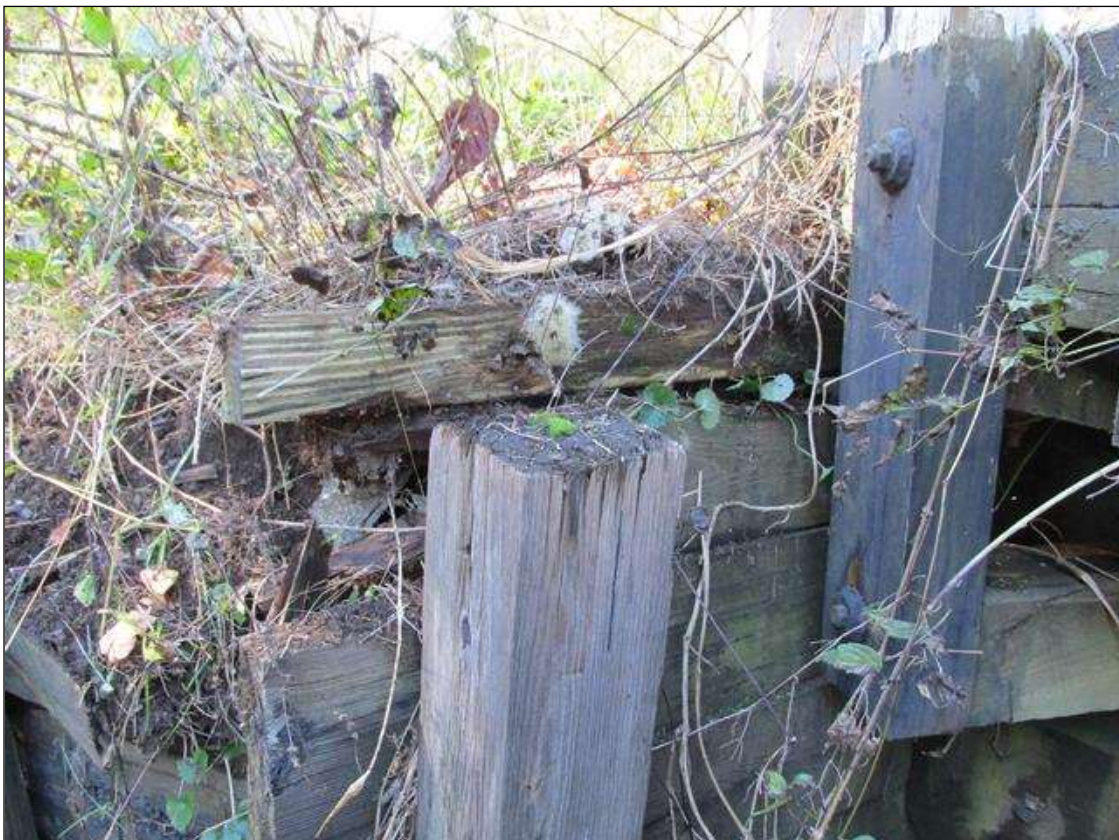
RIGHT END ABUT. (A) TIMBER BULKHEAD TOP (2) BOARDS DECAYED (+/- 6 SF)

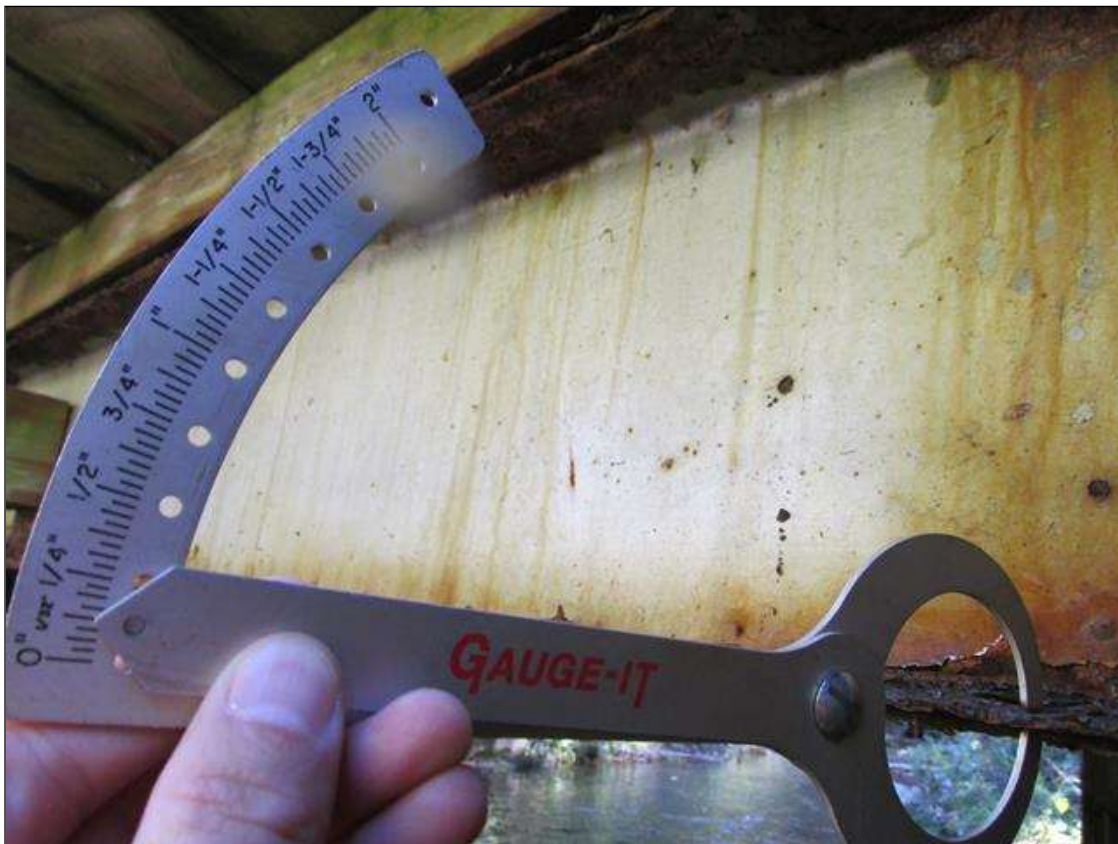
BEAM (1) CORROSION F/L ALONG TOP FLANGES AND (+/- 10 LF) ALONG BOTTOM FLANGES FROM ABUT. (A)  
BEAM END WITH (+/- 1/4") LOSS AND (+/- 1/8") REMAINING

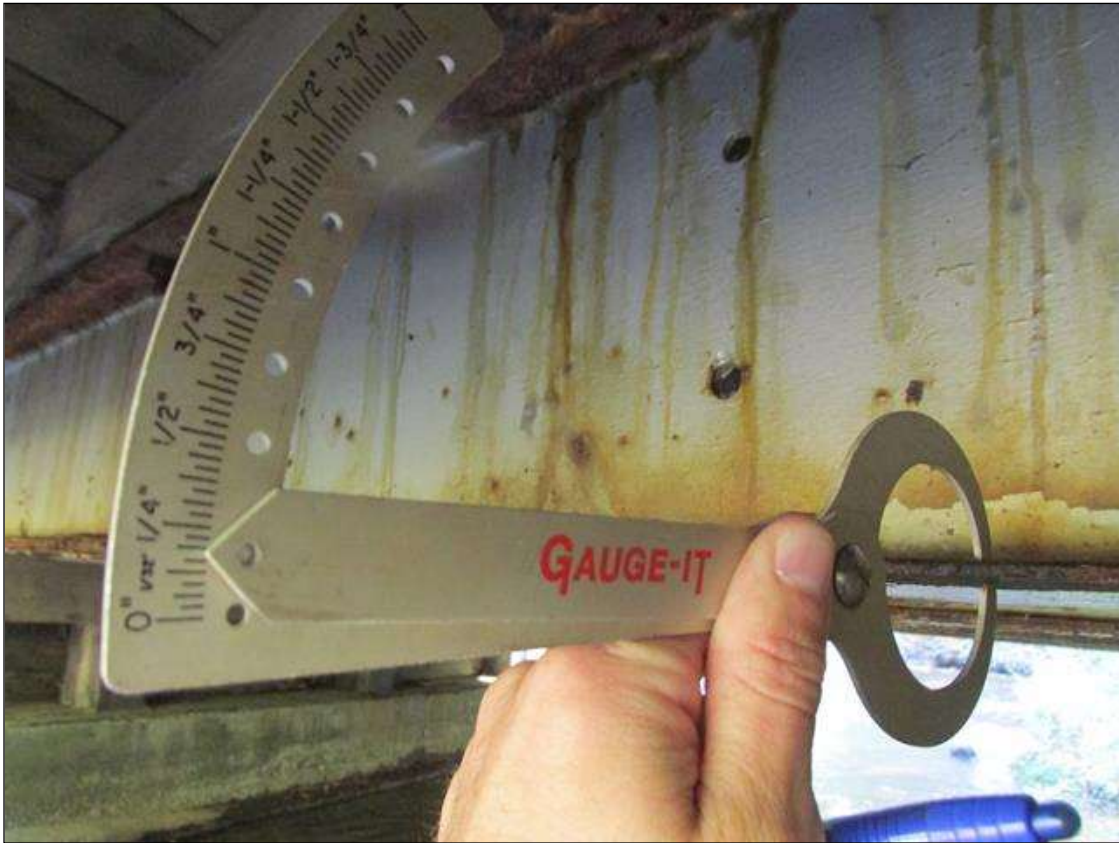
BEAM (2) CORROSION F/L ALONG TOP FLANGES AND (+/- 12 LF) ALONG BOTTOM FLANGES FROM ABUT. (A)  
BEAM END WITH (+/- 3/16") LOSS AND (+/- 3/16") REMAINING

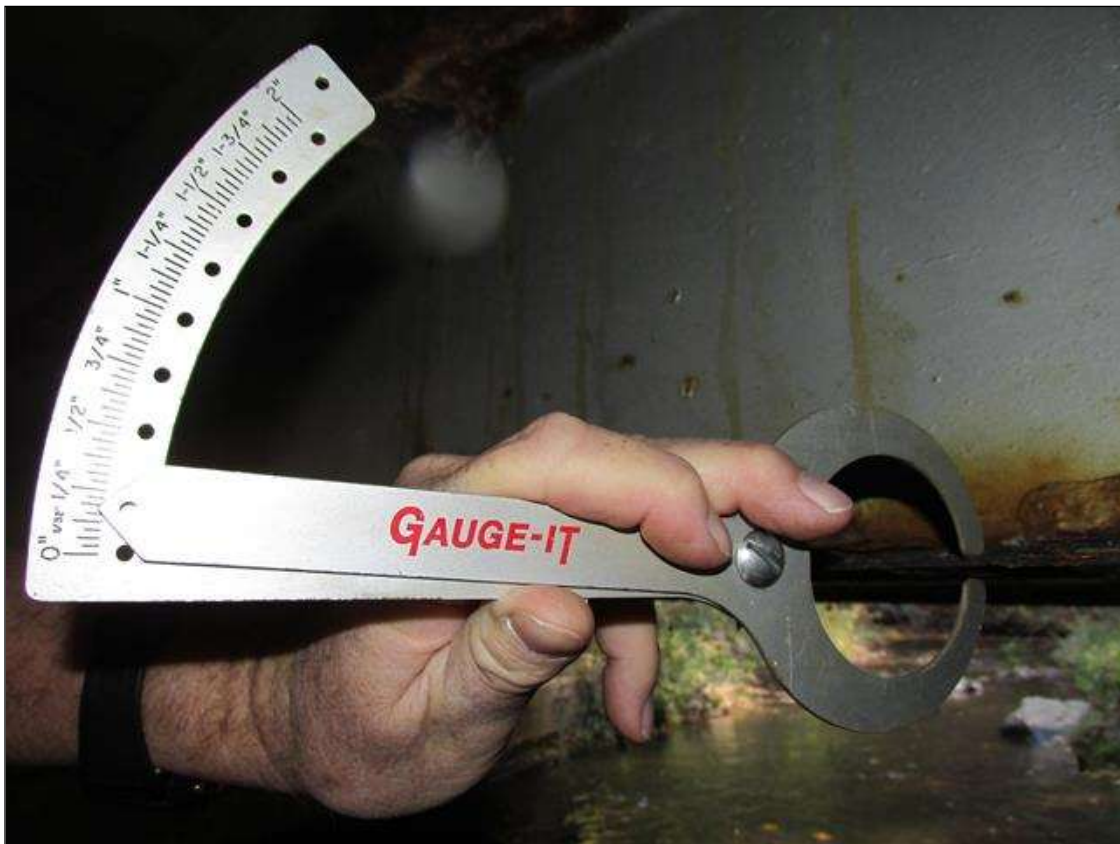
BEAM (3) CORROSION F/L ALONG TOP FLANGES AND (+/- 10 LF) ALONG BOTTOM FLANGES FROM ABUT. (A)  
BEAM END WITH (+/- 3/16") LOSS AND (+/- 3/16") REMAINING

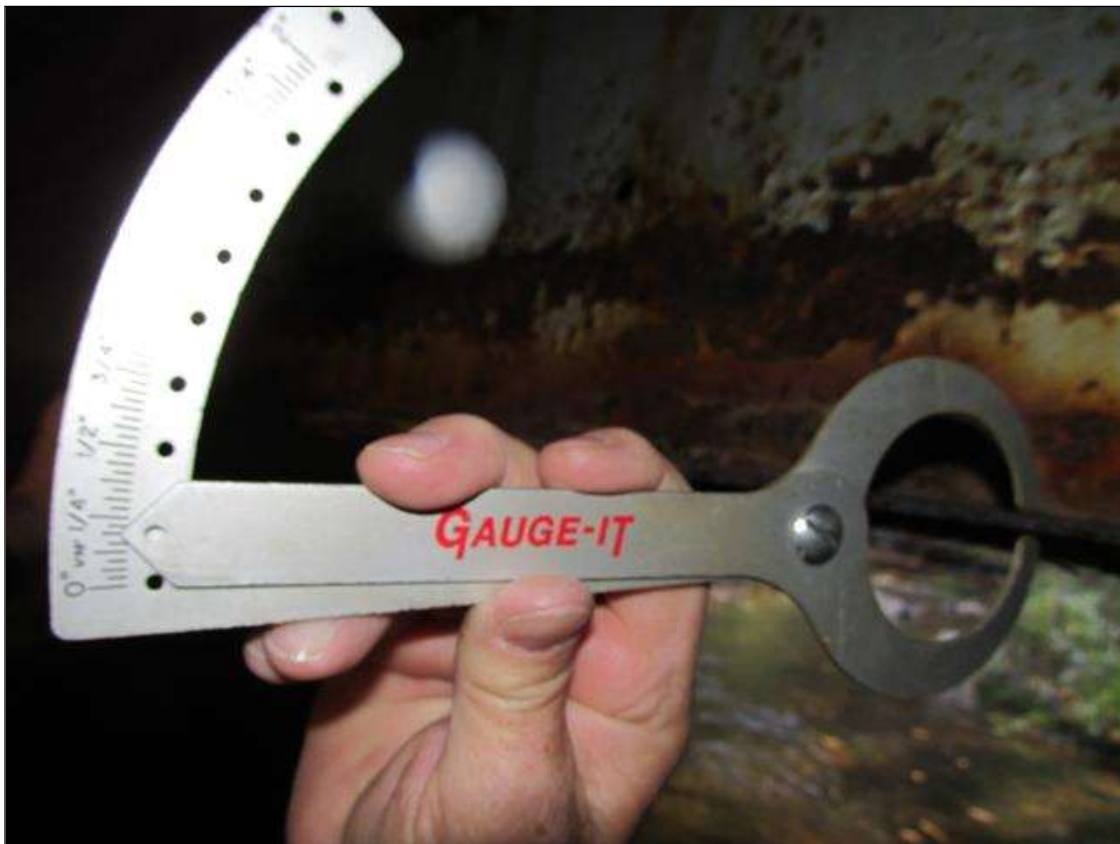
BEAM (4) CORROSION F/L ALONG TOP AND BOTTOM FLANGES WITH (+/- 3/16") LOSS AND (+/- 3/16") REMAINING SECTION

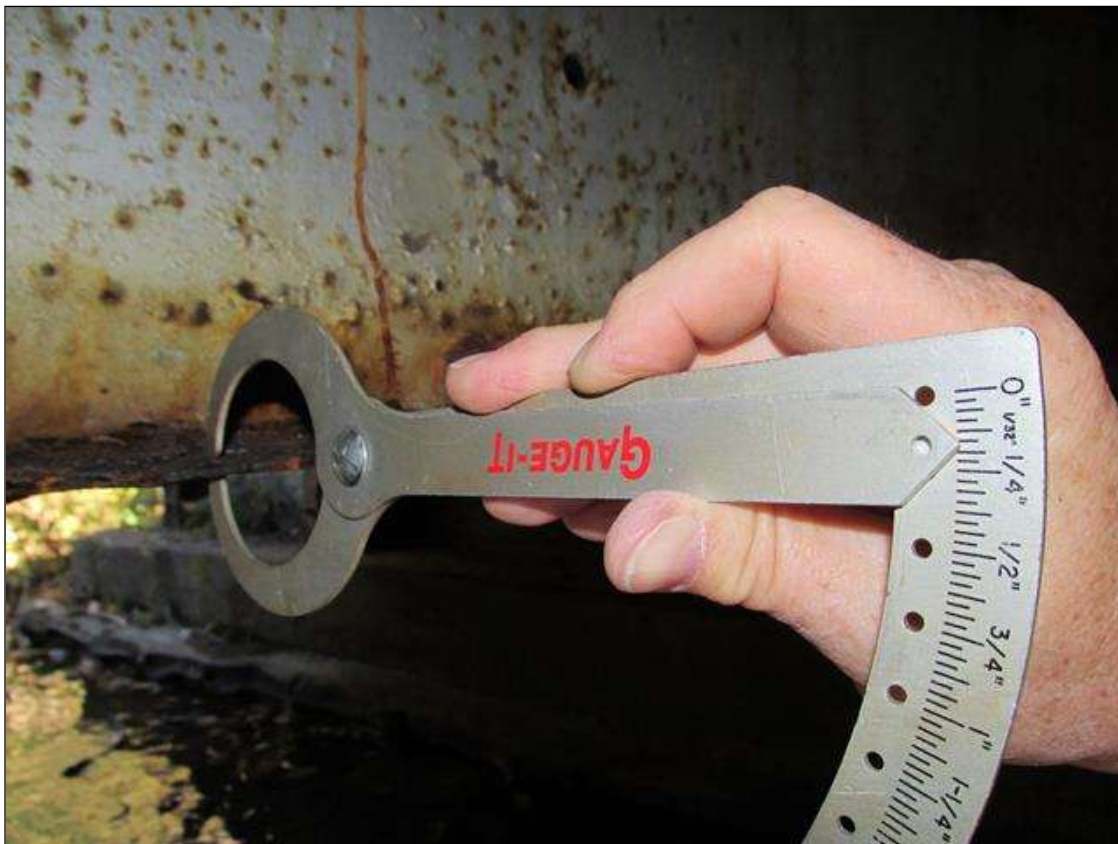
BEAM (6) CORROSION F/L ALONG TOP AND BOTTOM FLANGES WITH (+/- 3/16") LOSS AND (+/- 3/16")  
REMAINING SECTION

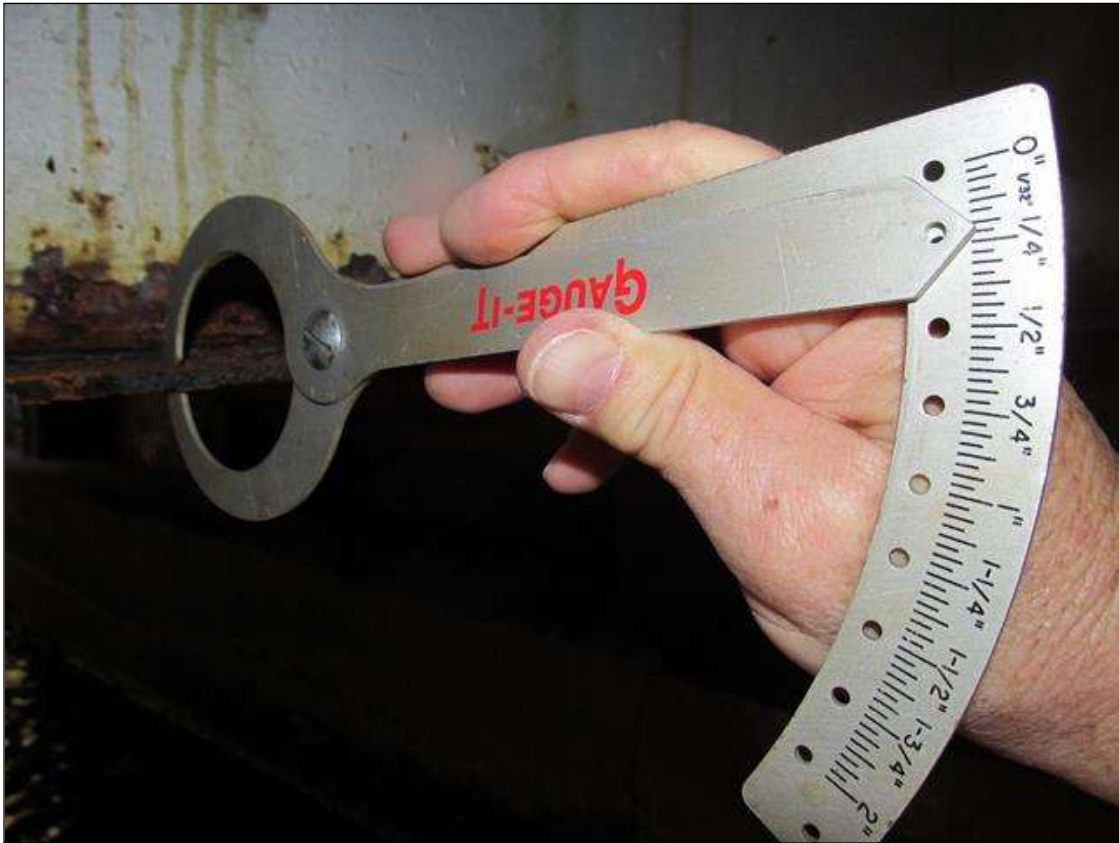
BEAM (8) CORROSION F/L ALONG TOP AND BOTTOM FLANGES WITH (+/- 3/16") LOSS AND (+/- 3/16") REMAINING SECTION
