NC DEPARTMENT OF TRANSPORTATION  
DIVISION OF HIGHWAYS  
STRUCTURE MANAGEMENT UNIT

## Structure Safety Report

### Routine Element Inspection

COUNTY: WATAUGA STRUCTURE NUMBER: 940048 FREQUENCY: 24 MONTHS

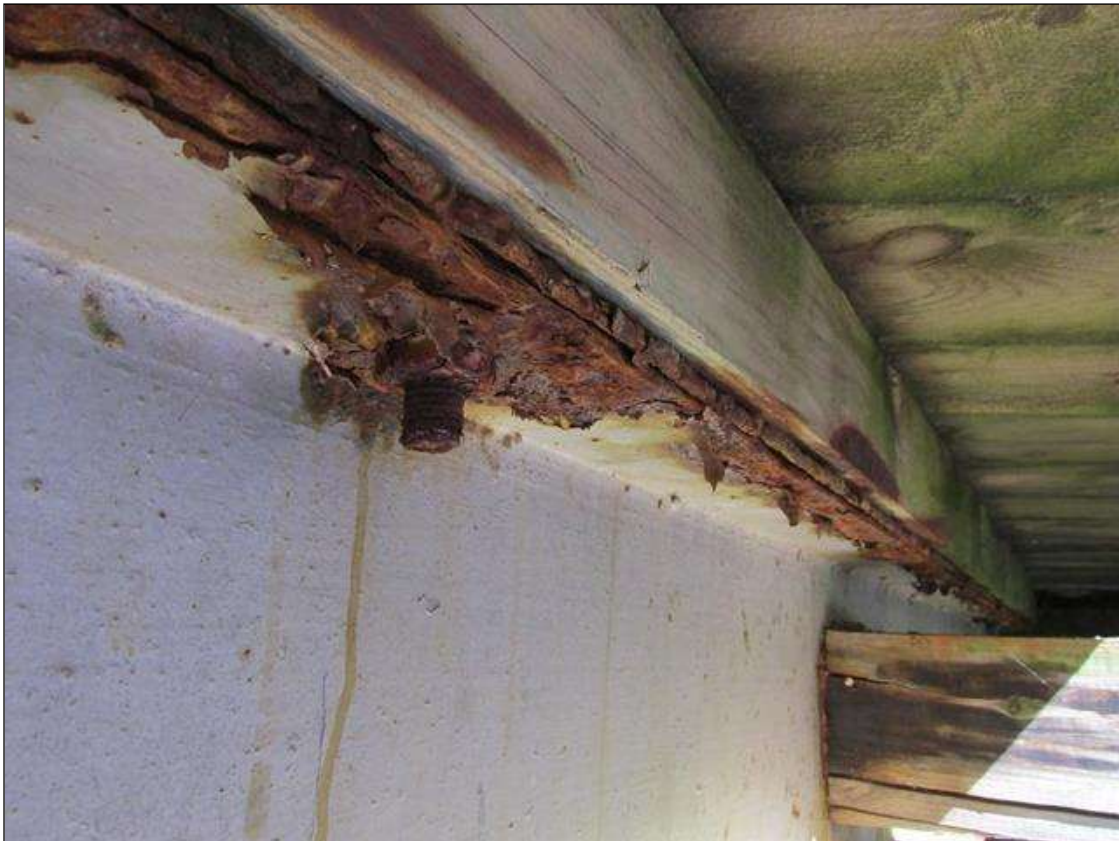
BEAM (9) CORROSION F/L ALONG TOP FLANGES WITH (+/- 3/16") LOSS AND (+/- 3/16") REMAINING SECTION

| MMS Code | Description of Function | Unit | Quantity | Remarks | Est. Cost |
|---|---|---|---|---|---|
| 3314 | Maintain Steel Superstructure Components | LF | 18 | BEAM (9) CORROSION F/L ALONG TOP FLANGES WITH (+/- 3/16") LOSS AND (+/- 3/16") REMAINING SECTION | |
