NC DEPARTMENT OF TRANSPORTATION  
DIVISION OF HIGHWAYS  
BRIDGE MANAGEMENT UNIT

# BRIDGE INSPECTION REPORT

COUNTY WATAUGA BRIDGE NUMBER 940261 INSPECTION CYCLE 0 YRS  
ROUTE SR1304 ACROSS COVE CREEK M.P. 0

INSPECTION DATE 07/02/2013

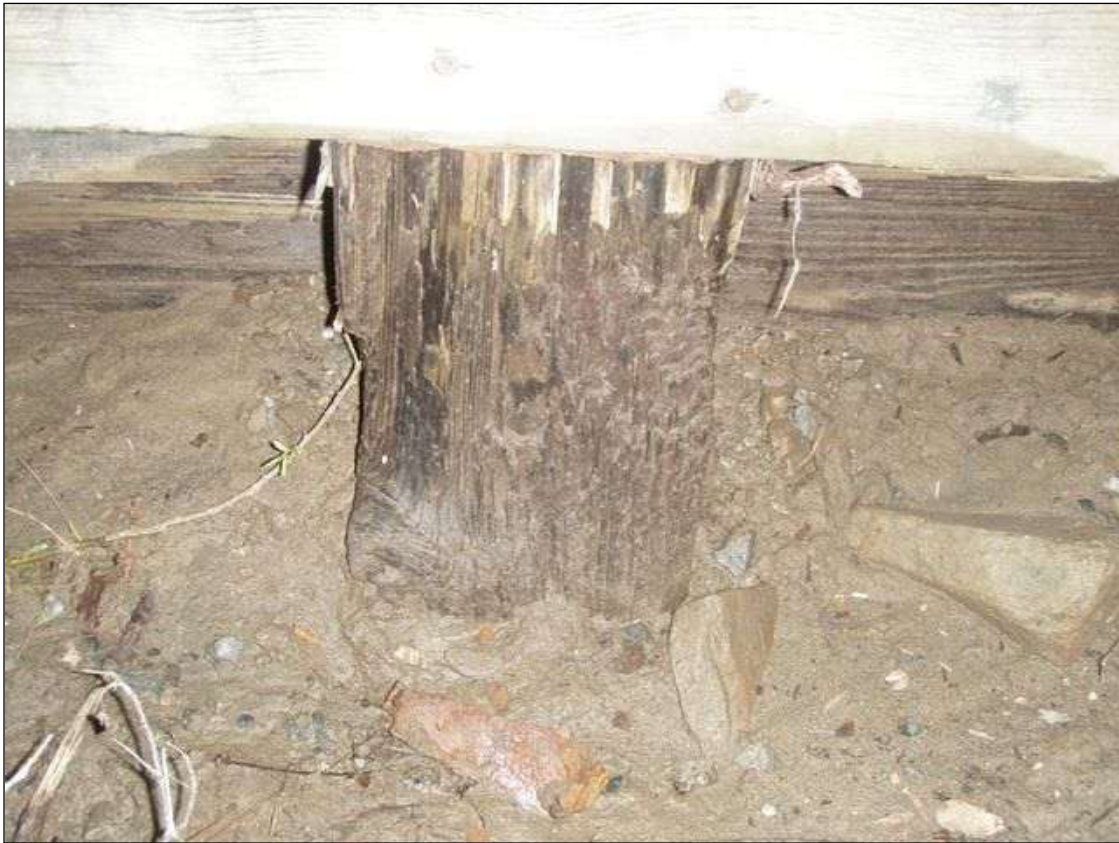
| Bridge I&A Form 1(82)H<br>State of North Carolina<br>Dept. of Transportation<br>Division of Highways | | <h1 style="text-align: center;">FIELD INSPECTION REPORT</h1> <p style="text-align: center;"><u>Bridge Inspection &amp; Analysis</u></p> | |
|---|---|---|--|
| 35b | P | DECAYED AREA UP TO 11" WIDE X 1'-2" HIGH X 1 1/2" DEEP IN POST 2 OF ABUTMENT 2 [SEE PHOTO, PRIORITY MAINTENANCE].<br>DECAYED AREA UP TO 5" WIDE X 3" HIGH X 1 1/2" DEEP IN PILE 1 OF ABUTMENT 1 [SEE PHOTO]. | |

DECAYED AREA UP TO 11" WIDE X 1'-2" HIGH X 1 1/2" DEEP IN POST 2 OF ABUTMENT 2 [PRIORITY MAINTENANCE]

| MMS Code | Description of Function | Unit | Quantity | Remarks | Est. Cost |
|---|---|---|---|---|---|
| 3344 | Repair / Replace Timber Substructure Components | LF | 1 | POST 2 OF ABUTMENT 2 HAS A DECAYED AREA UP TO 11" WIDE X 1'-2" HIGH X 1 1/2" DEEP [PRIORITY MAINTENANCE]. | |

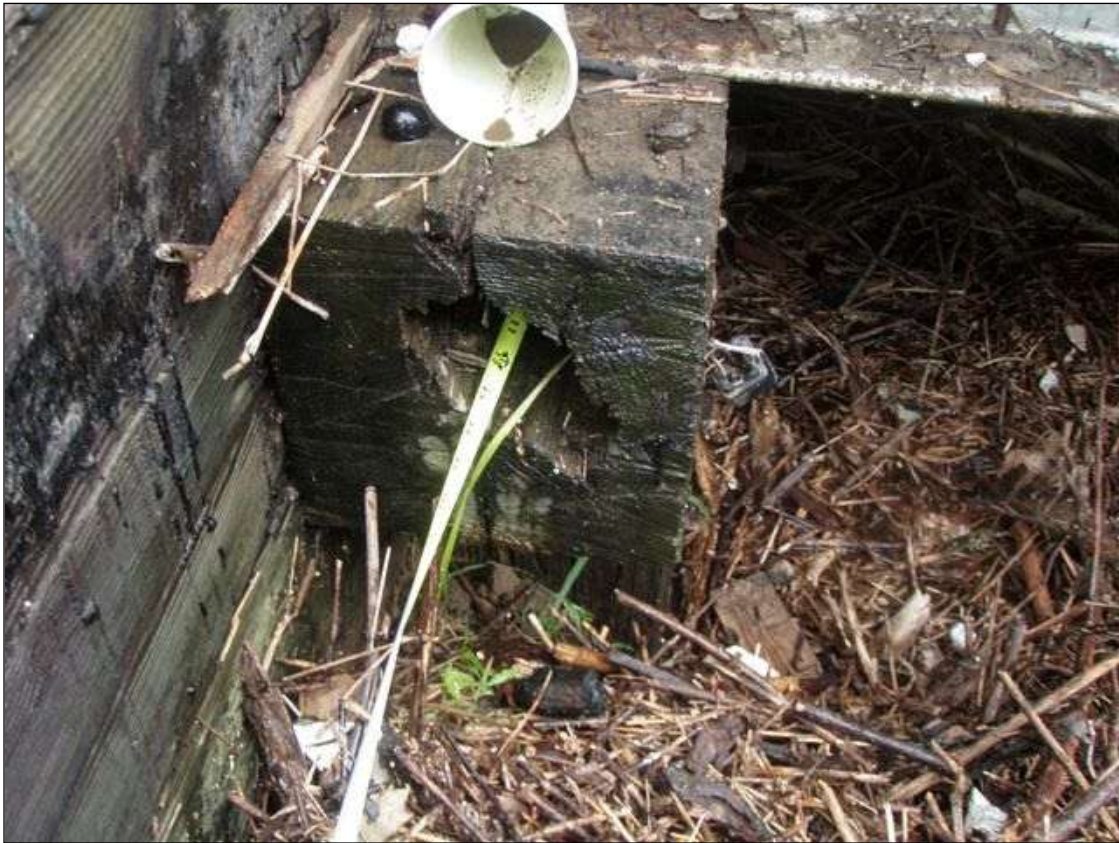
| Bridge I&A Form 1(82)H<br>State of North Carolina<br>Dept. of Transportation<br>Division of Highways | | <h1 style="text-align: center;">FIELD INSPECTION REPORT</h1> <p style="text-align: center;"><u>Bridge Inspection &amp; Analysis</u></p> | |
|---|---|---|--|
| 35a | P | DECAYED AREA UP TO 5" DIAMETER X 1'-2" DEEP IN THE NORTH END OF ABUTMENT 2 CAP [SEE PHOTO, PRIORITY MAINTENANCE].<br>DECAYED AREA UP TO 8" LONG X 6" HIGH X 7" DEEP IN THE SOUTH END OF ABUTMENT 1 CAP [SEE PHOTO, PRIORITY MAINTENANCE]. | |

DECAYED AREA UP TO 5" DIAMETER X 1'-2" DEEP IN THE NORTH END OF ABUTMENT 2 CAP [PRIORITY MAINTENANCE]

| MMS Code | Description of Function | Unit | Quantity | Remarks | Est. Cost |
|---|---|---|---|---|---|
| 3344 | Repair / Replace Timber Substructure Components | LF | 2 | NORTH END OF ABUTMENT 2 CAP HAS A DECAYED AREA UP TO 5" DIAMETER X 1'-2" DEEP [PRIORITY MAINTENANCE]. | |

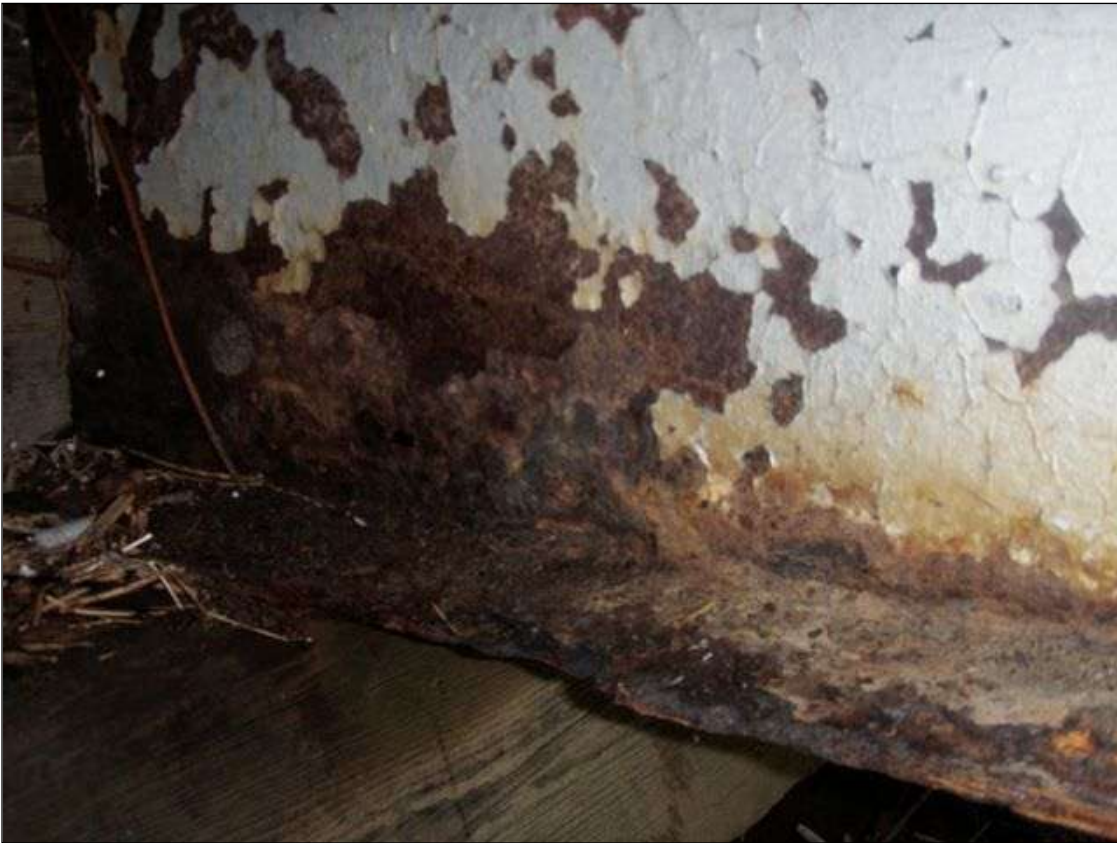
| Bridge I&A Form 1(82)H<br>State of North Carolina<br>Dept. of Transportation<br>Division of Highways | | <h1 style="text-align: center;">FIELD INSPECTION REPORT</h1> <p style="text-align: center;"><u>Bridge Inspection &amp; Analysis</u></p> | |
|---|---|---|--|
| 10 | P | 1'-6" LONG SECTION LOSS WITH UP TO 1/4" THICKNESS REMAINING ALONG THE BOTTOM FLANGE OF BEAM 4 END AT ABUTMENT 2 WITH A 1/4" DIAMETER HOLE IN THE WEB 10" FROM BEAM END [SEE PHOTO, PRIORITY MAINTENANCE].<br>TEMPORARY REPAIR IN WEBS OF BEAMS 5 AND 6 AT ABUTMENT 2 [SEE PHOTO].<br>TEMPORARY REPAIR TO FLANGES OF BEAMS 1 - 6 IN ABUTMENT 1 [SEE PHOTO].<br>PEELING PAINT AND SURFACE RUST ALONG BEAMS [SEE PHOTO]. | |

1'-6" SECTION LOSS ALONG THE BOTTOM FLANGE OF BEAM 4 END AT ABUTMENT 2 WITH A 1/4" DIAMETER HOLE IN THE WEB 10" FROM BEAM END [PRIORITY MAINTENANCE]

| MMS Code | Description of Function | Unit | Quantity | Remarks | Est. Cost |
|---|---|---|---|---|---|
| 3314 | Maintain Steel Superstructure Components | LF | 2 | END 1'-6" OF BEAM 4 FROM ABUTMENT 2 HAS SURFACE RUST WITH SECTION LOSS UP TO 1/4" THICK REMAINING. ADDITIONALLY, THERE IS A 1/4" DIAMETER HOLE IN THE WEB OF BEAM 4, 10" FROM THE END [PRIORITY MAINTENANCE]. | |

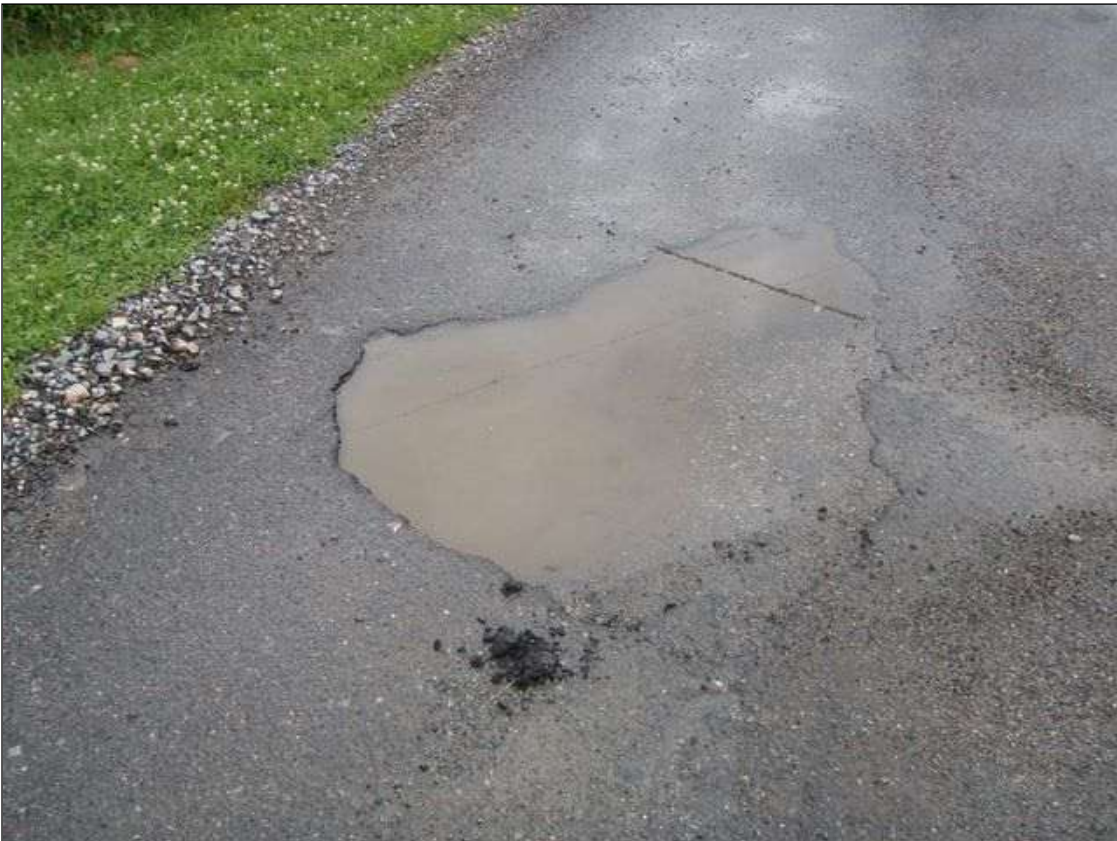
| Bridge I&A Form 1(82)H<br>State of North Carolina<br>Dept. of Transportation<br>Division of Highways | | <h1 style="text-align: center;">FIELD INSPECTION REPORT</h1> <p style="text-align: center;"><u>Bridge Inspection &amp; Analysis</u></p> | |
|---|---|---|--|
| 50 | P | 3' WIDE X 5'-4" LONG X 1-1/2" DEEP POTHOLE IN WEST APPROACH [SEE PHOTO].<br>SHALLOW POTHOLES WITH STANDING WATER ALONG ABUTMENT 1 JOINT [SEE PHOTO]. POTHOLES UP TO 4' LONG X 2' WIDE X 1" DEEP WITH STANDING WATER AT THE EAST APPROACH [SEE PHOTO]. | |

3' WIDE X 5'-4" LONG X 1-1/2" DEEP POTHOLE IN WEST APPROACH

| MMS Code | Description of Function | Unit | Quantity | Remarks | Est. Cost |
|---|---|---|---|---|---|
| 2816 | Asphalt Surface Repair or Replacement | SY | 20 | 3' WIDE X 5'-4" LONG X 1-1/2" DEEP POTHOLE IN WEST APPROACH AND POTHoles UP TO 4' LONG X 2' WIDE X 1" DEEP AND STANDING WATER IN ABUTMENT 2 APPROACH. | |

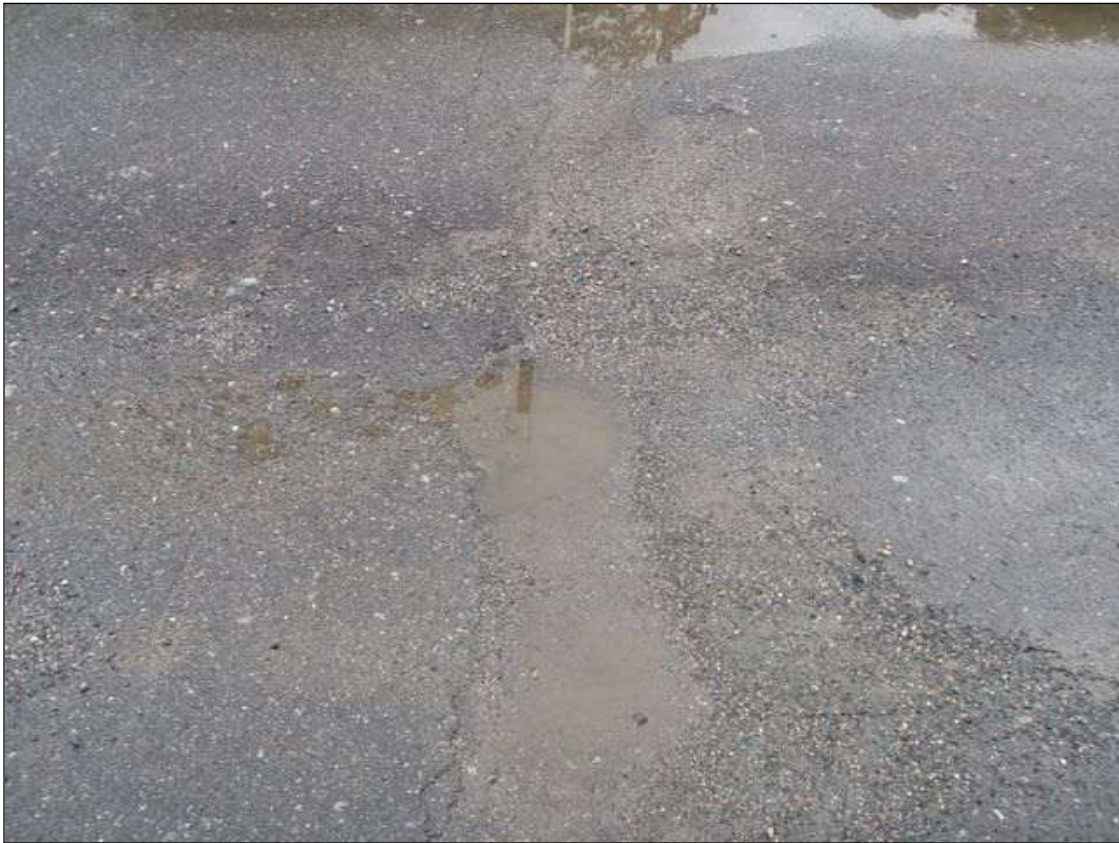
POTHOLES AND STANDING WATER IN ABUTMENT 1 JOINT

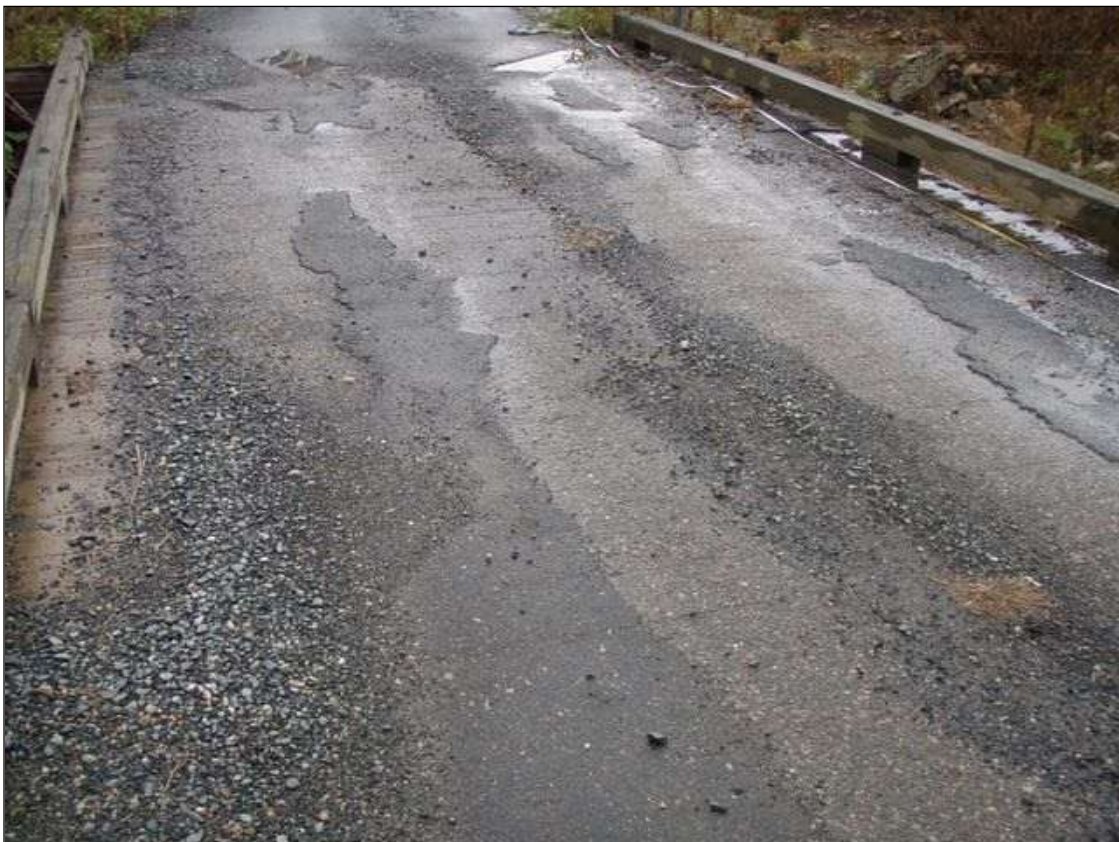
| Bridge I&A Form 1(82)H<br>State of North Carolina<br>Dept. of Transportation<br>Division of Highways | | <h1 style="text-align: center;">FIELD INSPECTION REPORT</h1> <p style="text-align: center;"><u>Bridge Inspection &amp; Analysis</u></p> | |
|---|---|---|--|
| 1 | P | MISSING AND BROKEN ASPHALT ON ENTIRE DECK SURFACE [SEE PHOTO]. | |

MISSING AND BROKEN ASPHALT ON ENTIRE DECK SURFACE

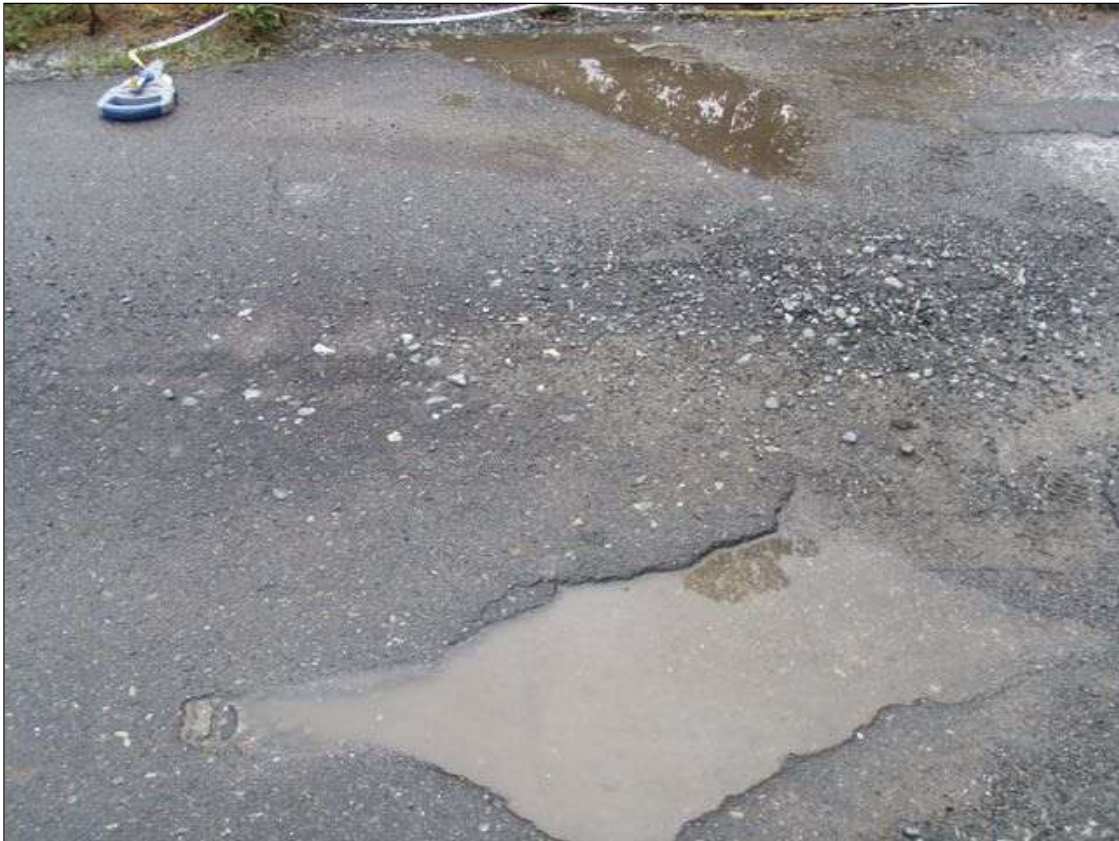
POTHOLES UP TO 4' LONG X 2' WIDE X 1" DEEP WITH STANDING WATER IN THE EAST APPROACH

| MMS Code | Description of Function | Unit | Quantity | Remarks | Est. Cost |
|---|---|---|---|---|---|
| 2816 | Asphalt Surface Repair or Replacement | SY | 1 | POTHoles UP TO 4' LONG X 2' WIDE X 1" DEEP AND STANDING WATER IN ABUTMENT 2 APPROACH | |

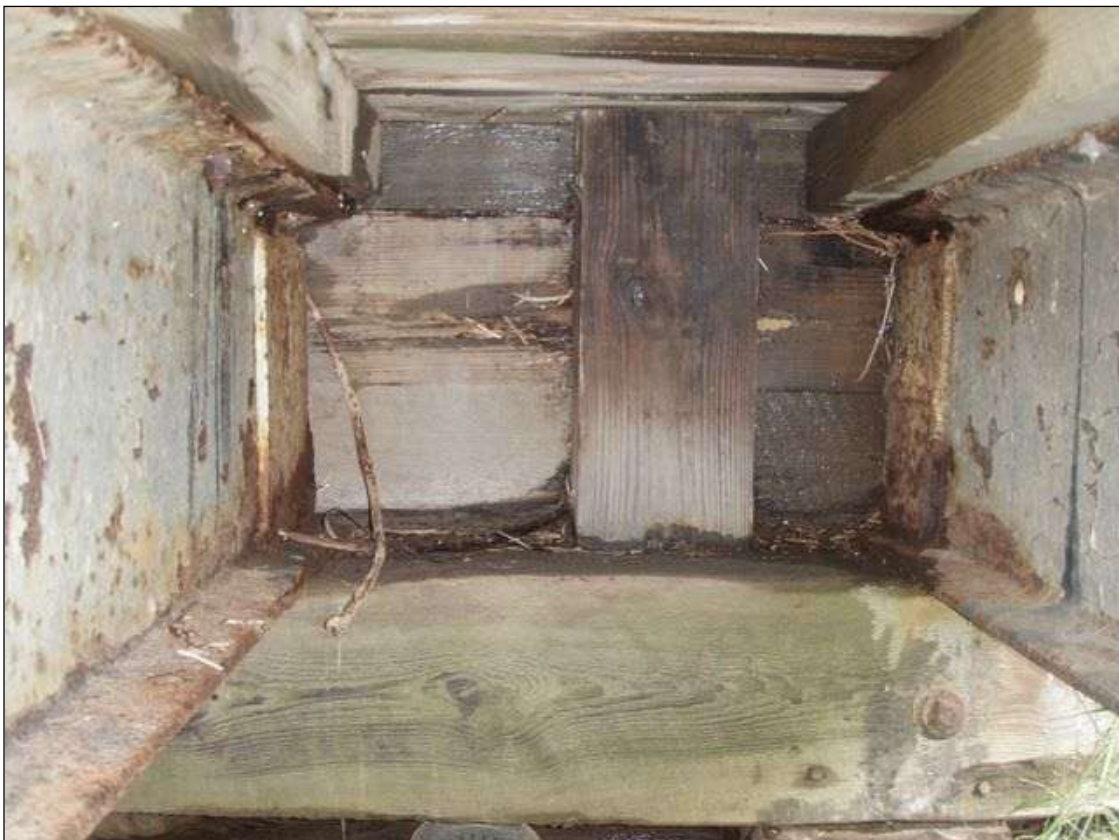
TEMPORARY REPAIR IN WEBS OF BEAMS 5 AND 6 AT ABUTMENT 2

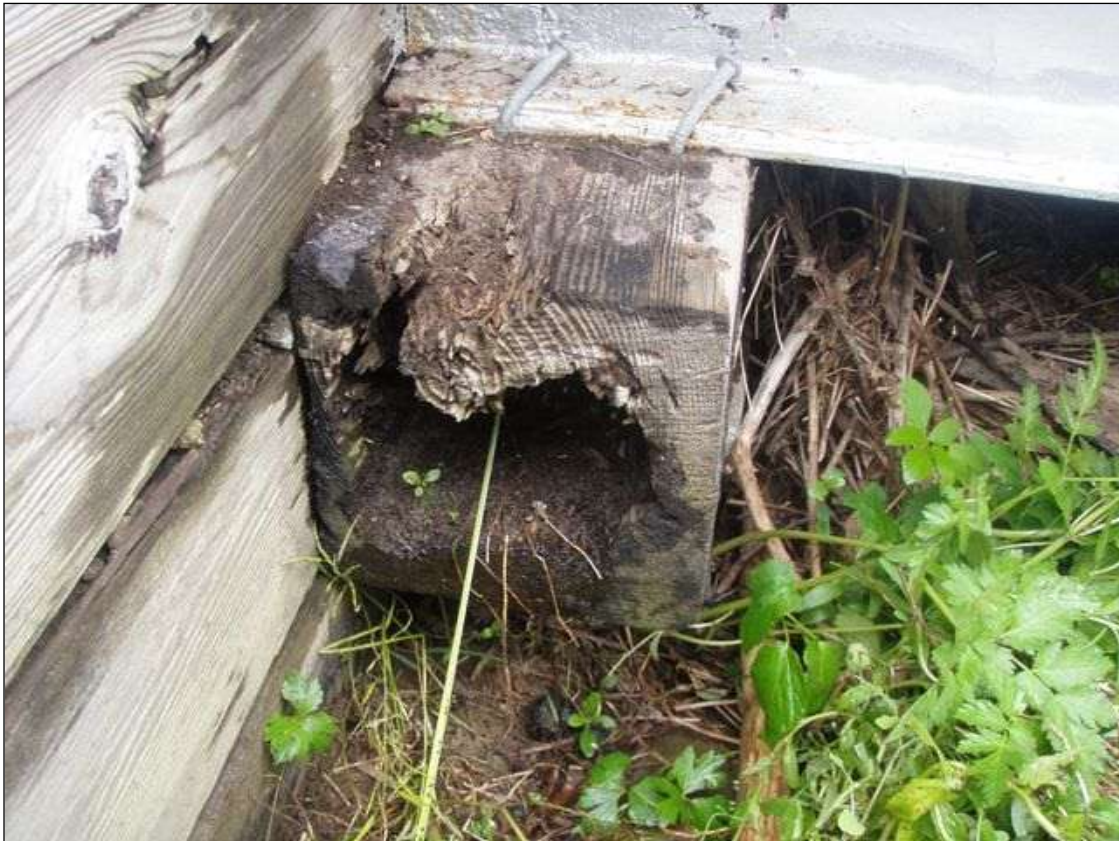
DECAYED AREA UP TO 8" LONG X 6" HIGH X 7" DEEP IN THE SOUTH END OF ABUTMENT 1 CAP

| MMS Code | Description of Function | Unit | Quantity | Remarks | Est. Cost |
|---|---|---|---|---|---|
| 3344 | Repair / Replace Timber Substructure Components | LF | 1 | DECAYED AREA UP TO 8" LONG X 6" HIGH X 7" DEEP IN THE SOUTH END OF ABUTMENT 1 CAP [PRIORITY MAINTENANCE] | |

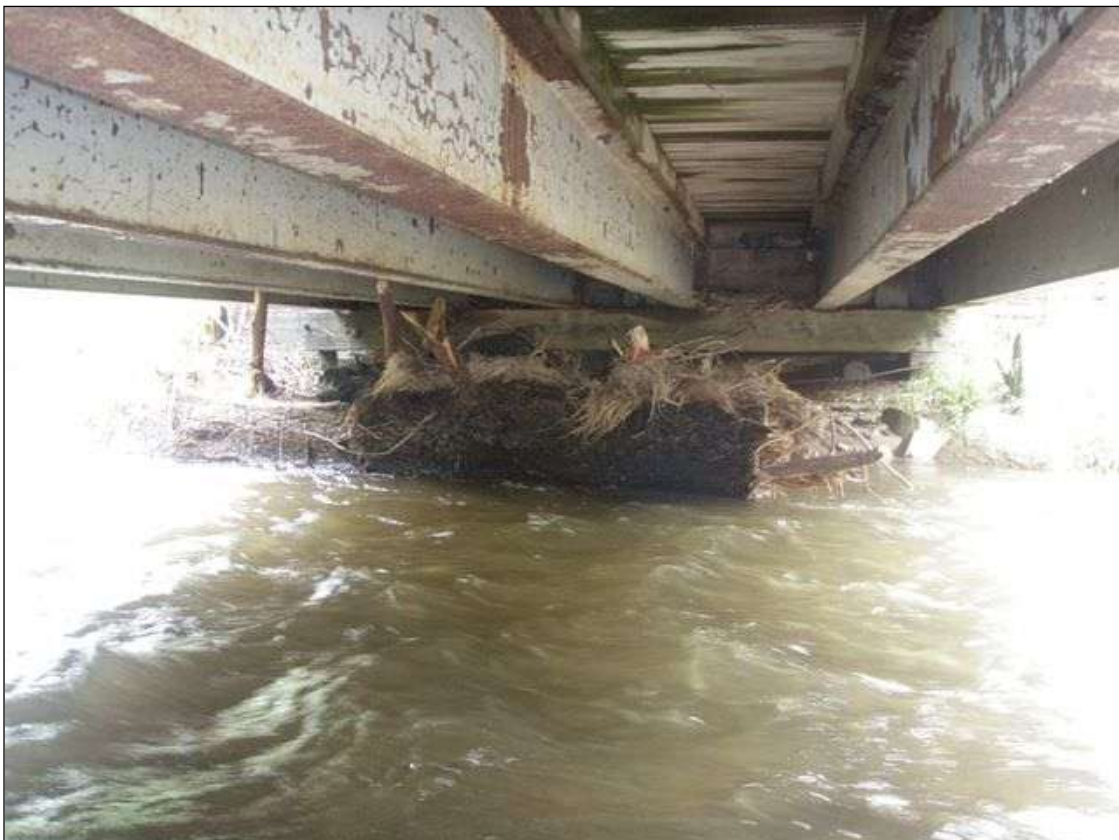
| Bridge I&A Form 1(82)H<br>State of North Carolina<br>Dept. of Transportation<br>Division of Highways | | <h1 style="text-align: center;">FIELD INSPECTION REPORT</h1> <p style="text-align: center;"><u>Bridge Inspection &amp; Analysis</u></p> | |
|---|---|---|--|
| 41 | P | DRIFT AT NORTHEAST END OF ABUTMENT 1 [SEE PHOTO]. DRIFT ALONG WEST END OF ABUTMENT 1 [SEE PHOTO]. | |

DRIFT AT NORTHEAST END

| MMS Code | Description of Function | Unit | Quantity | Remarks | Est. Cost |
|---|---|---|---|---|---|
| 3366 | Drift and Debris Removal | HR | 16 | REMOVE DRIFT. | |

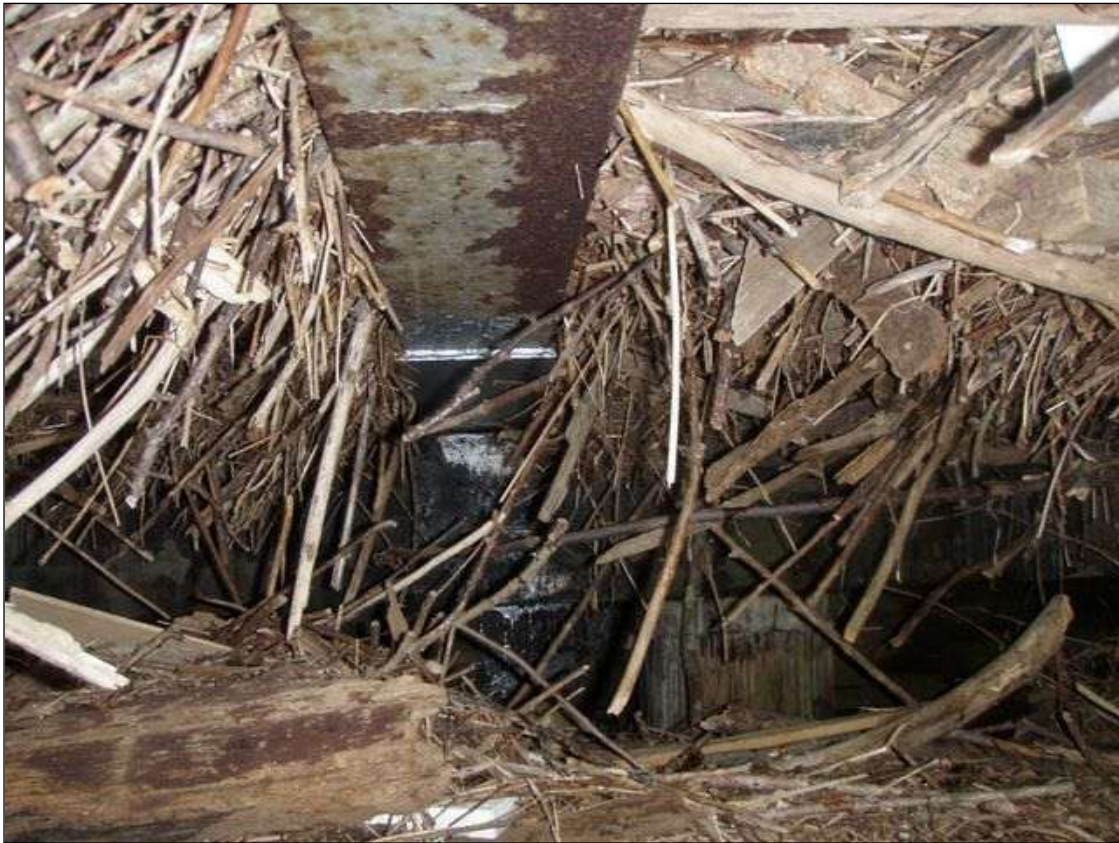
*Plates welded to both side of the web of beam 2  
at abut. 1.*

TEMPORARY REPAIR TO FLANGES IN BEAMS 1 - 6 IN ABUTMENT 1 (BEAM 3 SHOWN)

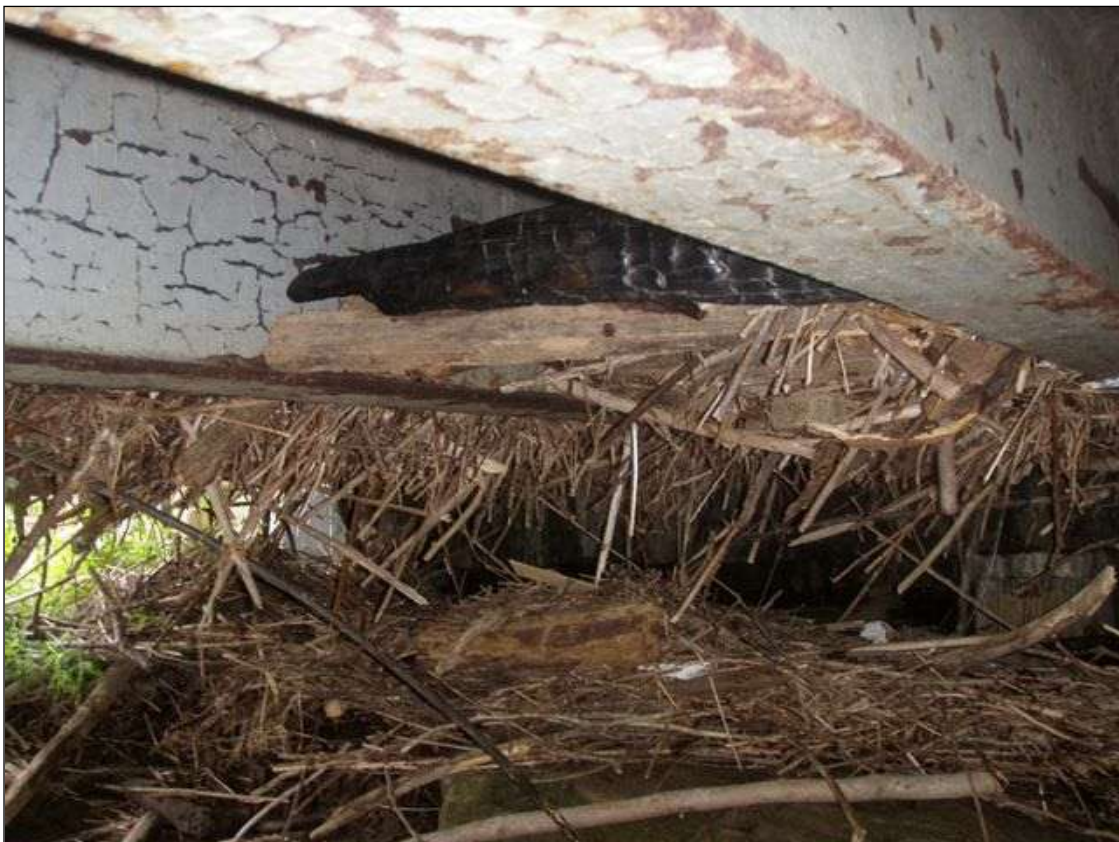
DRIFT ALONG WEST END OF ABUTMENT 1 (BAYS 4 AND 5 SHOWN)

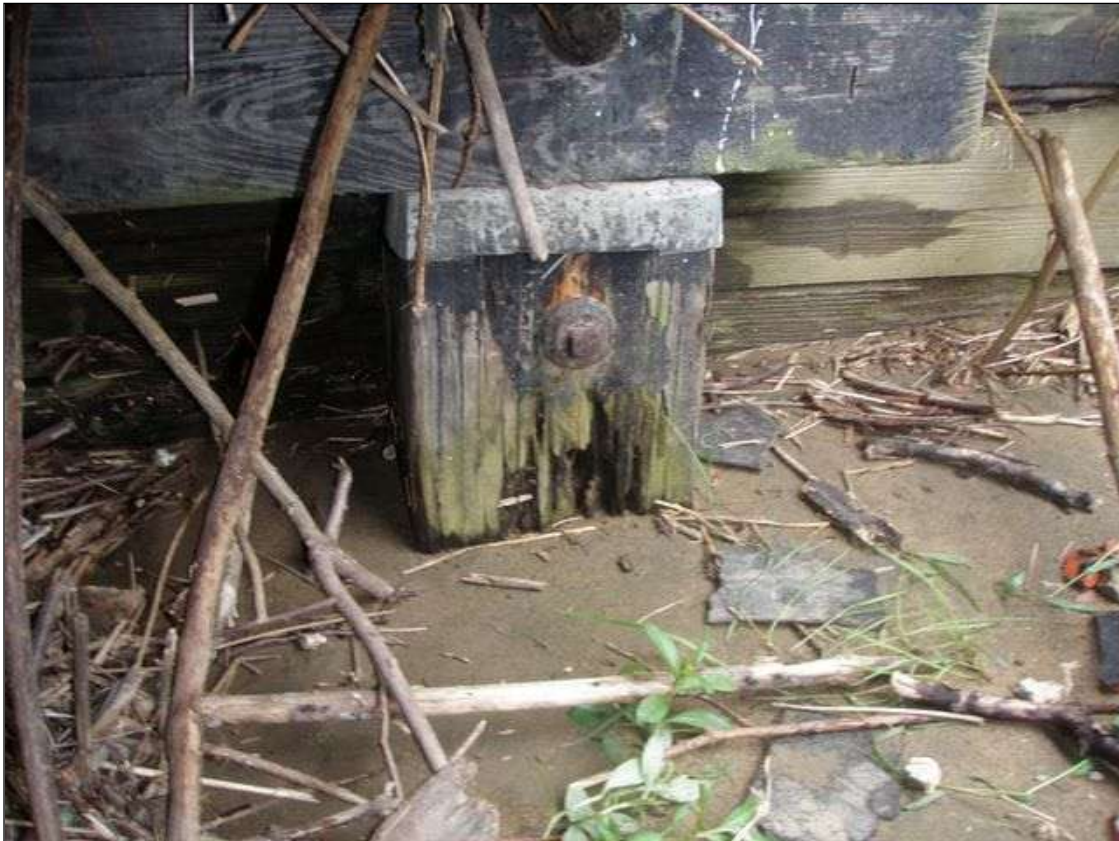
DECAYED AREA UP TO 5" WIDE X 3" HIGH X 1 1/2" DEEP IN PILE 1 OF ABUTMENT 1

| MMS Code | Description of Function | Unit | Quantity | Remarks | Est. Cost |
|---|---|---|---|---|---|
| 3344 | Repair / Replace Timber Substructure Components | LF | 1 | DECAYED AREA UP TO 5" WIDE X 3" HIGH X 1.5" DEEP IN PILE 1 OF ENDBENT 1 | |

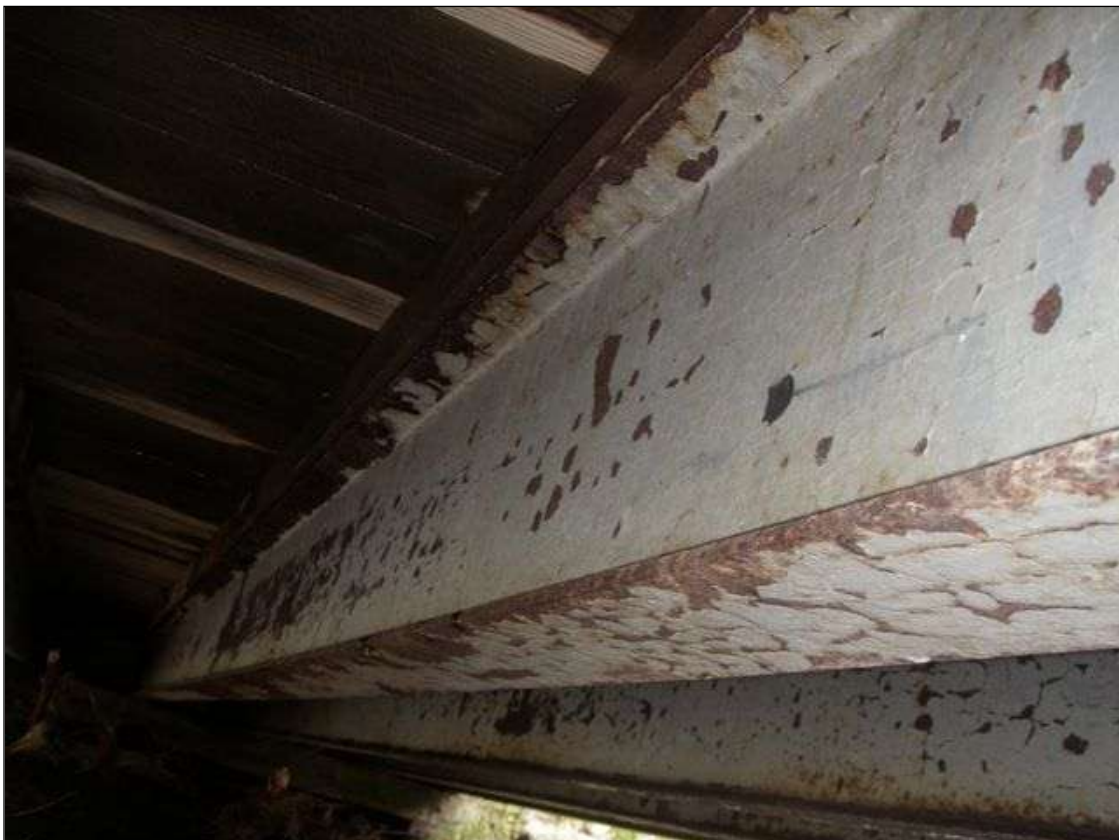
| Bridge I&A Form 1(82)H<br>State of North Carolina<br>Dept. of Transportation<br>Division of Highways | | <h1 style="text-align: center;">FIELD INSPECTION REPORT</h1> <p style="text-align: center;"><u>Bridge Inspection &amp; Analysis</u></p> | |
|---|---|---|--|
| 52 | P | PEELING PAINT AND SURFACE RUST ALONG BEAMS [SEE PHOTO]. | |

PEELING PAINT AND SURFACE RUST IN BEAM 3 (SIMILAR THROUGHOUT)

| MMS Code | Description of Function | Unit | Quantity | Remarks | Est. Cost |
|---|---|---|---|---|---|
| 5603 | Partial Cleaning and Painting of Structural Steel | SF | 300 | PEELING PAINT AND SURFACE RUST IN BEAM 3 (SIMILAR THROUGHOUT). | |
