NC DEPARTMENT OF TRANSPORTATION  
DIVISION OF HIGHWAYS  
STRUCTURE MANAGEMENT UNIT

## Structure Safety Report

### Routine Element Inspection

COUNTY: ALLEGHANY STRUCTURE NUMBER: 020142 FREQUENCY: 24 MONTHS

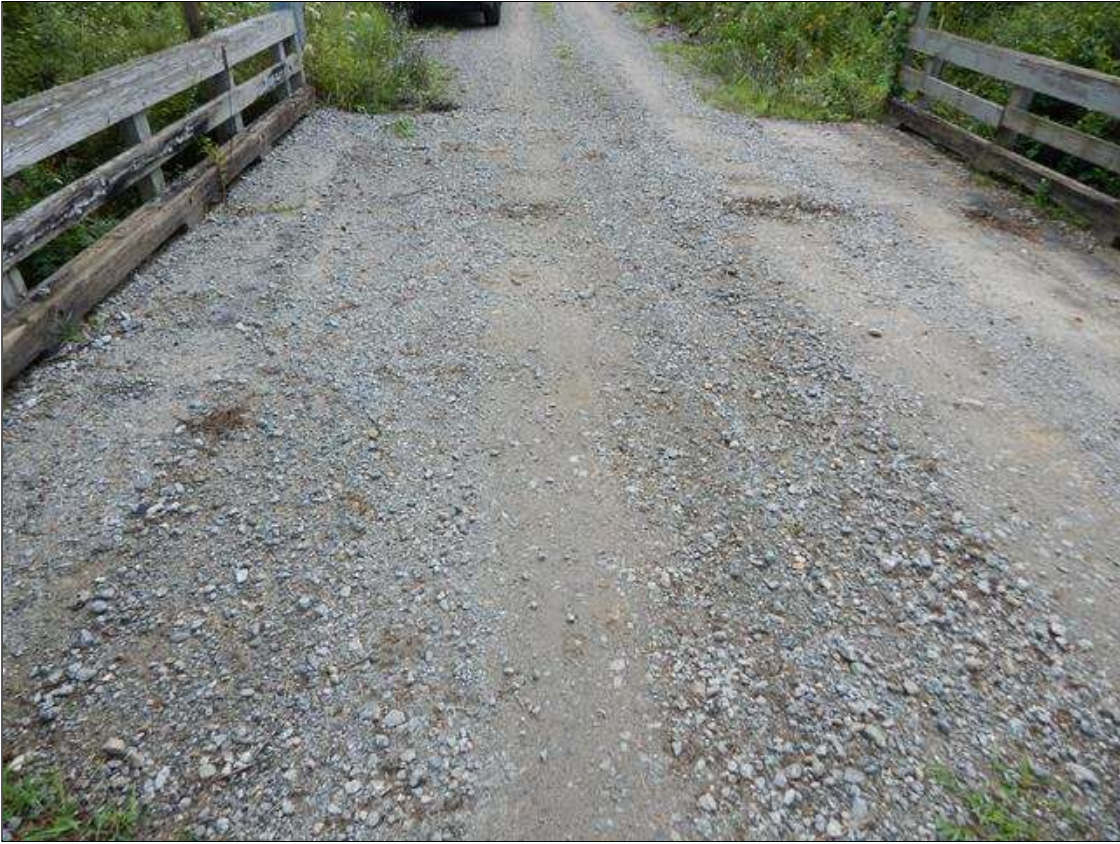
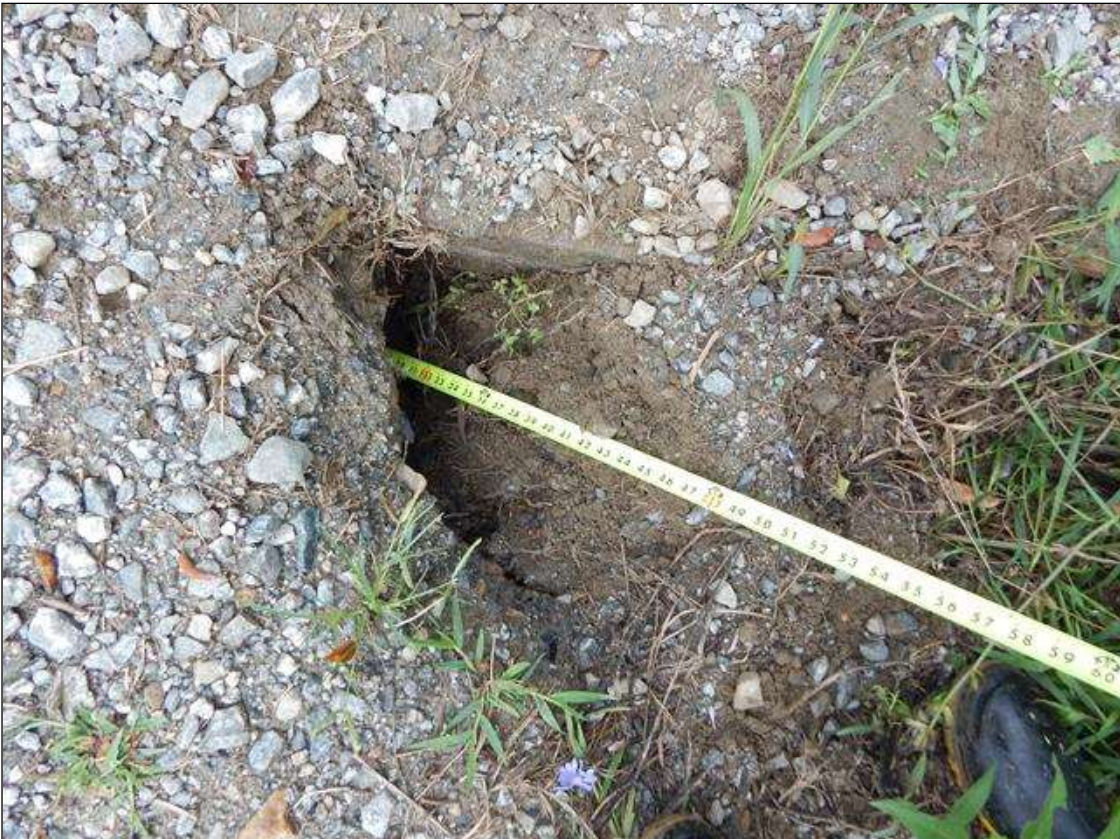
**Details** EXCESS GRAVEL ALONG ENTIRE WEARING SURFACE (+/- 476 SF)

EXCESS GRAVEL ALONG ENTIRE WEARING SURFACE (+/- 476 SF)

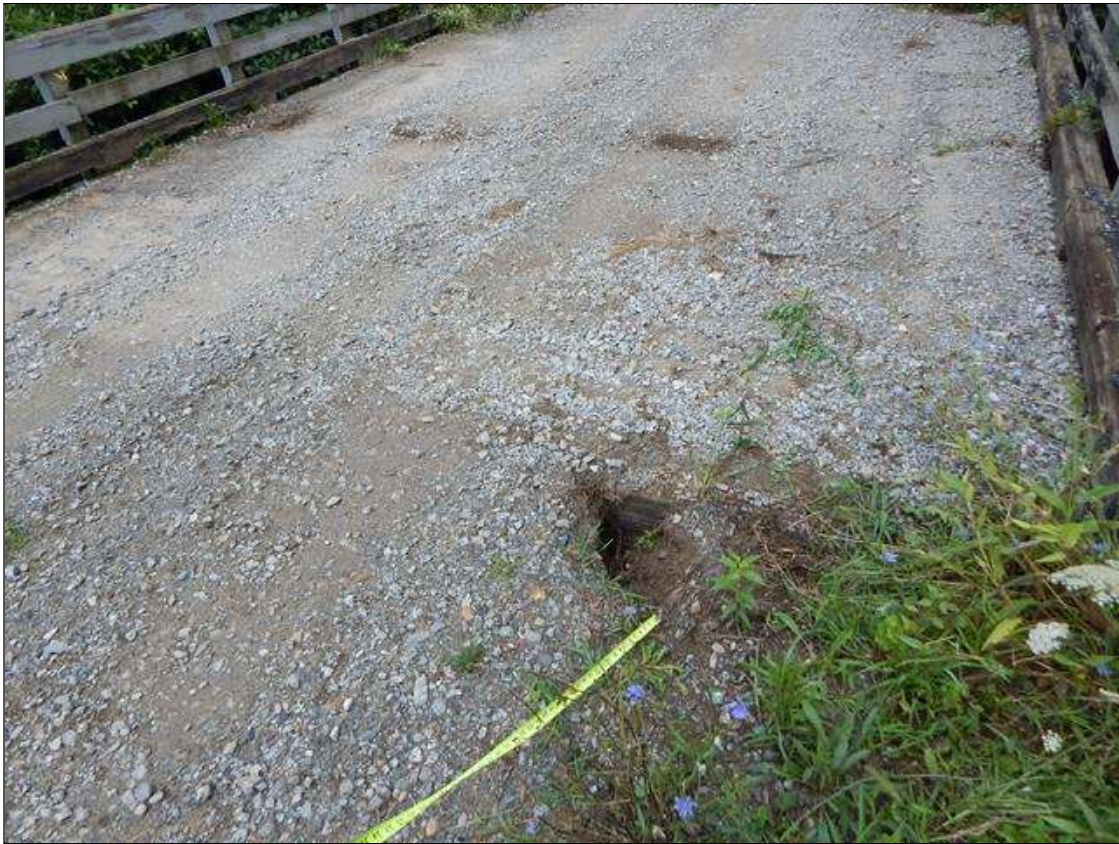
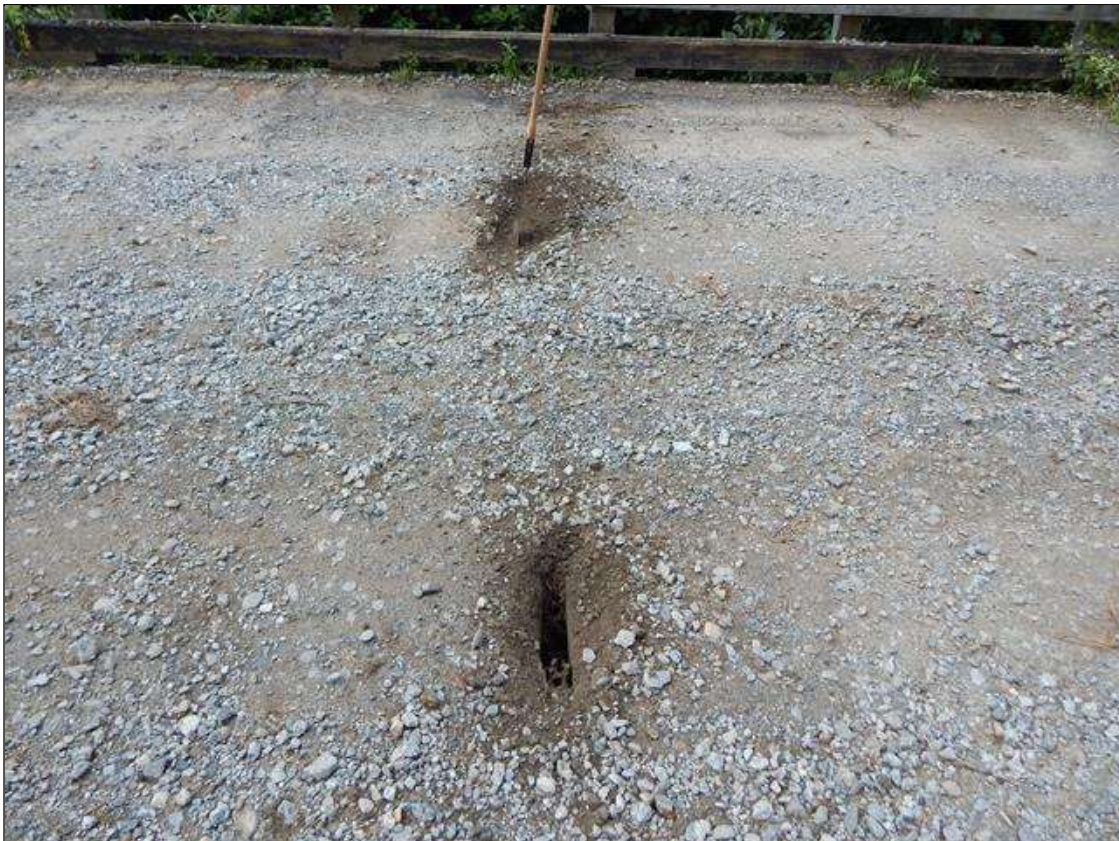
SOUTH EAST APPROACH ROADWAY EROSION BEHIND ABUT. (A) (+/- 1' DIA. X 4' D) IN RIGHT EDGE OF ROADWAY, DUE TO MISSING TIMBER ABUT. BOARD

| MMS Code | Description of Function | Unit | Quantity | Remarks | Est. Cost |
|---|---|---|---|---|---|
| 3352 | Maint Slope Protection | SF | 4 | SOUTH EAST APPROACH ROADWAY EROSION BEHIND ABUT. (A) (+/- 1' DIA. X 4' D) IN RIGHT EDGE OF ROADWAY, DUE TO MISSING TIMBER ABUTMENT BOARD | |

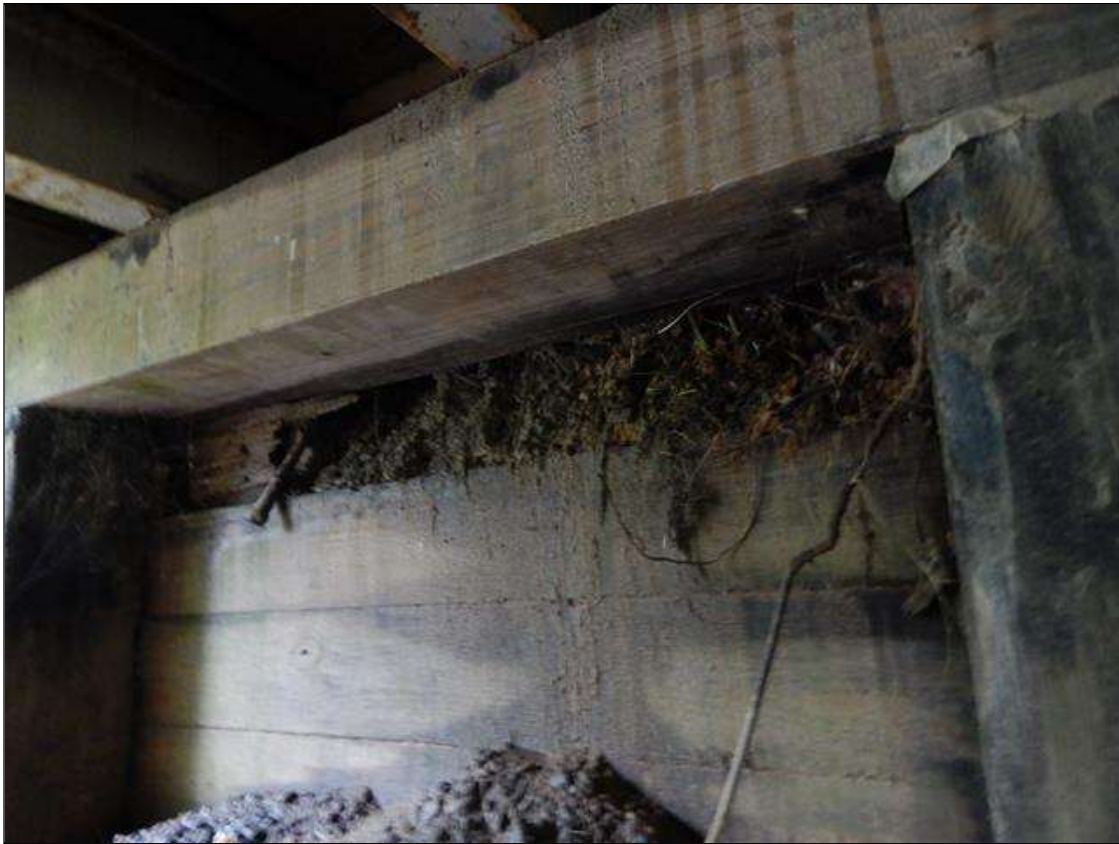
| Element Number | Defect Type | Defect Description | CS | CS Qty | Maint Qty | |
|---|---|---|---|---|---|---|
| 31 | Decay/Section Loss | (1) DECK BOARD MISSING MATERIAL AND DECAYED FULL WIDTH OF DECK (+/- 20' L) (+/- 10') FROM ABUT. (A) IN RIGHT WHEEL PATH | 3 | 20 | 20 | Square Feet |

Span 1 Deck: (1) DECK BOARD MISSING MATERIAL AND DECAYED FULL WIDTH OF DECK (+/- 20' L) (+/- 10') FROM ABUT. (A) IN RIGHT WHEEL PATH

| MMS Code | Description of Function | Unit | Quantity | Remarks | Est. Cost |
|---|---|---|---|---|---|
| 3324 | Maint / Repair / Replace Timber Deck Components | SF | 20 | Span 1 Deck: (1) DECK BOARD MISSING MATERIAL AND DECAYED FULL WIDTH OF DECK (+/- 20' L) (+/- 10') FROM ABUT. (A) IN RIGHT WHEEL PATH | |

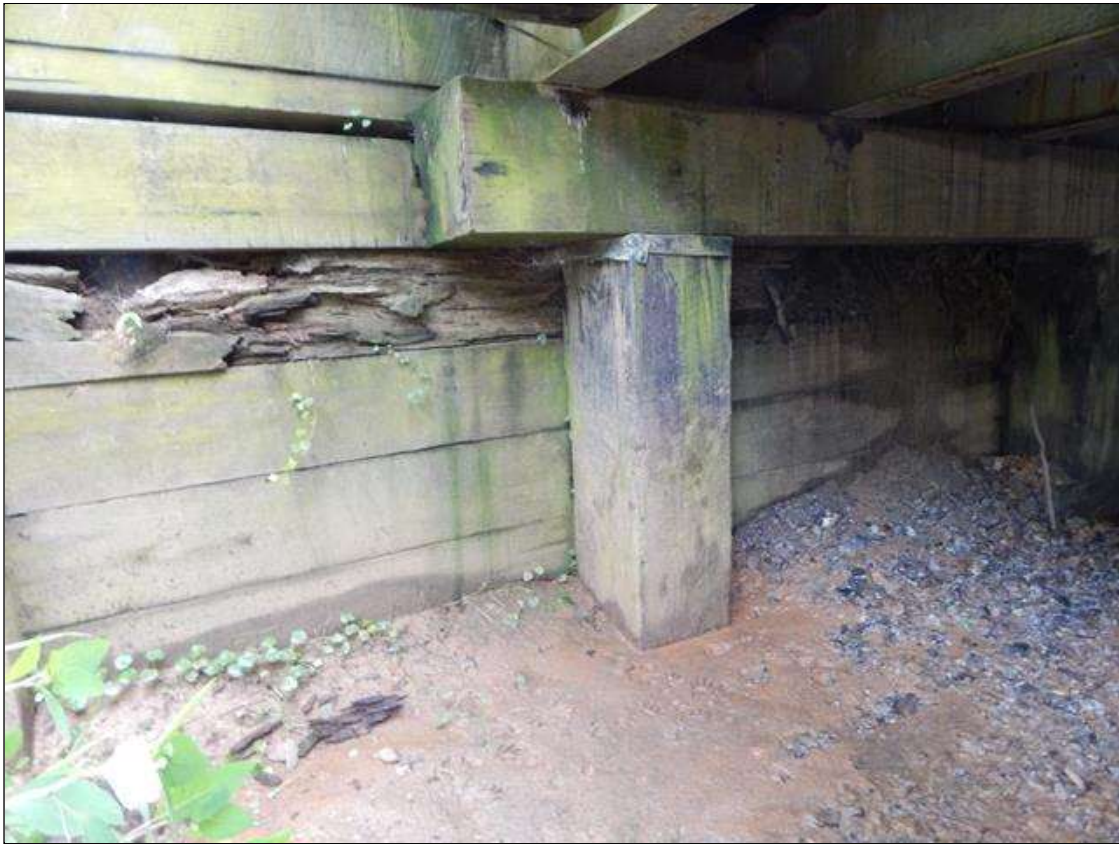
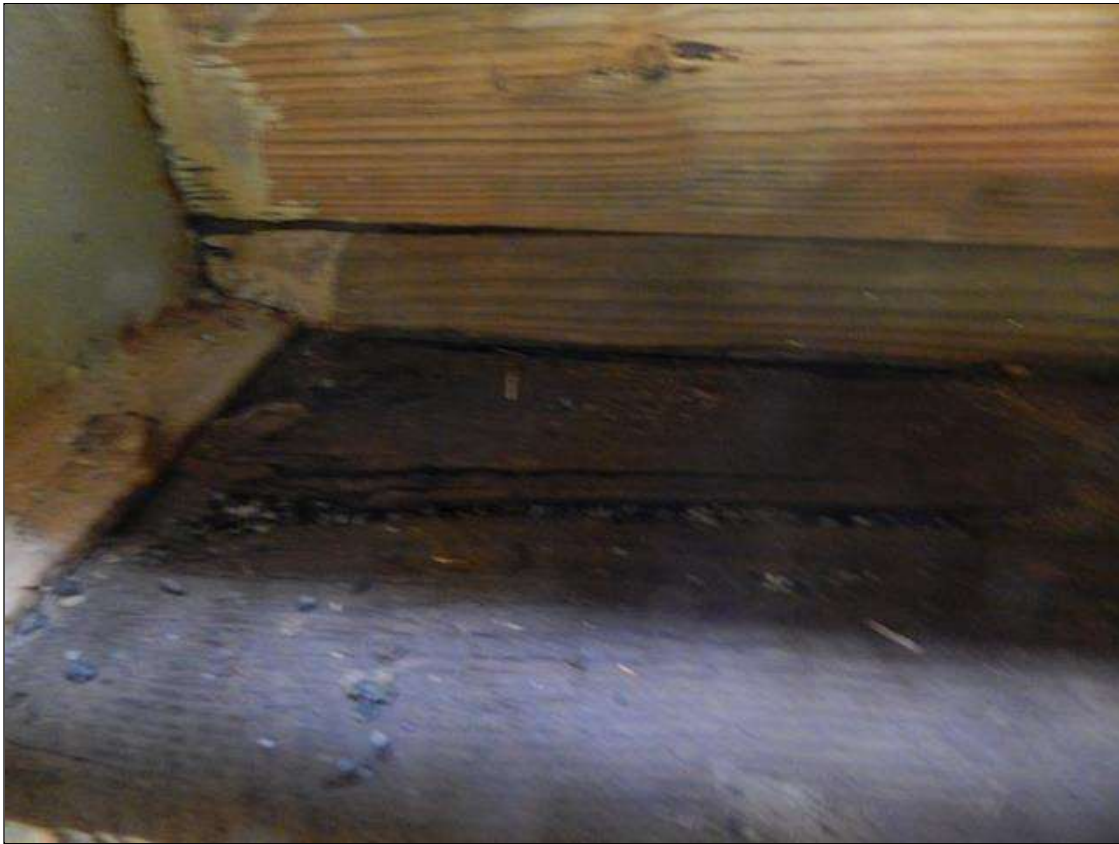
| Element Number | Defect Type | Defect Description | CS | CS Qty | Maint Qty |
|---|---|---|---|---|---|
| 216 | Decay/Section Loss | ABUT. (A) (1) TIMBER BULKHEAD BOARD DECAYED AND MISSING WITH LOSS OF FILL, RIGHT END OF ABUT. (A) AND EXTENDS TO POST 3 , CAUSING EROSION HOLE IN APPROACH ROADWAY | 3 | 10 | 10 Feet |

End Bent 1 Abutment/Backwall : ABUT. (A) (1) TIMBER BULKHEAD BOARD DECAYED AND MISSING WITH LOSS OF FILL, RIGHT END OF ABUT. (A) AND EXTENDS TO POST 3 , CAUSING EROSION HOLE IN APPROACH ROADWAY

| MMS Code | Description of Function | Unit | Quantity | Remarks | Est. Cost |
|---|---|---|---|---|---|
| 3346 | Repair / Maintain Timber Wings & Blkhds | SF | 10 | End Bent 1 Abutment/Backwall : ABUT. (A) (1) TIMBER BULKHEAD BOARD DECAYED AND MISSING WITH LOSS OF FILL, RIGHT END OF ABUT. (A) AND EXTENDS TO POST 3 , CAUSING EROSION HOLE IN APPROACH ROADWAY | |

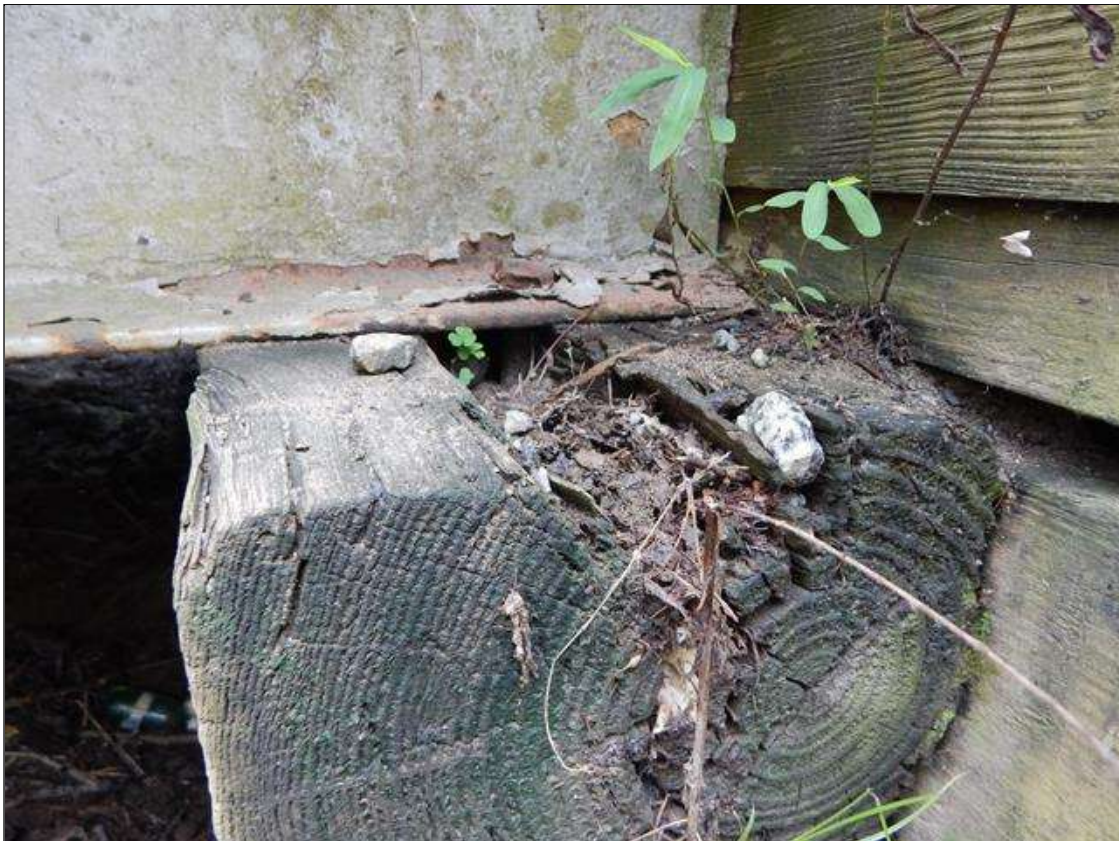
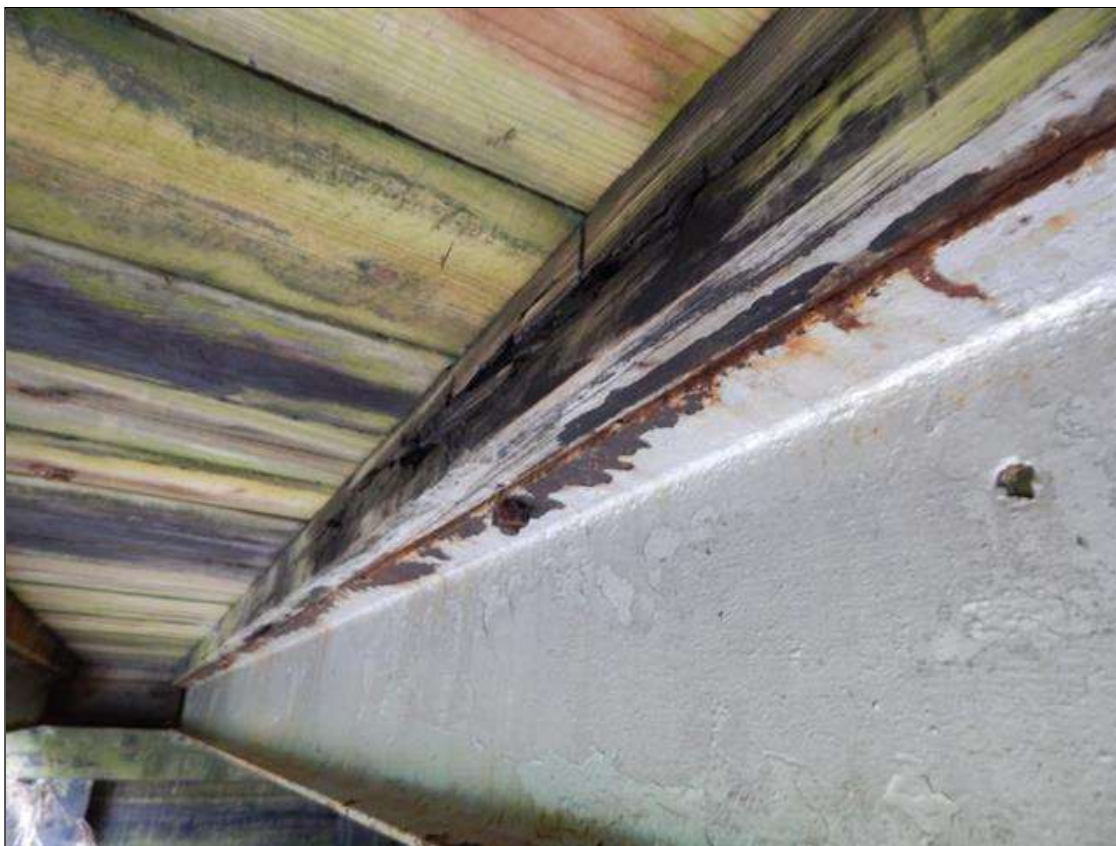
| Element Number | Defect Type | Defect Description | CS | CS Qty | Maint Qty | |
|---|---|---|---|---|---|---|
| 235 | Decay/Section Loss | LEFT END ABUT. (A) CAP DECAYED ALONG TOP CENTER AND EXTENDS UNDER BEAM (1) BEARING OVER TO BEAM (2) (+/- 4" W X 3" D X 2' L) | 3 | 2 | 2 | Feet |

Bent 1 Cap 1: LEFT END ABUT. (A) CAP DECAYED ALONG TOP CENTER AND EXTENDS UNDER BEAM (1) BEARING OVER TO BEAM (2) (+/- 4" W X 3" D X 2' L)

| MMS Code | Description of Function | Unit | Quantity | Remarks | Est. Cost |
|---|---|---|---|---|---|
| 3344 | Repair / Replace Timber Substructure Components | LF | 2 | Bent 1 Cap 1: LEFT END ABUT. (A) CAP DECAYED ALONG TOP CENTER AND EXTENDS UNDER BEAM (1) BEARING OVER TO BEAM (2) (+/- 4" W X 3" D X 2' L) | |

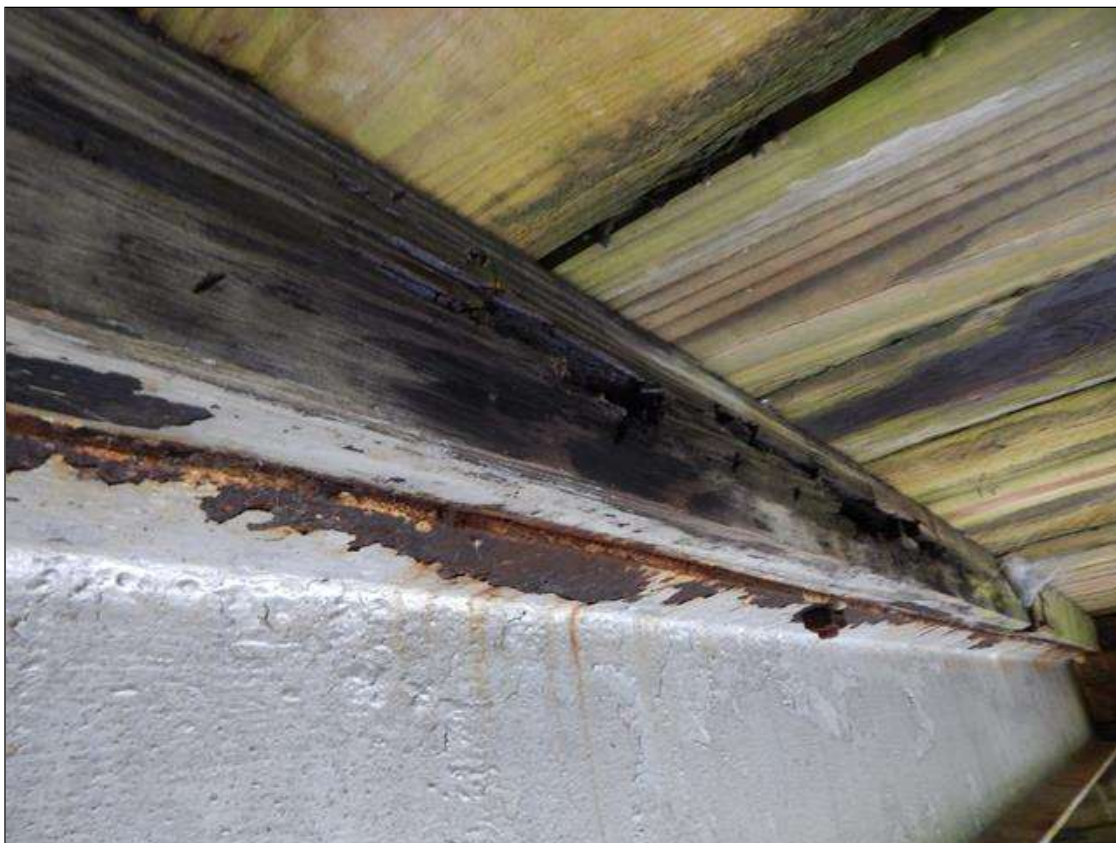
| Element Number | Defect Type | Defect Description | CS | CS Qty | Maint Qty | |
|---|---|---|---|---|---|---|
| 515 | Peeling/Bubbling/Cracking (steel Protective Coatings) | MISSING PAINT FULL LENGTH ALONG TOP FLANGE, ALL BEAMS SIMILAR. | 2 | 24 | 24 | Square Feet |

Span 1 Beam 2: MISSING PAINT FULL LENGTH ALONG TOP FLANGE, ALL BEAMS SIMILAR.

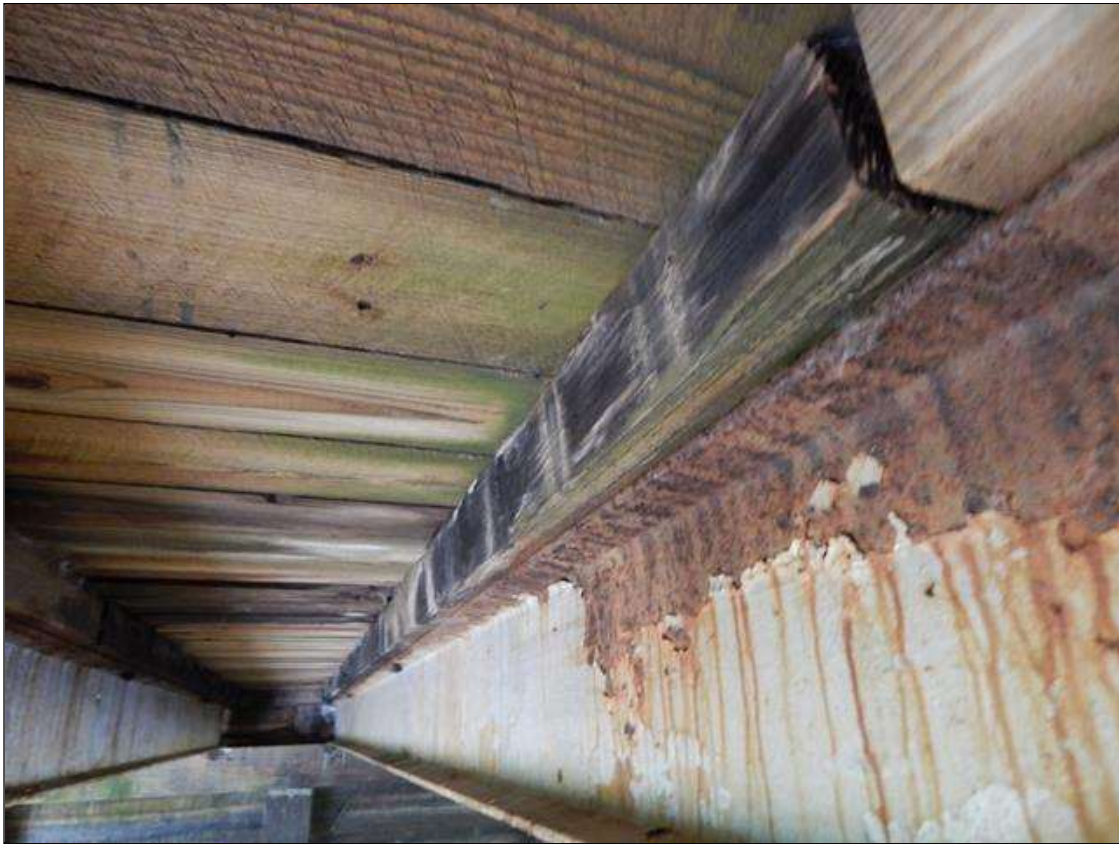
| Element Number | Defect Type | Defect Description | CS | CS Qty | Maint Qty | |
|---|---|---|---|---|---|---|
| 31 | Decay/Section Loss | BEAM (2) NAILER DECAYED AND SPLIT FULL LENGTH ALONG BEAM | 3 | 24 | 24 | Square Feet |

Span 1 Deck: BEAM (2) NAILER DECAYED AND SPLIT FULL LENGTH ALONG BEAM

| MMS Code | Description of Function | Unit | Quantity | Remarks | Est. Cost |
|---|---|---|---|---|---|
| 3324 | Maint / Repair / Replace Timber Deck Components | SF | 24 | Span 1 Deck: BEAM (2) NAILER DECAYED AND SPLIT FULL LENGTH ALONG BEAM | |

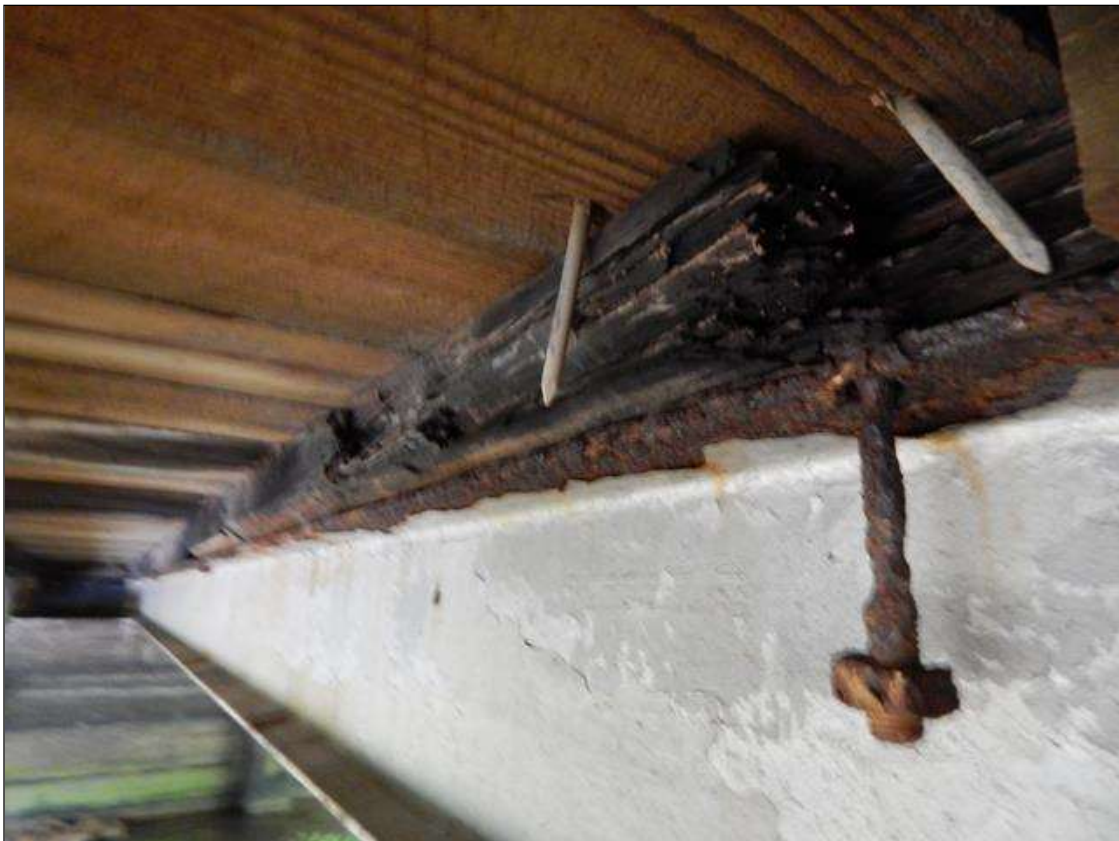
| Element Number | Defect Type | Defect Description | CS | CS Qty | Maint Qty | |
|---|---|---|---|---|---|---|
| 31 | Decay/Section Loss | BEAM (4) NAILER DECAYED AND SPLIT (5') FROM ABUT. (A) AND EXTENDS (+/- 19') TO ABUT. (B) | 3 | 19 | 19 | Square Feet |

Span 1 Deck: BEAM (4) NAILER DECAYED AND SPLIT (5') FROM ABUT. (A) AND EXTENDS (+/- 19') TO ABUT. (B)

| MMS Code | Description of Function | Unit | Quantity | Remarks | Est. Cost |
|---|---|---|---|---|---|
| 3324 | Maint / Repair / Replace Timber Deck Components | SF | 19 | Span 1 Deck: BEAM (4) NAILER DECAYED AND SPLIT (5') FROM ABUT. (A) AND EXTENDS (+/- 19') TO ABUT. (B) | |

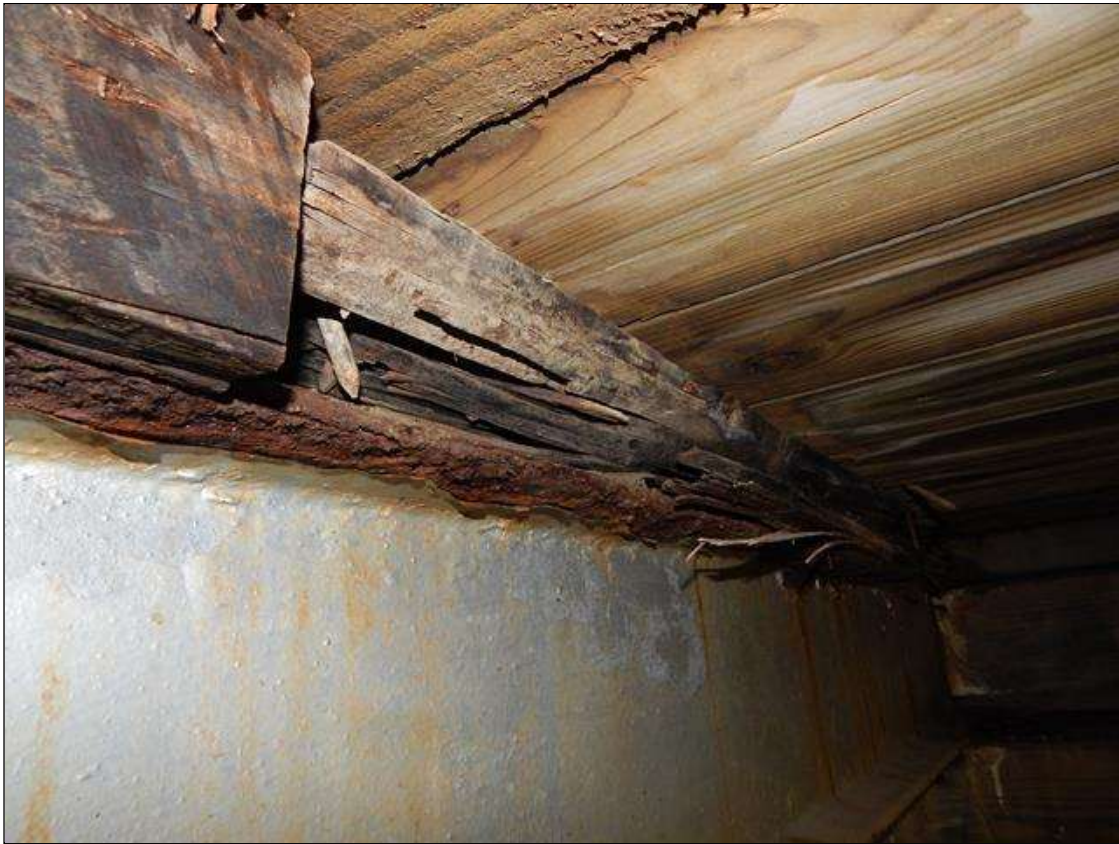
| Element Number | Defect Type | Defect Description | CS | CS Qty | Maint Qty | |
|---|---|---|---|---|---|---|
| 31 | Decay/Section Loss | BEAM (5) NAILER DECAYED AND SPLIT (5') FROM ABUT. (A) AND EXTENDS (+/- 5 LF) | 3 | 5 | 5 | Square Feet |

Span 1 Deck: BEAM (5) NAILER DECAYED AND SPLIT (5') FROM ABUT. (A) AND EXTENDS (+/- 5 LF)

| MMS Code | Description of Function | Unit | Quantity | Remarks | Est. Cost |
|---|---|---|---|---|---|
| 3324 | Maint / Repair / Replace Timber Deck Components | SF | 5 | Span 1 Deck: BEAM (5) NAILER DECAYED AND SPLIT (5') FROM ABUT. (A) AND EXTENDS (+/- 5 LF) | |

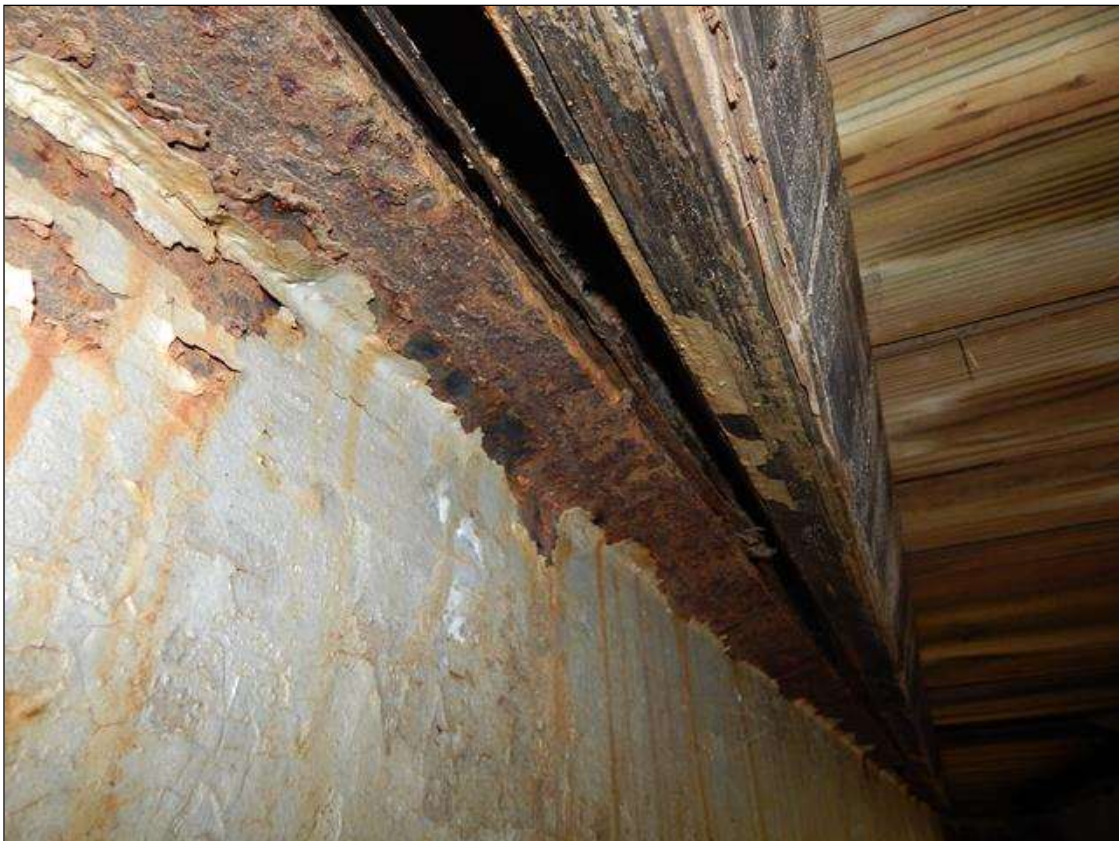
| Element Number | Defect Type | Defect Description | CS | CS Qty | Maint Qty | |
|---|---|---|---|---|---|---|
| 31 | Decay/Section Loss | BEAM (6) NAILER DECAYED FROM ABUT. (A) AND EXTENDS (+/- 5 LF) | 3 | 5 | 5 | Square Feet |

Span 1 Deck: BEAM (6) NAILER DECAYED FROM ABUT. (A) AND EXTENDS (+/- 5 LF)

| MMS Code | Description of Function | Unit | Quantity | Remarks | Est. Cost |
|---|---|---|---|---|---|
| 3324 | Maint / Repair / Replace Timber Deck Components | SF | 5 | Span 1 Deck: BEAM (6) NAILER DECAYED FROM ABUT. (A) AND EXTENDS (+/- 5 LF) | |

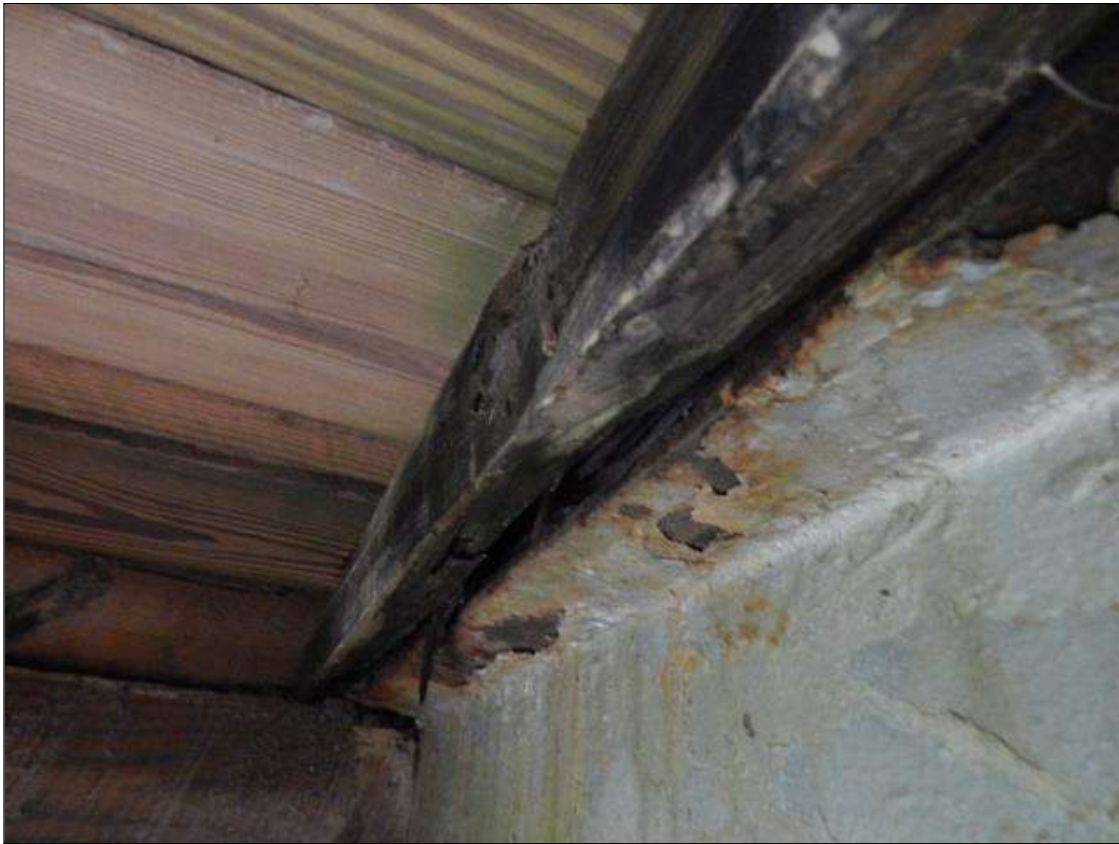
| Element Number | Defect Type | Defect Description | CS | CS Qty | Maint Qty | |
|---|---|---|---|---|---|---|
| 31 | Decay/Section Loss | BEAM (7) NAILER DECAYED AND SPLIT FULL LENGTH ALONG EDGE OF BEAM | 3 | 24 | 24 | Square Feet |

Span 1 Deck: BEAM (7) NAILER DECAYED AND SPLIT FULL LENGTH ALONG EDGE OF BEAM

| MMS Code | Description of Function | Unit | Quantity | Remarks | Est. Cost |
|---|---|---|---|---|---|
| 3324 | Maint / Repair / Replace Timber Deck Components | SF | 24 | Span 1 Deck: BEAM (7) NAILER DECAYED AND SPLIT FULL LENGTH ALONG EDGE OF BEAM | |

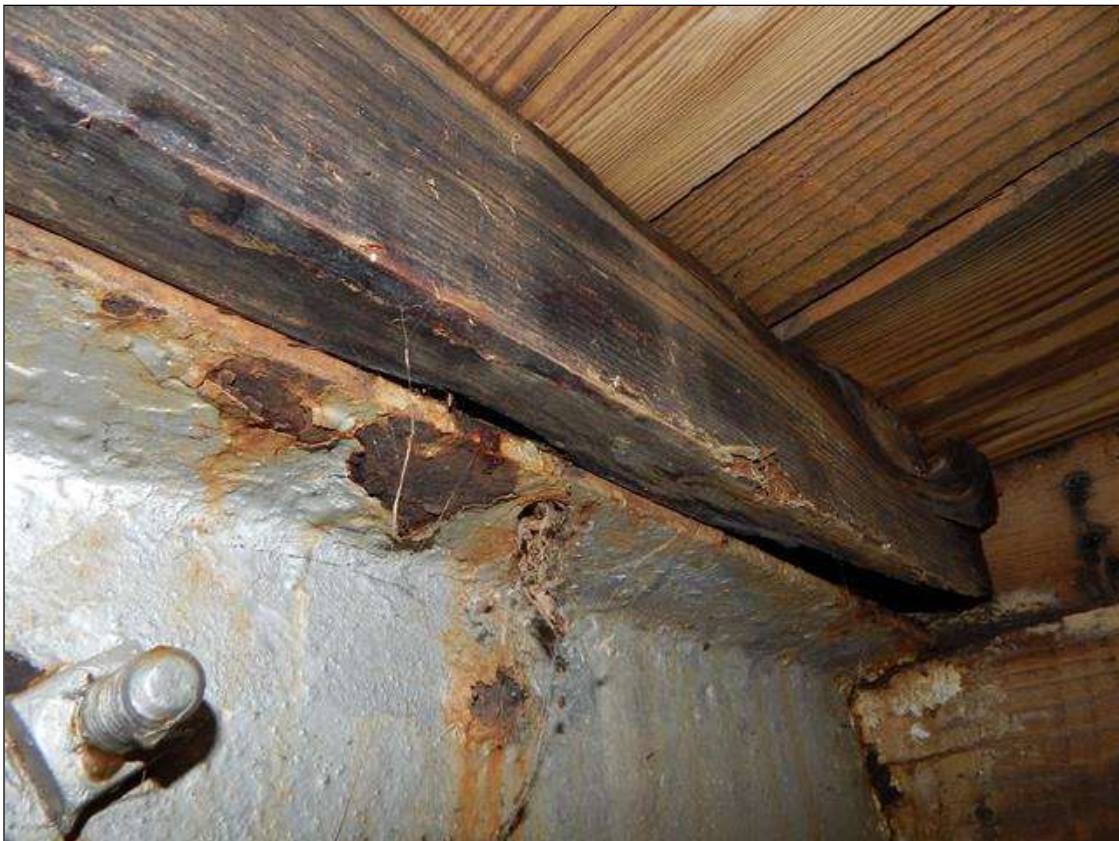
| Element Number | Defect Type | Defect Description | CS | CS Qty | Maint Qty | |
|---|---|---|---|---|---|---|
| 31 | Decay/Section Loss | BEAM (8) NAILER DECAYED FROM ABUT. (A) AND EXTENDS (+/- 4 LF) | 3 | 4 | 4 | Square Feet |

Span 1 Deck: BEAM (8) NAILER DECAYED FROM ABUT. (A) AND EXTENDS (+/- 4 LF)

| MMS Code | Description of Function | Unit | Quantity | Remarks | Est. Cost |
|---|---|---|---|---|---|
| 3324 | Maint / Repair / Replace Timber Deck Components | SF | 4 | Span 1 Deck: BEAM (8) NAILER DECAYED FROM ABUT. (A) AND EXTENDS (+/- 4 LF) | |

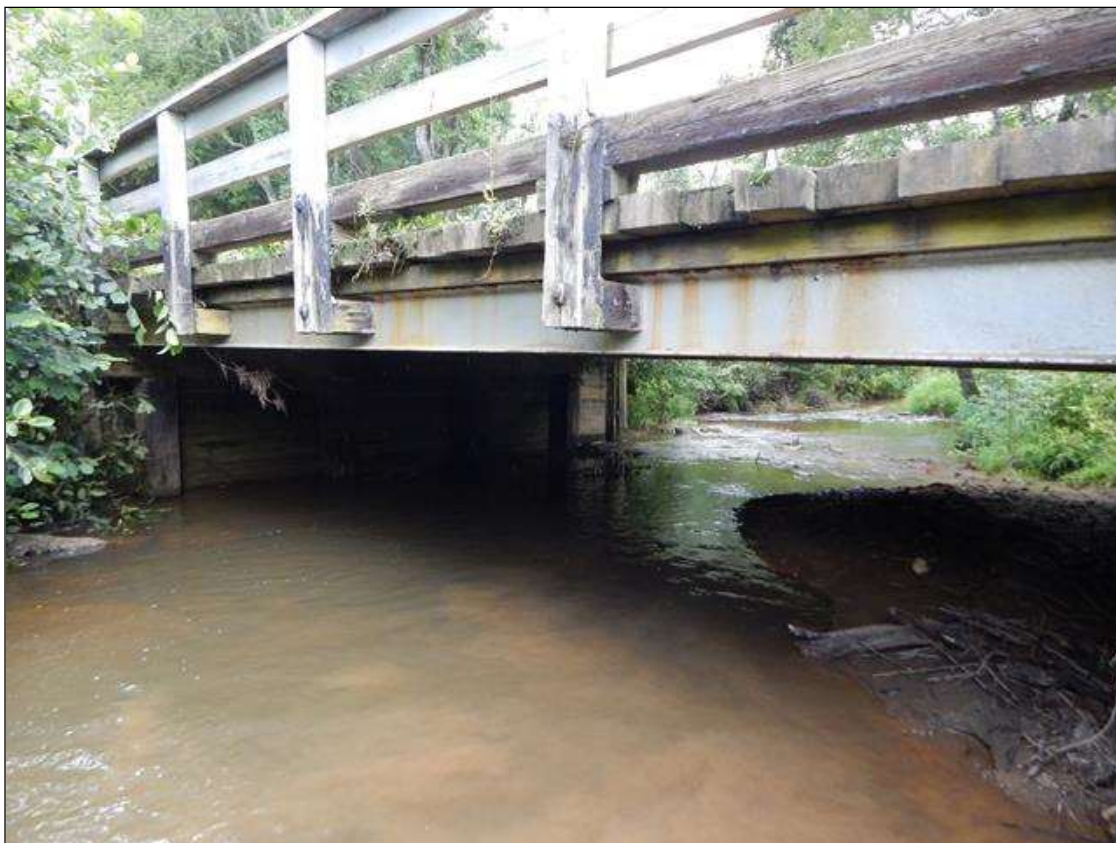
NO BEARING, ALL SIMILAR

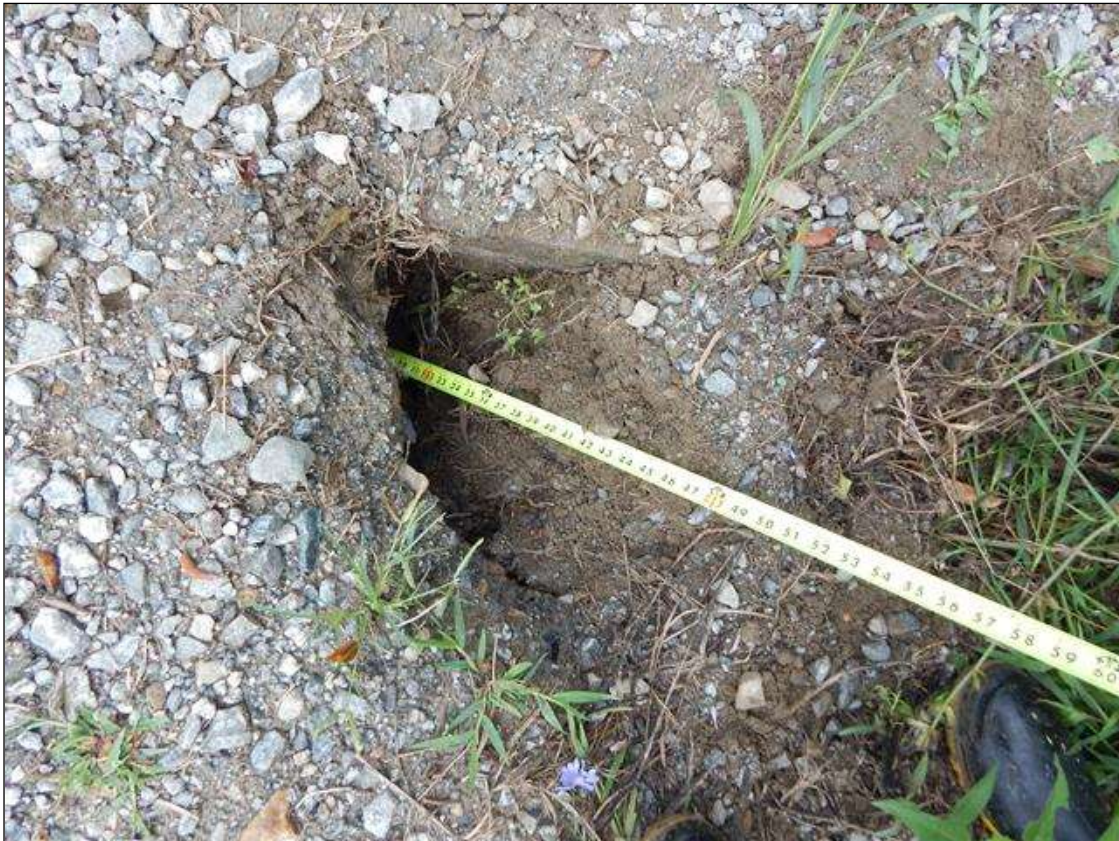
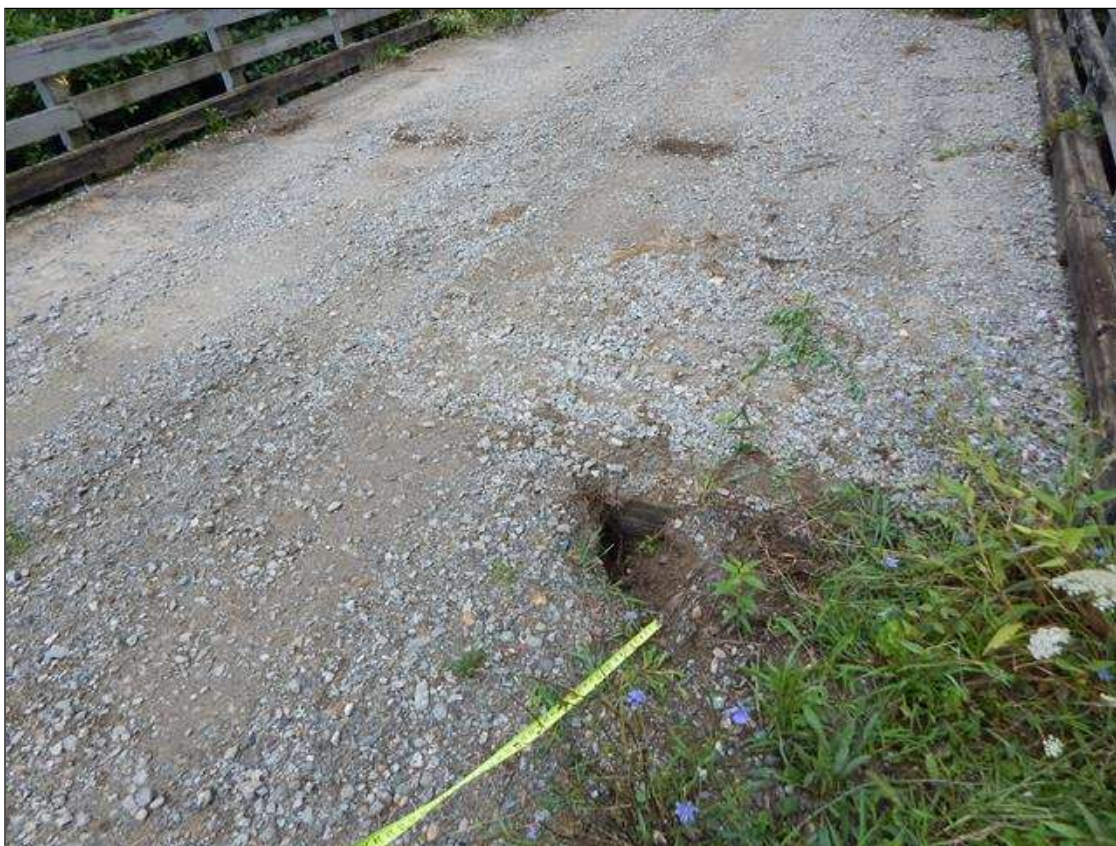
SOUTH EAST APPROACH ROADWAY EROSION BEHIND ABUT. (A) (+/- 1' DIA. X 4' D) IN RIGHT EDGE OF ROADWAY

SOUTH EAST APPROACH ROADWAY EROSION BEHIND ABUT. (A) (+/- 1' DIA. X 4' D) IN RIGHT EDGE OF ROADWAY, DUE TO MISSING TIMBER ABUT. BOARD
