NC DEPARTMENT OF TRANSPORTATION  
DIVISION OF HIGHWAYS  
STRUCTURE MANAGEMENT UNIT

## Structure Safety Report

### Routine Element Inspection - Contract

COUNTY: ASHE STRUCTURE NUMBER: 040160 FREQUENCY: 24 MONTHS

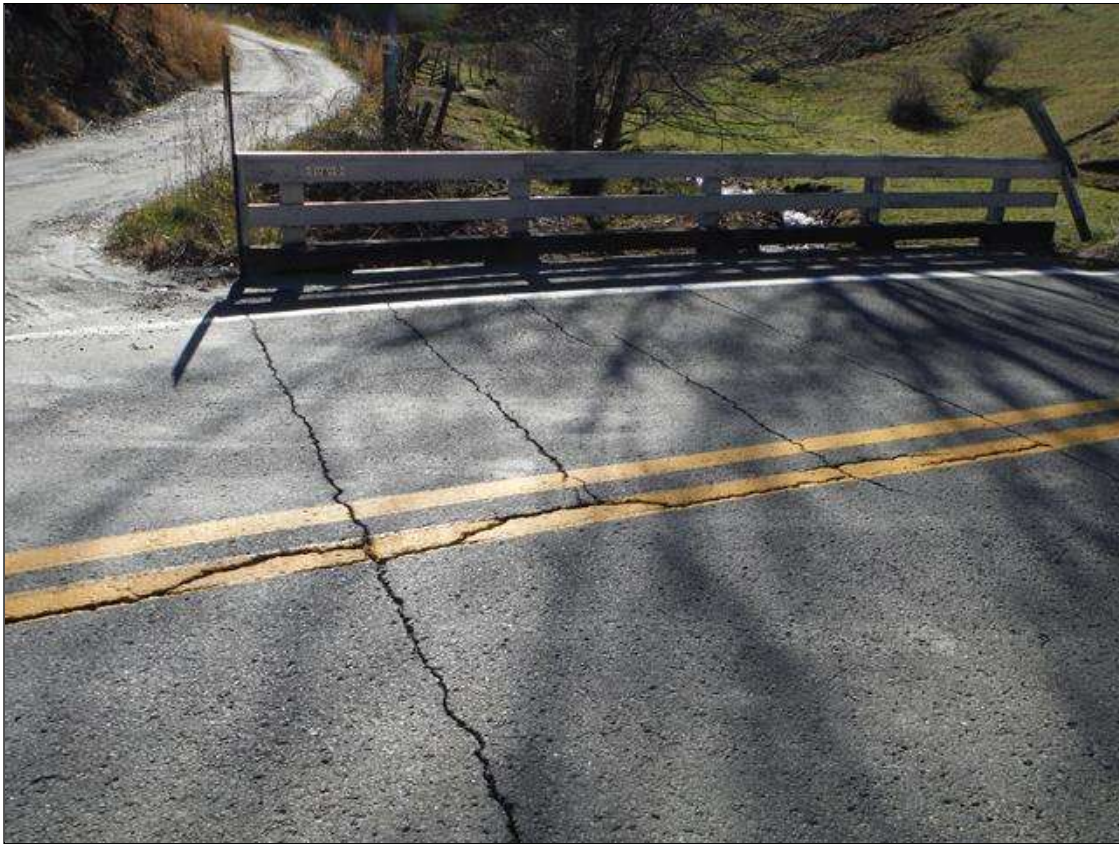
Span 1 Wearing Surface: 500 Square Feet of Crack (Wearing Surface): Width of more than 0.05 in. or spacing of less than 1.0 ft. TRANSVERSE CRACKING

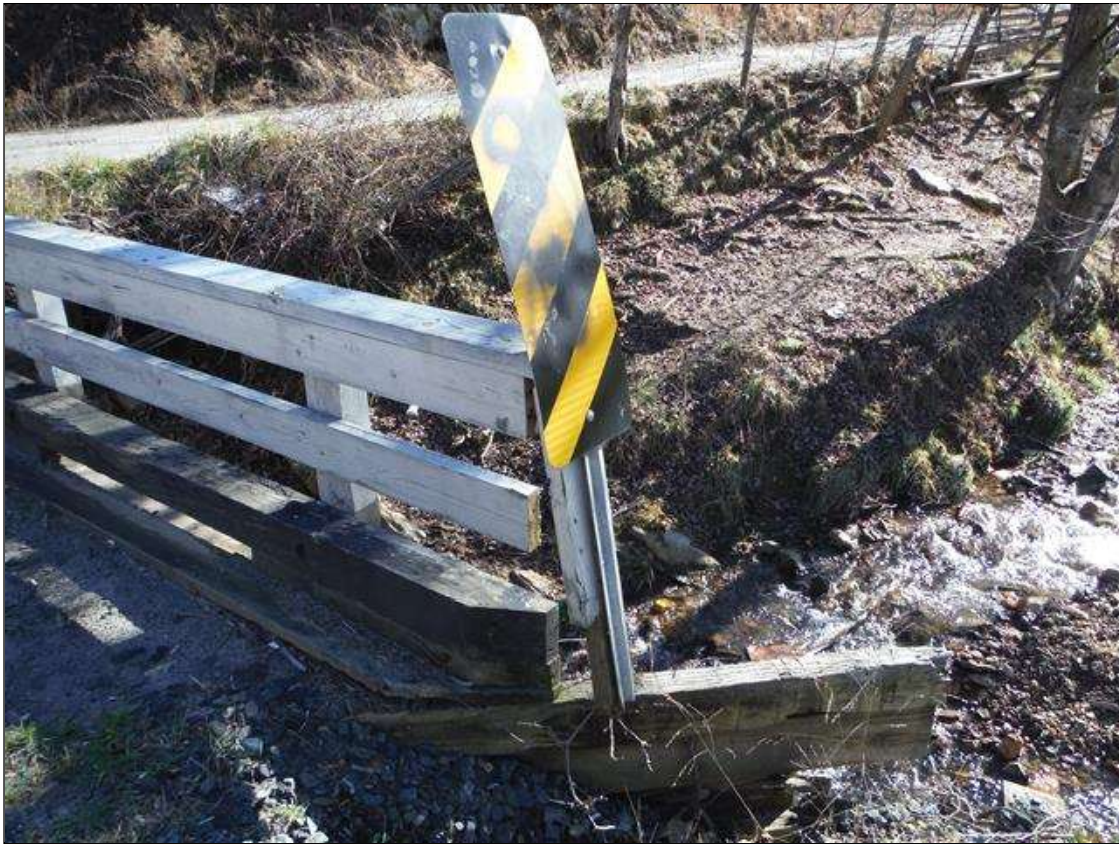
Span 1 Right Bridge Rail: 1 Feet of Connection: Missing bolts, rivets, or fasteners; broken welds; or pack rust with distortion but does not warrant a structural review. IMPACT DAMAGE WITH BROKEN END POST AT SOUTHEAST CORNER

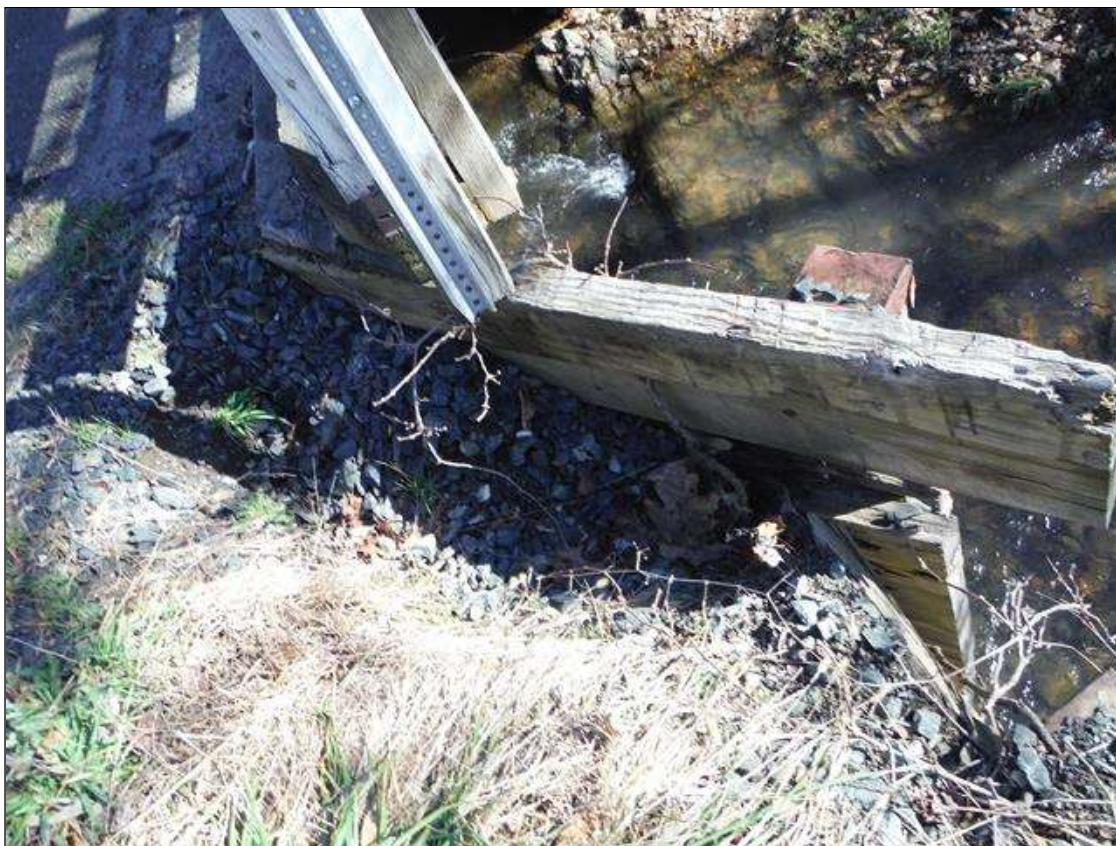
4 FT. X 2 FT. X 2 FT. DEEP AREA OF EROSION AT SOUTHEAST CORNER

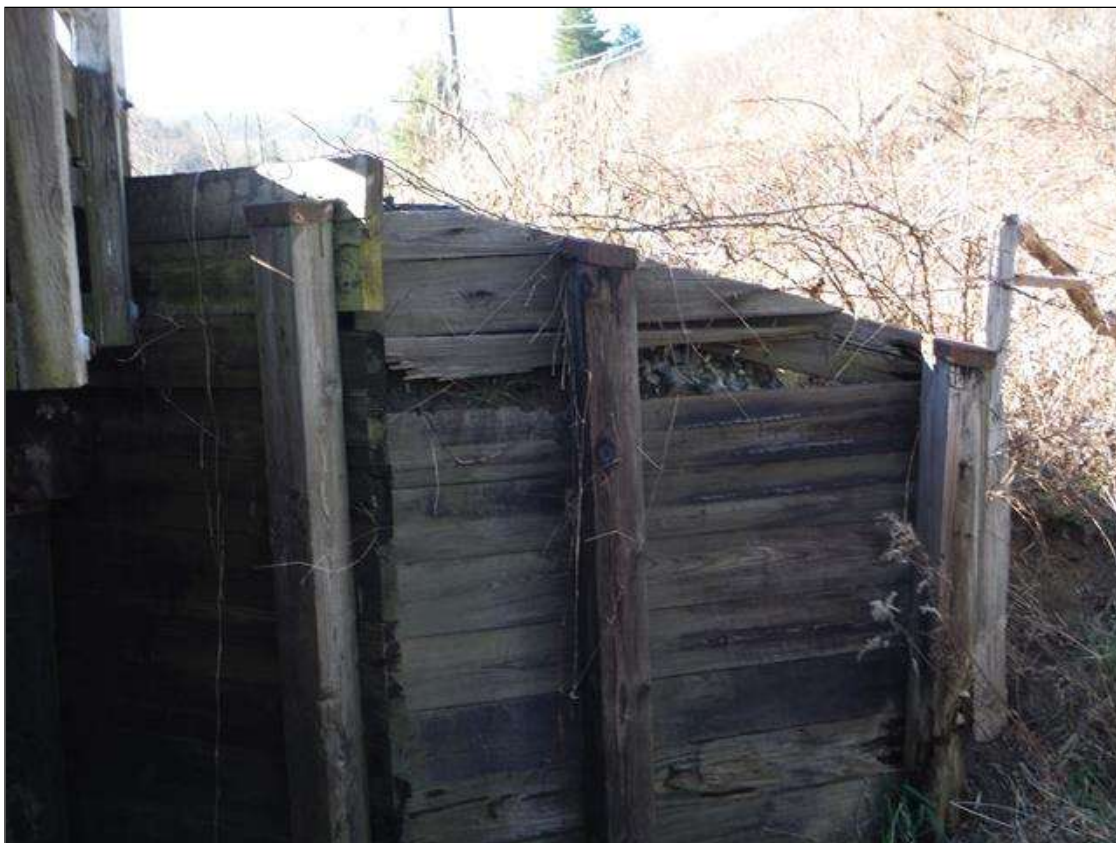
48" X 12" X FULL DEPTH AREA OF DECAY IN SOUTHWEST WINGWALL

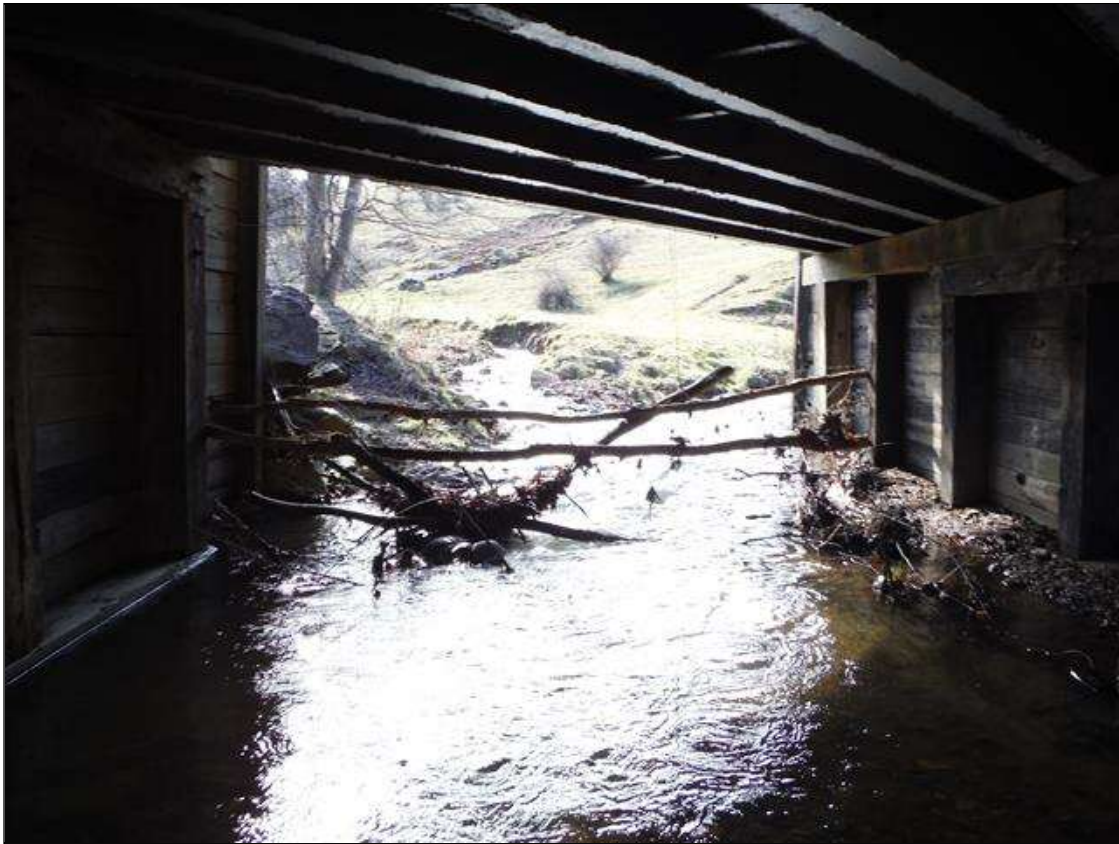
FENCE UNDER BRIDGE AT UPSTREAM END

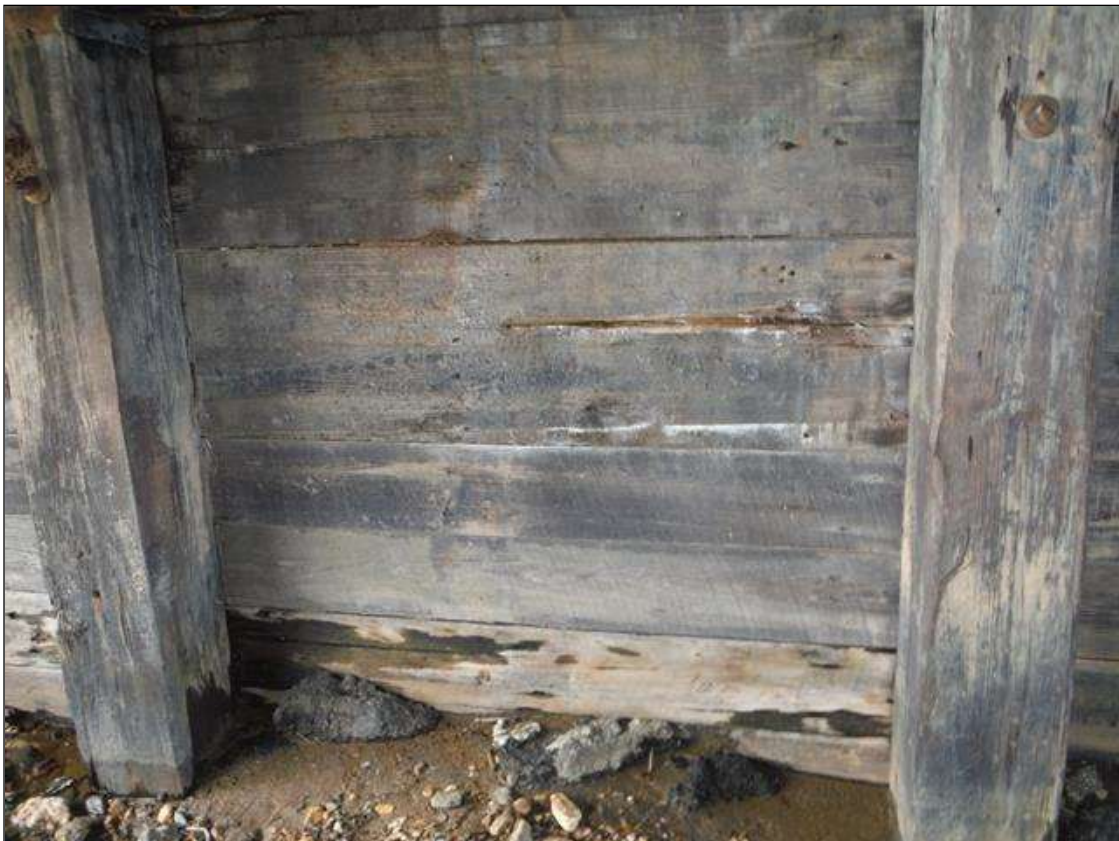
End Bent 1 Abutment/Backwall : 6 Feet of Decay/Section Loss: Affects less than 10% of the member section. 2 - 36" X 6" X 1" DEEP AREAS OF DECAY BAY 3

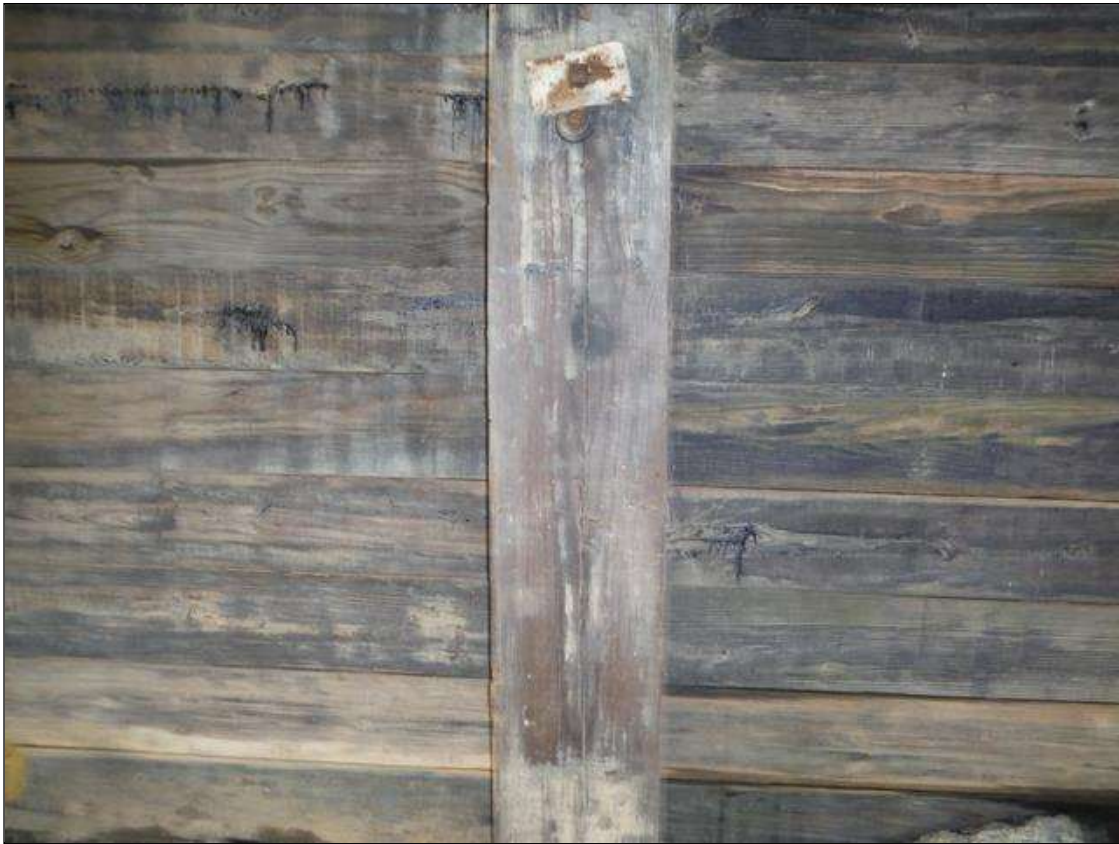
End Bent 1 Pile 2: 1 Each of Crack (Timber): Identified crack that is not arrested but does not requires structural review. 6 FT. LONG VERTICAL CRACK 1/4" WIDE IN NORTH FACE

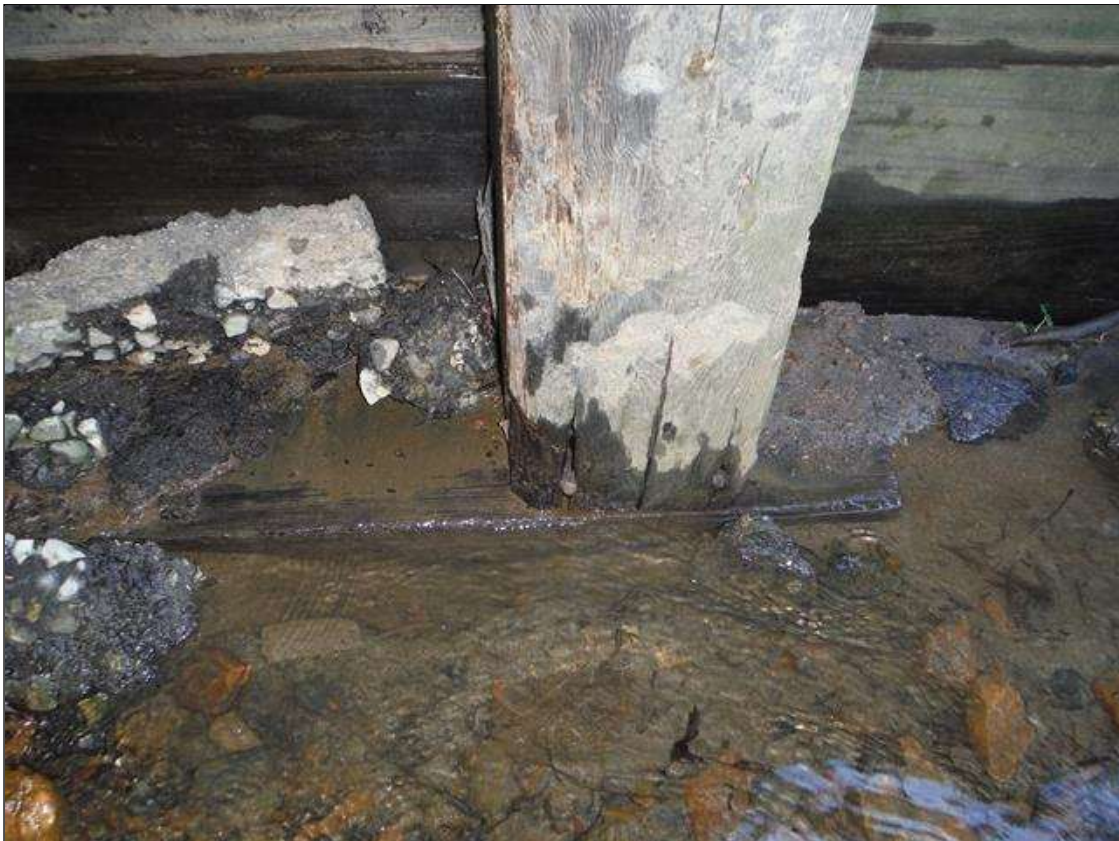
End Bent 1 Pile 1: 1 Each of Decay/Section Loss: Affects less than 10% of the member section. 6" X 6" X 1" DEEP AREA OF DECAY IN EAST FACE

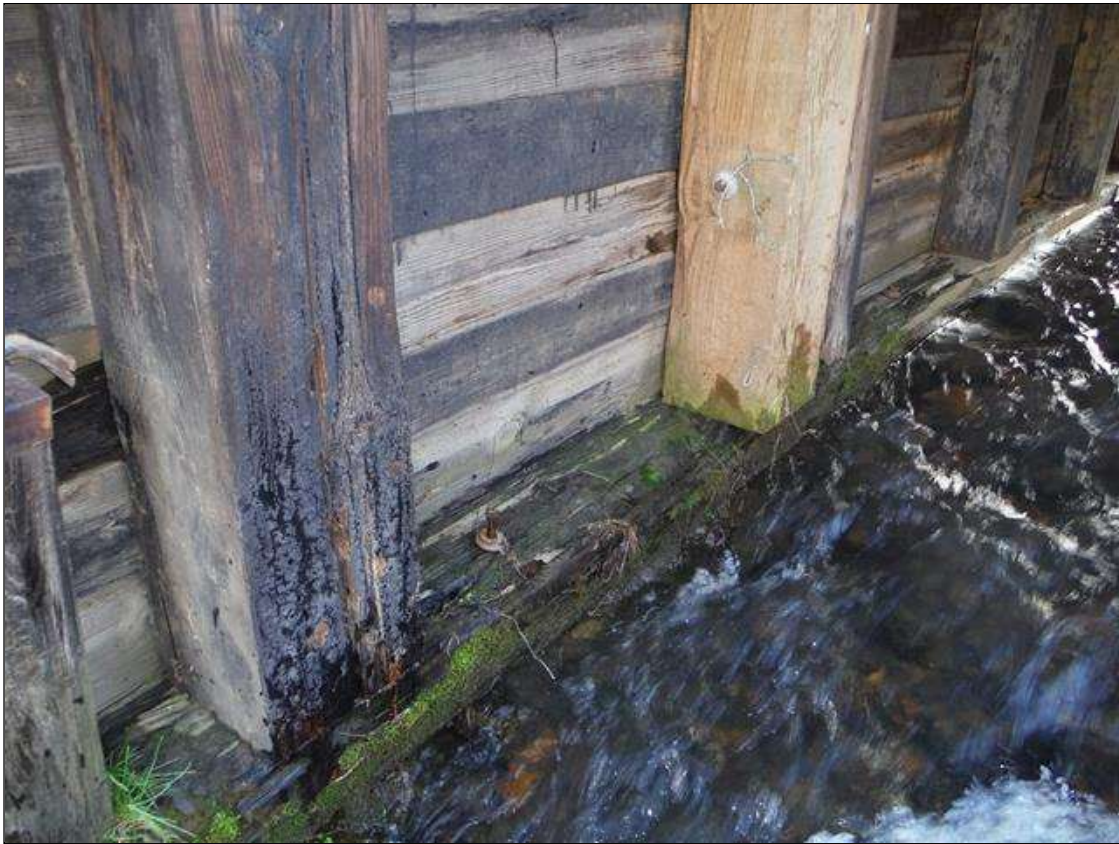
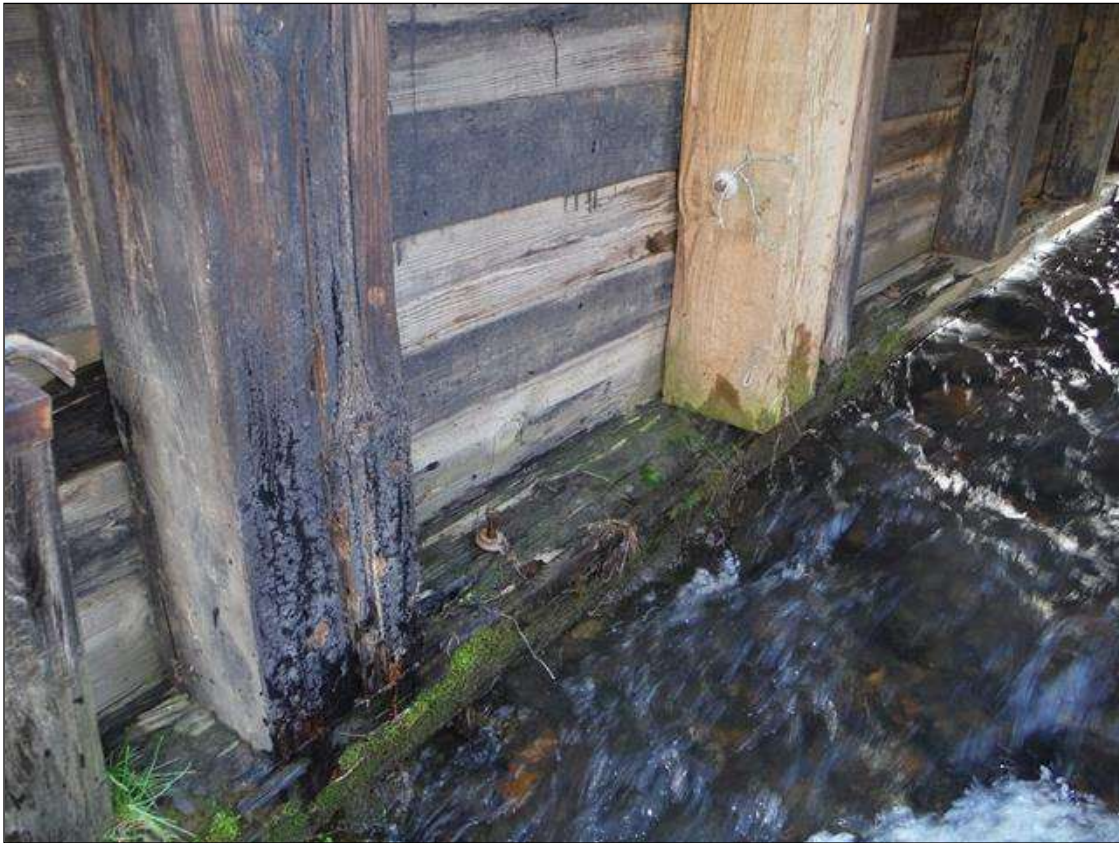
12 FT. LONG X 12" WIDE X 3" DEEP AREA OF DECAY IN TOP OF END BENT 2 SILL AT WEST END

| MMS Code | Description of Function | Unit | Quantity | Remarks | Est. Cost |
|---|---|---|---|---|---|
| 3344 | Repair / Replace Timber Substructure Components | LF | 12 | 12 FT. LONG X 12" WIDE X 3" DEEP AREA OF DECAY IN TOP OF END BENT 2 SILL AT WEST END | |

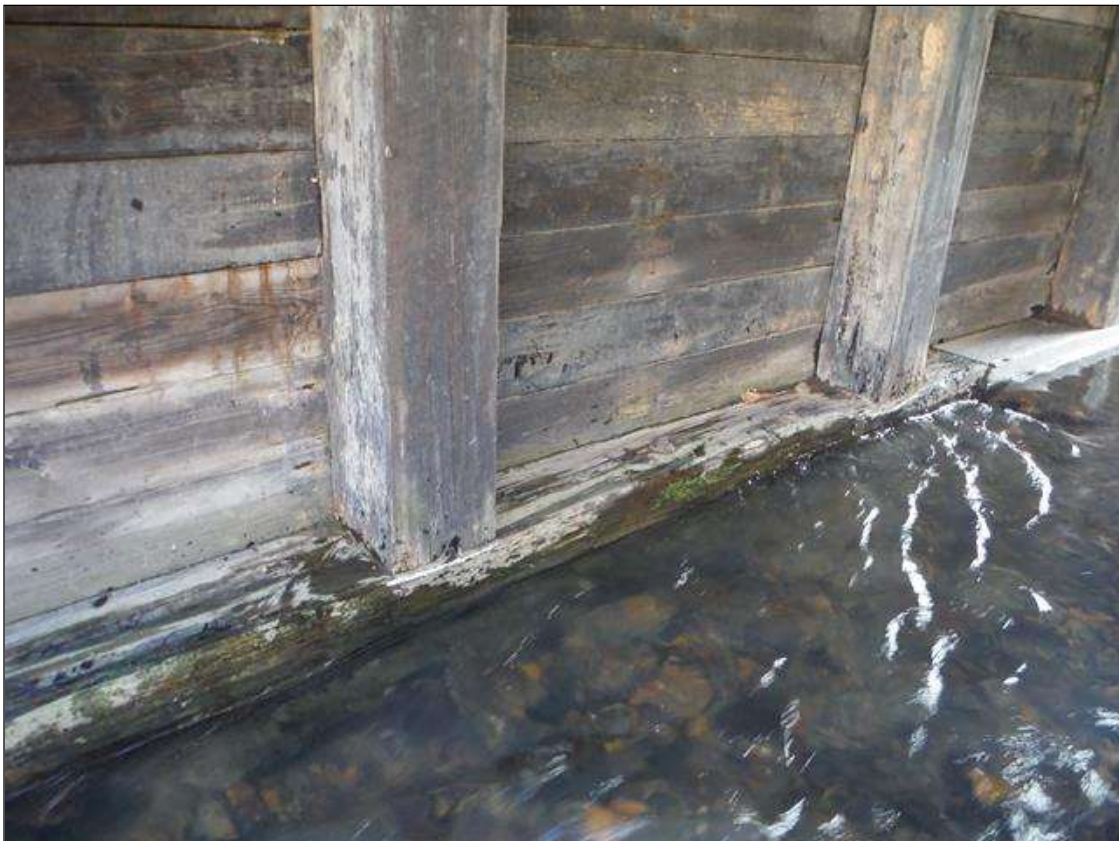
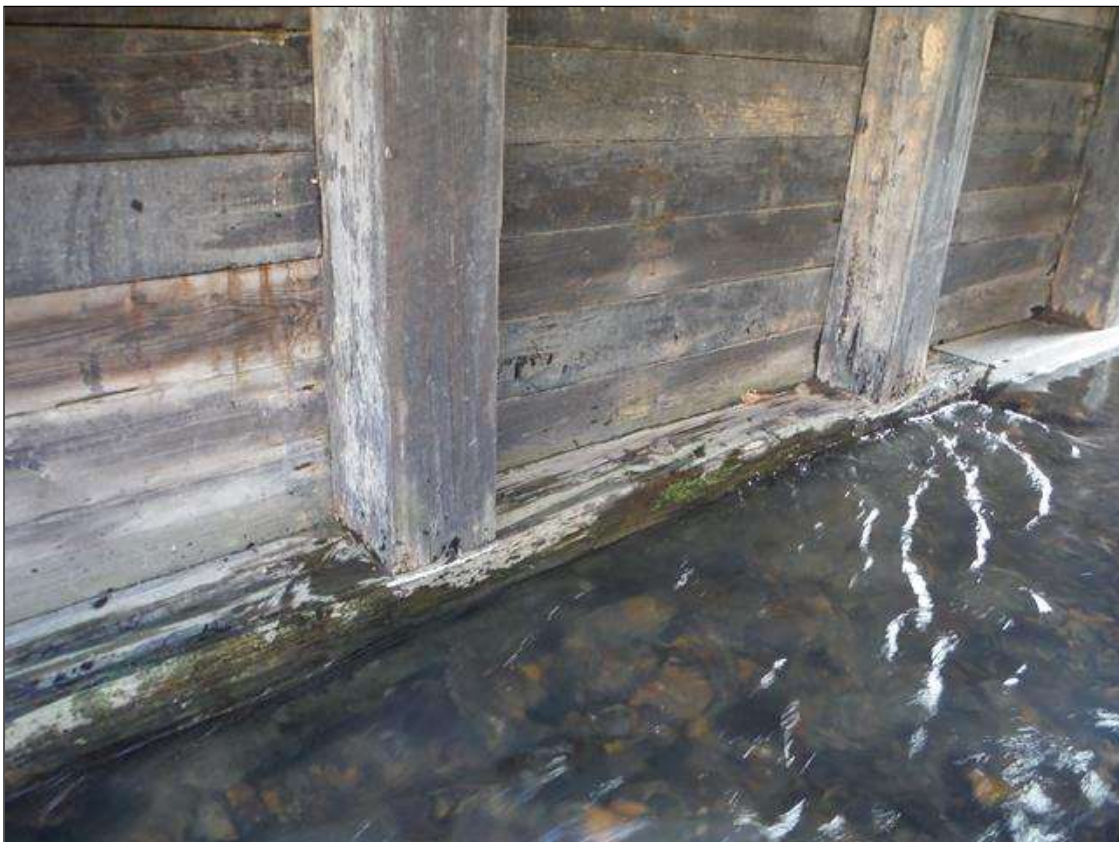
TOP OF END BENT 2 SILL CRUSHING UP TO 3/4" UNDER PILES 4 AND 5

| MMS Code | Description of Function | Unit | Quantity | Remarks | Est. Cost |
|---|---|---|---|---|---|
| 3344 | Repair / Replace Timber Substructure Components | LF | 2 | TOP OF END BENT 2 SILL CRUSHING UP TO 3/4" UNDER PILES 4 AND 5 | |

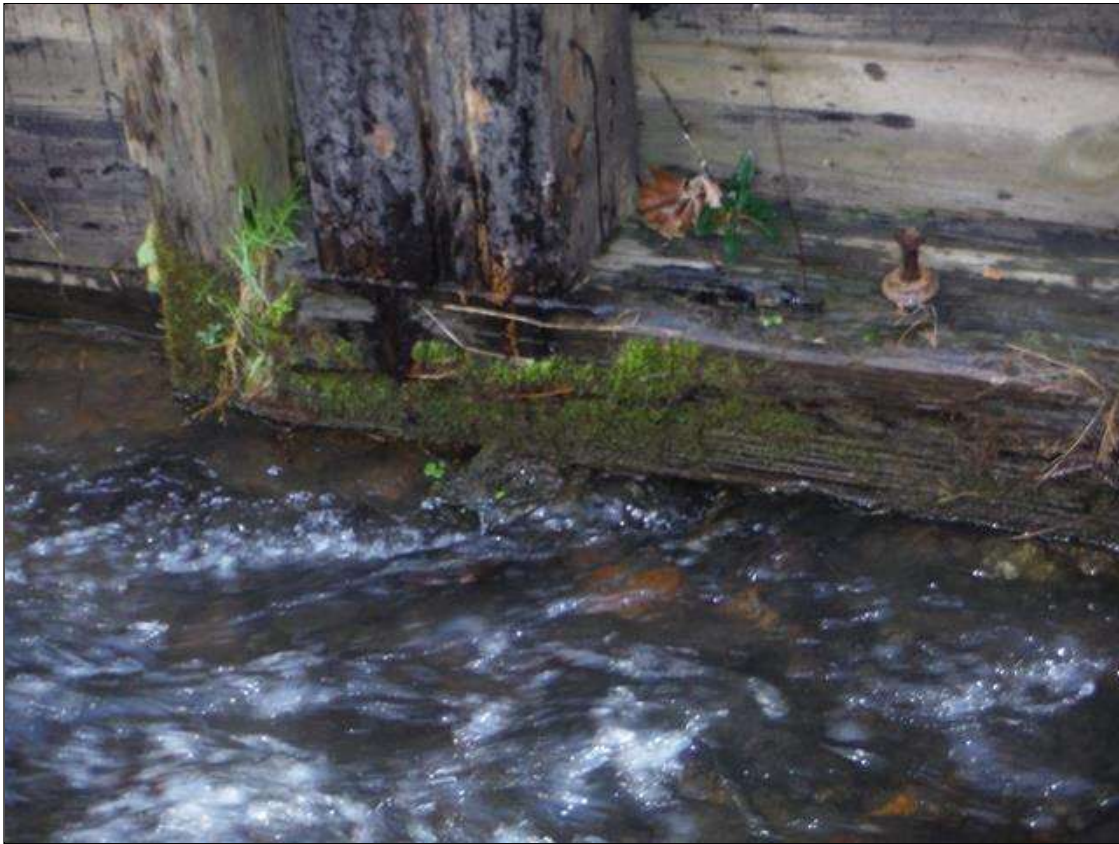
End Bent 2 Abutment/Backwall : 3 Feet of Scour: Exceeds tolerable limits but is less than the critical limits determined by scour evaluation and does not warrant structural review. 3 FT. X 1 FT. DEEP AREA OF SCOUR WITH 12" OF UNDERMINING OF SILL AT WEST END

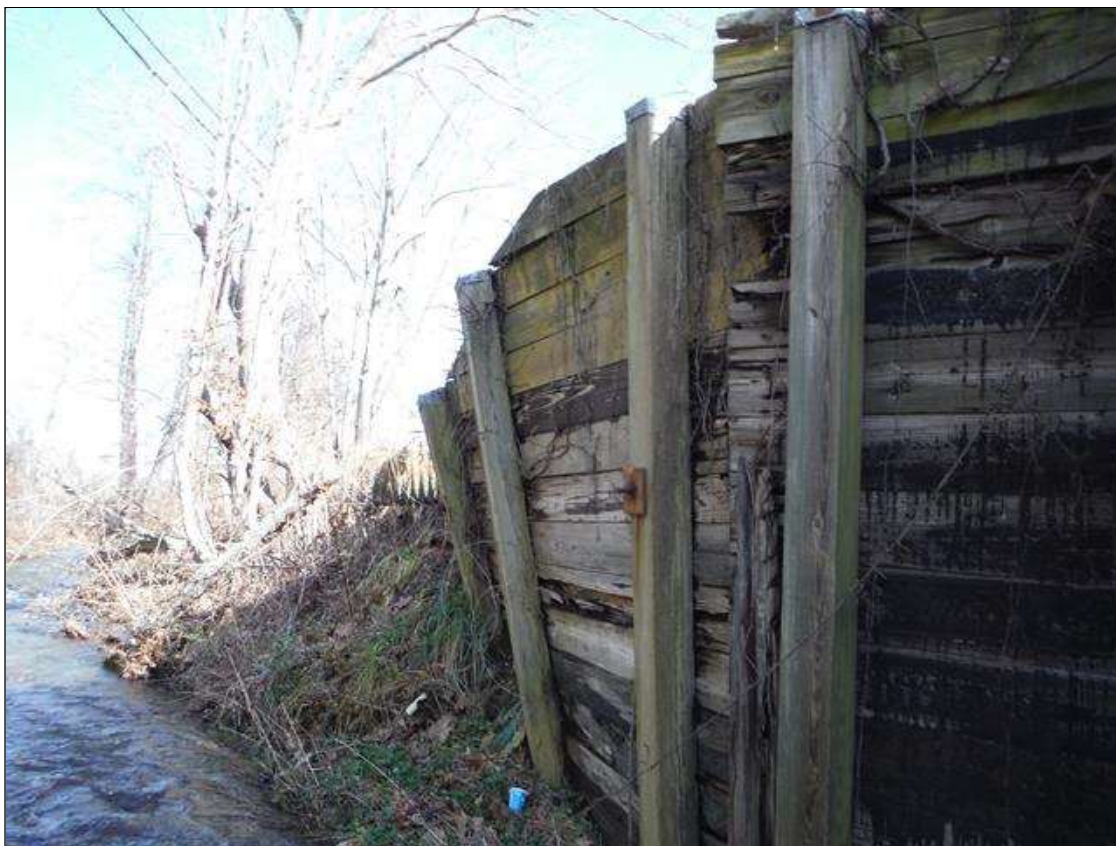
NORTHWEST WINGWALL LEANING TOWARDS STREAM 2 FT. AT TOP

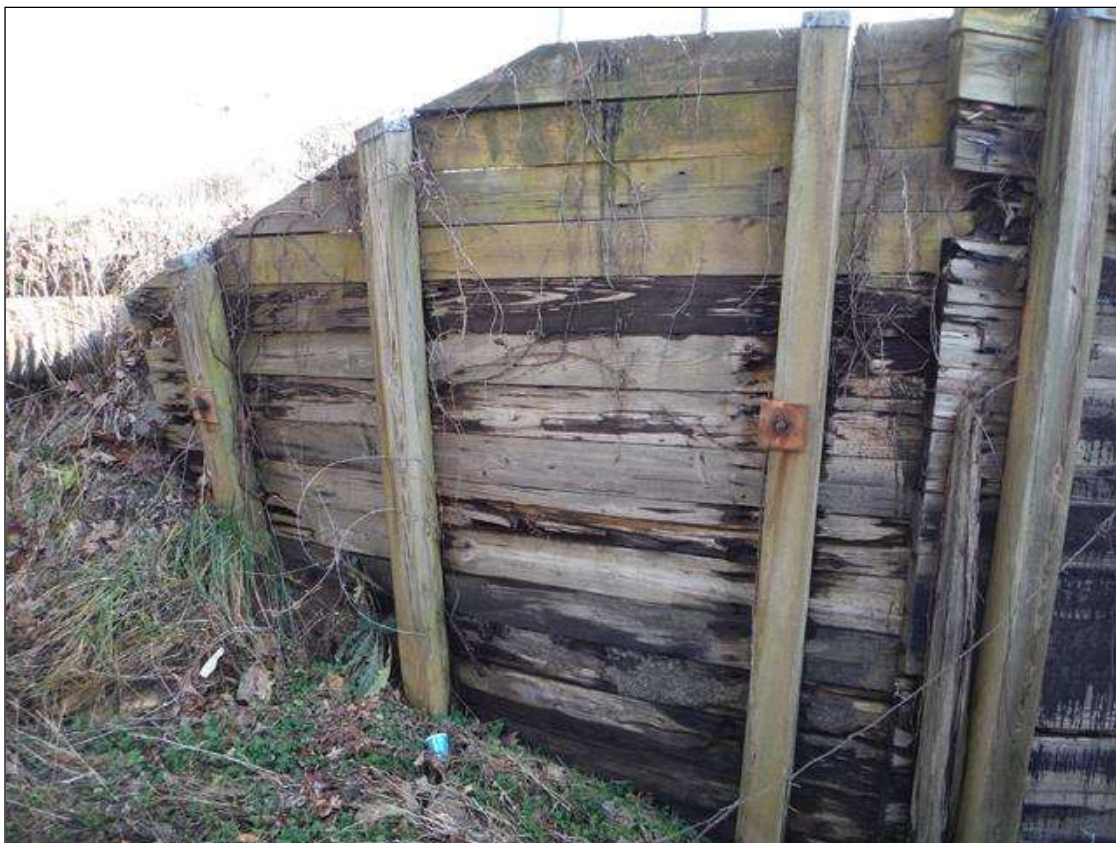
72" X 60" AREA OF DECAY IN NORTHWEST WINGWALL

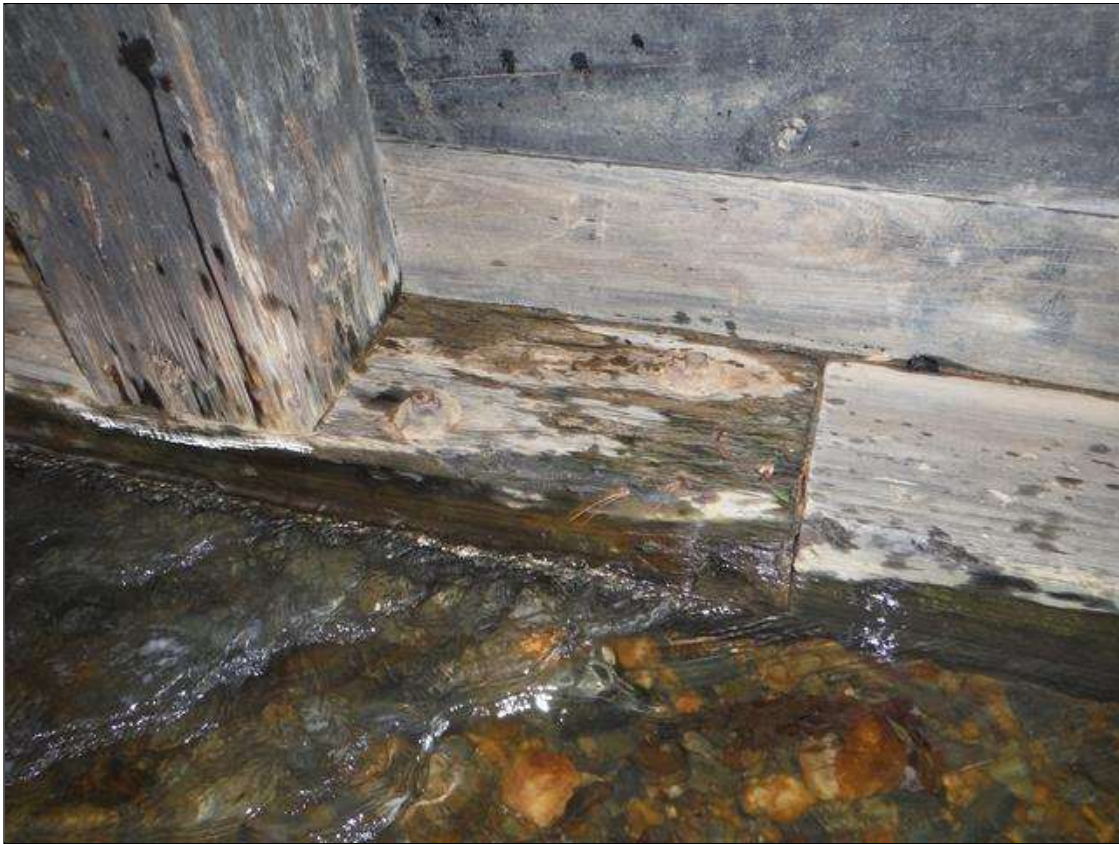
18" X 10" X 2" DEEP AREA OF DECAY IN END BENT 2 SILL BETWEEN PILES 5 AND 6

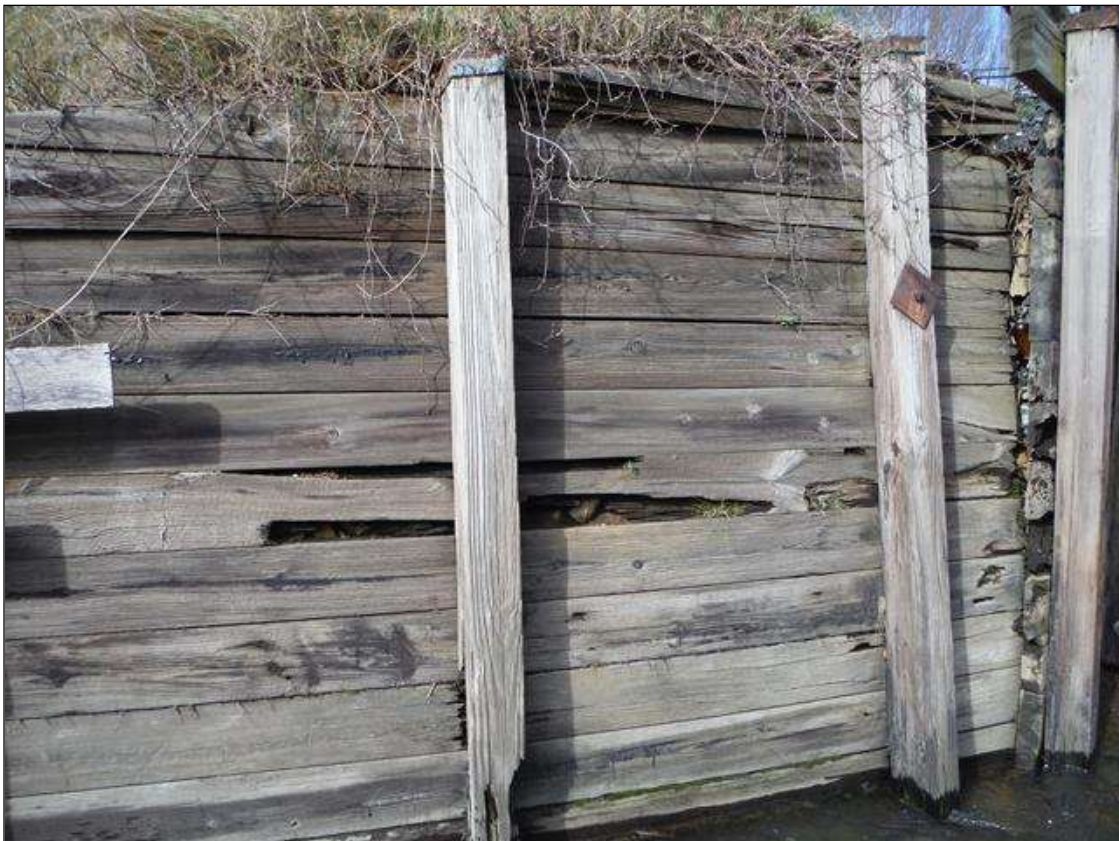
60" X 8" X FULL DEPTH AREA OF DECAY IN SOUTHEAST WINGWALL

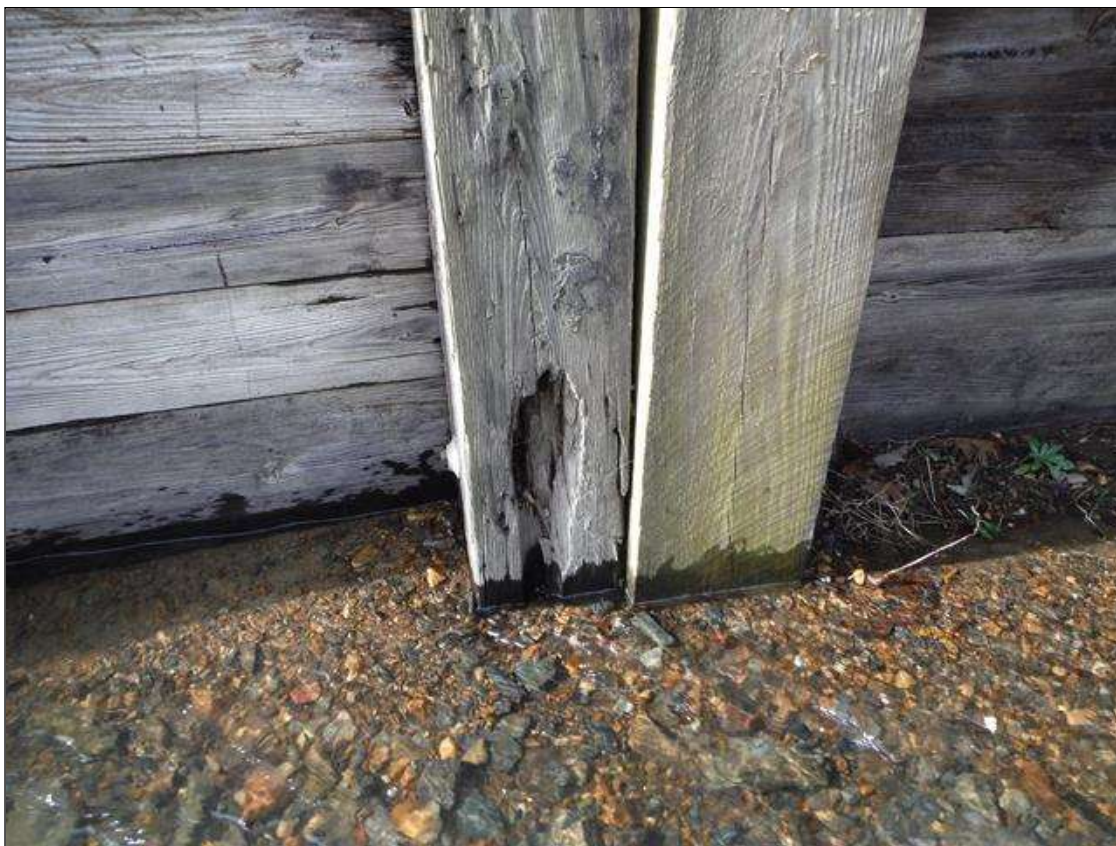
End Bent 2 Pile 8: 1 Each of Decay/Section Loss: Affects 10% or more of the member but does not warrant structural review. 15" X 5" X 4" DEEP AREA OF DECAY IN NORTH FACE

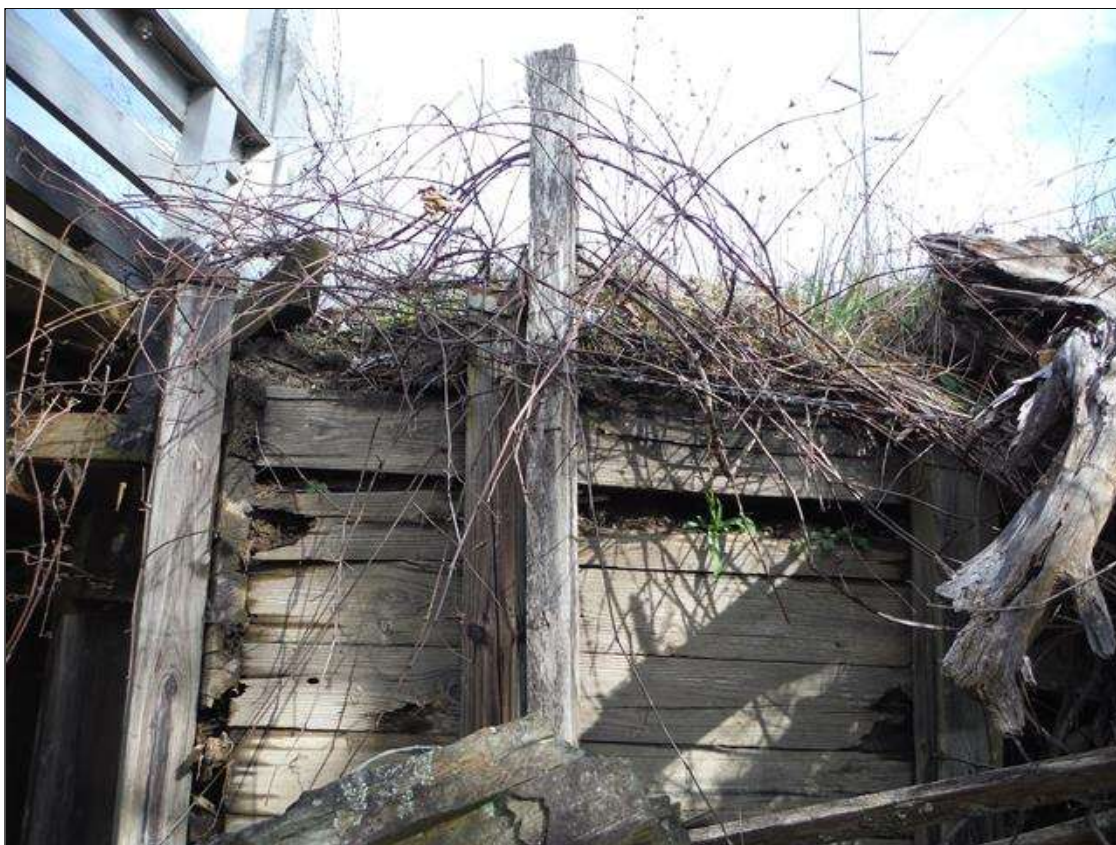
72" X 8" X FULL DEPTH AREA OF DECAY IN NORTHEAST WINGWALL

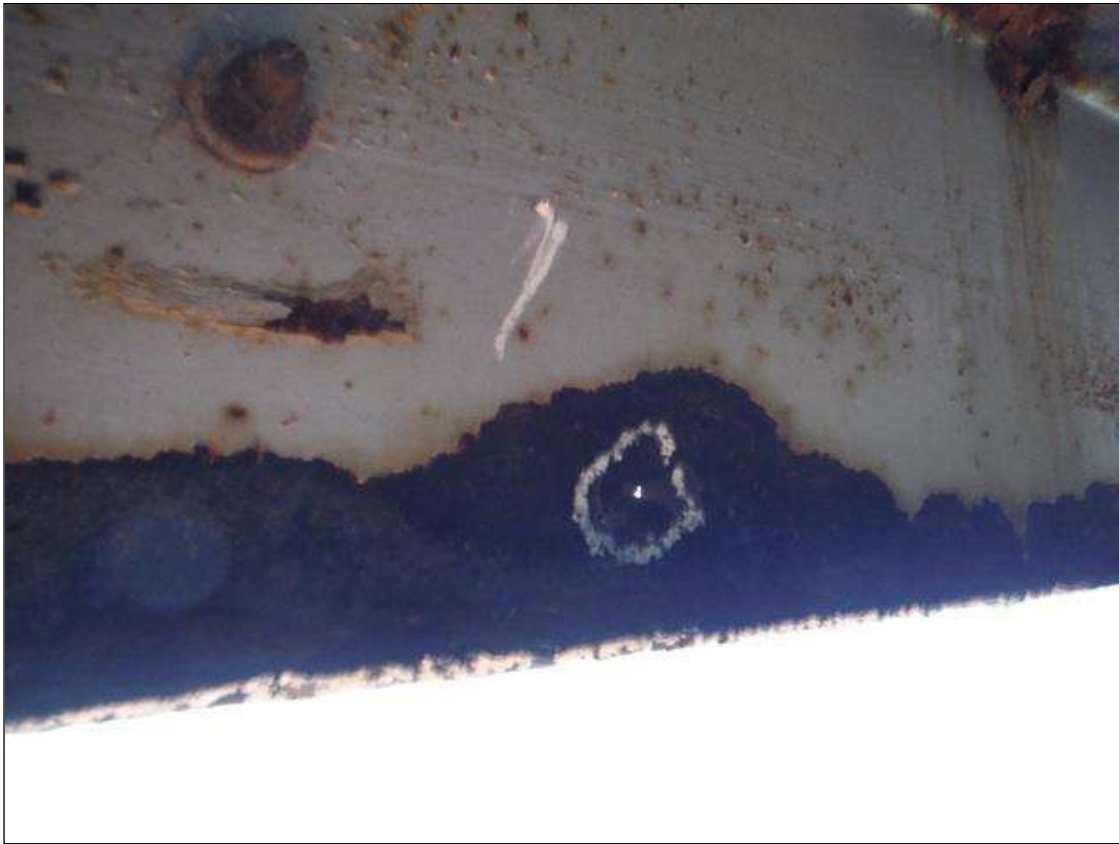
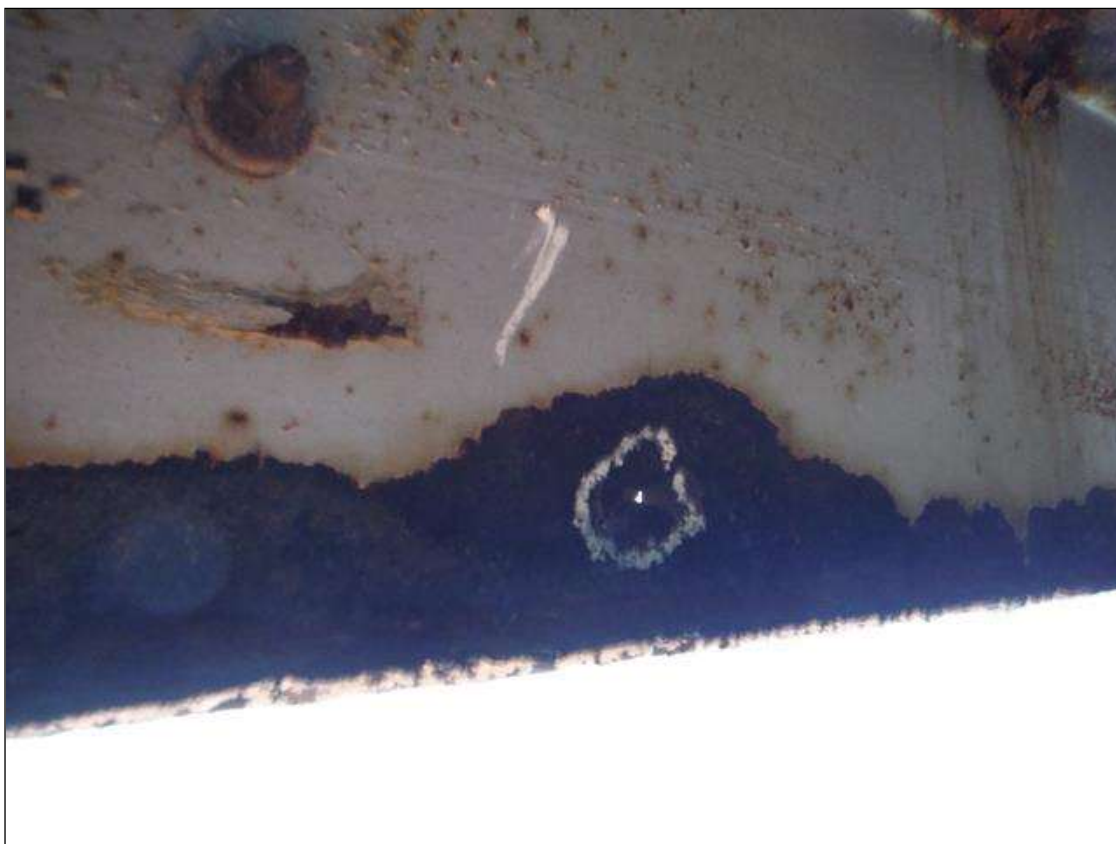
Span 1 Beam 1: 26 Feet of Corrosion: Section loss is evident or pack rust is present but does not warrant structural review. CORROSION WITH BOTTOM FLANGE TO KNIFES EDGE, 1/8" OF SECTION LOSS IN TOP FLANGE AND 3/16" OF SECTION LOSS IN WEB. PINHOLE IN WEB AT MIDSPAN

SPAN 1 BEAM 1: SECTION LOSS

| MMS Code | Description of Function | Unit | Quantity | Remarks | Est. Cost |
|---|---|---|---|---|---|
| 3314 | Maintain Steel Superstructure Components | LF | 26 | Span 1 Beam 1: 26 Feet of Corrosion: Section loss is evident or pack rust is present but does not warrant structural review. CORROSION WITH BOTTOM FLANGE TO KNIFES EDGE, 1/8" OF SECTION LOSS IN TOP FLANGE AND 3/16" OF SECTION LOSS IN WEB. PINHOLE IN WEB AT MIDSPAN | |

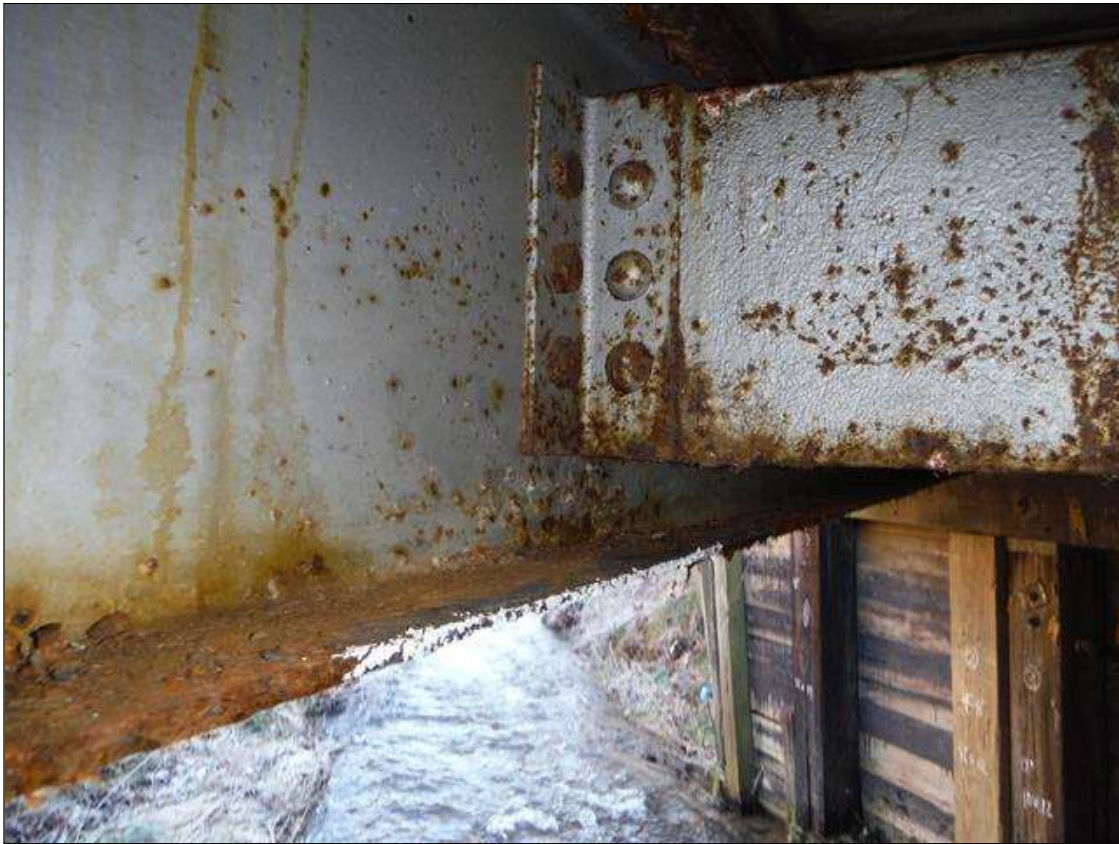
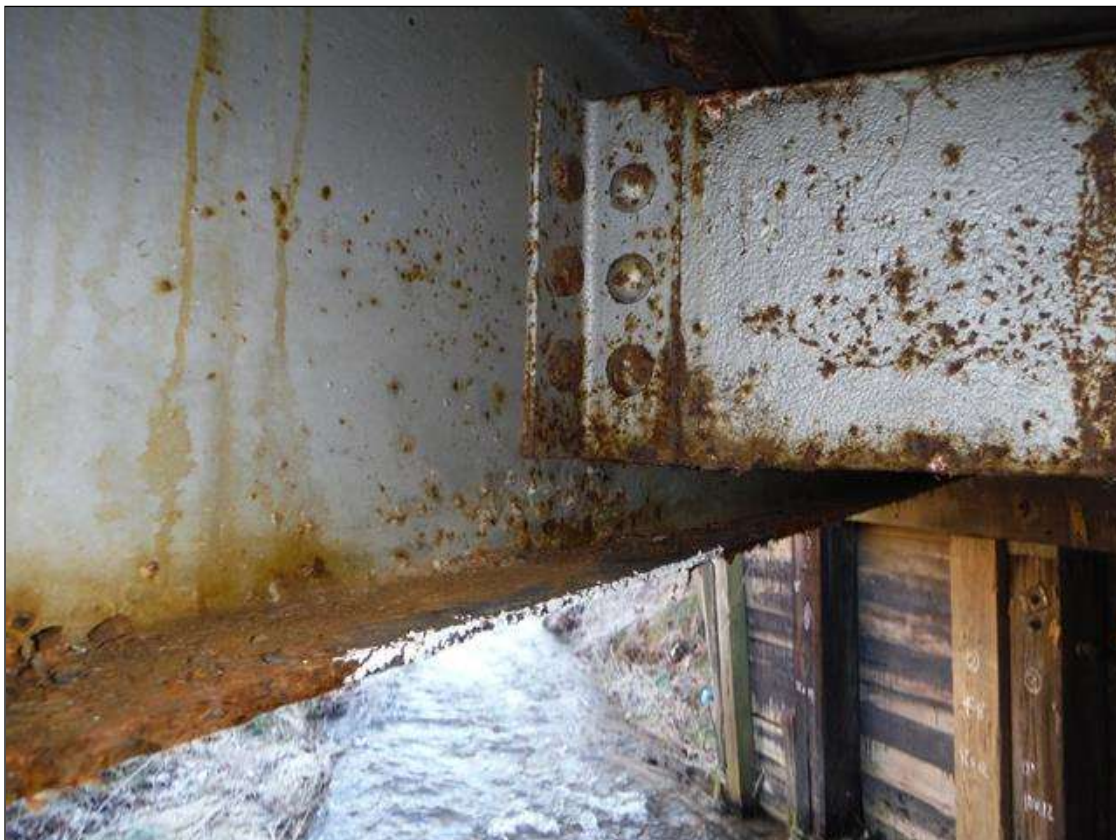
Span 1 Beam 2: 5 Feet of Corrosion: Section loss is evident or pack rust is present but does not warrant structural review. CORROSION WITH 3/16" OF SECTION LOSS IN BOTTOM FLANGE AND 1/8" OF SECTION LOSS IN TOP FLANGE AT MIDSPAN

SPAN 1 BEAM 2: SECTION LOSS

| MMS Code | Description of Function | Unit | Quantity | Remarks | Est. Cost |
|---|---|---|---|---|---|
| 3314 | Maintain Steel Superstructure Components | LF | 5 | Span 1 Beam 2: 5 Feet of Corrosion: Section loss is evident or pack rust is present but does not warrant structural review. CORROSION WITH 3/16" OF SECTION LOSS IN BOTTOM FLANGE AND 1/8" OF SECTION LOSS IN TOP FLANGE AT MIDSPAN | |
