NC DEPARTMENT OF TRANSPORTATION  
DIVISION OF HIGHWAYS  
STRUCTURE MANAGEMENT UNIT

## Structure Safety Report

### Routine Element Inspection - Contract

COUNTY: ASHE STRUCTURE NUMBER: 040160 FREQUENCY: 24 MONTHS

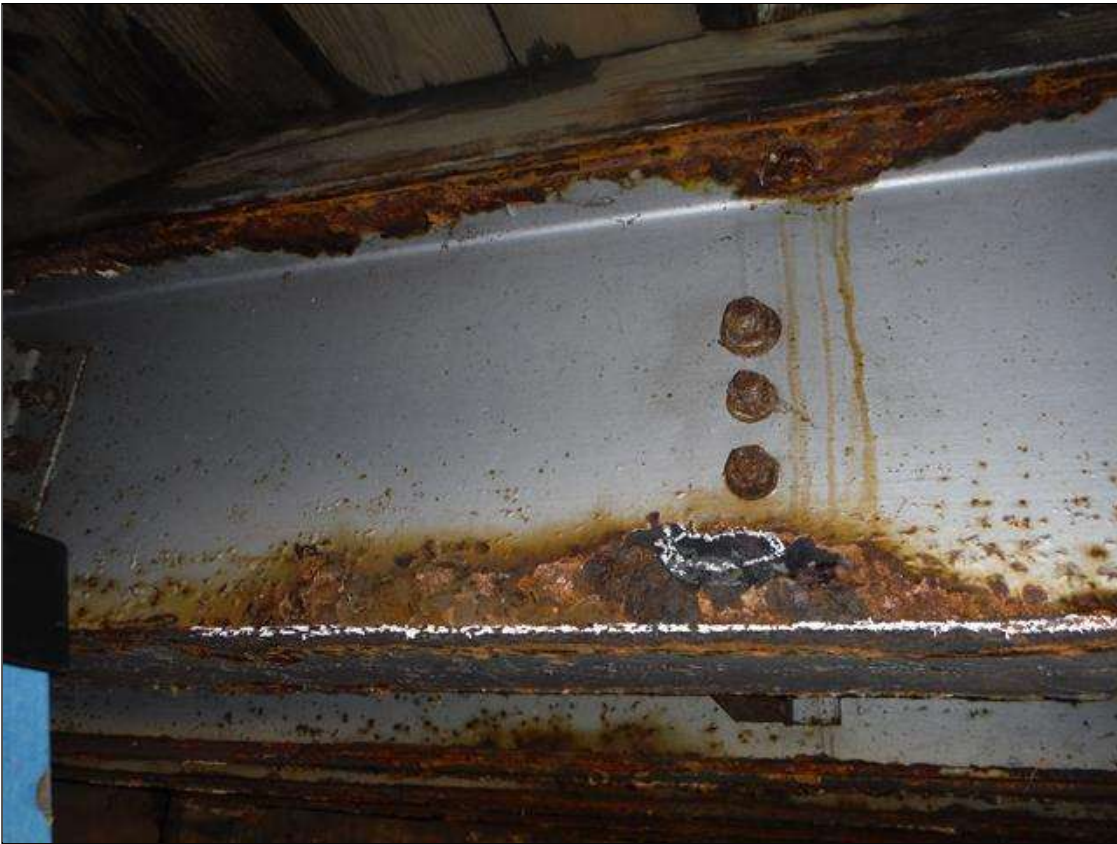
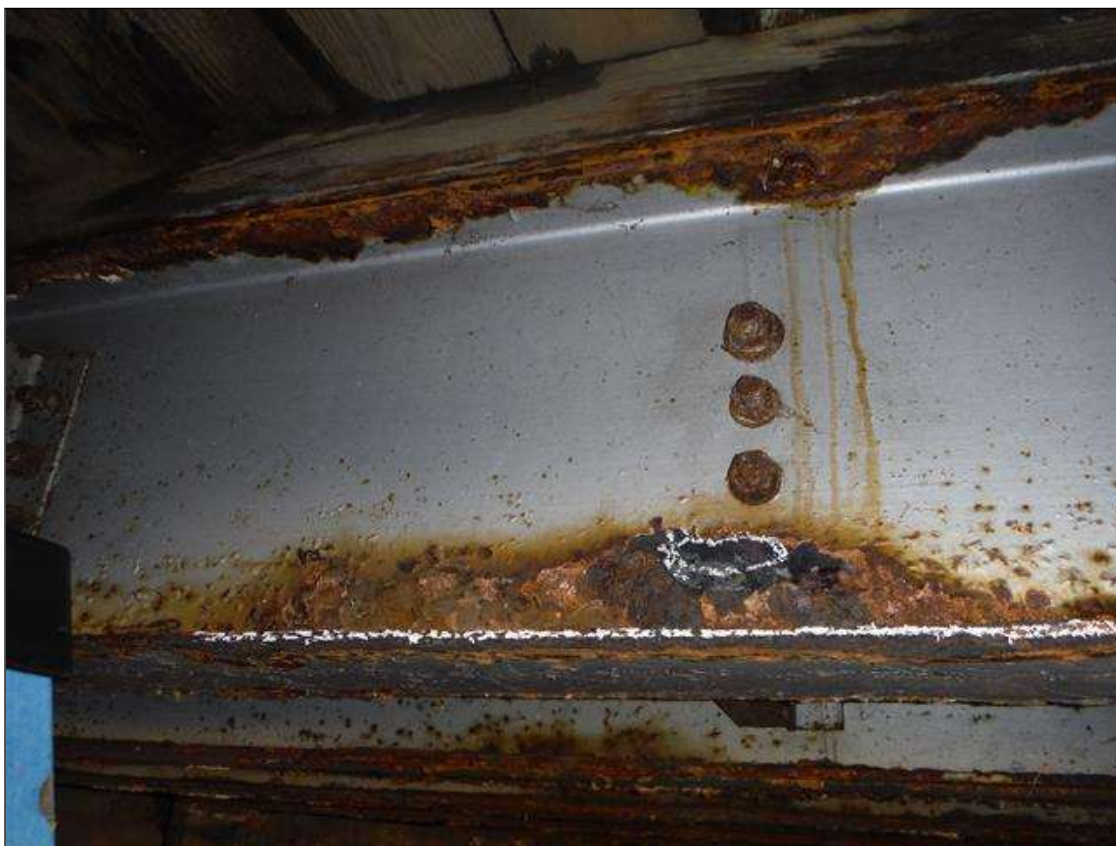
Span 1 Beam 3: 13 Feet of Corrosion: Section loss is evident or pack rust is present but does not warrant structural review. CORROSION WITH 5/16" OF SECTION LOSS IN BOTTOM FLANGE, 1/16" OF SECTION LOSS IN TOP FLANGE AND 1/8" OF SECTION LOSS IN WEB FROM END BENT 1 TO MIDSPAN

SPAN 1 BEAM 3: SECTION LOSS

| MMS Code | Description of Function | Unit | Quantity | Remarks | Est. Cost |
|---|---|---|---|---|---|
| 3314 | Maintain Steel Superstructure Components | LF | 13 | Span 1 Beam 3: 13 Feet of Corrosion: Section loss is evident or pack rust is present but does not warrant structural review. CORROSION WITH 5/16" OF SECTION LOSS IN BOTTOM FLANGE, 1/16" OF SECTION LOSS IN TOP FLANGE AND 1/8" OF SECTION LOSS IN WEB FROM END BENT 1 TO MIDSPAN | |

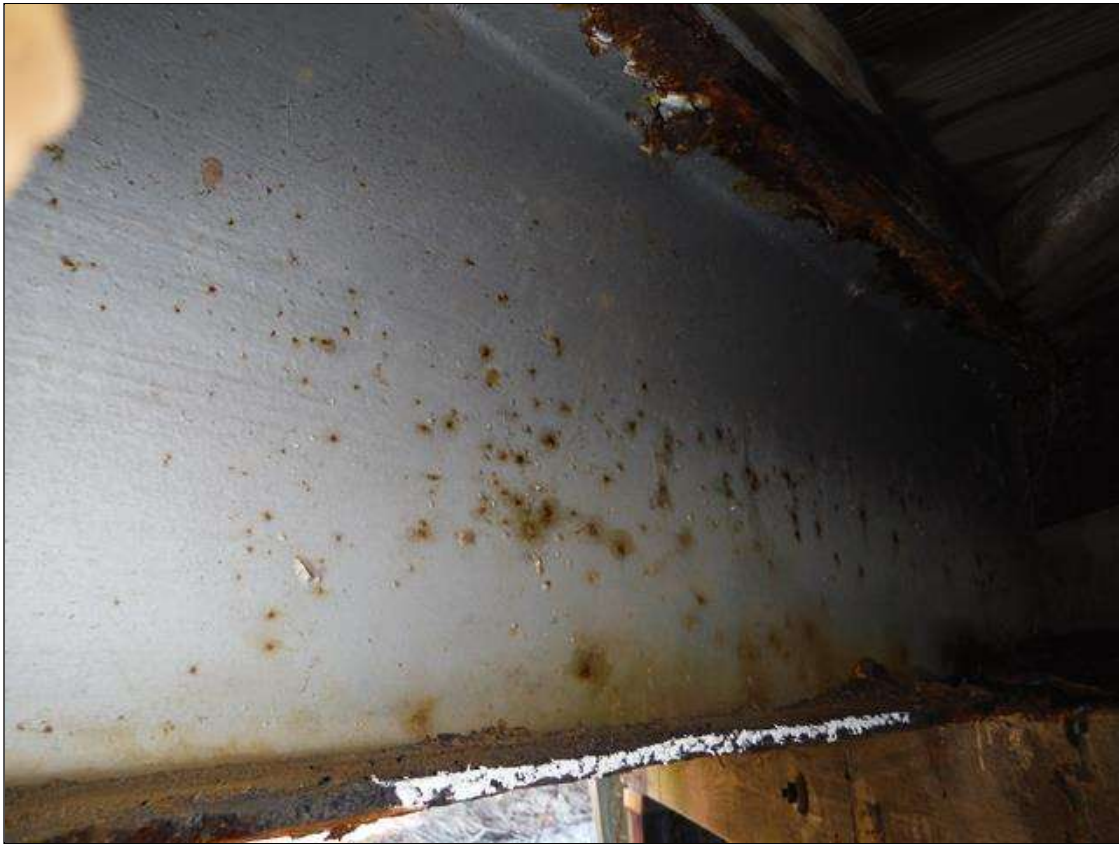
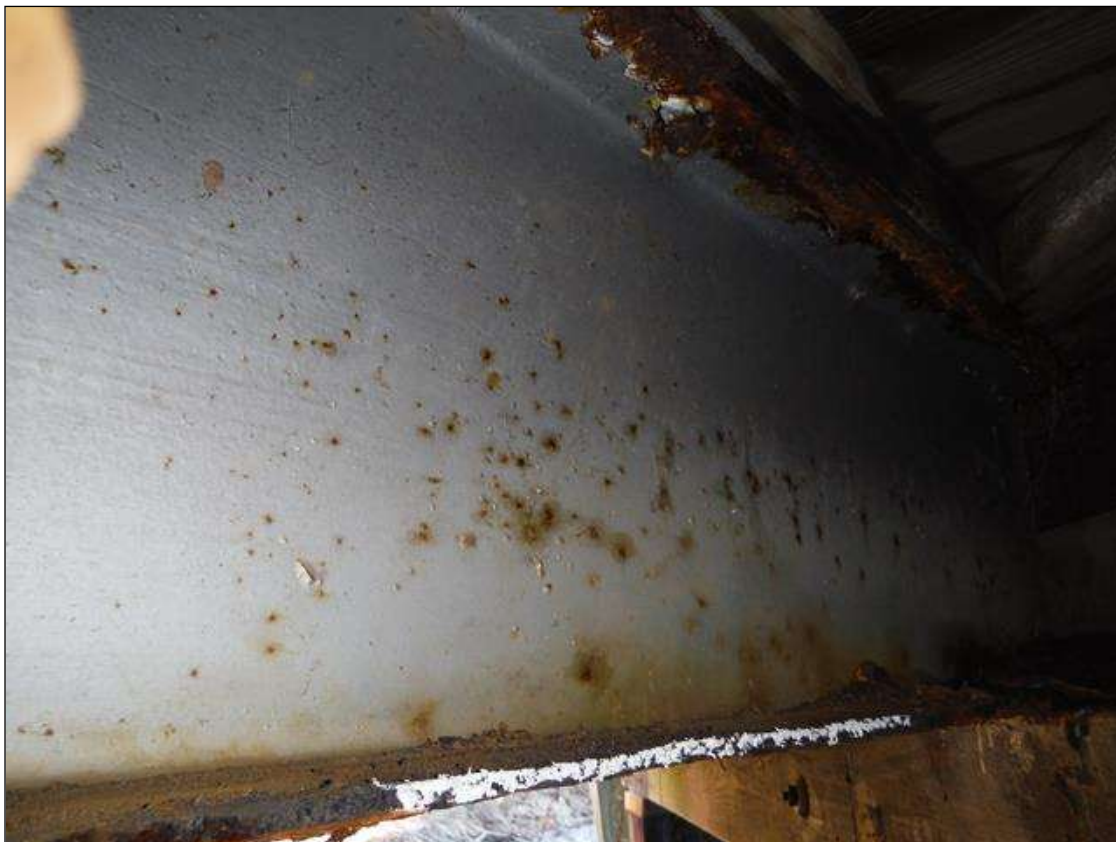
Span 1 Beam 3: 4 Feet of Corrosion: Section loss is evident or pack rust is present but does not warrant structural review. CORROSION WITH 3/16" OF SECTION LOSS IN BOTTOM FLANGE AND 1/16" OF SECTION LOSS IN TOP FLANGE AT END BENT 2

SPAN 1 BEAM 3: SECTION LOSS

| MMS Code | Description of Function | Unit | Quantity | Remarks | Est. Cost |
|---|---|---|---|---|---|
| 3314 | Maintain Steel Superstructure Components | LF | 4 | Span 1 Beam 3: 4 Feet of Corrosion: Section loss is evident or pack rust is present but does not warrant structural review. CORROSION WITH 3/16" OF SECTION LOSS IN BOTTOM FLANGE AND 1/16" OF SECTION LOSS IN TOP FLANGE AT END BENT 2 | |

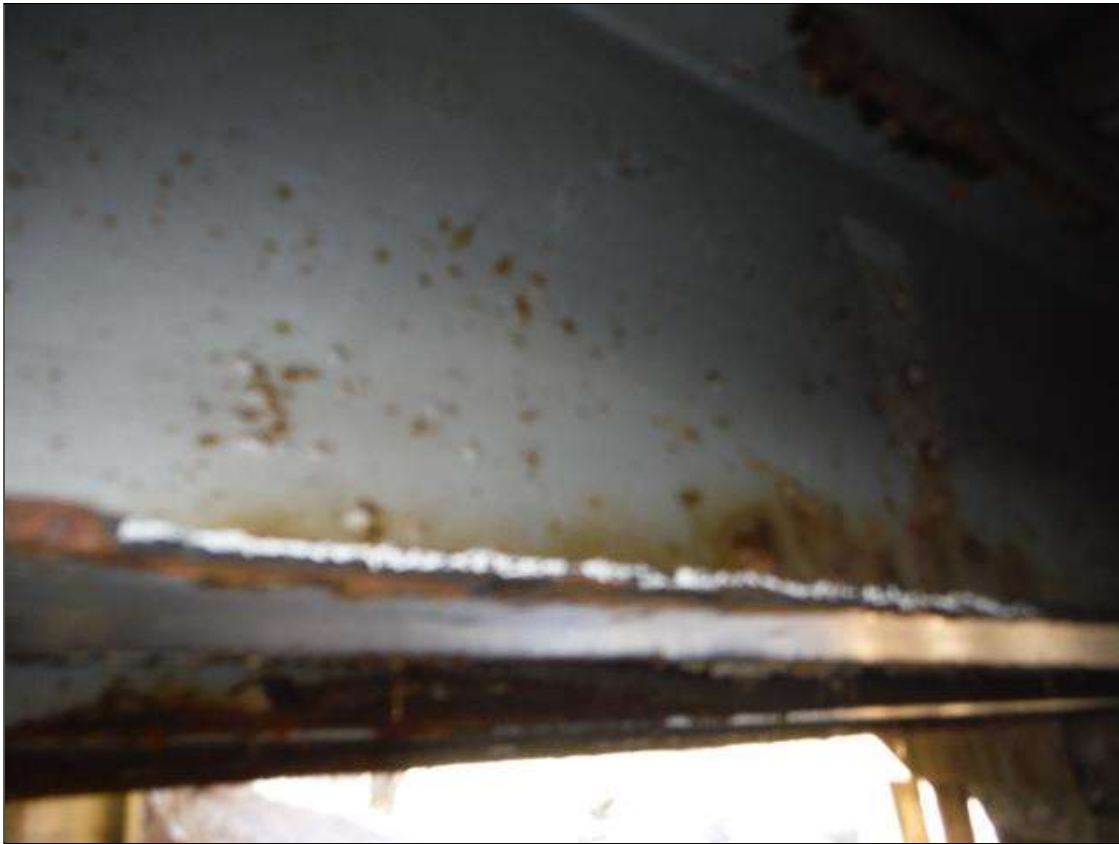
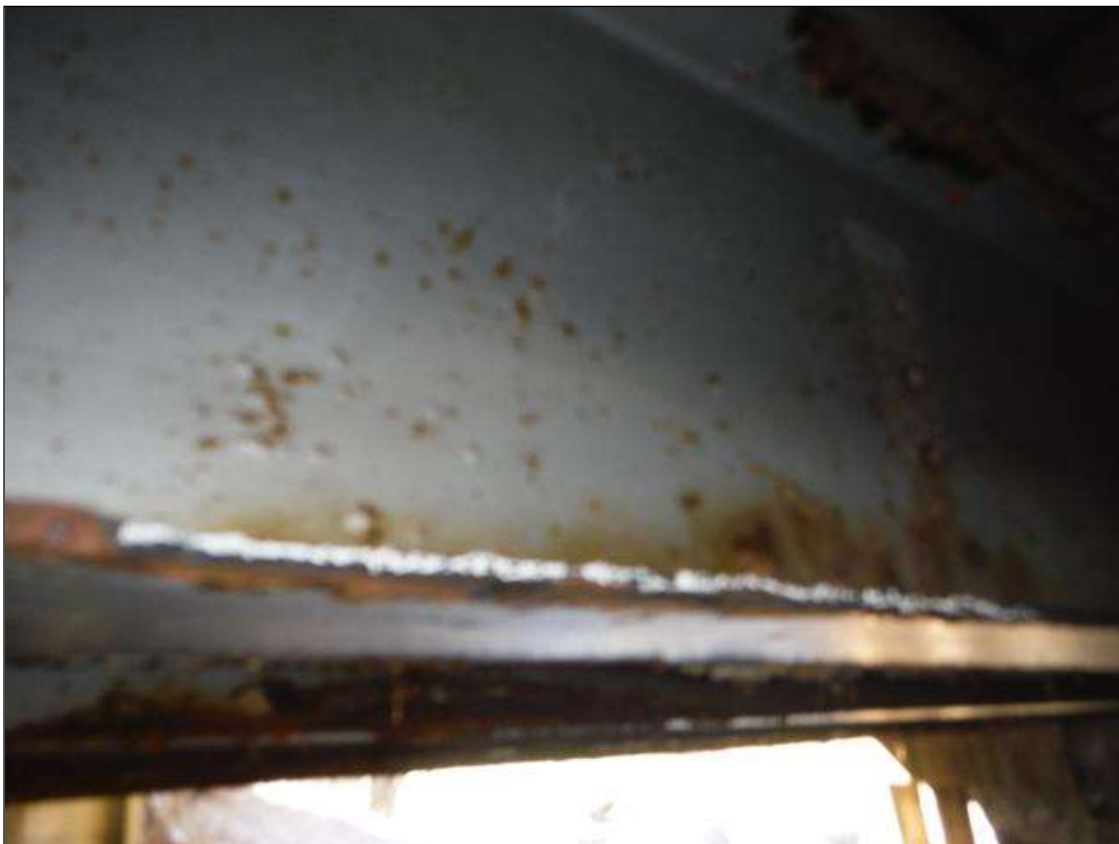
Span 1 Beam 4: 9 Feet of Corrosion: Section loss is evident or pack rust is present but does not warrant structural review. CORROSION WITH 1/4" OF SECTION LOSS IN BOTTOM FLANGE AT END BENT 1

SPAN 1 BEAM 4: SECTION LOSS

| MMS Code | Description of Function | Unit | Quantity | Remarks | Est. Cost |
|---|---|---|---|---|---|
| 3314 | Maintain Steel Superstructure Components | LF | 9 | Span 1 Beam 4: 9 Feet of Corrosion: Section loss is evident or pack rust is present but does not warrant structural review. CORROSION WITH 1/4" OF SECTION LOSS IN BOTTOM FLANGE AT END BENT 1 | |

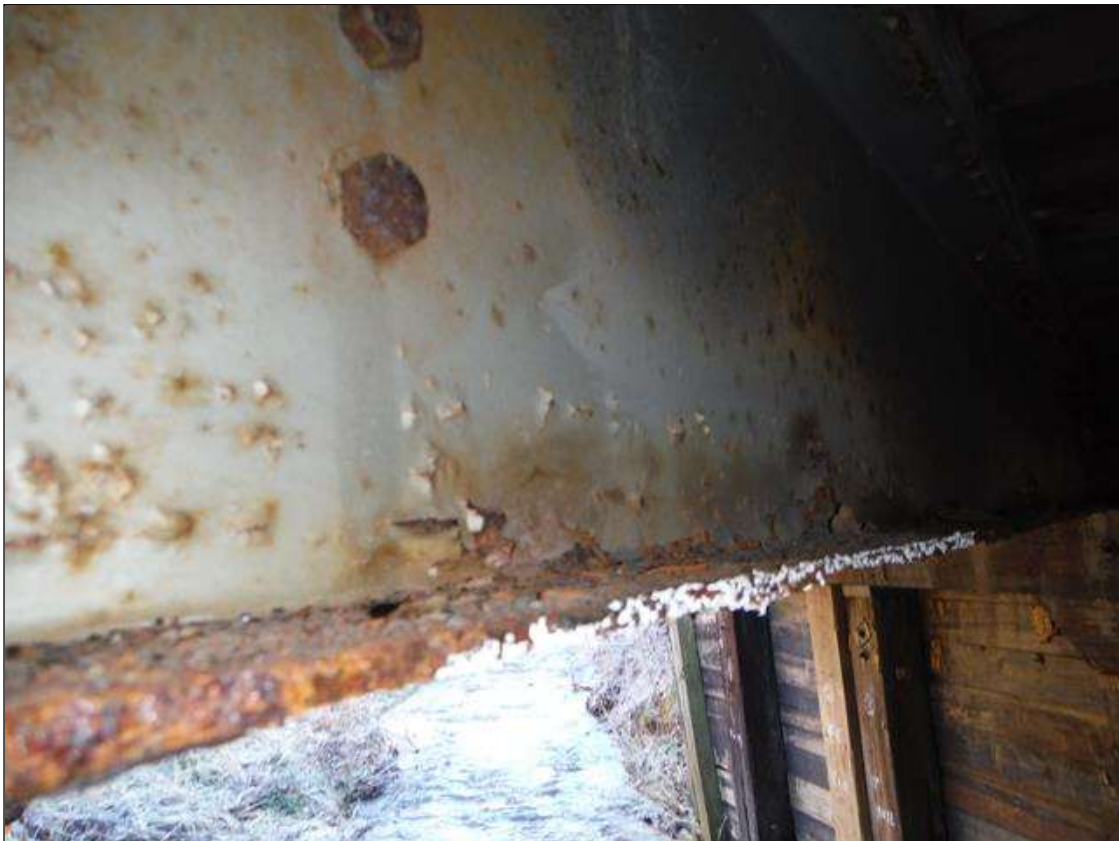
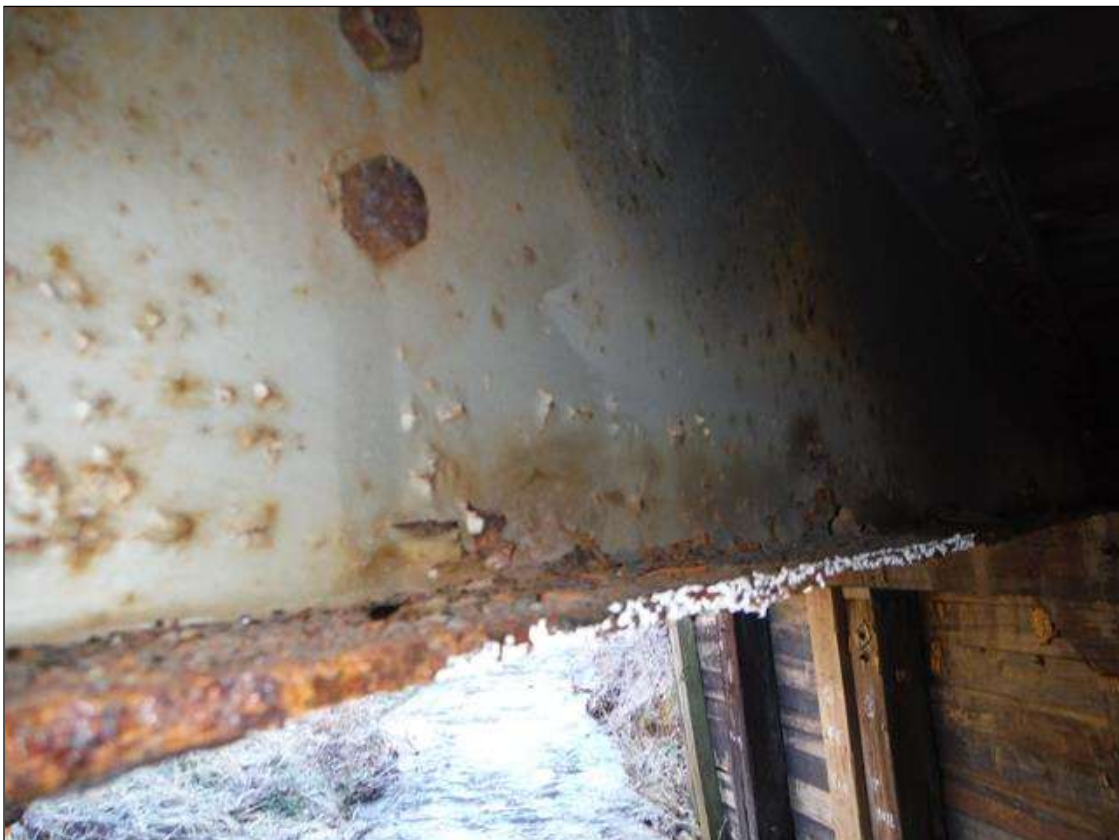
Span 1 Beam 4: 13 Feet of Corrosion: Section loss is evident or pack rust is present but does not warrant structural review. CORROSION WITH 1/8" OF SECTION LOSS IN BOTTOM FLANGE FROM MIDSPAN TO END BENT 2

SPAN 1 BEAM 4: SECTION LOSS

| MMS Code | Description of Function | Unit | Quantity | Remarks | Est. Cost |
|---|---|---|---|---|---|
| 3314 | Maintain Steel Superstructure Components | LF | 13 | Span 1 Beam 4: 13 Feet of Corrosion: Section loss is evident or pack rust is present but does not warrant structural review. CORROSION WITH 1/8" OF SECTION LOSS IN BOTTOM FLANGE FROM MIDSPAN TO END BENT 2 | |

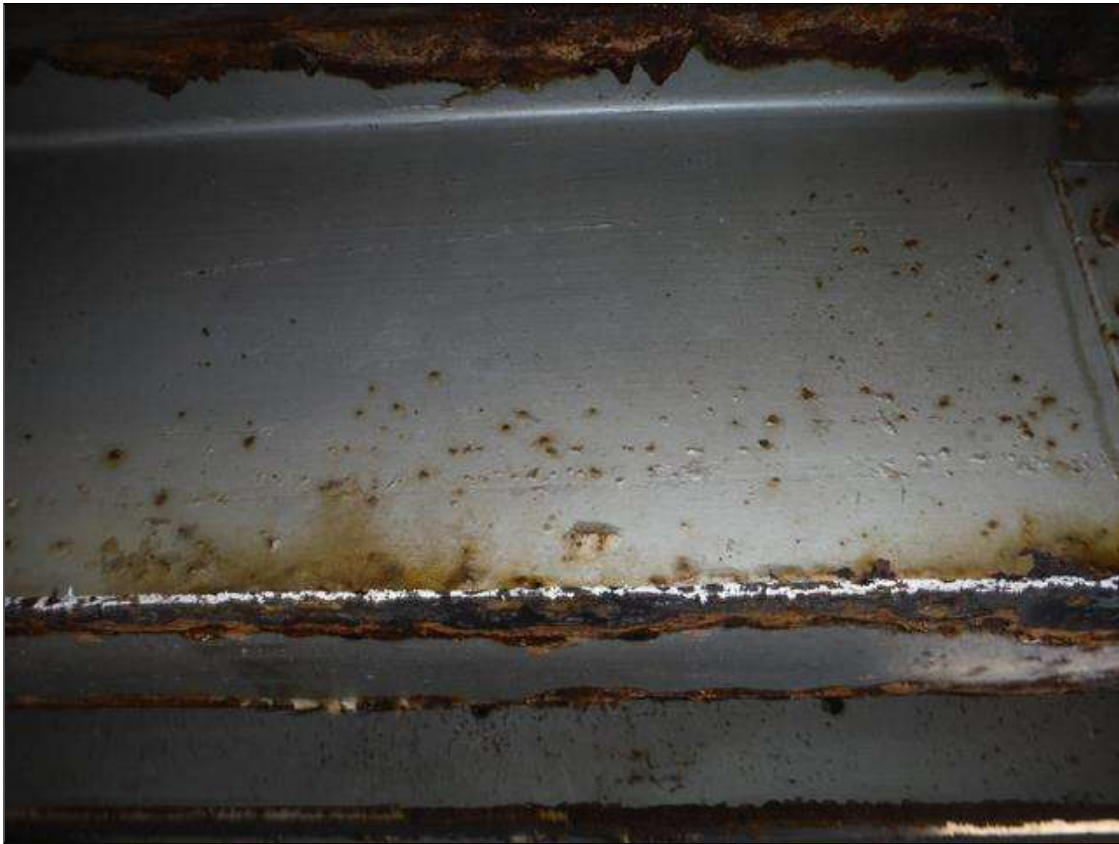
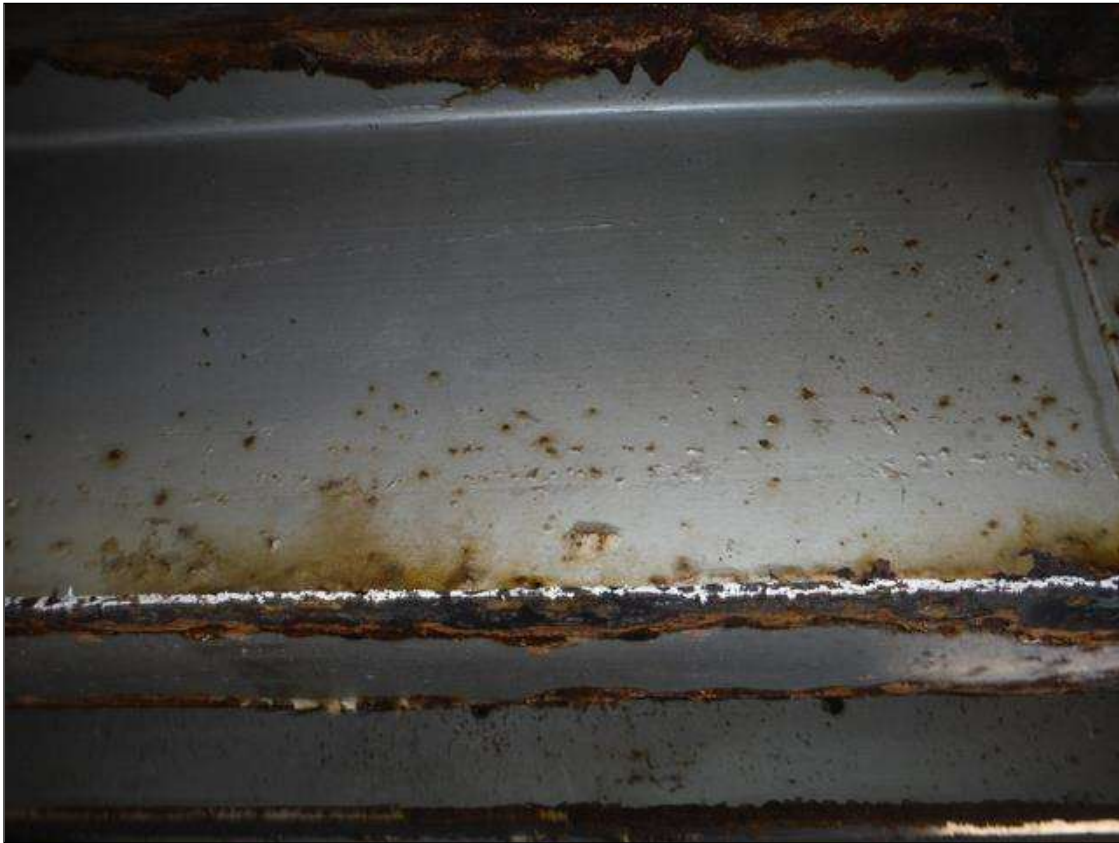
Span 1 Beam 5: 26 Feet of Corrosion: Section loss is evident or pack rust is present but does not warrant structural review. CORROSION WITH 5/16" OF SECTION LOSS IN BOTTOM FLANGE AND 1/8" OF SECTION LOSS IN TOP FLANGE

SPAN 1 BEAM 5: SECTION LOSS

| MMS Code | Description of Function | Unit | Quantity | Remarks | Est. Cost |
|---|---|---|---|---|---|
| 3314 | Maintain Steel Superstructure Components | LF | 26 | Span 1 Beam 5: 26 Feet of Corrosion: Section loss is evident or pack rust is present but does not warrant structural review. CORROSION WITH 5/16" OF SECTION LOSS IN BOTTOM FLANGE AND 1/8" OF SECTION LOSS IN TOP FLANGE | |

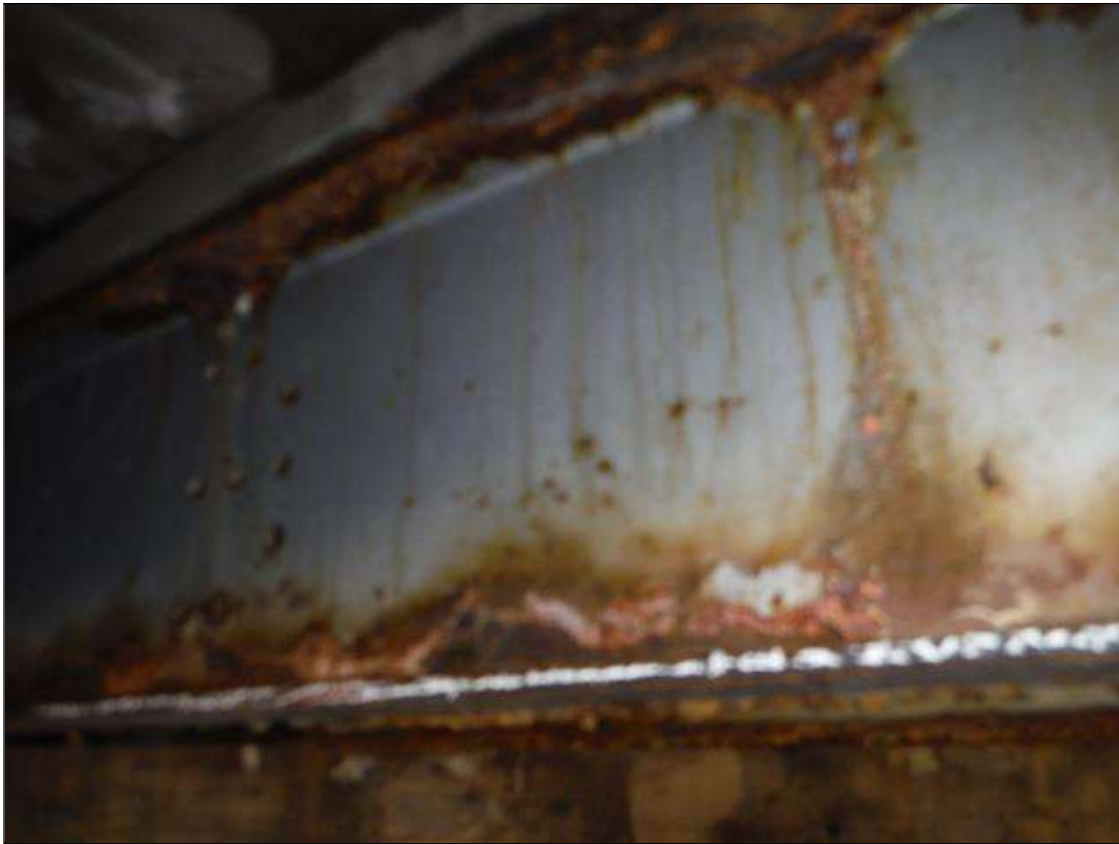
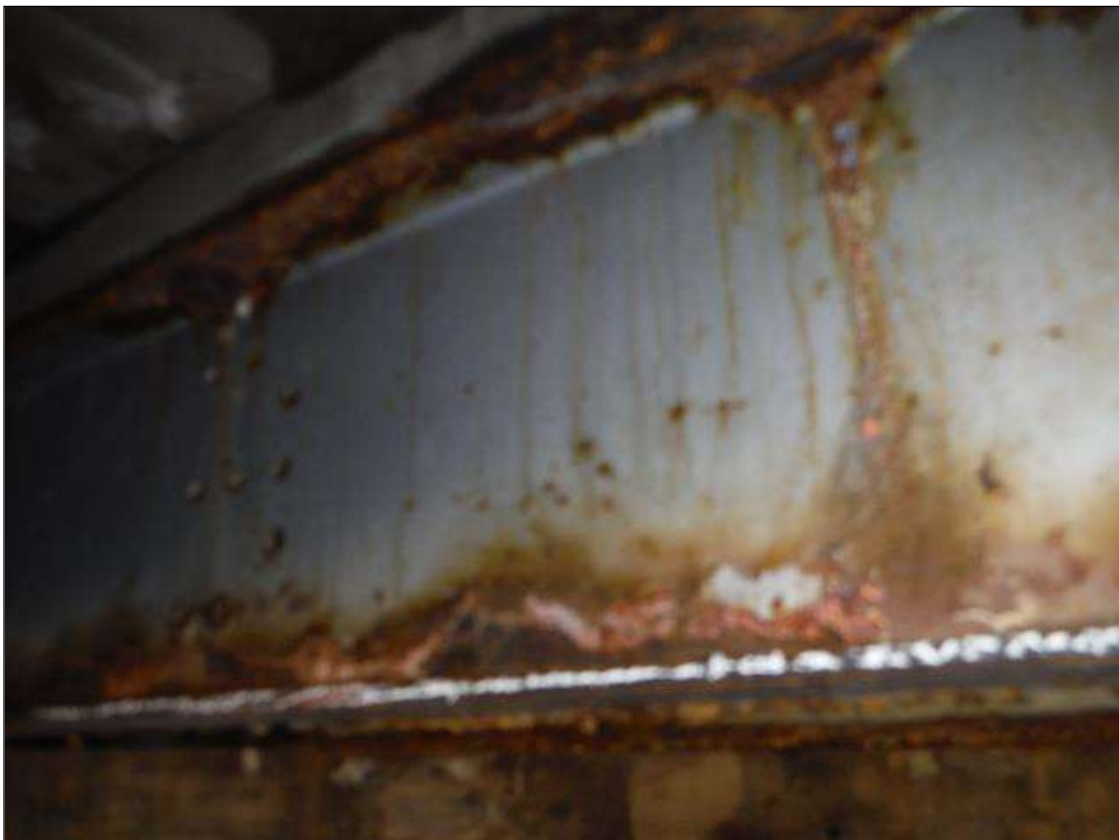
Span 1 Beam 6: 26 Feet of Corrosion: Section loss is evident or pack rust is present but does not warrant structural review. CORROSION WITH 5/16" OF SECTION LOSS IN BOTTOM FLANGE, 1/8" OF SECTION LOSS IN TOP FLANGE AND 1/16" OF SECTION LOSS IN WEB

SPAN 1 BEAM 6: SECTION LOSS

| MMS Code | Description of Function | Unit | Quantity | Remarks | Est. Cost |
|---|---|---|---|---|---|
| 3314 | Maintain Steel Superstructure Components | LF | 26 | Span 1 Beam 6: 26 Feet of Corrosion: Section loss is evident or pack rust is present but does not warrant structural review. CORROSION WITH 5/16" OF SECTION LOSS IN BOTTOM FLANGE, 1/8" OF SECTION LOSS IN TOP FLANGE AND 1/16" OF SECTION LOSS IN WEB | |

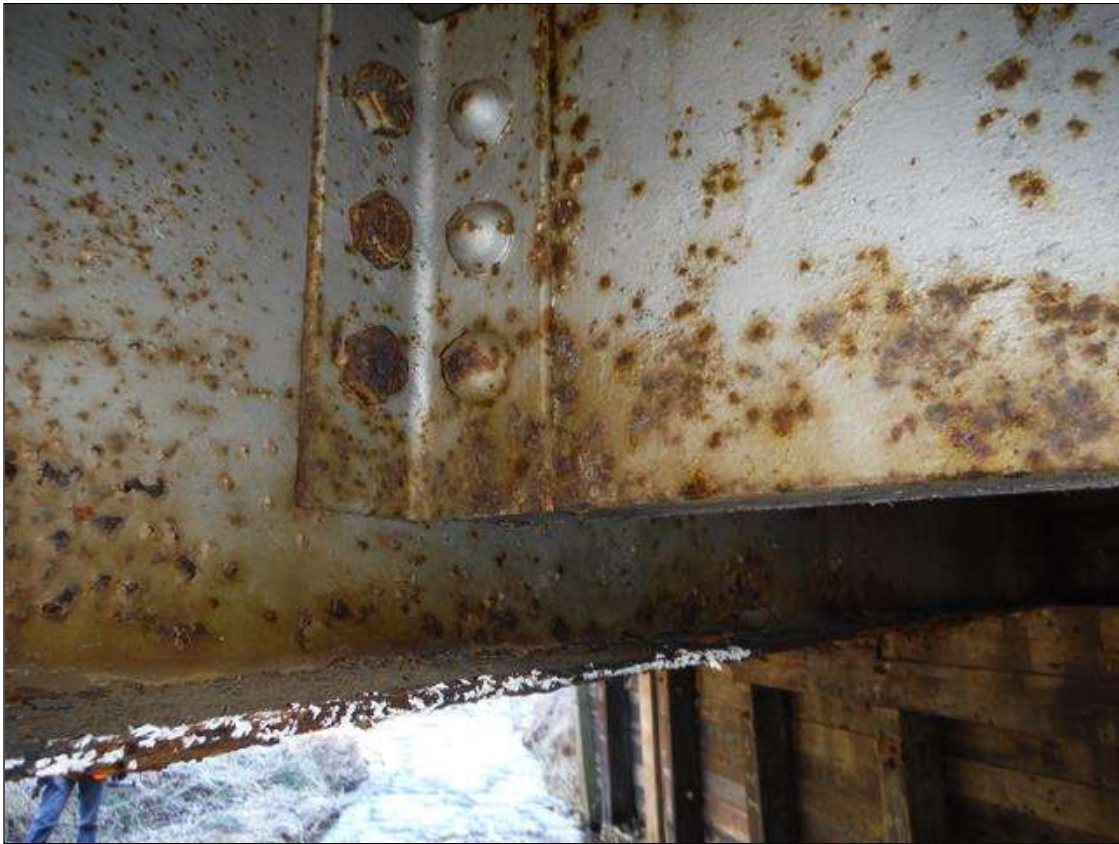
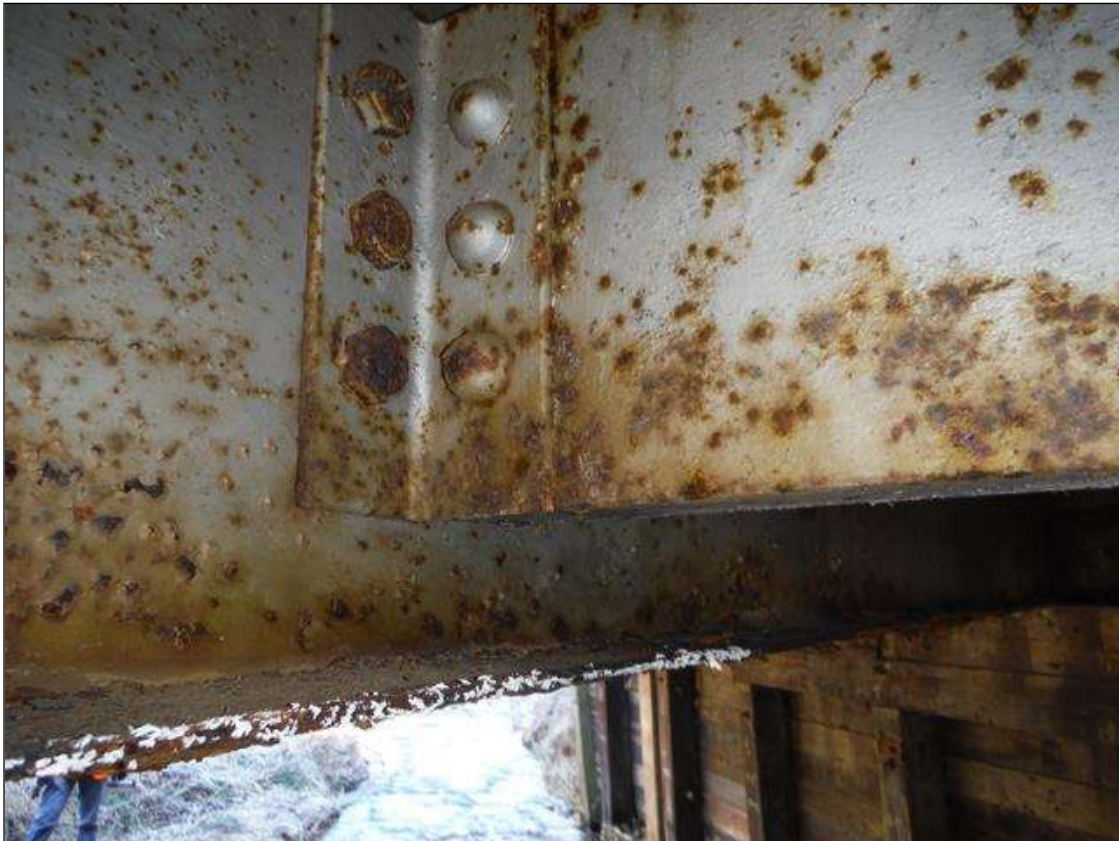
Span 1 Beam 7: 26 Feet of Corrosion: Section loss is evident or pack rust is present but does not warrant structural review. CORROSION WITH 5/16" OF SECTION LOSS IN BOTTOM FLANGE AND 1/8" OF SECTION LOSS IN TOP FLANGE

SPAN 1 BEAM 7: SECTION LOSS

| MMS Code | Description of Function | Unit | Quantity | Remarks | Est. Cost |
|---|---|---|---|---|---|
| 3314 | Maintain Steel Superstructure Components | LF | 26 | Span 1 Beam 7: 26 Feet of Corrosion: Section loss is evident or pack rust is present but does not warrant structural review. CORROSION WITH 5/16" OF SECTION LOSS IN BOTTOM FLANGE AND 1/8" OF SECTION LOSS IN TOP FLANGE | |

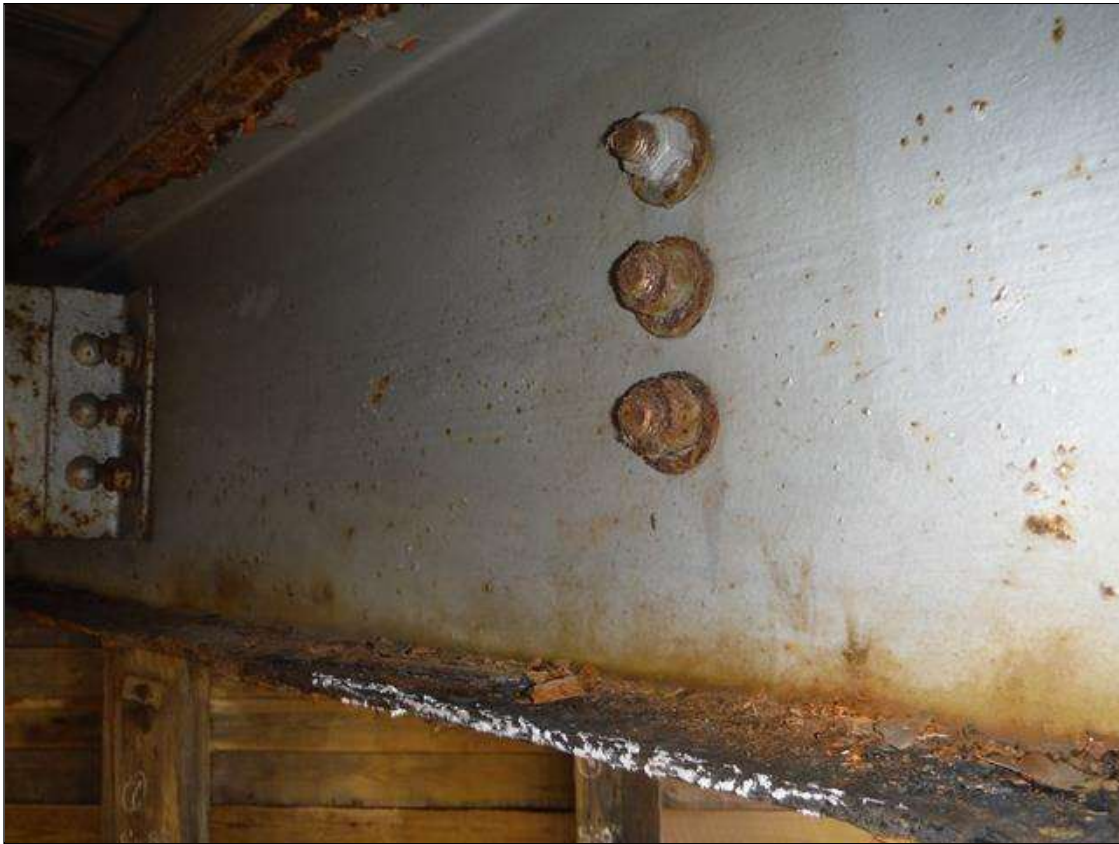
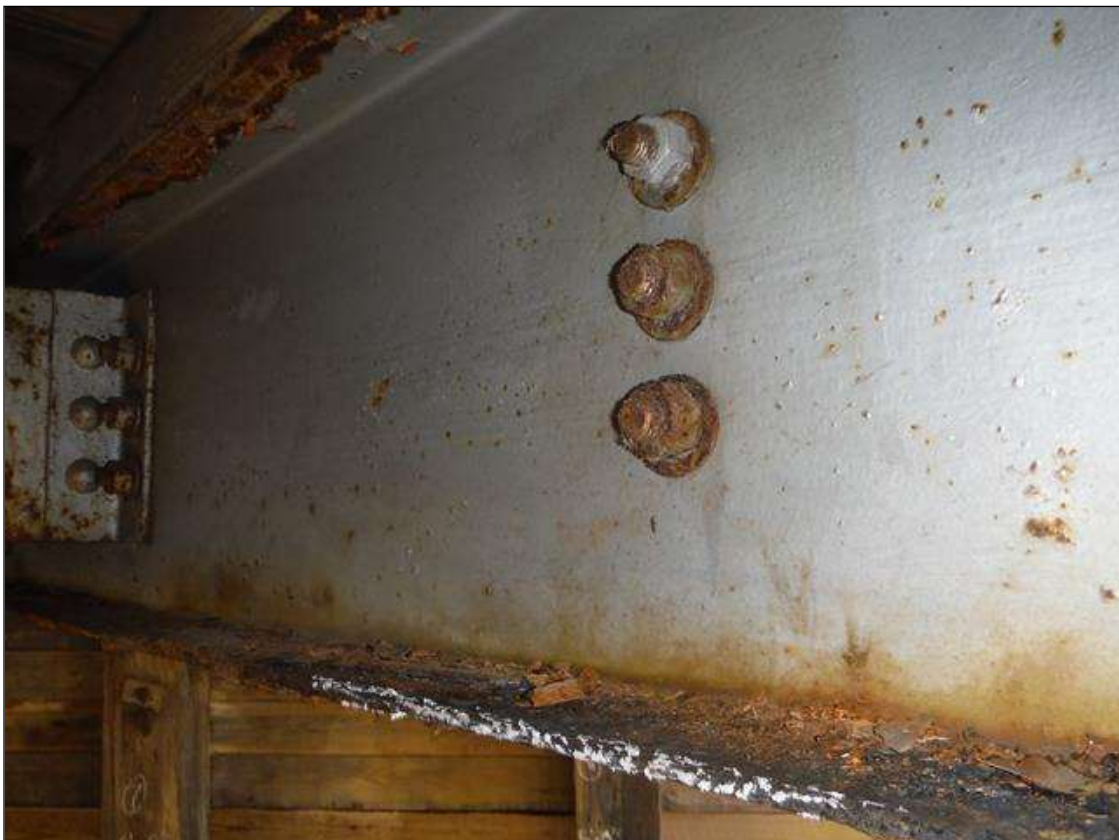
Span 1 Beam 8: 26 Feet of Corrosion: Section loss is evident or pack rust is present but does not warrant structural review. CORROSION WITH 3/16" OF SECTION LOSS IN BOTTOM FLANGE AND 1/8" OF SECTION LOSS IN TOP FLANGE

SPAN 1 BEAM 8: SECTION LOSS

| MMS Code | Description of Function | Unit | Quantity | Remarks | Est. Cost |
|---|---|---|---|---|---|
| 3314 | Maintain Steel Superstructure Components | LF | 26 | Span 1 Beam 8: 26 Feet of Corrosion: Section loss is evident or pack rust is present but does not warrant structural review. CORROSION WITH 3/16" OF SECTION LOSS IN BOTTOM FLANGE AND 1/8" OF SECTION LOSS IN TOP FLANGE | |

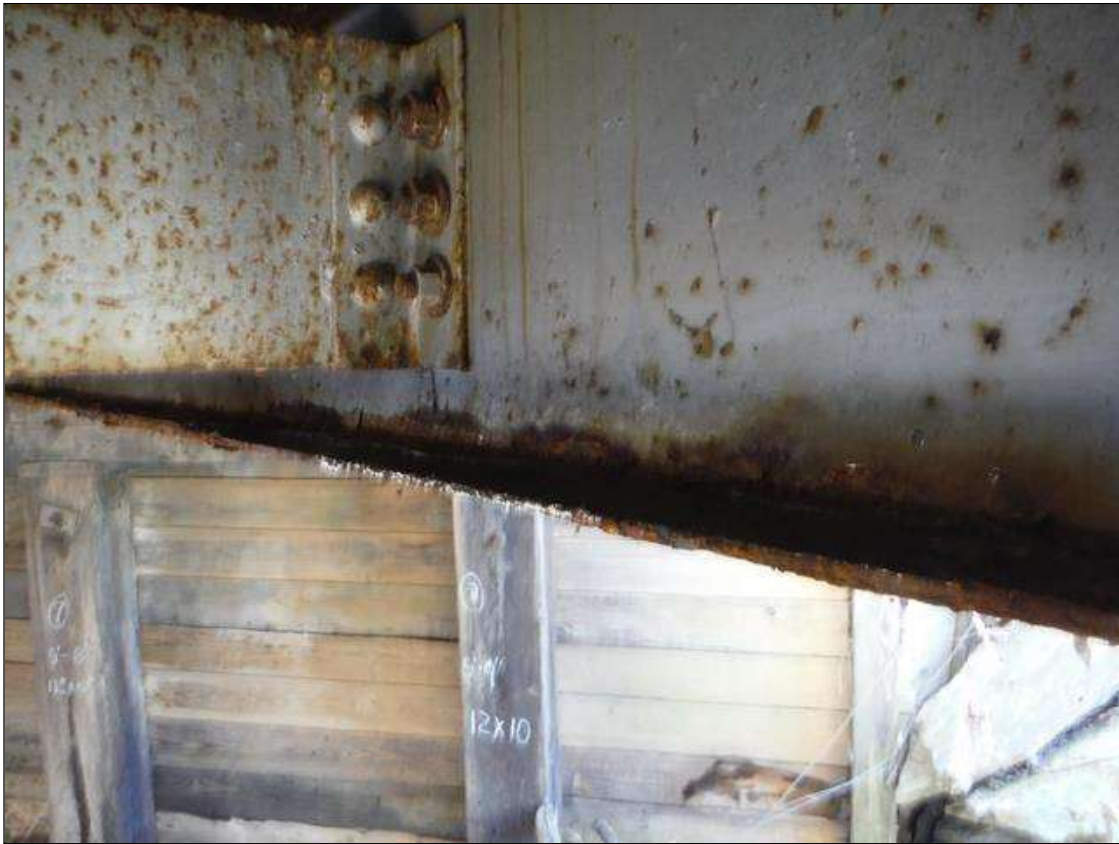
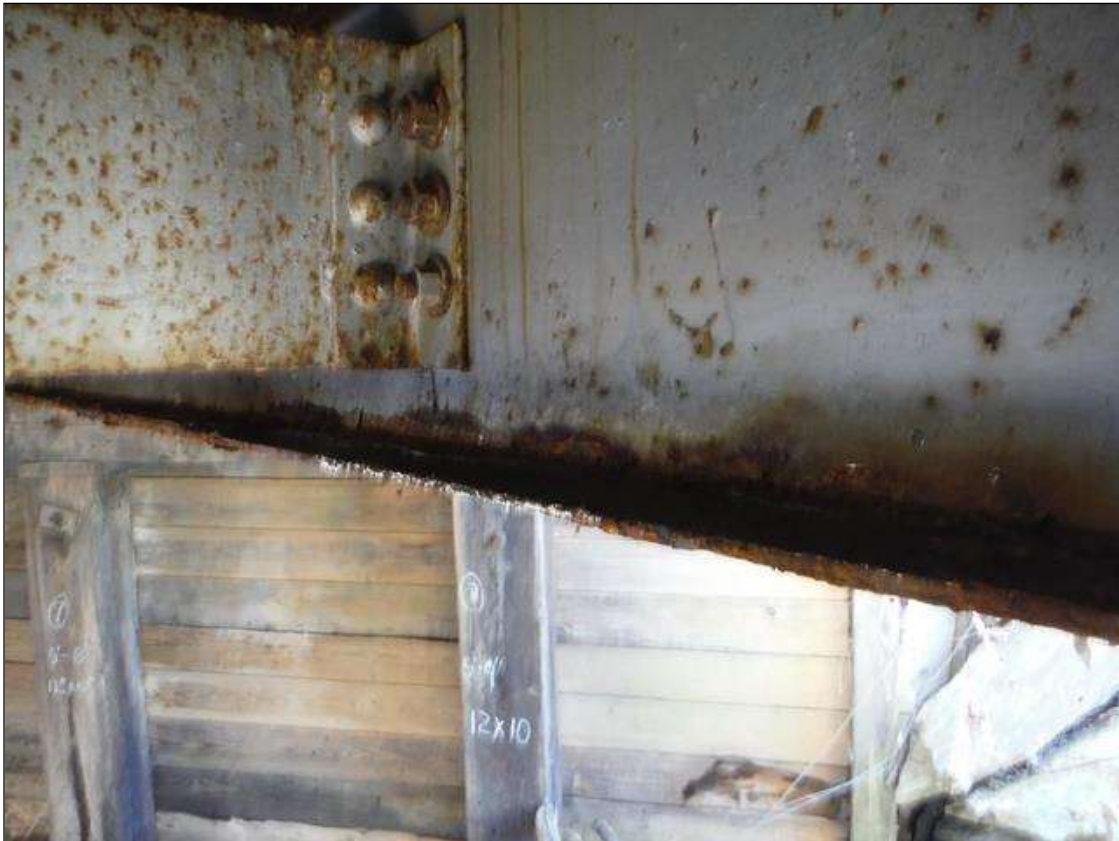
Span 1 Beam 9: 26 Feet of Corrosion: Section loss is evident or pack rust is present but does not warrant structural review. CORROSION WITH 3/16" OF SECTION LOSS IN BOTTOM FLANGE AND 1/8" OF SECTION LOSS IN TOP FLANGE

SPAN 1 BEAM 9: SECTION LOSS

| MMS Code | Description of Function | Unit | Quantity | Remarks | Est. Cost |
|---|---|---|---|---|---|
| 3314 | Maintain Steel Superstructure Components | LF | 26 | Span 1 Beam 9: 26 Feet of Corrosion: Section loss is evident or pack rust is present but does not warrant structural review. CORROSION WITH 3/16" OF SECTION LOSS IN BOTTOM FLANGE AND 1/8" OF SECTION LOSS IN TOP FLANGE | |

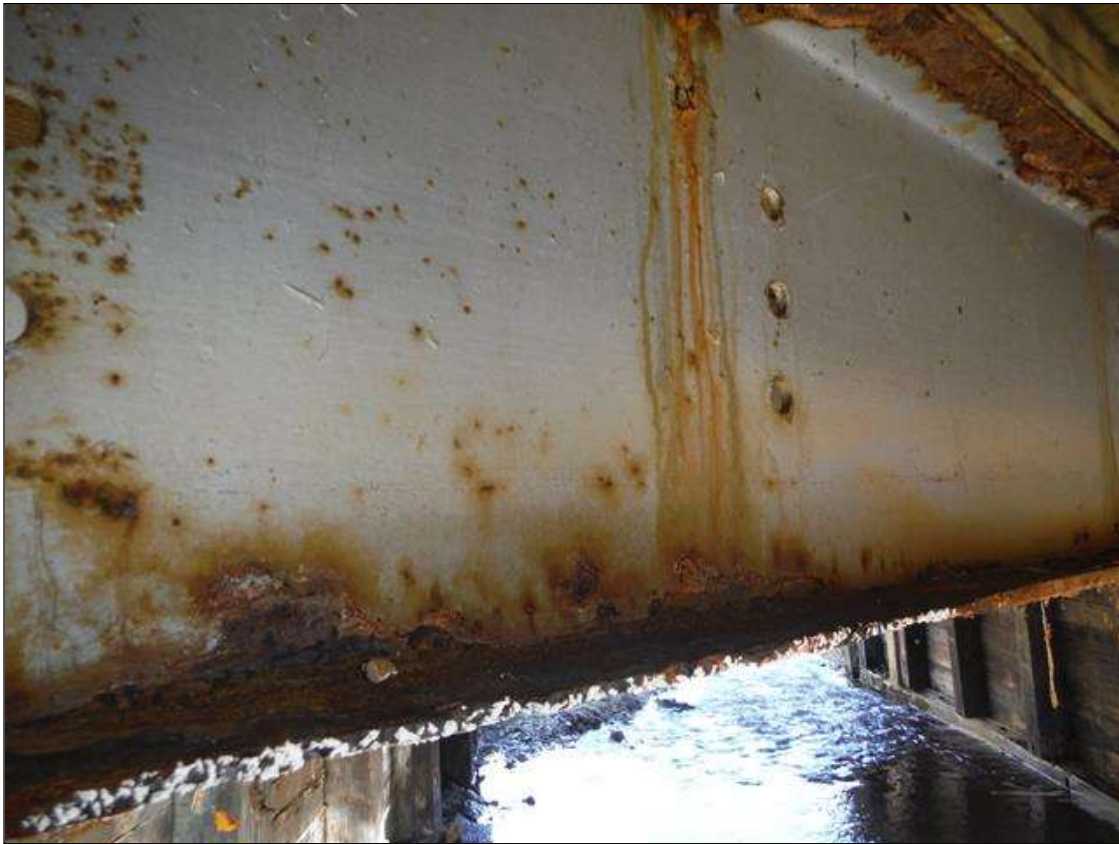
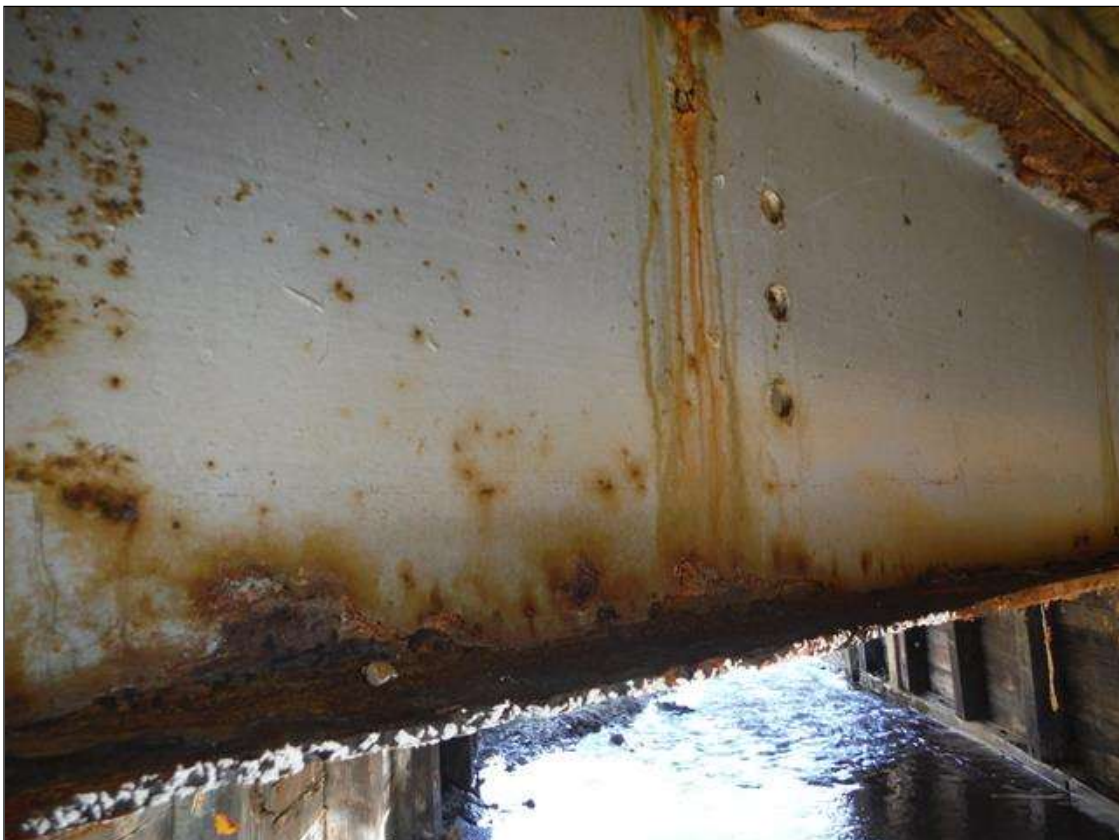
Span 1 Beam 10: 26 Feet of Corrosion: Section loss is evident or pack rust is present but does not warrant structural review. CORROSION WITH 5/16" OF SECTION LOSS IN BOTTOM FLANGE AND 1/8" OF SECTION LOSS IN TOP FLANGE

SPAN 1 BEAM 10: SECTION LOSS

| MMS Code | Description of Function | Unit | Quantity | Remarks | Est. Cost |
|---|---|---|---|---|---|
| 3314 | Maintain Steel Superstructure Components | LF | 26 | Span 1 Beam 10: 26 Feet of Corrosion: Section loss is evident or pack rust is present but does not warrant structural review. CORROSION WITH 5/16" OF SECTION LOSS IN BOTTOM FLANGE AND 1/8" OF SECTION LOSS IN TOP FLANGE | |

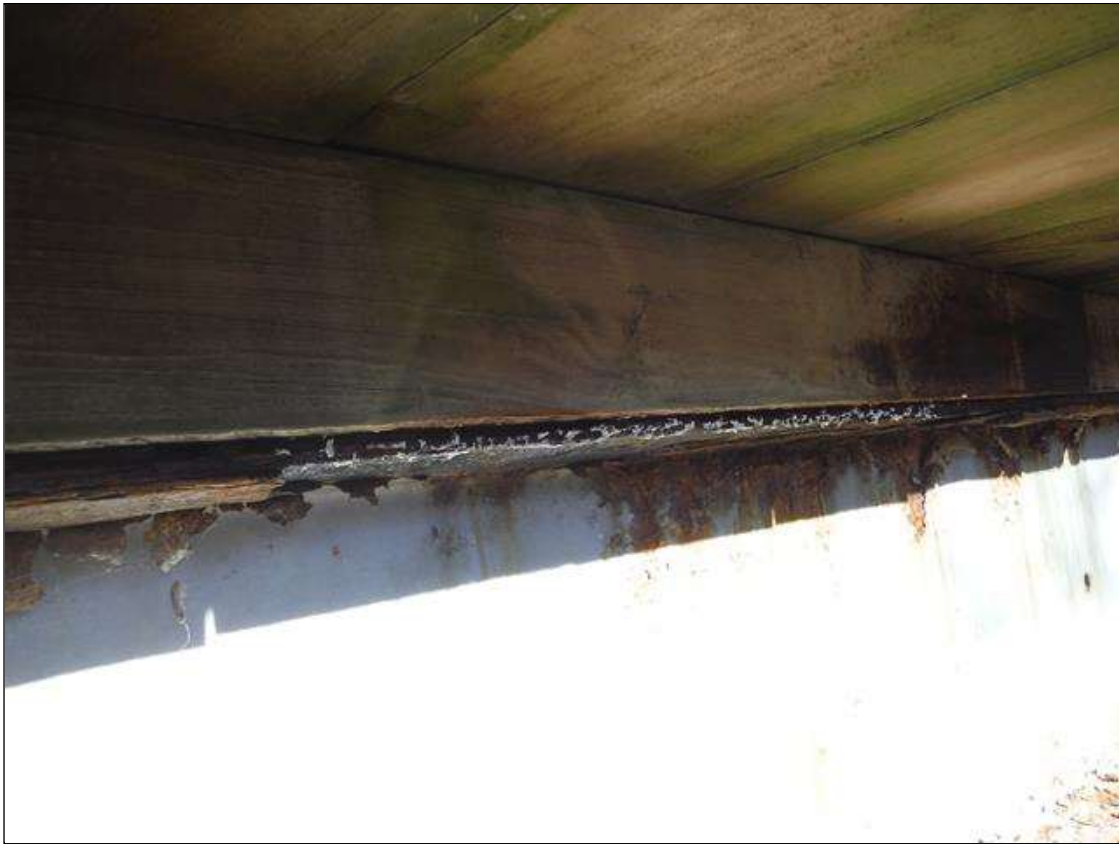
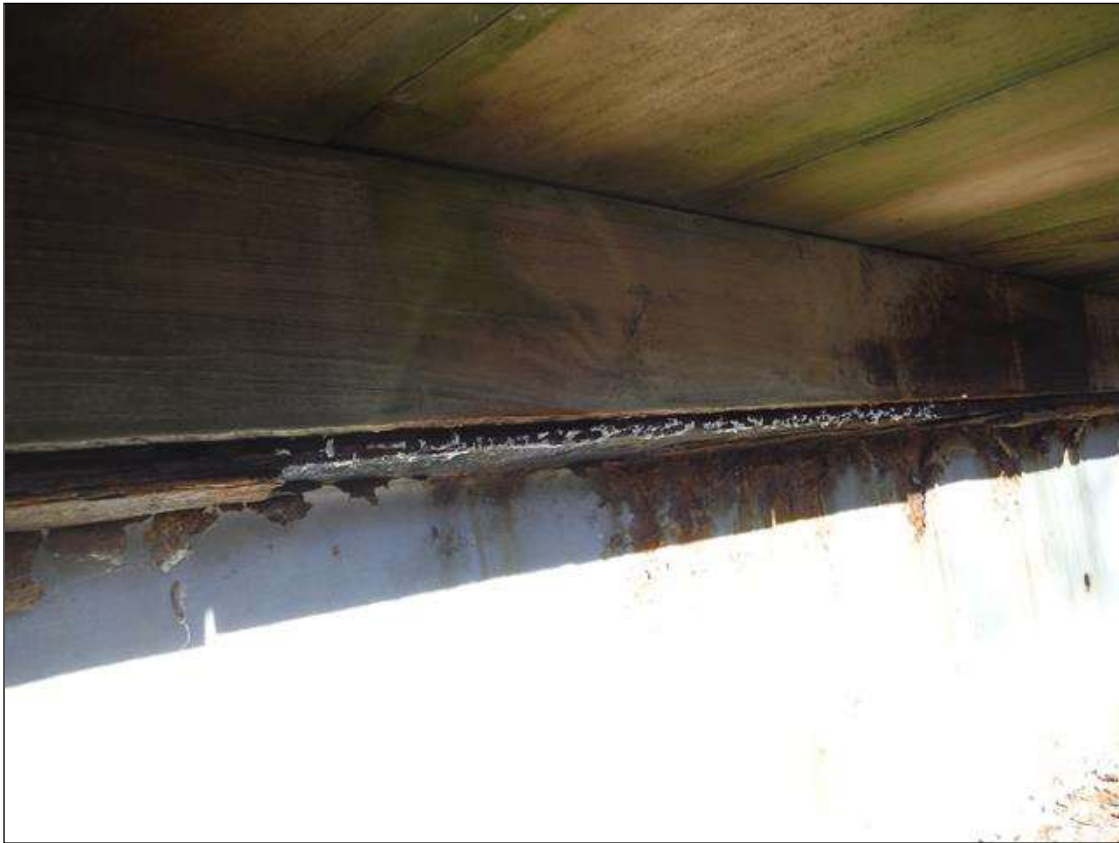
Span 1 Beam 11: 26 Feet of Corrosion: Section loss is evident or pack rust is present but does not warrant structural review. CORROSION WITH 1/16" OF SECTION LOSS IN BOTTOM FLANGE, 3/16" OF SECTION LOSS IN TOP FLANGE AND 1/16" OF SECTION LOSS IN WEB

SPAN 1 BEAM 11: SECTION LOSS

| MMS Code | Description of Function | Unit | Quantity | Remarks | Est. Cost |
|---|---|---|---|---|---|
| 3314 | Maintain Steel Superstructure Components | LF | 26 | Span 1 Beam 11: 26 Feet of Corrosion: Section loss is evident or pack rust is present but does not warrant structural review. CORROSION WITH 1/16" OF SECTION LOSS IN BOTTOM FLANGE, 3/16" OF SECTION LOSS IN TOP FLANGE AND 1/16" OF SECTION LOSS IN WEB | |
