NC DEPARTMENT OF TRANSPORTATION  
DIVISION OF HIGHWAYS  
STRUCTURE MANAGEMENT UNIT

## Structure Safety Report

### Routine Element Inspection

COUNTY: ASHE STRUCTURE NUMBER: 040321 FREQUENCY: 24 MONTHS

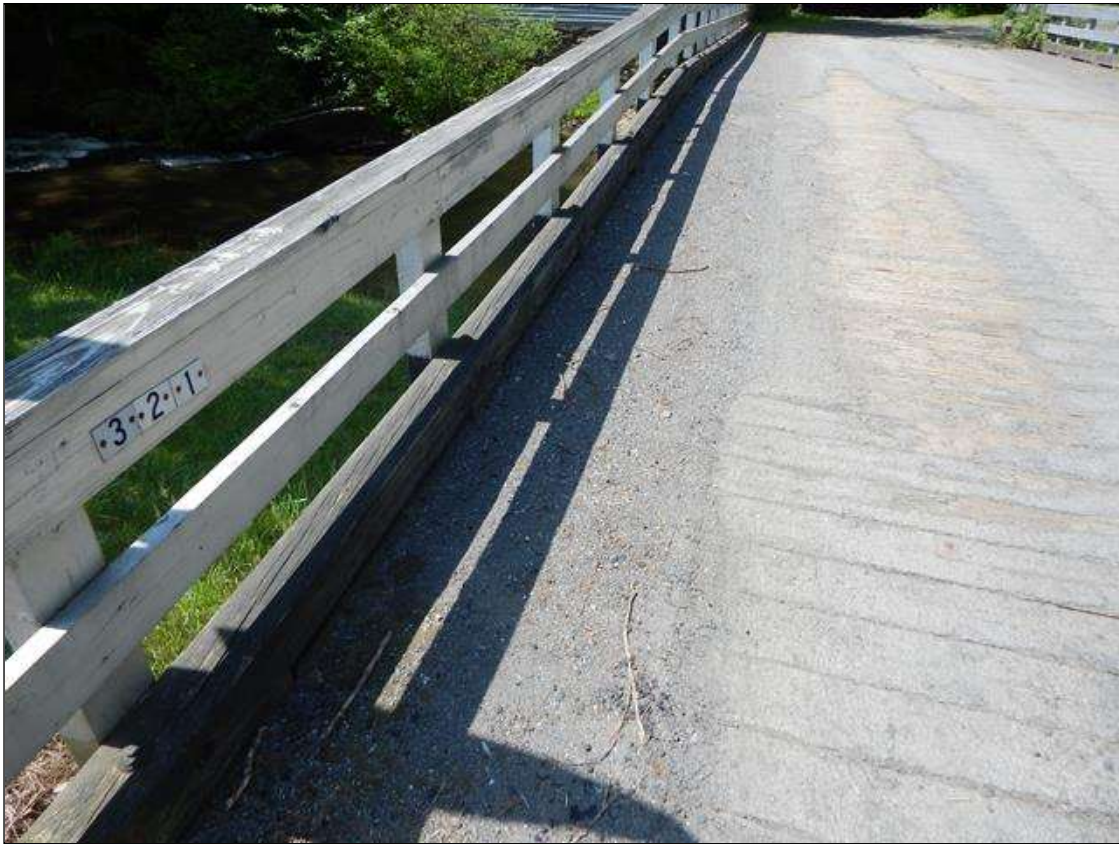
Details (2") UTILITY LEFT SIDE OF RAIL IS BROKEN (+/- 6 LF) ON NORTH END SPAN (1)

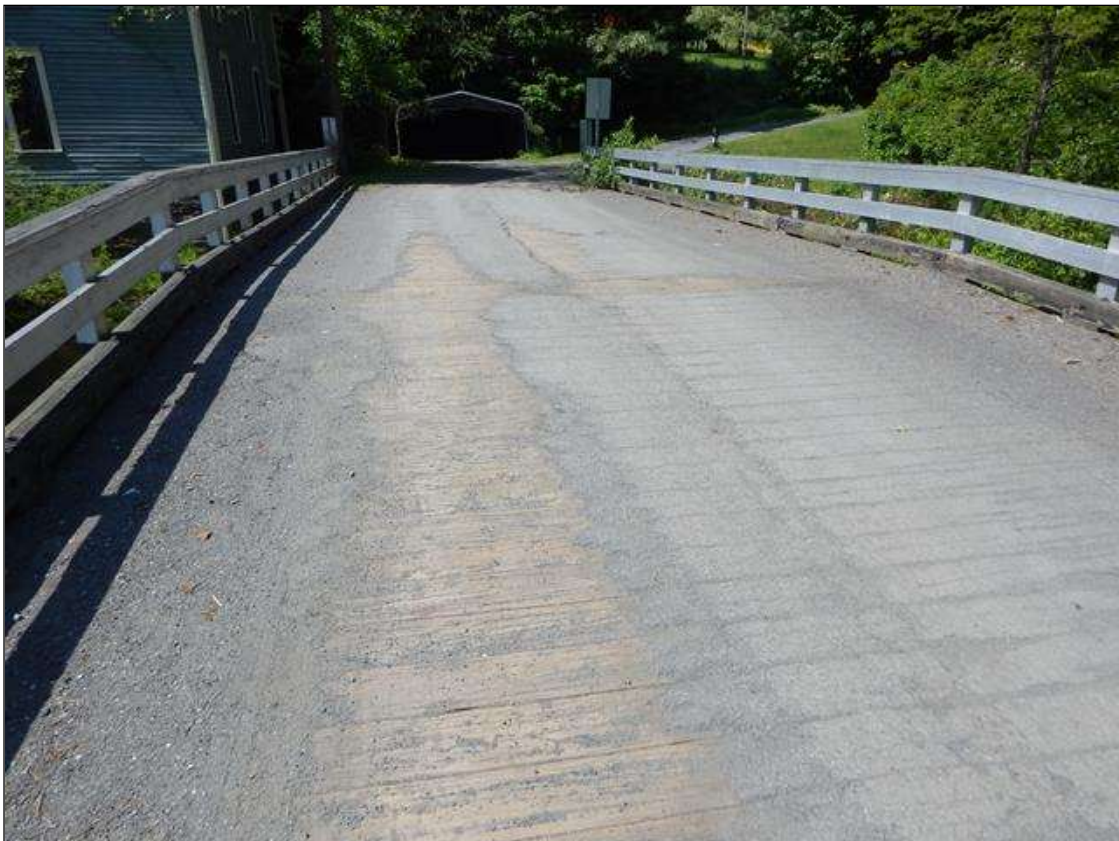
DECK DEBRIS FULL LENGTH ALONG EACH RAIL (+/- 1443 SF)

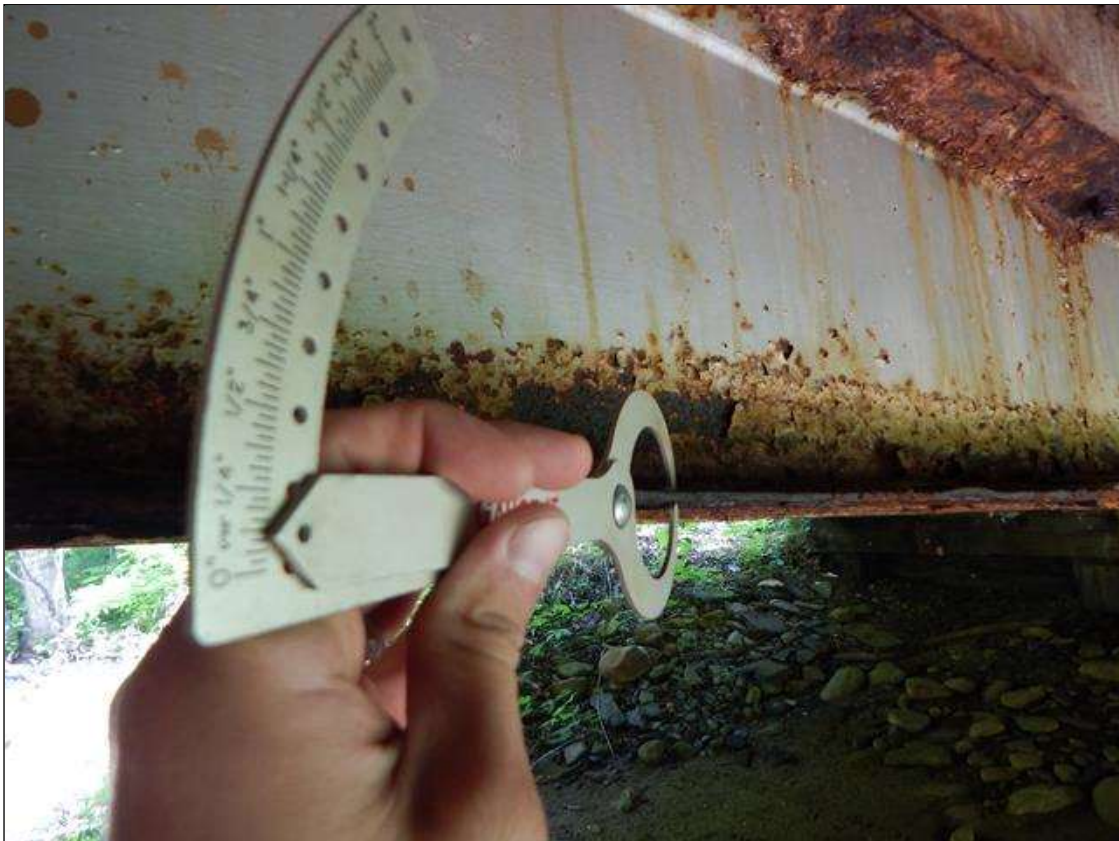
Span 1 Beam 8: CORROSION FULL LENGTH ALONG EDGES OF TOP AND BOTTOM FLANGE WITH NO MEASURABLE SECTION LOSS

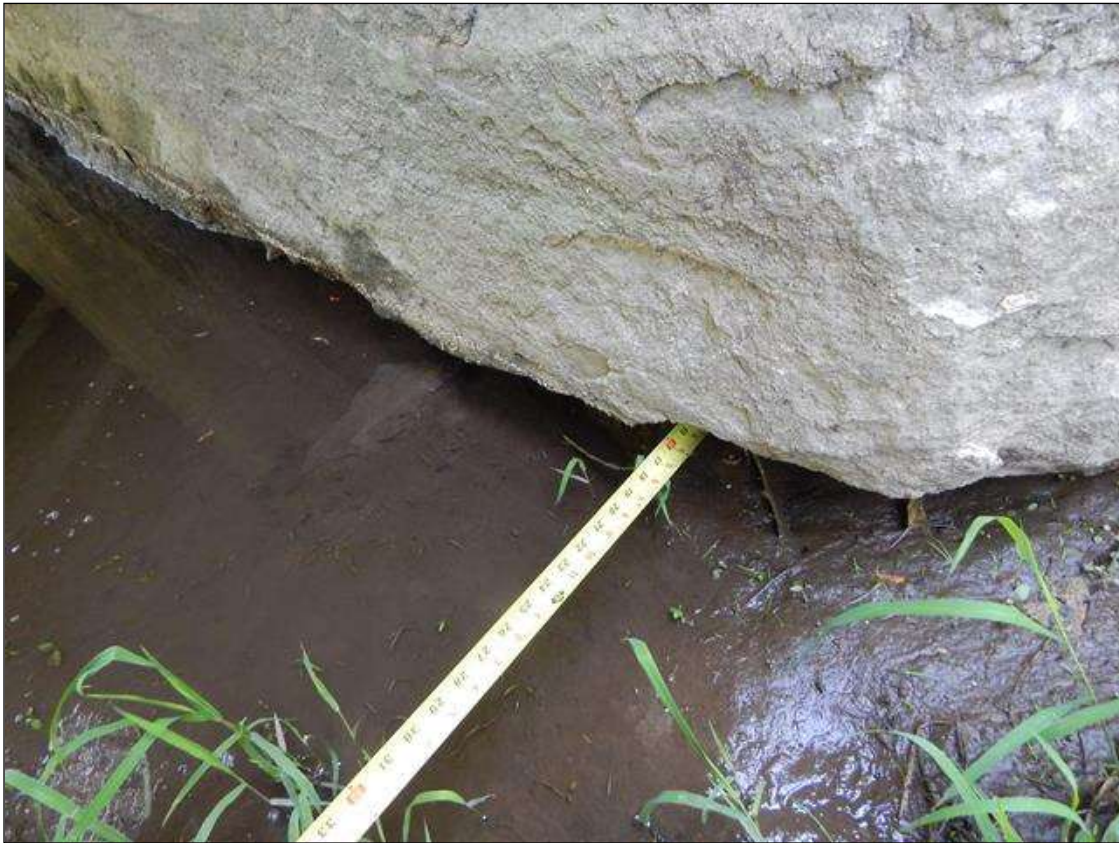
| MMS Code | MMS Description | Quantity |
|---|---|---|
| AREA OF UNDERMINING AT (SE) CORNER OF ABUTMENT (B)... ARE MEASURES APPROX. (3' L X 1' H) WITH PROBES UP TO 18" | | |

AREA OF UNDERMINING AT (SE) CORNER OF ABUTMENT (B)... ARE MEASURES APPROX. (3'L X 1' H) WITH PROBES UP TO 18"
