NC DEPARTMENT OF TRANSPORTATION  
DIVISION OF HIGHWAYS  
STRUCTURE MANAGEMENT UNIT

## Structure Safety Report

### Routine Element Inspection - Contract

COUNTY: SURRY STRUCTURE NUMBER: 850310 FREQUENCY: 24 MONTHS

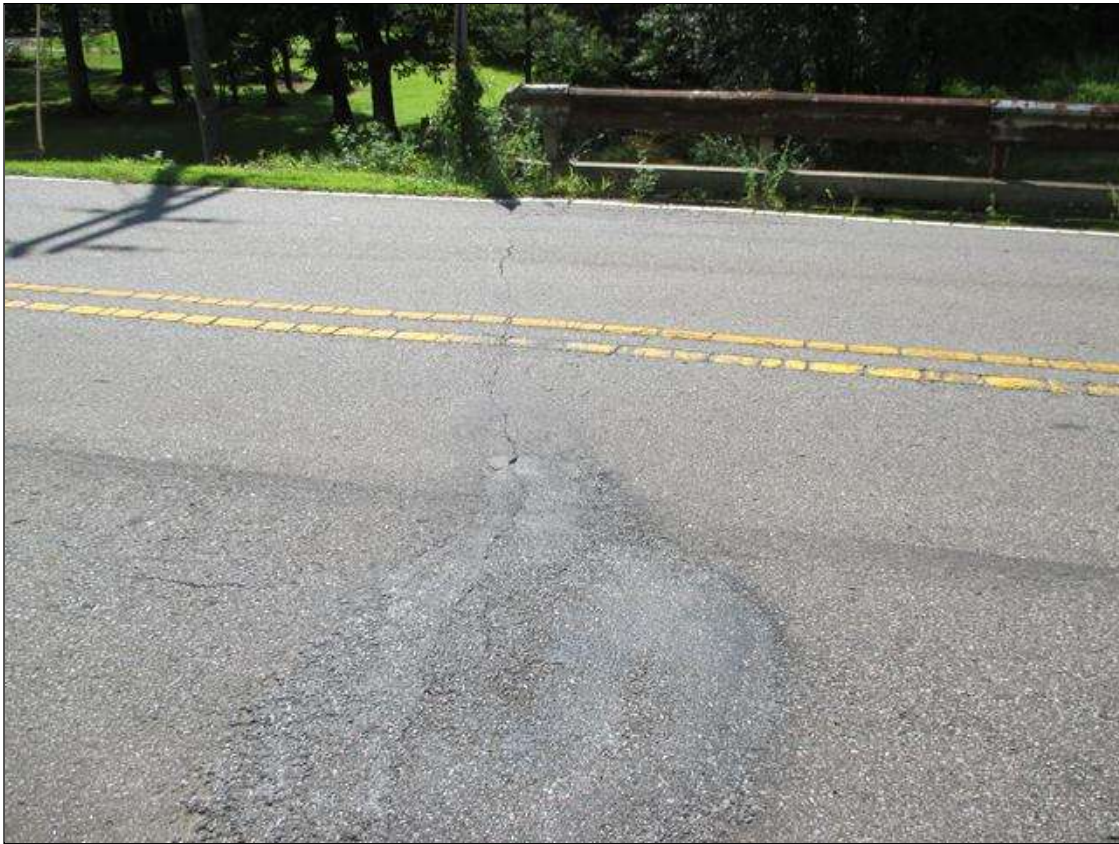
24 Square Feet of Crack (Wearing Surface): Width of more than 0.05 in. or spacing of less than 1.0 ft. at end bent 1

Span 1 Wearing Surface: 24 Square Feet of Crack (Wearing Surface): Width of more than 0.05 in. or spacing of less than 1.0 ft. at end bent 1

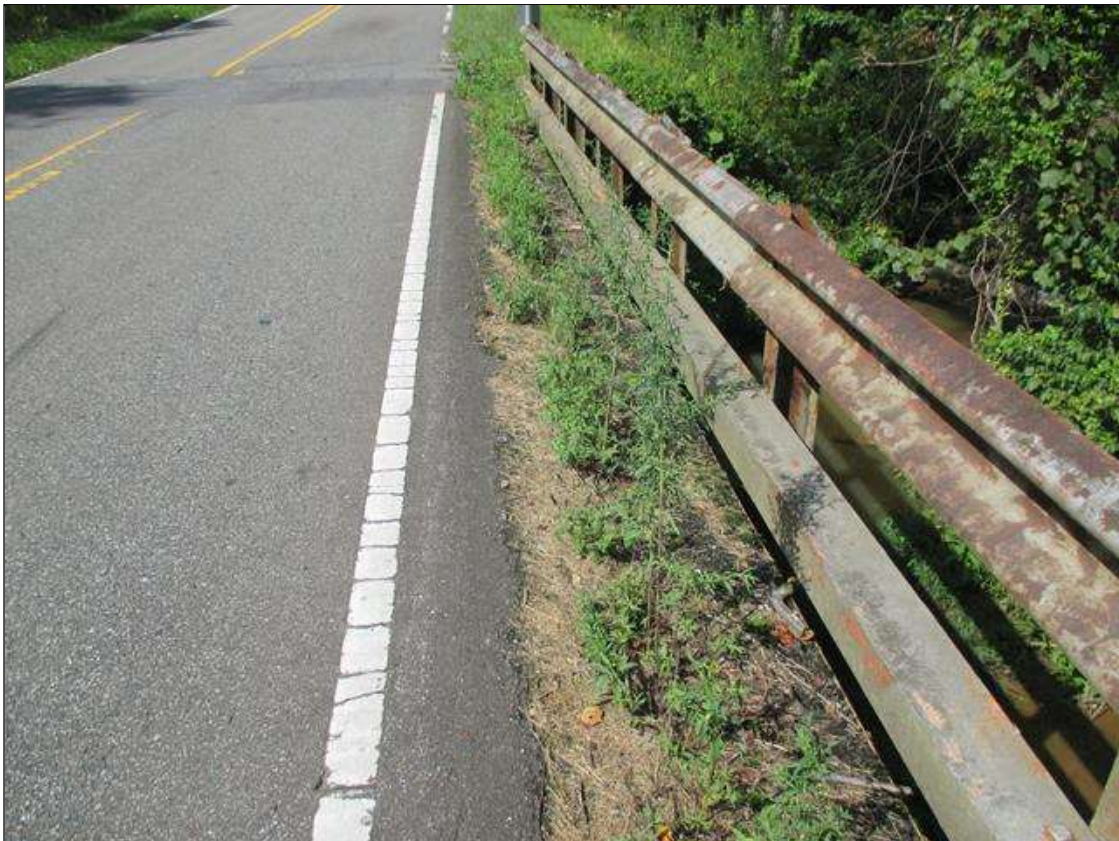
Vegetation overgrowth at upstream rail

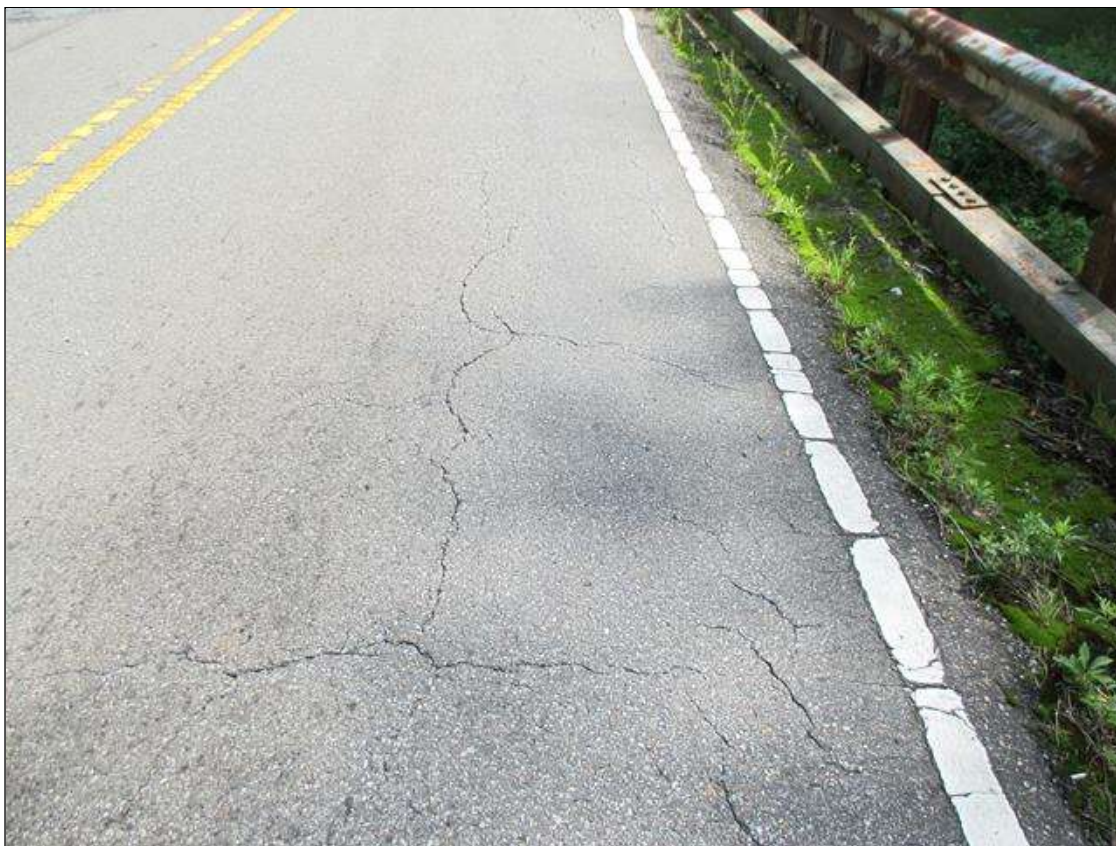
120 Square Feet of Crack (Wearing Surface): Width of more than 0.05 in. or spacing of less than 1.0 ft. in southbound lane

Span 1 Wearing Surface: 120 Square Feet of Crack (Wearing Surface): southbound lane

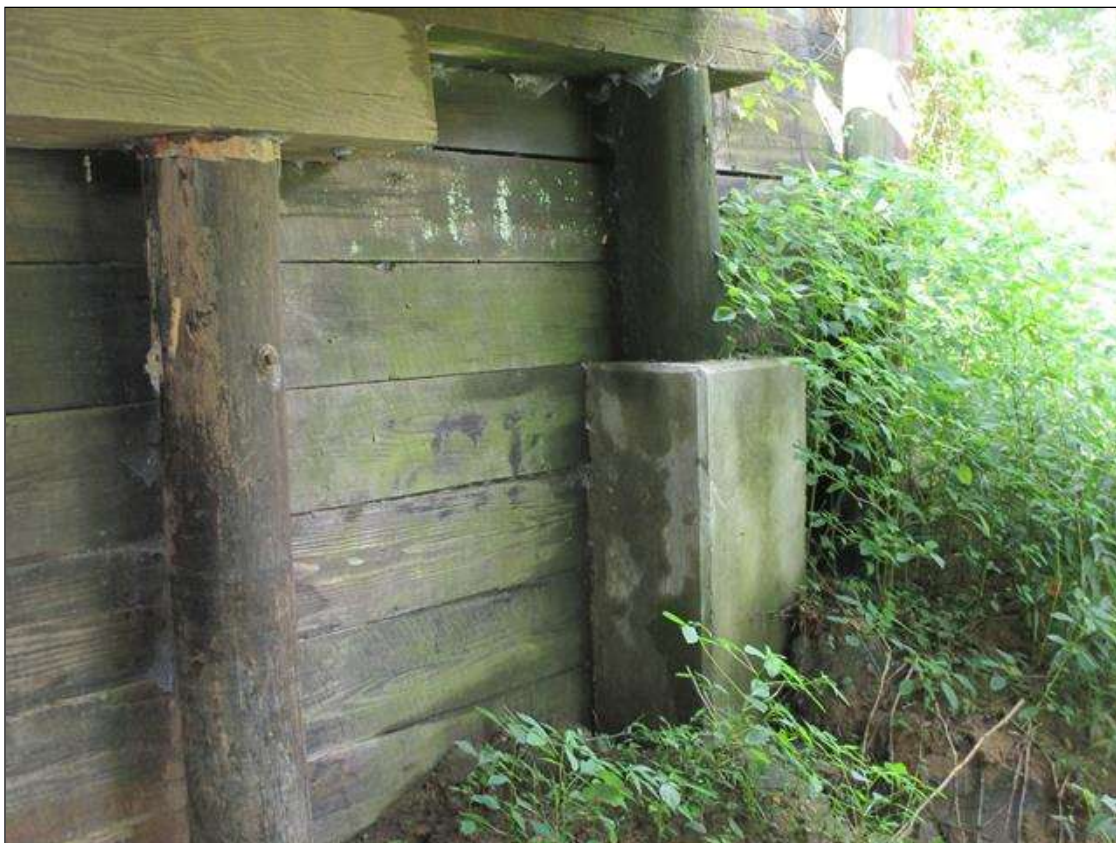
PILE # 5 AT ABUTMENT # 1 HAS BEEN ENCASED IN CONCRETE.

End bent 2 pile 5 concrete encasement

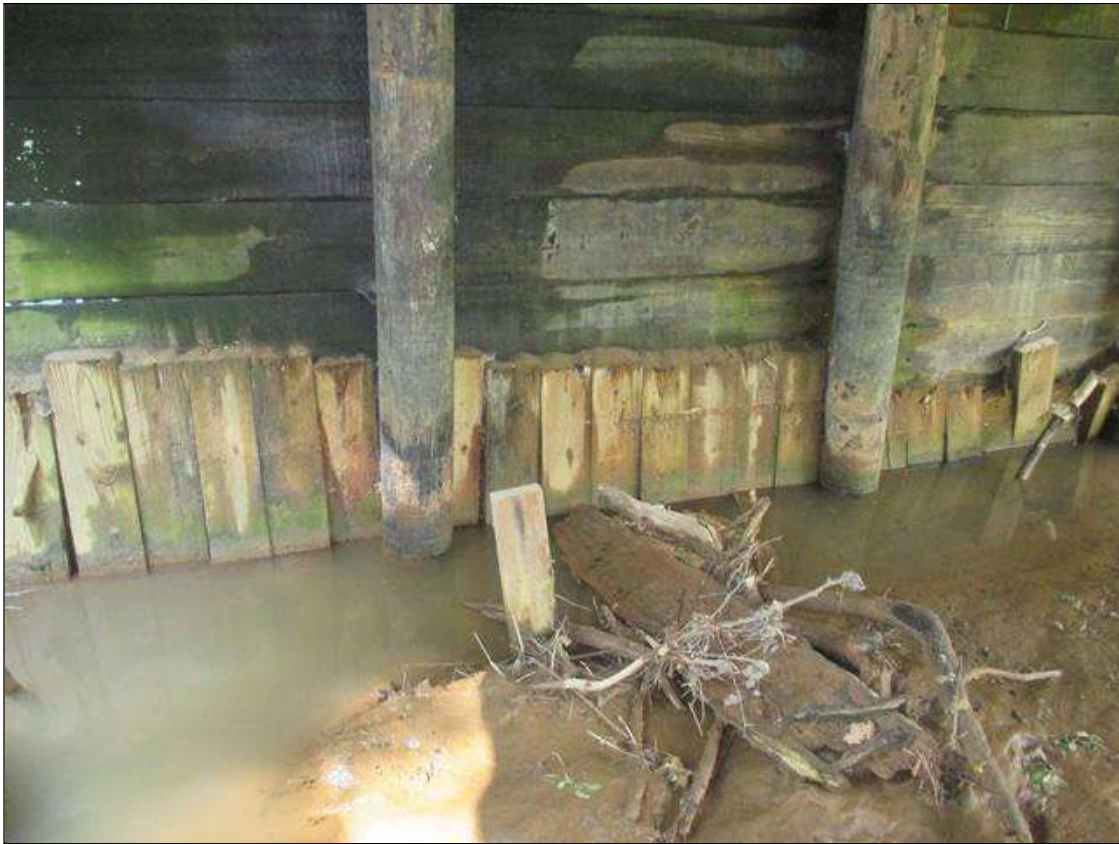
Repar to end bent 2 abutment

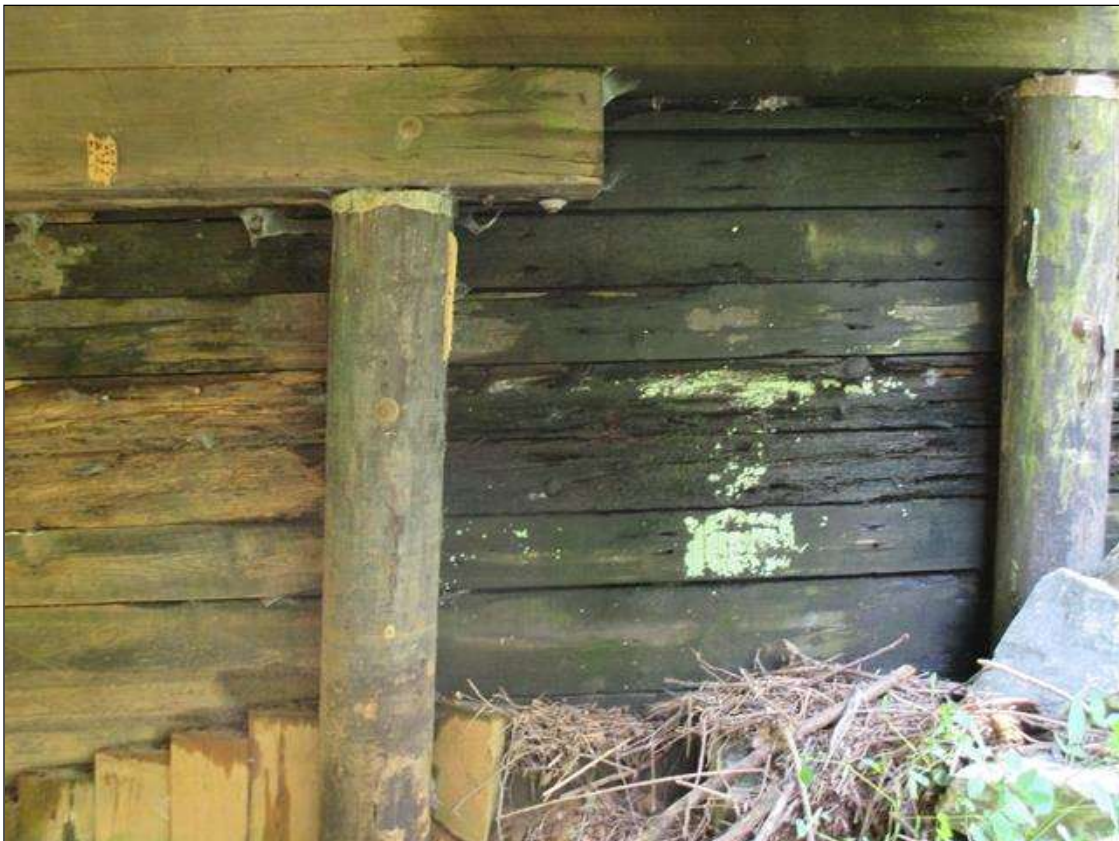
27 Feet of Decay/Section Loss: Affects 10% or more of the member but does not warrant structural review.

End Bent 1 Abutment/Backwall : 27 Feet of Decay/Section Loss: Affects 10% or more of the member but does not warrant structural review.

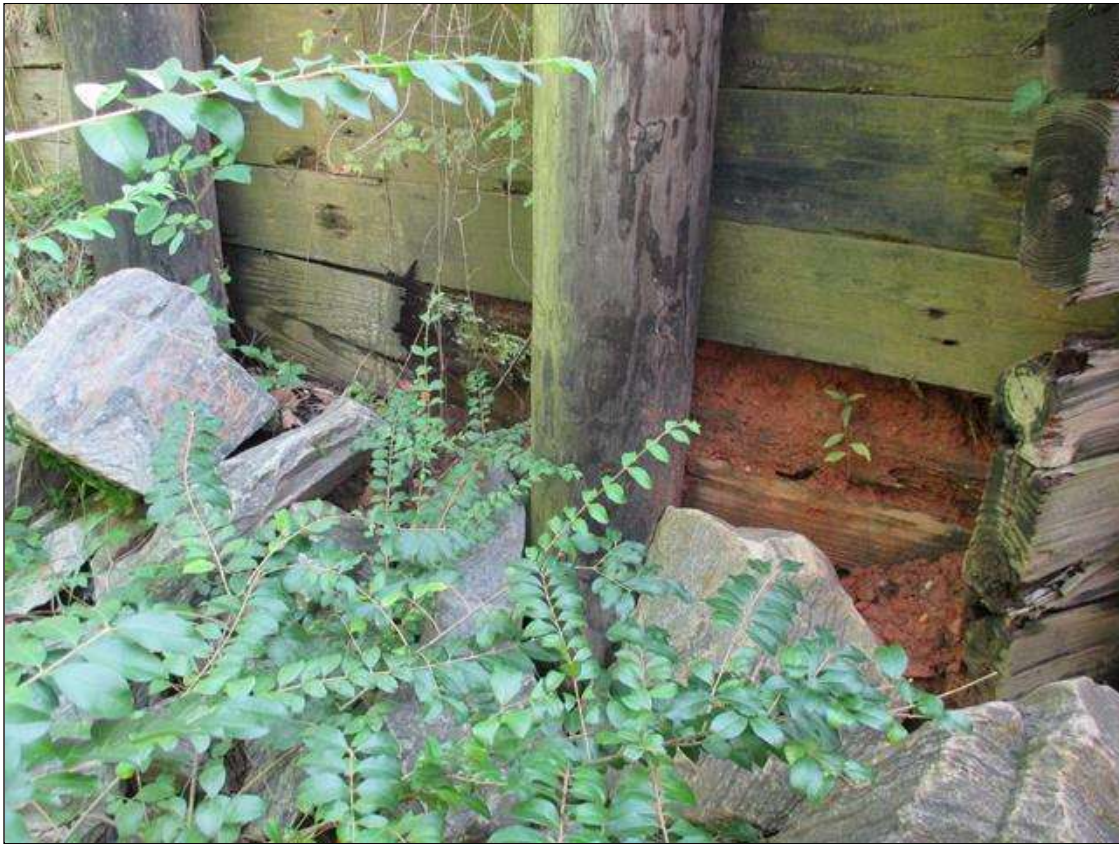
| Details | MAJOR DETERIORATION TO THE SOUTHEAST WINGWALL | | | | | |

Missing timber board at southeast wingwall behind abutment

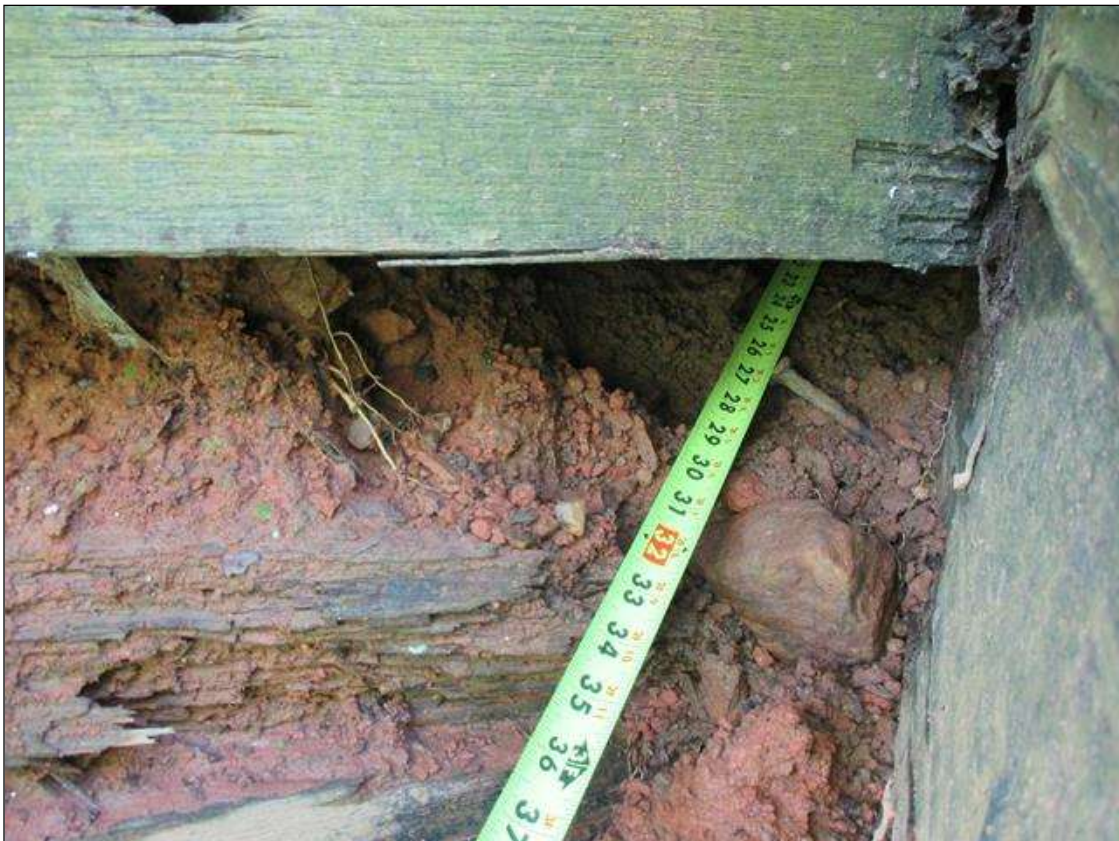
Erosion up to 3 feet behind abutment at southeast corner at missing wingwall timbers

| MMS Code | Description of Function | Unit | Quantity | Remarks | Est. Cost |
|---|---|---|---|---|---|
| 3344 | Repair / Replace Timber Substructure Components | LF | 8 | EROSION UP TO 3 FEET BEHIND ABUTMENT 1 AT SOUTHEAST CORNER AT MISSING WINGWALL TIMBERS | |

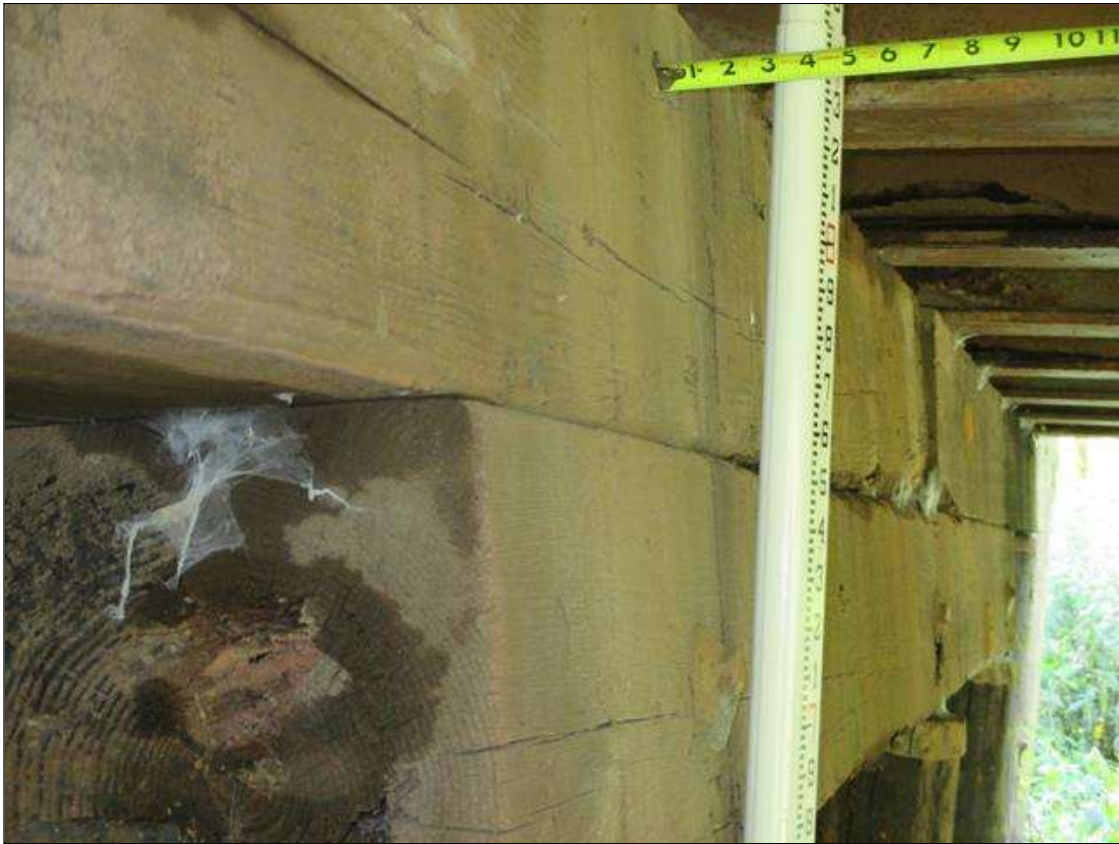
3" rotation of abutment 1 cap

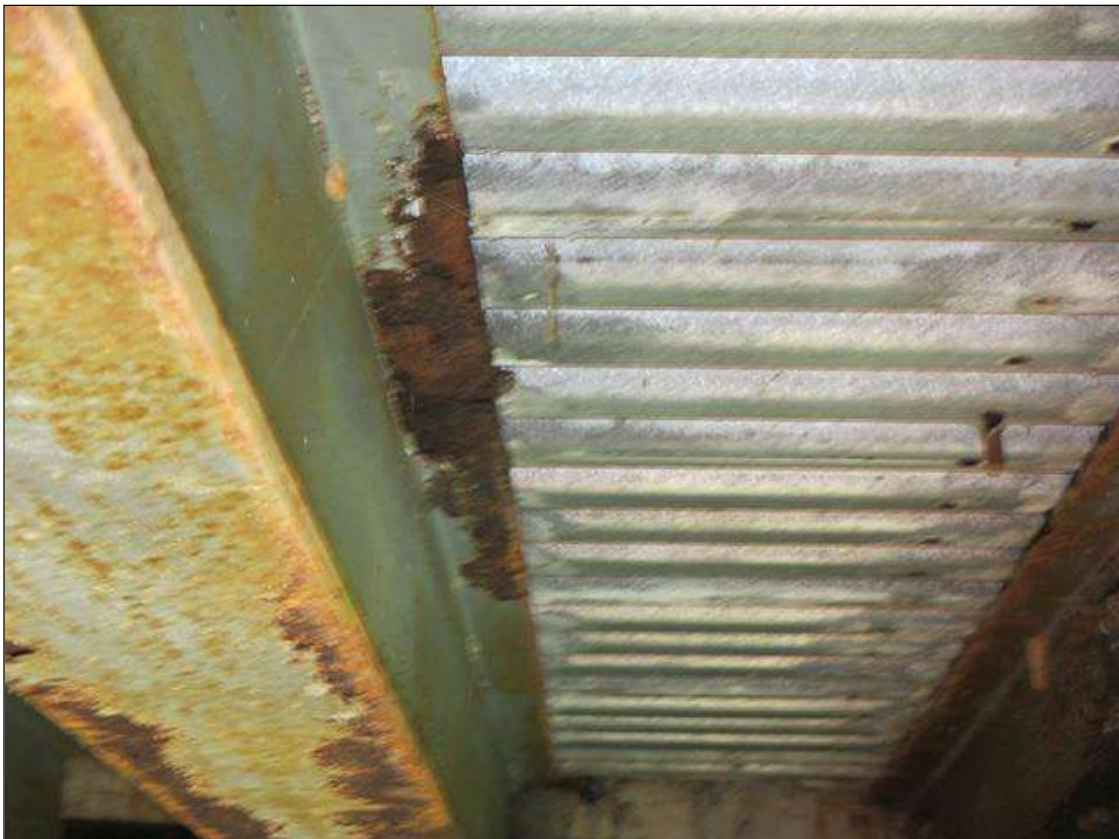
4 Feet of Corrosion: Section loss is evident or pack rust is present but does not warrant structural review 6 feet from end bent 1.

Span 1 Beam 2: 4 Feet of Corrosion: Section loss is evident or pack rust is present but does not warrant structural review 6 feet from end bent 1.

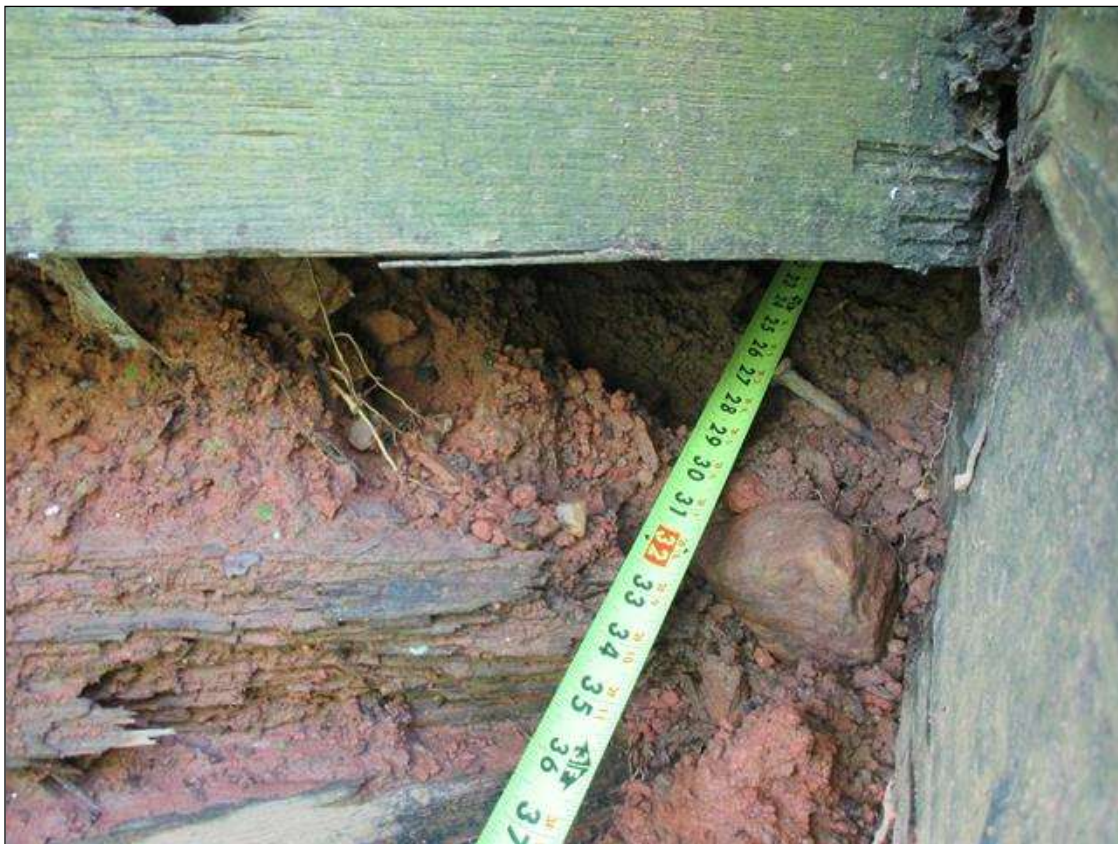
| MMS Code | MMS Description | Quantity |
|---|---|---|
| EROSION UP TO 3 FEET BEHIND ABUTMENT 1 AT SOUTHEAST CORNER AT MISSING WINGWALL TIMBERS | | |

EROSION UP TO 3 FEET BEHIND ABUTMENT AT SOUTHEAST CORNER AT MISSING WINGWALL TIMBERS

| MMS Code | MMS Description | Quantity |
|---|---|---|
| 3344 | Repair / Replace Timber Substructure Components | 8 LF |

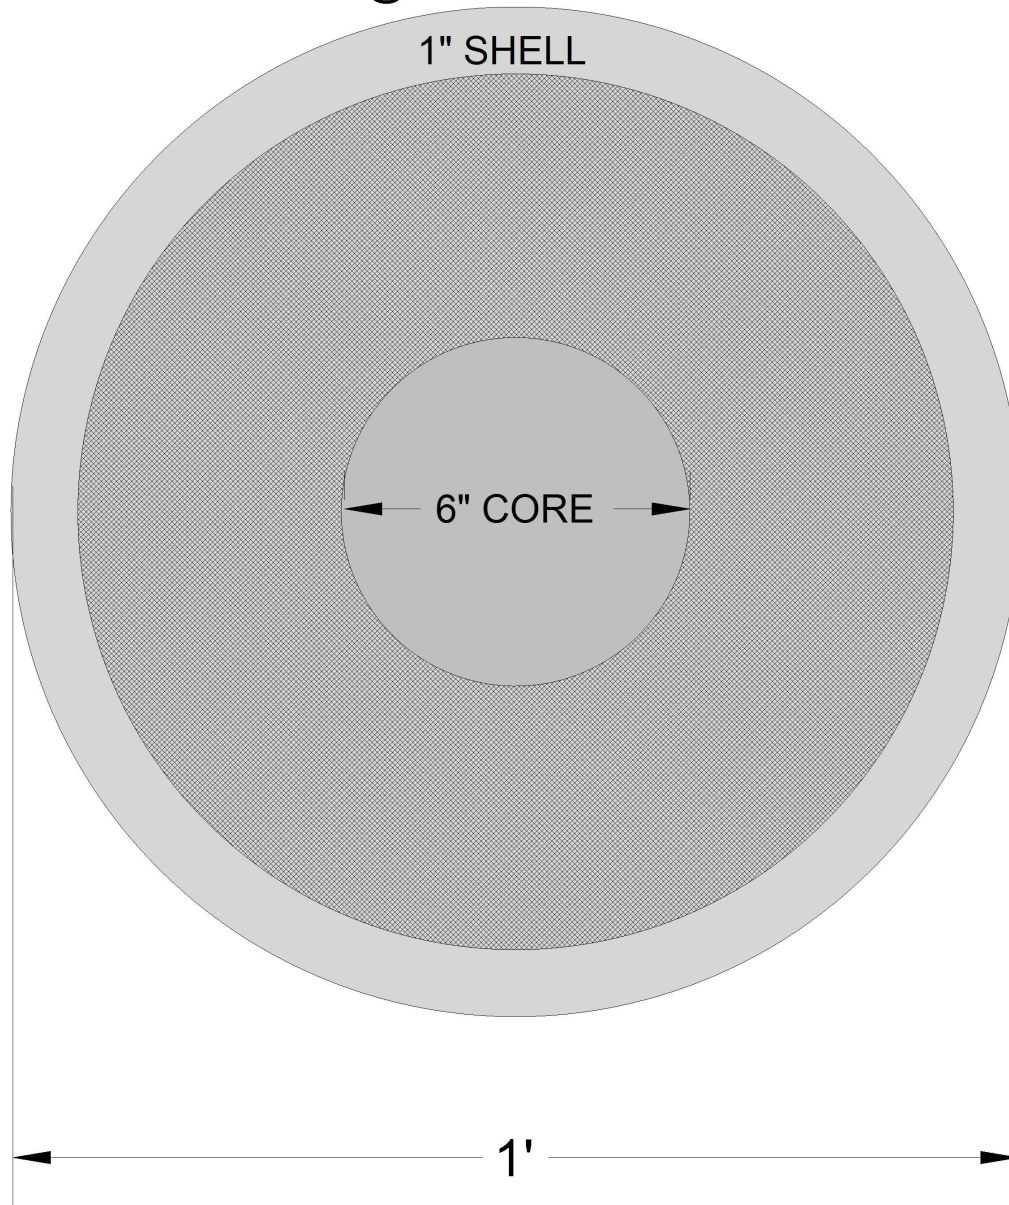
PILE DECAY

9/10/09 - PILE HAS BEEN ENC. IN CONC. 24" W X 16" D X 61" HIGH

PILE # 5 @ ABUT. # 2 DECAYED

DECAY BEGINS APPROX. 1' FROM GROUND & EXTENDS 5' UP PILE  
WITH 34 % REMAINING MATERIAL
