NC DEPARTMENT OF TRANSPORTATION  
DIVISION OF HIGHWAYS  
STRUCTURE MANAGEMENT UNIT

## Structure Safety Report

### Routine Element Inspection - Contract

COUNTY: MADISON STRUCTURE NUMBER: 560008 FREQUENCY: 24 MONTHS

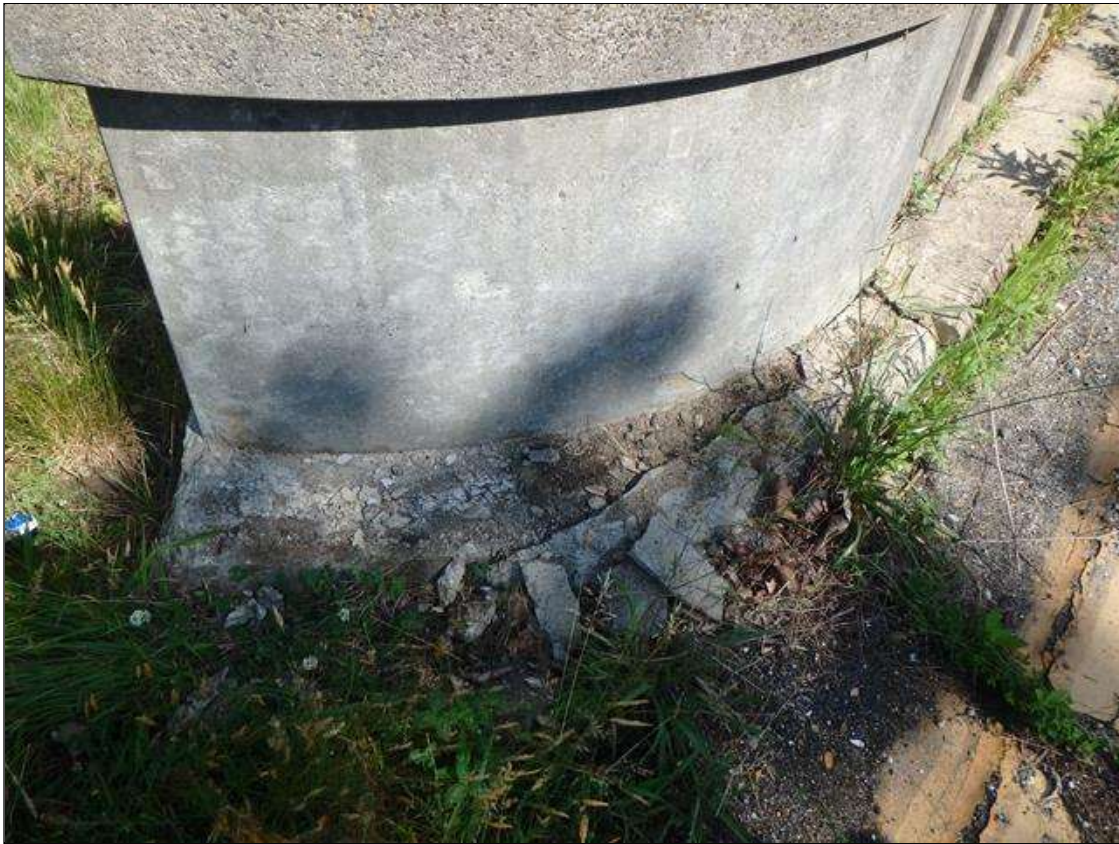
Span 1 Left Bridge Rail: SPALL 5 FT X 8" X UP TO 2" SOUTHWEST CORNER, NO EXPOSED REBAR, PREVIOUS REPAIR DELAMINATING FOR 3 FT

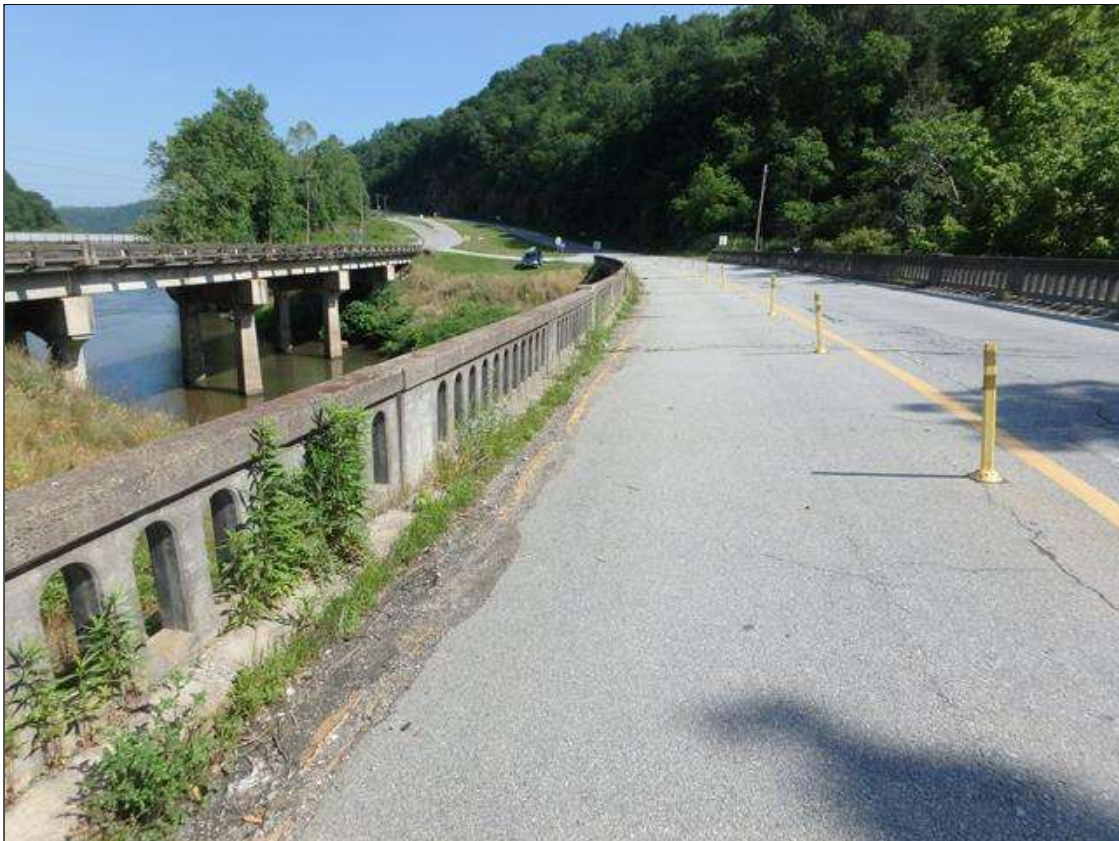
HEAVY VEGETATION AND DEBRIS ALONG LEFT GUTTER SIMILAR ALONG RIGHT

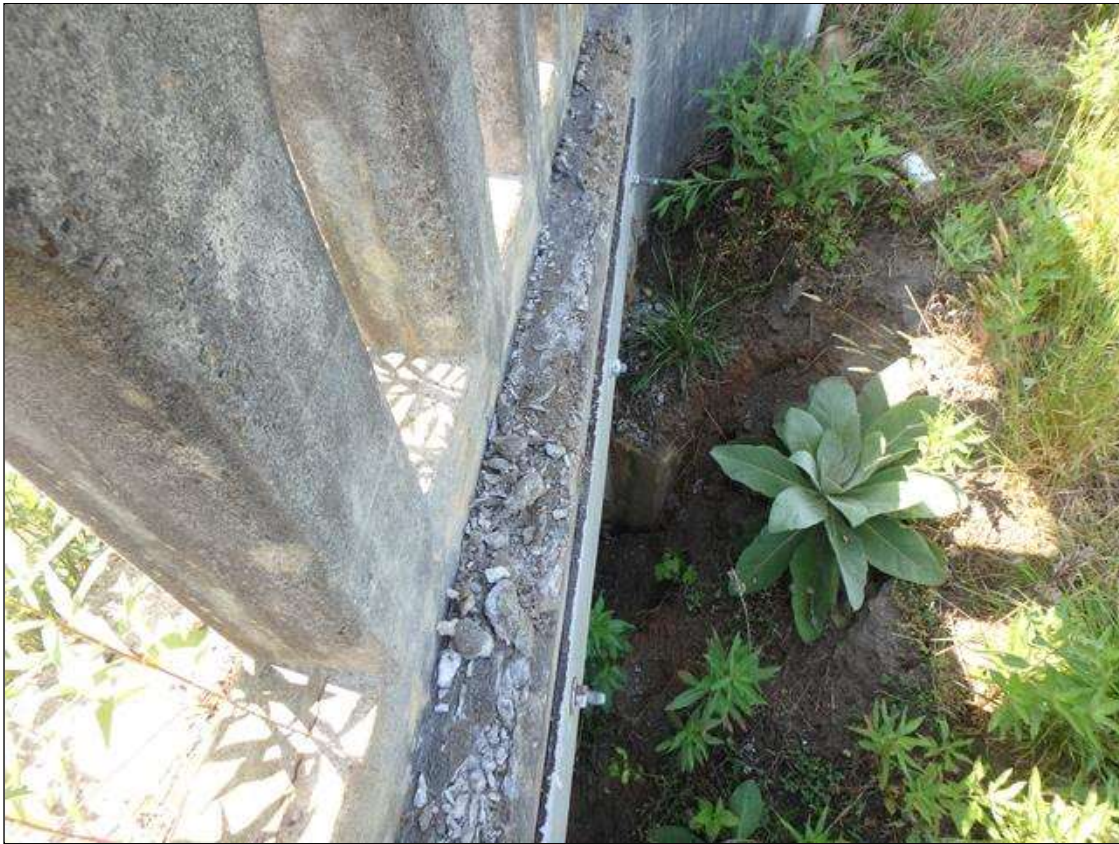
Span 1 Left Bridge Rail: SPALLING, CRACKING, DELAMINATION FOR 4" WIDE BEHIND BARRIER X 35 FT FROM END BENT 1

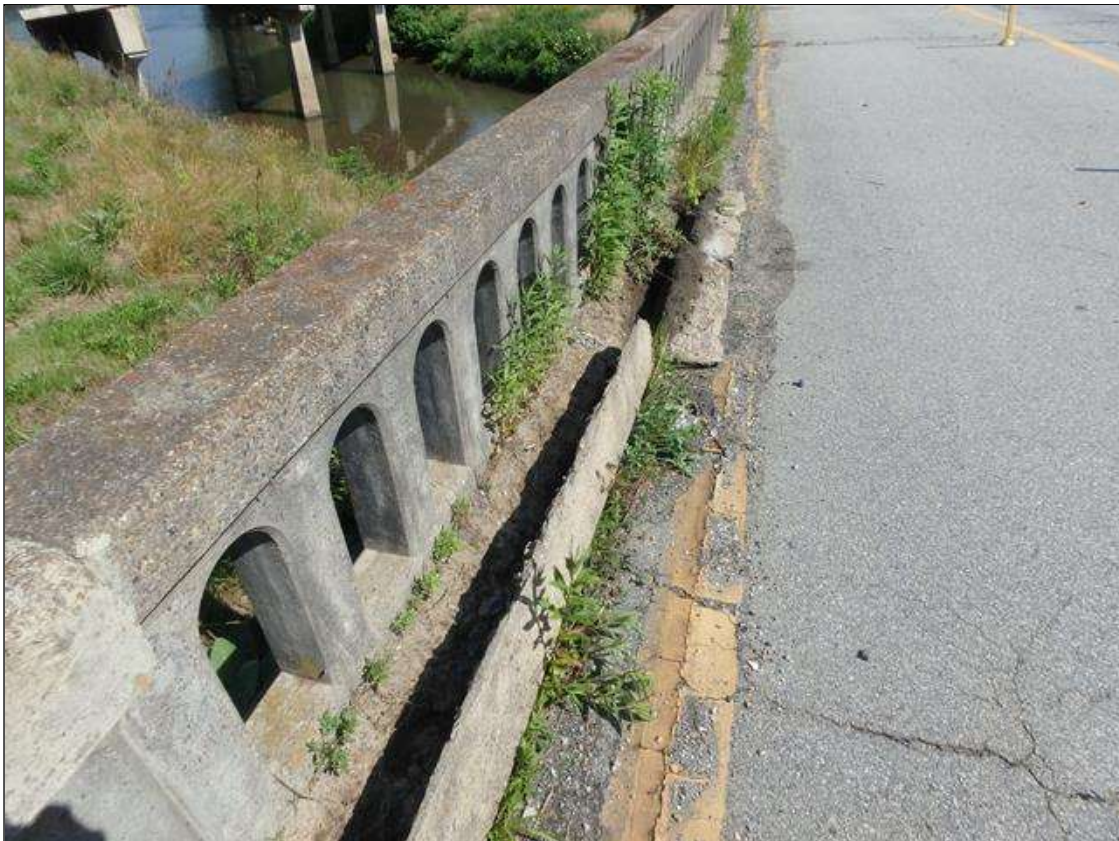
Span 1 Left Bridge Rail: SPALL/DELAMINATION UP TO FULL WIDTH OF CURB X FULL LENGTH

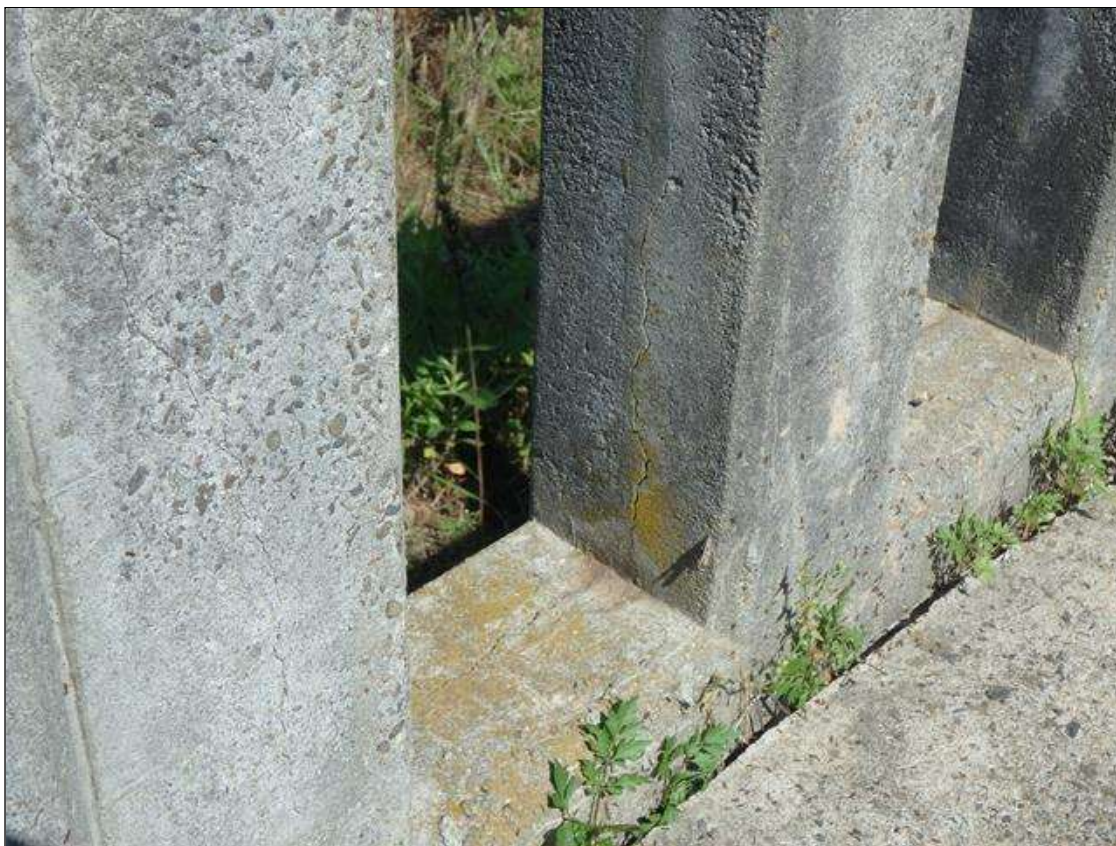
Span 1 Left Bridge Rail: SCATTERED LONGITUDINAL AND VERTICAL CRACKING THROUGHOUT RAIL

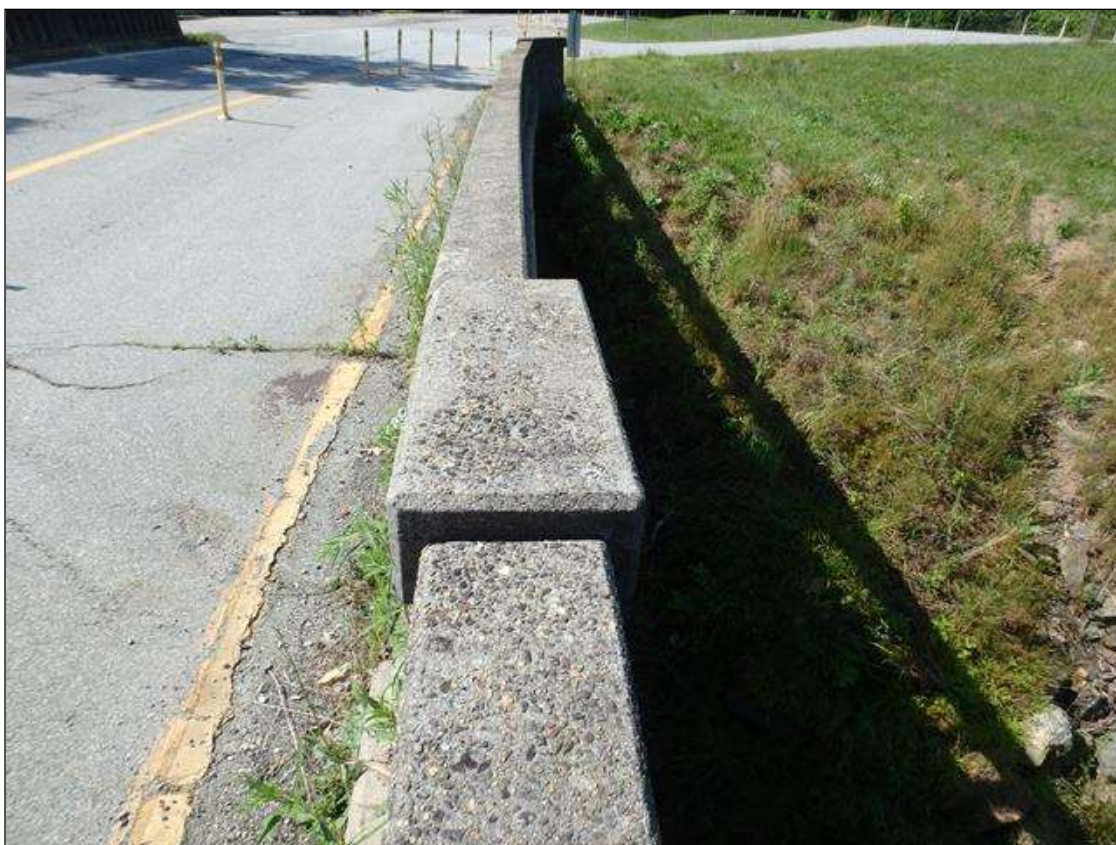
Span 1 Left Bridge Rail: CONCRETE ENDPOST AT BENT 1 MISALIGNMENT UP TO 2" TO THE WEST

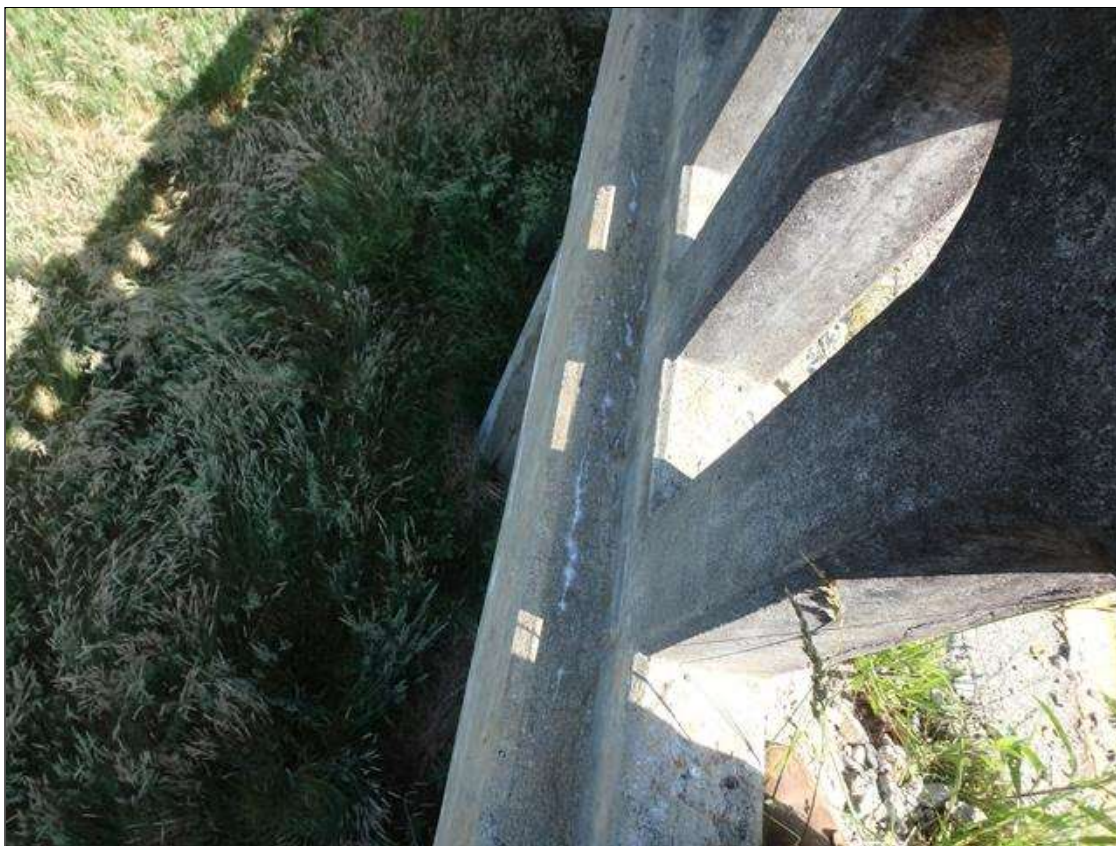
Span 4 Left Bridge Rail: 10 FT LONGITUDINAL HAIRLINE CRACKS WITH EFFLORESCENCE AT BENT 4

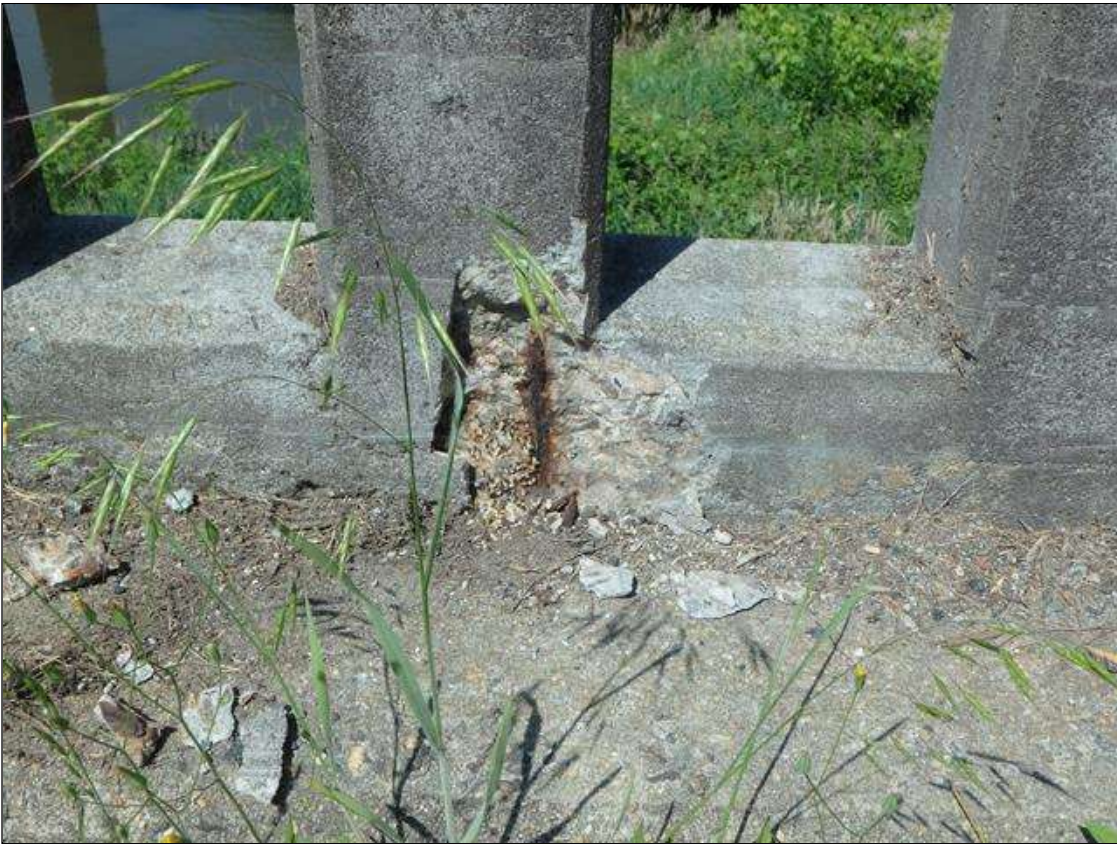
Span 5 Left Bridge Rail: SPALL 8" X 4" X 1" DEEP WITH EXPOSED REBAR, NO SECTION LOSS, 6 FT FROM BENT  
4

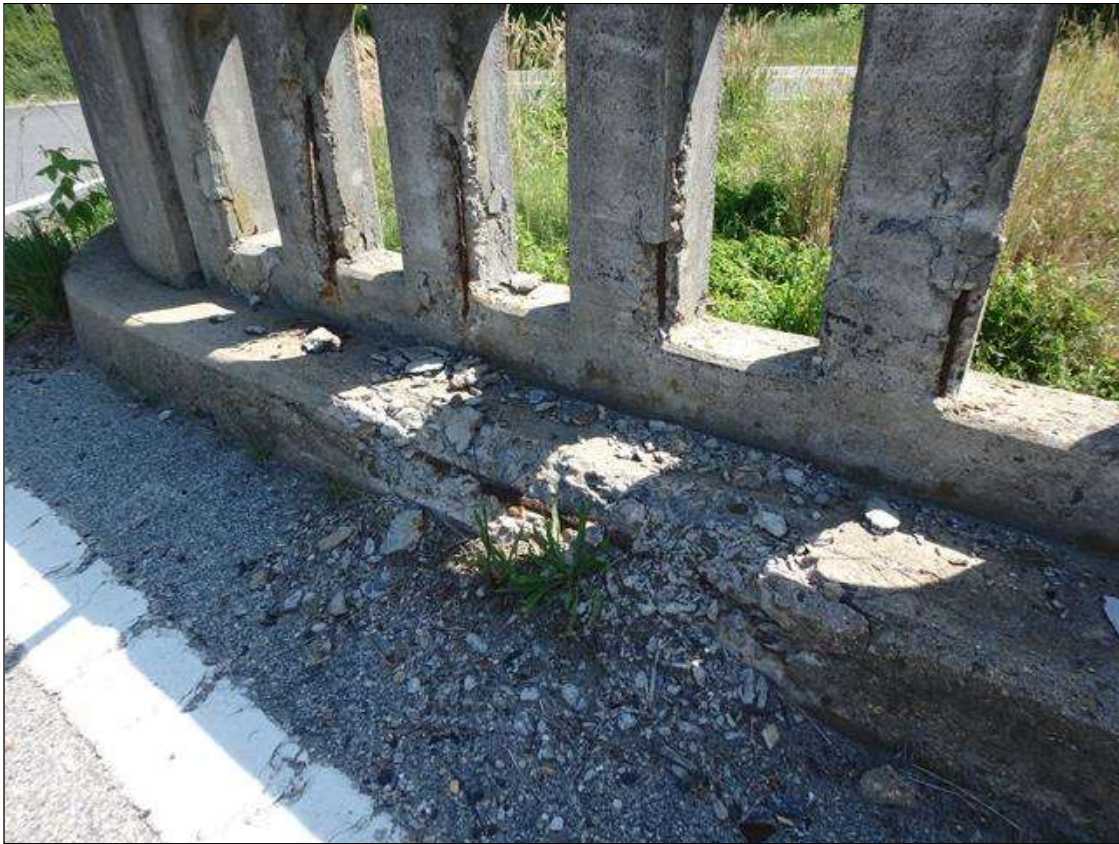
Span 5 Right Bridge Rail: SCATTERED SPALLS UP TO 14" X 2" X 2" DEEP WITH EXPOSED REBAR, UP TO 100 PERCENT SECTION LOSS, 5 FT FROM END BENT 2

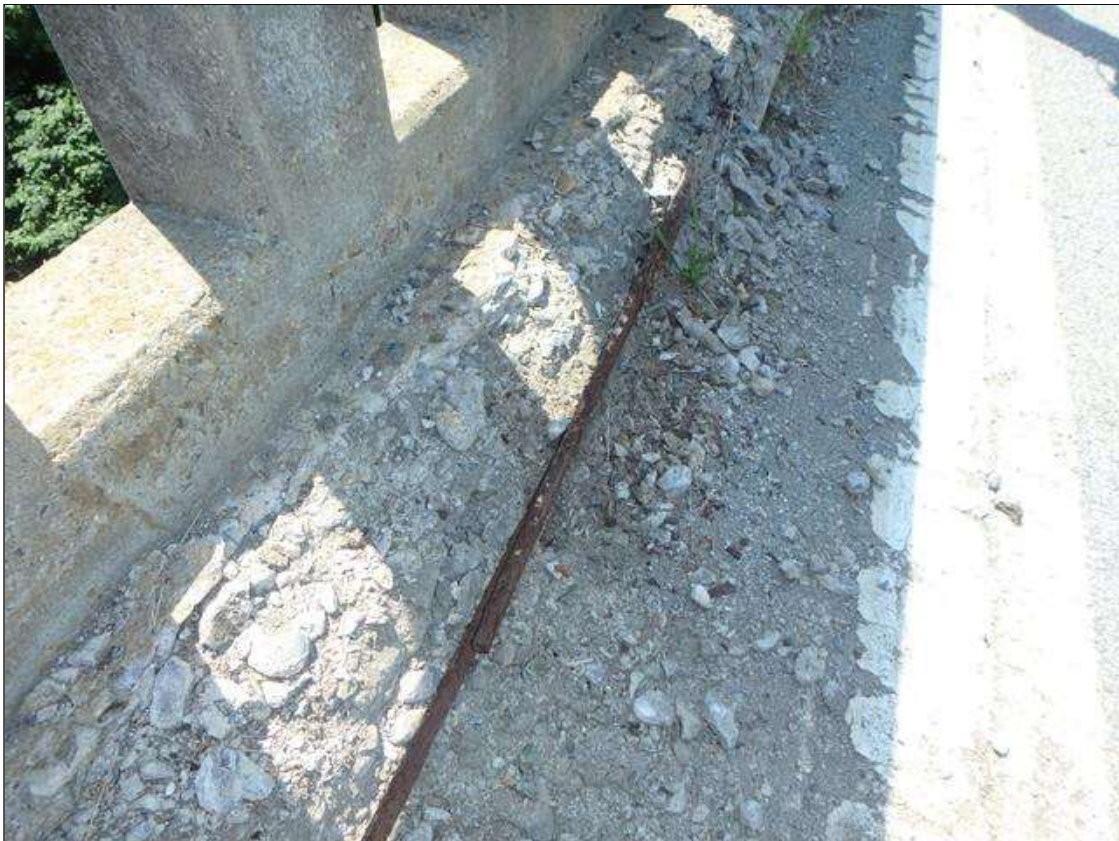
Span 2 Right Bridge Rail: SPALL/ DETERIORATING FOR 9" WIDE X FULL LENGTH, WITH EXPOSED REBAR STICKING OUT TOWARDS TRAVEL LANE FOR 15 FT, PRIORITY MAINTENANCE

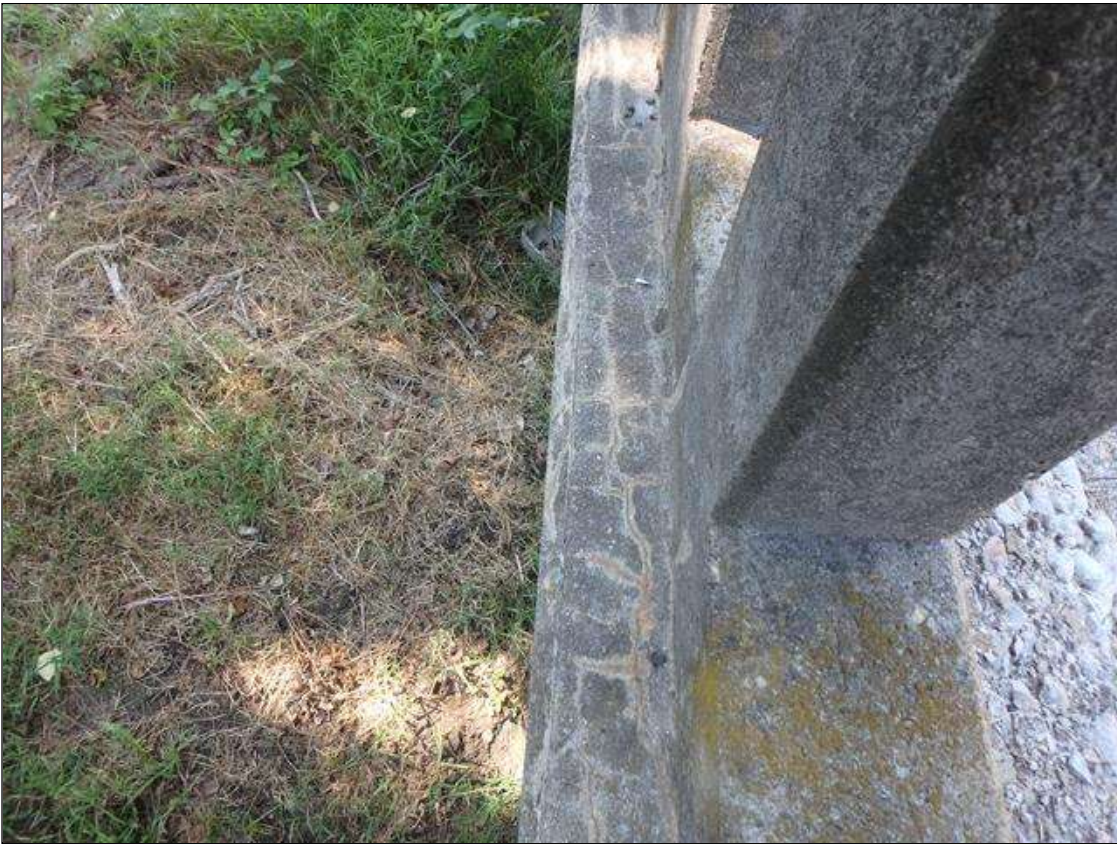
Span 1 Right Bridge Rail: HAIRLINE MAP CRACKING WITH EFFLORESCENCE FOR 4" X FULL LENGTH BEHIND BARRIER

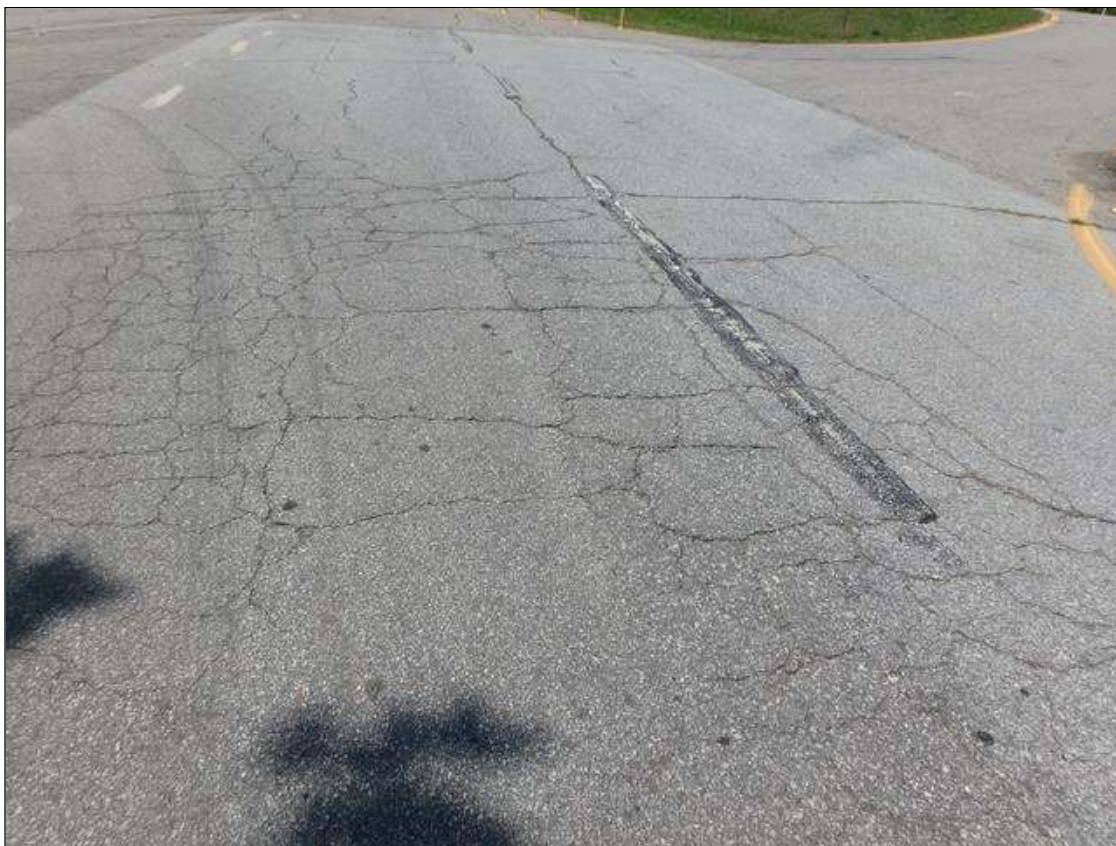
MAP CRACKING UP TO 1/2" IN SOUTH APPROACH , NORTH APPROACH SIMILAR

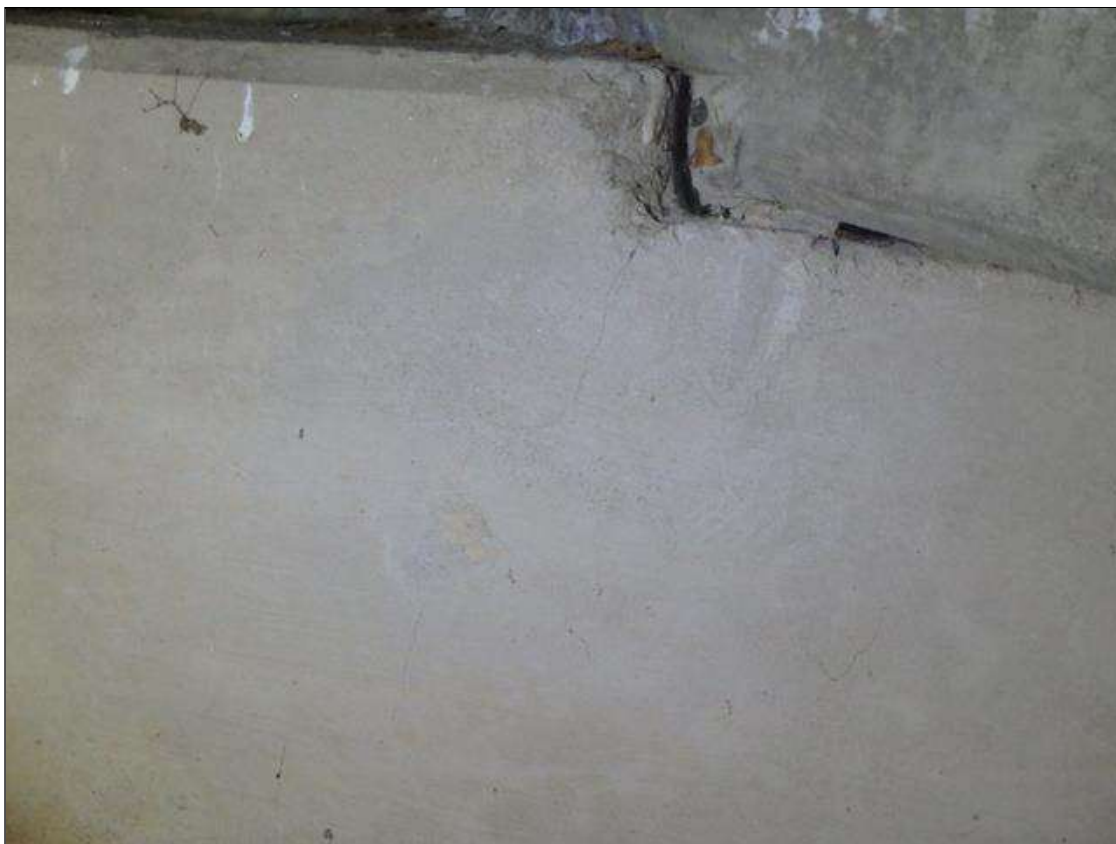
End Bent 2 Cap : 1 FT HAIRLINE VERTICAL CRACK AT CONCRETE STEP AT BEAM 4

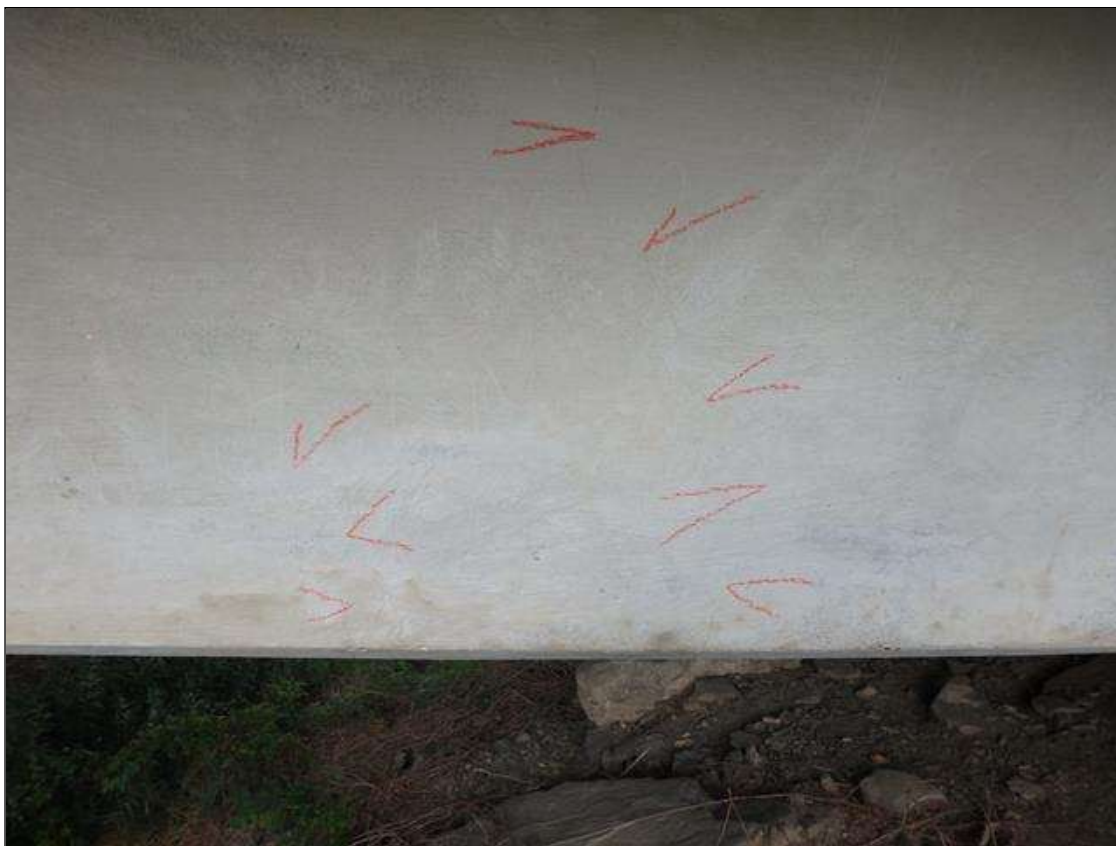
Span 5 Beam 5: SCATTERED HAIRLINE VERTICAL CRACKS UP TO 2 FT ALONG EAST FACE OF BEAM (13 TOTAL)

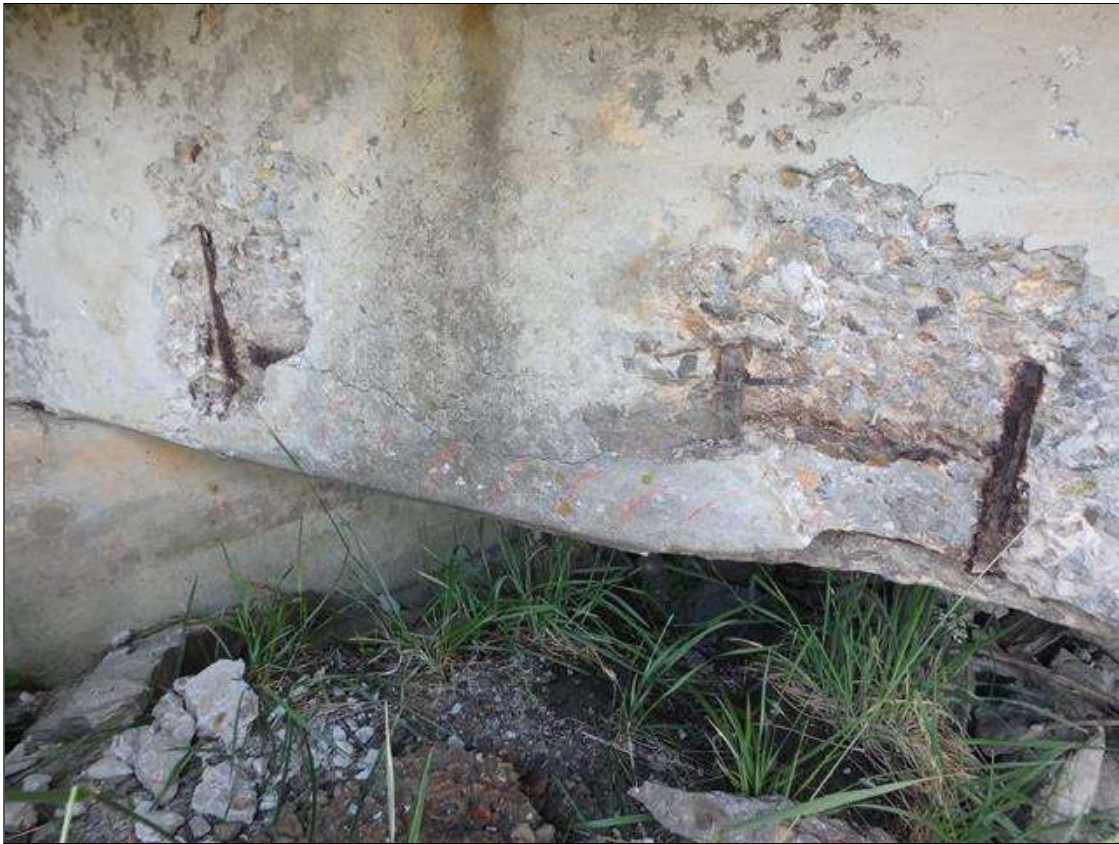
Span 5 Beam 1: TWO SPALLS UP TO 18" X 16" X 3" DEEP WITH EXPOSED REBAR, 10% SECTION LOSS, AND DELAMINATION 30" X 6" LOCATED 5 FT FROM END BENT 2

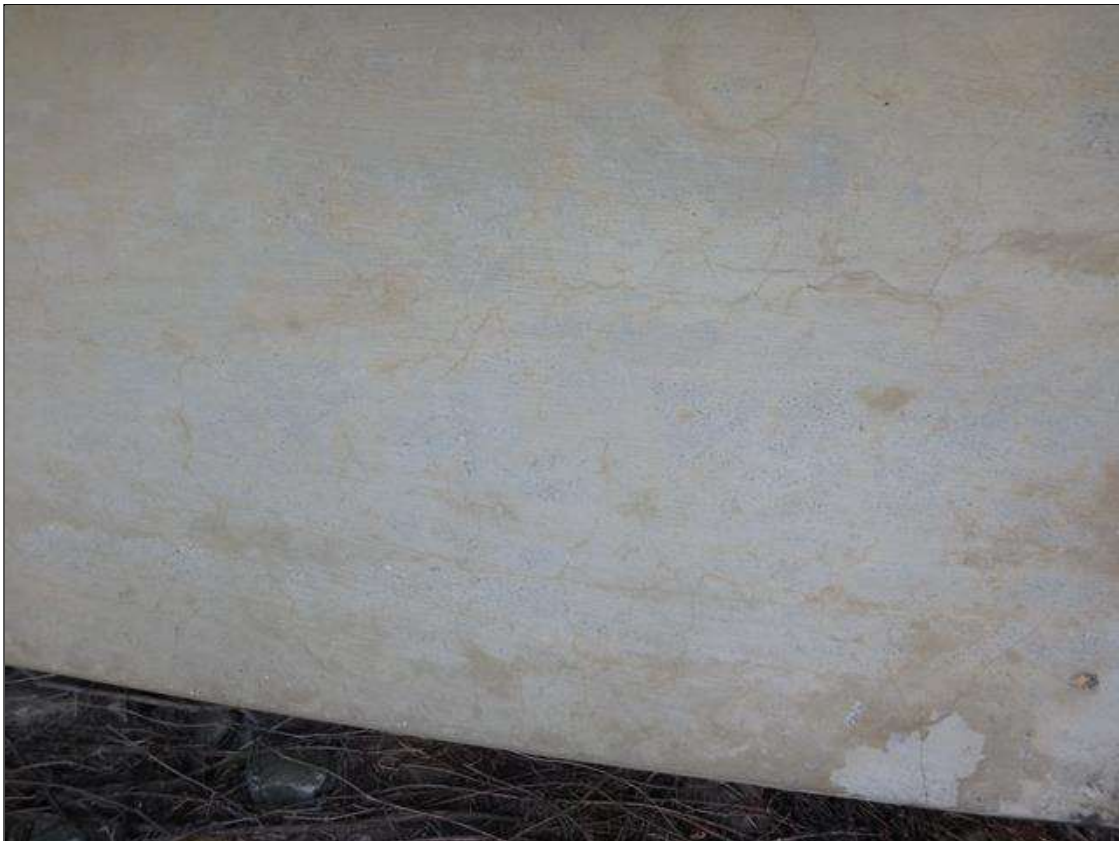
Span 5 Beam 1: SCATTERED HAIRLINE MAP CRACKING ALONG WEST FACE

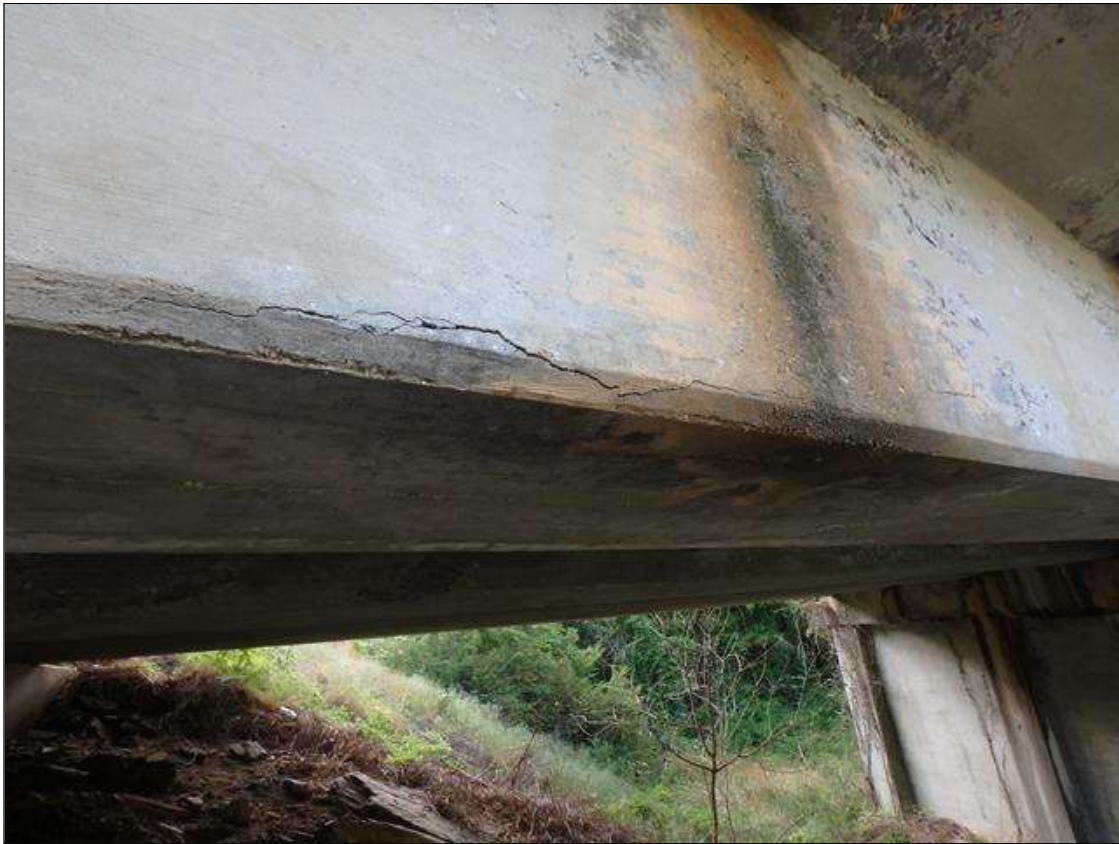
Span 5 Beam 1: LONGITUDINAL CRACK 4 FT X UP TO 1/8" ALONG WEST FACE NEAR MIDSPAN

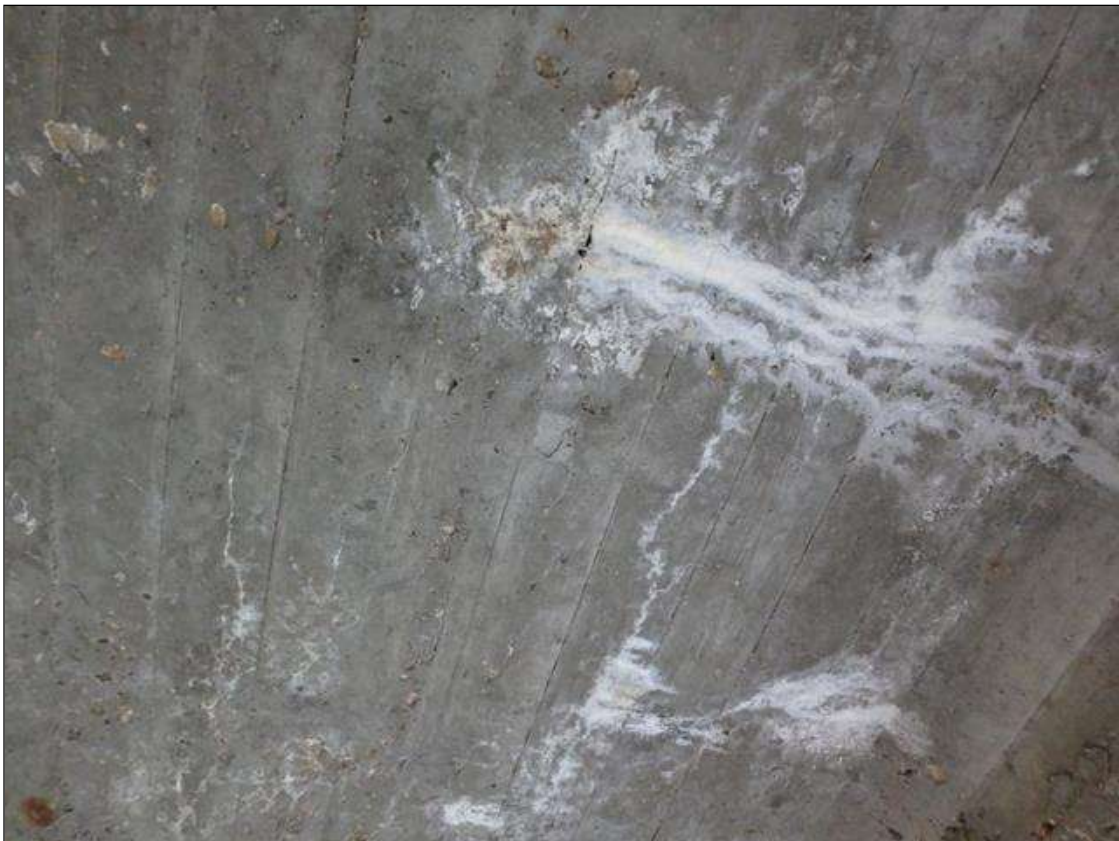
Span 5 Deck: HEAVY EFFLORESCENCE BUILDUP ALONG UNDERSIDE OF DECK IN BAY 1, 12 FT FROM END BENT 2

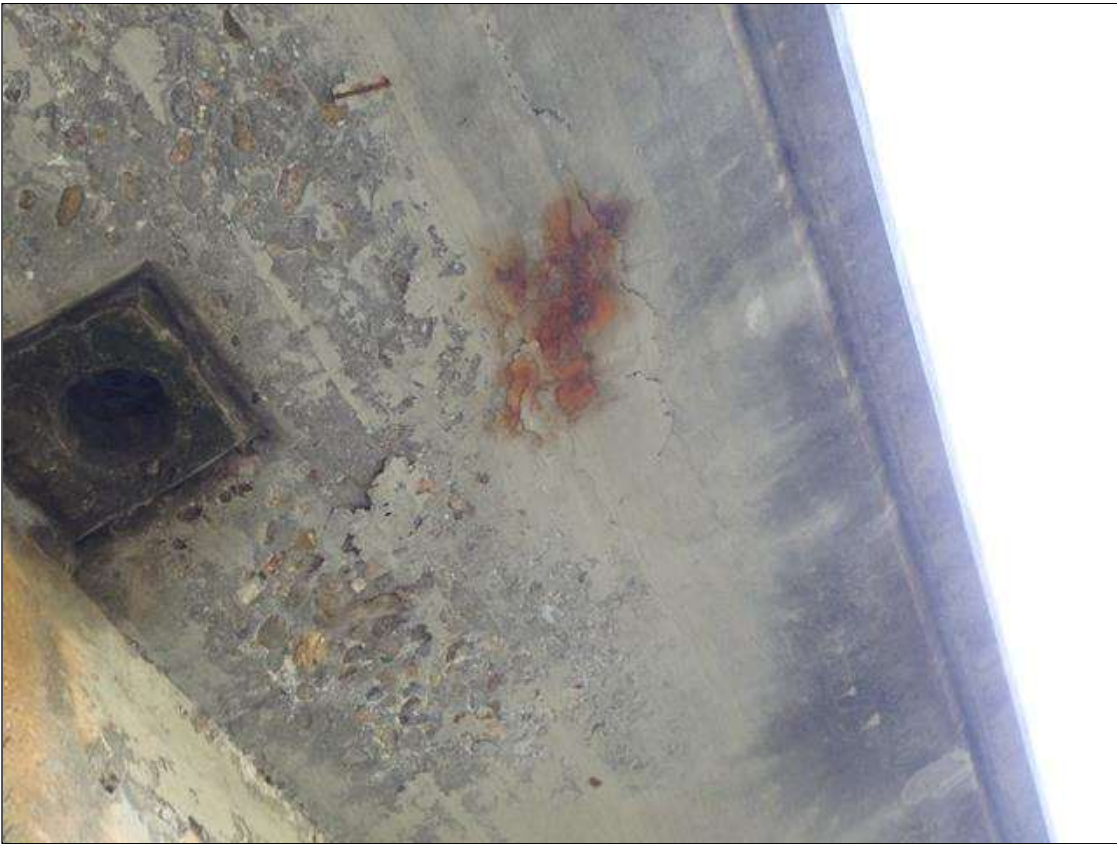
Span 5 Deck: DELAMINATION 2 FT X 4" WITH RUST STAINING ALONG UNDERSIDE OF DECK IN LEFT OVERHANG

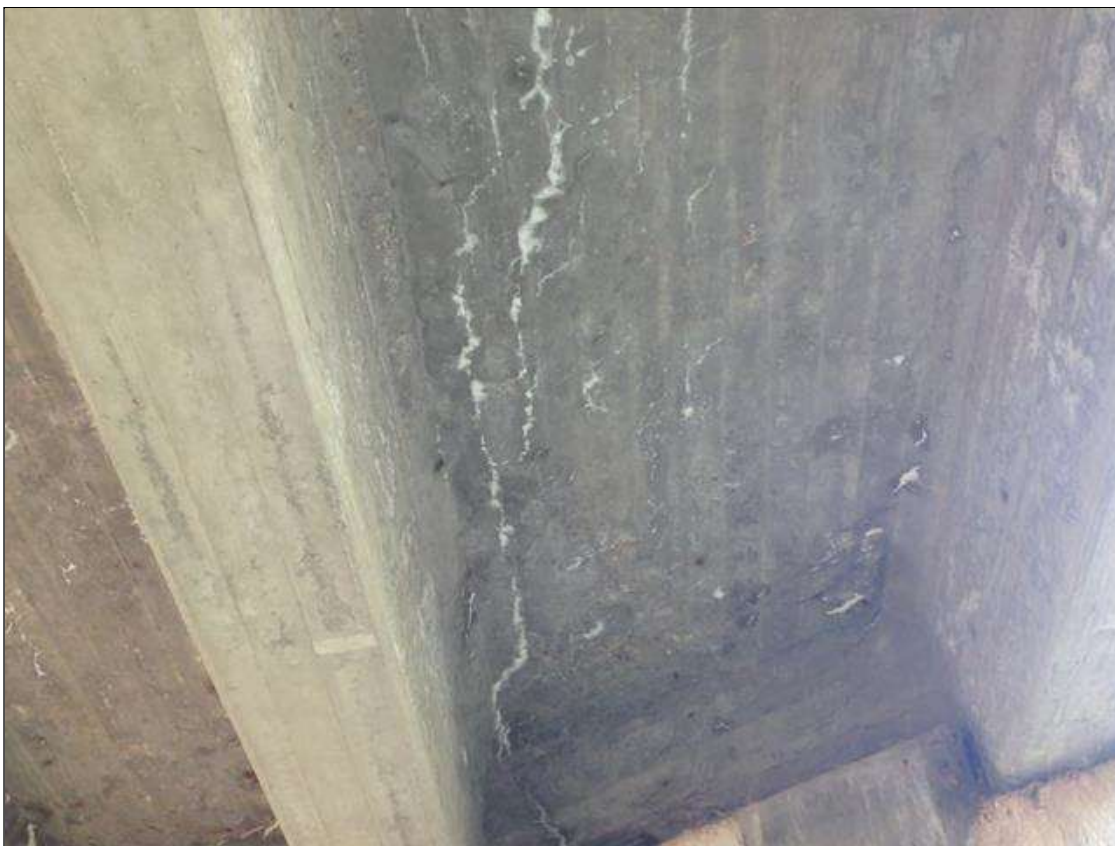
Span 5 Deck: HAIRLINE MAP CRACKING WITH EFFLORESCENCE BUILDUP IN BAY 1 AT BENT 4

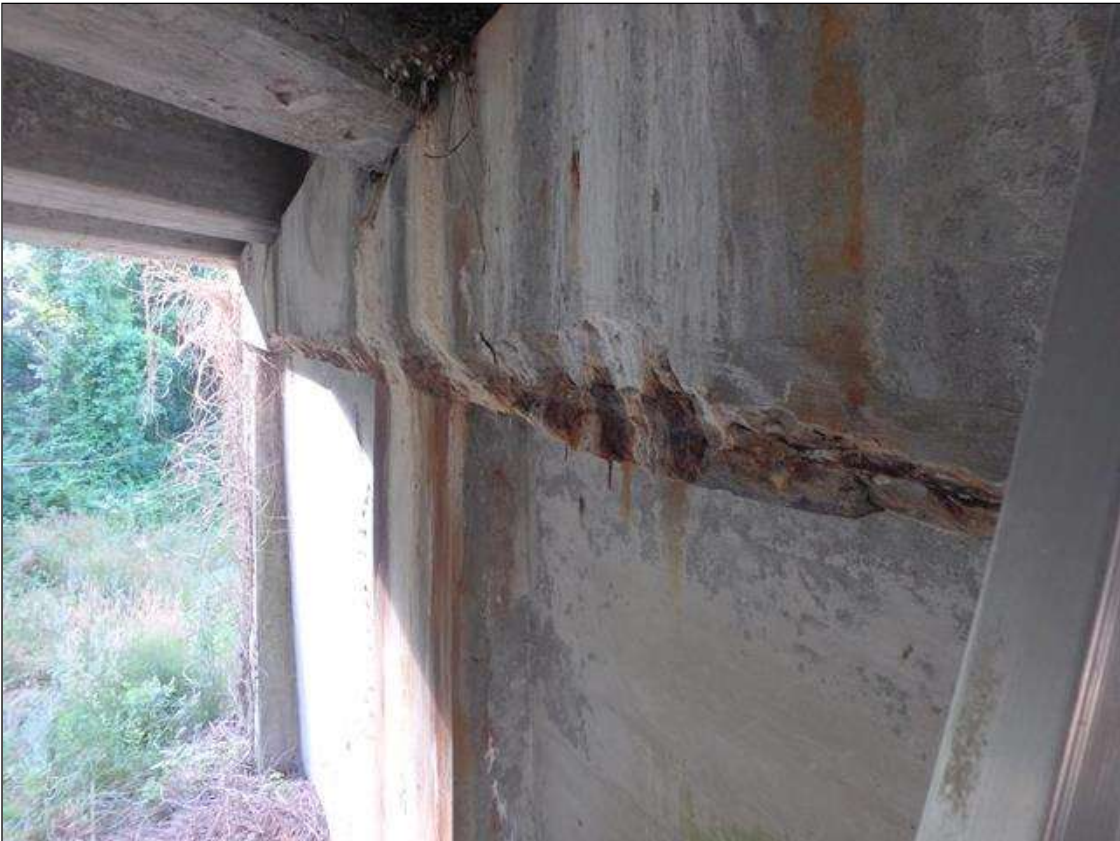
Bent 4 Cap : SPALL 19 FT X 1 FT X 1 FT WITH EXPOSED REBAR WITH 5% SECTION LOSS UNDER BEAMS 2, 3 AND 4, PRIORITY MAINTENANCE

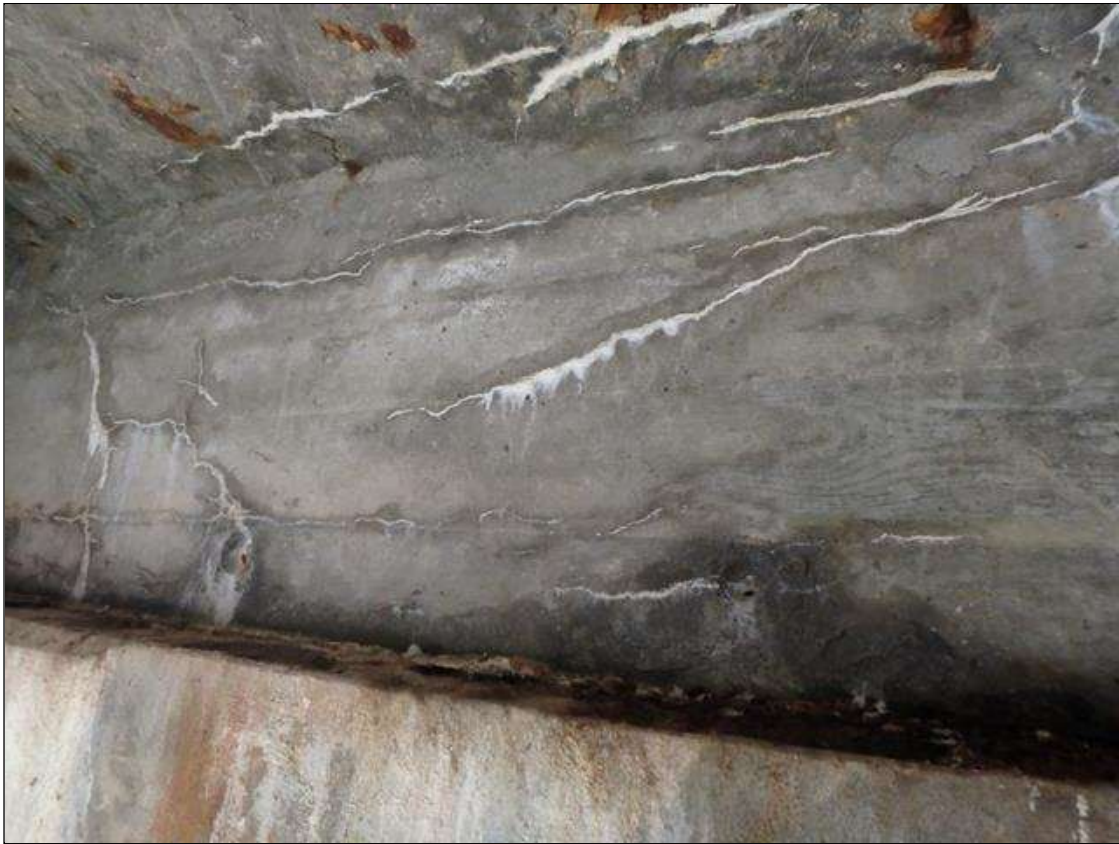
END DIAPHRAGM AT BENT 4, BAY 2, SPAN 5 FACE, CRACKING WITH EFFLORESCENCE BUILDUP, TYPICAL THROUGHOUT

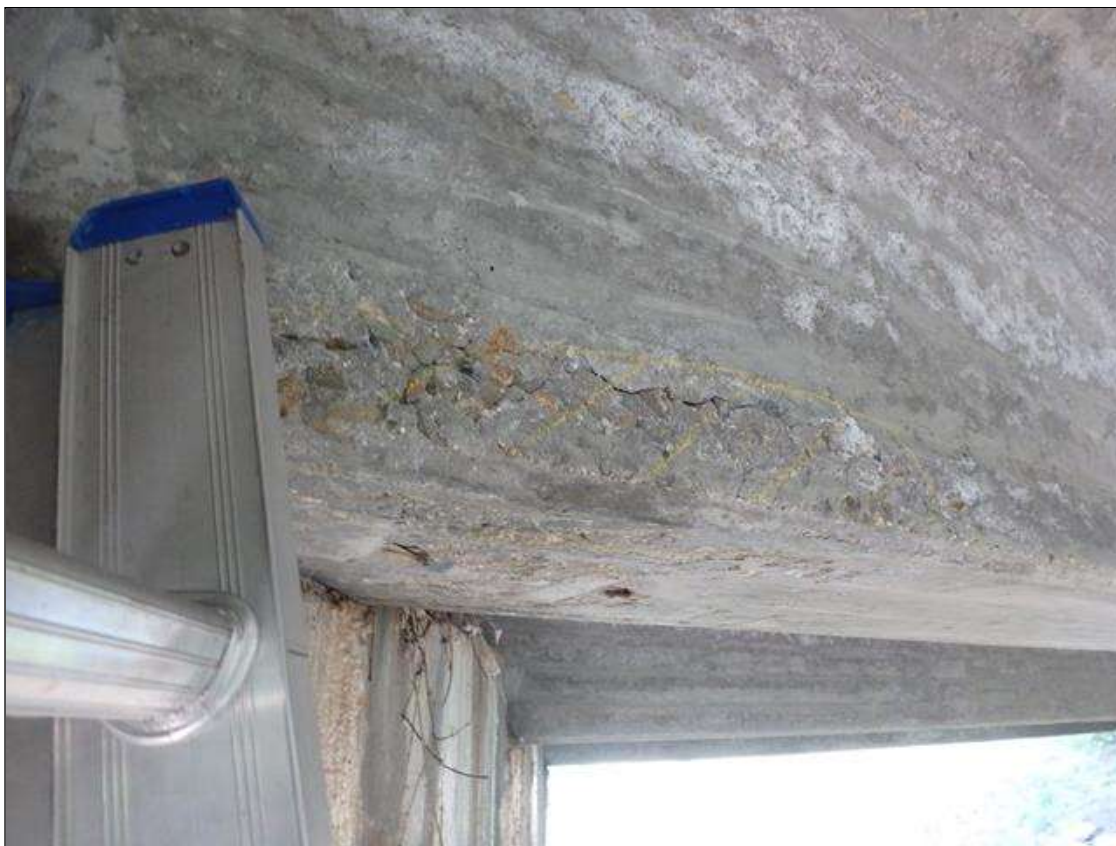
Span 5 Beam 3: DELAMINATION 3 FT X 6" ALONG BOTTOM AT BENT 4

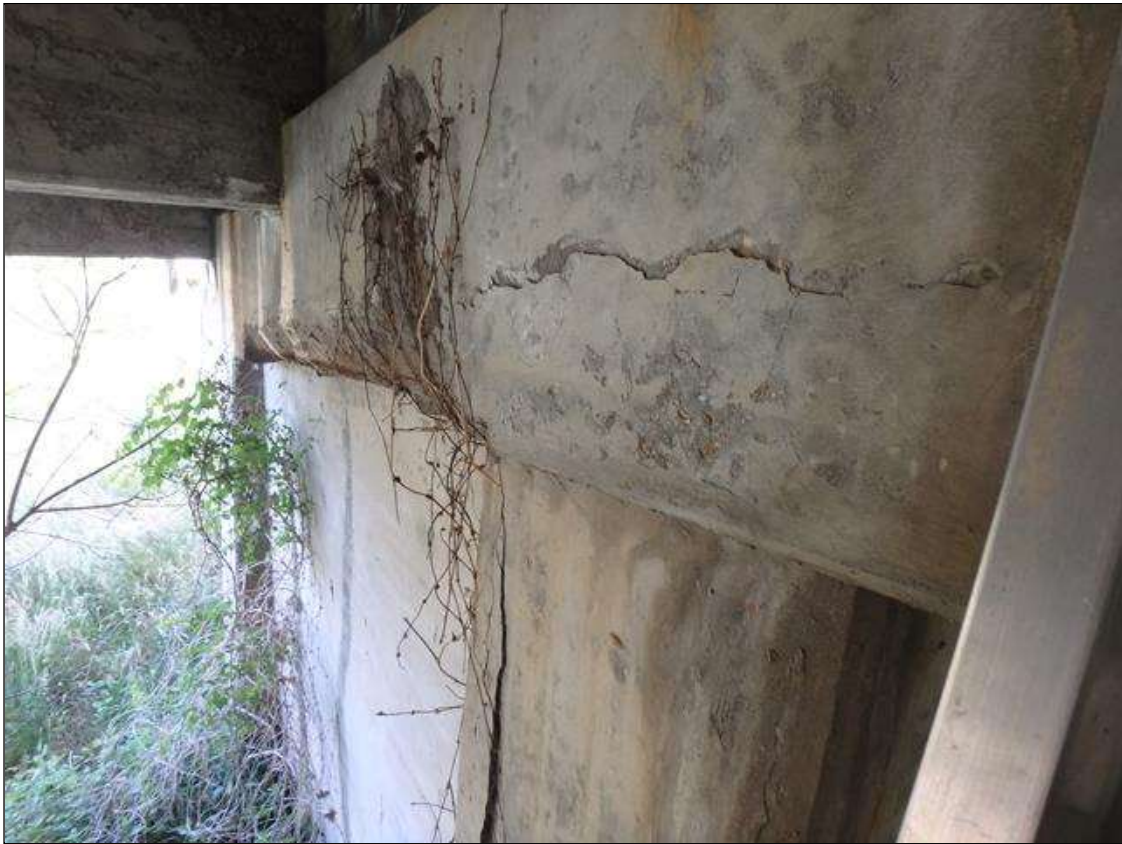
Bent 4 Cap : SPALL/DELAMINATION 12 FT X 1 FT X 1 FT WITH EXPOSED REBAR, NO SECTION LOSS, UNDER BEAMS 2 AND 3, SPAN 4 FACE
