NC DEPARTMENT OF TRANSPORTATION  
DIVISION OF HIGHWAYS  
STRUCTURE MANAGEMENT UNIT

## Structure Safety Report

### Routine Element Inspection - Contract

COUNTY: MADISON STRUCTURE NUMBER: 560008 FREQUENCY: 24 MONTHS

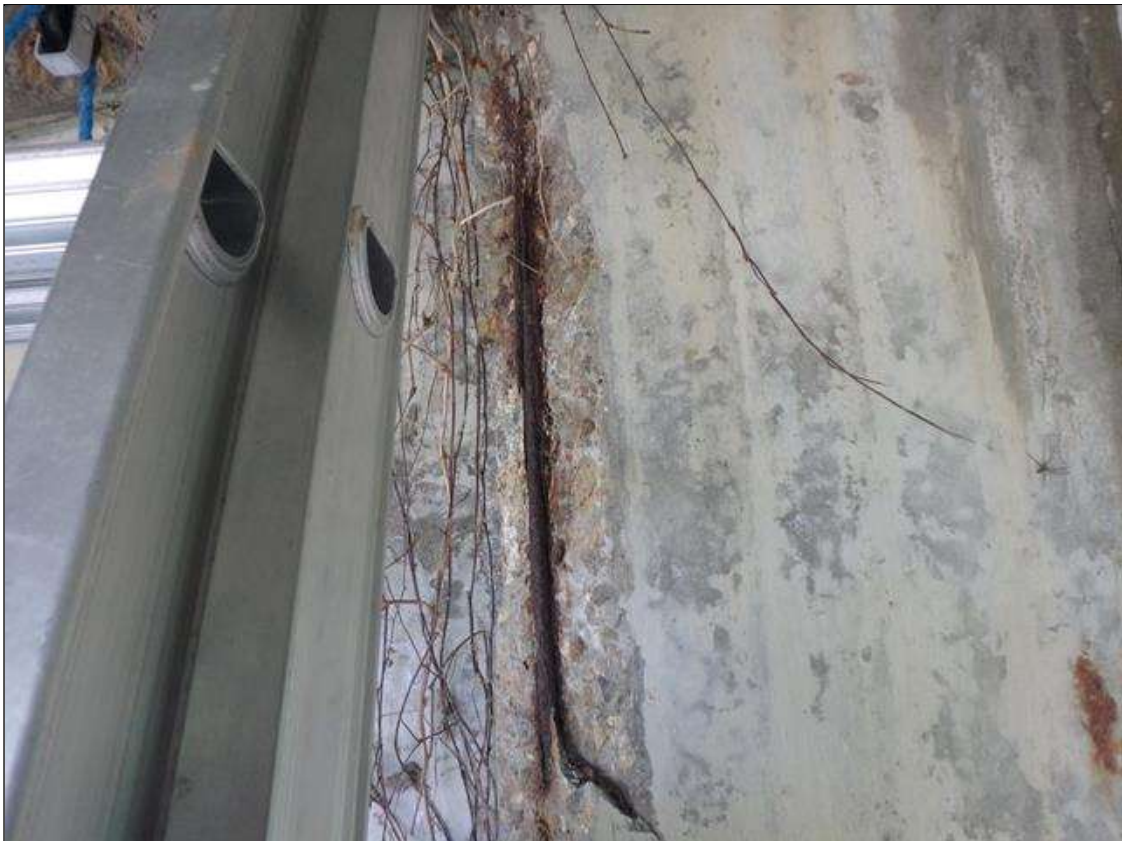
Bent 4 Pile 2: SPALL 5 FT X 9" X 8" WITH EXPOSED REBAR WITH 10% SECTION LOSS ALONG SOUTHWEST CORNER IN SPAN 4, PRIORITY MAINTENANCE

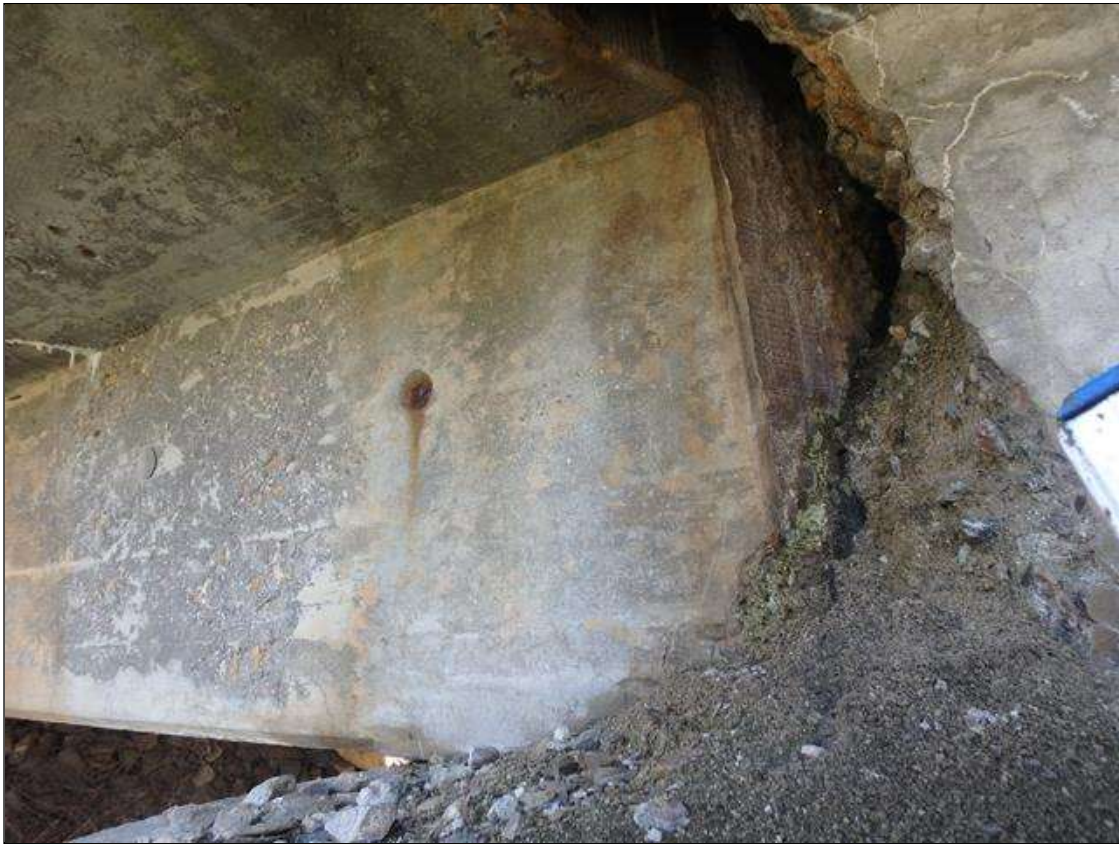
Span 4 Beam 1: SPALL 2 FT X 7" X 7", NO EXPOSED REBAR AT BENT 4

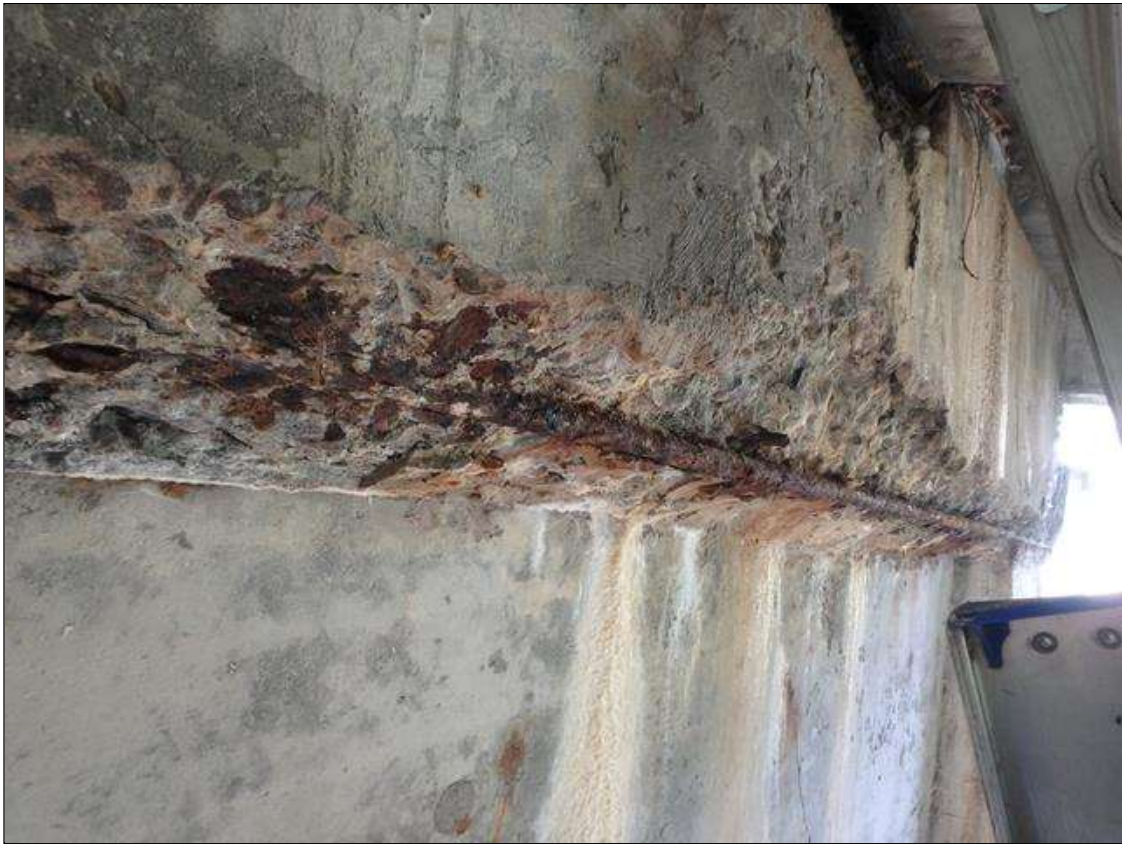
Bent 3 Cap : SPALL 15 FT X 1 FT X 1 FT WITH EXPOSED REBAR, NO SECTION LOSS, OVER COLUMN 1 AND IN BAY 1, SPAN 4 FACE, PRIORITY MAINTENANCE

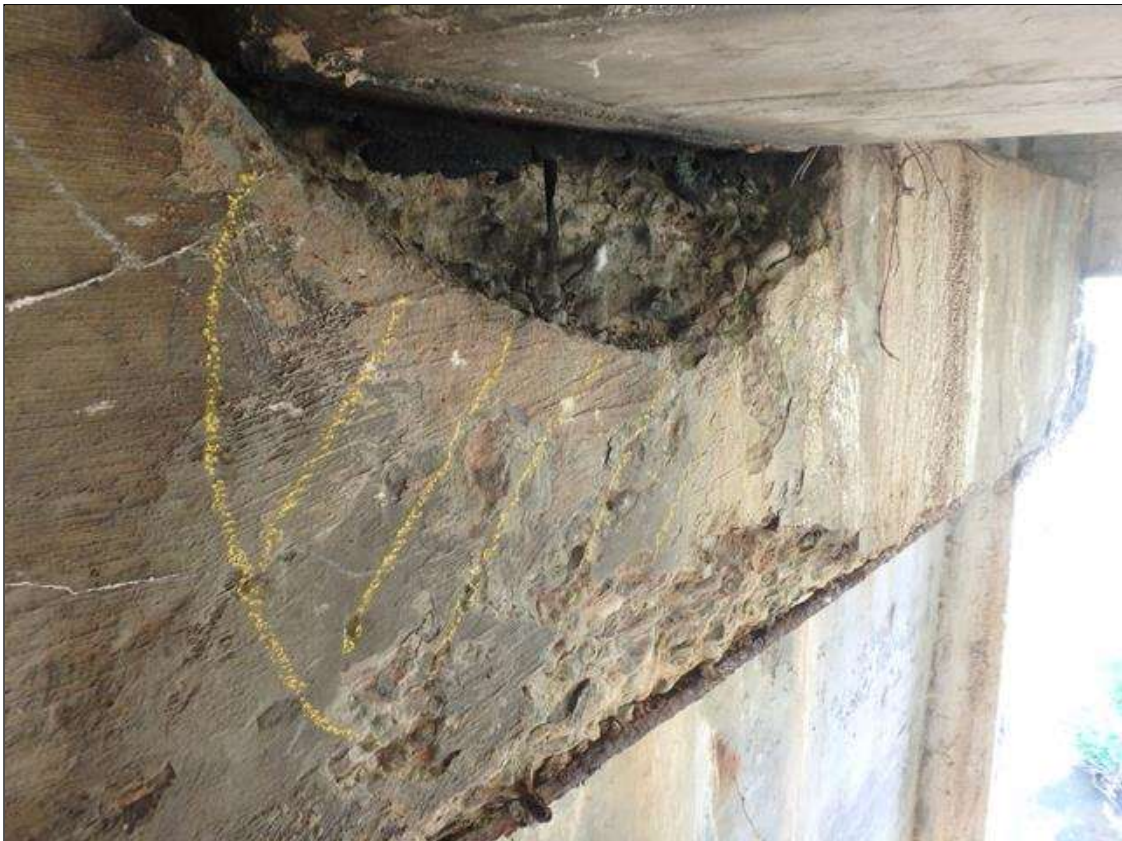
Bent 3 Cap : SPALL 2 FT X 7" X 3" DEEP, NO EXPOSED REBAR, RESULTING IN LOSS OF BEARING AREA UNDER BEAM 2, SPAN 4 FACE, PRIORITY MAINTENANCE

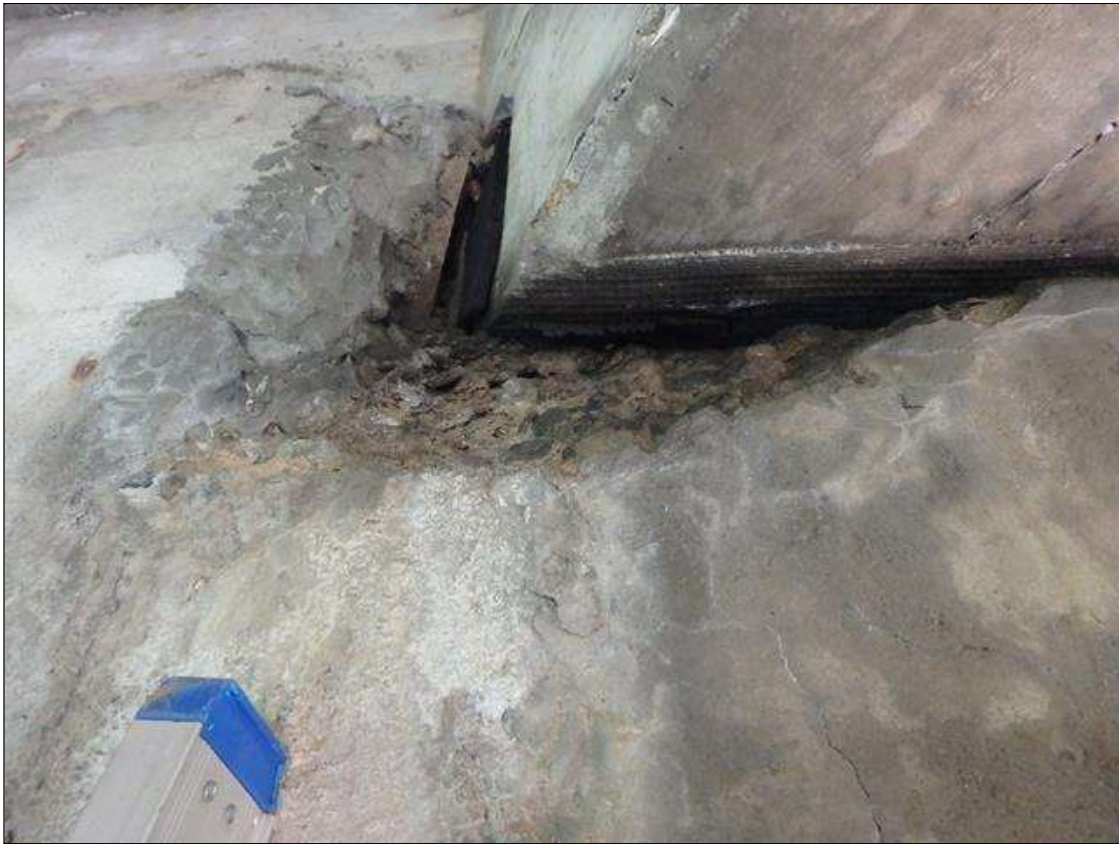
Bent 3 Cap : SPALL 18" X 6" X 3" DEEP, NO EXPOSED REBAR, RESULTING IN LOSS OF BEARING AREA UNDER BEAM 3, SPAN 4 FACE, PRIORITY MAINTENANCE

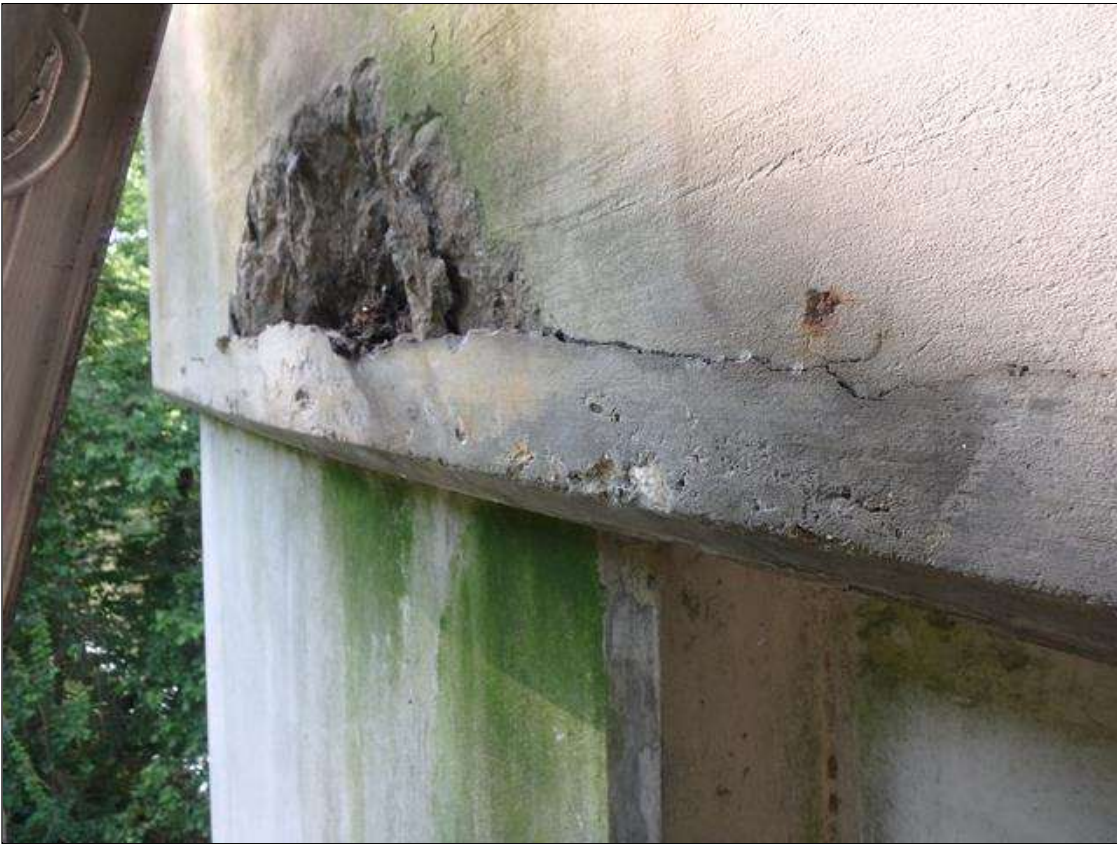
Bent 3 Cap : SPALL 18" X 18" X 2" DEEP, NO EXPOSED REBAR ABOVE COLUMN 3, SPAN 4 FACE

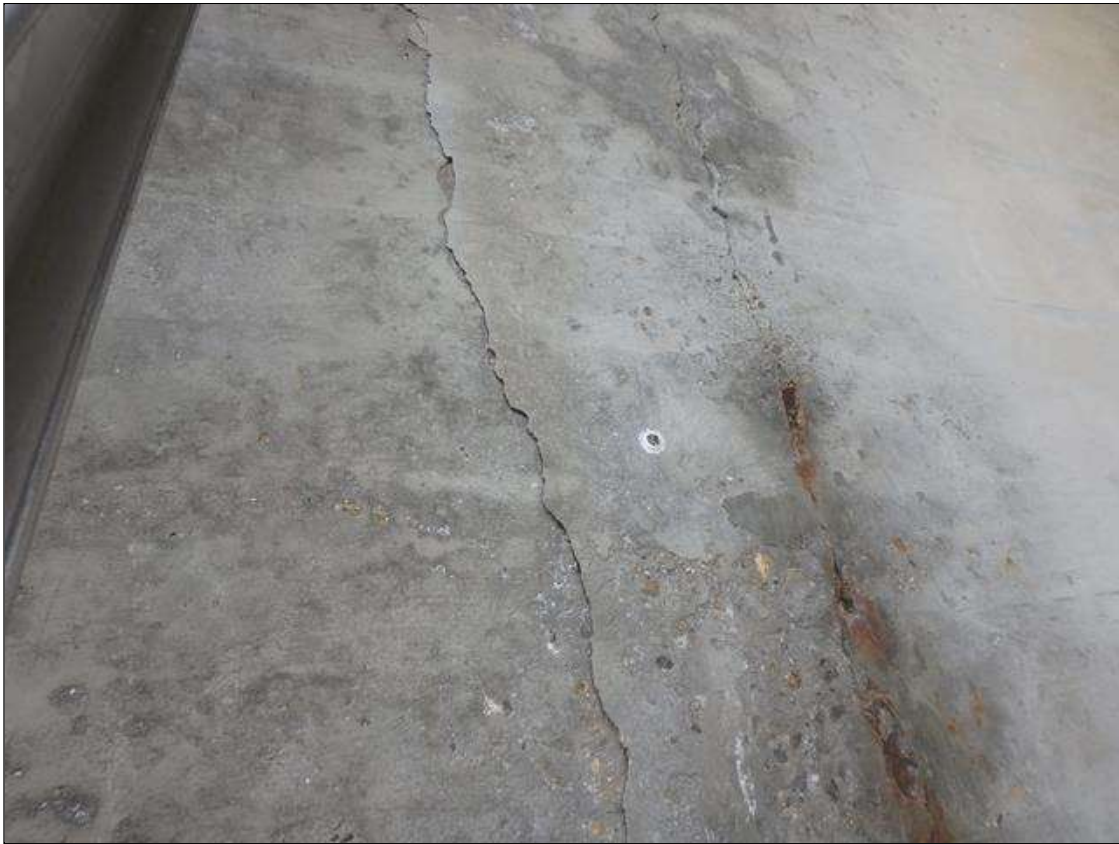
Bent 3 Cap : DELAMINATION 6 FT X 1 FT ADJACENT TO FULL HEIGHT VERTICAL CRACK UP TO 1/16" WITH RUST STAINING AND EFFLORESCENCE IN BAY 1 WALL, SPAN 3 FACE

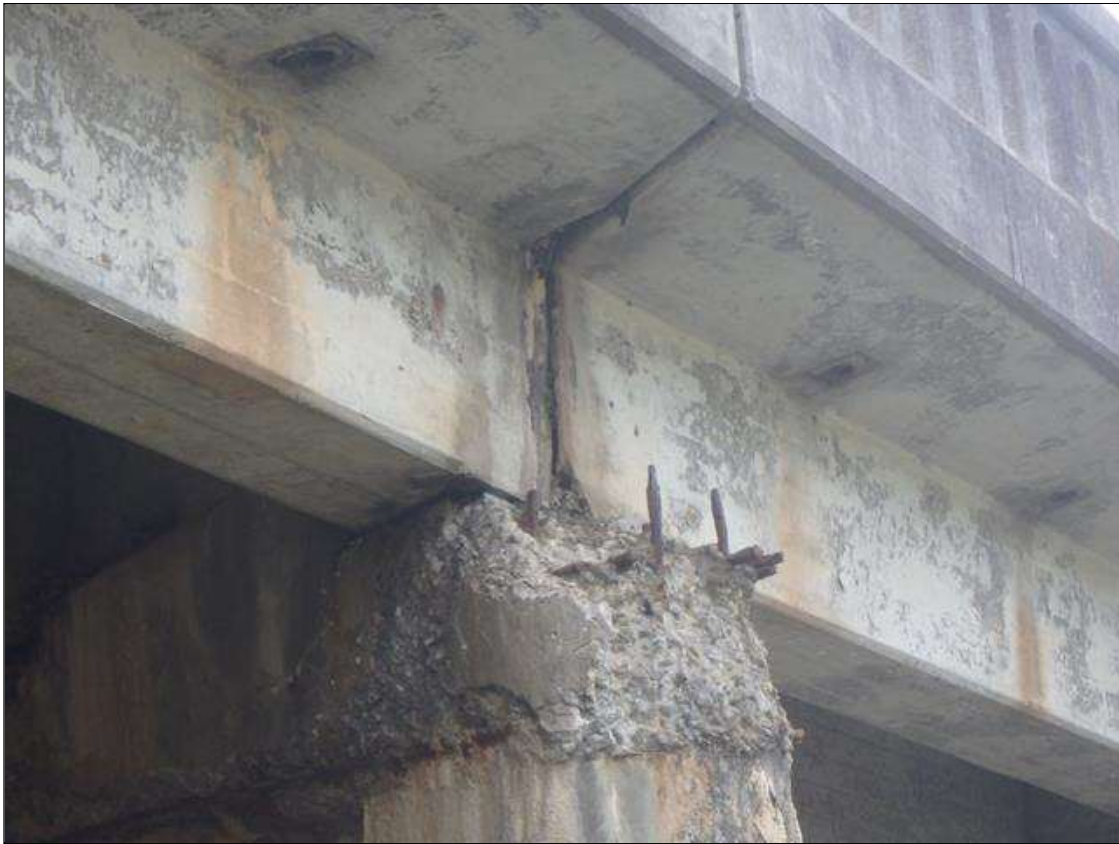
Bent 3 Cap : SPALL WITH DETERIORATING CONCRETE 3 FT X 2 FT X UP TO 1 FT WITH EXPOSED REBAR, NO SECTION LOSS, ALONG LEFT END OF CAP NEAR BEAM 1 BEARING, PRIORITY MAINTENANCE

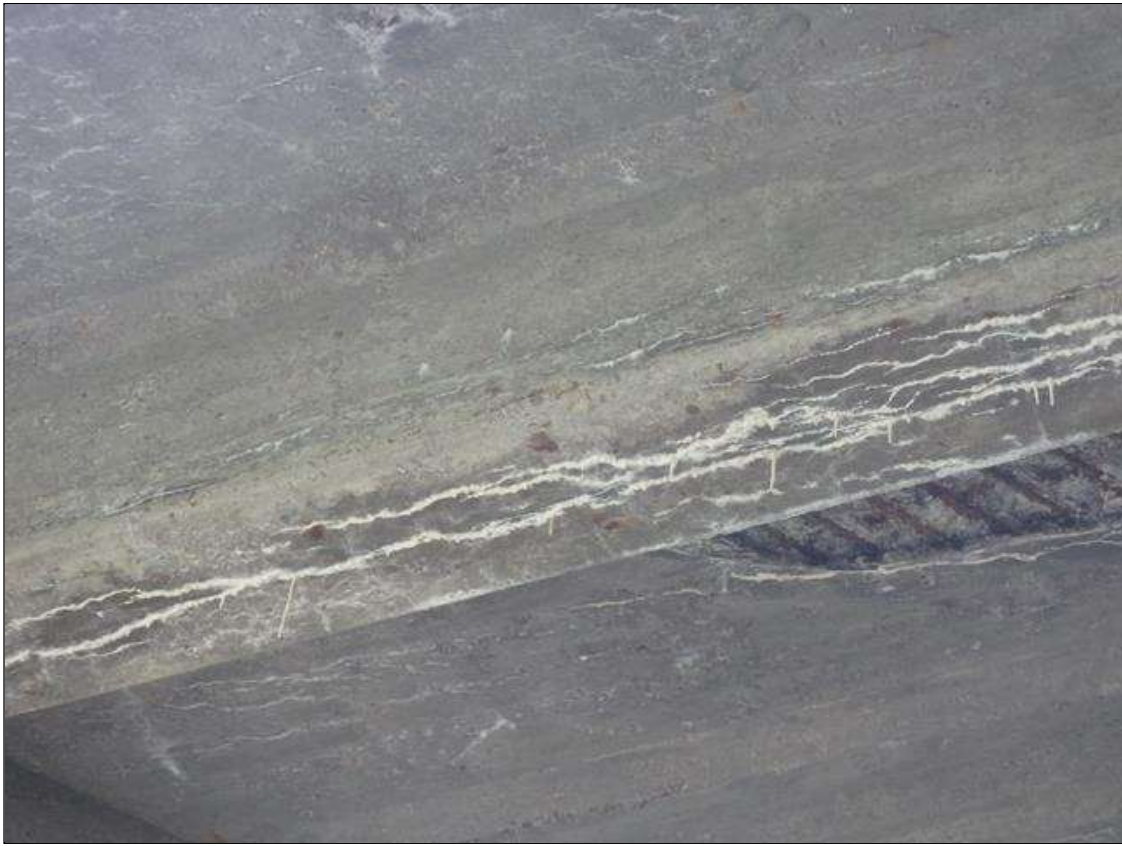
SCATTERED SURFACE DETERIORATION ALONG BOTTOM AND SIDE FACES  
 SCATTERED LONGITUDINAL AND MAP CRACKING WITH EFFLORESCENCE BUILDUP ALONG BOTTOM AND BOTH FACES, FULL LENGTH

Span 2 Beam 2: SCATTERED LONGITUDINAL AND MAP CRACKING WITH EFFLORESCENCE BUILDUP ALONG BOTTOM AND BOTH FACES, FULL LENGTH

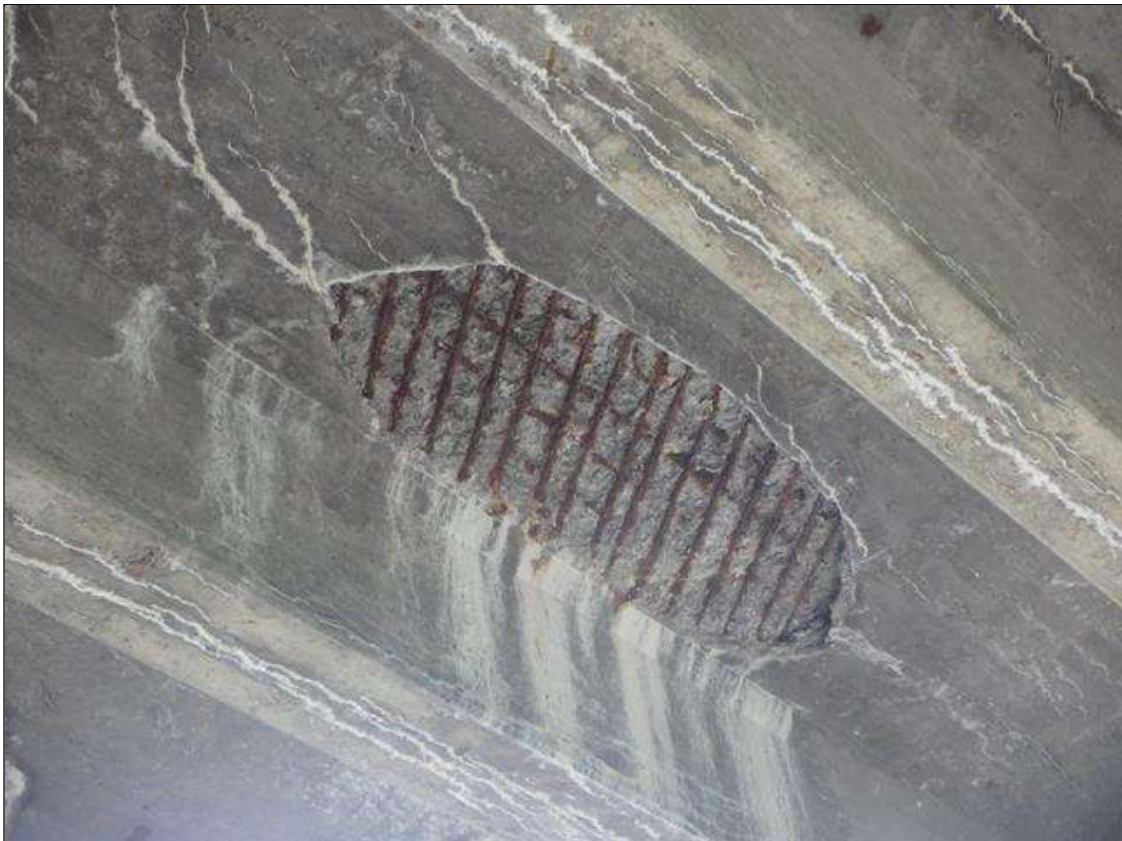
Span 2 Deck: SPALL 10 FT X 4 FT X 4" DEEP WITH EXPOSED REBAR IN BAY 2 NEAR BEAM 2, 10 FT FROM BENT 1, PRIORITY MAINTENANCE

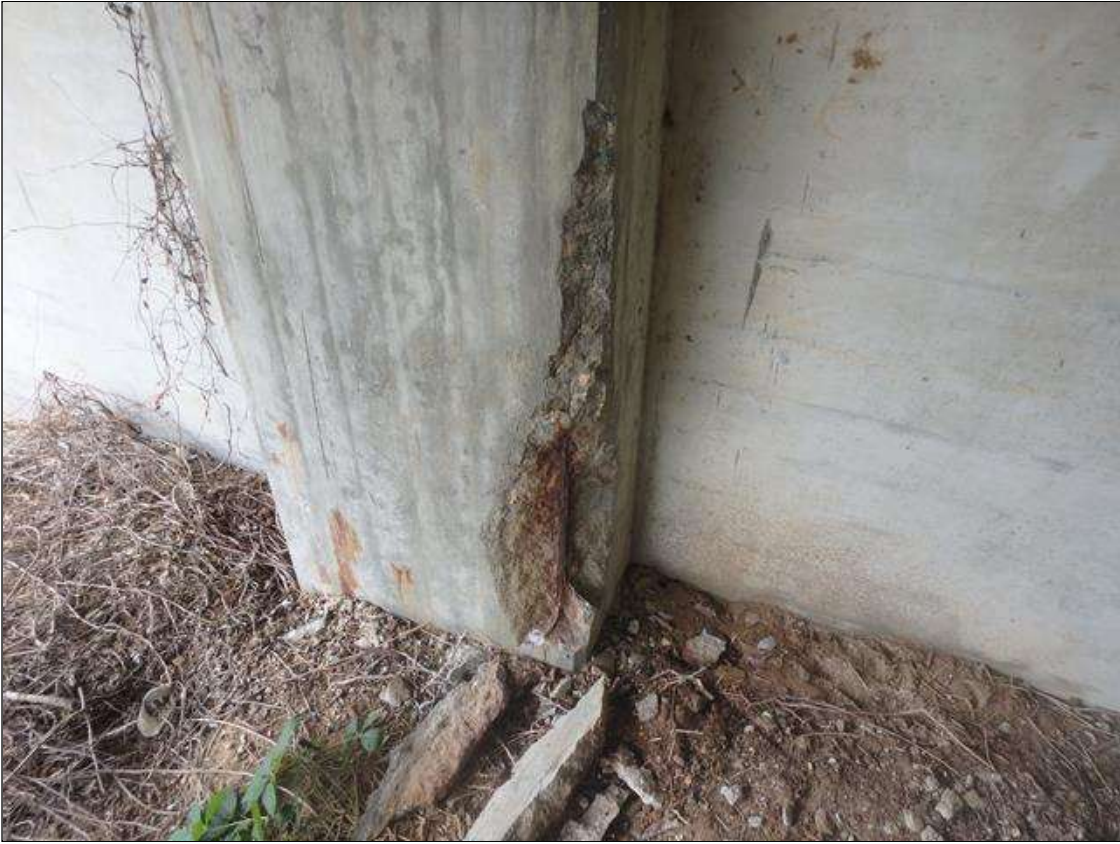
Bent 1 Pile 2: SPALL 3.5 FT X 8" X 6" WITH EXPOSED REBAR, 25% SECTION LOSS, ALONG BASE AT SOUTHEAST CORNER, SPAN 1, PRIORITY MAINTENANCE

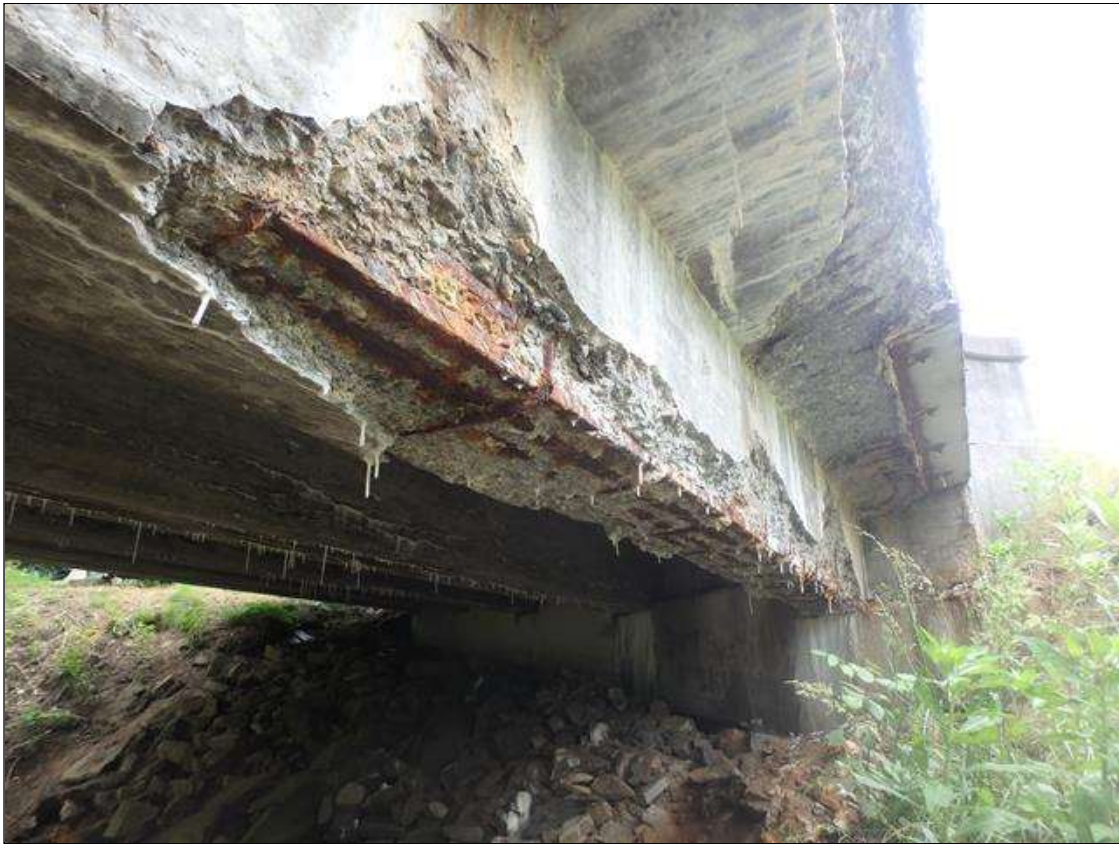
Span 1 Beam 1: SPALL UP TO 2 FT TALL X FULL WIDTH X 3" DEEP WITH EXPOSED REBAR, 20% SECTION LOSS WITH HEAVY EFFLORESCENCE BUILDUP FOR 17 FT FROM END BENT 1, PRIORITY MAINTENANCE

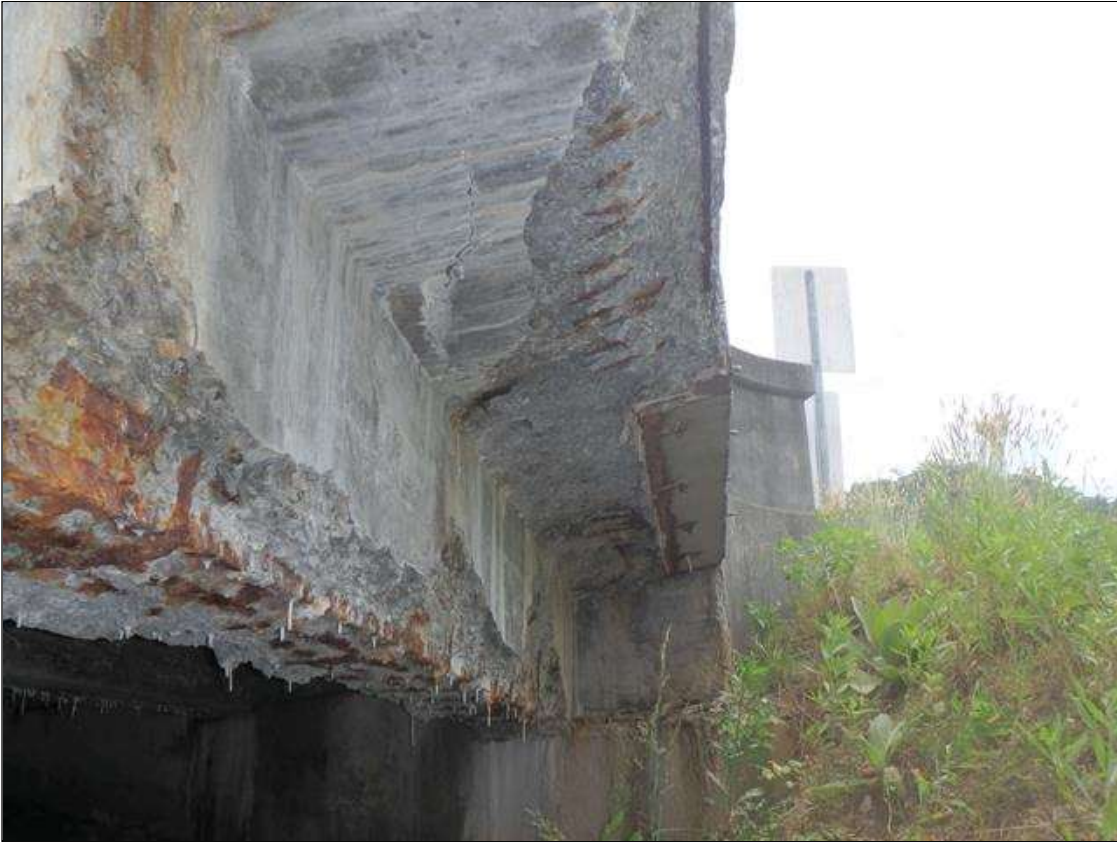
Span 1 Deck: SPALL UP TO FULL WIDTH X 3" DEEP FOR 17 FT FROM END BENT 1 ALONG UNDERSIDE OF LEFT OVERHANG, PRIORITY MAINTENANCE

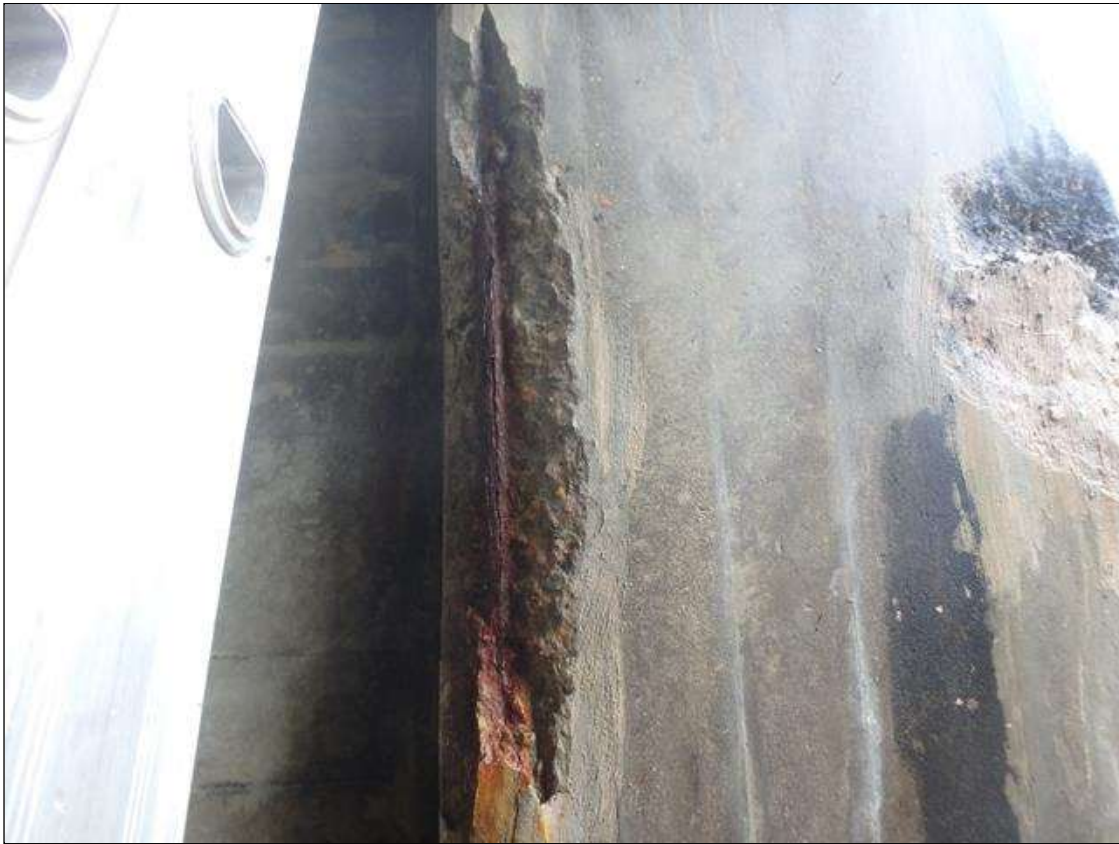
Bent 2 Pile 1: SPALL 3 FT X 6" X 6" WITH EXPOSED REBAR, 25% SECTION LOSS, AT MIDHEIGHT ALONG NORTHEAST CORNER, SPAN 3 FACE, PRIORITY MAINTENANCE

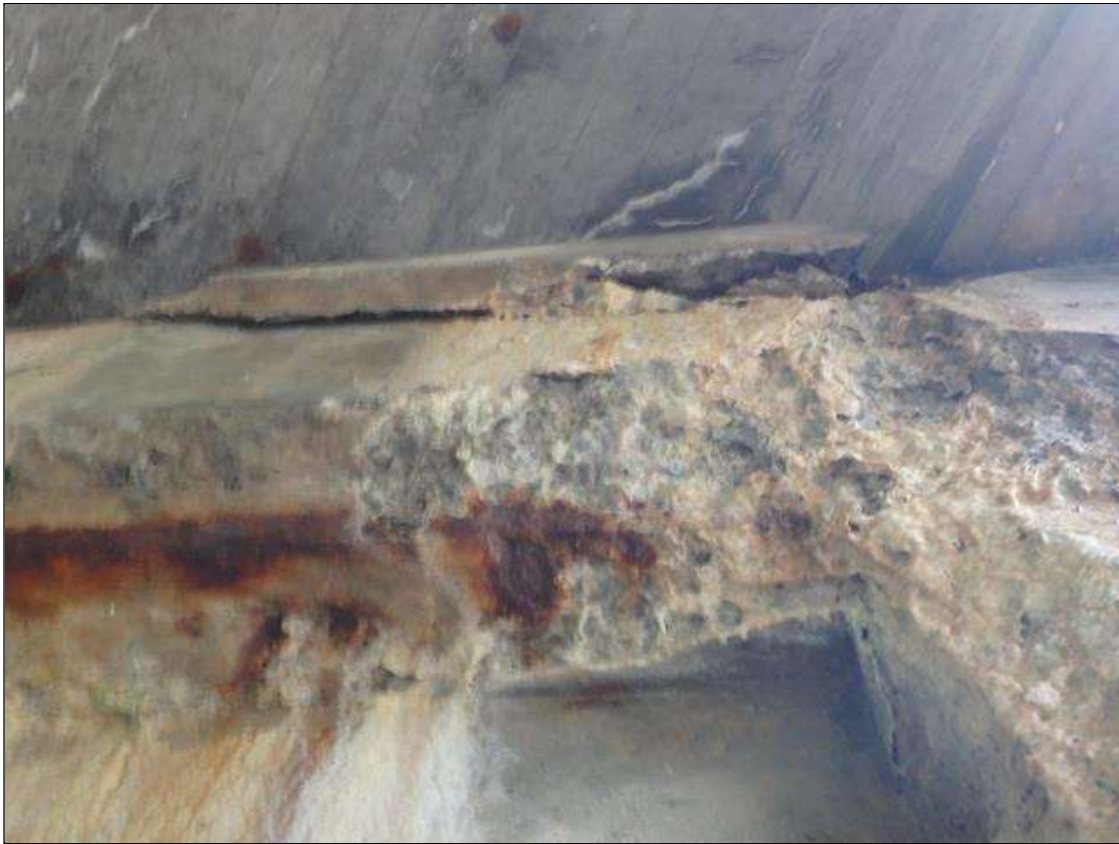
Bent 2 Cap : DELAMINATION/SPALL 3 FT X 1 FT X 3" IN IMMINENT DANGER OF FALLING, IN BAY NEAR BEAM 1, SPAN 3 FACE, PRIORITY MAINTENANCE

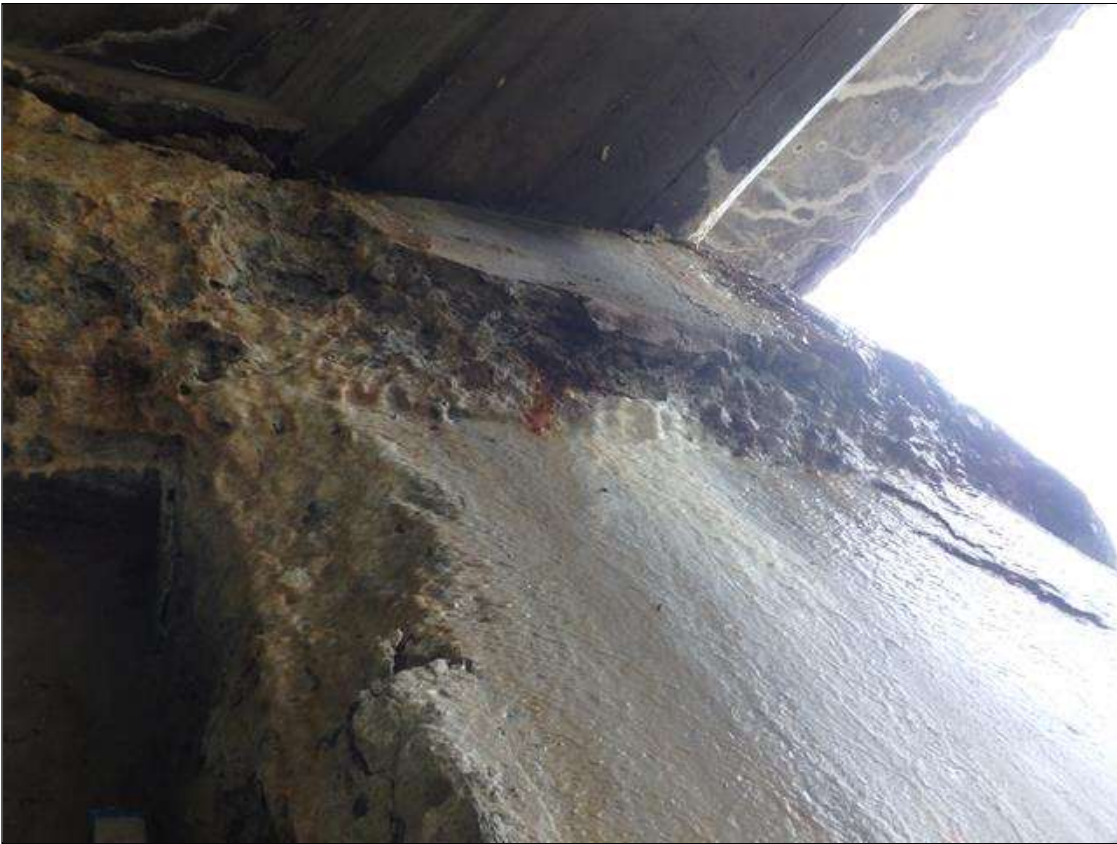
Bent 2 Cap : SPALL 4 FT X 1 FT X 2" DEEP WITH EXPOSED REBAR, NO SECTION LOSS ALONG BOTTOM OF CAP, BAY 1, SPAN 3 FACE

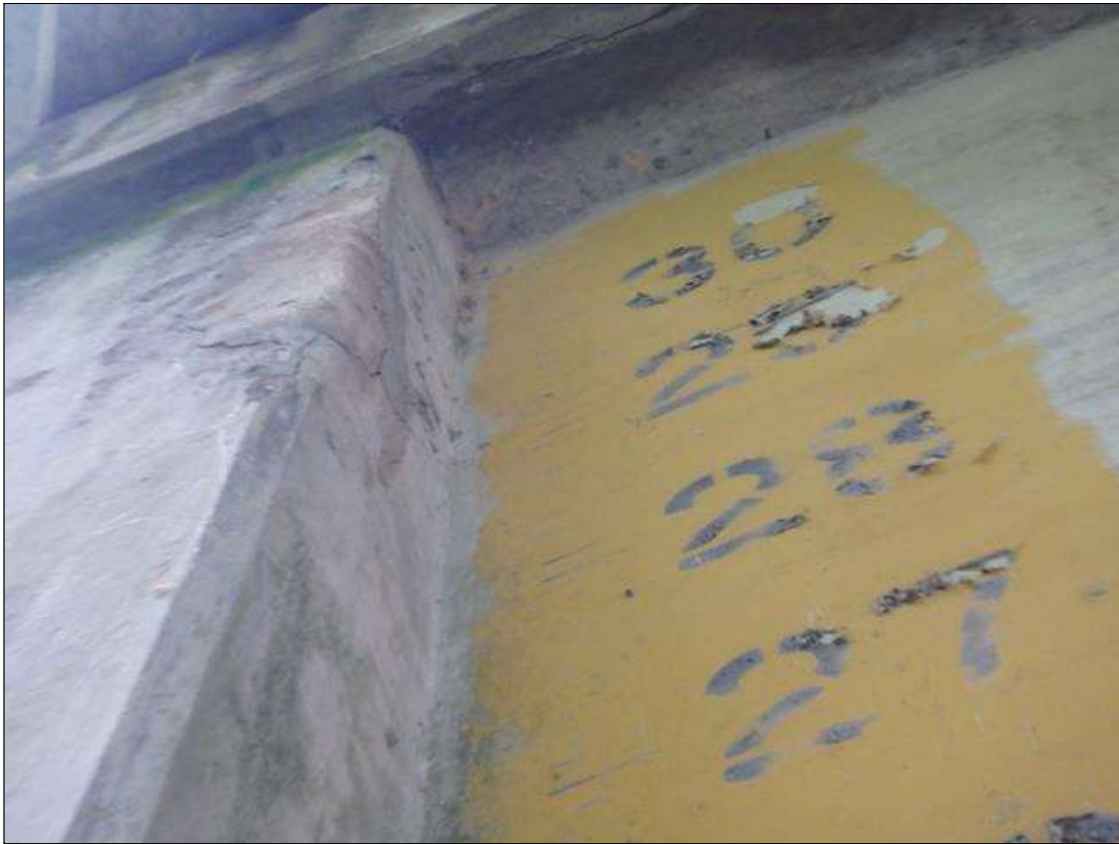
Bent 2 Pile 2: PATCHED AREA 3 FT X 6" X 6" WITH 1/16" CRACKING ALONG NORTHWEST CORNER, SPAN 3 SIDE

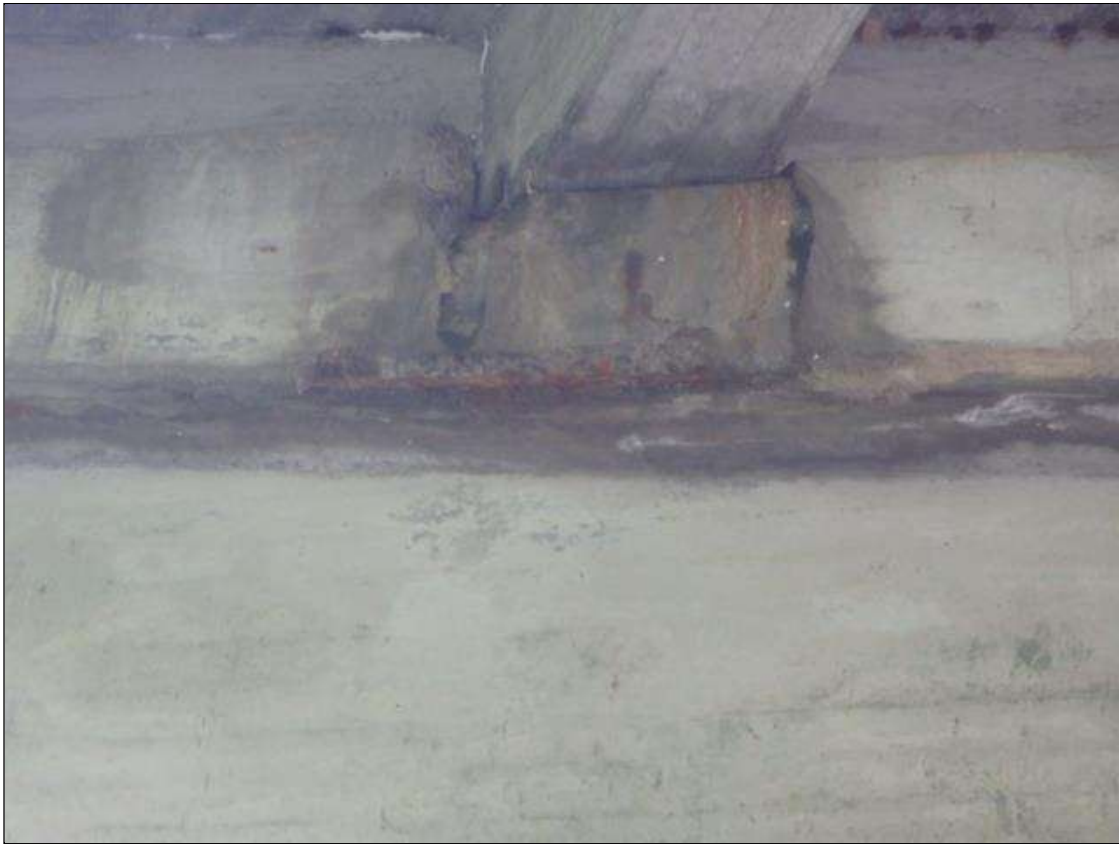
Bent 2 Cap : SPALL 3 FT X 6" X 3" DEEP WITH EXPOSED REBAR, NO SECTION LOSS UNDER BEAM 4, BOTTOM OF CAP, SPAN 3 FACE

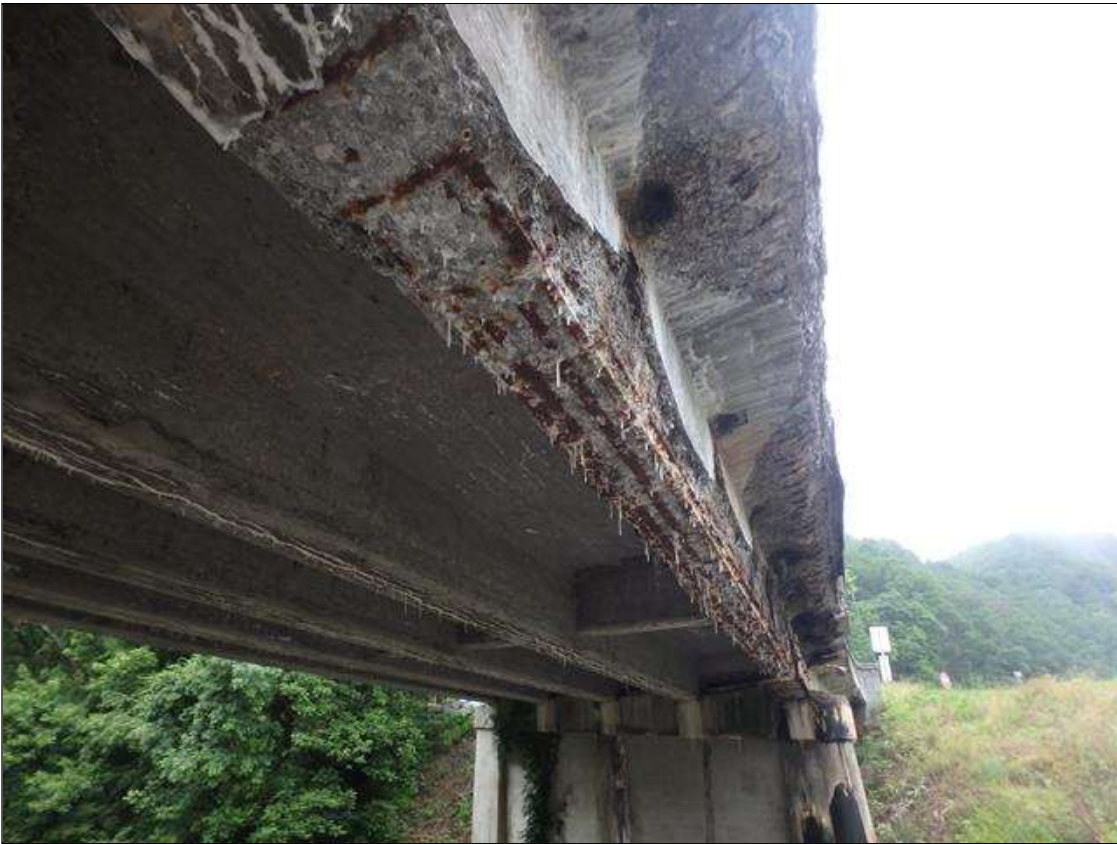
Span 2 Beam 1: SPALL UP TO FULL HEIGHT X UP TO FULL WIDTH X 4" DEEP WITH EXPOSED REBAR WITH 25% SECTION LOSS AND HEAVY EFFLORESCENCE BUILDUP, FULL LENGTH, PRIORITY MAINTENANCE

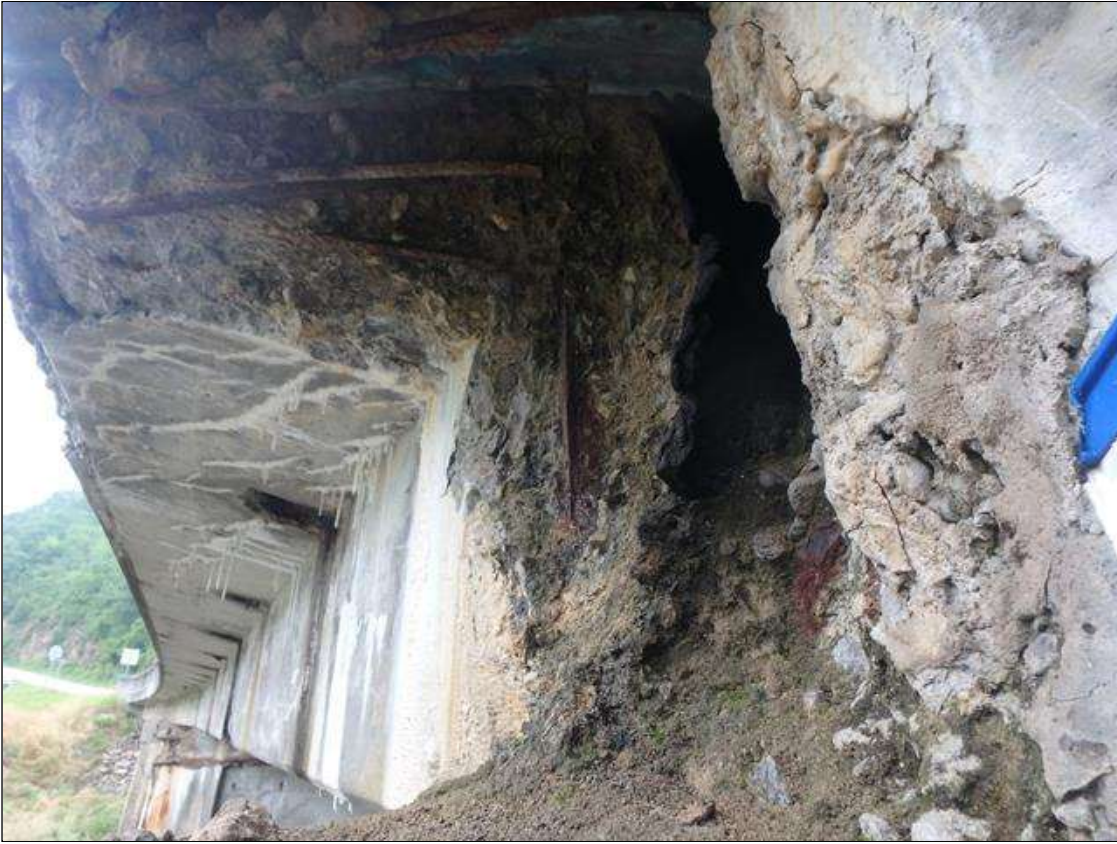
Span 3 Beam 1: SPALL 2 FT X 7" X UP TO 3" DEEP WITH EXPOSED REBAR, NO SECTION LOSS, AT BENT 2

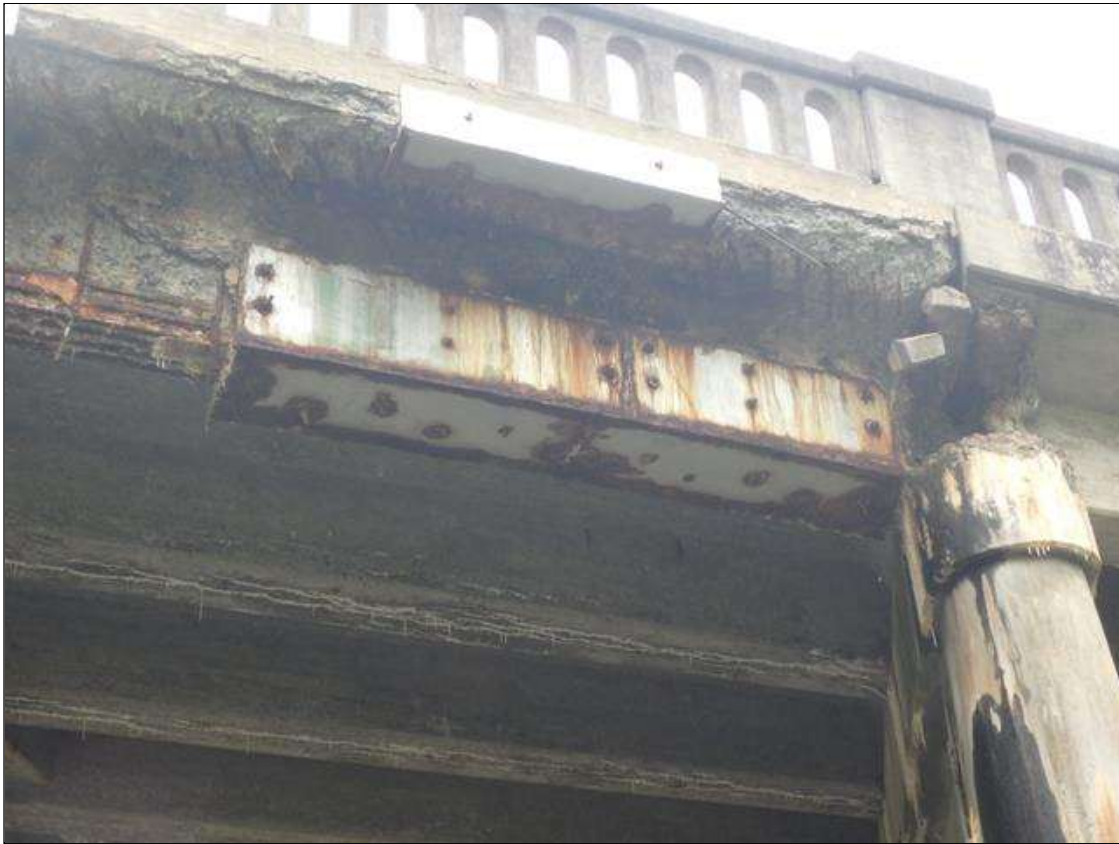
Span 2 Beam 1: TEMPORARY REPAIR AT BENT 1

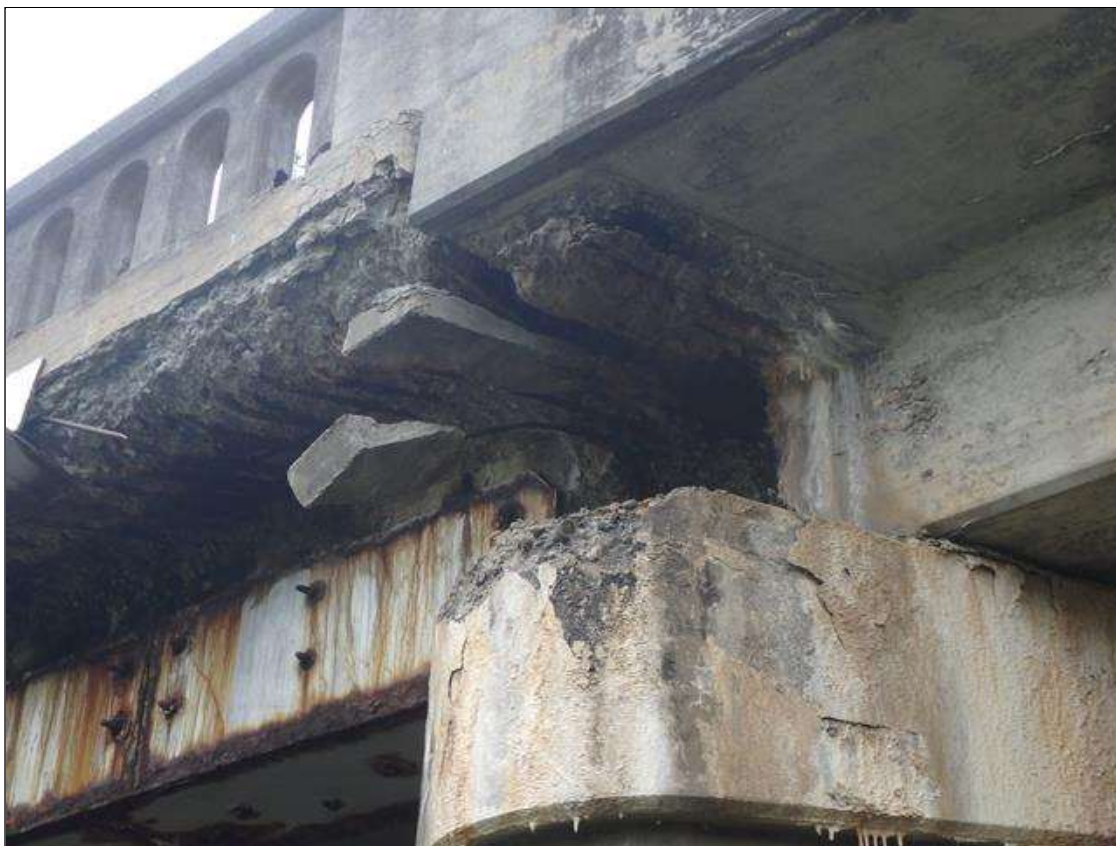
Span 2 Deck: SPALL 3 FT X 2 FT X UP TO 6" DEEP IN DANGER OF FALLING OFF AT BENT 1, PRIORITY MAINTENANCE

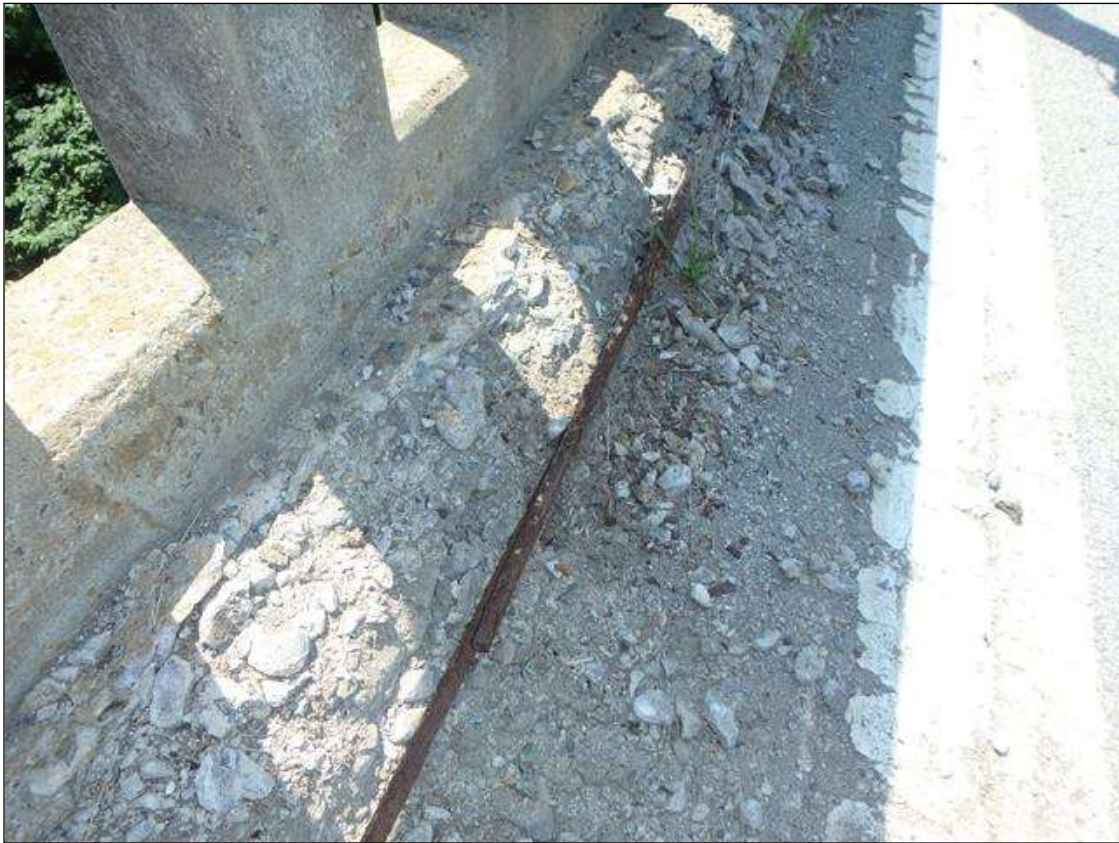
SPAN 2 RIGHT BRIDGE RAIL: SPALL/ DETERIORATING FOR 9" WIDE X FULL LENGTH, WITH EXPOSED REBAR STICKING OUT TOWARDS TRAVEL LANE FOR 15 FT, PM
