NC DEPARTMENT OF TRANSPORTATION  
DIVISION OF HIGHWAYS  
STRUCTURE MANAGEMENT UNIT

## Structure Safety Report

### Routine Element Inspection - Contract

COUNTY: MADISON STRUCTURE NUMBER: 560008 FREQUENCY: 24 MONTHS

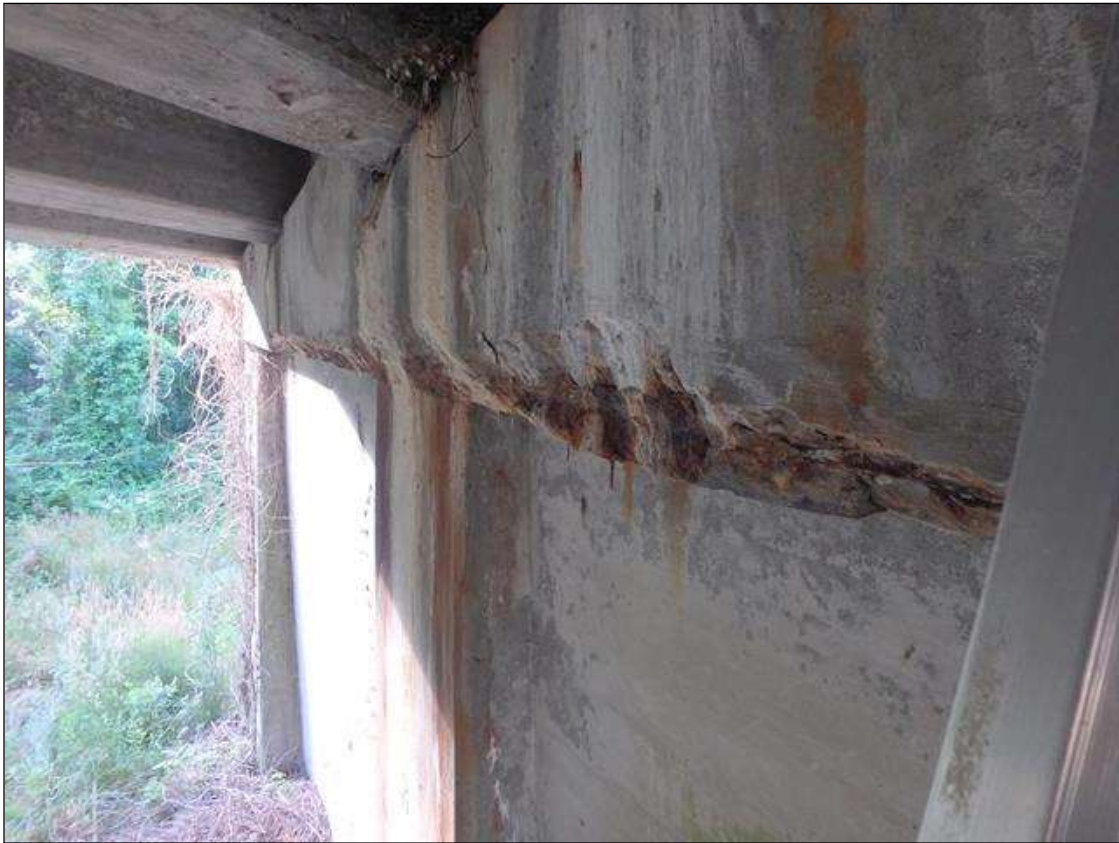
BENT 4 CAP : SPALL 19 FT X 1 FT X 1 FT WITH EXPOSED REBAR WITH 5% SECTION LOSS UNDER BEAMS 2, 3 AND 4, PRIORITY MAINTENANCE

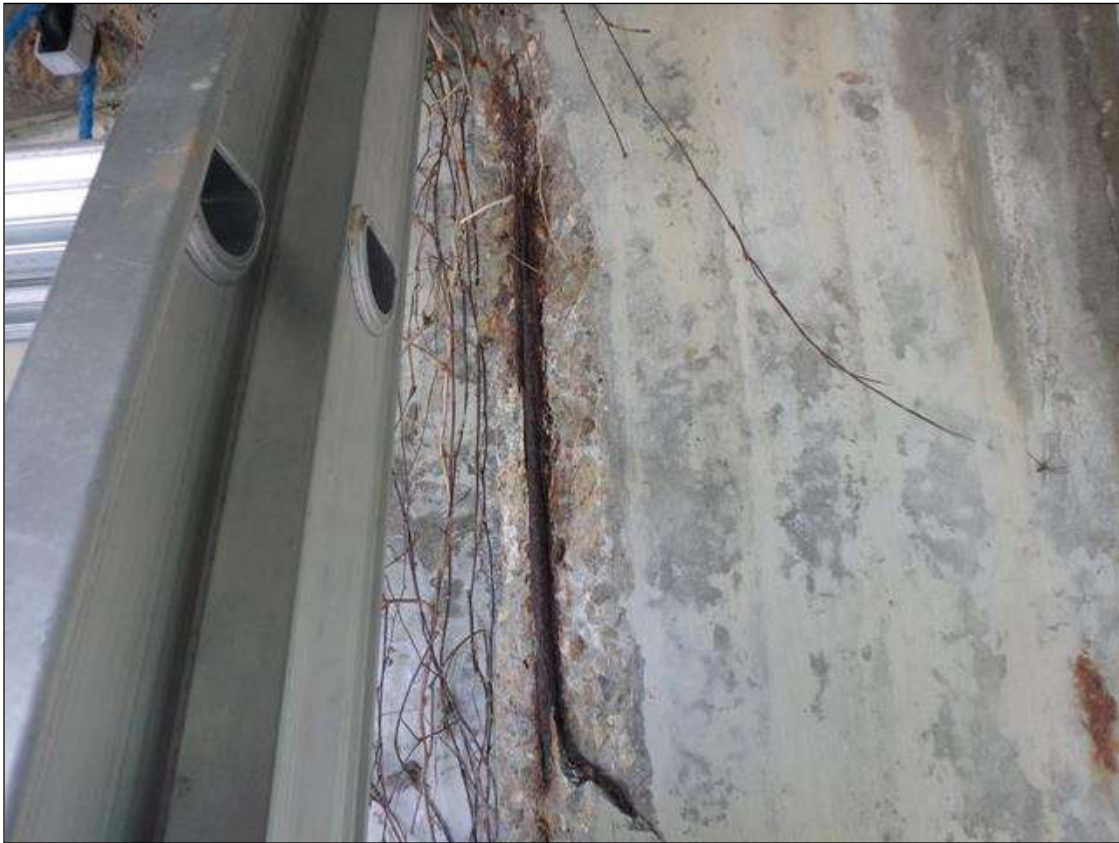
BENT 4 PILE 2: SPALL 5 FT X 9" X 8" WITH EXPOSED REBAR WITH 10% SECTION LOSS ALONG SOUTHWEST CORNER IN SPAN 4, PRIORITY MAINTENANCE

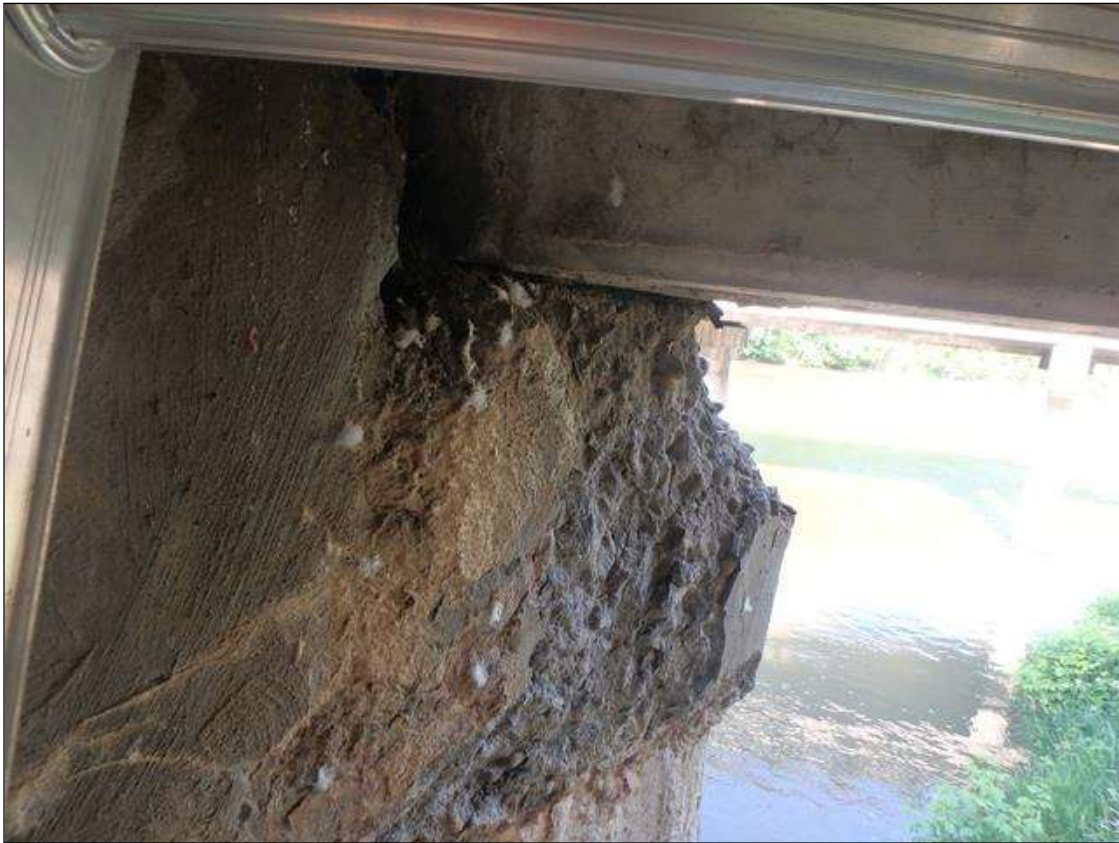
BENT 3 CAP : SPALL 2 FT X 2 FT X 3" UNDER BEAM 1, SPAN 4 FACE, RESULTING IN LOSS OF BEARING AREA,  
PRIORITY MAINTENANCE

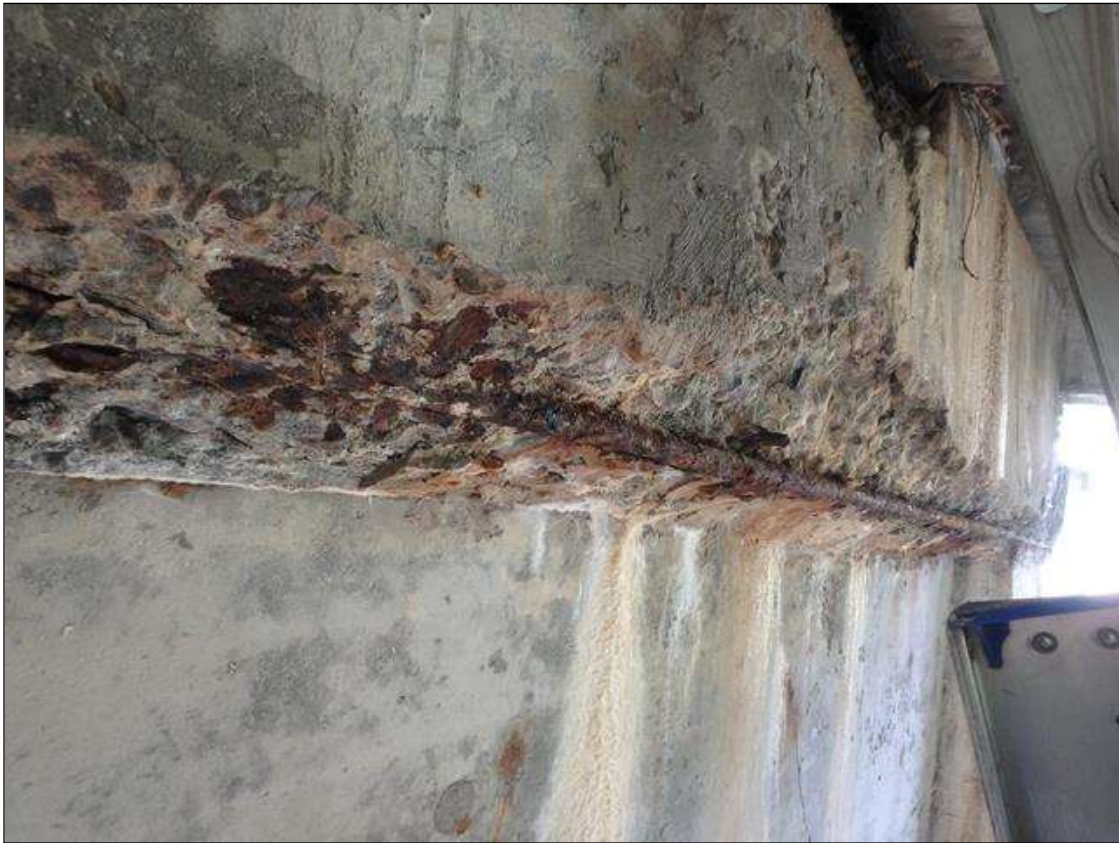
BENT 3 CAP : SPALL 15 FT X 1 FT X 1 FT WITH EXPOSED REBAR, NO SECTION LOSS, OVER COLUMN 1 AND IN BAY 1, SPAN 4 FACE, PRIORITY MAINTENANCE

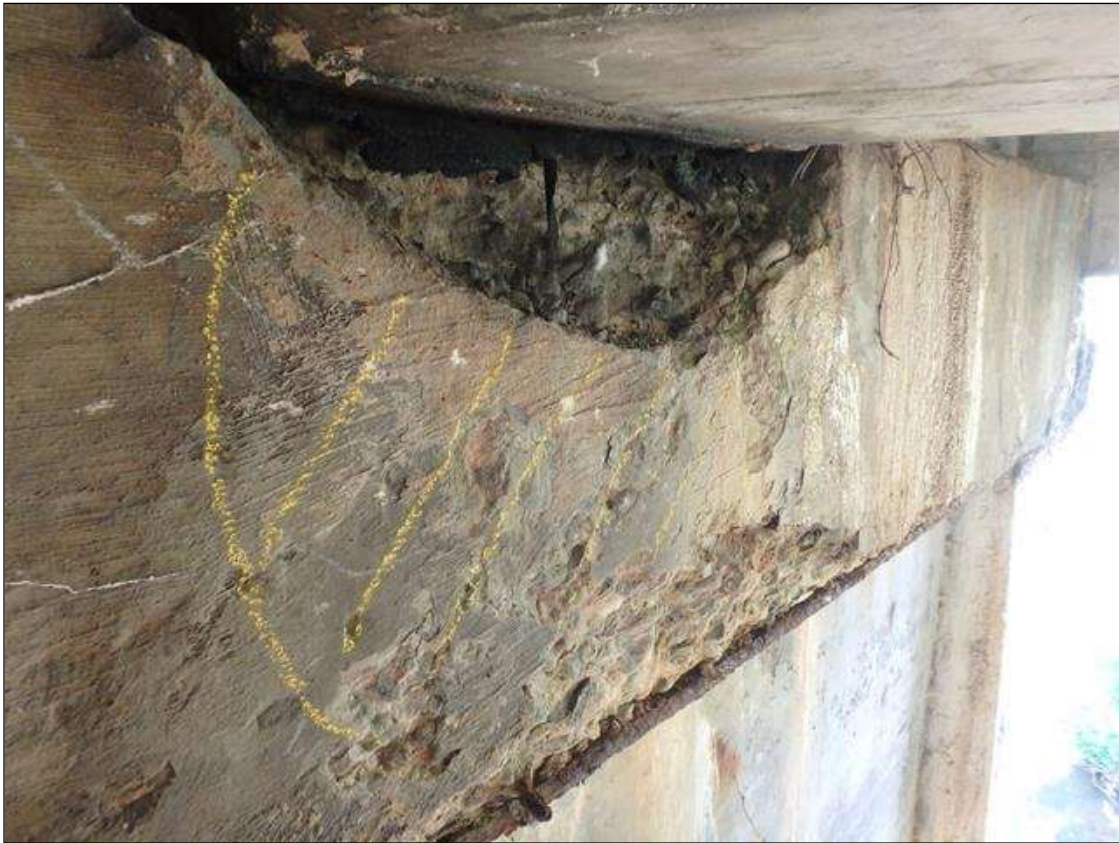
BENT 3 CAP : SPALL 2 FT X 7" X 3" DEEP, NO EXPOSED REBAR, RESULTING IN LOSS OF BEARING AREA  
UNDER BEAM 2, SPAN 4 FACE, PRIORITY MAINTENANCE

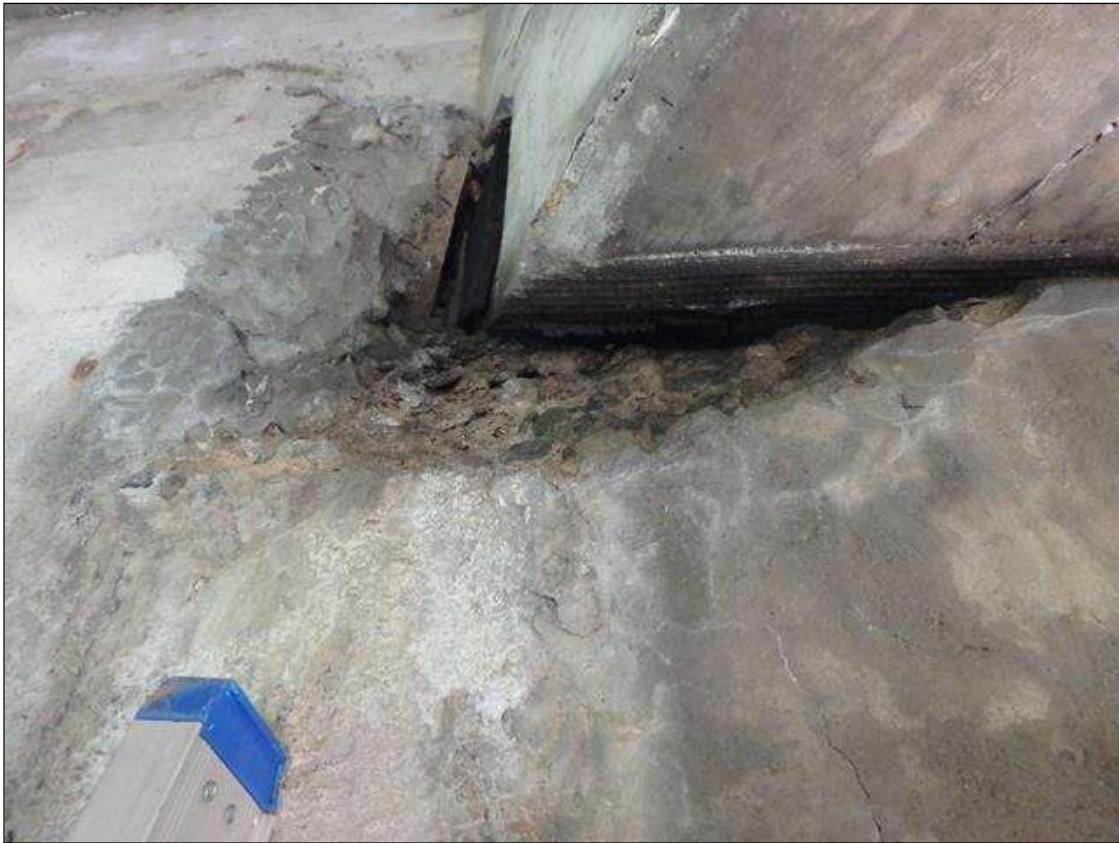
BENT 3 CAP : SPALL 18" X 6" X 3" DEEP, NO EXPOSED REBAR, RESULTING IN LOSS OF BEARING AREA  
UNDER BEAM 3, SPAN 4 FACE, PRIORITY MAINTENANCE

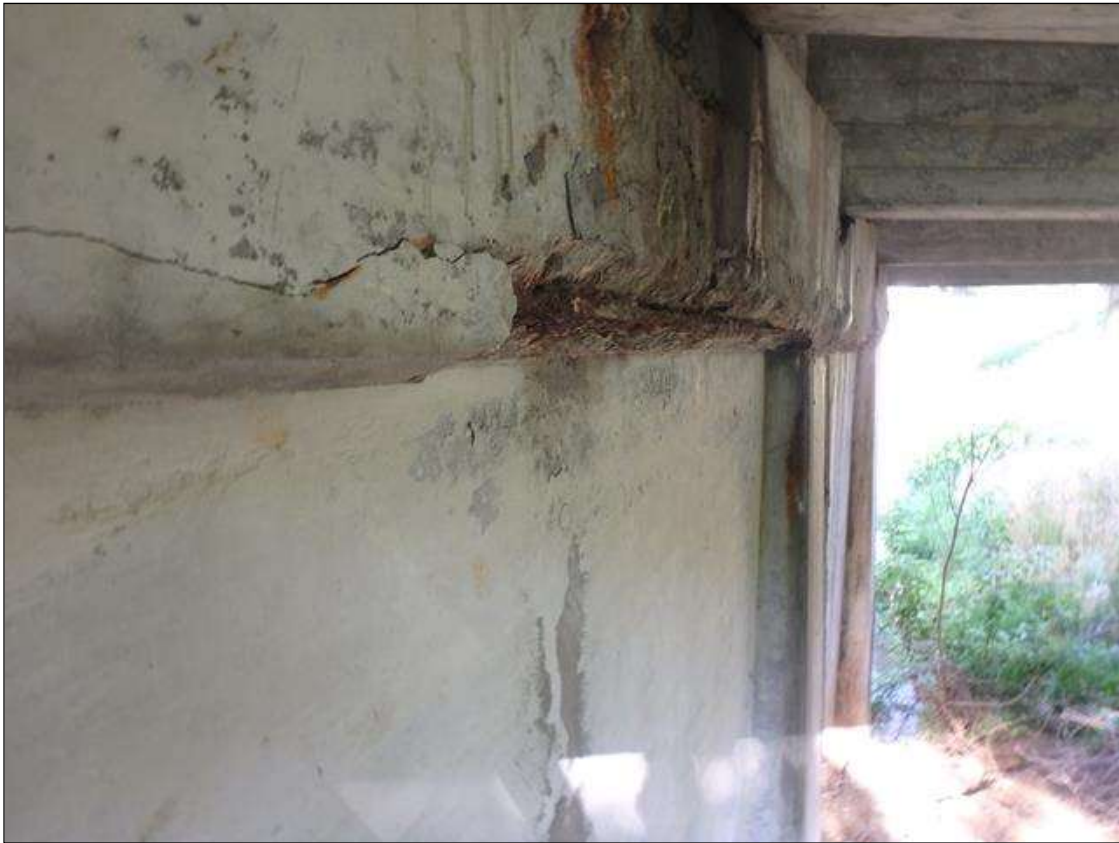
BENT 3 CAP : SPALL/DELAMINATION 10 FT X 1 FT X 1 FT WITH EXPOSED REBAR, 25% SECTION LOSS,  
ABOVE BAY 2 WALL, PRIORITY MAINTENANCE

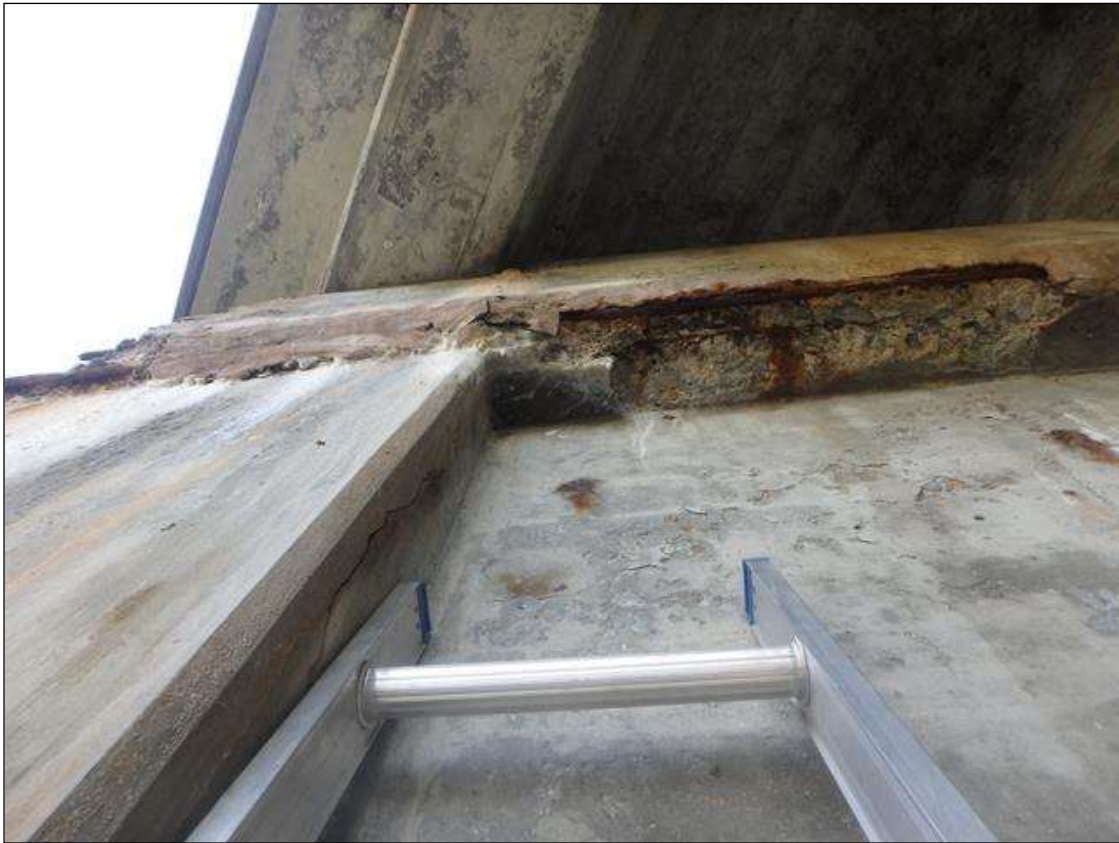
BENT 3 CAP : SPALL/DELAMINATION 6 FT X 1 FT X 6" WITH EXPOSED REBAR, 10% SECTION LOSS, NEAR COLUMN 1, SPAN 3 FACE, PRIORITY MAINTENANCE

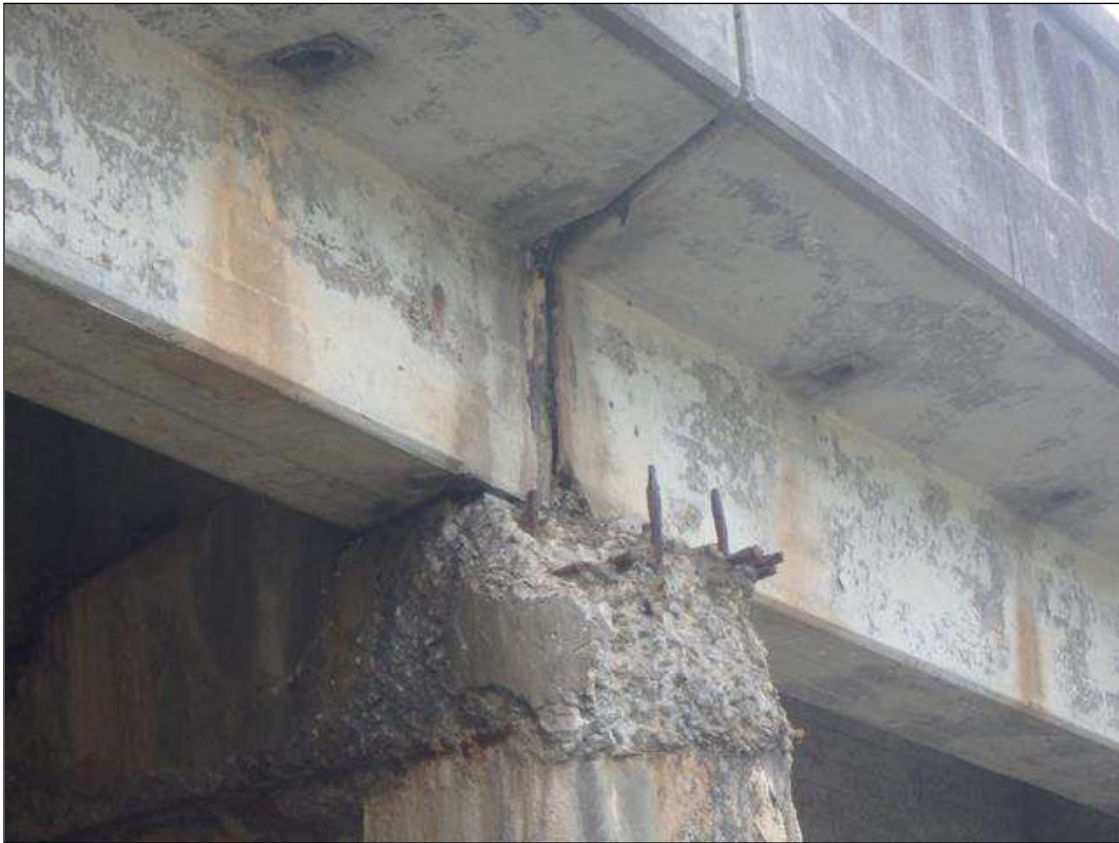
BENT 3 CAP : SPALL WITH DETERIORATING CONCRETE 3 FT X 2 FT X UP TO 1 FT WITH EXPOSED REBAR,  
NO SECTION LOSS, NEAR BEAM 1 BEARING, PRIORITY MAINTENANCE

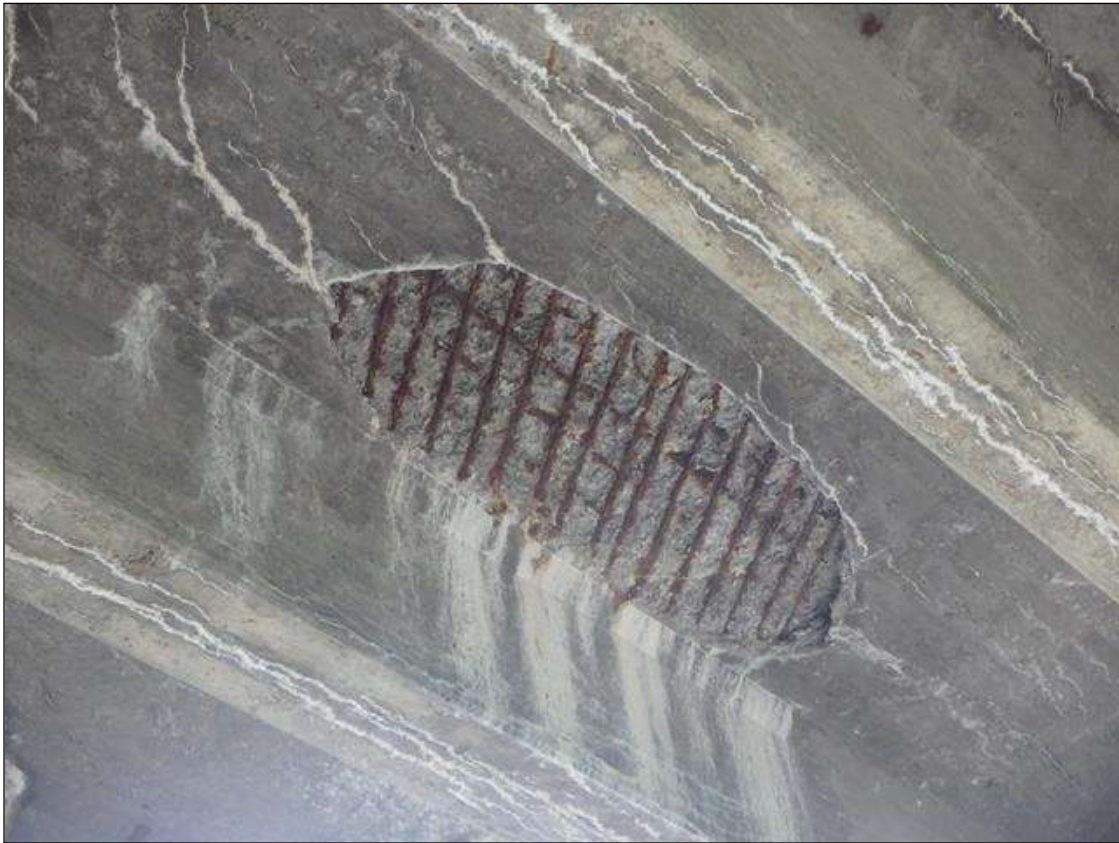
SPAN 2 DECK: SPALL 10 FT X 4 FT X 4" DEEP WITH EXPOSED REBAR IN BAY 2 NEAR BEAM 2, 10 FT FROM BENT 1, PRIORITY MAINTENANCE

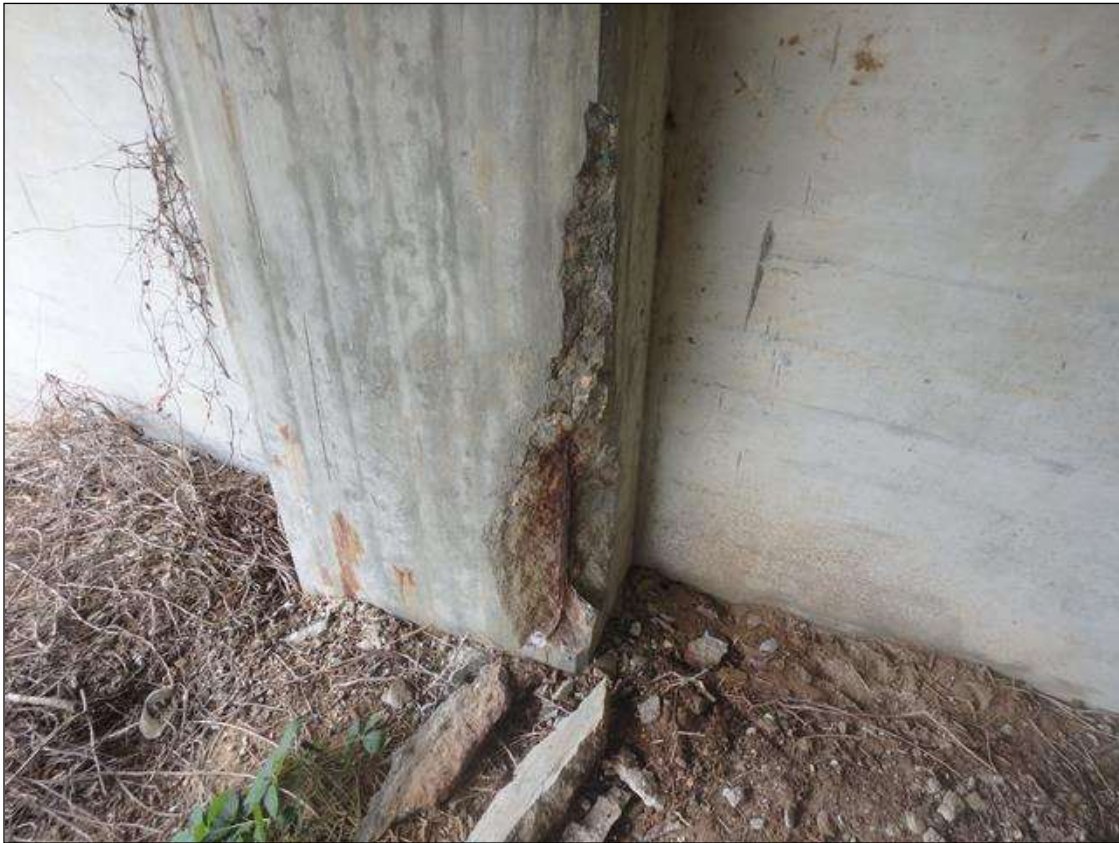
BENT 1 PILE 2: SPALL 3.5 FT X 8" X 6" WITH EXPOSED REBAR, 25% SECTION LOSS, ALONG BASE AT SOUTHEAST CORNER, SPAN 1, PRIORITY MAINTENANCE

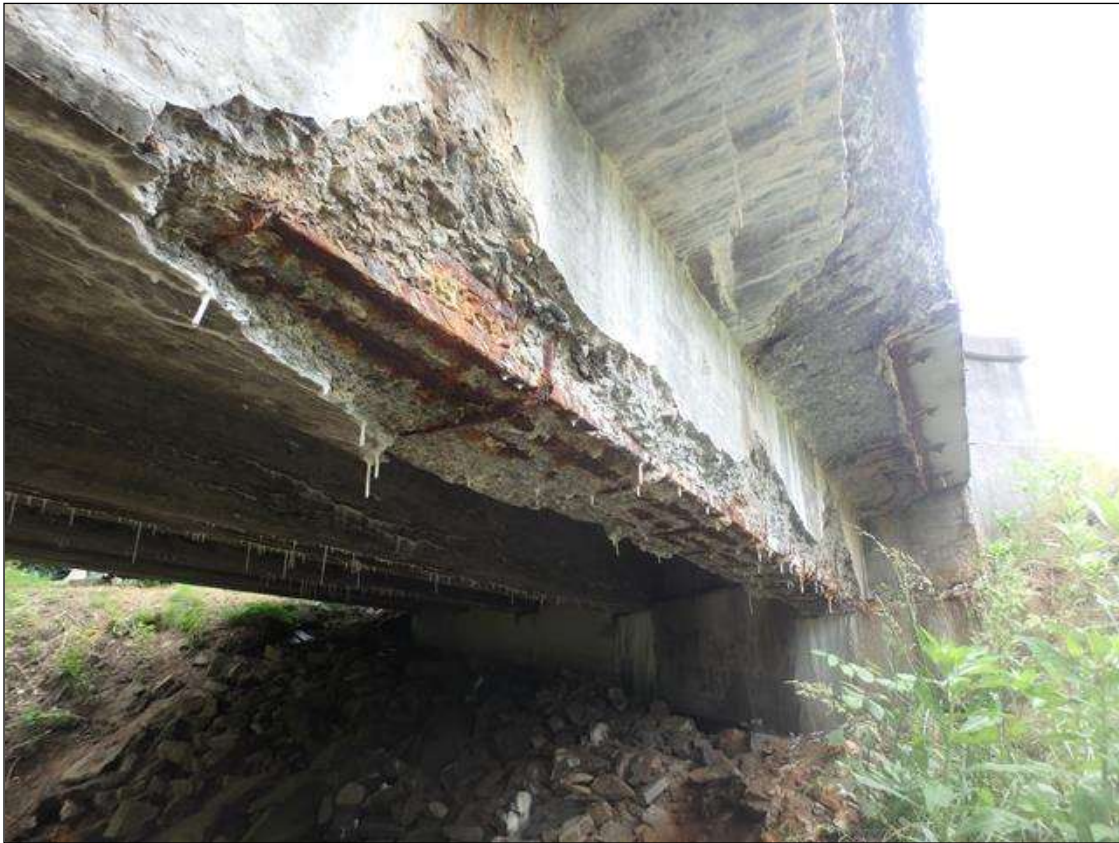
SPAN 1 BEAM 1: SPALL UP TO 2 FT TALL X FULL WIDTH X 3" DEEP WITH EXP REBAR, 20% SECTION LOSS  
WITH HEAVY EFFLO BUILDUP FOR 17 FT FROM END BENT 1, PM

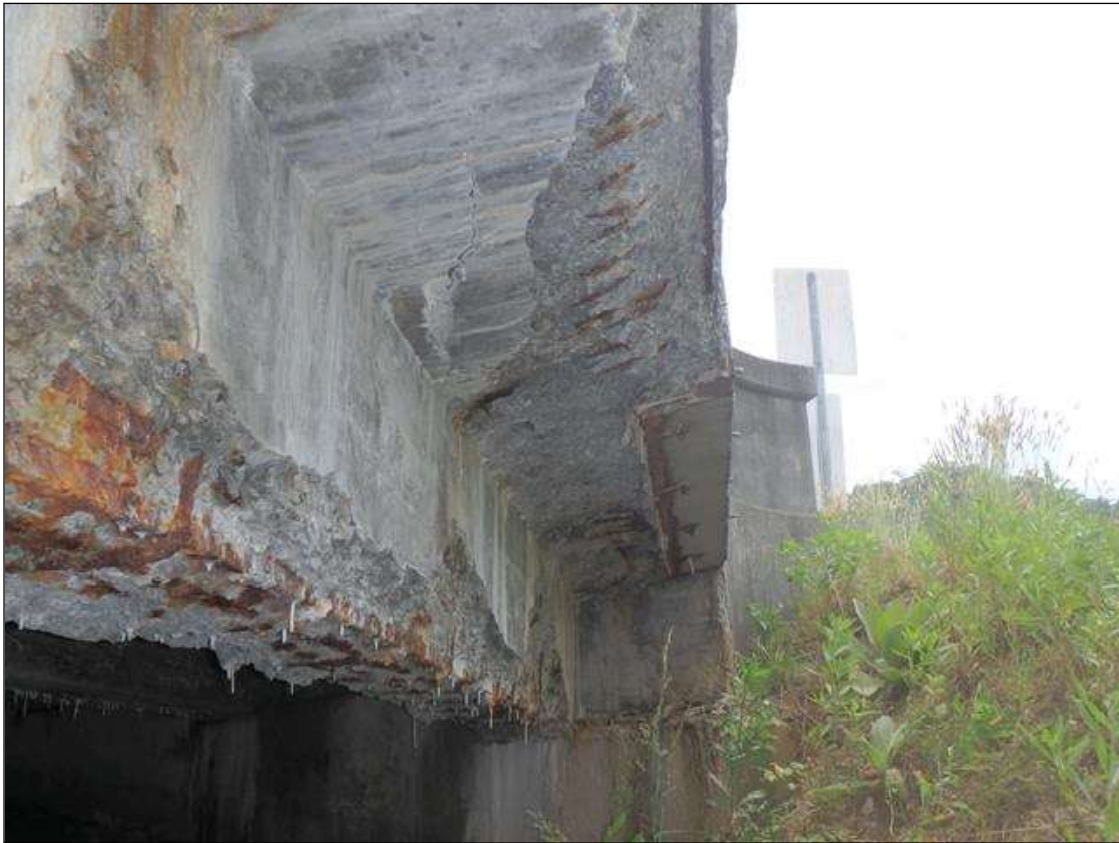
SPAN 1 DECK: SPALL UP TO FULL WIDTH X 3" DEEP WITH EXP REBAR, UP TO 25% SECTION LOSS, FOR 17 FT FROM END BENT 1 ALONG UNDERSIDE OF LEFT OVERHANG, PM

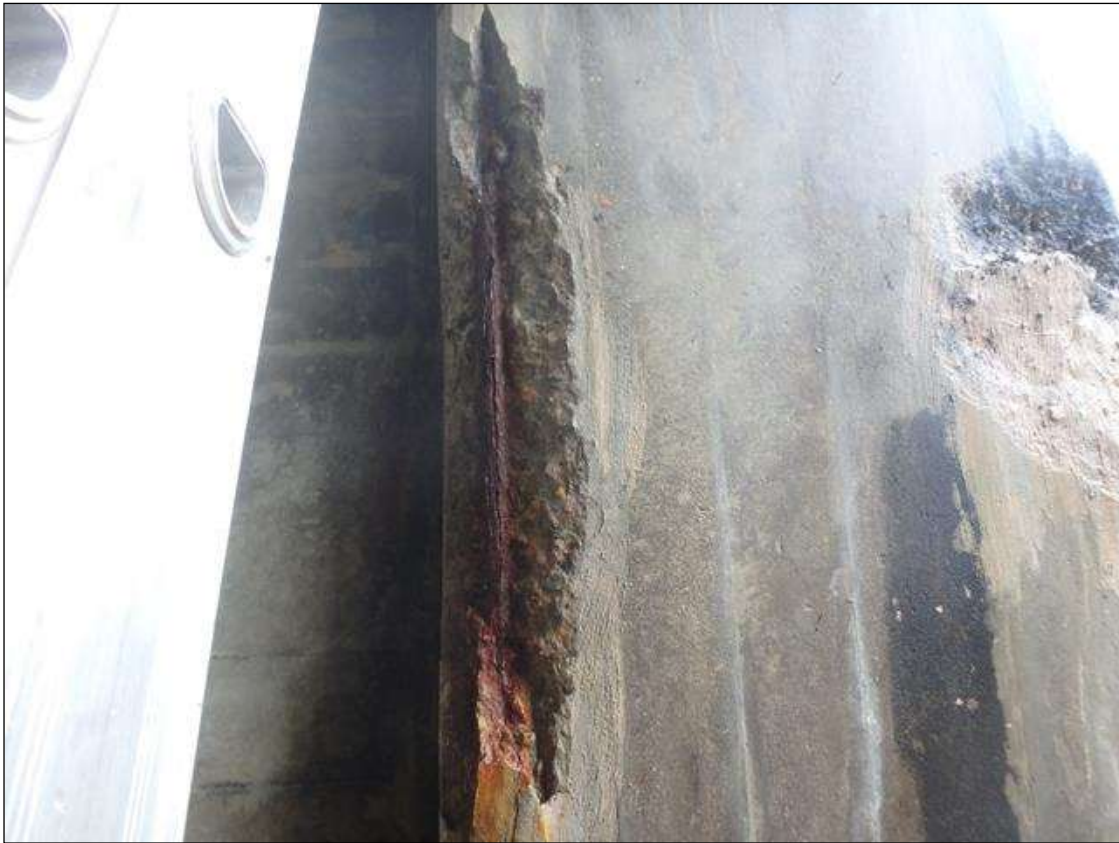
BENT 2 PILE 1: SPALL 3 FT X 6" X 6" WITH EXPOSED REBAR, 25% SECTION LOSS, AT MIDHEIGHT ALONG NORTHEAST CORNER, SPAN 3 FACE, PRIORITY MAINTENANCE

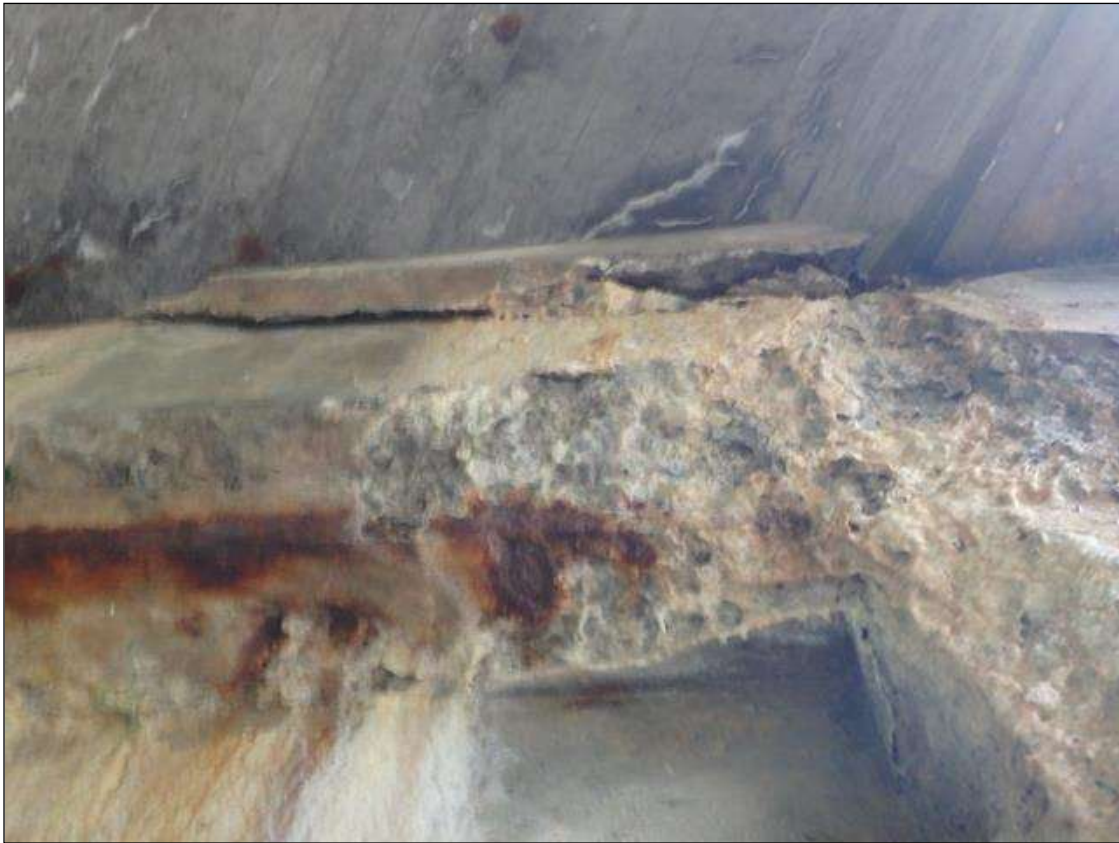
BENT 2 CAP : DELAMINATION/SPALL 3 FT X 1 FT X 3" IN IMMINENT DANGER OF FALLING, IN BAY NEAR BEAM 1, SPAN 3 FACE, PRIORITY MAINTENANCE

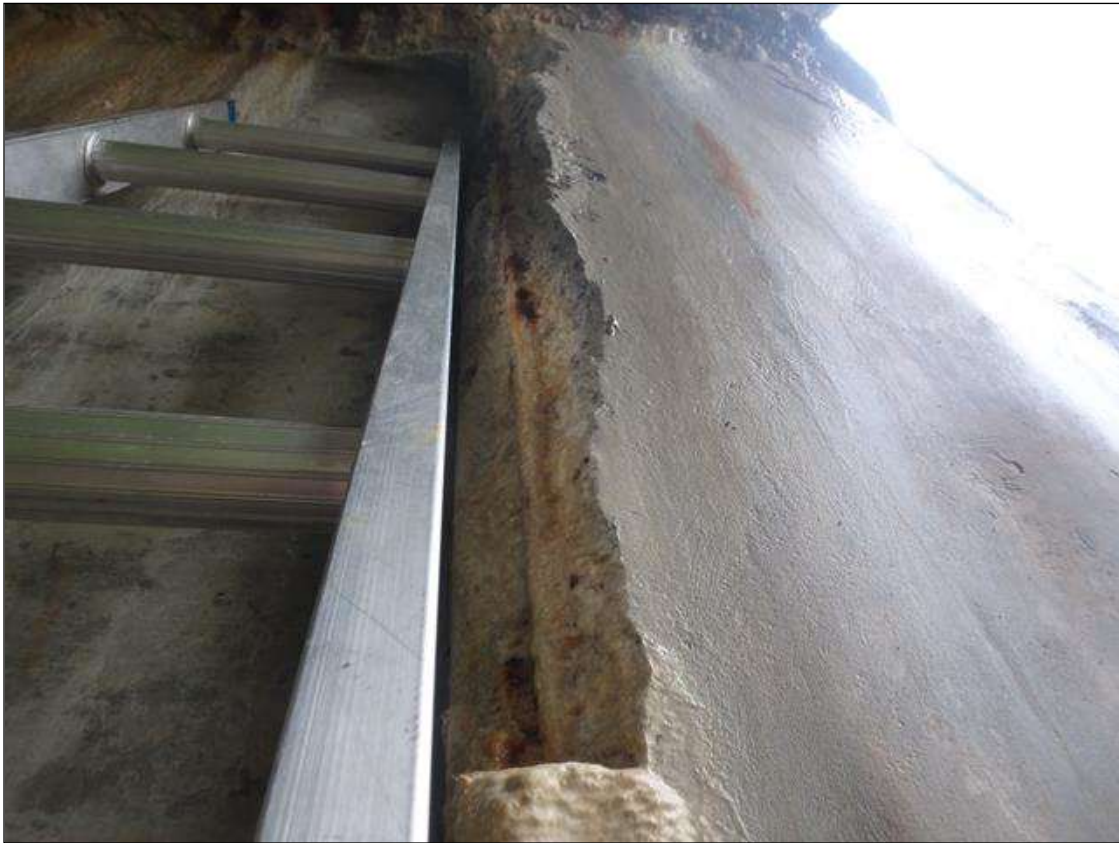
BENT 2 PILE 1: SPALL 5 FT X 6" X 4" WITH EXPOSED REBAR, NO SECTION LOSS, WITH HEAVY EFFLORESCENCE BUILDUP ALONG NORTHEAST CORNER NEAR CAP, PM

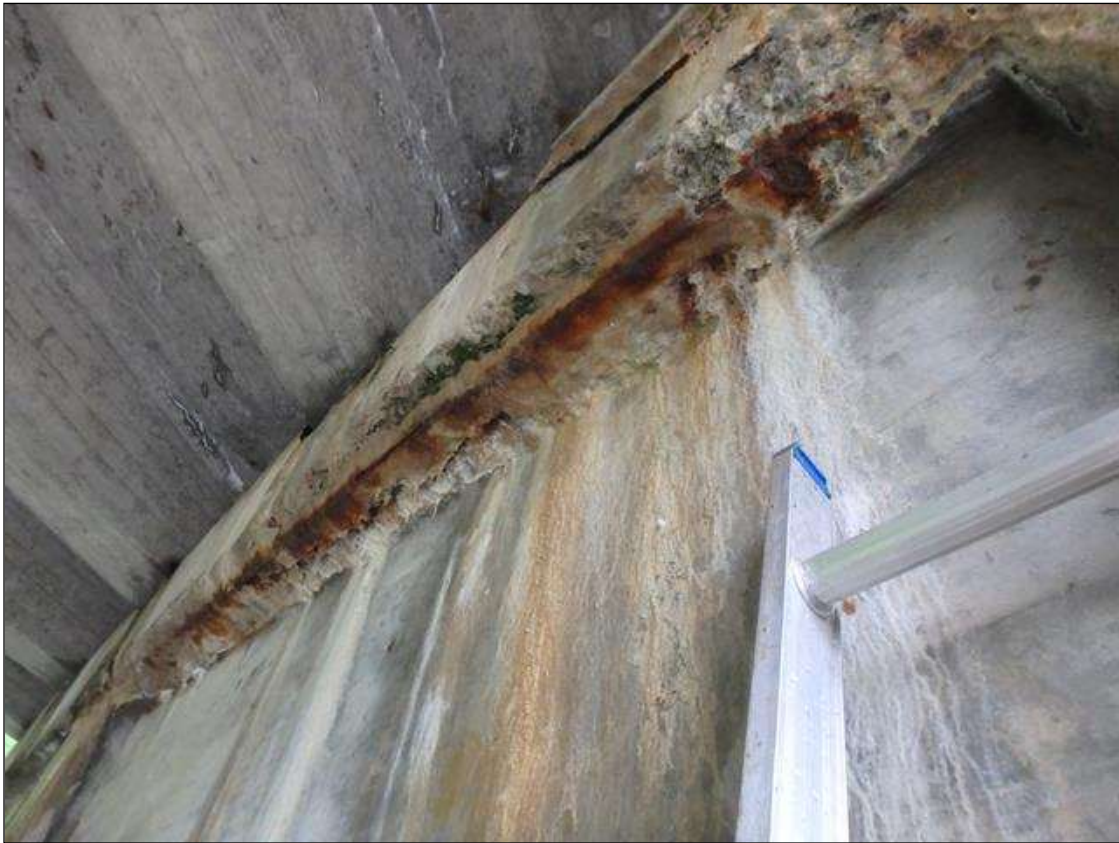
BENT 2 CAP : SPALL/DELAMINATION 15 FT X 6" WITH RUST STAINING AND EXP REBAR WITH 10% SECTION LOSS, ALONG BOTTOM OF CAP, BAY 1 WALL, SPAN 3 FACE, PM

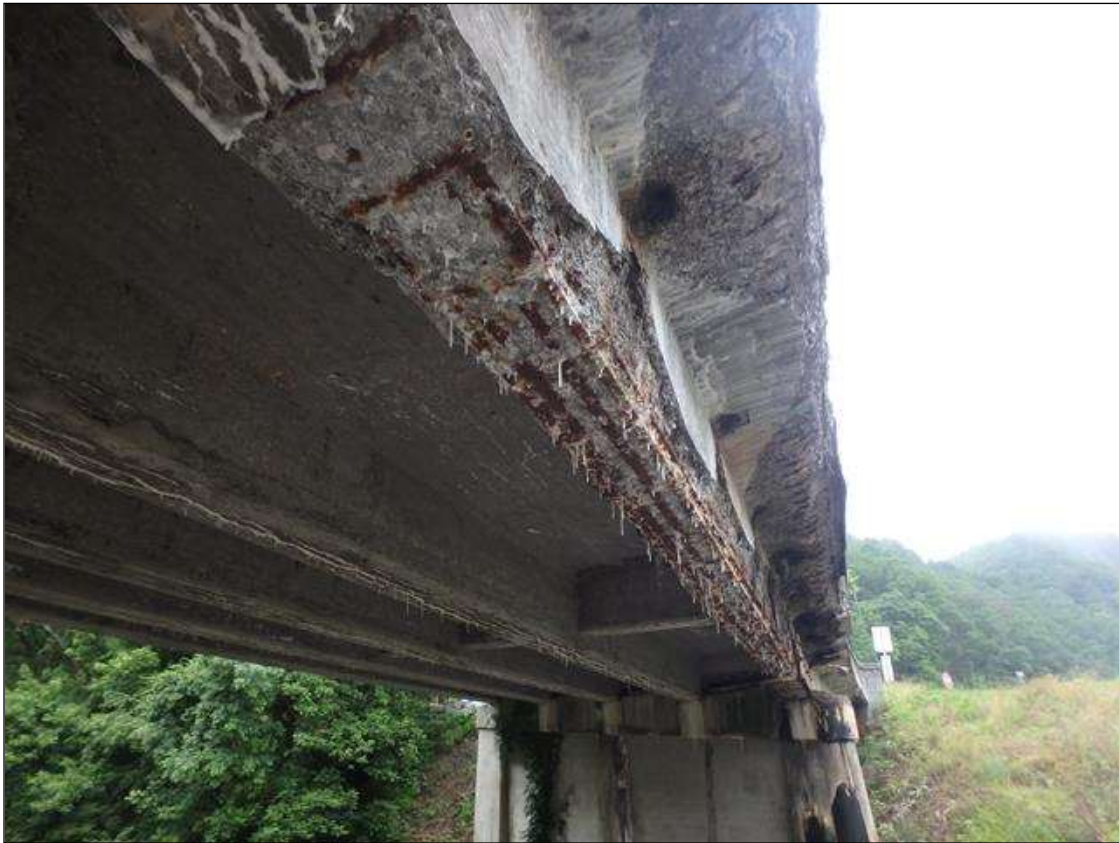
SPAN 2 BEAM 1: SPALL UP TO FULL HEIGHT X UP TO FULL WIDTH X 4" DEEP WITH EXPOSED REBAR WITH 25% SECTION LOSS AND HEAVY EFFLO BUILDUP, FULL LENGTH, PM

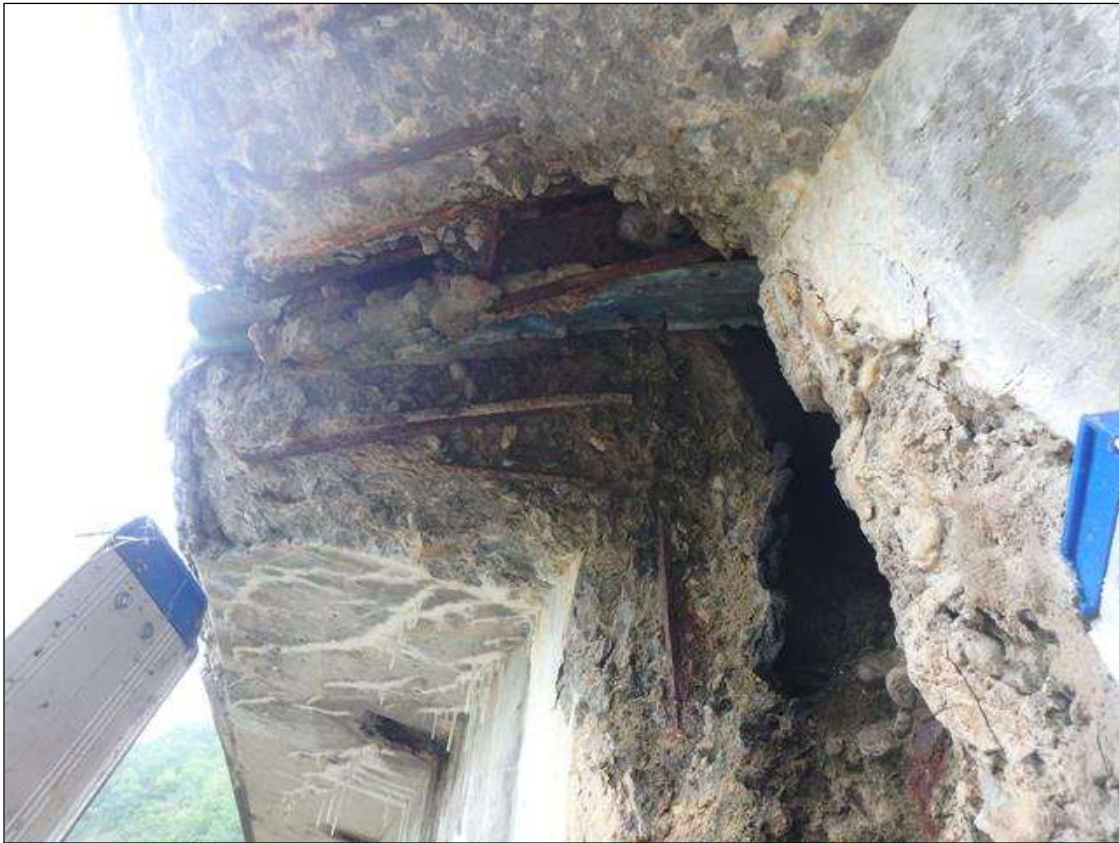
SPAN 3 DECK: SPALL 3 FT X 3 FT X UP TO 5" DEEP WITH EXPOSED REBAR, UP TO 100% SECTION LOSS, ALONG LEFT OVERHANG AT BENT 2, PRIORITY MAINTENANCE

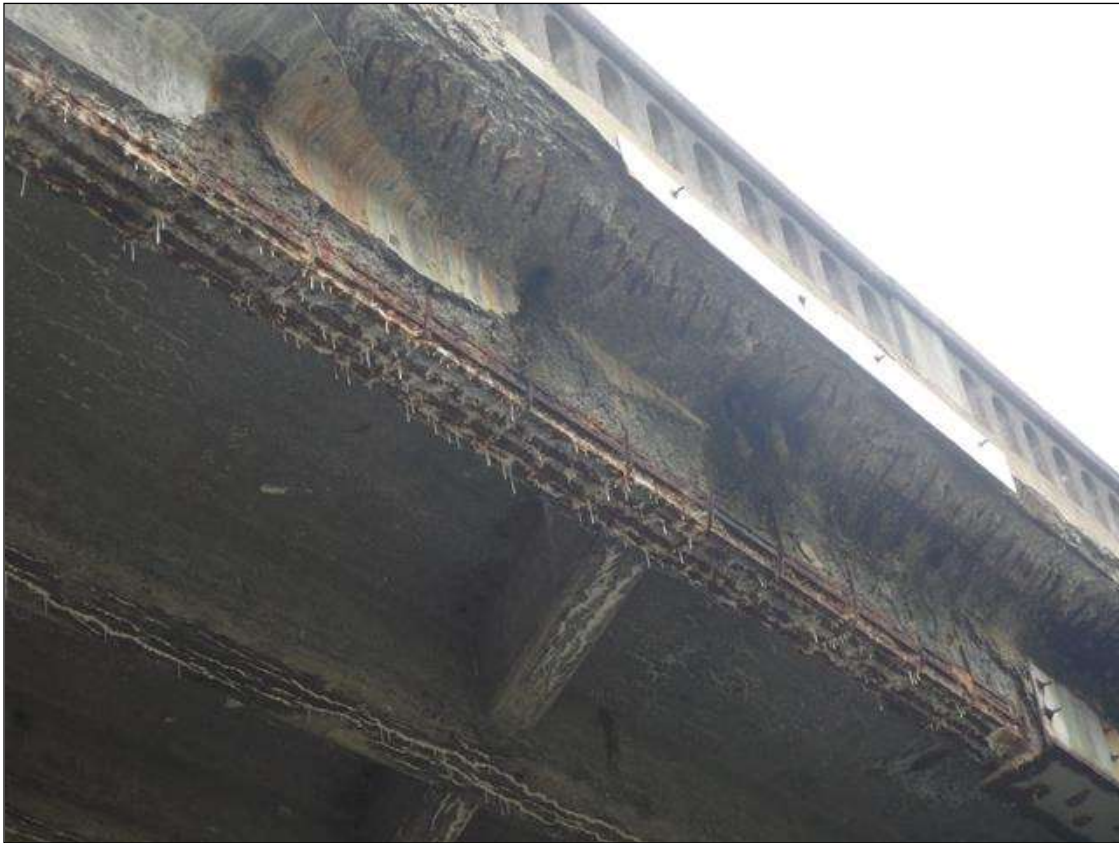
SPAN 2 DECK: SPALL FULL LENGTH X FULL WIDTH X UP TO 4" DEEP WITH EXPOSED REBAR WITH UP TO 100% SECTION LOSS ALONG UNDERSIDE OF LEFT OVERHANG, PM

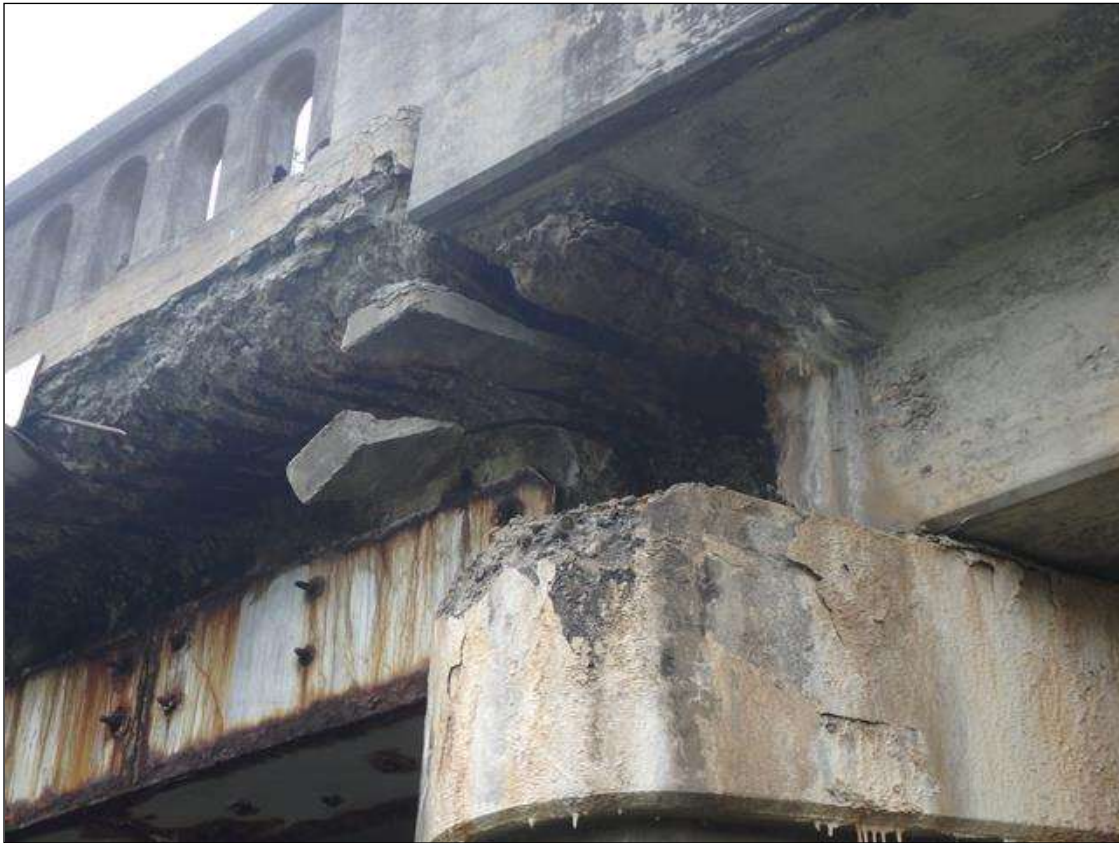
SPAN 2 DECK: SPALL 3 FT X 2 FT X UP TO 6" DEEP IN DANGER OF FALLING OFF AT BENT 1, PRIORITY MAINTENANCE
