NC DEPARTMENT OF TRANSPORTATION  
DIVISION OF HIGHWAYS  
STRUCTURE MANAGEMENT UNIT

## Structure Safety Report

### Routine Element Inspection - Contract

COUNTY: MADISON STRUCTURE NUMBER: 560009 FREQUENCY: 24 MONTHS

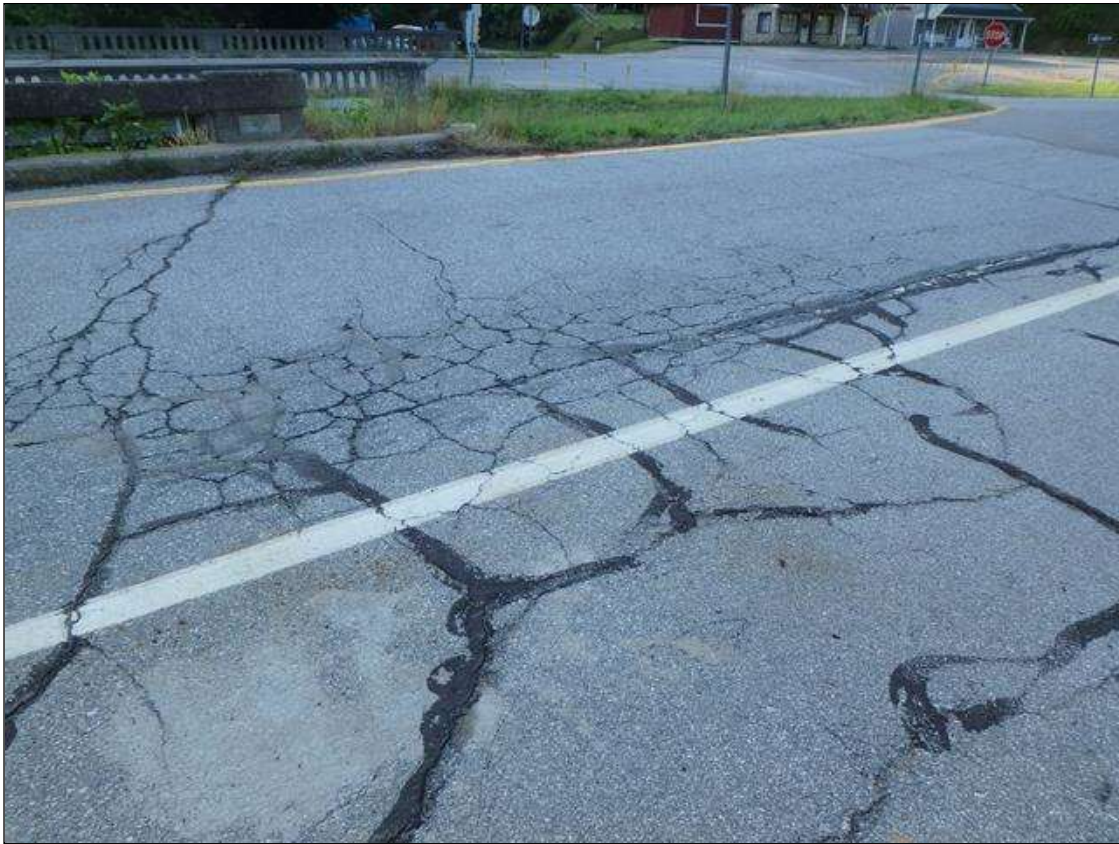
MAP CRACKING UP TO 1/2" IN SOUTH APPROACH , NORTH APPROACH SIMILAR

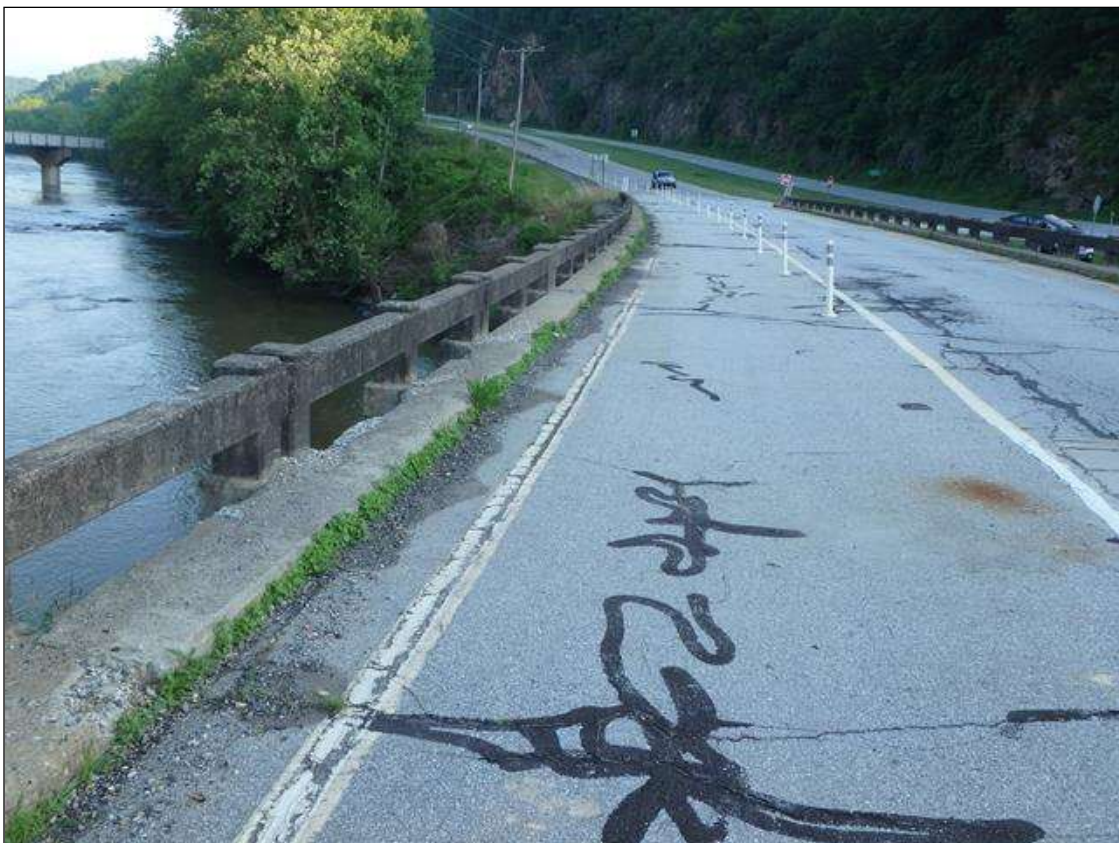
VEGETATION AND DEBRIS ALONG LEFT GUTTER, RIGHT GUTTER SIMILAR

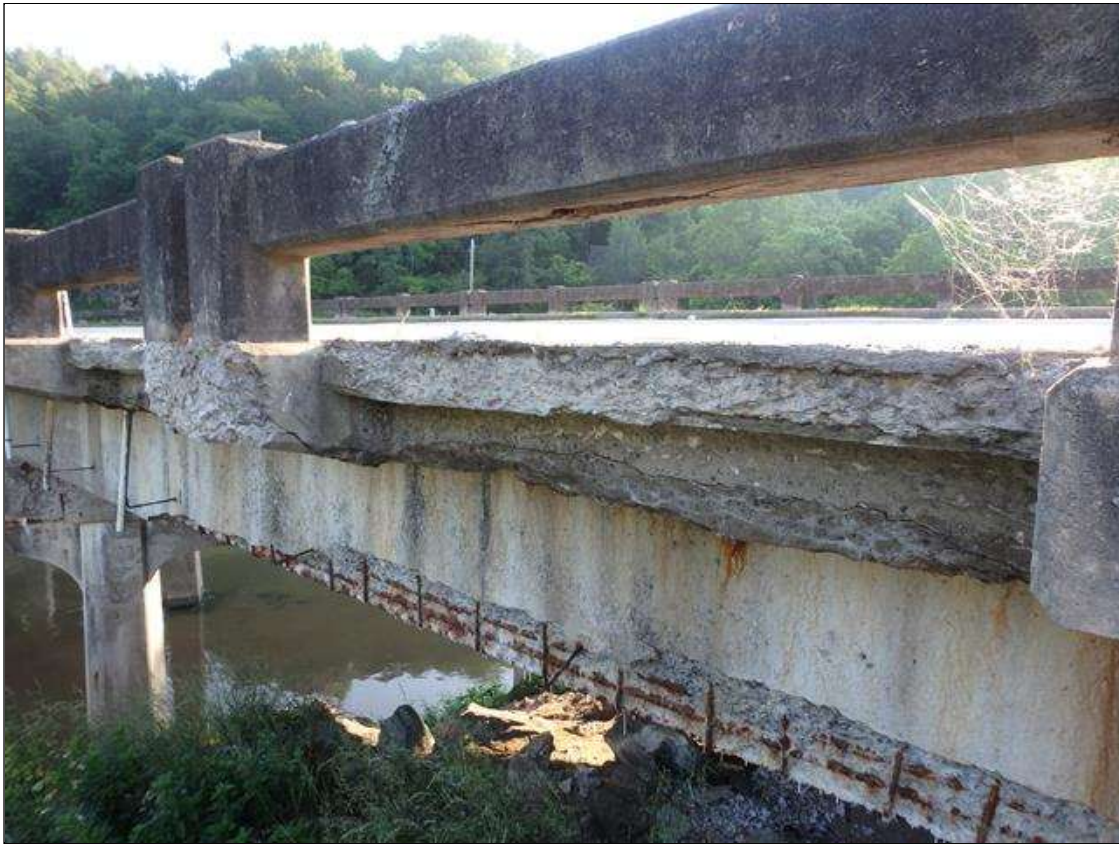
Span 1 Left Bridge Rail: SPALL 21 FT X 6" X UP TO 9" ALONG OUTSIDE EDGE OF CURB AND CONCRETE RAIL, CONCRETE IS SOFT AND DETERIORATING

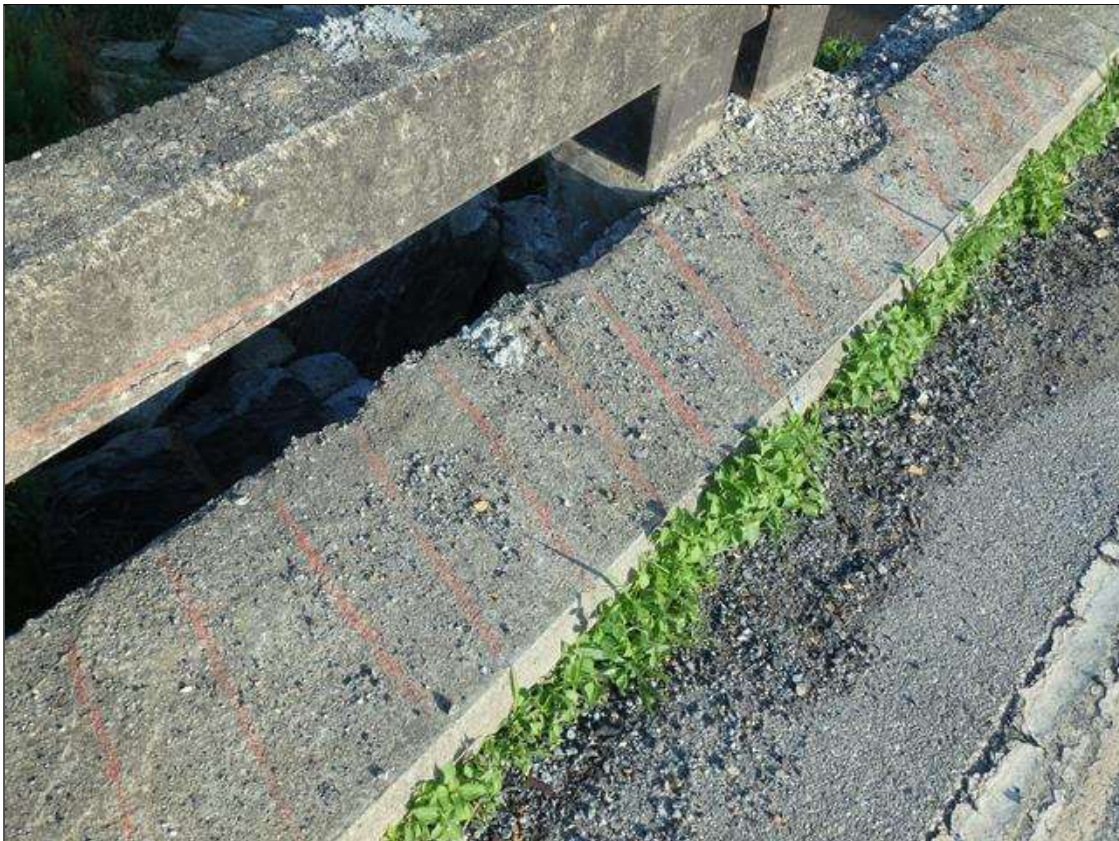
Span 1 Left Bridge Rail: DELAMINATION 10 FT X 20" LOCATED 15 FT FROM END BENT 1, TOP OF LEFT CURB

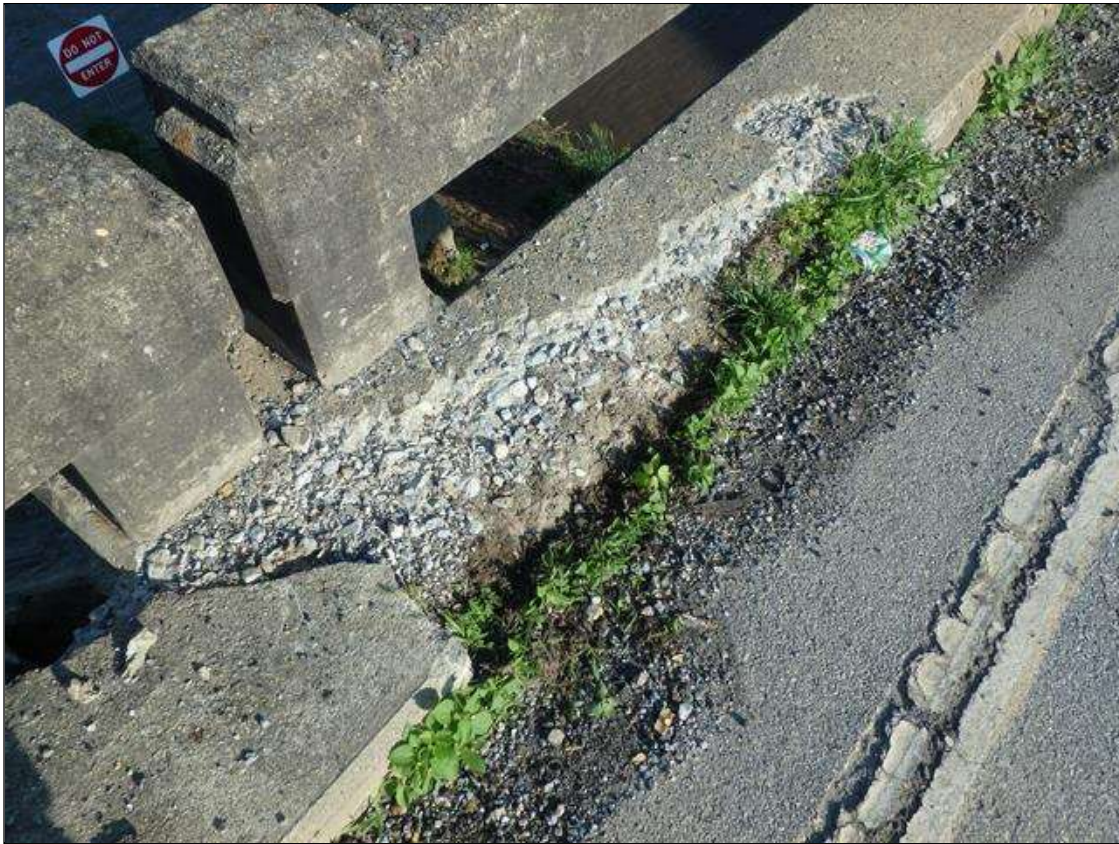
Span 1 Left Bridge Rail: SPALL 6 FT X UP TO 20" X 5" WITH EXPOSED REBAR, NO SECTION LOSS, 14 FT FROM BENT 1

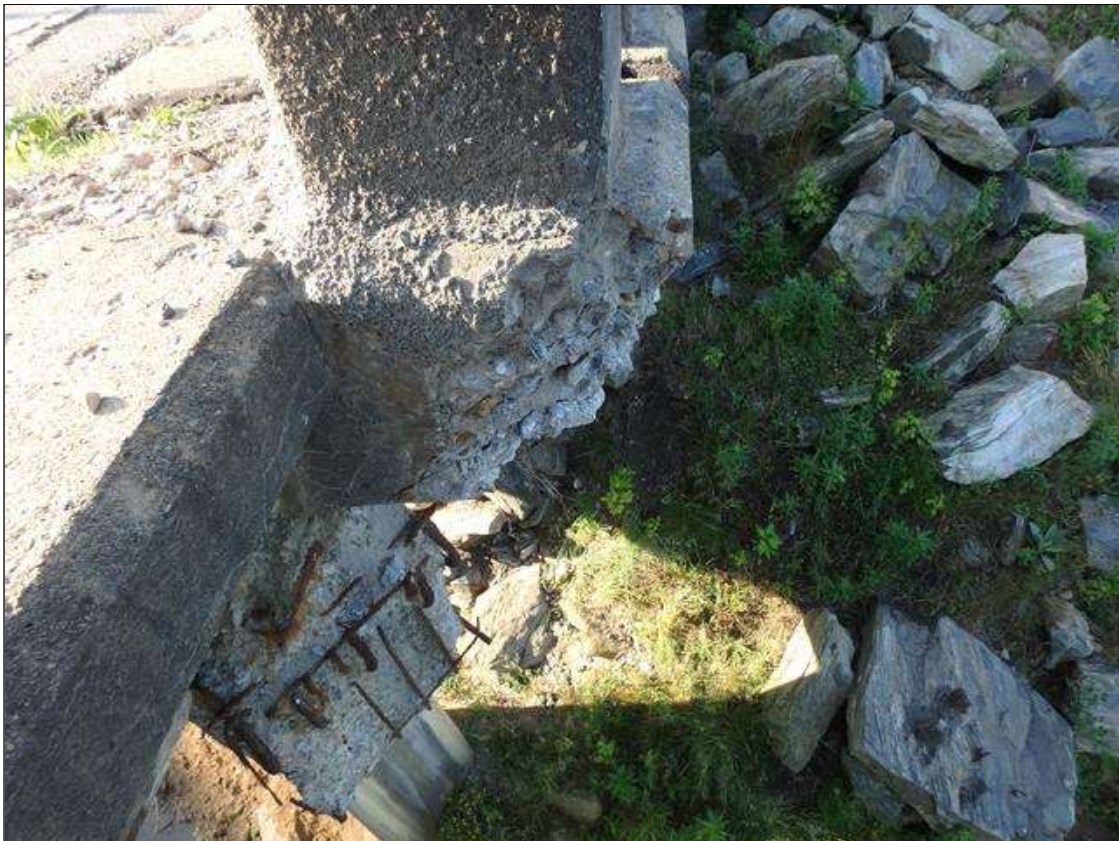
Span 2 Left Bridge Rail: SPALL 1 FT X 1 FT X UP TO 5" DEEP, NO EXPOSED REBAR, ALONG POST AT BENT 1, CONCRETE IS SOFT AND DETERIORATING

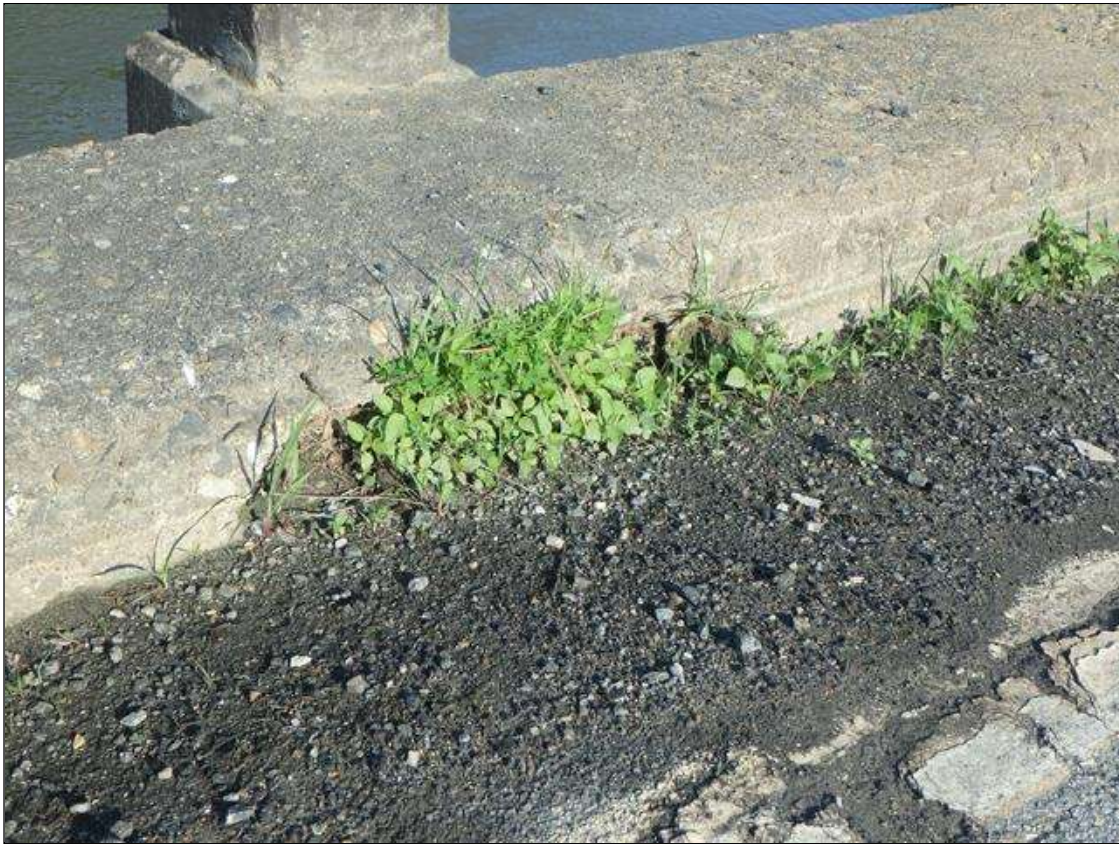
Span 3 Left Bridge Rail: SCATTERED SPALLS UP TO 26" X 5" X 2" DEEP WITH EXPOSED REBAR, NO SECTION LOSS (4 TOTAL)

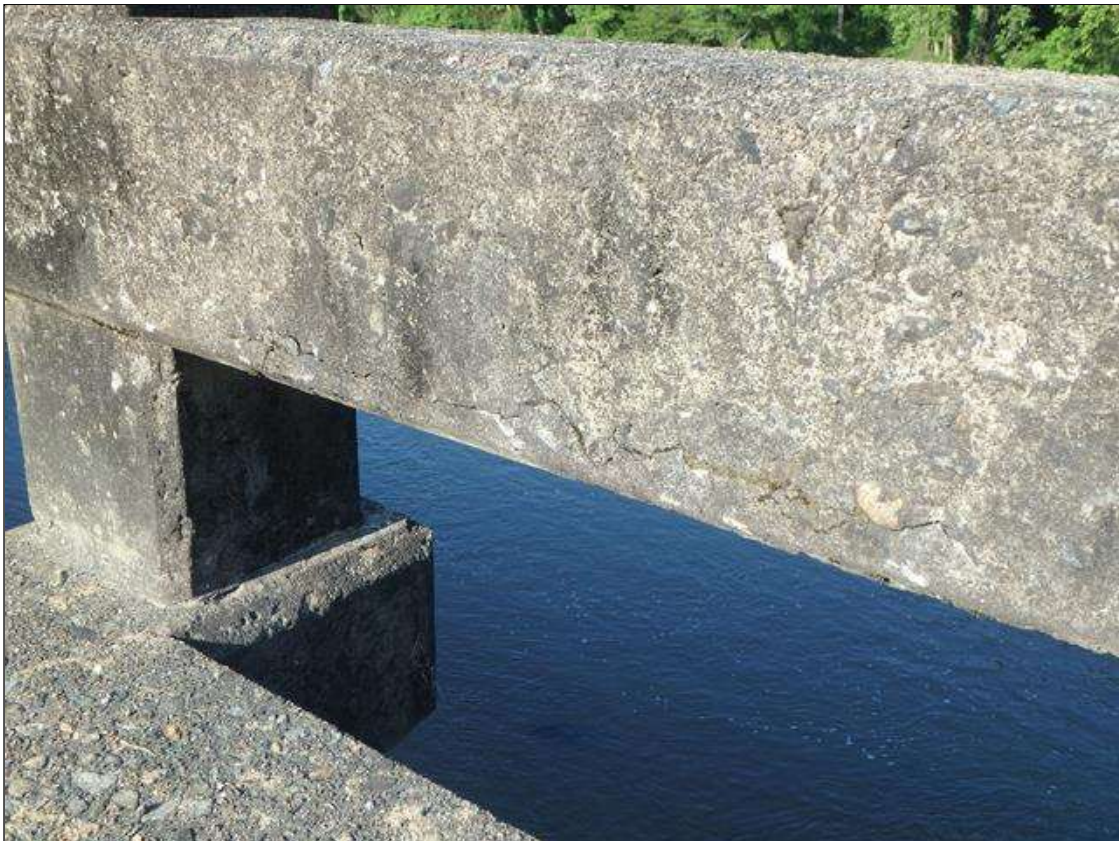
Span 3 Left Bridge Rail: 3 FT HORIZONTAL CRACK UP TO 1/16" ALONG BOTTOM OF RAIL, 5 FT FROM BENT 3

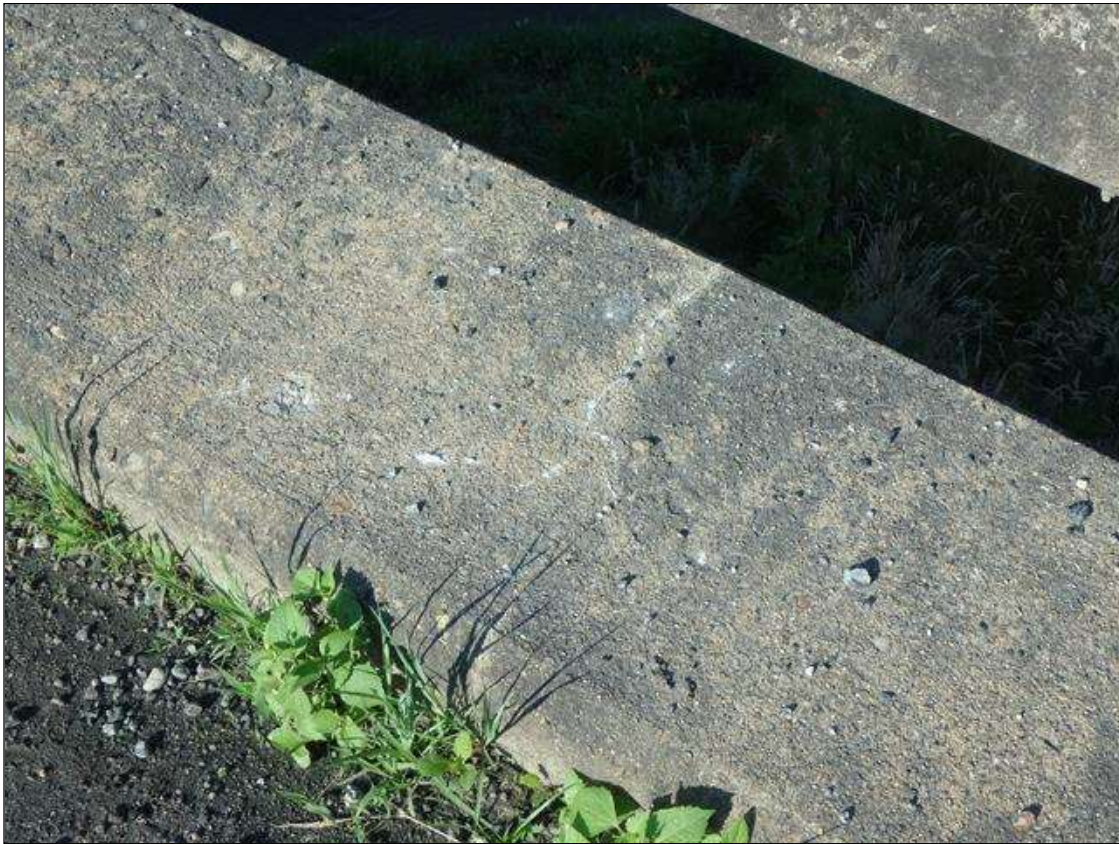
Span 5 Left Bridge Rail: FULL WIDTH HAIRLINE TRANSVERSE CRACK WITH EFFLORESCENCE IN TOP OF CURB, 12 FT FROM BENT 4

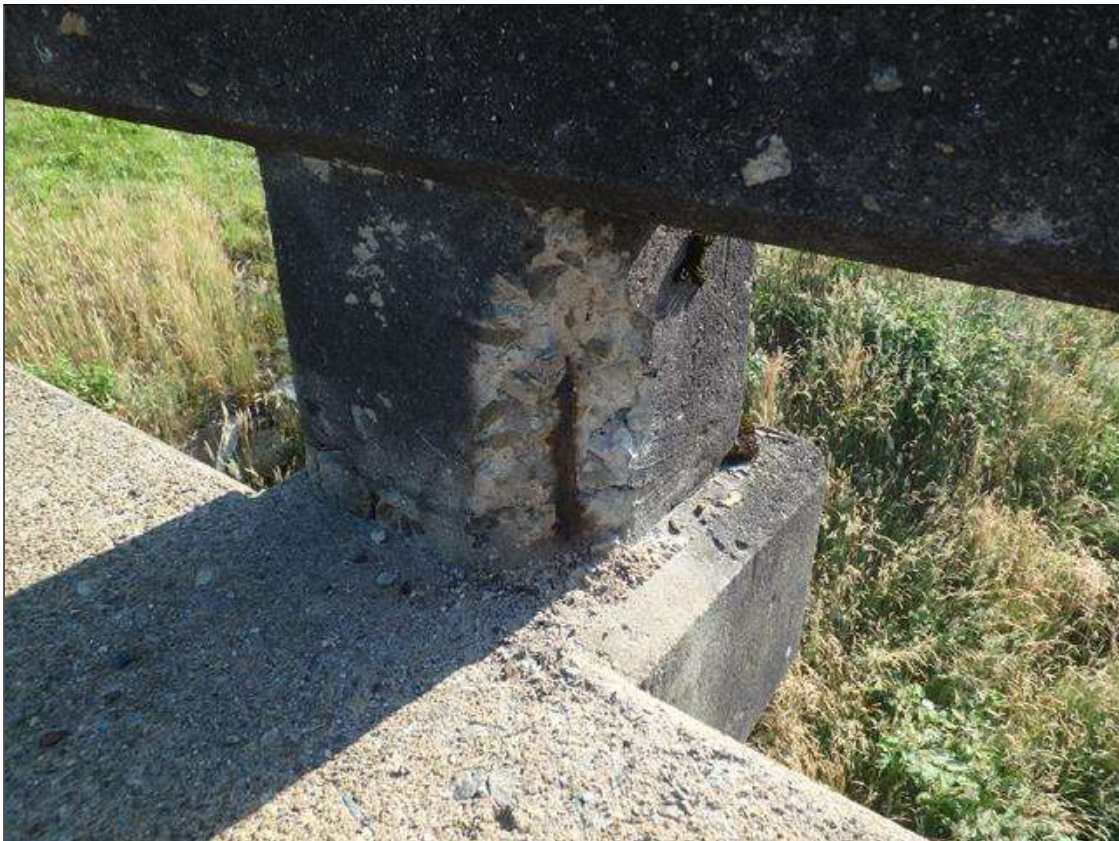
Span 4 Right Bridge Rail: SPALL 9" X 3" X 3" DEEP WITH EXPOSED REBAR, NO SECTION LOSS, ALONG CONCRETE POST AT MIDSPAN

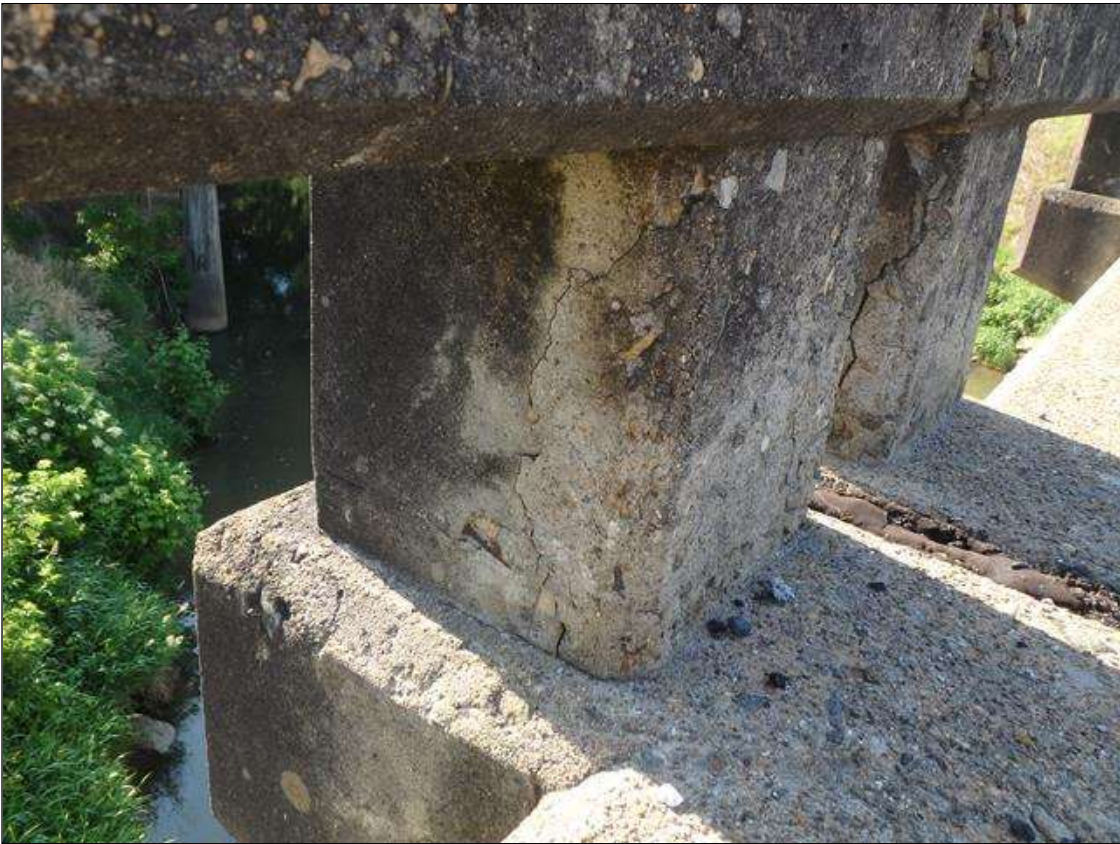
Span 4 Right Bridge Rail: 1 FT VERTICAL CRACK UP TO 1/16" ALONG CONCRETE POST AT BENT 3

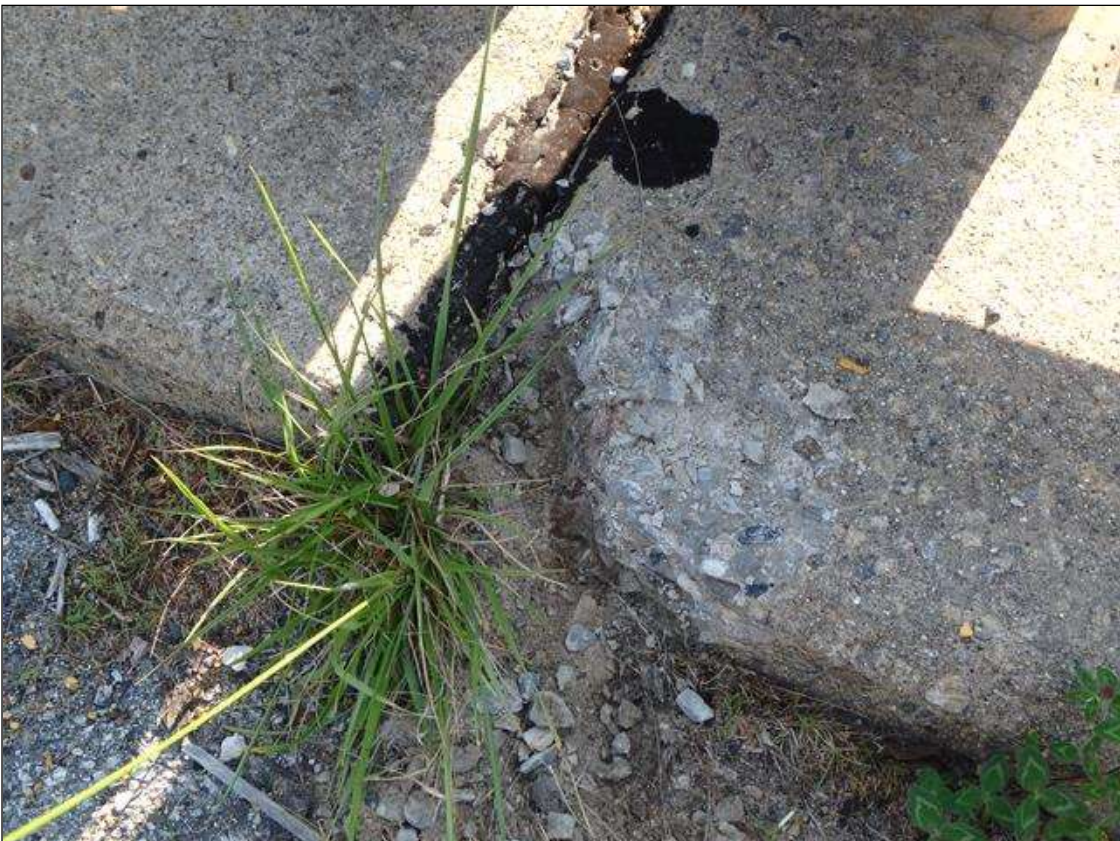
Span 1 Right Bridge Rail: SPALL 12" X 9" X 5" WITH EXPOSED REBAR, NO SECTION LOSS, ALONG TOP OF CURB AT BENT 1

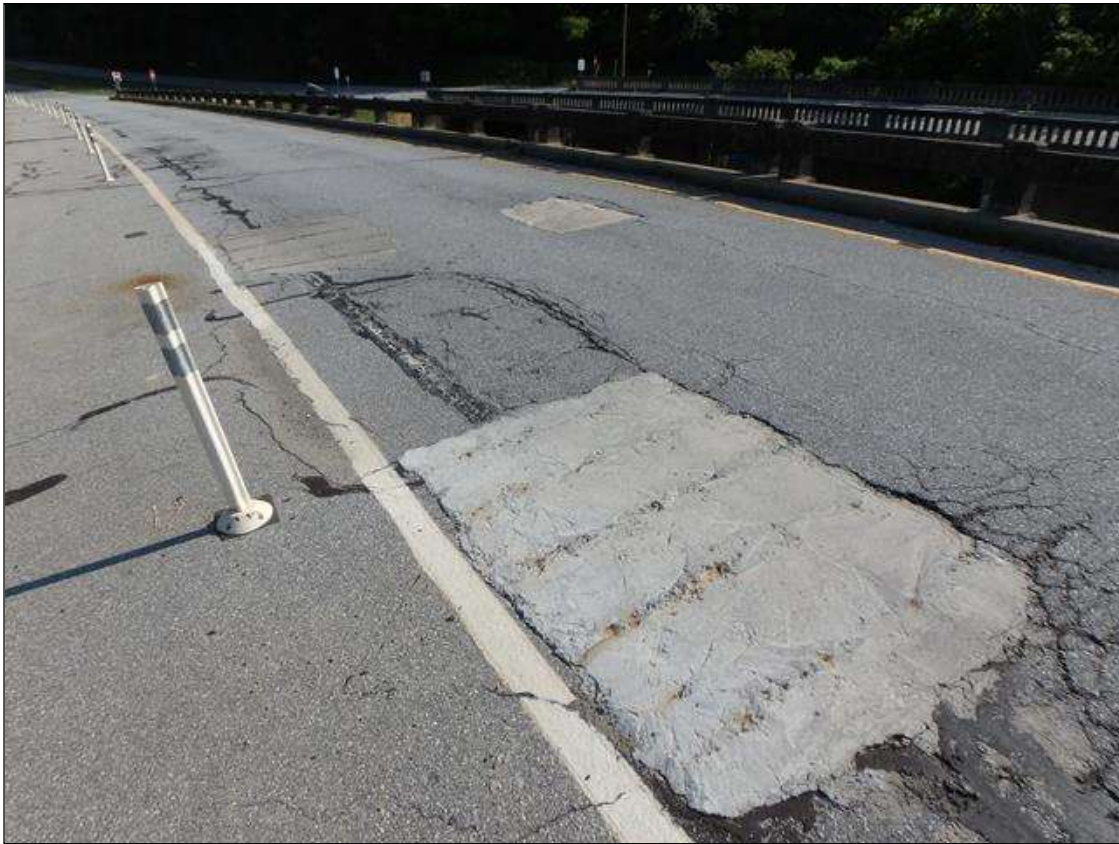
Span 1 Wearing Surface: 3 SOUND CONCRETE PATCHES, 6FT X 5FT, 8FT X 5FT, AND 5FT X 3FT SCATTERED

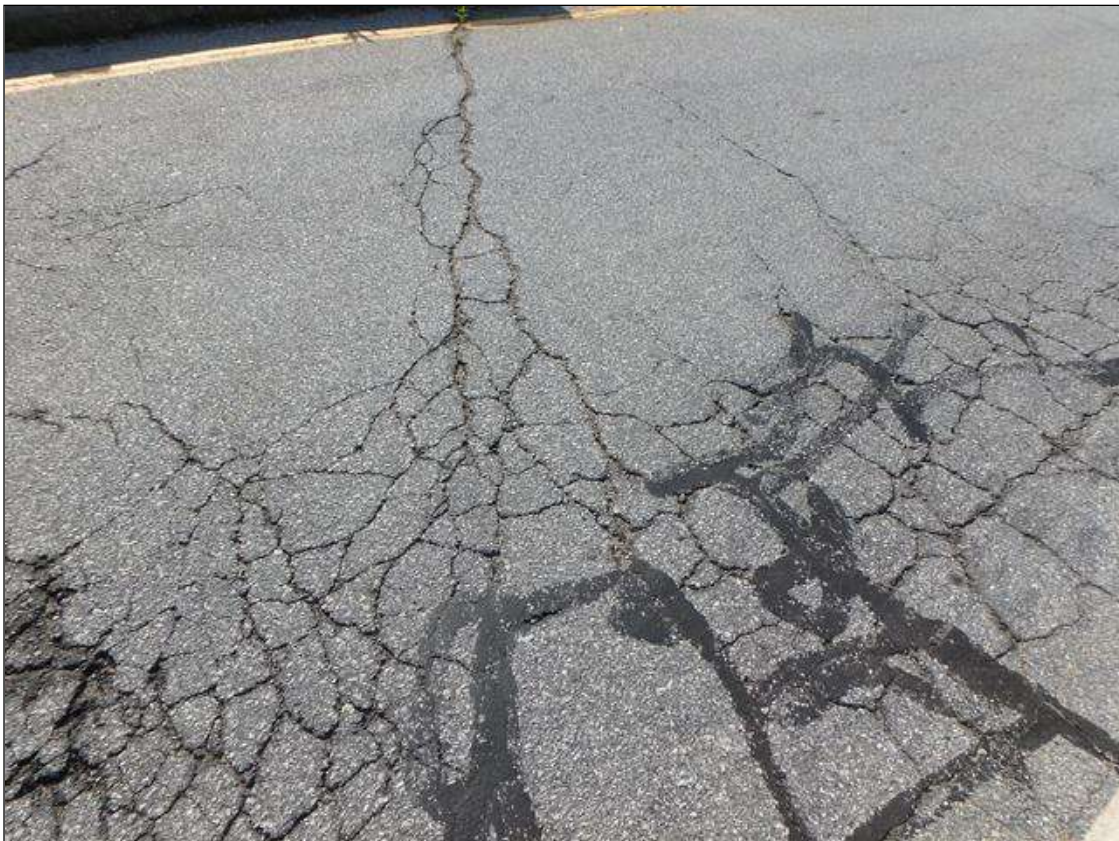
Span 1 Wearing Surface: TRANSVERSE CRACK AND MAP CRACKING UP TO 1" AT END BENT 1 IN TRAVEL LANE

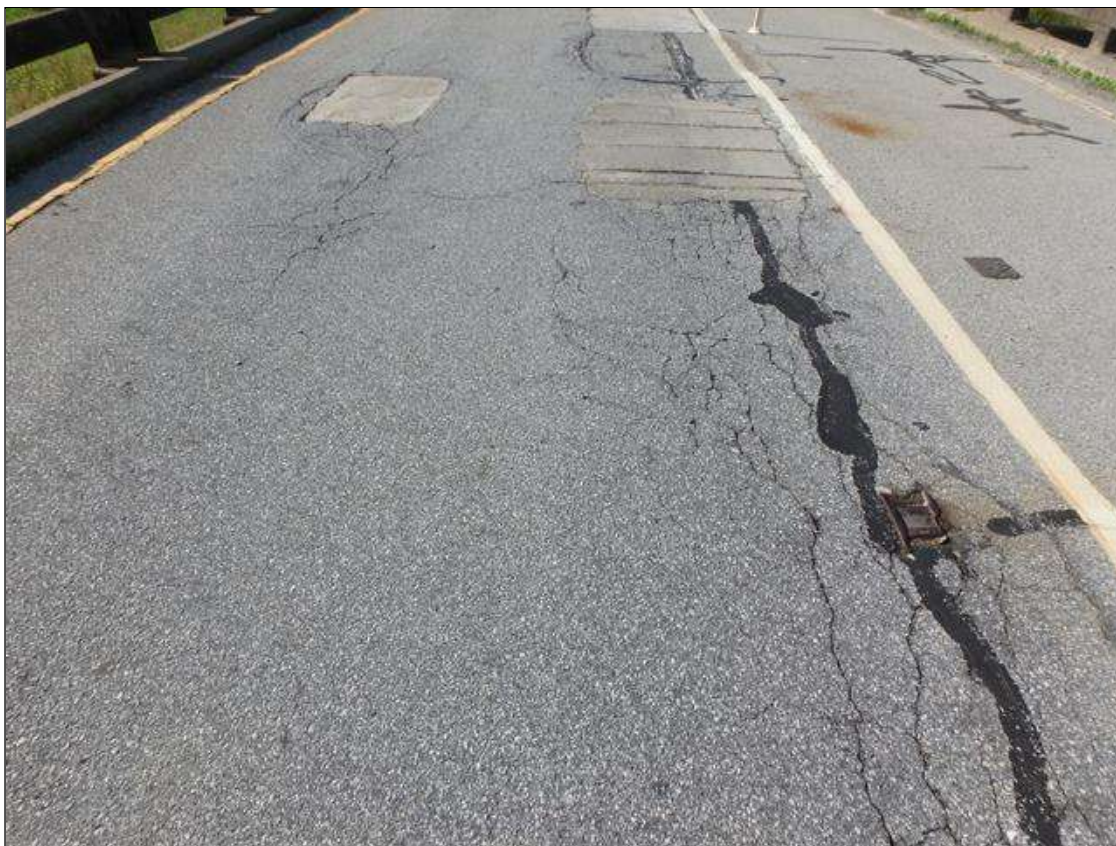
Span 1 Wearing Surface: SCATTERED MAP CRACKING UP TO 1" IN TRAVEL LANE

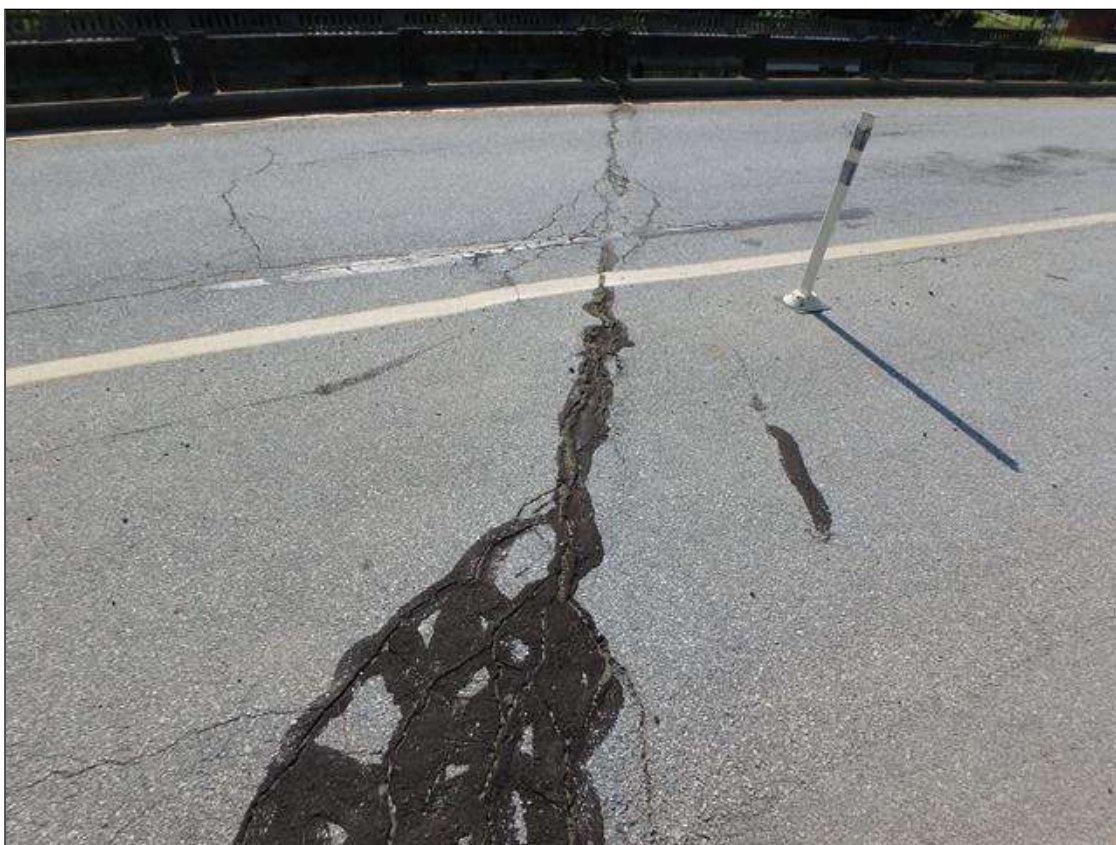
Span 2 Wearing Surface: FULL WIDTH TRANSVERSE CRACK UP TO 1" AT BENT 2

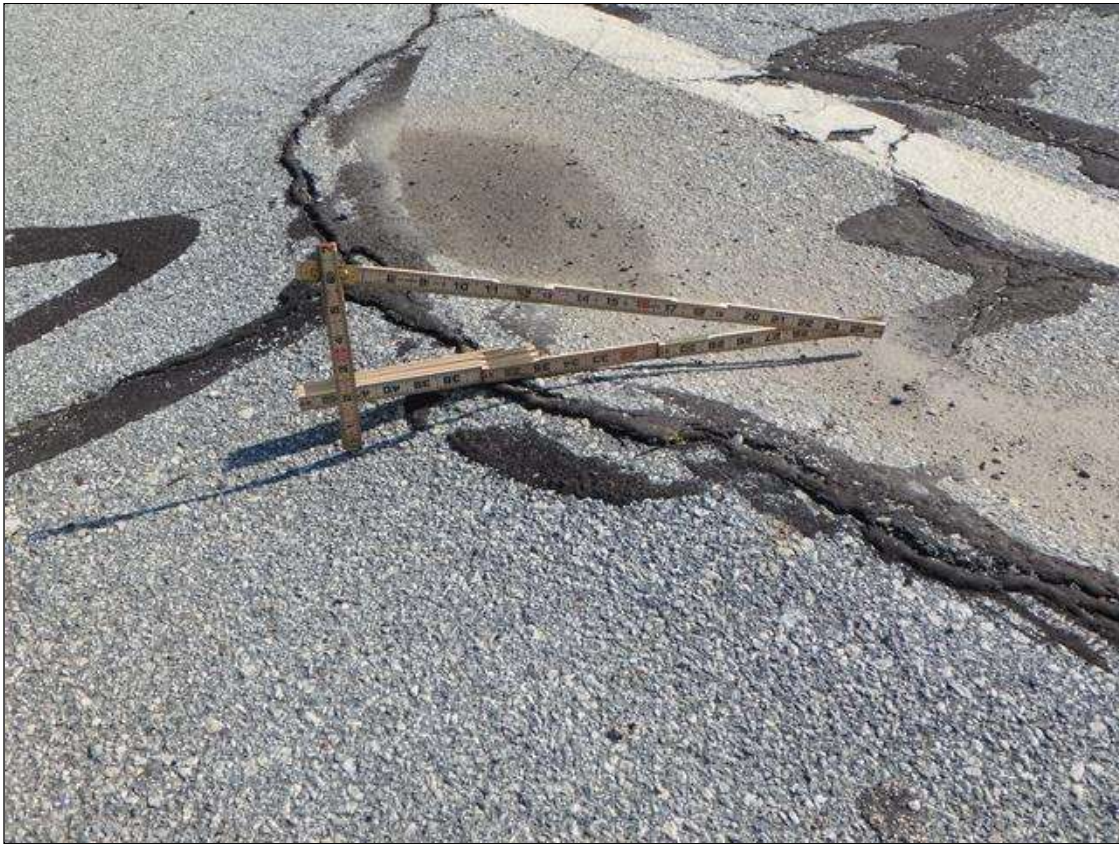
Span 3 Wearing Surface: ASPHALT WARPING FOR AREA 8 FT X 2 FT NEAR MIDSPAN AND CENTER OF BRIDGE

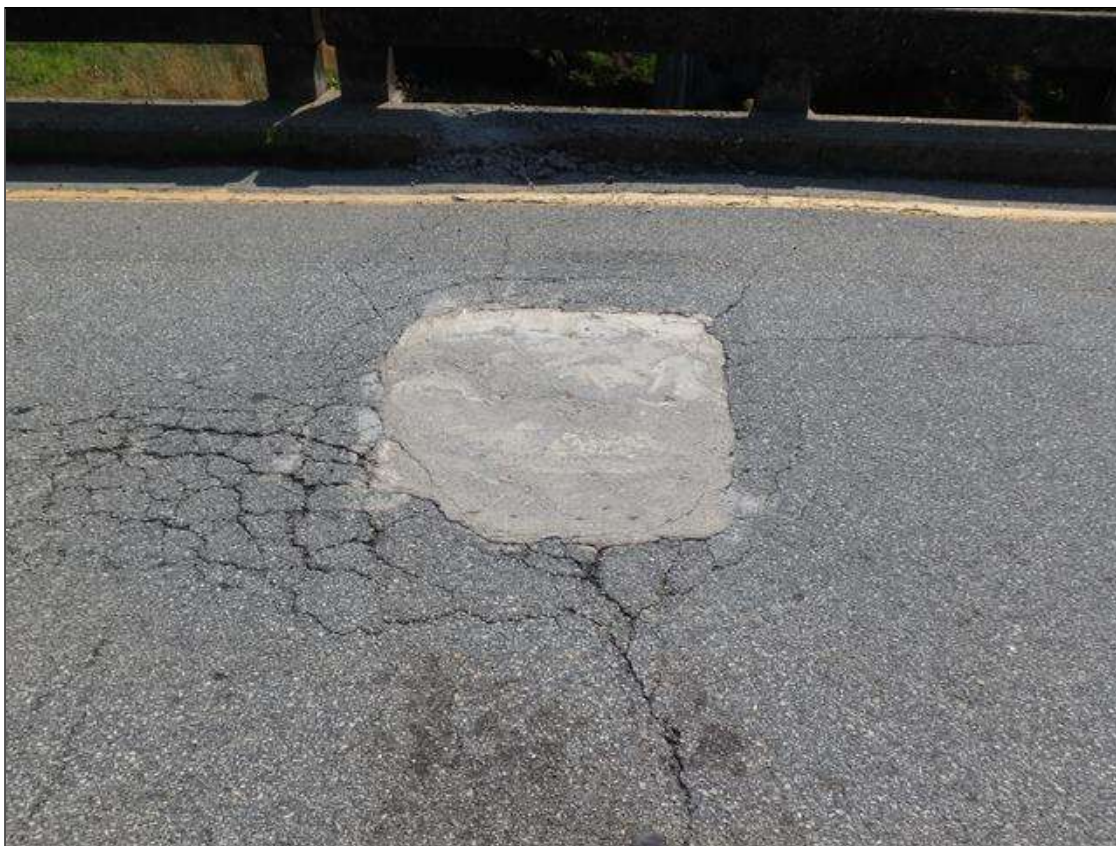
Span 4 Wearing Surface: 4FT X 4FT REPAIR IN TRAVEL LANE, 8FT FROM BENT 3, SOUND

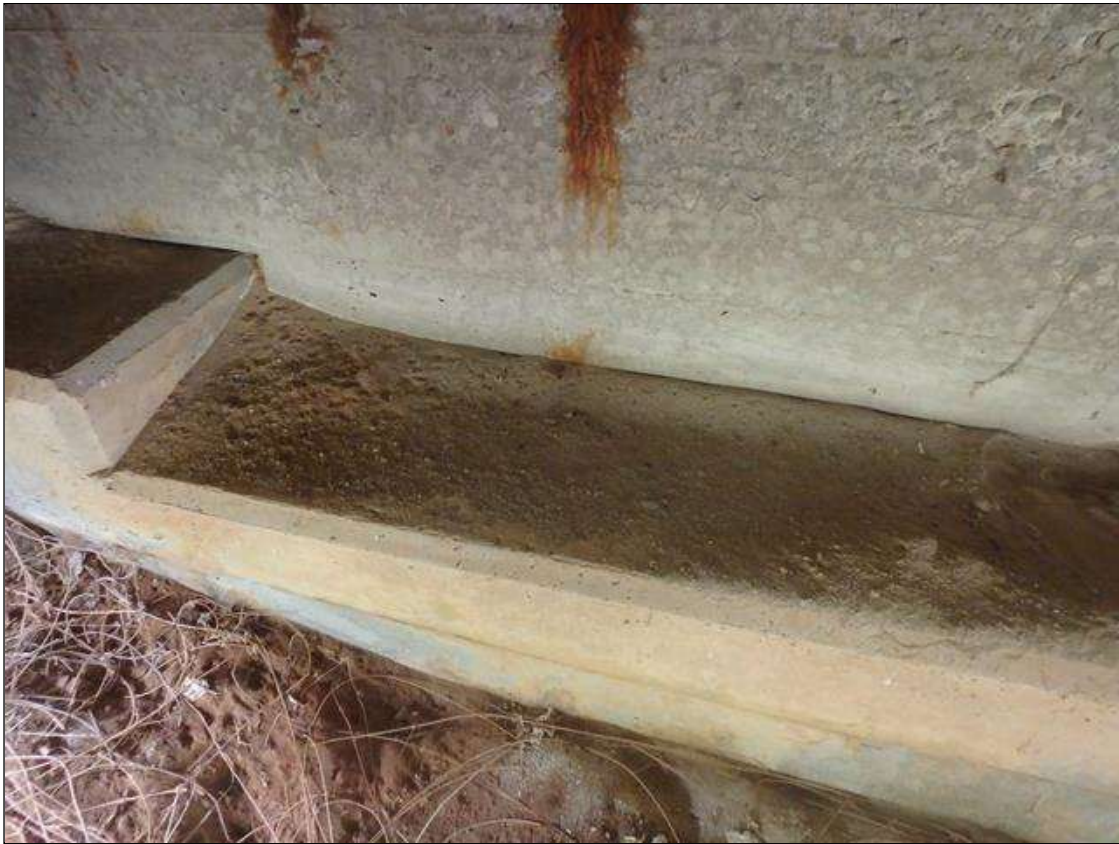
End Bent 1 Abutment/Backwall : DEBRIS ALONG TOP OF CAP, BAY 3, OTHERS SIMILAR

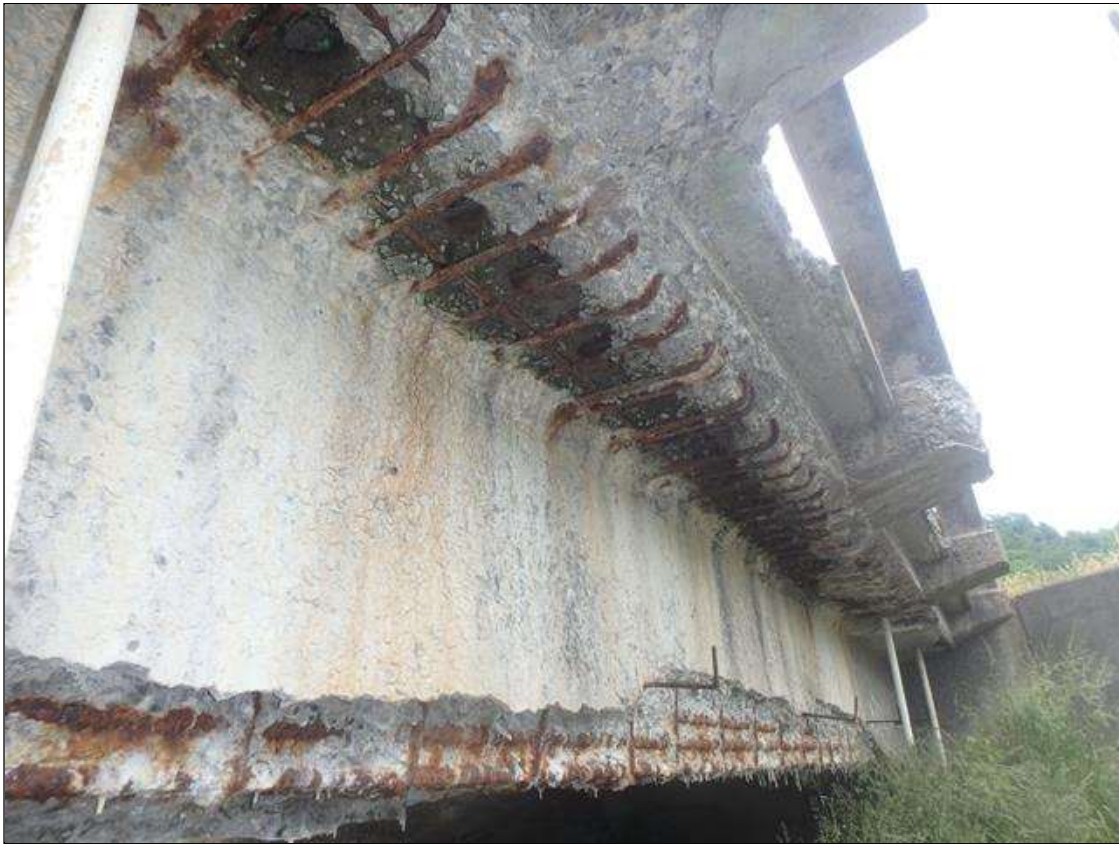
Span 1 Deck: SPALL 35 FT X 2 FT X UP TO 8" DEEP WITH EXPOSED REBAR, UP TO 50% SECTION LOSS, ALONG UNDERSIDE OF LEFT OVERHANG, PRIORITY MAINTENANCE

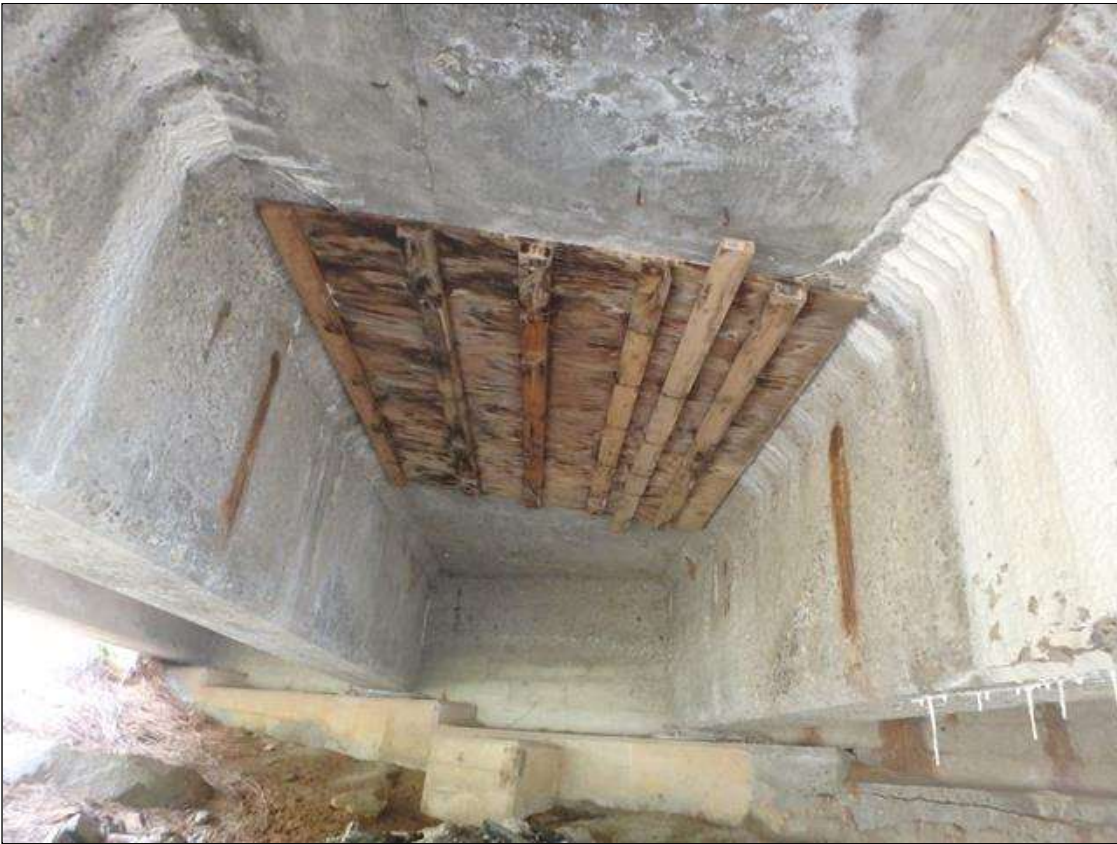
Span 1 Deck: FORMWORK FOR PATCH, 7 FT X 5.5 FT, 11 FT FROM END BENT 1, BAY 2

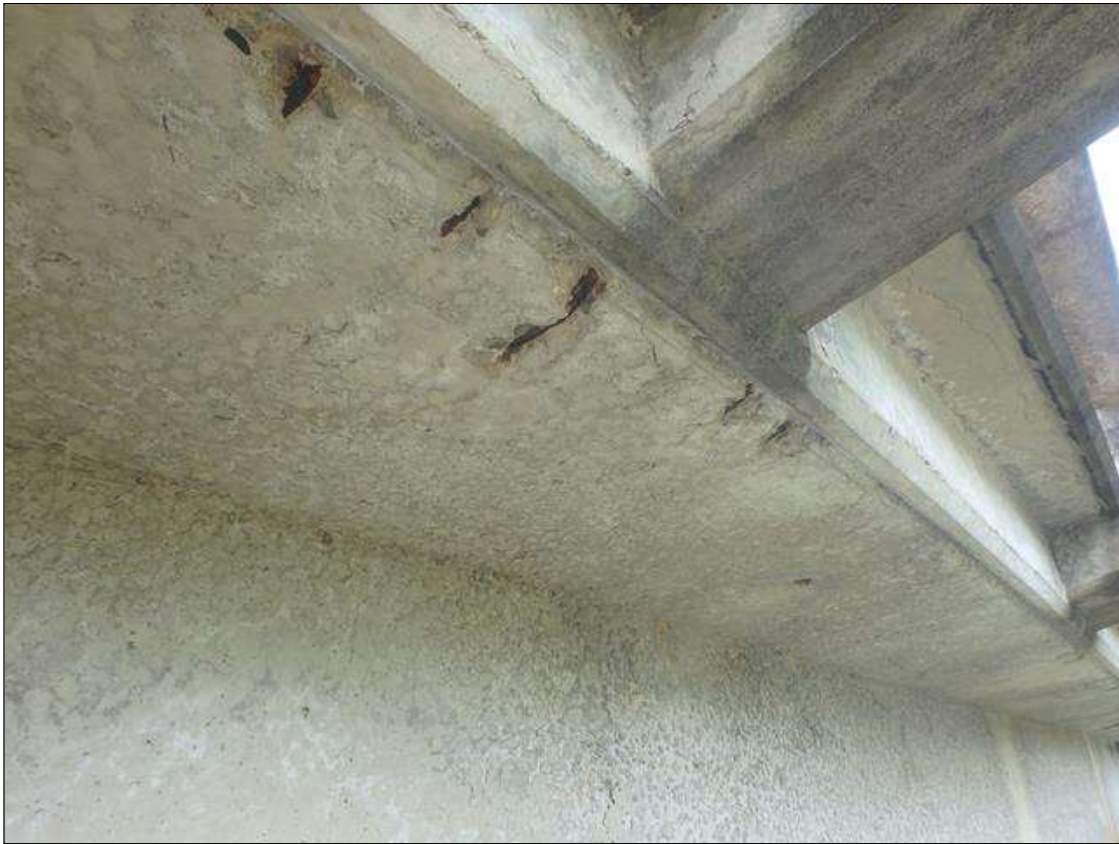
Span 1 Deck: SCATTERED EXPOSED REBAR UP TO 6", NO SECTION LOSS, THROUGHOUT UNDERSIDE OF RIGHT OVERHANG

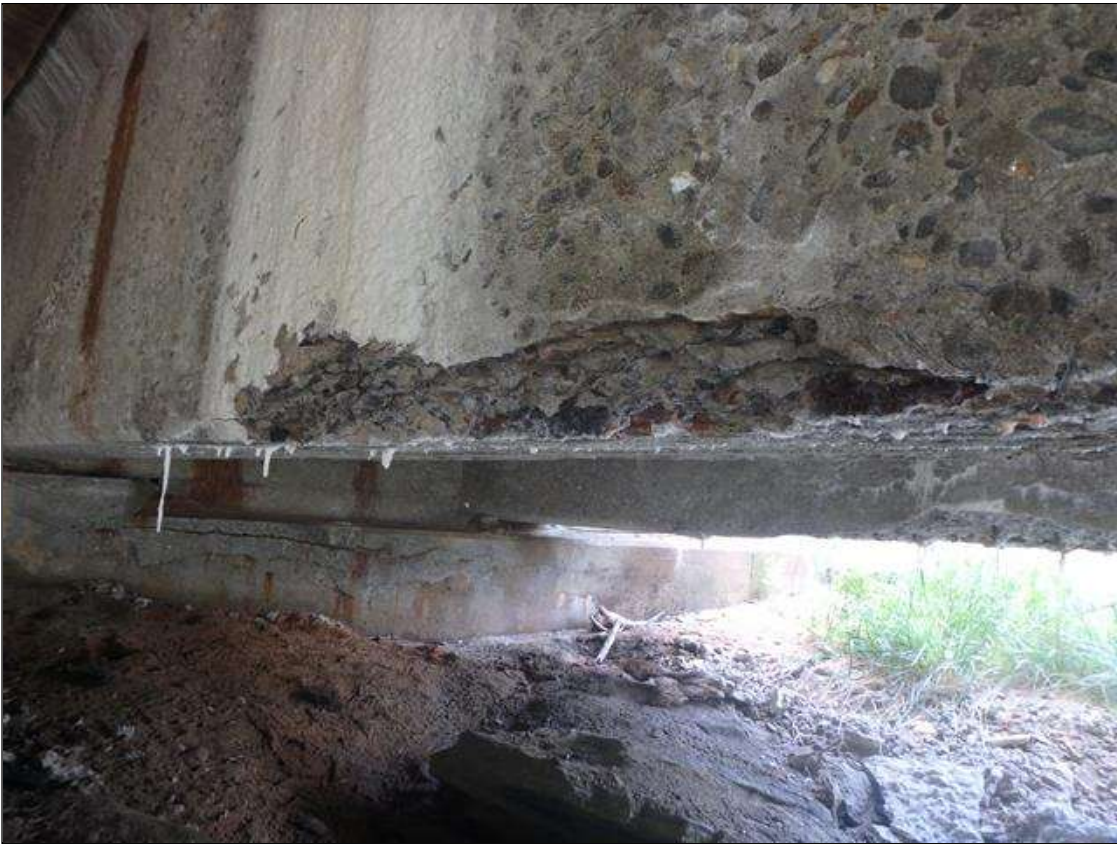
Span 1 Beam 2: SPALL 2.5 FT X UP 5" X 5" WITH EXPOSED REBAR, NO SECTION LOSS, AND ADJACENT CONCRETE DETERIORATING, 16 FT FROM END BENT 1

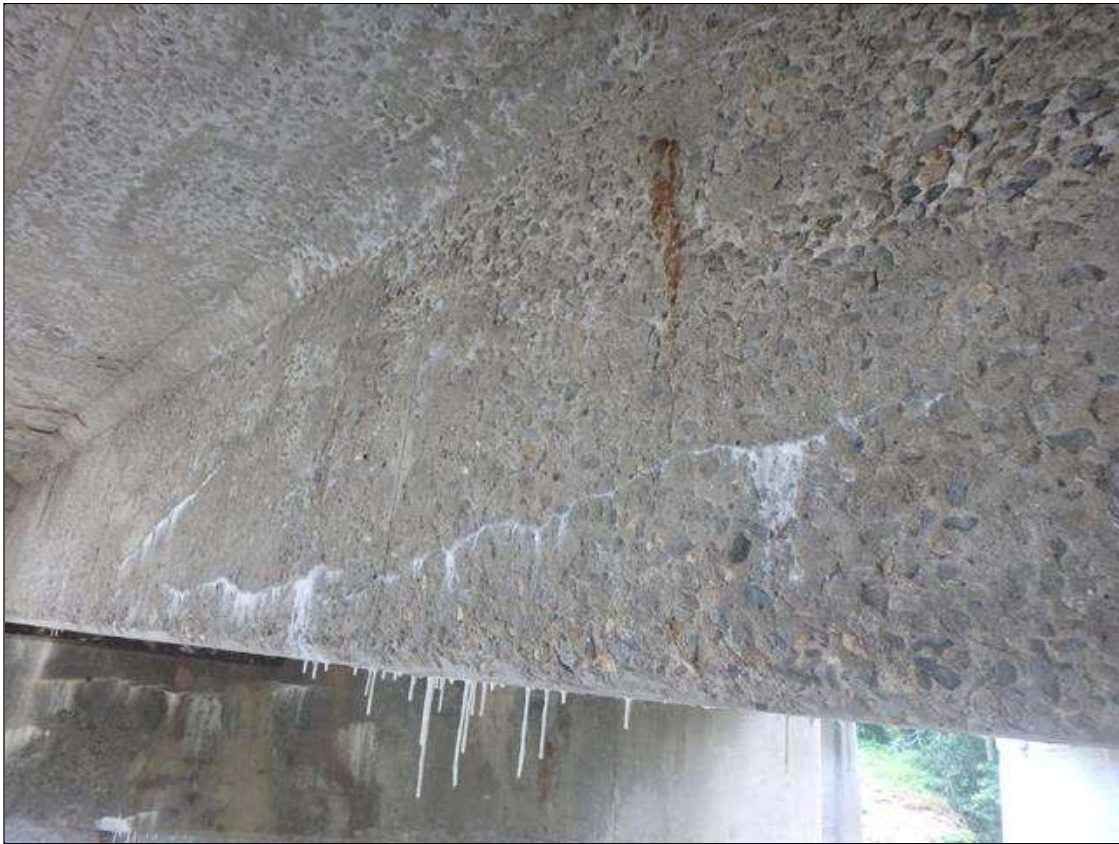
Span 1 Beam 2: LONGITUDINAL CRACKING UP TO 1/16" WITH EFFLORESCENCE BUILDUP AND RUST STAINING ALONG WEST FACE, 15 FT FROM BENT 1
