NC DEPARTMENT OF TRANSPORTATION  
DIVISION OF HIGHWAYS  
STRUCTURE MANAGEMENT UNIT

## Structure Safety Report

### Routine Element Inspection - Contract

COUNTY: MADISON STRUCTURE NUMBER: 560009 FREQUENCY: 24 MONTHS

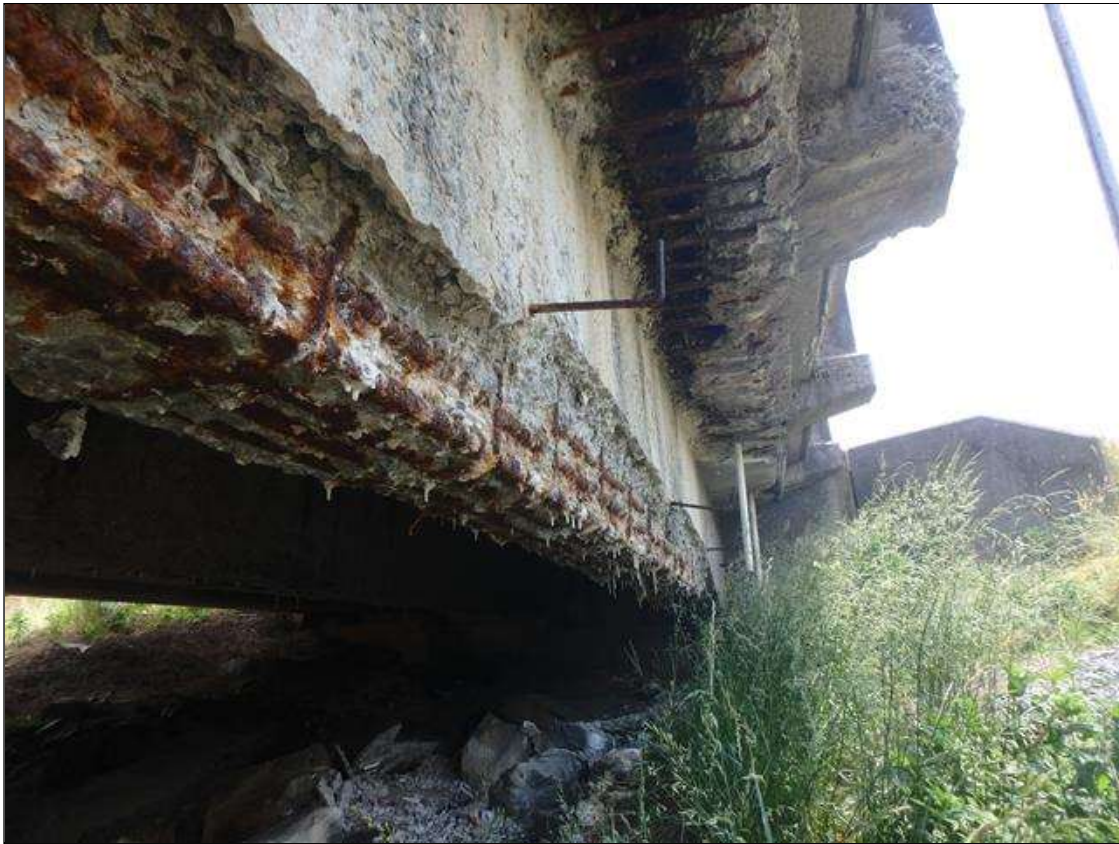
Span 1 Beam 1: SPALL FULL WIDTH BOTTOM FLANGE X UP TO 16" HIGH ALONG BOTH FACES AND UP TO 5" DEEP WITH EXPOSED REBAR, UP TO 25% SECTION LOSS, FROM MIDSPAN TO END BENT 1, PRIORITY MAINTENANCE

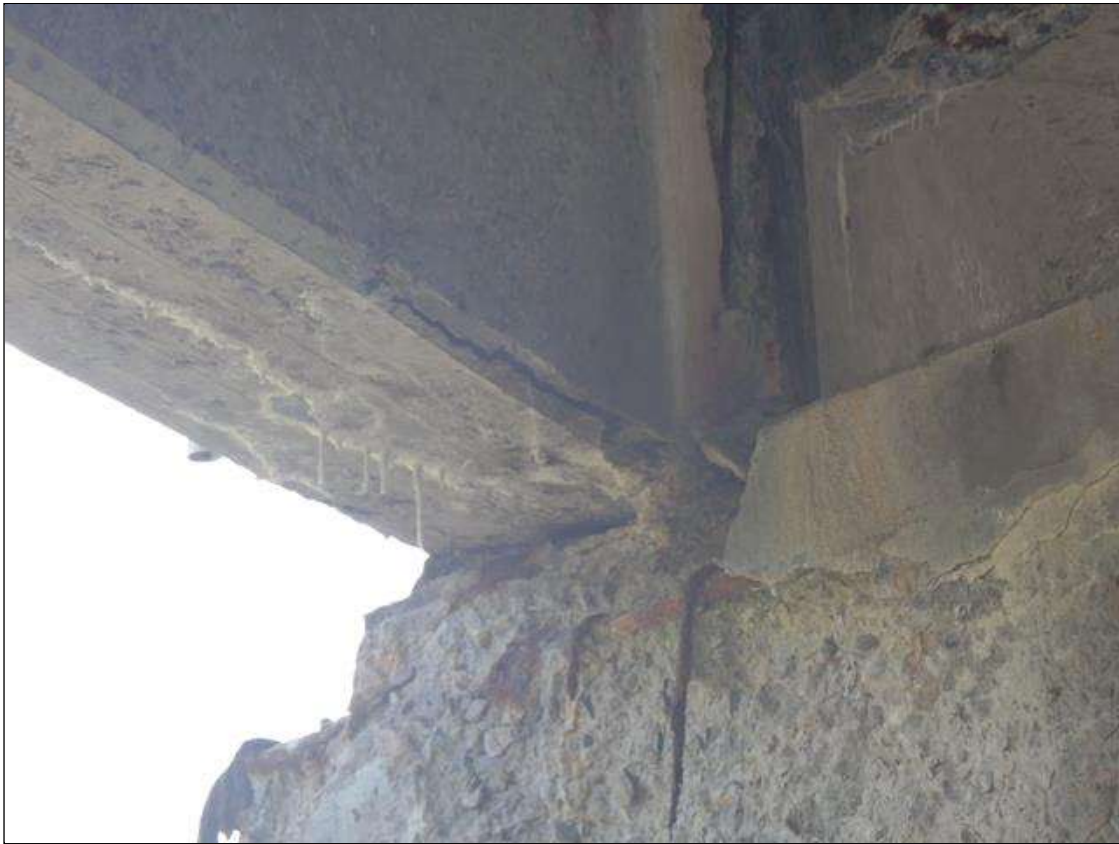
Span 1 Beam 1: DELAMINATION 2 FT X 6" ALONG BOTTOM AT BENT 1

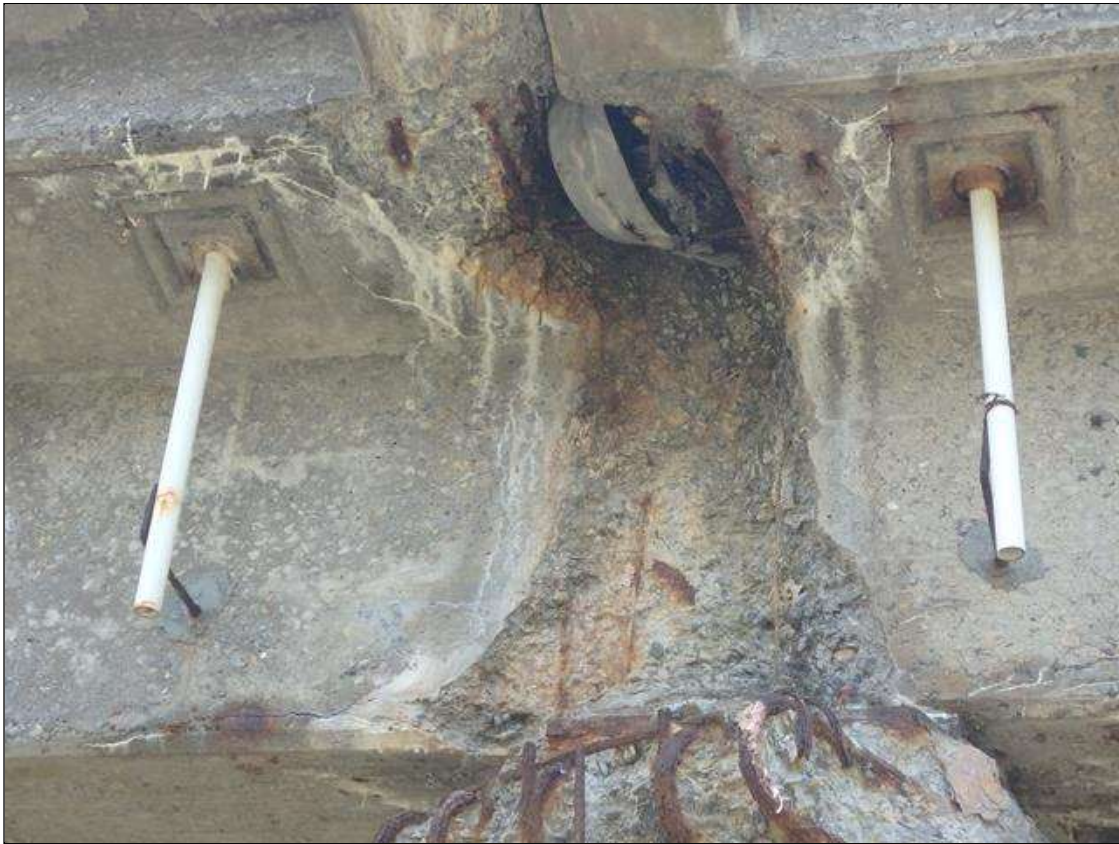
Span 1 Beam 1: SPALL 3 FT X 2 FT X UP TO 5" DEEP WITH EXPOSED REBAR AND DETERIORATING CONCRETE, NO SECTION LOSS, ALONG WEST FACE AT BENT 1, PRIORITY MAINTENANCE

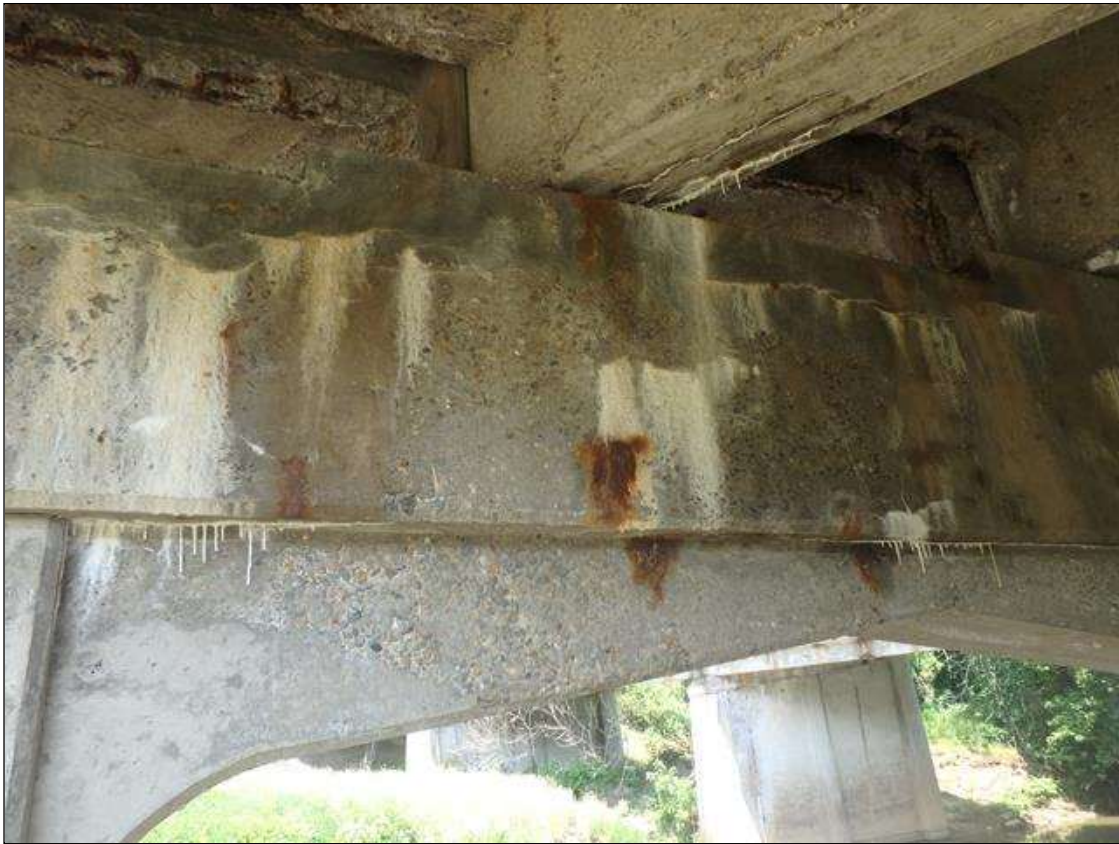
Bent 1 Cap : SCATTERED HORIZONTAL CRACKS WITH HEAVY EFFLORESCENCE BUILDUP AND RUST STAINING IN BAYS 1 AND 2, SPAN 1 FACE

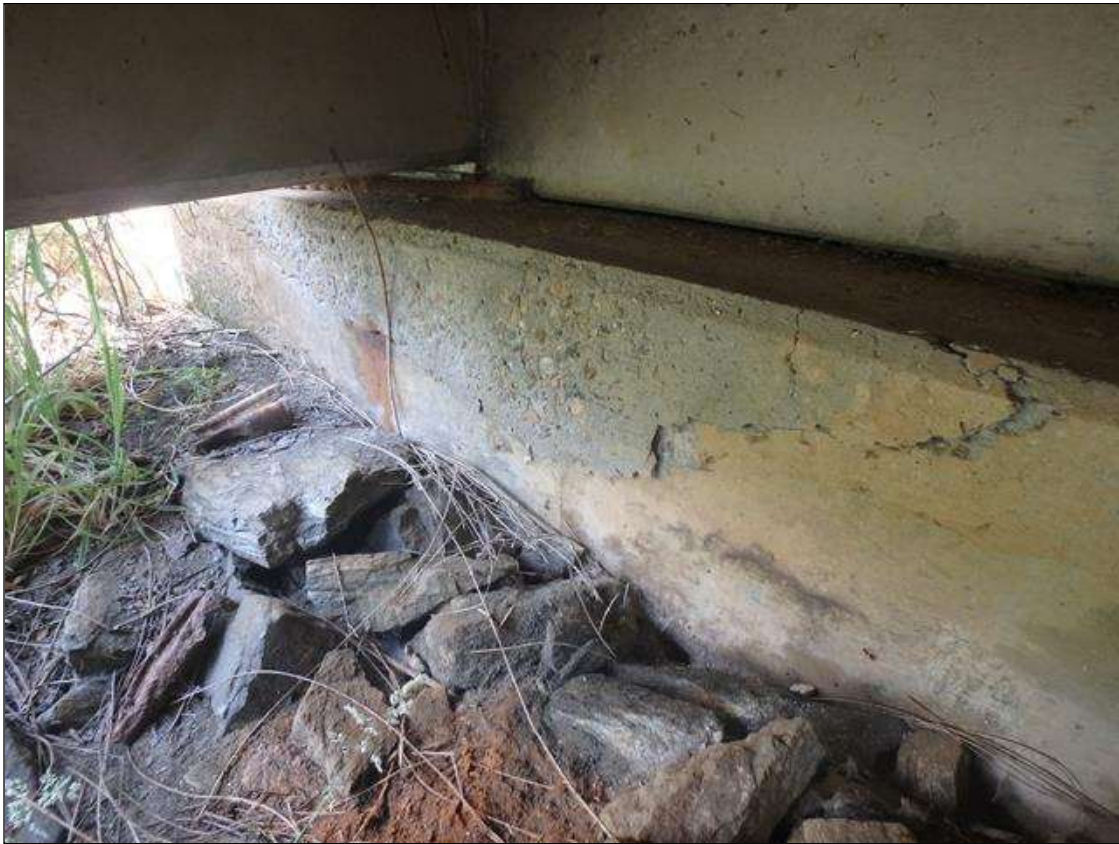
End Bent 2 Cap : DELAMINATION 5 FT X 1 FT X 5" WITH RUST STAINING IN BAY 1

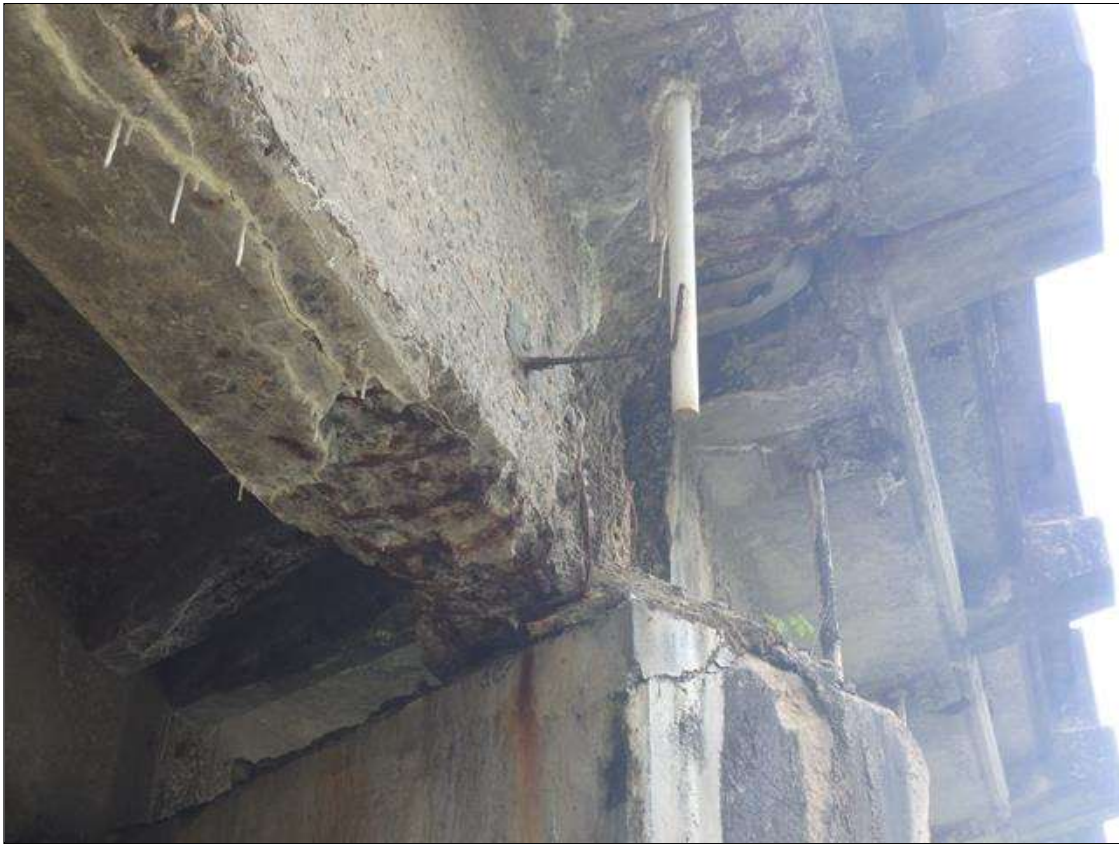
Span 5 Beam 1: SPALL FULL HEIGHT X FULL WIDTH X UP TO 5" DEEP WITH EXPOSED REBAR, UP TO 100% SECTION LOSS AT BENT 4, PRIORITY MAINTENANCE

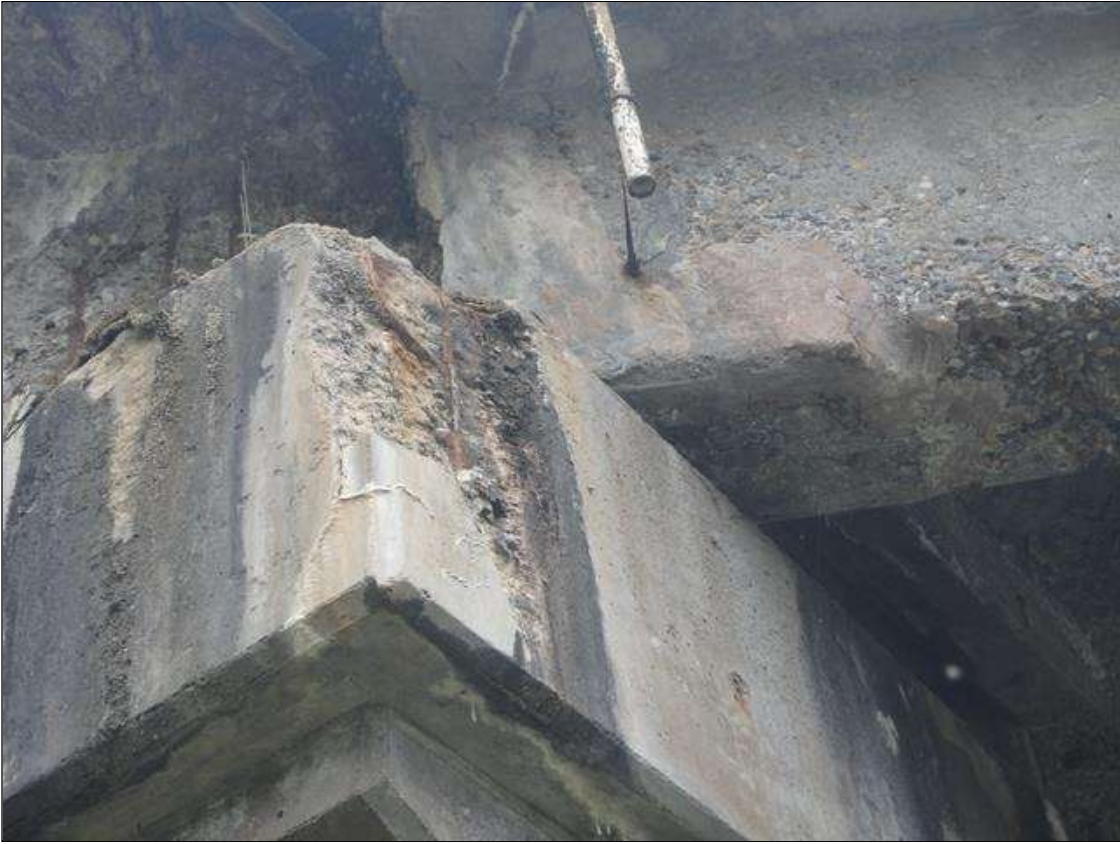
Bent 4 Cap : SPALL 2 FT X 3 FT X UP TO 4" DEEP WITH EXPOSED REBAR, UP TO 25% SECTION LOSS ALONG END OF CAP, SPAN 4 FACE, PRIORITY MAINTENANCE

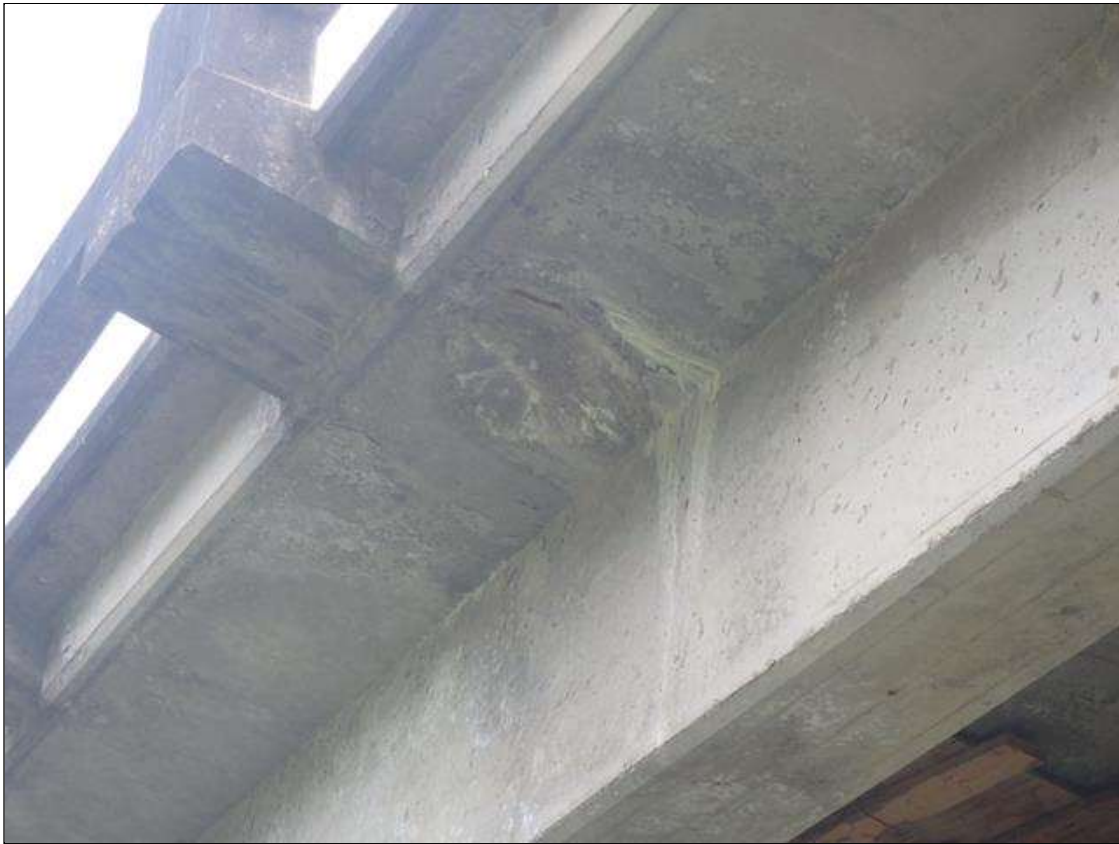
Span 4 Deck: SPALL 2 FT DIAMETER X 4" DEEP WITH EXPOSED REBAR, NO SECTION LOSS, ALONG UNDERSIDE OF RIGHT OVERHANG, 15 FT FROM BENT 3

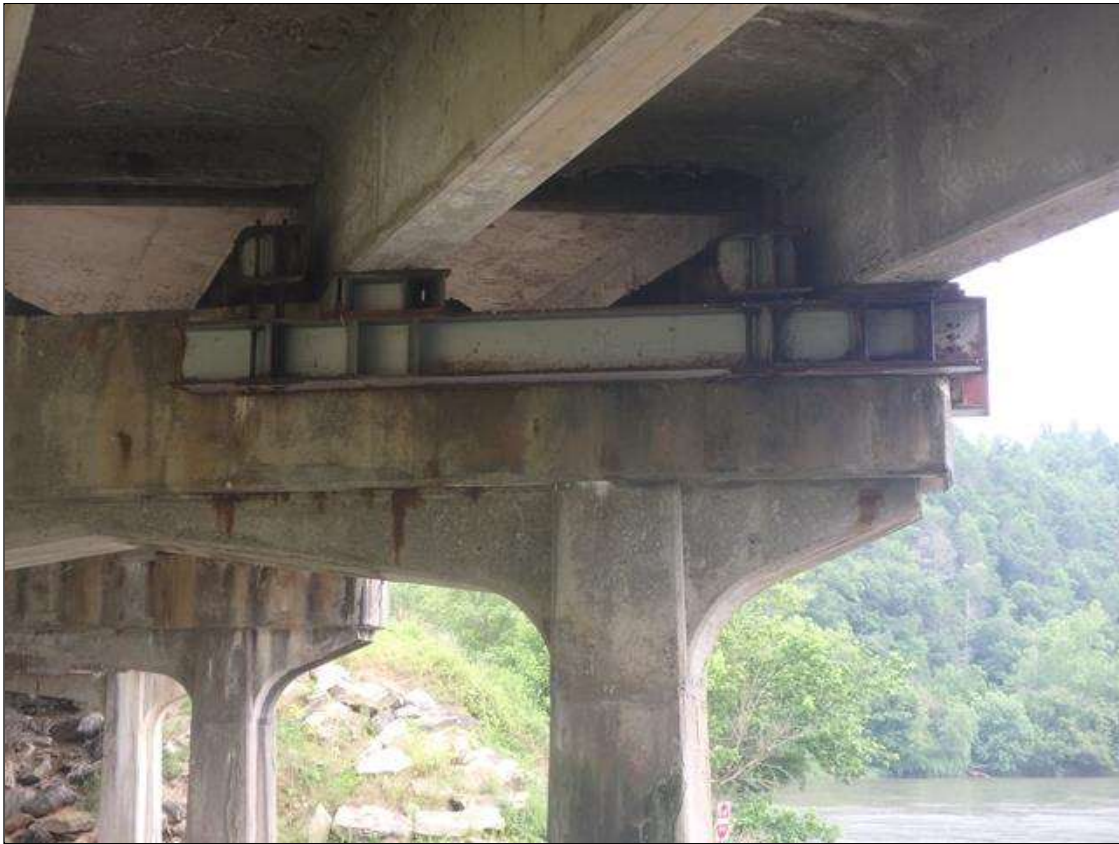
Bent 3 Cap : TEMPORARY REPAIR UNDER BEAMS 1 AND 2, SPAN 4 FACE, SPAN 3 FACE SIMILAR

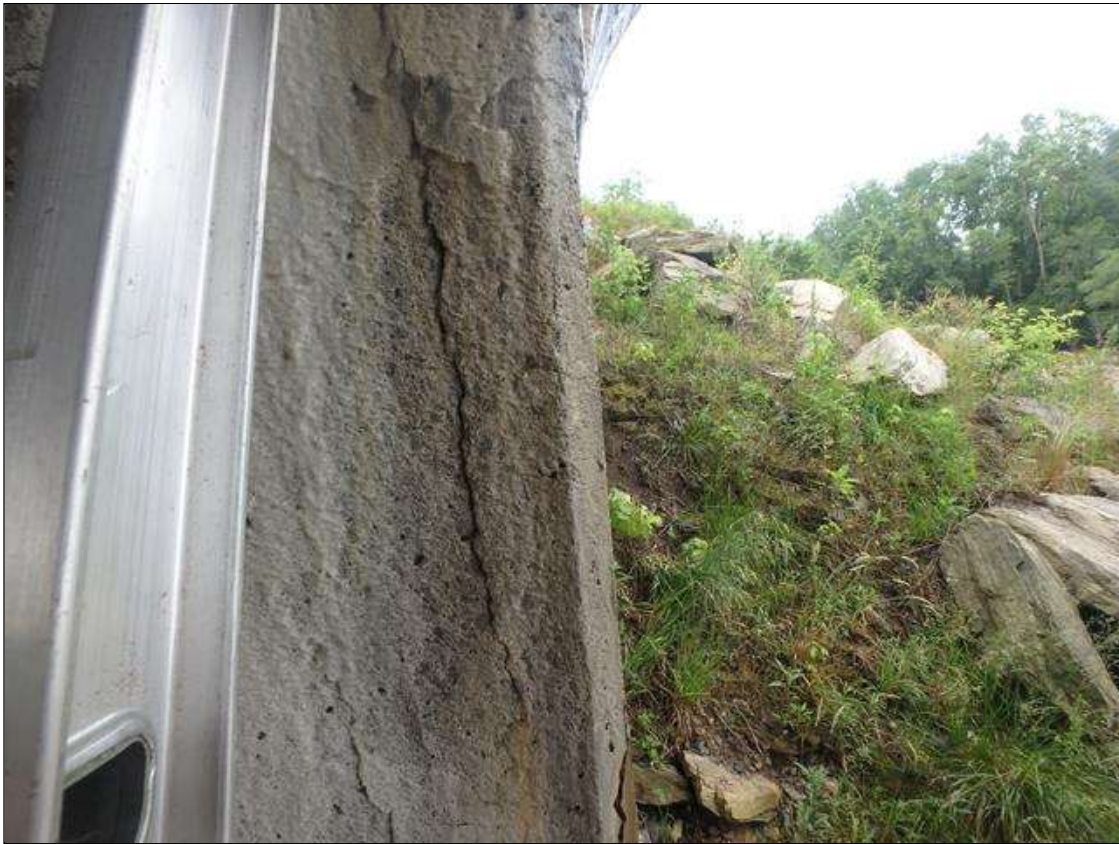
Bent 1 Pile 1: DELAMINATION 6 FT X 6" ALONG NORTHWEST CORNER

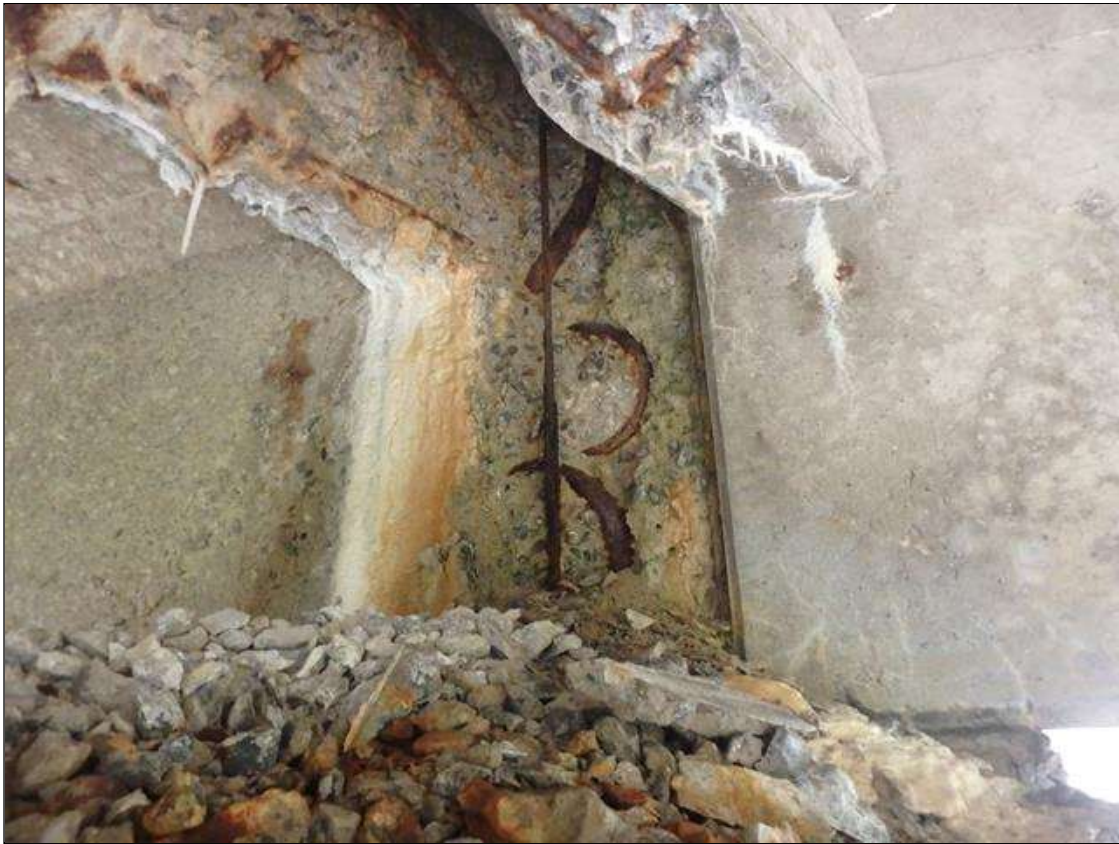
Span 1 Beam 1: SPALL 1.5 FT X 3 FT X UP TO 4" WITH EXPOSED REBAR, UP TO 25% SECTION LOSS, ALONG EAST FACE AT BENT 1, PRIORITY MAINTENANCE

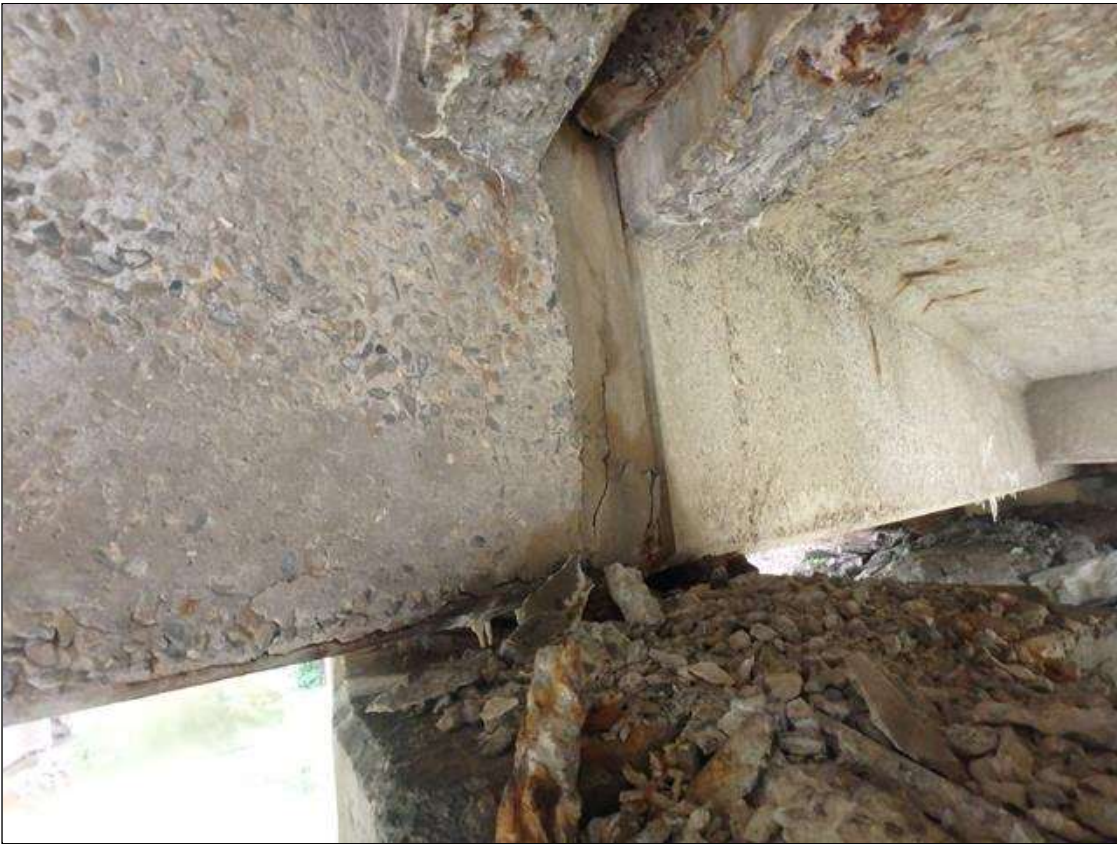
Span 2 Beam 2: DELAMINATION 8" DIAMETER, 1.5 FT VERTICAL CRACK UP TO 1/8" AND 3 FT LONGITUDINAL CRACK X UP TO 1/8" WITH RUST STAINING ALONG THE WEST FACE AT BENT 1

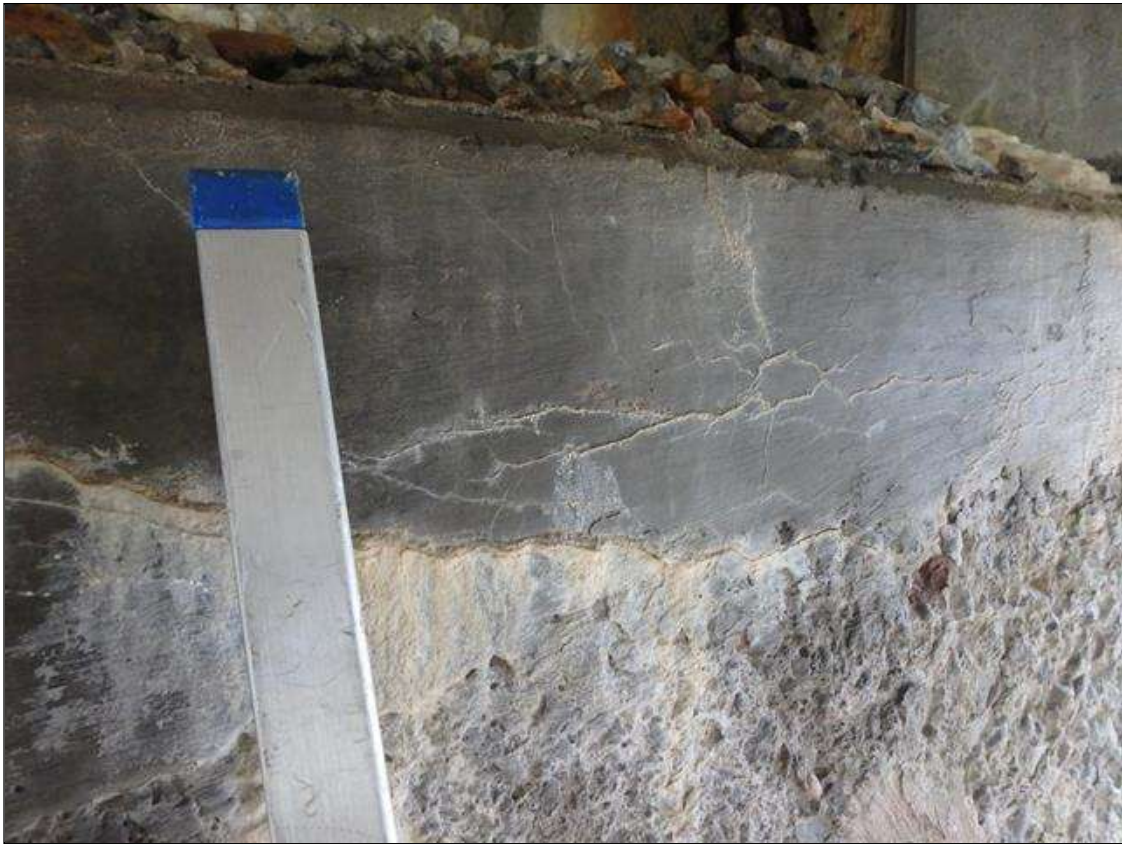
Bent 1 Cap : 4 FT OF HAIRLINE MAP CRACKING WITH EFFLORESCENCE BUILDUP IN BAY 1, SPAN 2 FACE

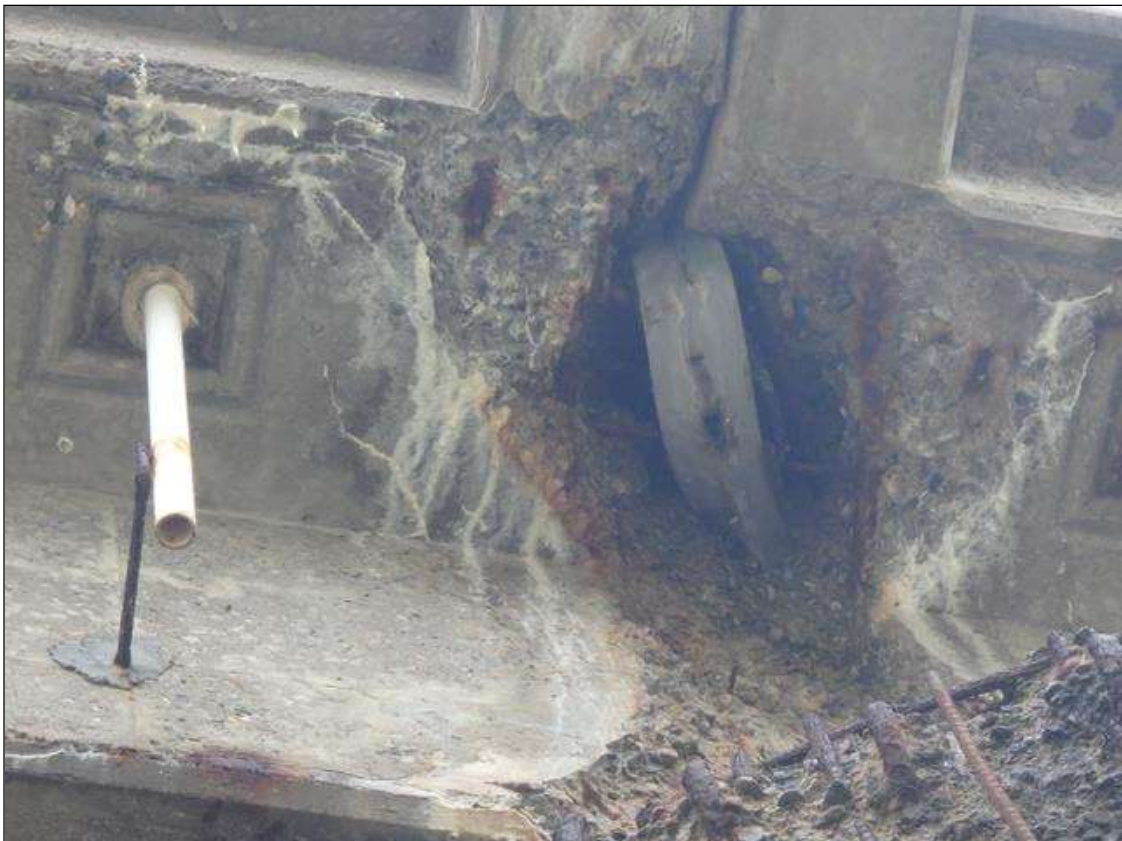
Span 2 Deck: SPALL 2 FT X 1 FT X UP TO 3" WITH EXPOSED REBAR, NO SECTION LOSS, ALONG UNDERSIDE OF LEFT OVERHANG AT BENT 1

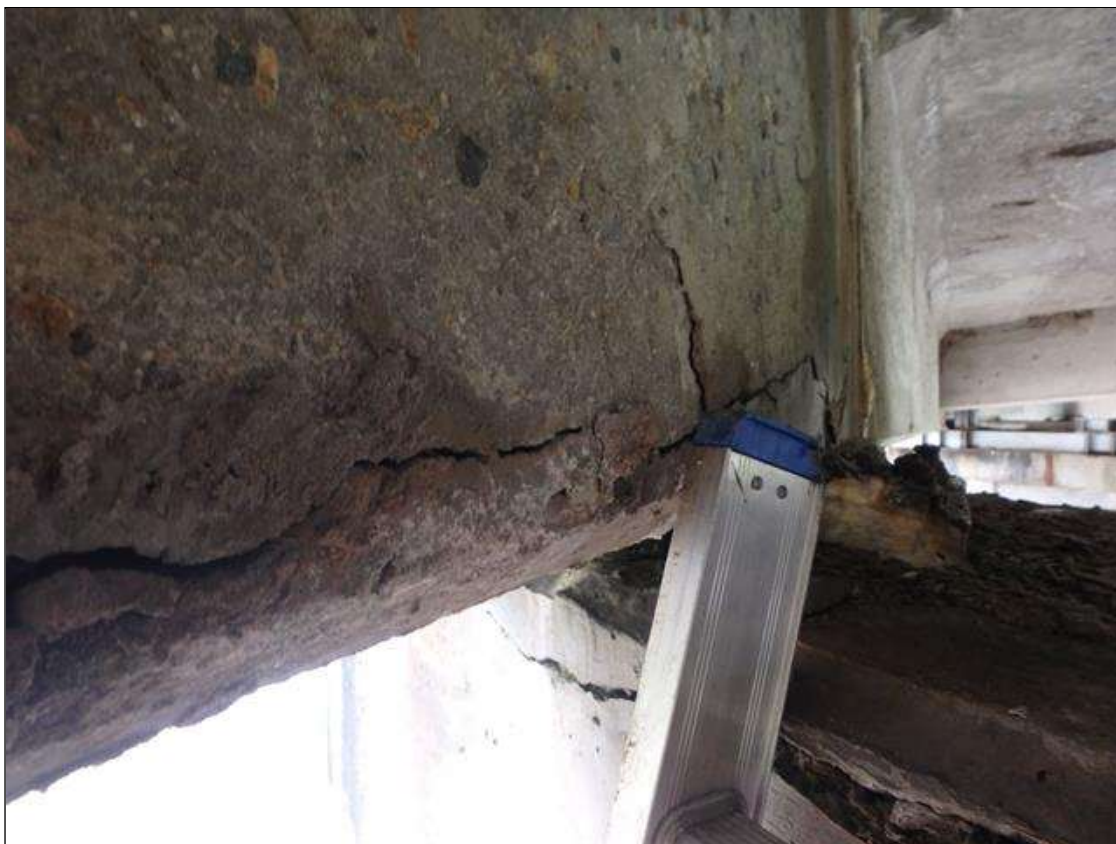
Span 2 Beam 1: DELAMINATION 3 FT X 4" ALONG BOTTOM AND EAST FACE AT BENT 2

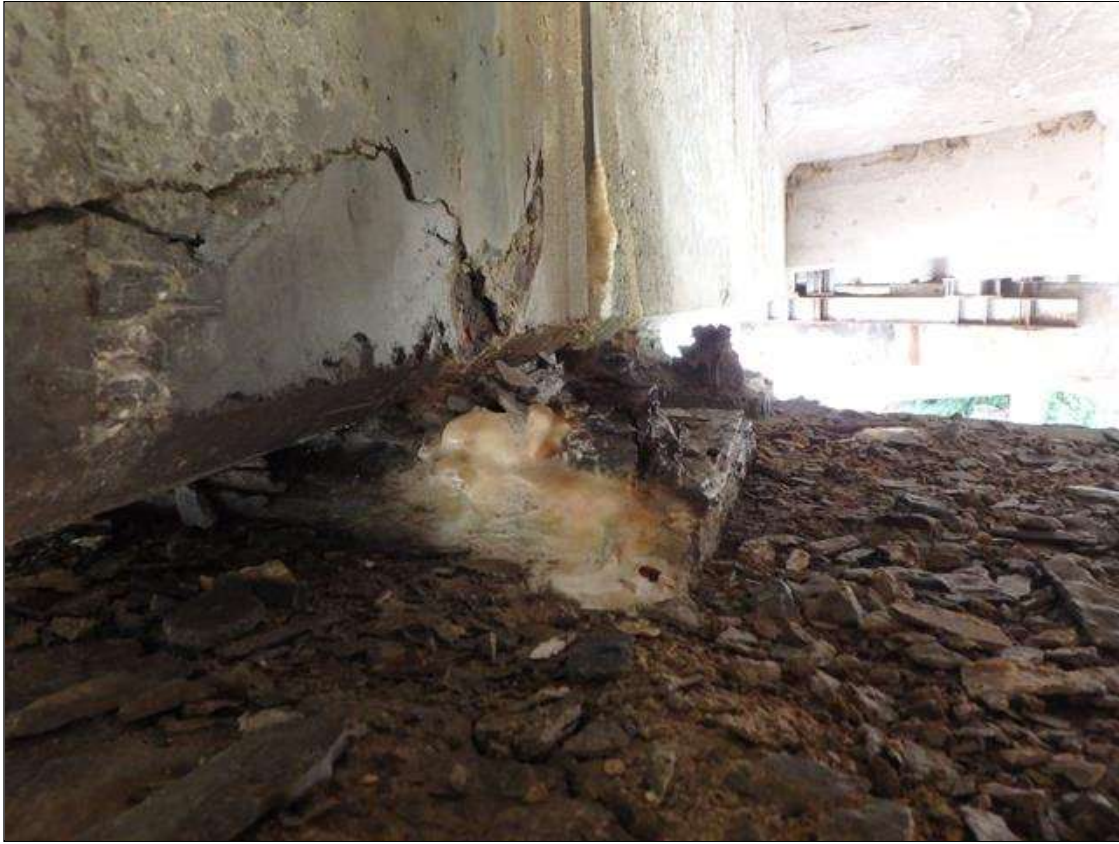
Span 2 Beam 1 Far Bearing : PACK RUST PRESENT

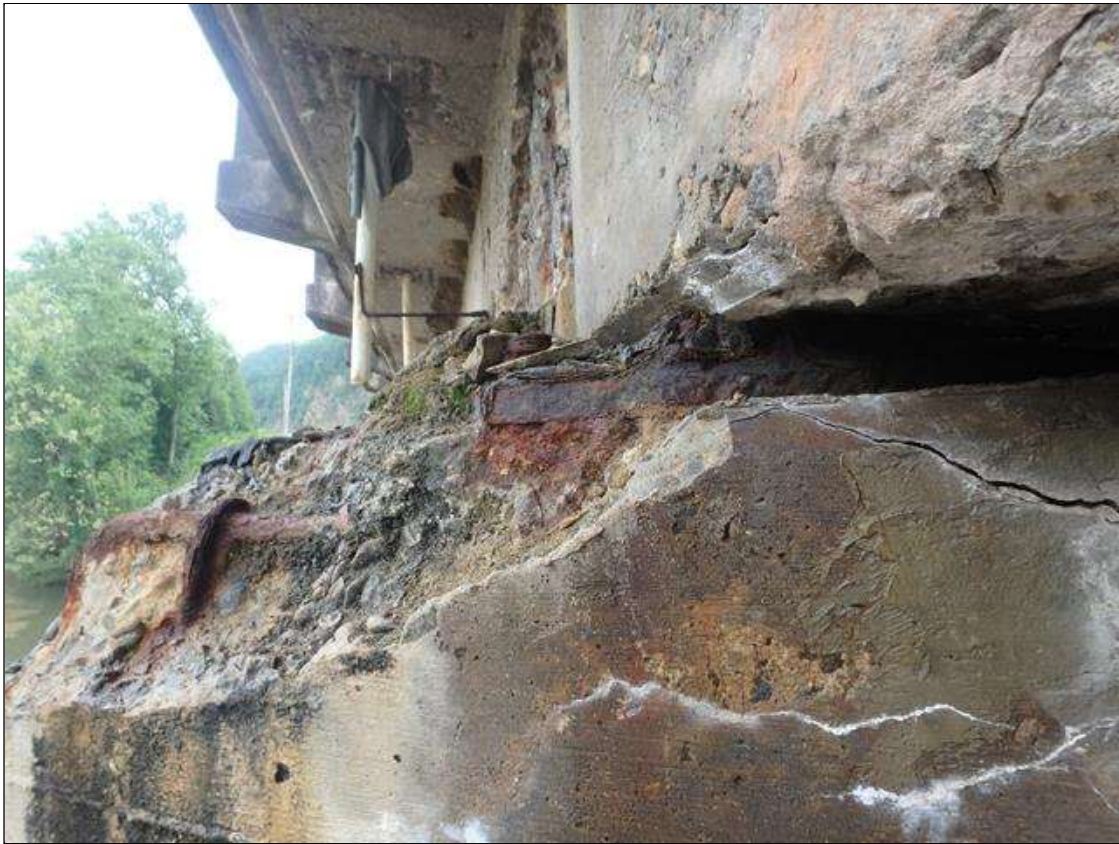
Bent 2 Cap : SPALL 3 FT X 1 FT X 1 FT UNDER BEAM 1 WITH EXPOSED REBAR, UP TO 10% SECTION LOSS, AND DETERIORATING CONCRETE AND LOSS OF BEARING FOR BEAM 1, SPAN 2 FACE, PRIORITY MAINTENANCE

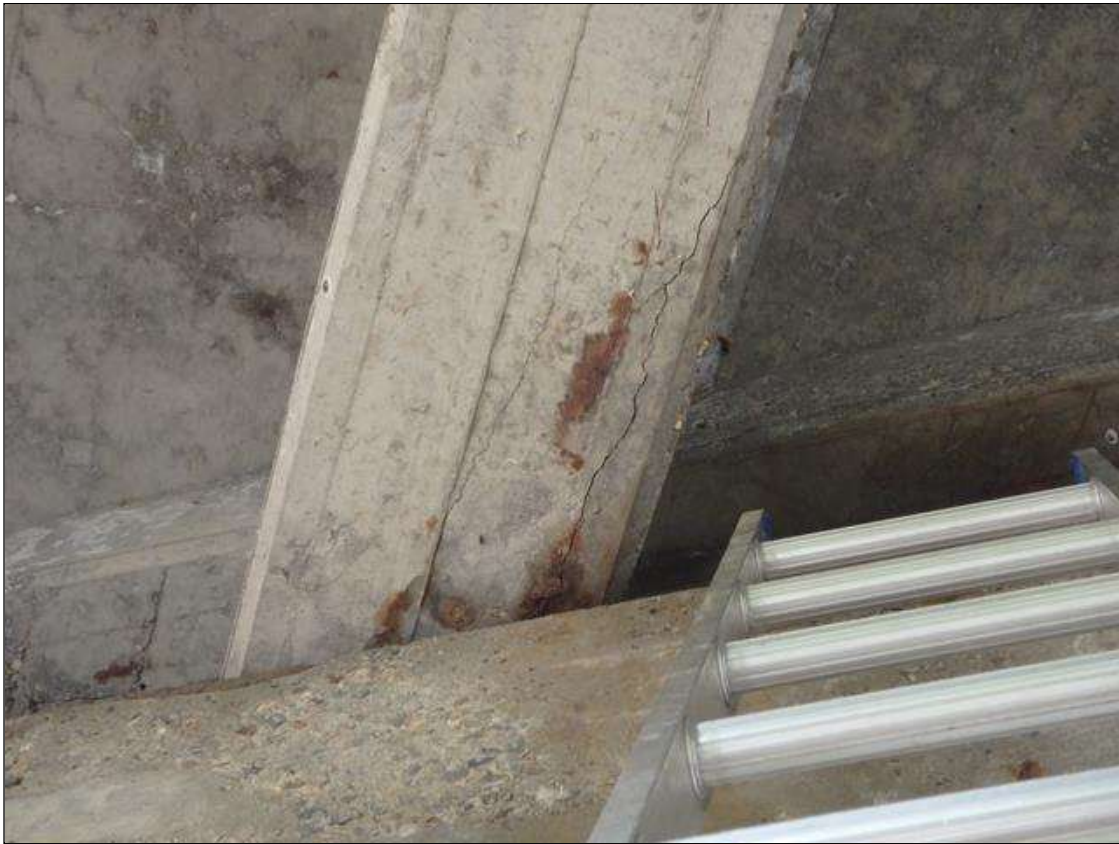
Span 2 Beam 2: TWO LONGITUDINAL CRACKS UP TO 3 FT X 1/16" ALONG BOTTOM AT BENT 2

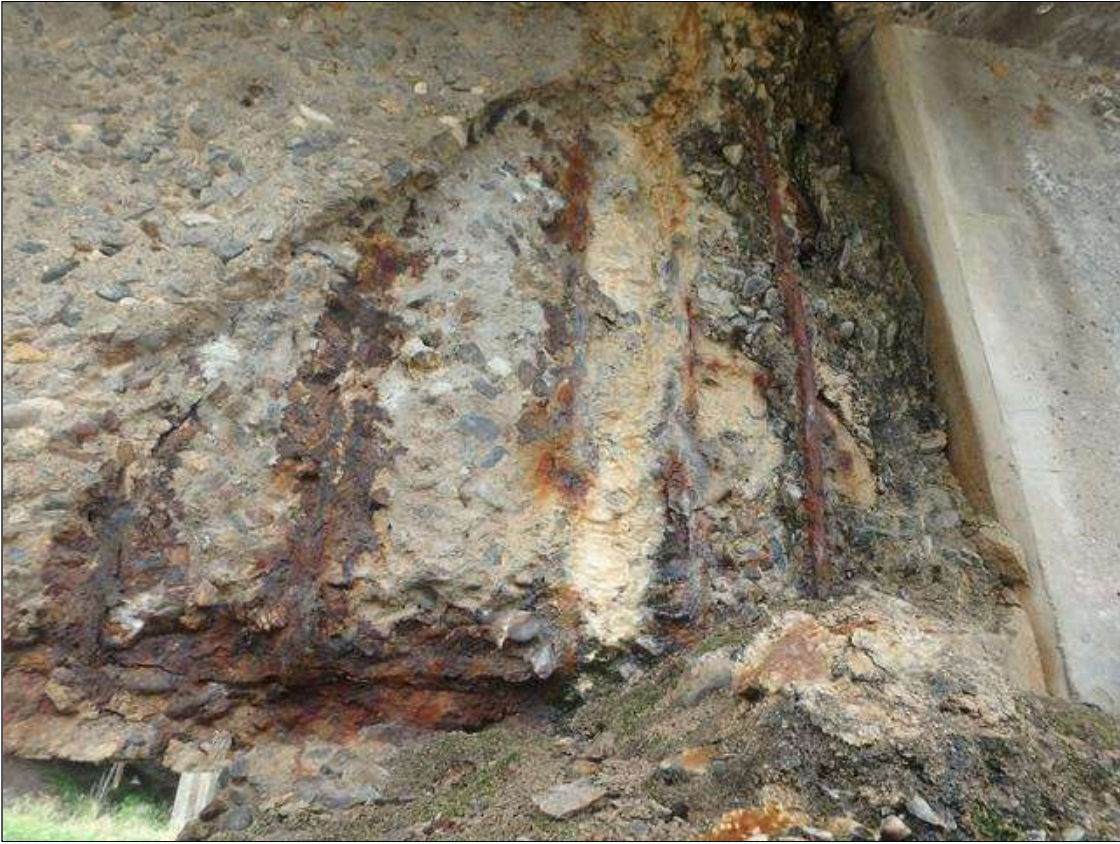
Span 3 Beam 1: SPALL 4 FT X 3 FT X UP TO 4" WITH EXPOSED REBAR, UP TO 25% SECTION LOSS, ALONG WEST FACE AT BENT 2, PRIORITY MAINTENANCE

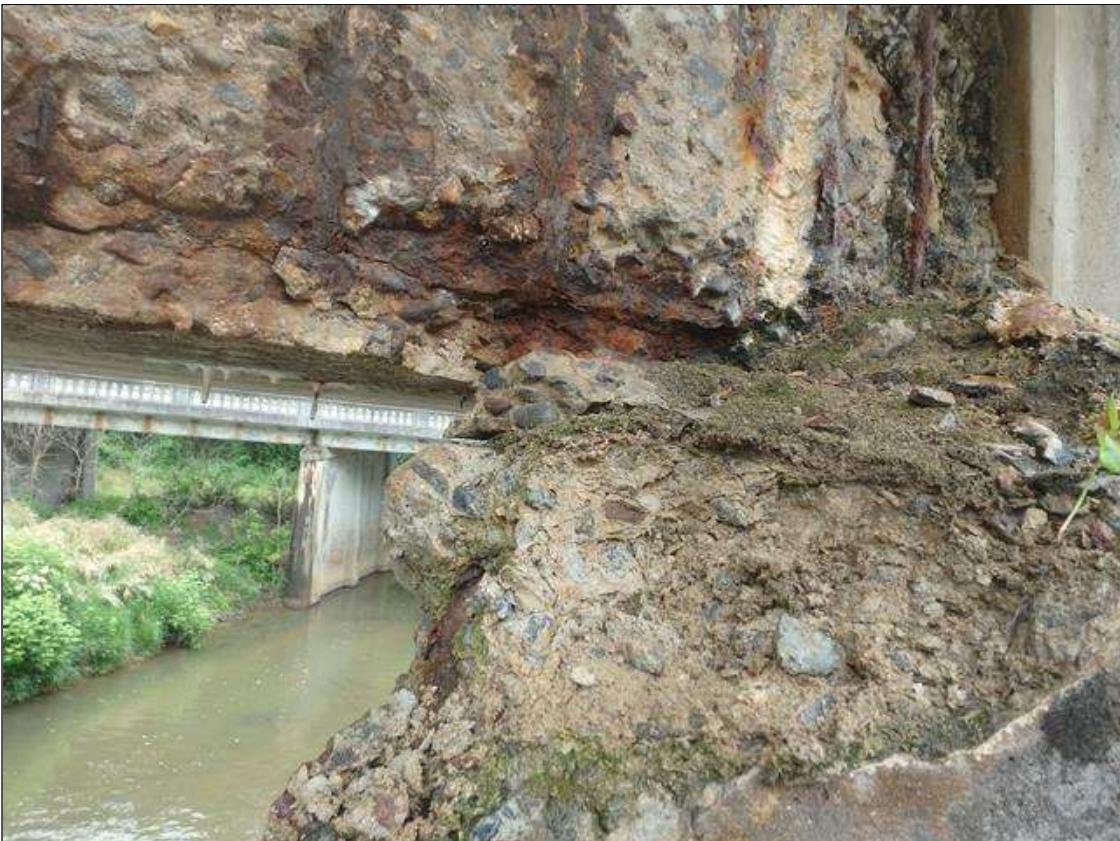
Bent 2 Cap : SPALL 1 FT X 1 FT X 4" DEEP, NO EXPOSED REBAR ALONG LEFT END OF CAP

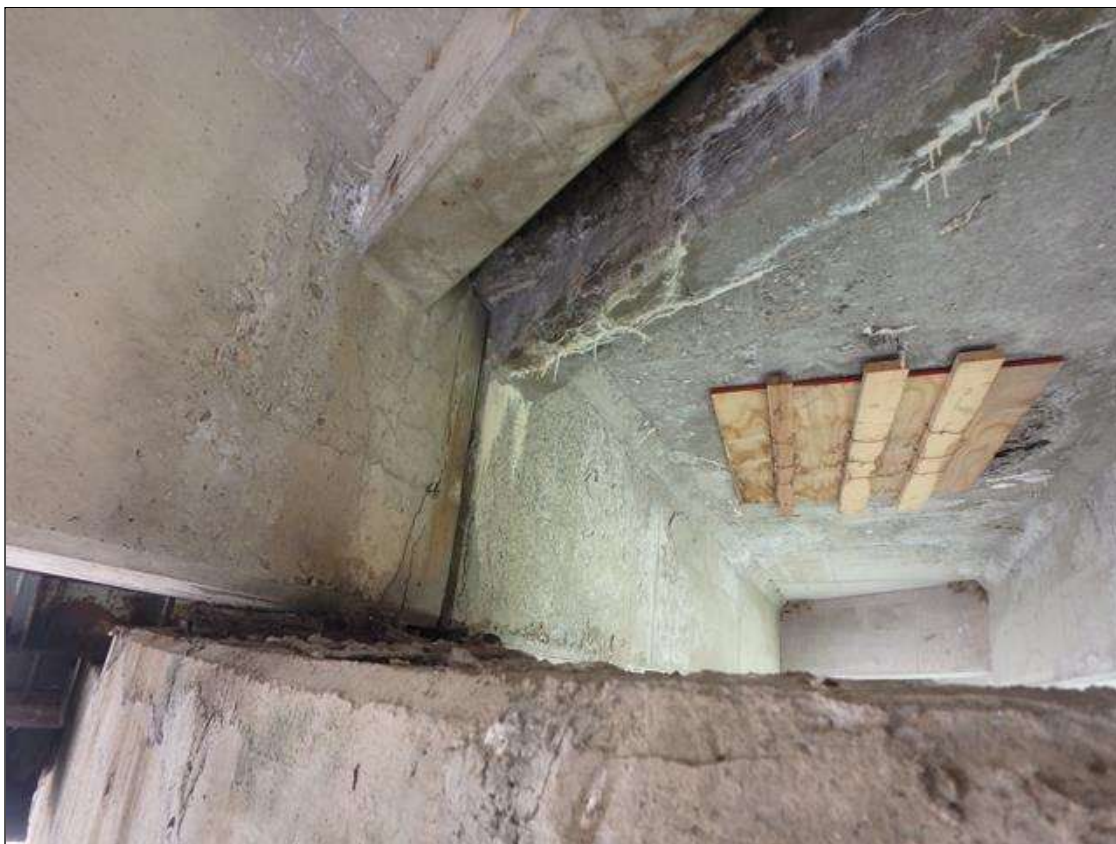
Span 3 Beam 3: 2 FT OF HAIRLINE MAP CRACKING ALONG EAST FACE AT BENT 3

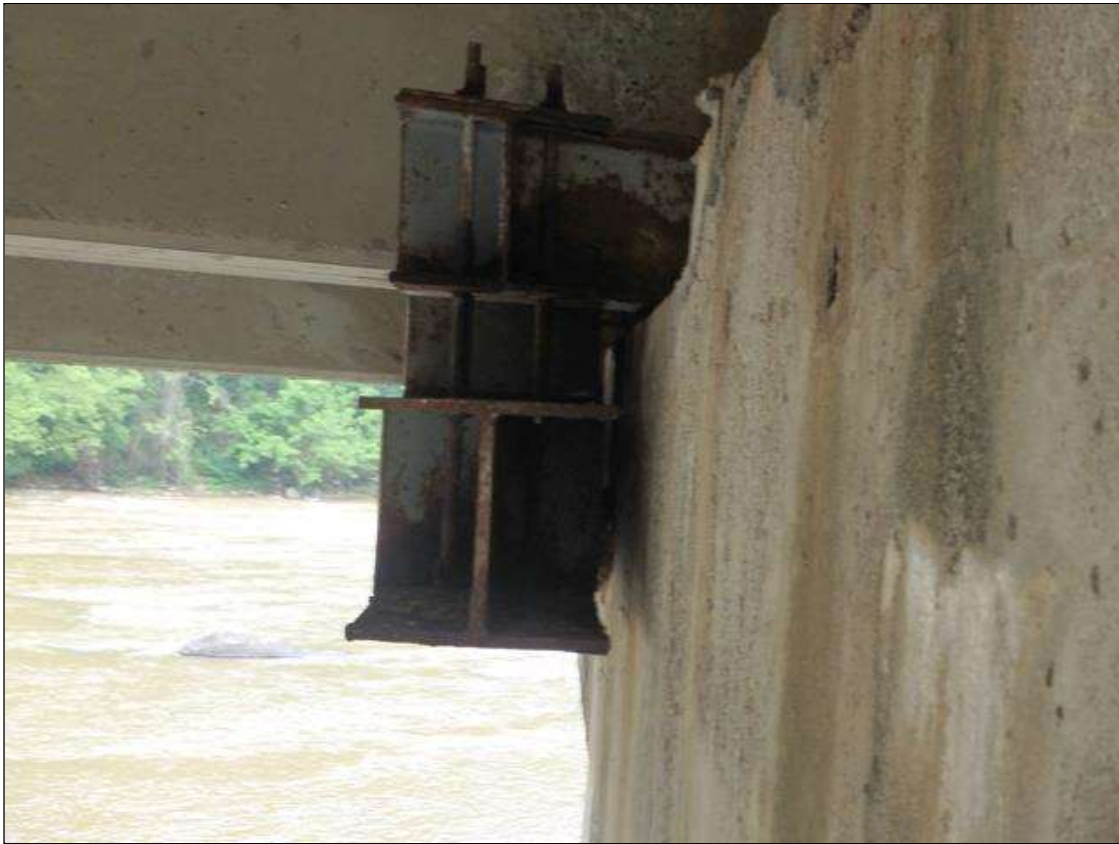
SURFACE CORROSION ALONG BENT 3 SADDLE SUPPORT

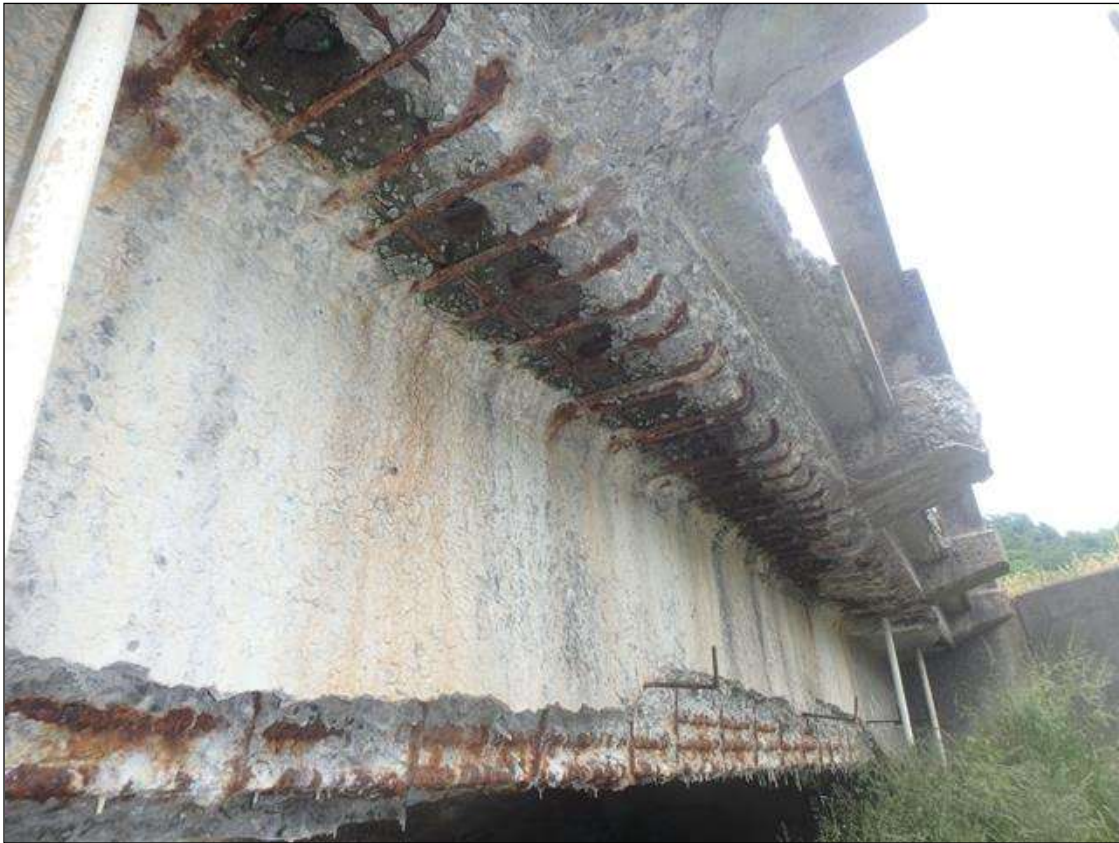
SPAN 1 DECK: SPALL 35 FT X 2 FT X UP TO 8" DEEP WITH EXPOSED REBAR, UP TO 50% SECTION LOSS, ALONG UNDERSIDE OF LEFT OVERHANG, PRIORITY MAINTENANCE
