NC DEPARTMENT OF TRANSPORTATION  
DIVISION OF HIGHWAYS  
STRUCTURE MANAGEMENT UNIT

## Structure Safety Report

### Routine Element Inspection - Contract

COUNTY: MADISON STRUCTURE NUMBER: 560009 FREQUENCY: 24 MONTHS

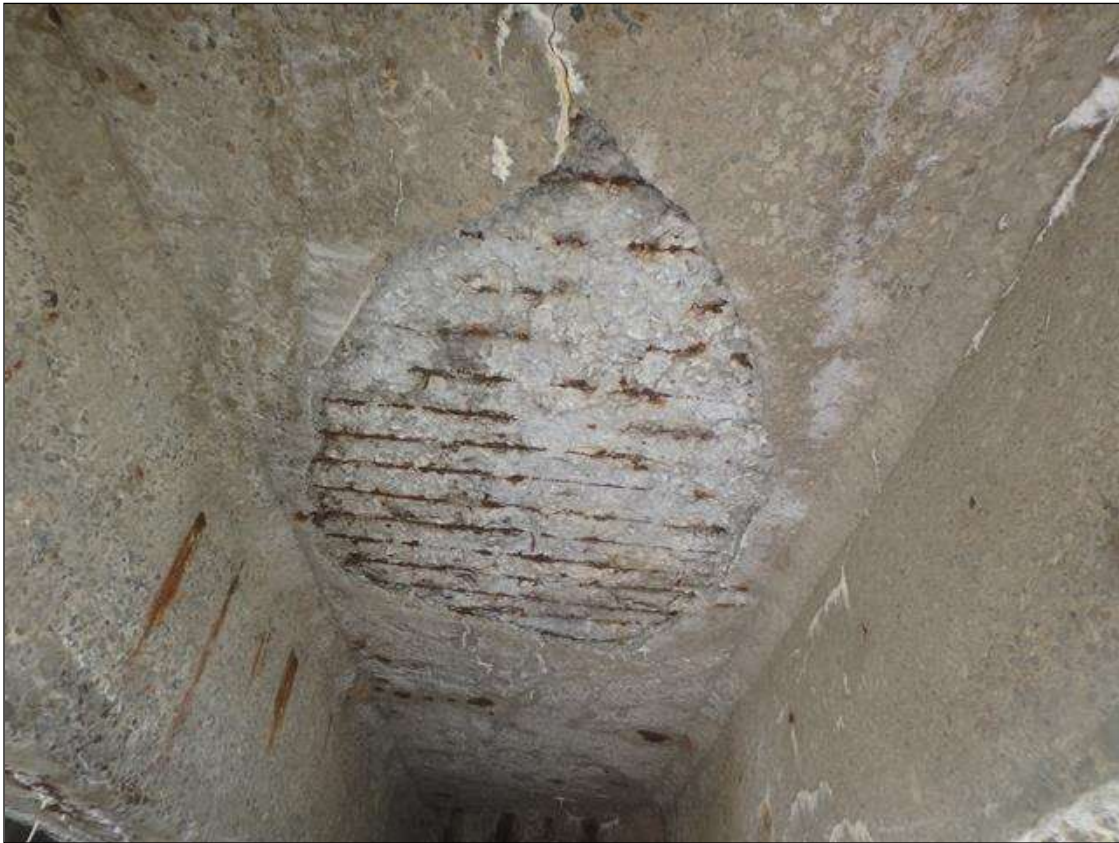
SPAN 1 DECK: SPALL 8 FT X 5 FT X UP TO 4" DEEP WITH EXPOSED REBAR, UP TO 100% SECTION LOSS, 15 FT FROM END BENT 1, BAY 1, PRIORITY MAINTENANCE

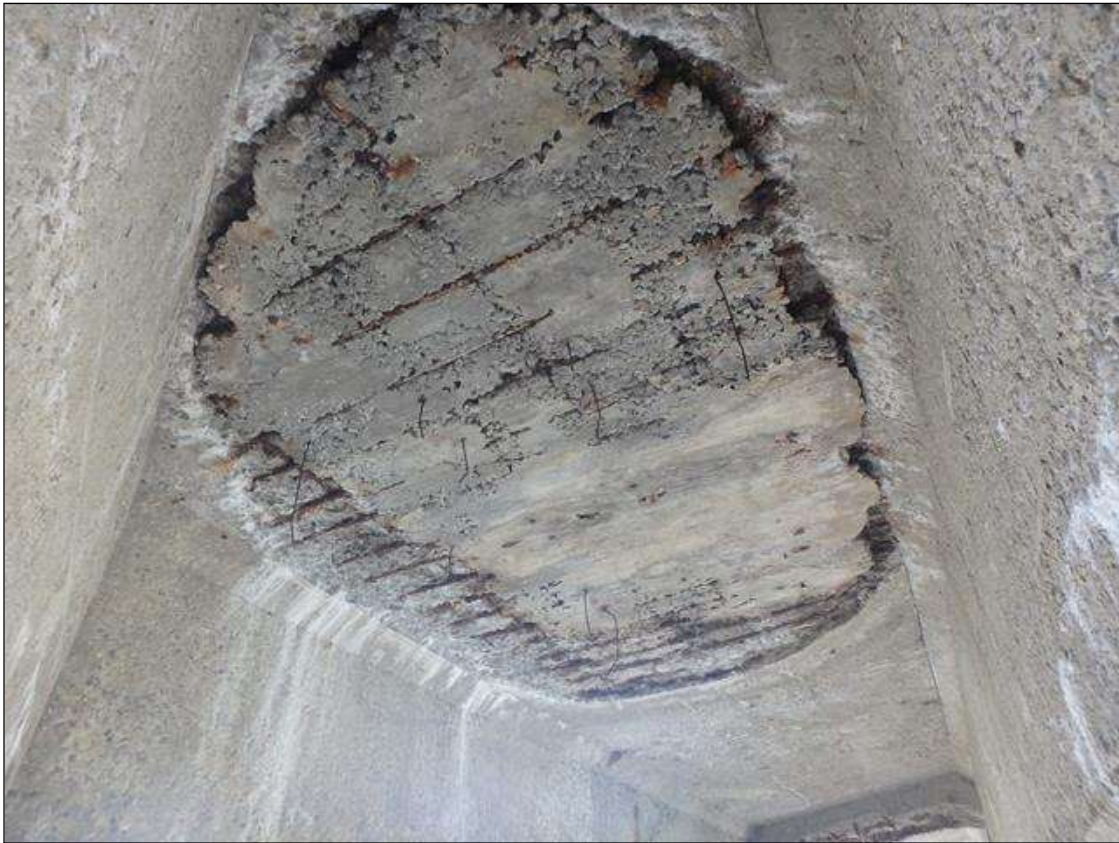
SPAN 1 DECK: SPALL 9 FT X 7 FT X UP TO 6" DEEP WITH EXPOSED REBAR, UP TO 50% SECTION LOSS, AND HONEYCOMBING, NEAR MIDSPAN, BAY 2, PRIORITY MAINTENANCE

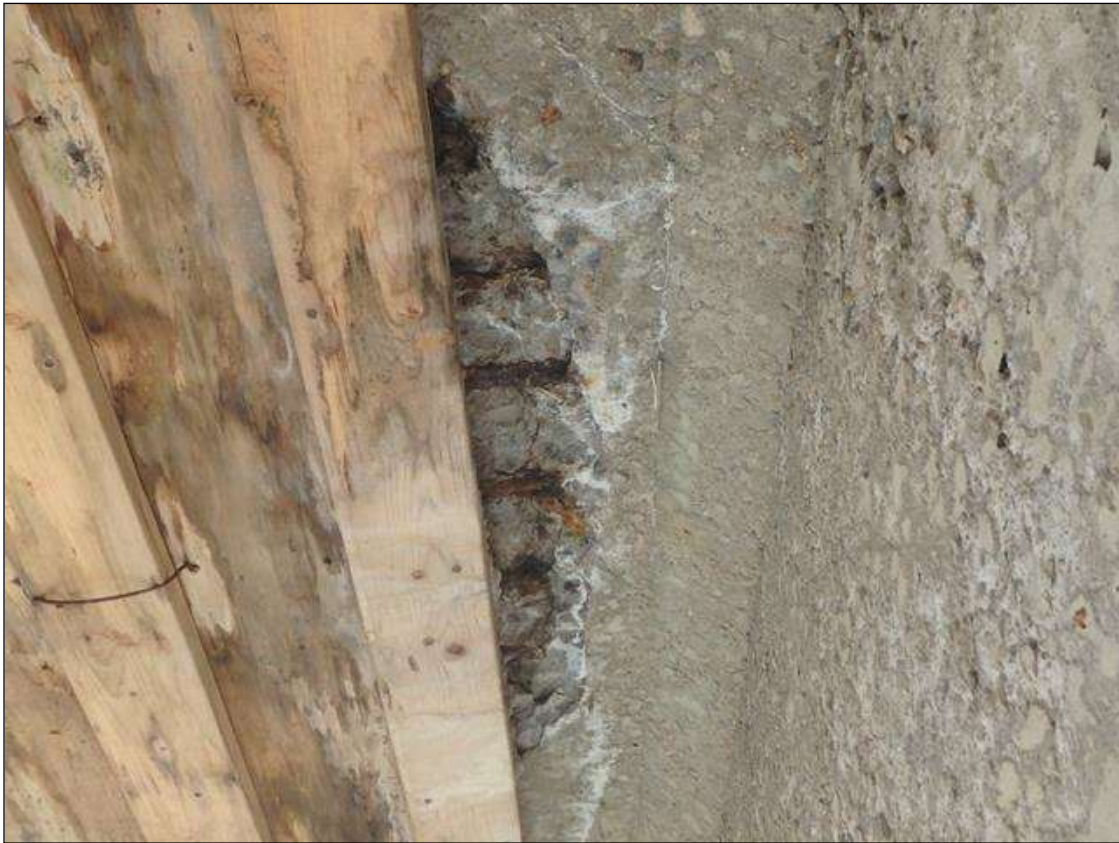
SPAN 1 DECK: SPALL 3 FT X 6" X UP TO 4" DEEP WITH EXPOSED REBAR, UP TO 50% SECTION LOSS, ADJACENT TO PATCH FORMWORK IN BAY, PRIORITY MAINTENANCE

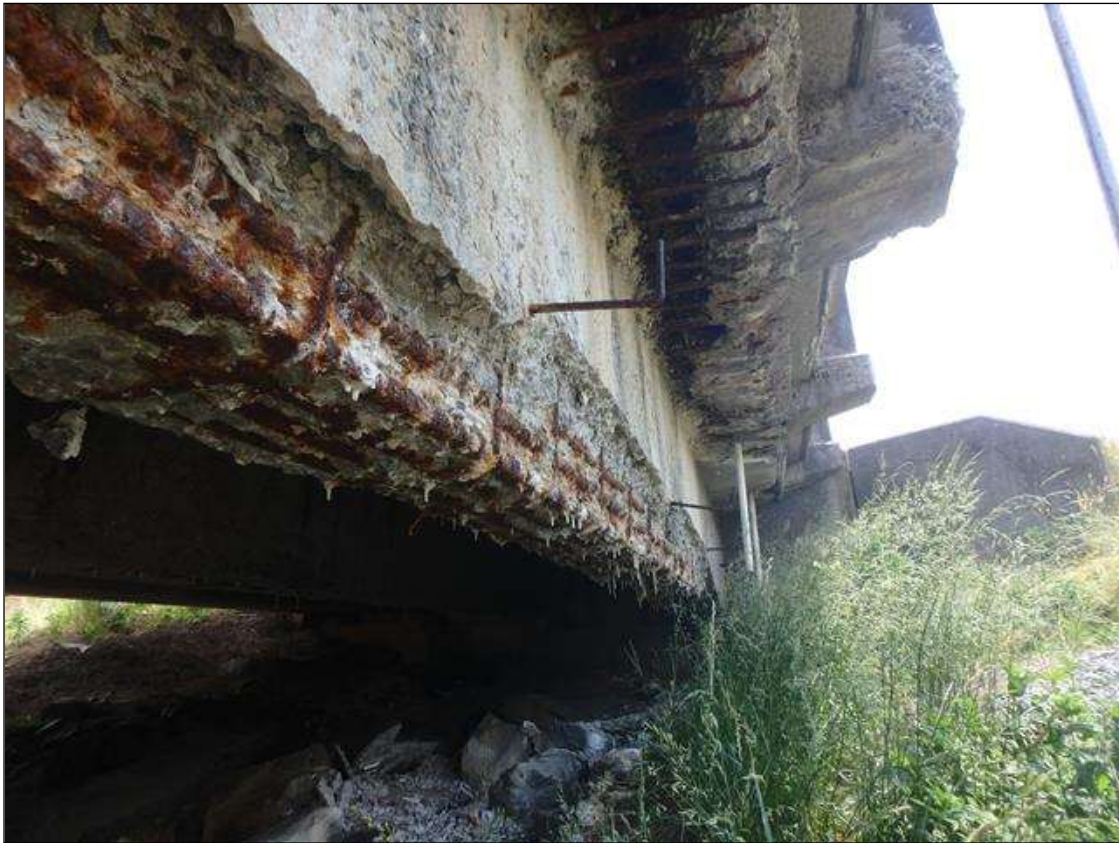
SPAN 1 BEAM 1: SPALL FULL WIDTH BOT FL X UP TO 16" ALONG BOTH FACES X UP TO 5" DEEP WITH EXP REBAR, UP TO 25% SEC LOSS, FROM MIDSPAN TO END BENT 1, PM

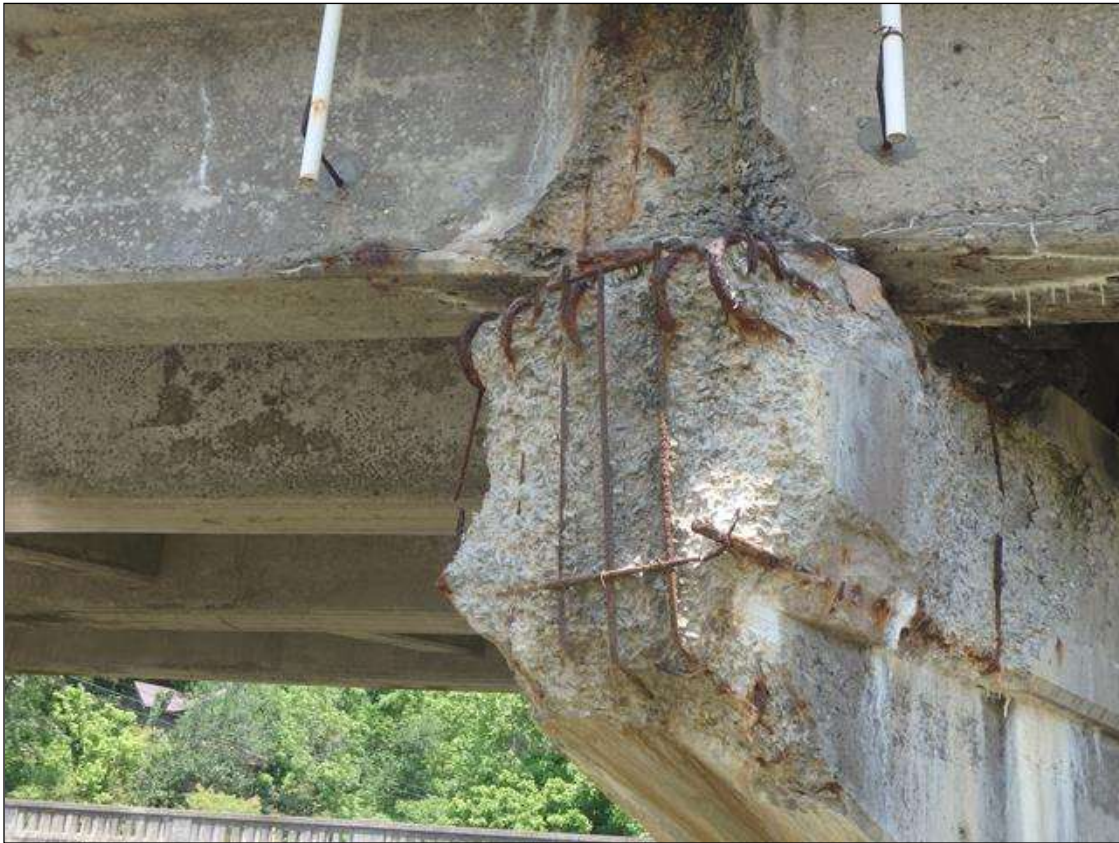
BENT 1 CAP : SPALL FULL WIDTH X FULL HEIGHT X UP TO 6" DEEP WITH EXPOSED REBAR, UP TO 100% SECTION LOSS AT LEFT END, PRIORITY MAINTENANCE

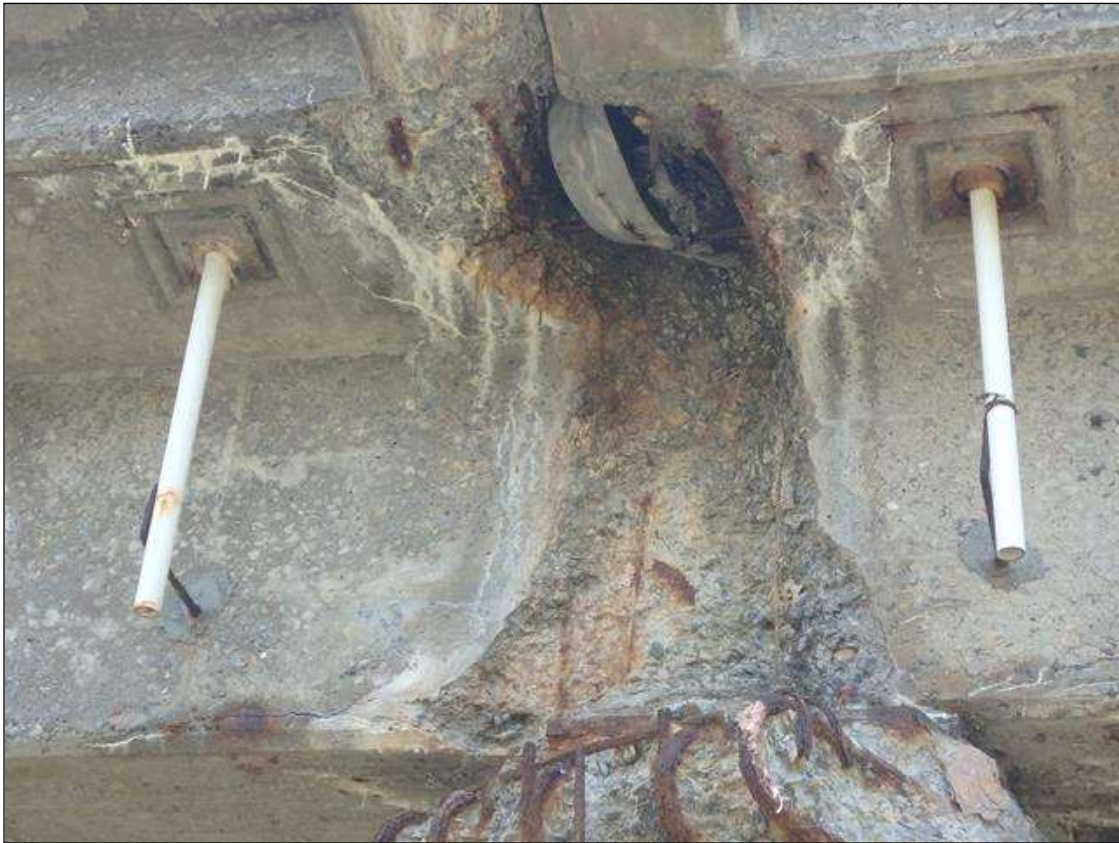
SPAN 1 BEAM 1: SPALL 3 FT X 2 FT X UP TO 5" DEEP WITH EXPOSED REBAR AND DETERIORATING CONCRETE, NO SECTION LOSS, ALONG WEST FACE AT BENT 1, PM

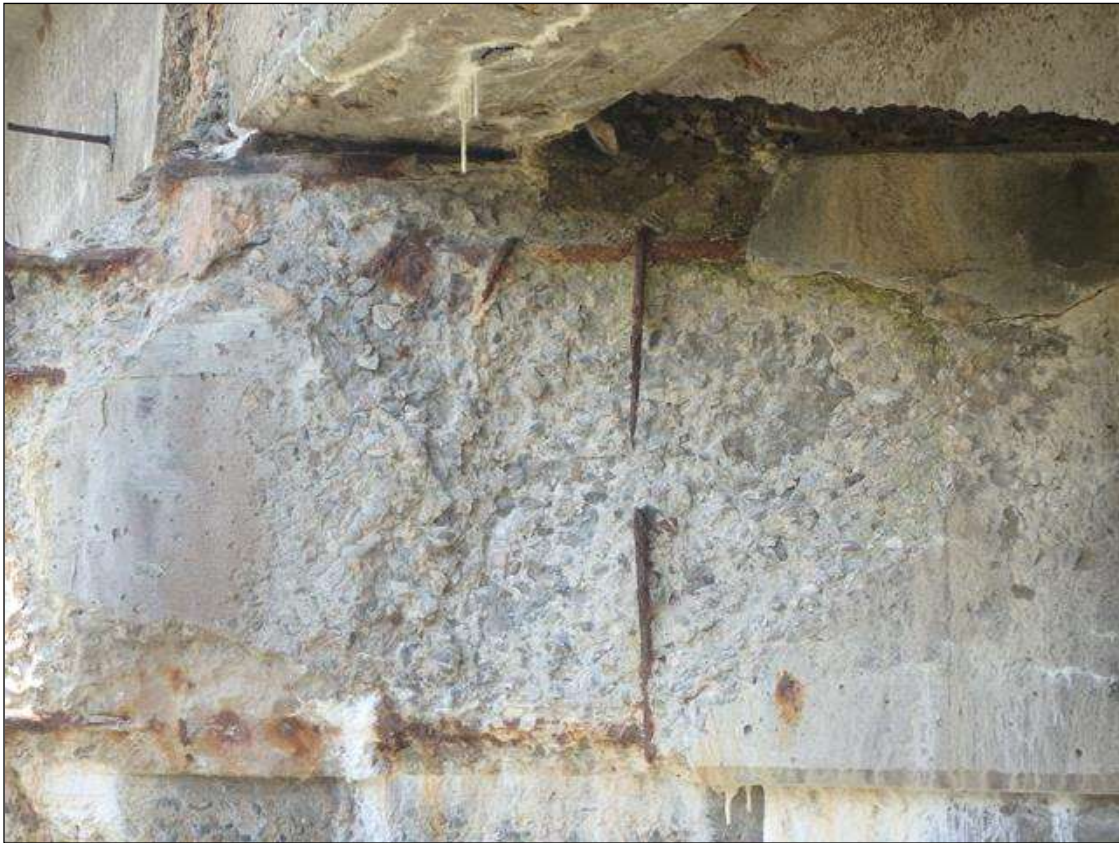
BENT 1 CAP : SPALL 4 FT X 3 FT X UP TO 5" WITH EXPOSED REBAR, UP TO 100% SECTION LOSS UNDER BEAM 1, AND LOSS OF BEARING AREA, SPAN 1 FACE, PM

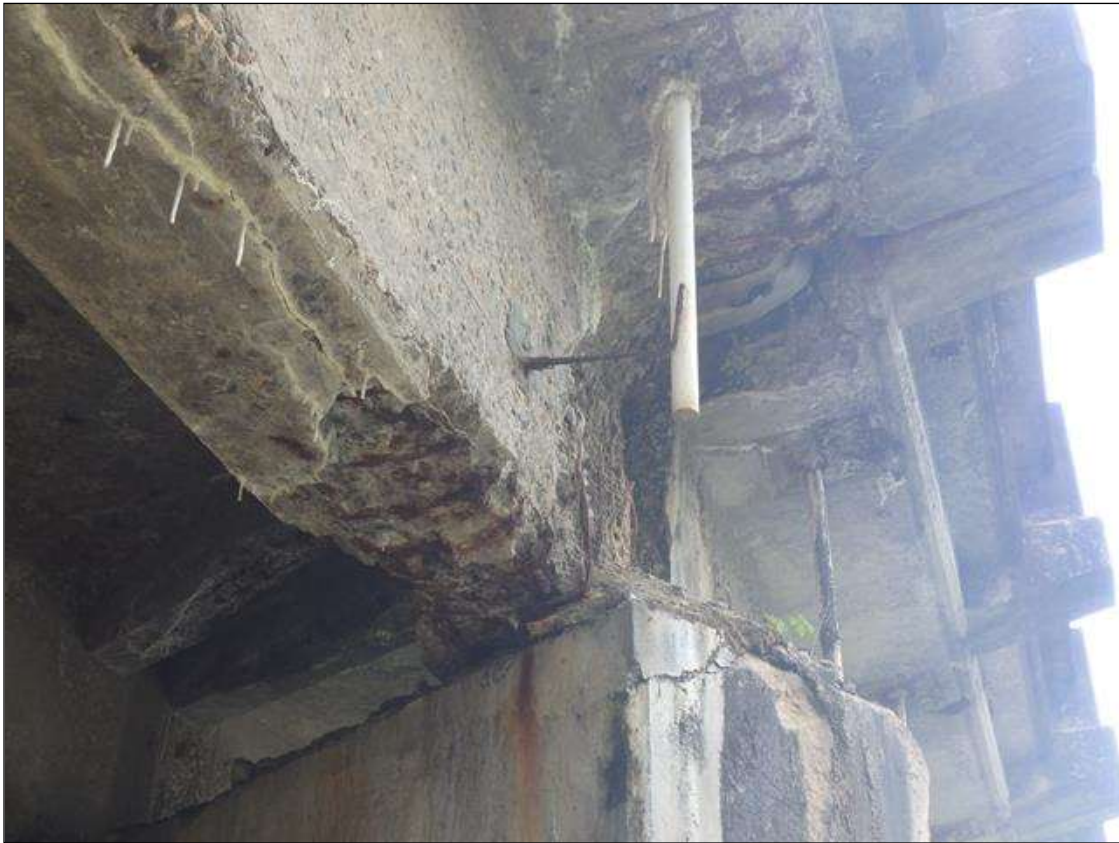
SPAN 5 BEAM 1: SPALL FULL HEIGHT X FULL WIDTH X UP TO 5" DEEP WITH EXPOSED REBAR, UP TO 100% SECTION LOSS AT BENT 4 FOR 4 FT, PRIORITY MAINTENANCE

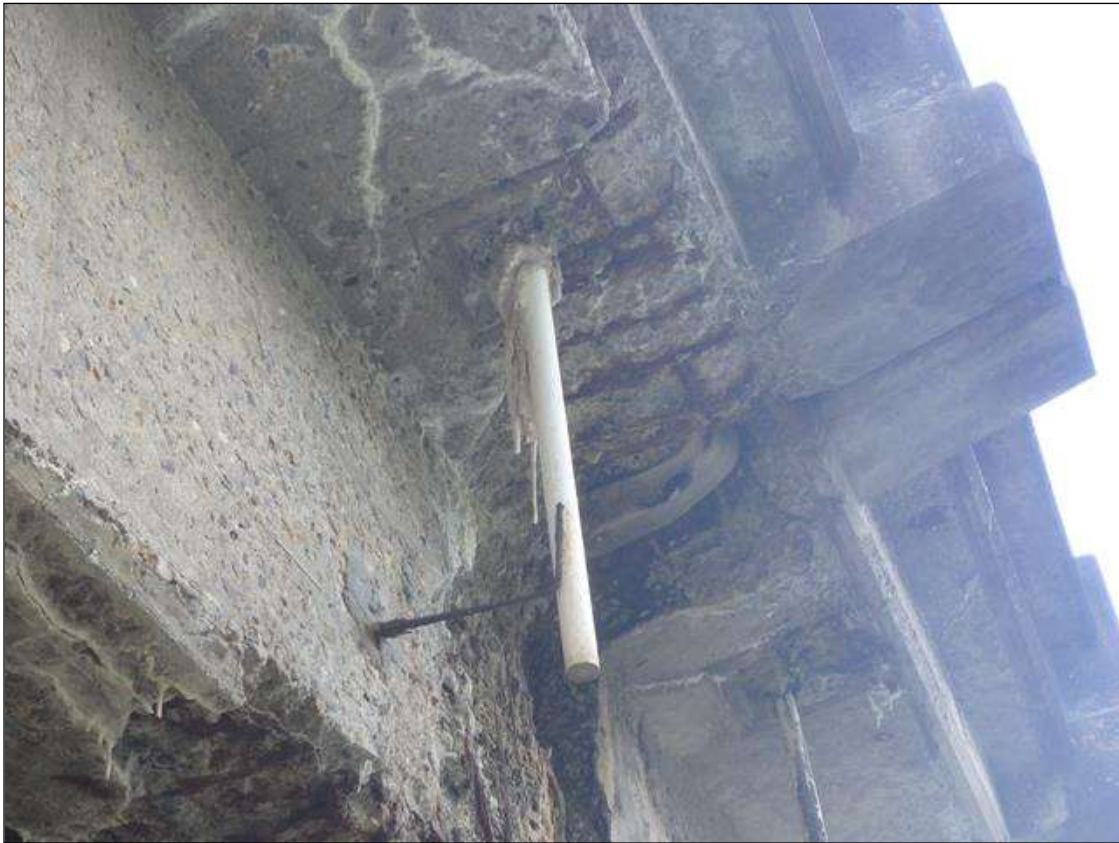
SPAN 5 DECK: SPALL 4 FT X 2 FT X UP TO 4" DEEP WITH EXPOSED REBAR, UP TO 25% SECTION LOSS  
ALONG UNDERSIDE OF LEFT OVERHANG AT BENT 4, PM

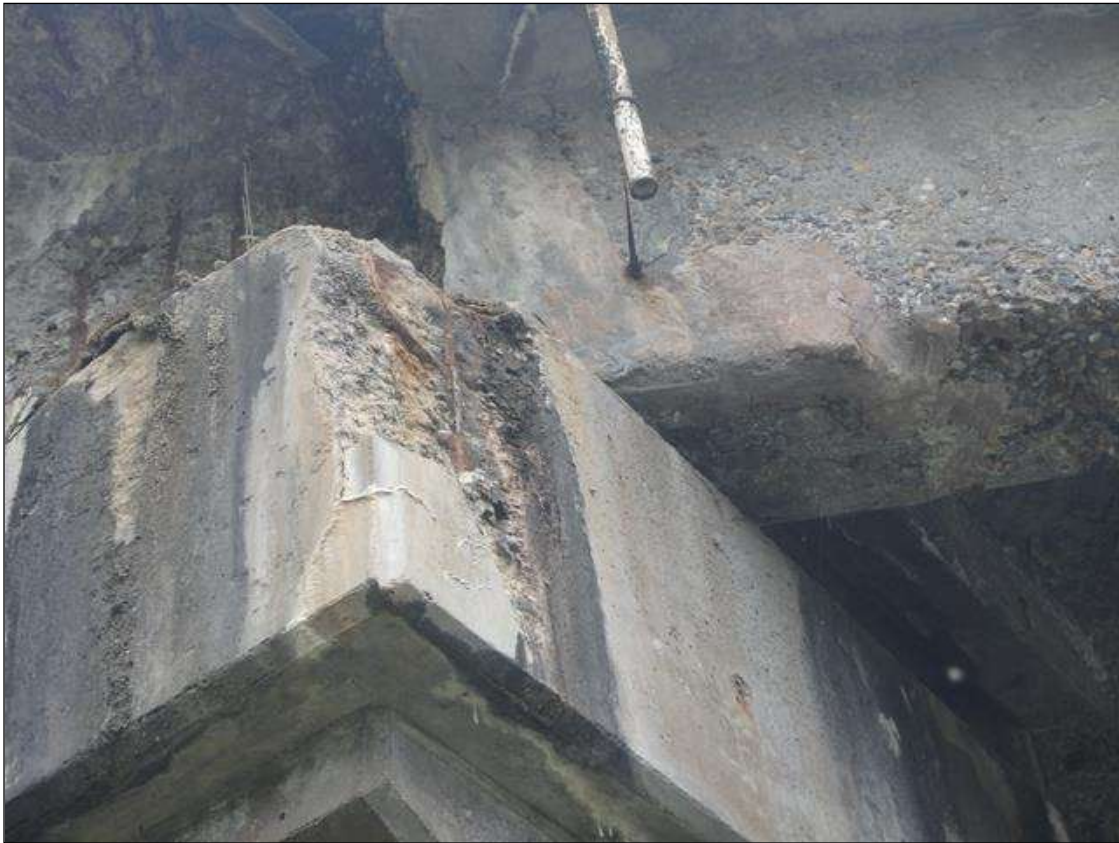
BENT 4 CAP : SPALL 2 FT X 3 FT X UP TO 4" DEEP WITH EXPOSED REBAR, UP TO 25% SECTION LOSS ALONG  
END OF CAP, SPAN 4 FACE, PRIORITY MAINTENANCE

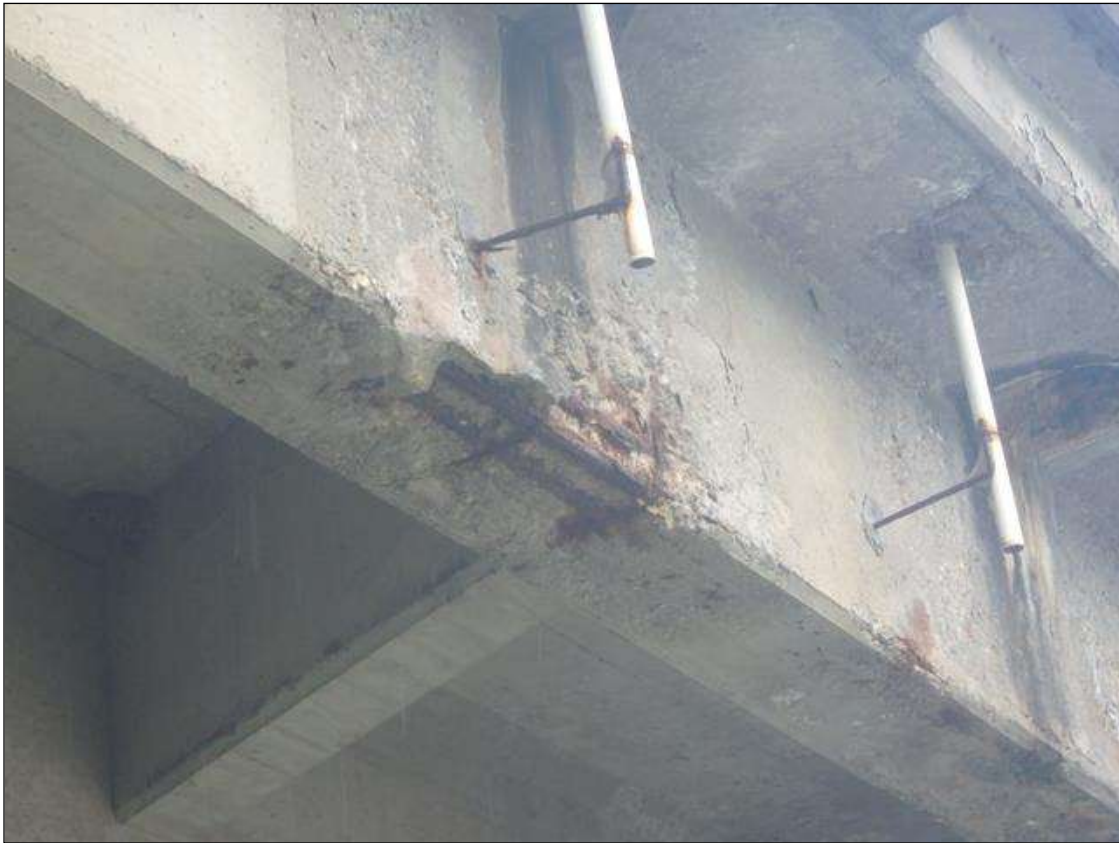
SPAN 4 BEAM 1: SPALL 4 FT X 1 FT X 1 FT WITH EXPOSED REBAR, UP TO 10% SECTION LOSS AT MIDSPAN, PRIORITY MAINTENANCE

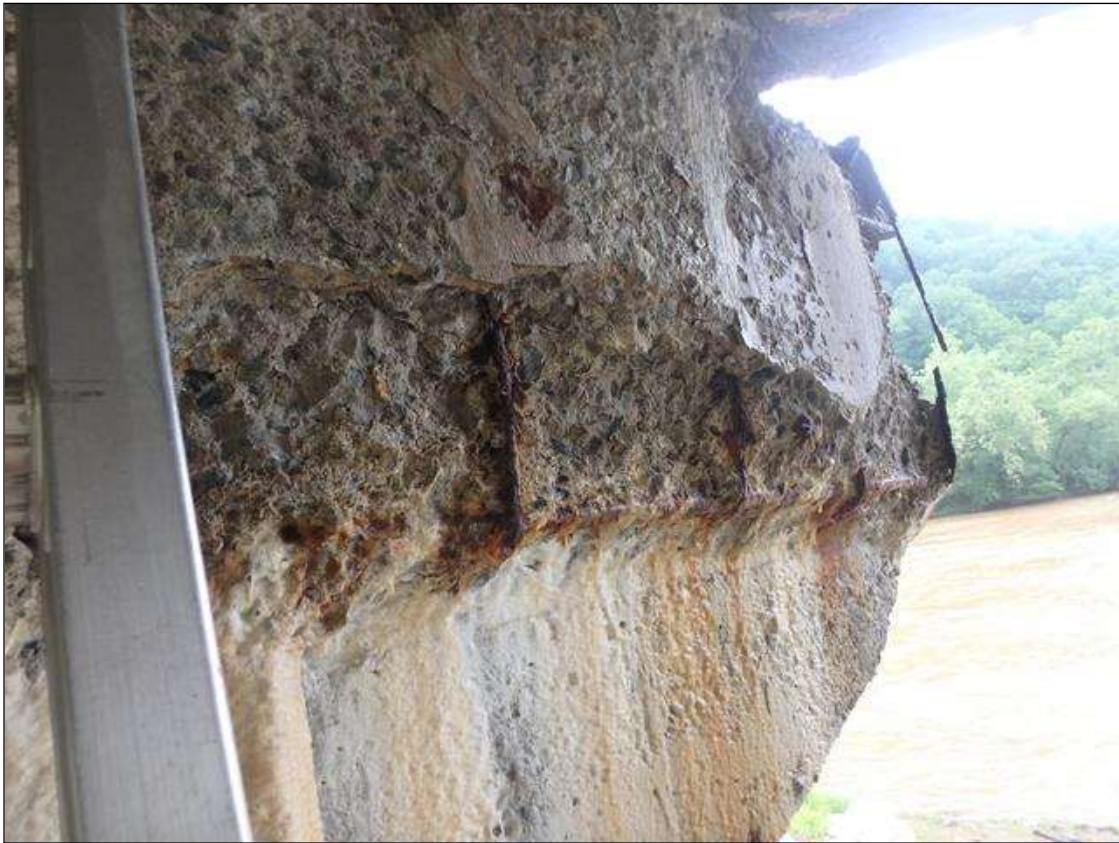
BENT 1 CAP : SPALL 6 FT X 1 FT X 6" WITH EXPOSED REBAR, UP TO 25% SECTION LOSS, AND  
DETERIORATING CONCRETE UNDER BEAM 1, SPAN 2 FACE, PM

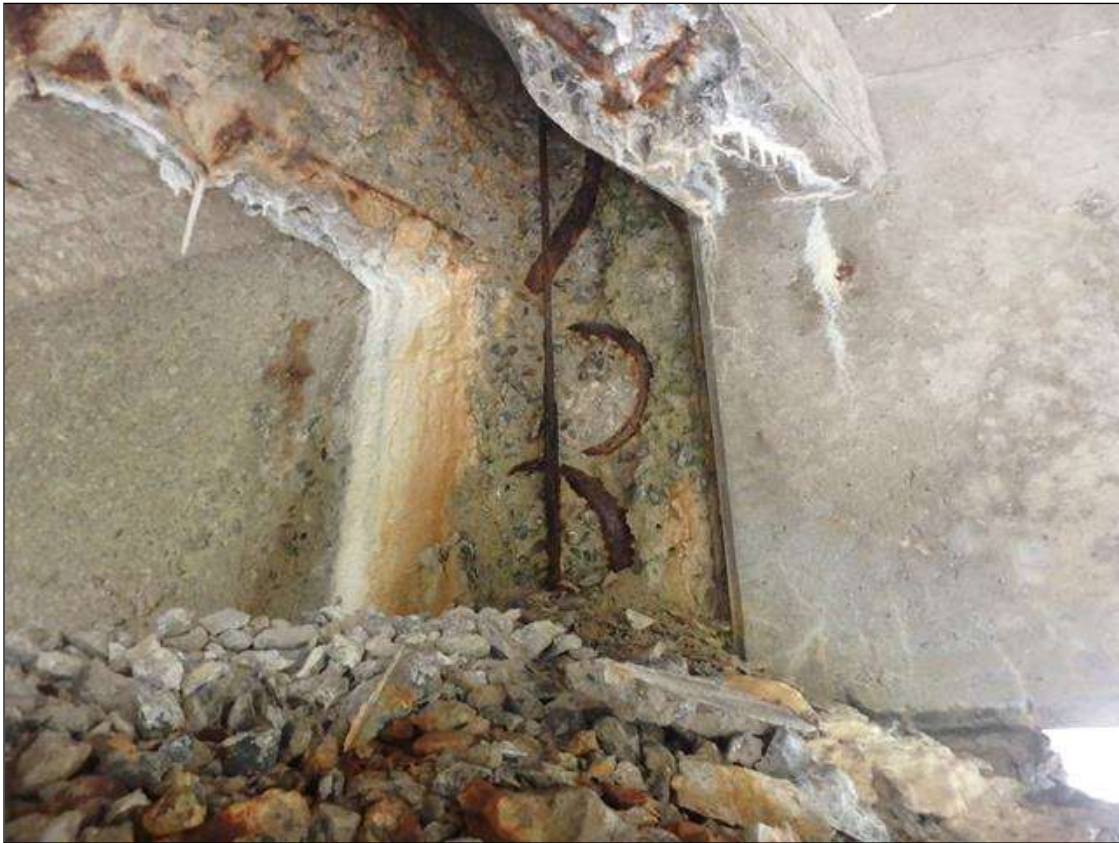
SPAN 1 BEAM 1: SPALL 1.5 FT X 3 FT X UP TO 4" WITH EXPOSED REBAR, UP TO 25% SECTION LOSS, ALONG EAST FACE AT BENT 1, PRIORITY MAINTENANCE

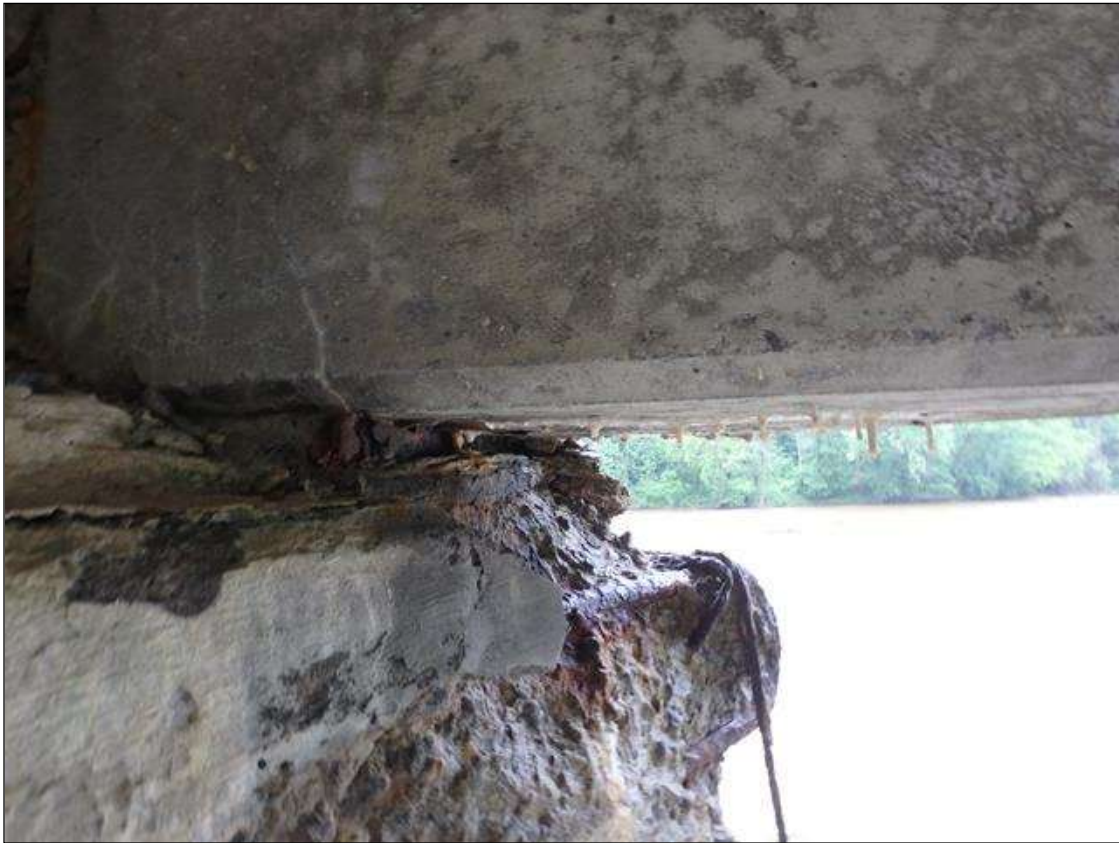
BENT 1 CAP : SPALL 2 FT X 1 FT X 6" DEEP WITH EXPOSED REBAR, SECTION LOSS UP TO 25%, AND LOSS OF BEARING AREA FOR BEAM 1, SPAN 2 FACE, PRIORITY MAINTENANCE

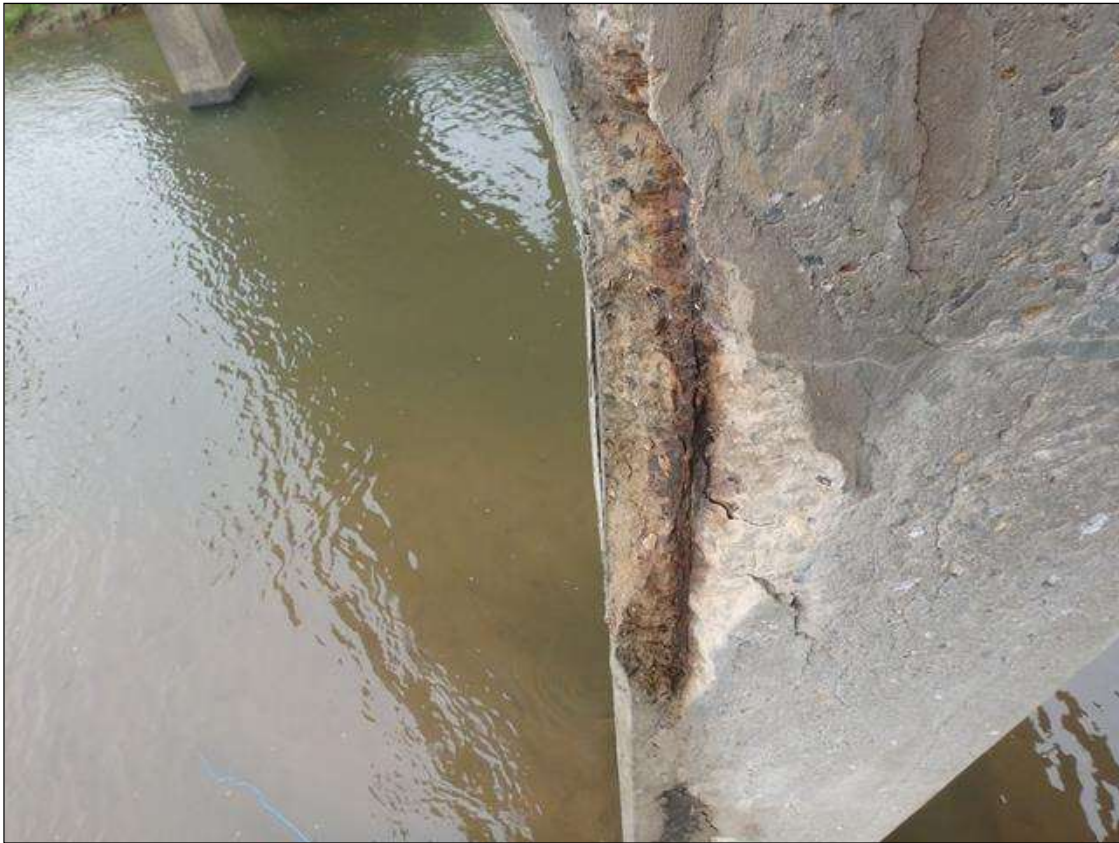
BENT 2 PILE 1: SPALL 4 FT X 10" X 6" WITH EXPOSED REBAR, 25% SECTION LOSS, ALONG SOUTHWEST CORNER, 5 FT BELOW CAP, PRIORITY MAINTENANCE

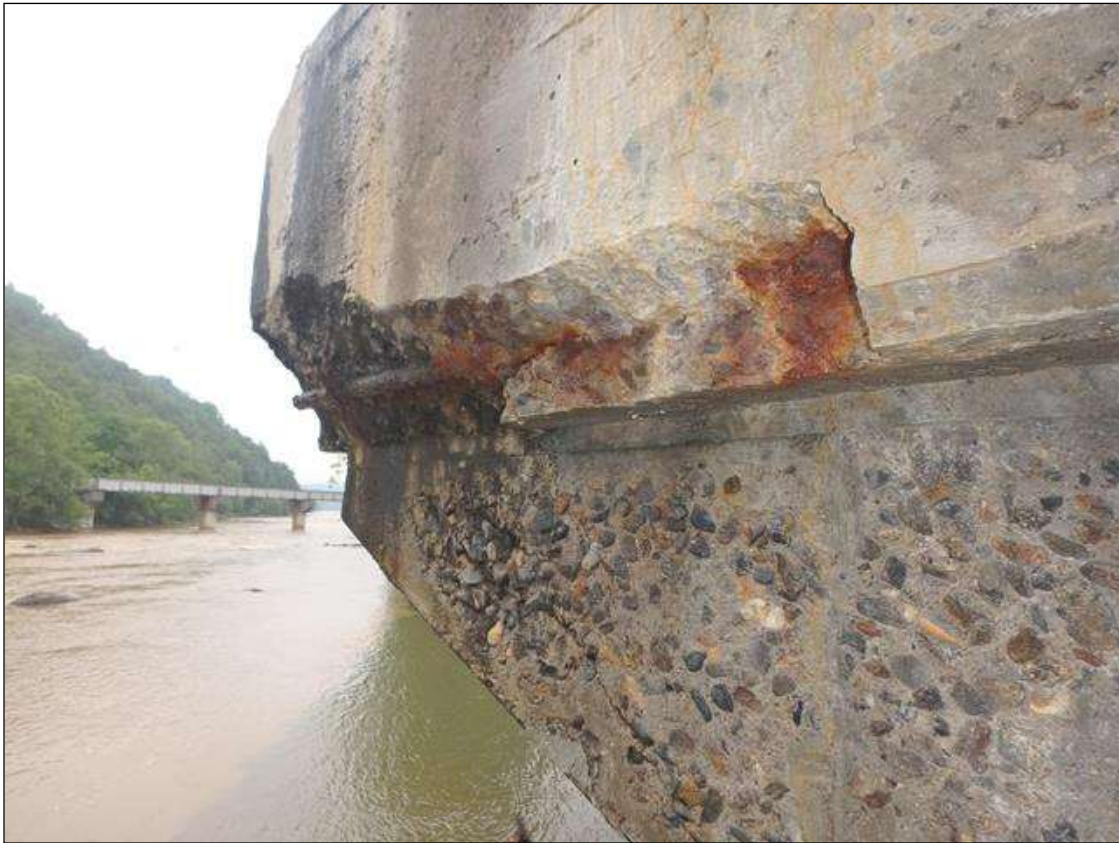
BENT 2 CAP : SPALL 8 FT X 1 FT X 6" WITH EXPOSED REBAR, NO SECTION LOSS, OVER COLUMN 1, SPAN 2  
FACE, PRIORITY MAINTENANCE

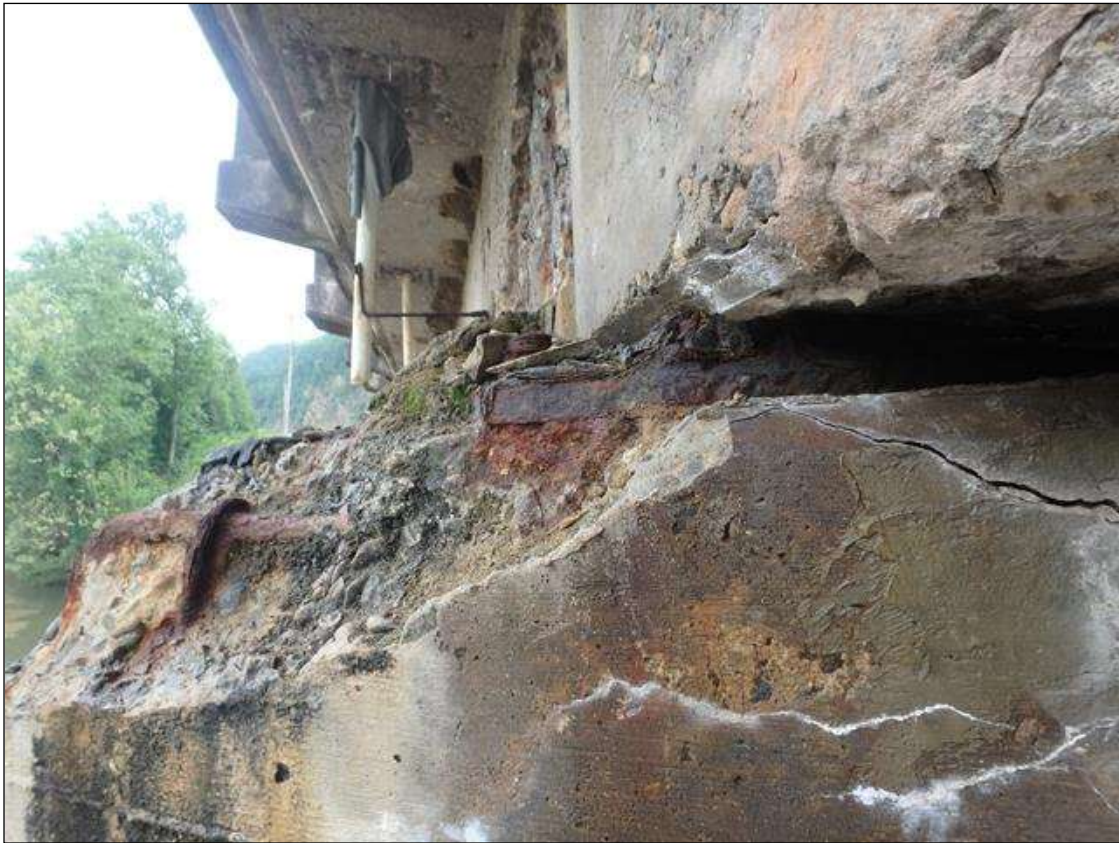
BENT 2 CAP : SPALL 3 FT X 1 FT X 1 FT UNDER BEAM 1 WITH EXP REB, UP TO 10% SEC LOSS,  
DETERIORATING CON, LOSS OF BEARING FOR BEAM 1, SPAN 2 FACE, PM

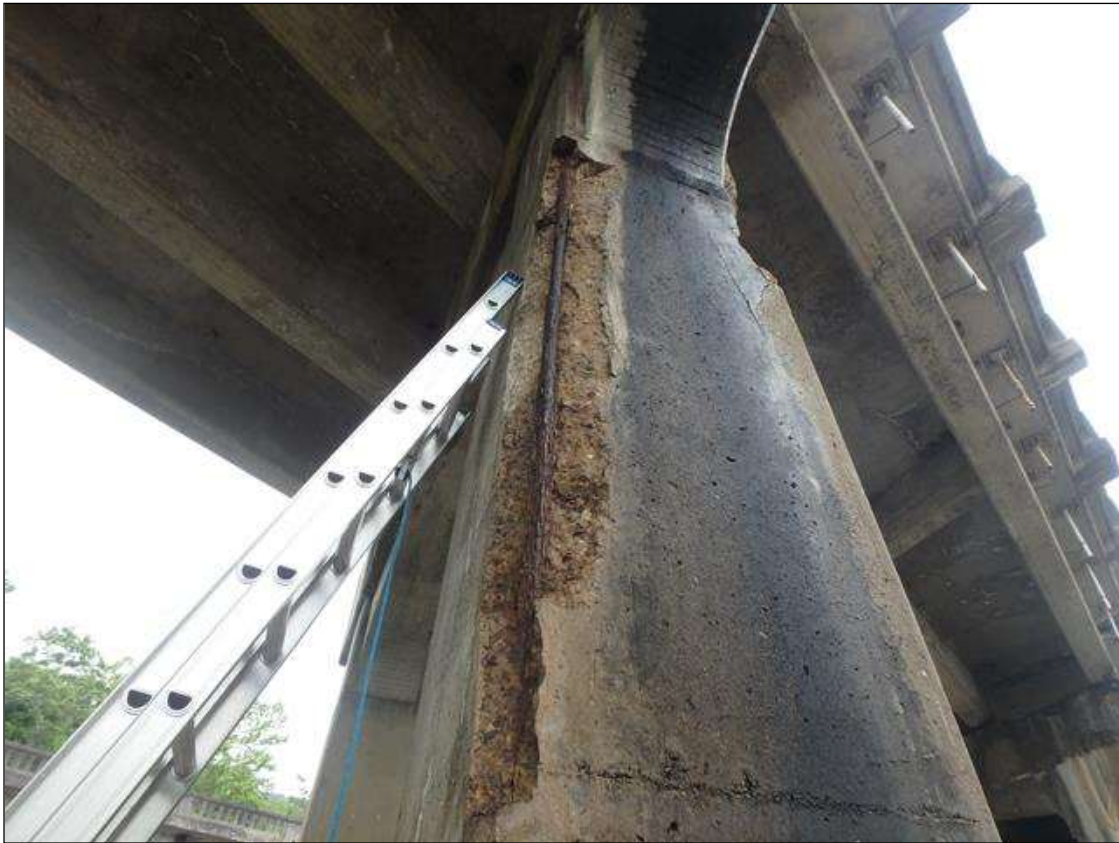
BENT 2 PILE 1: SPALL 8 FT X 1 FT X 8" WITH EXPOSED REBAR, 25% SECTION LOSS, ALONG NORTHWEST CORNER, PRIORITY MAINTENANCE

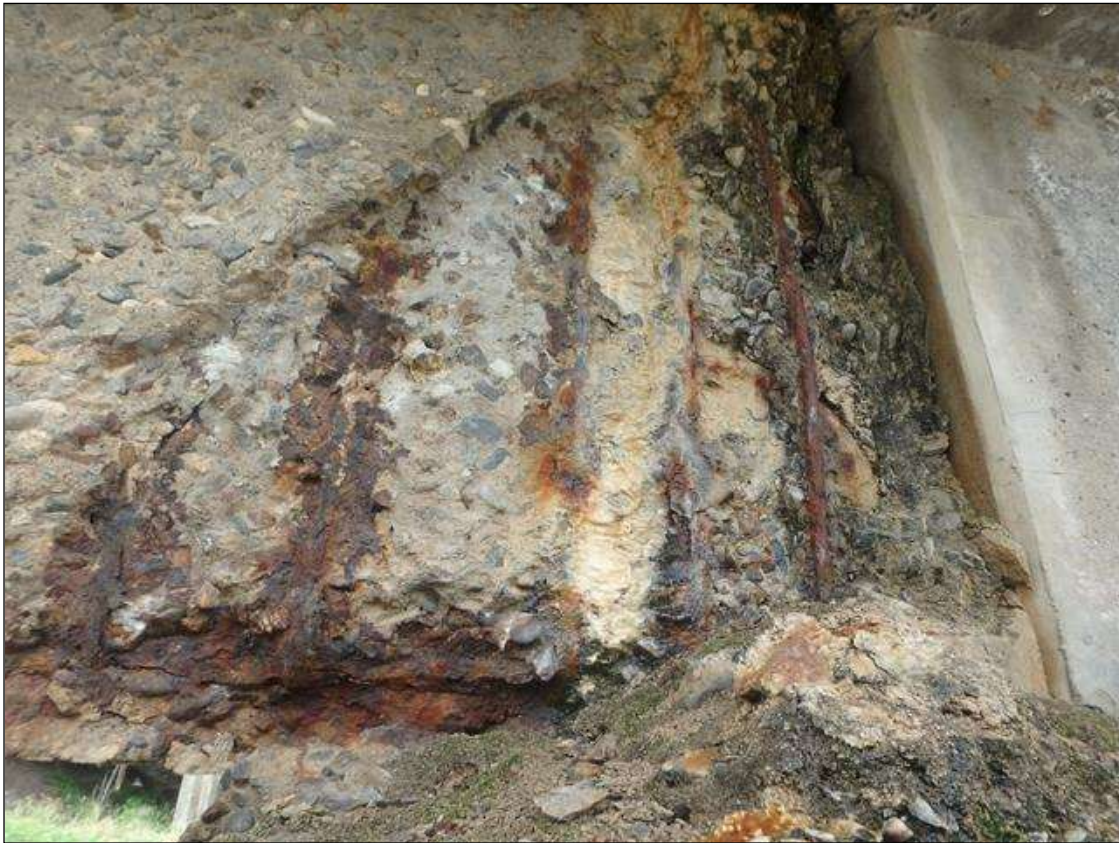
SPAN 3 BEAM 1: SPALL 4 FT X 3 FT X UP TO 4" WITH EXPOSED REBAR, UP TO 25% SECTION LOSS, ALONG WEST FACE AT BENT 2, PRIORITY MAINTENANCE
