# BRIDGE INSPECTION REPORT

INSPECTION TYPE: Routine Inspection

COUNTY ROBESON BRIDGE NUMBER 770026 INSPECTION CYCLE 2 YRS  
ROUTE SR1955 ACROSS TEN MILE SWAMP M.P. 0

INSPECTION DATE 05/15/2014

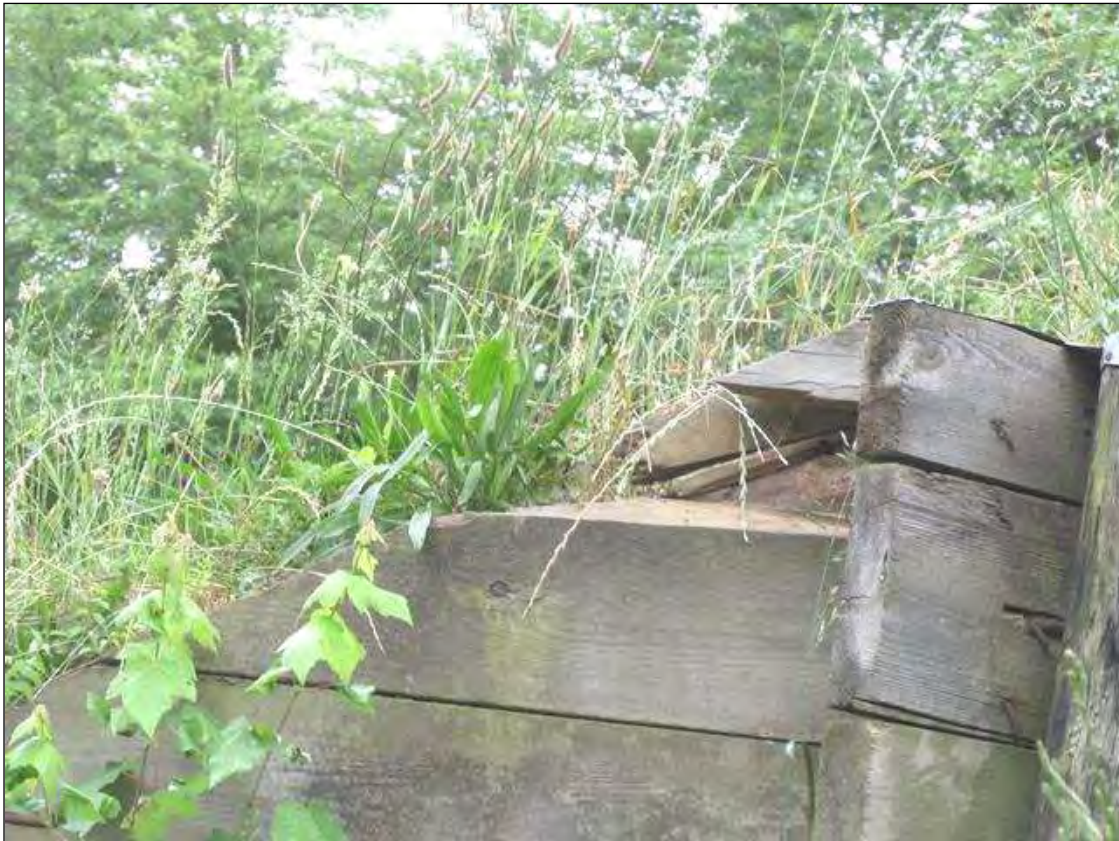
| 35c | F | ( TIMBER BULKHEADS ) THE TOP WINGWALL BOARD IS MISSING AT SOUTHEAST CORNER. (PHOTO) | |

TOP WINGWALL BOARD MISSING AT SOUTHEAST CORNER

| MMS Code | Description of Function | Unit | Quantity | Remarks | Est. Cost |
|---|---|---|---|---|---|
| 3346 | Repair / Maintain Timber Wings & Blkhdrs | SF | 2 | TOP WINGWALL BOARD MISSING AT SOUTHEAST CORNER | |

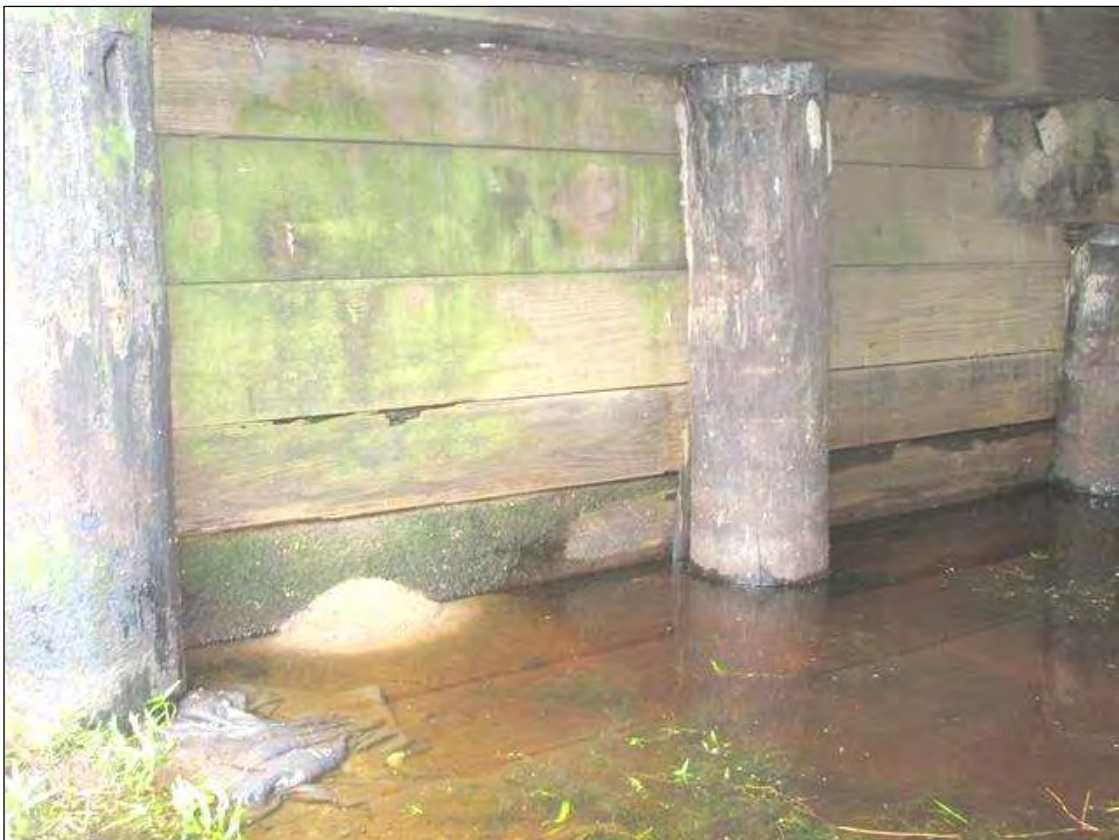
| | | END BENT 1 BULKHEAD BOARDS ARE DECAYED BETWEEN PILES 5 AND 6, AND 6 AND 7. (PHOTO) | |

END BENT 1 BULKHEAD BOARDS ARE DECAYED BETWEEN PILES 5 AND 6 , AND 6 AND 7

| MMS Code | Description of Function | Unit | Quantity | Remarks | Est. Cost |
|---|---|---|---|---|---|
| 3346 | Repair / Maintain Timber Wings & Blkhdrs | SF | 12 | END BENT 1 BULKHEAD BOARDS ARE DECAYED BETWEEN PILES 5 AND 6 , AND 6 AND 7 | |

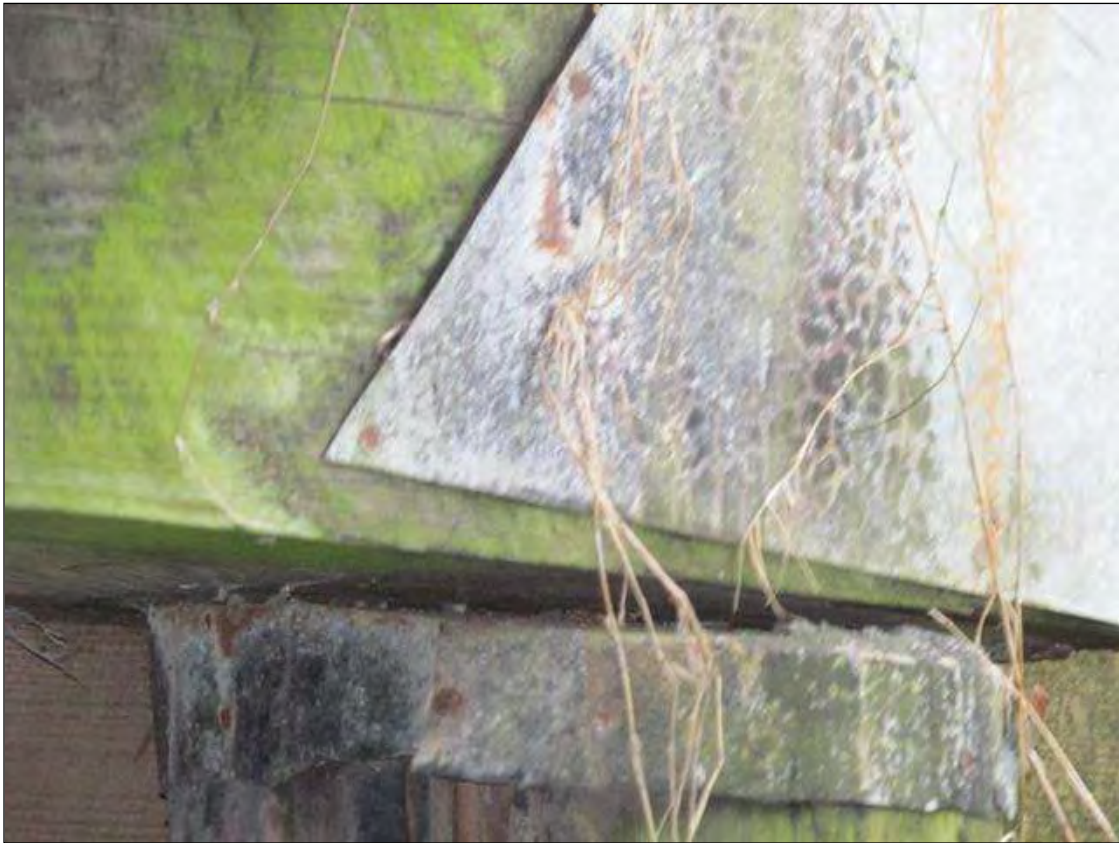
END BENT 1 MAIN CAP IS ROTATED 3/4" OUT OF PLUMB WITH 3/4" SPACING AT PILE TOPS

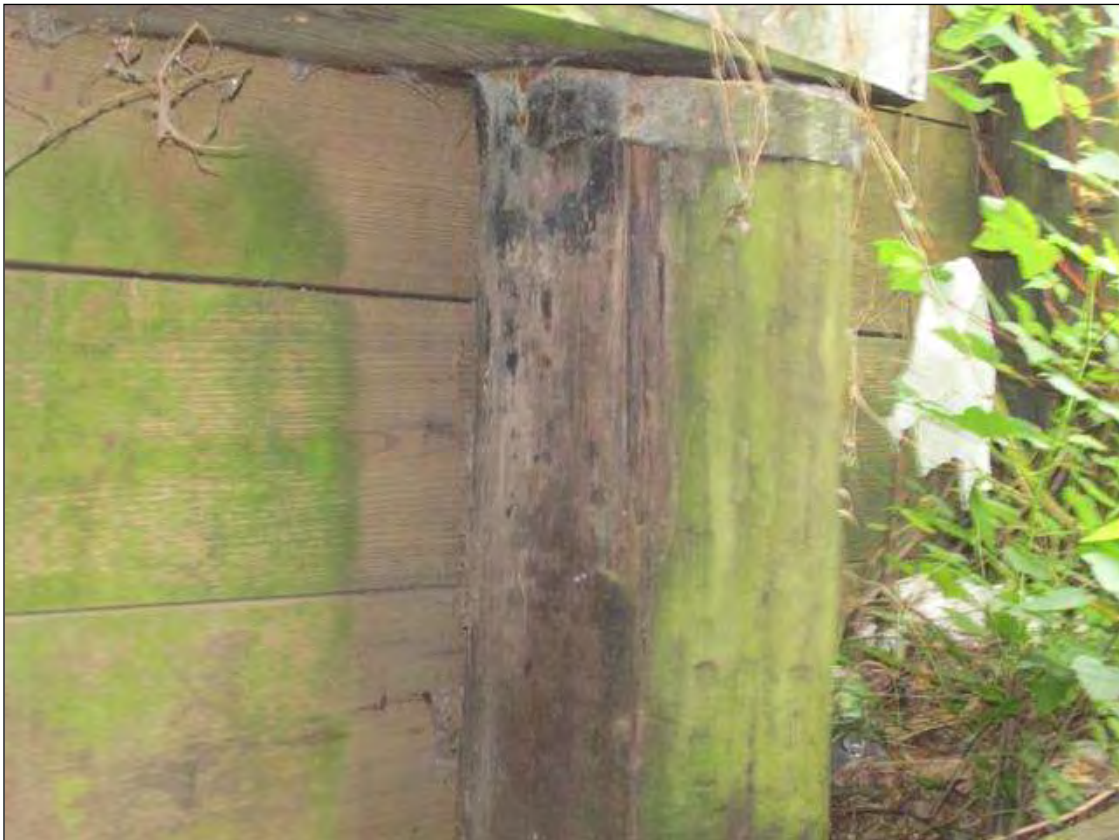
PILE 1 AT END BENT 1 IS SURFACE DECAYED

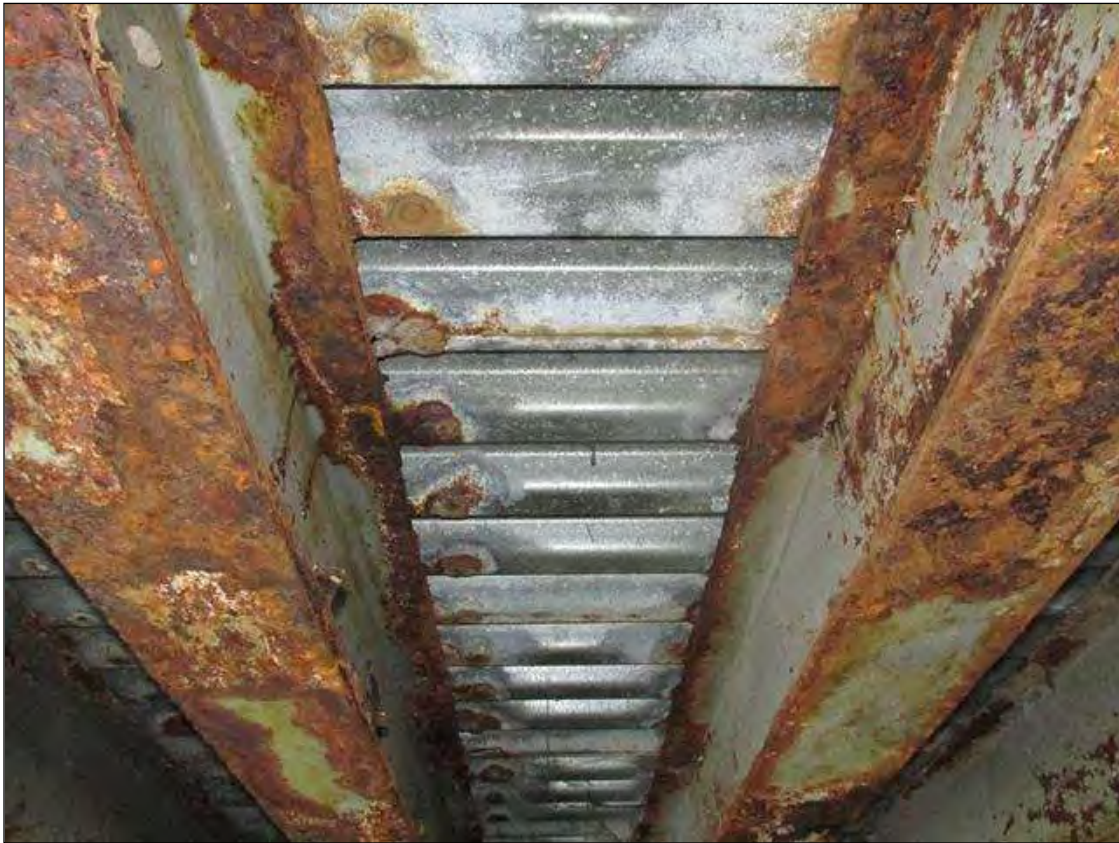
SPAN 1 SUPERSTRUCTURE WITH PAINT PEELING AND RUST, ALL SPANS ARE SIMILAR

| MMS Code | Description of Function | Unit | Quantity | Remarks | Est. Cost |
|---|---|---|---|---|---|
| 3342 | Clean and Paint Structural Steel | SF | 3970 | SPAN 1 SUPERSTRUCTURE WITH PAINT PEELING AND RUST , ALL SPANS ARE SIMILAR | |

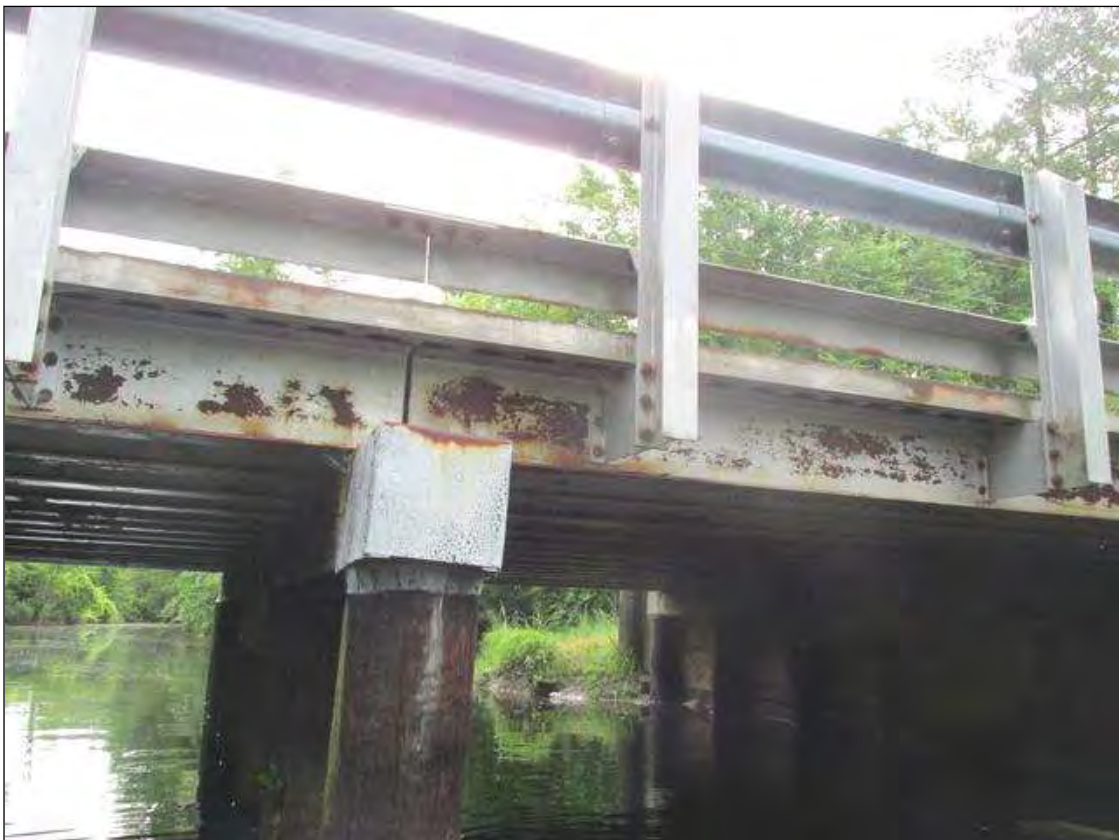
PAINT PEELING AND SURFACE RUST ON BEAM 1 EXTERIOR AT SPANS 1 AND 2

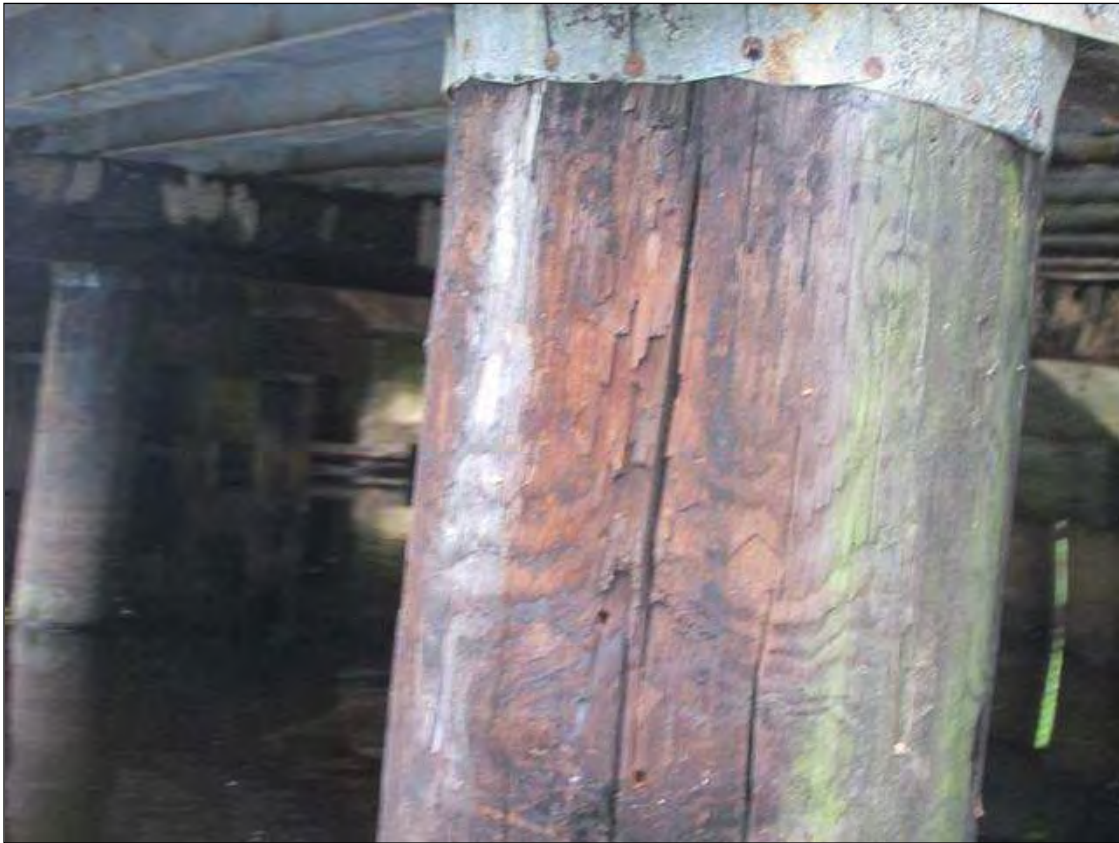
PILE 1 AT BENT 1 WEST FACE HAS 1/4" WIDE X 1" DEEP VERTICAL CHECK

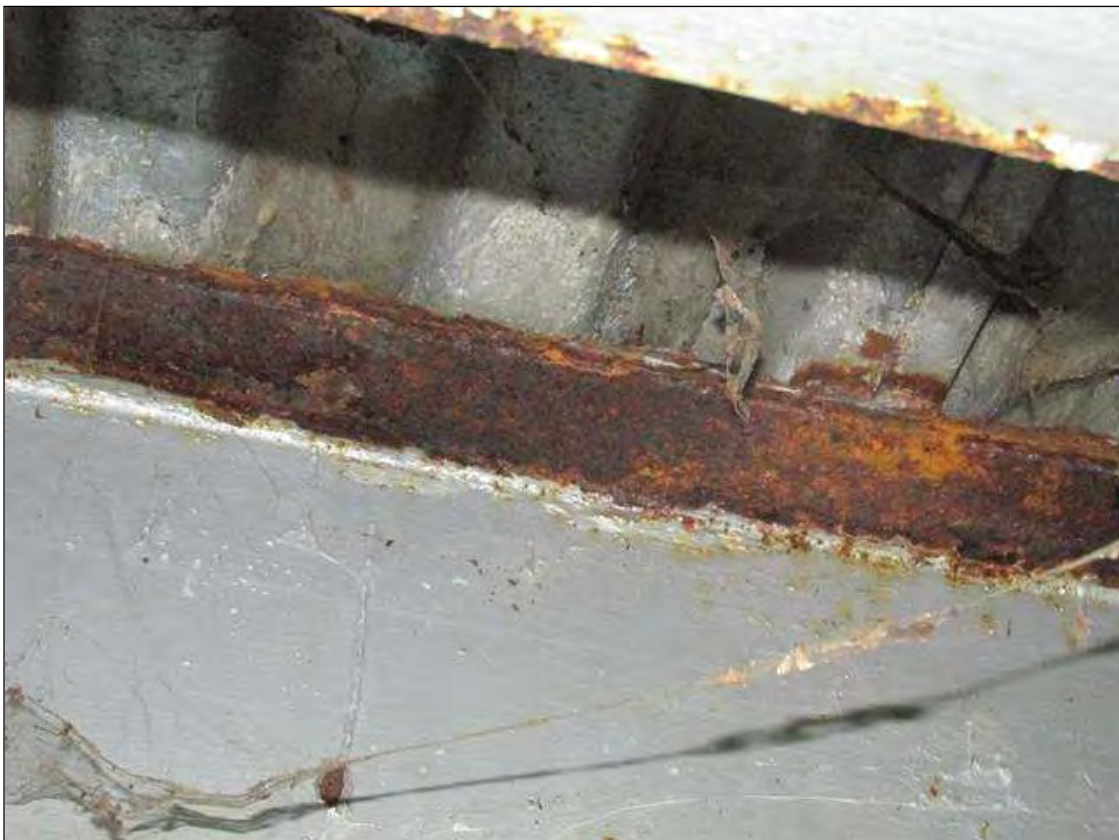
SPAN 1 BEAM FLANGES HAS RUST AND SCALING THROUGHOUT, ALL SPANS ARE SIMILAR

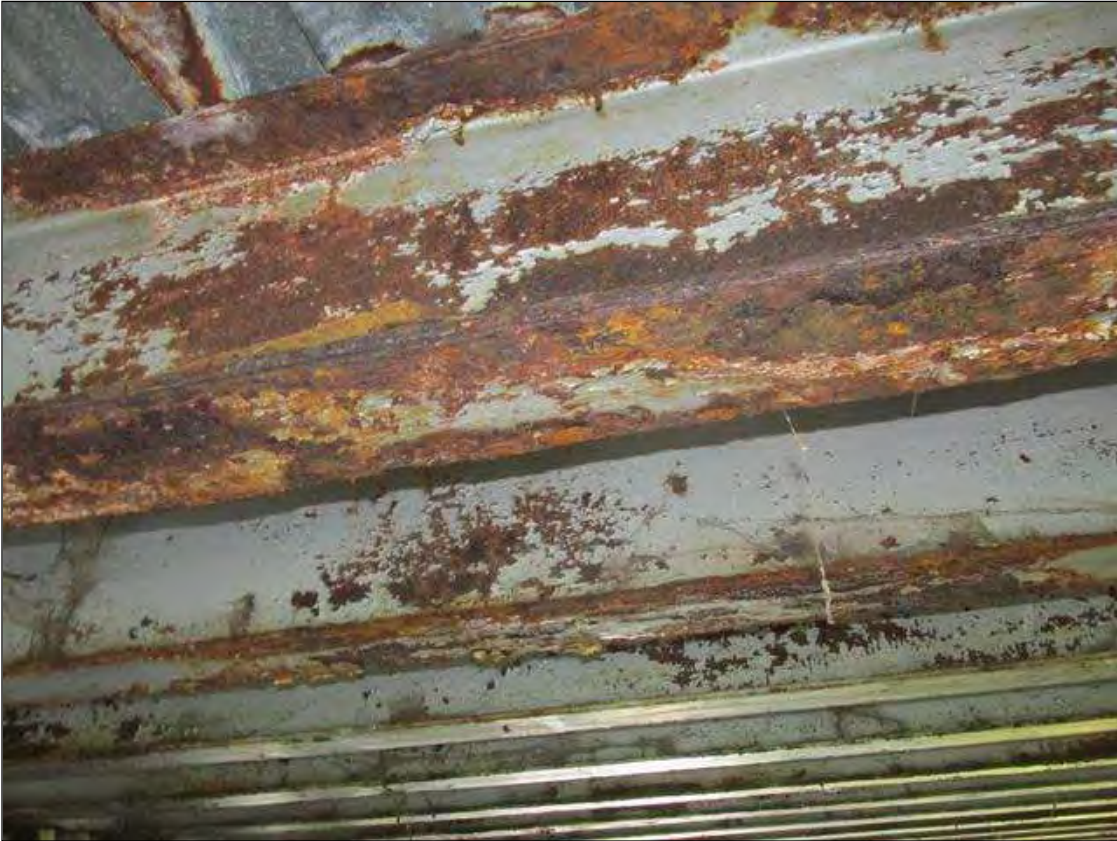
SPAN 1 BEAMS WEBS AND FLANGES, RUST AND SCALING IN MANY BEAMS

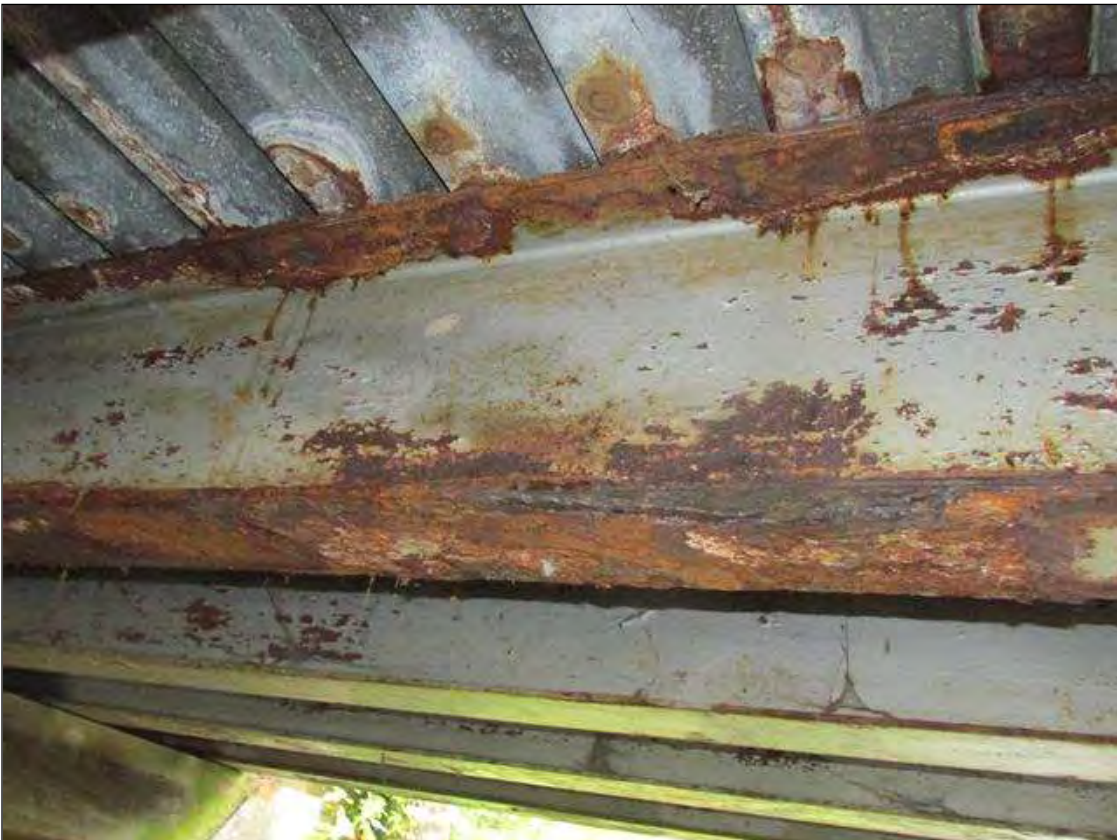
BEAM 4 IN SPAN 1 AT 10' FROM END BENT 1 3/16" SECTION LOSS IN B. FLANGE 14" L X 2" W WITH 1/8" REMAINING

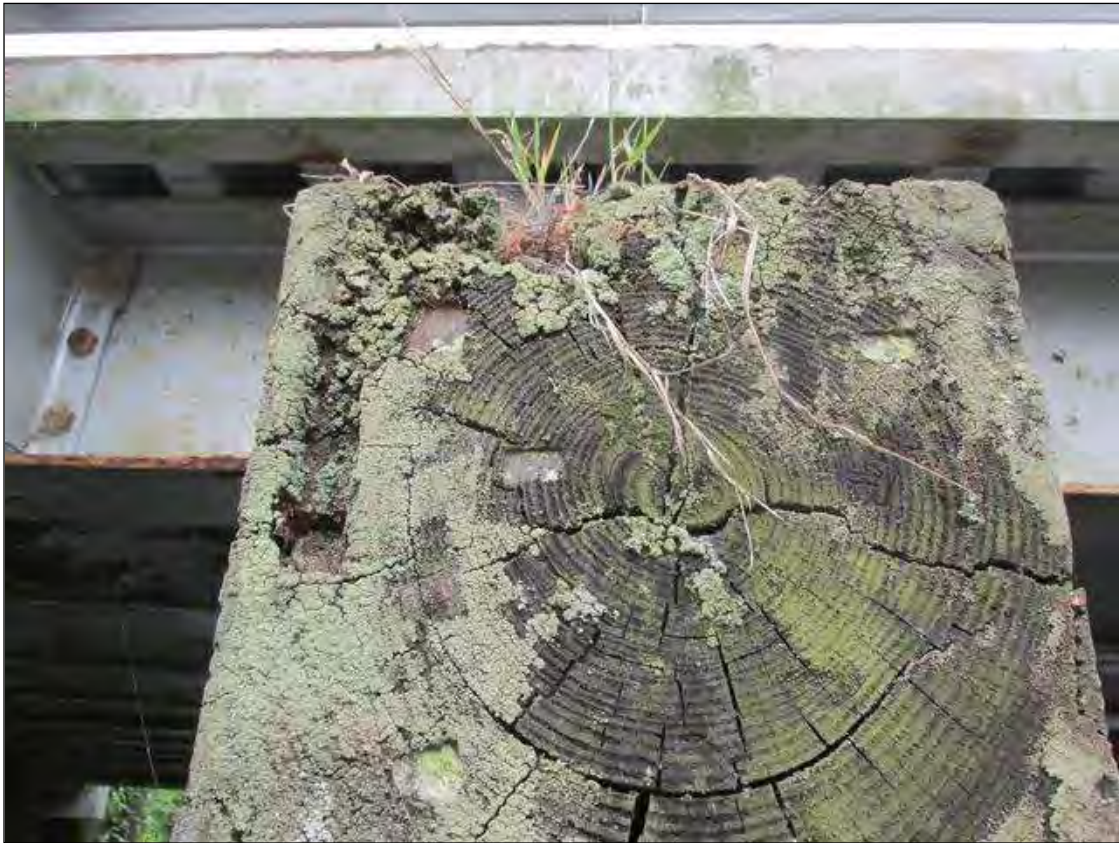
EAST END OF BENT 1 CAP IS DECAYED 6" W X 7" H X 3" D

| MMS Code | Description of Function | Unit | Quantity | Remarks | Est. Cost |
|---|---|---|---|---|---|
| 3344 | Repair / Replace Timber Substructure Components | LF | 1 | EAST END OF BENT 1 CAP IS DECAYED 6" W X 7" H X 3" D | |

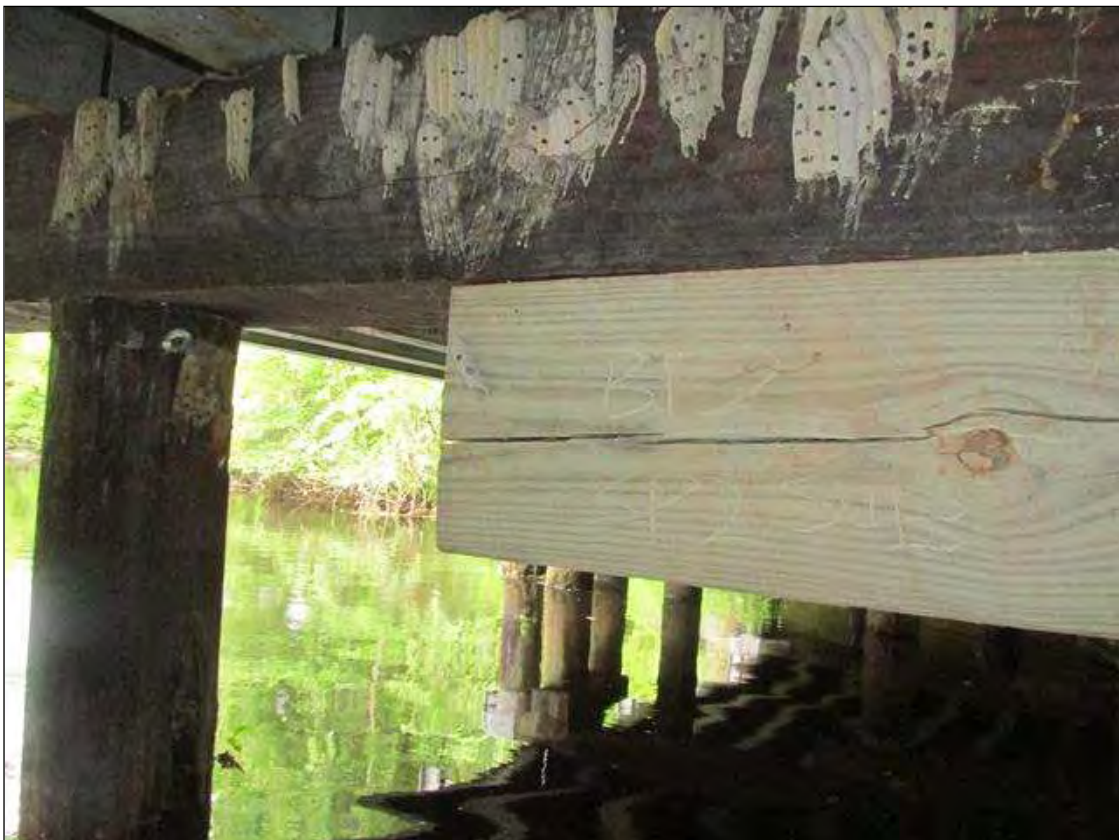
BENT 2 SUBCAP, SPAN 2 FACE HAS 1/4" CHECKS

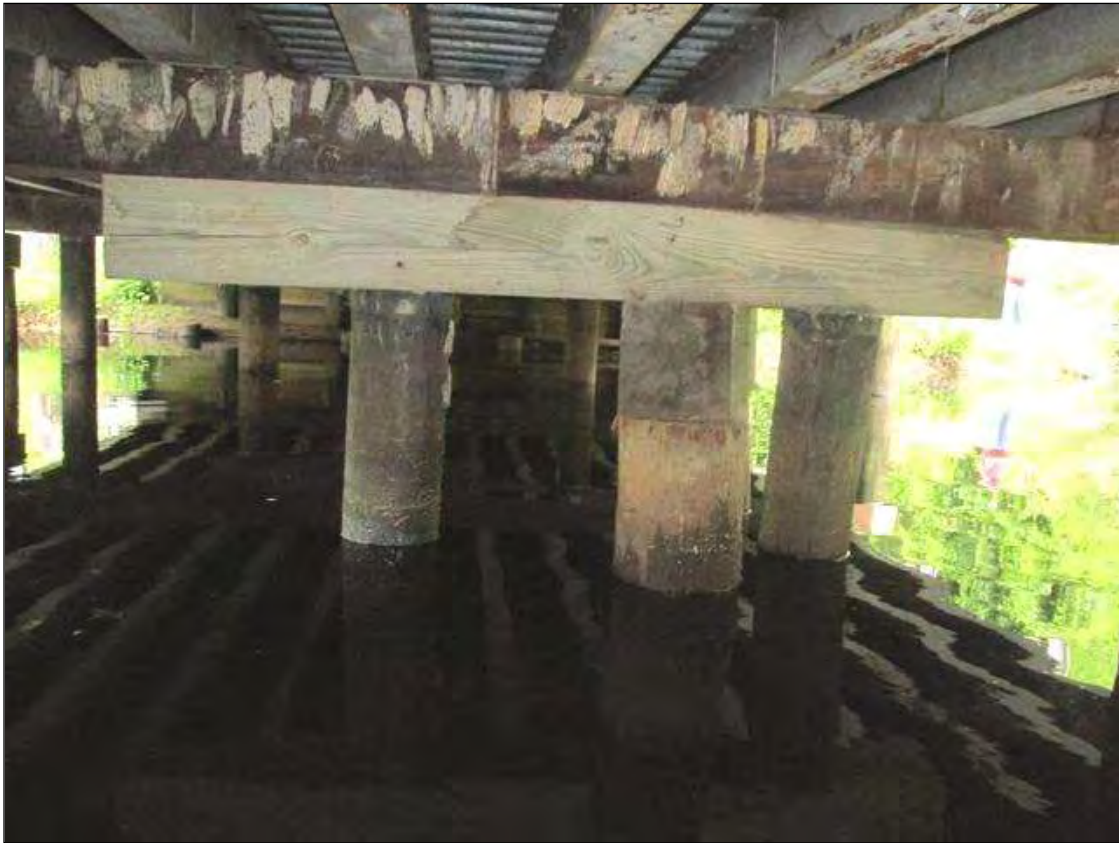
TIMBER CRUTCH BENT RIGHT OF PILE 4 AT BENT 2, TEMP REPAIR

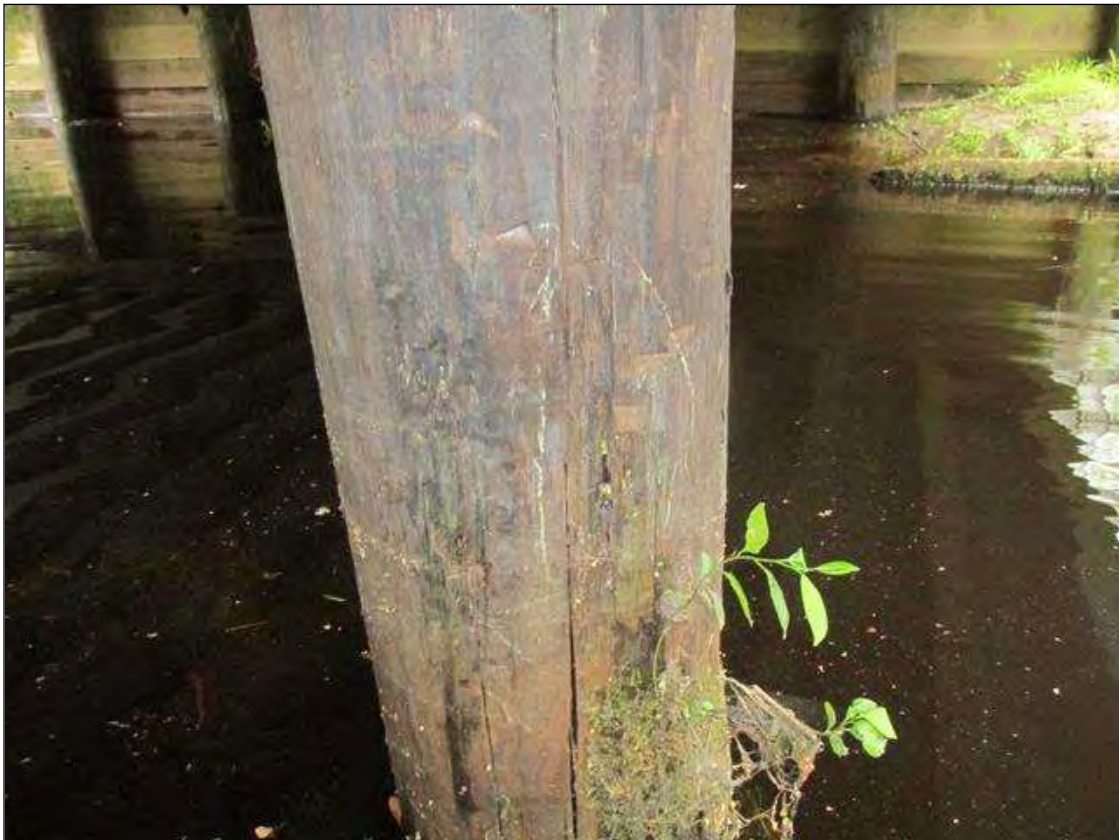
PILE 2 AT BENT 1 SPAN 2 NORTH FACE IS DELAMED AND SURFACE DECAYED 42" H X 8" W X 1" D

| MMS Code | Description of Function | Unit | Quantity | Remarks | Est. Cost |
|---|---|---|---|---|---|
| 3344 | Repair / Replace Timber Substructure Components | LF | 4 | PILE 2 AT BENT 1 SPAN 2 NORTH FACE IS DELAMED AND SURFACE DECAYED 42" H X 8" W X 1" D | |

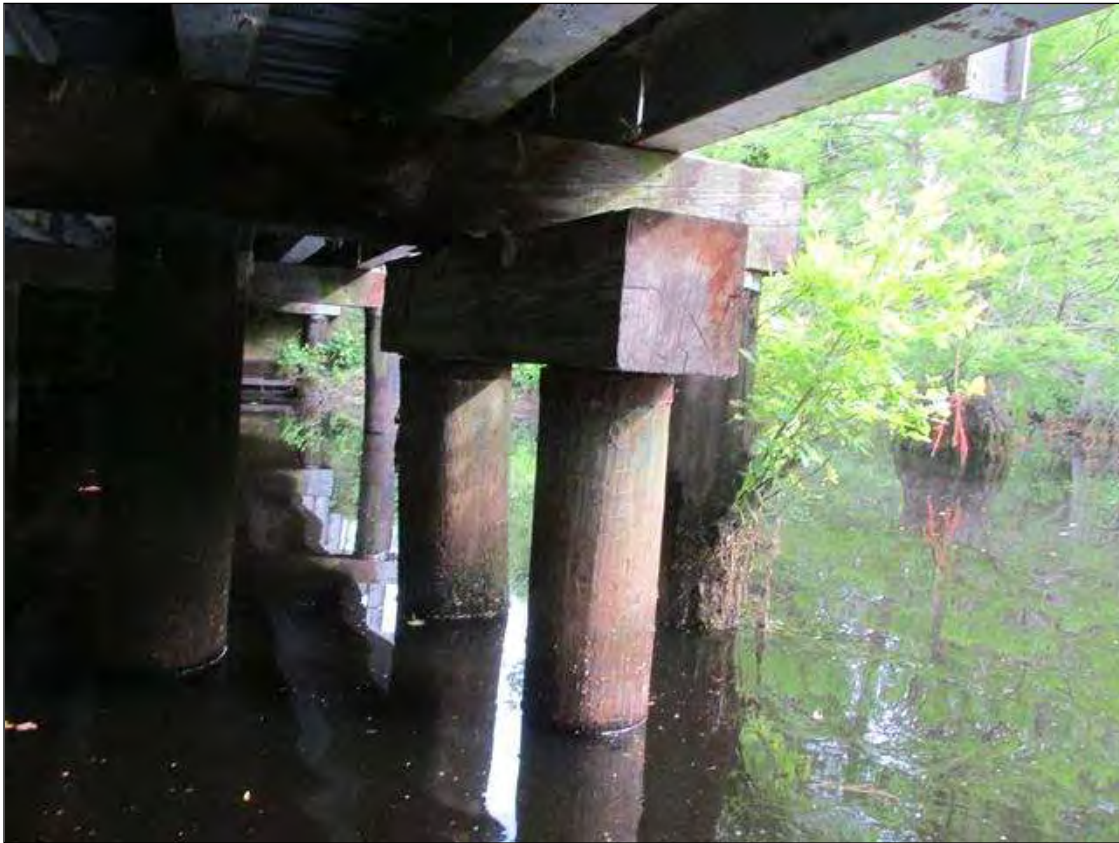
TIMBER CRUTCH BENT BETWEEN PILES 6 AND 7 AT BENT 2, TEMP REPAIR

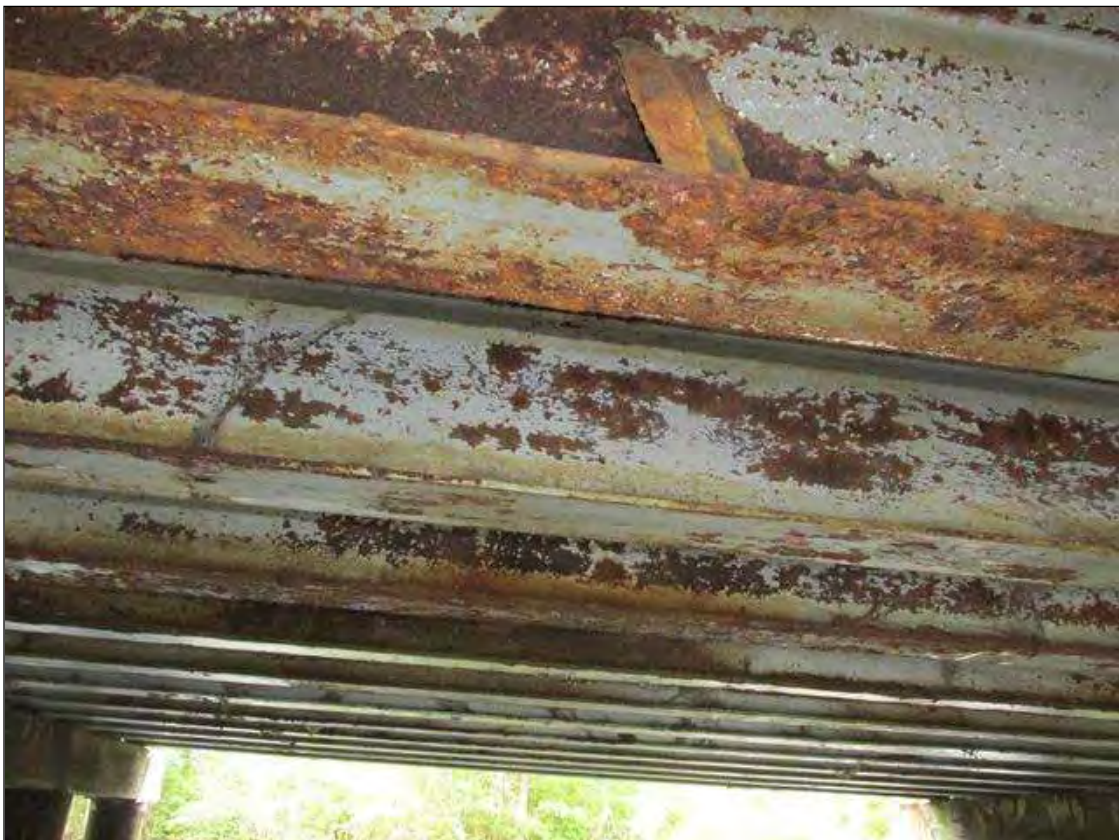
SPAN 2 UNDERSIDE, WITH PAINT PEELING AND SCALING RUST THROUGHOUT

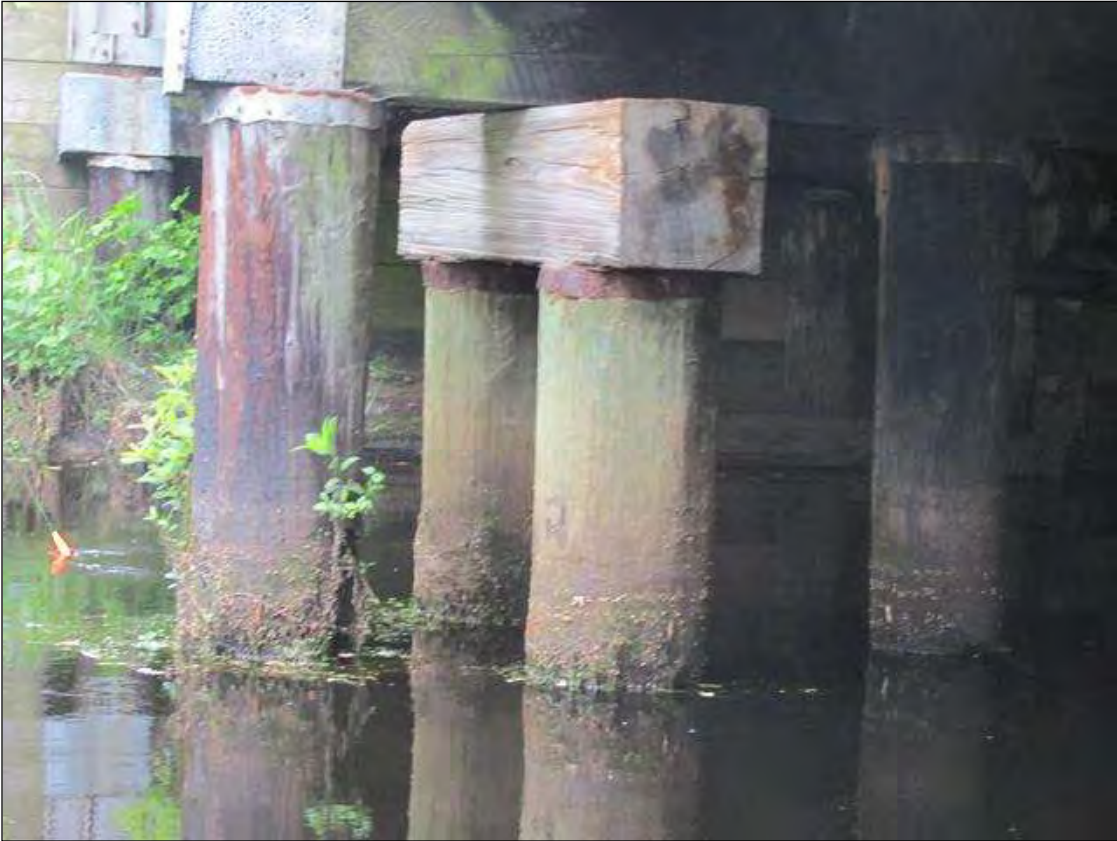
TIMBER CRUTCH BENT RIGHT OF PILE 1 AT BENT 3, TEMP REPAIR

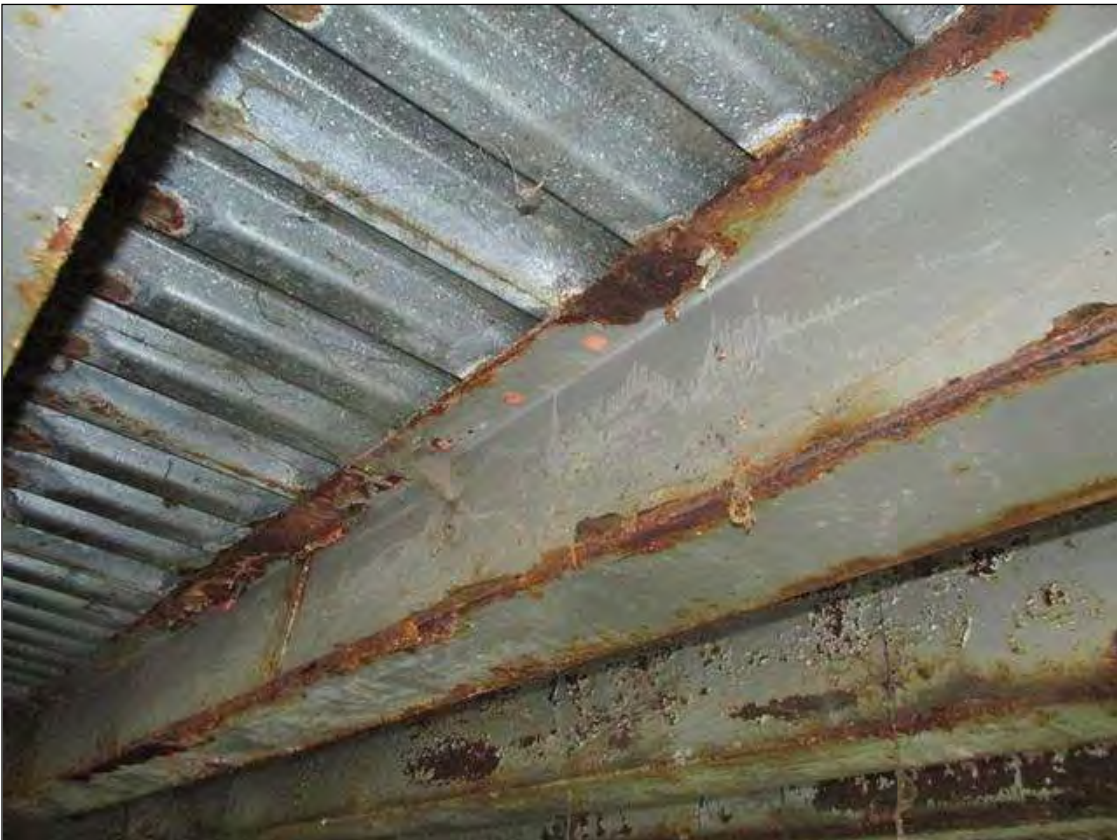
BEAM 5 IN SPAN 3 BOTH FLANGES RUST AND 1/8" SECTION LOSS, BEAMS 7 AND 8 IN SPAN 3 ARE SIMILAR

| MMS Code | Description of Function | Unit | Quantity | Remarks | Est. Cost |
|---|---|---|---|---|---|
| 3314 | Maintain Steel Superstructure Components | LF | 54 | BEAM 5 IN SPAN 3 BOTH FLANGES RUST & 1/8" SECTION LOSS , BEAMS 7 AND 8 IN SPAN 3 ARE SIMILAR | |

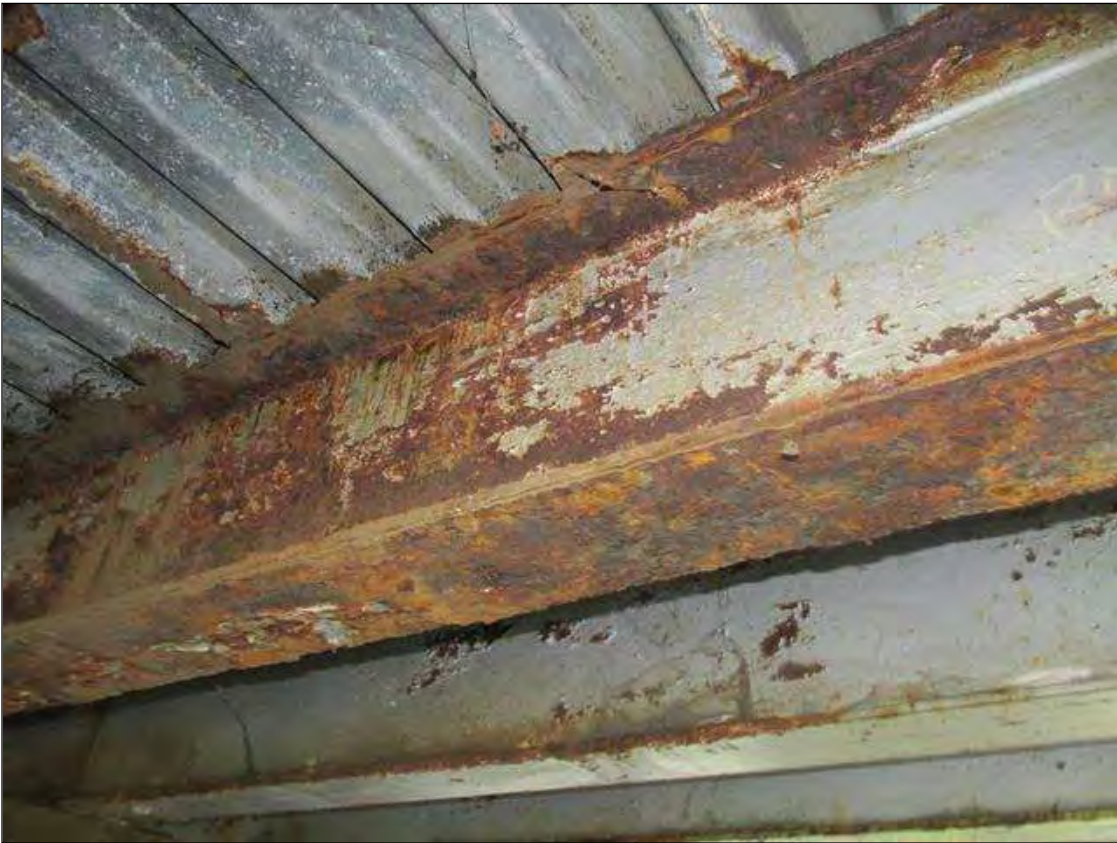
BEAM 8 IN SPAN 3 AT BENT 3 RUST AND 1/8" SECTION LOSS 8' LONG IN BOTH FLANGES

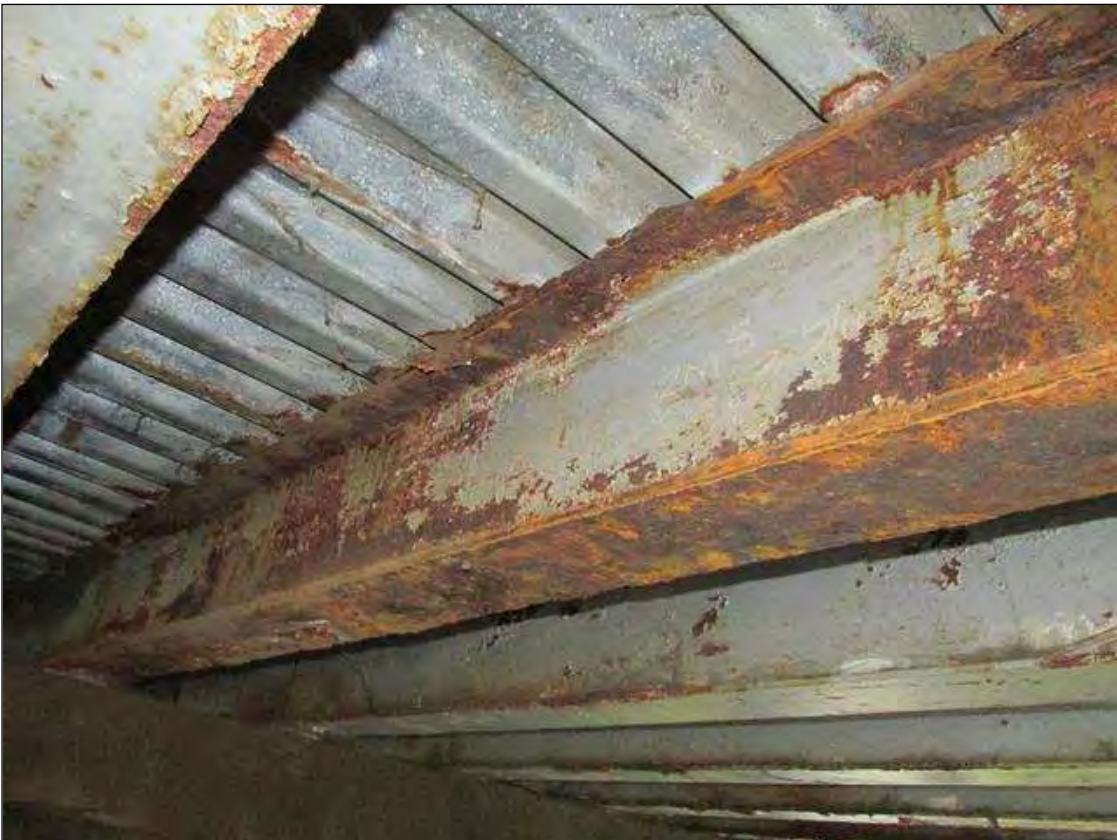
BEAM 8 IN SPAN 3 AT MID SPAN TO BENT 3 CAP RUST WITH 1/8" SECTION LOSS X 1" W X 8' L WITH 3/8" REMAINING

| MMS Code | Description of Function | Unit | Quantity | Remarks | Est. Cost |
|---|---|---|---|---|---|
| 3314 | Maintain Steel Superstructure Components | LF | 8 | BEAM 8 IN SPAN 3 AT MIDSPAN TO BENT 3 CAP RUST WITH 1/8" SECTION LOSS X 1" W X 8' L WITH 3/8" REMAINING | |

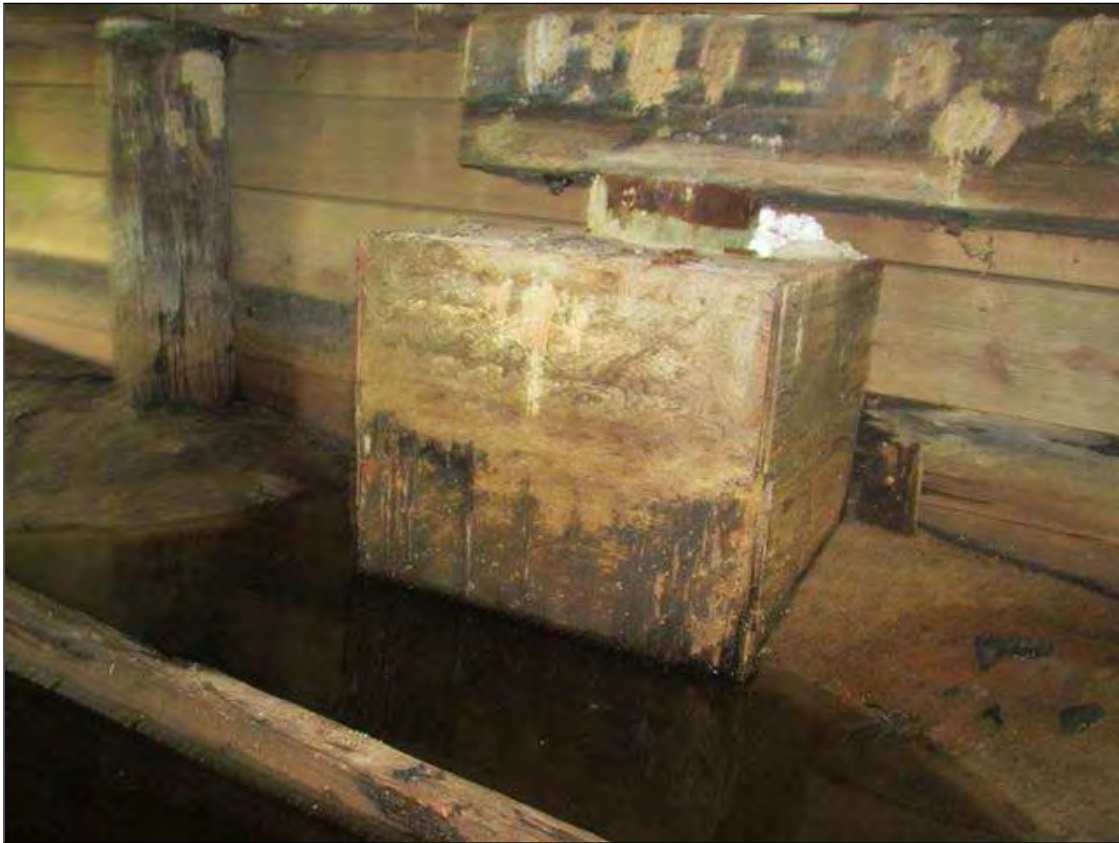
PILE 4 AT END BENT 2 IS ENCASED, TEMP REPAIR

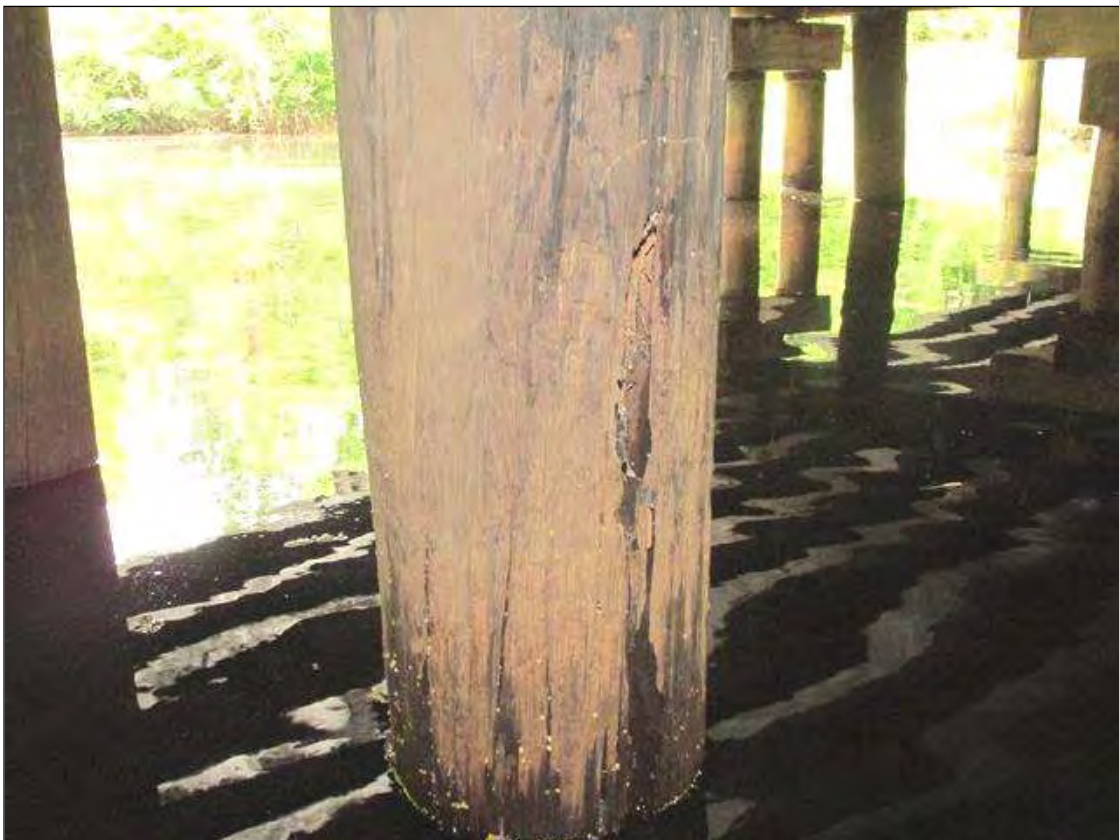
PILE 4 AT BENT 3 WEST FACE IS DECAYED 2' HIGH X 10" WIDE X 4" DEEP SEE SKETCH

| MMS Code | Description of Function | Unit | Quantity | Remarks | Est. Cost |
|---|---|---|---|---|---|
| 3344 | Repair / Replace Timber Substructure Components | LF | 2 | PILE 4 AT BENT 3 WEST FACE IS DECAYED 2' HIGH X 10" WIDE X 4" DEEP SEE SKETCH | |

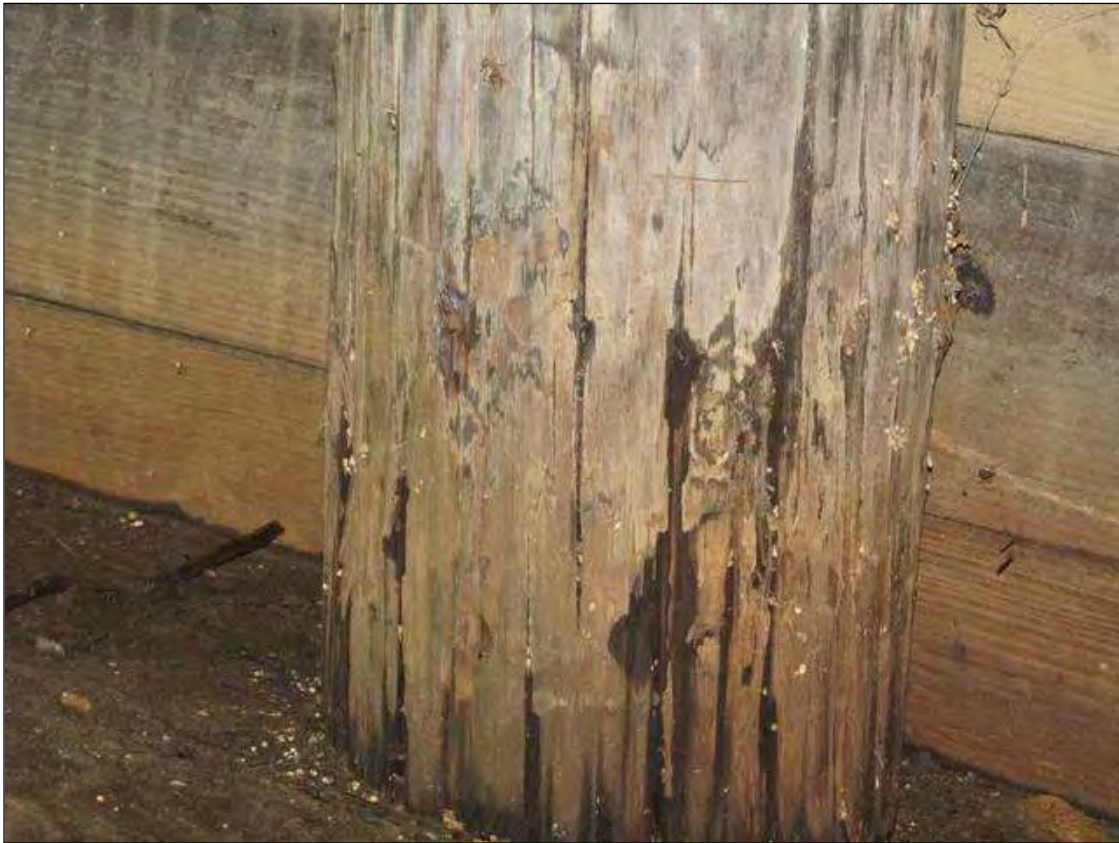
PILE 3 AT END BENT 2 IS DECAYED FULL CIRCUMFERENCE X 13" H X UP TO 2" DEEP

| MMS Code | Description of Function | Unit | Quantity | Remarks | Est. Cost |
|---|---|---|---|---|---|
| 3344 | Repair / Replace Timber Substructure Components | LF | 2 | PILE 3 AT END BENT 2 IS DECAYED FULL CIRCUMFERENCE X 13" H X UP TO 2" DEEP | |
