# BRIDGE INSPECTION REPORT

INSPECTION TYPE: Routine Inspection

COUNTY ROBESON BRIDGE NUMBER 770026 INSPECTION CYCLE 2 YRS  
ROUTE SR1955 ACROSS TEN MILE SWAMP M.P. 0

INSPECTION DATE 05/15/2014

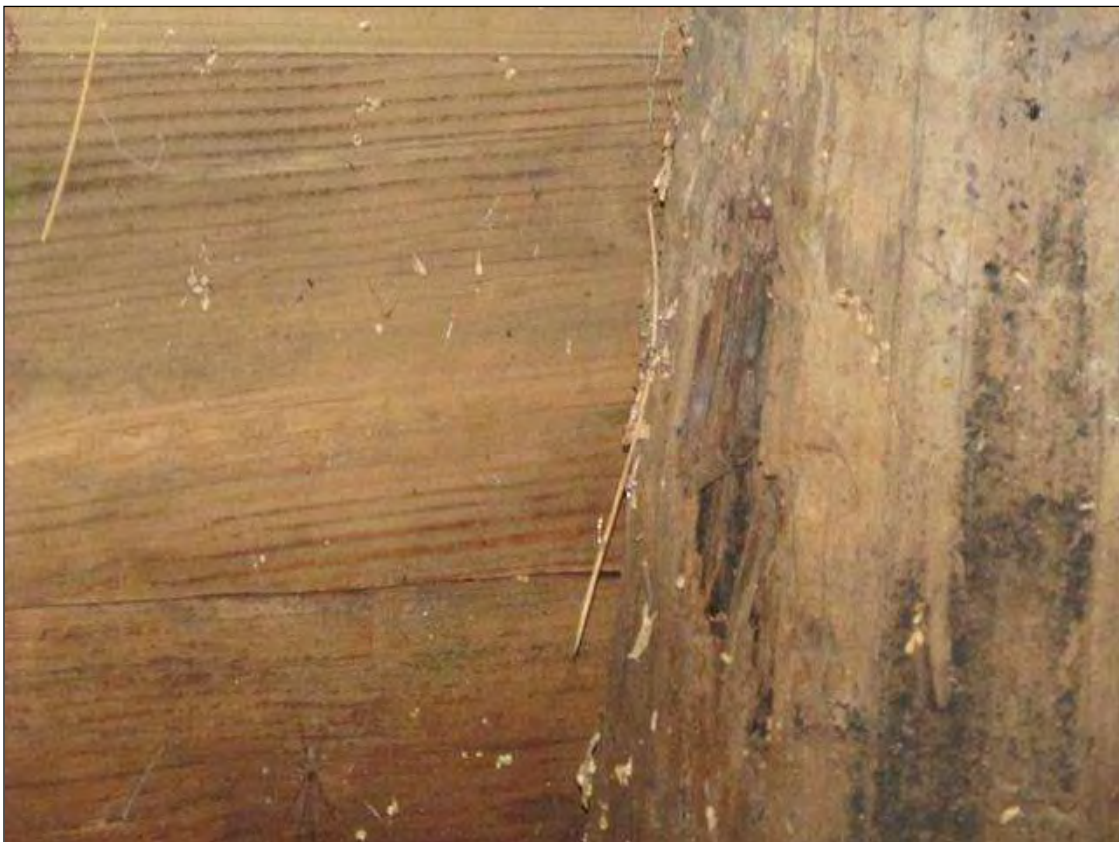
PILE 6 AT END BENT 2 IS SURFACE DECAYED 12" H X 4" W X UP TO 2" D

| MMS Code | Description of Function | Unit | Quantity | Remarks | Est. Cost |
|---|---|---|---|---|---|
| 3344 | Repair / Replace Timber Substructure Components | LF | 1 | PILE 6 AT END BENT 2 IS SURFACE DECAYED 12" H X 4" W X UP TO 2" D | |

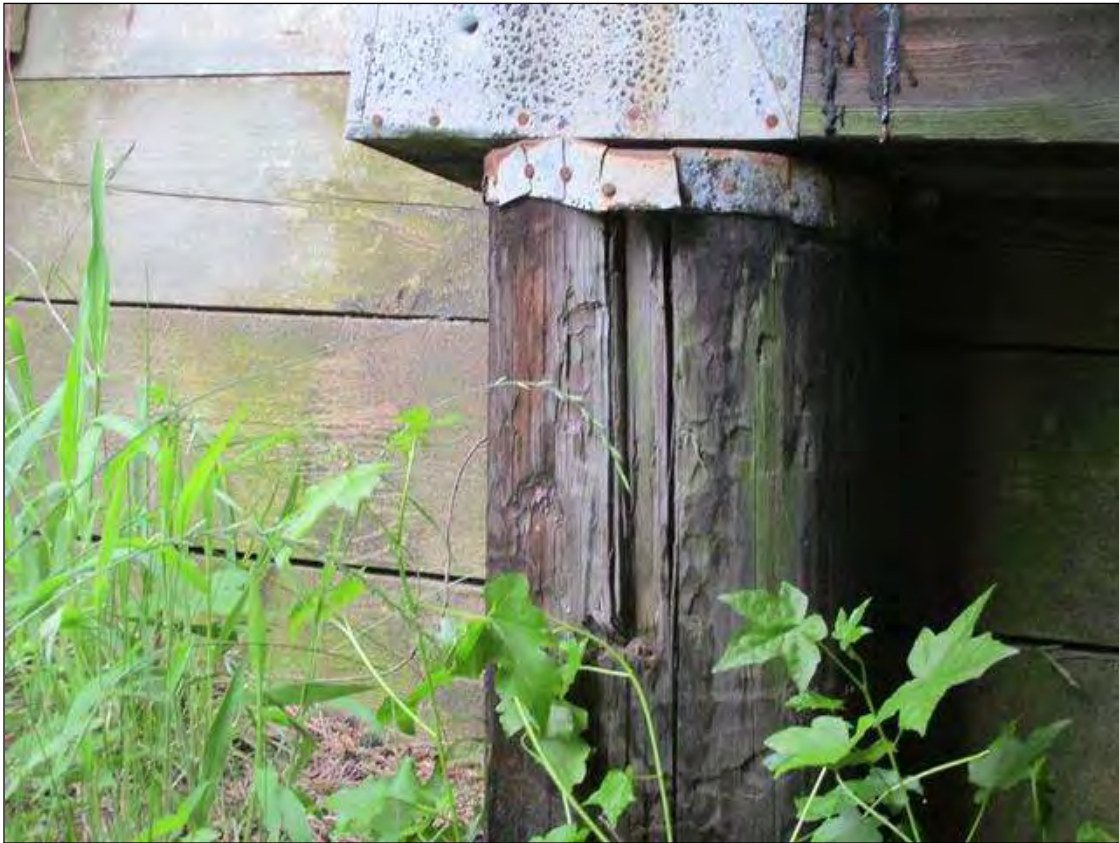
PILE 1 AT END BENT 2 HAS FIBER SEPARATION 12" H X 3" W X 1" D

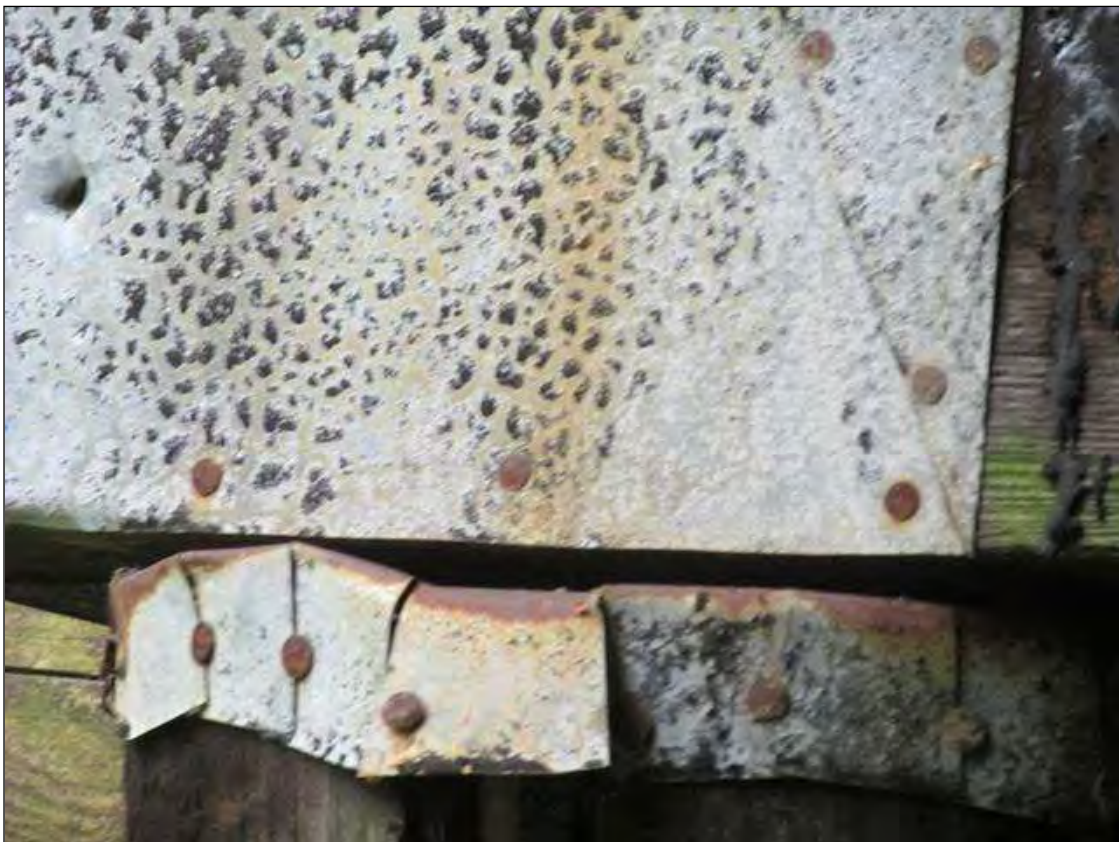
END BENT 2 MAIN CAP IS ROTATED 1/2" OFF TOP OF PILES

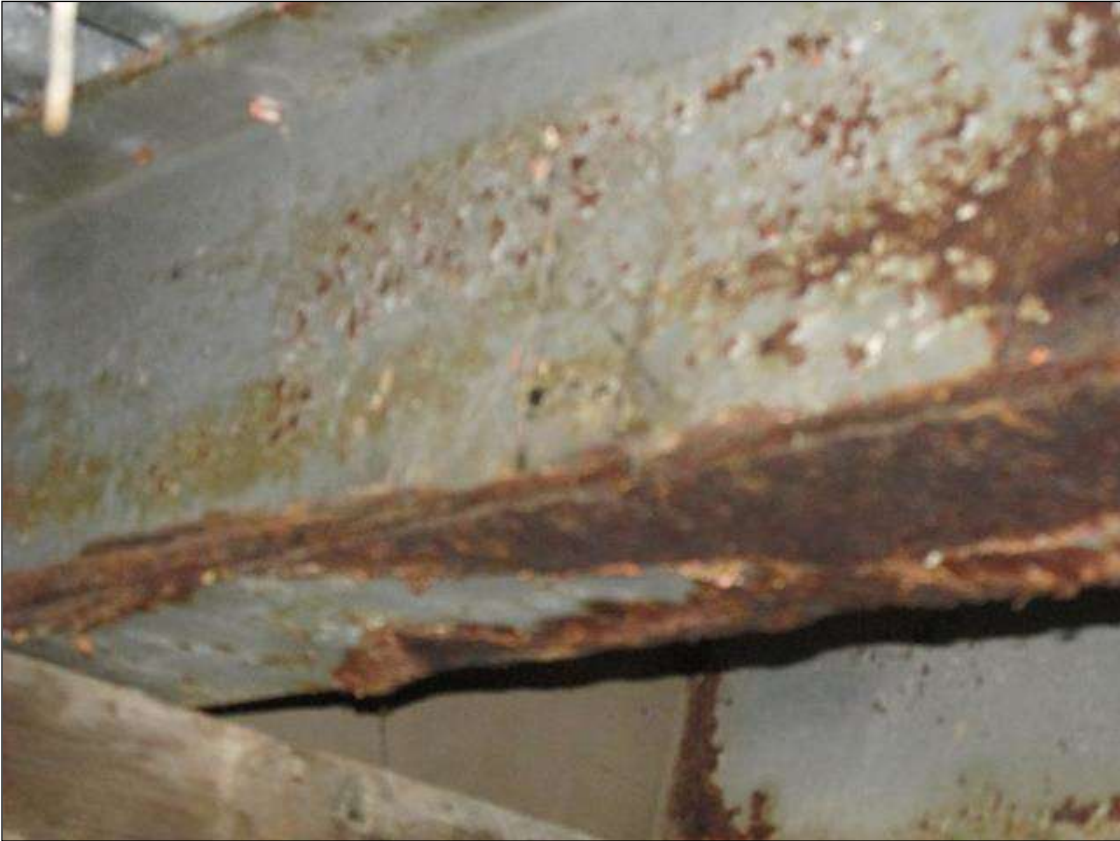
BEAM 7 IN SPAN 4, BAY 6 SIDE RUST ,1/8" SECTION LOSS 3' L X 2" H IN WEB, BEGINNING 3' FROM END BENT  
2 CAP

| MMS Code | Description of Function | Unit | Quantity | Remarks | Est. Cost |
|---|---|---|---|---|---|
| 3314 | Maintain Steel Superstructure Components | LF | 4 | BEAM 7 IN SPAN 4, BAY 6 SIDE RUST ,1/8" SECTION LOSS 3' L X 2" H IN WEB, BEGINNING 3' FROM END BENT 2 CAP | |

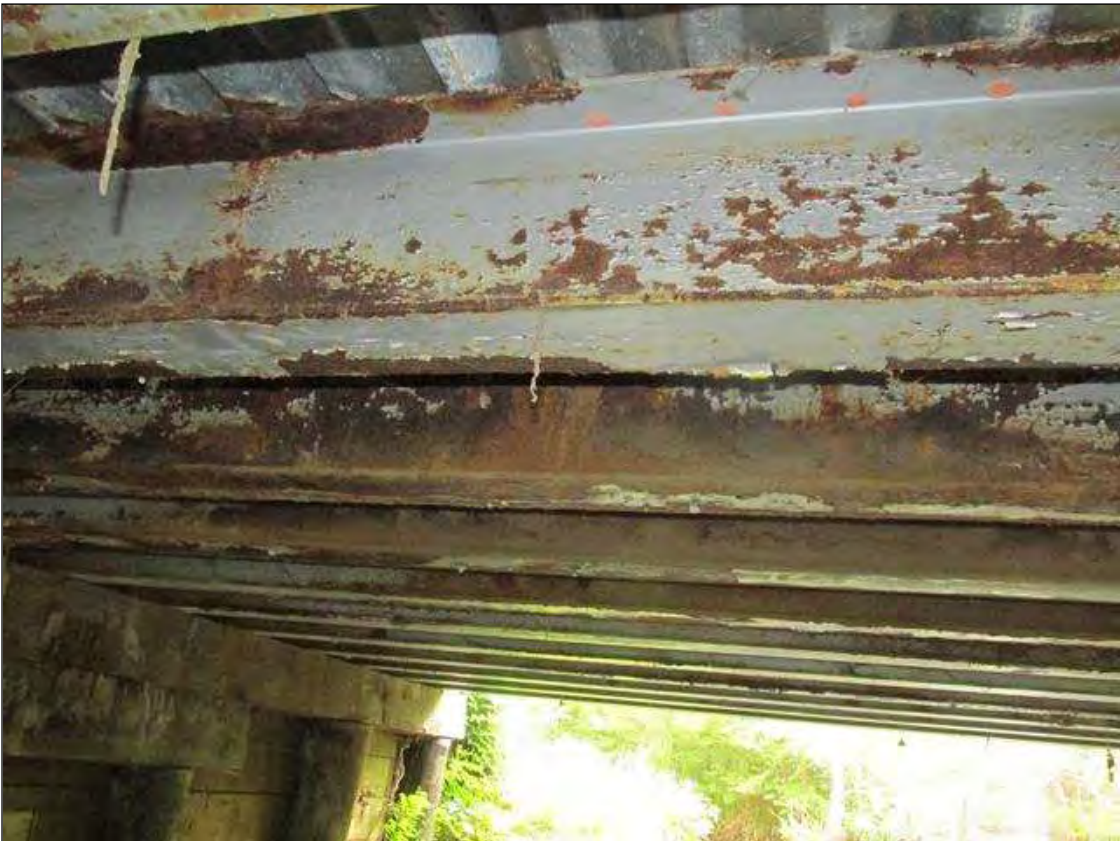
RUST IN SPAN 4 BEAMS, PAINT FAILURE ALL SPANS ARE SIMILAR

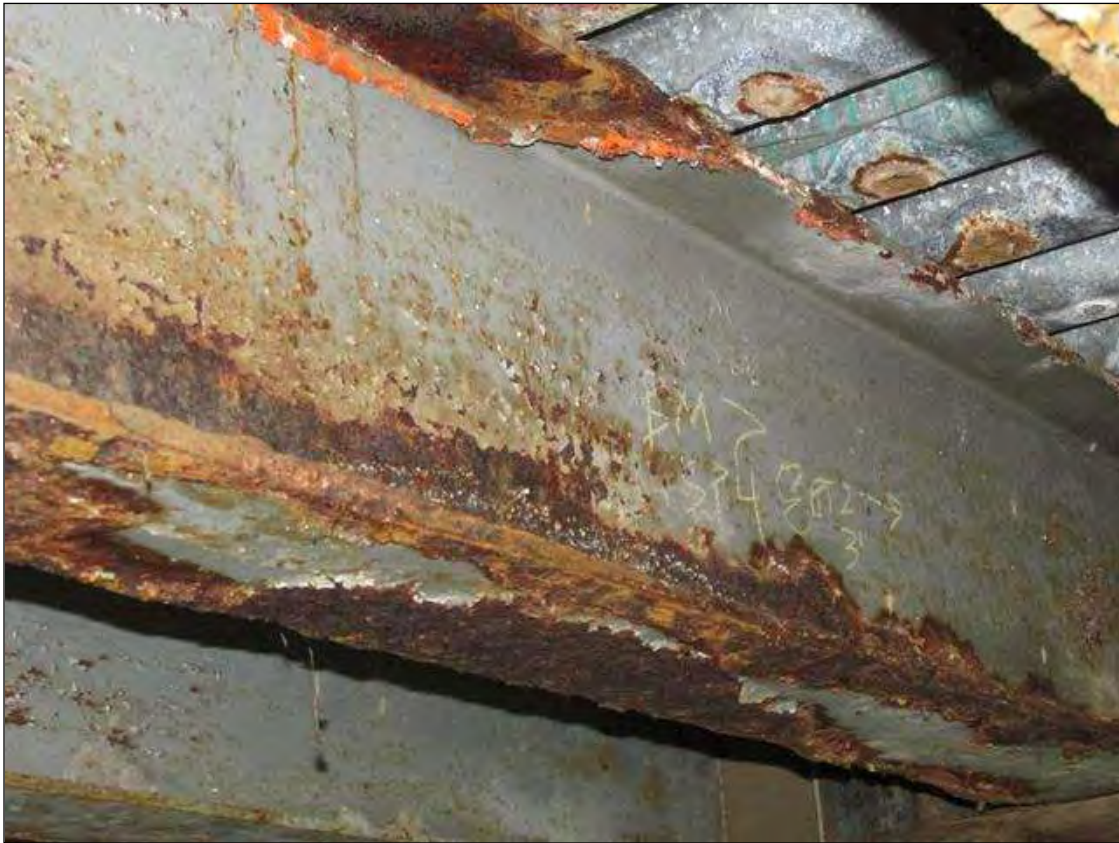
BEAM 7 SPAN 4 BAY 7 SIDE BOTTOM FLANGE RUST WITH 1/8" SECTION LOSS 3' L X 1 1/2" W FROM END  
BENT 2 CAP

| MMS Code | Description of Function | Unit | Quantity | Remarks | Est. Cost |
|---|---|---|---|---|---|
| 3314 | Maintain Steel Superstructure Components | LF | 3 | BEAM 7 SPAN 4 BAY 7 SIDE BOTTOM FLANGE RUST WITH 1/8" SECTION LOSS 3' L X 1 1/2" W FROM END BENT 2 CAP | |

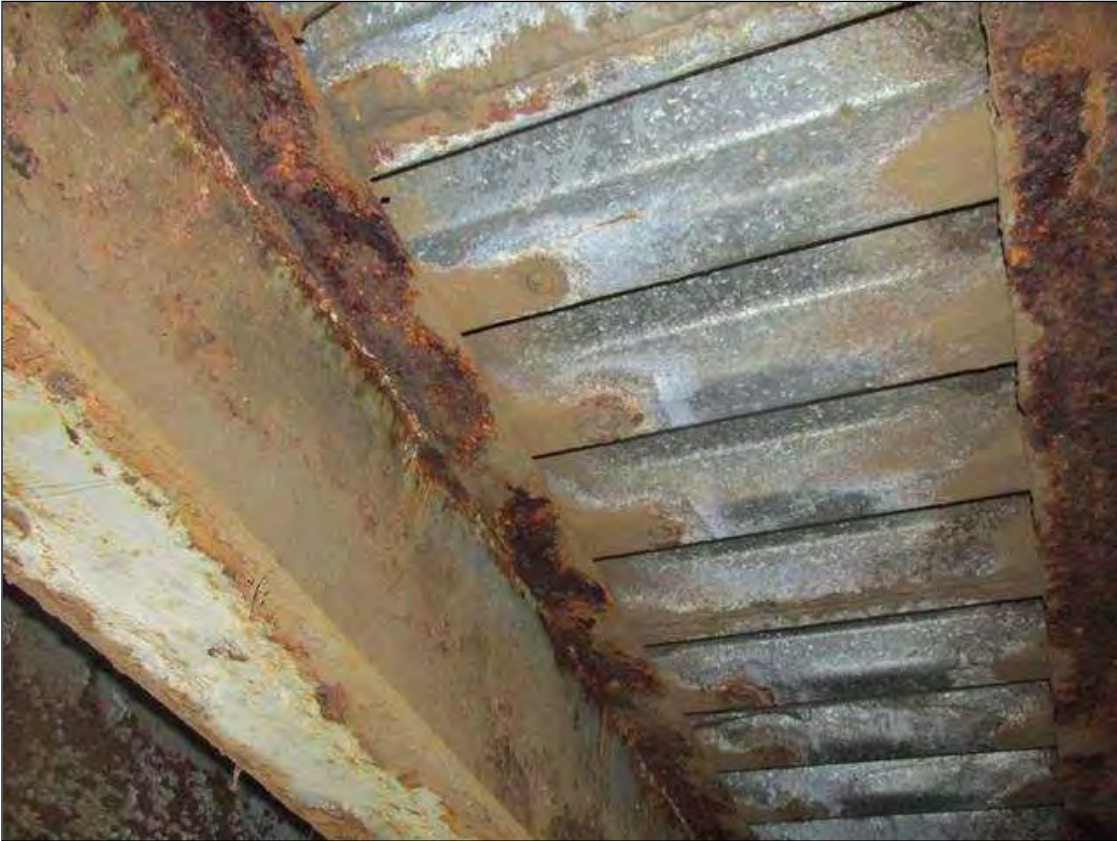
RUST AND CORROSION IN STEEL PLANK FLOOR IN SPAN 4 AT BAY 8, SIMILAR THROUGHOUT ALL SPANS IN ALL BAYS

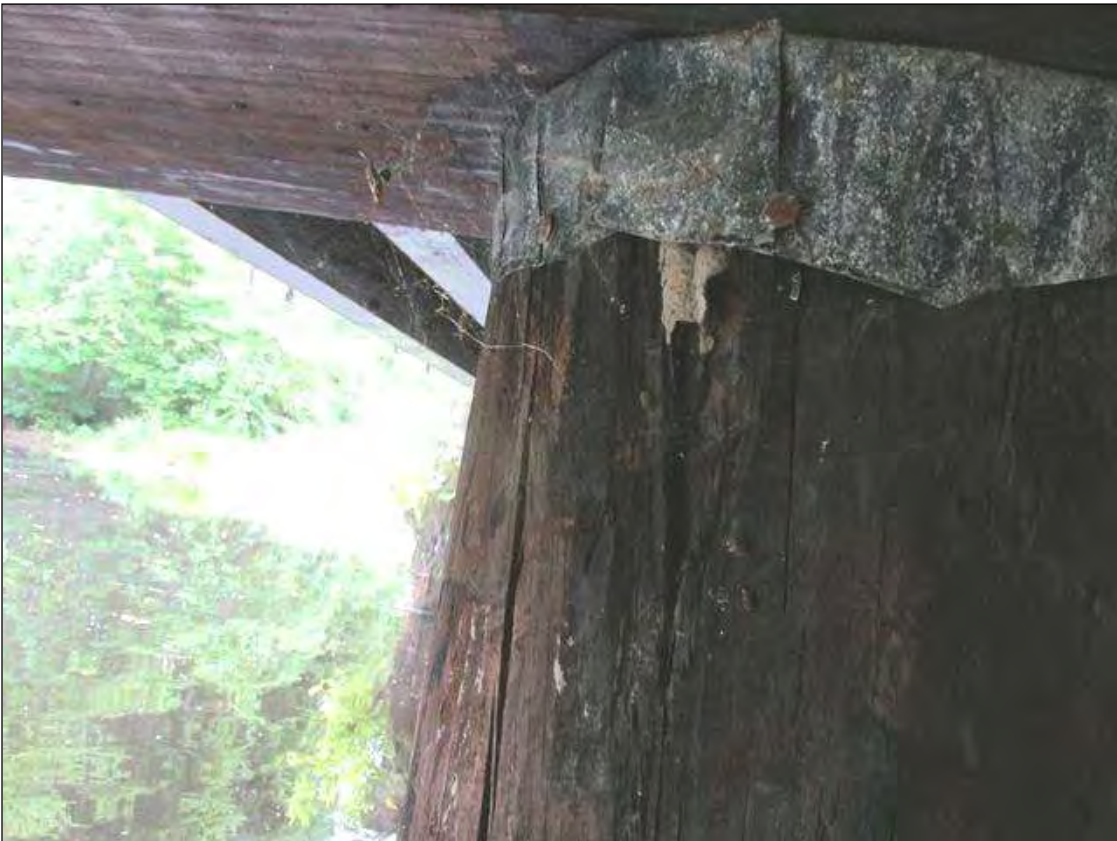
PILE 6 AT BENT 3, SPAN 4 FACE IS DECAYED 5" HIGH X 1 1/2" WIDE X 1" DEEP NEAR CAP

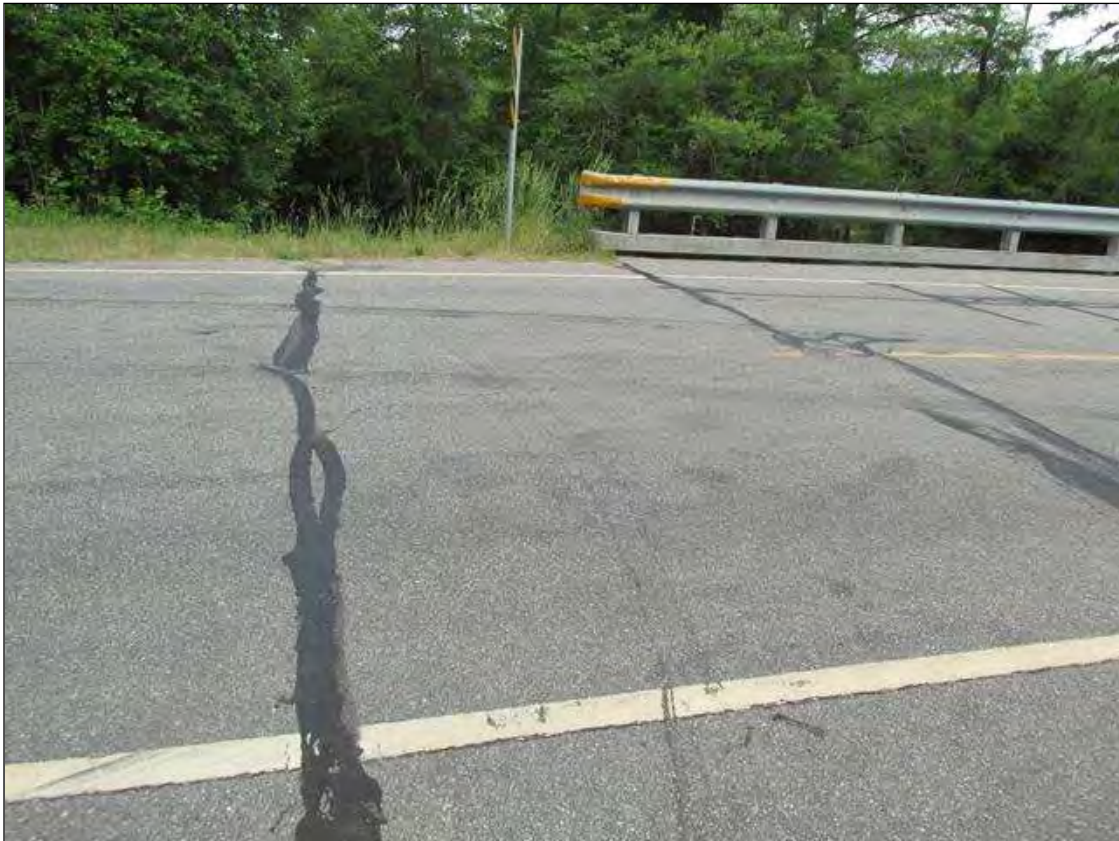
SEALED TRANSVERSE CRACKS IN SOUTH APPROACH ASPHALT WEARING SURFACE

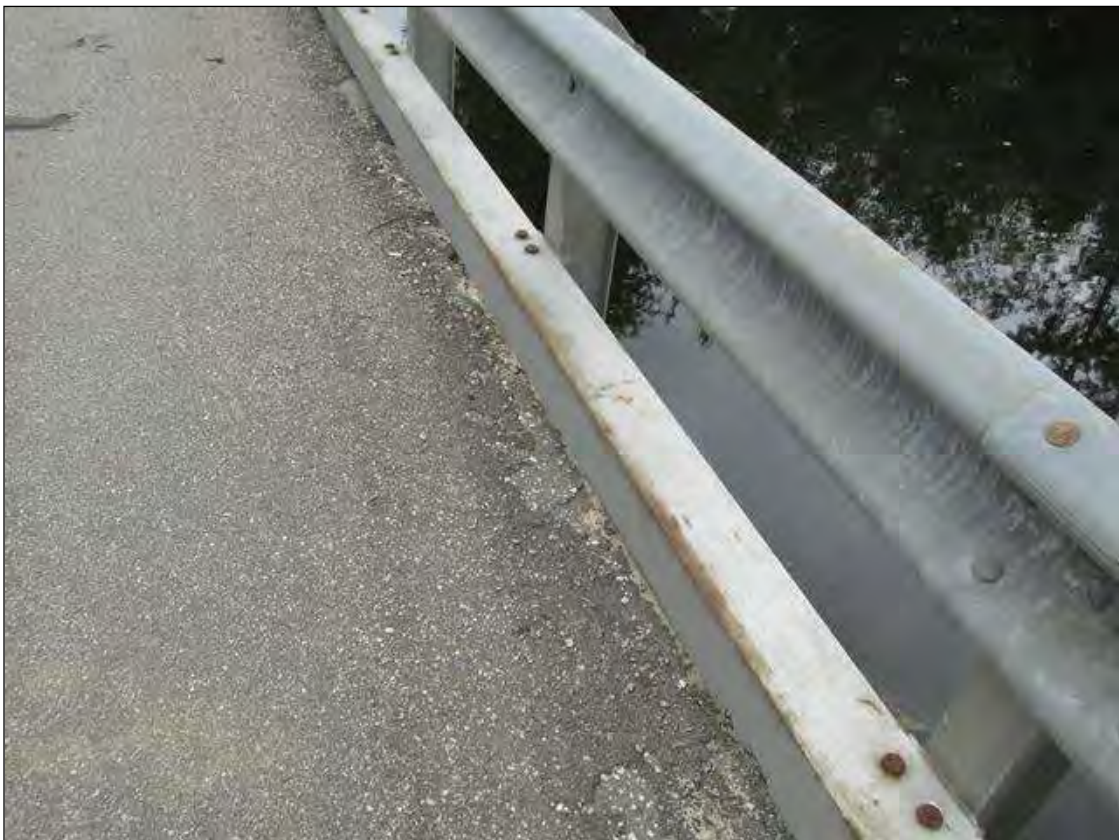
SURFACE RUST ON RIGHT STEEL WHEELGUARD

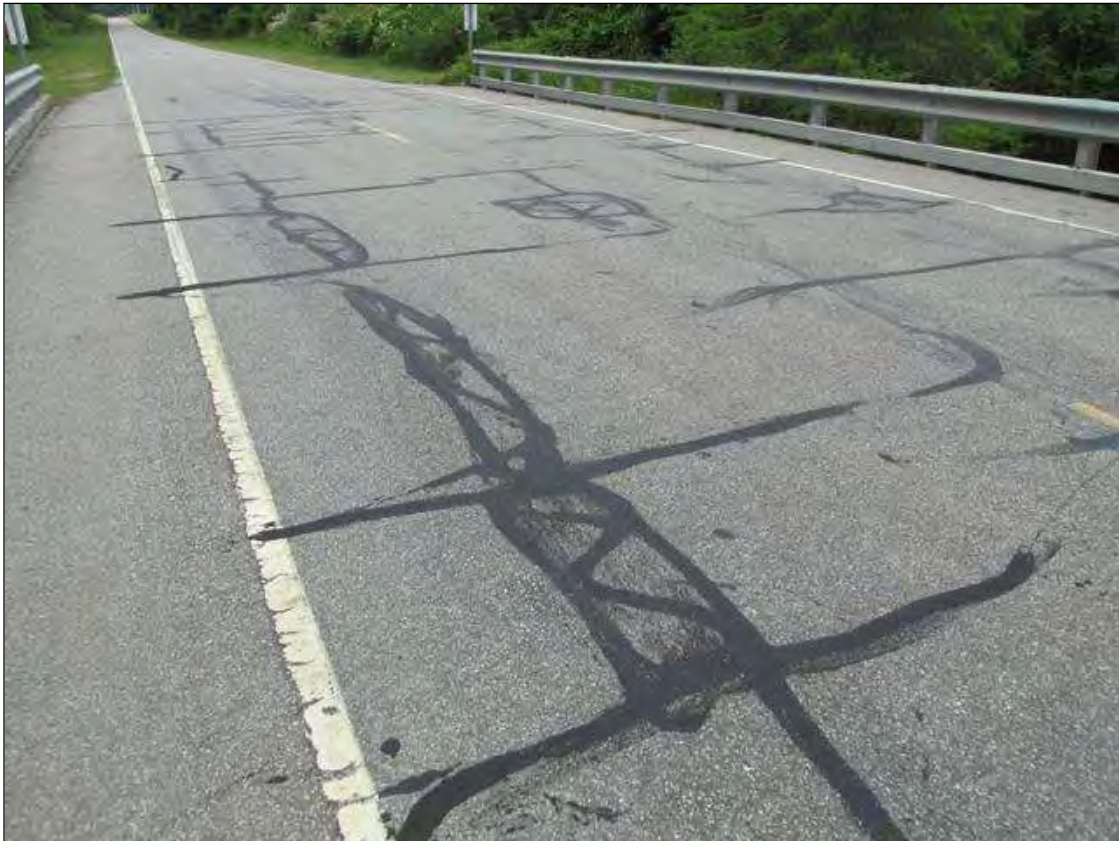
SEALED CRACKING IN ALL SPANS

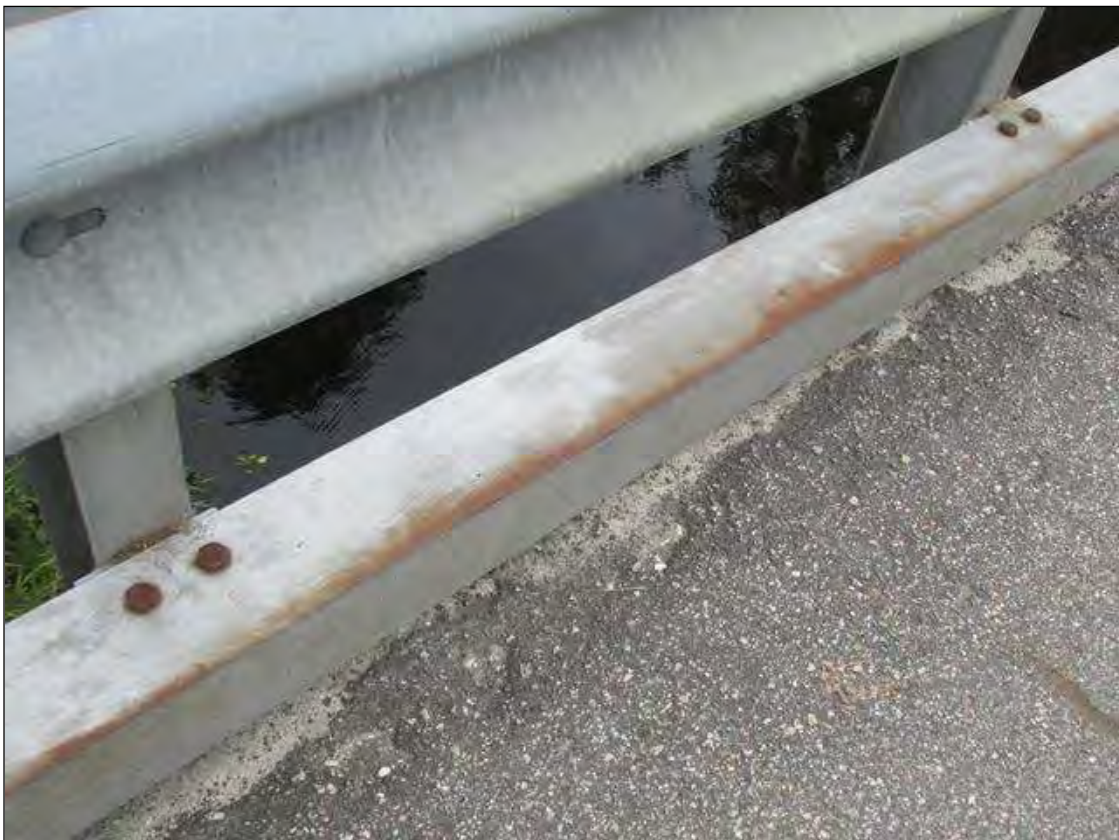
LEFT STEEL WHEELGUARD HAS SURFACE RUST

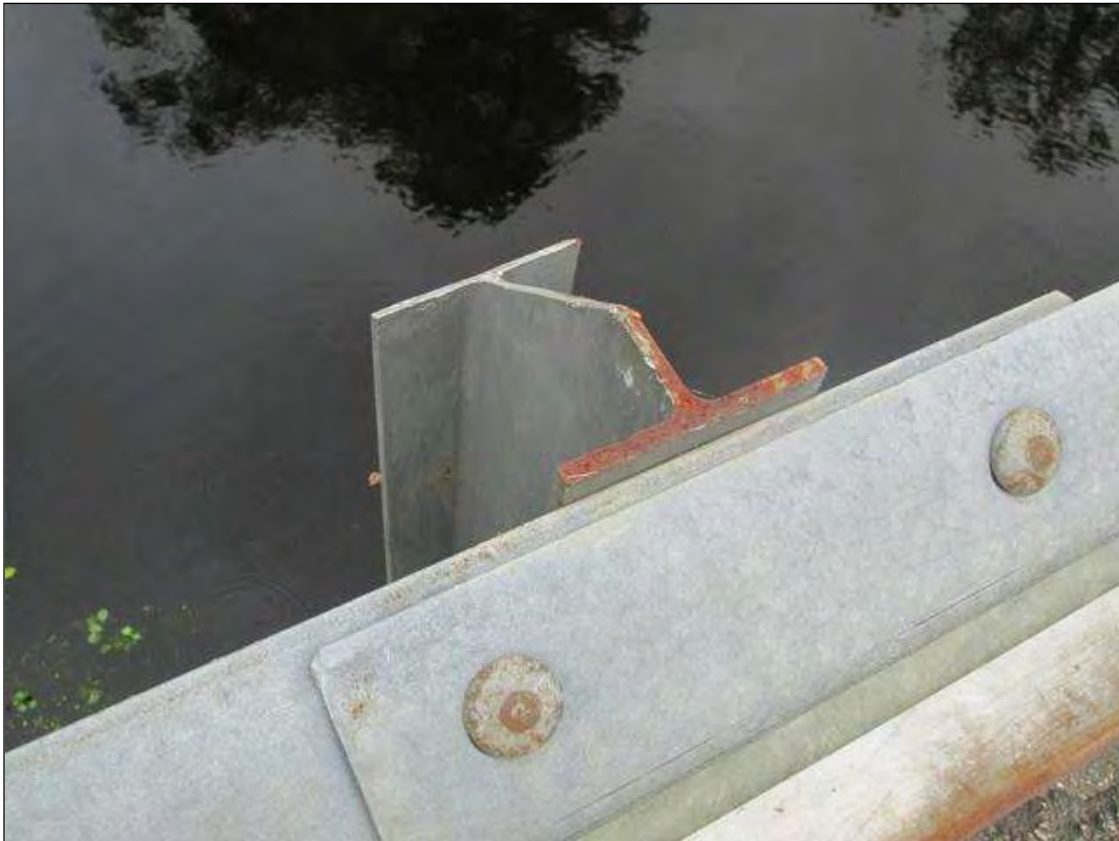
SURFACE RUST ON BOTH RAILS, MORE ON TOP OF POSTS

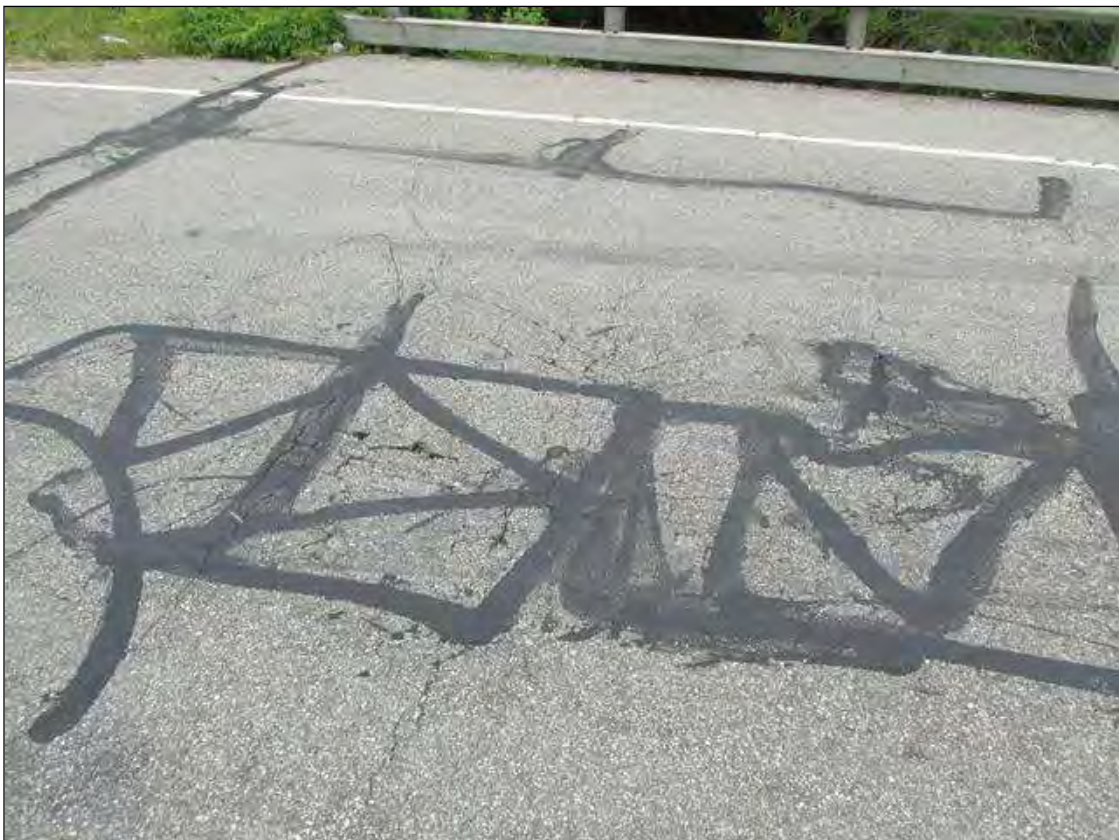
SPAN 4 ASPHALT WEARING SURFACE HAS CRACKING AND IS SETTLED UP TO 1 1/2" AT MIDSPAN

| MMS Code | Description of Function | Unit | Quantity | Remarks | Est. Cost |
|---|---|---|---|---|---|
| 2816 | Asphalt Surface Repair or Replacement | SY | 2 | SPAN 4 ASPHALT WEARING SURFACE HAS CRACKING AND IS SETTLED UP TO 1 1/2" AT MIDSPAN | |

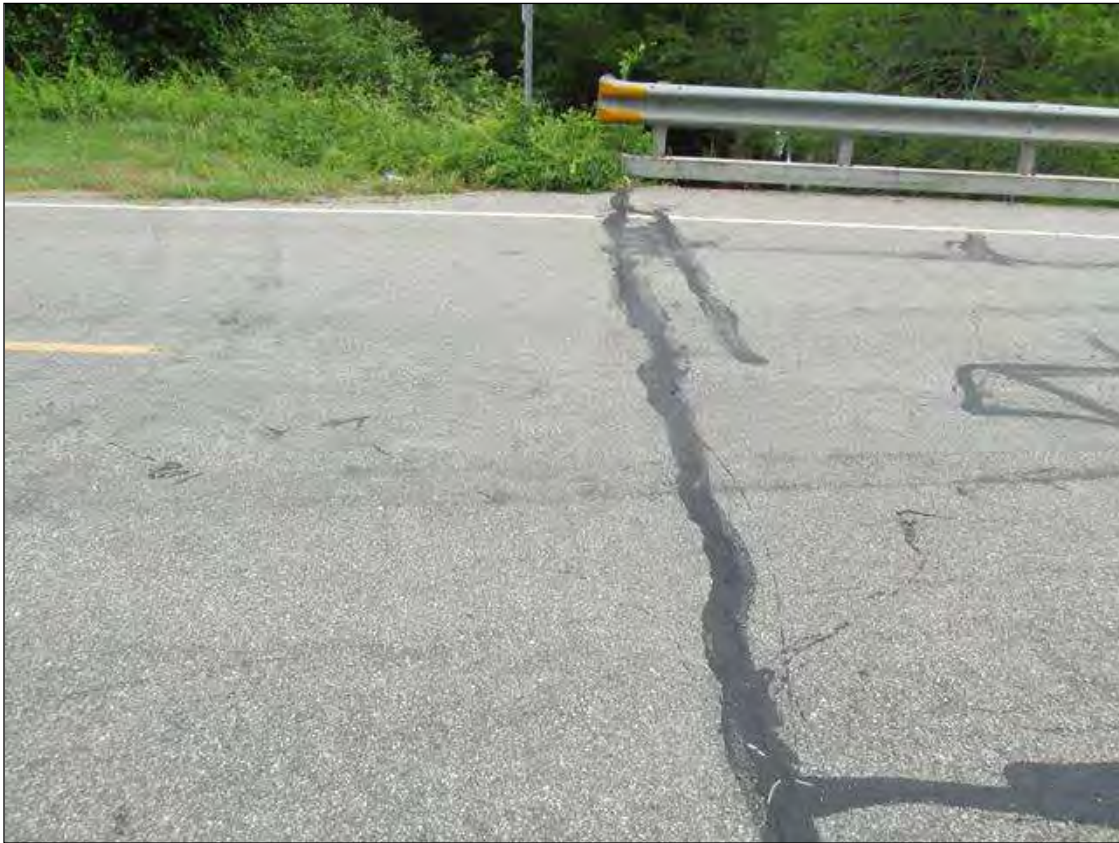
SEALED TRANSVERSE CRACKS IN NORTH APPROACH ASPHALT WEARING SURFACE

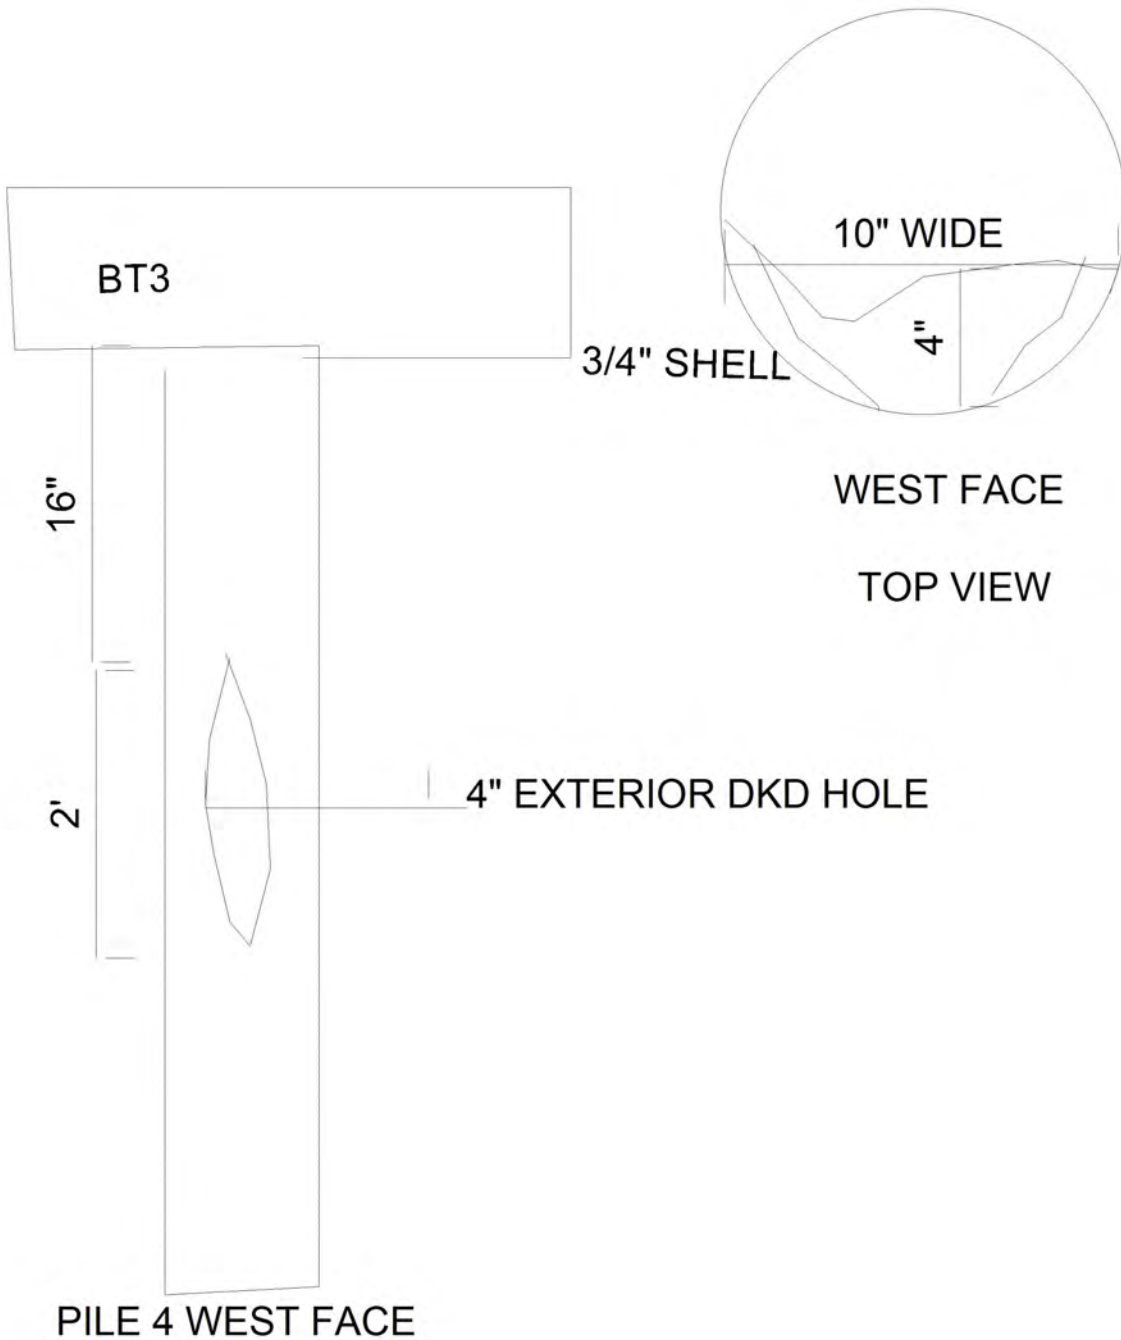
PILE 4 DECAY

| MMS Code | Description of Function | Unit | Quantity | Remarks | Est. Cost |
|---|---|---|---|---|---|
| 3344 | Repair / Replace Timber Substructure Components | LF | 2 | PILE 4 AT BENT 3 WEST FACE IS DECAYED 2' HIGH X 10" WIDE X 4" DEEP SEE SKETCH | |

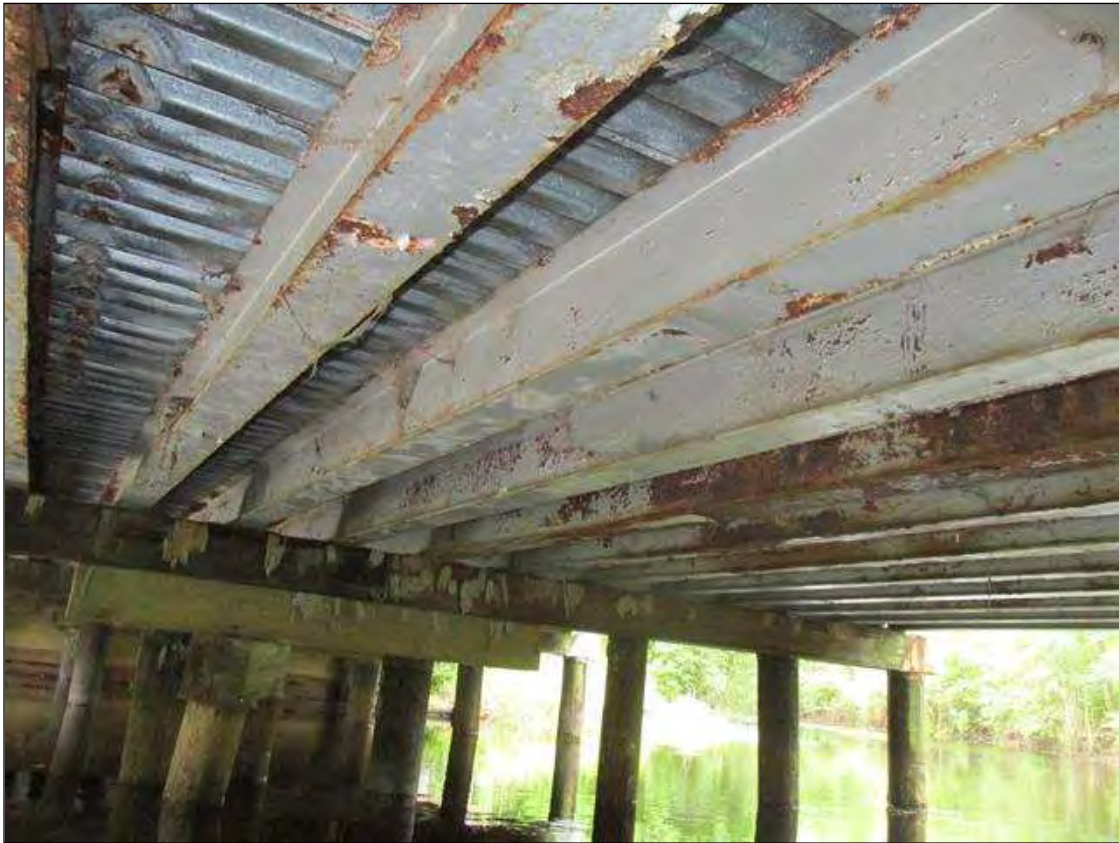
SPAN 3 UNDERSIDE, ALL SPANS ARE SIMILAR
